Visual Site Inspection Report

Project Name	H-600 Pipeline Spread I	AFE	124300139	Spread	H-600 Pipeline Spread I
Contractor	Precision			Report #	29880
Inspector	Justin Burch			Date/Time	10/18/2021 11:47 AM
Permit #	TBD	Inspection Type	VA SWPP	Station Begin	13958+31
State	VA	Inspection Area	Full	Station End	14062+17
County	Franklin	Ground	Damp	Temperature (°F)	68.00
Municipality	N/A	Weather	Sunny	Rain Gauge (in)	0.00
				Rain Accumulation Time (days)	6.00

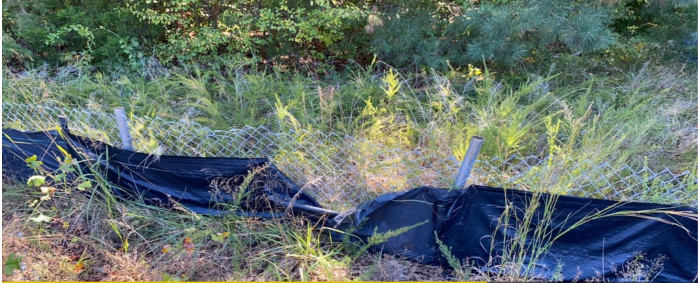
GPS Location			GPS Location		
5			6		
Field Station#			Field Station#		
14949+48			15034+00		
Pic 5 Desc.			Pic 6 Desc.		
Routine maintenance. Damage to perimeter CFS needs repaired.			Routine maintenance. CFS end treatment not properly filtering. Remove sediment.

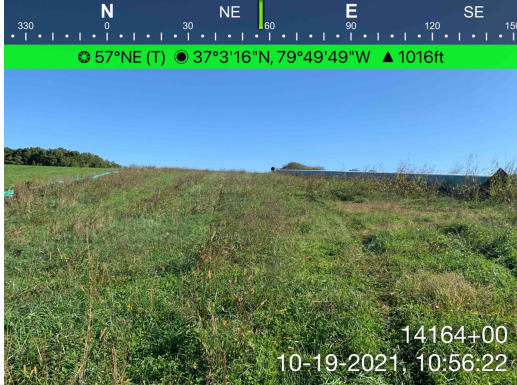
<p>14169+00 10-19-2021, 10:58:27</p>			
GPS Location	0	GPS Location	0		
Field Station#	14138+00	Field Station#	14169+00		
Pic 7 Desc.	Sump pit in acceptable condition		Pic 8 Desc.	Super silt fence in acceptable condition

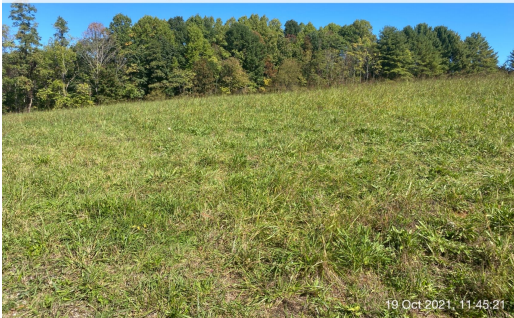
GPS Location	0	GPS Location	0	GPS Location	0
Field Station#	14549+00	Field Station#	14568+10	Field Station#	14599+00
Pic 1 Desc.	Approximately 14549+00. Overview of ROW.		Pic 2 Desc.	Approximately 14568+10. Overview of stream crossing, equipment bridge and ECDs at stream S-E18.

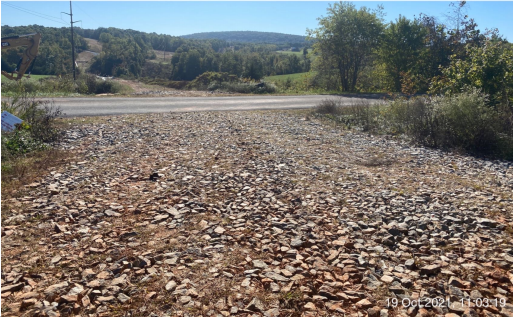
GPS Location	0	GPS Location	0	GPS Location	0
Field Station#	14576+00	Field Station#	14599+00	Field Station#	14615+50
Pic 3 Desc.	Approximately 14576+00. Overview of ROW.		Pic 4 Desc.	Approximately 14599+00. Overview of road crossing and RCEs.	
Pic 5 Desc.	Approximately 14611+17. Overview of stream crossing, equipment bridge and ECDs at stream S-E14.		Pic 6 Desc.	Approximately 14615+50. Overview of ROW.

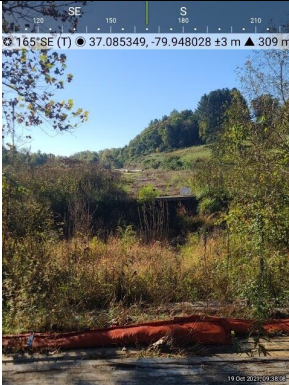
GPS Location	0000	GPS Location	0000		
Field Station#	13692+77	Field Station#	13686+00		
Pic 1 Desc.	Monitored stream crossing where equipment mats were removed during maintenance repairs, no environmental issues observed at the time of inspection.		Pic 2 Desc.	Row photo showing stabilized spoil piles and temporary vegetation on row. No environmental issues observed at the time of inspection.

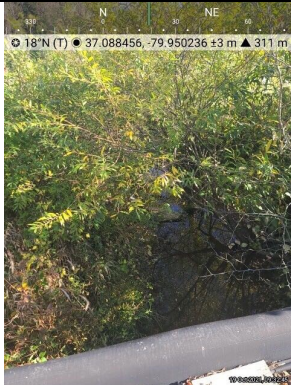
GPS Location	0000	GPS Location	0000		
Field Station#	13678+30	Field Station#	13678+71		
Pic 3 Desc.	Row photo showing vegetation, good coverage noted.		Pic 4 Desc.	Stream observation photo facing upstream during routine inspection today, no environmental issues observed at the time of inspection.

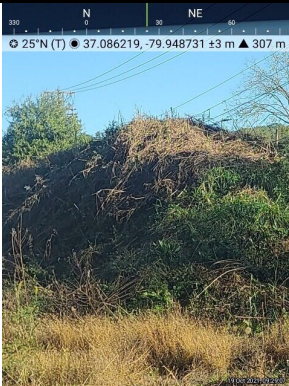
GPS Location	0000	GPS Location	0000		
Field Station#	13687+73	Field Station#	13678+71		
Pic 5 Desc.	Monitored stabilization on spoil piles , good stabilization noted during routine inspection.		Pic 6 Desc.	Stream observation photo facing downstream during routine inspection today, no environmental issues at the time of inspection.

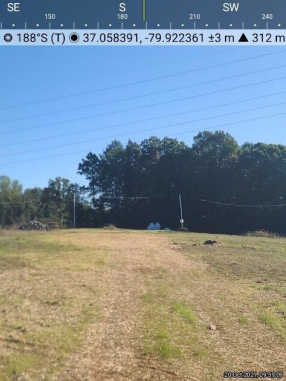
GPS Location	00000	GPS Location	00000		
Field Station#	13852+46	Field Station#	13759+00		
Pic 1 Desc.	Photo showing new vegetation growth in work space area where recently stabilized for winter months.		Pic 2 Desc.	Row photo showing vegetation growth, no environmental issues observed at the time of inspection.

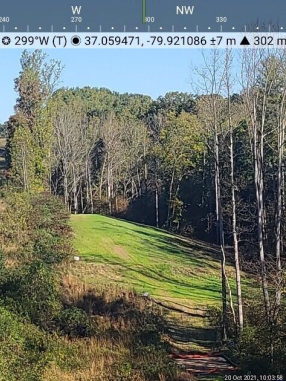
GPS Location	00000	GPS Location	00000		
Field Station#	13846+69	Field Station#	13850+00		
Pic 3 Desc.	Row photo showing winter coverage. No environmental issues observed at the time of inspection.		Pic 4 Desc.	Row photo showing vegetation growth in temporary section of row. Good coverage noted of winter stabilization.

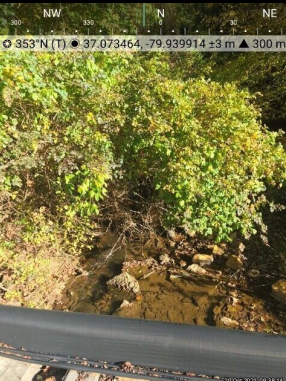
GPS Location	00000	GPS Location	00000		
Field Station#	13755+49	Field Station#	13755+49		
Pic 5 Desc.	Stream observation photo facing downstream during routine inspection today. No environmental issues observed at the time of inspection.		Pic 6 Desc.	Stream observation photo facing upstream during routine inspection today. No environmental issues observed at the time of inspection.

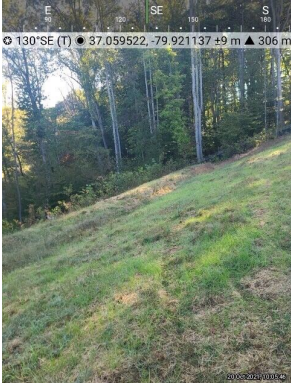
<div>Insert image here</div>		<div>Insert image here</div>	
GPS Location	00000	GPS Location			
Field Station#	13845+50	Field Station#			
Pic 7 Desc.	Monitored slope breakers and sump pits during today's inspection, good stabilization noted in temporary area.		Pic 8 Desc.		
<div>Insert image here</div>		<div>Insert image here</div>			
GPS Location		GPS Location			
Field Station#		Field Station#			
Pic 9 Desc.		Pic 10 Desc.			
<div>Insert image here</div>		<div>Insert image here</div>			
GPS Location		GPS Location			
Field Station#		Field Station#			
Pic 11 Desc.		Pic 12 Desc.

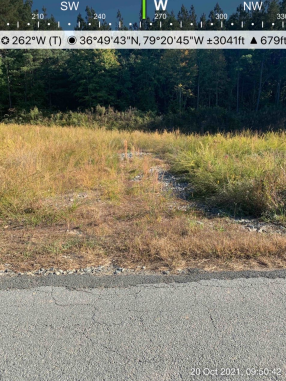
GPS Location	O	GPS Location	O		
Field Station#	22+00	Field Station#	13+93		
Pic 1 Desc.	Observing temporary stabilization	Pic 2 Desc.	Observing temporary stabilization and RCE

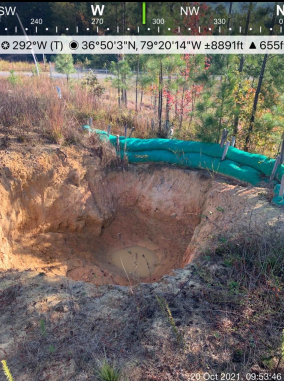
GPS Location	O	GPS Location	O		
Field Station#	12+00	Field Station#	8+00		
Pic 3 Desc.	Observing temporary stabilization, sump and end treatment	Pic 4 Desc.	Observing temporary stabilization		
Insert image here			Insert image here		
GPS Location		GPS Location			
Field Station#		Field Station#			
Pic 5 Desc.		Pic 6 Desc.

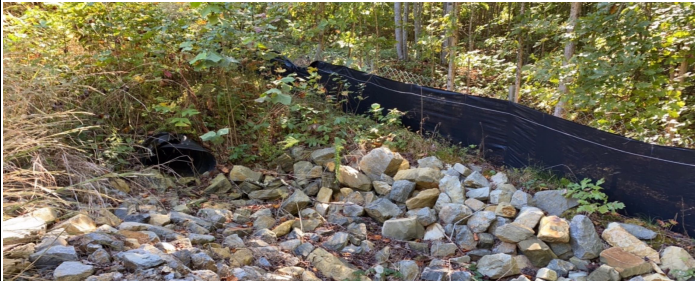
36°57'43" N 79°35'25" W 167°S COURSE 331° GPS Sandy Level, VA 24161, United States 10.20.2021 12:13:50 Accur +/-70.1 Ft ALT 0 Ft			36°57'40" N 79°35'13" W 281°W COURSE 57° GPS Sandy Level, VA 24161, United States 10.20.2021 12:22:00 Accur +/-134.8 Ft ALT 858 Ft		
GPS Location	5		GPS Location	6	
Field Station#	15073+50		Field Station#	15085+93	
Pic 5 Desc.	Slope drain tile outlet in good condition.		Pic 6 Desc.	Plunge pool and perimeter CFS in place and functional.

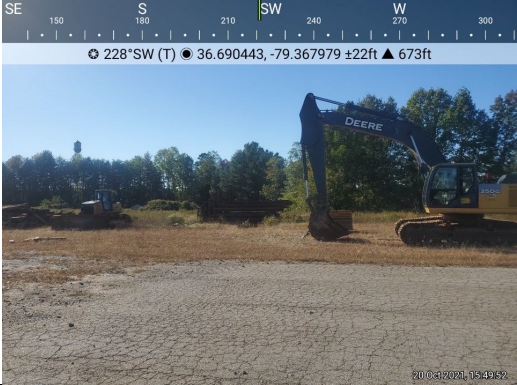
GPS Location	0	GPS Location	0		
Field Station#	0+00	Field Station#	0+00		
Pic 7 Desc.	LY-048 Equipment staging	Pic 8 Desc.	LY-048 West perimeter CFS		
Insert image here		Insert image here			
GPS Location		GPS Location			
Field Station#		Field Station#			
Pic 9 Desc.		Pic 10 Desc.			
Insert image here		Insert image here			
GPS Location		GPS Location			
Field Station#		Field Station#			
Pic 11 Desc.		Pic 12 Desc.

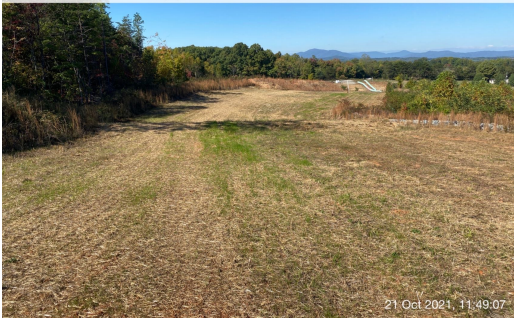
GPS Location	0		GPS Location	0	
Field Station#	14319+00		Field Station#	14333+50	
Pic 1 Desc.	Approximately 14319+00. Overview of ROW.		Pic 2 Desc.	Approximately 14333+50. Overview of road crossing and RCEs.

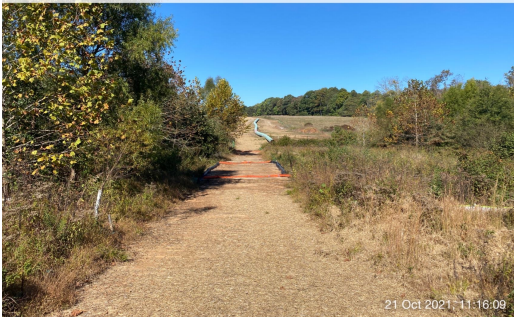
GPS Location	0		GPS Location	0	
Field Station#	14391+50		Field Station#	14415+00	
Pic 3 Desc.	Approximately 14391+50. Overview of stream crossing, equipment bridge and ECDs at stream S-A41.		Pic 4 Desc.	Approximately 14415+00. Overview of ROW.

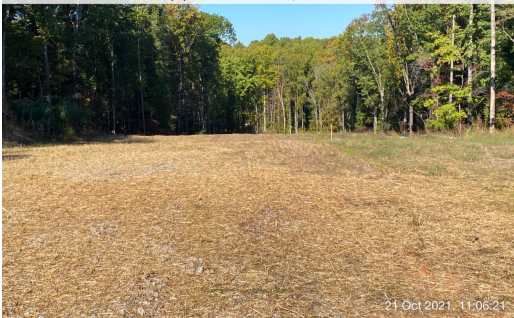
GPS Location	-		GPS Location	0	
Field Station#	14428+00		Field Station#	14451+00	
Pic 5 Desc.	Approximately 14428+00. Overview of ROW.		Pic 6 Desc.	Approximately 14451+00. Overview of ROW.

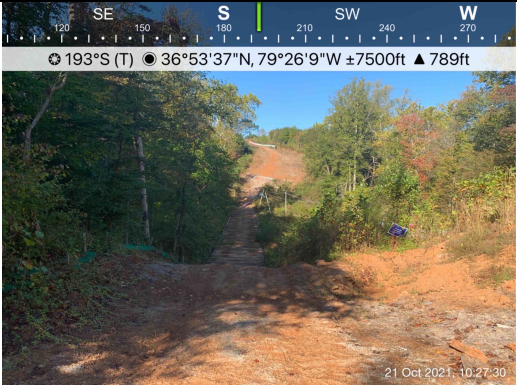
GPS Location	O	GPS Location	O		
Field Station#	15597+99	Field Station#	15610+00		
Pic 3 Desc.	Observing temporary stabilization, signage, buffer, equipment crossing and ECD's		Pic 4 Desc.	Observing temporary stabilization and ECD's

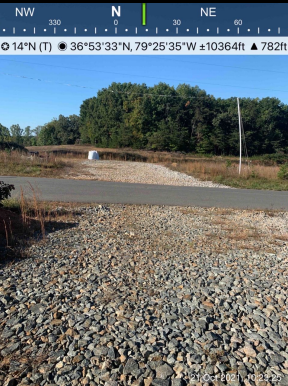
GPS Location	O	GPS Location	O		
Field Station#	15619+48	Field Station#	15636+45		
Pic 5 Desc.	Observing road crossing and RCE's		Pic 6 Desc.	Observing temporary stabilization, signage, buffer, equipment crossing and ECD's

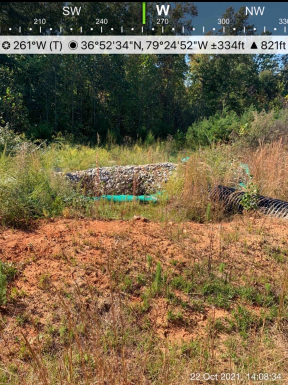
GPS Location	O	GPS Location	O		
Field Station#	15720+00	Field Station#	15740+00		
Pic 3 Desc.	Observing temporary stabilization,CWD outlet and ECD's	Pic 4 Desc.	Observing temporary stabilization, sump and end treatment

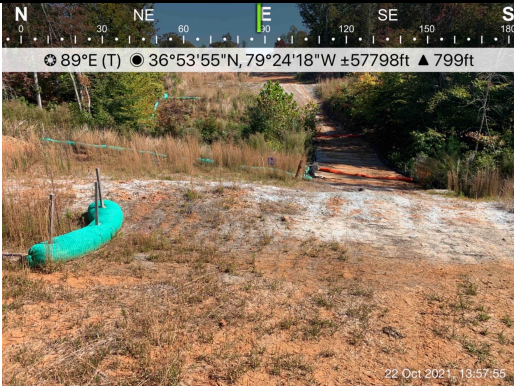
GPS Location	O	GPS Location	O		
Field Station#	15708+02	Field Station#	15696+00		
Pic 5 Desc.	Observing temporary stabilization,water bar,buffer, equipment crossing and ECD's	Pic 6 Desc.	Observing temporary stabilization, sump and end treatment

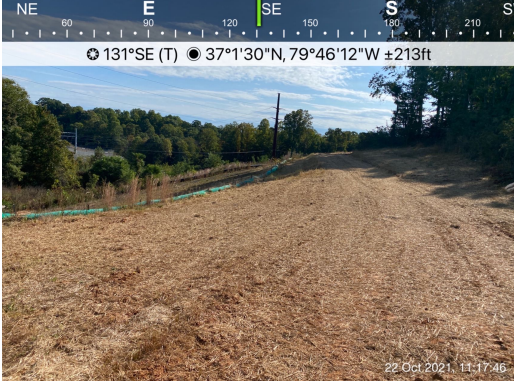
GPS Location	0	GPS Location	0		
Field Station#	14457+00	Field Station#	14471+00		
Pic 1 Desc.	Approximately 14457+00. Overview of ROW.		Pic 2 Desc.	Approximately 14471+00. Overview of ROW.
