Visual Site Inspection Report

Project Name	H-600 Pipeline Spread I	AFE	124300139	Spread	H-600 Pipeline Spread I
Contractor	Precision			Report #	30227
Inspector	John White			Date/Time	10/25/2021 11:28 AM
Permit #	TBD	Inspection Type	VA SWPP	Station Begin	15772+27
State	VA	Inspection Area	Full	Station End	15947+64
County	Pittsylvania	Ground	Dry	Temperature (°F)	70.00
Municipality	Chatham	Weather	Sunny	Rain Gauge (in)	0.00
				Rain Accumulation Time (days)	6.00

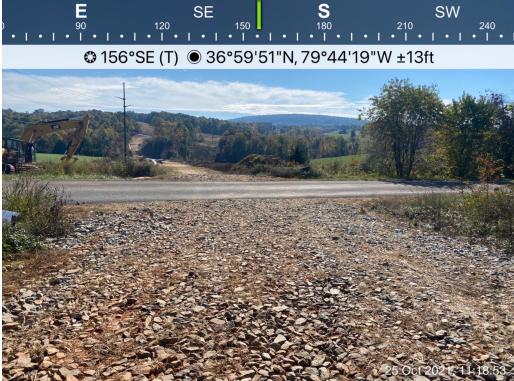
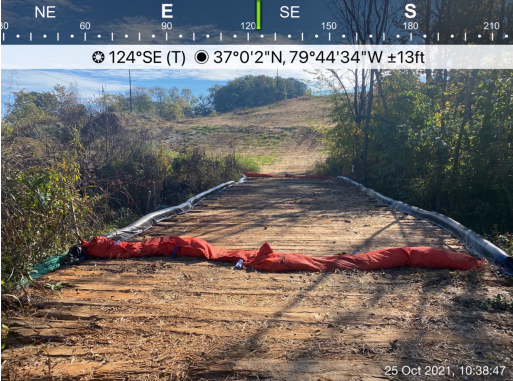
GPS Location	0	GPS Location	0		
Field Station#	14599+00	Field Station#	14582+85		
Pic 3 Desc.	Approximately 14599+00. Overview of road crossing and RCEs.		Pic 4 Desc.	Approximately 14582+85. Overview of stream crossing, equipment bridge and ECDs at stream S-E17.

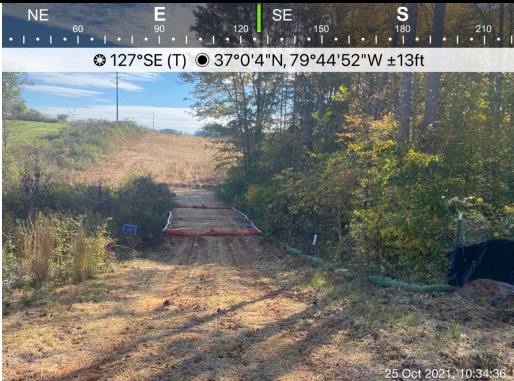
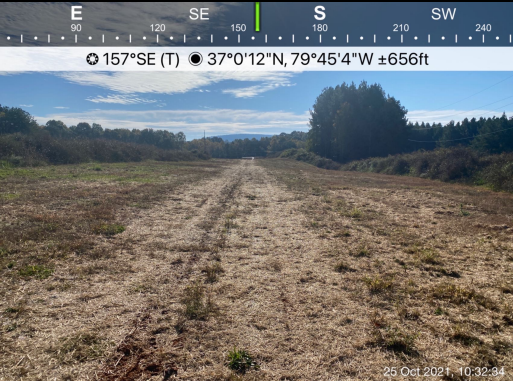
GPS Location	0	GPS Location	0		
Field Station#	14568+10	Field Station#	14555+00		
Pic 5 Desc.	Approximately 14568+10. Overview of stream crossing, equipment bridge and ECDs at stream S-E18.		Pic 6 Desc.	Approximately 14555+00. Overview of ROW.

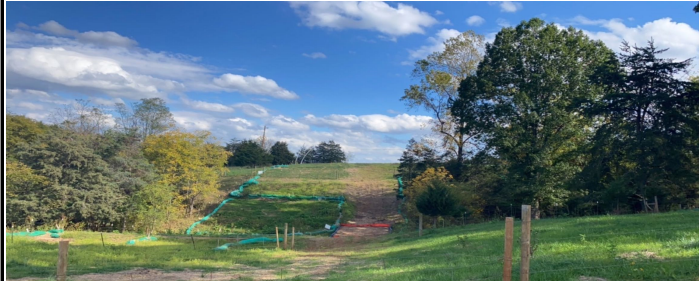
36°57'56" N 79°37'13" W 272°W COURSE 280' GPS 19101-19383 Snow Creek Rd, Penhook, VA 24137, United States Accur +/-50.5 Ft ALT 933 Ft			36°57'55" N 79°37'10" W 84°E COURSE 110' GPS 101-119 Ashworth Rd, Penhook, VA 24137, United States Accur +/-17.8 Ft ALT 0 Ft		
GPS Location	3		GPS Location	4	
Field Station#	14981+55		Field Station#	14983+00	
Pic 3 Desc.	Contractor unloading straw bales at road crossing		Pic 4 Desc.	Plunge pool performing intended function

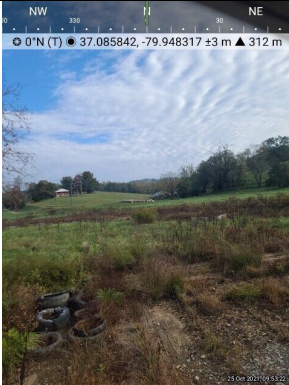
GPS Location	0000		GPS Location	0000	
Field Station#	13691+27		Field Station#	13691+35	
Pic 1 Desc.	Monitored ECDs around wetland area, all up to date and functioning at the time of inspection		Pic 2 Desc.	Monitored ECDs along the LOD, no environmental issues observed at the time of inspection.

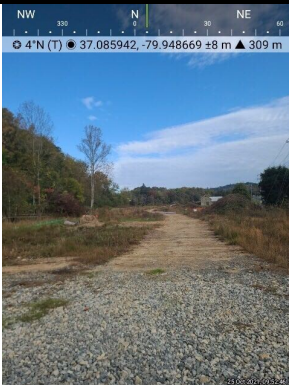
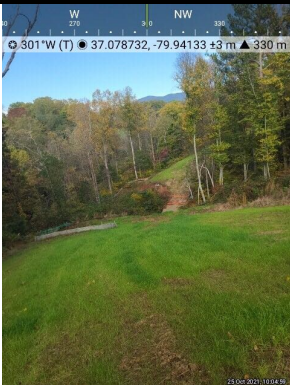
GPS Location	0000		GPS Location	0000	
Field Station#	13690+00		Field Station#	13730+00	
Pic 3 Desc.	Monitored RCE and equipment mats in low area along the row. No environmental issues observed at the time of inspection.		Pic 4 Desc.	Row photo showing winter vegetation growth . No environmental issues observed at the time of inspection.

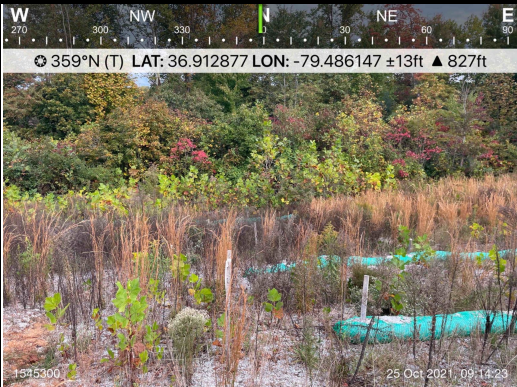
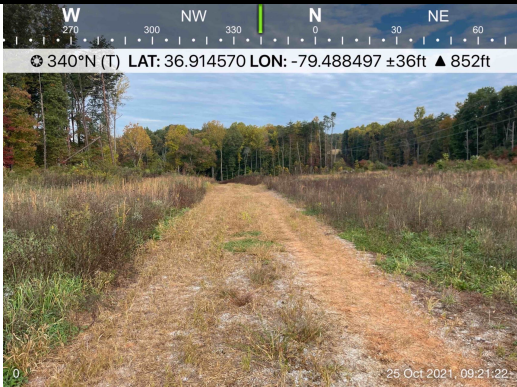
GPS Location	See photo		GPS Location	See photo	
Field Station#	15453+00		Field Station#	15440+00	
Pic 7 Desc.	CWD is in good condition.		Pic 8 Desc.	Vegetation continues to fill in throughout this section

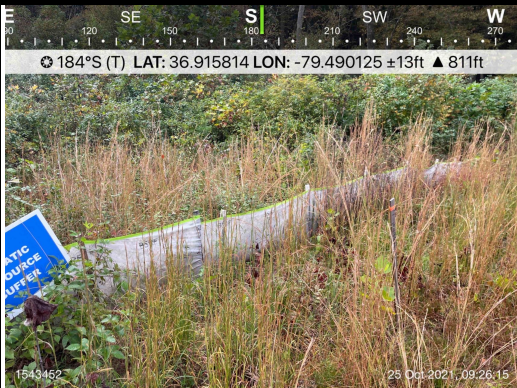
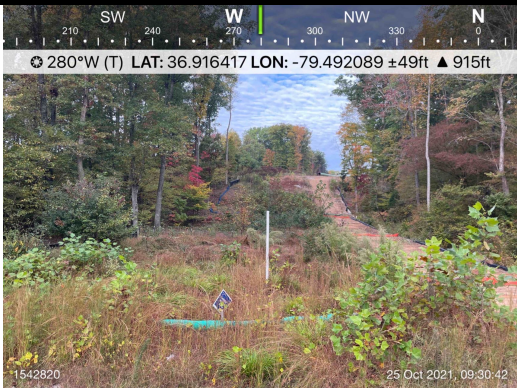
GPS Location	See photo		GPS Location	See photo	
Field Station#	15434+52		Field Station#	15428+20	
Pic 9 Desc.	P1 is in good condition at all stream and wetland crossings.		Pic 10 Desc.	Resource buffers are in good condition

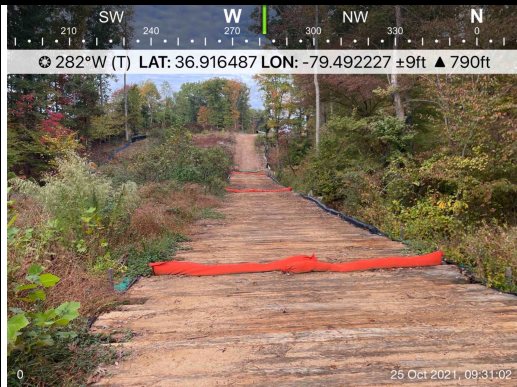
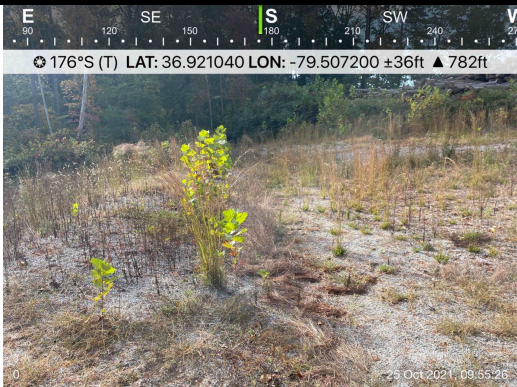
GPS Location	See photo		GPS Location	See photo	
Field Station#	15427+50		Field Station#	15381+00	
Pic 11 Desc.	Equipment bridge ECDs are in place and functioning.		Pic 12 Desc.	Waterbars are functioning as intended.

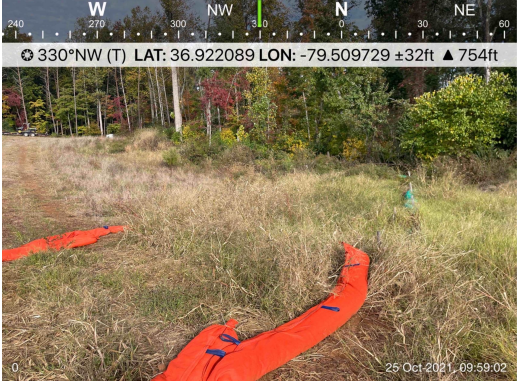
GPS Location	See photo	GPS Location			
Field Station#	15375+00	Field Station#			
Pic 13 Desc.	Drainage feature ECDs are in good condition and functioning.	Pic 14 Desc.			
Insert image here		Insert image here			
GPS Location		GPS Location			
Field Station#		Field Station#			
Pic 15 Desc.		Pic 16 Desc.			
Insert image here		Insert image here			
GPS Location		GPS Location			
Field Station#		Field Station#			
Pic 17 Desc.		Pic 18 Desc.

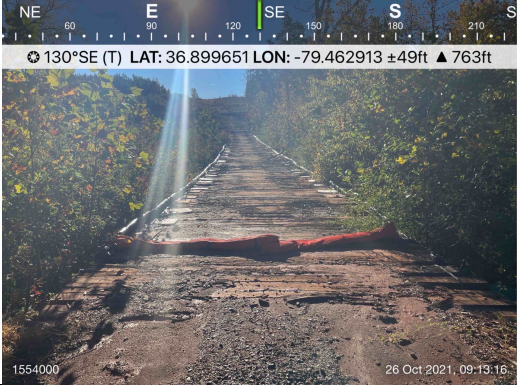
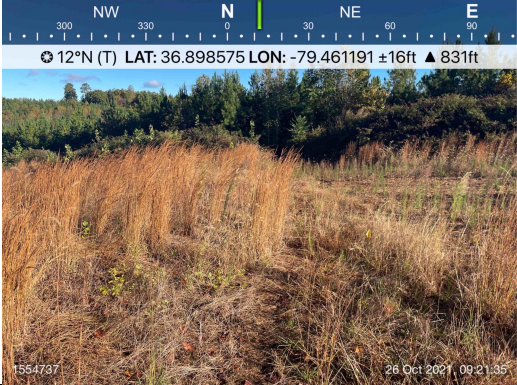
GPS Location	See photo		GPS Location	See photo	
Field Station#	15540+00		Field Station#	15547+37	
Pic 7 Desc.	Equipment bridge ECDs are in good condition and functioning.		Pic 8 Desc.	Waterbars are in good condition throughout this section.

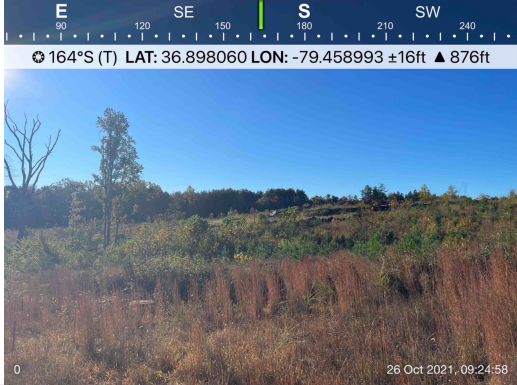
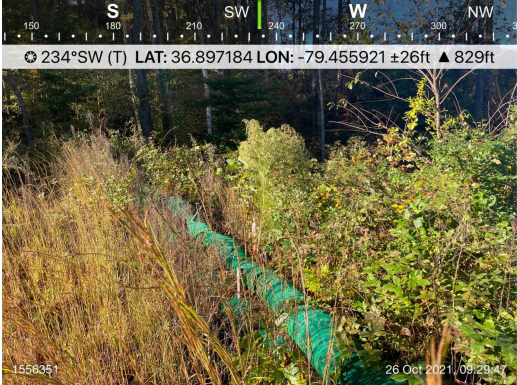
GPS Location	See photo		GPS Location	See photo	
Field Station#	15556+83		Field Station#	15563+51	
Pic 9 Desc.	No evidence of sedimentation from 3rd party disturbance.		Pic 10 Desc.	CFS remains in good condition.

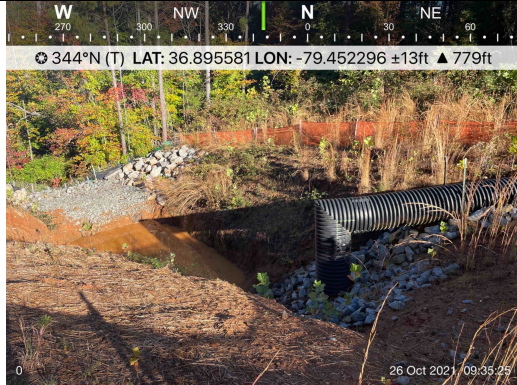
GPS Location	See photo		GPS Location	See photo	
Field Station#	15575+00		Field Station#	15584+23	
Pic 11 Desc.	Slope drain is functioning as intended.		Pic 12 Desc.	P1 needs to be restaked at road pipe outlet.

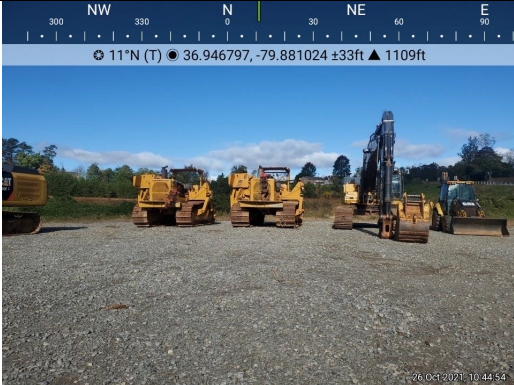
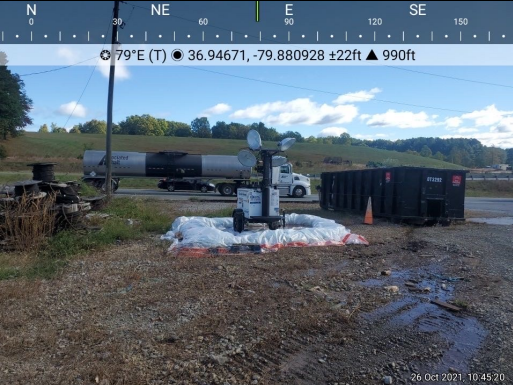
GPS Location	0	GPS Location	0		
Field Station#	0+00	Field Station#	0+00		
Pic 1 Desc.	LY-032 Equipment staging		Pic 2 Desc.	LY-032 Secondary containment

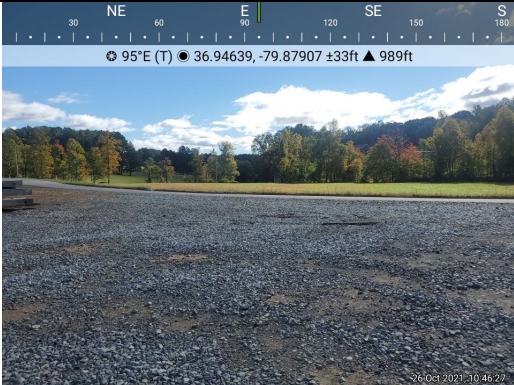
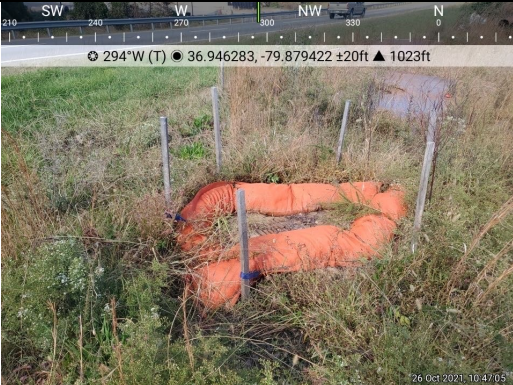
GPS Location	0	GPS Location	0		
Field Station#	0+00	Field Station#	0+00		
Pic 3 Desc.	LY-033 Rock construction entrance		Pic 4 Desc.	LY-033 Stormwater drain inlet protection

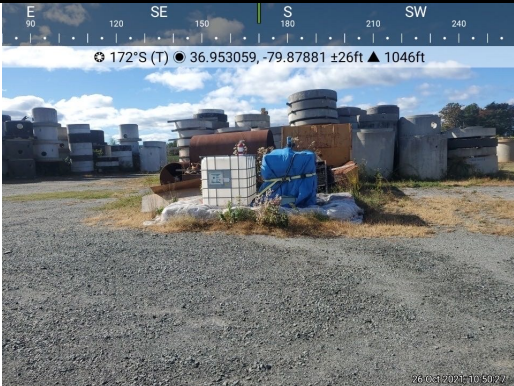
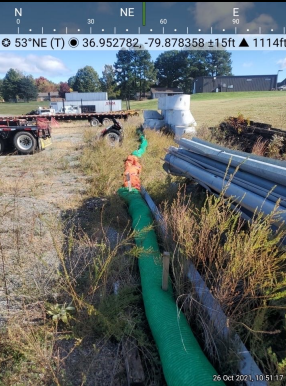
GPS Location	0	GPS Location	0		
Field Station#	0+00	Field Station#	0+00		
Pic 5 Desc.	ANC-006 Secondary containment		Pic 6 Desc.	ANC-006 South perimeter CFS

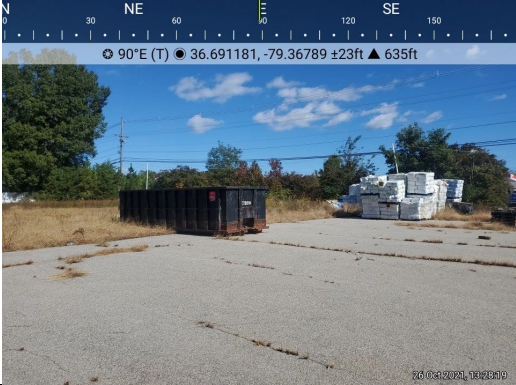
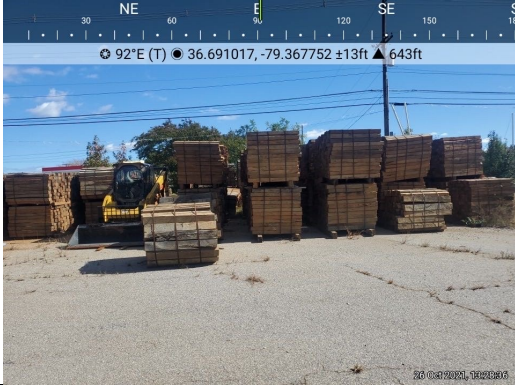
GPS Location	0	GPS Location	0		
Field Station#	0+00	Field Station#	0+00		
Pic 7 Desc.	LY-048 Waste management	Pic 8 Desc.	LY-048 Housekeeping		
Insert image here		Insert image here			
GPS Location		GPS Location			
Field Station#		Field Station#			
Pic 9 Desc.		Pic 10 Desc.			
Insert image here		Insert image here			
GPS Location		GPS Location			
Field Station#		Field Station#			
Pic 11 Desc.		Pic 12 Desc.

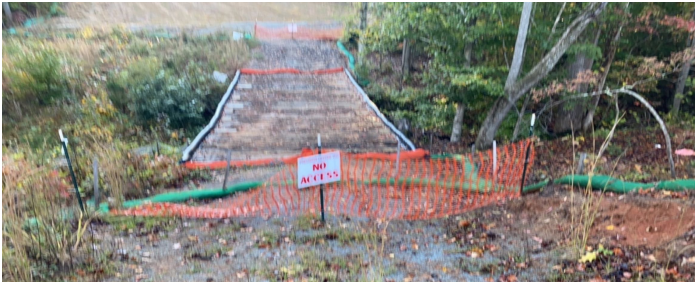
36°57'44" N 79°35'27" W 316°NW COURSE 28° GPS Penhook, VA 24137, United States 10.26.2021 08:36:33 Accur +/-98.3 Ft ALT 908 Ft			36°57'44" N 79°35'26" W 134°SE COURSE 5° GPS Penhook, VA 24137, United States 10.26.2021 08:37:06 Accur +/-63.6 Ft ALT 873 Ft		
GPS Location	1		GPS Location	2	
Field Station#	15072+00		Field Station#	15072+60	
Pic 1 Desc.	Routine maintenance. Replace row of P1 silt fence past effective lifespan.		Pic 2 Desc.	Routine maintenance. Repair damage to safety fence.

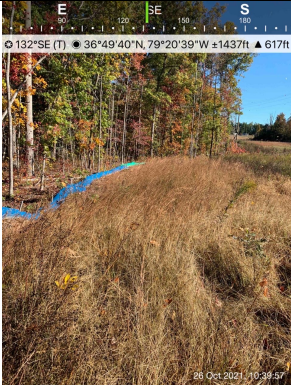
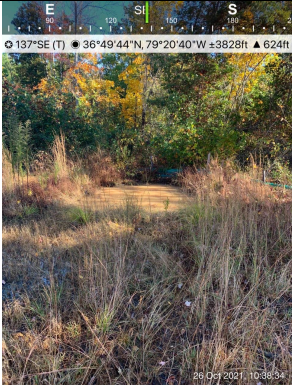
GPS Location	O	GPS Location	O		
Field Station#	19+00	Field Station#	13+50		
Pic 1 Desc.	Observing temporary stabilization and ECD's		Pic 2 Desc.	Observing temporary stabilization, sump and end treatment

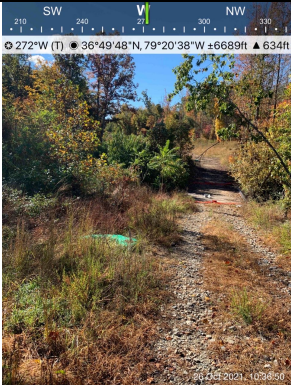
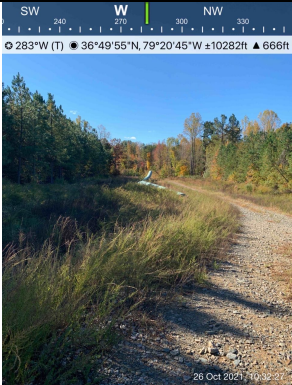
GPS Location	O	GPS Location	O		
Field Station#	12+65	Field Station#	6+00		
Pic 3 Desc.	Observing temporary stabilization, buffer, equipment crossing and ECD's		Pic 4 Desc.	Observing temporary stabilization and access road	
Insert image here			Insert image here		
GPS Location		GPS Location			
Field Station#		Field Station#			
Pic 5 Desc.			Pic 6 Desc.

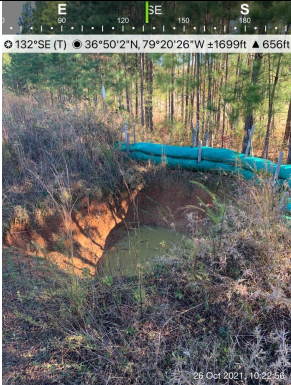
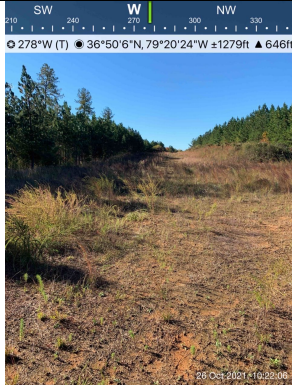
GPS Location	O	GPS Location	O		
Field Station#	8+00	Field Station#	7+00		
Pic 1 Desc.	Observing temporary stabilization, sump and end treatment		Pic 2 Desc.	Observing temporary stabilization

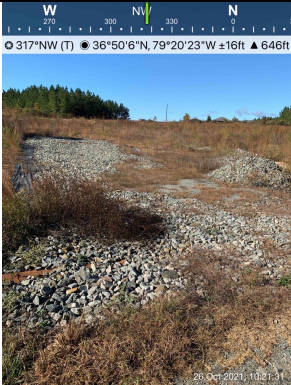
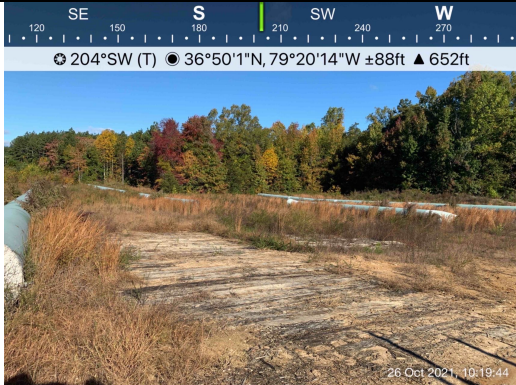
GPS Location	O	GPS Location	O		
Field Station#	13+77	Field Station#	22+00		
Pic 3 Desc.	Observing RCE and temporary stabilization		Pic 4 Desc.	Observing temporary stabilization	
Insert image here			Insert image here		
GPS Location		GPS Location			
Field Station#		Field Station#			
Pic 5 Desc.			Pic 6 Desc.

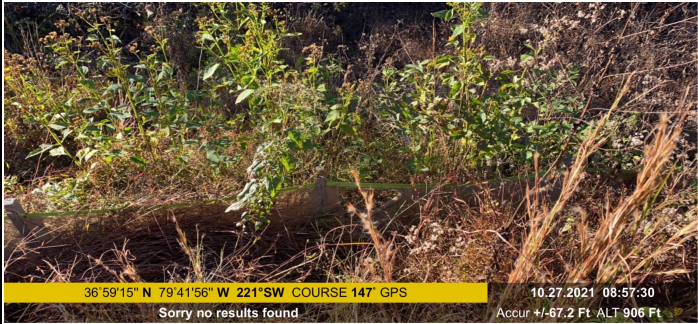
<p>36°59'15" N 79°41'56" W 221°SW COURSE 147° GPS Sorry no results found 10.27.2021 08:57:30 Accur +/-87.2 Ft ALT 906 Ft</p>			
GPS Location	1	GPS Location	2		
Field Station#	14721+62	Field Station#	14729+50		
Pic 1 Desc.	Routine maintenance. Replace perimeter CFS that is torn/fraying.		Pic 2 Desc.	Routine maintenance. Replace damaged P1 silt fence in resource buffer with holes in base of fabric.

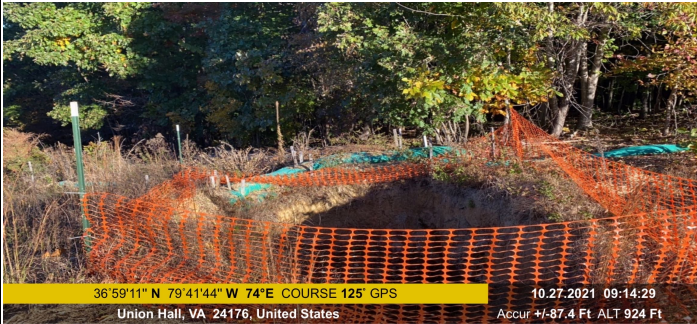
Pic 3 Desc.	Routine maintenance. CFS end treatment not properly filtering. Remove debris/sediment.		Pic 4 Desc.	Routine maintenance. CFS check dams missing stakes.

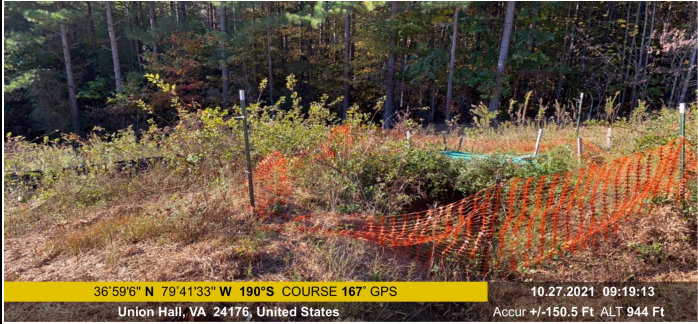
<p>36°59'6" N 79°41'33" W 190°S COURSE 167° GPS Union Hall, VA 24176, United States 10.27.2021 09:19:13 Accur +/-150.5 Ft ALT 944 Ft</p>			
GPS Location	5	GPS Location	6		
Field Station#	14739+00	Field Station#	14743+00		
Pic 5 Desc.	Routine maintenance. Repair safety fence around sump pit.		Pic 6 Desc.	Routine maintenance. Repair safety fence around sump pit.

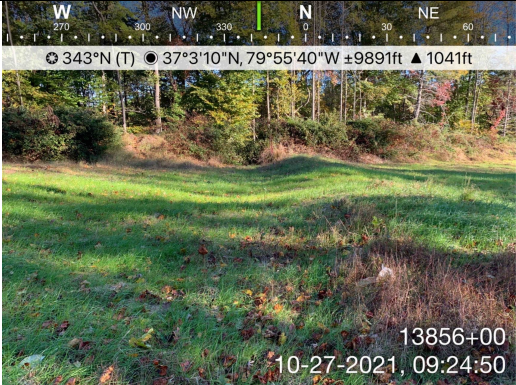
GPS Location	0	GPS Location	0		
Field Station#	13856+00	Field Station#	13856+00		
Pic 1 Desc.	Waterbar in acceptable condition		Pic 2 Desc.	Waterbar end treatment and P1 silt fence in acceptable conditions

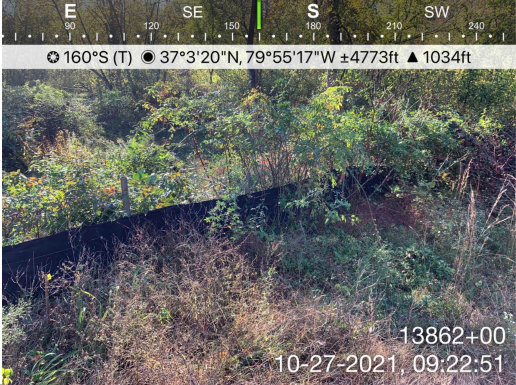
GPS Location	0	GPS Location	0		
Field Station#	13862+00	Field Station#	13873+00		
Pic 3 Desc.	Super silt fence in acceptable condition		Pic 4 Desc.	Clean water diversion berm and temporary vegetative stabilization in acceptable conditions

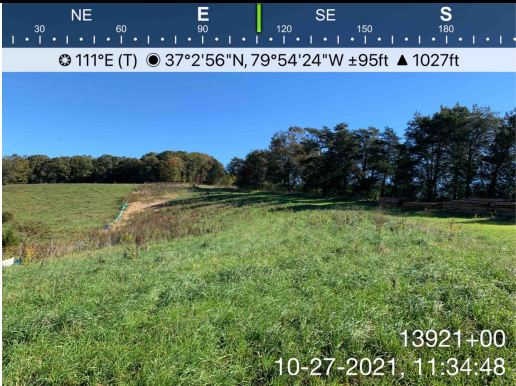
GPS Location	0	GPS Location	0		
Field Station#	13921+00	Field Station#	13954+00		
Pic 5 Desc.	Permanent vegetative stabilization in acceptable condition		Pic 6 Desc.	Sump pit and slope drain pipe in acceptable conditions

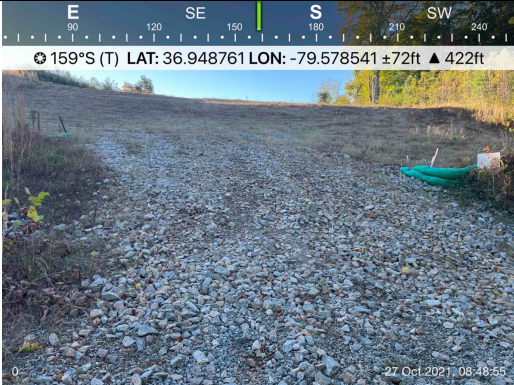
GPS Location	See photo		GPS Location	See photo	
Field Station#	15142+66		Field Station#	15159+00	
Pic 1 Desc.	RCE is in good condition at Rockcreek Rd.		Pic 2 Desc.	P1 has been damaged by livestock and needs to be replaced.

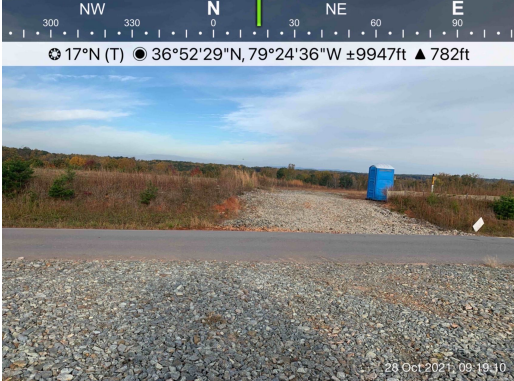
GPS Location	O	GPS Location	O		
Field Station#	15693+89	Field Station#	15706+00		
Pic 1 Desc.	Observing road crossing and RCE's	Pic 2 Desc.	Observing temporary stabilization, water bar, erosion control blanket and cfs checks

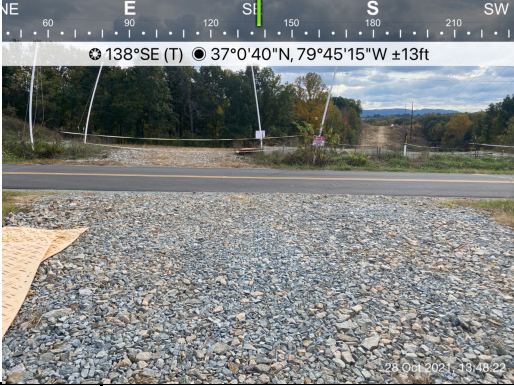
GPS Location	0	GPS Location	0		
Field Station#	14524+60	Field Station#	14546+33		
Pic 1 Desc.	Approximately 14524+60. Overview of road crossing and RCEs	Pic 2 Desc.	Approximately 14546+33. Overview of stream crossing, equipment bridge and ECDs at stream S-G17.

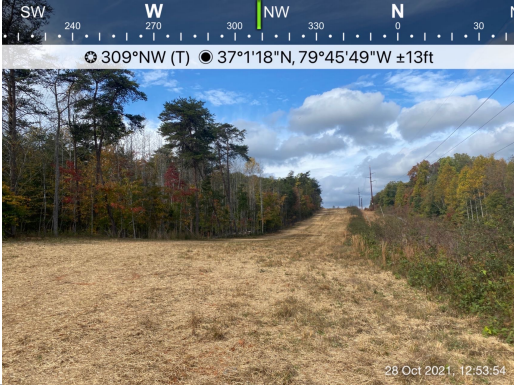
GPS Location	0	GPS Location	0		
Field Station#	14472+00	Field Station#	14463+00		
Pic 3 Desc.	Approximately 14472+00. Overview of ROW.	Pic 4 Desc.	Approximately 14463+00. Overview of ROW.

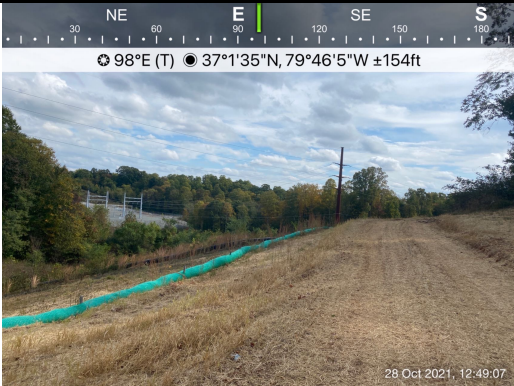
GPS Location	0	GPS Location	0		
Field Station#	14456+00	Field Station#	14531+58		
Pic 5 Desc.	Approximately 14456+00. Overview of ROW.	Pic 6 Desc.	Approximately 14531+58. Overview of stream crossing, equipment bridge and ECDs at stream S-G18.

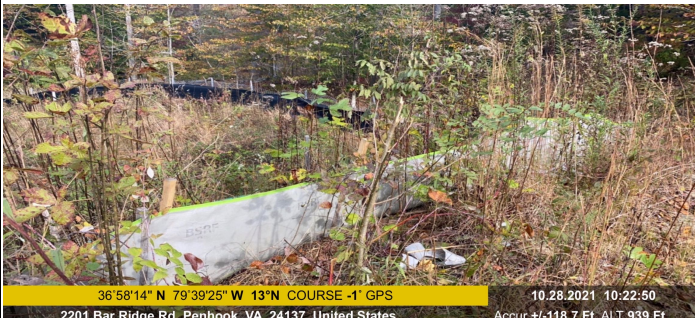
36°58'14" N 79°39'25" W 13°N COURSE -1° GPS 2201 Bar Ridge Rd, Penhook, VA 24137, United States 10/28/2021 10:22:50 Accur +/-118.7 Ft ALT 939 Ft			36°58'9" N 79°38'47" W 81°E COURSE 53° GPS Penhook, VA 24137, United States 10/28/2021 10:40:03 Accur +/-187.3 Ft ALT 874 Ft		
GPS Location	5	GPS Location	6		
Field Station#	14870+93	Field Station#	14904+00		
Pic 5 Desc.	Contractor replaced row of P1 silt fence per punch list item		Pic 6 Desc.	Recently seeded and stabilized ROW in temporary section

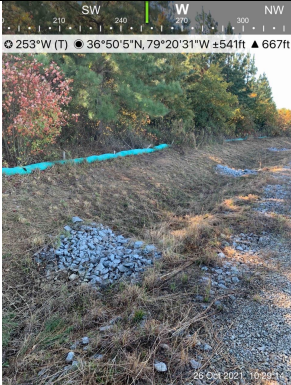
GPS Location	O	GPS Location	O		
Field Station#	00+00	Field Station#	00+00		
Pic 1 Desc.	Observing temporary stabilization, drainage ditch with rock check dams and ECD's		Pic 2 Desc.	Observing Lay down yard

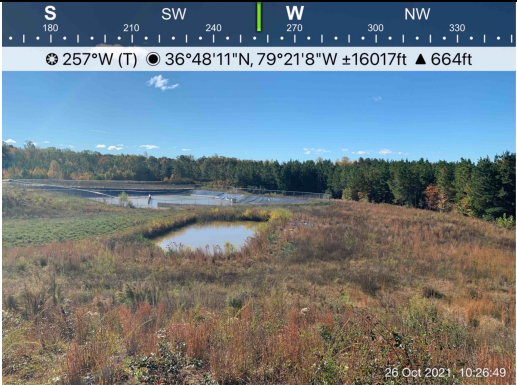
GPS Location	O	GPS Location	O		
Field Station#	00+00	Field Station#	00+00		
Pic 3 Desc.	Observing temporary stabilization, sediment basin and storm water pond		Pic 4 Desc.	Observing RCE	
Insert image here			Insert image here		
GPS Location		GPS Location			
Field Station#		Field Station#			
Pic 5 Desc.		Pic 6 Desc.
