Visual Site Inspection Report

Project Name H-600 Pipeline Spread I		AFE 124300139	Spread H-600 Pipeline Spread I
Contractor Precision		Report # 29313	
Inspector Ben Farmer		Date/Time 10/4/2021 12:39 PM	
Permit # TBD	Inspection Type VA SWPP	Station Begin 15480+67	
State VA	Inspection Area Partial	Station End 15584+23	
County Pittsylvania	Ground Damp	Temperature (°F) 72.00	
Municipality Chatham	Weather Cloudy	Rain Gauge (in) 0.00	
			Rain Accumulation Time (days) 0.00

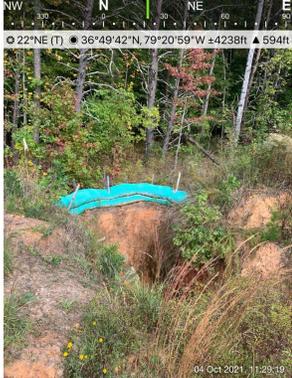
<p>GPS: 309°NW (T) ● 36°51'21"N, 79°23'32"W ±216ft ▲ 839ft 04 Oct 2021 09:30:39</p>		
GPS Location	O		GPS Location	O	
Field Station#	16008+00		Field Station#	15826+00	
Pic 1 Desc.	Observing temporary stabilization, sump and end treatment		Pic 2 Desc.	Observing CFS that requires maintenance (3rd party damage)

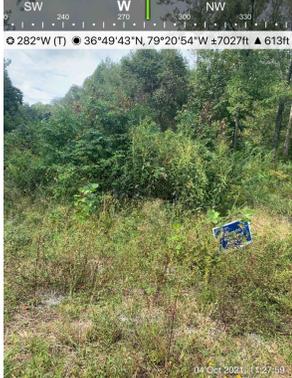
<p>GPS: 152°SE (T) ● 36°49'46"N, 79°20'49"W ±656ft ▲ 633ft 04 Oct 2021 11:26:02</p>		
GPS Location	O		GPS Location	O	
Field Station#	16004+00		Field Station#	16010+00	
Pic 3 Desc.	Observing temporary stabilization, signage and buffer		Pic 4 Desc.	Observing temporary stabilization, CWD outlet and ECD's

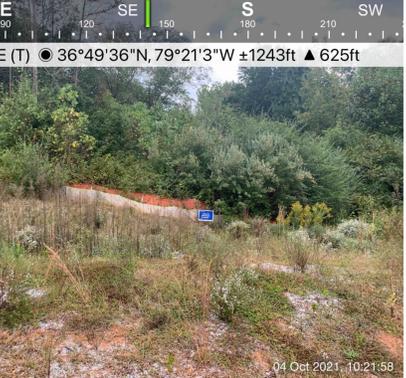
GPS Location	O		GPS Location	O	
Field Station#	15999+00		Field Station#	15997+50	
Pic 5 Desc.	Observing temporary stabilization, signage, buffer and ECD's		Pic 6 Desc.	Observing temporary stabilization, CWD outlet and ECD's

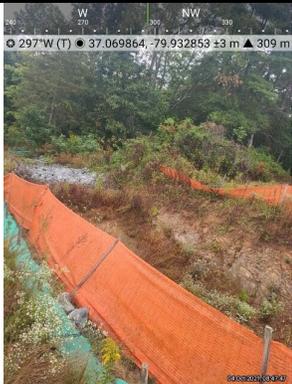
GPS Location	00000	GPS Location	00000		
Field Station#	13784+30	Field Station#	13834+04		
Pic 1 Desc.	Monitored sump pit and ECDs before scheduled rain events for this week. No environmental issues observed at the time of inspection.		Pic 2 Desc.	Row photo showing winter vegetation growth in area recently seeded and stabilized.

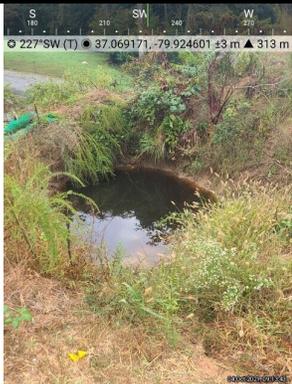
GPS Location	0000	GPS Location	0000		
Field Station#	13811+11	Field Station#	13832+80		
Pic 3 Desc.	Monitored sump pit and end treatment, no environmental issues observed at the time of inspection.		Pic 4 Desc.	Monitored equipment bridge and protection, row stabilized, no environmental issues observed at the time of inspection

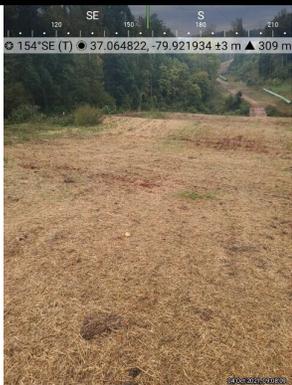
GPS Location	0000	GPS Location	0000		
Field Station#	13830+00	Field Station#	13786+00		
Pic 5 Desc.	Row photo showing new winter vegetation growth.		Pic 6 Desc.	Row photo showing new winter vegetation growth.

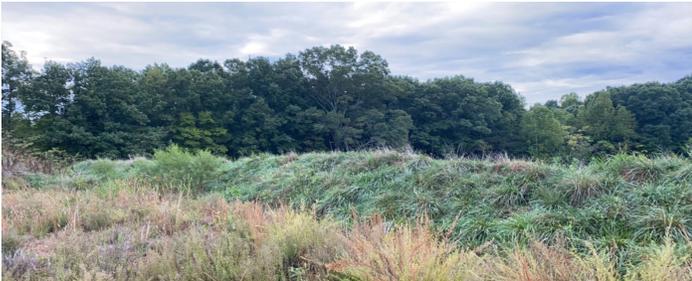
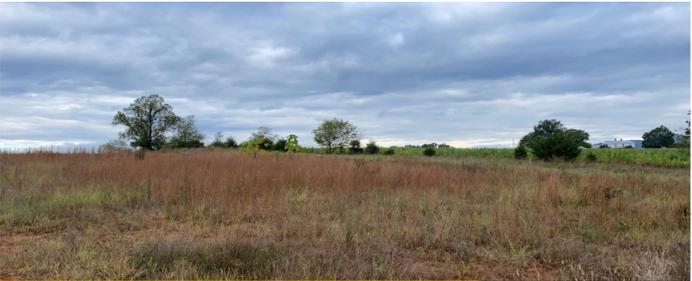
<small>36°57'45" N 79°35'33" W 157°SE COURSE 293' GPS 1918-2164 Armstrong Rd, Penhook, VA 24137, United States</small>		<small>10.04.2021 09:21:42 Accur +/-45.4 Ft ALT 0 Ft</small>		<small>36°57'46" N 79°35'30" W 16°N COURSE 30' GPS 1918-2164 Armstrong Rd, Penhook, VA 24137, United States</small>	
<small>10.04.2021 09:23:00 Accur +/-89.1 Ft ALT 913 Ft</small>					
GPS Location	1	GPS Location	2		
Field Station#	15066+00	Field Station#	15069+00		
Pic 1 Desc.	Temporary diversion berm stabilized and vegetated.		Pic 2 Desc.	Picture of temporary stabilization and vegetation along ROW. ECDs in place and functional.

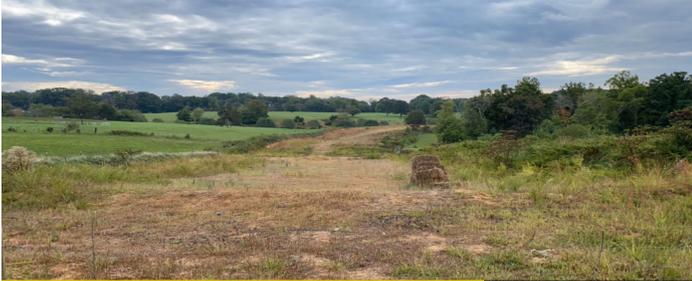
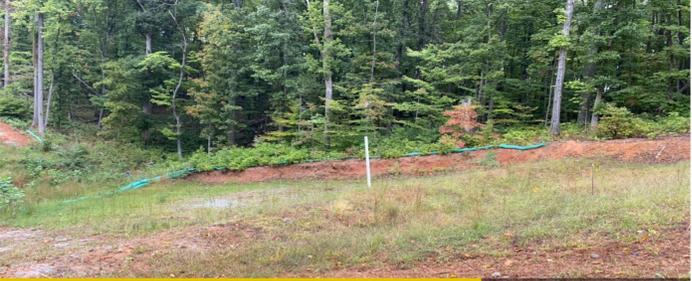
<small>36°57'42" N 79°35'16" W 153°SE COURSE 131' GPS 13685 W Gretna Rd, Sandy Level, VA 24161, United States</small>		<small>10.04.2021 09:42:56 Accur +/-32.1 Ft ALT 896 Ft</small>		<small>36°56'53" N 79°34'43" W 98°E COURSE 24' GPS 336-520 Rockcreek Rd, Sandy Level, VA 24161, United States</small>	
<small>10.04.2021 09:57:01 Accur +/-15.4 Ft ALT 878 Ft</small>					
GPS Location	5	GPS Location	6		
Field Station#	15087+00	Field Station#	15141+00		
Pic 5 Desc.	Picture of temporary stabilization and vegetation along ROW. ECDs in place and functional.		Pic 6 Desc.	Picture of temporary stabilization and vegetation along ROW. ECDs in place and functional.

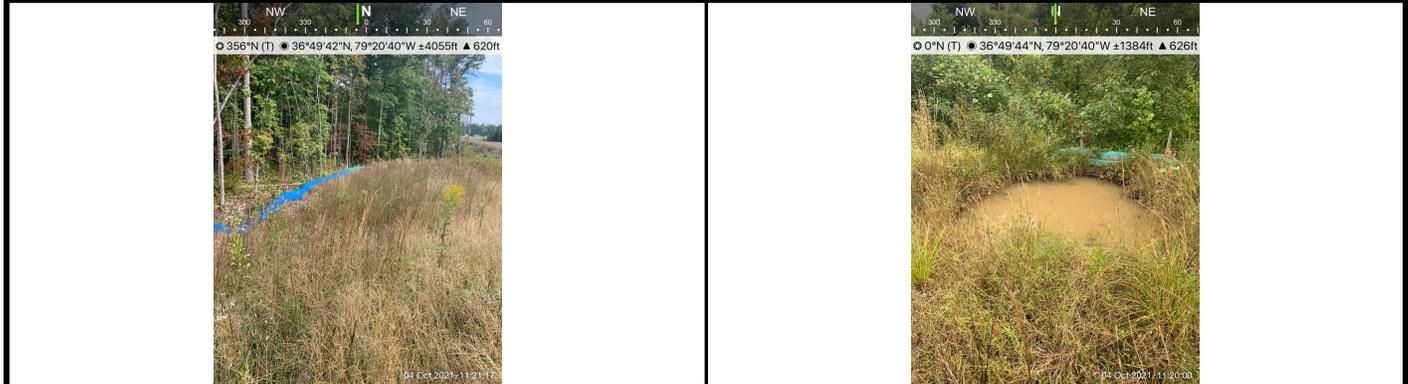
Pic 1 Desc.	Observing temporary stabilization and ECD's	Pic 2 Desc.	Observing temporary stabilization, sump and end treatment
--------------------	---	--------------------	---

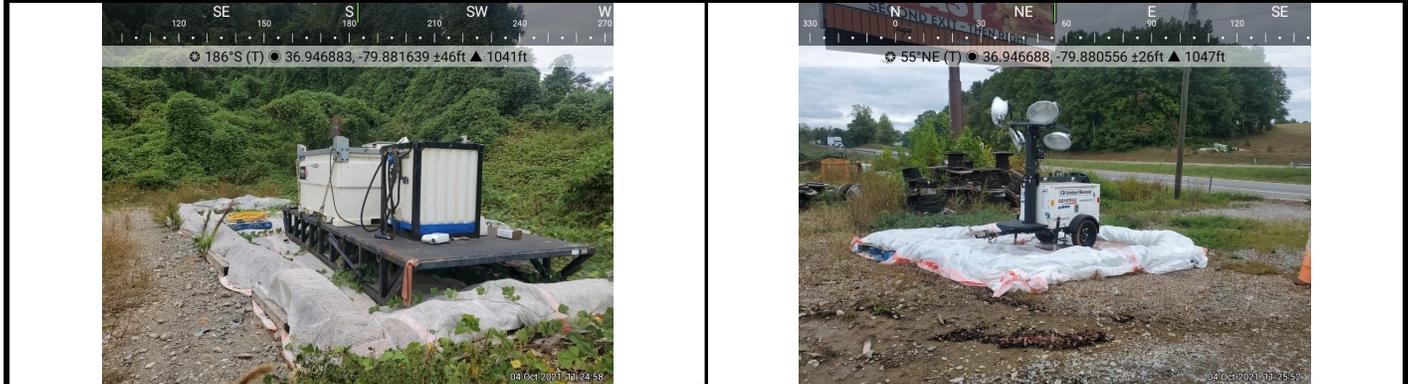
GPS Location	0	GPS Location	0
Field Station#	0+00	Field Station#	0+00
Pic 1 Desc.	LY-032 Secondary containment	Pic 2 Desc.	LY-032 Secondary containment

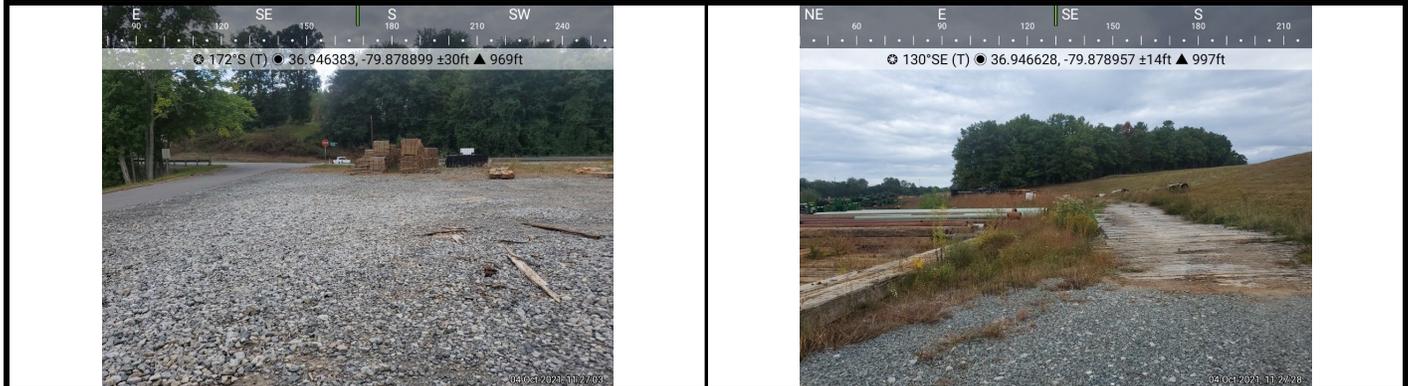
GPS Location	0	GPS Location	0
Field Station#	0+00	Field Station#	0+00
Pic 3 Desc.	LY-033 Rock construction entrance	Pic 4 Desc.	LY-033 Timber mats

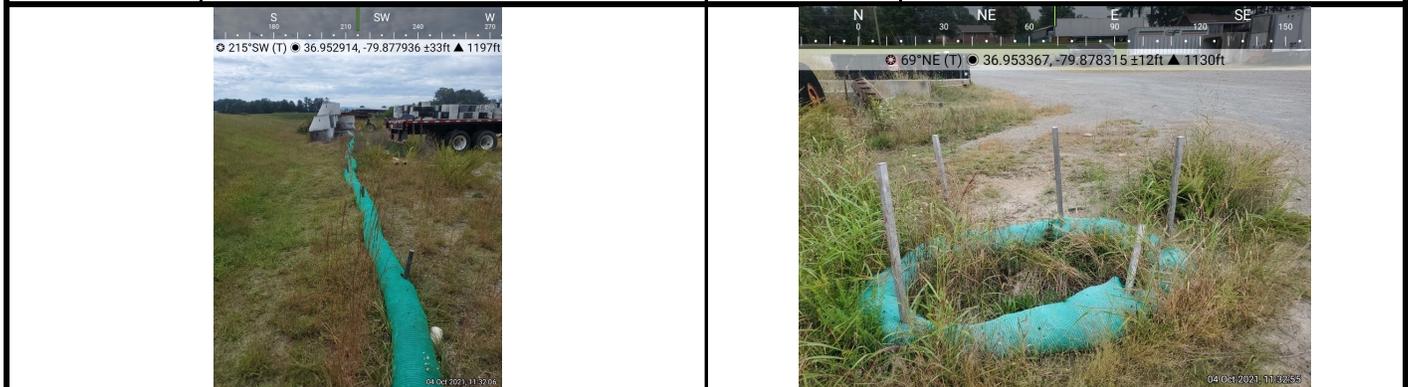
GPS Location	0	GPS Location	0
Field Station#	0+00	Field Station#	0+00
Pic 5 Desc.	ANC-006 East perimeter CFS	Pic 6 Desc.	ANC-006 Stormwater drain inlet protection

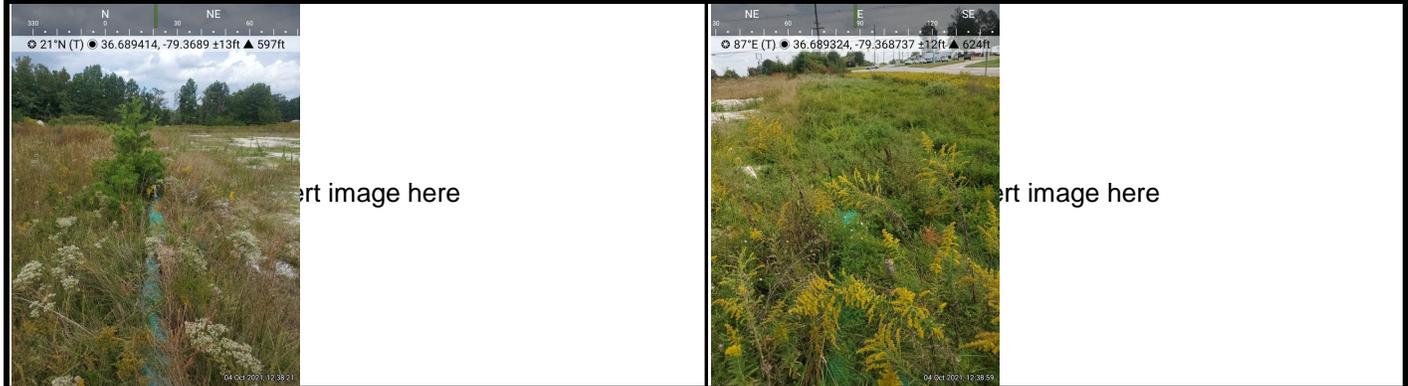
Pic 7 Desc.	LY-048 West perimeter CFS	Pic 8 Desc.	LY-048 South perimeter CFS
--------------------	---------------------------	--------------------	----------------------------

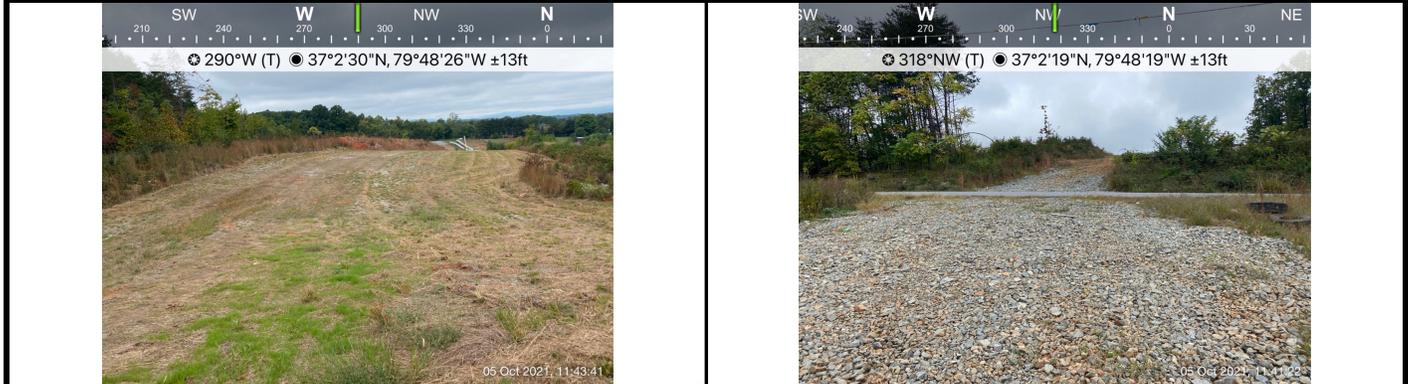
GPS Location	0	GPS Location	0
Field Station#	14318+50	Field Station#	14333+50
Pic 1 Desc.	Approximately 14318+50. Overview of ROW.	Pic 2 Desc.	14333+50. Overview of road crossing and RCEs.

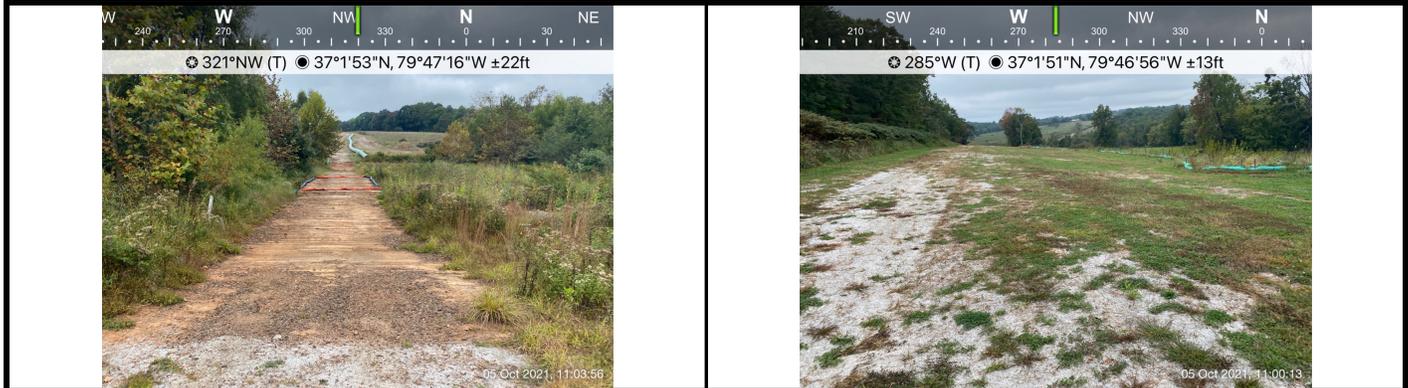
GPS Location	0	GPS Location	0
Field Station#	14391+50	Field Station#	14405+00
Pic 3 Desc.	Approximately 14391+50. Overview of stream crossing, equipment bridge and ECDs at stream S-A41.	Pic 4 Desc.	Approximately 14405+00. Overview of ROW.

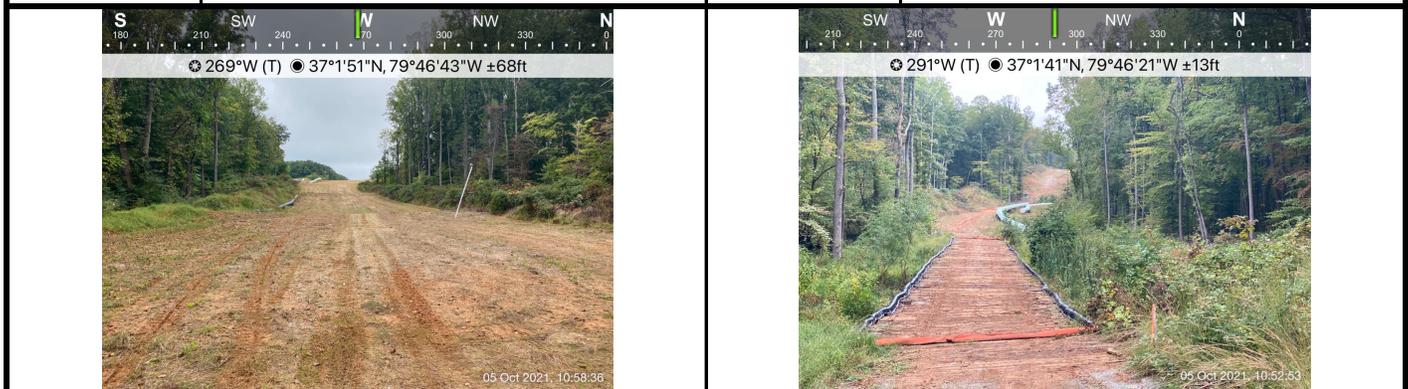
GPS Location	0	GPS Location	0
Field Station#	14416+00	Field Station#	14438+49
Pic 5 Desc.	Approximately 14416+00. Overview of ROW.	Pic 6 Desc.	Approximately 14438+49. Overview of stream crossing, equipment bridge and ECDs at stream S-IJ47.

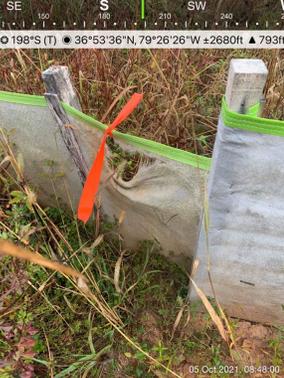
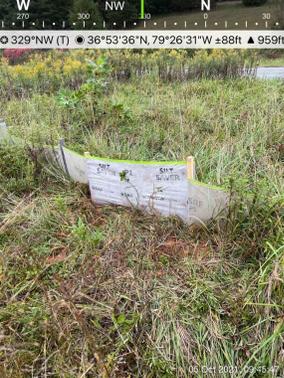
GPS Location	O	GPS Location	O		
Field Station#	15610+00	Field Station#	15610+00		
Pic 1 Desc.	Observing P1 that requires maintenance (damaged by wildlife)	Pic 2 Desc.	Observing P1 that received maintenance

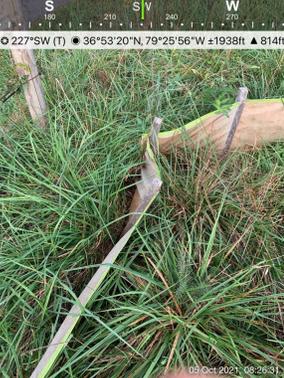
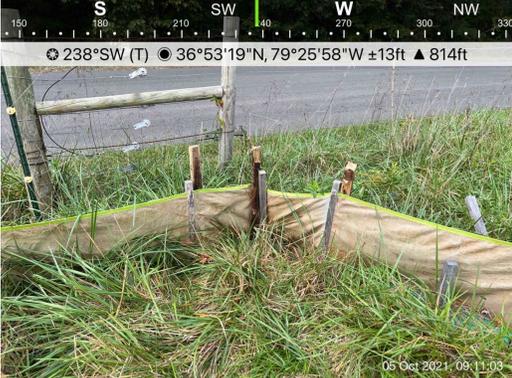
GPS Location	O	GPS Location	O		
Field Station#	15646+50	Field Station#	15646+50		
Pic 3 Desc.	Observing P1 that requires maintenance	Pic 4 Desc.	Observing P1 that received maintenance

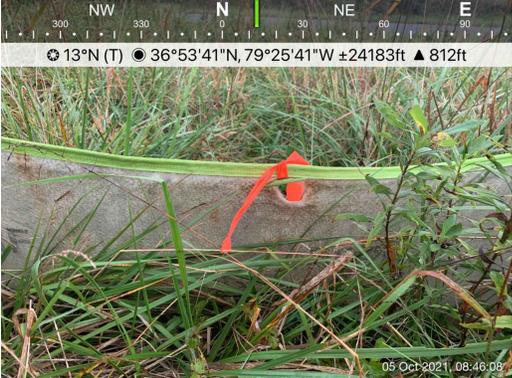
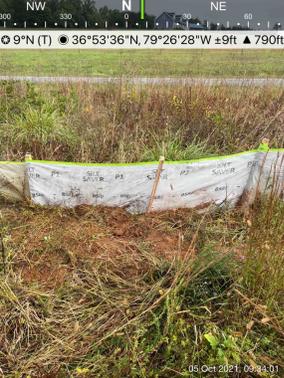
GPS Location	O	GPS Location	O		
Field Station#	16012+00	Field Station#	16012+00		
Pic 5 Desc.	Observing P1 that required maintenance	Pic 6 Desc.	Observing p1 that received maintenance

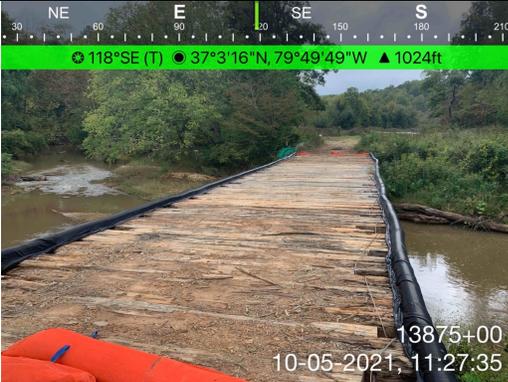
<p>13875+00 10-05-2021, 11:27:35</p>

<p>13878+00 10-05-2021, 11:20:23</p>			
GPS Location 0		GPS Location 0			
Field Station# 13875+00		Field Station# 13878+00			
Pic 1 Desc. Equipment bridge in acceptable condition		Pic 2 Desc. Temporary vegetative stabilization in acceptable condition

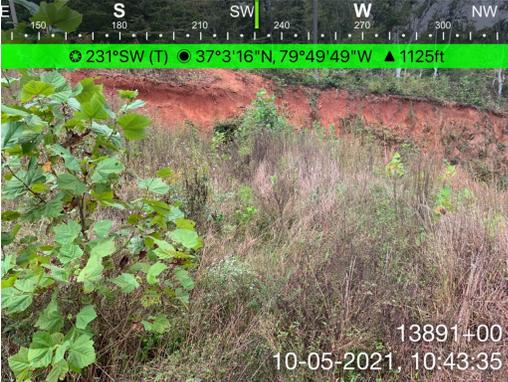
<p>13891+00 10-05-2021, 10:43:35</p>

<p>13891+00 10-05-2021, 10:44:30</p>			
GPS Location 0		GPS Location 0			
Field Station# 13891+00		Field Station# 13891+00			
Pic 3 Desc. Waterbar in acceptable condition		Pic 4 Desc. Sump pit and slope drain pipe in acceptable conditions

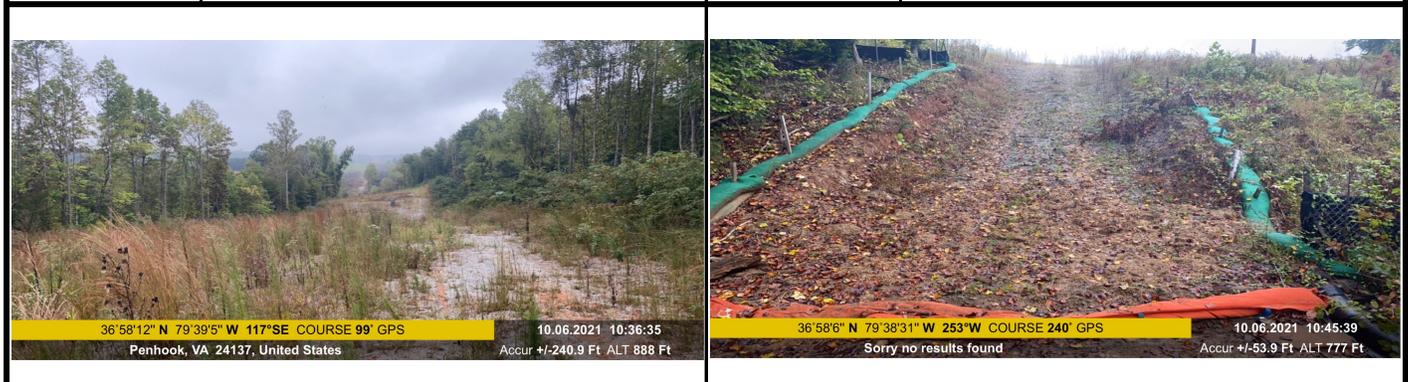
GPS Location	5	GPS Location	6
Field Station#	14898+00	Field Station#	14915+96
Pic 5 Desc.	Picture of temporary stabilization and vegetation along ROW	Pic 6 Desc.	Contractor completed punch list items in section then seeded and stabilized disturbed area

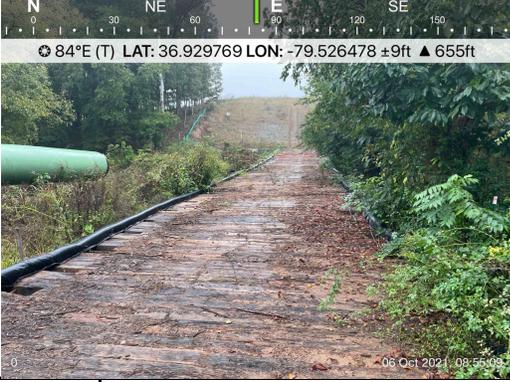
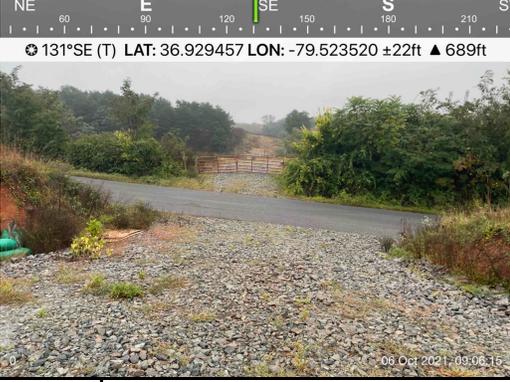
GPS Location	See photo	GPS Location	See photo
Field Station#	15312+00	Field Station#	15323+24
Pic 5 Desc.	Equipment bridge ECDs are in place and functioning.	Pic 6 Desc.	RCEs are in good condition at all road crossings.

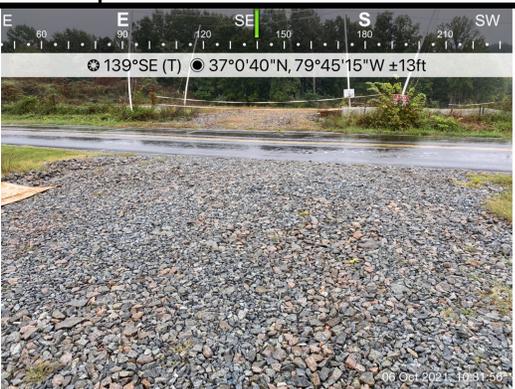
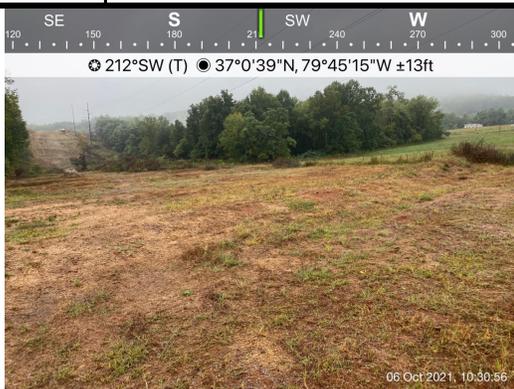
GPS Location	0	GPS Location	0		
Field Station#	14524+50	Field Station#	14530+00		
Pic 3 Desc.	Approximately 14524+50. Overview of road crossing and RCEs.		Pic 4 Desc.	Approximately 14530+00. Overview of ROW.

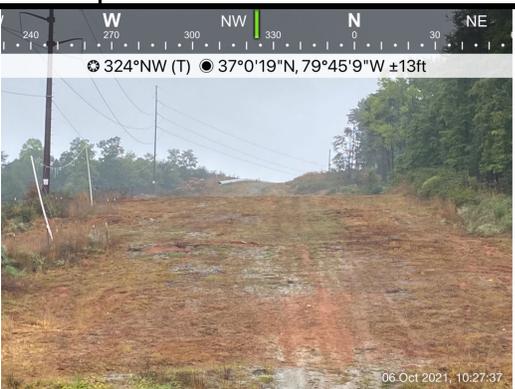
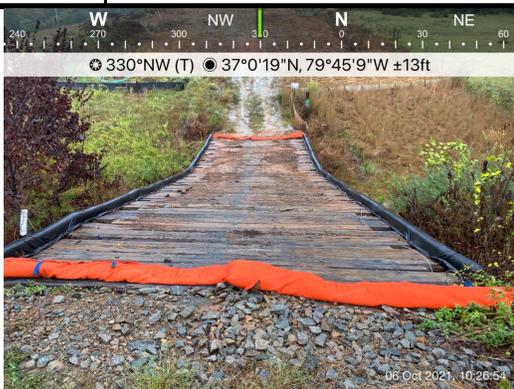
GPS Location	0	GPS Location	0		
Field Station#	14540+00	Field Station#	14546+33		
Pic 5 Desc.	Approximately 14540+00. Overview of ROW.		Pic 6 Desc.	Approximately 14546+33. Overview of stream crossing, equipment bridge and ECDs at stream S-G17.

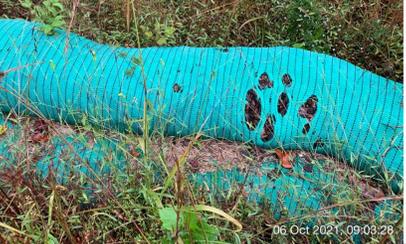
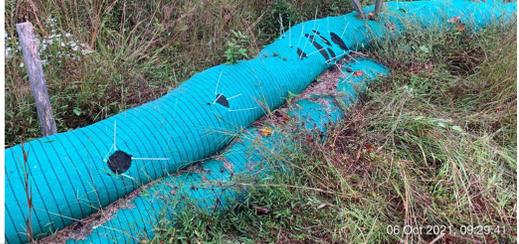
GPS Location	O
GPS Location	O	GPS Location	O	Field Station#	15677+55
Field Station#	15677+55	Field Station#	15677+55	Pic 3 Desc.	Observing CFS that required maintenance
Pic 3 Desc.	Observing CFS that required maintenance	Pic 4 Desc.	Observing CFS that received maintenance	Pic 4 Desc.	Observing CFS that received maintenance

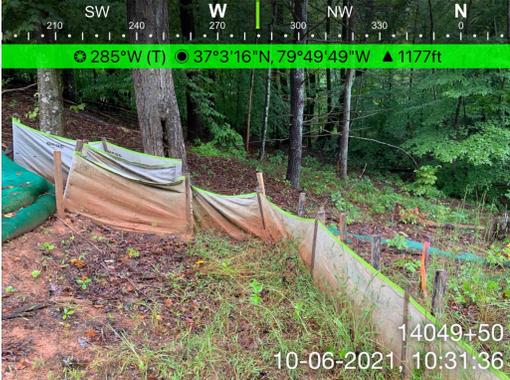
GPS Location	0	GPS Location	0		
Field Station#	14049+50	Field Station#	14061+00		
Pic 7 Desc.	P1 silt fence after repair by contractor		Pic 8 Desc.	Triple stack CFS is undermined and dislocated, contractor repaired immediately

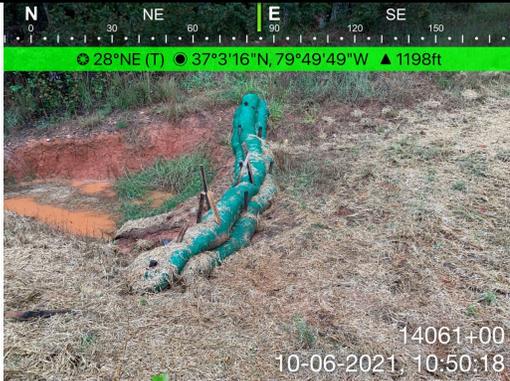
GPS Location	0	GPS Location	0		
Field Station#	14061+00	Field Station#	14057+00		
Pic 9 Desc.	Triple stack CFS after maintenance by contractor		Pic 10 Desc.	Super silt fence and P1 silt fence in acceptable conditions

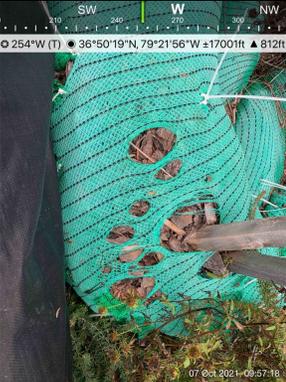
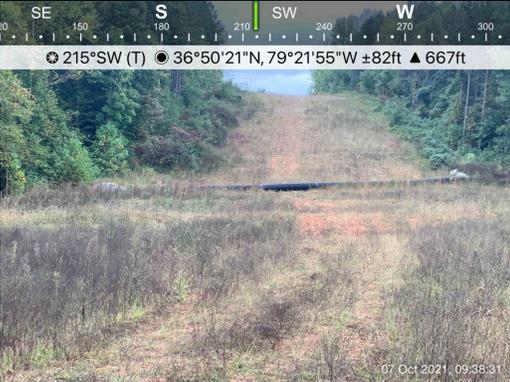
GPS Location	O	GPS Location	O
Field Station#	15837+00	Field Station#	15934+00
Pic 1 Desc.	Observing CFS that requires maintenance	Pic 2 Desc.	Observing temporary stabilization and CWD pipe

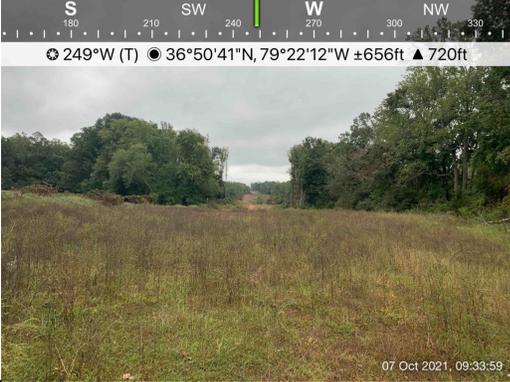
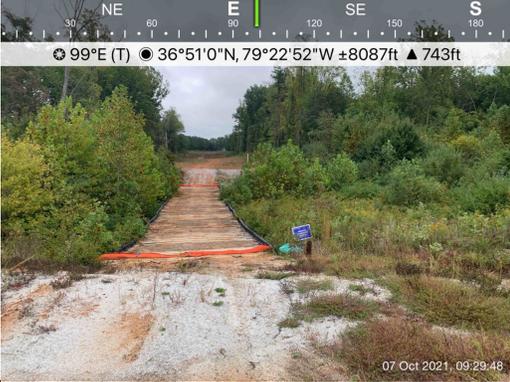
GPS Location	O	GPS Location	O
Field Station#	15913+00	Field Station#	15878+08
Pic 3 Desc.	Observing temporary stabilization	Pic 4 Desc.	Observing temporary stabilization, signage, buffer, equipment crossing and ECD's

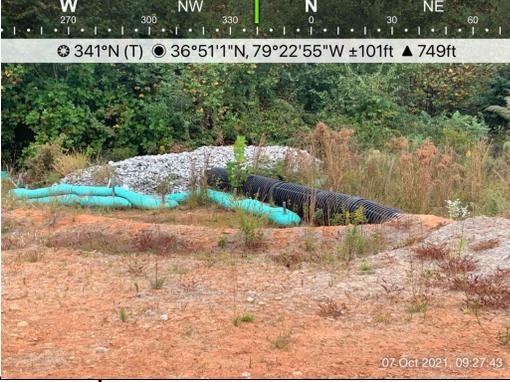
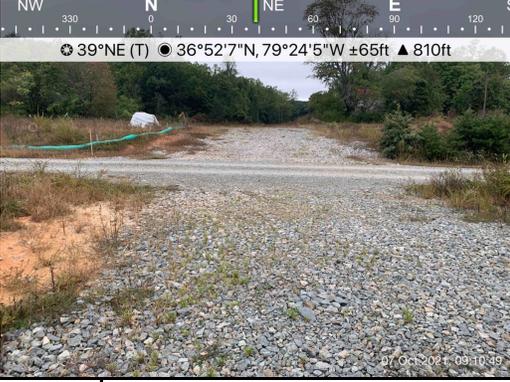
GPS Location	O	GPS Location	O
Field Station#	15860+00	Field Station#	15772+27
Pic 5 Desc.	Observing temporary stabilization, CWD outlet and ECD's	Pic 6 Desc.	Observing access road and RCE's

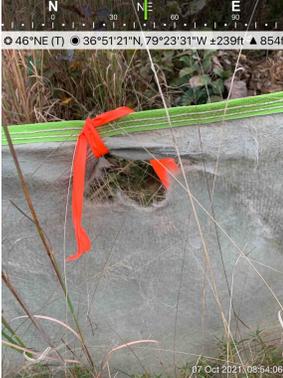
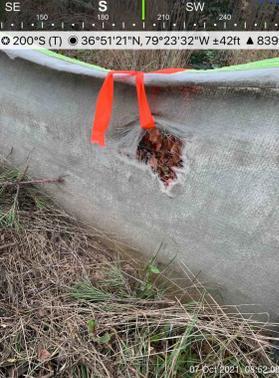
<p>ert image here</p>		
GPS Location	O		GPS Location	O	
Field Station#	15826+88		Field Station#	15826+88	
Pic 7 Desc.	Observing P1 that requires maintenance		Pic 8 Desc.	Observing P1 that requires maintenance

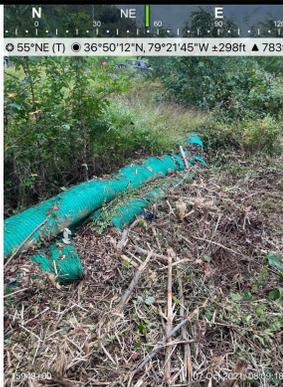
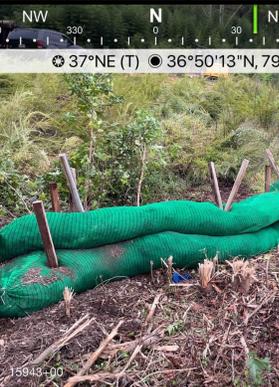
Performed SWPPP Inspection on this section. There were issues identified and added to the punch list. The Contractor is working on repairing the identified issues. The 3rd party damages were caused by the County mowing. Other than that there were no issues to report at the time of Inspection.

<p>ert image here</p>		
GPS Location	O		GPS Location	O	
Field Station#	15947+50		Field Station#	15947+50	
Pic 9 Desc.	Observing CFS that required maintenance (3rd party damage)		Pic 10 Desc.	Observing new CFS that was installed

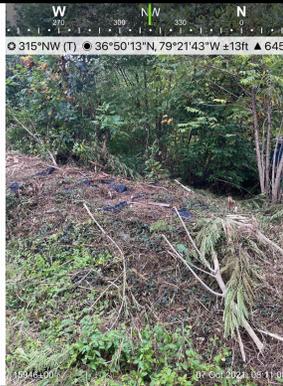
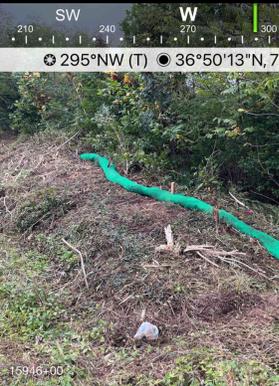
<p>ert image here</p>		
GPS Location	O		GPS Location	O	
Field Station#	15947+50		Field Station#	15947+50	
Pic 11 Desc.	Observing CFS that requires maintenance (3rd party damage)		Pic 12 Desc.	Observing new CFS that was installed

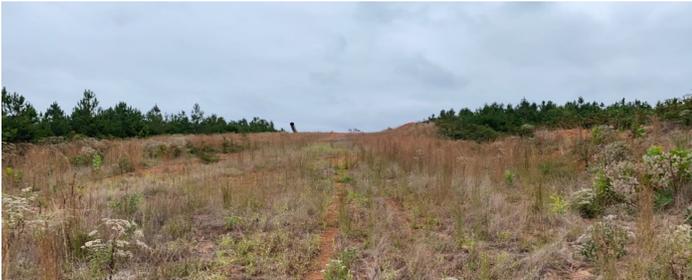
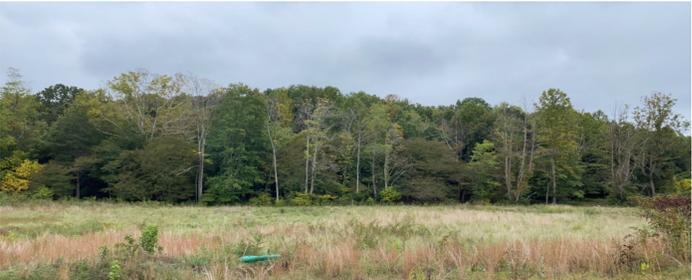
GPS Location	3		GPS Location	4	
Field Station#	15033+00		Field Station#	15043+00	
Pic 3 Desc.	Picture of temporary stabilization and vegetation along ROW		Pic 4 Desc.	Extra workspace stabilized and vegetated

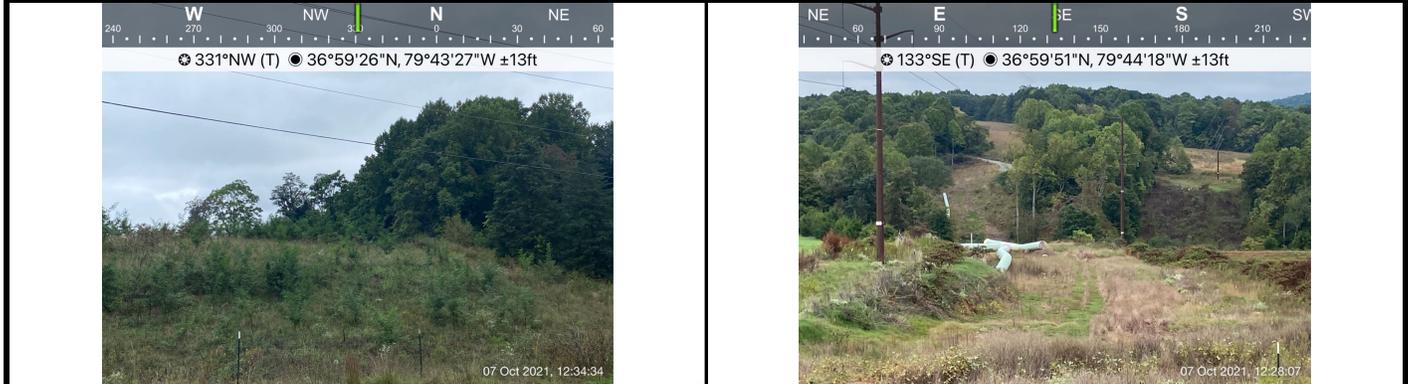
Pic 1 Desc.	Approximately 14646+00. Overview of ROW.	Pic 2 Desc.	Approximately 14603+00. Overview of ROW.
--------------------	--	--------------------	--

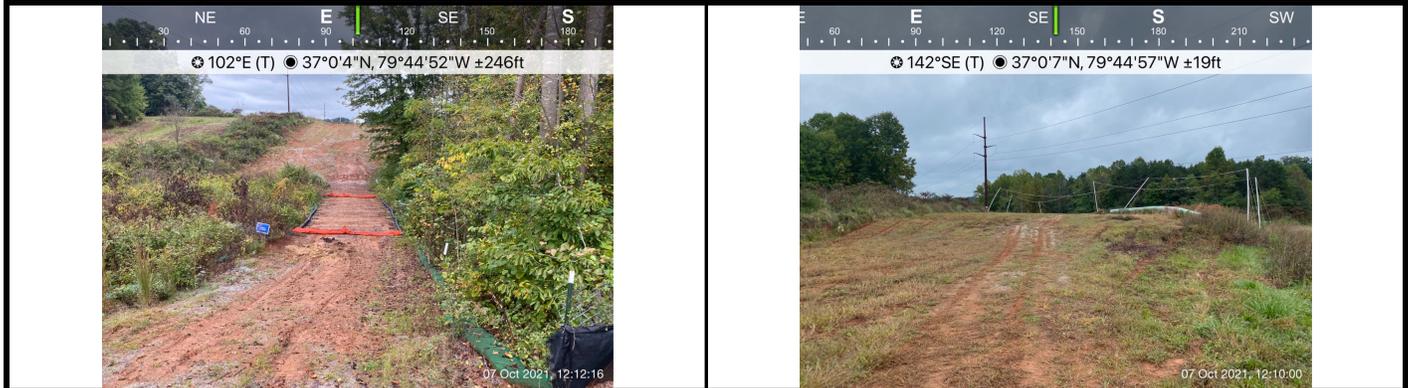
Pic 3 Desc.	Approximately 14568+10. Overview of stream crossing, equipment bridge and ECDs at stream S-E18.	Pic 4 Desc.	Approximately 14563+00. Overview of ROW.
--------------------	---	--------------------	--

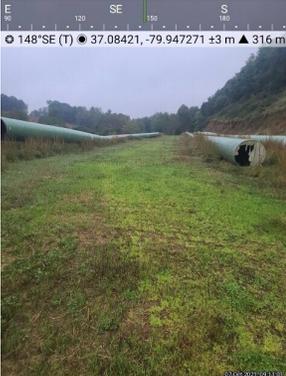
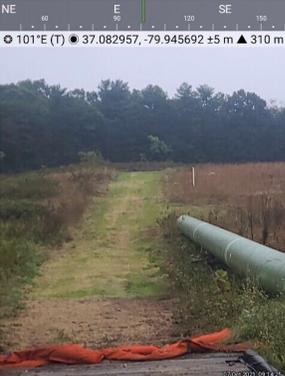
GPS Location	00000	GPS Location	0000		
Field Station#	13697+90	Field Station#	13705+40		
Pic 1 Desc.	Row photo taken during light rain events showing new winter vegetation growth.		Pic 2 Desc.	Photo showing new winter vegetation growth in area recently stabilized.

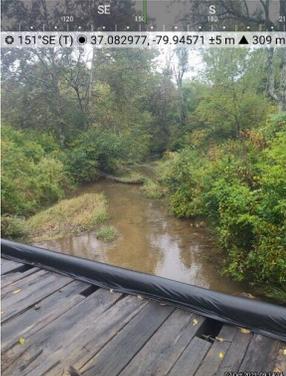
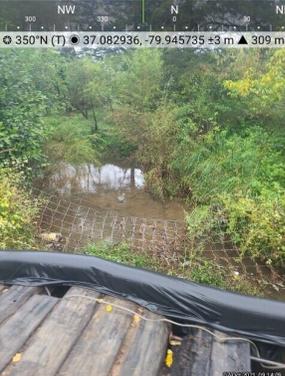
GPS Location	0000	GPS Location	0000		
Field Station#	13704+90	Field Station#	13704+90		
Pic 3 Desc.	Stream observation photo facing downstream during routine inspection today, no environmental issues observed at the time of inspection.		Pic 4 Desc.	Stream observation photo facing upstream during routine inspection today, no environmental issues observed at the time of inspection.

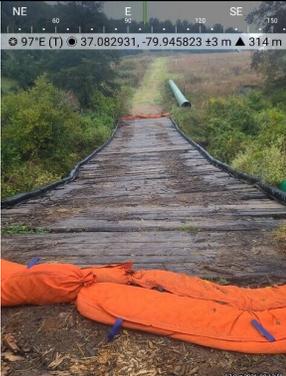
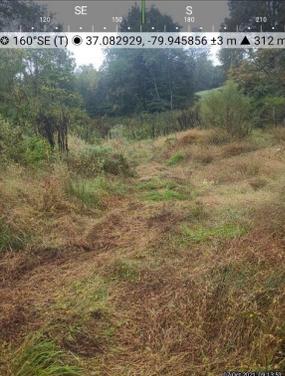
GPS Location	0000	GPS Location	00000		
Field Station#	13704+90	Field Station#	13704+08		
Pic 5 Desc.	Monitored equipment bridge and protection while inspection row conditions during rain events, no environmental issues observed at the time of inspection.		Pic 6 Desc.	Photo showing area where 3rd party mowing activities have been done inside the LOD in efforts to cross the row, documented as non project related activities.

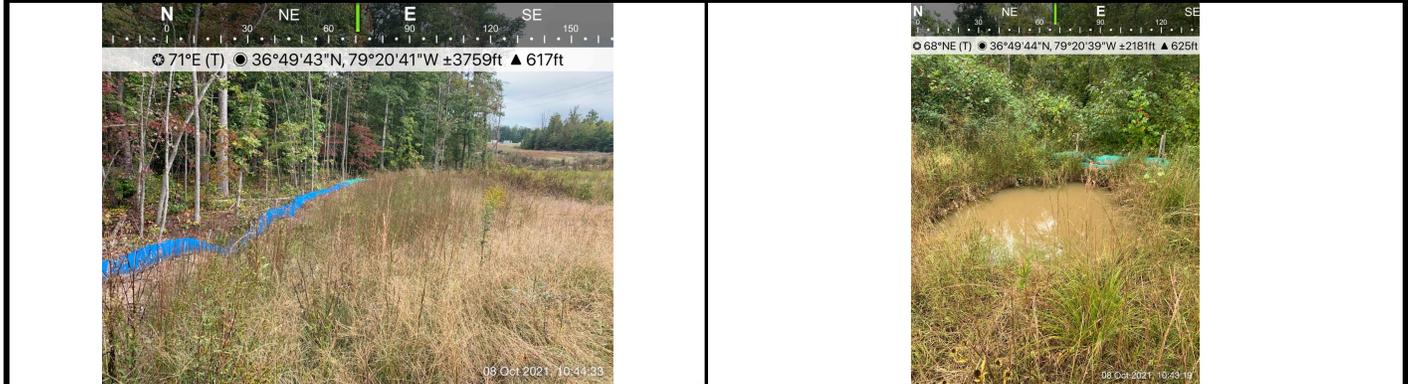
Field Station#	19+00
-----------------------	-------

Pic 1 Desc.	Observing temporary stabilization and ECD's
--------------------	---

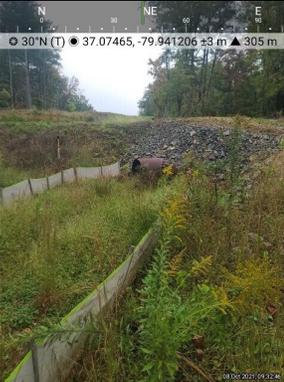
GPS Location	0000	GPS Location	0000
Field Station#	13748+97	Field Station#	13828+00
Pic 1 Desc.	Stream observation photo facing upstream during routine inspection today, ECDs in place at road crossing.	Pic 2 Desc.	Monitored ECDs along the edge of the LOD, no environmental issues observed at the time of inspection.

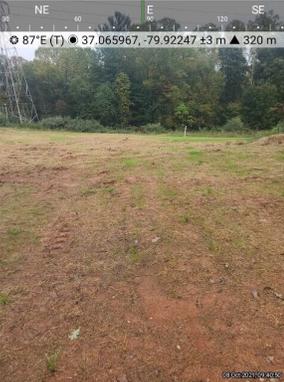
GPS Location	0000	GPS Location	0000
Field Station#	13826+85	Field Station#	13748+97
Pic 3 Desc.	Row photo showing new winter vegetation growth .	Pic 4 Desc.	Stream observation photo facing downstream during routine inspection today, no environmental issues observed at the time of inspection.

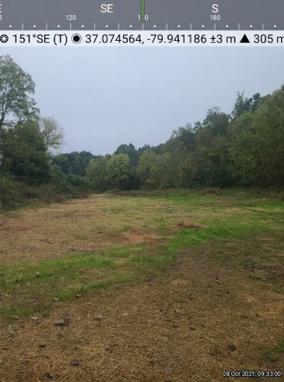
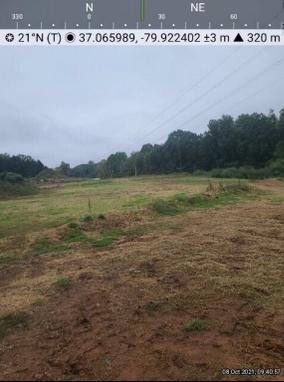
GPS Location	0000	GPS Location	0000
Field Station#	13749+50	Field Station#	13826+70
Pic 5 Desc.	Photo showing new vegetation growth in area recently stabilized for winter.	Pic 6 Desc.	Photo showing new vegetation growth in area recently stabilized for winter.

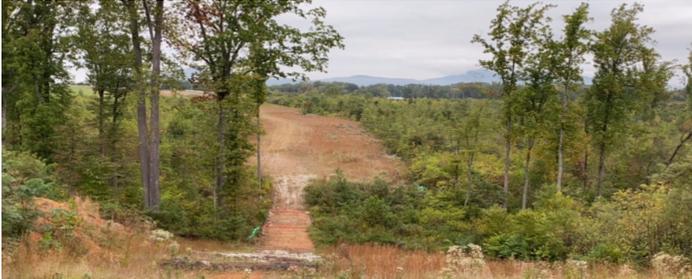
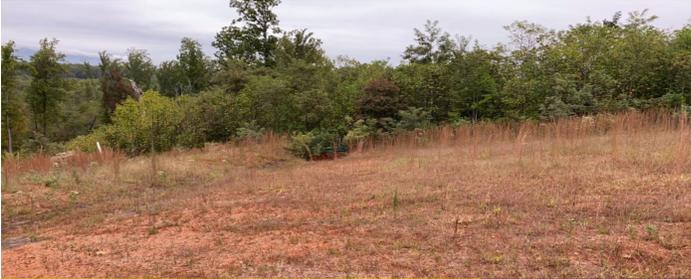
<small>36°57'5" N 79°34'49" W 344°N COURSE 327° GPS Sandy Level, VA 24161, United States</small>		<small>10.08.2021 09:12:52 Accur +/-15.4 Ft ALT 916 Ft</small>	<small>36°57'4" N 79°34'49" W 16°N COURSE 107° GPS Sandy Level, VA 24161, United States</small>		<small>10.08.2021 09:12:17 Accur +/-70.4 Ft ALT 895 Ft</small>
GPS Location	1		GPS Location	2	
Field Station#	15126+40		Field Station#	15129+00	
Pic 1 Desc.	Equipment bridge and surrounding ECDs in place and functional at stream crossing and resource buffer		Pic 2 Desc.	Water bar and perimeter controls performing intended functions

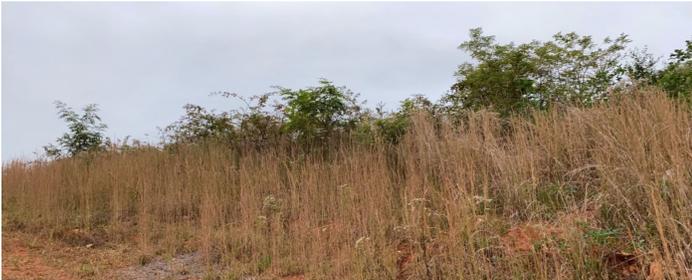
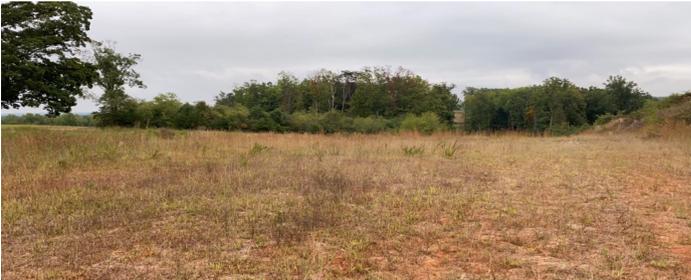
GPS Location	3		GPS Location	4	
Field Station#	15131+00		Field Station#	15134+00	
Pic 3 Desc.	Temporary diversion berm stabilized and vegetated		Pic 4 Desc.	Picture of temporary stabilization and vegetation along ROW; no issues observed

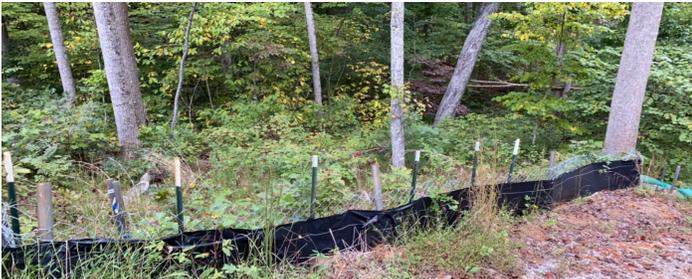
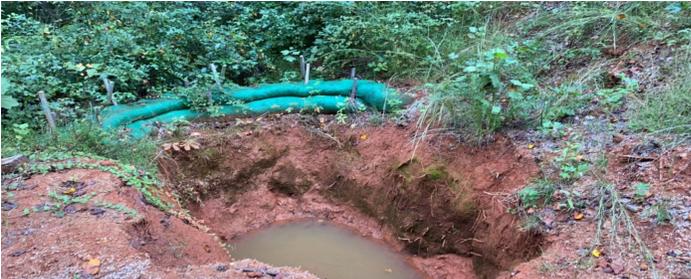
<small>36°56'54" N 79°34'43" W 313°NW COURSE 296° GPS 337-521 Rockcreek Rd, Sandy Level, VA 24161, United States</small>		<small>10.08.2021 08:57:22 Accur +/-49.9 Ft ALT 860 Ft</small>	<small>36°56'54" N 79°34'43" W 242°SW COURSE 325° GPS 337-521 Rockcreek Rd, Sandy Level, VA 24161, United States</small>		<small>10.08.2021 08:58:03 Accur +/-446.6 Ft ALT 860 Ft</small>
GPS Location	5		GPS Location	6	
Field Station#	15141+00		Field Station#	15139+00	
Pic 5 Desc.	Perimeter SSF in good condition		Pic 6 Desc.	Sump pit and CFS end treatment performing intended functions

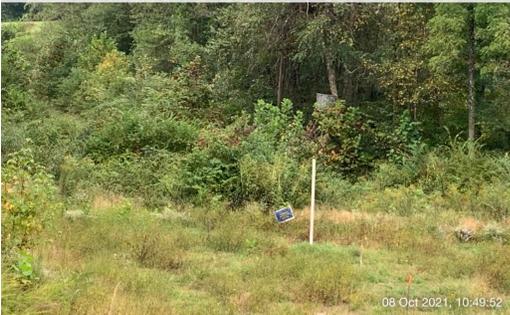
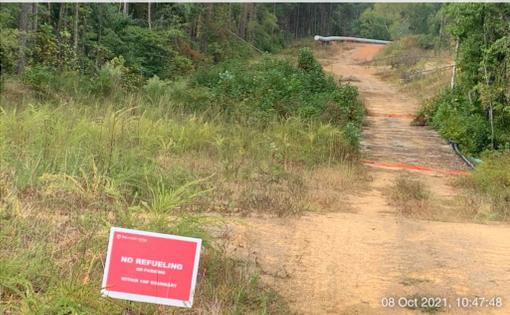
<small>08 Oct 2021, 10:47:48</small>	
GPS Location	O	GPS Location	O
Field Station#	16004+00	Field Station#	16016+36
Pic 1 Desc.	Observing temporary stabilization, signage and buffer	Pic 2 Desc.	Observing temporary stabilization, signage, buffer, equipment crossing and ECD's

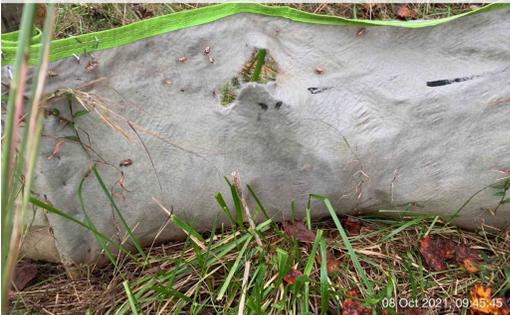
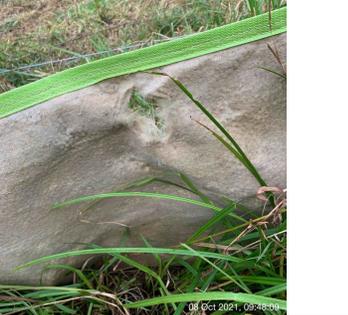
<small>08 Oct 2021, 09:38:00</small>	
GPS Location	O	GPS Location	O
Field Station#	15961+10	Field Station#	15961+30
Pic 3 Desc.	Observing P1 that requires maintenance (damaged by livestock)	Pic 4 Desc.	Observing P1 that requires maintenance

E&S BMPs	Compliance Level	Corrective Action	Corrective Time Frame	Date Repaired
Compost Filter Sock	Communication	Contractor performed maintenance		10/8/2021
Cleanwater Diversion Pipe	Acceptable			
Equipment Bridge	Acceptable			
Housekeeping	Acceptable			
Rock Filter Outlet	Acceptable			
Sediment Filter Log	Acceptable			
Sensitive Resource Buffer	Acceptable			
Sensitive Resource Signage	Acceptable			
Silt Fence (Filter Fabric Fence)	Communication	Contractor is working on repairs

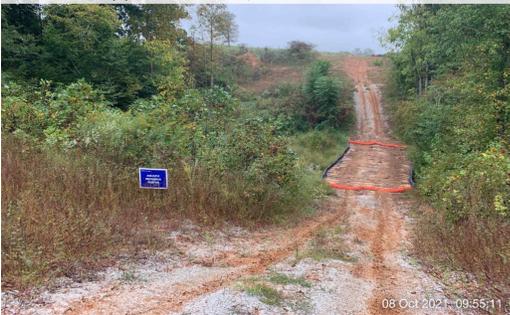
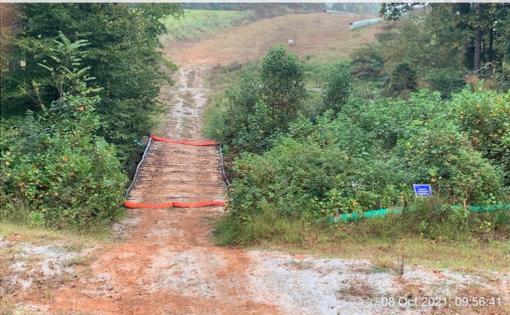
<small>08 Oct 2021, 09:56:41</small>	
GPS Location	O	GPS Location	O
Field Station#	15977+35	Field Station#	15987+31
Pic 5 Desc.	Observing temporary stabilization, signage, buffer, equipment crossing and ECD's	Pic 6 Desc.	Observing temporary stabilization, signage, buffer, equipment crossing and ECD's

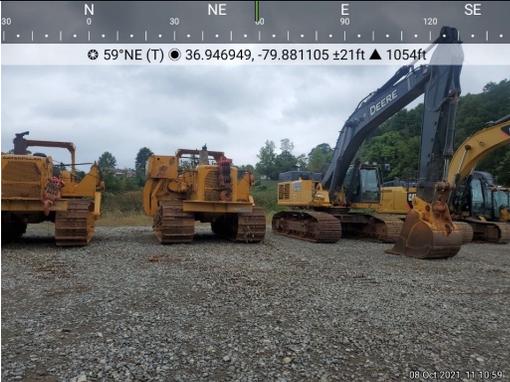
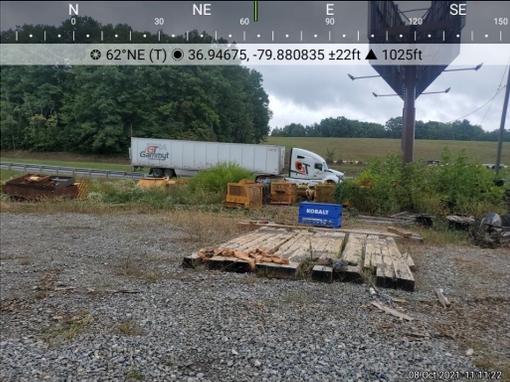
<p>62°NE (T) ● 36.94675, -79.880835 ±22ft ▲ 1025ft</p>	
GPS Location 0		GPS Location 0	
Field Station# 0+00		Field Station# 0+00	
Pic 1 Desc. LY-032 Equipment staging		Pic 2 Desc. LY-032 Housekeeping

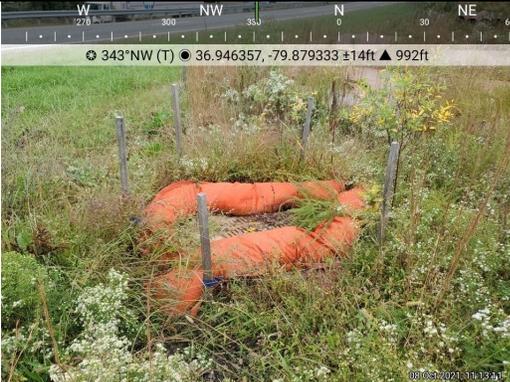
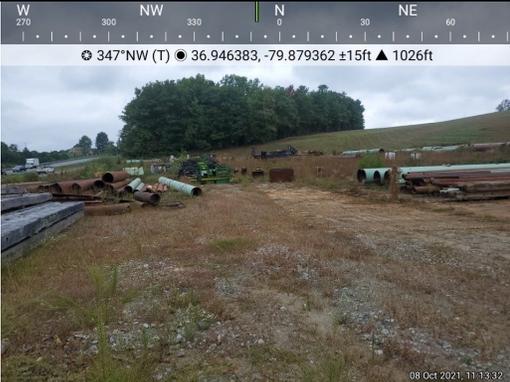
<p>347°NW (T) ● 36.946383, -79.879362 ±15ft ▲ 1026ft</p>	
GPS Location 0		GPS Location 0	
Field Station# 0+00		Field Station# 0+00	
Pic 3 Desc. LY-033 Stormwater drain inlet protection		Pic 4 Desc. LY-033 Staging area

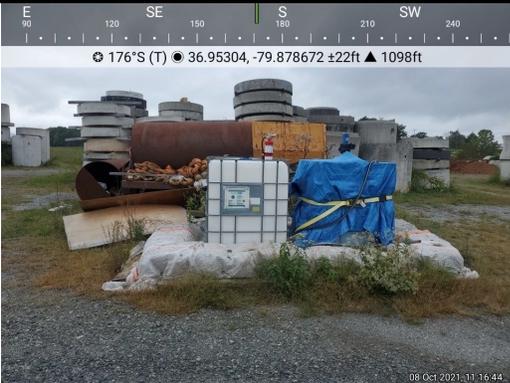
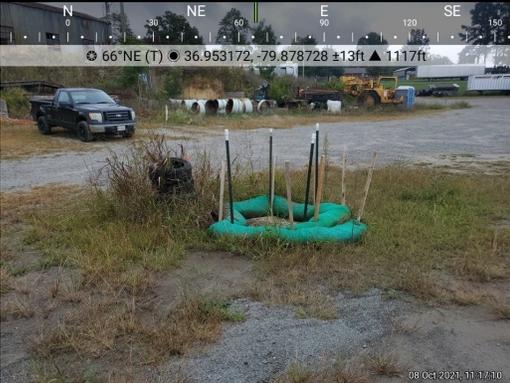
<p>66°NE (T) ● 36.953172, -79.878728 ±13ft ▲ 1117ft</p>	
GPS Location 0		GPS Location 0	
Field Station# 0+00		Field Station# 0+00	
Pic 5 Desc. ANC-006 Secondary containment		Pic 6 Desc. ANC-006 Stormwater drain inlet protection

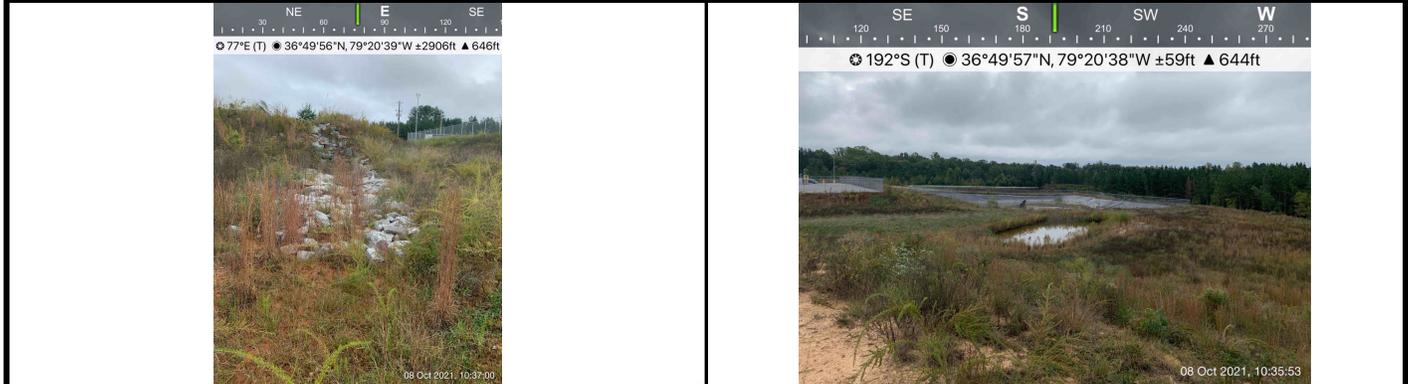
Pic 1 Desc.	Observing temporary stabilization and rock drain	Pic 2 Desc.	Observing temporary stabilization, sediment basin and storm water pond
--------------------	--	--------------------	--
