# Visual Site Inspection Report

<b>Project Name</b>	H-600 Pipeline Spread I	<b>AFE</b>	124300139	<b>Spread</b>	H-600 Pipeline Spread I
<b>Contractor</b>	Precision			<b>Report #</b>	30564
<b>Inspector</b>	Logan Box			<b>Date/Time</b>	11/1/2021 2:59 PM
<b>Permit #</b>	TBD	<b>Inspection Type</b>	VA SWPP	<b>Station Begin</b>	13748+30
<b>State</b>	VA	<b>Inspection Area</b>	Partial	<b>Station End</b>	13853+45
<b>County</b>	Franklin	<b>Ground</b>	Damp	<b>Temperature (°F)</b>	65.00
<b>Municipality</b>	N/A	<b>Weather</b>	Cloudy	<b>Rain Gauge (in)</b>	0.00
				<b>Rain Accumulation Time (days)</b>	0.00

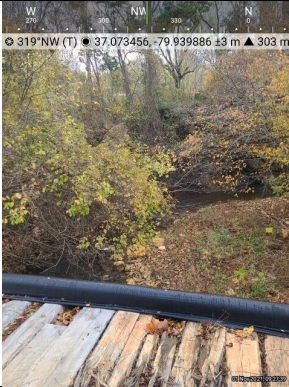
<b>GPS Location</b>	00000	<b>GPS Location</b>	00000		
<b>Field Station#</b>	13755+49	<b>Field Station#</b>	13770+69		
<b>Pic 1 Desc.</b>	Stream observation photo facing downstream during routine inspection. No environmental issues observed at the time of inspection.		<b>Pic 2 Desc.</b>	Stream observation photo facing downstream during routine inspection today.

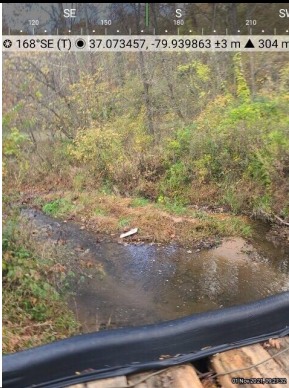
<b>GPS Location</b>	0000	<b>GPS Location</b>	00000		
<b>Field Station#</b>	13770+70	<b>Field Station#</b>	1376+90		
<b>Pic 3 Desc.</b>	Monitored equipment bridge and protection, observed ECDs in the stream crossing area. No environmental issues observed at the time of inspection.		<b>Pic 4 Desc.</b>	Observed ECDs and temporary stabilization throughout. No environmental issues observed at the time of inspection.

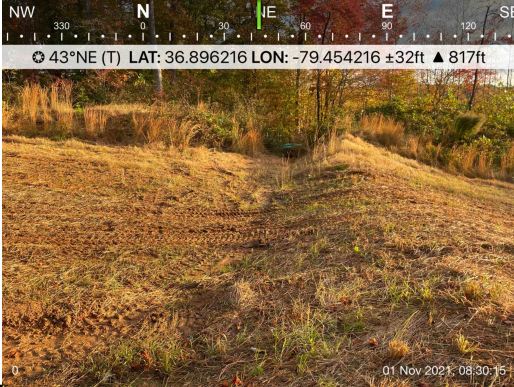
<b>GPS Location</b>	See photo		<b>GPS Location</b>	See photo	
<b>Field Station#</b>	15584+00		<b>Field Station#</b>	15574+87	
<b>Pic 1 Desc.</b>	P1 is in good condition around road pipe outlet.		<b>Pic 2 Desc.</b>	Slope drain is in good condition and functioning as intended.

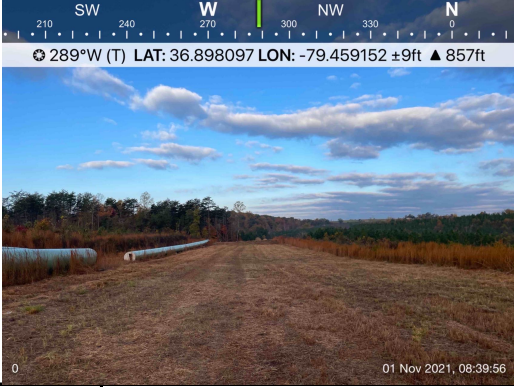
<b>GPS Location</b>	See photo		<b>GPS Location</b>	See photo	
<b>Field Station#</b>	15571+00		<b>Field Station#</b>	15556+83	
<b>Pic 3 Desc.</b>	Waterbars are in good condition throughout this section.		<b>Pic 4 Desc.</b>	No evidence of sedimentation from 3rd party disturbance.

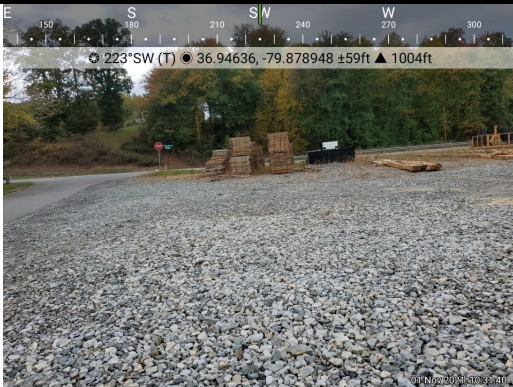
GPS Location	0	GPS Location	0		
Field Station#	0+00	Field Station#	0+00		
Pic 3 Desc.	LY-033 Rock construction entrance	Pic 4 Desc.	LY-033 Stormwater drain inlet protection

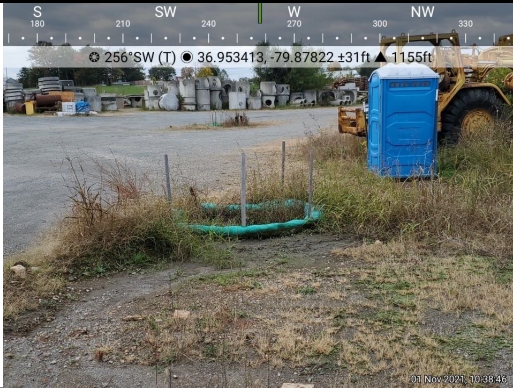
GPS Location	0	GPS Location	0		
Field Station#	0+00	Field Station#	0+00		
Pic 5 Desc.	ANC-006 Stormwater drain inlet protection	Pic 6 Desc.	ANC-006 Waste management

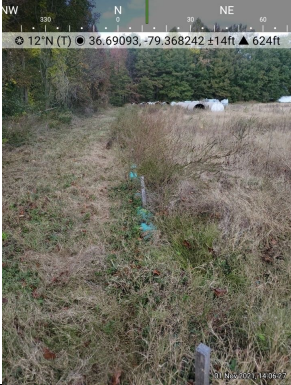
<b>GPS Location</b>	0	<b>GPS Location</b>	0		
<b>Field Station#</b>	0+00	<b>Field Station#</b>	0+00		
<b>Pic 7 Desc.</b>	LY-048 West perimeter CFS	<b>Pic 8 Desc.</b>	LY-048 Equipment staging		
Insert image here		Insert image here			
<b>GPS Location</b>		<b>GPS Location</b>			
<b>Field Station#</b>		<b>Field Station#</b>			
<b>Pic 9 Desc.</b>		<b>Pic 10 Desc.</b>			
Insert image here		Insert image here			
<b>GPS Location</b>		<b>GPS Location</b>			
<b>Field Station#</b>		<b>Field Station#</b>			
<b>Pic 11 Desc.</b>		<b>Pic 12 Desc.</b>

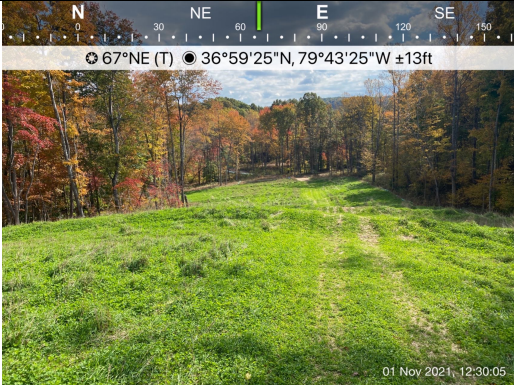
<b>GPS Location</b>	0	<b>GPS Location</b>	0		
<b>Field Station#</b>	14652+00	<b>Field Station#</b>	14673+10		
<b>Pic 1 Desc.</b>	Approximately 14652+00. Overview of ROW.	<b>Pic 2 Desc.</b>	Approximately 14673+10. Overview of stream crossing, equipment bridge and ECDs at stream S-H37.

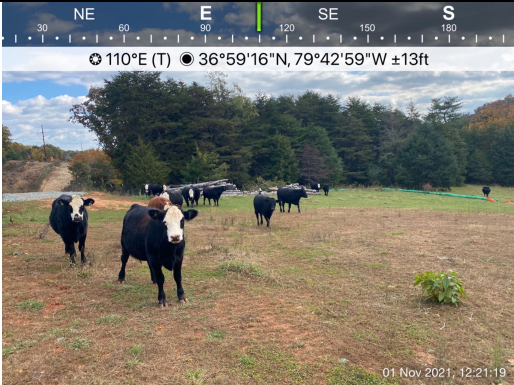
<b>GPS Location</b>	0	<b>GPS Location</b>	0		
<b>Field Station#</b>	14676+50	<b>Field Station#</b>	14689+36		
<b>Pic 3 Desc.</b>	Approximately 14676+50. Overview of ROW.	<b>Pic 4 Desc.</b>	Approximately 14689+36. Overview of stream crossing, equipment bridge and ECDs at stream S-H34.

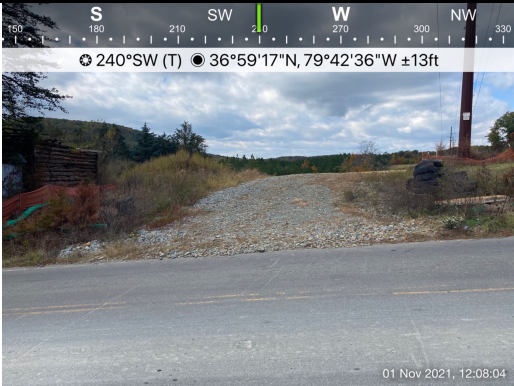
<b>GPS Location</b>	0	<b>GPS Location</b>	0		
<b>Field Station#</b>	14694+50	<b>Field Station#</b>	14691+00		
<b>Pic 5 Desc.</b>	Approximately 14694+50. Overview of road crossing and RCE.	<b>Pic 6 Desc.</b>	Approximately 14691+00. Overview of ROW.

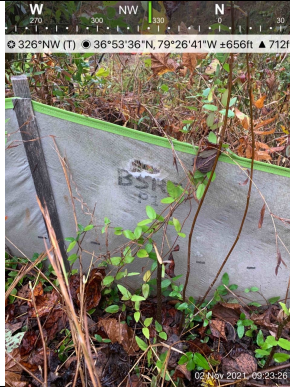
<b>GPS Location</b>	O	<b>GPS Location</b>	O		
<b>Field Station#</b>	15595+00	<b>Field Station#</b>	15601+00		
<b>Pic 1 Desc.</b>	Observing water bar that requires stabilization and curlex installed		<b>Pic 2 Desc.</b>	Observing P1 that requires maintenance

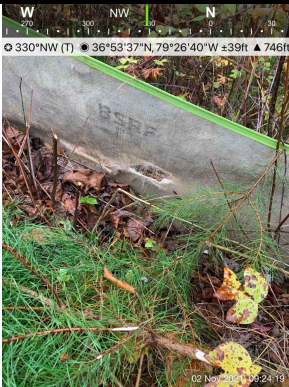
<b>GPS Location</b>	O	<b>GPS Location</b>	O		
<b>Field Station#</b>	15601+00	<b>Field Station#</b>	15602+00		
<b>Pic 3 Desc.</b>	Observing P1 that requires maintenance		<b>Pic 4 Desc.</b>	Observing P1 that requires maintenance

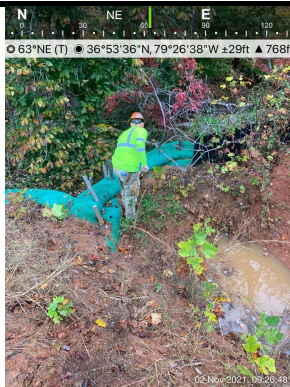
<b>GPS Location</b>	O	<b>GPS Location</b>	O		
<b>Field Station#</b>	15603+00	<b>Field Station#</b>	15603+50		
<b>Pic 5 Desc.</b>	Observing CFS that requires maintenance		<b>Pic 6 Desc.</b>	Observing the Contractor performing ECD maintenance

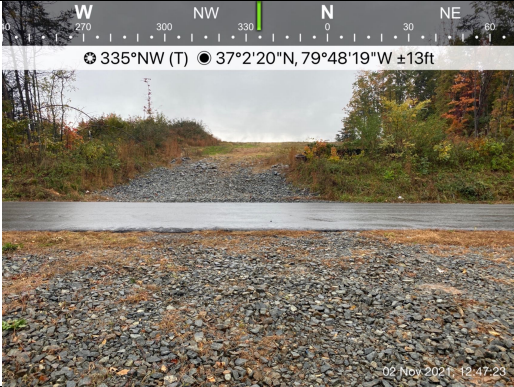
<b>GPS Location</b>	0	<b>GPS Location</b>	0		
<b>Field Station#</b>	14333+00	<b>Field Station#</b>	14314+79		
<b>Pic 1 Desc.</b>	Approximately 14333+00. Overview of road crossing and RCEs.	<b>Pic 2 Desc.</b>	Approximately 14314+79. Overview of stream crossing, equipment bridge and ECDs at stream S-GG4.

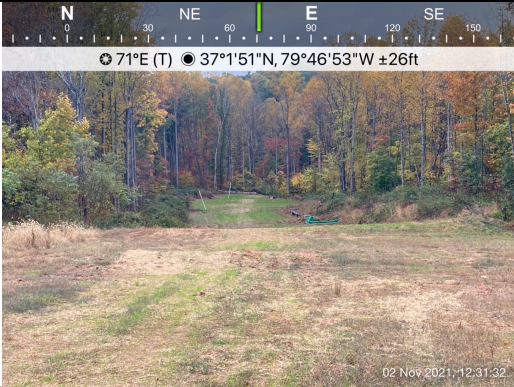
<b>GPS Location</b>	0	<b>GPS Location</b>	0		
<b>Field Station#</b>	14415+00	<b>Field Station#</b>	14451+00		
<b>Pic 3 Desc.</b>	Approximately 14415+00. Overview of ROW.	<b>Pic 4 Desc.</b>	Approximately 14451+00. Overview of ROW.

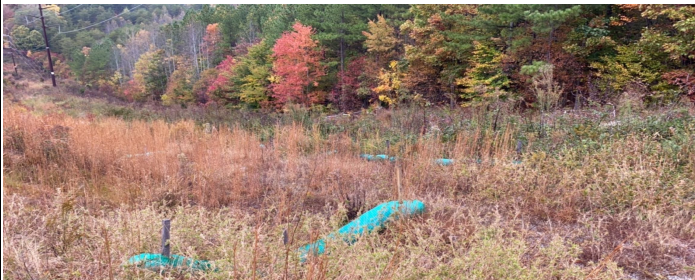
11.02.2021 10:38:13 Accur +/-20.6 Ft ALT 931 Ft			11.02.2021 10:37:34 Accur +/-374.3 Ft ALT 896 Ft		
<b>GPS Location</b>	1	<b>GPS Location</b>	2		
<b>Field Station#</b>	14737+00	<b>Field Station#</b>	14743+00		
<b>Pic 1 Desc.</b>	Contractor repaired CFS check dam per punch list item		<b>Pic 2 Desc.</b>	Contractor repaired safety fence per punch list item

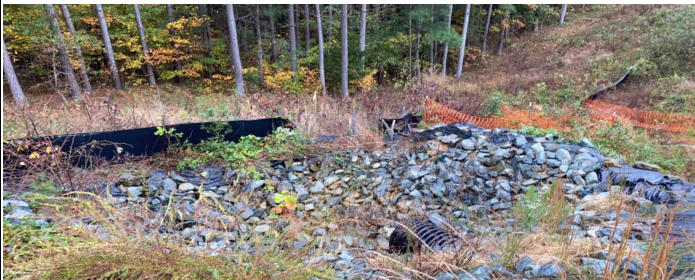
11.02.2021 10:35:45 Accur +/-2004.4 Ft ALT 896 Ft			11.02.2021 10:30:25 Accur +/-71.2 Ft ALT 954 Ft		
<b>GPS Location</b>	3	<b>GPS Location</b>	4		
<b>Field Station#</b>	14742+00	<b>Field Station#</b>	14754+00		
<b>Pic 3 Desc.</b>	Plunge pool performing intended function		<b>Pic 4 Desc.</b>	Contractor repaired erosion and seeded and stabilized disturbed area per punch list item

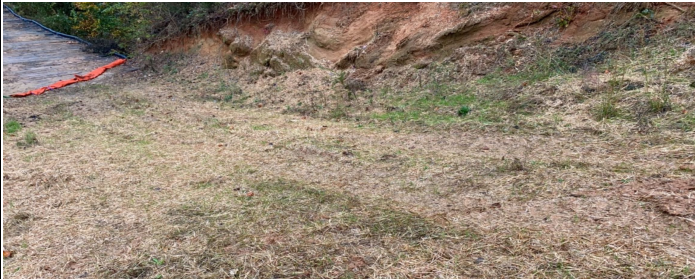
11.02.2021 10:51:15 Accur +/-107.5 Ft ALT 940 Ft			11.02.2021 10:52:17 Accur +/-656.2 Ft ALT 936 Ft		
<b>GPS Location</b>	5	<b>GPS Location</b>	6		
<b>Field Station#</b>	14765+75	<b>Field Station#</b>	14766+50		
<b>Pic 5 Desc.</b>	Vegetation beginning to grow in travel lane where recently seeded and stabilized		<b>Pic 6 Desc.</b>	Contractor repaired perimeter P1 silt fence per punch list item

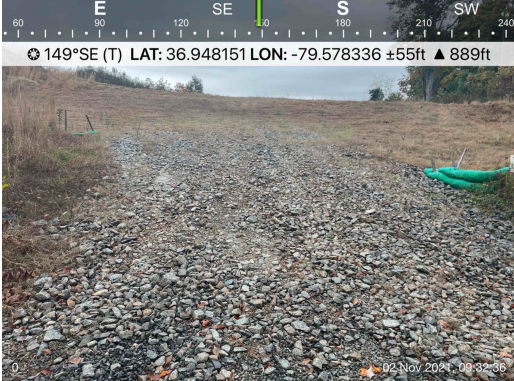
<b>GPS Location</b>	See photo	<b>GPS Location</b>	See photo		
<b>Field Station#</b>	15142+66	<b>Field Station#</b>	15152+00		
<b>Pic 1 Desc.</b>	RCE is in good condition at Rockcreek Rd.	<b>Pic 2 Desc.</b>	Perimeter CFS is in good condition throughout this section.

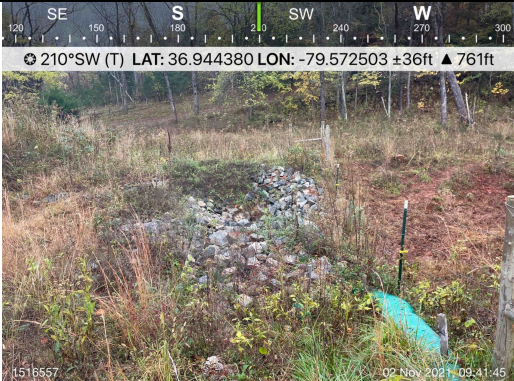
<b>GPS Location</b>	See photo	<b>GPS Location</b>	See photo		
<b>Field Station#</b>	15165+57	<b>Field Station#</b>	15166+00		
<b>Pic 3 Desc.</b>	Rock filter inlet remains in good condition.	<b>Pic 4 Desc.</b>	Rock filter outlet remains in good condition

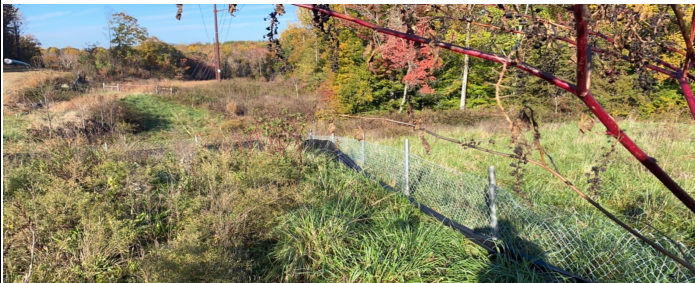
Pic 3 Desc.	Routine maintenance. SSF needs fabric reattached to fencing.		Pic 4 Desc.	Contractor replaced P1 silt fence per punch list item.

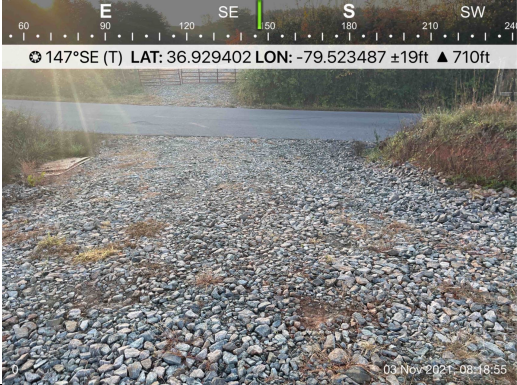
<b>GPS Location</b>	See photo		<b>GPS Location</b>	See photo	
<b>Field Station#</b>	15323+24		<b>Field Station#</b>	15338+00	
<b>Pic 7 Desc.</b>	RCEs are in good condition at all road crossings.		<b>Pic 8 Desc.</b>	CWD remains in good condition.

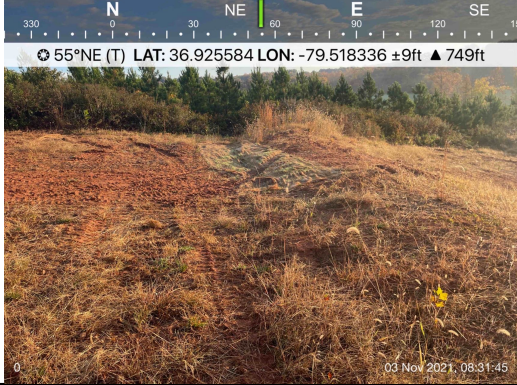
<b>GPS Location</b>	See photo		<b>GPS Location</b>	See photo	
<b>Field Station#</b>	15343+00		<b>Field Station#</b>	15346+00	
<b>Pic 9 Desc.</b>	Waterbars are in good condition throughout this section.		<b>Pic 10 Desc.</b>	P1 is in good condition at all stream and wetland buffers.

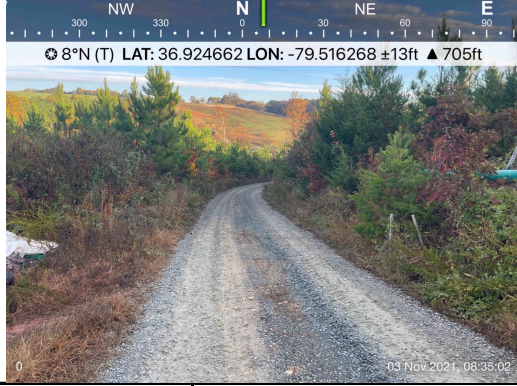
<b>GPS Location</b>	See photo		<b>GPS Location</b>	See photo	
<b>Field Station#</b>	15350+00		<b>Field Station#</b>	15360+00	
<b>Pic 11 Desc.</b>	MVP-PI-332 remains in good condition with controls in place.		<b>Pic 12 Desc.</b>	Vegetation continues to fill in throughout this section.

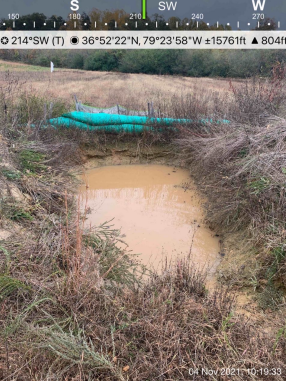
<b>GPS Location</b>	O	<b>GPS Location</b>	O		
<b>Field Station#</b>	15780+00	<b>Field Station#</b>	15782+00		
<b>Pic 1 Desc.</b>	Observing temporary stabilization, sump and end treatment	<b>Pic 2 Desc.</b>	Observing P1 that requires maintenance

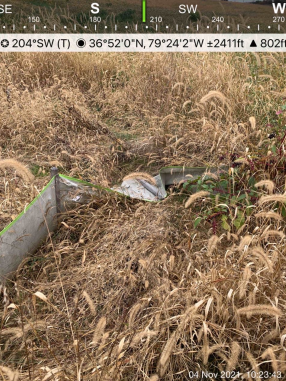
<b>GPS Location</b>	O	<b>GPS Location</b>	O		
<b>Field Station#</b>	15782+50	<b>Field Station#</b>	15784+00		
<b>Pic 3 Desc.</b>	Observing P1 that requires maintenance	<b>Pic 4 Desc.</b>	Observing CFS that requires maintenance

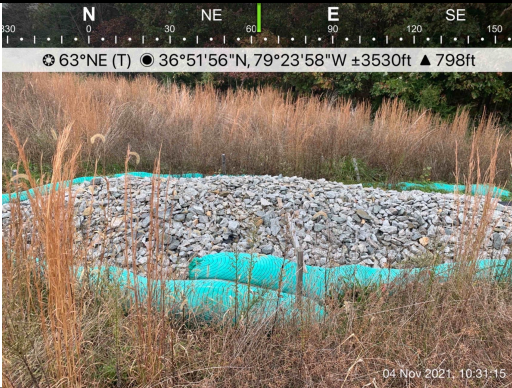
<b>GPS Location</b>	O	<b>GPS Location</b>	O		
<b>Field Station#</b>	15786+00	<b>Field Station#</b>	15794+77		
<b>Pic 5 Desc.</b>	Observing temporary stabilization, CWD outlet and ECD's	<b>Pic 6 Desc.</b>	Observing temporary stabilization, signage, buffer, equipment crossing and ECD's

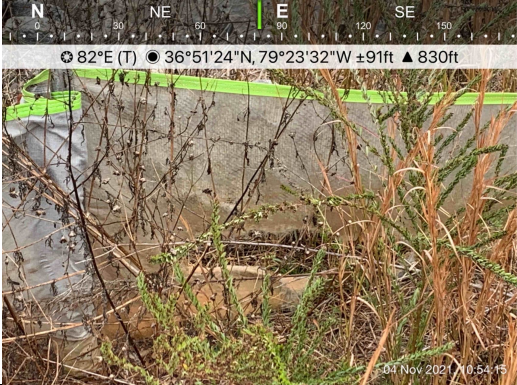
<b>GPS Location</b>	O	<b>GPS Location</b>	O		
<b>Field Station#</b>	15825+00	<b>Field Station#</b>	15826+77		
<b>Pic 7 Desc.</b>	Observing P1 that requires maintenance	<b>Pic 8 Desc.</b>	Observing road crossing and RCE's

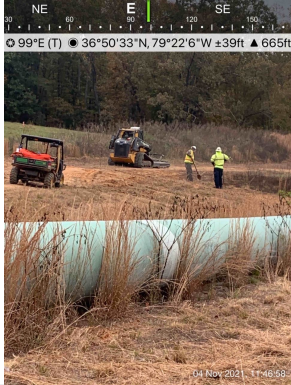
<b>GPS Location</b>	O	<b>GPS Location</b>	O		
<b>Field Station#</b>	15920+00	<b>Field Station#</b>	15840+00		
<b>Pic 9 Desc.</b>	Observing the Contractor mowing the ROW	<b>Pic 10 Desc.</b>	Observing temporary stabilization,CWD outlet and ECD's		
Insert image here		Insert image here			
<b>GPS Location</b>		<b>GPS Location</b>			
<b>Field Station#</b>		<b>Field Station#</b>			
<b>Pic 11 Desc.</b>		<b>Pic 12 Desc.</b>

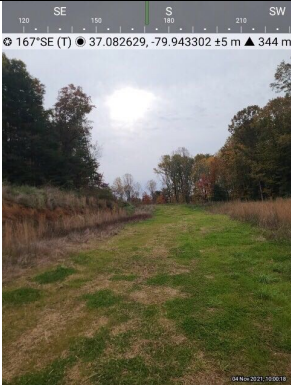
<b>GPS Location</b>	0000	<b>GPS Location</b>	0000		
<b>Field Station#</b>	13710+00	<b>Field Station#</b>	13700+00		
<b>Pic 1 Desc.</b>	Vegetation observation photo showing good temporary coverage.		<b>Pic 2 Desc.</b>	Vegetation observation photo showing good temporary coverage.

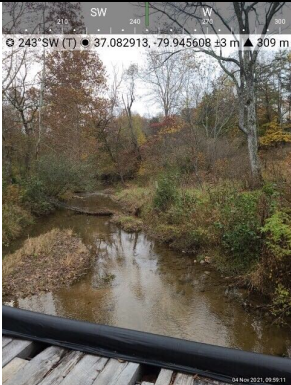
<b>GPS Location</b>	0000	<b>GPS Location</b>	0000		
<b>Field Station#</b>	13705+07	<b>Field Station#</b>	13705+07		
<b>Pic 3 Desc.</b>	Stream observation photo facing downstream during routine inspection today, no environmental issues observed at the time of inspection.		<b>Pic 4 Desc.</b>	Stream observation photo facing upstream during routine inspection today. No environmental issues observed at the time of inspection.

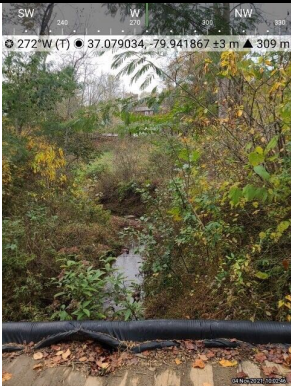
<b>Pic 5 Desc.</b>	Stream observation photo facing downstream during routine inspection today. No environmental issues observed at the time of inspection.		<b>Pic 6 Desc.</b>	Stream observation photo facing upstream during routine inspection today, no environmental issues observed at the time of inspection.

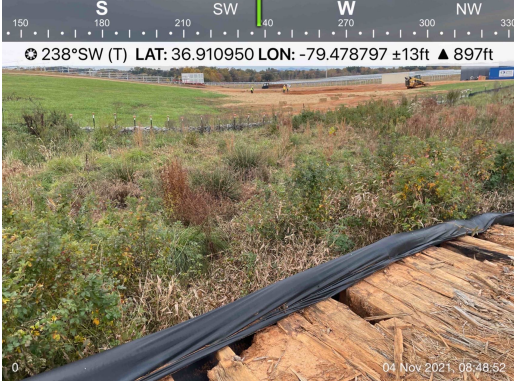
<b>GPS Location</b>	See photo		<b>GPS Location</b>	See photo	
<b>Field Station#</b>	15475+00		<b>Field Station#</b>	15465+00	
<b>Pic 1 Desc.</b>	3rd party rock outlet appears to be in good condition.		<b>Pic 2 Desc.</b>	No evidence of sedimentation from 3rd party disturbance.

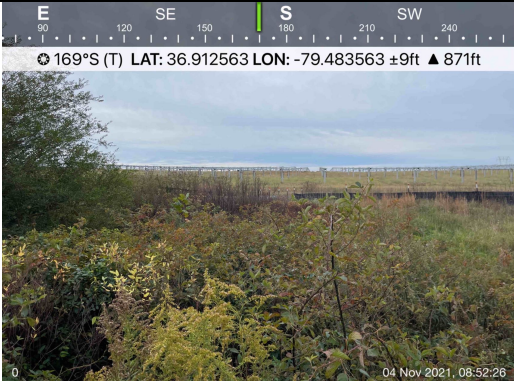
<b>GPS Location</b>	See photo		<b>GPS Location</b>	See photo	
<b>Field Station#</b>	15460+81		<b>Field Station#</b>	15460+81	
<b>Pic 3 Desc.</b>	No evidence of sedimentation from 3rd party disturbance into CWD inlet.		<b>Pic 4 Desc.</b>	CWD remains in good condition.

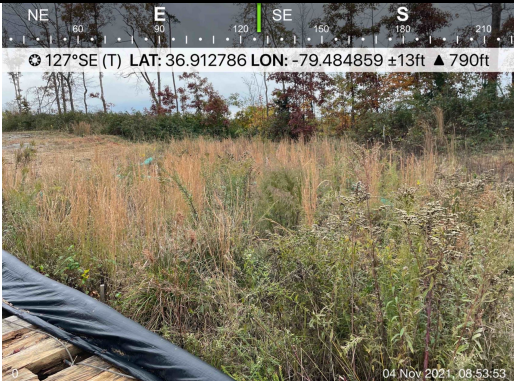
<b>GPS Location</b>	See photo		<b>GPS Location</b>	See photo	
<b>Field Station#</b>	15457+00		<b>Field Station#</b>	15453+00	
<b>Pic 5 Desc.</b>	No evidence of sedimentation within drainage feature		<b>Pic 6 Desc.</b>	CWD remains in good condition.

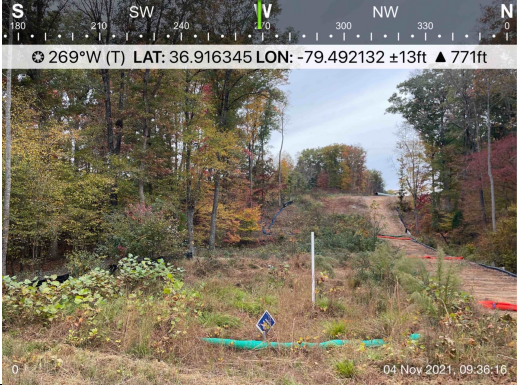
<b>GPS Location</b>	See photo	<b>GPS Location</b>	See photo		
<b>Field Station#</b>	15414+50	<b>Field Station#</b>	15414+50		
<b>Pic 13 Desc.</b>	Resource buffers remain in good condition.	<b>Pic 14 Desc.</b>	Equipment bridge ECDs are in place and functioning.

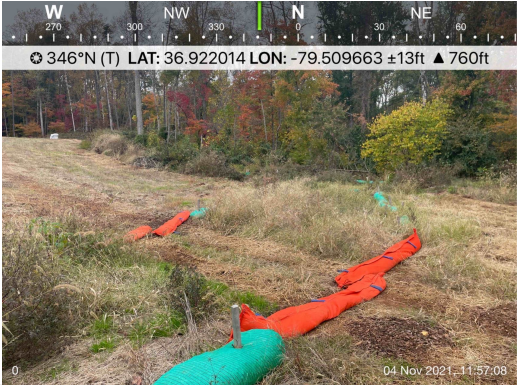
<div style="text-align: center;">Insert image here</div>			
<b>GPS Location</b>	See photo	<b>GPS Location</b>			
<b>Field Station#</b>	15375+00	<b>Field Station#</b>			
<b>Pic 15 Desc.</b>	Drainage ECDs are in good condition and functioning.	<b>Pic 16 Desc.</b>			
<div style="text-align: center;">Insert image here</div>		<div style="text-align: center;">Insert image here</div>			
<b>GPS Location</b>		<b>GPS Location</b>			
<b>Field Station#</b>		<b>Field Station#</b>			
<b>Pic 17 Desc.</b>		<b>Pic 18 Desc.</b>

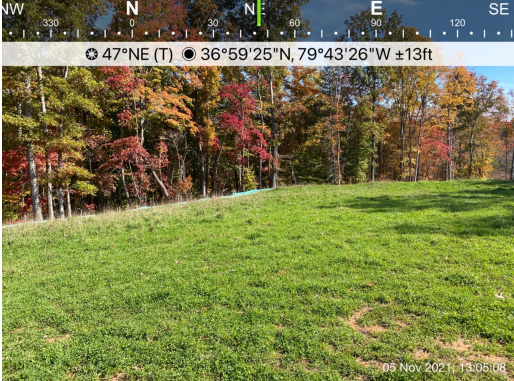
<b>GPS Location</b>	0	<b>GPS Location</b>	0		
<b>Field Station#</b>	14651+00	<b>Field Station#</b>	14673+10		
<b>Pic 1 Desc.</b>	Approximately 14651+00. Overview of ROW.	<b>Pic 2 Desc.</b>	Approximately 14673+10. Overview of stream crossing, equipment bridge and ECDs at stream S-H37.

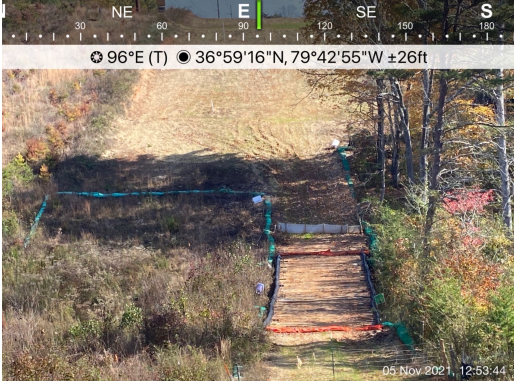
<b>GPS Location</b>	0	<b>GPS Location</b>	0		
<b>Field Station#</b>	14680+30	<b>Field Station#</b>	14689+36		
<b>Pic 3 Desc.</b>	Approximately 14680+30. Overview of stream crossing, equipment bridge and ECDs at stream S-H36.	<b>Pic 4 Desc.</b>	Approximately 14689+36. Overview of stream crossing, equipment bridge and ECDs at stream S-H34.

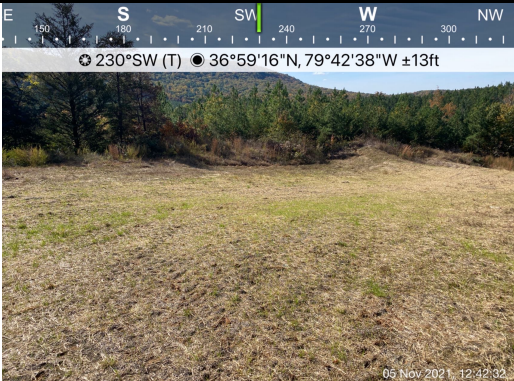
<b>GPS Location</b>	0	<b>GPS Location</b>	0		
<b>Field Station#</b>	14692+00	<b>Field Station#</b>	14694+60		
<b>Pic 5 Desc.</b>	Approximately 14692+00. Overview of ROW.	<b>Pic 6 Desc.</b>	Approximately 14694+60. Overview road crossing and RCE.

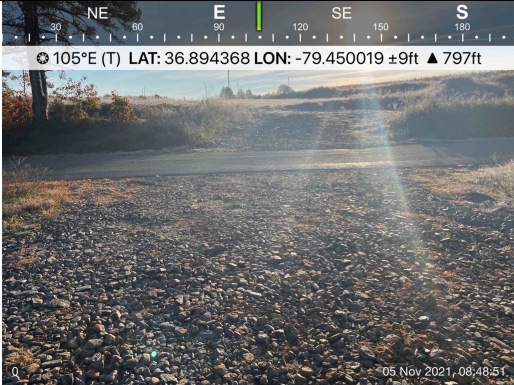
<b>GPS Location</b>	See photo		<b>GPS Location</b>	See photo	
<b>Field Station#</b>	15584+23		<b>Field Station#</b>	15584+00	
<b>Pic 1 Desc.</b>	RCEs are in good condition at all road crossings.		<b>Pic 2 Desc.</b>	P1 is in good condition around road pipe outlet.

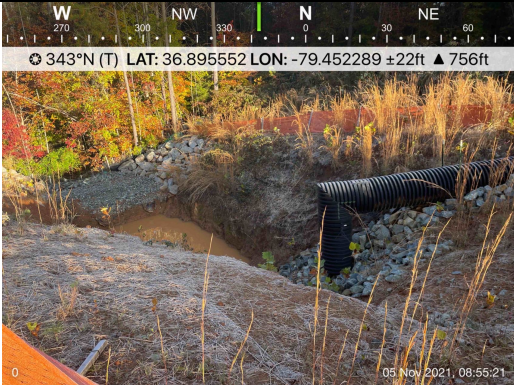
<b>GPS Location</b>	See photo		<b>GPS Location</b>	See photo	
<b>Field Station#</b>	15575+00		<b>Field Station#</b>	15556+83	
<b>Pic 3 Desc.</b>	Slope drain is in good condition and functioning.		<b>Pic 4 Desc.</b>	No evidence of sedimentation from 3rd party disturbance.

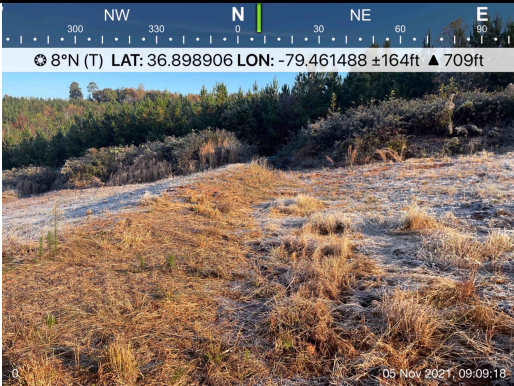
<b>GPS Location</b>	See photo		<b>GPS Location</b>	See photo	
<b>Field Station#</b>	15545+00		<b>Field Station#</b>	15542+00	
<b>Pic 5 Desc.</b>	Waterbars are functioning as intended.		<b>Pic 6 Desc.</b>	Equipment bridge ECDs are in place and functioning.

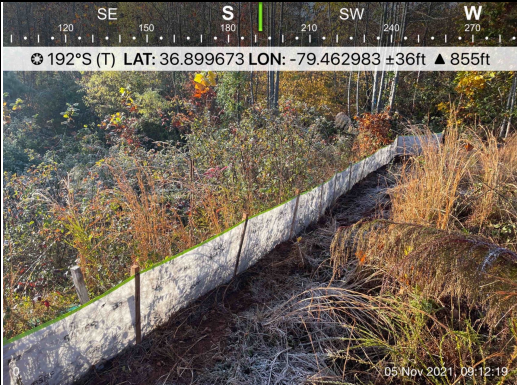
GPS Location	See photo		GPS Location	See photo	
Field Station#	15540+00		Field Station#	15515+00	
Pic 7 Desc.	P1 is in good condition at all stream and wetland buffers.		Pic 8 Desc.	CWDs are functioning as intended.

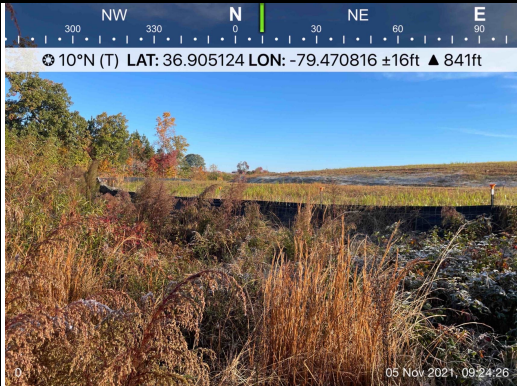
GPS Location	See photo		GPS Location	See photo	
Field Station#	15510+00		Field Station#	15501+00	
Pic 9 Desc.	3rd party ECDs appear to be in good condition.		Pic 10 Desc.	No evidence of sedimentation from 3rd party disturbance.

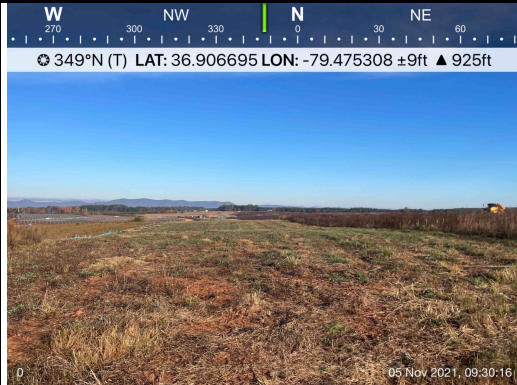
<div>Insert image here</div>			
GPS Location	See photo		GPS Location		
Field Station#	15495+00		Field Station#		
Pic 11 Desc.	Vegetation continues to fill in throughout this section.		Pic 12 Desc.

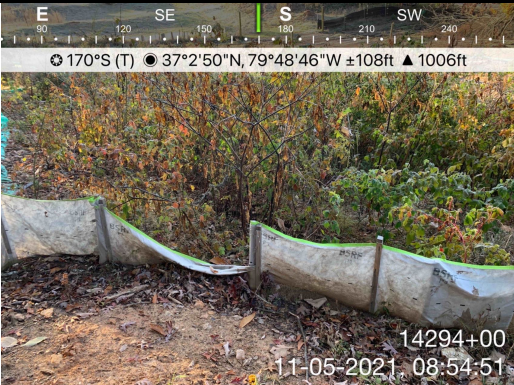
GPS Location		0		GPS Location	
Field Station#		14295+00		14294+00	
Pic 1 Desc.		P1 silt fence damaged by livestock		Pic 2 Desc.

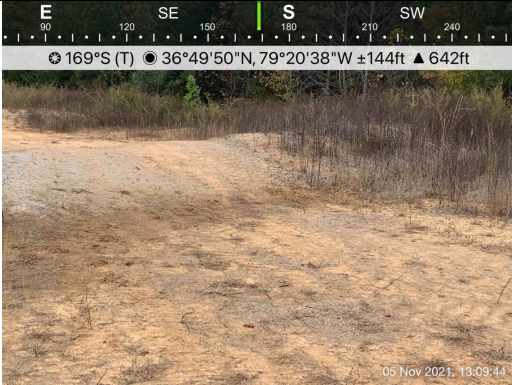
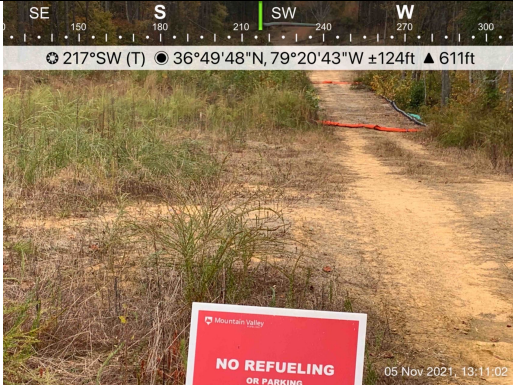
<b>GPS Location</b>	O	<b>GPS Location</b>	O		
<b>Field Station#</b>	16023+00	<b>Field Station#</b>	16016+36		
<b>Pic 1 Desc.</b>	Observing temporary stabilization and water bar	<b>Pic 2 Desc.</b>	Observing temporary stabilization, signage, buffer, equipment crossing and ECD's

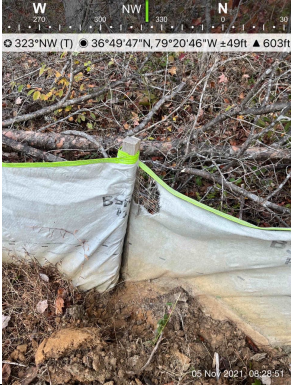
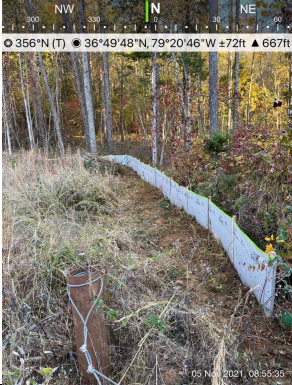
<b>GPS Location</b>	O	<b>GPS Location</b>	O		
<b>Field Station#</b>	16015+50	<b>Field Station#</b>	16015+50		
<b>Pic 7 Desc.</b>	Observing p1 that required maintenance	<b>Pic 8 Desc.</b>	Observing new p1		
Insert image here		Insert image here			
<b>GPS Location</b>		<b>GPS Location</b>			
<b>Field Station#</b>		<b>Field Station#</b>			
<b>Pic 9 Desc.</b>		<b>Pic 10 Desc.</b>			
Insert image here		Insert image here			
<b>GPS Location</b>		<b>GPS Location</b>			
<b>Field Station#</b>		<b>Field Station#</b>			
<b>Pic 11 Desc.</b>		<b>Pic 12 Desc.</b>

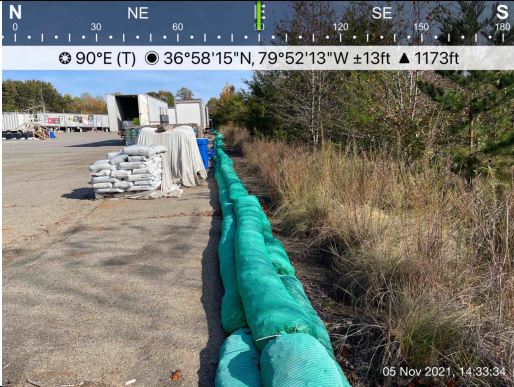
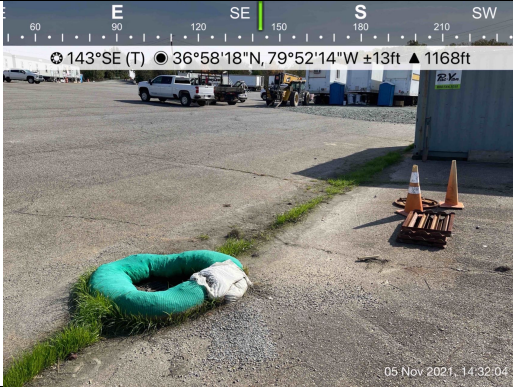
GPS Location	See picture		GPS Location	See picture	
Field Station#	0000+00		Field Station#	0000+00	
Pic 1 Desc.	Perimeter ECD's on south end of LY-046 in good condition.		Pic 2 Desc.	Inlet protection for catch basin on north end of LY-046 in good condition

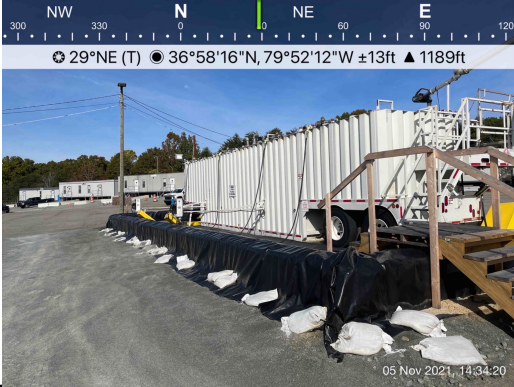
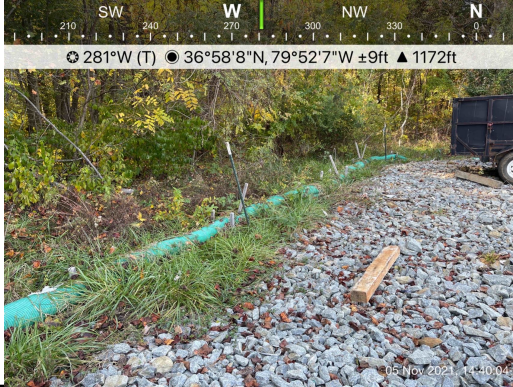
GPS Location	See picture		GPS Location	See picture	
Field Station#	0000+00		Field Station#	0000+00	
Pic 3 Desc.	Secondary containment structure for fuel cell at LY-046 in good condition		Pic 4 Desc.	Perimeter ECD's on northwest corner of employee parking area at LY-045 in good condition.

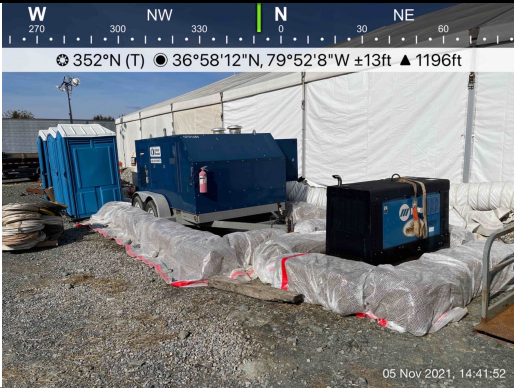
Insert image here			
GPS Location	See picture		GPS Location		
Field Station#	0000+00		Field Station#		
Pic 5 Desc.	Secondary containment structure for behind tent at LY-045 in good condition.		Pic 6 Desc.

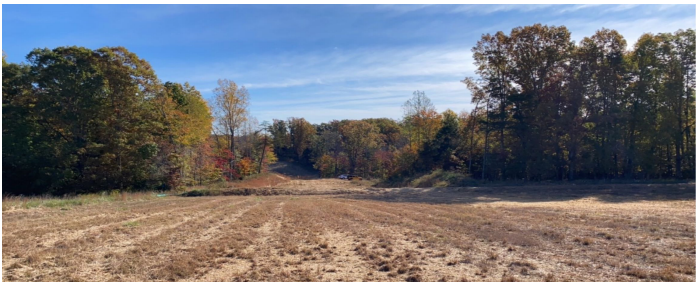
36°57'19" N 79°34'56" W 207°SW COURSE 108° GPS 8851-8969 Museville Rd, Sandy Level, VA 24161, United States 11.05.2021 10:17:17 Accur +/-59.7 Ft ALT 934 Ft			36°57'46" N 79°35'32" W 121°SE COURSE 78° GPS 1918-2164 Armstrong Rd, Penhook, VA 24137, United States 11.05.2021 11:19:26 Accur +/-399.6 Ft ALT 914 Ft		
GPS Location	1	GPS Location	2		
Field Station#	15113+25	Field Station#	15067+00		
Pic 1 Desc.	Routine maintenance. Repair damaged P1 silt fence.	Pic 2 Desc.	Recently seeded and stabilized ROW in temporary section.

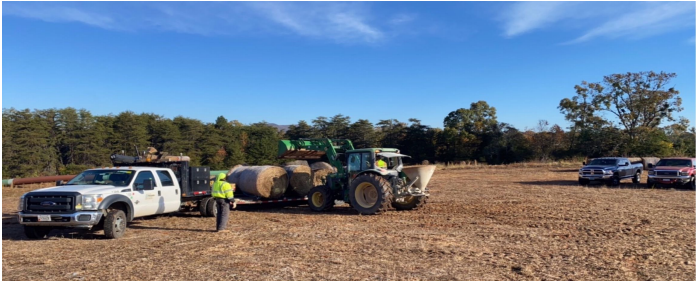
36°57'42" N 79°35'16" W 177°S COURSE 360° GPS Sandy Level, VA 24161, United States 11.05.2021 11:29:58 Accur +/-90.1 Ft ALT 856 Ft			36°57'20" N 79°34'57" W 48°NE COURSE 0° GPS 8851-8969 Museville Rd, Sandy Level, VA 24161, United States 11.05.2021 10:02:12 Accur +/-68.3 Ft ALT 0 Ft		
GPS Location	5	GPS Location	6		
Field Station#	15084+00	Field Station#	15112+00		
Pic 5 Desc.	Recently seeded and stabilized ROW in temporary section.	Pic 6 Desc.	Contractor unloading straw bales at road crossing for stabilization.
