Visual Site Inspection Report

Project Name	H-600 Pipeline Spread I	AFE	124300139	Spread	H-600 Pipeline Spread I
Contractor	Precision			Report #	31178
Inspector	Ben Farmer			Date/Time	11/15/2021 1:09 PM
Permit #	TBD	Inspection Type	VA SWPP	Station Begin	15260+00
State	VA	Inspection Area	Partial	Station End	15370+62
County	Pittsylvania	Ground	Dry	Temperature (°F)	39.00
Municipality	Chatham	Weather	Sunny	Rain Gauge (in)	0.00
				Rain Accumulation Time (days)	0.00

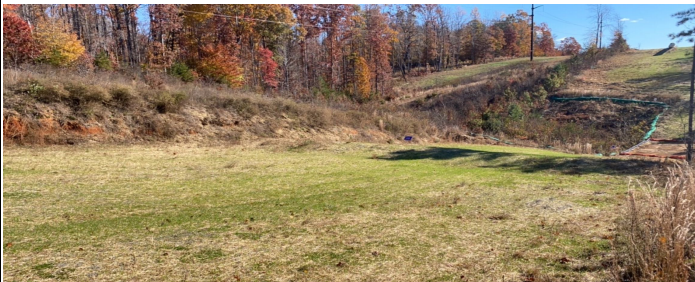
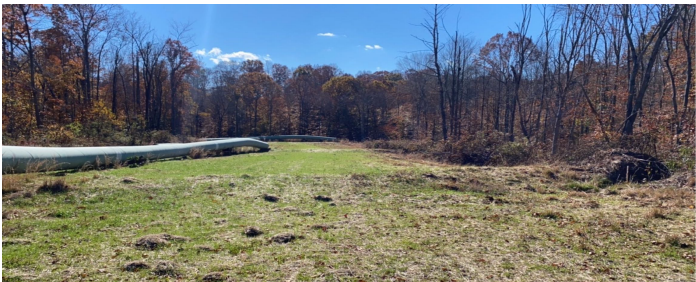
36°58'36" N 79°40'41" W 109°E COURSE 160° GPS Penhook, VA 24137, United States 11.15.2021 10:47:14 Accur +/-65.8 Ft ALT 943 Ft			36°58'32" N 79°40'33" W 193°S COURSE 105° GPS Penhook, VA 24137, United States 11.15.2021 10:54:40 Accur +/-317.9 Ft ALT 963 Ft		
GPS Location	1	GPS Location	2		
Field Station#	14804+00	Field Station#	14820+00		
Pic 1 Desc.	New vegetation growing along ROW where contractor recently seeded and stabilized		Pic 2 Desc.	New vegetation growing along ROW where contractor recently seeded and stabilized

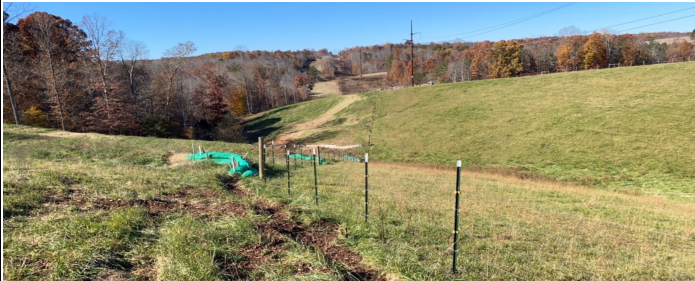
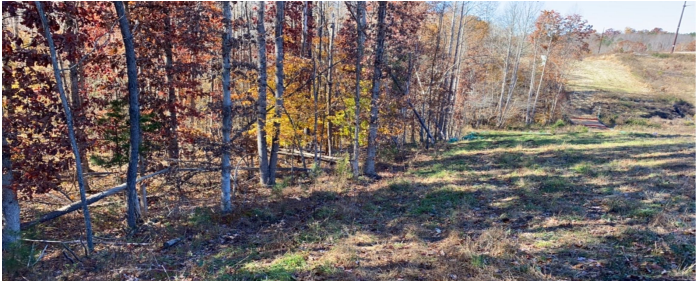
36°58'23" N 79°40'12" W 291°W COURSE -1° GPS Penhook, VA 24137, United States 11.15.2021 11:41:37 Accur +/-656.2 Ft ALT 870 Ft			36°58'5" N 79°38'28" W 246°SW COURSE -1° GPS Penhook, VA 24137, United States 11.15.2021 11:47:11 Accur +/-19.3 Ft ALT 803 Ft		
GPS Location	5	GPS Location	6		
Field Station#	14926+00	Field Station#	14919+00		
Pic 5 Desc.	Perimeter of ROW where contractor removed ECDs with approval; water bar end treatments left in place		Pic 6 Desc.	Perimeter of ROW where contractor removed ECDs with approval

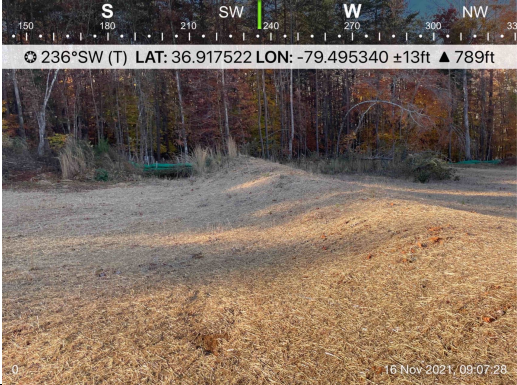
<p>Insert image here</p>			
GPS Location	See photo	GPS Location			
Field Station#	15417+00	Field Station#			
Pic 13 Desc.	Waterbars are in good condition throughout this area.	Pic 14 Desc.			
<p>Insert image here</p>		<p>Insert image here</p>			
GPS Location		GPS Location			
Field Station#		Field Station#			
Pic 15 Desc.		Pic 16 Desc.			
<p>Insert image here</p>		<p>Insert image here</p>			
GPS Location		GPS Location			
Field Station#		Field Station#			
Pic 17 Desc.		Pic 18 Desc.

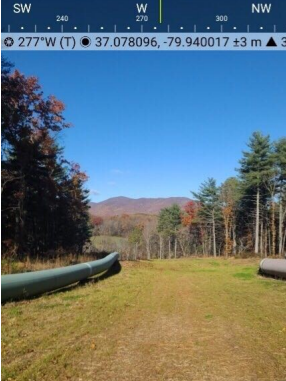
GPS Location	00000		GPS Location	0000	
Field Station#	13731+00		Field Station#	13732+90	
Pic 1 Desc.	Observed winter stabilization throughout the row with no environmental issues observed at the time of inspection.		Pic 2 Desc.	Monitored ECDs along the LOD during inspection today, no environmental issues observed at the time of inspection.

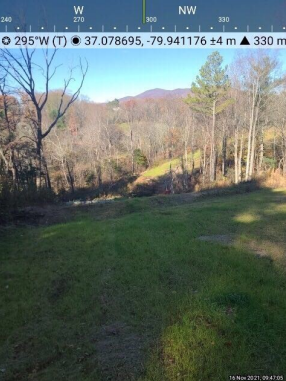
GPS Location	0000		GPS Location	0000	
Field Station#	13729+70		Field Station#	13731+30	
Pic 3 Desc.	Monitored vegetation and slope breakers during routine inspection. No environmental issues observed at the time of inspection.		Pic 4 Desc.	Monitored vegetation and ECDs , no environmental issues observed at the time of inspection.

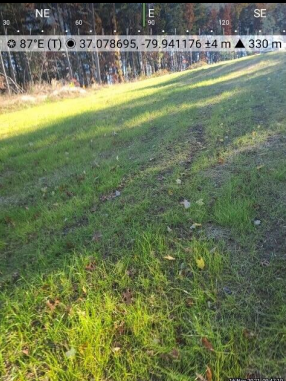
GPS Location	0000		GPS Location	0000	
Field Station#	13728+50		Field Station#	13678+80	
Pic 5 Desc.	Observed temporary winter vegetation growth, good coverage noted, no environmental issues observed at the time of inspection.		Pic 6 Desc.	Observed ECDs along the LOD and near stream crossing, no environmental issues observed at the time of inspection I

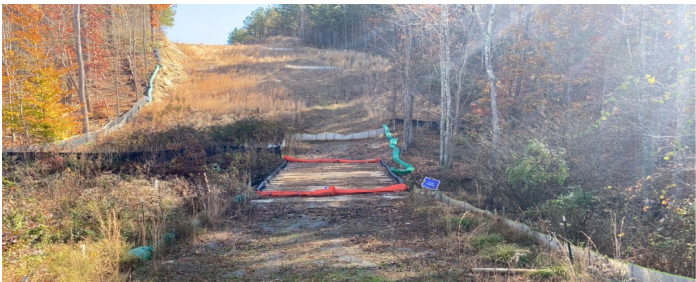
36°58'3" N 79°38'12" W 112°E COURSE 127° GPS 2082 Ramsey Memorial Rd, Penhook, VA 24137, United States 11.16.2021 11:40:15 Accur +/-91.8 Ft ALT 830 Ft			36°58'1" N 79°37'51" W 134°SE COURSE 0° GPS Sorry no results found 11.16.2021 11:51:28 Accur +/-82.8 Ft ALT 0 Ft		
GPS Location	1		GPS Location	2	
Field Station#	14932+89		Field Station#	14950+47	
Pic 1 Desc.	Equipment bridge and surrounding ECDs in place and functional at stream crossing and resource buffer		Pic 2 Desc.	Equipment bridge and surrounding ECDs in place and functional at stream crossing and resource buffer

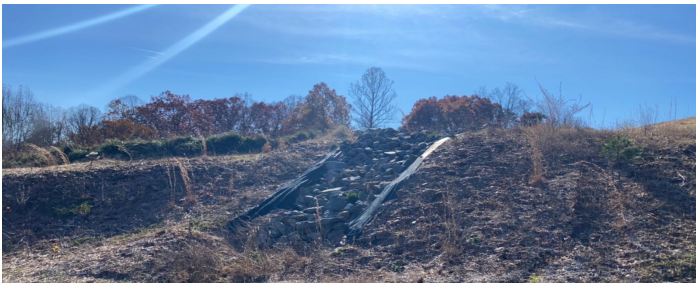
GPS Location	3		GPS Location	4	
Field Station#	14930+00		Field Station#	14931+00	
Pic 3 Desc.	Perimeter SSF in place and functional		Pic 4 Desc.	Rock-lined channel in good condition

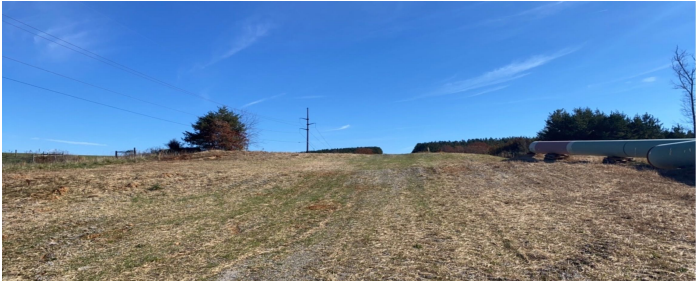
36°58'3" N 79°38'8" W 208°SW COURSE 202° GPS 11.16.2021 11:41:38 Accur +/-100.3 Ft ALT 0 Ft			36°58'2" N 79°38'4" W 120°SE COURSE 110° GPS Sorry no results found 11.16.2021 11:43:21 Accur +/-101.1 Ft ALT 818 Ft		
GPS Location	5		GPS Location	6	
Field Station#	14938+00		Field Station#	14944+00	
Pic 5 Desc.	Sump pit and CFS end treatment performing intended functions		Pic 6 Desc.	New vegetation growing along ROW where contractor recently seeded and stabilized

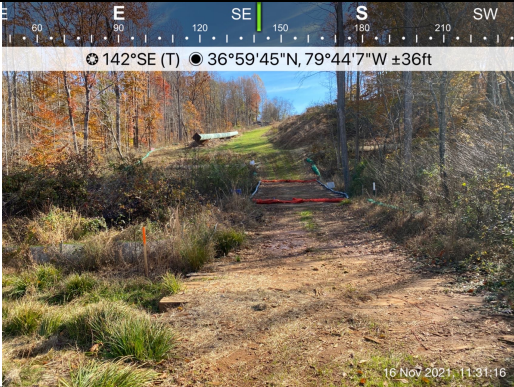
GPS Location	0	GPS Location	0		
Field Station#	14611+20	Field Station#	14568+10		
Pic 3 Desc.	Approximately 14611+20. Overview of stream crossing, equipment bridge and ECDs at stream S-E14.		Pic 4 Desc.	Approximately 14568+10. Overview of stream crossing, equipment bridge and ECDs at stream S-E18.

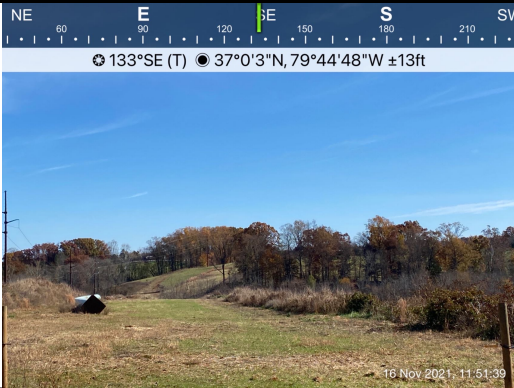
GPS Location	0	GPS Location	0		
Field Station#	14576+00	Field Station#	14615+00		
Pic 5 Desc.	Approximately 14576+00. Overview of ROW.		Pic 6 Desc.	Approximately 14615+00. Overview of ROW.

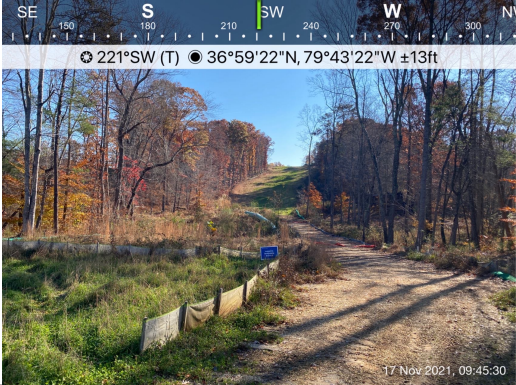
GPS Location	0	GPS Location	0		
Field Station#	14656+90	Field Station#	14666+00		
Pic 3 Desc.	Approximately 14656+90. Overview of stream crossing, equipment bridge and ECDs at stream S-H38.		Pic 4 Desc.	Approximately 14666+00. Overview of ROW.

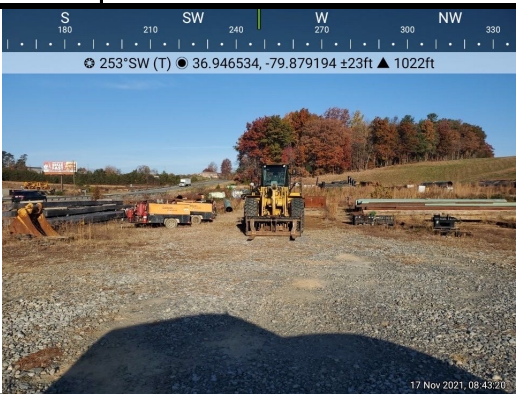
GPS Location	0		GPS Location	0	
Field Station#	0+00		Field Station#	0+00	
Pic 5 Desc.	LY-033 Equipment staging and RCE		Pic 6 Desc.	ANC-006 Stormwater drain inlet protection

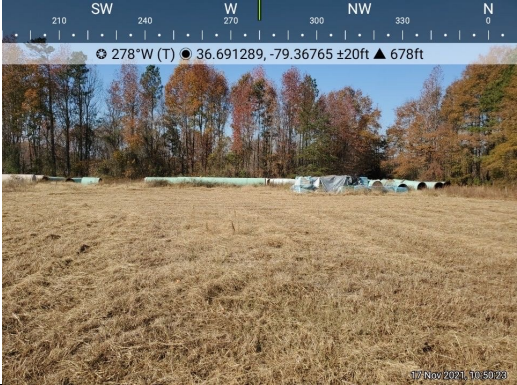
GPS Location	0	GPS Location	0		
Field Station#	0+00	Field Station#	0+00		
Pic 7 Desc.	LY-048 Temporary stabilization	Pic 8 Desc.	LY-048 North perimeter CFS		
Insert image here		Insert image here			
GPS Location		GPS Location			
Field Station#		Field Station#			
Pic 9 Desc.		Pic 10 Desc.			
Insert image here		Insert image here			
GPS Location		GPS Location			
Field Station#		Field Station#			
Pic 11 Desc.		Pic 12 Desc.

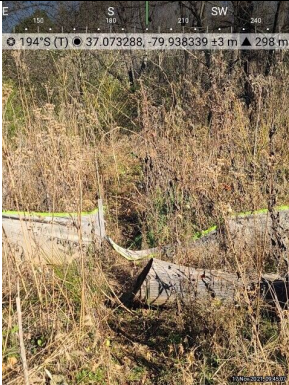
GPS Location	0000	GPS Location	0000		
Field Station#	13760+50	Field Station#	13756+30		
Pic 1 Desc.	P1 requires maintenance due to wildlife damages, documented and added to the punch list for repairs.	Pic 2 Desc.	P1 requires maintenance due to being weathered and torn, documented and added to the punch list for repair by the contractor

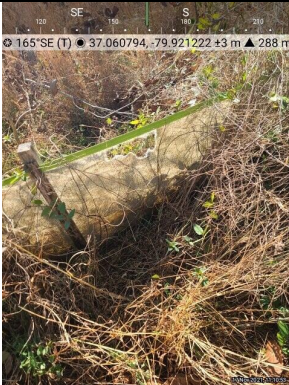
GPS Location	00000	GPS Location	00000		
Field Station#	13846+58	Field Station#	13794+32		
Pic 3 Desc.	P1 requires maintenance due to being weathered and torn, documented and added to the punch list for repair by the contractor	Pic 4 Desc.	P1 requires maintenance due to being weathered and torn, documented and added to the punch list for repair by the contractor

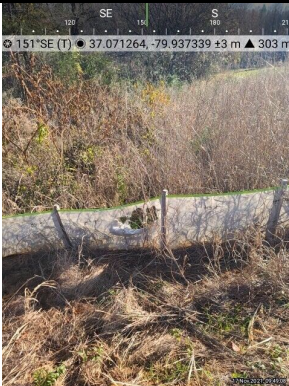
GPS Location	0000	GPS Location	0000		
Field Station#	13768+00	Field Station#	13768+00		
Pic 5 Desc.	P1 requires maintenance due to being weathered and torn, documented and added to the punch list for repair by the contractor	Pic 6 Desc.	Additional photo showing P1 requires maintenance due to being weathered and torn, documented and added to the punch list for repair by the contractor

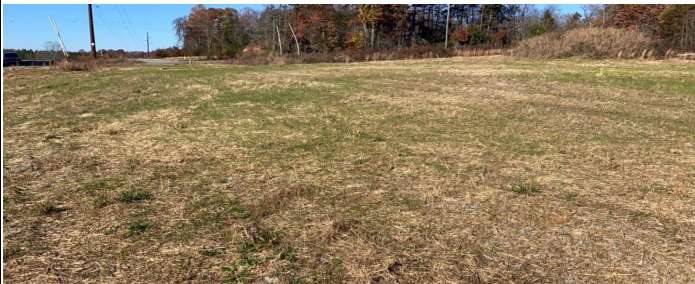
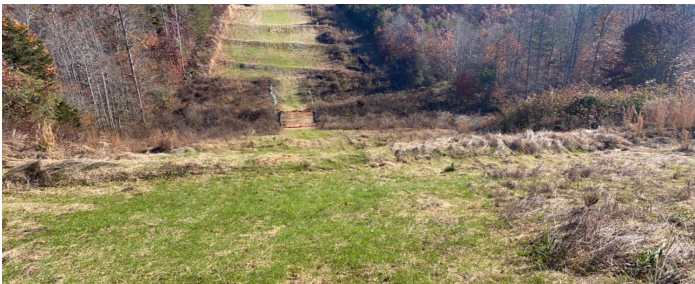
36°59'17" N 79°42'33" W 289°W COURSE 194' GPS 1558-2498 Jacks Creek Rd, Union Hall, VA 24176, United States Accur +/-55.7 Ft ALT 925 Ft			36°59'17" N 79°42'32" W 111°E COURSE 114' GPS 1558-2498 Jacks Creek Rd, Union Hall, VA 24176, United States Accur +/-15.3 Ft ALT 938 Ft		
GPS Location	1	GPS Location	2		
Field Station#	14696+00	Field Station#	14699+00		
Pic 1 Desc.	New vegetation growing along ROW where contractor recently seeded and stabilized		Pic 2 Desc.	New vegetation growing along ROW where contractor recently seeded and stabilized; all ECDs in place and functional

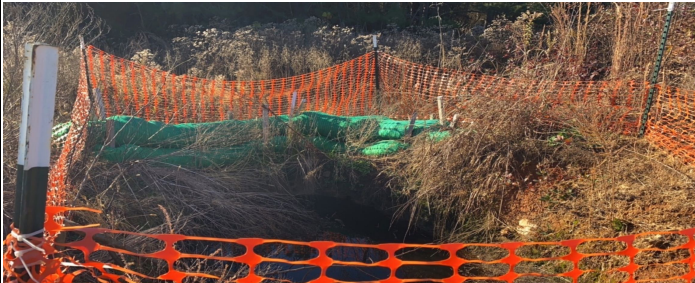
GPS Location	3	GPS Location	4		
Field Station#	14756+00	Field Station#	14758+16		
Pic 3 Desc.	Perimeter SSF in place and functional		Pic 4 Desc.	RCE at Indian Cave Rd in good condition

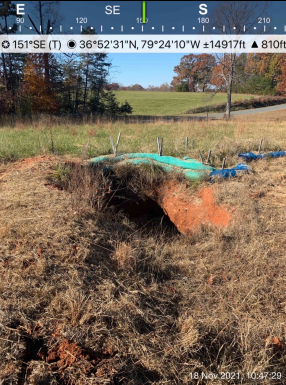
GPS Location	O	GPS Location	O		
Field Station#	15644+00	Field Station#	15632+00		
Pic 1 Desc.	Observing temporary stabilization, sump and end treatment	Pic 2 Desc.	Observing temporary stabilization

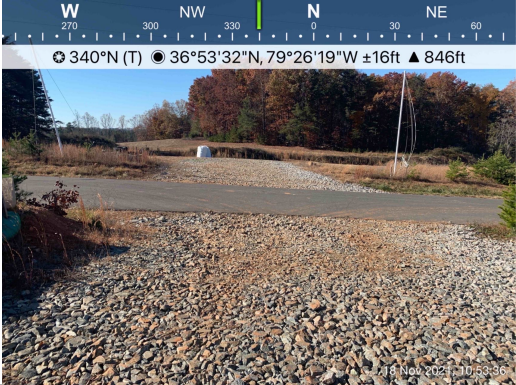
GPS Location	O	GPS Location	O		
Field Station#	15619+48	Field Station#	15610+00		
Pic 3 Desc.	Observing road crossing and RCE's	Pic 4 Desc.	Observing temporary stabilization

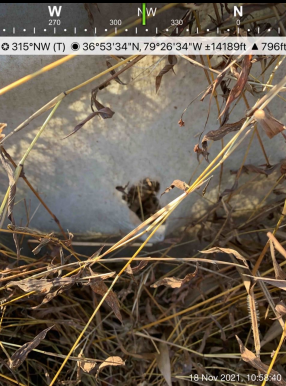
GPS Location	O	GPS Location	O		
Field Station#	15595+00	Field Station#	15594+50		
Pic 5 Desc.	Observing P1 that requires maintenance	Pic 6 Desc.	Observing P1 that requires maintenance

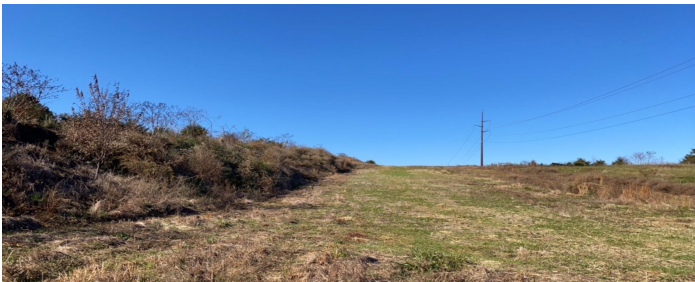
36°58'18" N 79°39'44" W 300°NW COURSE 253' GPS 2201 Bar Ridge Rd, Penhook, VA 24137, United States 11.19.2021 10:20:15 Accur +/-53.0 Ft ALT 949 Ft			36°58'19" N 79°39'50" W 8°N COURSE 244' GPS 355 Listening Hill Rd, Penhook, VA 24137, United States 11.19.2021 10:22:41 Accur +/-15.4 Ft ALT 947 Ft		
GPS Location	1		GPS Location	2	
Field Station#	14854+75		Field Station#	14842+00	
Pic 1 Desc.	Routine maintenance. Fallen tree down on perimeter CFS and equipment bridge requires maintenance.		Pic 2 Desc.	Temporary diversion berm and ROW stabilized and vegetated.

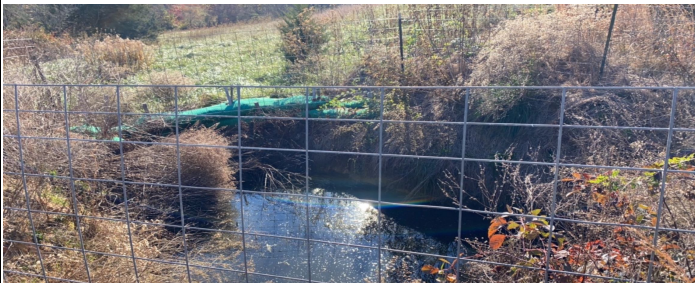
GPS Location	3		GPS Location	4	
Field Station#	14848+00		Field Station#	14850+00	
Pic 3 Desc.	Sump pit and CFS end treatment performing intended functions.		Pic 4 Desc.	CWD pipe and outlet performing intended functions.

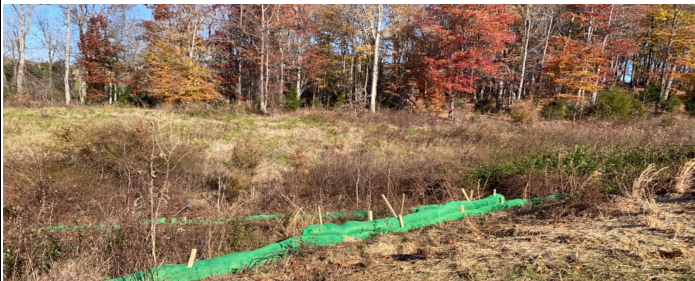
36°58'19" N 79°39'43" W 327°NW COURSE 0' GPS 2201 Bar Ridge Rd, Penhook, VA 24137, United States 11.19.2021 10:19:53 Accur +/-101.4 Ft ALT 0 Ft			36°58'16" N 79°39'31" W 116°SE COURSE 186' GPS 1760 Bar Ridge Rd, Penhook, VA 24137, United States 11.19.2021 10:29:24 Accur +/-44.5 Ft ALT 959 Ft		
GPS Location	5		GPS Location	6	
Field Station#	14857+00		Field Station#	14867+00	
Pic 5 Desc.	Perimeter CFS in good condition.		Pic 6 Desc.	New vegetation growing along ROW where contractor recently seeded and stabilized.

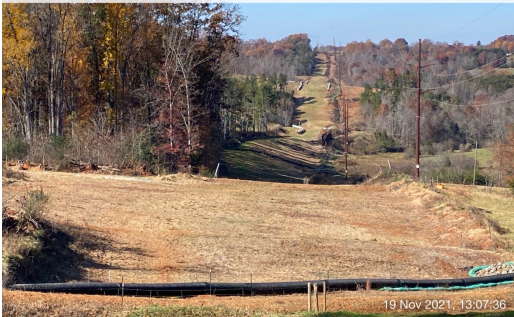
GPS Location	0	GPS Location	0		
Field Station#	14519+00	Field Station#	14524+50		
Pic 3 Desc.	Approximately 14519+00. Overview of ROW. ROW sparsely vegetated due to livestock being present in area.		Pic 4 Desc.	Approximately 14524+50. Overview of road crossing and RCEs.

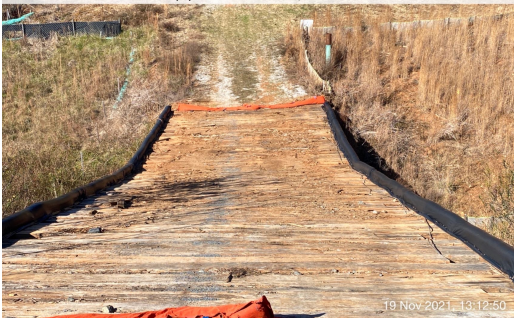
GPS Location	0	GPS Location	0		
Field Station#	14546+33	Field Station#	14529+00		
Pic 5 Desc.	Approximately 14546+33. Overview of stream crossing, equipment bridge and ECDs at stream S-G17.		Pic 6 Desc.	Approximately 14529+00. Overview of ROW.

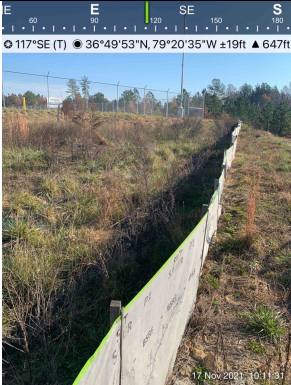
GPS Location	O	GPS Location	O		
Field Station#	00+00	Field Station#	00+00		
Pic 1 Desc.	Observing temporary stabilization and ECD's	Pic 2 Desc.	Observing temporary stabilization, storm water pond and ECD's

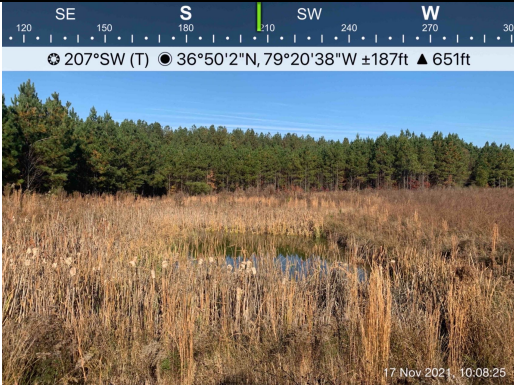
GPS Location	O	GPS Location	O		
Field Station#	00+00	Field Station#	00+00		
Pic 3 Desc.	Observing temporary stabilization and sediment basin	Pic 4 Desc.	Observing temporary stabilization and sediment basin		
Insert image here			Insert image here		
GPS Location		GPS Location			
Field Station#		Field Station#			
Pic 5 Desc.		Pic 6 Desc.
