Visual Site Inspection Report

Project Name	H-600 Pipeline Spread I	AFE	124300139	Spread	H-600 Pipeline Spread I
Contractor	Precision			Report #	31695
Inspector	Ben Farmer			Date/Time	11/29/2021 1:52 PM
Permit #	TBD	Inspection Type	VA SWPP	Station Begin	15370+62
State	VA	Inspection Area	Partial	Station End	15480+67
County	Pittsylvania	Ground	Dry	Temperature (°F)	38.00
Municipality	Chatham	Weather	Sunny	Rain Gauge (in)	0.00
				Rain Accumulation Time (days)	0.00

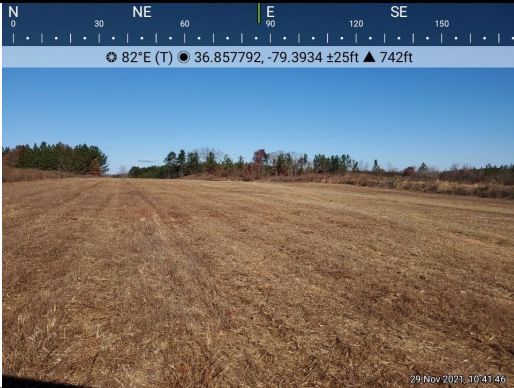
GPS Location	0	GPS Location	0		
Field Station#	15823+00	Field Station#	15840+00		
Pic 5 Desc.	CIS Mill Creek Rd Stabilization	Pic 6 Desc.	Clean water diversion channel

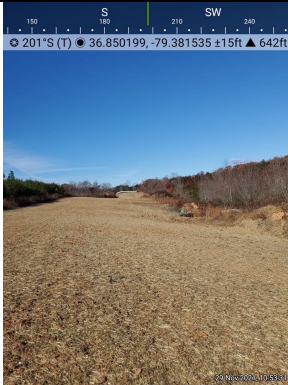
ert image here	
GPS Location	0	GPS Location	0		
Field Station#	15860+00	Field Station#	15865+00		
Pic 7 Desc.	Waterbar with CFS checks		Pic 8 Desc.	Temporary stabilization

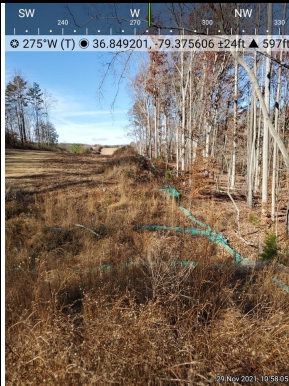
ert image here	
GPS Location	0	GPS Location	0		
Field Station#	15865+00	Field Station#	15913+00		
Pic 9 Desc.	Perimeter CFS		Pic 10 Desc.	GAS S-H55 ECDs

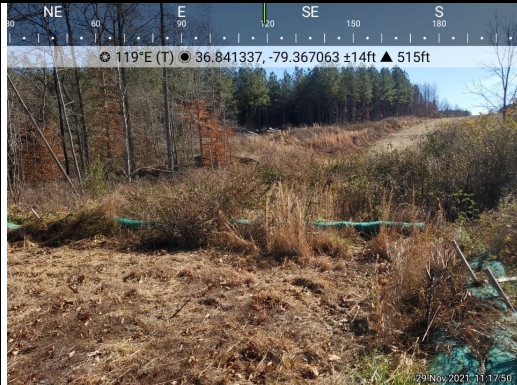
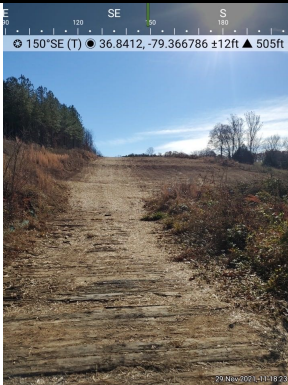
ert image here	
GPS Location	0	GPS Location	0		
Field Station#	15923+00	Field Station#	15924+00		
Pic 11 Desc.	CIS S-GG11 CFS		Pic 12 Desc.	GAS S-GG11 Stabilization

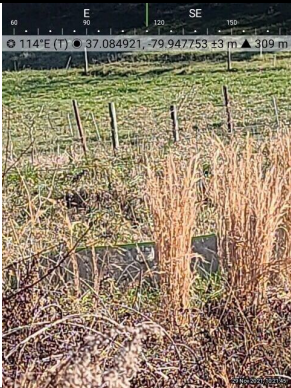
GPS Location	0000	GPS Location	0000		
Field Station#	13693+00	Field Station#	13704+13		
Pic 5 Desc.	P1 requires maintenance due to being weathered and torn, documented and added to the punch list to be repaired.		Pic 6 Desc.	Photo showing 3rd party activities crossing the row near wetland area, documented as non project related activities, will continue to monitor.

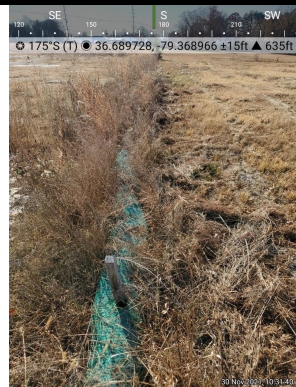
GPS Location	0		GPS Location	0	
Field Station#	0+00		Field Station#	0+00	
Pic 1 Desc.	LY-048 Equipment staging		Pic 2 Desc.	LY-048 West perimeter CFS

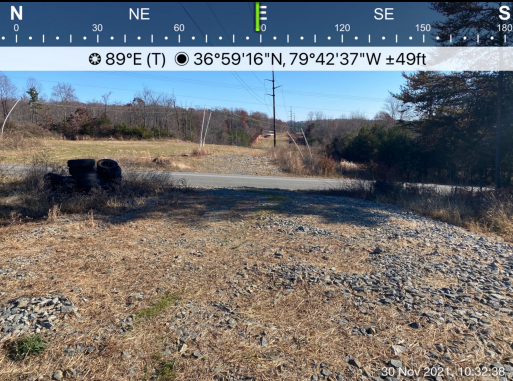
GPS Location	0	GPS Location	0		
Field Station#	14689+36	Field Station#	14694+50		
Pic 5 Desc.	Approximately 14689+36. Overview of stream crossing, equipment bridge and ECDs at stream S-H34.		Pic 6 Desc.	Approximately 14694+50. Overview of road crossing and RCE.

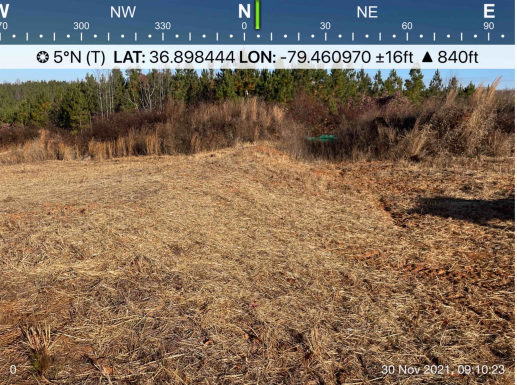
GPS Location	See photo		GPS Location	See photo	
Field Station#	15540+00		Field Station#	15547+37	
Pic 9 Desc.	Equipment bridge ECDs are in place and functioning.		Pic 10 Desc.	Waterbars are in good condition throughout this section.

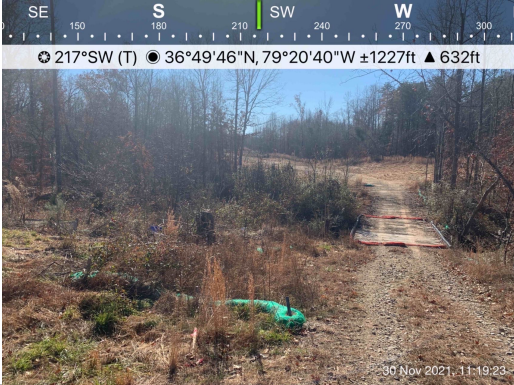
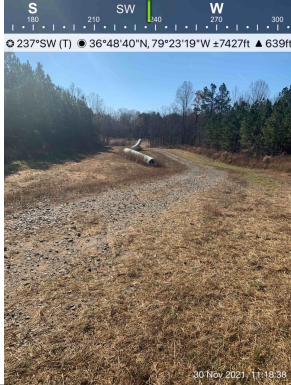
GPS Location	O	GPS Location	O		
Field Station#	12+65	Field Station#	6+00		
Pic 3 Desc.	Observing temporary stabilization, signage, buffer, equipment crossing and ECD's		Pic 4 Desc.	Observing temporary stabilization and access road	
Insert image here			Insert image here		
GPS Location		GPS Location			
Field Station#		Field Station#			
Pic 5 Desc.			Pic 6 Desc.

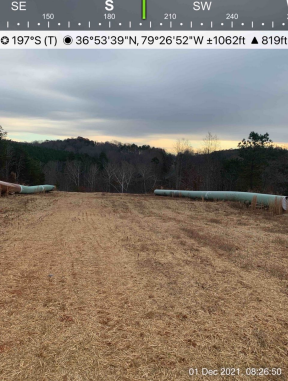
GPS Location	O	GPS Location	O		
Field Station#	15593+00	Field Station#	15595+60		
Pic 1 Desc.	Observing temporary stabilization and water bars	Pic 2 Desc.	Observing temporary stabilization, signage, buffer, equipment crossing and ECD's

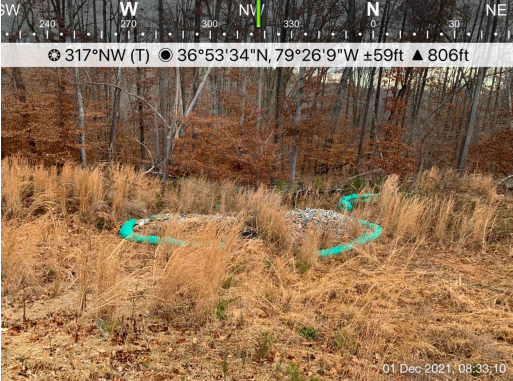
GPS Location	O	GPS Location	O		
Field Station#	15619+48	Field Station#	15630+00		
Pic 3 Desc.	Observing road crossing and RCE's	Pic 4 Desc.	Observing temporary stabilization, CWD outlet and ECD's

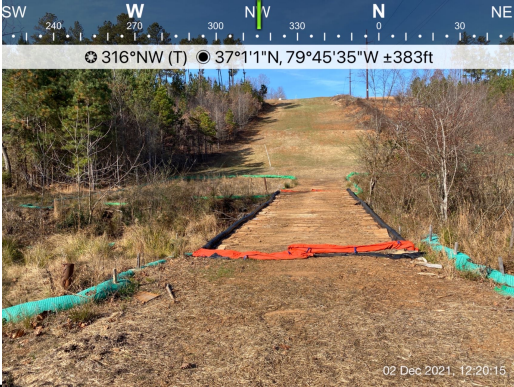
GPS Location	0	GPS Location	0		
Field Station#	14496+60	Field Station#	14510+00		
Pic 3 Desc.	Approximately 14496+60. Overview of stream crossing, equipment bridge and ECDs at stream S-G20.		Pic 4 Desc.	Approximately 14510+00. Overview of ROW.

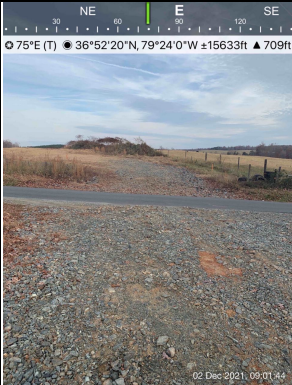
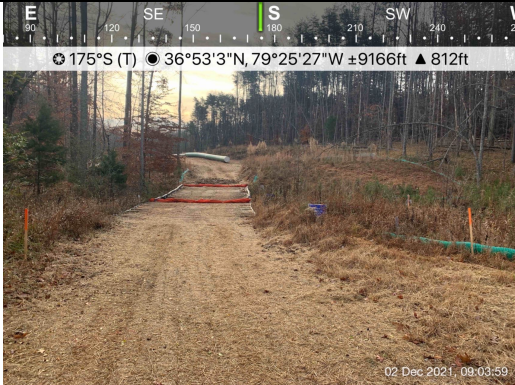
GPS Location	O	GPS Location	O		
Field Station#	15647+03	Field Station#	15658+43		
Pic 7 Desc.	Observing road crossing and RCE's		Pic 8 Desc.	Observing temporary stabilization, signage, buffer, equipment crossing and ECD's

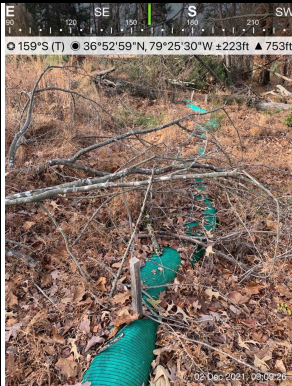
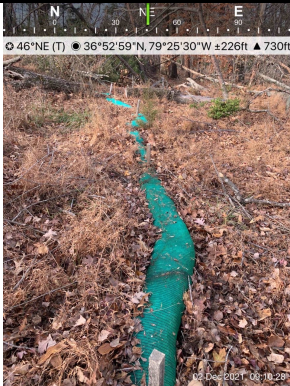
GPS Location	O	GPS Location	O		
Field Station#	15678+57	Field Station#	15678+57		
Pic 9 Desc.	Observing limbs that needed to be removed from the CFS		Pic 10 Desc.	Observing limbs removed from the CFS

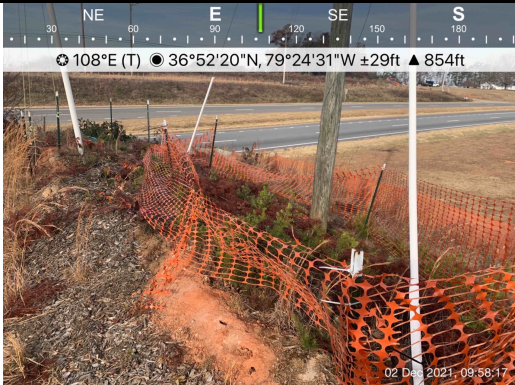
GPS Location	O	GPS Location	O		
Field Station#	15678+57	Field Station#	15744+50		
Pic 11 Desc.	Observing P1 that requires maintenance		Pic 12 Desc.	Observing safety fence that requires maintenance

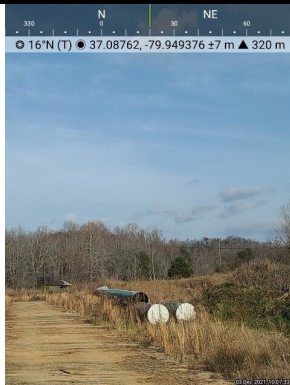
GPS Location	00000	GPS Location	00000		
Field Station#	13692+64	Field Station#	13682+00		
Pic 3 Desc.	Stream observation photo facing upstream during routine inspection, no environmental issues observed at the time of inspection.		Pic 4 Desc.	Row photo showing stabilization on spoil piles and equipment mats in place.

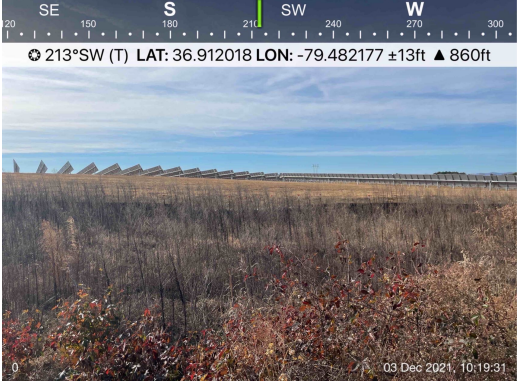
GPS Location	See photo	GPS Location			
Field Station#	15465+00	Field Station#			
Pic 13 Desc.	No evidence of sedimentation from 3rd party disturbance.	Pic 14 Desc.			
Insert image here		Insert image here			
GPS Location		GPS Location			
Field Station#		Field Station#			
Pic 15 Desc.		Pic 16 Desc.			
Insert image here		Insert image here			
GPS Location		GPS Location			
Field Station#		Field Station#			
Pic 17 Desc.		Pic 18 Desc.
