Visual Site Inspection Report

Project Name	H-600 Pipeline Spread I	AFE	124300139	Spread	H-600 Pipeline Spread I
Contractor	Precision			Report #	30896
Inspector	Justin Burch			Date/Time	11/8/2021 11:46 AM
Permit #	TBD	Inspection Type	VA SWPP	Station Begin	13853+45
State	VA	Inspection Area	Full	Station End	13958+31
County	Franklin	Ground	Damp	Temperature (°F)	69.00
Municipality	N/A	Weather	Sunny	Rain Gauge (in)	0.10
				Rain Accumulation Time (days)	6.00

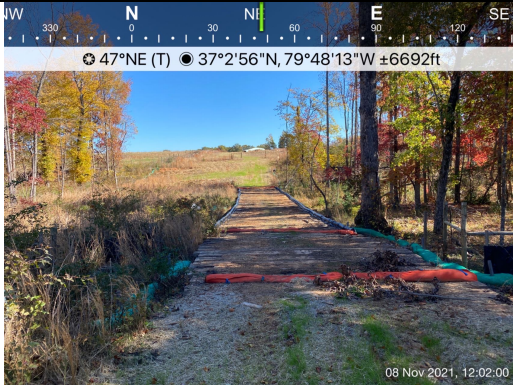
GPS Location	0	GPS Location	0		
Field Station#	14320+00	Field Station#	14328+00		
Pic 1 Desc.	Approximately 14320+00. Overview of ROW.	Pic 2 Desc.	Approximately 14328+00. SSF requires maintenance.

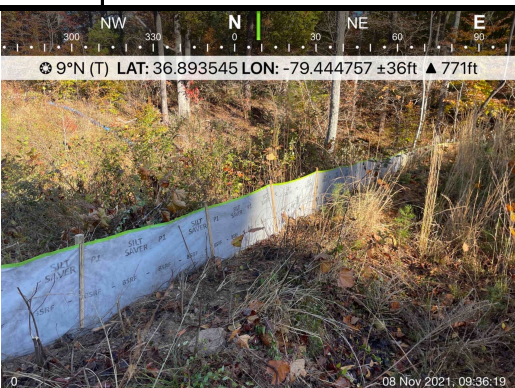
GPS Location	See photo		GPS Location	See photo	
Field Station#	15584+23		Field Station#	15595+00	
Pic 1 Desc.	RCEs are in good condition at all road crossings.		Pic 2 Desc.	CWD is functioning as intended.

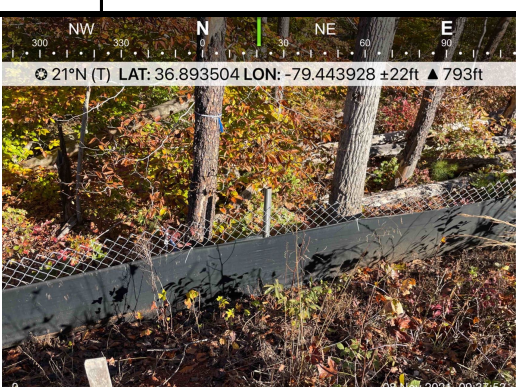
GPS Location	See photo		GPS Location	See photo	
Field Station#	15595+00		Field Station#	15598+00	
Pic 3 Desc.	Equipment bridge ECDs are in place and functioning.		Pic 4 Desc.	P1 is in good condition at all stream and wetland buffers.

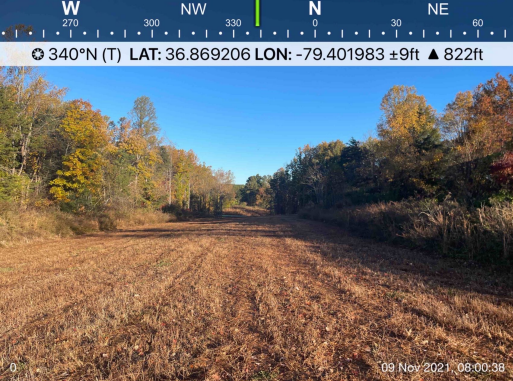
GPS Location	See photo		GPS Location	See photo	
Field Station#	15772+27		Field Station#	15770+00	
Pic 1 Desc.	RCEs are in good condition at all road crossings.		Pic 2 Desc.	Vegetation continues to fill in throughout this section.

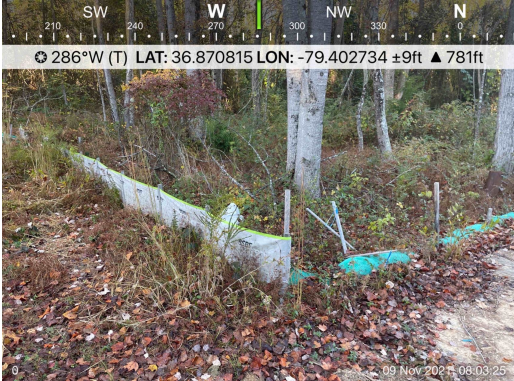
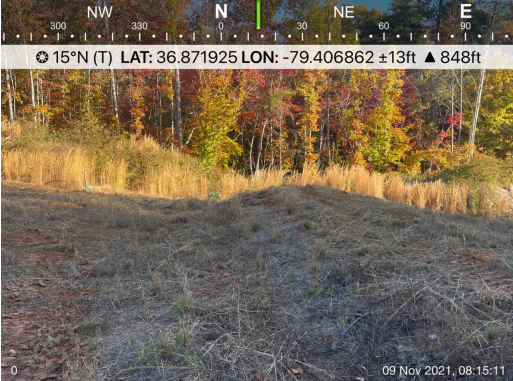
GPS Location	See photo		GPS Location	See photo	
Field Station#	15763+80		Field Station#	15750+00	
Pic 3 Desc.	P1 is in good condition at all stream and wetland buffers.		Pic 4 Desc.	Waterbars are in good condition throughout this section.

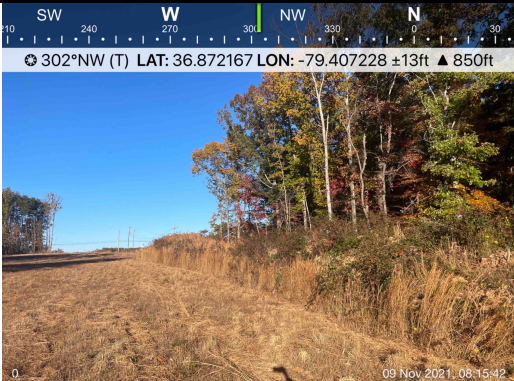
GPS Location	See photo		GPS Location	See photo	
Field Station#	15748+00		Field Station#	15735+00	
Pic 5 Desc.	Vegetation continues to fill in throughout this section.		Pic 6 Desc.	CWDs are functioning as intended.

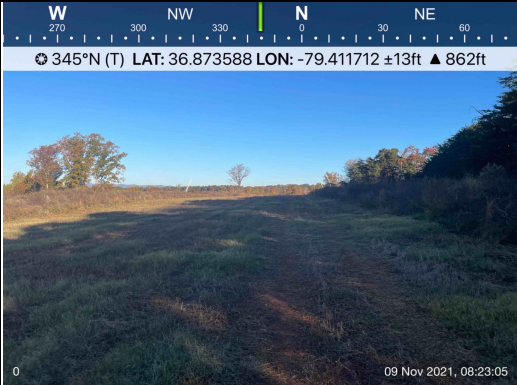
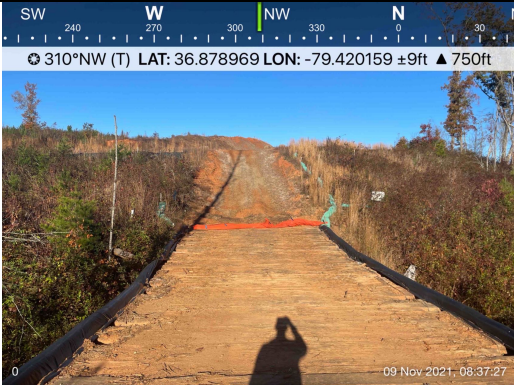
GPS Location	See photo		GPS Location	See photo	
Field Station#	15732+00		Field Station#	15700+00	
Pic 7 Desc.	Vegetation continues to fill in throughout this section.		Pic 8 Desc.	Equipment bridge ECDs are in place and functioning.

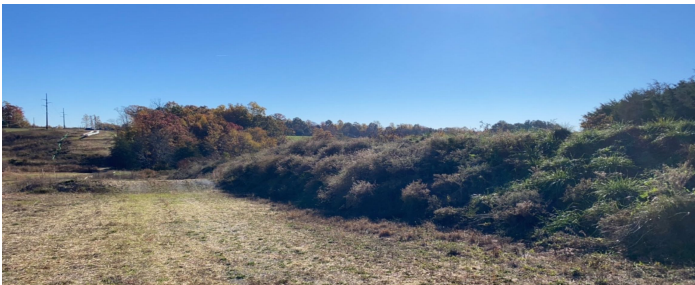
36°58'23" N 79°40'10" W 317°NW COURSE -1' GPS 1120 Listening Hill Rd, Penhook, VA 24137, United States 11.09.2021 09:27:52 Accur +/-17.5 Ft ALT 940 Ft			36°58'24" N 79°40'10" W 310°NW COURSE 62' GPS 1120 Listening Hill Rd, Penhook, VA 24137, United States 11.09.2021 09:27:25 Accur +/-55.2 Ft ALT 0 Ft		
GPS Location	1		GPS Location	2	
Field Station#	14832+61		Field Station#	14834+00	
Pic 1 Desc.	Contractor repaired damaged P1 silt fence per punch list item.		Pic 2 Desc.	Contractor repaired perimeter SSF per punch list item.

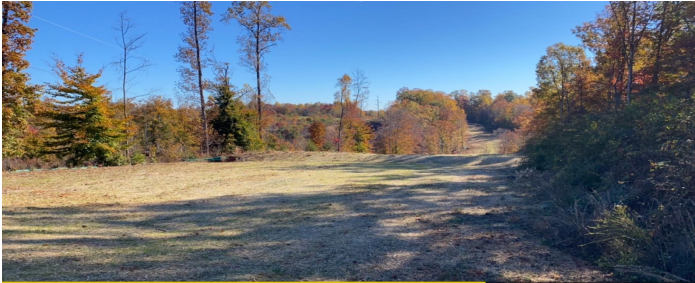
36°58'23" N 79°40'7" W 73°E COURSE -1' GPS Penhook, VA 24137, United States 11.09.2021 09:34:39 Accur +/-259.3 Ft ALT 915 Ft			36°58'20" N 79°39'53" W 128°SE COURSE -1' GPS Penhook, VA 24137, United States 11.09.2021 09:39:16 Accur +/-73.8 Ft ALT 915 Ft		
GPS Location	3		GPS Location	4	
Field Station#	14836+00		Field Station#	14847+00	
Pic 3 Desc.	New vegetation growing along ROW where contractor recently seeded and stabilized.		Pic 4 Desc.	New vegetation growing along ROW where contractor recently seeded and stabilized.

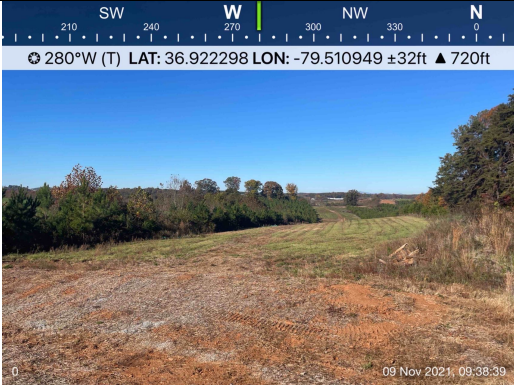
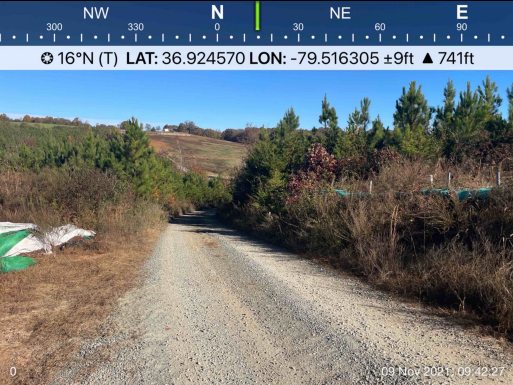
GPS Location	See photo		GPS Location	See photo	
Field Station#	15370+00		Field Station#	15350+00	
Pic 1 Desc.	Vegetation continues to fill in throughout this section.		Pic 2 Desc.	MVP-PI-332 is in good condition with controls in place.

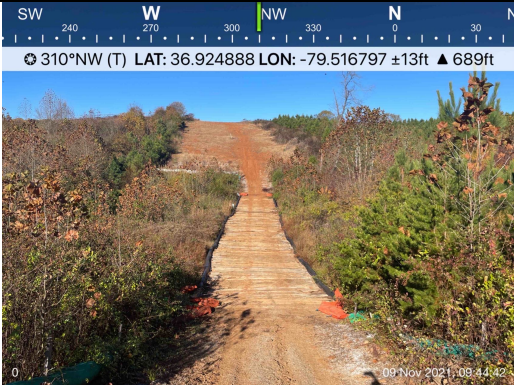
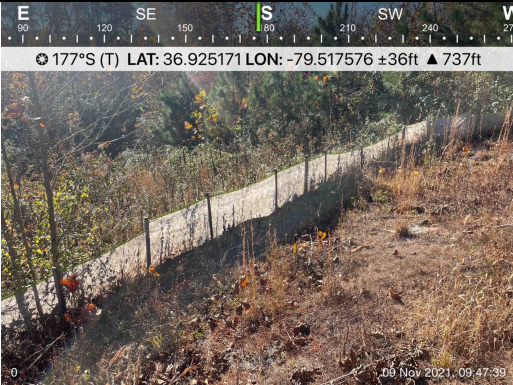
GPS Location	See photo		GPS Location	See photo	
Field Station#	15346+87		Field Station#	15346+00	
Pic 3 Desc.	Equipment bridge ECDs are in place and functioning.		Pic 4 Desc.	P1 is in good condition at all,stream and wetland buffers.

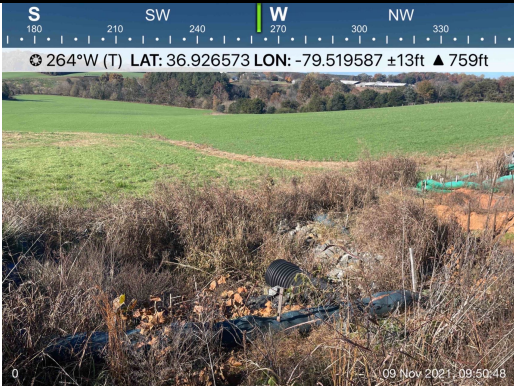
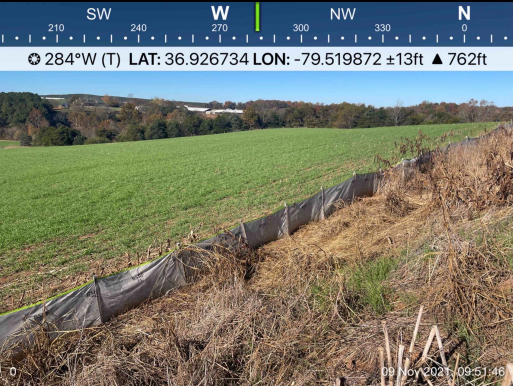
GPS Location	See photo		GPS Location	See photo	
Field Station#	15338+00		Field Station#	15336+00	
Pic 5 Desc.	CWDs are functioning as intended.		Pic 6 Desc.	Perimeter P1 remains in good condition.

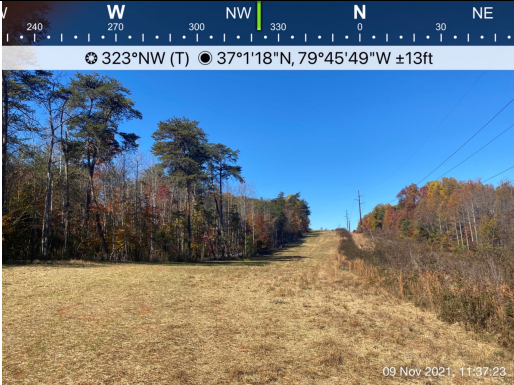
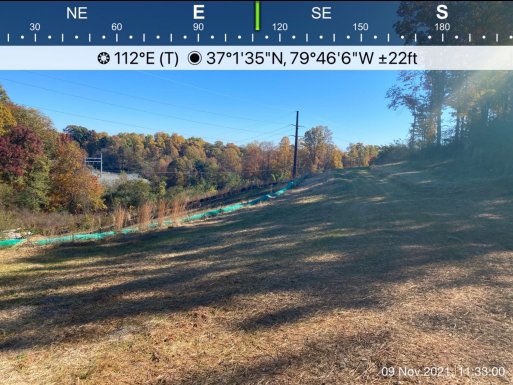
GPS Location	0	GPS Location	0		
Field Station#	14471+00	Field Station#	14455+50		
Pic 1 Desc.	Approximately 14471+00. Overview of ROW.	Pic 2 Desc.	Approximately 14455+50. Overview of ROW.

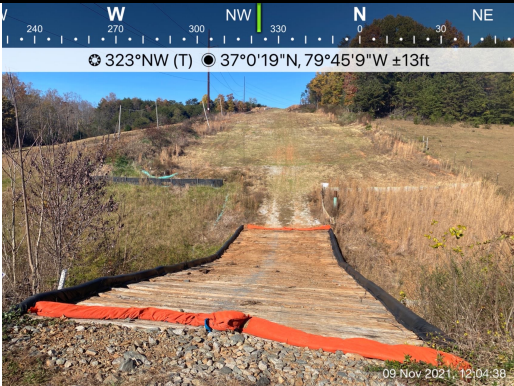
GPS Location	0	GPS Location	0		
Field Station#	14546+33	Field Station#	14486+60		
Pic 5 Desc.	Approximately 14546+33. Overview of stream crossing, equipment bridge and ECDs at stream S-G17.	Pic 6 Desc.	Approximately 14486+60. Overview of stream crossing, equipment bridge and ECDs at stream S-G22.

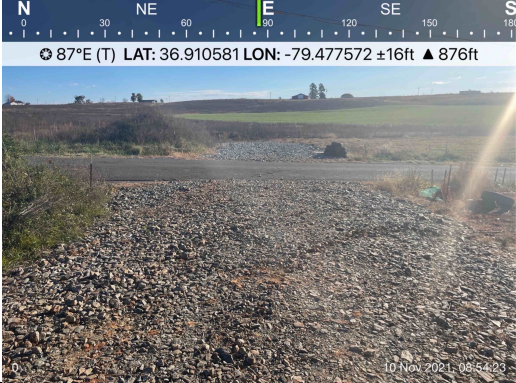
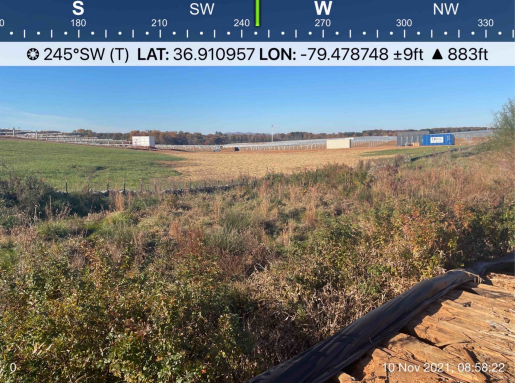
GPS Location	See photo	GPS Location	See photo		
Field Station#	15480+67	Field Station#	15475+00		
Pic 1 Desc.	RCEs are in good condition at all road crossings.	Pic 2 Desc.	3rd party rock outlet appears to be in good condition.

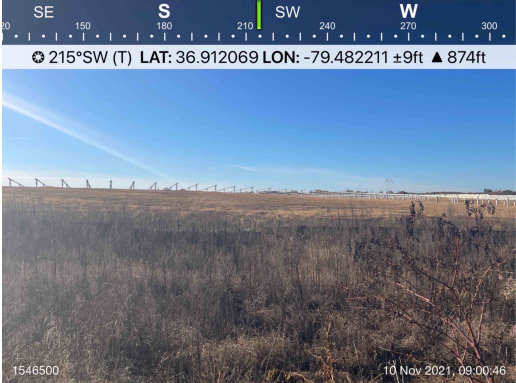
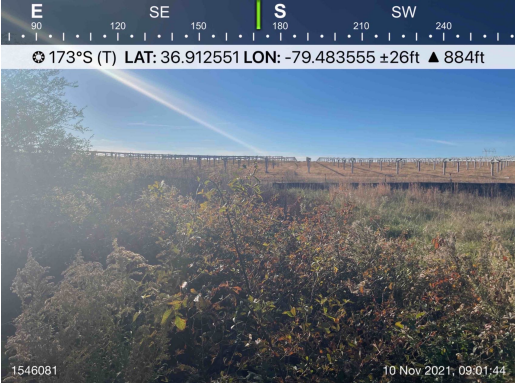
GPS Location	See photo	GPS Location	See photo		
Field Station#	15465+00	Field Station#	15460+81		
Pic 3 Desc.	No evidence of sedimentation from 3rd party disturbance.	Pic 4 Desc.	No evidence of sedimentation from 3rd party disturbance into CWD inlet.

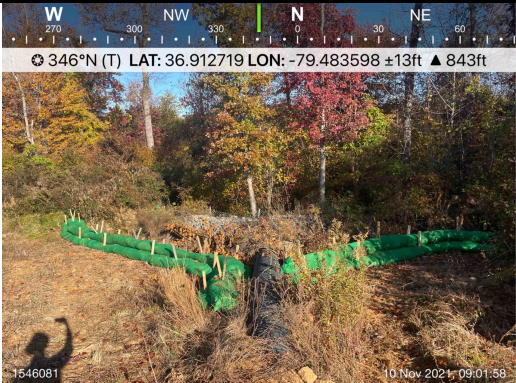
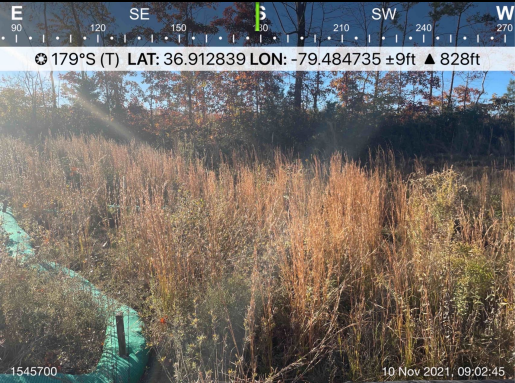
GPS Location	See photo	GPS Location	See photo		
Field Station#	15460+81	Field Station#	15457+00		
Pic 5 Desc.	CWD remains in good condition.	Pic 6 Desc.	No evidence of sedimentation within drainage feature.

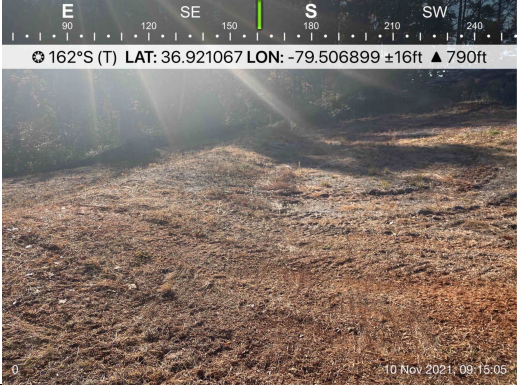
GPS Location	See photo	GPS Location			
Field Station#	15380+00	Field Station#			
Pic 13 Desc.	Waterbars are functioning as intended.	Pic 14 Desc.			
Insert image here		Insert image here			
GPS Location		GPS Location			
Field Station#		Field Station#			
Pic 15 Desc.		Pic 16 Desc.			
Insert image here		Insert image here			
GPS Location		GPS Location			
Field Station#		Field Station#			
Pic 17 Desc.		Pic 18 Desc.

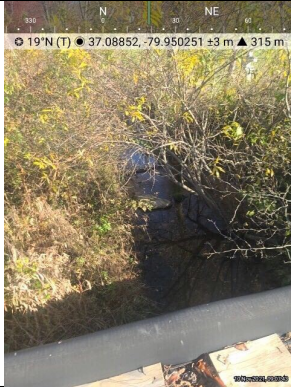
GPS Location	0000	GPS Location	0000		
Field Station#	13678+71	Field Station#	13678+71		
Pic 1 Desc.	Stream observation photo facing upstream during routine inspection.		Pic 2 Desc.	Stream observation photo facing downstream during routine inspection today, no environmental issues observed at the time of inspection.

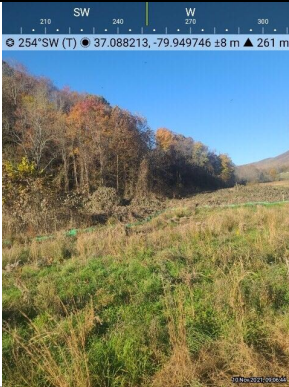
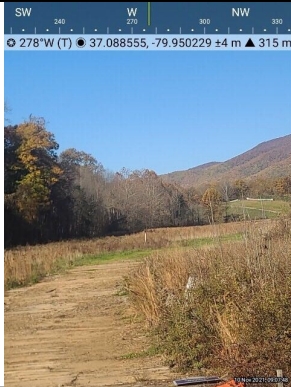
GPS Location	0000	GPS Location	0000		
Field Station#	13679+40	Field Station#	13677+50		
Pic 3 Desc.	Monitored ECDs throughout the LOD, no environmental issues observed at the time of inspection I		Pic 4 Desc.	Row photo showing vegetation and equipment mats in place. No environmental issues observed at the time of inspection.

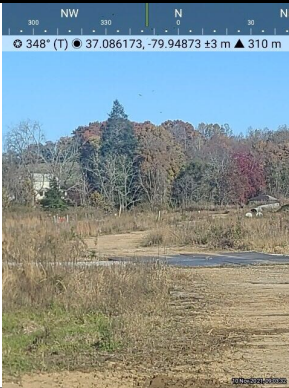
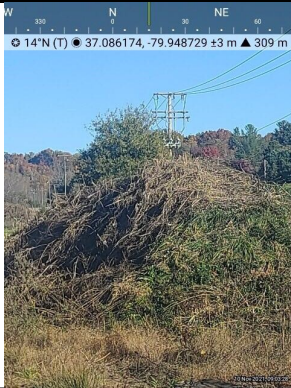
GPS Location	0000	GPS Location	0000		
Field Station#	13687+40	Field Station#	13687+69		
Pic 5 Desc.	Additional photo showing equipment mats in place in low lying area of row. No environmental issues observed at the time of inspection.		Pic 6 Desc.	Spoil pile stabilized, no environmental issues observed at the time of inspection.

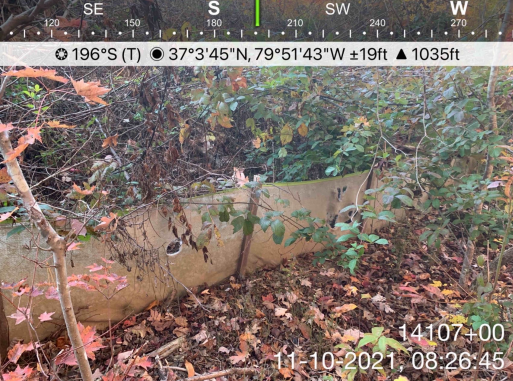
GPS Location	0	GPS Location	0		
Field Station#	14141+00	Field Station#	14107+00		
Pic 1 Desc.	Excessive sediment on equipment bridge, wattles are deteriorated		Pic 2 Desc.	P1 silt fence damaged by wildlife, holes in fabric and broken stakes from 14106+00 to 14107+50

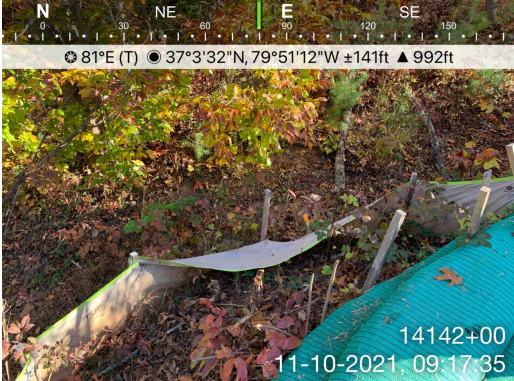
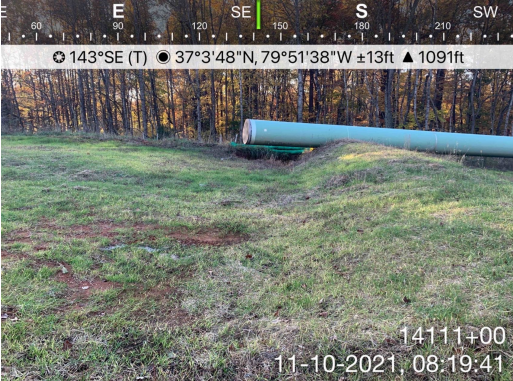
GPS Location	0	GPS Location	0		
Field Station#	14142+00	Field Station#	14111+00		
Pic 3 Desc.	P1 silt fence damaged by wildlife		Pic 4 Desc.	Waterbar in acceptable condition

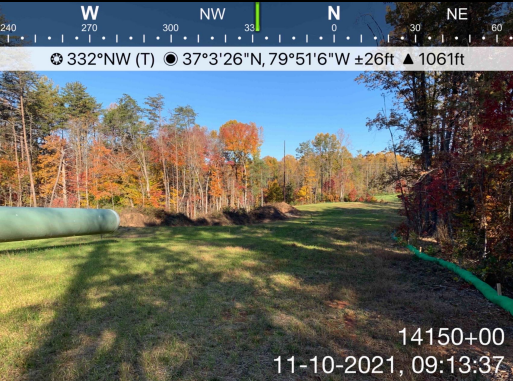
GPS Location	0	GPS Location	0		
Field Station#	14111+00	Field Station#	14150+00		
Pic 5 Desc.	Waterbar end treatment in acceptable condition		Pic 6 Desc.	Temporary vegetative stabilization and perimeter CFS in acceptable conditions

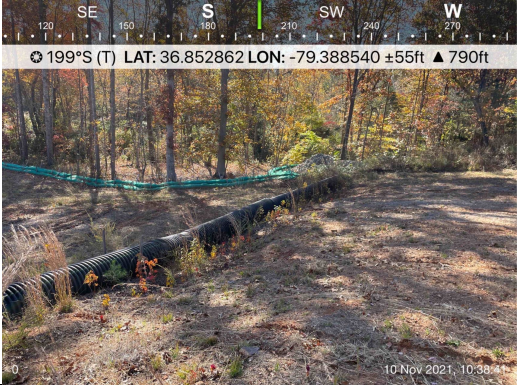
GPS Location	See photo		GPS Location	See photo	
Field Station#	15833+00		Field Station#	15846+00	
Pic 7 Desc.	CFS checks remain in good condition.		Pic 8 Desc.	CWD is in good condition.

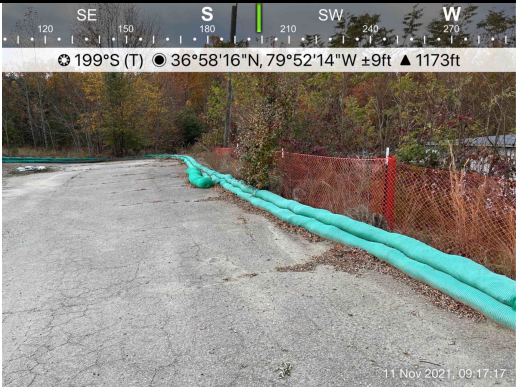
GPS Location	See pic		GPS Location	See pic	
Field Station#	0000+00		Field Station#	0000+00	
Pic 1 Desc.	Perimeter ECD's on southwest corner of LY-046 in good condition.		Pic 2 Desc.	Secondary containment structure for fuel cell at LY-046 in good condition.

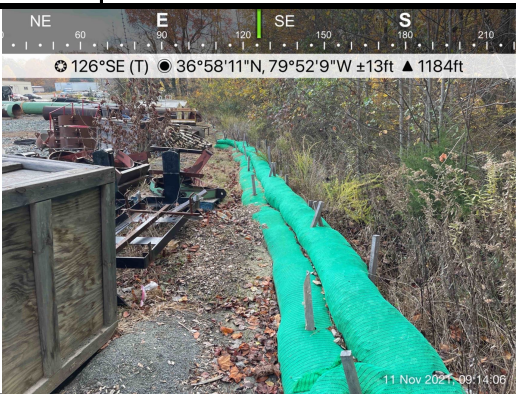
GPS Location	See pic		GPS Location	See pic 4	
Field Station#	0000+00		Field Station#	0000+00	
Pic 5 Desc.	Perimeter ECD's on west side of LY-045 near conex in good condition.		Pic 6 Desc.	Secondary containment structure liner at wash station replaced by contractor, item completed.

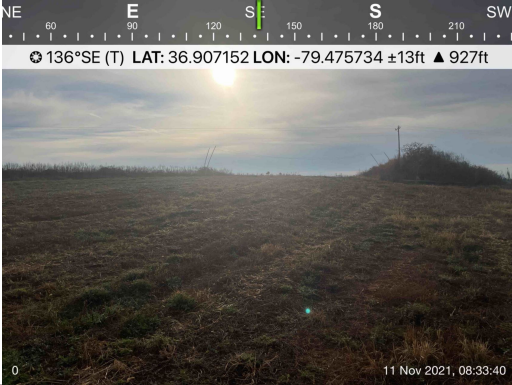
GPS Location	See photo	GPS Location	See photo		
Field Station#	15494+00	Field Station#	15496+70		
Pic 3 Desc.	Vegetation continues to fill in throughout this section.	Pic 4 Desc.	RCEs are in good condition at all road crossings.

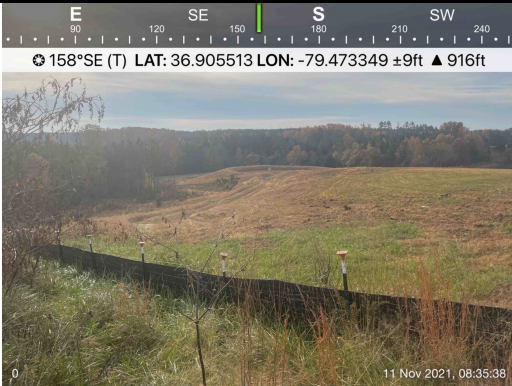
GPS Location	See photo	GPS Location	See photo		
Field Station#	15501+00	Field Station#	15507+00		
Pic 5 Desc.	No evidence of sedimentation from 3rd party disturbance.	Pic 6 Desc.	P1 is in good condition at all stream and wetland buffers.

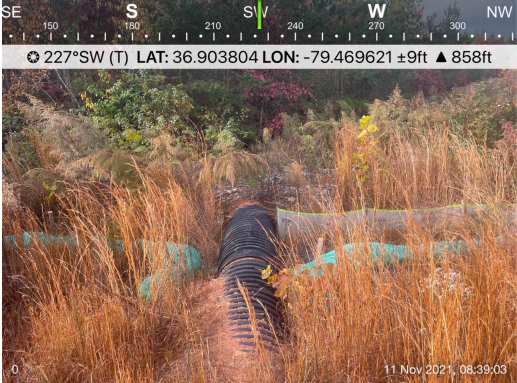
GPS Location	See photo		GPS Location	See photo	
Field Station#	15510+00		Field Station#	15515+00	
Pic 7 Desc.	3rd party ECDs appear to be in good condition.		Pic 8 Desc.	CWDs are functioning as intended.

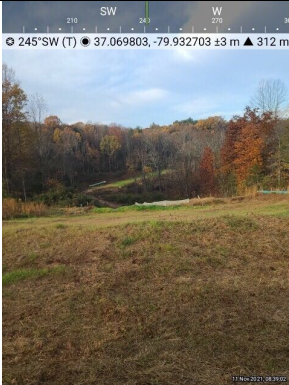
GPS Location	00000	GPS Location	0000		
Field Station#	13784+35	Field Station#	13805+19		
Pic 1 Desc.	Monitored ECDs and temporary winter vegetation growth, no environmental issues observed at the time of inspection.		Pic 2 Desc.	P1 requires maintenance due to broken stakes, documented and added to the punch list for repairs.

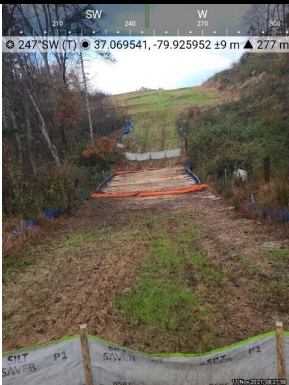
GPS Location	0000	GPS Location	00000		
Field Station#	13805+79	Field Station#	13786+90		
Pic 3 Desc.	Monitored ECDs and stream crossings during inspection today, all functioning properly at the time of inspection.		Pic 4 Desc.	Monitored temporary winter vegetation growth, no environmental issues observed at the time of inspection.

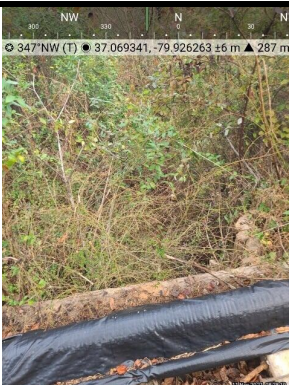
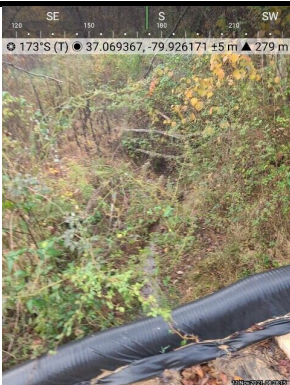
GPS Location	0000	GPS Location	0000		
Field Station#	13805+69	Field Station#	13805+69		
Pic 5 Desc.	Stream observation photo facing downstream during routine inspection today, no environmental issues observed at the time of inspection.		Pic 6 Desc.	Stream observation photo facing downstream during routine inspection today, no environmental issues observed at the time of inspection.

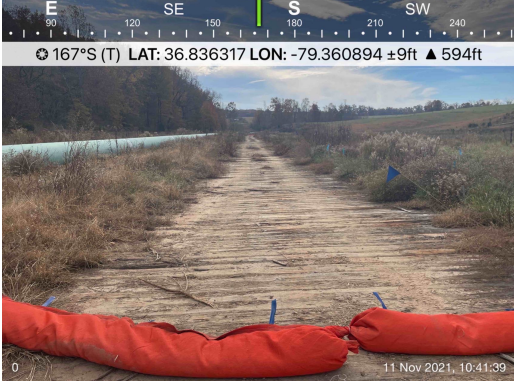
GPS Location	See photo		GPS Location	See photo	
Field Station#	15950+00		Field Station#	15962+32	
Pic 1 Desc.	Wetland buffer ECDs are in place and functioning.		Pic 2 Desc.	P1 needs to be restaked.

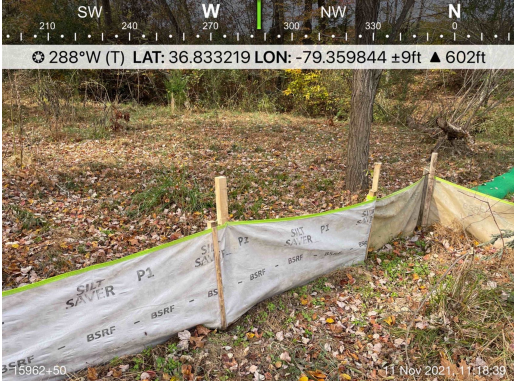
GPS Location	See photo		GPS Location	See photo	
Field Station#	15962+32		Field Station#	15962+50	
Pic 3 Desc.	Environmental crew has corrected this issue.		Pic 4 Desc.	P1 is degraded and needs to be replaced.

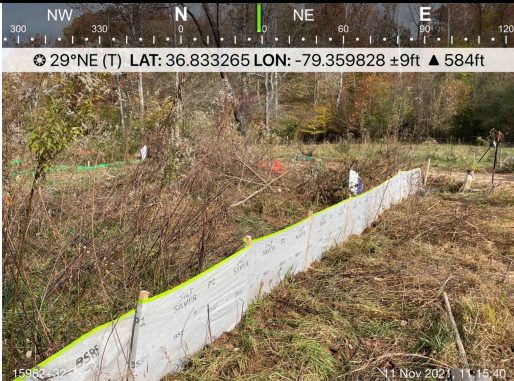
GPS Location	See photo		GPS Location	See photo	
Field Station#	15962+50		Field Station#	15970+00	
Pic 5 Desc.	Environmental crew has corrected this issue.		Pic 6 Desc.	CWD is functioning as intended.

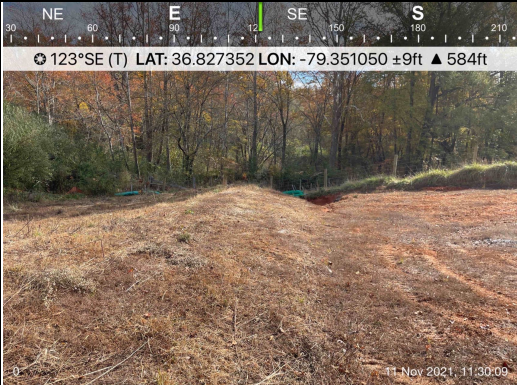
GPS Location	See photo		GPS Location	See photo	
Field Station#	15999+00		Field Station#	15999+00	
Pic 7 Desc.	Waterbars are in good condition condition throughout this section.		Pic 8 Desc.	Waterbar end treatments are functioning as intended.

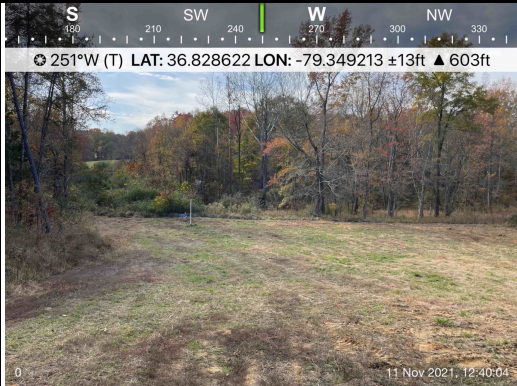
GPS Location	See photo		GPS Location	See photo	
Field Station#	16005+00		Field Station#	16016+00	
Pic 9 Desc.	Vegetation continues to fill in throughout this section.		Pic 10 Desc.	Resource buffers remain in good condition.

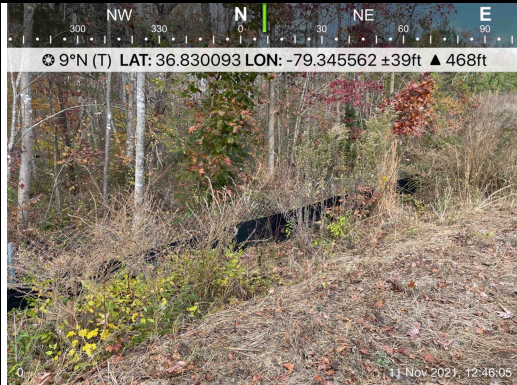
Insert image here			
GPS Location	See photo		GPS Location		
Field Station#	16018+00		Field Station#		
Pic 11 Desc.	Perimeter SSF is in good condition.		Pic 12 Desc.

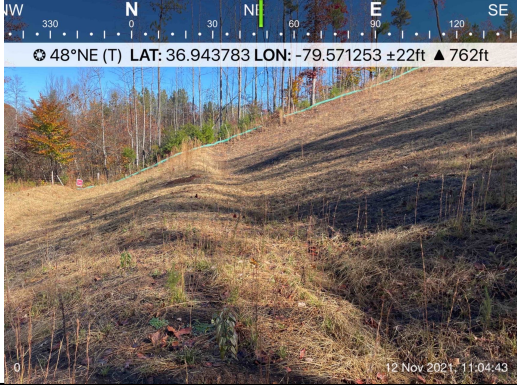
GPS Location	See photo		GPS Location	See photo	
Field Station#	15170+00		Field Station#	15170+00	
Pic 9 Desc.	Waterbars are in good condition.		Pic 10 Desc.	Slope drain is in good condition.

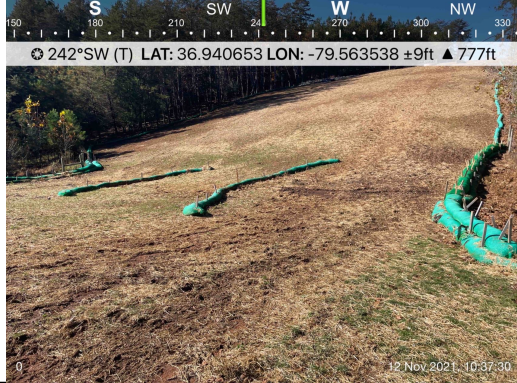
GPS Location	See photo		GPS Location	See photo	
Field Station#	15195+00		Field Station#	15230+00	
Pic 11 Desc.	Drainage ECDs are in good condition and functioning.		Pic 12 Desc.	Vegetation continues to fill in throughout this section.

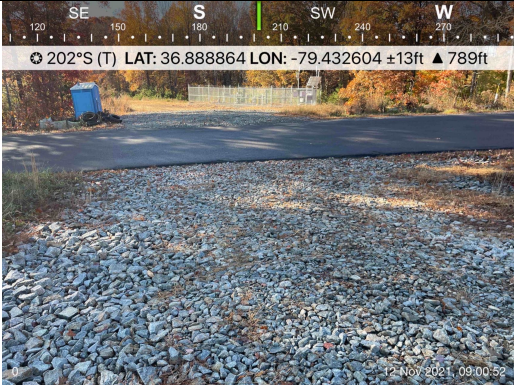
GPS Location	See photo		GPS Location	See photo	
Field Station#	15647+03		Field Station#	15636+46	
Pic 1 Desc.	RCEs are in good condition at all road crossings.		Pic 2 Desc.	P1 is in good condition at all stream and wetland buffers.

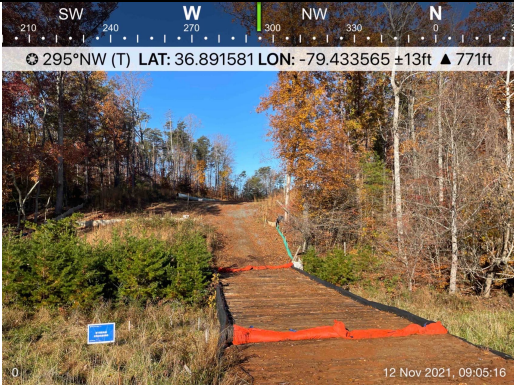
GPS Location	See photo		GPS Location	See photo	
Field Station#	15636+46		Field Station#	15630+00	
Pic 3 Desc.	Equipment bridge ECDs are in place and functioning.		Pic 4 Desc.	CWDs are functioning as intended.

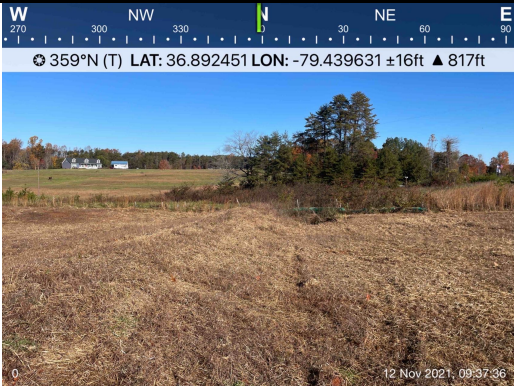
GPS Location	See photo		GPS Location	See photo	
Field Station#	15616+00		Field Station#	15610+00	
Pic 5 Desc.	Waterbars are in good condition.		Pic 6 Desc.	Perimeter CFS is in good condition.

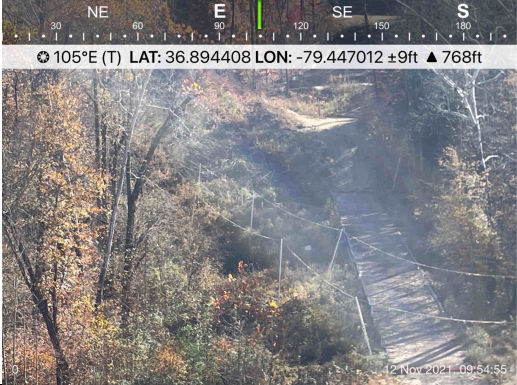
GPS Location	See photo		GPS Location	See photo	
Field Station#	15596+70		Field Station#	15590+00	
Pic 7 Desc.	Resource buffers remain in good condition.		Pic 8 Desc.	This area has been stabilized.	
Insert image here			Insert image here		
GPS Location			GPS Location		
Field Station#			Field Station#		
Pic 9 Desc.			Pic 10 Desc.		
Insert image here			Insert image here		
GPS Location			GPS Location		
Field Station#			Field Station#		
Pic 11 Desc.			Pic 12 Desc.

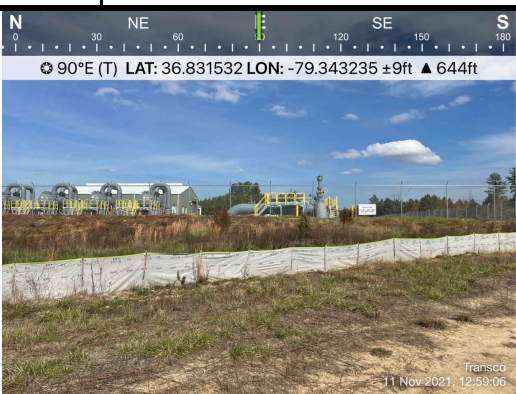
GPS Location	See photo		GPS Location	See photo	
Field Station#	00+00		Field Station#	00+00	
Pic 3 Desc.	P1 is in good condition around basin.		Pic 4 Desc.	Vegetation continues to fill in throughout this area.

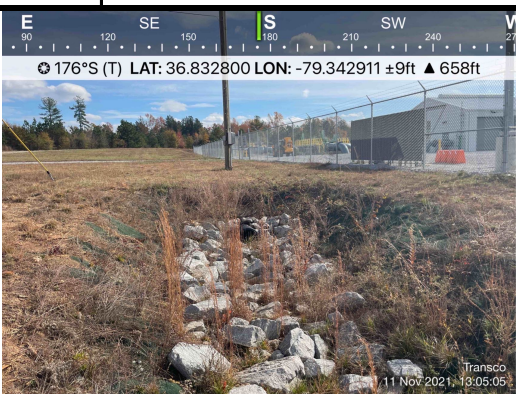
GPS Location	See photo		GPS Location	See photo	
Field Station#	00+00		Field Station#	00+00	
Pic 5 Desc.	Rock lined channel is in good condition.		Pic 6 Desc.	Sediment traps are in good condition and functioning.
