Visual Site Inspection Report

Project Name	H-600 Pipeline Spread I	AFE	124300139	Spread	H-600 Pipeline Spread I
Contractor	Precision			Report #	28659
Inspector	Ben Davenport			Date/Time	9/20/2021 8:20 AM
Permit #	TBD	Inspection Type	VA SWPP	Station Begin	14802+19
State	VA	Inspection Area	Partial	Station End	14928+52
County	Franklin	Ground	Damp	Temperature (°F)	75.00
Municipality	N/A	Weather	Cloudy	Rain Gauge (in)	0.00
				Rain Accumulation Time (days)	0.00

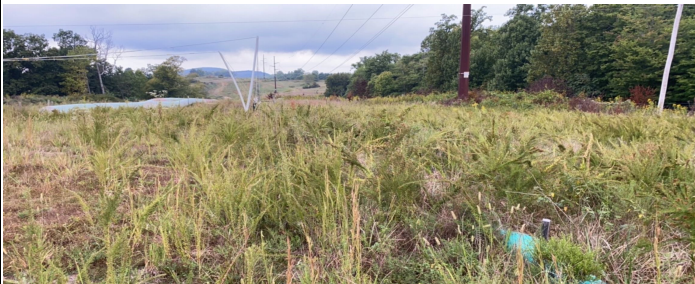
<p>36°58'17" N 79°39'37" W 318°NW COURSE 288° GPS 1592-2298 Bar Ridge Rd, Penhook, VA 24137, United States 09.20.2021 09:24:01 Accur +/-26.7 Ft ALT 986 Ft</p>		
GPS Location	1	GPS Location	2		
Field Station#	14858+50	Field Station#	14861+00		
Pic 1 Desc.	Picture of temporary stabilization and vegetation along ROW. Perimeter CFS in good condition.		Pic 2 Desc.	Portajon properly contained in secondary containment

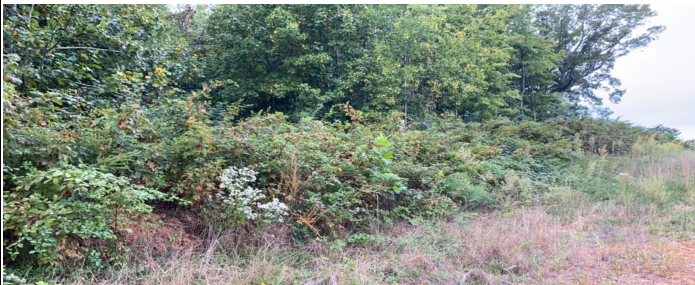
GPS Location	3	GPS Location	4		
Field Station#	14865+00	Field Station#	14878+00		
Pic 3 Desc.	Temporary diversion berm stabilized and vegetated		Pic 4 Desc.	Picture of temporary stabilization and vegetation along ROW

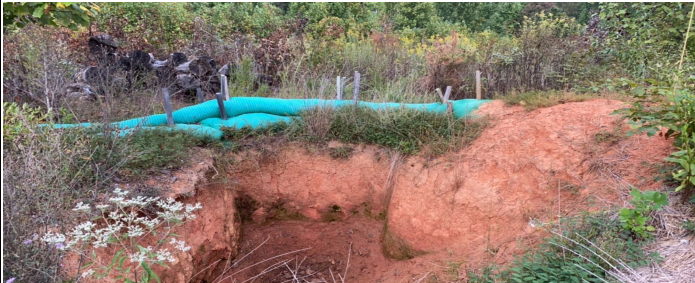
<p>36°58'4" N 79°38'19" W 342°N COURSE 307° GPS 2019 Ramsey Memorial Rd, Penhook, VA 24137, United States 09.20.2021 09:12:07 Accur +/-15.4 Ft ALT 875 Ft</p>		
GPS Location	5	GPS Location	6		
Field Station#	14883+00	Field Station#	14923+00		
Pic 5 Desc.	Sump pit and CFS end treatment performing intended functions		Pic 6 Desc.	Picture of ROW in final cleanup area

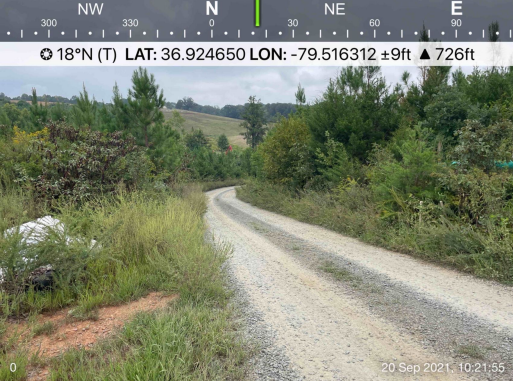
GPS Location	See photo		GPS Location	See photo	
Field Station#	15370+00		Field Station#	15350+00	
Pic 1 Desc.	Vegetation continues to fill in throughout this section.		Pic 2 Desc.	MVP-PI-332 remains in good condition with controls in place.

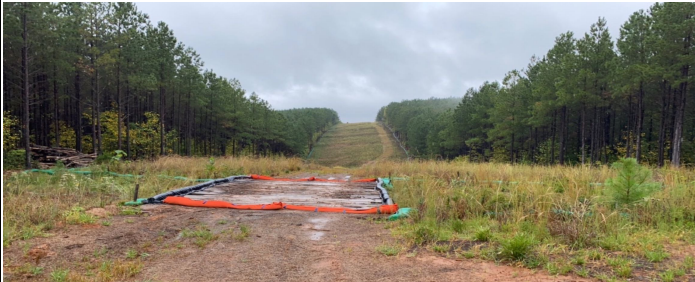
36°57'58" N 79°37'25" W 252°W COURSE 300' GPS Penhook, VA 24137, United States 09.21.2021 13:26:41 Accur +/-250.0 Ft ALT 933 Ft			36°57'57" N 79°37'23" W 271°W COURSE 237' GPS Penhook, VA 24137, United States 09.21.2021 13:25:05 Accur +/-421.4 Ft ALT 938 Ft		
GPS Location	1	GPS Location	2		
Field Station#	14968+69	Field Station#	14961+00		
Pic 1 Desc.	Equipment bridge and surrounding ECDs in place and functional at natural drainage area		Pic 2 Desc.	Picture of final cleanup area along ROW

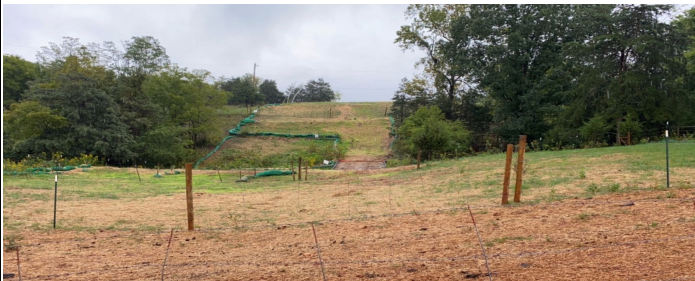
36°57'53" N 79°37'3" W 104°E COURSE 164' GPS Penhook, VA 24137, United States 09.21.2021 13:36:59 Accur +/-39.8 Ft ALT 929 Ft			36°57'53" N 79°37'5" W 302°NW COURSE -1' GPS 121-175 Ashworth Rd, Penhook, VA 24137, United States 09.21.2021 13:38:52 Accur +/-52.8 Ft ALT 930 Ft		
GPS Location	5	GPS Location	6		
Field Station#	14991+00	Field Station#	14982+00		
Pic 5 Desc.	New vegetation growing along ROW where environmental maintenance was performed		Pic 6 Desc.	Temporary diversion berm stabilized and vegetated

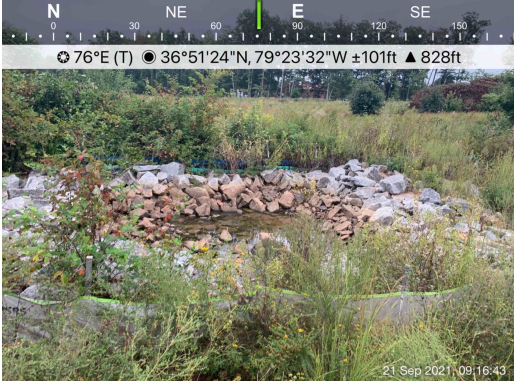
GPS Location	O	GPS Location	O		
Field Station#	15825+00	Field Station#	15788+00		
Pic 3 Desc.	Observing temporary stabilization,plunge pool and ECD's	Pic 4 Desc.	Observing temporary stabilization and safety fence that requires maintenance

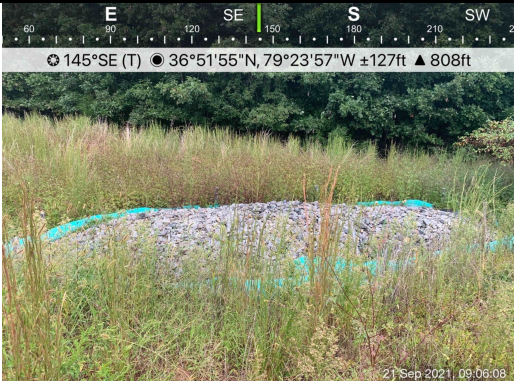
GPS Location	O	GPS Location	O		
Field Station#	15787+00	Field Station#	15794+77		
Pic 5 Desc.	Observing temporary stabilization,CWD outlet and ECD's	Pic 6 Desc.	Observing temporary stabilization, buffer, equipment crossing and ECD's

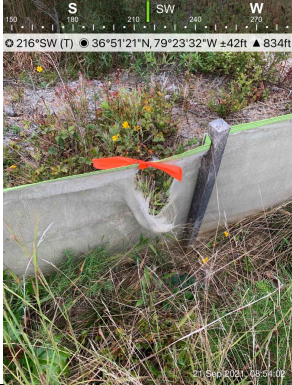
<p>S 216°SW (T) 36°51'21"N, 79°23'32"W ±42ft ▲834ft 21 Sep 2021, 08:58:02</p>			
GPS Location	O	GPS Location	O		
Field Station#	15810+00	Field Station#	15827+00		
Pic 7 Desc.	Observing temporary stabilization		Pic 8 Desc.	Observing P1 that requires maintenance

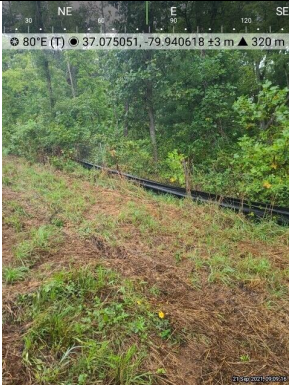
GPS Location	00000	GPS Location	00000		
Field Station#	13746+90	Field Station#	13747+10		
Pic 1 Desc.	Reinforced silt fence requires maintenance, documented and added to the punch list for repair by the contractor.		Pic 2 Desc.	Monitored sump pit and end treatment, no environmental issues observed at the time of inspection during light rain events today.

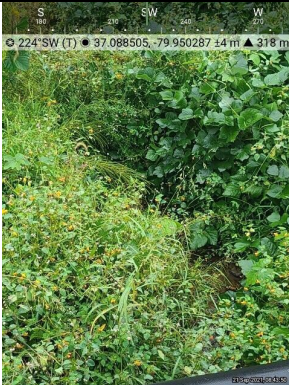
GPS Location	0000	GPS Location	00000		
Field Station#	13678+71	Field Station#	13678+71		
Pic 3 Desc.	Stream observation photo facing downstream during routine inspection today, light rain events throughout the day. No environmental issues observed at the time of inspection.		Pic 4 Desc.	Stream observation photo facing upstream showing good vegetation on stream banks, no environmental issues observed at the time of inspection.

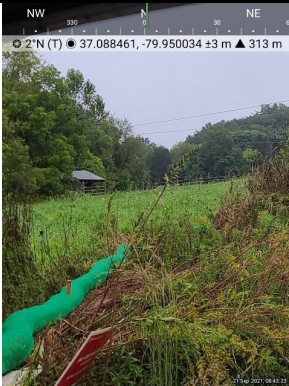
Field Station#	13679+00	Field Station#	13745+20		
Pic 5 Desc.	Monitored LOD ECDs during light rain events.		Pic 6 Desc.	Row photo during light rain events showing row that has been recently seeding in efforts for winter stabilization.

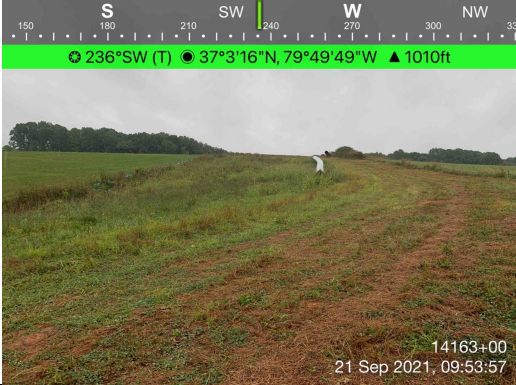
GPS Location	0	GPS Location	0		
Field Station#	14170+00	Field Station#	14163+00		
Pic 7 Desc.	Temporary vegetative stabilization and super silt fence in acceptable conditions		Pic 8 Desc.	Permanent vegetative stabilization in acceptable condition	
Insert image here		Insert image here			
GPS Location		GPS Location			
Field Station#		Field Station#			
Pic 9 Desc.			Pic 10 Desc.		
Insert image here		Insert image here			
GPS Location		GPS Location			
Field Station#		Field Station#			
Pic 11 Desc.			Pic 12 Desc.

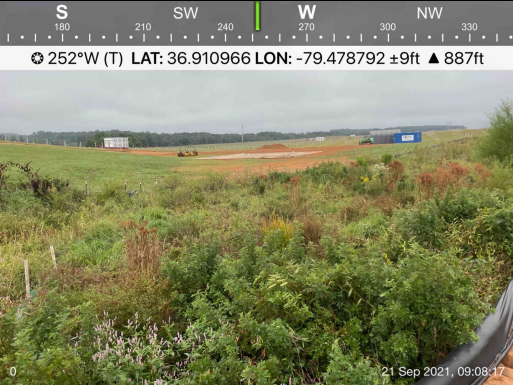
GPS Location	See photo		GPS Location	See photo	
Field Station#	15480+67		Field Station#	15475+00	
Pic 1 Desc.	RCEs are in good condition at all road crossings.		Pic 2 Desc.	3rd party rock outlet appears to be in good condition along this drainage.

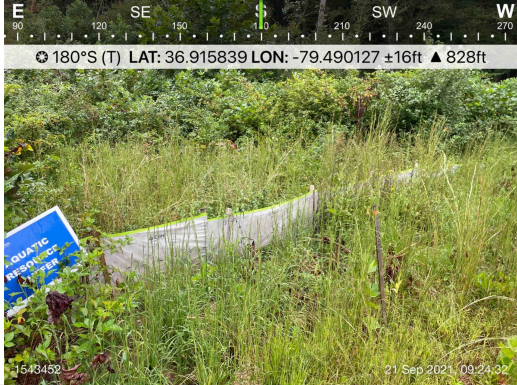
GPS Location	See photo		GPS Location	See photo	
Field Station#	15434+52		Field Station#	15426+70	
Pic 9 Desc.	P1 is in good condition at all stream and wetland buffers.		Pic 10 Desc.	Equipment bridge ECDs are in place and functioning.

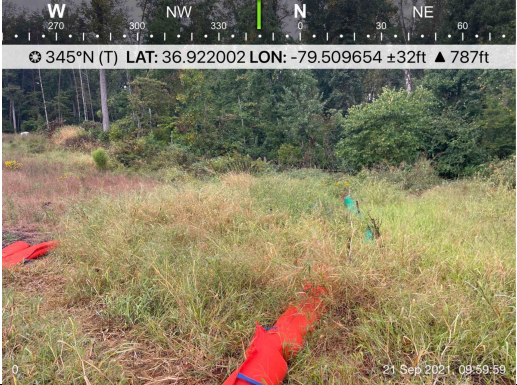
GPS Location	See photo	GPS Location	See photo		
Field Station#	15380+00	Field Station#	15375+00		
Pic 13 Desc.	Waterbars are functioning as intended.	Pic 14 Desc.	Drainage ECDs are in place and functioning.		
Insert image here		Insert image here			
GPS Location		GPS Location			
Field Station#		Field Station#			
Pic 15 Desc.		Pic 16 Desc.			
Insert image here		Insert image here			
GPS Location		GPS Location			
Field Station#		Field Station#			
Pic 17 Desc.		Pic 18 Desc.

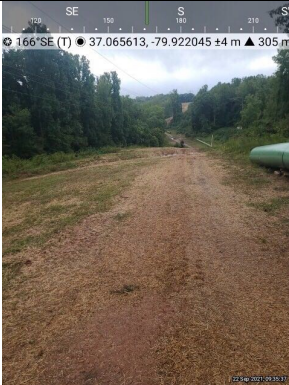
GPS Location	00000	GPS Location	00000		
Field Station#	13830+00	Field Station#	13784+30		
Pic 1 Desc.	Saturated row photo taken during rain events today. No environmental issues observed at the time of inspection.		Pic 2 Desc.	Monitored sump pit and plunge pool during rain events today. No environmental issues observed at the time of inspection.

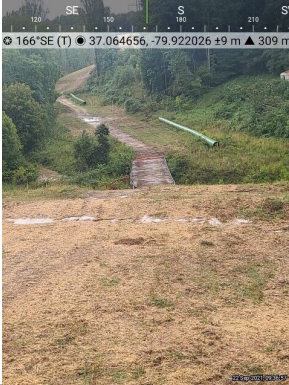
GPS Location	0000	GPS Location	0000		
Field Station#	13832+70	Field Station#	13787+30		
Pic 3 Desc.	Monitored row conditions during rain events, no environmental issues observed at the time of inspection.		Pic 4 Desc.	Row photo taken during rain events today with a total of 4" at the time of inspection.

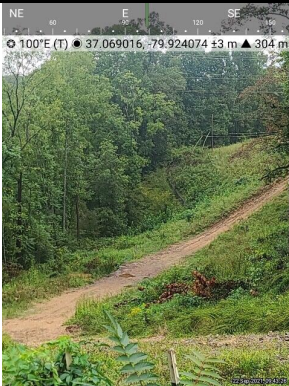
GPS Location	00000	GPS Location	0000		
Field Station#	13816+80	Field Station#	13784+00		
Pic 5 Desc.	Row photo taken during rain events, total of 4" at time of inspection.		Pic 6 Desc.	Monitored ECDs on hill side above stream crossing, no environmental issues observed at the time of inspection.

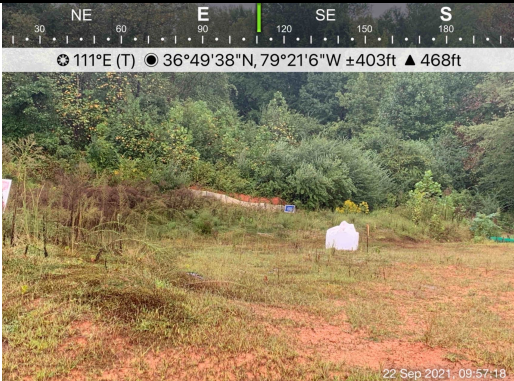
GPS Location	O	GPS Location	O		
Field Station#	15999+00	Field Station#	15997+00		
Pic 5 Desc.	Observing temporary stabilization, signage, buffer and ECD's	Pic 6 Desc.	Observing temporary stabilization, CWD outlet and ECD's

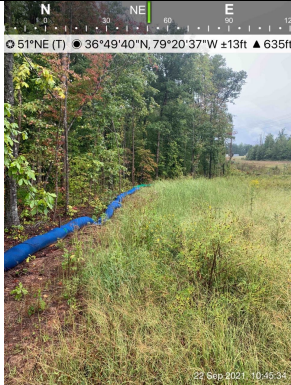
GPS Location	O	GPS Location	O		
Field Station#	4+00	Field Station#	19+00		
Pic 1 Desc.	Observing CFS that requires maintenance	Pic 2 Desc.	Observing temporary stabilization and ECD's

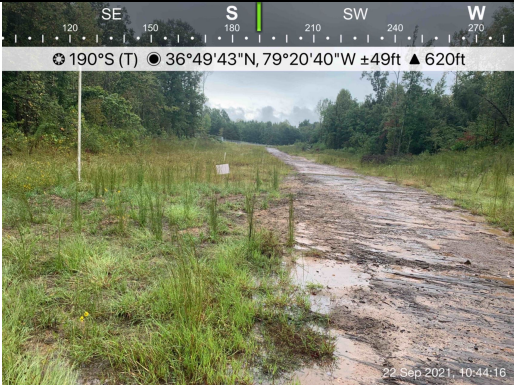
GPS Location	O	GPS Location	O		
Field Station#	15+00	Field Station#	12+65		
Pic 3 Desc.	Observing temporary stabilization	Pic 4 Desc.	Observing temporary stabilization, buffer, equipment crossing and ECD's		
Insert image here		Insert image here			
GPS Location		GPS Location			
Field Station#		Field Station#			
Pic 5 Desc.		Pic 6 Desc.

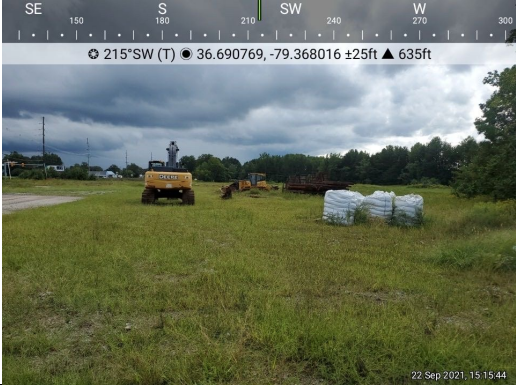
GPS Location	0	GPS Location	0		
Field Station#	0+00	Field Station#	0+00		
Pic 7 Desc.	LY-048 Equipment staging	Pic 8 Desc.	LY-048 Temporary vegetation		
Insert image here		Insert image here			
GPS Location		GPS Location			
Field Station#		Field Station#			
Pic 9 Desc.		Pic 10 Desc.			
Insert image here		Insert image here			
GPS Location		GPS Location			
Field Station#		Field Station#			
Pic 11 Desc.		Pic 12 Desc.

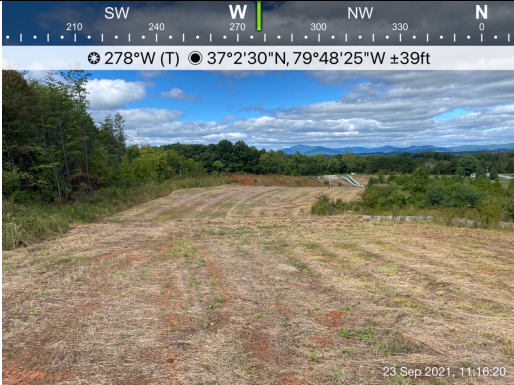
GPS Location	0	GPS Location	0		
Field Station#	14320+00	Field Station#	14330+00		
Pic 1 Desc.	Approximately 14320+00. Overview of ROW.	Pic 2 Desc.	Approximately 14330+00. CFS requires maintenance.

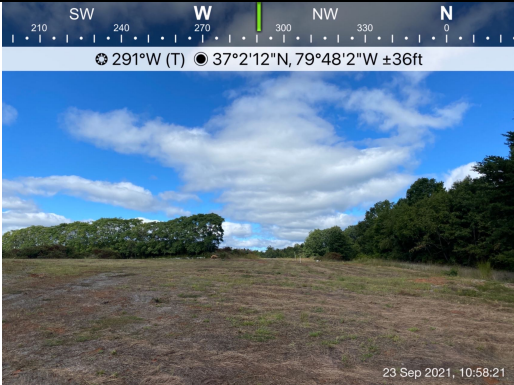
GPS Location	0	GPS Location	0		
Field Station#	14346+00	Field Station#	14375+00		
Pic 3 Desc.	Approximately 14346+00. Overview of ROW.	Pic 4 Desc.	Approximately 14375+00. Overview of ROW.

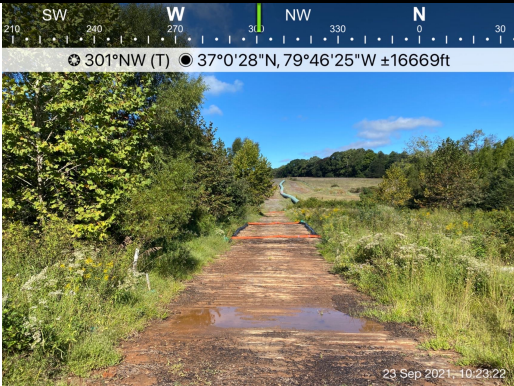
GPS Location	0	GPS Location	0		
Field Station#	14391+50	Field Station#	14451+00		
Pic 5 Desc.	Approximately 14391+50. Overview of stream crossing, equipment bridge and ECDs at stream S-A41.	Pic 6 Desc.	Approximately 14451+00. Overview of ROW.

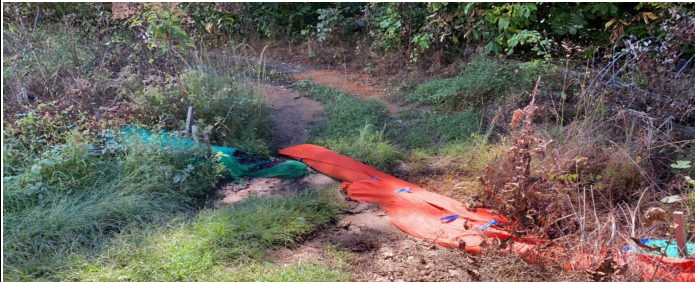
36°58'42" N 79°40'56" W 175°S COURSE 156° GPS 245 Zeigler Ln, Union Hall, VA 24176, United States 09.23.2021 12:14:14 Accur +/-84.7 Ft ALT 866 Ft			36°58'54" N 79°41'12" W 121°SE COURSE 0° GPS 09.23.2021 12:04:54 Accur +/-50.2 Ft ALT 0 Ft		
GPS Location	1	GPS Location	2		
Field Station#	14787+75	Field Station#	14770+00		
Pic 1 Desc.	Routine maintenance. Minor sediment accumulation at perimeter of ROW. Damage to perimeter CFS from landowner damage.		Pic 2 Desc.	Minor sediment accumulation in throat of water bar from minor rill erosion on slope. Sump not overwhelmed. Will monitor area.

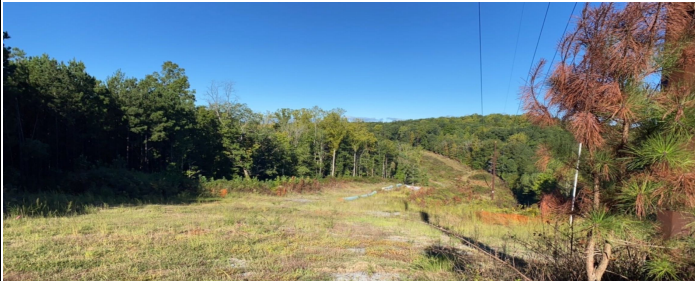
36°59'11" N 79°41'44" W 292°W COURSE 262° GPS Union Hall, VA 24176, United States 09.23.2021 09:16:07 Accur +/-60.7 Ft ALT 947 Ft			36°58'43" N 79°41'1" W 275°W COURSE 156° GPS Union Hall, VA 24176, United States 09.23.2021 12:11:29 Accur +/-202.8 Ft ALT 866 Ft		
GPS Location	5	GPS Location	6		
Field Station#	14738+00	Field Station#	14784+00		
Pic 5 Desc.	Picture of temporary stabilization and vegetation along ROW.		Pic 6 Desc.	Sump pit and perimeter controls performing intended functions.

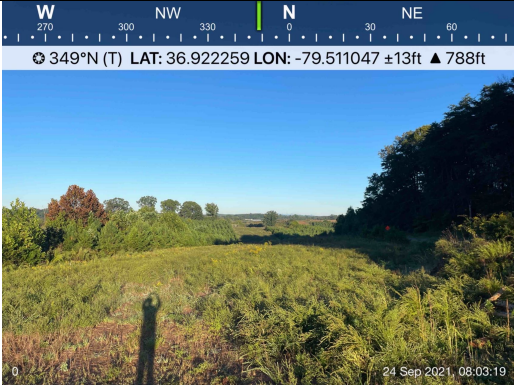
GPS Location	See photo		GPS Location	See photo	
Field Station#	15370+00		Field Station#	15351+00	
Pic 1 Desc.	Vegetation continues to fill in throughout this section.		Pic 2 Desc.	CFS has been damaged and needs to be repaired.

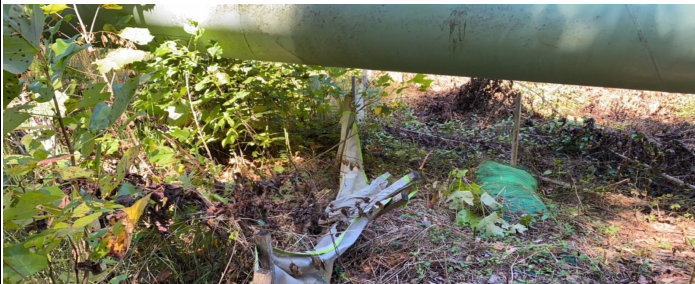
36°58'24" N 79°40'23" W 6°N COURSE 39' GPS Penhook, VA 24137, United States 09.23.2021 13:01:09 Accur +/-91.6 Ft ALT 867 Ft			36°58'6" N 79°38'32" W 139°SE COURSE 301' GPS Sorry no results found 09.24.2021 12:07:08 Accur +/-29.6 Ft ALT 770 Ft		
GPS Location	1	GPS Location	2		
Field Station#	14823+00	Field Station#	14915+96		
Pic 1 Desc.	Routine maintenance. Replace damaged panels of P1 silt fence in resource buffer.		Pic 2 Desc.	Routine maintenance. Bridge wattles overtopping with sediment. Repair and stabilize.

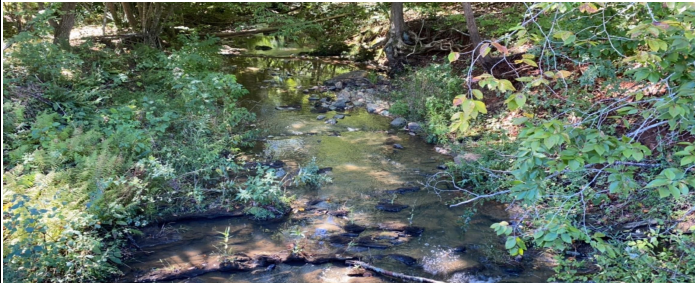
36°58'6" N 79°38'31" W 230°SW COURSE 273' GPS Sorry no results found 09.24.2021 12:06:54 Accur +/-65.3 Ft ALT 803 Ft			36°58'6" N 79°38'27" W 292°W COURSE 0' GPS Sorry no results found 09.24.2021 12:05:17 Accur +/-42.5 Ft ALT 0 Ft		
GPS Location	5	GPS Location	6		
Field Station#	14907+52	Field Station#	14920+00		
Pic 5 Desc.	Stream running clear downstream of ROW crossing		Pic 6 Desc.	Picture of temporary stabilization and vegetation along ROW
