Visual Site Inspection Report

Project Name	H-600 Pipeline Spread I	AFE	124300139	Spread	H-600 Pipeline Spread I
Contractor	Precision			Report #	29015
Inspector	Ben Farmer			Date/Time	9/27/2021 2:31 PM
Permit #	TBD	Inspection Type	VA SWPP	Station Begin	15370+62
State	VA	Inspection Area	Partial	Station End	15480+67
County	Pittsylvania	Ground	Dry	Temperature (°F)	60.00
Municipality	Chatham	Weather	Sunny	Rain Gauge (in)	0.00
				Rain Accumulation Time (days)	0.00

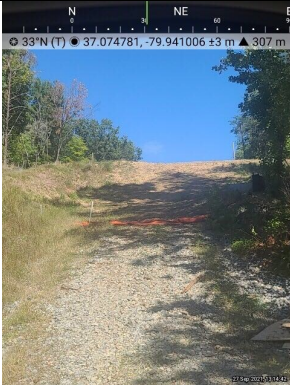
GPS Location	0000	GPS Location	0000		
Field Station#	13692+67	Field Station#	13748+14		
Pic 1 Desc.	Monitored stream banks where equipment mats were removed during previous maintenance repairs. No environmental issues observed at the time of inspection.		Pic 2 Desc.	Monitored RCEs and ECDs at road crossing. No environmental issues observed at the time of inspection.

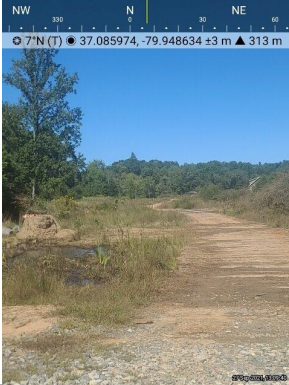
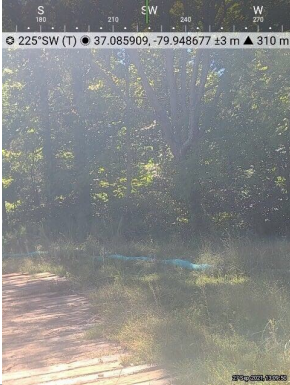
GPS Location	0000	GPS Location	000		
Field Station#	13689+40	Field Station#	13690+66		
Pic 3 Desc.	Additional row photo showing row conditions, no environmental issues observed at the time of inspection.		Pic 4 Desc.	Row photo showing ECDs in place and functioning on LOD. No environmental issues observed at the time of inspection.

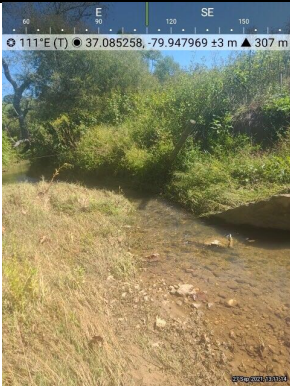
GPS Location	0000	GPS Location	0000		
Field Station#	13692+64	Field Station#	13692+64		
Pic 5 Desc.	Stream observation photo facing downstream during routine inspection today, no environmental issues observed at the time of inspection.		Pic 6 Desc.	Stream observation photo facing upstream during routine inspection no environmental issues observed at the time of inspection.

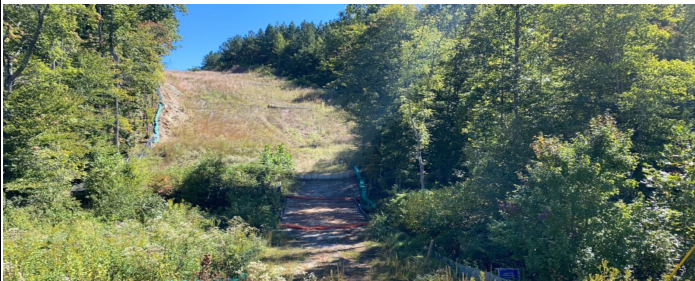
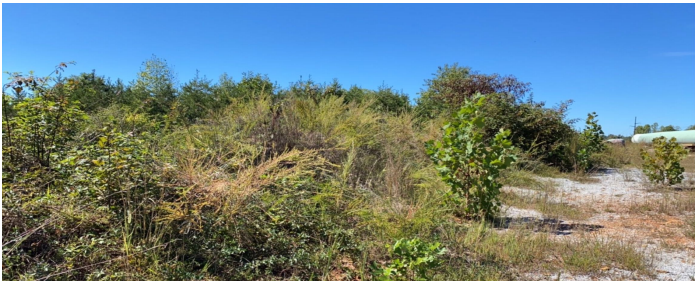
36°58'1" N 79°37'52" W 130°SE COURSE 98° GPS Sorry no results found 09.27.2021 13:03:17 Accur +/-56.5 Ft ALT 841 Ft			36°58'0" N 79°37'56" W 295°NW COURSE 216° GPS Sorry no results found 09.27.2021 13:06:00 Accur +/-16.7 Ft ALT 844 Ft		
GPS Location	5		GPS Location	6	
Field Station#	14950+47		Field Station#	14945+00	
Pic 5 Desc.	Equipment bridge and surrounding ECDs in place and functional at stream crossing and resource buffer		Pic 6 Desc.	Temporary diversion berm stabilized and vegetated

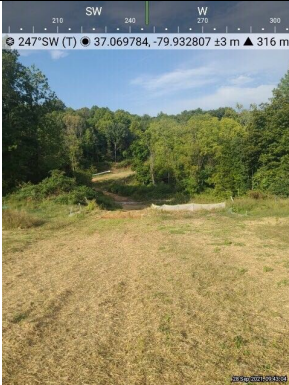
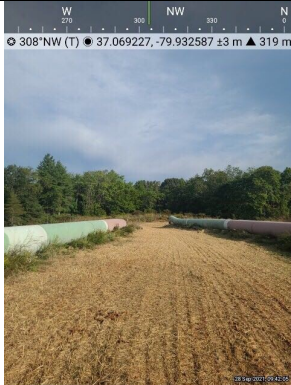
GPS Location	00000	GPS Location	00000		
Field Station#	13783+80	Field Station#	13784+35		
Pic 1 Desc.	Monitored row conditions where winter stabilization has been completed, some new vegetation growth as seen in photo.		Pic 2 Desc.	Stabilization on row after winter seeding and mulching has been completed. No issues observed at the time of inspection.

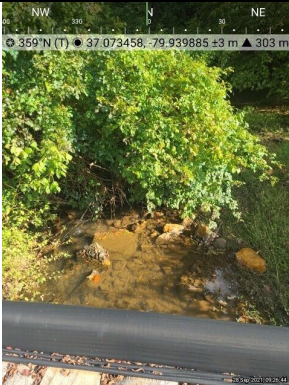
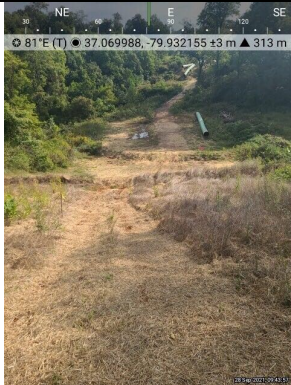
GPS Location	0000	GPS Location	00000		
Field Station#	13755+71	Field Station#	13786+90		
Pic 3 Desc.	Stream observation photo facing downstream during routine inspection today. No environmental issues observed at the time of inspection.		Pic 4 Desc.	Hill above stream crossing stabilized. No environmental issues observed at the time of inspection.

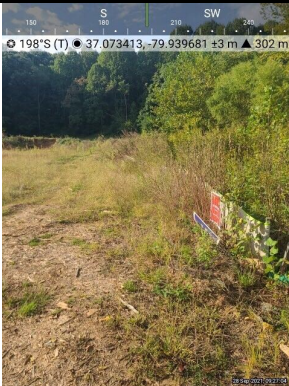
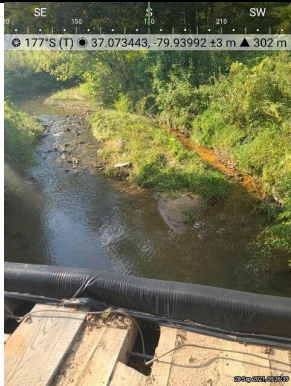
GPS Location	00000	GPS Location	0000		
Field Station#	13755+74	Field Station#	13755+71		
Pic 5 Desc.	ECDs at stream crossing in place and functioning at the time of inspection.		Pic 6 Desc.	Stream observation photo facing upstream during routine inspection today, no environmental issues observed at the time of inspection.

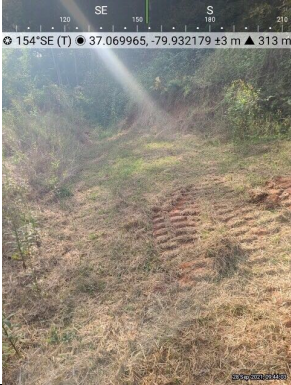
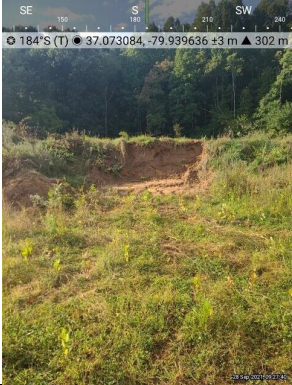
GPS Location	0000	GPS Location	00000		
Field Station#	13786+90	Field Station#	13756+55		
Pic 7 Desc.	New vegetation coming up in mouth of slope breaker after winter stabilization has been completed.		Pic 8 Desc.	Photo showing land owner disturbance to spoil pile, Documented and sent in to be added to the punch list to be stabilized.

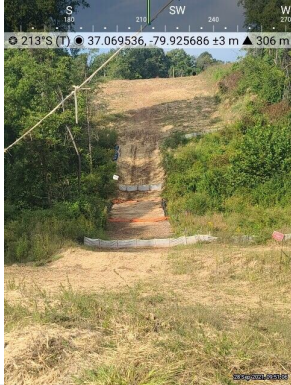
GPS Location	00000	GPS Location			
Field Station#	13805+90	Field Station#			
Pic 9 Desc.	Monitored equipment bridge and ECDs , hill sides stabilized. No environmental issues observed at the time of inspection.		Pic 10 Desc.

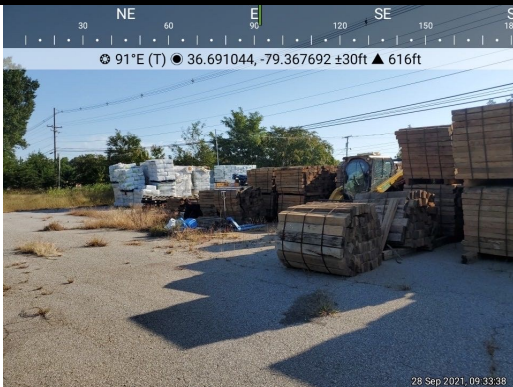
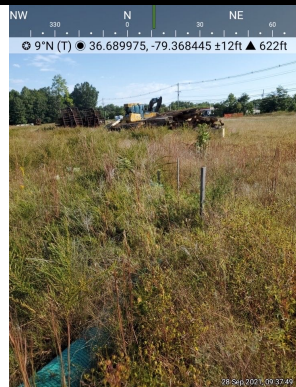
GPS Location	0		GPS Location	0	
Field Station#	0+00		Field Station#	0+00	
Pic 1 Desc.	LY-048 Material staging		Pic 2 Desc.	LY-048 West perimeter CFS

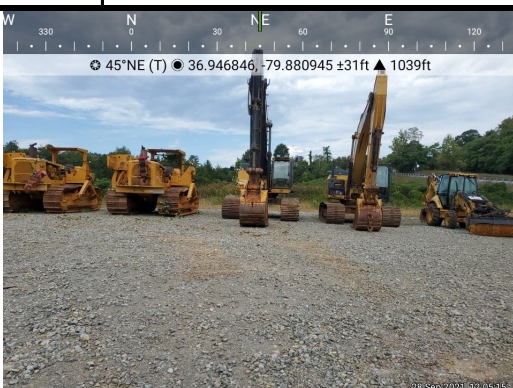
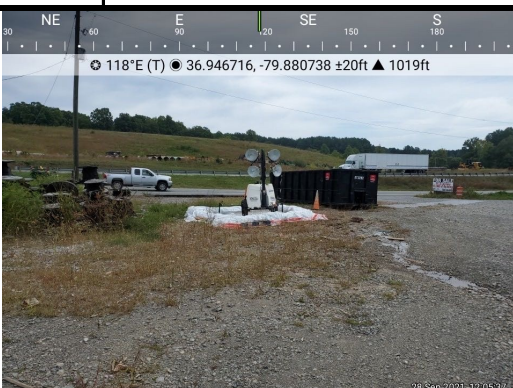
GPS Location	0		GPS Location	0	
Field Station#	0+00		Field Station#	0+00	
Pic 3 Desc.	LY-032 Equipment staging		Pic 4 Desc.	LY-032 Secondary containment

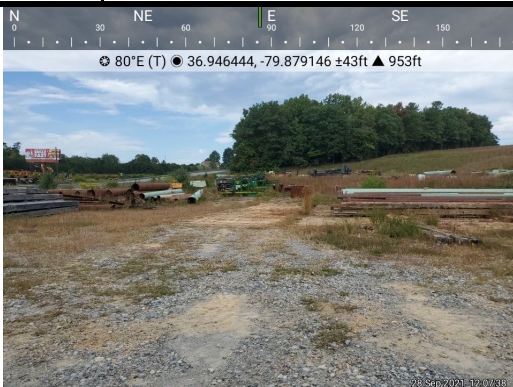
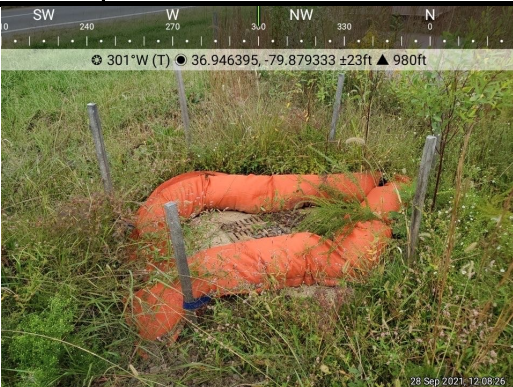
GPS Location	0		GPS Location	0	
Field Station#	0+00		Field Station#	0+00	
Pic 5 Desc.	LY-033 Staging		Pic 6 Desc.	LY-033 Stormwater drain inlet

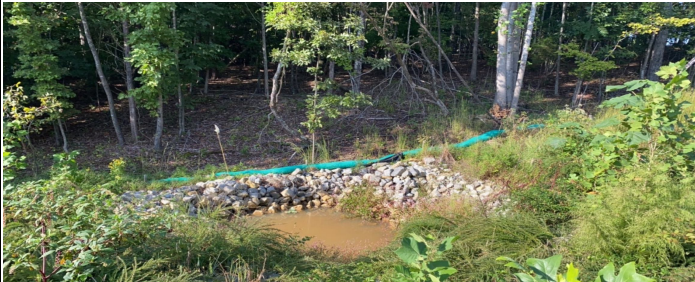
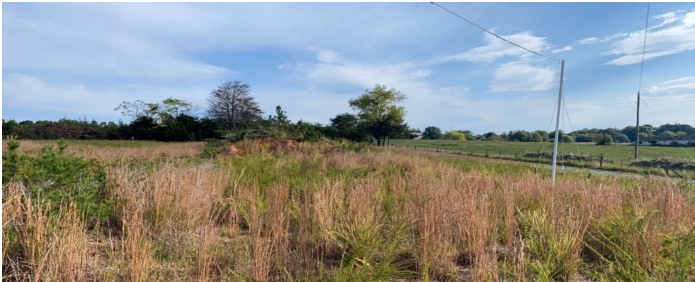
36°57'45" N 79°35'28" W 243°SW COURSE 0° GPS Sandy Level, VA 24161, United States 09.28.2021 09:35:43 Accur +/-49.3 Ft ALT 0 Ft			36°57'43" N 79°35'17" W 73°E COURSE 101° GPS Sandy Level, VA 24161, United States 09.28.2021 09:41:33 Accur +/-79.2 Ft ALT 857 Ft		
GPS Location	1		GPS Location	2	
Field Station#	15070+00		Field Station#	15079+42	
Pic 1 Desc.	Plunge pool performing intended function		Pic 2 Desc.	Extra workspace stabilized and vegetated

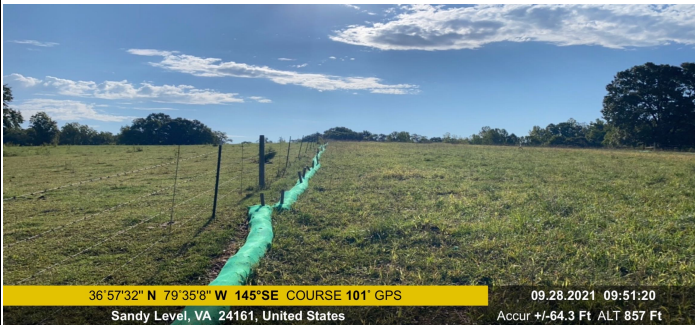
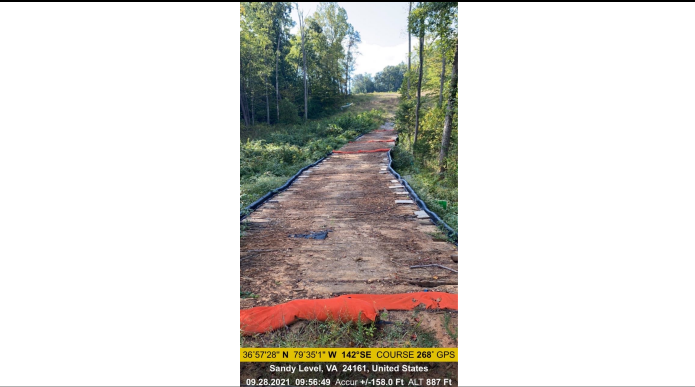
36°57'32" N 79°35'8" W 145°SE COURSE 101° GPS Sandy Level, VA 24161, United States 09.28.2021 09:51:20 Accur +/-64.3 Ft ALT 857 Ft			36°57'28" N 79°35'11" W 142°SE COURSE 268° GPS Sandy Level, VA 24161, United States 09.28.2021 09:58:49 Accur +/-158.9 Ft ALT 887 Ft		
GPS Location	3		GPS Location	4	
Field Station#	15097+00		Field Station#	15104+28	
Pic 3 Desc.	Perimeter CFS in good condition in final cleanup area		Pic 4 Desc.	Equipment bridge and surrounding ECDs in place and functional at stream crossing and resource buffer

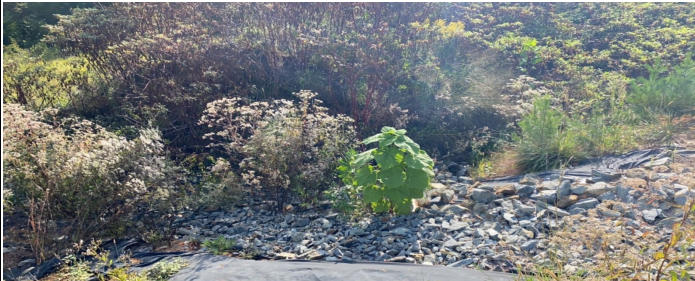
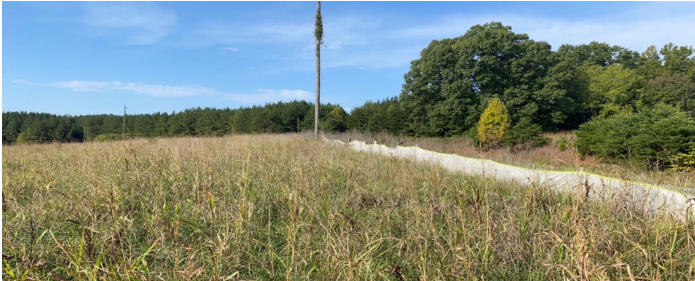
36°57'22" N 79°34'55" W 158°SE COURSE 209° GPS Sandy Level, VA 24161, United States 09.28.2021 10:02:13 Accur +/-31.8 Ft ALT 922 Ft			36°57'19" N 79°34'55" W 226°SW COURSE 214° GPS 8851-8969 Museville Rd, Sandy Level, VA 24161, United States 09.28.2021 10:04:24 Accur +/-286.9 Ft ALT 924 Ft		
GPS Location	5		GPS Location	6	
Field Station#	15111+00		Field Station#	15113+25	
Pic 5 Desc.	Rock-lined channel performing intended function on slope		Pic 6 Desc.	Perimeter P1 silt fence in good condition in extra workspace

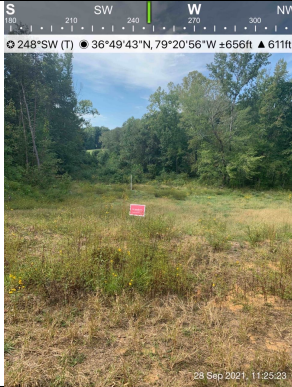
GPS Location	O	GPS Location	O		
Field Station#	16006+00	Field Station#	16004+50		
Pic 1 Desc.	CFS requires maintenance	Pic 2 Desc.	Observing temporary stabilization, signage and buffer

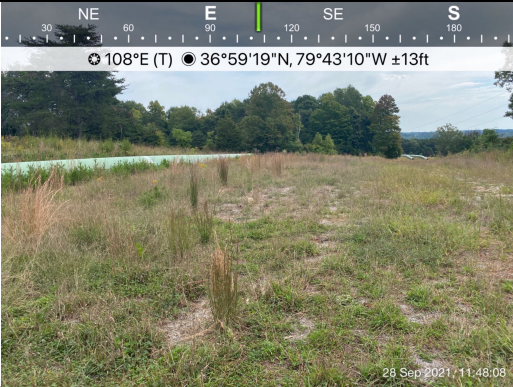
GPS Location	0	GPS Location	0		
Field Station#	14654+00	Field Station#	14667+00		
Pic 3 Desc.	Approximately 14654+00. Overview of ROW.		Pic 4 Desc.	Approximately 14667+00. Overview of ROW.

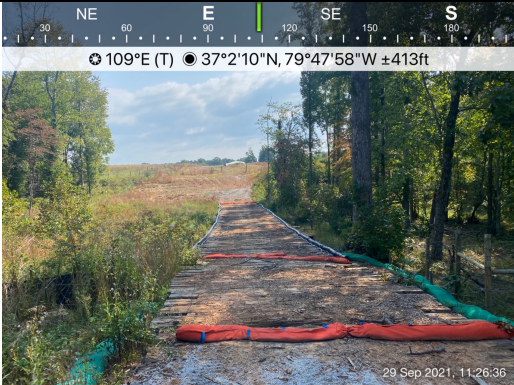
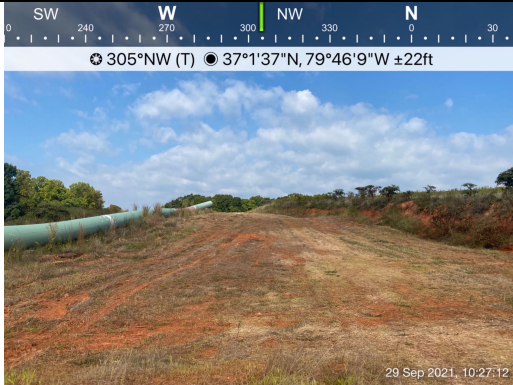
GPS Location	0	GPS Location	0		
Field Station#	14343+53	Field Station#	14451+11		
Pic 3 Desc.	Approximately 14353+53. Overview of stream crossing, equipment bridge and ECDs at stream S-A38.	Pic 4 Desc.	Approximately 14451+11. Overview of ROW.

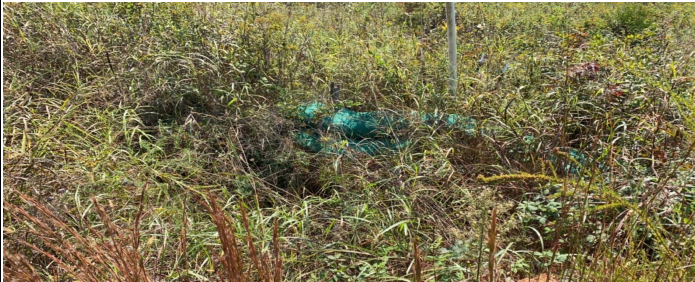
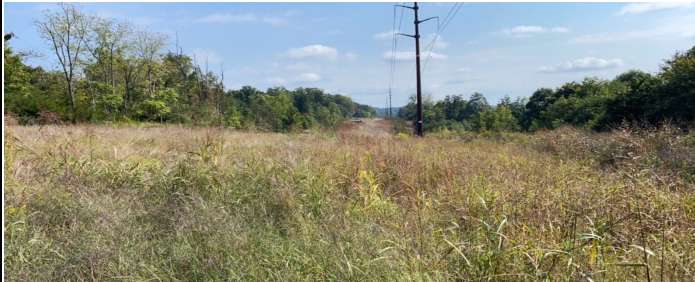
36°59'17" N 79°42'35" W 17°N COURSE 96° GPS 09.29.2021 12:12:17 Accur +/-15.4 Ft ALT 924 Ft			36°59'17" N 79°42'35" W 41°NE COURSE 96° GPS 09.29.2021 12:12:28 Sorry no results found Accur +/-15.4 Ft ALT 943 Ft		
GPS Location	1		GPS Location	2	
Field Station#	14735+00		Field Station#	14697+00	
Pic 1 Desc.	Sump pit and CFS end treatment performing intended functions		Pic 2 Desc.	ROW stabilized and vegetated in temporary area

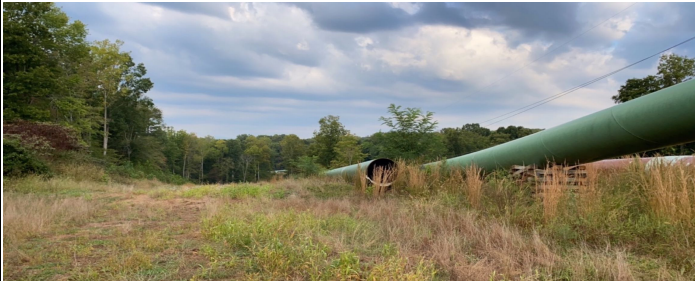
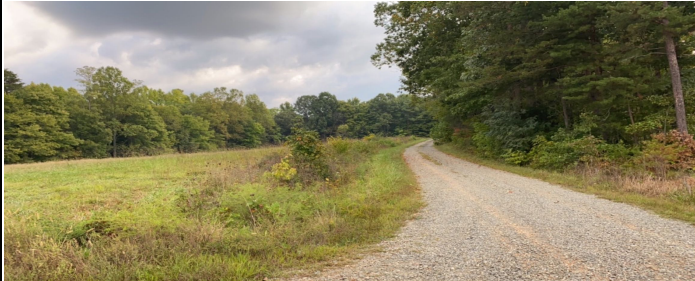
36°58'37" N 79°40'43" W 221°SW COURSE 222° GPS 09.29.2021 08:49:29 Union Hall, VA 24176, United States Accur +/-98.4 Ft ALT 856 Ft			36°58'37" N 79°40'40" W 131°SE COURSE 127° GPS 09.29.2021 08:50:14 Union Hall, VA 24176, United States Accur +/-32.8 Ft ALT 867 Ft		
GPS Location	5		GPS Location	6	
Field Station#	14800+00		Field Station#	14802+19	
Pic 5 Desc.	ROW stabilized and vegetated in temporary area		Pic 6 Desc.	RCE at MVP-FR-323 in good condition

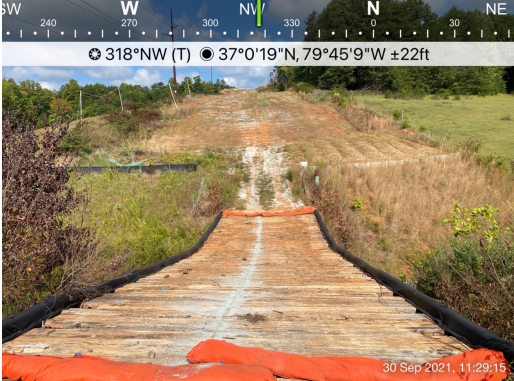
GPS Location	0	GPS Location	0		
Field Station#	14546+75	Field Station#	14524+60		
Pic 1 Desc.	Approximately 14546+75. Overview of stream crossing, equipment bridge and ECDs at stream S-G17.		Pic 2 Desc.	Approximately 14524+60. Overview of road crossing and RCEs.

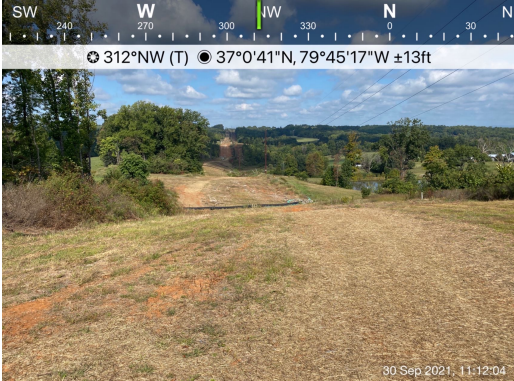
GPS Location	0	GPS Location	0		
Field Station#	14520+00	Field Station#	14474+00		
Pic 3 Desc.	Approximately 14520+00. Overview of ROW.		Pic 4 Desc.	Approximately 14474+00. Overview of ROW.

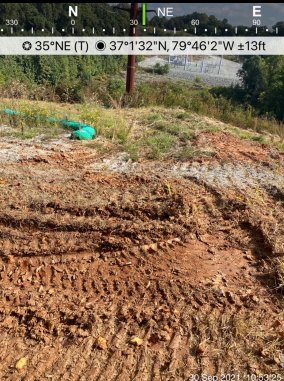
GPS Location	0	GPS Location	0		
Field Station#	14456+00	Field Station#	14478+00		
Pic 5 Desc.	Approximately 14456+00-14460+00. Repair ruts I water bar troughs,seed and stabilize.		Pic 6 Desc.	Approximately 14478+00. P-1 damaged by livestock. Replace damaged sections.

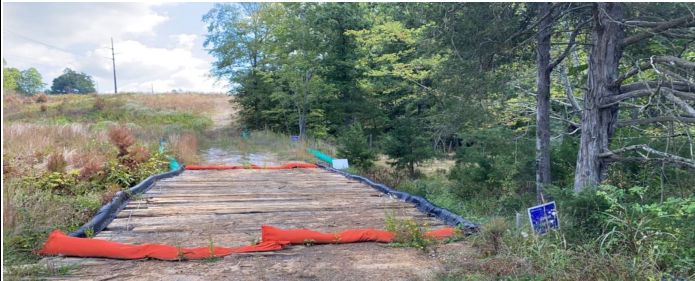
36°58'19" N 79°39'47" W 138°SE COURSE 90° GPS 355 Listening Hill Rd, Penhook, VA 24137, United States 09.30.2021 12:44:01 Accur +/-84.5 Ft ALT 945 Ft			36°58'18" N 79°39'43" W 189°S COURSE 310° GPS 2201 Bar Ridge Rd, Penhook, VA 24137, United States 09.30.2021 12:45:32 Accur +/-24.2 Ft ALT 951 Ft		
GPS Location	5		GPS Location	6	
Field Station#	14853+39		Field Station#	14867+00	
Pic 5 Desc.	Equipment bridge and surrounding ECDs in place and functional at stream crossing and resource buffer		Pic 6 Desc.	Water bar performing intended function

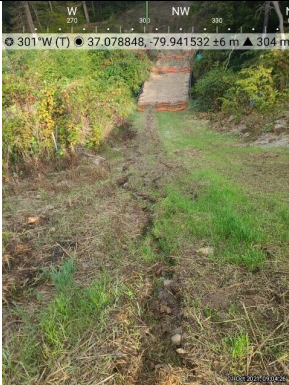
GPS Location	0000	GPS Location	0000		
Field Station#	13728+73	Field Station#	13728+23		
Pic 1 Desc.	Erosion on hill side above stream crossing, recommended installing erosion control, documented and added to the punch list.		Pic 2 Desc.	CFS over topped with sediment, recommended removing sediment, documented and added to the punch list.

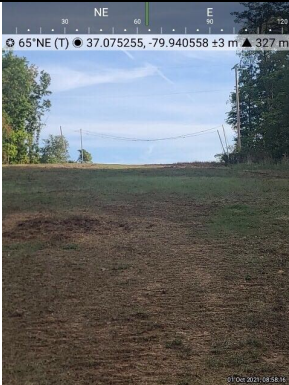
GPS Location	0000	GPS Location	0000		
Field Station#	13743+15	Field Station#	13732+00		
Pic 3 Desc.	Vegetation observation photo showing winter vegetation growth after recent stabilization activities.		Pic 4 Desc.	Vegetation observation photo showing winter vegetation growth after recent stabilization activities.

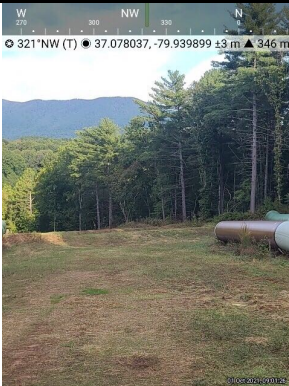
GPS Location	0000	GPS Location	00000		
Field Station#	13734+23	Field Station#	13729+60		
Pic 5 Desc.	Vegetation observation photo showing winter vegetation growth after recent stabilization activities.		Pic 6 Desc.	Monitored ECDs and sump pit on hill side above stream crossing, no environmental issues observed at the time of inspection.

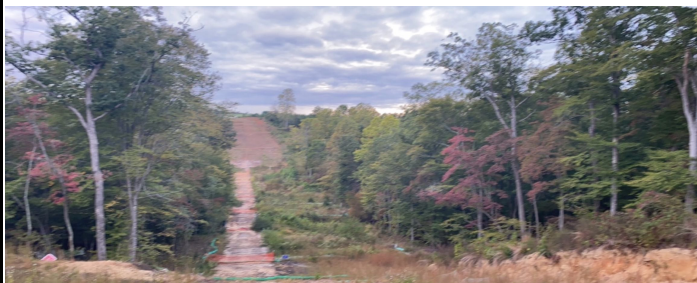
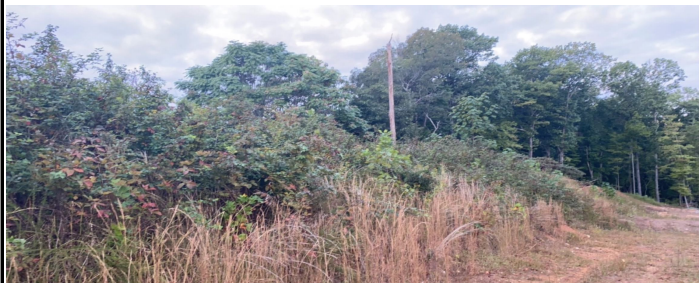
36°57'55" N 79°35'53" W 293°W COURSE 324' GPS Penhook, VA 24137, United States 10.01.2021 07:30:32 Accur +/-83.6 Ft ALT 869 Ft			36°57'49" N 79°35'41" W 287°W COURSE 253' GPS 1923-2165 Armstrong Rd, Penhook, VA 24137, United States 10.01.2021 07:25:22 Accur +/-107.1 Ft ALT 926 Ft		
GPS Location	5		GPS Location	6	
Field Station#	15025+98		Field Station#	15068+00	
Pic 5 Desc.	Equipment bridge and surrounding ECDs in place and functional at stream crossing and resource buffer; ROW stabilized in temporary		Pic 6 Desc.	Temporary diversion berm stabilized and vegetated

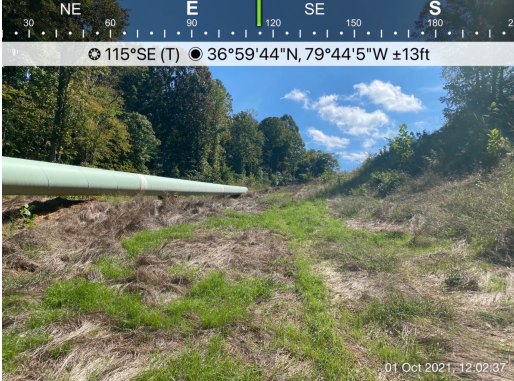
GPS Location	0	GPS Location	0		
Field Station#	14614+00	Field Station#	14611+25		
Pic 1 Desc.	Approximately 14614+00. Overview of ROW.		Pic 2 Desc.	Approximately 14611+25. Overview of stream crossing, equipment bridge and ECDs at stream S-E14.

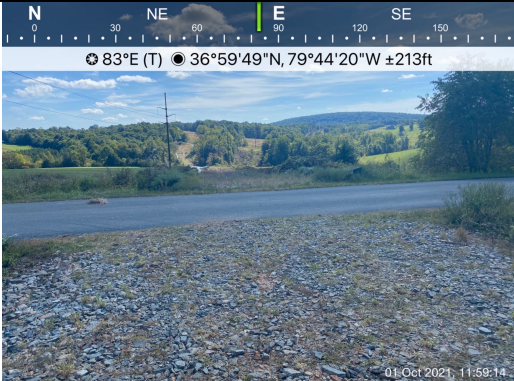
GPS Location	0	GPS Location	0		
Field Station#	14599+00	Field Station#	14575+00		
Pic 3 Desc.	Approximately 14599+00. Overview of road crossing and RCEs.		Pic 4 Desc.	Approximately 14575+00. Overview of ROW.

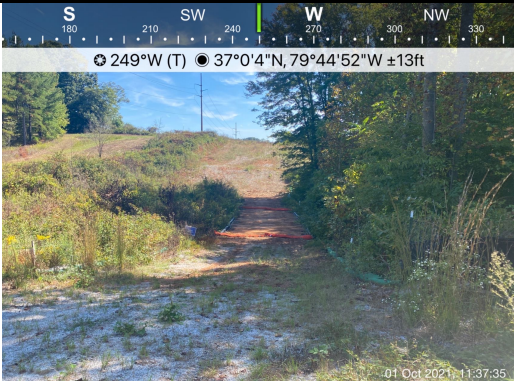
GPS Location	0	GPS Location	0		
Field Station#	14568+10	Field Station#	14550+00		
Pic 5 Desc.	Approximately 14568+10. Overview of stream crossing, equipment bridge and ECDs at stream S-E18.		Pic 6 Desc.	Approximately 14550+00. Overview of ROW.
