Visual Site Inspection Report

Project Name	H-600 Pipeline Spread G	AFE	124300137	Spread	H-600 Pipeline Spread G
Contractor	Precision			Report #	33100
Inspector	David Schoolcraft			Date/Time	1/10/2022 2:26 PM
Permit #	TBD	Inspection Type	VA SWPP	Station Begin	11023+80
State	VA	Inspection Area	Full	Station End	11098+47
County	Giles	Ground	Wet	Temperature (°F)	30.00
Municipality	N/A	Weather	Sunny	Rain Gauge (in)	0.40
				Rain Accumulation Time (days)	1.00

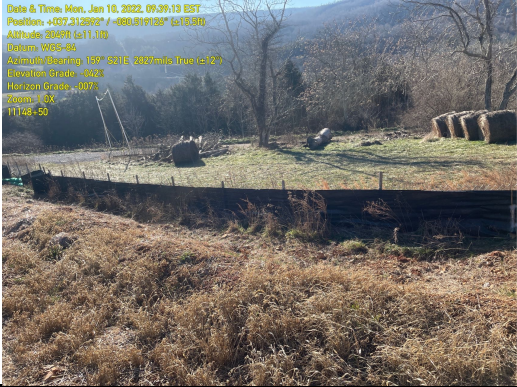
GPS Location		See photo		GPS Location	
Field Station#		11148+50		Field Station#	
Pic 7 Desc.		Supersilt fence perimeter control in place		Pic 8 Desc.	
<p>Date & Time: Mon, Jan 10, 2022 09:40:09 EST Position: +037.310907° / -080.003846° (s:16.49) Altitude: 20000 (s:26.20) Datum: WGS 84 Azimuth/Bearing: 49° 33'11.000"mils True (s:12°) Elevation Grade: -003 Horizon Grade: -003 Zoom: 1.0X 11135+00</p>

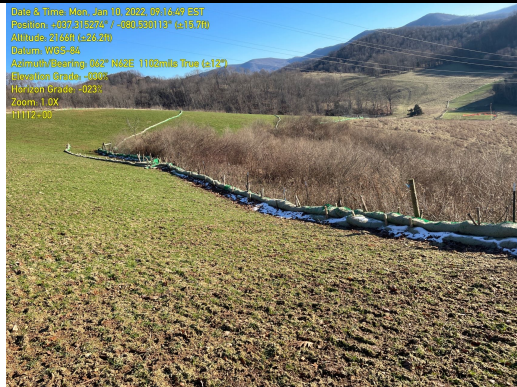
GPS Location		See photo		GPS Location	
Field Station#		11112+00		Field Station#	
Pic 11 Desc.		Triple stack CFS perimeter control in place		Pic 12 Desc.

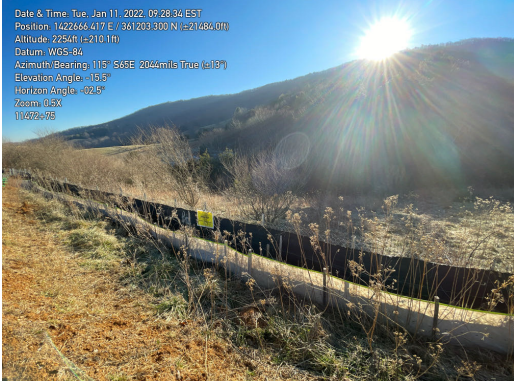
<p>Date & Time: Tue, Jan 11, 2022, 09:34:35 EST Position: 1427761.407 E / 360081.072 N (±13.6ft) Altitude: 2227ft (±13.1ft) Datum: WGS-84 Azimuth/Bearing: 102° N46E 1742mils True (±13°) Elevation Angle: -15.6° Horizon Angle: -04.8° Zoom: 11.0X 11480+00</p>		GPS Location	1
Field Station#		11472+75	GPS Location	2	
Pic 1 Desc.		Karst feature protection.	Pic 2 Desc.		Slope drain inlet protection.

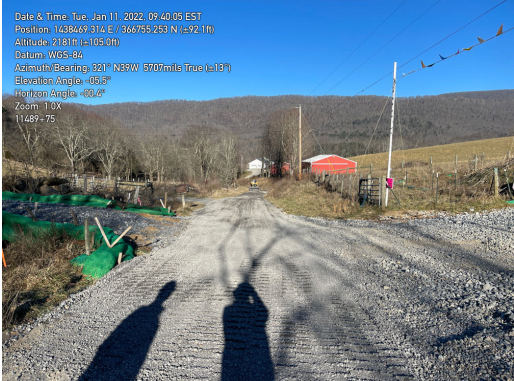
Field Station#		11489+75	GPS Location	4	
Pic 3 Desc.		Crews grading Stevers Gap access.	Pic 4 Desc.		Section of RoW showing conditions and controls.

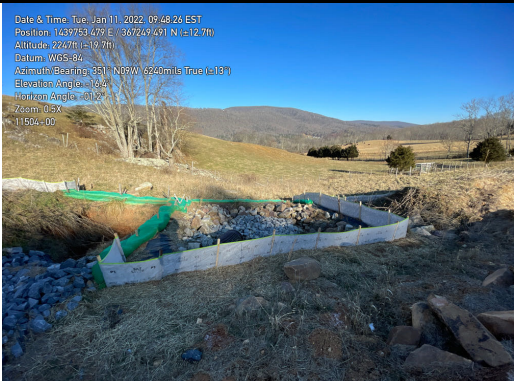
<p>Date & Time: Tue, Jan 11, 2022, 09:50:37 EST Position: 1440035.021 E / 367381.378 N (±32.7ft) Altitude: 2225ft (±39.4ft) Datum: WGS-84 Azimuth/Bearing: 119° S41E 2116mils True (±13°) Elevation Angle: -15.1° Horizon Angle: -02.8° Zoom: 0.5X S-PP3, 11507+78</p>		GPS Location	5
Field Station#		11504+00	GPS Location	6	
Pic 5 Desc.		Plunge pool functional.	Pic 6 Desc.		S-PP3.

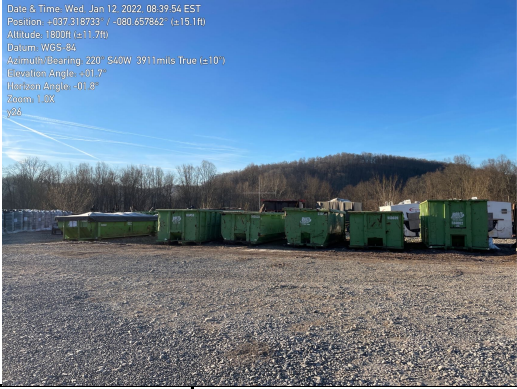
Insert image here			
GPS Location	See photo	GPS Location			
Field Station#	12005+00	Field Station#			
Pic 7 Desc.	Housekeeping functional	Pic 8 Desc.			
Insert image here		Insert image here			
GPS Location		GPS Location			
Field Station#		Field Station#			
Pic 9 Desc.		Pic 10 Desc.			
Insert image here		Insert image here			
GPS Location		GPS Location			
Field Station#		Field Station#			
Pic 11 Desc.		Pic 12 Desc.

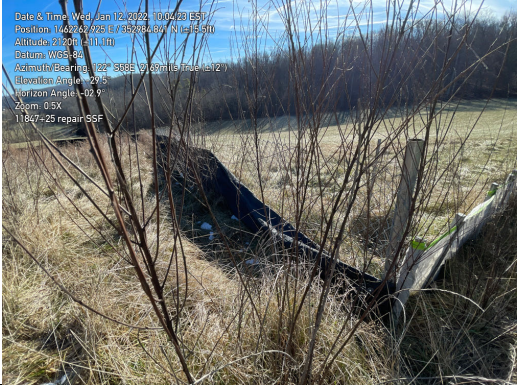
<p><small>Date & Time: Wed Jan 12, 2022, 10:15:13 EST Position: 1461705.765 E / 353999.800 N (+42.2ft) Altitude: 2234ft (+29.4m) Datum: WGS 84 Azimuth/Bearing: 344° N16W 611mils True (+12°) Elevation Angle: -00.2° Horizon Angle: -01.8° Zoom: 1.0X 11833+75</small></p>			
GPS Location	7	GPS Location	8		
Field Station#	11847+25	Field Station#	11833+75		
Pic 7 Desc.	Representational photo of downed SSF.	Pic 8 Desc.	Section of RoW showing conditions and controls.

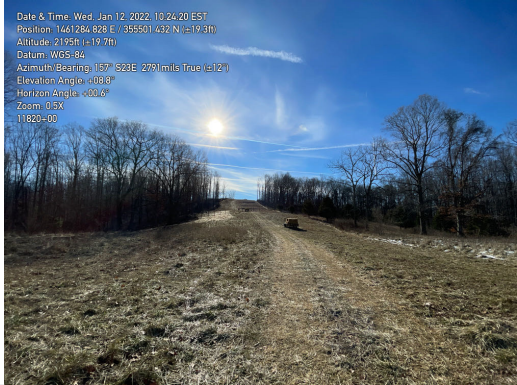
GPS Location	9	GPS Location			
Field Station#	11820+00	Field Station#			
Pic 9 Desc.	Crews installing permanent fencing.	Pic 10 Desc.			
<p style="text-align: center;">Insert image here</p>		<p style="text-align: center;">Insert image here</p>			
GPS Location		GPS Location			
Field Station#		Field Station#			
Pic 11 Desc.		Pic 12 Desc.

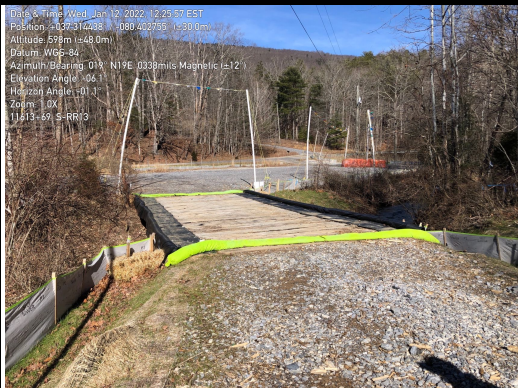
GPS Location	On photo		GPS Location	On photo	
Field Station#	11613+69		Field Station#	11608+17	
Pic 9 Desc.	SRR13 is stable with ECDs in place at access road MN-258.04.		Pic 10 Desc.	The S-006 crossing is stable with well vegetated buffers and ECDs in place.	
  <p>Date & Time: Wed Jan 12, 2022, 12:32:58 EST Position: +037.313423 / -080.406567 (+5.0m) Altitude: 594m (+8.0m) Datum: WGS-84 Azimuth/Bearing: 182° S62W 3236mils Magnetic (+12°) Elevation Angle: 25.2° Horizon Angle: -02.2° Zoom: 1.0X 11601+20</p>				  <p>Date & Time: Wed Jan 12, 2022, 12:32:58 EST Position: +037.313423 / -080.406567 (+5.0m) Altitude: 594m (+8.0m) Datum: WGS-84 Azimuth/Bearing: 182° S62W 3236mils Magnetic (+12°) Elevation Angle: 25.2° Horizon Angle: -02.2° Zoom: 1.0X 11601+20</p>	
GPS Location	On photo		GPS Location	On photo	
Field Station#	11601+20		Field Station#	11663+75	
Pic 11 Desc.	Perimeter ECDs in place.		Pic 12 Desc.	Example of fabric blown loose from SSF chain link fencing. Maintenance need and location given to contractor.

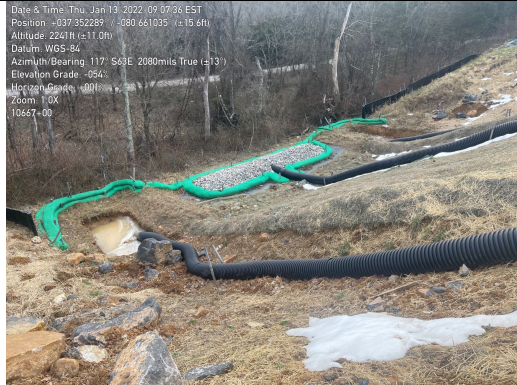
<p>Date & Time: Thu Jan 13, 2022, 09:23:29 EST Position: +037.350272° / -080.458409° (±15.1ft) Altitude: 2061ft (±11.7ft) Datum: WGS-84 Azimuth Bearing: 080° N80E 1622mils True (±13°) Elevation Angle: -005° Horizon Angle: -001° Zoom: 0.5X 10679+00</p>  			
GPS Location		See photo		GPS Location	
Field Station#		10667+00		Field Station#	
Pic 11 Desc.		Slope drain pipe in place		Pic 12 Desc.

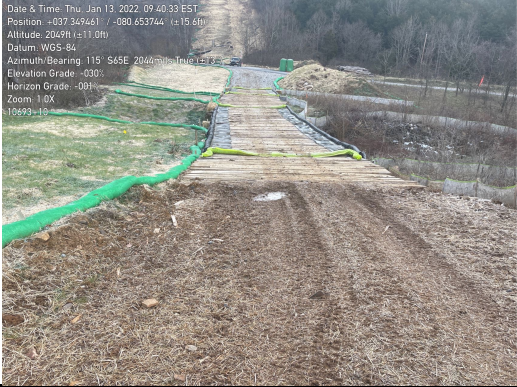
<p><small>Date & Time: Thu, Jan 13, 2022 09:40:33 EST Position: +037.349501 / -080.653744 / ±15.6m Altitude: 2284ft (±19.7m) Datum: WGS-84 Azimuth/Bearing: 291° N49W 5173mils True (±12.1) Elevation Angle: +08.4° Horizon Angle: +01.8° Zoom: 1.0X 10733+18</small></p>			
GPS Location	See photo	GPS Location	See photo		
Field Station#	10693+10	Field Station#	10733+18		
Pic 13 Desc.	Equipment bridge functional	Pic 14 Desc.	Equipment bridge functional

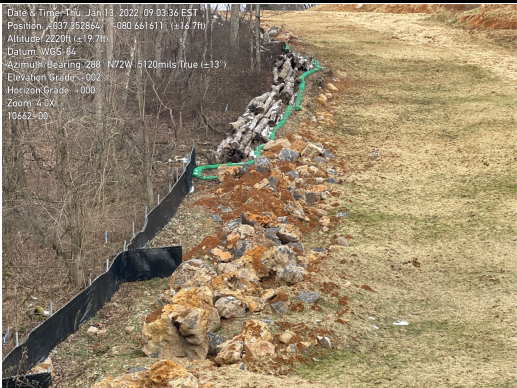
GPS Location	See photo	GPS Location			
Field Station#	10662+00	Field Station#			
Pic 15 Desc.	SSF functional	Pic 16 Desc.			
<p style="text-align: center;">Insert image here</p>		<p style="text-align: center;">Insert image here</p>			
GPS Location		GPS Location			
Field Station#		Field Station#			
Pic 17 Desc.		Pic 18 Desc.

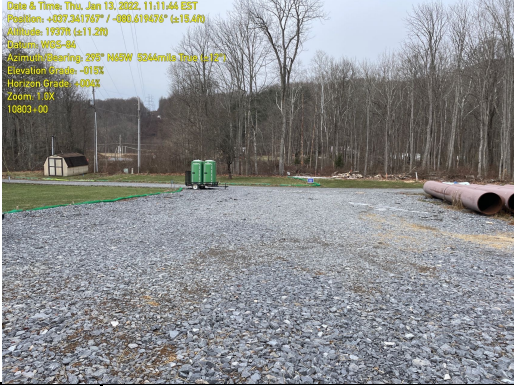
<p>Date & Time: Thu, Jan 13, 2022, 11:10:57 EST Position: +037.341764° / -000.619037° (±20.13) Altitude: 1940ft (±20.40) Datum: WGS-84 Azimuth/Bearing: 012° N12E 5210mils True (±12°) Elevation Grade: -017% Horizon Grade: +002% Zoom: 1.0x 10805+00</p>			
GPS Location	See photo	GPS Location	See photo		
Field Station#	10803+00	Field Station#	10805+00		
Pic 1 Desc.	RCE in place	Pic 2 Desc.	P1 silt fence in place

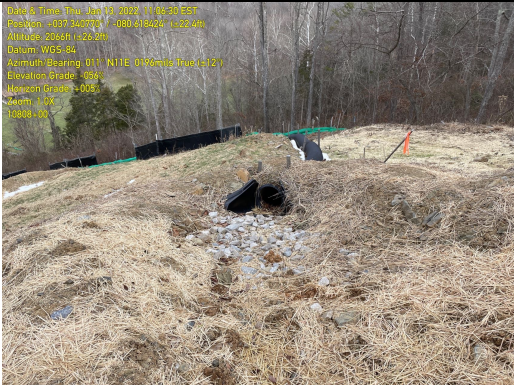
GPS Location	See photo	GPS Location	See photo		
Field Station#	10808+00	Field Station#	10812+50		
Pic 3 Desc.	Stone inlet protection in place	Pic 4 Desc.	Cleanwater diversion outlet protection in place

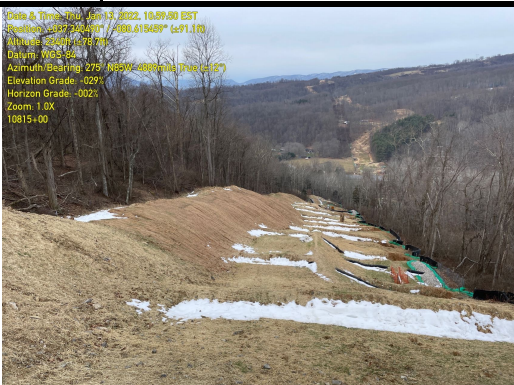
<p>Date & Time: Thu, Jan 13, 2022, 10:57:47 EST Position: +037.340761° / -000.619397° (±11.60) Altitude: 2099ft (±19.70) Datum: WGS-84 Azimuth/Bearing: 215° S35W 5100mils True (±12°) Elevation Grade: -014% Horizon Grade: +002% Zoom: 1.0x 10831+00</p>			
GPS Location	See photo	GPS Location	See photo		
Field Station#	10815+00	Field Station#	10831+50		
Pic 5 Desc.	Erosion control blanket in place	Pic 6 Desc.	Triple protection ECDs in place at karst feature

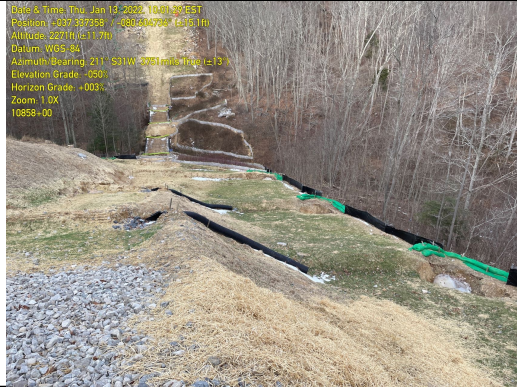
GPS Location	See photo	GPS Location	See photo		
Field Station#	10858+00	Field Station#	10859+00		
Pic 11 Desc.	End treatments in place	Pic 12 Desc.	Supersilt fence fabric in place

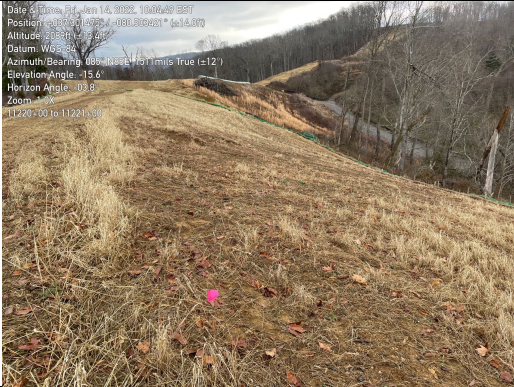
GPS Location	See photo	GPS Location	See photo		
Field Station#	11220+00	Field Station#	11221+00		
Pic 1 Desc.	Permanent vegetation need re-seeded and stabilized w/ curlex	Pic 2 Desc.	Permanent vegetation need re-seeded and stabilized w/ curlex

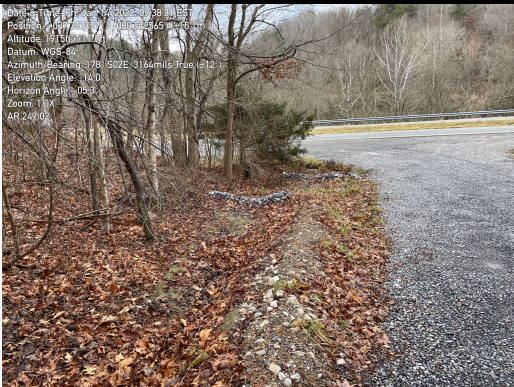
GPS Location	See photo	GPS Location	See photo		
Field Station#	11184+79	Field Station#	11199+00		
Pic 3 Desc.	Rock check dam in place	Pic 4 Desc.	Erosion control blanket in place

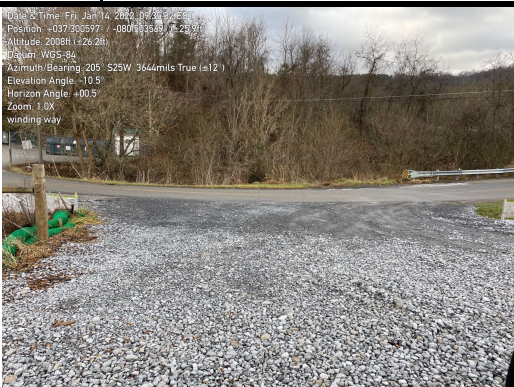
GPS Location	See photo	GPS Location	See photo		
Field Station#	11227+59	Field Station#	11227+59		
Pic 5 Desc.	RCE functional	Pic 6 Desc.	SSF in place

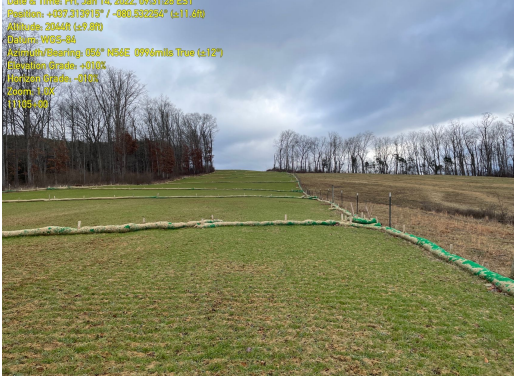
GPS Location	See photo	GPS Location	See photo		
Field Station#	11105+00	Field Station#	11112+00		
Pic 1 Desc.	Permanent vegetation is present	Pic 2 Desc.	CFS triple stack perimeter control in place		
<p>Date & Time Fri, Jan 14, 2022, 09:45:34 EST Position: +037.315450° / -060.527623° (±9.870) Altitude: 2047ft (±105.00) Datum: WGS-84 Azimuth/Bearing: 080° S89E 1618mils True (±12°) Elevation Grade: +020X Horizon Grade: +000X Zoom: 1.0X 111123+00</p>

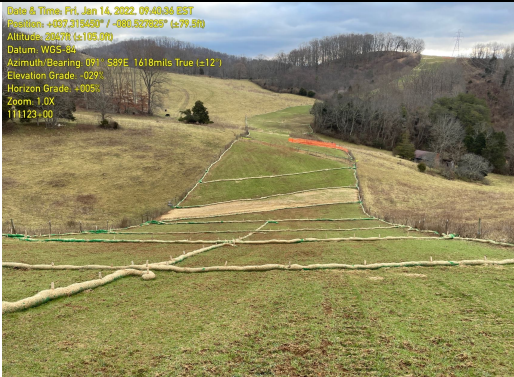
GPS Location	See photo	GPS Location	See photo		
Field Station#	11123+00	Field Station#	11134+00		
Pic 3 Desc.	Temporary CFS waterbars in place	Pic 4 Desc.	Permanent waterbars in place		
<p>Date & Time Fri, Jan 14, 2022, 09:55:29 EST Position: +037.3131777° / -060.520034° (±41.110) Altitude: 2110ft (±19.30) Datum: WGS-84 Azimuth/Bearing: 057° N57E 0940mils True (±12°) Elevation Grade: +010X Horizon Grade: +010X Zoom: 1.0X 11146+00</p>

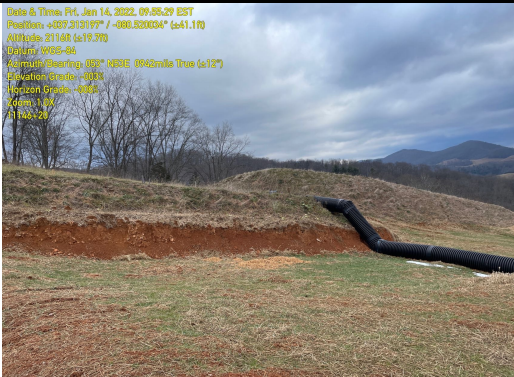
GPS Location	See photo	GPS Location	See photo		
Field Station#	11146+00	Field Station#	11148+00		
Pic 5 Desc.	Cleanwater diversion berm in place	Pic 6 Desc.	Supersilt fence perimeter control in place

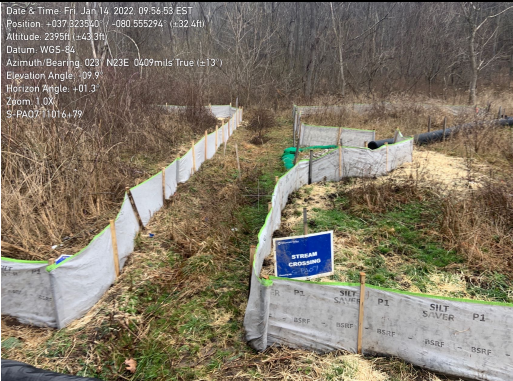
GPS Location	See photo	GPS Location	See photo		
Field Station#	10985+94	Field Station#	11016+79		
Pic 3 Desc.	S-E24	Pic 4 Desc.	S-PA07		
<p> Date & Time: Fri Jan 14, 2022 10:14:38 EST Position: +037 233500 / -080 555294 (+1.0ft) Altitude: 2335ft (+28.0ft) Datum: WGS 84 Azimuth Bearing: 327 N13W 6169mils True (+13) Elevation Angle: -04.3 Horizon Angle: -01.7 Zoom: 1.0x SRR5 11015+52 </p>

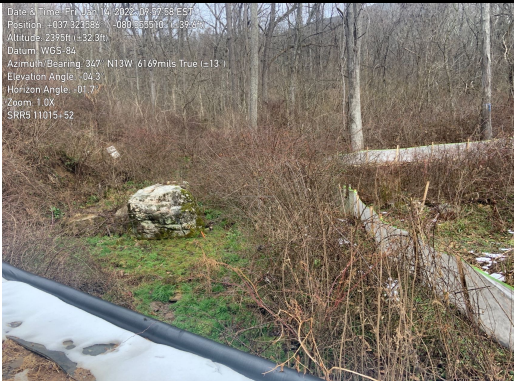
GPS Location	See photo	GPS Location	See photo		
Field Station#	11015+52	Field Station#	10993+95		
Pic 5 Desc.	SRR5	Pic 6 Desc.	Section of Row showing conditions and controls
