Visual Site Inspection Report

Project Name	H-600 Pipeline Spread G	AFE	124300137	Spread	H-600 Pipeline Spread G
Contractor	Precision			Report #	33354
Inspector	Daniel Fortune			Date/Time	1/18/2022 8:34 PM
Permit #	TBD	Inspection Type	VA SWPP	Station Begin	11524+16
State	VA	Inspection Area	Partial	Station End	11600+01
County	Montgomery	Ground	Frozen	Temperature (°F)	23.00
Municipality	N/A	Weather	Below Freezing Temp	Rain Gauge (in)	0.00
				Rain Accumulation Time (days)	0.00

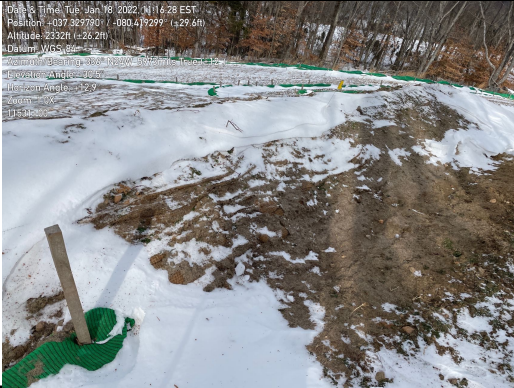
<p>Date & Time: Tue, Jan 18, 2022, 11:29:49 EST Position: +037.418549 / -080.741590 (Error) Altitude: 1833ft (Error) Datum: WGS-84 Azimuth/Bearing: 117° S43E 2080mils Error (Error) Elevation Grade: +01.9° True North Grade: +00.0° Zoom: 1.0X 11524+16</p>			
GPS Location	See Photo	GPS Location	See Photo		
Field Station#	11531+00	Field Station#	11524+16		
Pic 5 Desc.	View of ECB over permanent water bar.	Pic 6 Desc.	Equipment bridge condition S-QQ2

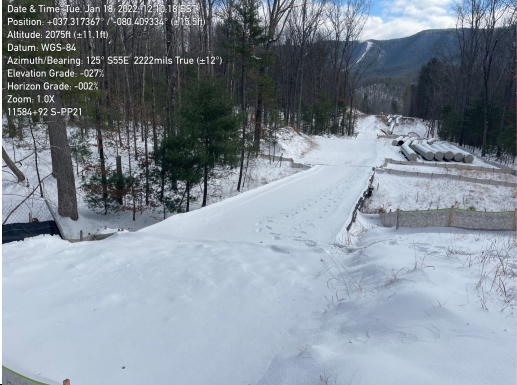
<p><small>Date & Time: Tue, Jan 18, 2022, 12:11:59 EST Position: +037.317357° / -080.409357° (±30.2ft) Altitude: 2071ft (±39.4ft) Datum: WGS-84 Azimuth/Bearing: 247° S47W 4391mils True (±12°) Elevation Grade: -04% Horizon Grade: -002% Zoom: 0.5X 11584+92 S-PP21</small></p>			
GPS Location	See Photo	GPS Location	See Photo		
Field Station#	11584+92	Field Station#	11584+92		
Pic 13 Desc.	Distant view of the equipment bridge condition S-PP21.	Pic 14 Desc.	View looking down stream. S-PP21

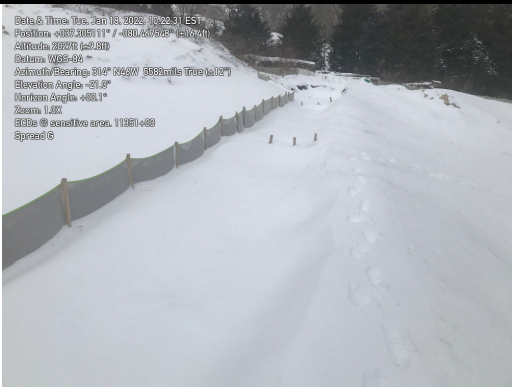
GPS Location	See photo		GPS Location	see photo	
Field Station#	11351+00		Field Station#	11390+00	
Pic 3 Desc.	ECDs @ sensitive area		Pic 4 Desc.	ROW

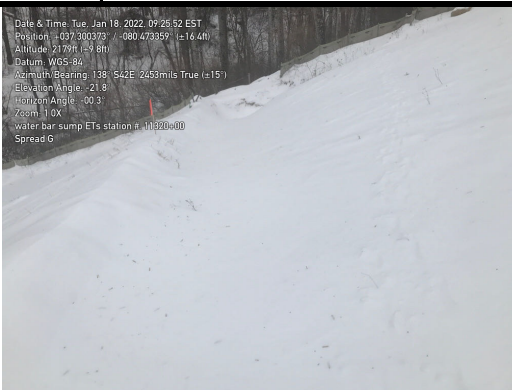
GPS Location	see photo		GPS Location	see photo	
Field Station#	11320+00		Field Station#	11292+00	
Pic 5 Desc.	Water bars sumps		Pic 6 Desc.	S-MM 18

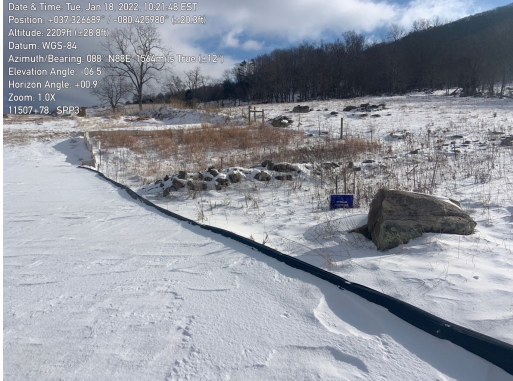
GPS Location		See photo		GPS Location		See photo
Field Station#		11507+78		Field Station#		11505+50
Pic 3 Desc.		Section of Row showing conditions and controls at SPP3		Pic 4 Desc.		Clean water diversion pipe with outlet protection
<div><div><div>Date & Time: Tue Jan 18, 2022 10:15:40 EST Position: +037.322899 / -080.426987 (+2079.9ft) Altitude: 2220ft (+29.1ft) Datum: WGS-84 Azimuth/Bearing: 007 N07E 0124mils True (±12°) Elevation Angle: -15.0° Horizon Angle: -00.1° Zoom: 1.0X 11504+00</div>

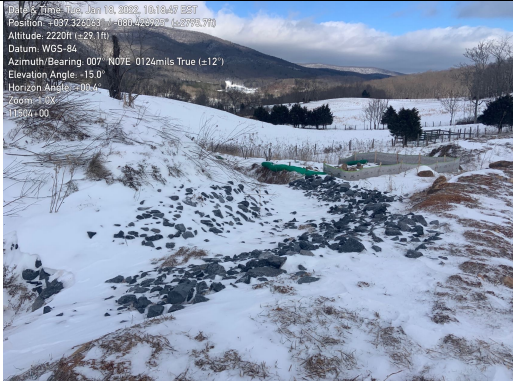
</div></div>			
GPS Location		See photo		GPS Location		See photo
Field Station#		11504+00		Field Station#		11495+00
Pic 5 Desc.		Rock lined channel		Pic 6 Desc.		Section of Row showing conditions and controls

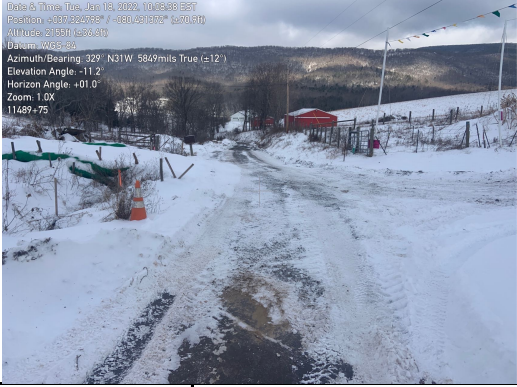
<p><small>Date & Time: Tue, Jan 18, 2022, 10:53:58 EST Position: +037.322456° / -080.435230° (+656.2ft) Altitude: 2239ft (+23.1ft) Datum: WGS-84 Azimuth/Bearing: 030° N30E 6533mils True (+13°) Elevation Angle: +00.0° Horizon Angle: +00.0° Zoom: 1.0X 11482+86</small></p>			
GPS Location	See photo	GPS Location	See photo		
Field Station#	11489+75	Field Station#	11482+86		
Pic 7 Desc.	Stevens Gap access RD at P/L crossing	Pic 8 Desc.	Section of Row showing conditions and controls

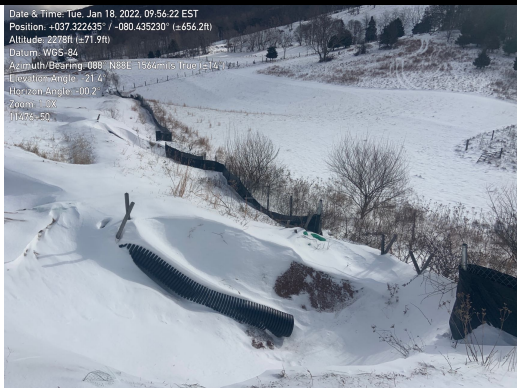
GPS Location	See photo	GPS Location	See photo		
Field Station#	11476+50	Field Station#	11472+80		
Pic 9 Desc.	Downed SSF added to the punch list for maintenance	Pic 10 Desc.	Karst ECD's are in place		
Insert image here		Insert image here			
GPS Location		GPS Location			
Field Station#		Field Station#			
Pic 11 Desc.		Pic 12 Desc.

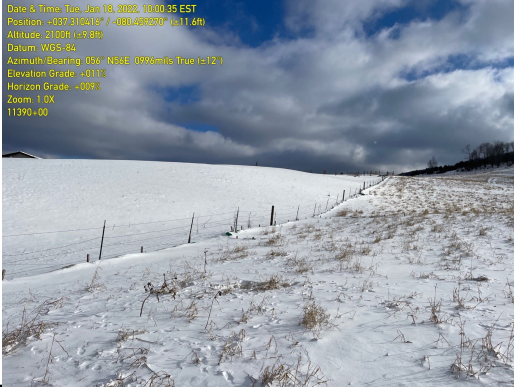
GPS Location	See photo	GPS Location	See photo		
Field Station#	11390+00	Field Station#	11397+00		
Pic 3 Desc.	CFS perimeter control in place	Pic 4 Desc.	Level spreader in place

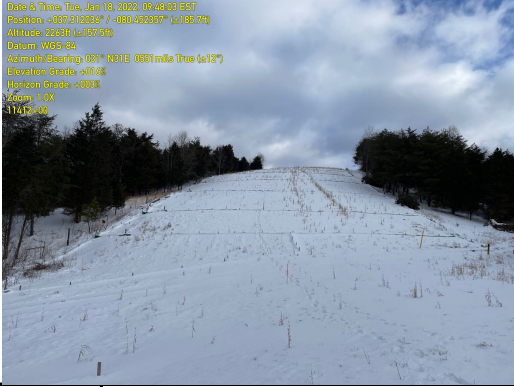
GPS Location	See photo	GPS Location	See photo		
Field Station#	11412+00	Field Station#	11420+00		
Pic 5 Desc.	CFS temporary waterbars in place	Pic 6 Desc.	Vegetation present

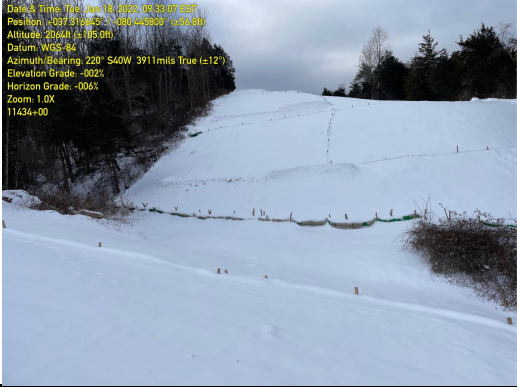
GPS Location		See photo		GPS Location	
Field Station#		11434+00		Field Station#	
Pic 7 Desc.		Permanent waterbar in place		Pic 8 Desc.	
<p>Date & Time: Tue, Jan 18, 2022, 09:12:48 EST Position: +407.319945° / -080.436217° (±15.1ft) Altitude: 2158ft (±12.7ft) Datum: WGS-84 Azimuth/Bearing: 238° S58W 4231mils True (±12°) Elevation Grade: -025% Horizon Grade: -010% Zoom: 1.0X 11452+00</p>

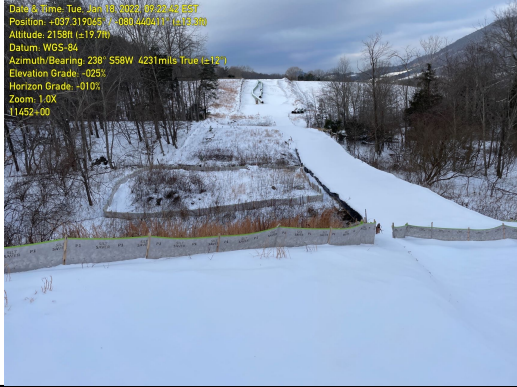
GPS Location		See photo		GPS Location	
Field Station#		11452+00		Field Station#	
Pic 9 Desc.		Stream buffer in place		Pic 10 Desc.	
<p>Date & Time: Tue, Jan 18, 2022, 09:24:47 EST Position: +407.320025° / -080.436243° (±15.1ft) Altitude: 2248ft (±12.1ft) Datum: WGS-84 Azimuth/Bearing: 253° S89W 5193mils True (±12°) Elevation Grade: -022% Horizon Grade: -007% Zoom: 1.0X 11469+00</p>

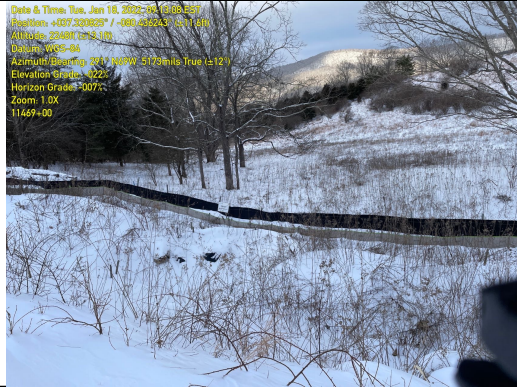
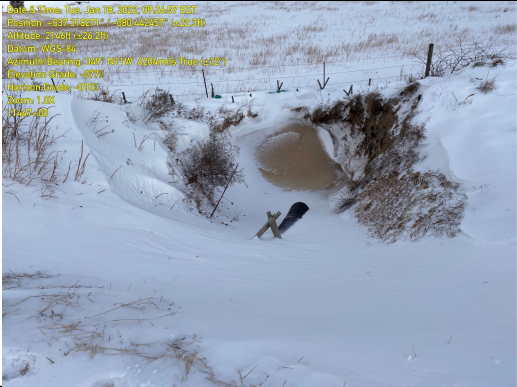
GPS Location		See photo		GPS Location	
Field Station#		11469+00		Field Station#	
Pic 11 Desc.		Triple protection ECDs in place at karst feature		Pic 12 Desc.

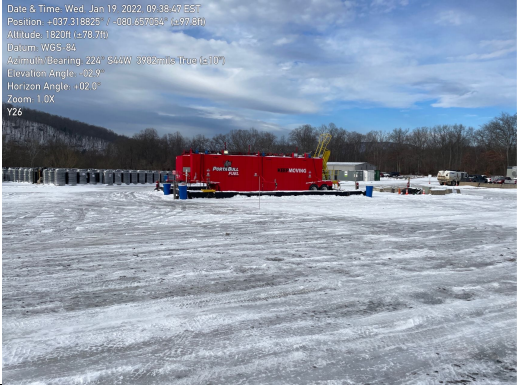
GPS Location	See photo	GPS Location			
Field Station#	12005+00	Field Station#			
Pic 7 Desc.	Secondary containment in place	Pic 8 Desc.			
Insert image here		Insert image here			
GPS Location		GPS Location			
Field Station#		Field Station#			
Pic 9 Desc.		Pic 10 Desc.			
Insert image here		Insert image here			
GPS Location		GPS Location			
Field Station#		Field Station#			
Pic 11 Desc.		Pic 12 Desc.

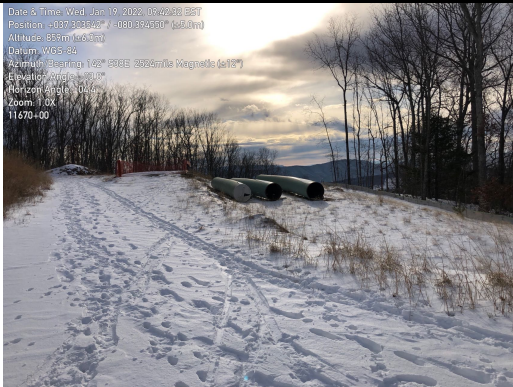
<p>Date & Time: Wed Jan 19, 2022 09:51:12 EST Position: +037.304502° / +080.376384° (±15.0m) Altitude: 820m (±4.0m) Datum: WGS-84 Azimuth/Bearing: 030° N 80E 1030mils Magnetic (±12°) Elevation Angle: -31.2° Horizon Angle: -00.0° Zoom: 1.0X 11663+00</p>			
GPS Location				On photo				GPS Location				On photo			
Field Station#				11670+00				Field Station#				11663+00			
Pic 1 Desc.				The top of Brush Mountain is stable.				Pic 2 Desc.				Sumps and end treatments acceptable.

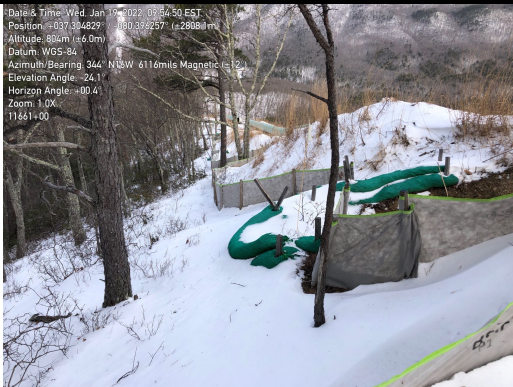
GPS Location				On photo				GPS Location				On photo			
Field Station#				11661+00				Field Station#				11657+00			
Pic 3 Desc.				Perimeter ECDs are in place.				Pic 4 Desc.				ECDs at edge of LOD care in place.

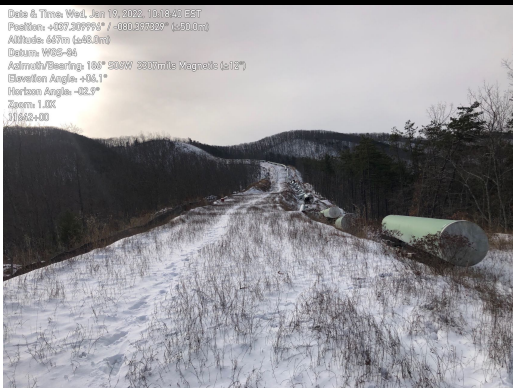
<p>Date & Time: Wed Jan 19, 2022 10:31:42 EST Position: +037.313425° / +080.377362° (±30.0m) Altitude: 599m (±48.0m) Datum: WGS-84 Azimuth/Bearing: 077° N 77E 1369mils Magnetic (±12°) Elevation Angle: -27.5° Horizon Angle: -03.3° Zoom: 1.0X 11630+00</p>			
GPS Location				On photo				GPS Location				On photo			
Field Station#				11642+00				Field Station#				11630+00			
Pic 5 Desc.				Slope breakers are in place.				Pic 6 Desc.				Sumps and end treatments are in acceptable condition.

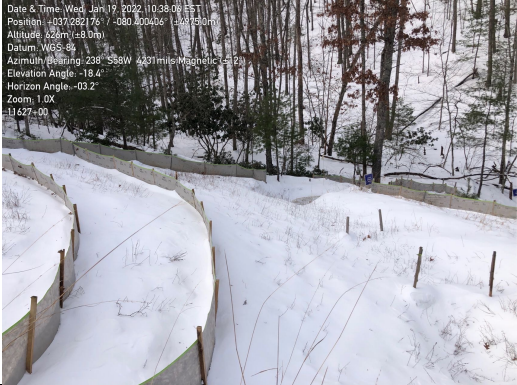
GPS Location		On photo		GPS Location	
Field Station#		11627+00		Field Station#	
Pic 7 Desc.		ECDs are in place at resource crossings.		Pic 8 Desc.	
<p>Date & Time: Wed, Jan 19, 2022, 10:50:19 EST Position: +037.313657° / -080.402627° (±50.0m) Altitude: 595m (±96.0m) Datum: WGS-84 Azimuth/Bearing: 151° S23E 2.68mils Magnetic (±13°) Elevation Angle: -17.4° Horizon Angle: -07.0° Zoom: 1.0X 11618+00</p>

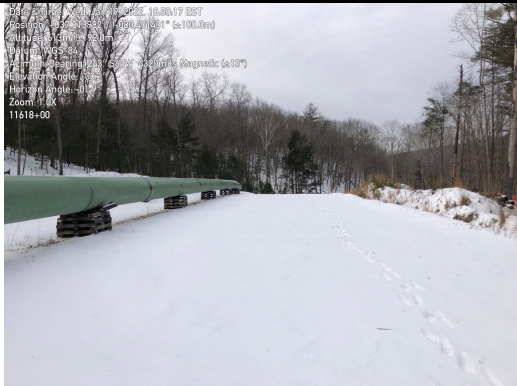
GPS Location		On photo		GPS Location	
Field Station#		11618+00		Field Station#	
Pic 9 Desc.		The ROW is currently stable.		Pic 10 Desc.	
<p>Date & Time: Wed, Jan 19, 2022, 08:27:10 EST Position: +037.314064° / -080.402794° (±30.0m) Altitude: 581m (±8.0m) Datum: WGS-84 Azimuth/Bearing: 034° N34E 0.00mils Magnetic (±11°) Elevation Angle: -13.4° Horizon Angle: -00.0° Zoom: 1.0X 11613+69</p>

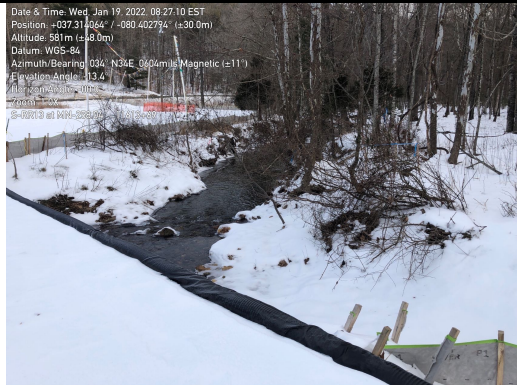
GPS Location		On photo		GPS Location	
Field Station#		11613+69		Field Station#	
Pic 11 Desc.		The S-RR13 crossing at access road MN-258.04 is stable with ECDs in place.		Pic 12 Desc.	
				The S-006 crossing is currently stable and has not been impacted.

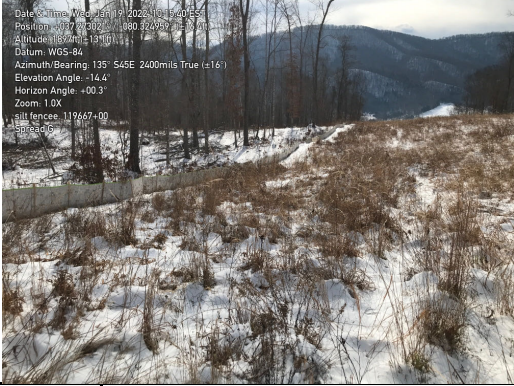
<p>Date & Time: Wed Jan 19, 2022, 10:27:01 EST Position: +037 277624 / -080 326475 (±16.4ft) Altitude: 2099ft (±9.8ft) Datum: WGS-84 Azimuth/Bearing: 171° 50PE 3040mils True (±16°) Elevation Angle: -25.2° Horizon Angle: -00.3° Zoom: 1.0X Silt fence: 11967+00 Spread G</p>			
GPS Location	See Photo		GPS Location	See photo	
Field Station#	11967+00		Field Station#	11965+00	
Pic 1 Desc.	Silt Fence Perimeter controls		Pic 2 Desc.	Water bars

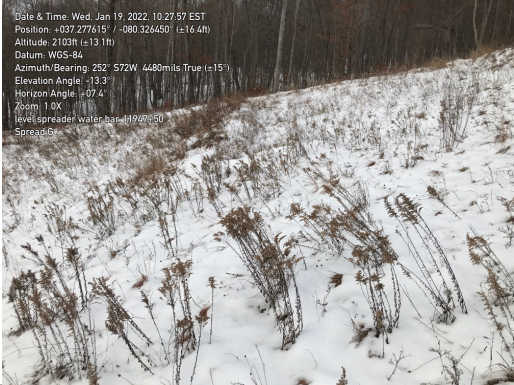
GPS Location	See Photo		GPS Location	See Photo	
Field Station#	11947+50		Field Station#	11978+86	
Pic 3 Desc.	Level spreader and water bar		Pic 4 Desc.	Karst Protection

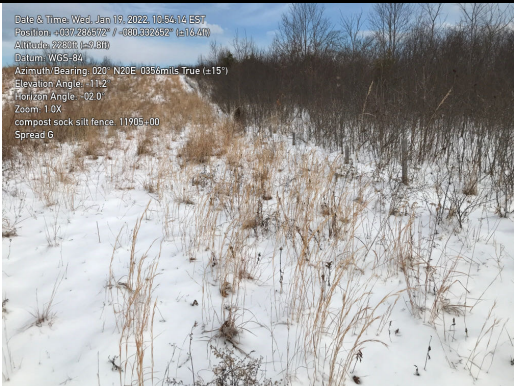
<p>Date & Time: Wed Jan 19, 2022, 11:40:02 EST Position: +037 283592 / -080 352492 (±16.4ft) Altitude: 2228ft (±3.8ft) Datum: WGS-84 Azimuth/Bearing: 000° N00E 0356mils True (±15°) Elevation Angle: -11.2° Horizon Angle: -02.0° Zoom: 1.0X Compost sock silt fence: 11905+00 Spread G</p>			
GPS Location	See Photo		GPS Location	See Photo	
Field Station#	11905+00		Field Station#	12005+00	
Pic 5 Desc.	Section of ROW showing conditions and controls		Pic 6 Desc.	Spread Break stabilization

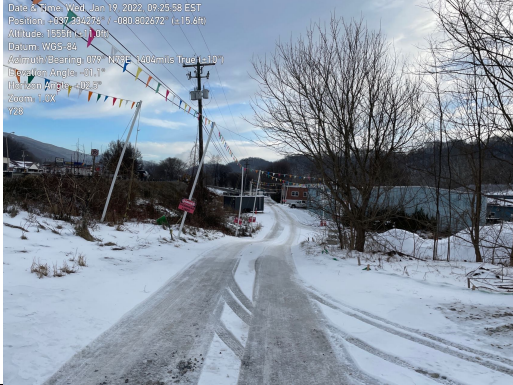
<p>Date & Time: Wed Jan 19, 2022 10:46:27 EST Position: 43°37'59.90"N / -83°02'26.72"W Altitude: 1555ft (474.10m) Datum: WGS-84 Azimuth Bearing: 291° NGS 5123m True (±10°) Elevation Angle: +8.1° Horizon Angle: -00.2° Zoom: 1.0X Y28</p>		
GPS Location	See photo		GPS Location	See photo	
Field Station#	12005+00		Field Station#	12005+00	
Pic 1 Desc.	RCE functional		Pic 2 Desc.	CFS perimeter controls in place

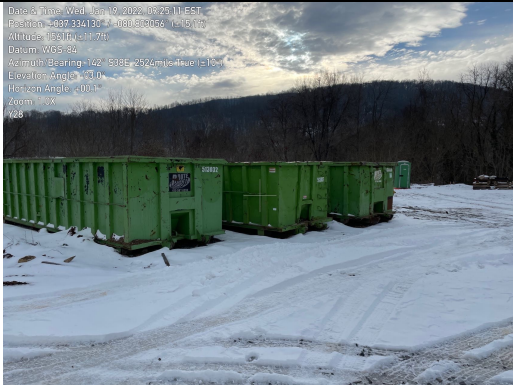
GPS Location	See photo		GPS Location	See photo	
Field Station#	12005+00		Field Station#	12005+00	
Pic 3 Desc.	Housekeeping in good condition		Pic 4 Desc.	CFS perimeter controls functional

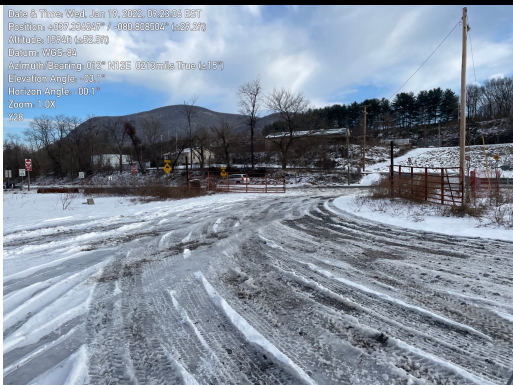
<p>Date & Time: Wed Jan 19, 2022 09:22:04 EST Position: 43°37'59.90"N / -83°02'26.72"W Altitude: 1527ft (465.20m) Datum: WGS-84 Azimuth Bearing: 291° NGS 5123m True (±10°) Elevation Angle: +13.3° Horizon Angle: -06.7° Zoom: 1.0X Y28</p>		
GPS Location	See photo		GPS Location	See photo	
Field Station#	12005+00		Field Station#	12005+00	
Pic 5 Desc.	RCE functional		Pic 6 Desc.	CFS perimeter controls in place

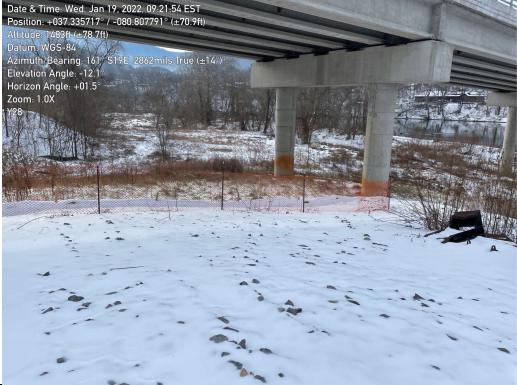
GPS Location	See photo	GPS Location			
Field Station#	12005+00	Field Station#			
Pic 7 Desc.	CFS perimeter controls & safety fence in place	Pic 8 Desc.			
Insert image here		Insert image here			
GPS Location		GPS Location			
Field Station#		Field Station#			
Pic 9 Desc.		Pic 10 Desc.			
Insert image here		Insert image here			
GPS Location		GPS Location			
Field Station#		Field Station#			
Pic 11 Desc.		Pic 12 Desc.

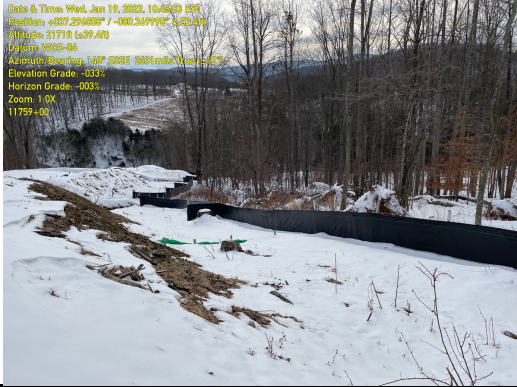
GPS Location	See photo		GPS Location	See photo	
Field Station#	11752+00		Field Station#	11759+00	
Pic 7 Desc.	Waterbars in place		Pic 8 Desc.	Supersilt fence perimeter control in place	
<p>Date & Time: Wed, Jan 19, 2022, 15:49:09 EST Position: +037.294107° / -080.348891° (±11.8m) Datum: WGS-84 Altitude: 20001 (±17.7m) Azimuth/Bearing: 098° S82E 1742mils True (±12°) Elevation Grade: -019% Horizon Grade: -001% Zoom: 1.0X 11766+00</p>

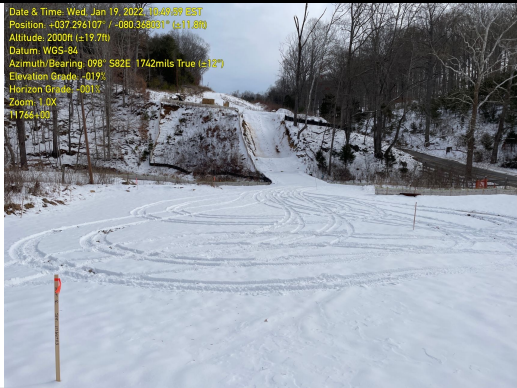
GPS Location	See photo		GPS Location	See photo	
Field Station#	11766+00		Field Station#	11775+00	
Pic 9 Desc.	RCE in place		Pic 10 Desc.	Supersilt fence perimeter control in place	
<p>Date & Time: Wed, Jan 19, 2022, 08:38:33 EST Position: +037.294534° / -080.343383° (±50.4m) Datum: WGS-84 Altitude: 18131 (±510.0m) Azimuth/Bearing: 300° S20W 3558mils True (±12°) Elevation Grade: -022% Horizon Grade: +004% Zoom: 1.0X 11778+00</p>

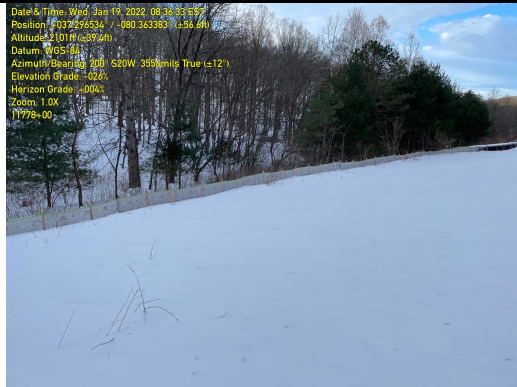
GPS Location	See photo		GPS Location	See photo	
Field Station#	11778+00		Field Station#	11782+00	
Pic 11 Desc.	P1 silt fence perimeter control in place		Pic 12 Desc.	Cleanwater drainage feature in place

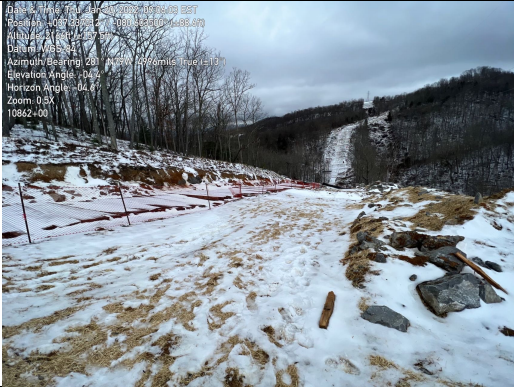
<p>Date & Time: Thu Jan 20, 2022 09:17:56 EST Position: +037.33561 / -080.598286 (+9.71) Altitude: 2287ft (+89.4m) Datum: WGS-84 Azimuth/Bearing: 027 S81E 1224mils True (+12) Elevation Angle: -11.8 Horizon Angle: -11.8 Zoom: 0.5X 10862+00</p>			
GPS Location	See photo	GPS Location	see photo		
Field Station#	10862+00	Field Station#	10878+00		
Pic 1 Desc.	Area of open ditch	Pic 2 Desc.	Water bars/ temporary vegetation

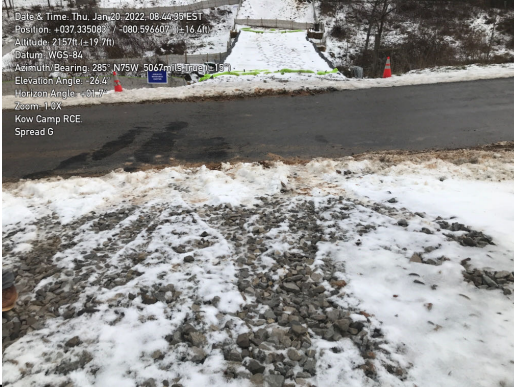
GPS Location	see photo	GPS Location	see photo		
Field Station#	10883+56	Field Station#	10888+00		
Pic 3 Desc.	Kow Camp	Pic 4 Desc.	Sump ETs

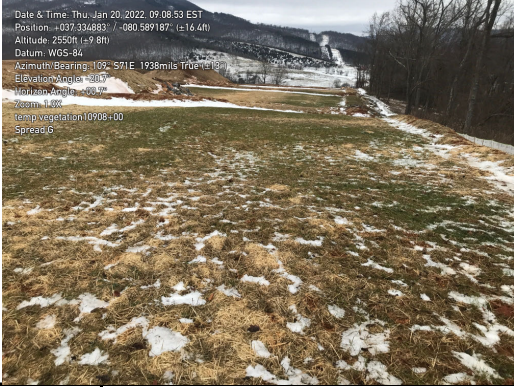
<p>Date & Time: Thu Jan 20, 2022 09:25:53 EST Position: +037.331649 / -080.583221 (+16.4m) Altitude: 2146ft (+9.8ft) Datum: WGS-84 Azimuth/Bearing: 327 N33W 5813mils True (+18) Elevation Angle: -21.1 Horizon Angle: +02.7 Zoom: 1.0X S-Y 3 10928+00 Spread G</p>			
GPS Location	see photo	GPS Location	see photo		
Field Station#	10908+00	Field Station#	10928+00		
Pic 5 Desc.	Temporary Vegetation	Pic 6 Desc.	S-Y 3

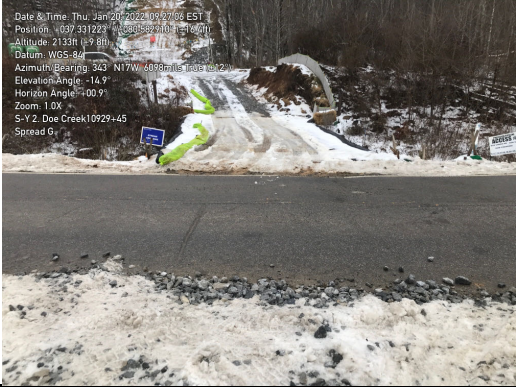
GPS Location	See photo	GPS Location	See photo		
Field Station#	10929+45	Field Station#	10889+00		
Pic 7 Desc.	S-Y 2	Pic 8 Desc.	Restabilizing soil pile

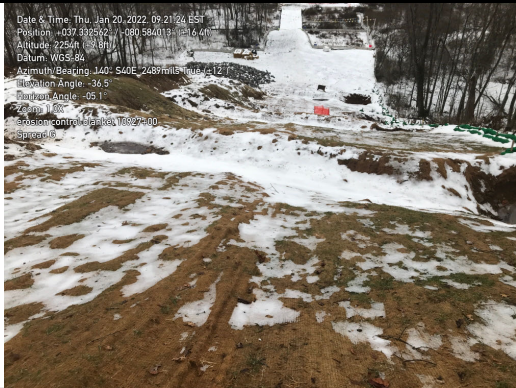
<p style="text-align: center;">Insert image here</p>			
GPS Location	See photo	GPS Location			
Field Station#	10927+00	Field Station#			
Pic 9 Desc.	Erosion control blanket.	Pic 10 Desc.			
<p style="text-align: center;">Insert image here</p>		<p style="text-align: center;">Insert image here</p>			
GPS Location		GPS Location			
Field Station#		Field Station#			
Pic 11 Desc.		Pic 12 Desc.

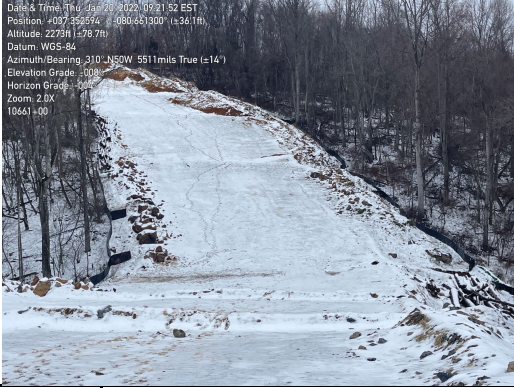
<p>Date & Time: Thu, Jan 20, 2022, 09:22:16 EST Position: +037.352524° / -080.661252° (±15.1ft) Altitude: 2243ft (±11.7ft) Datum: WGS-84 Azimuth/Bearing: 053° NS3E 0942mils True (±14°) Elevation Grade: -080% Horizon Grade: +002% Zoom: 0.5X 10665+00</p>			
GPS Location	See Photo	GPS Location	See Photo		
Field Station#	10661+00	Field Station#	10665+00		
Pic 1 Desc.	Distant view of temporary stabilized row and perimeter super silt fence. No visible issues at this time.	Pic 2 Desc.	Temporary slope drain pipe into frozen sump pit. No Issues at this time.

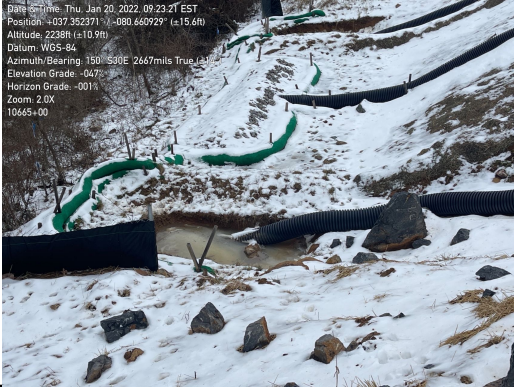
GPS Location	See Photo	GPS Location	See Photo		
Field Station#	10665+00	Field Station#	10669+00		
Pic 3 Desc.	View of frozen TLS and sump pit conditions. No Issues at this time.	Pic 4 Desc.	CWDP conditions. No Issues at this time.

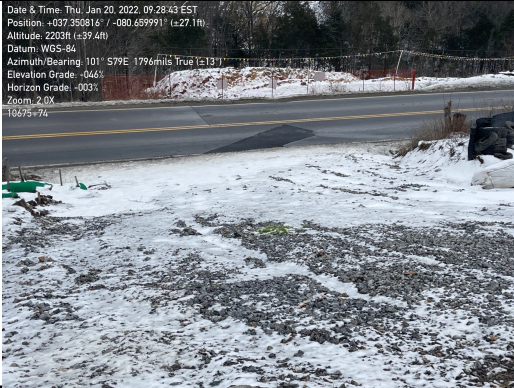
<p>Date & Time: Thu, Jan 20, 2022, 09:30:00 EST Position: +037.352820° / -080.659777° (±26.8ft) Altitude: 2177ft (±26.4ft) Datum: WGS-84 Azimuth/Bearing: 100° S79W 3330mils True (±12°) Elevation Grade: -045% Horizon Grade: +005% Zoom: 0.5X 10675+74</p>			
GPS Location	See Photo	GPS Location	See Photo		
Field Station#	10675+74	Field Station#	10675+74		
Pic 5 Desc.	RCE conditions at Big Stoney Rd Access. No Issues at this time.	Pic 6 Desc.	Flume pipe inlet at RCE entrance to big Stoney row. No Issues at this time.

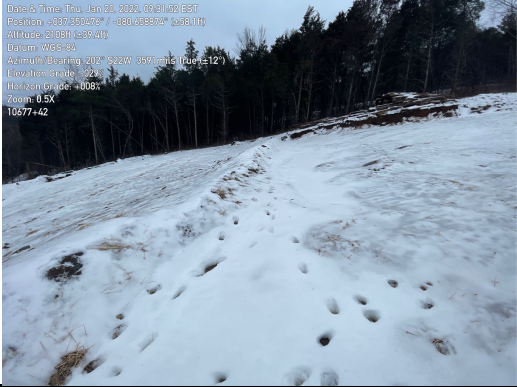
<p>Date & Time: Thu Jan 20, 2022, 09:58:00 EST Position: +39.530552° / -89.683332° (s11.51) Altitude: 3117ft (s11.51) Datum: WGS-84 Azimuth Bearing: 102° (022° Azimuth True (s12°)) Elevation Grade: -008% Horizon Grade: +008% Zoom: 0.5X 10677+42</p>			
GPS Location	See Photo		GPS Location	See Photo	
Field Station#	10677+42		Field Station#	10677+42	
Pic 7 Desc.	Temporary water bar condition. No Issues.		Pic 8 Desc.	View of temporary stabilization.

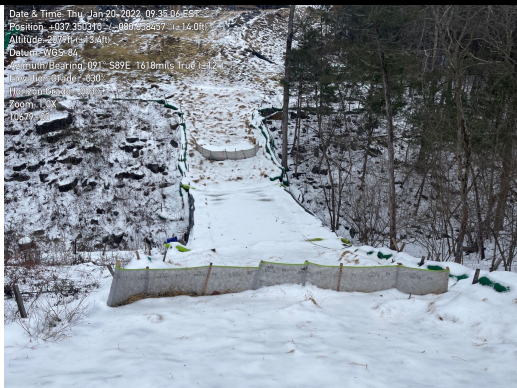
GPS Location	See Photo		GPS Location	See Photo	
Field Station#	10679+00		Field Station#	10680+00	
Pic 9 Desc.	View of S-G30 equipment bridge condition.		Pic 10 Desc.	Temporary stabilization of row.

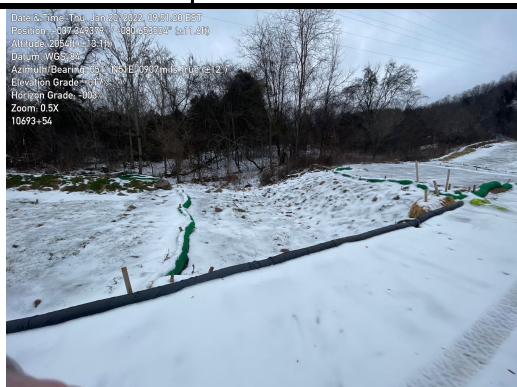
<p>Date & Time: Thu Jan 20, 2022, 09:58:00 EST Position: +39.530472° / -89.683332° (s11.51) Altitude: 3117ft (s11.51) Datum: WGS-84 Azimuth Bearing: 102° (022° Azimuth True (s12°)) Elevation Grade: -008% Horizon Grade: +008% Zoom: 0.5X 10694+24</p>			
GPS Location	See Photo		GPS Location	See Photo	
Field Station#	10693+54		Field Station#	10694+24	
Pic 11 Desc.	Ice covered drainage feature.		Pic 12 Desc.	Ice covered drainage feature.

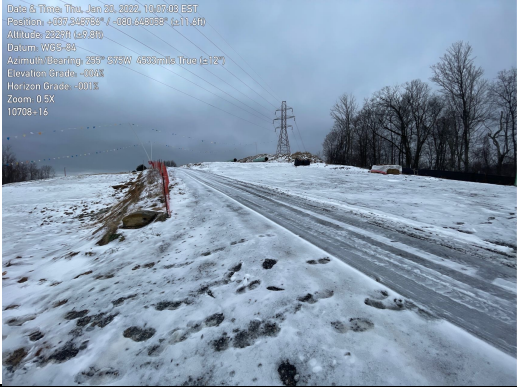
<p>Date & Time: Thu, Jan 20, 2022, 09:42:57 EST Position: +43° 54'53"N / -86° 43'33"W (-11.43) Altitude: 2281ft (±9.4ft) Datum: WGS-84 Azimuth/Bearing: 09° 58'E 1760mils True (±12) Elevation Angle: -00° Horizon Grade: -00% Zoom: 0.5X 10712+49</p>			
GPS Location	See Photo	GPS Location	See Photo		
Field Station#	10708+16	Field Station#	10712+49		
Pic 13 Desc.	AR 241.04 Icy conditions.	Pic 14 Desc.	S-G33 Equipment bridge conditions.

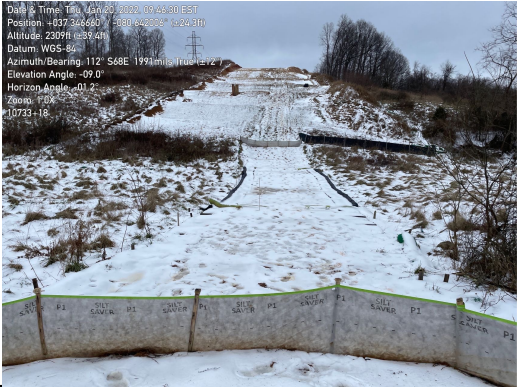
GPS Location	See Photo	GPS Location	See Photo		
Field Station#	10733+18	Field Station#	10743+00		
Pic 15 Desc.	View of frozen W-Z11 conditions.	Pic 16 Desc.	Frozen drainage feature equipment bridge crossing condition.

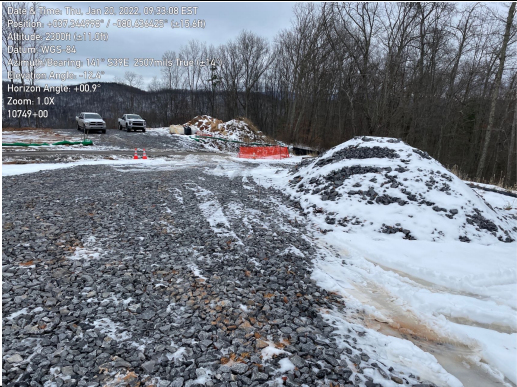
<p>Date & Time: Thu, Jan 20, 2022, 09:59:57 EST Position: +43° 54'53"N / -86° 43'33"W (-11.43) Altitude: 2300ft (±11.3ft) Datum: WGS-84 Azimuth/Bearing: 101° 33'E 2500mils True (±12) Elevation Angle: -01.2° Horizon Grade: -00.9° Zoom: 1.0X 10749+00</p>		<p>Insert image here</p>			
GPS Location	See Photo	GPS Location	See Photo		
Field Station#	10749+00	Field Station#			
Pic 17 Desc.	RCE conditions at Hendricks Rd access.	Pic 18 Desc.

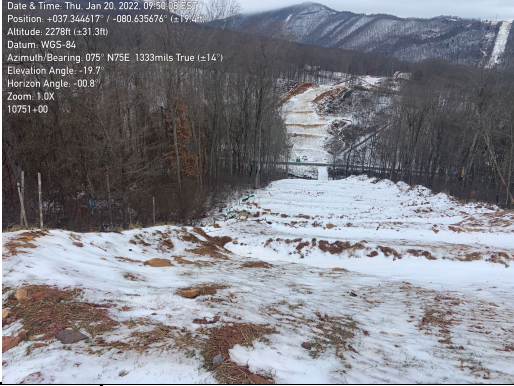
GPS Location	See photo	GPS Location	See photo		
Field Station#	10751+00	Field Station#	10758+35		
Pic 1 Desc.	Section of Row showing conditions and controls	Pic 2 Desc.	Overview of controls at S-G35		
<p>Date & Time: Thu Jan 20, 2022, 09:56:46 EST Position: +037.344822° / -080.630004° (±11.2ft) Altitude: 2071ft (±11.2ft) Datum: WGS-84 Azimuth/Bearing: 035° N35E 0689mils True (±15°) Elevation Angle: -17.7° Horizon Angle: -01.1° Zoom: 1.0X 10758+35 S-G35</p>

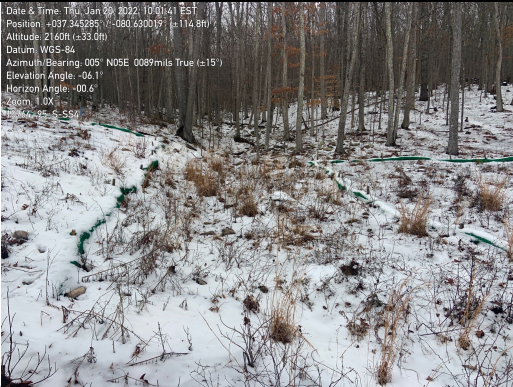
GPS Location	See photo	GPS Location	See photo		
Field Station#	10758+35	Field Station#	10764+95		
Pic 3 Desc.	S-G35	Pic 4 Desc.	S-SS4		
<p>Date & Time: Thu Jan 20, 2022, 10:06:53 EST Position: +037.344295° / -080.629193° (±128.9ft) Altitude: 2144ft (±42.4ft) Datum: WGS-84 Azimuth/Bearing: 152° S28E 2702mils True (±15°) Elevation Angle: -19.9° Horizon Angle: -01.4° Zoom: 1.0X 10771+75</p>

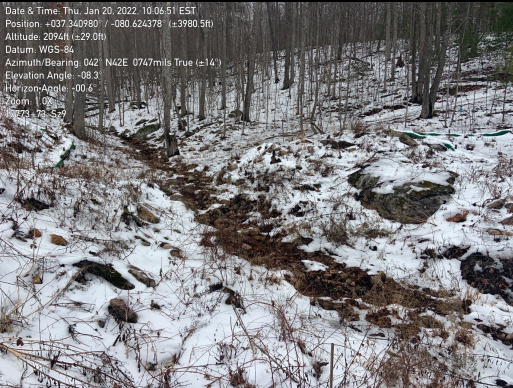
GPS Location	See photo	GPS Location	See photo		
Field Station#	10771+75	Field Station#	10773+73		
Pic 5 Desc.	Clean water diversion pipe and level spreader	Pic 6 Desc.	SZ9

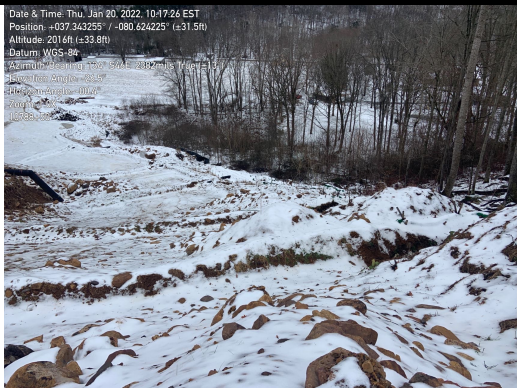
GPS Location	See photo	GPS Location	See photo		
Field Station#	10788+50	Field Station#	10794+35		
Pic 9 Desc.	Section of Row showing conditions and controls	Pic 10 Desc.	Clean water diversion pipe and inlet are in acceptable condition		
<p>Insert image here</p>		<p>Insert image here</p>			
GPS Location		GPS Location			
Field Station#		Field Station#			
Pic 11 Desc.		Pic 12 Desc.

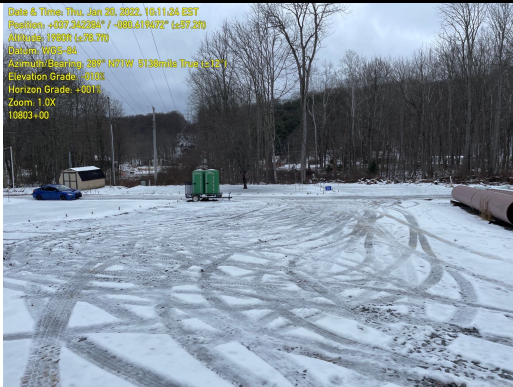
GPS Location		See photo				GPS Location		See photo			
Field Station#		10803+00				Field Station#		10805+00			
Pic 1 Desc.		RCE in place				Pic 2 Desc.		P1 silt fence in place at sensitive resource			
<p>Date & Time: Thu, Jan 20, 2022, 10:07:23 EST Position: +037.342984° / -080.618371° (+15.6M) Altitude: 2086ft (+11.0M) Datum: WGS-84 Azimuth/Bearing: 015° N15E 0267mils True (+12°) Elevation Grade: -05% Horizon Grade: +016% Zoom: 1.0X 10808+15</p>

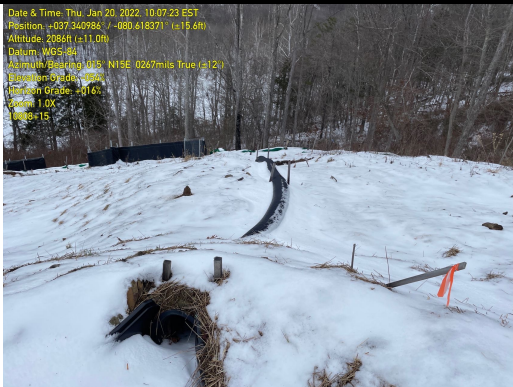
GPS Location		See photo				GPS Location		See photo			
Field Station#		10808+15				Field Station#		10812+50			
Pic 3 Desc.		Slope drain in place				Pic 4 Desc.		Cleanwater diversion outlet protection in place			
<p>Date & Time: Thu, Jan 20, 2022, 10:05:46 EST Position: +037.340033° / -080.61891° (+19.3M) Altitude: 2519ft (+57.20) Datum: WGS-84 Azimuth/Bearing: 212° S37W 0558mils True (+12°) Elevation Grade: -013% Horizon Grade: +007% Zoom: 1.0X 10831+50</p>

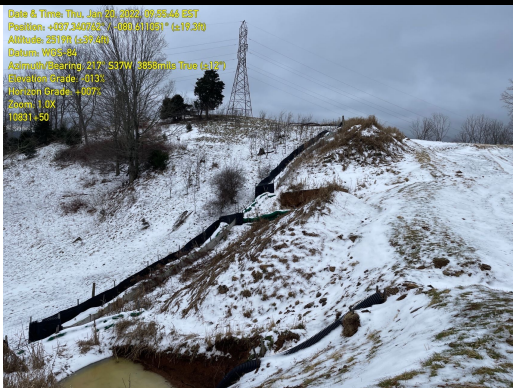
GPS Location		See photo				GPS Location		See photo			
Field Station#		10831+50				Field Station#		10815+00			
Pic 5 Desc.		Triple protection ECDs in place at karst feature				Pic 6 Desc.		Waterbars in place

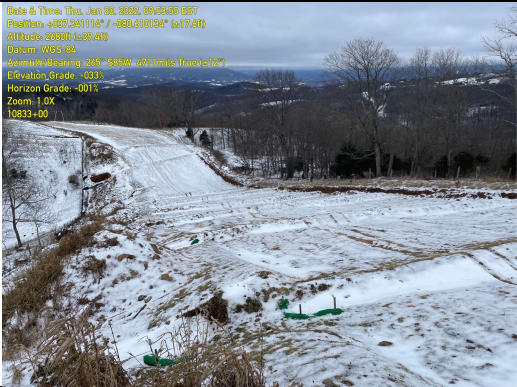
GPS Location	See photo	GPS Location	See photo		
Field Station#	10833+00	Field Station#	10843+75		
Pic 7 Desc.	Waterbars in place	Pic 8 Desc.	Cleanwater diversion berm in place		
<p>Date & Time: Thu, Jan 20, 2022, 09:53:39 EST Position: +407.343116° / -880.410134° (±17.40) Altitude: 22091 (±28.2m) Datum: WGS-84 Azimuth/Bearing: 302° (±15.40) (±11.11 miles True (±12°)) Elevation Grade: -016 Horizon Grade: -000 Zoom: 1.0X 10848+00</p>

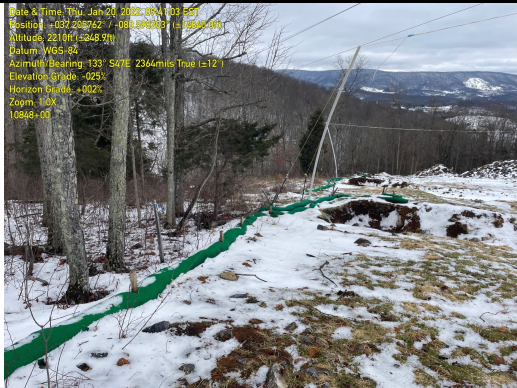
GPS Location	See photo	GPS Location	See photo		
Field Station#	10848+00	Field Station#	10855+00		
Pic 9 Desc.	CFS perimeter control in place	Pic 10 Desc.	Stream buffer in place		
<p>Date & Time: Thu, Jan 20, 2022, 09:53:39 EST Position: +407.343116° / -880.410134° (±17.40) Altitude: 22091 (±28.2m) Datum: WGS-84 Azimuth/Bearing: 302° (±15.40) (±11.11 miles True (±12°)) Elevation Grade: -016 Horizon Grade: -000 Zoom: 1.0X 10858+00</p>

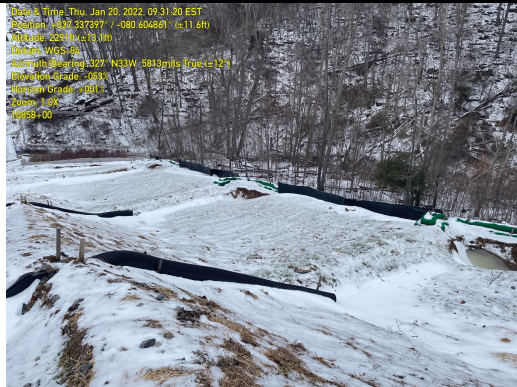
GPS Location	See photo	GPS Location	See photo		
Field Station#	10858+00	Field Station#	10859+00		
Pic 11 Desc.	End treatments in place	Pic 12 Desc.	Supersilt fence perimeter control in place

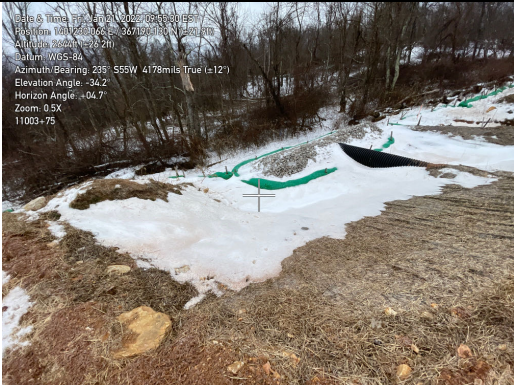
GPS Location	3	GPS Location	4		
Field Station#	11003+75	Field Station#	10995+50		
Pic 3 Desc.	CWDP outlet protection.	Pic 4 Desc.	P-1 perimeter controls functional.

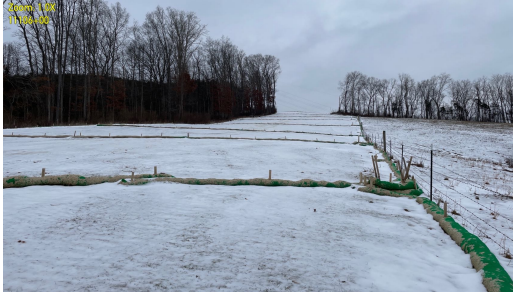
GPS Location				See photo				GPS Location				See photo			
Field Station#				11106+00				Field Station#				11112+00			
Pic 1 Desc.				CFS end treatments in place				Pic 2 Desc.				CFS triple stack perimeter control in place			
<p>Date & Time: Fri, Jan 21, 2022, 09:45:45 EST Position: +437.314614° / -900.522934° (±11.270) Altitude: 21100 (±39.400) Datum: WGS-84 Azimuth/Bearing: 290° N20W 3156mils True (±12°) Elevation Grade: +001% Horizontal Grade: +000% Zoom: 1.00 11120+00</p>  				<p>Date & Time: Fri, Jan 21, 2022, 09:46:29 EST Position: +437.314614° / -900.522934° (±15.110) Altitude: 20090 (±11.710) Datum: WGS-84 Azimuth/Bearing: 123° S37E 2180mils True (±12°) Elevation Grade: +010% Horizontal Grade: +001% Zoom: 1.00 11135+00</p>

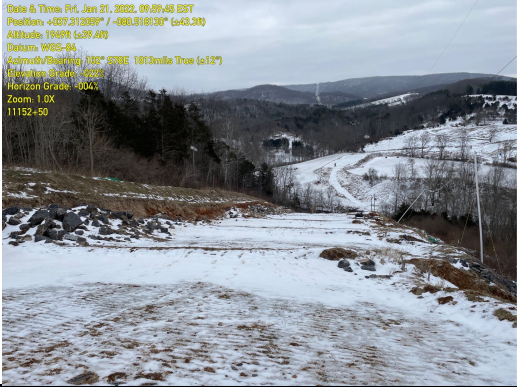
GPS Location	See photo		GPS Location	See photo	
Field Station#	11148+50		Field Station#	11152+50	
Pic 7 Desc.	Supersilt fence perimeter control in place		Pic 8 Desc.	Waterbars in place	
<p><small>Date & Time: Fri, Jan 21, 2022, 10:09:46 EST Position: +037.311591° / -060.514407° (±29.80) Altitude: 1800ft (±49.30) Datum: WGS-84 Azimuth/Bearing: 100° S205° 1770mils True (±12°) Elevation Grade: +003° Horizon Grade: +003° Zoom: 1.0X 11163+00</small></p>

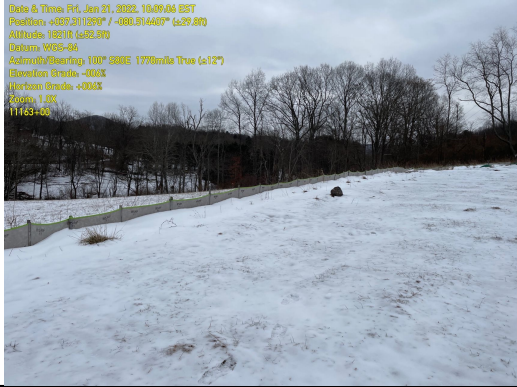
GPS Location	See photo		GPS Location	See photo	
Field Station#	11163+00		Field Station#	11167+00	
Pic 9 Desc.	P1 silt fence perimeter control in place		Pic 10 Desc.	Cleanwater diversion outlet protection in place	
<p><small>Date & Time: Fri, Jan 21, 2022, 10:11:09 EST Position: +037.310391° / -060.514312° (±18.10) Altitude: 1873ft (±11.50) Datum: WGS-84 Azimuth/Bearing: 100° S22W 2891mils True (±12°) Elevation Grade: +003° Horizon Grade: +003° Zoom: 1.0X 11168+00</small></p>

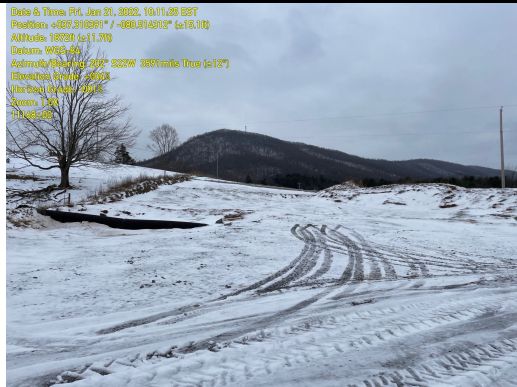
GPS Location	See photo		GPS Location	See photo	
Field Station#	11168+00		Field Station#	11177+00	
Pic 11 Desc.	RCE in place		Pic 12 Desc.	Level spreader in place

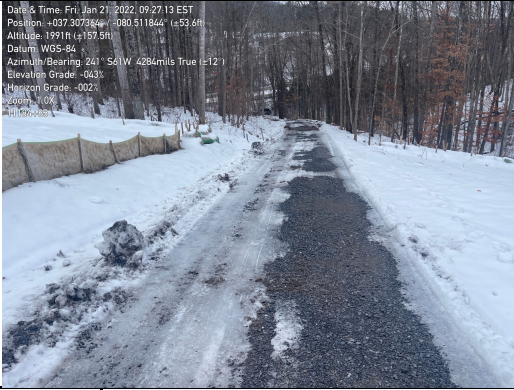
<p>Date & Time: Fri, Jan 21, 2022, 09:27:38 EST Position: +037.307369° / -080.511877° (+53.6ft) Altitude: 1928ft (+26.2ft) Datum: WGS-84 Azimuth/Bearing: 205° N55W 5626mils True (+13°) Elevation Grade: -015% Horizon Grade: -005% Zoom: 1.0x 11188+00</p>			
GPS Location	See Photo		GPS Location	See Photo	
Field Station#	11184+85		Field Station#	11188+00	
Pic 1 Desc.	Access Road 249.02 conditions. Gravel may have been graded into the drain path by L/O.		Pic 2 Desc.	Ditch line. No Settlement. Final Restoration Area

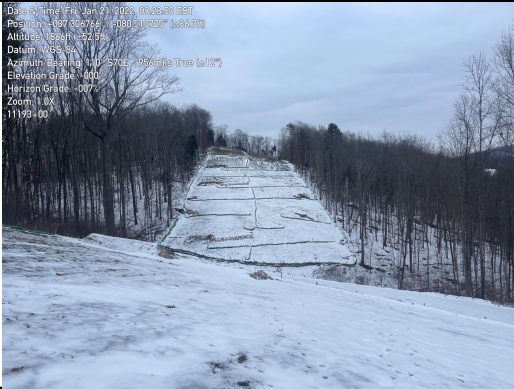
GPS Location	See Photo		GPS Location	See Photo	
Field Station#	11193+00		Field Station#	11191+41	
Pic 3 Desc.	Snow and Ice row coverage. Final Restoration Area		Pic 4 Desc.	Frozen Drainage Feature condition. Final Restoration Area

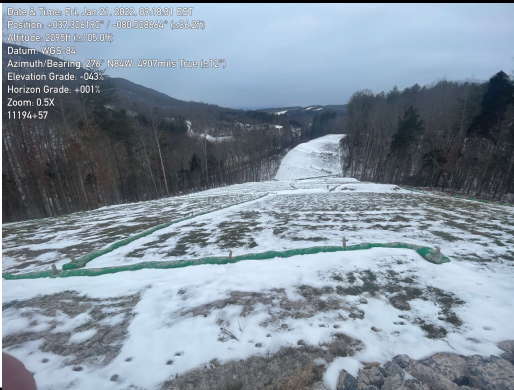
<p>Date & Time: Fri, Jan 21, 2022, 09:19:45 EST Position: +037.306160° / -080.508444° (+53.0ft) Altitude: 2053ft (+105.0ft) Datum: WGS-84 Azimuth/Bearing: 110° S50E 5956mils True (+12°) Elevation Grade: -00% Horizon Grade: -007% Zoom: 1.0x 11198+00</p>			
GPS Location	See Photo		GPS Location	See Photo	
Field Station#	11194+57		Field Station#	11198+00	
Pic 5 Desc.	Frozen vegetation and CFS Final Restoration Area		Pic 6 Desc.	Permanent water bar condition Final Restoration Area

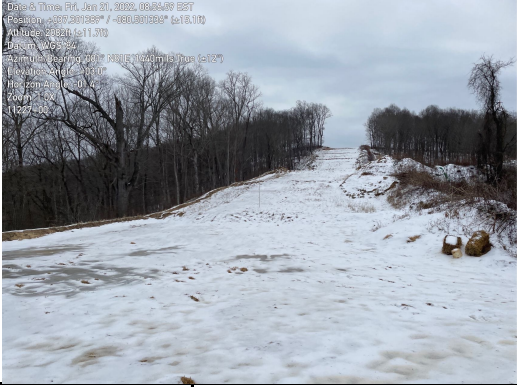
<p> <small> Date & Time: Fri, Jan 21, 2022 10:54:57 EST Location: +39.28133° / -90.08193° (±11.8%) Altitude: 33741 (±11.8%) Datum: WGS-84 Azimuth/Bearing: 195° S15W 3467mils True (±12°) Elevation Grade: -057° Horizon Grade: +005° Zoom: 0.5X 11227+50 </small> </p>			
GPS Location	See Photo	GPS Location	See Photo		
Field Station#	11227+00	Field Station#	11222+50		
Pic 13 Desc.	Frozen row conditions	Pic 14 Desc.	Stone Inlet protection

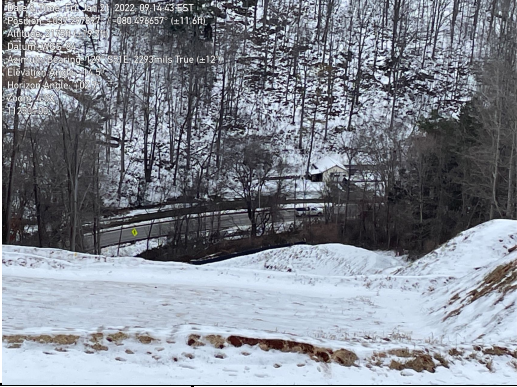
GPS Location	See Photo	GPS Location			
Field Station#	11250+00	Field Station#			
Pic 15 Desc.	Temporary stabilized row conditions. Functional water bars in view.	Pic 16 Desc.			
<div style="text-align: center;">Insert image here</div>		<div style="text-align: center;">Insert image here</div>			
GPS Location		GPS Location			
Field Station#		Field Station#			
Pic 17 Desc.		Pic 18 Desc.
