Visual Site Inspection Report

Project Name H-600 Pipeline Spread G		AFE 124300137	Spread H-600 Pipeline Spread G
Contractor Precision		Report # 33551	
Inspector Jared Saunders		Date/Time 1/24/2022 1:22 PM	
Permit # TBD	Inspection Type VA SWPP	Station Begin	11353+67
State VA	Inspection Area Partial	Station End	11471+56
County Giles	Ground Frozen	Temperature (°F)	40.00
Municipality N/A	Weather Below Freezing Temp	Rain Gauge (in)	0.00
			Rain Accumulation Time (days) 1.00

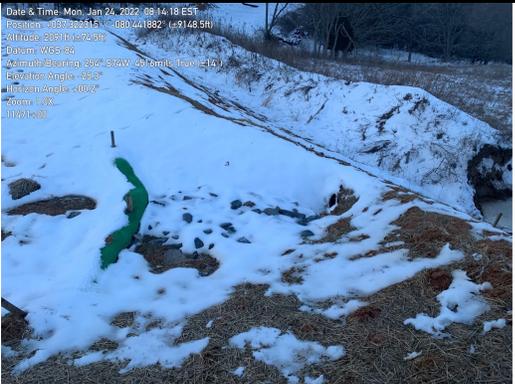
GPS Location	See photo for GPS location.		GPS Location	See photo for GPS location.	
Field Station#	11471+00		Field Station#	11453+00	
Pic 1 Desc.	Rock inlet in place at slope drain inlet.		Pic 2 Desc.	Slope drain over fill slope, sump pit, and end treatment in place.	
<p>Date & Time: Mon, Jan 24, 2022, 08:17:31 EST Position: -037.320599 / -080.436399 (±1666.2ft) Altitude: 2246ft (±114.8ft) Datum: WGS-84 Azimuth/Bearing: 287° N73W 5102mils True (±14°) Elevation Angle: -25.8° Horizon Angle: -01.5° Zoom: 1.0X 11468+00</p>

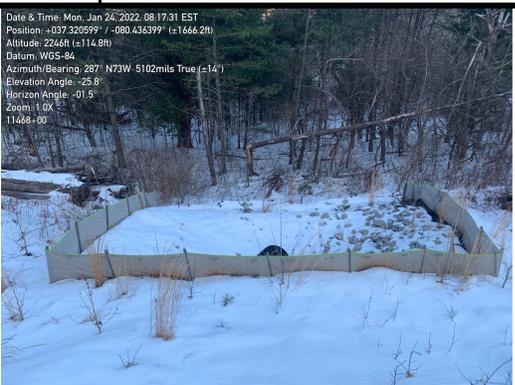
GPS Location	See photo for GPS location.		GPS Location	See photo for GPS location.	
Field Station#	11468+00		Field Station#	11433+00	
Pic 3 Desc.	Plunge pool and clean water drainage pipe in place.		Pic 4 Desc.	Permanent waterbars with level spreaders in place.	
<p>Date & Time: Mon, Jan 24, 2022, 08:39:51 EST Position: -037.316958 / -080.445831 (±1513ft) Altitude: 2056ft (±101.9ft) Datum: WGS-84 Azimuth/Bearing: 276° N84W 3226mils True (±14°) Elevation Angle: -23.6° Horizon Angle: -04.1° Zoom: 1.0X 11353+00</p>

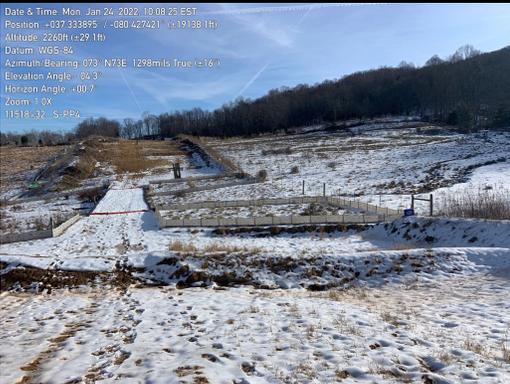
GPS Location	see photo	GPS Location	see photo		
Field Station#	11520+00	Field Station#	11518+32		
Pic 1 Desc.	Section of Row showing conditions and controls	Pic 2 Desc.	S-PP4

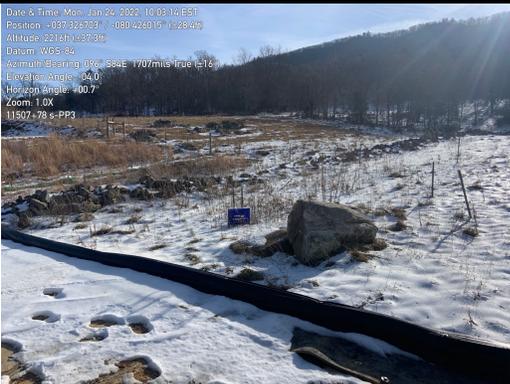
GPS Location	See photo	GPS Location	see photo		
Field Station#	11507+78	Field Station#	11504+00		
Pic 3 Desc.	S-PP3	Pic 4 Desc.	Rock lined channel is in acceptable condition

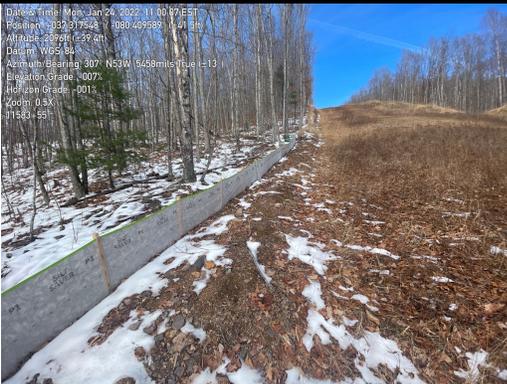
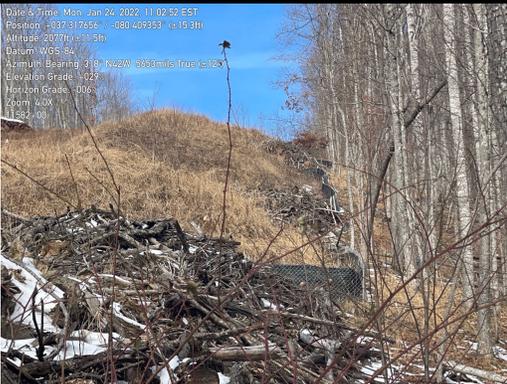
GPS Location	See Photo	GPS Location	See Photo		
Field Station#	11583+55	Field Station#	11582+00		
Pic 3 Desc.	Perimeter P1 silt fencing	Pic 4 Desc.	Temporary vegetation over top soil pile and perimeter super silt fence.

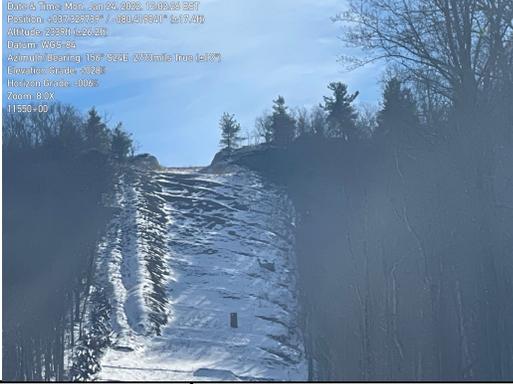
GPS Location	See Photo	GPS Location	See Photo
Field Station#	11587+42	Field Station#	11550+00
Pic 9 Desc.	View looking down stream	Pic 10 Desc.	Temporary stabilized row. Slope covered in ice and snow.

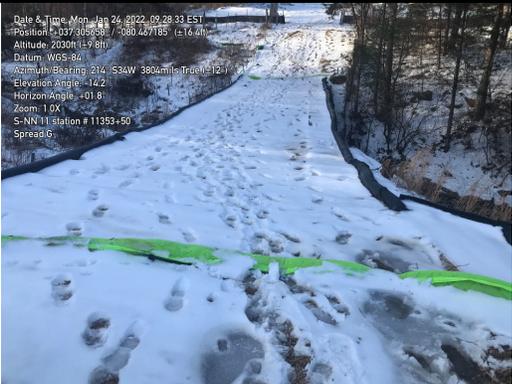
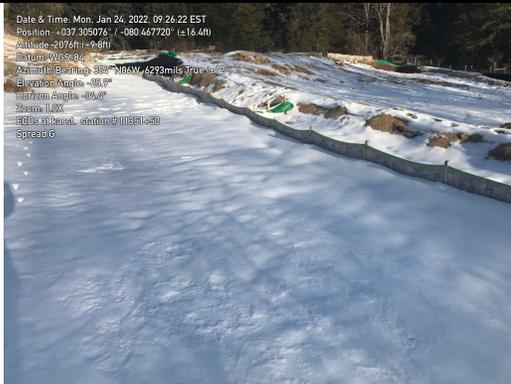
<p>Date & Time: Mon, Jan 24, 2022, 09:26:22 EST Position: +037.305076 / -080.467720 (±16.4ft) Altitude: 2076ft (±9.8ft) Datum: WGS-84 Azimuth/Bearing: 889.1104W 4293mils True (±16) Elevation Angle: -38.9 Horizon Angle: +09.4 Zoom: 1.0X GPS 31 level, station # 11351+50 Spread G</p>			
GPS Location	See photo		GPS Location	see photo	
Field Station#	11353+50		Field Station#	11351+50	
Pic 1 Desc.	S-NN 11		Pic 2 Desc.	ECDs at Karst

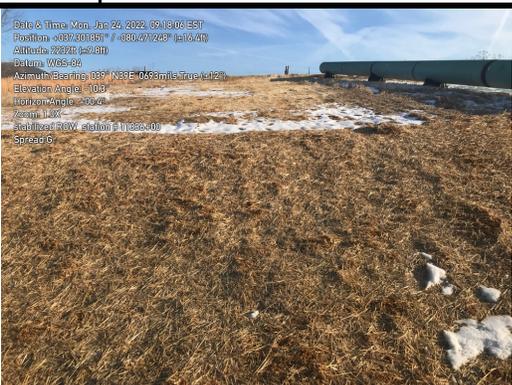
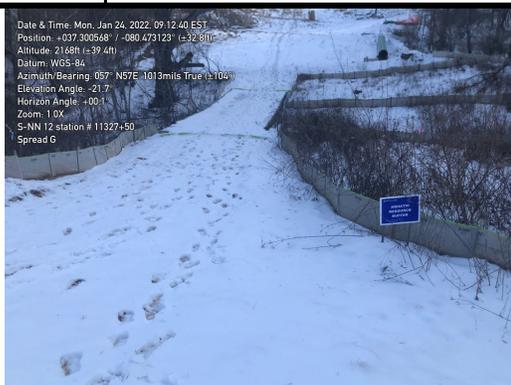
GPS Location	see photo		GPS Location	see photo	
Field Station#	11336+00		Field Station#	11327+50	
Pic 3 Desc.	Stabilized ROW		Pic 4 Desc.	S-NN 12

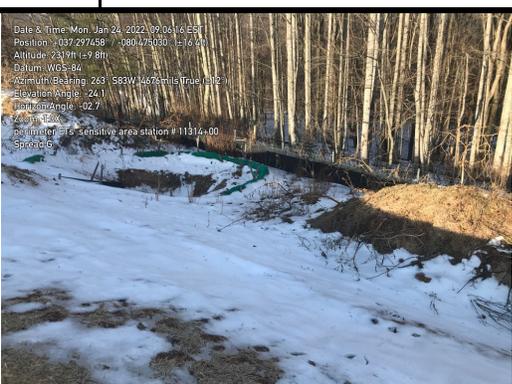
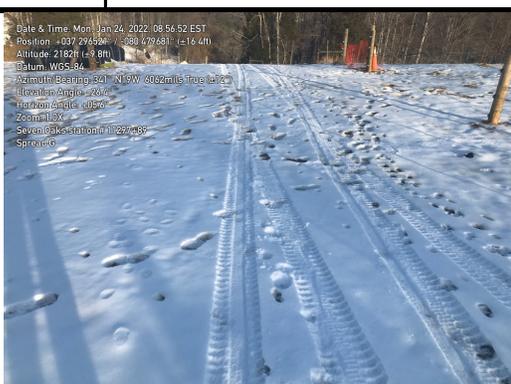
<p>Date & Time: Mon, Jan 24, 2022, 08:56:52 EST Position: +037.296594 / -080.479681 (±16.4ft) Altitude: 2182ft (±9.8ft) Datum: WGS-84 Azimuth/Bearing: 341.1N19W 6102mils True (±16) Elevation Angle: -24.6 Horizon Angle: +05.0 Zoom: 1.0X Spread G station # 11297+89 Spread G</p>			
GPS Location	see photo		GPS Location	see photo	
Field Station#	11314+00		Field Station#	11297+89	
Pic 5 Desc.	Perimeter ECDs in sensitive area		Pic 6 Desc.	AR Seven Oaks

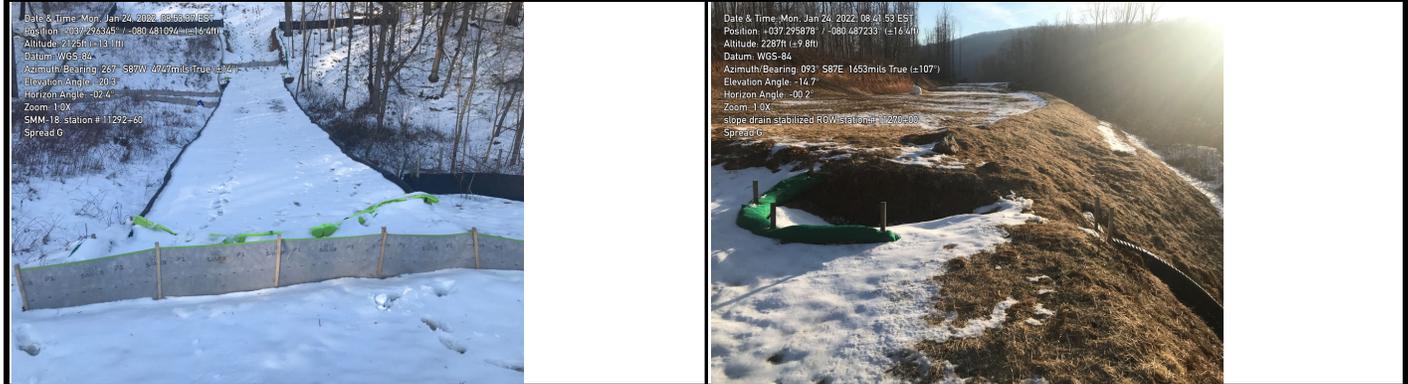
GPS Location	See photo	GPS Location	See photo
Field Station#	11292+60	Field Station#	11270+00
Pic 7 Desc.	S MM-18	Pic 8 Desc.	Slope drain

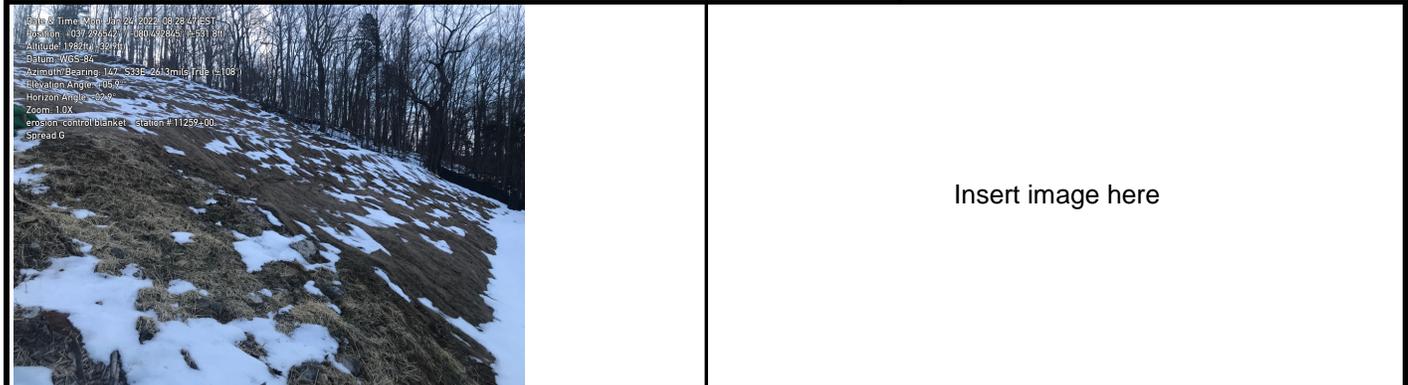
GPS Location	see photo	GPS Location	
Field Station#	11259+00	Field Station#	
Pic 9 Desc.	Erosion control blanket	Pic 10 Desc.

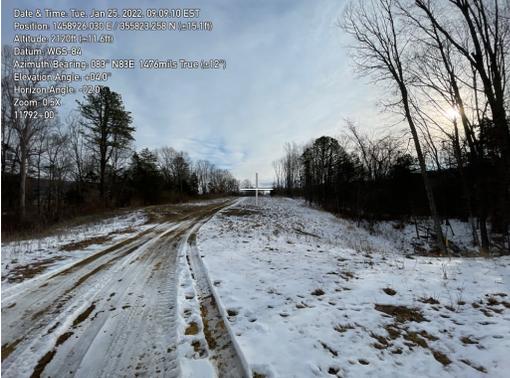
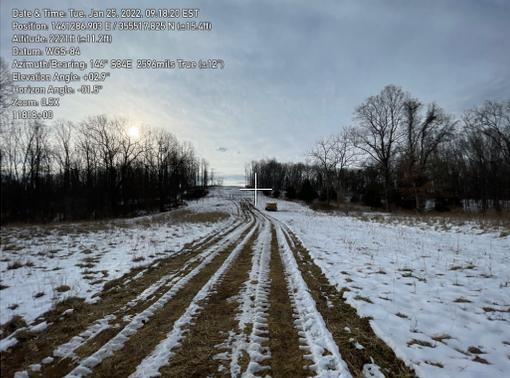
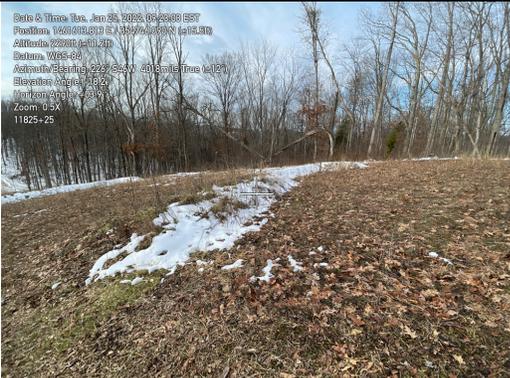
GPS Location 1		GPS Location 2		GPS Location 3			
Field Station# 11792+00		Field Station# 11818+00		Field Station# 11825+25			
Pic 1 Desc. Section of RoW showing conditions and controls.		Pic 2 Desc. Section of RoW showing conditions and controls.		Pic 3 Desc. Representational photo of waterbar and level spreader.

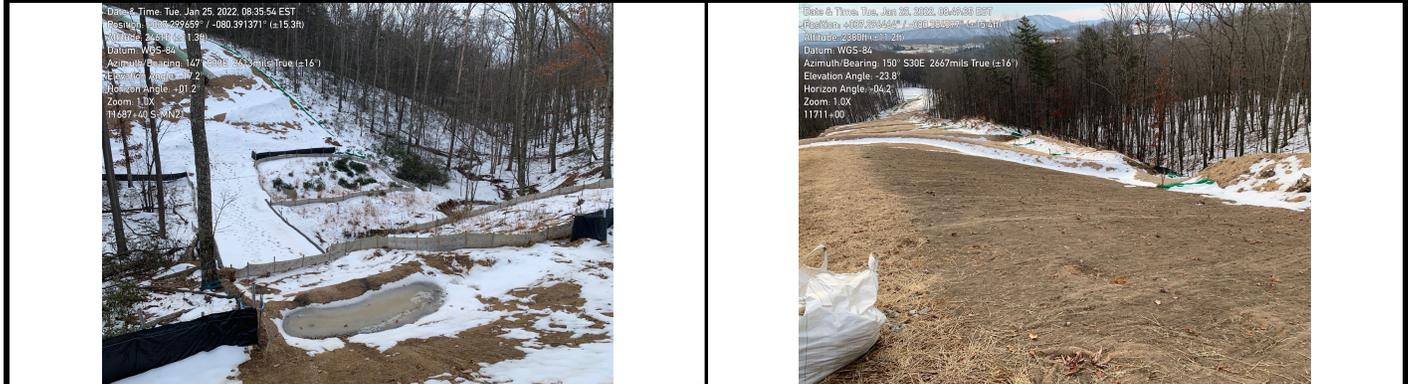
GPS Location	See photo for GPS location.	GPS Location	See photo for GPS location.
Field Station#	11687+40	Field Station#	11711+00
Pic 1 Desc.	Sensitive resource buffer in place at stream S-MN21.	Pic 2 Desc.	ROW temporarily stabilized with ECB.

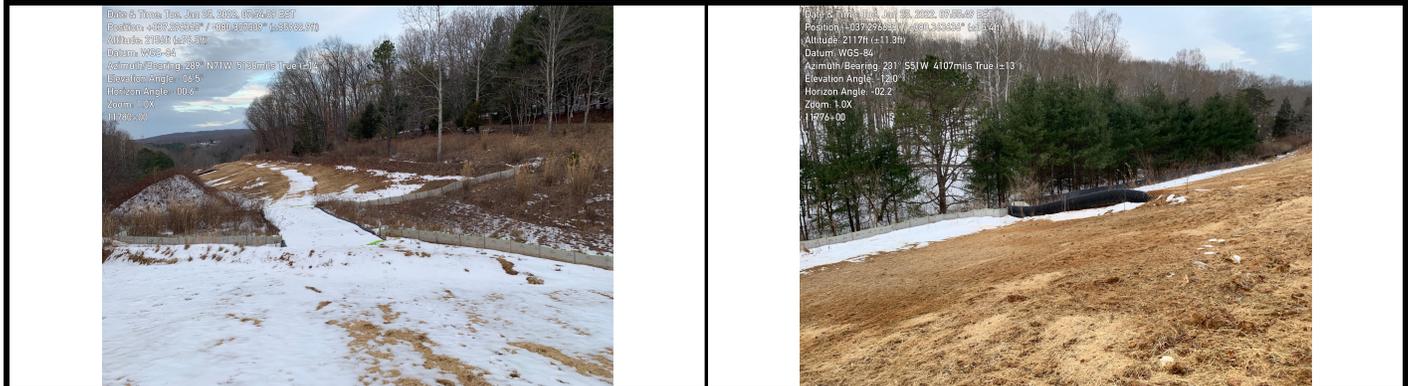
GPS Location	See photo for GPS location.	GPS Location	See photo for GPS location.
Field Station#	11780+00	Field Station#	11776+00
Pic 3 Desc.	Clean water drainage feature in place.	Pic 4 Desc.	Clean water diversion pipe in place.

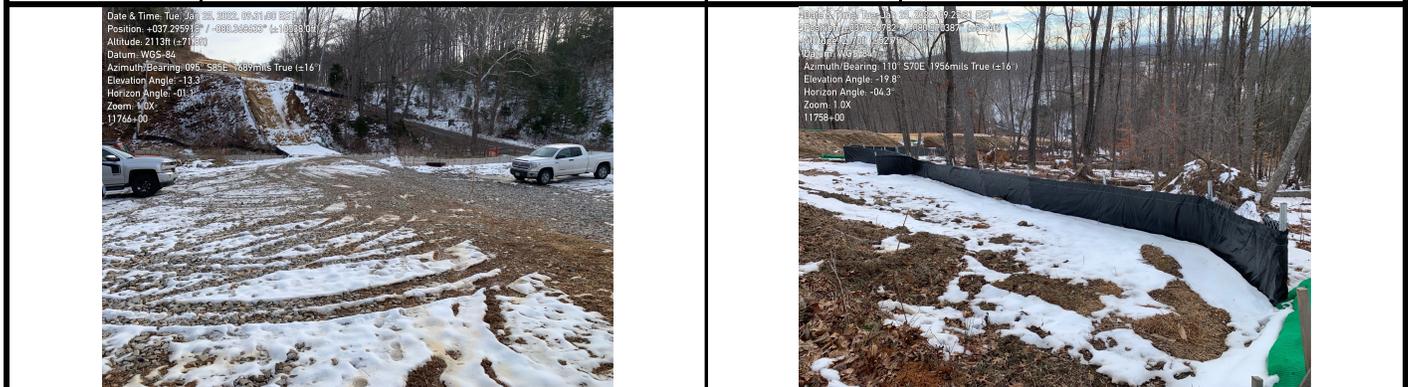
GPS Location	See photo for GPS location.	GPS Location	See photo for GPS location.
Field Station#	11766+00	Field Station#	11758+00
Pic 5 Desc.	RCE in place at MLV 26.	Pic 6 Desc.	Super silt fence in place along LOD.

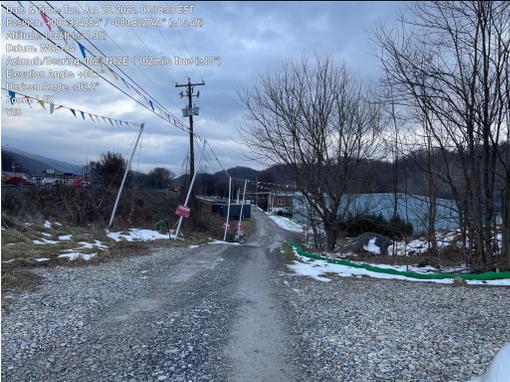
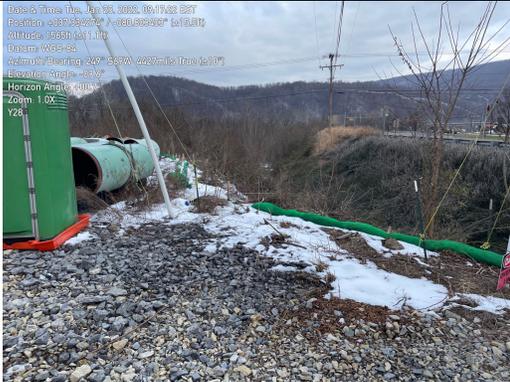
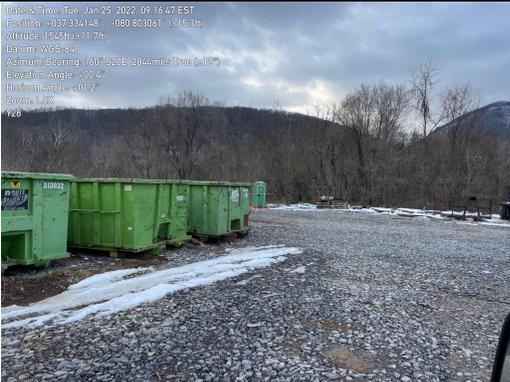
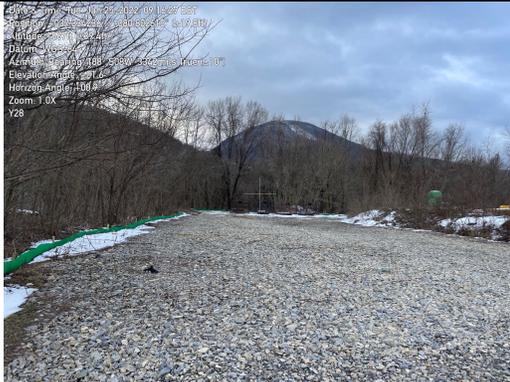
GPS Location	See photo	GPS Location	See photo	GPS Location	See photo		
Field Station#	12005+00	Field Station#	12005+00	Field Station#	12005+00		
Pic 1 Desc.	AR in good condition	Pic 2 Desc.	CFS perimeter controls functional	Pic 3 Desc.	Housekeeping trash in place

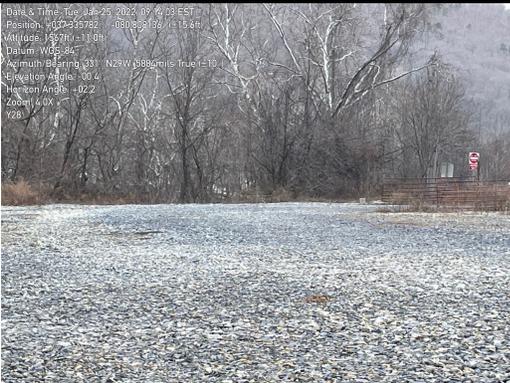
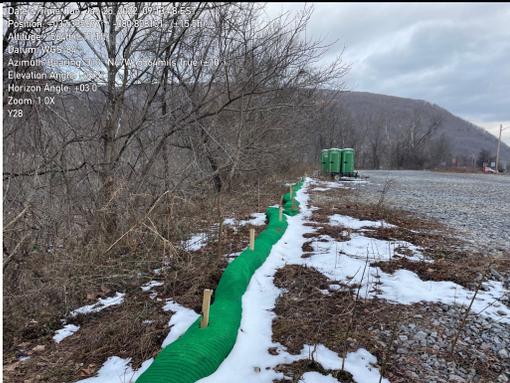
GPS Location	See photo	GPS Location	See photo	GPS Location	See photo		
Field Station#	12005+00	Field Station#	12005+00	Field Station#	12005+00		
Pic 5 Desc.	RCE functional	Pic 6 Desc.	CFS perimeter controls functional	Pic 7 Desc.	RCE functional		
Pic 8 Desc.		Pic 8 Desc.		Pic 8 Desc.

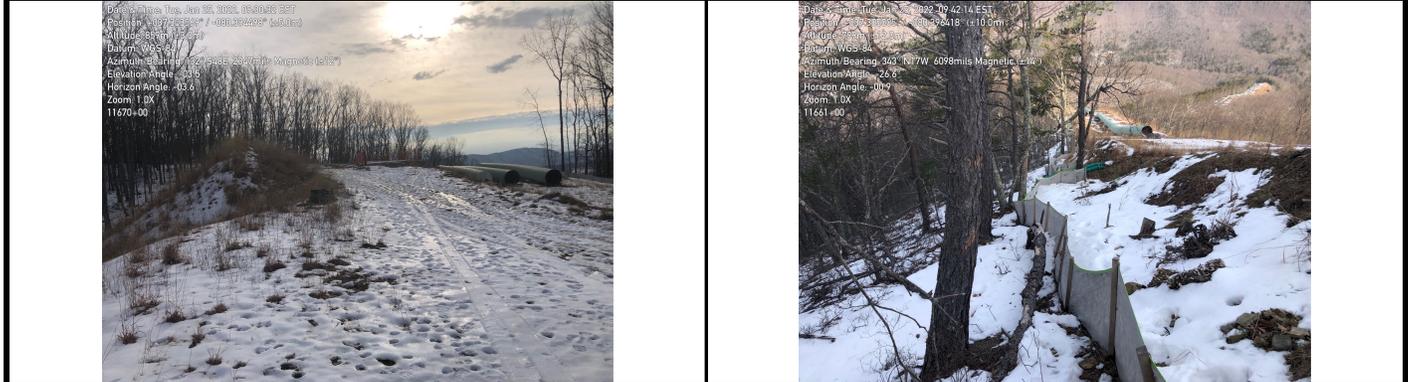
GPS Location	On photo	GPS Location	On photo
Field Station#	11670+00	Field Station#	11661+00
Pic 1 Desc.	ROW stable at top of Brush Mountain.	Pic 2 Desc.	Perimeter ECDs are in place. ROW is stable.

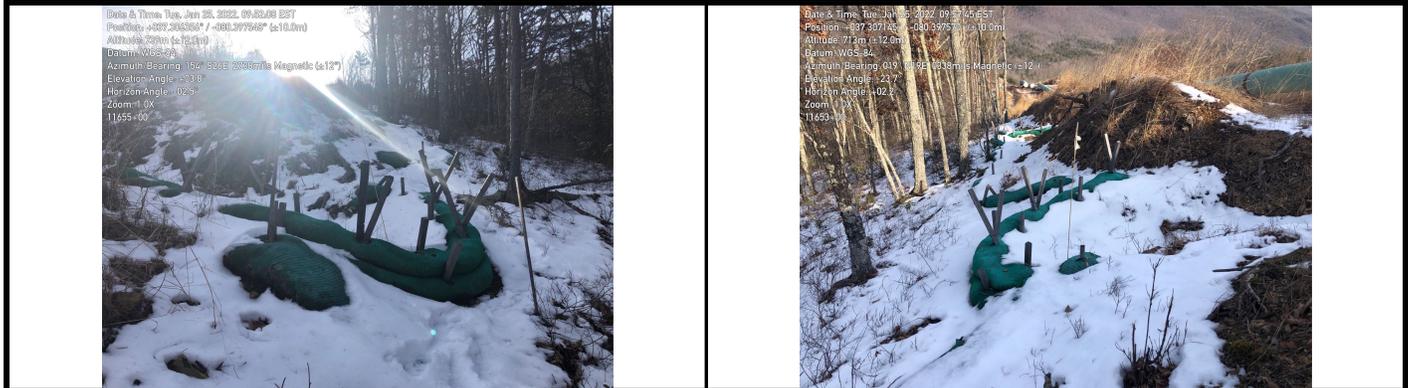
GPS Location	On photo	GPS Location	On photo
Field Station#	11655+00	Field Station#	11653+00
Pic 3 Desc.	Perimeter ECDs are in place. No movement of sediment discovered.	Pic 4 Desc.	ECDs along perimeter are in place. No maintenance needs were identified.

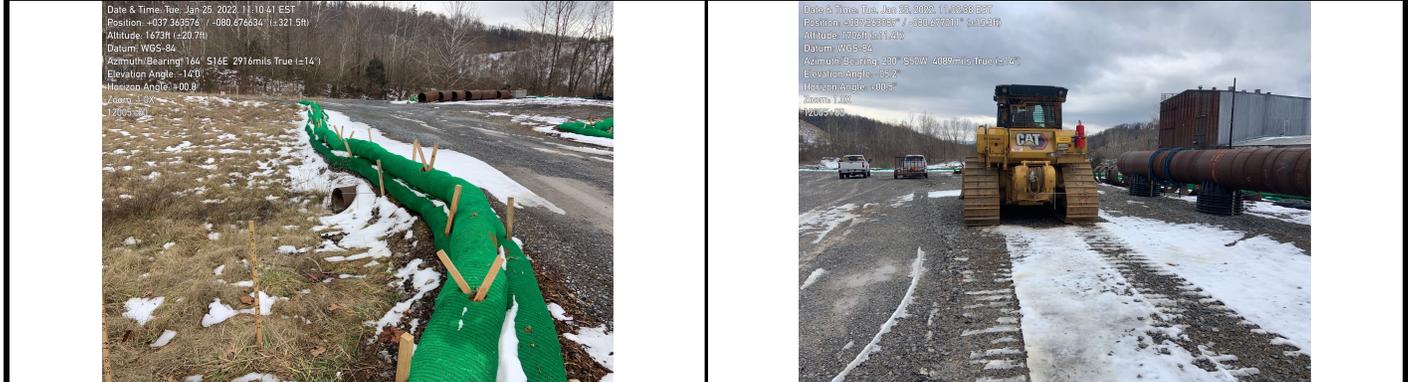
Pic 1 Desc.	Culvert in place	Pic 2 Desc.	Equipment checked no visible leaks or spills
--------------------	------------------	--------------------	--

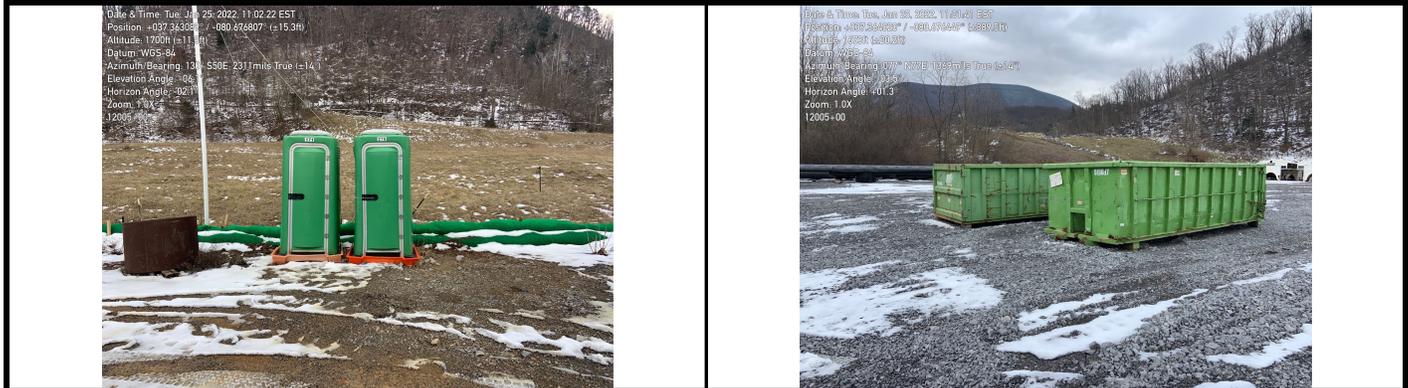
Pic 3 Desc.	Secondary containment in place	Pic 4 Desc.	Dumpsters in place
--------------------	--------------------------------	--------------------	--------------------

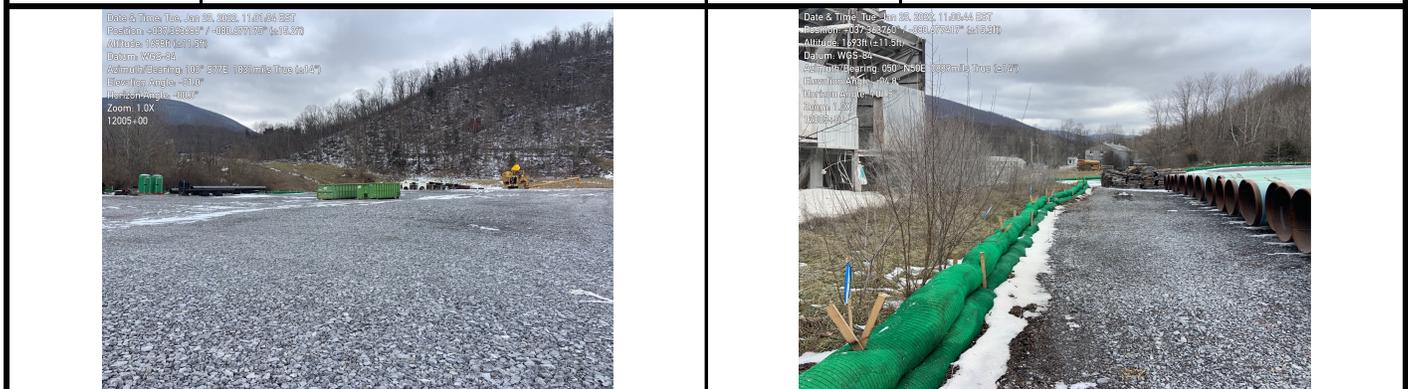
Pic 5 Desc.	Rock surface of RCE is in acceptable condition	Pic 6 Desc.	CFS perimeter controls are in acceptable condition
--------------------	--	--------------------	--

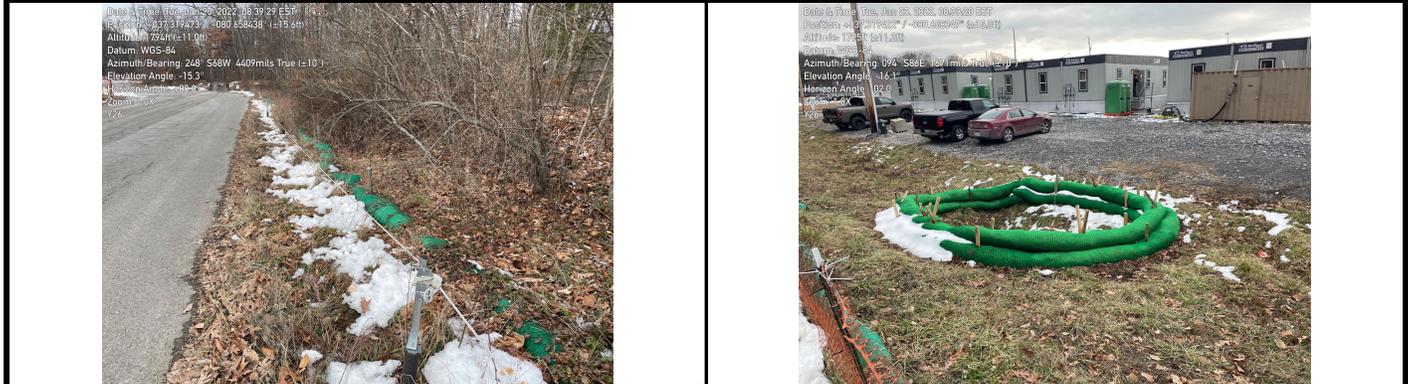
GPS Location	See photo	GPS Location	See photo
Field Station#	12005+00	Field Station#	12005+00
Pic 1 Desc.	CFS perimeter controls in place	Pic 2 Desc.	CFS Inlet protection in place

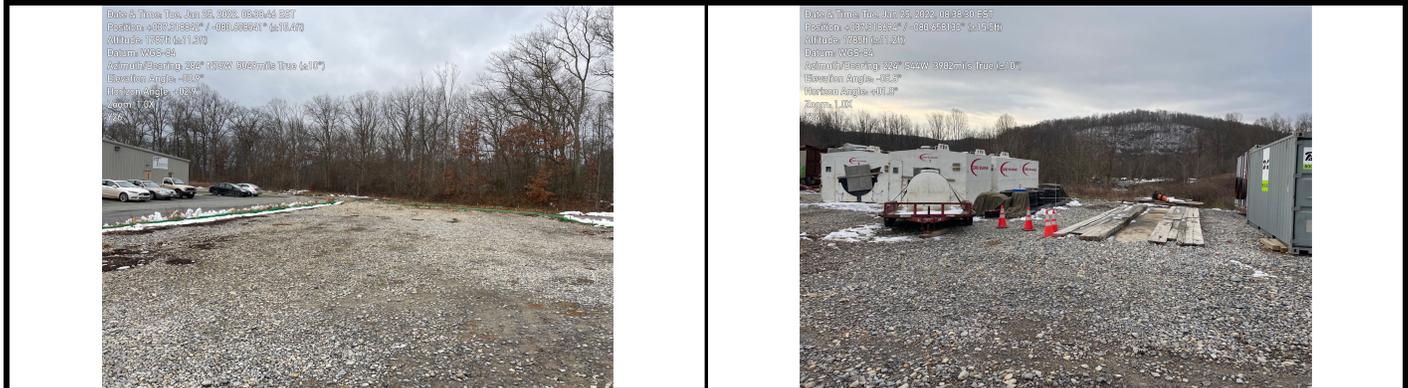
GPS Location	See photo	GPS Location	See photo
Field Station#	12005+00	Field Station#	12005+00
Pic 3 Desc.	CFS perimeter controls in place	Pic 4 Desc.	Secondary containment in place

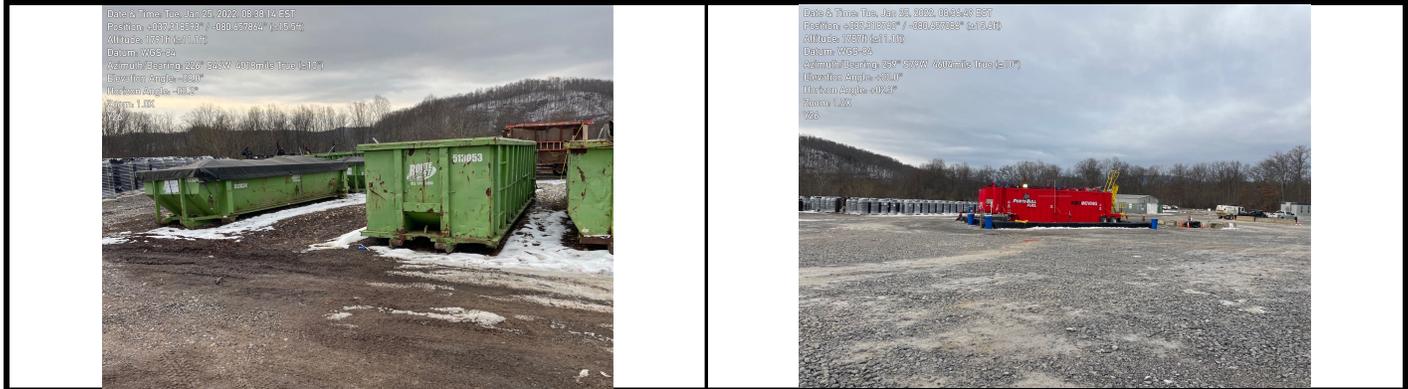
GPS Location	See photo	GPS Location	See photo
Field Station#	12005+00	Field Station#	12005+00
Pic 5 Desc.	Housekeeping trash in place	Pic 6 Desc.	Secondary containment in place

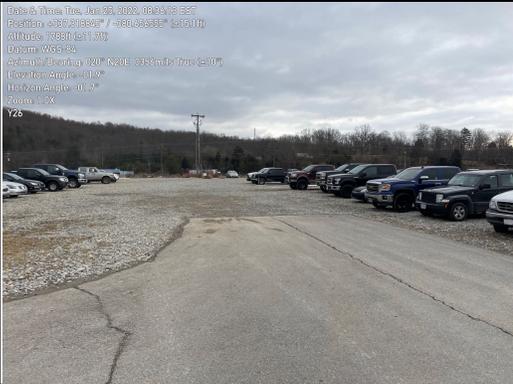
Pic 7 Desc.	RCE in good condition	Pic 8 Desc.	
--------------------	-----------------------	--------------------	--

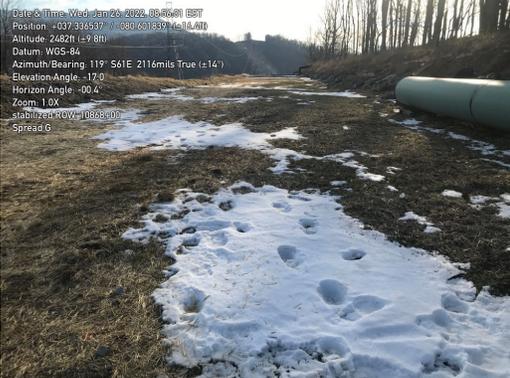
<p>Date & Time: Wed, Jan 26, 2022, 08:06:01 EST Position: +037.336597° / -080.608837° (-934.40ft) Altitude: 2482ft (-9.8ft) Datum: WGS-84 Azimuth/Bearing: 119° S61E 211.6mils True (-14°) Elevation Angle: -17.0° Horizon Angle: -00.4° Zoom: 1.0X Stabilized ROW: 10868+00 Spread G</p>		<p>GPS Location See photo</p> <p>Field Station# 10859+46</p> <p>Pic 1 Desc. Kow camp RCE</p>		<p>GPS Location see photo</p> <p>Field Station# 10868+00</p> <p>Pic 2 Desc. Stabilized ROW</p>

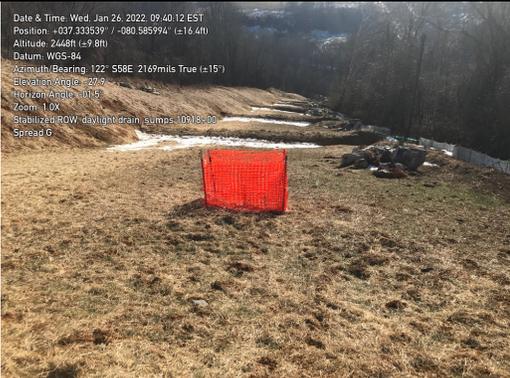
<p>Date & Time: Wed, Jan 26, 2022, 09:40:12 EST Position: +037.333531° / -080.585974° (-916.4ft) Altitude: 2448ft (-9.8ft) Datum: WGS-84 Azimuth/Bearing: 122° S68E 21.69mils True (-15°) Elevation Angle: -27.9° Horizon Angle: -01.5° Zoom: 1.0X Stabilized ROW, daylight drain, sumps: 10918+00 Spread G</p>		<p>GPS Location see photo</p> <p>Field Station# 10872+00</p> <p>Pic 3 Desc. Level spreader</p>		<p>GPS Location see photo</p> <p>Field Station# 10918+00</p> <p>Pic 4 Desc. Stabilized ROW, daylight drain, sumps</p>

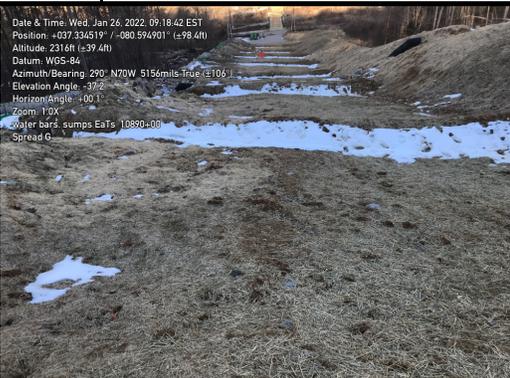
<p>Date & Time: Wed, Jan 26, 2022, 09:18:42 EST Position: +037.334519° / -080.594901° (-908.4ft) Altitude: 2318ft (-9.4ft) Datum: WGS-84 Azimuth/Bearing: 290° N70W 51.56mils True (-10°) Elevation Angle: -37.2° Horizon Angle: +00.1° Zoom: 1.0X Water bars, sumps, ETs: 10890+00 Spread G</p>		<p>GPS Location see photo</p> <p>Field Station# 10883+00</p> <p>Pic 5 Desc. S-A 32, Kow Camp pavement</p>		<p>GPS Location see photo</p> <p>Field Station# 10890+00</p> <p>Pic 6 Desc. Water bars sumps, ETs</p>

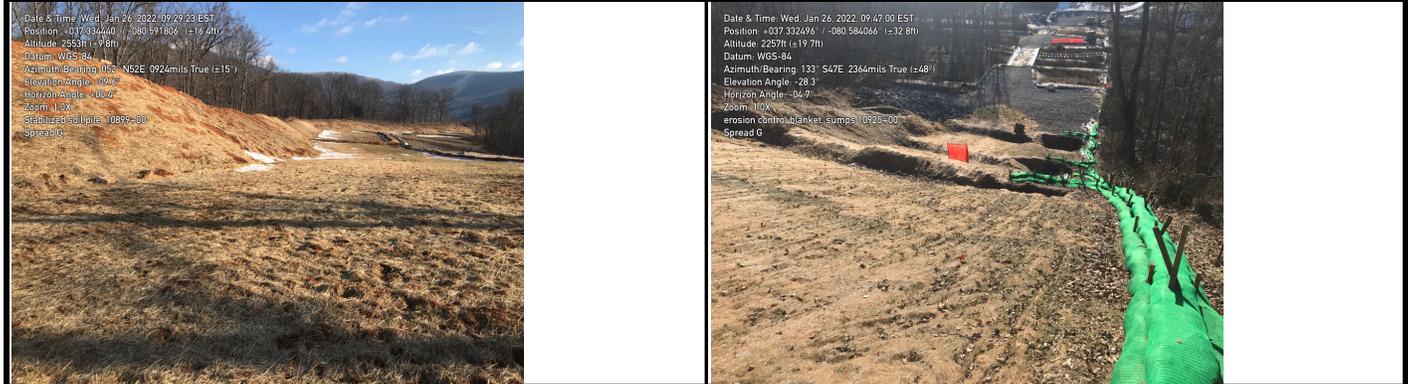
Pic 7 Desc.	Stabilized Soil piles	Pic 8 Desc.	Erosion control blanket, sumps.
--------------------	-----------------------	--------------------	---------------------------------

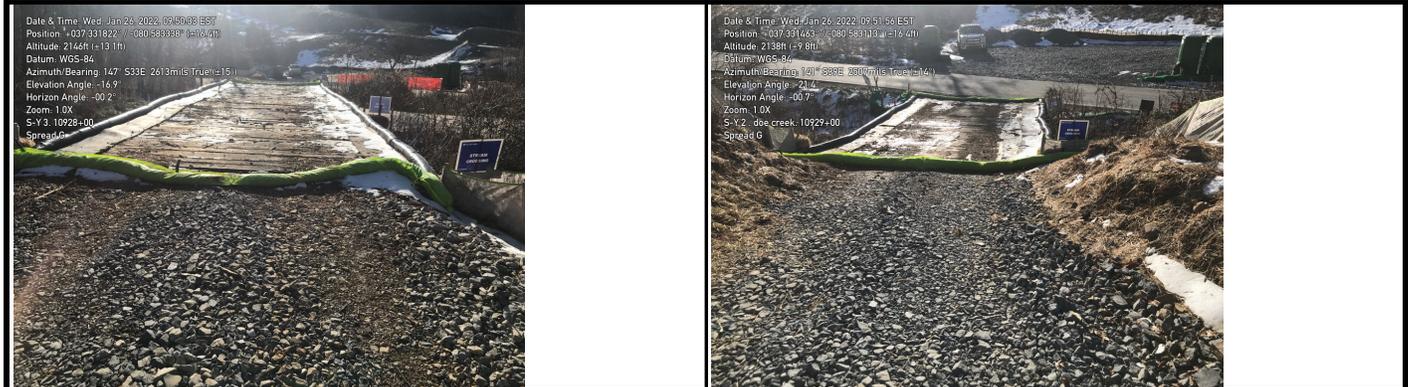
GPS Location	see photo	GPS Location	see photo
Field Station#	10928+00	Field Station#	10929+00
Pic 9 Desc.	S-Y 3	Pic 10 Desc.	S-Y 2, Doe Creek

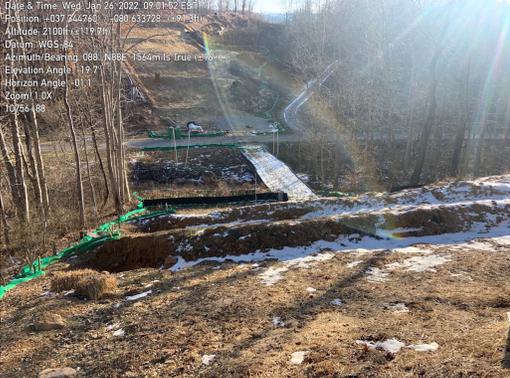
<p>Date & Time: Wed Jan 26 2022 09:14:2 EST Position: +037 342886 / -080 631130 Altitude: 2180ft (663m) Datum: WGS 84 Azimuth Bearing: 088.188E 1544mils True (+16) Elevation Angle: 119.7 Horizon Angle: 01.1 Zoom: 1.0x 10756+88</p>		<p>GPS Location See photo</p> <p>Field Station# 10750+50</p> <p>Pic 1 Desc. RCE is maintained in acceptable condition</p>		<p>GPS Location See photo</p> <p>Field Station# 10756+88</p> <p>Pic 2 Desc. Section of Row showing conditions and controls</p>

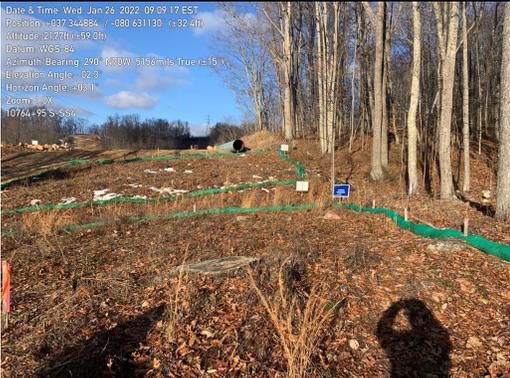
<p>Date & Time: Wed Jan 26 2022 09:09:17 EST Position: +037 342886 / -080 631130 Altitude: 2177ft (663m) Datum: WGS 84 Azimuth Bearing: 290.020W 3160mils True (+15) Elevation Angle: 92.3 Horizon Angle: 00.31 Zoom: 1.0x 10764+95</p>		<p>GPS Location See photo</p> <p>Field Station# 10758+35</p> <p>Pic 3 Desc. S-G35 showing conditions and controls</p>		<p>GPS Location See photo</p> <p>Field Station# 10764+95</p> <p>Pic 4 Desc. S-SS4 showing conditions and controls</p>

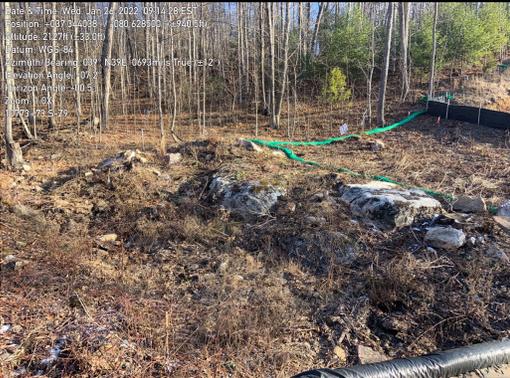
<p>Date & Time: Wed Jan 26 2022 09:10:58 EST Position: +037 342886 / -080 631130 Altitude: 2171ft (661m) Datum: WGS 84 Azimuth Bearing: 097.138E 0699mils True (+2) Elevation Angle: 97.2 Horizon Angle: -06.5 Zoom: 1.0x 10773+73</p>		<p>GPS Location See photo</p> <p>Field Station# 10771+75</p> <p>Pic 5 Desc. Clean water diversion pipe and level spreader</p>		<p>GPS Location See photo</p> <p>Field Station# 10773+73</p> <p>Pic 6 Desc. S-Z9 showing conditions and controls</p>

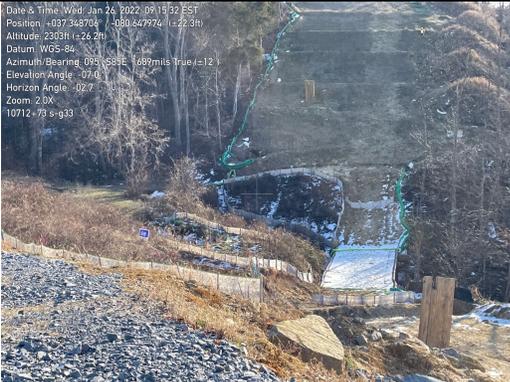
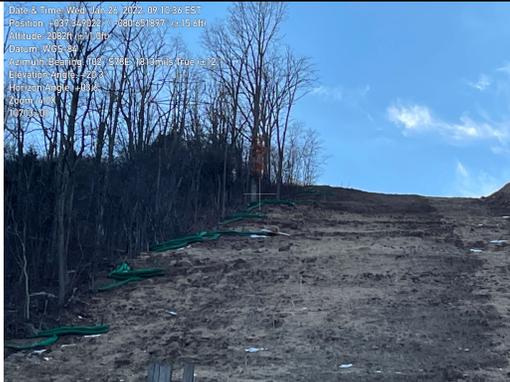
GPS Location See photo		GPS Location See photo			
Field Station# 10708+22		Field Station# 10712+73			
Pic 1 Desc. Skid steer dressing up AR 241.04		Pic 2 Desc. Equipment bridge functional

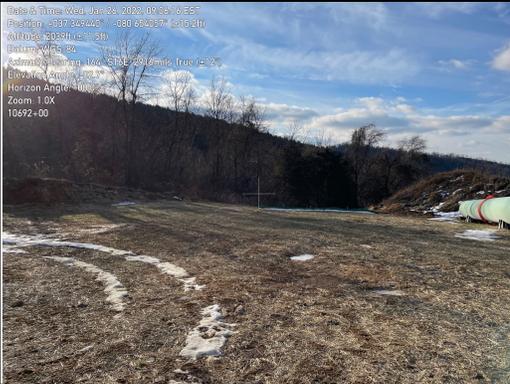
GPS Location	See photo
Field Station#	10692+00
Pic 7 Desc.	AR 241 in good condition

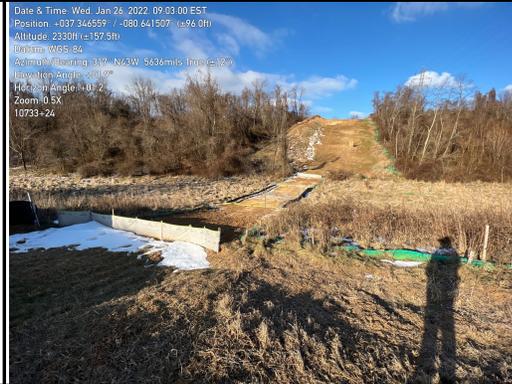
GPS Location	See photo
Field Station#	10733+24
Pic 8 Desc.	Equipment bridge functional

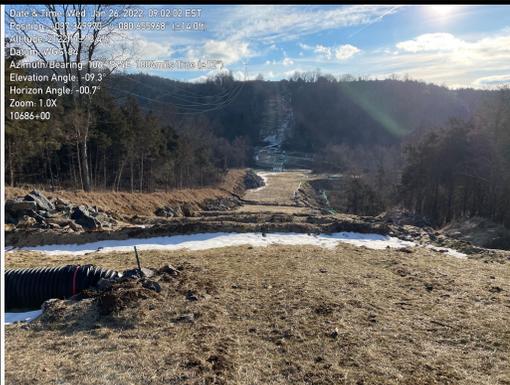
GPS Location	See photo
Field Station#	10686+00
Pic 9 Desc.	Water bars in place

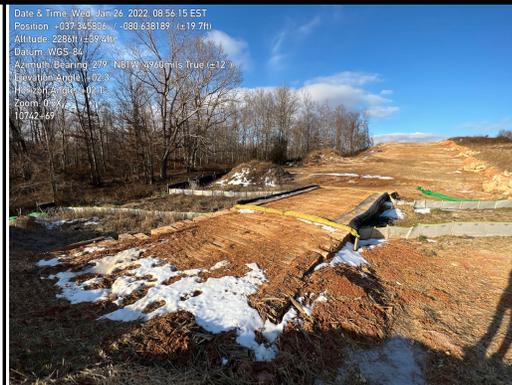
GPS Location	See photo
Field Station#	10742+69
Pic 10 Desc.	Clean water drainage feature functional

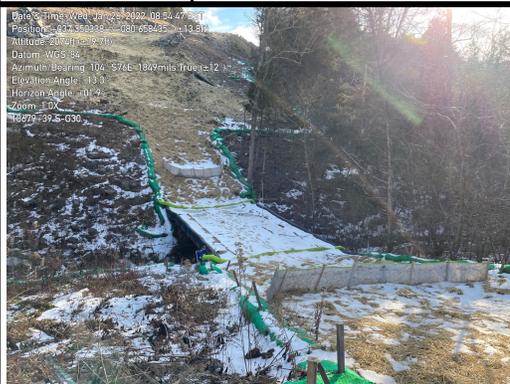
GPS Location	See photo
Field Station#	10679+39
Pic 11 Desc.	P1 in place

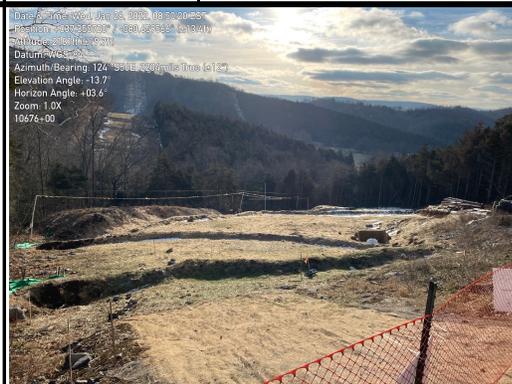
GPS Location	See photo
Field Station#	10676+00
Pic 12 Desc.	Erosion control blanket & water bars in place

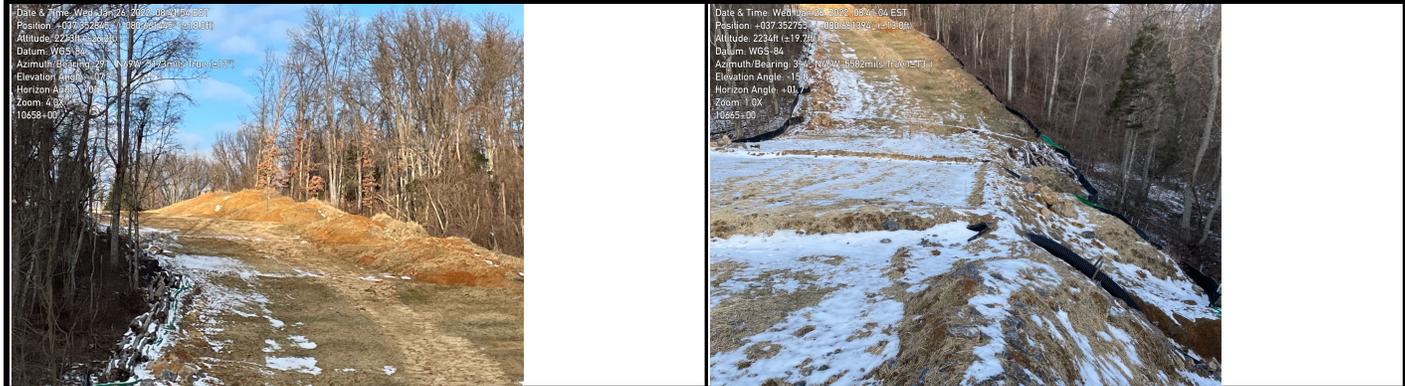
GPS Location	See photo	GPS Location	See photo
Field Station#	10658+00	Field Station#	10665+00
Pic 13 Desc.	Water bars in place	Pic 14 Desc.	SSF functional

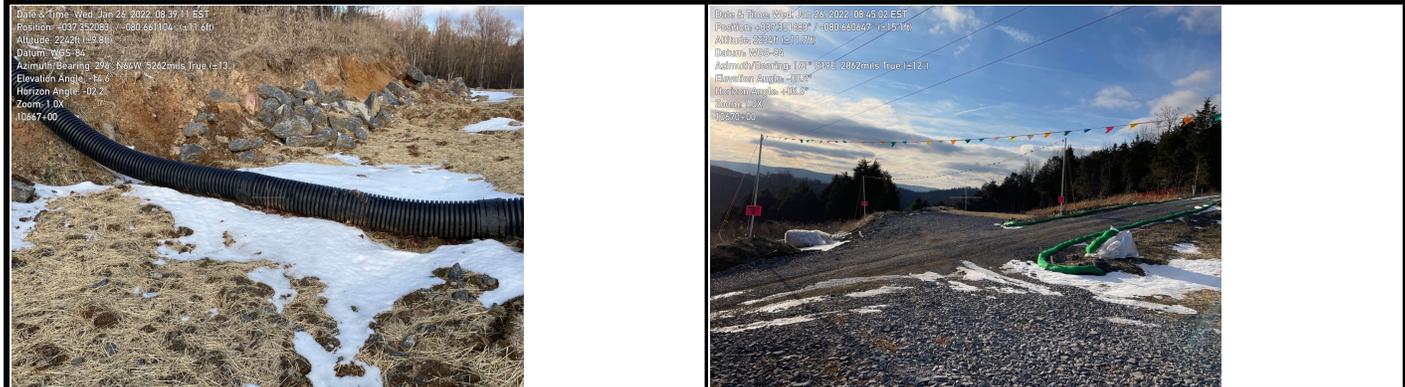
GPS Location	See photo	GPS Location	See photo
Field Station#	10667+00	Field Station#	10670+00
Pic 15 Desc.	Clean water drainage pipe in place	Pic 16 Desc.	RCE functional

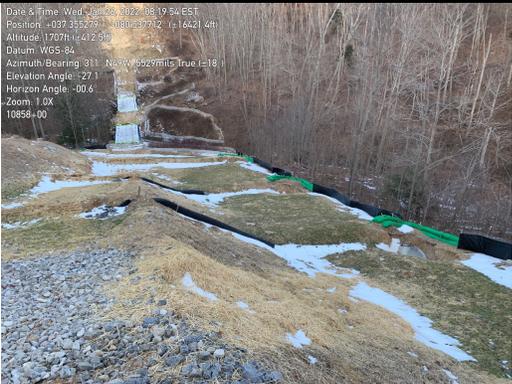
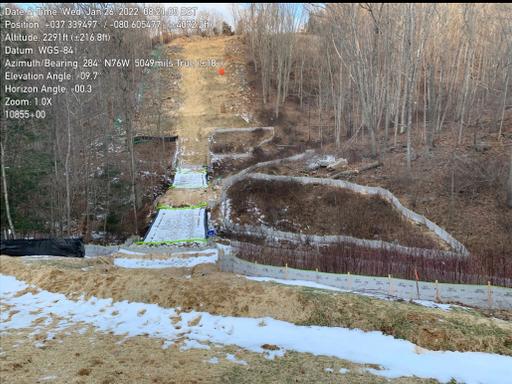
<p><small>Date & Time: Wed Jan 26 2022 08:21:00 EST Position: +037.339427° -1080.604771° -12629.0in Altitude: 2291ft (-216.8ft) Datum: WGS-84 Azimuth/Bearing: 284° N76W 5049mils True (-18) Elevation Angle: -09.7 Horizon Angle: -00.3 Zoom: 1.0X 10855+00</small></p>		
GPS Location	See photo for GPS location.	GPS Location	See photo for GPS location.	
Field Station#	10858+00	Field Station#	10855+00	
Pic 1 Desc.	Slope drains in place over two-tone.	Pic 2 Desc.	Sensitive resource buffer in place at streams S-A33 and S-A34.

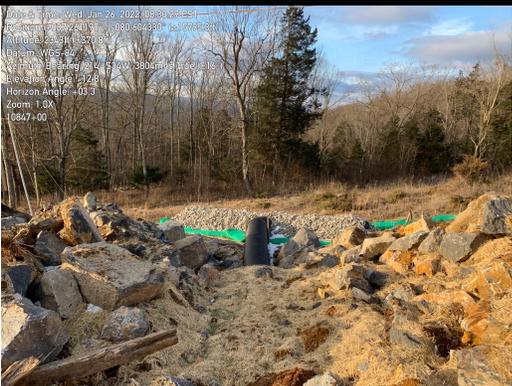
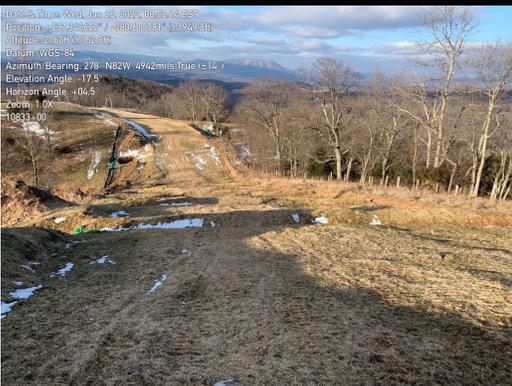
GPS Location	See photo for GPS location.	GPS Location	See photo for GPS location.	
Field Station#	10847+00	Field Station#	10833+00	
Pic 3 Desc.	Clean water diversion pipe and level spreader in place.	Pic 4 Desc.	ROW temporarily stabilized. Waterbars in place.

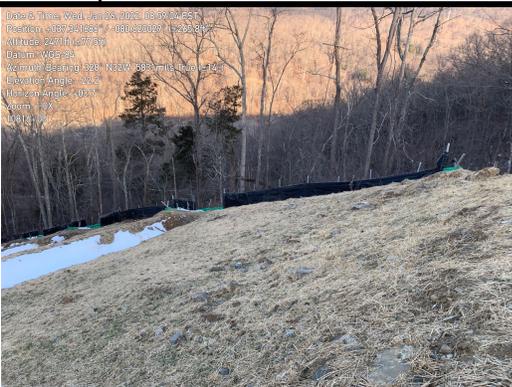
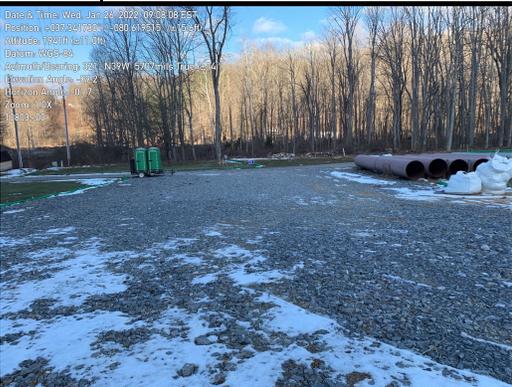
Pic 5 Desc.	Waterbar, end treatment, sump pit, and super silt fence in place.	Pic 6 Desc.	RCE in place at Acher Trail access.

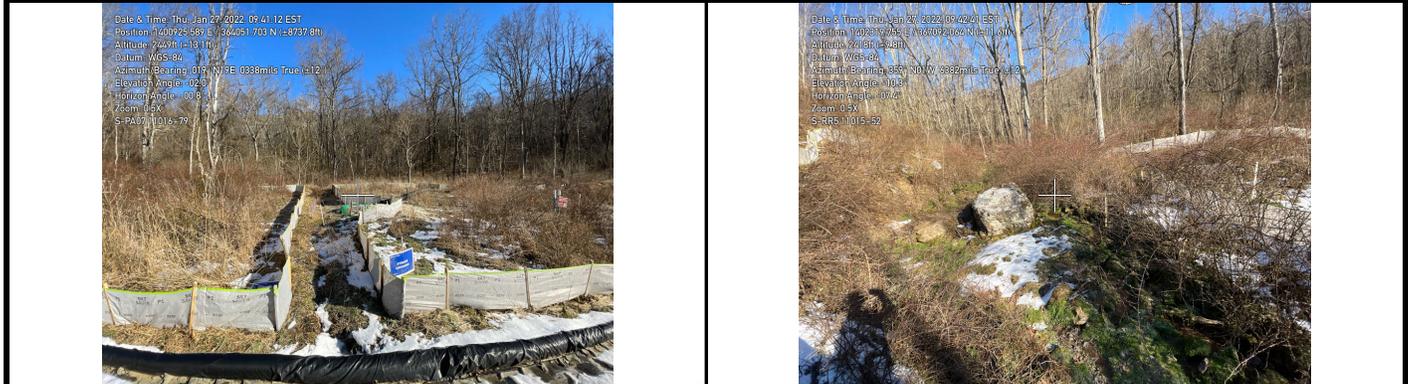
GPS Location	1	GPS Location	2
Field Station#	11016+79	Field Station#	11015+52
Pic 1 Desc.	S-PA07.	Pic 2 Desc.	S-RR5.

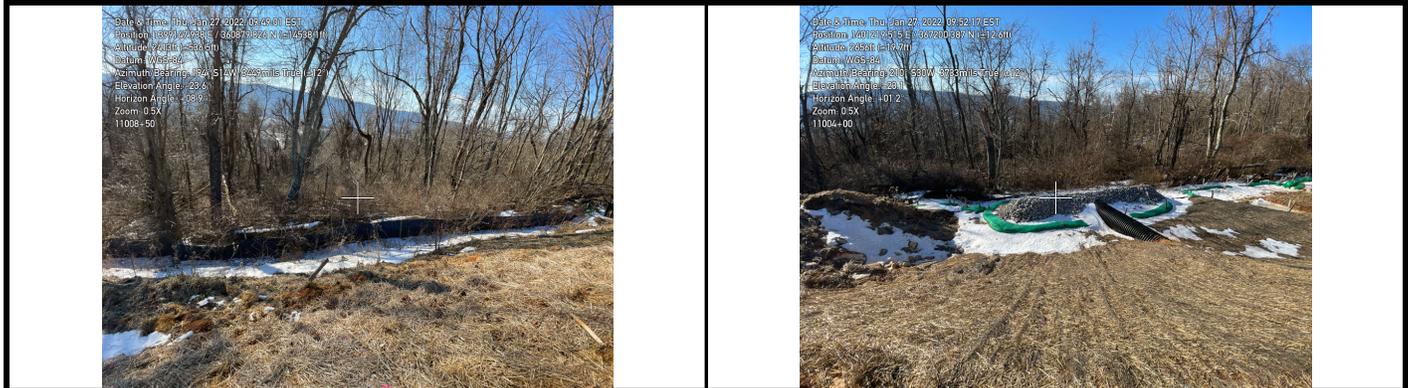
GPS Location	3	GPS Location	4
Field Station#	11088+50	Field Station#	11004+00
Pic 3 Desc.	SSF perimeter controls functional.	Pic 4 Desc.	CWDP outlet protection functional.

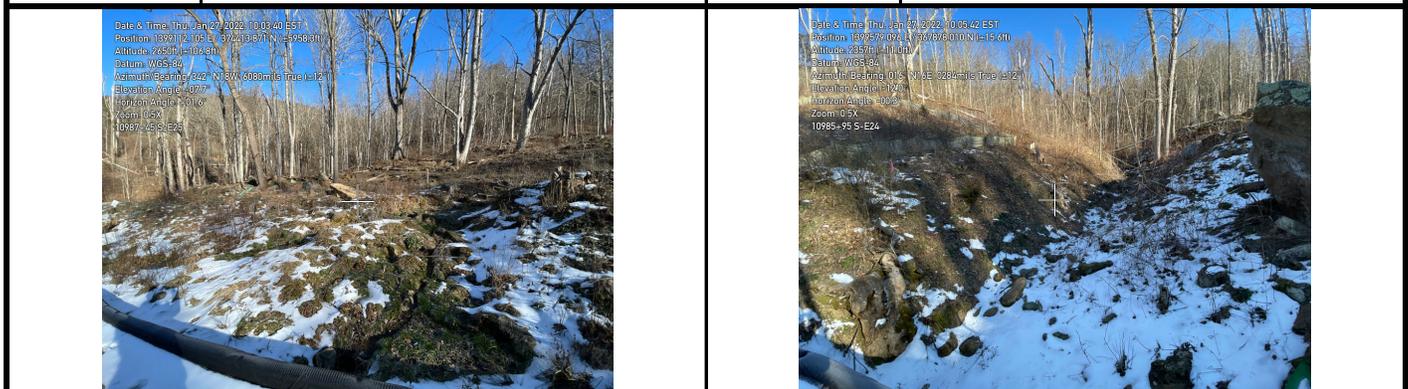
GPS Location	5	GPS Location	6
Field Station#	10987+45	Field Station#	10985+95
Pic 5 Desc.	S-E25.	Pic 6 Desc.	S-E24.
