Visual Site Inspection Report

Project Name H-600 Pipeline Spread G		AFE 124300137	Spread H-600 Pipeline Spread G
Contractor Precision		Report # 33551	
Inspector Jared Saunders		Date/Time 1/24/2022 1:22 PM	
Permit # TBD	Inspection Type VA SWPP	Station Begin	11353+67
State VA	Inspection Area Partial	Station End	11471+56
County Giles	Ground Frozen	Temperature (°F)	40.00
Municipality N/A	Weather Below Freezing Temp	Rain Gauge (in)	0.00
			Rain Accumulation Time (days) 1.00

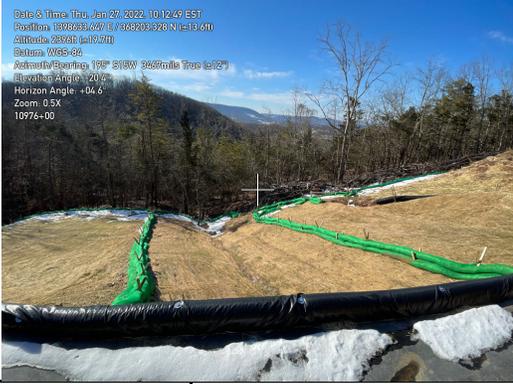
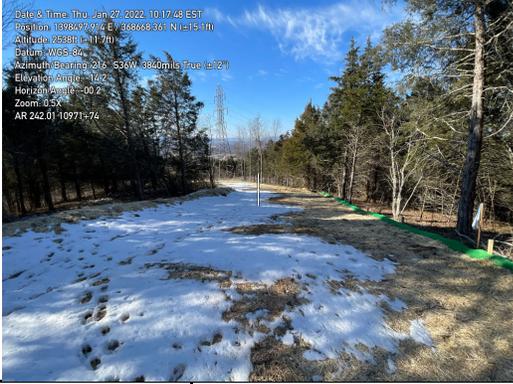
<p><small>Date & Time: Thu, Jan 27, 2022, 10:17:48 EST Position: 1898637272 E / 368688281 N (+15.11) Altitude: 2393ft (+73.21m) Datum: WGS-84 Azimuth/Bearing: 215° S34W 3820mils True (+12°) Elevation Angle: +12.2° Horizon Angle: +00.2° Zoom: 0.5X AR 242.01 10971+74</small></p>	
GPS Location	7	GPS Location	8
Field Station#	10976+00	Field Station#	10971+74
Pic 7 Desc.	Clear water drainage.	Pic 8 Desc.	AR 242.01 showing conditions and controls.

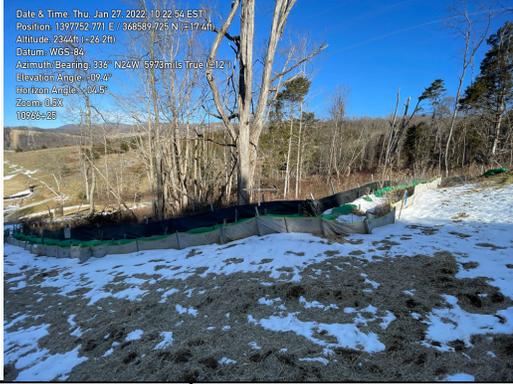
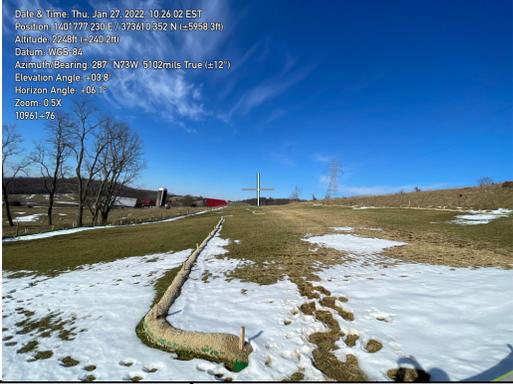
GPS Location	9	GPS Location	10
Field Station#	10966+25	Field Station#	10961+76
Pic 9 Desc.	Karst feature protection functional.	Pic 10 Desc.	Section of restored RoW showing conditions and controls.

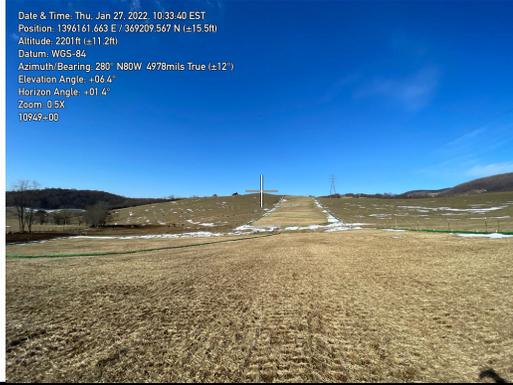
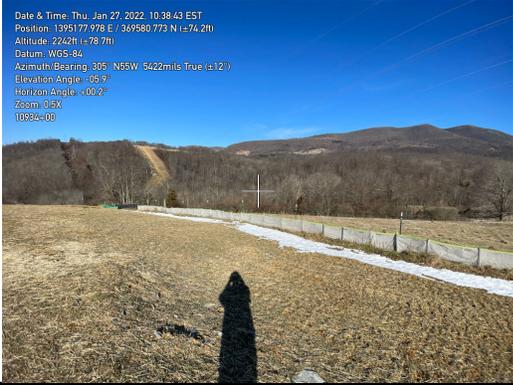
<p><small>Date & Time: Thu, Jan 27, 2022, 10:38:43 EST Position: 1395177978 E / 369580773 N (+174.2ft) Altitude: 2242ft (+68.71m) Datum: WGS-84 Azimuth/Bearing: 305° N55W 5422mils True (+12°) Elevation Angle: +05.9° Horizon Angle: +00.2° Zoom: 0.5X 10934+00</small></p>	
GPS Location	11	GPS Location	12
Field Station#	10949+00	Field Station#	10934+00
Pic 11 Desc.	Section of restored RoW showing conditions and controls.	Pic 12 Desc.	P-1 perimeter controls functional.

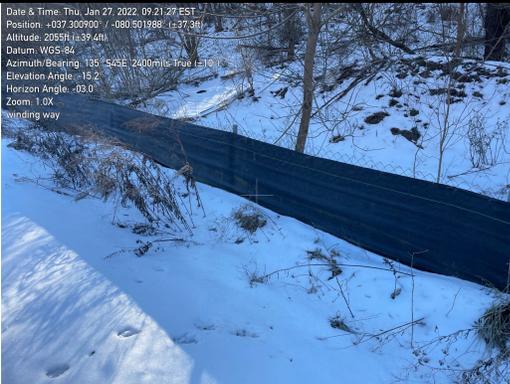
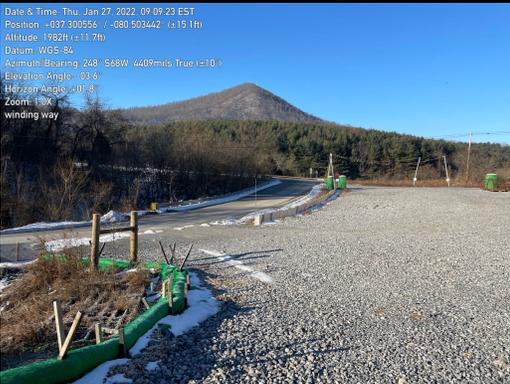
GPS Location	See photo	GPS Location	See photo
Field Station#	11227+59	Field Station#	11227+59
Pic 1 Desc.	SSF functional	Pic 2 Desc.	RCE functional

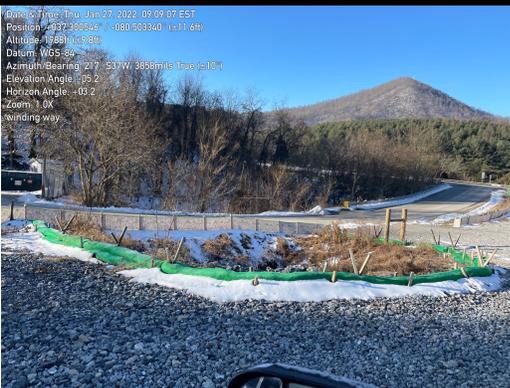
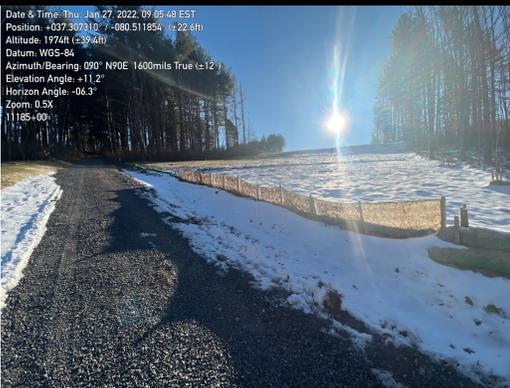
GPS Location	See photo	GPS Location	See photo
Field Station#	11227+59	Field Station#	11185+00
Pic 3 Desc.	CFS controls functional	Pic 4 Desc.	AR 249.02 functional

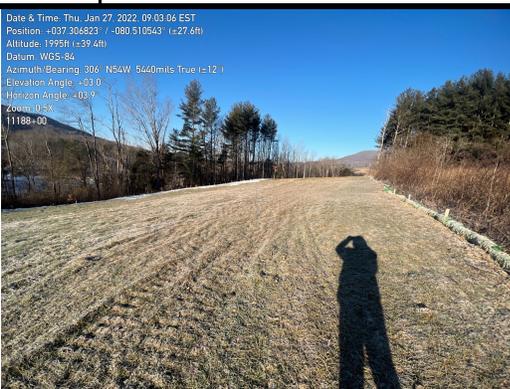
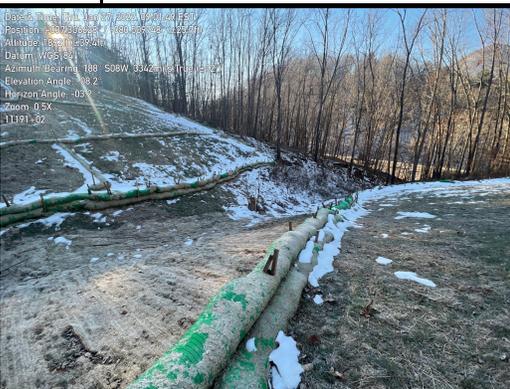
GPS Location	See photo	GPS Location	See photo
Field Station#	11188+00	Field Station#	11191+02
Pic 5 Desc.	Stabilization in place	Pic 6 Desc.	Clean water drainage feature functional

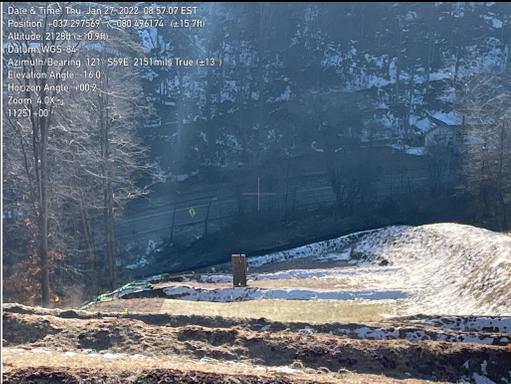
GPS Location	See photo
Field Station#	11251+00
Pic 7 Desc.	Water bars in place

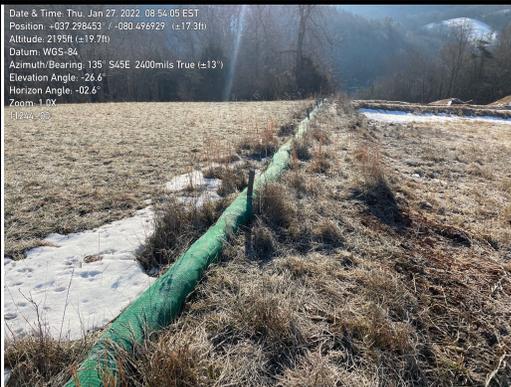
GPS Location	See photo
Field Station#	11245+00
Pic 9 Desc.	Stabilization in place

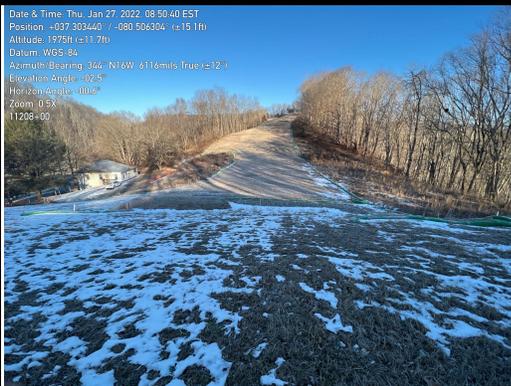
GPS Location	See photo
Field Station#	11205+00
Pic 11 Desc.	CFS controls in place

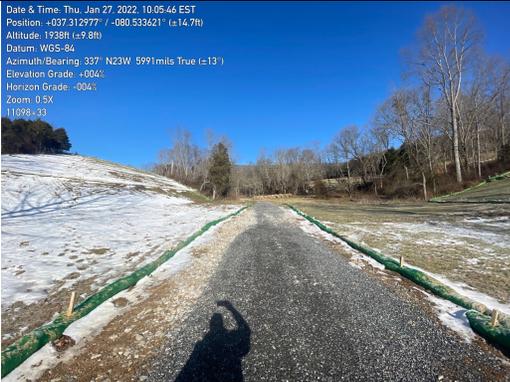
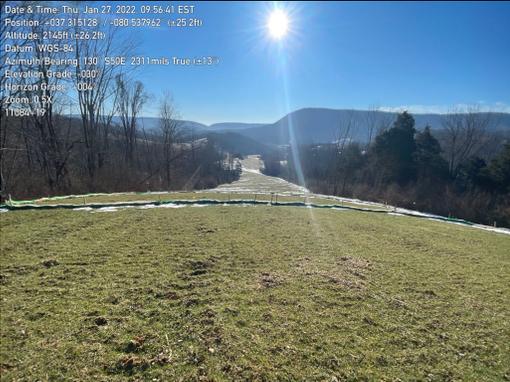
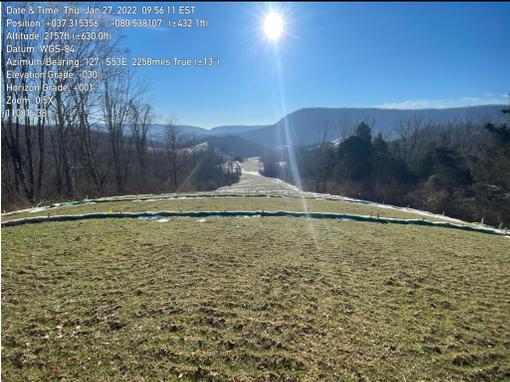
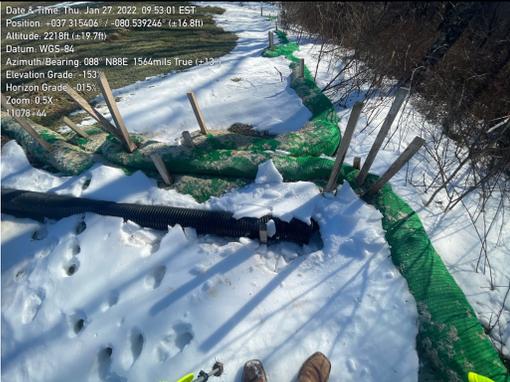
GPS Location SEE PHOTO		GPS Location SEE PHOTO		GPS Location SEE PHOTO			
Field Station# 11098+33		Field Station# 11084+19		Field Station# 11081+38			
Pic 1 Desc. AR 245.02		Pic 2 Desc. Row conditions. Final Restoration Area. Annual grasses visible. (Other = CFS water bar). No erosion issues.		Pic 3 Desc. Row conditions. Final Restoration Area. Annual grasses visible. (Other = CFS water bar). No erosion issues.			
GPS Location SEE PHOTO		GPS Location SEE PHOTO		GPS Location SEE PHOTO			
Field Station# 11081+38		Field Station# 11078+44		Field Station# 11078+44			
Pic 3 Desc. Row conditions. Final Restoration Area. Annual grasses visible. (Other = CFS water bar). No erosion issues.		Pic 4 Desc. Approximately 6" corrugated surface drain tile outlet to perimeter CFS. Drain tile extends from surface upslope across the final restored		Pic 5 Desc. Row conditions. Final Restoration Area. Annual grasses visible. (Other = CFS water bar). No erosion issues.

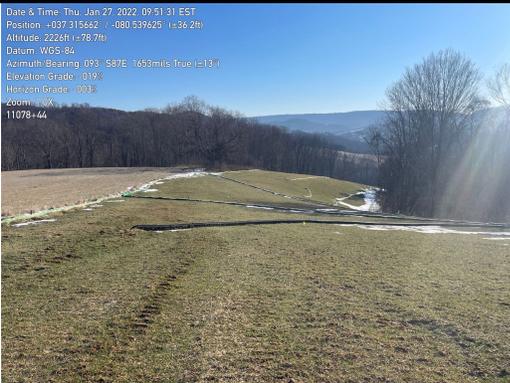
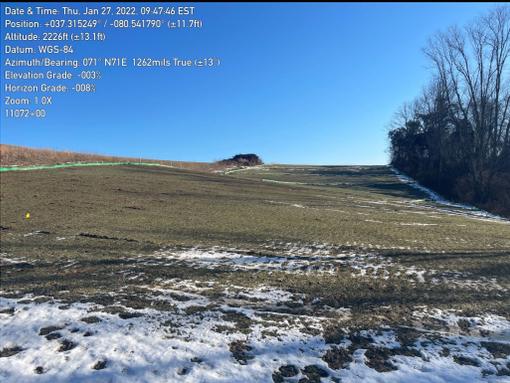
GPS Location SEE PHOTO			
Field Station# 11078+44		Field Station# 11072+00		Field Station# 11072+00			
Pic 5 Desc. Row conditions. Final Restoration Area. Annual grasses visible. (Other = CFS water bar). No erosion issues.		Pic 6 Desc. Row conditions. Final Restoration Area. Annual grasses visible. (Other = CFS water bar). No erosion issues.		Pic 6 Desc. Row conditions. Final Restoration Area. Annual grasses visible. (Other = CFS water bar). No erosion issues.

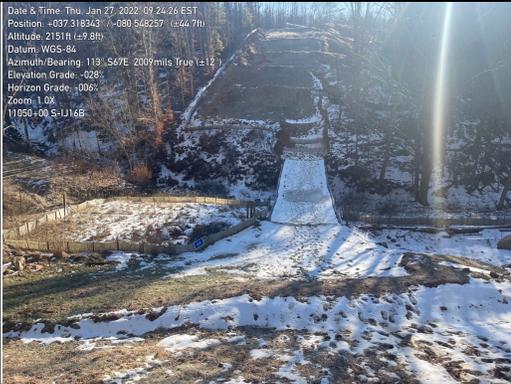
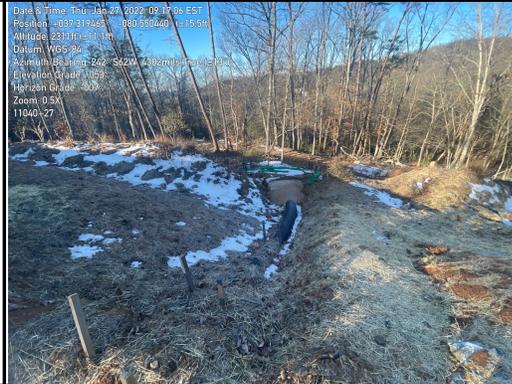
Pic 13 Desc.	View of stream buffer zones, temporary stabilization of row and stable water bar conditions.
---------------------	--

Pic 14 Desc.	TSP to sump pit conditions.
---------------------	-----------------------------

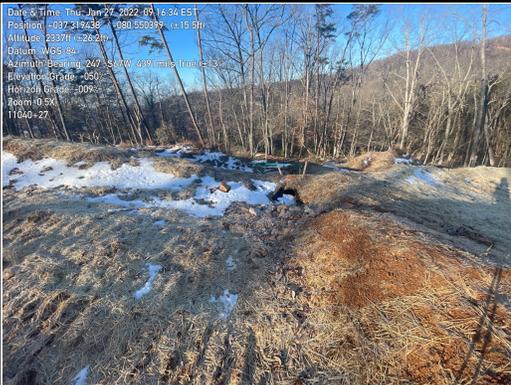
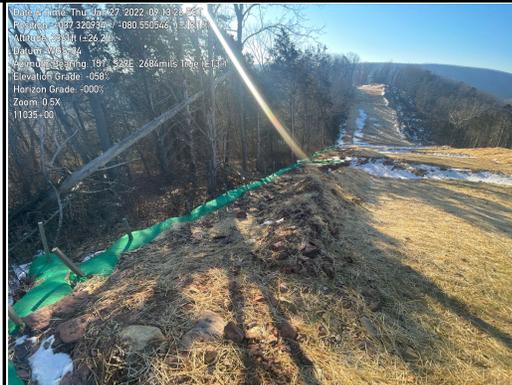
Pic 15 Desc.	Stone inlet protection conditions
---------------------	-----------------------------------

Pic 16 Desc.	Temporary diversion dike and perimeter CFS.
---------------------	---

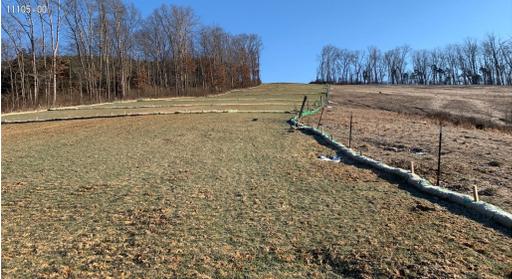
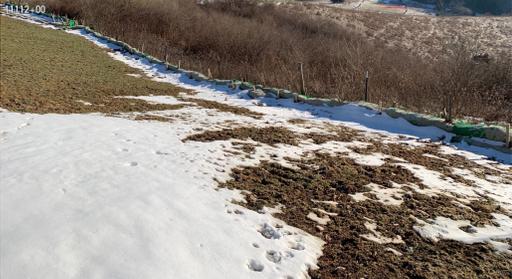
GPS Location	See photo for GPS location.	GPS Location	See photo for GPS location.	
Field Station#	11105+00	Field Station#	11112+00	
Pic 1 Desc.	ROW permanently stabilized.	Pic 2 Desc.	Triple stack 18 inch CFS in place along LOD.	
<p>Date & Time: Thu Jan 27 2022 09:28:09 EST Position: -037.312908 / -080.519319 (+15.4h) Altitude: 2108ft (+27.8h) Datum: WGS-84 Azimuth/Bearing: 161° S19E 2842mils True (±12.1) Elevation Angle: -27.9 Horizon Angle: -04.3 Zoom: 1.0X 11144+20</p>

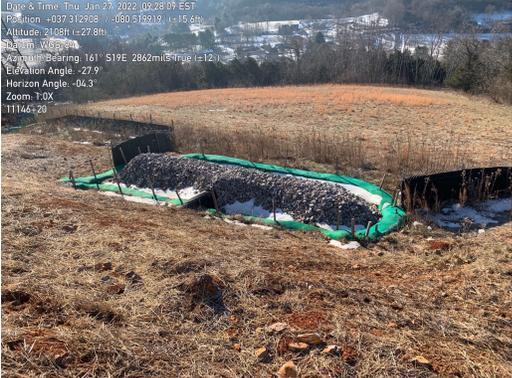
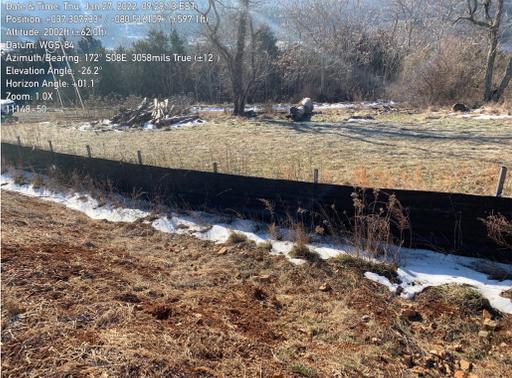
GPS Location	See photo for GPS location.	GPS Location	See photo for GPS location.	
Field Station#	11146+20	Field Station#	11148+50	
Pic 3 Desc.	Clean water diversion pipe and level spreader in place.	Pic 4 Desc.	Super silt fence in place along LOD.	
<p>Date & Time: Thu Jan 27 2022 09:48:01 EST Position: -037.312312 / -080.514297 (+26.2h) Altitude: 1853ft (+24.3h) Datum: WGS-84 Azimuth/Bearing: 214° S33W 3822mils True (±12.1) Elevation Angle: -06.7 Horizon Angle: -12.7 Zoom: 1.0X 11168+00</p>

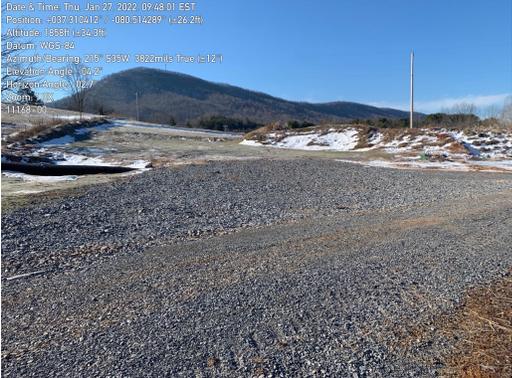
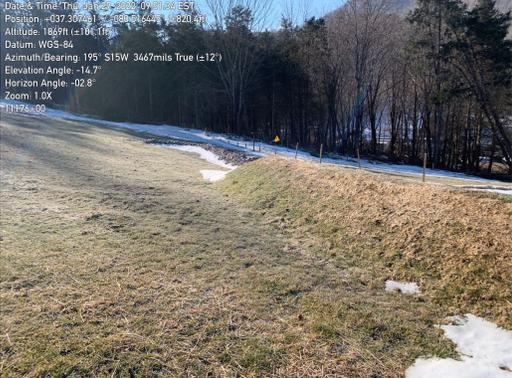
GPS Location	See photo for GPS location.	GPS Location	See photo for GPS location.	
Field Station#	11168+00	Field Station#	11176+00	
Pic 5 Desc.	RCE in place at AR 249.02.	Pic 6 Desc.	Permanent waterbar with level spreader in place.

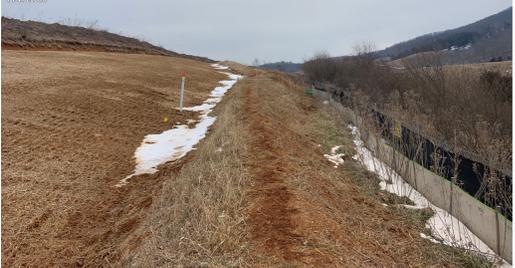
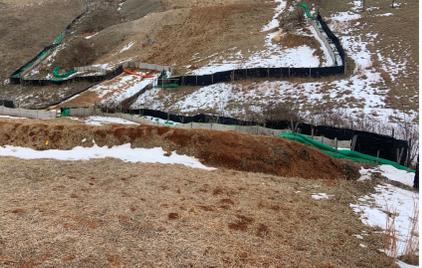
GPS Location	See photo		GPS Location	see photo	
Field Station#	11472+80		Field Station#	11478+79	
Pic 1 Desc.	Section of Row showing conditions and controls		Pic 2 Desc.	Section of Row showing conditions and controls	
<p>Date & Time: Fri, Jan 28, 2022, 09:46:17 EST Position: +48.325598° / -080.432293° (+452.8ft) Altitude: 2168ft (+66.2ft) Datum: WGS-84 Azimuth/Bearing: 354° N04W 632mils True (+16°) Elevation Angle: -17.3° Horizon Angle: -01.3° Zoom: 1.0X 11488+75</p>

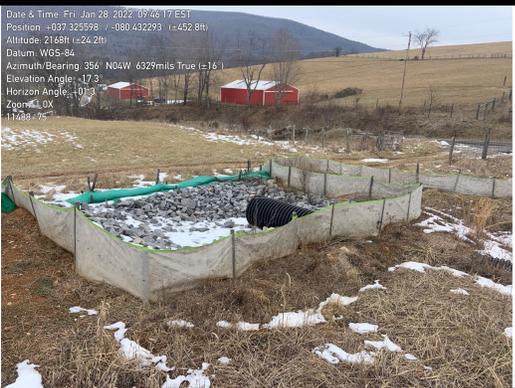
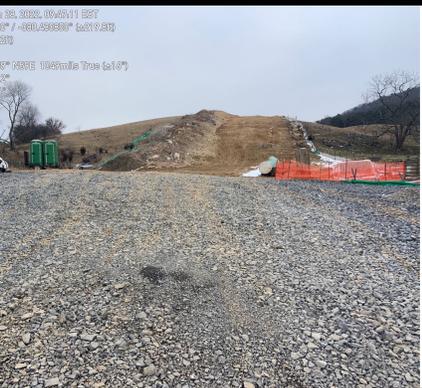
GPS Location	see photo		GPS Location	See photo	
Field Station#	11488+75		Field Station#	11490+00	
Pic 3 Desc.	Plunge pool is in acceptable condition		Pic 4 Desc.	RCE is maintained and in acceptable condition	
<p>Date & Time: Fri, Jan 28, 2022, 09:56:53 EST Position: +48.261937° / +80.45833° (+19.0) Altitude: 2245ft (+68.0m) Datum: WGS-84 Azimuth/Bearing: 012° N12E 0213mils True (+16°) Elevation Angle: -13.5° Horizon Angle: +01.8° Zoom: 1.0X 11504+00</p>

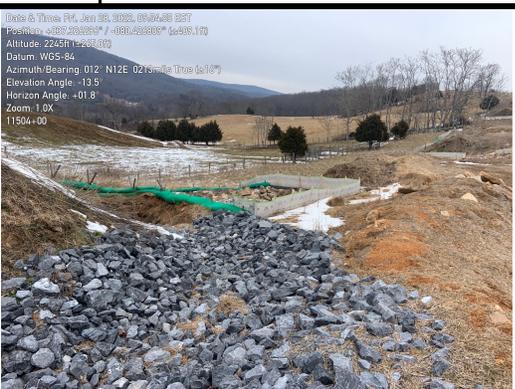
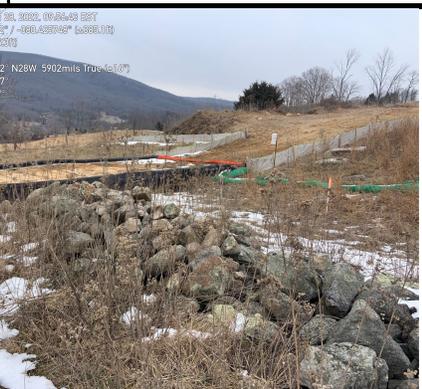
GPS Location	See photo		GPS Location	see photo	
Field Station#	11504+00		Field Station#	11507+78	
Pic 5 Desc.	Rock lined channel		Pic 6 Desc.	Controls at S-PP3

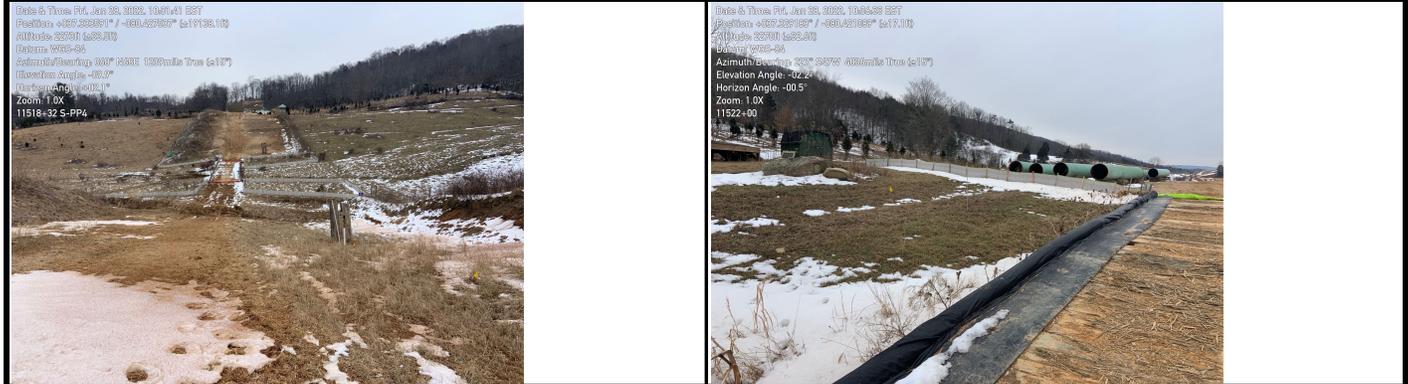
Pic 7 Desc.	S-PP4 showing conditions and controls	Pic 8 Desc.	P1 silt fence and equipment bridge are in acceptable condition
--------------------	---------------------------------------	--------------------	--

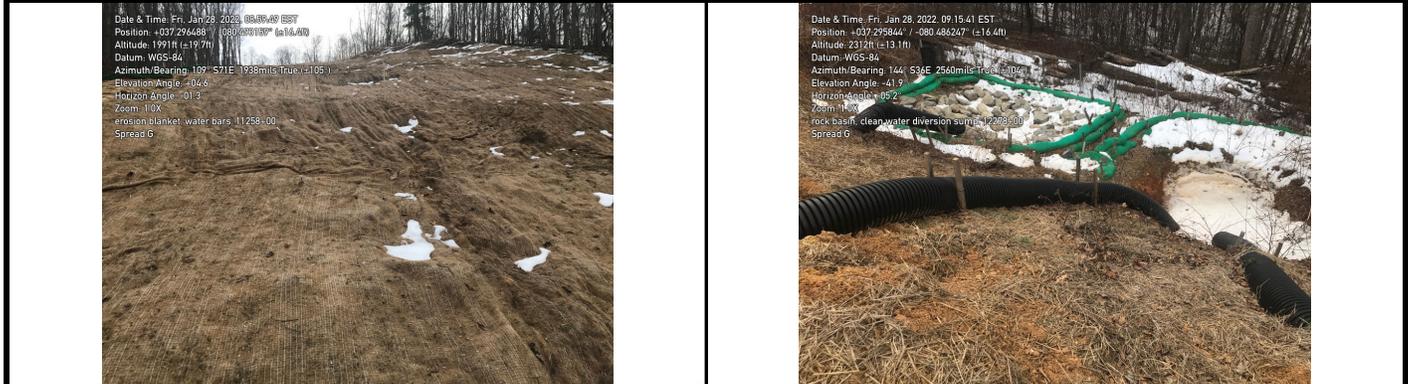
GPS Location	See photo	GPS Location	see photo
Field Station#	11258+00	Field Station#	11278+00
Pic 1 Desc.	Erosion blanket water bars	Pic 2 Desc.	Rock Basin, clean water diversion, sump

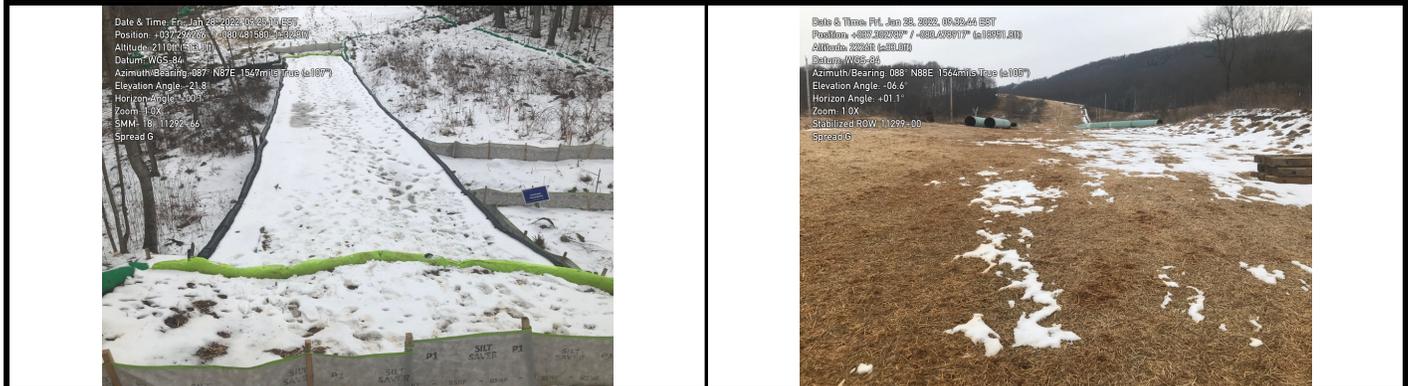
GPS Location	see photo	GPS Location	see photo
Field Station#	11292+66	Field Station#	11299+00
Pic 3 Desc.	SMM-18	Pic 4 Desc.	Stabilized ROW

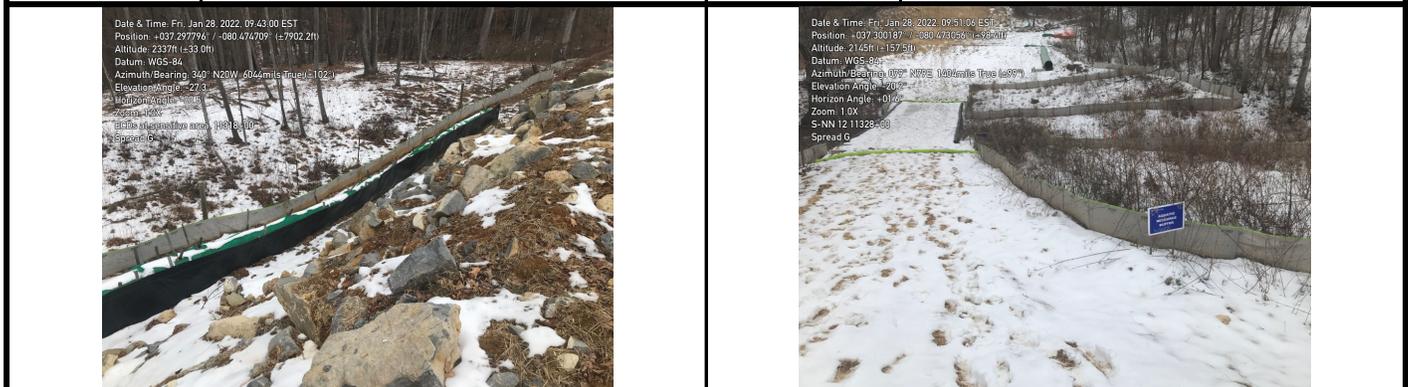
GPS Location	see photo	GPS Location	see photo
Field Station#	11318+00	Field Station#	11328+00
Pic 5 Desc.	ECDs at sensitive area	Pic 6 Desc.	S-NN 12

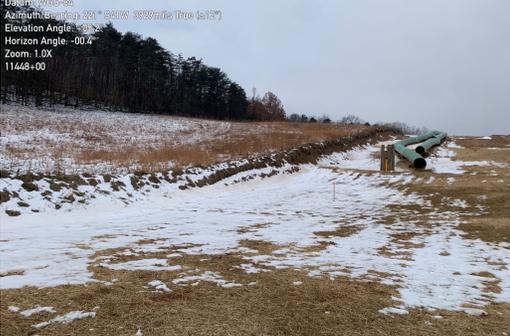
<p><small>Date & Time: Fri, Jan 28, 2022, 06:00:12 EST Position: -037.318683 / -080.443347 (+7114.2ft) Altitude: 2144ft (+652.2ft) Datum: WGS-84 Azimuth/Bearing: 231° S61W 3229mils True (+13°) Elevation Angle: -11.2° Horizon Angle: -00.4° Zoom: 1.0X 11448+00</small></p>			
GPS Location	See photo for GPS location.		GPS Location	See photo for GPS location.	
Field Station#	11451+00		Field Station#	11448+00	
Pic 1 Desc.	Sensitive resource buffer in place at streams S-0012 and S-0013.		Pic 2 Desc.	Clean water diversion berm in place.

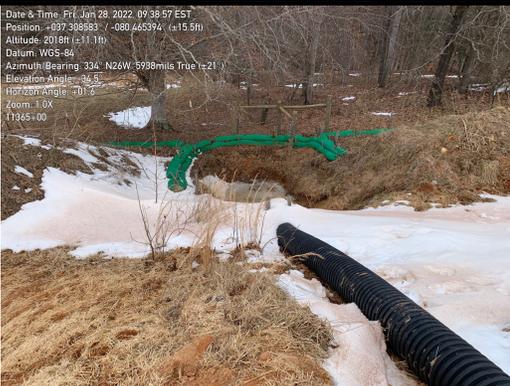
GPS Location	See photo for GPS location.		GPS Location	See photo for GPS location.	
Field Station#	11467+00		Field Station#	11365+00	
Pic 3 Desc.	Plunge pool and clean water diversion pipe in place.		Pic 4 Desc.	Slope drain in place over fill slope.

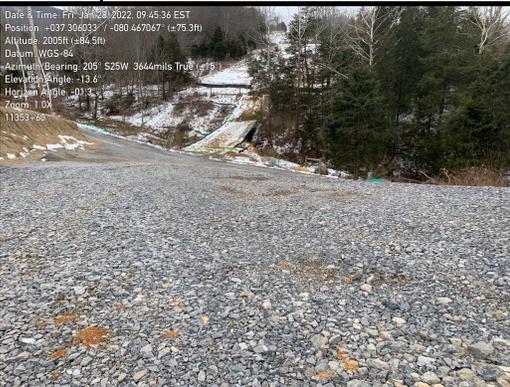
Pic 5 Desc.	ROW permanently restored. Waterbar and level spreader in place.		Pic 6 Desc.	RCE in place at Old Furnace Road.

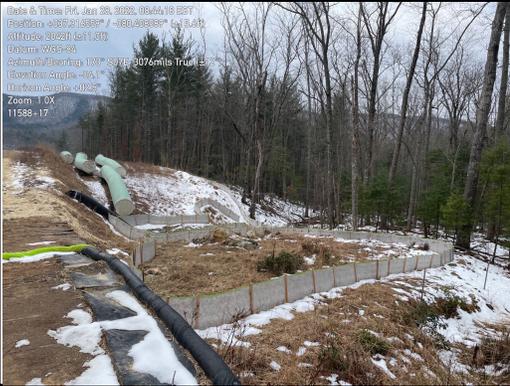
Field Station# 11588+17

Pic 7 Desc. Buffers in place

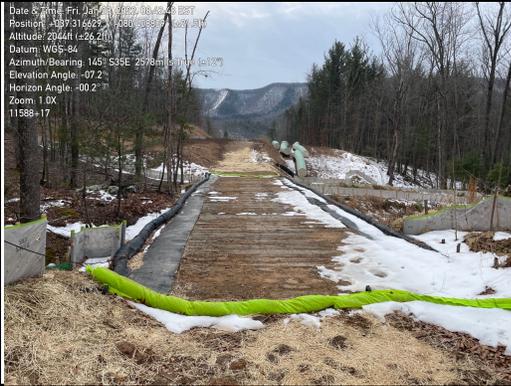
Field Station# 11588+17

Pic 8 Desc. Wattles in place

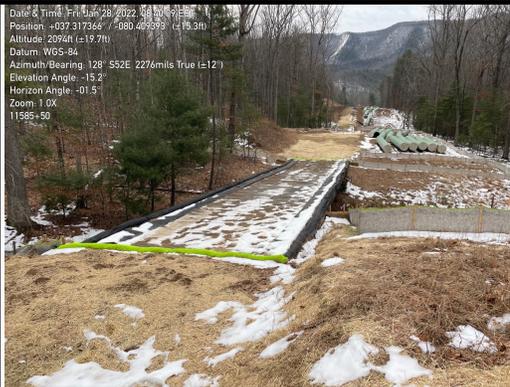
Field Station# 11585+50

Pic 9 Desc. Equipment bridge functional

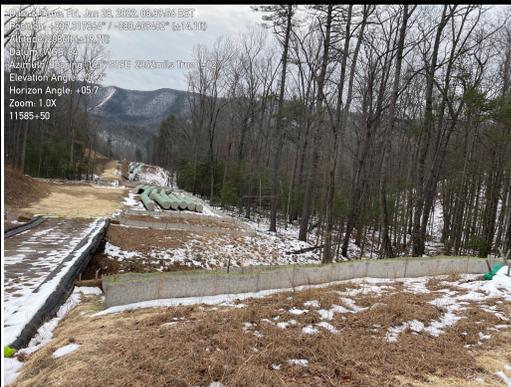
Field Station# 11585+50

Pic 10 Desc. Buffers in place

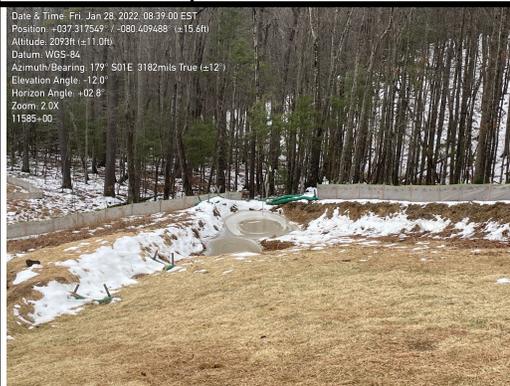
Field Station# 11585+00

Pic 11 Desc. ET functional
