Visual Site Inspection Report

Project Name	H-600 Pipeline Spread G	AFE	124300137	Spread	H-600 Pipeline Spread G
Contractor	Precision			Report #	32841
Inspector	Joe Sweeden			Date/Time	1/3/2022 12:14 PM
Permit #	TBD	Inspection Type	VA SWPP	Station Begin	10859+46
State	VA	Inspection Area	Partial	Station End	10929+80
County	Giles	Ground	Frozen	Temperature (°F)	28.00
Municipality	N/A	Weather	Snow/Sleet	Rain Gauge (in)	1.75
				Rain Accumulation Time (days)	1.00

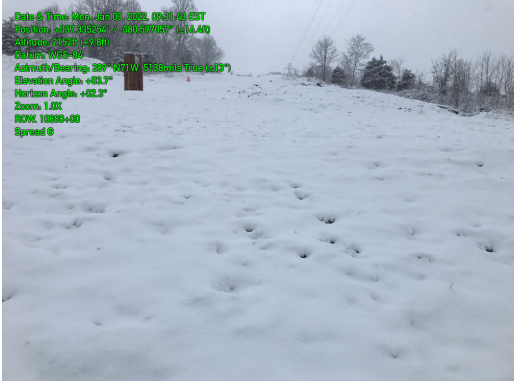
GPS Location	see photo		GPS Location	see photo	
Field Station#	10880+00		Field Station#	10928+00	
Pic 3 Desc.	ROW		Pic 4 Desc.	S-Y 3

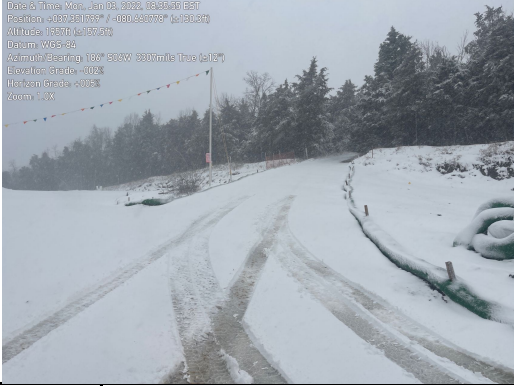
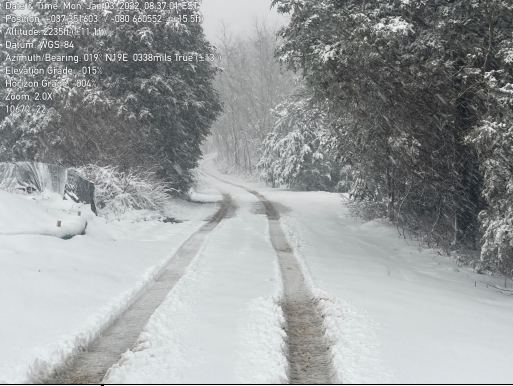
<p>Date & Time: Mon Jan 03 2022 08:37:55 EST Position: +037 351688° / +080 669138° (+15.51ft) Altitude: 2232ft (+11.0ft) Datum: WGS 84 Azimuth Bearing: 019° N 9E 0338mils True (+18°) Elevation Grade: +01% Horizon Grade: +00% Zoom: 2.0X 10669+50</p>			
GPS Location		See Photo		GPS Location	
Field Station#		10670+22		Field Station#	
Pic 1 Desc.		AR MVP - GI- 240 conditions		Pic 2 Desc.

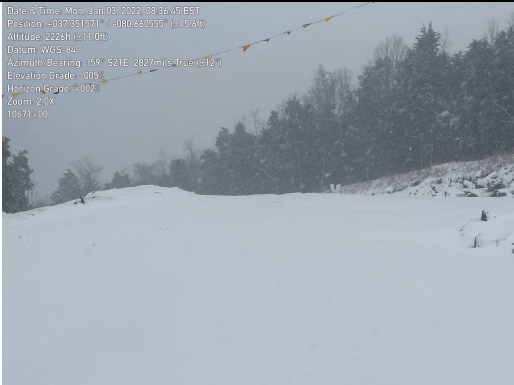
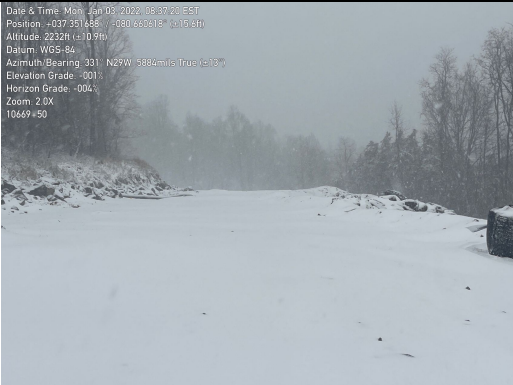
GPS Location		See Photo		GPS Location	
Field Station#		10671+00		Field Station#	
Pic 3 Desc.		Snow covered row conditions		Pic 4 Desc.

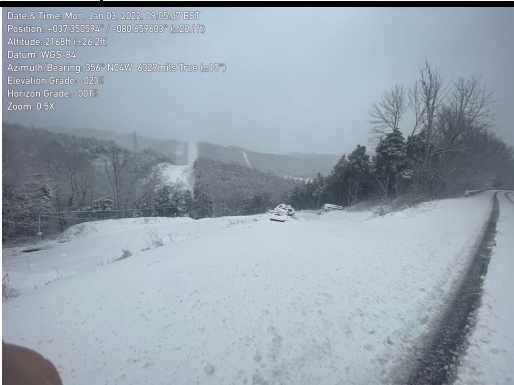
<p>Date & Time: Mon Jan 03 2022 10:20:01 EST Position: +037 351688° / +080 669138° (+15.51ft) Altitude: 2029ft (+11.7ft) Datum: WGS 84 Azimuth Bearing: 310° N 44W 5911mils True (+18°) Elevation Grade: +00% Horizon Grade: +00% Zoom: 0.5X 10698+41</p>			
GPS Location		See Photo		GPS Location	
Field Station#		10674+75		Field Station#	
Pic 5 Desc.		RCE conditions at Big Stoney AR.		Pic 6 Desc.	
				S-G32 Equipment Bridge Crossing.

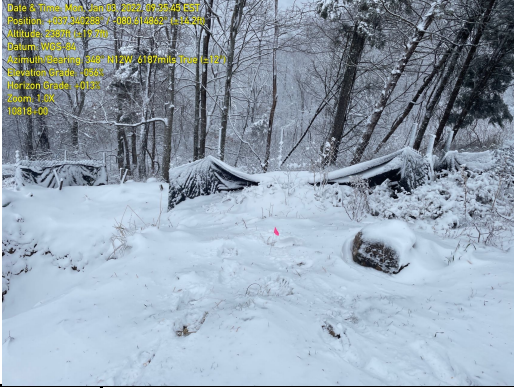
<p>Date & Time: Mon, Jan 03, 2022, 04:29:32 EST Position: +37.337566° / -78.602331° (s13.74) Altitude: 2327ft (s11.74) Datum: WGS 84 Azimuth Bearing: 307° N63W 3300mils True (s12) Elevation Grade: -480ft Horizon Grade: -480ft Zoom: 1.0x 10859+00</p>			
GPS Location	See photo	GPS Location	See photo		
Field Station#	10818+00	Field Station#	10859+00		
Pic 1 Desc.	Supersilt fence fabric down	Pic 2 Desc.	Supersilt fence perimeter control in place

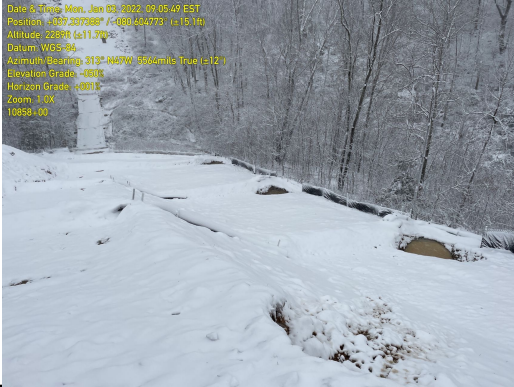
GPS Location	See photo	GPS Location	See photo		
Field Station#	10858+00	Field Station#	10855+00		
Pic 3 Desc.	Slope drain in place	Pic 4 Desc.	Stream buffer in place

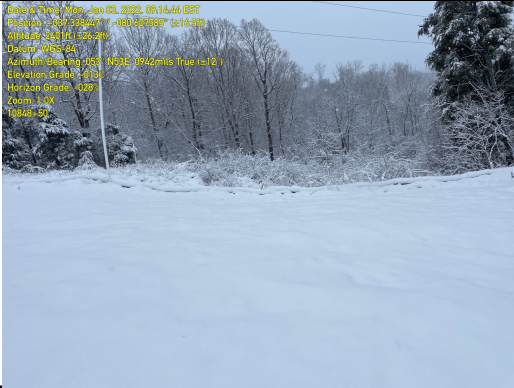
<p>Date & Time: Mon, Jan 03, 2022, 04:14:50 EST Position: +37.339432° / -78.603987° (s14.29) Altitude: 2370ft (s17.29) Datum: WGS 84 Azimuth Bearing: 337° N63W 3300mils True (s12) Elevation Grade: -475ft Horizon Grade: -475ft Zoom: 1.0x 10843+75</p>			
GPS Location	See photo	GPS Location	See photo		
Field Station#	10848+50	Field Station#	10843+75		
Pic 5 Desc.	CFS perimeter control in place	Pic 6 Desc.	Cleanwater diversion pipe in place

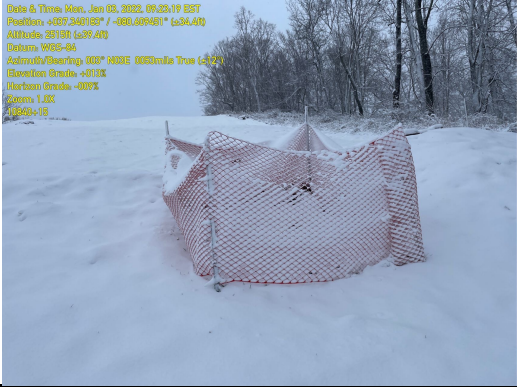
GPS Location		See photo		GPS Location	
Field Station#		10840+15		Field Station#	
Pic 7 Desc.		Daylight drain in place		Pic 8 Desc.	
				Waterbars in place	
<p>Date & Time Mon, Jan 03, 2022 09:30:49 EST Position: +407.340601° / -98.412025° (-34.50) Altitude: 35040 (-34.50) Datum: WGS-84 Azimuth/Heading: 287° 300° 450miles True (-12°) Elevation Grade: +00% Horizontal Grade: +010% Zoom: 1.0X 10828+00</p>

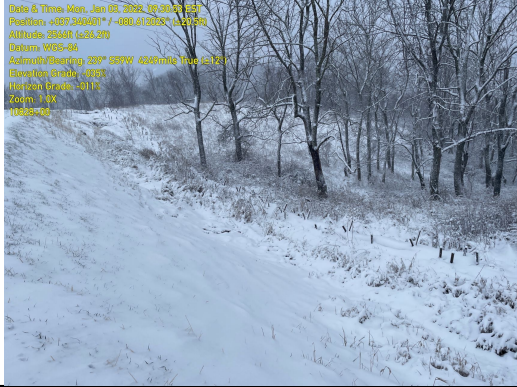
GPS Location		See photo		GPS Location	
Field Station#		10828+00		Field Station#	
Pic 9 Desc.		CFS triple stack perimeter control in place		Pic 10 Desc.	
				Cleanwater outlet protection in place	
<p>Date & Time Mon, Jan 03, 2022 09:44:19 EST Position: +407.341894° / -98.418979° (-31.50) Altitude: 18300 (-31.50) Datum: WGS-84 Azimuth/Heading: 100° NONE 013miles True (-12°) Elevation Grade: +01% Horizontal Grade: +000% Zoom: 1.0X 10805+00</p>

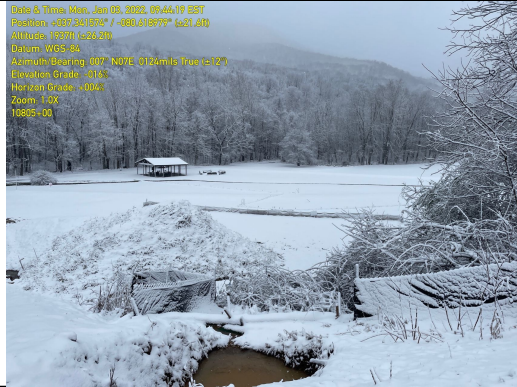
GPS Location		See photo		GPS Location	
Field Station#		10805+00		Field Station#	
Pic 11 Desc.		P1 silt fence in place a resource		Pic 12 Desc.	
				RCE in place

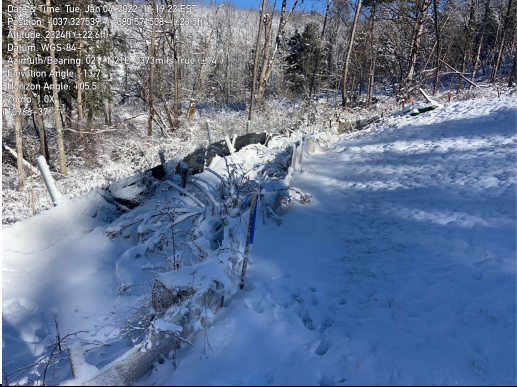
<p>Date & Time: Tue, Jan 04, 2022, 11:16:18 EST Position: +037.327231 / -080.570237 (+34.31ft) Altitude: 2428ft (+26.8ft) Datum: WGS-84 Azimuth/Bearing: 0° 14.2W 372mils true (+0°) Elevation Angle: +16.9° Horizon Angle: +05.3° Zoom: 1.0X 11097+73</p>			
GPS Location	See photo		GPS Location	See photo	
Field Station#	10966+37		Field Station#	10969+73	
Pic 7 Desc.	Karst ECD's are in acceptable condition		Pic 8 Desc.	Water bars are in acceptable condition

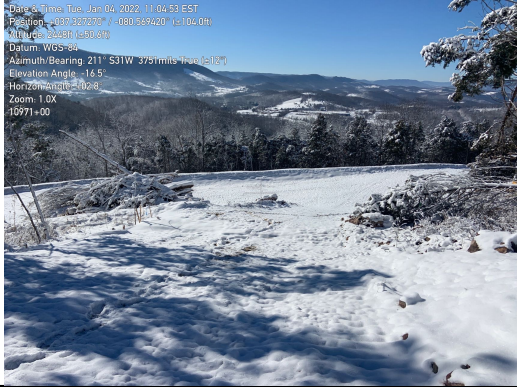
GPS Location	See photo		GPS Location	See photo	
Field Station#	10971+00		Field Station#	10971+74	
Pic 9 Desc.	Temporary construction berm is in acceptable condition		Pic 10 Desc.	Equipment bridge is maintained in acceptable condition

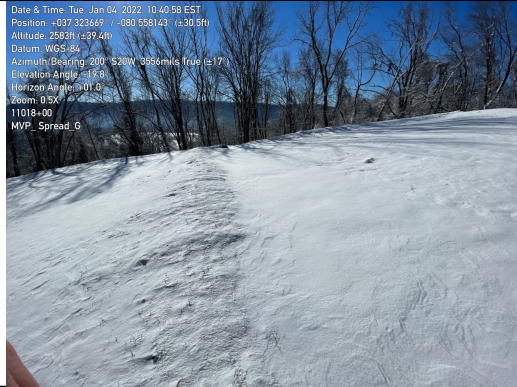
<p>Date & Time: Tue, Jan 04, 2022, 10:25:28 EST Position: +037.323362 / -080.558431 (+30.4ft) Altitude: 2421ft (+21.2ft) Datum: WGS-84 Azimuth/Bearing: 219° S39W 383mils true (+0°) Elevation Angle: +25.5° Horizon Angle: +02.2° Zoom: 0.5X 11019+00 MVP_Spread: 0</p>			
GPS Location	See photo		GPS Location	See photo	
Field Station#	11018+00		Field Station#	11019+00	
Pic 11 Desc.	Water bar is in acceptable condition		Pic 12 Desc.	Daylight drain with outlet protection is in acceptable condition

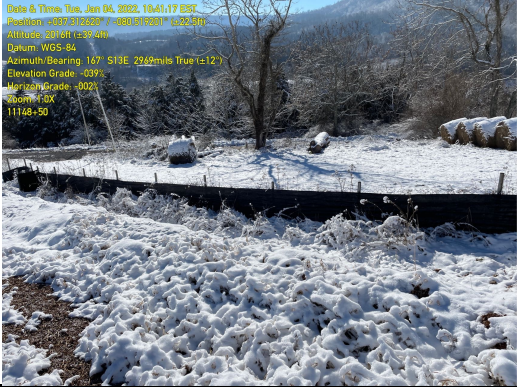
GPS Location		See photo		GPS Location	
Field Station#		11148+50		Field Station#	
Pic 7 Desc.		Supersilt fence perimeter control in place		Pic 8 Desc.	
<p>Date & Time: Tue, Jan 04, 2022, 10:52:24 EST Position: -93° 51'04.13" W - 39° 01'03.10" N (31.54m) Altitude: 1057 ft (322.3m) Datum: WGS-84 Azimuth/Bearing: 340° N105W 1889mils True (±12°) Elevation Grade: -021° Horizon Grade: -000° Zoom: 1.0X 11167+00</p>

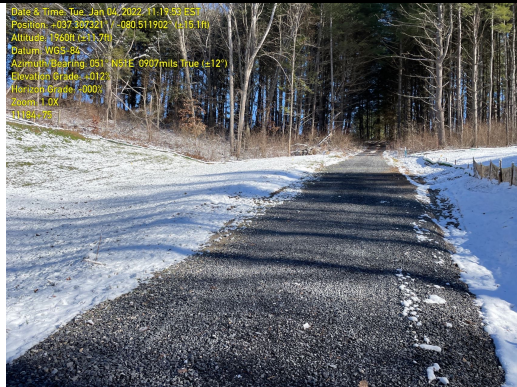
GPS Location		See photo		GPS Location	
Field Station#		11167+00		Field Station#	
Pic 9 Desc.		Cleanwater diversion outlet protection in place		Pic 10 Desc.	
<p>Date & Time: Tue, Jan 04, 2022, 11:17:45 EST Position: -93° 51'07.22" W - 39° 01'19.02" N (11.6 m) Altitude: 1360 ft (415.2m) Datum: WGS-84 Azimuth/Bearing: 051° N41E 0907mils True (±12°) Elevation Grade: -012° Horizon Grade: -000° Zoom: 1.0X 11184+75</p>

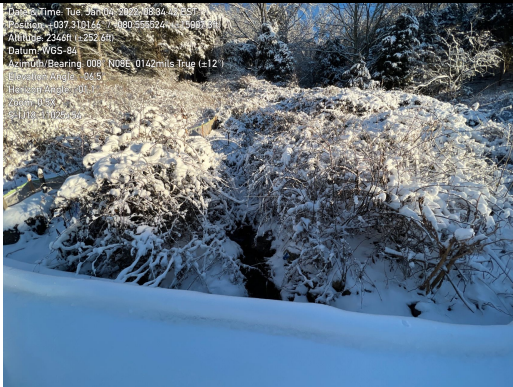
</div></div></div>							
GPS Location		See Photo				GPS Location		See Photo							
Field Station#		11025+54				Field Station#		11029+00							
Pic 1 Desc.		S-IJ18				Pic 2 Desc.		Section of row showing conditions and controls							
<div><div><div>Date & Time: Tue Jan 04, 2022 09:09:07 EST Position: +037.317441 / +080.545004 (+15.1ft) Altitude: 2183ft (+9.8m) Datum: WGS-84 Azimuth/Bearing: 121 S59E 2151mils True (+25°) Elevation Angle: -07.1° Horizon Angle: -04.5° Zoom: 0.5X 11055+00 Karst</div><div>

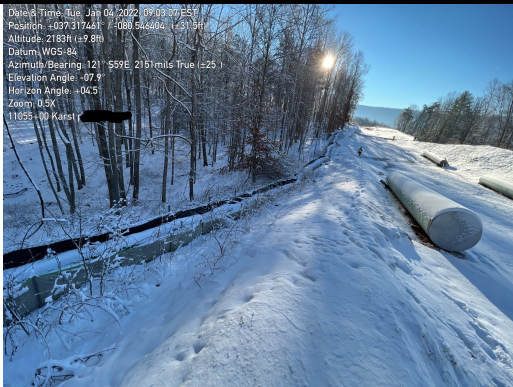
GPS Location		See Photo				GPS Location		See Photo							
Field Station#		11055+00				Field Station#		11050+10							
Pic 3 Desc.		Karst Protection				Pic 4 Desc.		S-IJ16b&17							
<div><div><div>Date & Time: Tue Jan 04, 2022 09:24:54 EST Position: +037.315215 / +080.537848 (+14.0ft) Altitude: 2151ft (+13.4ft) Datum: WGS-84 Azimuth/Bearing: 115 S45E 2046mils True (+12°) Elevation Angle: -00.5° Horizon Angle: -00.5° Zoom: 0.5X 11084+00</div><div>

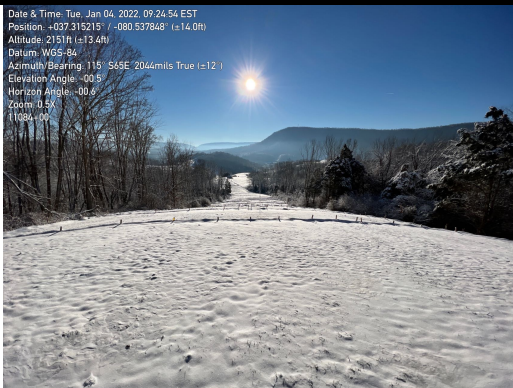
</div></div></div>							
GPS Location		See Photo				GPS Location		See Photo							
Field Station#		11084+00				Field Station#		11098+43							
Pic 5 Desc.		Section of row showing CFS water bars				Pic 6 Desc.		AR 245.02

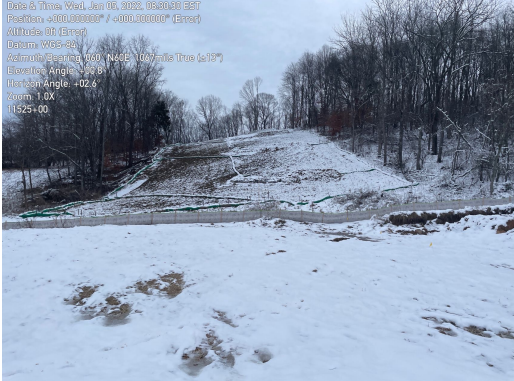
GPS Location		See Photo		GPS Location	
Field Station#		11525+00		Field Station#	
Pic 1 Desc.		Snow covered row conditions prior to drainage feature.		Pic 2 Desc.	
<p>Date & Time: Wed, Jan 05, 2022, 06:42:52 EST Position: +400.858587° / +400.858587° (Elev) Altitude: 2222 (±21.37) Datum: WGS-84 Azimuth/Bearing: 135° NAE 100mils True (±12°) Elevation Angle: +12.5° Horizon Angle: +02.6° Zoom: 1.0X 11525+00</p>

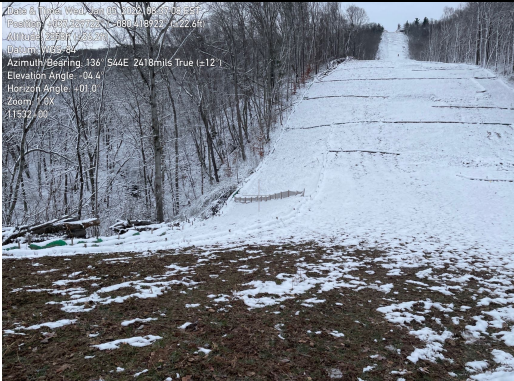
GPS Location		See Photo		GPS Location	
Field Station#		11532+00		Field Station#	
Pic 3 Desc.		Final Restoration Area.		Pic 4 Desc.	
<p>Date & Time: Wed, Jan 05, 2022, 06:42:52 EST Position: +400.858587° / +400.858587° (Elev) Altitude: 2222 (±21.37) Datum: WGS-84 Azimuth/Bearing: 135° NAE 100mils True (±12°) Elevation Angle: +12.5° Horizon Angle: +02.6° Zoom: 1.0X 11581+00</p>

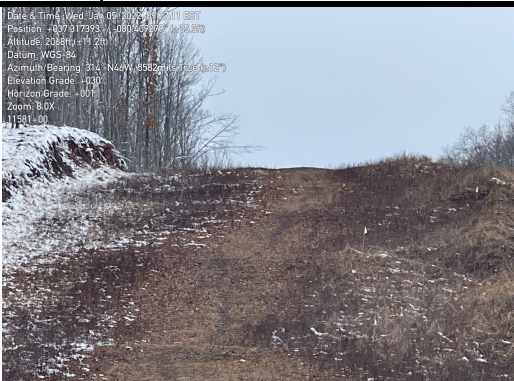
GPS Location		See Photo		GPS Location	
Field Station#		11581+00		Field Station#	
Pic 5 Desc.		View of temporary stabilization of row conditions		Pic 6 Desc.

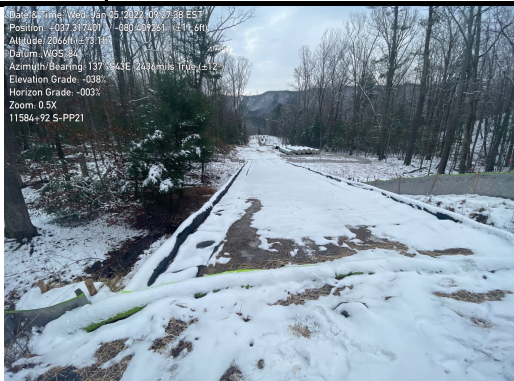
GPS Location	See Photo		GPS Location	See Photo	
Field Station#	11584+92		Field Station#	1185+00	
Pic 7 Desc.	S-PP21 View looking down stream.		Pic 8 Desc.	P1 fencing around the S-PP21 stream resource.

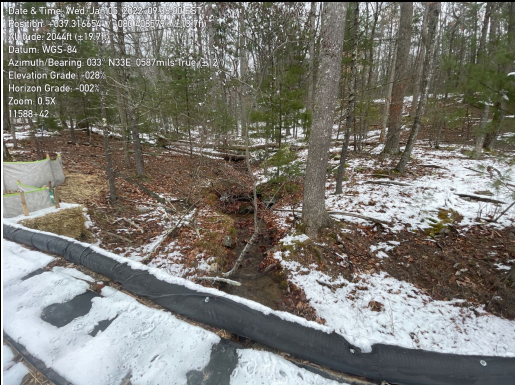
GPS Location				See Photo				GPS Location				See Photo			
Field Station#				11588+42				Field Station#				11588+42			
Pic 13 Desc.				S-PP20 View lookin g upstream. No issues at this time.				Pic 14 Desc.				S-PP20 View looking down stream. No issues at this time.			
<p>Date & Time: Wed Jan 05 2022 09:13:55 EST Position: +037.316425° N -080.408210° W Altitude: 2044ft (+26.2ft) Datum: WGS-84 Azimuth/Bearing: 219° S39W 3893mils True (+12°) Elevation Grade: +061° Horizon Grade: +002° Zoom: 0.5X 11589+77</p>

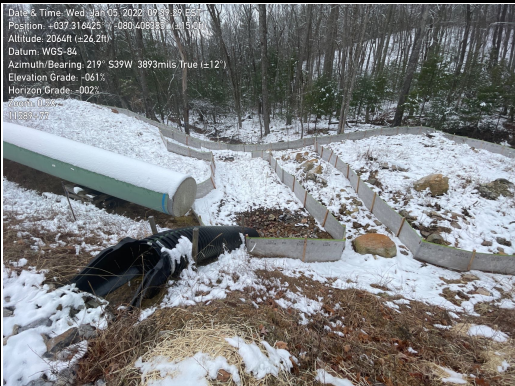
GPS Location				See Photo				GPS Location				See Photo			
Field Station#				11589+77				Field Station#				11590+00			
Pic 15 Desc.				TSDP Conditions				Pic 16 Desc.				Temporary vegetated top soil pile			
<p>Date & Time: Wed Jan 05 2022 09:43:46 EST Position: +037.315961° N -080.408210° W Altitude: 2045ft (+26.2ft) Datum: WGS-84 Azimuth/Bearing: 91° N44W 5582mils True (+12°) Elevation Grade: +049° Horizon Grade: +006° Zoom: 1.0X 11591+00</p>

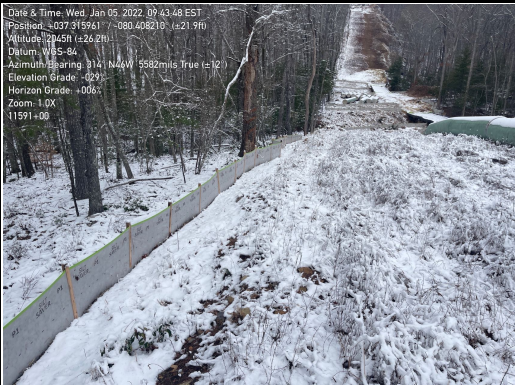
GPS Location				See Photo				GPS Location				See Photo			
Field Station#				11591+00				Field Station#				11592+00			
Pic 17 Desc.				P1 perimeter silt fencing functional				Pic 18 Desc.				P1 Silt fencing protecting sediment migration into fallen timber pile

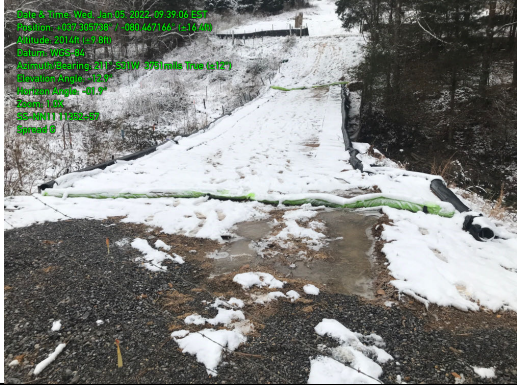
<p>Photo 8: Old Furnace. 11353+67 Station: 11353+67 Elevation: 11353+67 Azimuth/Bearing: 322° 40' 00" N Elevation Angle: -23.1° Horizon Angle: -00.7° Zoom: 1.00 Old Furnace. 11353+67 Spread 0</p>			
GPS Location	See photo	GPS Location	see photo		
Field Station#	11348+00	Field Station#	11353+67		
Pic 7 Desc.	Sump/Karst protection	Pic 8 Desc.	Old Furnace

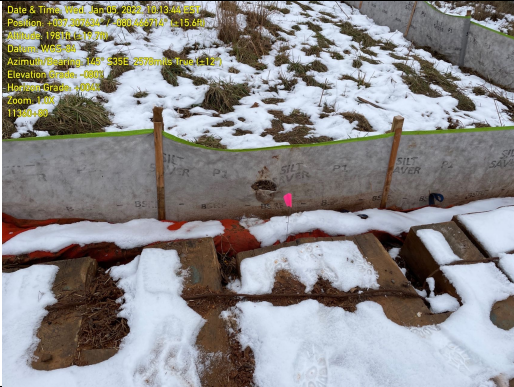
GPS Location	See photo	GPS Location	See photo		
Field Station#	11360+80	Field Station#	11470+00		
Pic 1 Desc.	Hole in P1 silt fence	Pic 2 Desc.	Stone inlet protection in place		
<p>Date & Time: Wed Jan 05 2022 09:12:12 EST Position: 4371321038 / -080 435867 (s20.3N) Altitude: 2256ft (+16.3ft) Datum: WGS-84 Azimuth/Bearing: 277° N83W 4924mils True (+12°) Elevation Grade: -04% Horizon Grade: -00% Zoom: 1.0x 11/30/2021</p>

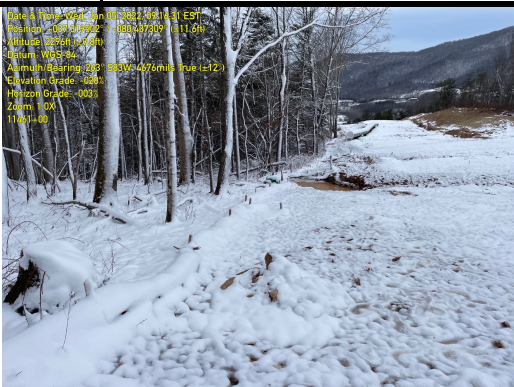
GPS Location	See photo	GPS Location	See photo		
Field Station#	11469+00	Field Station#	11467+00		
Pic 3 Desc.	Triple protection ECDs in place at karst feature	Pic 4 Desc.	Plunge pool in place		
<p>Date & Time: Wed Jan 05 2022 09:14:41 EST Position: 4371321038 / -080 435867 (s20.3N) Altitude: 2135ft (+19.7ft) Datum: WGS-84 Azimuth/Bearing: 259° S79W 4406mils True (+12°) Elevation Grade: -00% Horizon Grade: -00% Zoom: 1.0x 11/30/2021</p>

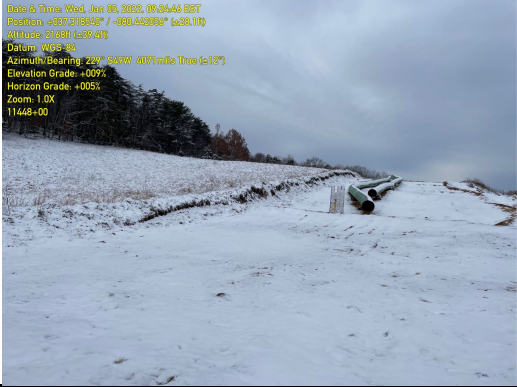
GPS Location	See photo		GPS Location	See photo	
Field Station#	11448+00		Field Station#	11433+00	
Pic 7 Desc.	Cleanwater diversion berm in place		Pic 8 Desc.	Level spreader in place	
<p>Date & Time: Wed, Jan 05, 2022, 09:54:55 EST Position: +037.318040° / -080.446346° (±32.8ft) Altitude: 2049ft (±39.4ft) Datum: WGS-84 Azimuth/Bearing: 102° N29W 801mils True (±12°) Elevation Grade: -026% Horizon Grade: +029% Zoom: 1.0X 11397+00</p>

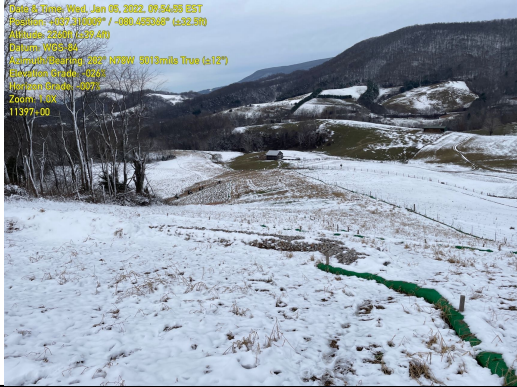
GPS Location	See photo		GPS Location	See photo	
Field Station#	11397+00		Field Station#	11363+00	
Pic 9 Desc.	CFS temporary waterbars in place		Pic 10 Desc.	End treatments in place	
<p>Date & Time: Wed, Jan 05, 2022, 10:13:13 EST Position: +037.307810° / -080.446475° (±17.0ft) Altitude: 1966ft (±19.7ft) Datum: WGS-84 Azimuth/Bearing: 057° N57E 1013mils True (±12°) Elevation Grade: +013% Horizon Grade: -003% Zoom: 1.0X 11362+00</p>

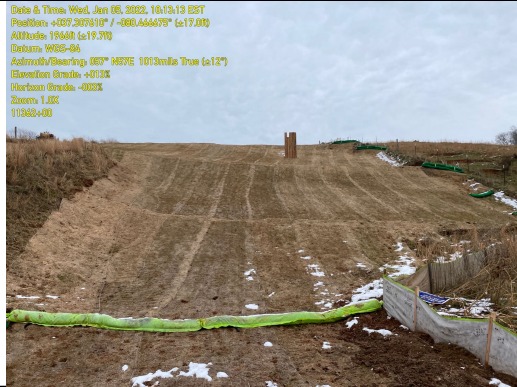
GPS Location	See photo		GPS Location	See photo	
Field Station#	11362+00		Field Station#	11353+50	
Pic 11 Desc.	Erosion control blanket in place		Pic 12 Desc.	RCE in place

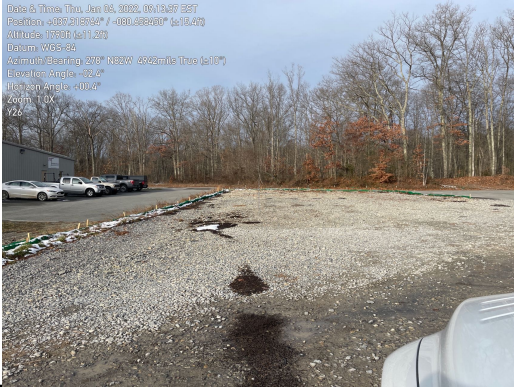
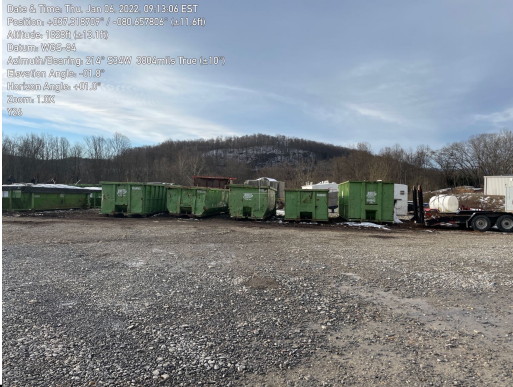
GPS Location	See photo		GPS Location	See photo	
Field Station#	12005+00		Field Station#	12005+00	
Pic 3 Desc.	CFS perimeter controls functional		Pic 4 Desc.	Containment in place

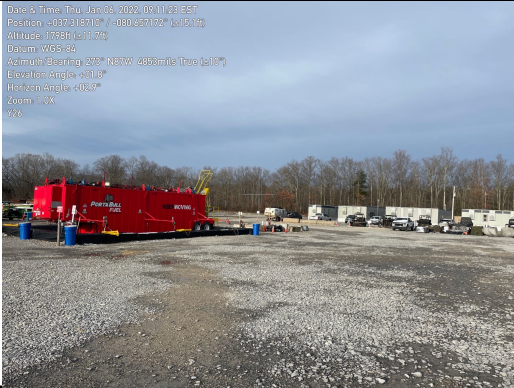
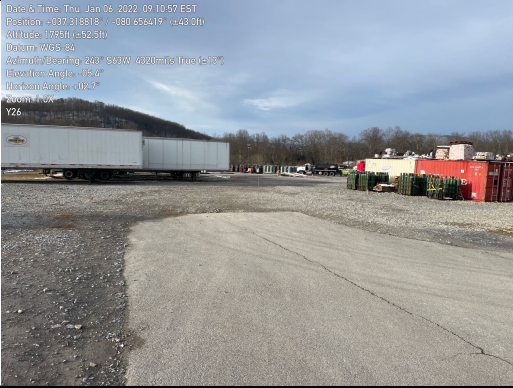
GPS Location	See photo		GPS Location	See photo	
Field Station#	12005+00		Field Station#	12005+00	
Pic 5 Desc.	Secondary containment functional		Pic 6 Desc.	RCE functional

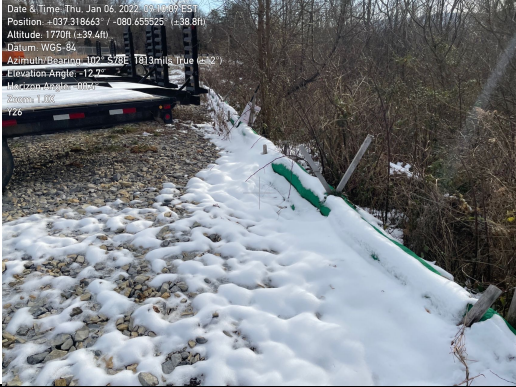
GPS Location	See photo	GPS Location			
Field Station#	12005+00	Field Station#			
Pic 7 Desc.	CFS triple stack in place	Pic 8 Desc.			
Insert image here		Insert image here			
GPS Location		GPS Location			
Field Station#		Field Station#			
Pic 9 Desc.		Pic 10 Desc.			
Insert image here		Insert image here			
GPS Location		GPS Location			
Field Station#		Field Station#			
Pic 11 Desc.		Pic 12 Desc.

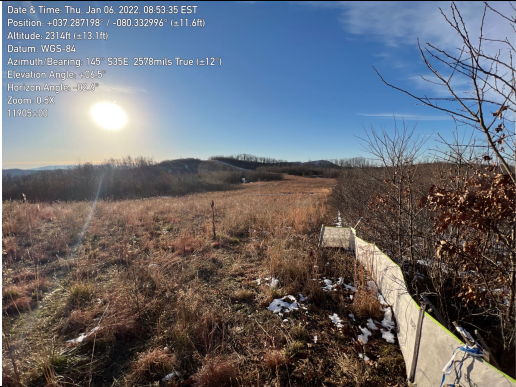
GPS Location		See Photo		GPS Location	
Field Station#		11905+00		Field Station#	
Pic 1 Desc.		Section of ROW showing conditions and controls		Pic 2 Desc.	
<p>Date & Time: Thu Jan 06, 2022 09:15:50 EST Position: +037.277912° / -080.330600° (±11.6ft) Altitude: 2160ft (±13.1ft) Datum: WGS-84 Azimuth/Bearing: 138° 54SE 2453mils True (±12°) Elevation Angle: -05.7° Horizon Angle: -01.9° Zoom: 0.5X 11947+00</p>

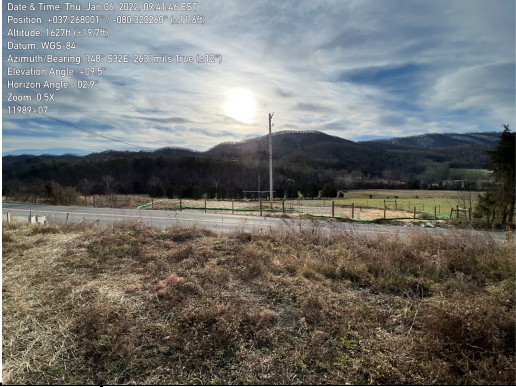
GPS Location		See Photo		GPS Location	
Field Station#		11989+07		Field Station#	
Pic 5 Desc.		Catawba Road		Pic 6 Desc.	
				Stabilization at Spread Break

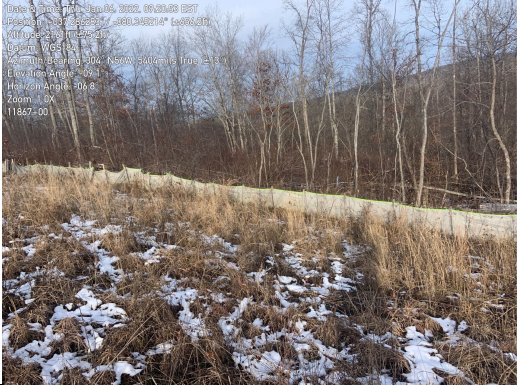
GPS Location	See photo	GPS Location	See photo		
Field Station#	11855+00	Field Station#	11867+00		
Pic 7 Desc.	Permanent water bars and level spreader are in acceptable condition	Pic 8 Desc.	P1 silt fence is in acceptable condition		
<small> Date & Time: Thu, Jan 06, 2022, 09:54:03 EST Position: 4387.29724° N - 80.50777° W 425.25' Altitude: 2193 ft (668 m) Datum: WGS 84 Azimuth: Bearing: 318.142° W 365 m (1035 ft) 15.5° Elevation Angle: 11.5° Horizon Angle: 10.2° Zoom: 1.0X 11886+00 </small>

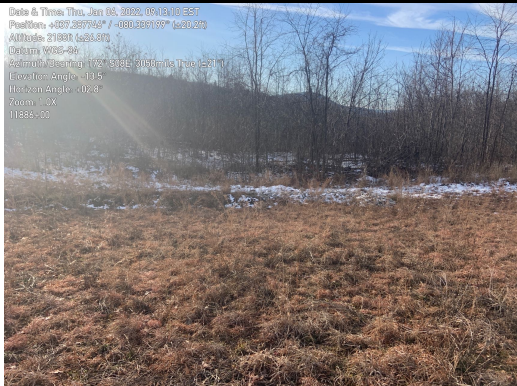
GPS Location	See photo	GPS Location	See photo		
Field Station#	11886+00	Field Station#	11895+00		
Pic 9 Desc.	Permanent water bars and vegetation are in acceptable condition	Pic 10 Desc.	Vegetation is in acceptable condition		
Insert image here		Insert image here			
GPS Location		GPS Location			
Field Station#		Field Station#			
Pic 11 Desc.		Pic 12 Desc.

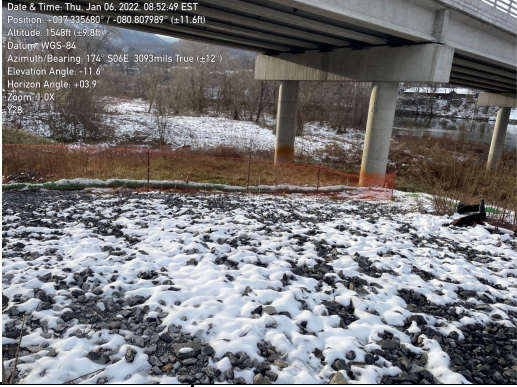
Insert image here	
GPS Location	See photo	GPS Location			
Field Station#	12005+00	Field Station#			
Pic 7 Desc.	CFS perimeter controls & safety fence in place	Pic 8 Desc.			
Insert image here		Insert image here			
GPS Location		GPS Location			
Field Station#		Field Station#			
Pic 9 Desc.		Pic 10 Desc.			
Insert image here		Insert image here			
GPS Location		GPS Location			
Field Station#		Field Station#			
Pic 11 Desc.		Pic 12 Desc.

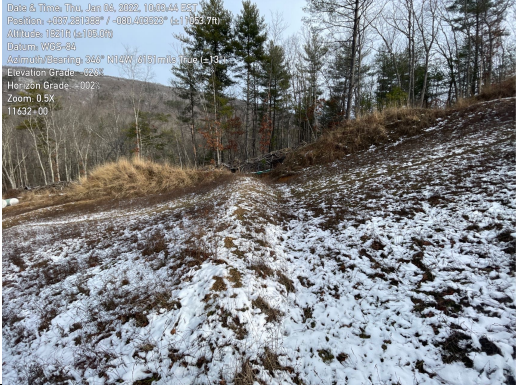
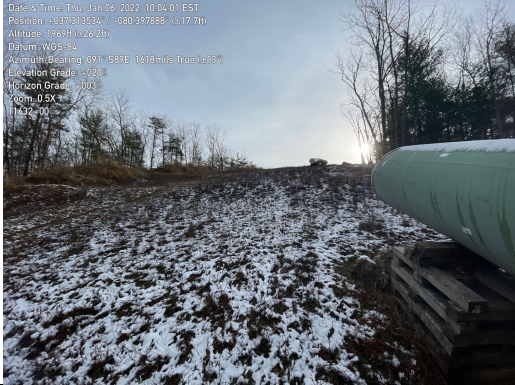
<p>Date & Time: Thu, Jan 06, 2022, 10:04:01 EST Position: +037.313643° -080.397888° (x:17.7m) Altitude: 1960ft (+52.5m) Datum: WGS-84 Azimuth Bearing: 091° SSW 1218mils True (+2.7°) Elevation Grade: +002° Horizon Grade: +002° Zoom: 0.5x 11632+00</p>			
GPS Location	See Photo		GPS Location	See Photo	
Field Station#	11632+00		Field Station#	11632+00	
Pic 1 Desc.	Current temporary water bar and row conditions		Pic 2 Desc.	Temporary vegetation condition

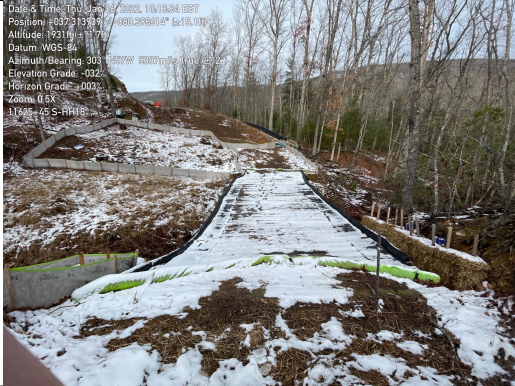
<p>Jan 6, 2022 at 11:40:33 AM +37.314103° -80.399081° Punch list 11624+00-11627+00 Stabilized row</p>

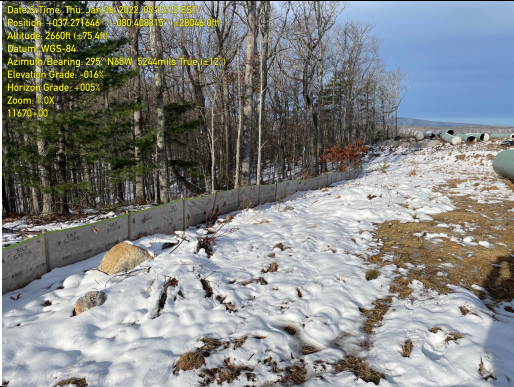
GPS Location	See photo	GPS Location	See photo		
Field Station#	11670+00	Field Station#	11678+00		
Pic 1 Desc.	P1 silt fence perimeter control in place	Pic 2 Desc.	End treatments in place		
<p>Date & Time: Thu, Jan 06, 2022, 09:21:45 EST Position: +037.299975° / -080.391923° (±15.1m) Altitude: 2550ft (±11.7m) Datum: WGS-84 Azimuth/Bearing: 101° S9E 1796mils True (±12°) Elevation Grade: -042° Horizon Grade: -003° Zoom: 1.0X 11682+50</p>

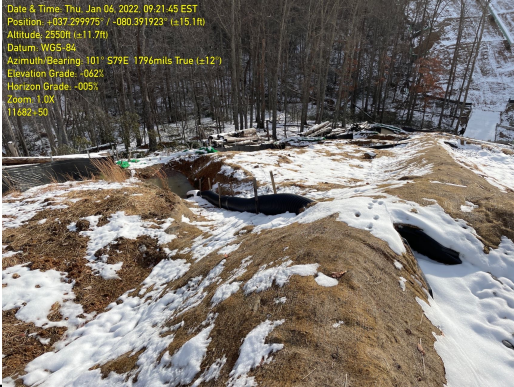
GPS Location	See photo	GPS Location	See photo		
Field Station#	11682+50	Field Station#	11689+00		
Pic 3 Desc.	Slope drain in place	Pic 4 Desc.	Erosion control blanket in place		
<p>Date & Time: Thu, Jan 06, 2022, 09:33:25 EST Position: +037.297554° / -080.394597° (±16.6m) Altitude: 2380ft (±9.7m) Datum: WGS-84 Azimuth/Bearing: 329° N26W 634mils True (±12°) Elevation Grade: -073° Horizon Grade: +004° Zoom: 1.0X 11689+00</p>

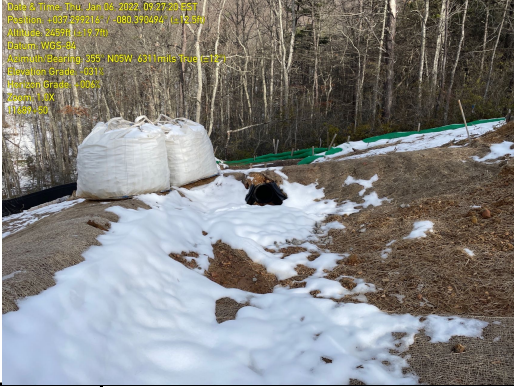
GPS Location	See photo	GPS Location	See photo		
Field Station#	11689+50	Field Station#	11705+00		
Pic 5 Desc.	Stone inlet protection in place	Pic 6 Desc.	Stream buffer in place

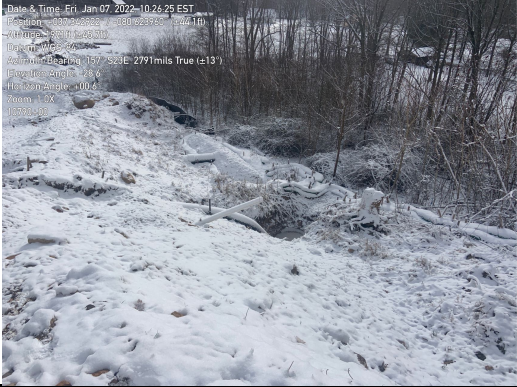
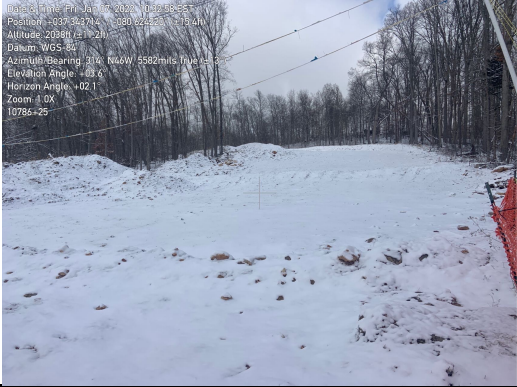
GPS Location	See photo	GPS Location	See photo		
Field Station#	10790+00	Field Station#	10786+25		
Pic 7 Desc.	Sump pit and daylight drain are in place	Pic 8 Desc.	Water bars are in acceptable condition

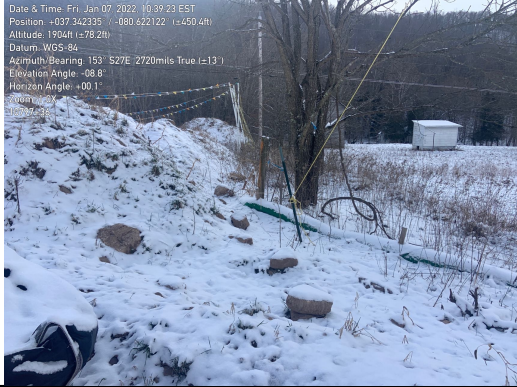
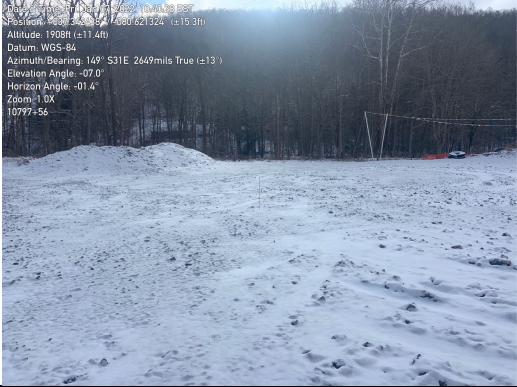
GPS Location	See photo	GPS Location	See photo		
Field Station#	10797+36	Field Station#	10797+56		
Pic 9 Desc.	CFS perimeter controls are in acceptable condition	Pic 10 Desc.	Rock surface of RCE is in acceptable condition		
Insert image here		Insert image here			
GPS Location		GPS Location			
Field Station#		Field Station#			
Pic 11 Desc.		Pic 12 Desc.

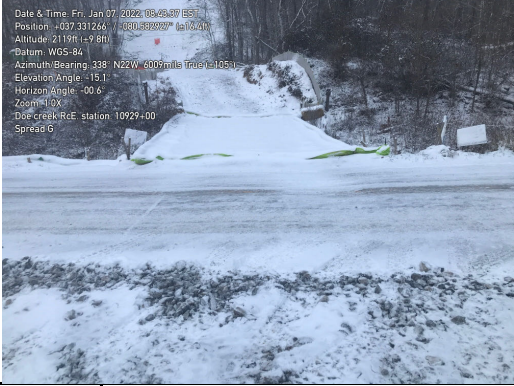
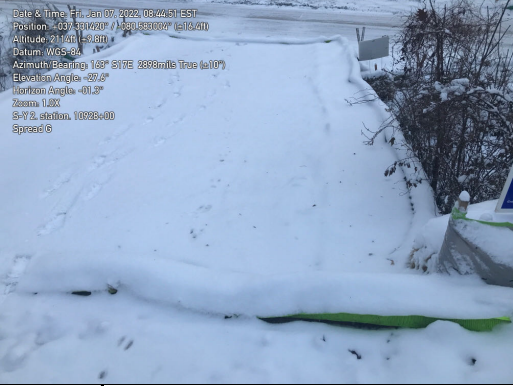
GPS Location	See photo		GPS Location	see photo	
Field Station#	10929+00		Field Station#	10928+50	
Pic 1 Desc.	Doe Creek RCE		Pic 2 Desc.	S-Y 2

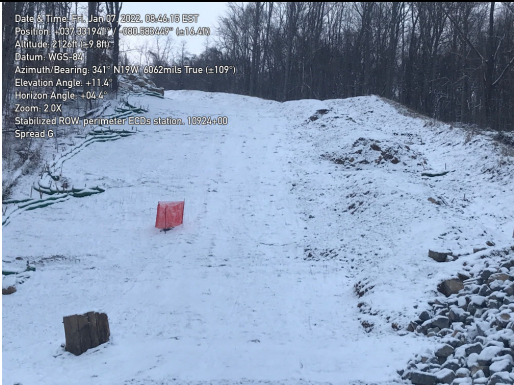
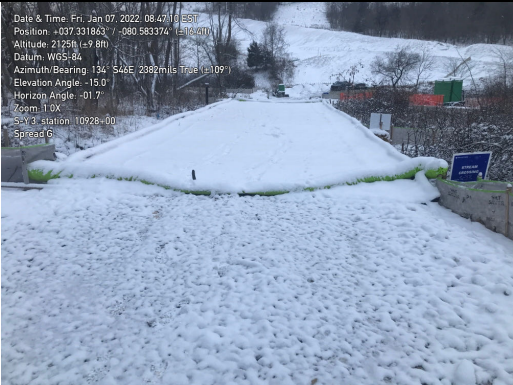
GPS Location	see photo		GPS Location	see photo	
Field Station#	10924+00		Field Station#	10928+00	
Pic 3 Desc.	Stabilized ROW		Pic 4 Desc.	S-Y 3

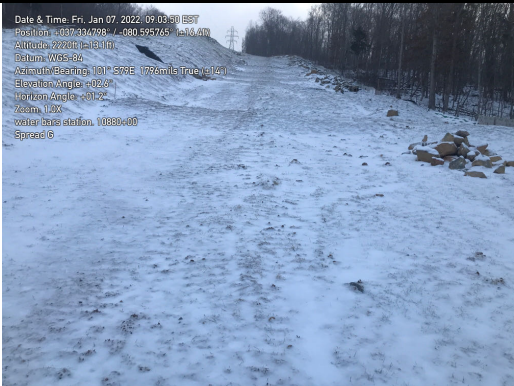
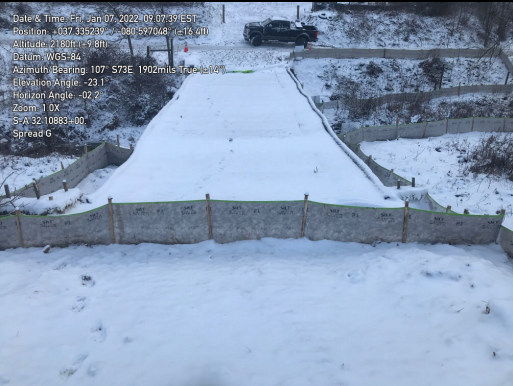
GPS Location	see photo		GPS Location	see photo	
Field Station#	10880+00		Field Station#	10883+00	
Pic 5 Desc.	Water bars/ Stabilized ROW		Pic 6 Desc.	S-A 32

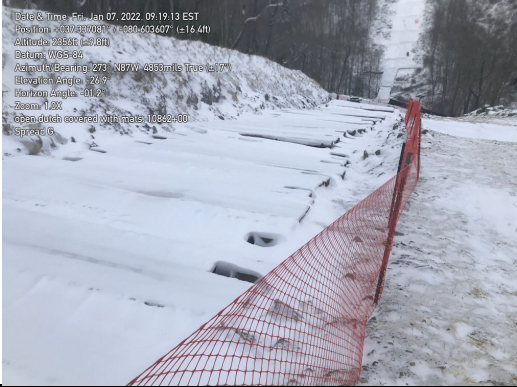
<p><small>Date & Time: Fri, Jan 07, 2022, 09:19:13 EST Position: 43°49'08"N / 76°38'59"W (±16.4M) Altitude: 2289ft (±7.9M) Datum: WGS-84 Azimuth/Bearing: 273° N87W, 4389mils True (±1°) Elevation Angle: -09.5° Horizon Angle: -101.8° Zoom: 1.0x Open ditch covered with mats 10862+00 Spread: 6</small></p>

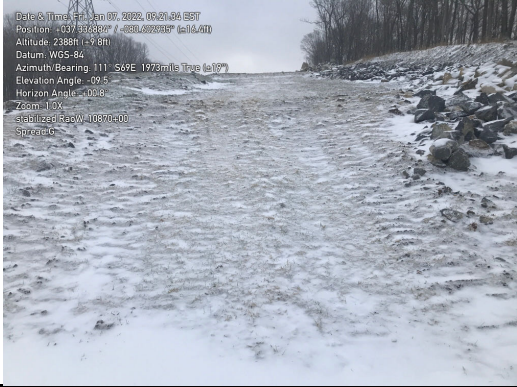
<p><small>Date & Time: Fri, Jan 07, 2022, 09:21:04 EST Position: 43°49'33"N / 76°38'59"W (±16.4M) Altitude: 2289ft (±7.9M) Datum: WGS-84 Azimuth/Bearing: 111° S59E, 1972mils True (±1°) Elevation Angle: -09.5° Horizon Angle: -101.8° Zoom: 1.0x Stabilized Pav 10870+00 Spread: 6</small></p>			
GPS Location	See photo	GPS Location	see photo		
Field Station#	10862+00	Field Station#	10870+00		
Pic 7 Desc.	Open ditch covered with mats	Pic 8 Desc.	Stabilized ROW		
Insert image here		Insert image here			
GPS Location		GPS Location

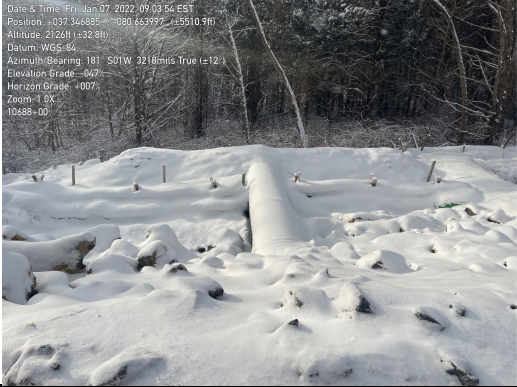
GPS Location	See Photo		GPS Location	See Photo	
Field Station#	10688+00		Field Station#	10685+00	
Pic 7 Desc.	Frozen and snow covered TLS.		Pic 8 Desc.	Snow covered row conditions	
<small> Date & Time: Fri Jan 07 2022 09:01:16 EST Position: +037 350316 / -080 657621 (±1519.7ft) Altitude: 2100ft (±10.9ft) Datum: WGS-84 Azimuth/Bearing: 199° S19W 3538mils True (±12°) Elevation Grade: -05% Horizon Grade: -00% Zoom: 1.0X 10681+24 </small>		<small> Date & Time: Fri Jan 07 2022 09:00:41 EST Position: +037 350341 / -080 657619 (±1519.7ft) Altitude: 2097ft (±10.9ft) Datum: WGS-84 Azimuth/Bearing: 188° S08W 3342mils True (±12°) Elevation Grade: -09% Horizon Grade: -00% Zoom: 0.5X 10681+24 </small>

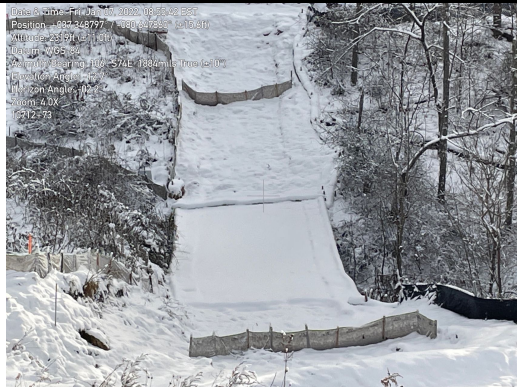
GPS Location	See Photo		GPS Location	See Photo	
Field Station#	10712+73		Field Station#	10698+16	
Pic 11 Desc.	S-G32 Equipment bridge condition		Pic 12 Desc.	S-G32 Equipment bridge condition

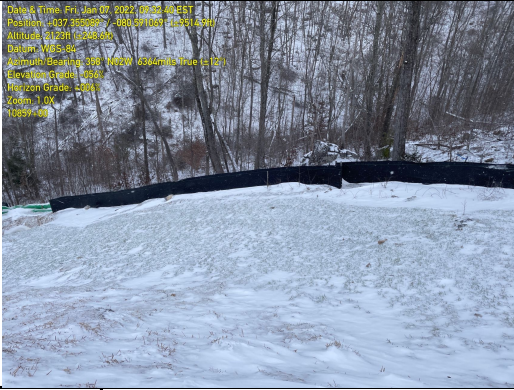
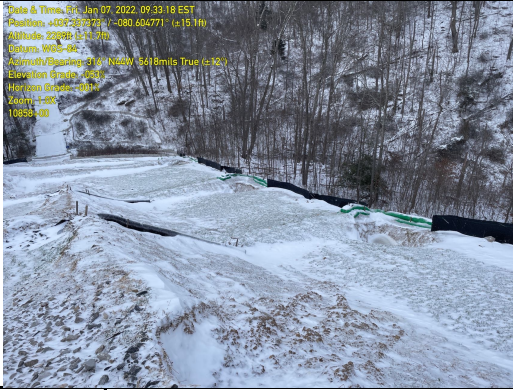
<p>Date & Time: Fri, Jan 07, 2022, 09:33:18 EST Position: +037.2397077 / -080.6064977 (-80.6065) Altitude: 24369 (+39.40) Datum: WGS-84 Azimuth/Heading: 110° N00W 1648mils True (+30°) Elevation Grade: -016% Horizon Grade: +001% Zoom: 1.0X 10858+00</p>			
GPS Location	See photo		GPS Location	See photo	
Field Station#	10859+00		Field Station#	10858+00	
Pic 1 Desc.	Supersilt fence perimeter control in place		Pic 2 Desc.	End treatments in place

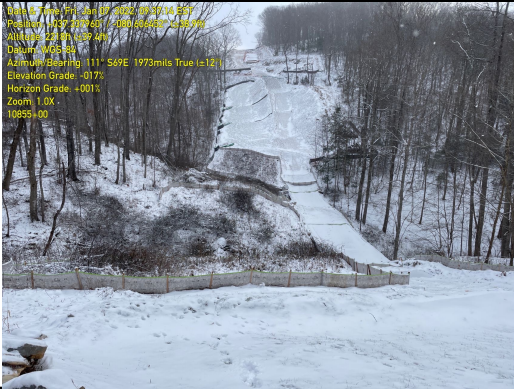
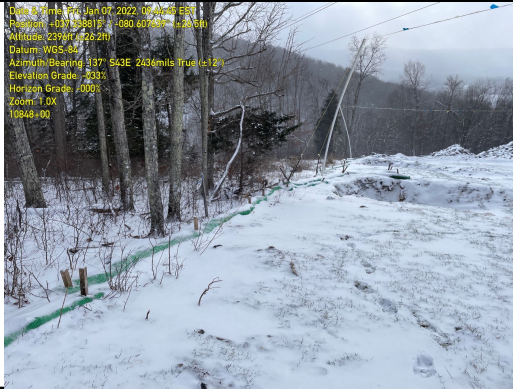
GPS Location	See photo		GPS Location	See photo	
Field Station#	10855+00		Field Station#	10848+00	
Pic 3 Desc.	Stream buffer in place		Pic 4 Desc.	CFS perimeter control in place

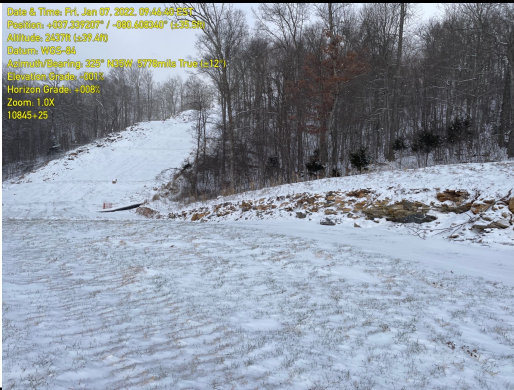
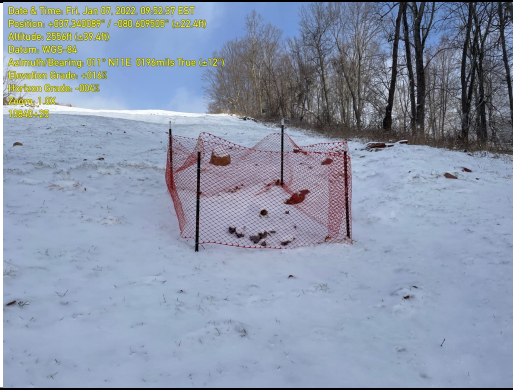
<p>Date & Time: Fri, Jan 07, 2022, 09:43:37 EST Position: +037.2397077 / -080.6064977 (-80.6065) Altitude: 25540 (+39.40) Datum: WGS-84 Azimuth/Heading: 011° N01E 0144mils True (+12°) Elevation Grade: +014% Horizon Grade: -003% Zoom: 1.0X 10840+25</p>			
GPS Location	See photo		GPS Location	See photo	
Field Station#	10845+25		Field Station#	10840+25	
Pic 5 Desc.	Cleanwater diversion berm in place		Pic 6 Desc.	Daylight drain in place

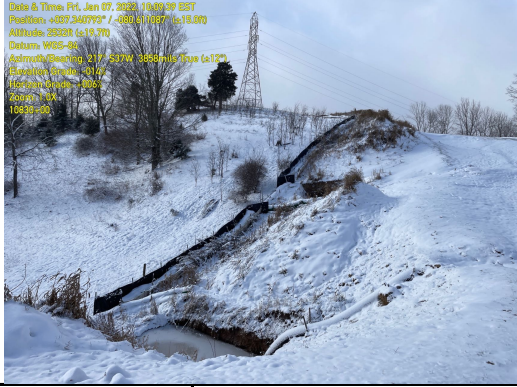
GPS Location		See photo		GPS Location	
Field Station#		10830+00		Field Station#	
Pic 9 Desc.		Triple protection ECDs in place at karst feature		Pic 10 Desc.	
<p>Date & Time: Fri, Jan 07, 2022, 10:27:09 EST Position: +429.241780° / -900.618040° (±12.00) Datum: WGS-84 Azimuth/Bearing: 003° N03E 003° true (±12°) Elevation Grade: -012 Horizon Grade: -000 Zoom: 1.0X 10805+00</p>

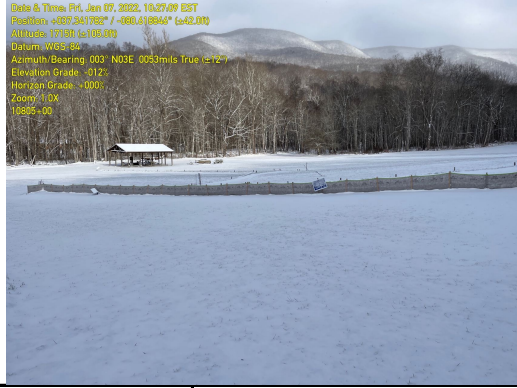
<p>Date & Time: Fri, Jan 07, 2022, 10:26:34 EST Position: +429.241740° / -900.618490° (±12.00) Datum: WGS-84 Azimuth/Bearing: 012° N02W 012° true (±12°) Elevation Grade: -012 Horizon Grade: -000 Zoom: 1.0X 10803+00</p>  			
GPS Location		See photo		GPS Location	
Field Station#		10805+00		Field Station#	
Pic 11 Desc.		P1 silt fence in place at sensitive resource		Pic 12 Desc.
