Visual Site Inspection Report

Project Name	H-600 Pipeline Spread G	AFE	124300137	Spread	H-600 Pipeline Spread G
Contractor	Precision			Report #	33771
Inspector	Eric Hanlon			Date/Time	1/31/2022 8:18 AM
Permit #	TBD	Inspection Type	VA SWPP	Station Begin	12005+00
State	VA	Inspection Area	Full	Station End	12005+00
County	Giles	Ground	Frozen	Temperature (°F)	27.00
Municipality	N/A	Weather	Sunny	Rain Gauge (in)	0.00
				Rain Accumulation Time (days)	1.00

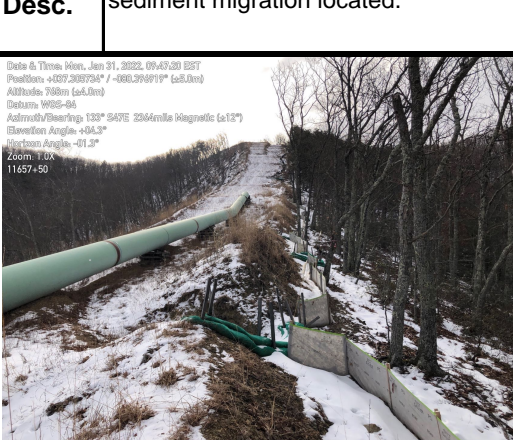
GPS Location	On photo		GPS Location	On photo	
Field Station#	11659+00		Field Station#	11657+50	
Pic 3 Desc.	Perimeter ECDs were checked for maintenance needs.		Pic 4 Desc.	Perimeter ECDs are in place and functional.

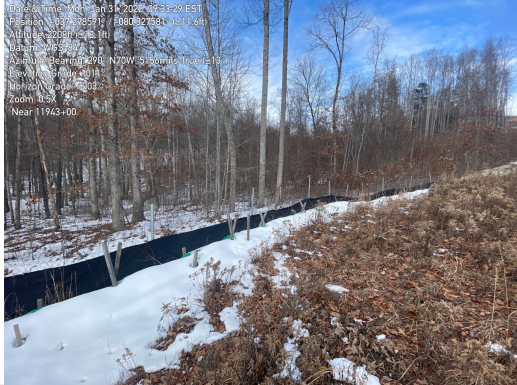
GPS Location		See Photo		GPS Location	
Field Station#		11913+00		Field Station#	
Pic 7 Desc.		View of P1 silt fence requiring maintenance.		Pic 8 Desc.	
				Final Restoration Area. View of permanent grasses and perimeter CFS.	
<p> <small> Date & Time: Mon, Jan 31, 2022 10:53:55 Position: +38°28393" / -98°03310" (±11.30) Altitude: 1537M (±15.10) Datum: WGS-84 Geoid Heighting: 100° NAD 83 Geoid: 100M Horizontal Grade: 0.00 Zoom: 0.5X Near: 11943+00 </small> </p>

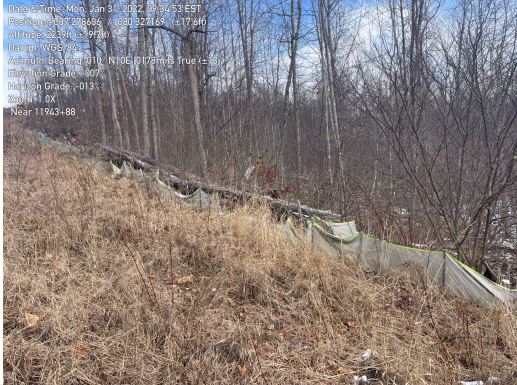
GPS Location		See Photo		GPS Location	
Field Station#		11943+00		Field Station#	
Pic 9 Desc.		Perimeter super silt fence and snow covered CFS protecting sensitive resource area.		Pic 10 Desc.	
				P1 silt fence requiring maintenance.	
<p> <small> Date & Time: Mon, Jan 31, 2022 10:54:00 Position: +38°28393" / -98°03310" (±11.30) Altitude: 1537M (±15.10) Datum: WGS-84 Geoid Heighting: 100° NAD 83 Geoid: 100M Horizontal Grade: 0.00 Zoom: 0.5X Near: 11946+50 </small> </p>  		<p> <small> Date & Time: Mon, Jan 31, 2022 10:54:00 Position: +38°28393" / -98°03310" (±11.30) Altitude: 1537M (±15.10) Datum: WGS-84 Geoid Heighting: 100° NAD 83 Geoid: 100M Horizontal Grade: 0.00 Zoom: 0.5X Near: 11978+86 </small> </p>

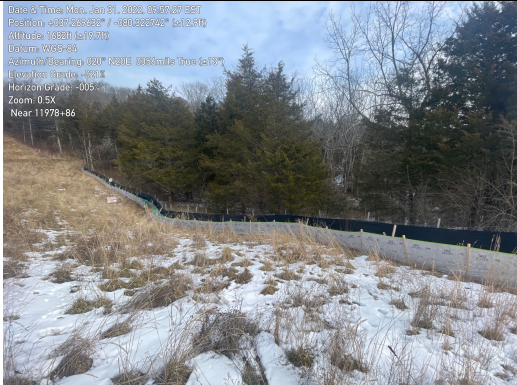
GPS Location		See Photo		GPS Location	
Field Station#		11946+50		Field Station#	
Pic 11 Desc.		Water bar conditions after snow melt		Pic 12 Desc.	
				Protected sensitive resource areas in Final Restoration Area

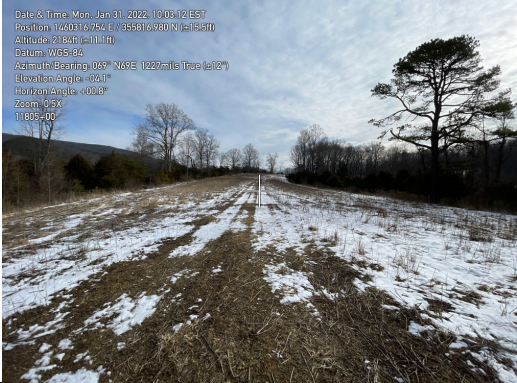
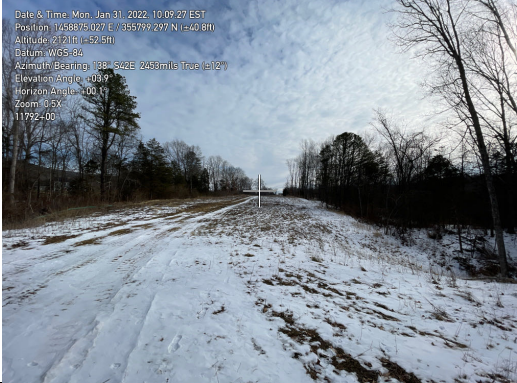
GPS Location	7	GPS Location	8		
Field Station#	11805+00	Field Station#	11792+00		
Pic 7 Desc.	Section of restored RoW showing conditions and controls.		Pic 8 Desc.	Section of restored RoW showing conditions and controls.	
Insert image here		Insert image here			
GPS Location		GPS Location			
Field Station#		Field Station#

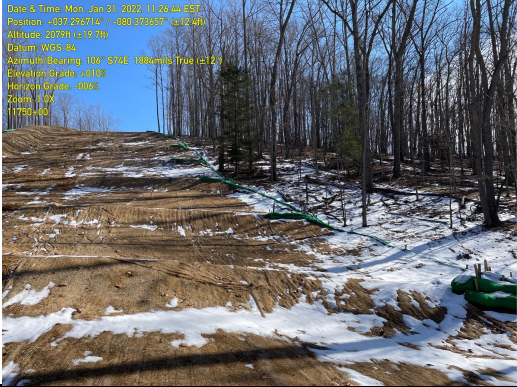
GPS Location		See photo		GPS Location	
Field Station#		11750+00		Field Station#	
Pic 7 Desc.		End treatments in place		Pic 8 Desc.	
				Supersilt fence perimeter control in place	
<p>Date & Time: Mon, Jan 31, 2022, 11:43:22 EST Position: +037.296977° / -080.368997° (±13.3M) Altitude: 1997ft (±16.7M) Datum: WGS-84 Azimuth/Bearing: 094° S86E 167mils True (±12°) Elevation Grade: +01% Horizon Grade: +00% Zoom: 1.0X 11766+00</p>

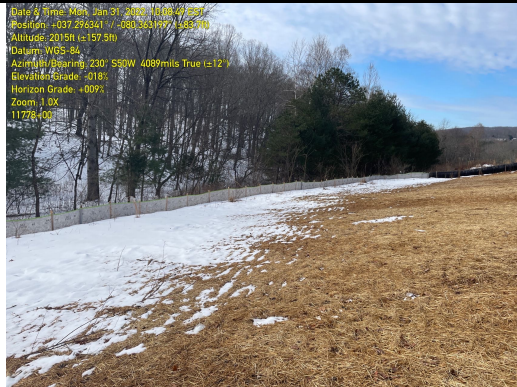
GPS Location		See photo		GPS Location	
Field Station#		11778+00		Field Station#	
Pic 11 Desc.		P1 silt fence perimeter control in place		Pic 12 Desc.	
				Cleanwater drainage feature in place

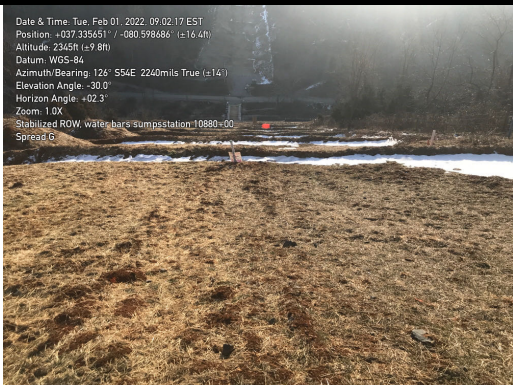
GPS Location		see photo				GPS Location		see photo			
Field Station#		10880+00				Field Station#		10883+10			
Pic 5 Desc.		Stabilized ROW, water bars, sumps				Pic 6 Desc.		S-A 32

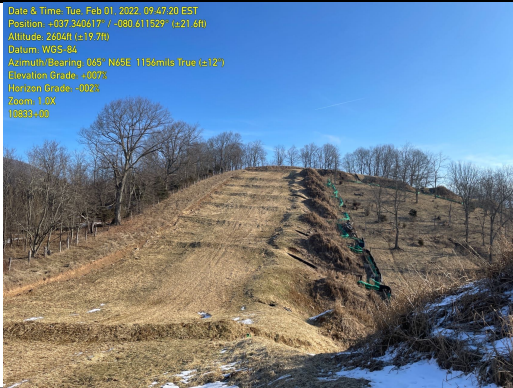
<p>Date & Time: Tue, Feb 01, 2022, 09:47:20 EST Position: +037 340411° / +000 011927° (+21.80) Altitude: 2494ft (+21.80) Datum: WGS-84 Azimuth/Bearing: 065° N06E 115mils True (+0.2°) Elevation Grade: -007% Horizon Grade: -092% Zoom: 1.0X 10833+00</p>			
GPS Location	See photo	GPS Location	See photo		
Field Station#	10820+00	Field Station#	10833+00		
Pic 5 Desc.	CFS perimeter control in place	Pic 6 Desc.	Waterbars in place

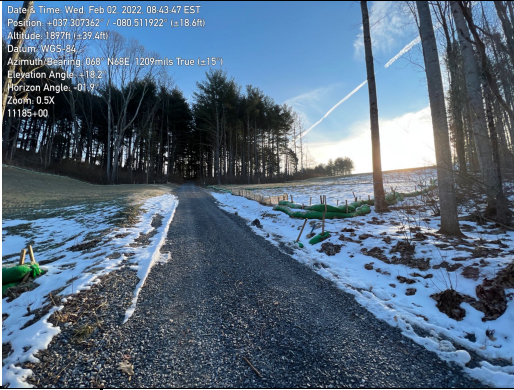
GPS Location		See Photo		GPS Location	
Field Station#		11185+00		Field Station#	
Pic 1 Desc.		Access road 249.02		Pic 2 Desc.	
<p>Date & Time: Wed Feb 02, 2022, 09:55:55 EST Position: +037.306008 / -080.508372 (±13.5ft) Altitude: 2038ft (±19.7ft) Datum: WGS-84 Azimuth/Bearing: 066 N44E 1138mils True (±12.1) Elevation Angle: +23.9 Horizon Angle: -06.9 Zoom: 1.0X 11194+00</p>

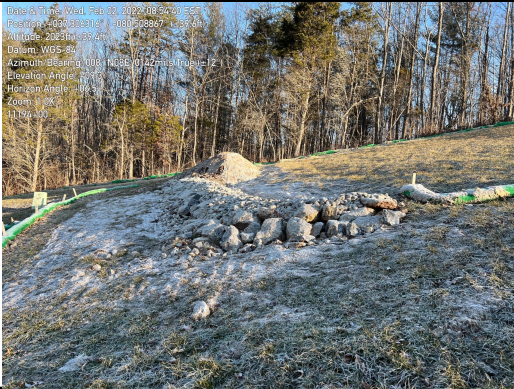
GPS Location		See Photo		GPS Location	
Field Station#		11194+00		Field Station#	
Pic 3 Desc.		Level Spreader		Pic 4 Desc.	
<p>Date & Time: Wed Feb 02, 2022, 09:54:40 EST Position: +037.295904 / -080.494379 (±36.6ft) Altitude: 2073ft (±36.3ft) Datum: WGS-84 Azimuth/Bearing: 055 N55E 0978mils True (±12.1) Elevation Angle: -21.8 Horizon Angle: -01.1 Zoom: 0.5X 11249+00</p>

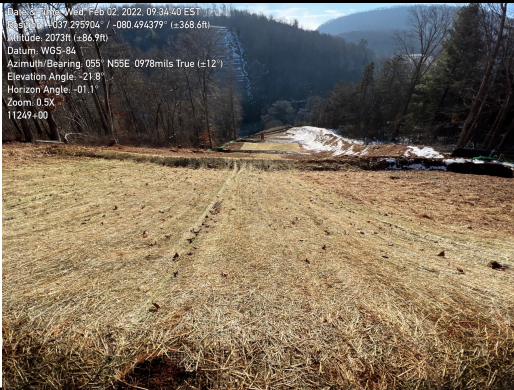
GPS Location		See Photo		GPS Location	
Field Station#		11249+00		Field Station#	
Pic 5 Desc.		Erosion controls blanked		Pic 6 Desc.

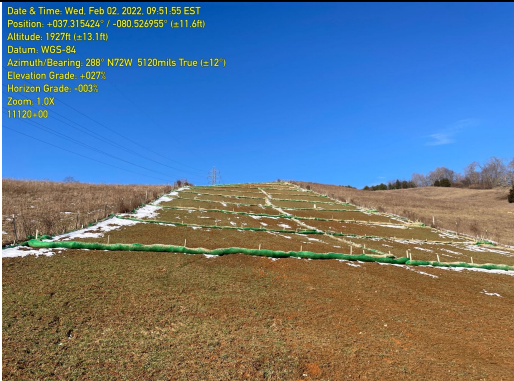
GPS Location	See photo	GPS Location	See photo		
Field Station#	11120+00	Field Station#	11135+00		
Pic 3 Desc.	CFS temporary waterbars in place	Pic 4 Desc.	Level spreader in place		
<p>Date & Time: Wed Feb 02, 2022, 10:13:10 EST Position: +037.314324° / -080.526959° (±11.6M) Altitude: 2076ft (±9.6M) Datum: WGS-84 Azimuth/Bearing: 113° S40E 2009mils True (±12°) Elevation Grade: +003° Horizon Grade: -003° Zoom: 1.0X 11141+00</p>

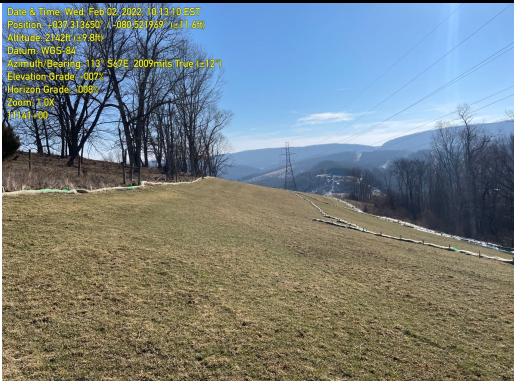
GPS Location	See photo	GPS Location	See photo		
Field Station#	11141+00	Field Station#	11146+80		
Pic 5 Desc.	Permanent vegetation present	Pic 6 Desc.	Cleanwater diversion berm in place

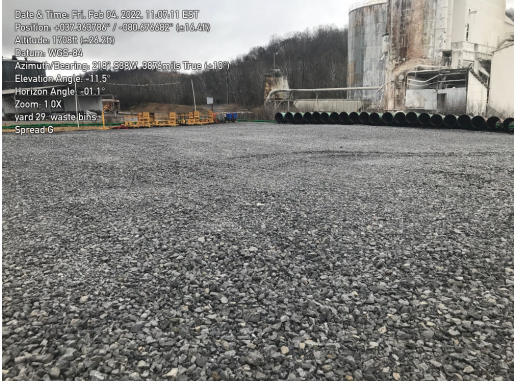
GPS Location	see photo		GPS Location	see photo	
Field Station#	12005+00		Field Station#	12005+00	
Pic 3 Desc.	Yard 29		Pic 4 Desc.	Compost sock

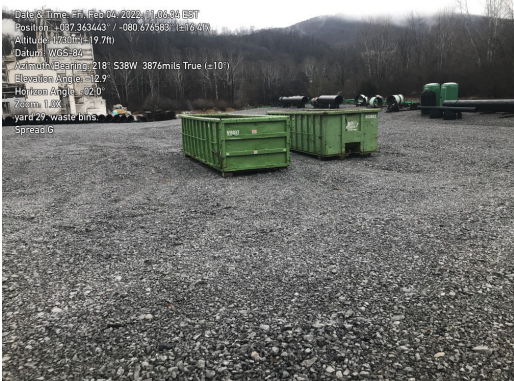
GPS Location	see photo		GPS Location	see photo	
Field Station#	12005+00		Field Station#	12005+00	
Pic 5 Desc.	Trash receptacles		Pic 6 Desc.	Yard 29 RCE

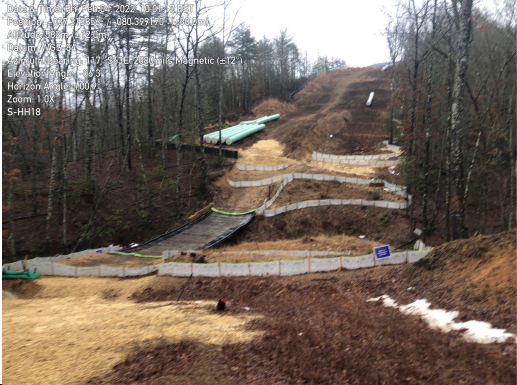
GPS Location	On photo	GPS Location	On photo		
Field Station#	11626+04	Field Station#	11618+00		
Pic 7 Desc.	The S-HH18 crossing is stable.	Pic 8 Desc.	Slope drain and sump functioning properly.

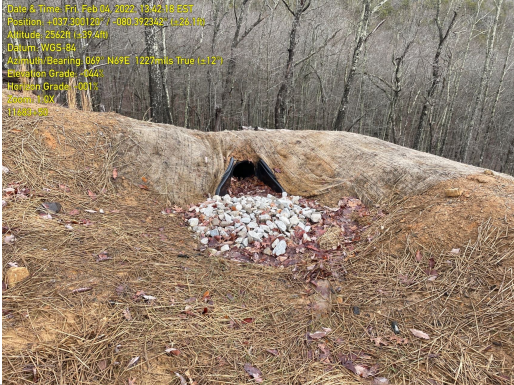
GPS Location	See photo	GPS Location	See photo		
Field Station#	11683+50	Field Station#	11688+00		
Pic 3 Desc.	Stone inlet protection in place	Pic 4 Desc.	Erosion control blanket in place

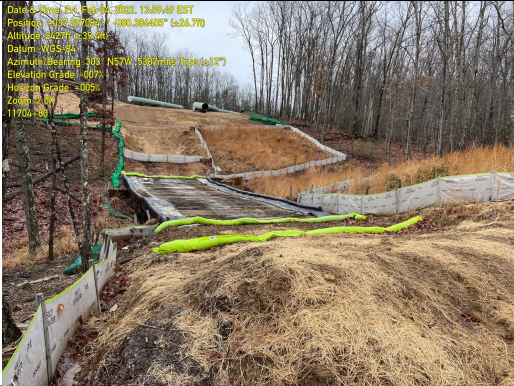
GPS Location	See photo	GPS Location	See photo		
Field Station#	11704+80	Field Station#	11712+00		
Pic 5 Desc.	Sediment filter logs in place	Pic 6 Desc.	Waterbars in place

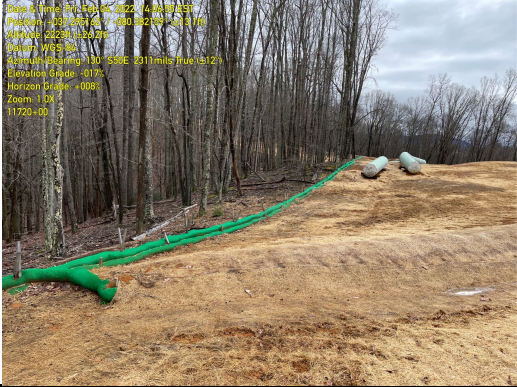
GPS Location	See photo	GPS Location	See photo		
Field Station#	11749+00	Field Station#	11766+25		
Pic 9 Desc.	CFS triple stack end treatments in place	Pic 10 Desc.	RCE in place		
<p><small>Date & Time: Fri, Feb 04, 2022, 11:04:13 EST Position: +037.294407° / -080.363942° (±12.1M) Altitude: 2099M (±26.2M) Datum: WGS-84 Azimuth/Bearing: 229° S49W 4071mils True (±12°) Elevation Grade: +024 Horizon Grade: +010 Zoom: 1.0X 11775+00</small></p>

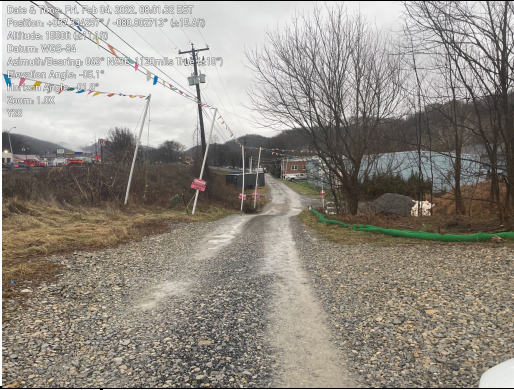
<p>Date & Time: Fri, Feb 04, 2022, 06:01:11 EST Position: +48° 29' 24.92" / -90.93371° (-90.93) Altitude: 18470 (-11.50) Datum: WGS-84 Admbr/Bearing: 165° 28' 33" (304m True (-10°) Elevation Angle: -35.1° Horizon Angle: -00.0° Zoom: 1.0X Y28</p>			
GPS Location	See photo	GPS Location	See photo		
Field Station#	12005+00	Field Station#	12005+00		
Pic 1 Desc.	AR in good condition	Pic 2 Desc.	CFS perimeter controls in place

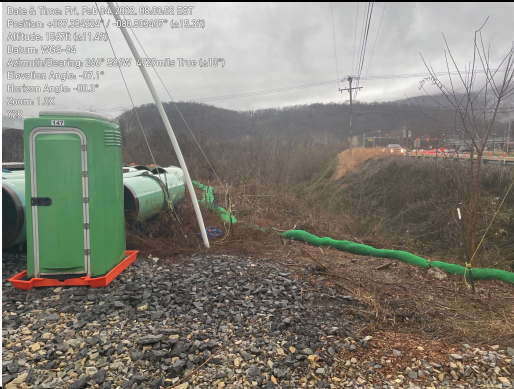
GPS Location	See photo	GPS Location	See photo		
Field Station#	12005+00	Field Station#	12005+00		
Pic 3 Desc.	CFS perimeter controls in place	Pic 4 Desc.	Housekeeping in good condition

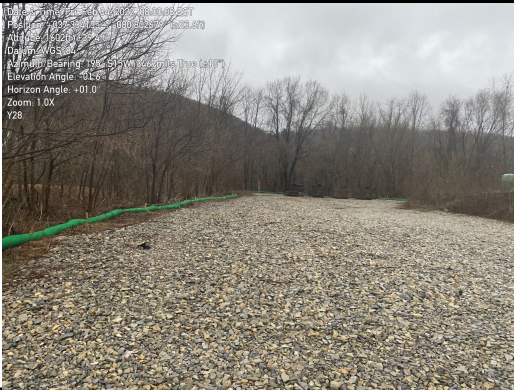
<p>Date & Time: Fri, Feb 04, 2022, 06:00:57 EST Position: +48° 29' 24.92" / -90.93371° (-90.93) Altitude: 18470 (-11.50) Datum: WGS-84 Admbr/Bearing: 165° 28' 33" (304m True (-10°) Elevation Angle: -35.1° Horizon Angle: -00.0° Zoom: 1.0X Y28</p>			
GPS Location	See photo	GPS Location	See photo		
Field Station#	12005+00	Field Station#	12005+00		
Pic 5 Desc.	CFS perimeter controls functional	Pic 6 Desc.	RCE functional

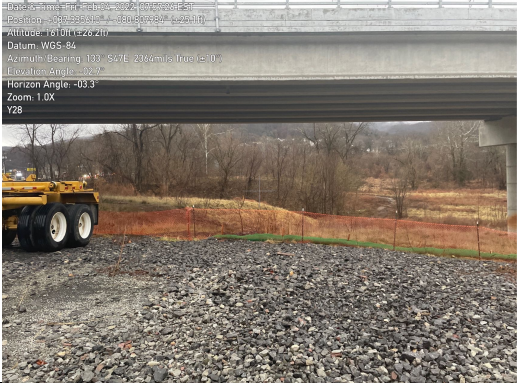
Insert image here	
GPS Location	See photo	GPS Location			
Field Station#	12005+00	Field Station#			
Pic 7 Desc.	CFS perimeter & safety fence in place	Pic 8 Desc.			
Insert image here		Insert image here			
GPS Location		GPS Location			
Field Station#		Field Station#			
Pic 9 Desc.		Pic 10 Desc.			
Insert image here		Insert image here			
GPS Location		GPS Location			
Field Station#		Field Station#			
Pic 11 Desc.		Pic 12 Desc.
