Visual Site Inspection Report

Project Name	H-600 Pipeline Spread G	AFE	124300137	Spread	H-600 Pipeline Spread G
Contractor	Precision			Report #	32221
Inspector	Clint Sears			Date/Time	12/13/2021 1:20 PM
Permit #	TBD	Inspection Type	VA SWPP	Station Begin	10929+80
State	VA	Inspection Area	Full	Station End	11023+80
County	Giles	Ground	Wet	Temperature (°F)	55.00
Municipality	N/A	Weather	Sunny	Rain Gauge (in)	0.30
				Rain Accumulation Time (days)	1.00

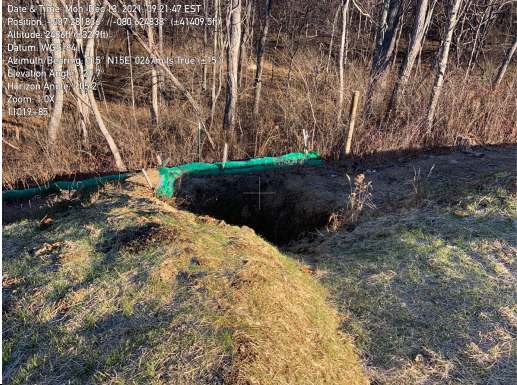
<p>Insert image here</p>		
GPS Location	See photo	GPS Location			
Field Station#	11019+85	Field Station#			
Pic 7 Desc.	Sump pit and CFS perimeter controls are in acceptable condition	Pic 8 Desc.			
<p>Insert image here</p>		<p>Insert image here</p>			
GPS Location		GPS Location			
Field Station#		Field Station#			
Pic 9 Desc.		Pic 10 Desc.			
<p>Insert image here</p>		<p>Insert image here</p>			
GPS Location		GPS Location			
Field Station#		Field Station#			
Pic 11 Desc.		Pic 12 Desc.

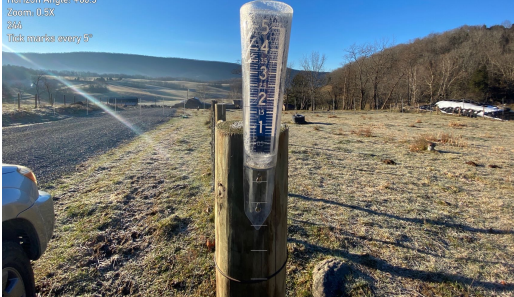
GPS Location	See Photo	GPS Location	See Photo		
Field Station#	11023+80	Field Station#	11023+80		
Pic 1 Desc.	.3 inches of rain in gauged 244	Pic 2 Desc.	Land owner disturbance on and off of LOD. Crews need to stabilize within LOD		
<p>Date & Time: Mon, Dec 13, 2021, 09:27:28 EST Position: +037 326777 / -080 552611 (+232.4ft) Altitude: 2412ft (+73.9m) Datum: WGS 84 Azimuth Bearing: 098 N09E 0911mils True (+14.1) Elevation Angle: +00.2 Horizon Angle: +01.9 Zoom: 0.5x S 1018 11025+54 Tick marks every 5"</p>

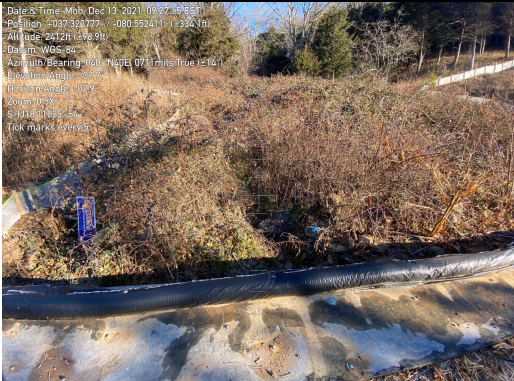
GPS Location	See Photo	GPS Location	See Photo		
Field Station#	11025+54	Field Station#	11026+00		
Pic 3 Desc.	S-IJ18	Pic 4 Desc.	Remove construction materials from inside buffer		
<p>Date & Time: Mon, Dec 13, 2021, 09:30:06 EST Position: +037 311203 / -080 550921 (+286.3ft) Altitude: 2170ft (+53.0m) Datum: WGS 84 Azimuth Bearing: 037 N37E 0658mils True (+5.2) Elevation Angle: +03.3 Horizon Angle: +10.4 Zoom: 0.5x S 1018 11050+10 Tick marks every 5"</p>

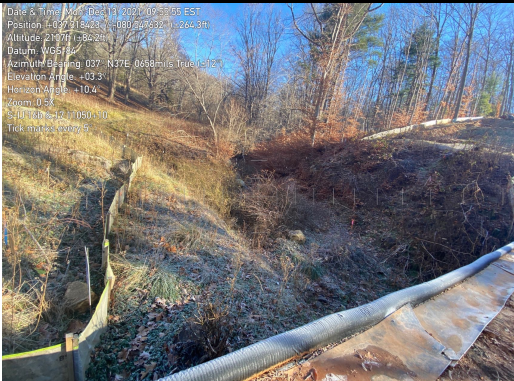
GPS Location	See Photo	GPS Location	See Photo		
Field Station#	11050+10	Field Station#	11084+50		
Pic 5 Desc.	Stream S-IJ16b & 17	Pic 6 Desc.	Overview showing conditions and controls

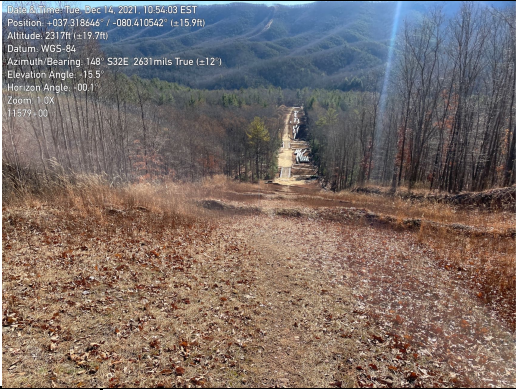
<p>Date & Time: Tue, Dec 14, 2021, 10:43:34 EST Position: +037.321044 / -080.412877 (±15.9ft) Altitude: 2525ft (±11.1ft) Datum: WGS-84 Azimuth/Bearing: 130.530E 2311mils True (±12.1) Elevation Angle: -31.1 Horizon Angle: -05.3 Zoom: 1.0x 11567+97</p>			
GPS Location	See photo	GPS Location	See photo		
Field Station#	11579+00	Field Station#	11567+97		
Pic 1 Desc.	Water bars in place	Pic 2 Desc.	Equipment bridge in place

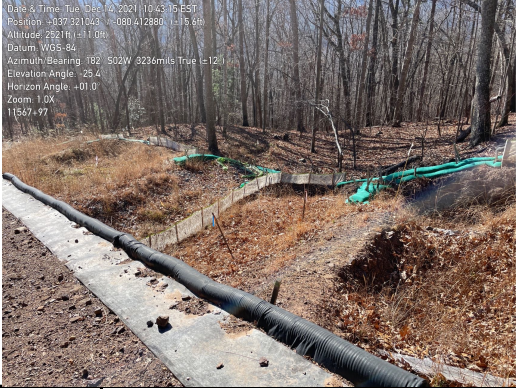
GPS Location	See photo	GPS Location	See photo		
Field Station#	11567+97	Field Station#	11583+42		
Pic 3 Desc.	Buffers in place	Pic 4 Desc.	ET functional

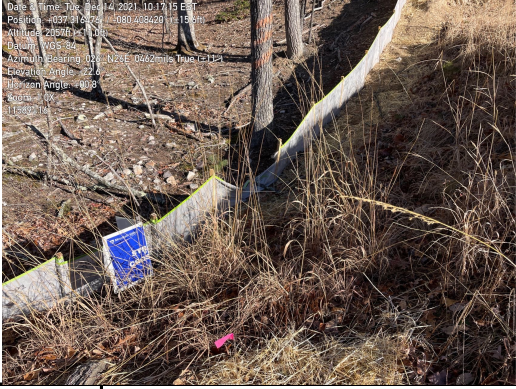
<p>Date & Time: Tue, Dec 14, 2021, 10:06:04 EST Position: +037.314224 / -080.406547 (±14.2ft) Altitude: 1970ft (±13.3ft) Datum: WGS-84 Azimuth/Bearing: 147.533E 2613mils True (±12.1) Elevation Angle: -14.1 Horizon Angle: -01.2 Zoom: 1.0x 11598+00</p>			
GPS Location	See photo	GPS Location	See photo		
Field Station#	11589+16	Field Station#	11598+00		
Pic 5 Desc.	P1 damaged	Pic 6 Desc.	RCE functional

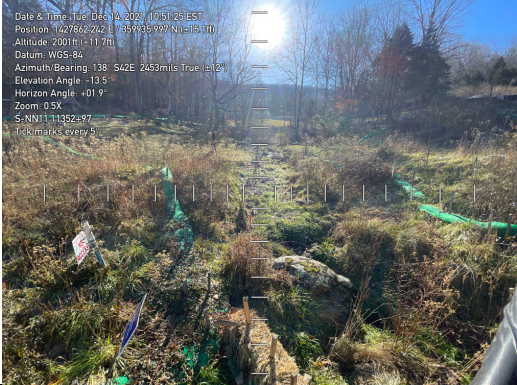
GPS Location	7	GPS Location	8		
Field Station#	11351+25	Field Station#	11352+97		
Pic 7 Desc.	Section of RoW showing conditions and controls.		Pic 8 Desc.	S-NN11 and controls.	
Insert image here		Insert image here			
GPS Location		GPS Location			
Field Station#		Field Station#			
Pic 9 Desc.		Pic 10 Desc.			
Insert image here		Insert image here			
GPS Location		GPS Location			
Field Station#		Field Station#			
Pic 11 Desc.		Pic 12 Desc.

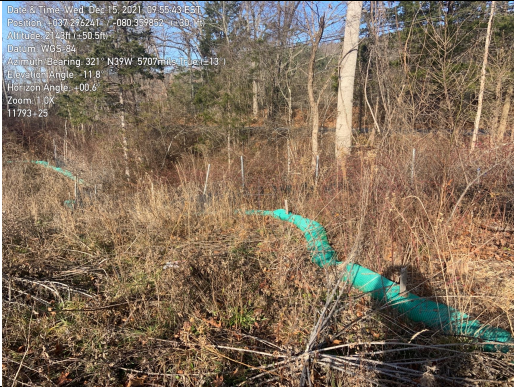
<p>Date & Time: Wed Dec 15 2021 1:54:18 EST Position: 43° 22' 21" N 76° 59' 55" W Altitude: 2223 ft (678 m) Datum: WGS 84 Azimuth Bearing: 164° N64°E 138 m to Tree (10') Elevation Angle: -05.0° Horizontal Angle: -00.7° Zoom: 1.0x 11819+56</p>			
GPS Location	See photo	GPS Location	See photo		
Field Station#	11793+25	Field Station#	11819+56		
Pic 1 Desc.	CFS perimeter controls in place	Pic 2 Desc.	Adequate vegetation

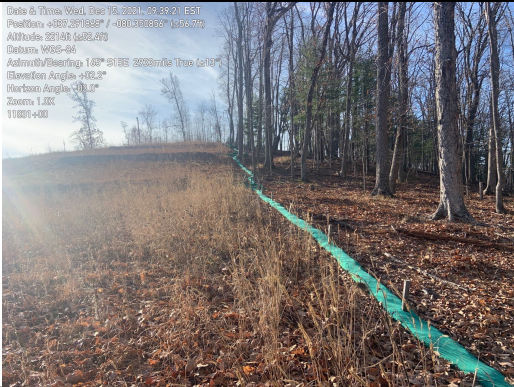
GPS Location	See photo	GPS Location	See photo		
Field Station#	11831+00	Field Station#	11854+00		
Pic 3 Desc.	CFS perimeter controls are in acceptable condition	Pic 4 Desc.	Permanent water bars and level spreader are in acceptable condition

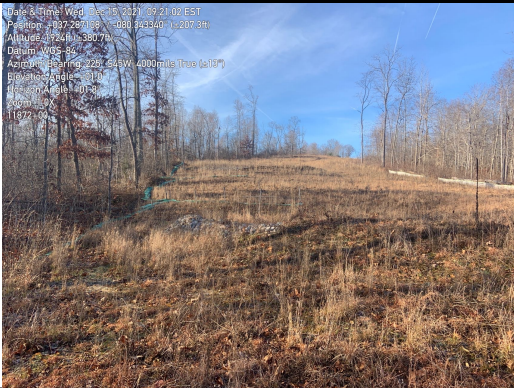
<p>Date & Time: Wed Dec 15 2021 1:59:04 EST Position: 43° 27' 23.7" N 76° 58' 34.6" W Altitude: 2176 ft (663 m) Datum: WGS 84 Azimuth Bearing: 124° S14°E 293 m to Tree (10') Elevation Angle: -05.2° Horizontal Angle: -02.7° Zoom: 1.0x 11882+15</p>			
GPS Location	See photo	GPS Location	See photo		
Field Station#	11872+00	Field Station#	11882+15		
Pic 5 Desc.	Permanent water bars and perimeter controls are in acceptable condition	Pic 6 Desc.	P1 silt fence is in acceptable condition

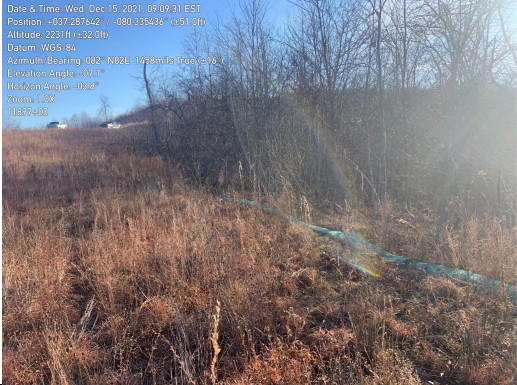
GPS Location	See photo	GPS Location			
Field Station#	11897+00	Field Station#			
Pic 7 Desc.	CFS perimeter controls are in place	Pic 8 Desc.			
Insert image here		Insert image here			
GPS Location		GPS Location			
Field Station#		Field Station#			
Pic 9 Desc.		Pic 10 Desc.			
Insert image here		Insert image here			
GPS Location		GPS Location			
Field Station#		Field Station#			
Pic 11 Desc.		Pic 12 Desc.

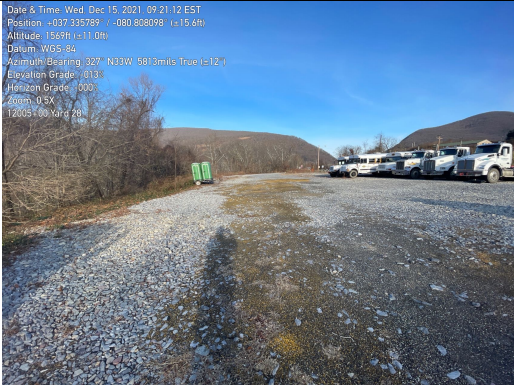
<p>Date & Time: Wed Dec 15 2021 09:20:43 EST Position: +037 333769 / -080 808098 (s:15.4ft) Altitude: 1555ft (s:11.0ft) Datum: WGS 84 Azimuth Bearing: 327° N33W 5813mils True (s:12.1) Elevation Grade: -0.13% Horizon Grade: 1000 Zoom: 0.5X 12005+00 Yard 28</p>			
GPS Location	See Photo	GPS Location	See Photo		
Field Station#	12005+00	Field Station#	12005+00		
Pic 1 Desc.	RCE requiring maintenance	Pic 2 Desc.	Perimeter CFS requiring maintenance/replacement.

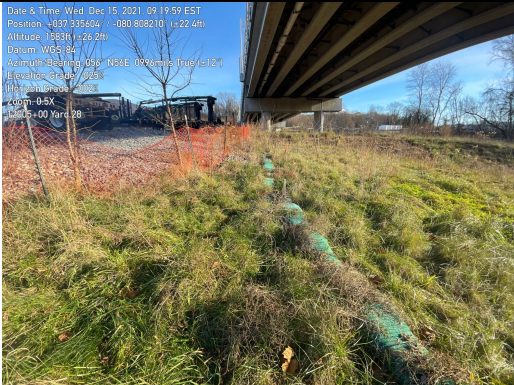
GPS Location	See Photo	GPS Location			
Field Station#	12005+00	Field Station#			
Pic 3 Desc.	Perimeter CFS requiring maintenance/replacement	Pic 4 Desc.			
<p style="text-align: center;">Insert image here</p>		<p style="text-align: center;">Insert image here</p>			
GPS Location		GPS Location			
Field Station#		Field Station#			
Pic 5 Desc.		Pic 6 Desc.

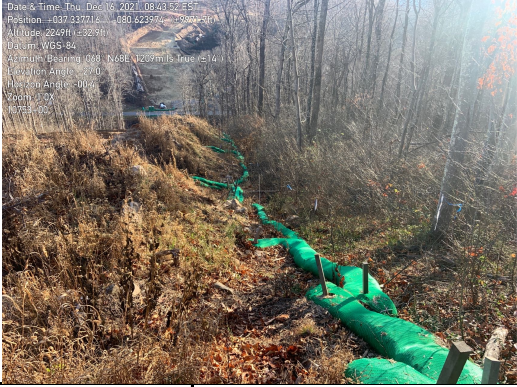
<p>Insert image here</p>			
GPS Location	See photo	GPS Location			
Field Station#	10753+00	Field Station#			
Pic 7 Desc.	CFS perimeter controls are in acceptable condition in this area	Pic 8 Desc.			
<p>Insert image here</p>		<p>Insert image here</p>			
GPS Location		GPS Location			
Field Station#		Field Station#			
Pic 9 Desc.		Pic 10 Desc.			
<p>Insert image here</p>		<p>Insert image here</p>			
GPS Location		GPS Location			
Field Station#		Field Station#			
Pic 11 Desc.		Pic 12 Desc.

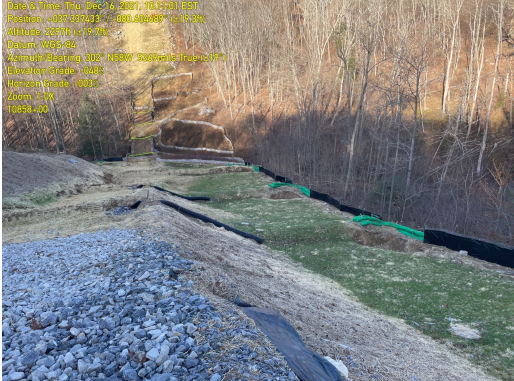
<p>Date & Time: Thu, Dec 16, 2021, 10:54:11 EST Position: +037 241807 / -080 669477 (s43.3N) Altitude: 2622ft (s79.7m) Datum: WGS 84 Azimuth/Bearing: 101° N089° 010mils True (s12°) Elevation Grade: -03% Horizon Grade: -00% Zoom: 1.0X 10854+00</p>			
GPS Location		See photo		GPS Location	
Field Station#		10858+00		Field Station#	
Pic 1 Desc.		End treatments in place		Pic 2 Desc.

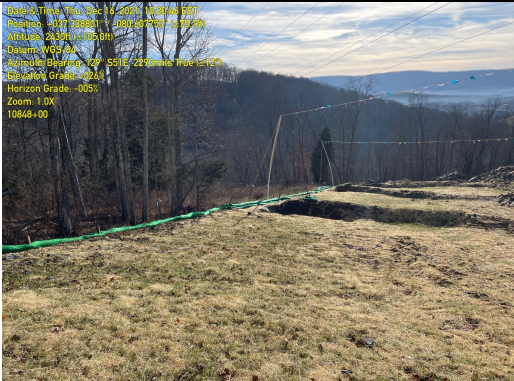
GPS Location		See photo		GPS Location	
Field Station#		10848+00		Field Station#	
Pic 3 Desc.		CFS perimeter control in place		Pic 4 Desc.

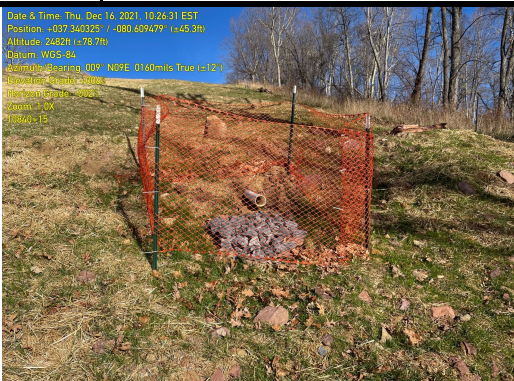
<p>Date & Time: Thu, Dec 16, 2021, 10:30:41 EST Position: +037 241807 / -080 669477 (s43.3N) Altitude: 2622ft (s79.7m) Datum: WGS 84 Azimuth/Bearing: 200° S06W 4729mils True (s12°) Elevation Grade: -03% Horizon Grade: -00% Zoom: 1.0X 10833+00</p>			
GPS Location		See photo		GPS Location	
Field Station#		10840+15		Field Station#	
Pic 5 Desc.		Daylight drain in place		Pic 6 Desc.

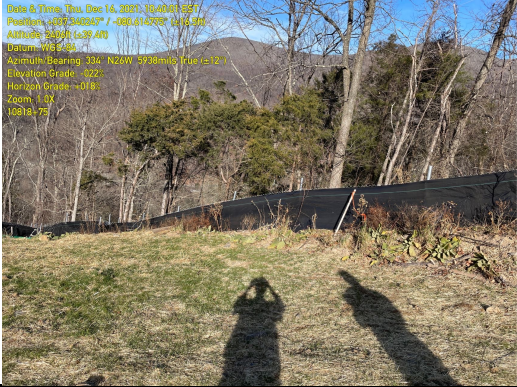
GPS Location	See photo	GPS Location	See photo		
Field Station#	10818+75	Field Station#	10816+00		
Pic 7 Desc.	Supersilt fence perimeter control in place	Pic 8 Desc.	Waterbars in place		
<p>Date & Time: Thu, Dec 16, 2021, 10:44:00 EST Position: +38°34'03.45" / -80°41'52.00" Is15.402 Altitude: 2250ft ±11.000 Datum: WGS-84 Azimuth/Bearing: 277° N83W 49.222222 True ±11° Elevation Grade: -02% Horizon Grade: -00% Zoom: 1.0X 10815+00</p>

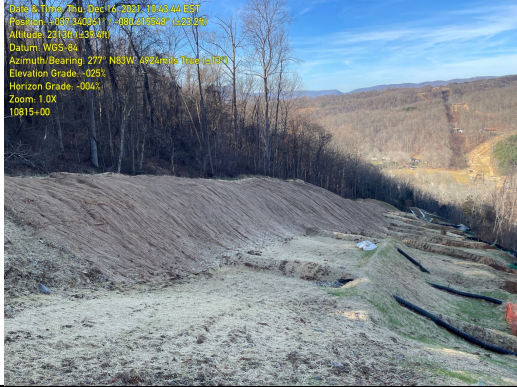
GPS Location	See photo	GPS Location	See photo		
Field Station#	10815+00	Field Station#	10812+50		
Pic 9 Desc.	Erosion control blanket in place	Pic 10 Desc.	Cleanwater diversion outlet protection in place		
<p>Date & Time: Thu, Dec 16, 2021, 10:45:07 EST Position: +38°34'03.45" / -80°41'52.00" Is15.402 Altitude: 2250ft ±11.000 Datum: WGS-84 Azimuth/Bearing: 336° N26W 39.886666 True ±12° Elevation Grade: -02% Horizon Grade: -01% Zoom: 1.0X 10808+15</p>

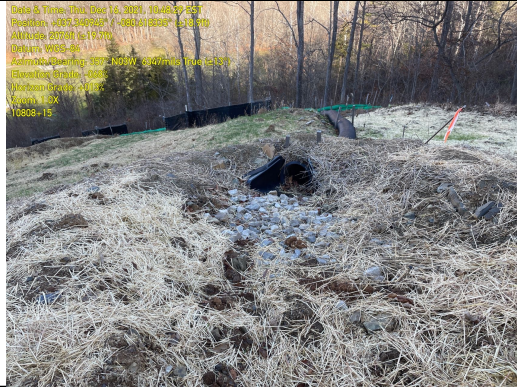
<p>Date & Time: Thu, Dec 16, 2021, 10:45:07 EST Position: +38°34'03.45" / -80°41'52.00" Is15.402 Altitude: 2250ft ±11.000 Datum: WGS-84 Azimuth/Bearing: 336° N26W 39.886666 True ±12° Elevation Grade: -02% Horizon Grade: -01% Zoom: 1.0X 10803+00</p>  			
GPS Location	See photo	GPS Location	See photo		
Field Station#	10808+15	Field Station#	10803+00		
Pic 11 Desc.	Stone inlet protection in place	Pic 12 Desc.	RCE in place

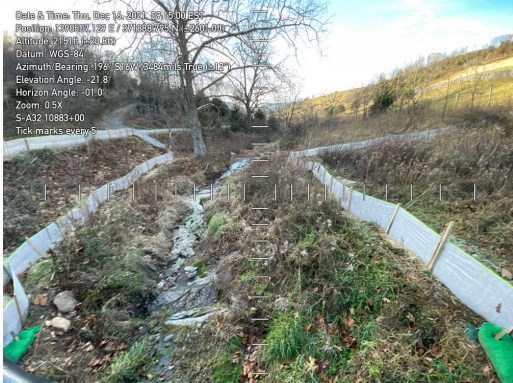
GPS Location 1		GPS Location 2			
Field Station# 10883+00		Field Station# 10927+75			
Pic 1 Desc. S-A32 and controls.		Pic 2 Desc. S-Y3 and controls.

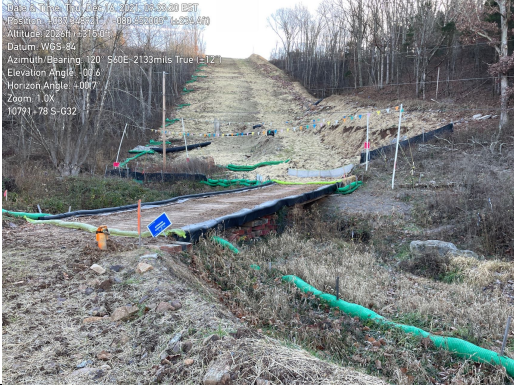
<p>Date & Time: Thu, Dec 16, 2021, 09:00:00 EST Position: +037 349332 / +080 653269 (+15.4ft) Altitude: 2045ft (+10.9ft) Datum: WGS-84 Azimuth/Bearing: 299 NW 5209mils true (+13°) Elevation Angle: +1.74 Horizon Angle: +00.3 Zoom: 1.0x 10712+63</p>			
GPS Location	See photo	GPS Location	See photo		
Field Station#	10791+78	Field Station#	10712+63		
Pic 1 Desc.	Equipment bridge functional	Pic 2 Desc.	Wattles & P1 functional

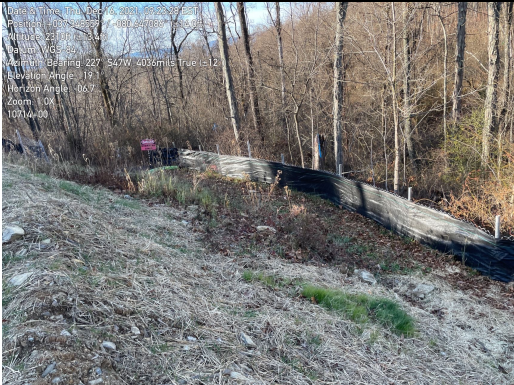
GPS Location	See photo	GPS Location	See photo		
Field Station#	10714+00	Field Station#	10694+54		
Pic 3 Desc.	SSF functional	Pic 4 Desc.	Clean water drainage feature functional

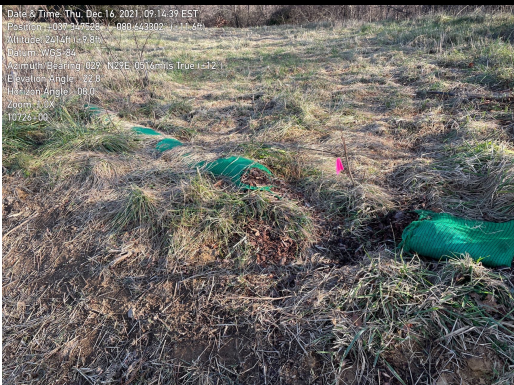
7. Identify all remedial measures that have been taken since the previous inspection was conducted.					
Comments (Reference above questions as appropriate.)					
Completed a VA SWPPP inspection from ST# 10655+00 (MP 201.6) to ST# 10749+92 (MP 203.6). Compliance issues noted: @ 10726+00 CFS damaged & needs triangle dike put in place. Observance: Perimeter controls in place and functional ROW has been temporary stabilized. No areas with open ditch. All other ECDs and BMPs functional at time of inspection. 50' buffers in place at stream crossings S-G33, S-G32, S-G30 and W-Z11. AR-240, 241.04, 241.01, 241, Hendrickson and Big Stony creek road crossing RCEs are maintained in acceptable condition. Buffalo Anklets rain gauge measured 0.0" of rainfall accumulated on 12/16/21. The ROW is dry and in stable condition. No sensitive resources have been impacted.					
Note: It is a condition of National Pollutant Discharge Elimination System and Erosion and Sediment permits that a maintenance program be conducted to provide for the operation and maintenance of all BMPs to be inspected on a weekly basis and after each stormwater event. Please list in the space provided comments to note if repairs or replacement are needed or have been made for BMPs as a result of the inspection. Failure to conduct the required inspection may result in permit suspension or the imposition of civil penalties. If supplemental monitoring is required as part of a permit condition this form may be used to meet those monitoring requirements.

<p>Date & Time: Thu, Dec 16, 2021, 09:12:38 EST Position: +037 349324 / +080 643070 (+15.1ft) Altitude: 2379ft (+11.7ft) Datum: WGS-84 Azimuth/Bearing: 325 N35W 5778mils true (+12°) Elevation Angle: +03.3 Horizon Angle: +01.8 Zoom: 1.0x 10728+00</p>			
GPS Location	See photo	GPS Location	See photo		
Field Station#	10726+00	Field Station#	10728+00		
Pic 5 Desc.	Perimeter CFS is damaged do to land owner travel. Needs replaced with triangle dike.	Pic 6 Desc.	Temporary stabilization functional

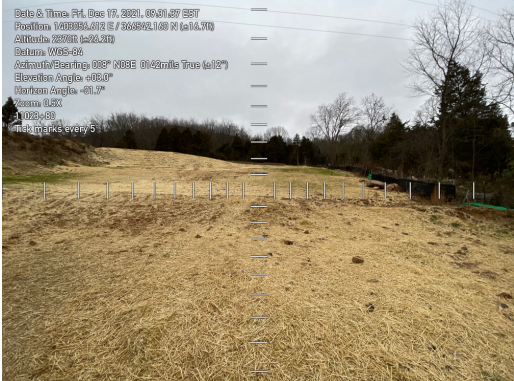
GPS Location	1	GPS Location	2		
Field Station#	11023+80	Field Station#	11025+54		
Pic 1 Desc.	Section of RoW showing conditions and controls.	Pic 2 Desc.	S-IJ18.

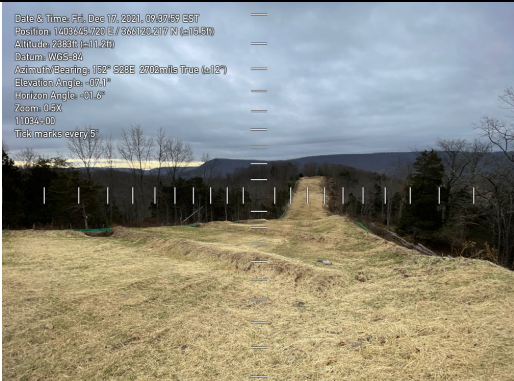
GPS Location	3	GPS Location	4		
Field Station#	11034+00	Field Station#	11071+80		
Pic 3 Desc.	Section of RoW showing conditions and controls.	Pic 4 Desc.	Section of RoW showing conditions and controls.

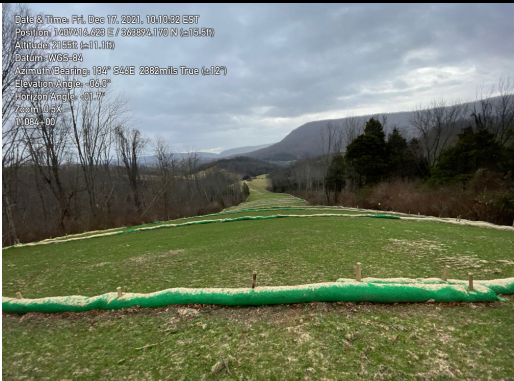
GPS Location	5	GPS Location	6		
Field Station#	11084+00	Field Station#	11098+47		
Pic 5 Desc.	Section of RoW showing conditions and controls.	Pic 6 Desc.	Section of RoW showing conditions and controls.

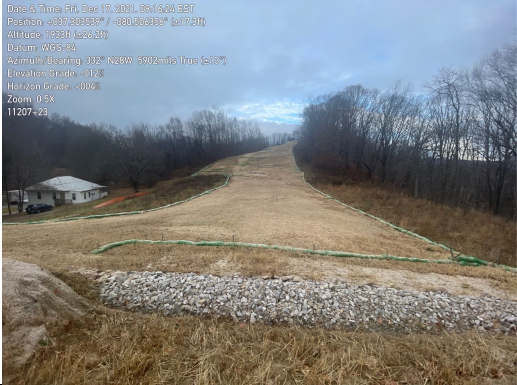
GPS Location	See photo	GPS Location	See photo		
Field Station#	11207+23	Field Station#	11245+00		
Pic 7 Desc.	Permanent water bars in place	Pic 8 Desc.	Water bars in place and functional		
<p>Date & Time: Fri, Dec 17, 2021, 09:14:15 EST Position: +037.298276° / -080.496997° (±14.0m) Altitude: 2228ft (±14.4ft) Datum: WGS-84 Azimuth/Bearing: 132° S48E 2347mils True (±12°) Elevation Angle: -23.7° Horizon Angle: -00.2° Zoom: 1.0X 11243+00</p>  		<p>Date & Time: Fri, Dec 17, 2021, 09:08:29 EST Position: +037.299187° / -080.498215° (±14.0m) Altitude: 2244ft (±13.4ft) Datum: WGS-84 Azimuth/Bearing: 309° N51W 5493mils True (±12°) Elevation Angle: -27.6° Horizon Angle: -04.7° Zoom: 1.0X 11239+00</p>

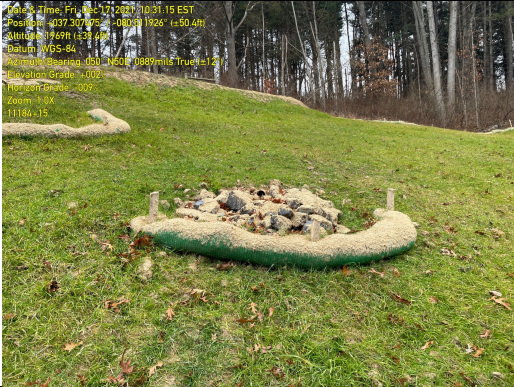
<p>Date & Time Fri, Dec 17, 2021, 10:33:48 EST Position: +027.310597° / -080.514314° (±15.1m) Altitude: 1849ft (±11.7m) Datum: WGS-84 Azimuth/Bearing: 209° S29W 3714mils True (±12°) Elevation Grade: +007% Horizontal Grade: +000% Zoom: 1.00 11184+00</p>			
GPS Location	See photo		GPS Location	See photo	
Field Station#	11184+15		Field Station#	11168+00	
Pic 1 Desc.	Daylight drain in place		Pic 2 Desc.	RCE in place

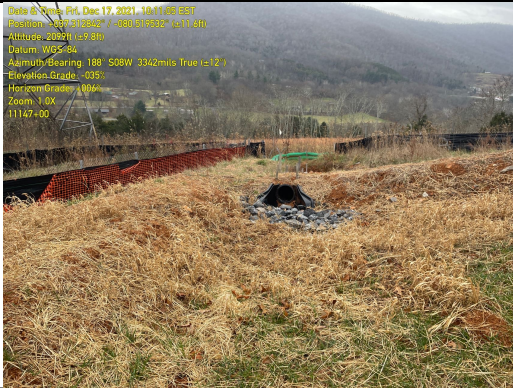
<p>Date & Time Fri, Dec 17, 2021, 10:17:08 EST Position: +027.311825° / -080.519522° (±11.2m) Altitude: 2039ft (±9.8m) Datum: WGS-84 Azimuth/Bearing: 188° S08W 3342mils True (±12°) Elevation Grade: -035% Horizontal Grade: +004% Zoom: 1.00 11147+00</p>			
GPS Location	See photo		GPS Location	See photo	
Field Station#	11148+50		Field Station#	11147+00	
Pic 5 Desc.	Supersilt fence perimeter control in place		Pic 6 Desc.	Stone inlet protection in place

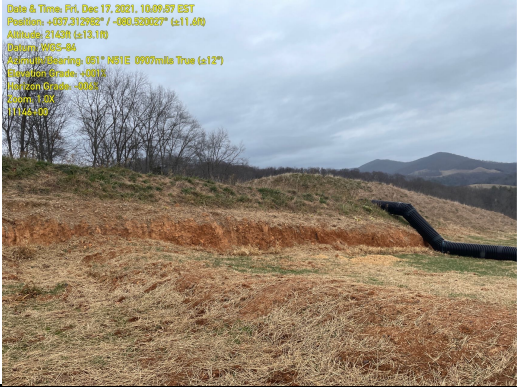
GPS Location		See photo		GPS Location	
Field Station#		11146+00		Field Station#	
Pic 7 Desc.		Cleanwater diversion berm in place		Pic 8 Desc.	
<p>Date & Time: Fri, Dec 17, 2021, 09:36:58 EST Position: +037.315430° / -060.527050° (s17.40) Altitude: 19028 (s26.20) Datum: WGS-84 Azimuth/Bearing: 300° MAGW 0333mils True (s12°) Elevation Grade: +02% Horizon Grade: -00% Zoom: 1.0X 11118+00</p>

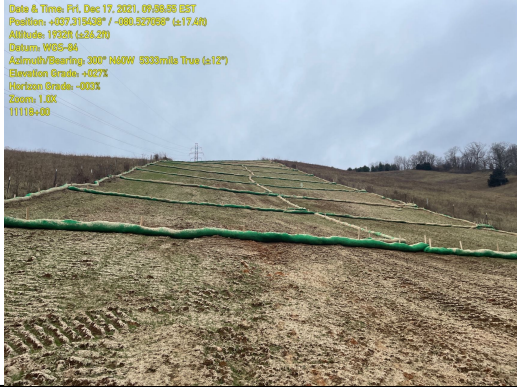
GPS Location		See photo		GPS Location	
Field Station#		11118+00		Field Station#	
Pic 9 Desc.		Temporary CFS waterbars		Pic 10 Desc.	
<p>Date & Time: Fri, Dec 17, 2021, 10:15:24 EST Position: +037.308902° / -060.515810° (s15.10) Altitude: 19116 (s11.70) Datum: WGS-84 Azimuth/Bearing: 094° S84E 1707mils True (s12°) Elevation Grade: -01% Horizon Grade: -00% Zoom: 1.0X 11178+00</p>

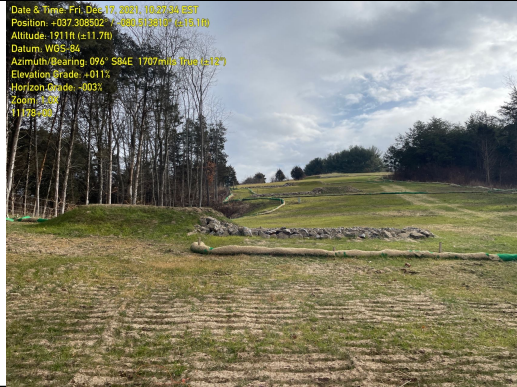
GPS Location		See photo		GPS Location	
Field Station#		11178+00		Field Station#	
Pic 11 Desc.		Level spreader in place		Pic 12 Desc.

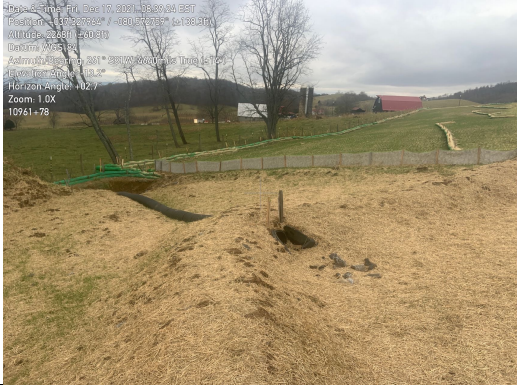
GPS Location	See photo	GPS Location	See photo		
Field Station#	10957+00	Field Station#	10961+78		
Pic 7 Desc.	CFS perimeter controls and CFS water bars are in place	Pic 8 Desc.	Stone inlet protection, slope drain pipe and sump pit are in place		
<p>Date & Time: Fri, Dec 17, 2021, 08:27:52 EST Position: +487.23382° / -080.87432° (+326.81) Altitude: 2251ft (+232.1ft) Datum: WGS-84 Azimuth/Bearing: 069° N69E 122°mils True (+2.1°) Elevation Angle: -02.0 Horizon Angle: -02.3 Zoom: 1.0X 10972+00</p>  		<p>Date & Time: Fri, Dec 17, 2021, 08:27:52 EST Position: +487.23382° / -080.87432° (+326.81) Altitude: 2251ft (+232.1ft) Datum: WGS-84 Azimuth/Bearing: 104° S74E 184°mils True (+16°) Elevation Angle: -17.1 Horizon Angle: -01.3 Zoom: 1.0X 10985+58</p>

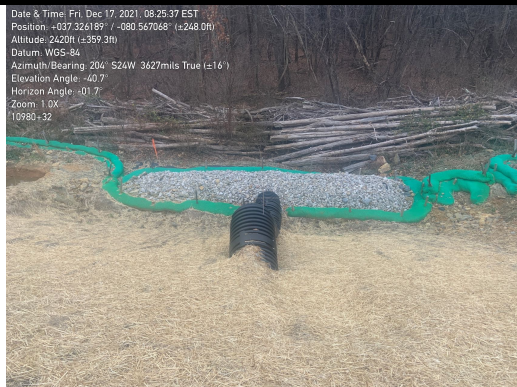
GPS Location	See photo	GPS Location	see photo		
Field Station#	10980+32	Field Station#	10977+29		
Pic 11 Desc.	Clean water diversion pipe and level spreader are in acceptable condition	Pic 12 Desc.	Erosion control blanket is in acceptable condition
