Visual Site Inspection Report

Project Name	H-600 Pipeline Spread G	AFE	124300137	Spread	H-600 Pipeline Spread G
Contractor	Precision			Report #	31916
Inspector	Eric Hanlon			Date/Time	12/6/2021 7:04 AM
Permit #	TBD	Inspection Type	VA SWPP	Station Begin	10655+00
State	VA	Inspection Area	Full	Station End	10749+92
County	Giles	Ground	Dry	Temperature (°F)	56.00
Municipality	N/A	Weather	Sunny	Rain Gauge (in)	0.00
				Rain Accumulation Time (days)	1.00

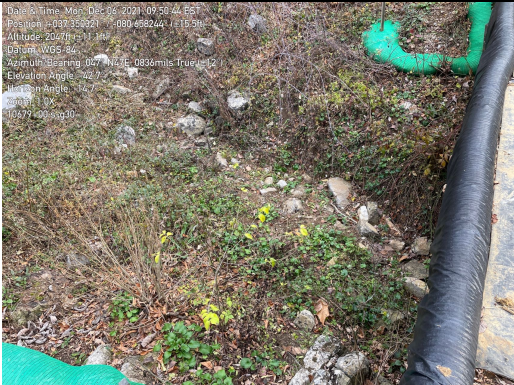
GPS Location	See photo	GPS Location	See photo		
Field Station#	10679+00	Field Station#	10679+00		
Pic 3 Desc.	S-G30 in good condition	Pic 4 Desc.	Equipment bridge functional

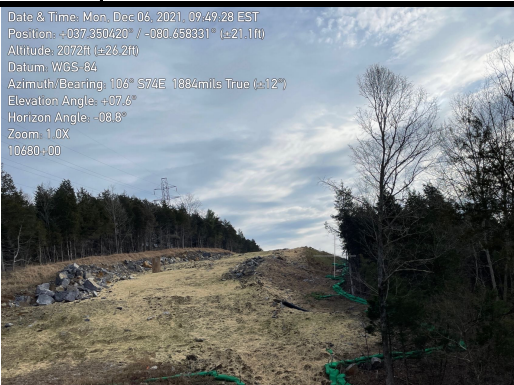
<p>Date & Time: Mon, Dec 06, 2021, 09:49:28 EST Position: +037.350420° / +080.659331° (±21.1ft) Altitude: 2178ft (±13.4ft) Datum: WGS-84 Azimuth/Bearing: 276° N84W 4907mils True (±12°) Elevation Angle: +02.4° Horizon Angle: +01.7° Zoom: 1.0X 10675+00</p>			
GPS Location	See photo	GPS Location	See photo		
Field Station#	10680+00	Field Station#	10675+00		
Pic 5 Desc.	CFS perimeter controls functional	Pic 6 Desc.	RCE functional

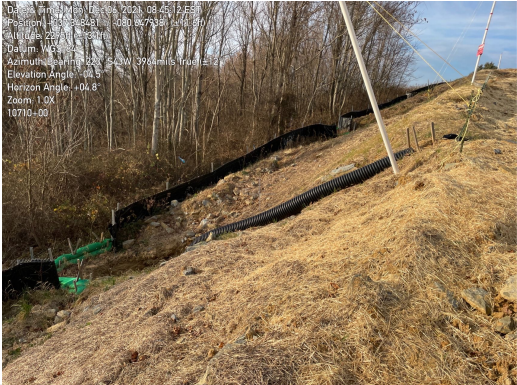
GPS Location	See photo	GPS Location	See photo		
Field Station#	10710+00	Field Station#	10713+00		
Pic 15 Desc.	SSF functional	Pic 16 Desc.	S-G33 in good condition

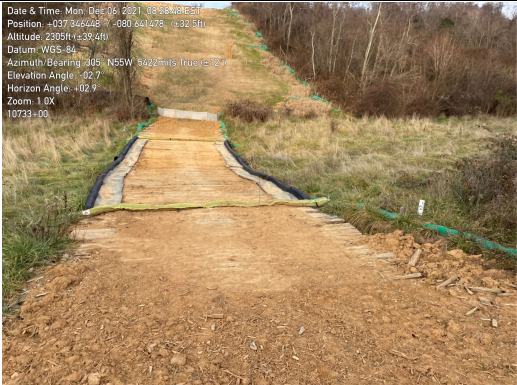
GPS Location	See photo	GPS Location	See photo		
Field Station#	10733+00	Field Station#	10742+69		
Pic 17 Desc.	W-Z11 in good condition	Pic 18 Desc.	Clean water drainage feature functional

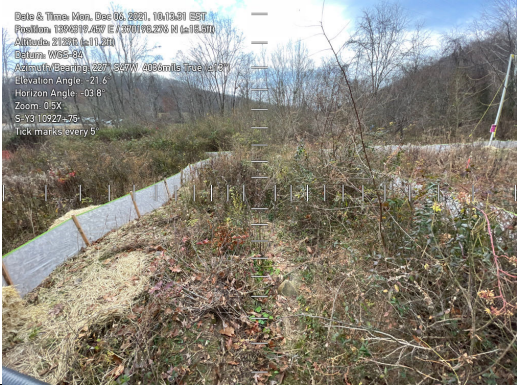
GPS Location	7	GPS Location	8		
Field Station#	10927+75	Field Station#	10929+50		
Pic 7 Desc.	S-Y3 and controls.	Pic 8 Desc.	S-Y2 and controls.		
Insert image here		Insert image here			
GPS Location		GPS Location			
Field Station#		Field Station#			
Pic 9 Desc.		Pic 10 Desc.			
Insert image here		Insert image here			
GPS Location		GPS Location			
Field Station#		Field Station#			
Pic 11 Desc.		Pic 12 Desc.

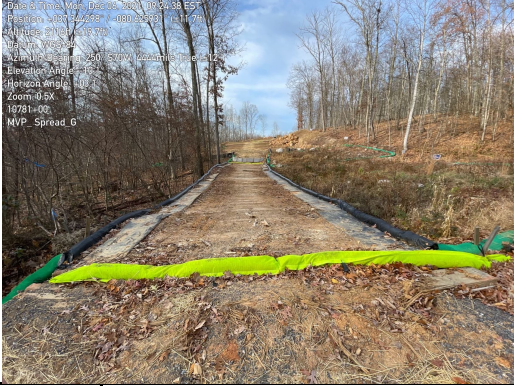
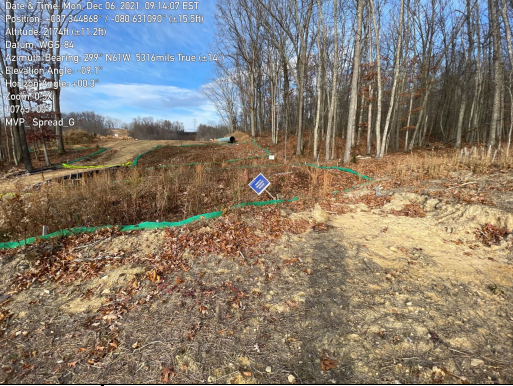
<p>Date & Time: Mon, Dec 06, 2021, 09:14:07 EST Position: +031.2447121, -080.631672, 19781+00 Altitude: 2065ft (1=32.4ft) Datum: WGS-84 Azimuth/Bearing: 289° NottW 5314mils True (2.5°) Elevation Angle: +0.1° Horizon Angle: +0.0° Zoom: 0.5X 19781+00 MVP Spread G</p>			
GPS Location	See photo		GPS Location	See photo	
Field Station#	10781+00		Field Station#	10765+00	
Pic 1 Desc.	Equipment bridge is maintained in acceptable condition		Pic 2 Desc.	Aquatic resource signage and buffer zones are in acceptable condition

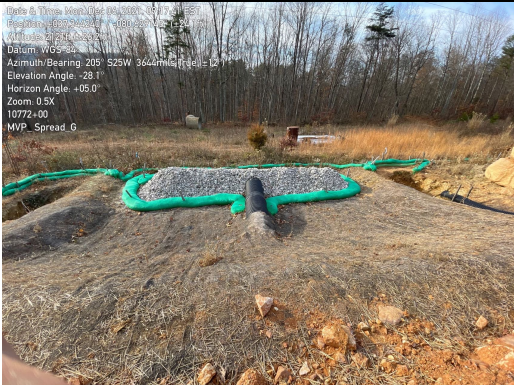
GPS Location	See photo		GPS Location	See photo	
Field Station#	10772+00		Field Station#	10758+00	
Pic 3 Desc.	Clean water diversion pipe and level spreader are in acceptable condition		Pic 4 Desc.	CFS perimeter controls and SSF are in acceptable condition

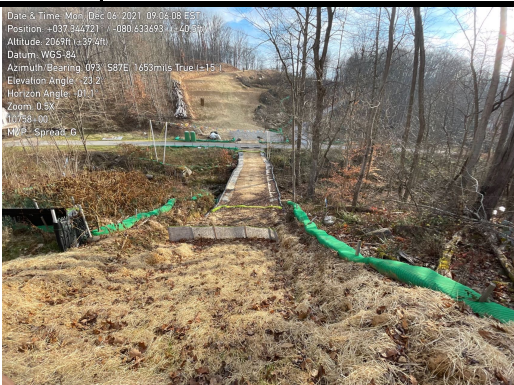
<p>Date & Time: Mon, Dec 06, 2021, 09:08:03 EST Position: +031.2447121, -080.631672, 19759+00 Altitude: 1987ft (1=19.7ft) Datum: WGS-84 Azimuth/Bearing: 253.573W 4498mils True (2=1°) Elevation Angle: +25.2° Horizon Angle: +00.4° Zoom: 0.5X 10759+00 MVP Spread G</p>			
GPS Location	See photo		GPS Location	See photo	
Field Station#	10758+00		Field Station#	10759+00	
Pic 5 Desc.	Temporary stabilization is acceptable		Pic 6 Desc.	RCE is maintained in acceptable condition

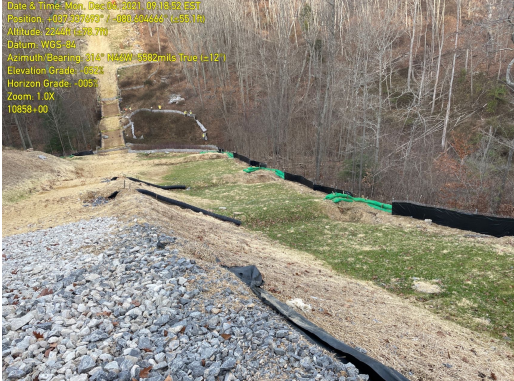
GPS Location	See photo	GPS Location	See photo		
Field Station#	10858+00	Field Station#	10855+00		
Pic 1 Desc.	End treatments in place	Pic 2 Desc.	Stream buffer in place		
<p>Date & Time Wed, Dec 08, 2021 09:33:53 EST Position: +003.33679° / -089.467702° (s23.22) Altitude: 2313ft (s19.7m) Datum: WGS-84 Azimuth Bearing: 314° 30'30" 2098mils True (s12.1) Elevation Grade: -003 Horizon Grade: -005 Zoom: 1.0X 10848+50</p>

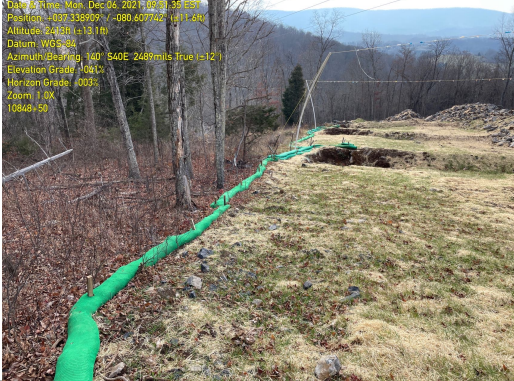
GPS Location	See photo	GPS Location	See photo		
Field Station#	10848+50	Field Station#	10843+25		
Pic 3 Desc.	CFS perimeter control in place	Pic 4 Desc.	Cleanwater diversion berm in place		
<p>Date & Time Wed, Dec 08, 2021 09:33:53 EST Position: +003.33679° / -089.467702° (s23.22) Altitude: 2313ft (s19.7m) Datum: WGS-84 Azimuth Bearing: 314° 30'30" 2098mils True (s12.1) Elevation Grade: -003 Horizon Grade: -005 Zoom: 1.0X 10840+35</p>

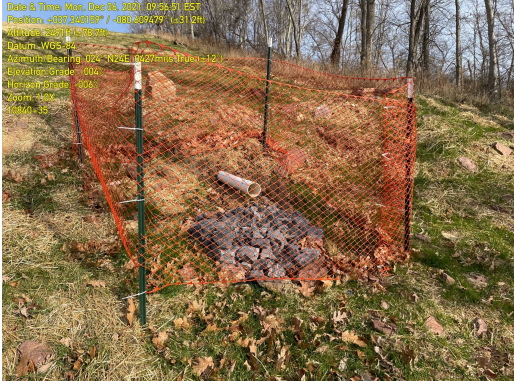
GPS Location	See photo	GPS Location	See photo		
Field Station#	10840+35	Field Station#	10833+00		
Pic 5 Desc.	Daylight drain in place	Pic 6 Desc.	Waterbars in place

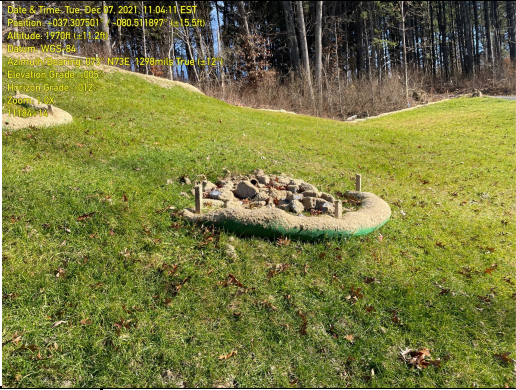
GPS Location	See photo	GPS Location	See photo		
Field Station#	11184+14	Field Station#	11168+00		
Pic 1 Desc.	Daylight drain in place	Pic 2 Desc.	RCE in place

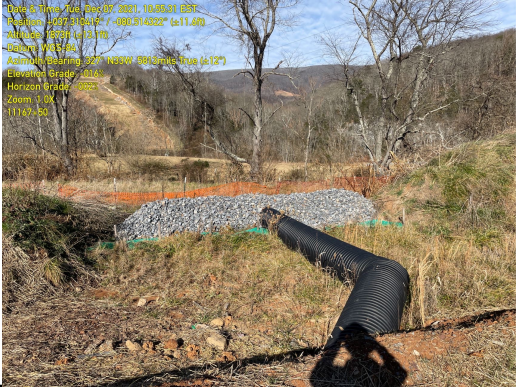
GPS Location	See photo	GPS Location	See photo		
Field Station#	11167+50	Field Station#	11163+00		
Pic 3 Desc.	Cleanwater diversion outlet protection in place	Pic 4 Desc.	P1 silt fence perimeter control in place

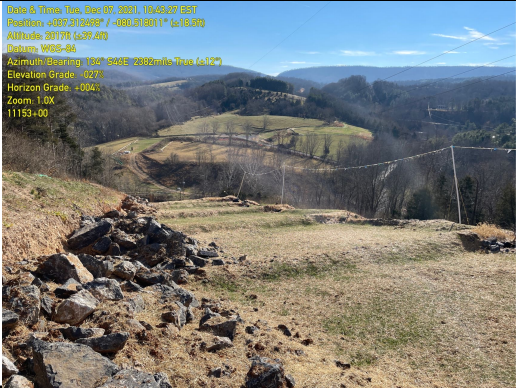
GPS Location	See photo	GPS Location	See photo		
Field Station#	11153+00	Field Station#	11148+00		
Pic 5 Desc.	Waterbars in place	Pic 6 Desc.	Supersilt fence perimeter control in place

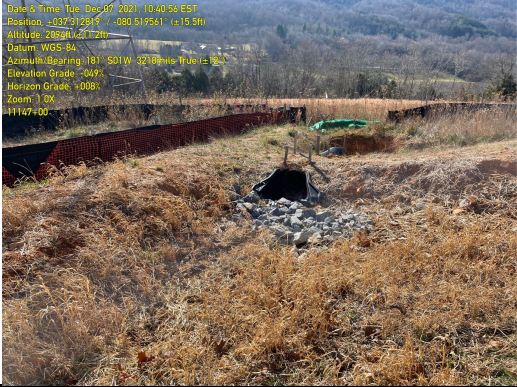
GPS Location	See photo	GPS Location	See photo		
Field Station#	11147+00	Field Station#	11146+00		
Pic 7 Desc.	Stone inlet protection in place	Pic 8 Desc.	Cleanwater diversion berm in place

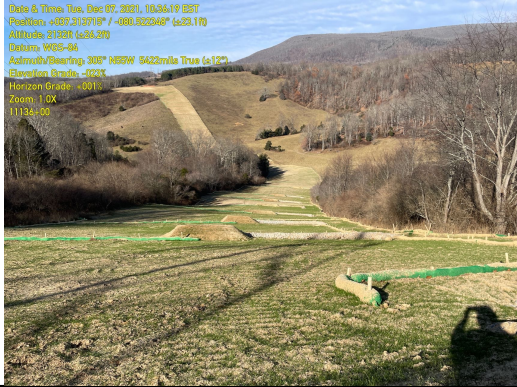
GPS Location	See photo	GPS Location	See photo		
Field Station#	11136+00	Field Station#	11120+00		
Pic 9 Desc.	Level spreaders in place	Pic 10 Desc.	CFS waterbars in place

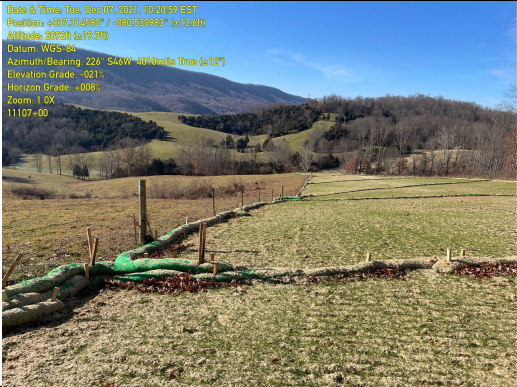
GPS Location	See photo	GPS Location	See photo		
Field Station#	11112+00	Field Station#	11107+00		
Pic 11 Desc.	CFS triple stack perimeter control in place	Pic 12 Desc.	CFS end treatments in place

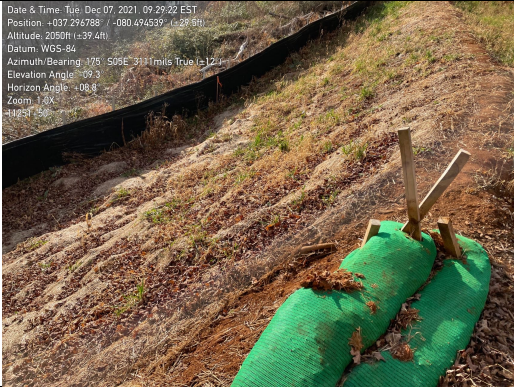
<p>Date & Time: Tue, Dec 07, 2021, 09:29:41 EST Position: -037.234782, -080.494539 (+29.9ft) Altitude: 2114ft (+19.7ft) Datum: WGS-84 Azimuth/Bearing: 130° S50E 2311mils True (+12°) Elevation Angle: -15.7 Horizon Angle: +00.2 Zoom: 1.0x 11248+00</p>			
GPS Location		See photo		GPS Location	
Field Station#		11251+50		Field Station#	
Pic 1 Desc.		SSF functional		Pic 2 Desc.	
				Temporary stabilization functional

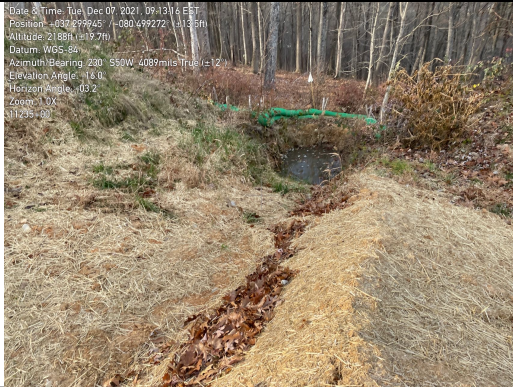
GPS Location		See photo		GPS Location	
Field Station#		11240+00		Field Station#	
Pic 3 Desc.		Rock inlet functional		Pic 4 Desc.	
				ET functional

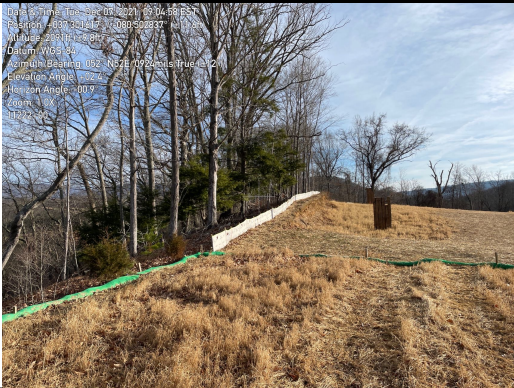
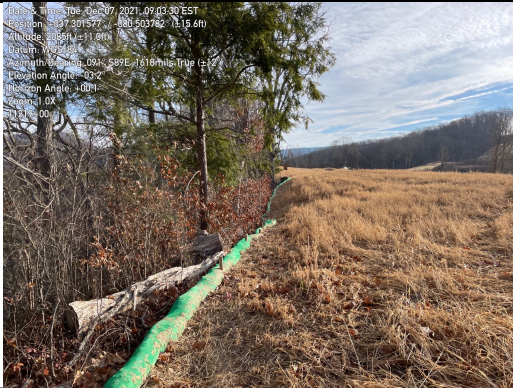
<p>Date & Time: Tue, Dec 07, 2021, 09:03:30 EST Position: -037.229060, -080.498272 (+15.1ft) Altitude: 2188ft (+9.7ft) Datum: WGS-84 Azimuth/Bearing: 094° S89E 1618mils True (+12°) Elevation Angle: -03.2 Horizon Angle: -00.1 Zoom: 1.0x 11219+00</p>			
GPS Location		See photo		GPS Location	
Field Station#		11222+00		Field Station#	
Pic 5 Desc.		P1 functional		Pic 6 Desc.	
				CFS perimeter controls functional

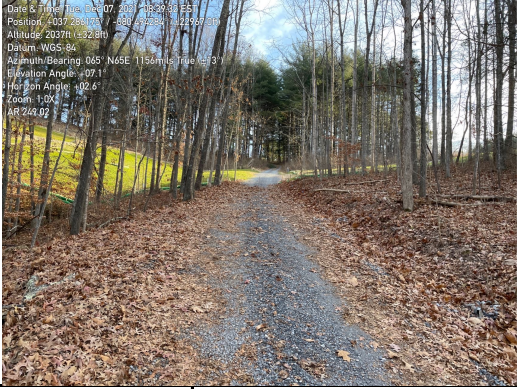
GPS Location	See photo	GPS Location			
Field Station#	11184+85	Field Station#			
Pic 13 Desc.	AR 249.02 in good condition	Pic 14 Desc.			
Insert image here		Insert image here			
GPS Location		GPS Location			
Field Station#		Field Station#			
Pic 15 Desc.		Pic 16 Desc.			
Insert image here		Insert image here			
GPS Location		GPS Location			
Field Station#		Field Station#			
Pic 17 Desc.		Pic 18 Desc.

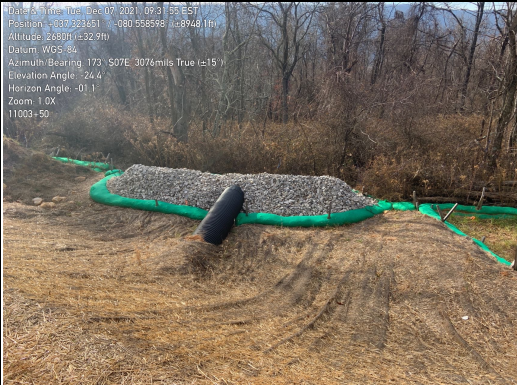
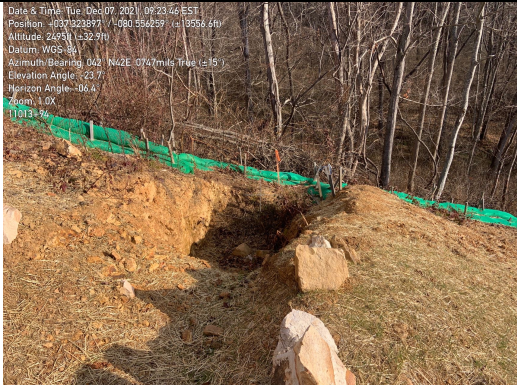
GPS Location	See photo	GPS Location	See photo		
Field Station#	11003+50	Field Station#	11093+14		
Pic 7 Desc.	Clean water diversion pipe and level spreader acceptable	Pic 8 Desc.	Sump pit functional

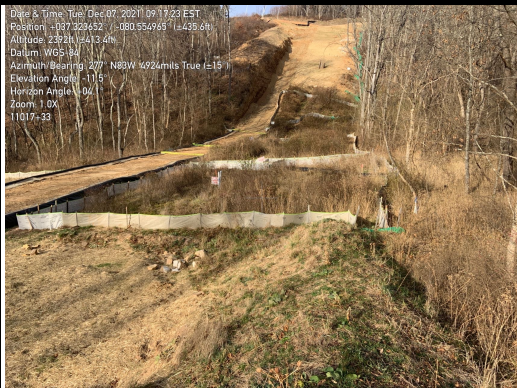
GPS Location	See photo	GPS Location	See photo		
Field Station#	11017+33	Field Station#	11023+80		
Pic 9 Desc.	Sensitive resource buffer is in acceptable condition	Pic 10 Desc.	p1 silt fence is damaged and needs repaired or replaced

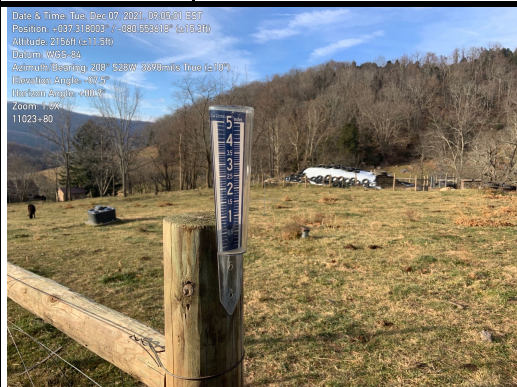
<p>Insert image here</p>			
GPS Location	See photo	GPS Location			
Field Station#	11023+80	Field Station#			
Pic 11 Desc.	Checked rain gage at AR244 0 inches of rain	Pic 12 Desc.

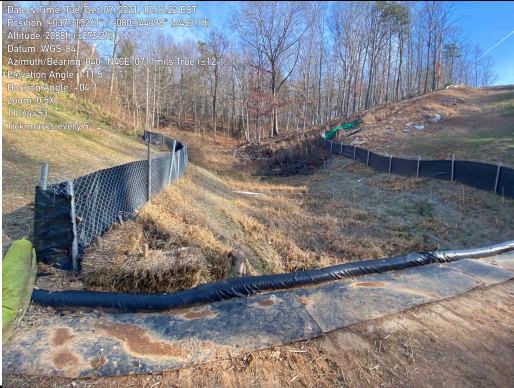
GPS Location	See Photo	GPS Location	See Photo		
Field Station#	11064+53	Field Station#	11084+50		
Pic 5 Desc.	Drainage feature	Pic 6 Desc.	Section of ROW showing conditions and controls

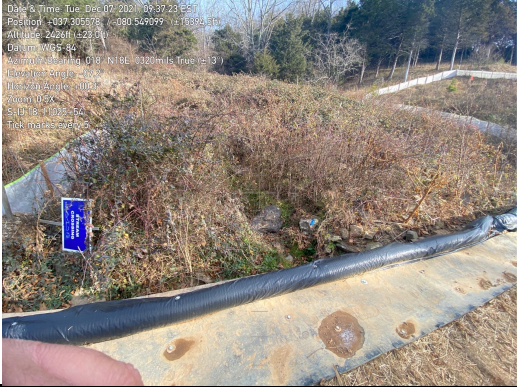
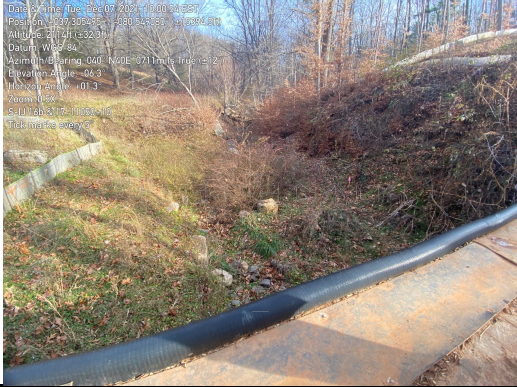
GPS Location	See Photo	GPS Location	See photo		
Field Station#	11025+54	Field Station#	11050+10		
Pic 7 Desc.	S-IJ18	Pic 8 Desc.	S-IJ16B and S-IJ17		
Insert image here		Insert image here			
GPS Location		GPS Location			
Field Station#		Field Station#			
Pic 9 Desc.		Pic 10 Desc.			
Insert image here		Insert image here			
GPS Location		GPS Location			
Field Station#		Field Station#			
Pic 11 Desc.		Pic 12 Desc.

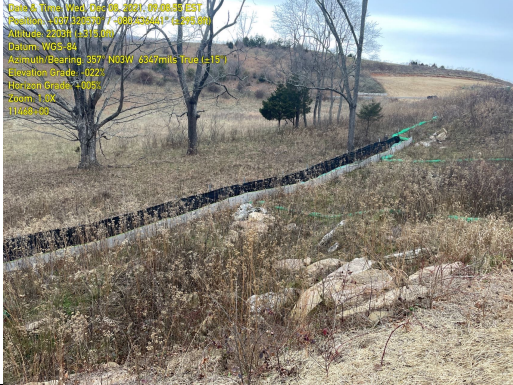
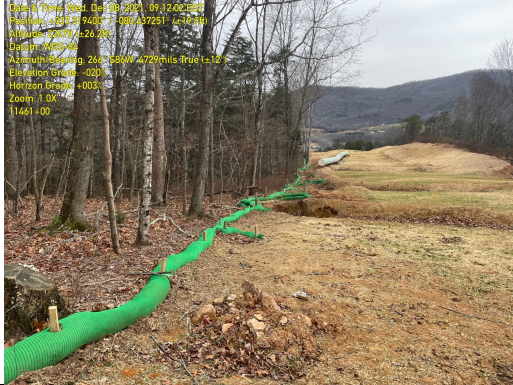
<p>Date & Time: Wed, Dec 08, 2021, 09:12:53 EST Position: +037.31959° / -080.43921° (+23.14) Altitude: 2639ft (+26.28) Datum: WGS-84 Azimuth/Bearing: 246° S60W 4720mils True (+12.5) Elevation Grade: +022% Horizon Grade: +000% Zoom: 1.0X 11461+00</p>		
GPS Location	See photo		GPS Location	See photo
Field Station#	11468+00		Field Station#	11461+00
Pic 1 Desc.	Triple protection ECDs in place at karst feature		Pic 2 Desc.	CFS perimeter control in place

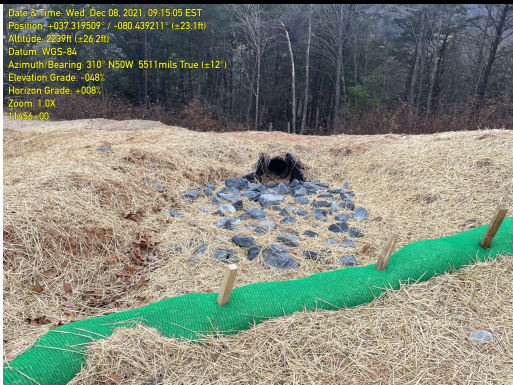
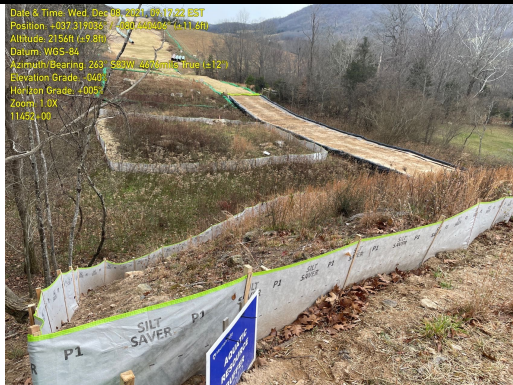
GPS Location	See photo		GPS Location	See photo
Field Station#	11456+00		Field Station#	11452+00
Pic 3 Desc.	Stone inlet protection in place		Pic 4 Desc.	Stream buffer in place

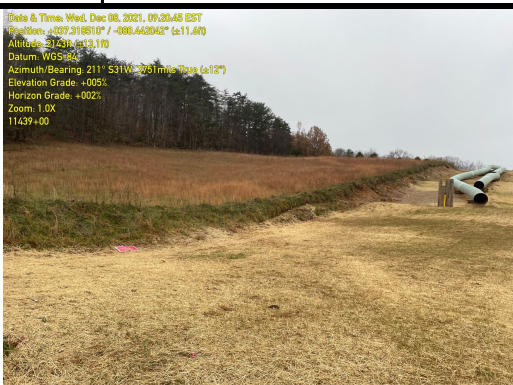
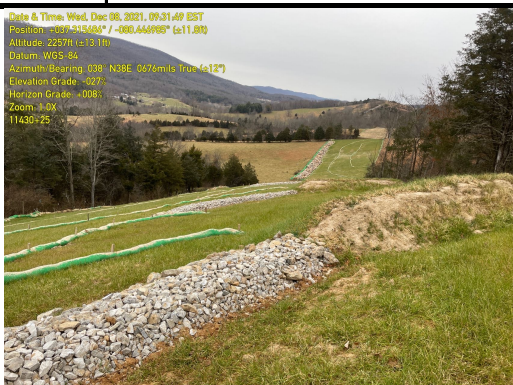
<p>Date & Time: Wed, Dec 08, 2021, 09:31:49 EST Position: +037.31959° / -080.44696° (+11.80) Altitude: 2257ft (+13.10) Datum: WGS-84 Azimuth/Bearing: 038° N38E 0676mils True (+12.2) Elevation Grade: +027% Horizon Grade: +008% Zoom: 1.0X 11430+25</p>		
GPS Location	See photo		GPS Location	See photo
Field Station#	11439+00		Field Station#	11430+25
Pic 5 Desc.	Cleanwater diversion berm in place		Pic 6 Desc.	Level spreaders in place

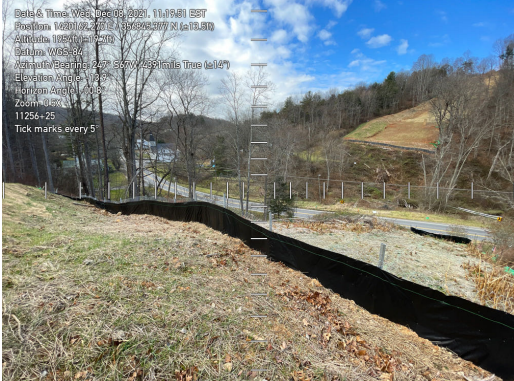
GPS Location 1		GPS Location 2			
Field Station# 11256+25		Field Station# 11294+00			
Pic 1 Desc. SSF functional.		Pic 2 Desc. Section of RoW showing conditions and controls.

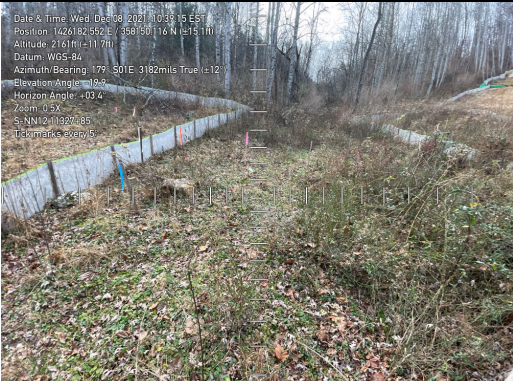
GPS Location 3		GPS Location 4			
Field Station# 11292+80		Field Station# 11327+85			
Pic 3 Desc. S-MM18 and controls.		Pic 4 Desc. S-NN12 and controls.

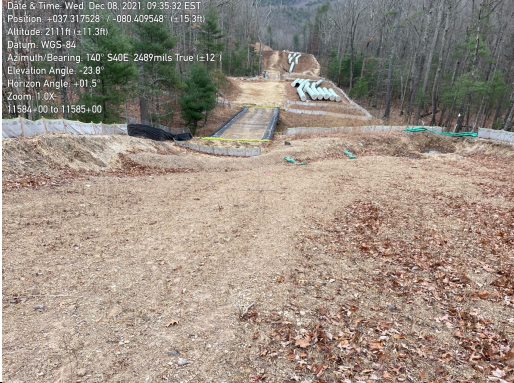
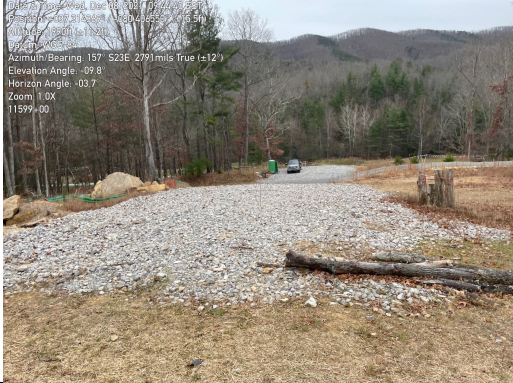
<p>Date & Time: Wed, Dec 08, 2021, 09:35:32 EST Position: +037.317528 / -080.429546 (±15.3ft) Altitude: 2111ft (±11.3ft) Datum: WGS-84 Azimuth/Bearing: 157° S23E 2791mils True (±12°) Elevation Angle: -09.8° Horizon Angle: -03.7° Zoom: 1.0X 11599+00</p>			
GPS Location		See photo		GPS Location	
Field Station#		11584+00		Field Station#	
Pic 1 Desc.		Needs re-stabilized		Pic 2 Desc.	
				RCE functional	
  <p>Date & Time: Wed, Dec 08, 2021, 09:40:08 EST Position: +037.316648 / -080.428591 (±20.3ft) Altitude: 2027ft (±39.4ft) Datum: WGS-84 Azimuth/Bearing: 185° S05W 3289mils True (±12°) Elevation Angle: -19.1° Horizon Angle: -03.9° Zoom: 1.0X 11588+22</p>		  <p>Date & Time: Wed, Dec 08, 2021, 09:40:08 EST Position: +037.316648 / -080.428591 (±20.3ft) Altitude: 2034ft (±13.4ft) Datum: WGS-84 Azimuth/Bearing: 186° S04W 3271mils True (±12°) Elevation Angle: -09.8° Horizon Angle: -03.9° Zoom: 1.0X 11589+00</p>

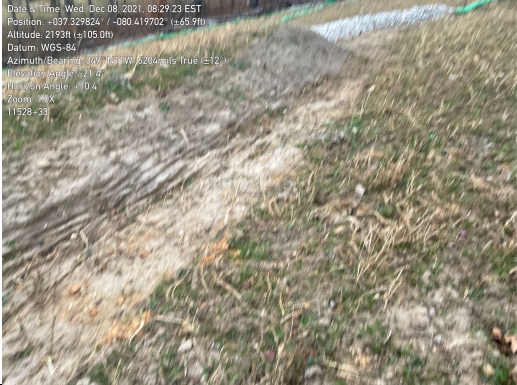
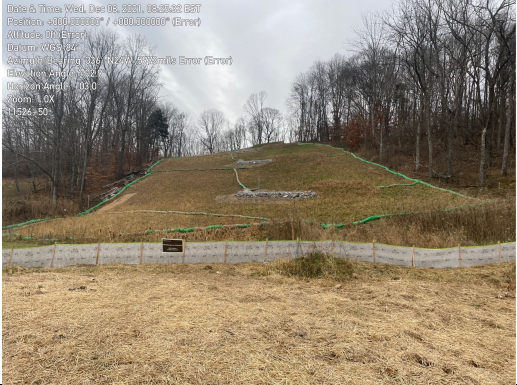
GPS Location	See photo	GPS Location	See photo		
Field Station#	11528+33	Field Station#	11526+50		
Pic 13 Desc.	Erosion control blanket in place	Pic 14 Desc.	Permanent stabilization functional		
Insert image here		Insert image here			
GPS Location		GPS Location			
Field Station#		Field Station#			
Pic 15 Desc.		Pic 16 Desc.			
Insert image here		Insert image here			
GPS Location		GPS Location			
Field Station#		Field Station#			
Pic 17 Desc.		Pic 18 Desc.

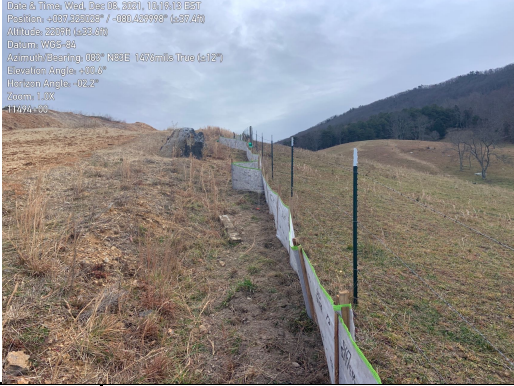
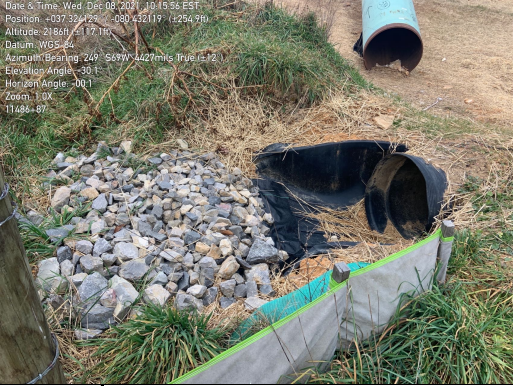
GPS Location		See photo		GPS Location	
Field Station#		11494+00		Field Station#	
Pic 1 Desc.		P1 silt fence is in acceptable condition		Pic 2 Desc.

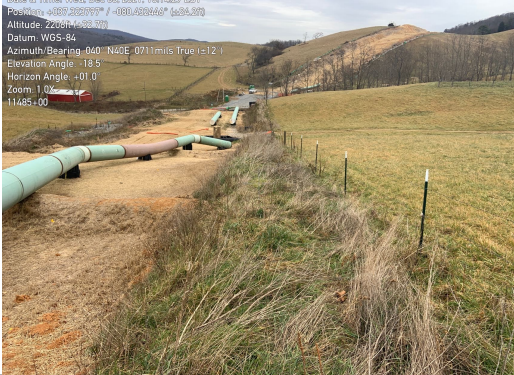
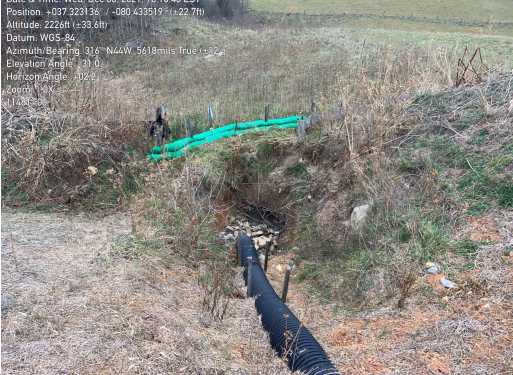
GPS Location		see photo		GPS Location	
Field Station#		11485+00		Field Station#	
Pic 3 Desc.		Clean water diversion berm is acceptable		Pic 4 Desc.

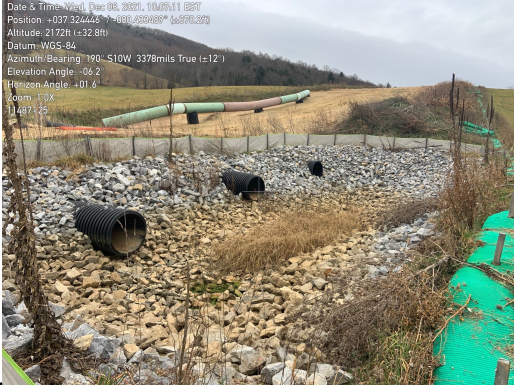
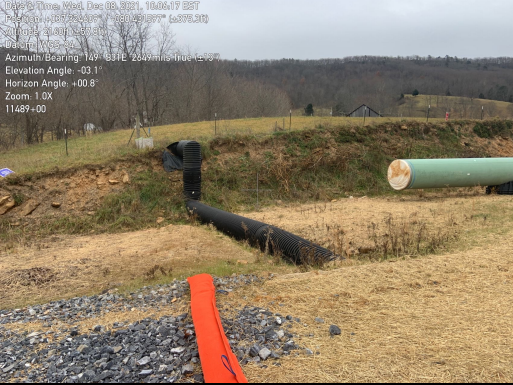
GPS Location		See photo		GPS Location	
Field Station#		11487+25		Field Station#	
Pic 5 Desc.		Plunge pool is in acceptable condition		Pic 6 Desc.	
				Clean water diversion pipe is in place

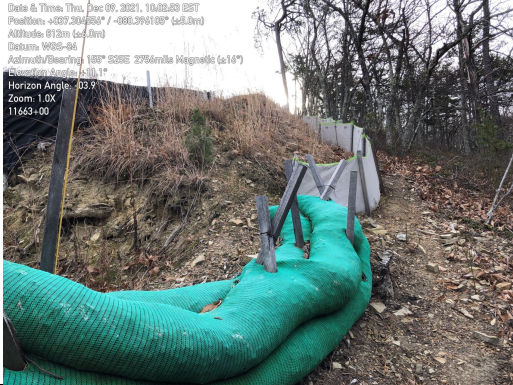
GPS Location	On photo		GPS Location	On photo	
Field Station#	11663+00		Field Station#	11655+00	
Pic 1 Desc.	Perimeter ECDs are in place and functional.		Pic 2 Desc.	No sediment movement at sumps or end treatments.

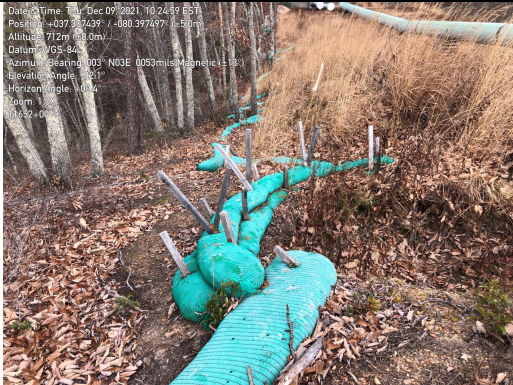
GPS Location	On photo		GPS Location	On photo	
Field Station#	11652+00		Field Station#	11644+00	
Pic 3 Desc.	Sumps and end treatments are functional.		Pic 4 Desc.	ROW surface is stable.

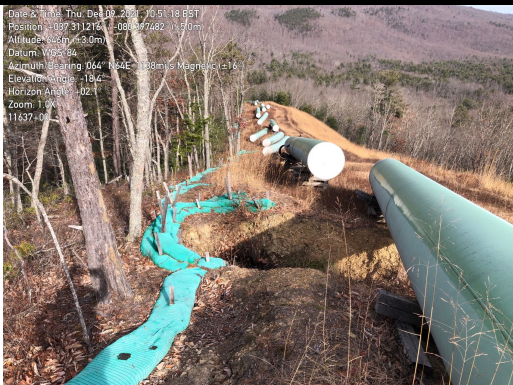
GPS Location	On photo		GPS Location	On photo	
Field Station#	11637+00		Field Station#	11616+04	
Pic 5 Desc.	Perimeter ECDs are in place and functional.		Pic 6 Desc.	The S-HH18 crossing is stable with no impact to stream.

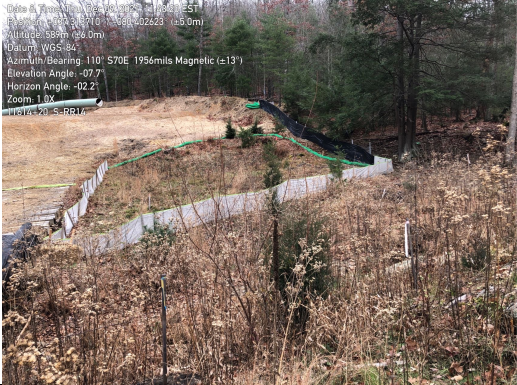
GPS Location	On photo	GPS Location	On photo		
Field Station#	11614+20	Field Station#	11608+17		
Pic 7 Desc.	The S-RR14 crossing is stable with no impact occurring.	Pic 8 Desc.	The S-006 crossing is stable with no impact visible.		
Insert image here		Insert image here			
GPS Location		GPS Location			
Field Station#		Field Station#			
Pic 9 Desc.		Pic 10 Desc.			
Insert image here		Insert image here			
GPS Location		GPS Location			
Field Station#		Field Station#			
Pic 11 Desc.		Pic 12 Desc.

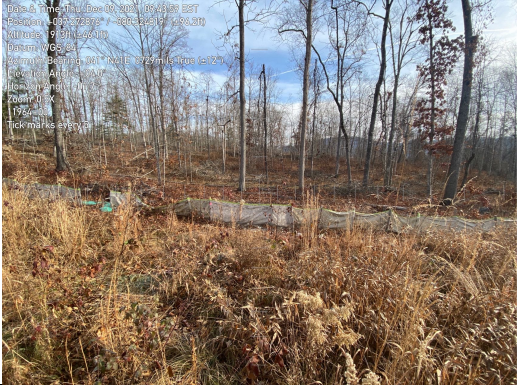
<p> <small> Date & Time Thu Dec 9, 2021, 09:52:57 EST Position: +48°22'32" N -88°53'12" W (48.3750, -88.8867) Altitude: 1350 ft (411 m) Datum: WGS-84 Azimuth/Bearing: 33° (NNW) 500m True (±12°) Elevation Angle: +11.5° Horizon Angle: -0.01° Zoom: 0.5X 11978+86 Tick marks every 5° </small> </p>			
GPS Location	See Photo	GPS Location	See Photo		
Field Station#	11964+00	Field Station#	11978+86		
Pic 7 Desc.	Damaged P1	Pic 8 Desc.	Karst Protection

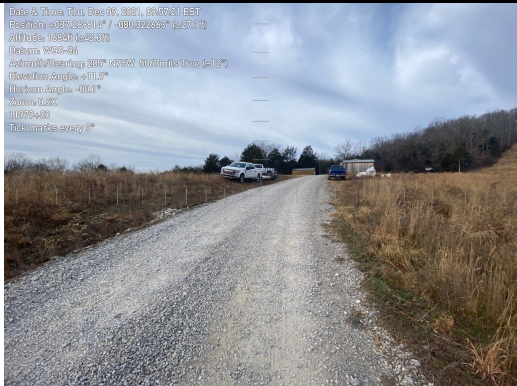
GPS Location	See Photo	GPS Location	See Photo		
Field Station#	11979+00	Field Station#	12005+00		
Pic 9 Desc.	Access 266	Pic 10 Desc.	Stabilization		
Insert image here		Insert image here			
GPS Location		GPS Location			
Field Station#		Field Station#			
Pic 11 Desc.		Pic 12 Desc.

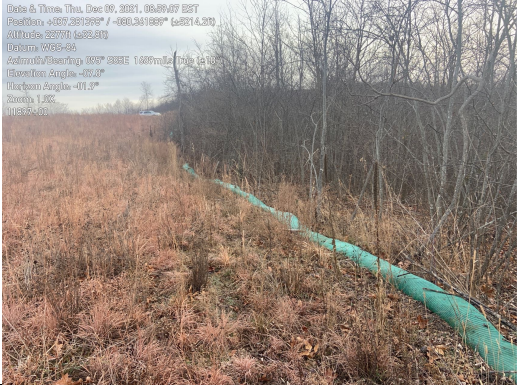
<p>Insert image here</p>			
GPS Location	See photo	GPS Location			
Field Station#	11897+00	Field Station#			
Pic 7 Desc.	CFS perimeter controls in place	Pic 8 Desc.			
<p>Insert image here</p>		<p>Insert image here</p>			
GPS Location		GPS Location			
Field Station#		Field Station#			
Pic 9 Desc.		Pic 10 Desc.			
<p>Insert image here</p>		<p>Insert image here</p>			
GPS Location		GPS Location			
Field Station#		Field Station#			
Pic 11 Desc.		Pic 12 Desc.

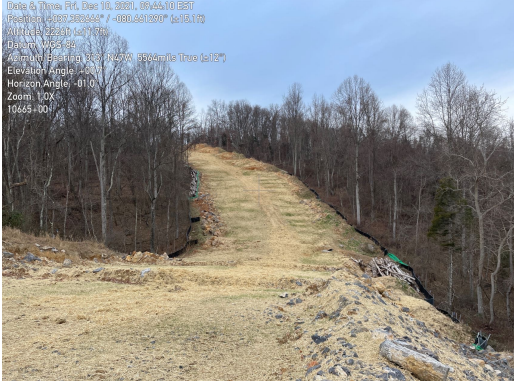
GPS Location		See photo		GPS Location	
Field Station#		10655+00		Field Station#	
Pic 1 Desc.		Temporary stabilization functional		Pic 2 Desc.	
				AR 240 RCE functional

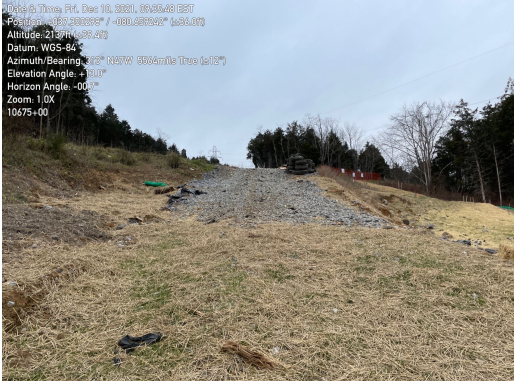
GPS Location		See photo		GPS Location	
Field Station#		10675+00		Field Station#	
Pic 3 Desc.		RCE @ Big Stoney functional		Pic 4 Desc.	
				S-G30 functional

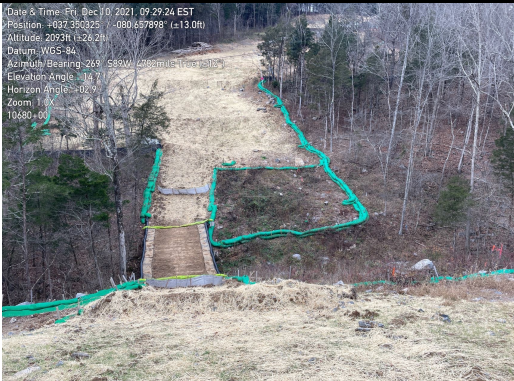
GPS Location		See photo		GPS Location	
Field Station#		10680+00		Field Station#	
Pic 5 Desc.		50' buffer in place		Pic 6 Desc.	
				Temporary stabilization functional

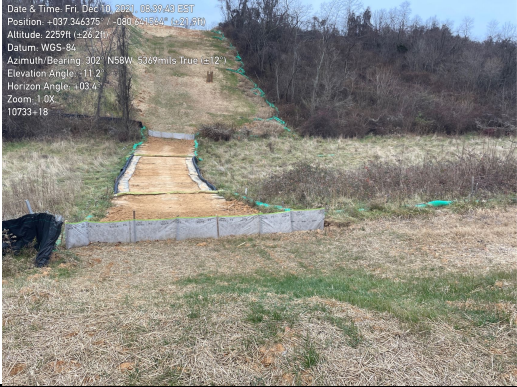
GPS Location	See photo	GPS Location	See photo		
Field Station#	10733+18	Field Station#	10736+00		
Pic 13 Desc.	Equipment bridge functional @ W-Z11	Pic 14 Desc.	Water bars & inlet in place		
<p>Date & Time: Fri, Dec 10, 2021, 08:36:20 EST Position: +037.345960° / -080.639236° (+14.0ft) Altitude: 2238ft (+13.4ft) Datum: WGS-84 Azimuth/Bearing: 199° (S19°W) 353mils True (+12°) Elevation Angle: -28.7° Horizon Angle: +05.0° Zoom: 1.0X 10740+00</p>

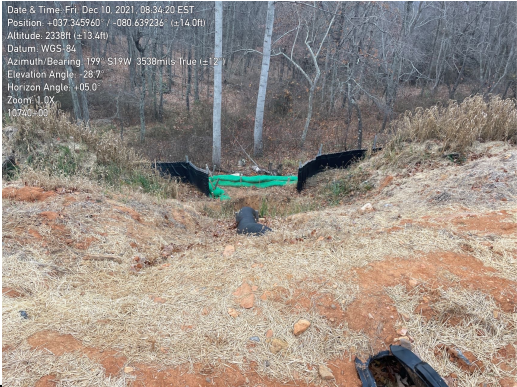
GPS Location	See photo	GPS Location	See photo		
Field Station#	10740+00	Field Station#	10742+69		
Pic 15 Desc.	ET functional	Pic 16 Desc.	Clean water drainage feature functional		
<p>Date & Time: Fri, Dec 10, 2021, 08:40:00 EST Position: +037.345960° / -080.639236° (+14.0ft) Altitude: 2238ft (+13.4ft) Datum: WGS-84 Azimuth/Bearing: 302° (NSW) 539mils True (+12°) Elevation Angle: +11.2° Horizon Angle: +03.4° Zoom: 1.0X 10749+00</p>

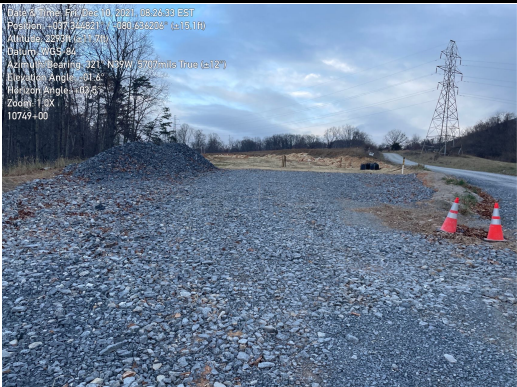
<p>Insert image here</p>	
GPS Location	See photo	GPS Location			
Field Station#	10749+00	Field Station#			
Pic 17 Desc.	Hendrickson RCE functional	Pic 18 Desc.

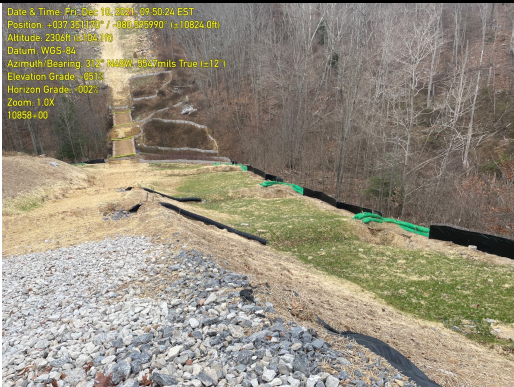
GPS Location		See photo		GPS Location	
Field Station#		10858+00		Field Station#	
Pic 1 Desc.		End treatments in place		Pic 2 Desc.	
<p>Date & Time: Fri, Dec 10, 2021, 10:00:16 EST Position: +407.339292° / -80.699990° (+10824.0M) Altitude: 2423M (+39.6M) Datum: WGS 84 Azimuth/Bearing: 345° N12W 610Mils True (+12.1) Elevation Grade: +000% Horizon Grade: +001% Zoom: 1.0X 10843+75</p>

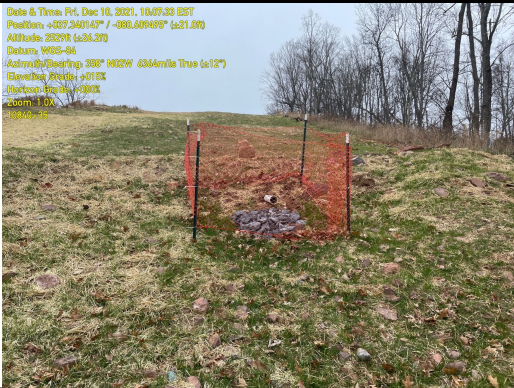
GPS Location		See photo		GPS Location	
Field Station#		10848+00		Field Station#	
Pic 3 Desc.		CFS perimeter control in place		Pic 4 Desc.	
<p>Date & Time: Fri, Dec 10, 2021, 10:07:33 EST Position: +407.340143° / -80.699499° (+10824.0M) Altitude: 2329M (+36.2M) Datum: WGS 84 Azimuth/Bearing: 353° N02W 634Mils True (+12.1) Elevation Grade: +015% Horizon Grade: +000% Zoom: 1.0X 10840+35</p>
