# Visual Site Inspection Report

<b>Project Name</b>	H-600 Pipeline Spread G	<b>AFE</b>	124300137	<b>Spread</b>	H-600 Pipeline Spread G
<b>Contractor</b>	Precision			<b>Report #</b>	34355
<b>Inspector</b>	Daniel Fortune			<b>Date/Time</b>	2/14/2022 11:09 AM
<b>Permit #</b>	TBD	<b>Inspection Type</b>	VA SWPP	<b>Station Begin</b>	11023+80
<b>State</b>	VA	<b>Inspection Area</b>	Partial	<b>Station End</b>	11098+47
<b>County</b>	Giles	<b>Ground</b>	Frozen	<b>Temperature (°F)</b>	23.00
<b>Municipality</b>	N/A	<b>Weather</b>	Below Freezing Temp	<b>Rain Gauge (in)</b>	0.00
				<b>Rain Accumulation Time (days)</b>	0.00

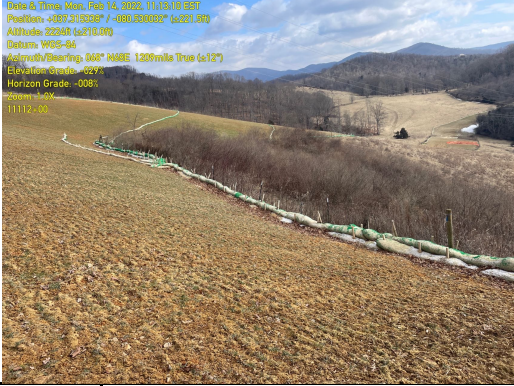
<b>GPS Location</b>	See photo	<b>GPS Location</b>	See photo		
<b>Field Station#</b>	11112+00	<b>Field Station#</b>	11120+00		
<b>Pic 1 Desc.</b>	CFS triple stack perimeter control in place	<b>Pic 2 Desc.</b>	CFS temporary waterbars in place		
<p>Date &amp; Time: Mon, Feb 14, 2022, 11:34:54 EST  Position: +027.314056° / -080.522213° (±11.40)  Altitude: 2020ft (±13.10)  Datum: WGS-84  Azimuth/Bearing: 312° N42W 556ft/mile True (±12°)  Elevation Grade: +02%  Horizon Grade: +001%  Zoom: 1.0X  11134+00</p>

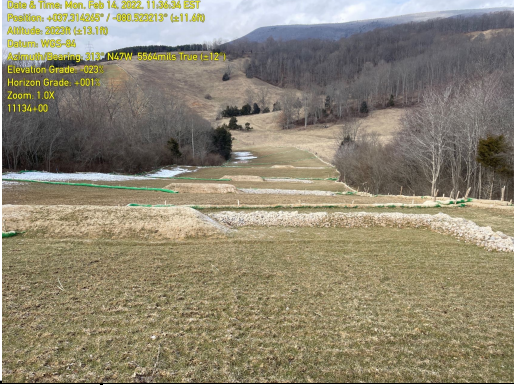
<b>GPS Location</b>	See photo	<b>GPS Location</b>	See photo		
<b>Field Station#</b>	11134+00	<b>Field Station#</b>	11140+50		
<b>Pic 3 Desc.</b>	Permanent waterbars in place	<b>Pic 4 Desc.</b>	Permanent vegetation present		
<p>Date &amp; Time: Mon, Feb 14, 2022, 11:43:33 EST  Position: +027.313381° / -080.522008° (±11.40)  Altitude: 2105ft (±9.40)  Datum: WGS-84  Azimuth/Bearing: 071° N07E 1222ft/mile True (±12°)  Elevation Grade: +01%  Horizon Grade: -002%  Zoom: 1.0X  11146+25</p>

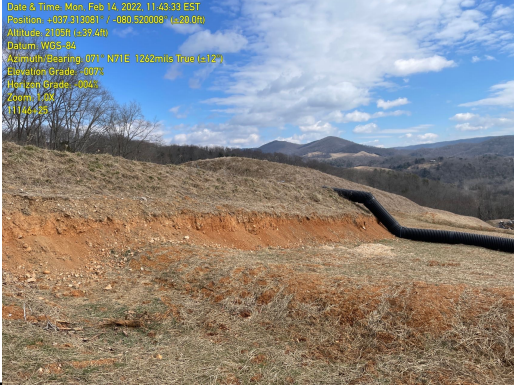
<b>GPS Location</b>	See photo	<b>GPS Location</b>	See photo		
<b>Field Station#</b>	11146+25	<b>Field Station#</b>	11148+00		
<b>Pic 5 Desc.</b>	Cleanwater diversion berm in place	<b>Pic 6 Desc.</b>	Supersilt fence perimeter control in place

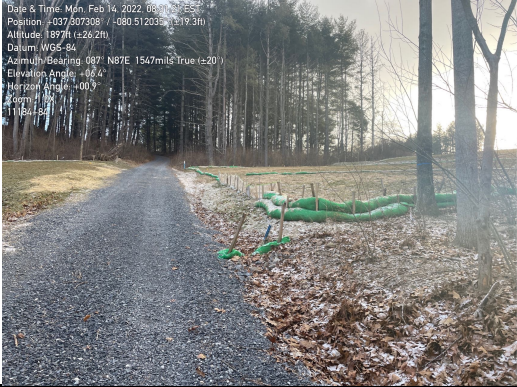
<b>Field Station#</b>	11184+84	<b>Field Station#</b>	11184+79		
<b>Pic 7 Desc.</b>	Perimeter CFS & P1 in place	<b>Pic 8 Desc.</b>	Rock check dams in place		
Insert image here		Insert image here			
<b>GPS Location</b>		<b>GPS Location</b>			
<b>Field Station#</b>		<b>Field Station#</b>			
<b>Pic 9 Desc.</b>		<b>Pic 10 Desc.</b>			
Insert image here		Insert image here			
<b>GPS Location</b>		<b>GPS Location</b>			
<b>Field Station#</b>		<b>Field Station#</b>			
<b>Pic 11 Desc.</b>		<b>Pic 12 Desc.</b>

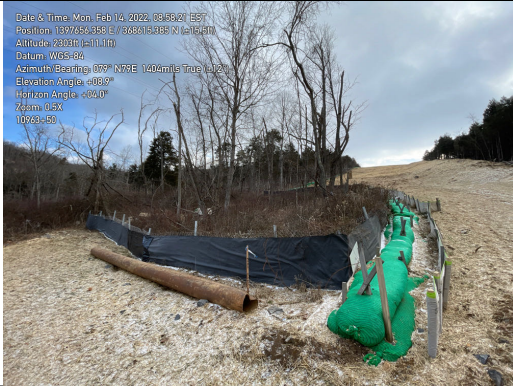
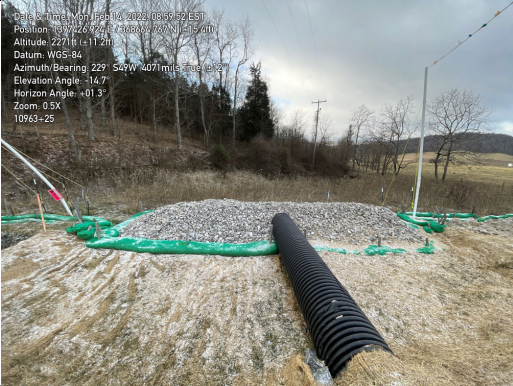
GPS Location	5	GPS Location	6		
Field Station#	10963+50	Field Station#	10963+25		
Pic 5 Desc.	Karst feature protection functional.		Pic 6 Desc.	CWDP outlet protection functional.

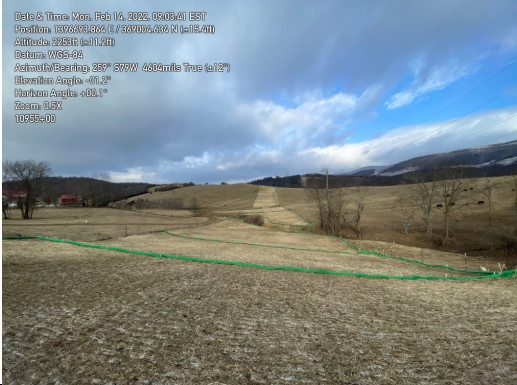
<b>GPS Location</b>	7	<b>GPS Location</b>	8		
<b>Field Station#</b>	10955+00	<b>Field Station#</b>	10940+50		
<b>Pic 7 Desc.</b>	Section of restored RoW showing conditions and controls.		<b>Pic 8 Desc.</b>	Section of restored RoW showing conditions and controls.	
<p>Date &amp; Time: Mon, Feb 14, 2022, 09:11:34 EST  Position: 1395166.463 E / 369516.016 N (+15.50)  Altitude: 2284ft (+11.10)  Datum: WGS-84  Azimuth/Bearing: 349° N18W 4716mils True (+12°)  Elevation Angle: -01.2°  Horizon Angle: +02.5°  Zoom: 0.5X  10938+00</p>

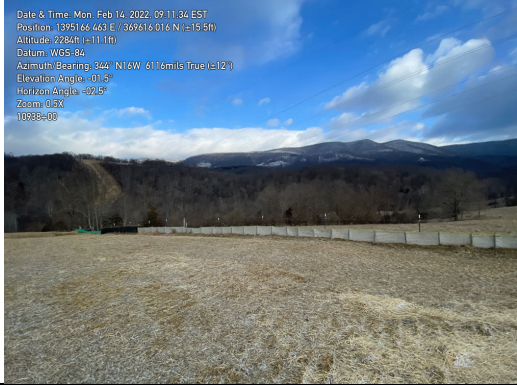
<b>GPS Location</b>	9	<b>GPS Location</b>	10		
<b>Field Station#</b>	10938+00	<b>Field Station#</b>	10934+75		
<b>Pic 9 Desc.</b>	SSF and P-1 perimeter controls functional.		<b>Pic 10 Desc.</b>	CWDP outlet protection functional.	
<p>Date &amp; Time: Mon, Feb 14, 2022, 09:16:03 EST  Position: 1394991.095 E / 369735.035 N (+15.50)  Altitude: 2185ft (+11.00)  Datum: WGS-84  Azimuth/Bearing: 322° N88W 5024mils True (+12°)  Elevation Angle: -10.6°  Horizon Angle: +00.0°  Zoom: 0.5X  10930+25</p>

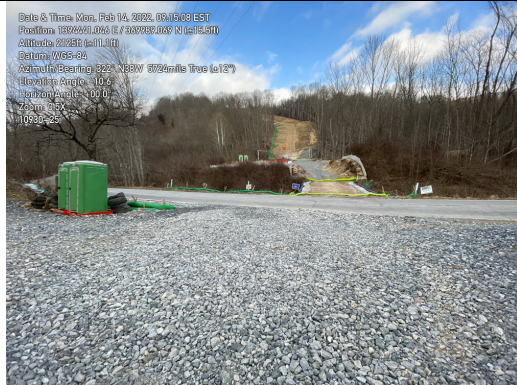
<p>Insert image here</p>			
<b>GPS Location</b>	11	<b>GPS Location</b>			
<b>Field Station#</b>	10930+25	<b>Field Station#</b>			
<b>Pic 11 Desc.</b>	RCE Doe Creek rd.		<b>Pic 12 Desc.</b>

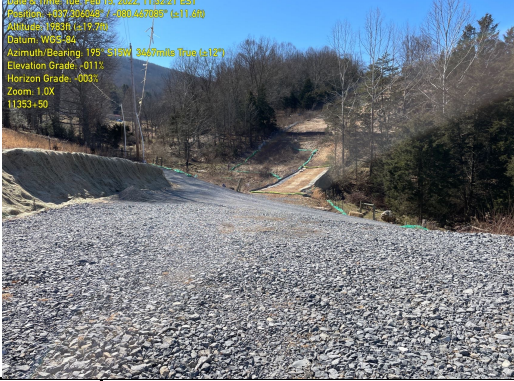
<b>GPS Location</b>	See photo	<b>GPS Location</b>	See photo		
<b>Field Station#</b>	11353+50	<b>Field Station#</b>	11362+00		
<b>Pic 1 Desc.</b>	RCE in place	<b>Pic 2 Desc.</b>	Erosion control blanket in place		
<p>Date &amp; Time: Tue, Feb 15, 2022, 11:25:57 EST  Position: +037.308018 / -080.466119 (±10.2M)  Altitude: 1981ft (±39.4ft)  Datum: WGS-84  Azimuth/Bearing: 164° S14E 2916mils True (±12°)  Elevation Grade: -027%  Horizon Grade: -014%  Zoom: 1.0X  11363+00</p>

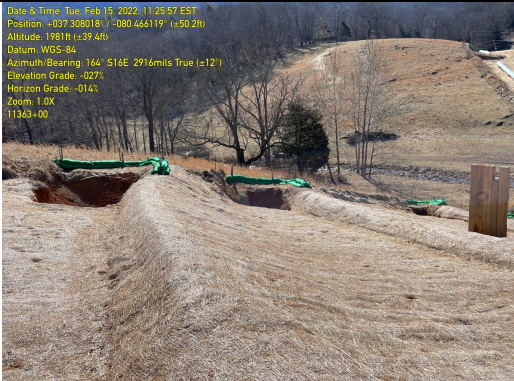
<b>GPS Location</b>	See photo	<b>GPS Location</b>	See photo		
<b>Field Station#</b>	11363+00	<b>Field Station#</b>	11397+00		
<b>Pic 3 Desc.</b>	End treatments in place	<b>Pic 4 Desc.</b>	Level spreader in place		
<p>Date &amp; Time: Tue, Feb 15, 2022, 10:54:28 EST  Position: +037.311941 / -080.459493 (±11.6M)  Altitude: 2222ft (±9.8ft)  Datum: WGS-84  Azimuth/Bearing: 040° N40E 0711mils True (±12°)  Elevation Grade: +005%  Horizon Grade: +000%  Zoom: 1.0X  11410+00</p>

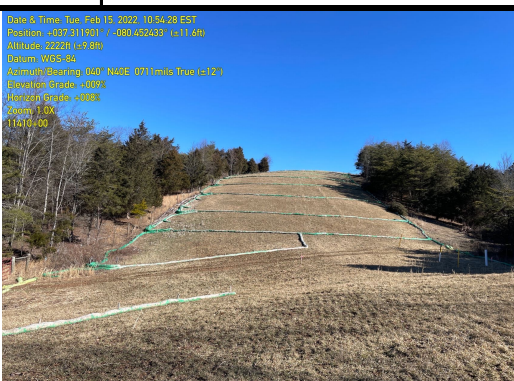
<b>GPS Location</b>	See photo	<b>GPS Location</b>	See photo		
<b>Field Station#</b>	11410+00	<b>Field Station#</b>	11418+50		
<b>Pic 5 Desc.</b>	CFS temporary waterbars in place	<b>Pic 6 Desc.</b>	Permanent vegetation present

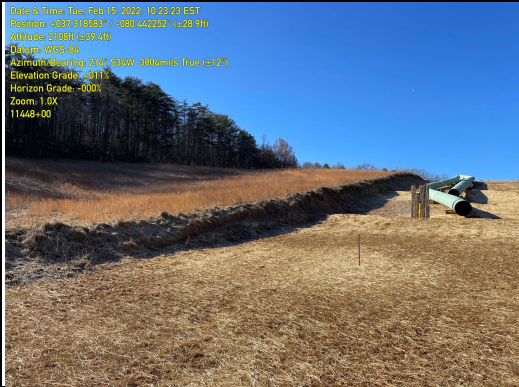
GPS Location	See photo		GPS Location	See photo	
Field Station#	11432+00		Field Station#	11448+00	
Pic 7 Desc.	Permanent waterbar in place		Pic 8 Desc.	Cleanwater diversion berm in place

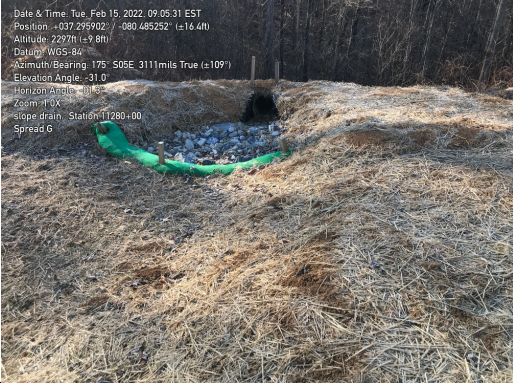
<p>Date &amp; Time: Tue, Feb 15, 2022, 08:50:17 EST Position: +037.296422 / -080.493205 (±16.4ft) Altitude: 2011ft (±13.1ft) Datum: WGS-84 Azimuth/Bearing: 309° N51W 5493mils True (±128°) Elevation Angle: -33.7° Horizon Angle: -03.7° Zoom: 1.0X Erosion blanket: 42' Station 11257+00 Spread G</p>

<p>Date &amp; Time: Tue, Feb 15, 2022, 09:05:31 EST Position: +037.295902 / -080.485252 (±16.4ft) Altitude: 2257ft (±9.8ft) Datum: WGS-84 Azimuth/Bearing: 175° S05E 3111mils True (±109°) Elevation Angle: -31.0° Horizon Angle: -01.3° Zoom: 1.0X Slope drain: Station 11280+00 Spread G</p>		<b>GPS Location</b>	See photo
<b>Field Station#</b>	12257+00	<b>Field Station#</b>	11280+00	<b>GPS Location</b>	see photo
<b>Pic 1 Desc.</b>	Erosion blanket	<b>Pic 2 Desc.</b>	Slope drain

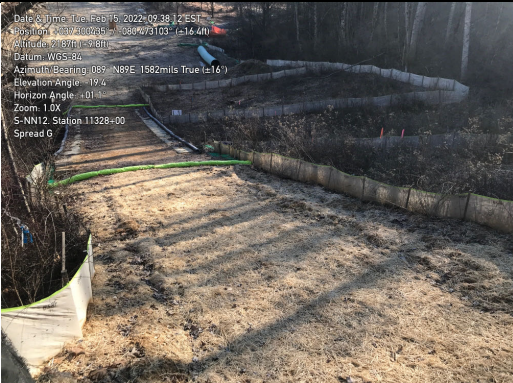
<p>Date &amp; Time: Tue, Feb 15, 2022, 09:31:16 EST Position: +037.297324 / -080.474557 (±16.4ft) Altitude: 2314ft (±9.8ft) Datum: WGS-84 Azimuth/Bearing: 003° N03E 0030mils True (±16°) Elevation Angle: -21.3° Horizon Angle: -01.5° Zoom: 1.0X Stabilized ROW: Station 11320+00 Spread G</p>

<p>Date &amp; Time: Tue, Feb 15, 2022, 09:38:12 EST Position: +037.297095 / -080.473103 (±16.4ft) Altitude: 2307ft (±9.8ft) Datum: WGS-84 Azimuth/Bearing: 089° N89E 1582mils True (±16°) Elevation Angle: -19.4° Horizon Angle: -01.1° Zoom: 1.0X S-NN12: Station 11328+00 Spread G</p>		<b>GPS Location</b>	see photo
<b>Field Station#</b>	11320+00	<b>Field Station#</b>	11328+00	<b>GPS Location</b>	see photo
<b>Pic 5 Desc.</b>	Stabilized ROW	<b>Pic 6 Desc.</b>	S-NN 12

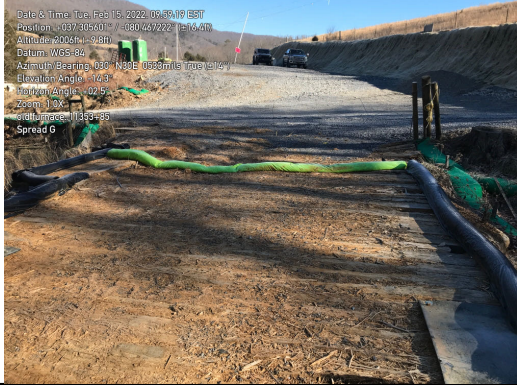
<p style="text-align: center;">Insert image here</p>			
<b>GPS Location</b>	see photo	<b>GPS Location</b>			
<b>Field Station#</b>	11353+50	<b>Field Station#</b>			
<b>Pic 9 Desc.</b>	Old furnace	<b>Pic 10 Desc.</b>			
<p style="text-align: center;">Insert image here</p>		<p style="text-align: center;">Insert image here</p>			
<b>GPS Location</b>		<b>GPS Location</b>			
<b>Field Station#</b>		<b>Field Station#</b>			
<b>Pic 11 Desc.</b>		<b>Pic 12 Desc.</b>

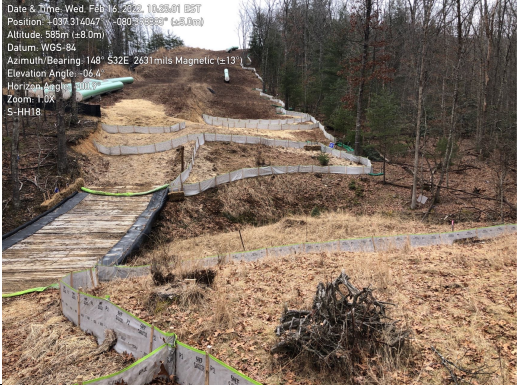
<p><small>Date &amp; Time: Wed Feb 16, 2022 10:59:59 EST Position: +037 314047 / -080 55973 (±3326.9m) Altitude: 585m (±8.0m) Datum: WGS-84 Azimuth/Bearing: 168° S2E 2631mils Magnetic (±13°) Elevation Angle: -08.4° Horizon Angle: +00.3° Zoom: 1.0X S-HH18</small></p>			
<b>GPS Location</b>	On photo	<b>GPS Location</b>	On photo		
<b>Field Station#</b>	11634+00	<b>Field Station#</b>	11626+04		
<b>Pic 7 Desc.</b>	Sumps and end treatments in place and acceptable condition.	<b>Pic 8 Desc.</b>	The S-HH18 crossing is stable.

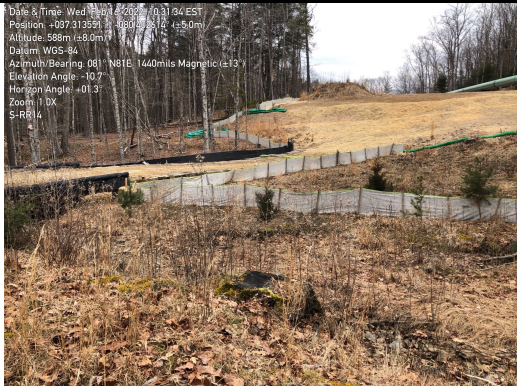
<p><small>Date &amp; Time: Wed Feb 16, 2022 10:31:04 EST Position: +037 313591 / -080 55973 (±3326.9m) Altitude: 585m (±8.0m) Datum: WGS-84 Azimuth/Bearing: 081° N81E 1440mils Magnetic (±13°) Elevation Angle: -10.7° Horizon Angle: +01.3° Zoom: 1.0X S-RR14</small></p>

<b>GPS Location</b>	On photo	<b>GPS Location</b>	On photo		
<b>Field Station#</b>	11614+20	<b>Field Station#</b>	11608+17		
<b>Pic 9 Desc.</b>	The S-RR14 crossing is stable.	<b>Pic 10 Desc.</b>	The S-006 crossing is stable.		
Insert image here		Insert image here			
<b>GPS Location</b>		<b>GPS Location</b>			
<b>Field Station#</b>		<b>Field Station#</b>			
<b>Pic 11 Desc.</b>		<b>Pic 12 Desc.</b>

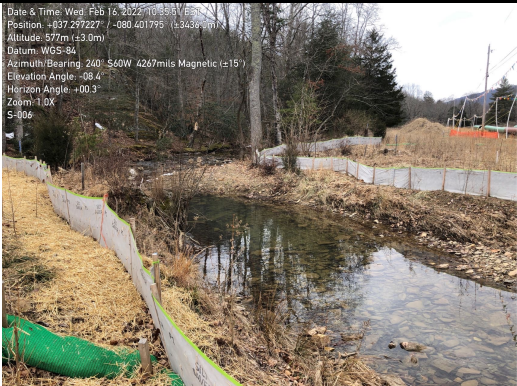
<p><small>Date &amp; Time: Wed Feb 16, 2022 10:59:59 EST Position: +037 277227 / -080 401795 (±3438.7m) Altitude: 572m (±3.0m) Datum: WGS-84 Azimuth/Bearing: 240° S40W 4267mils Magnetic (±15°) Elevation Angle: -08.4° Horizon Angle: +00.3° Zoom: 1.0X S-006</small></p>

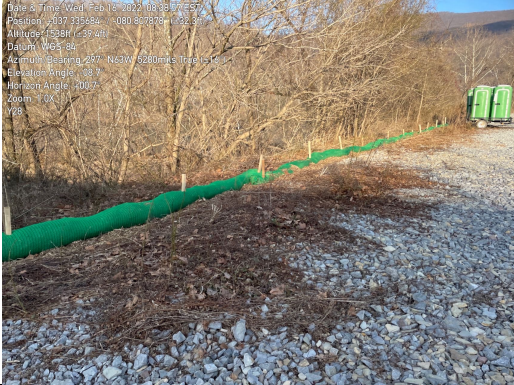
<p>Date &amp; Time: Wed, Feb 16, 2022, 08:39:11 EST Position: +037.335619° / -080.807952° (-16.11ft) Altitude: 1555ft (-11.1ft) Datum: WGS-84 Azimuth Bearing: 257° N83W 528ft/mile True (+10°) Elevation Angle: +01.2° Horizon Angle: +00.1° Zoom: 1.0X Y28</p>			
<b>GPS Location</b>	See photo	<b>GPS Location</b>	See photo		
<b>Field Station#</b>	12005+00	<b>Field Station#</b>	12005+00		
<b>Pic 1 Desc.</b>	Perimeter CFS controls functional	<b>Pic 2 Desc.</b>	Perimeter CFS controls & safety fence in place

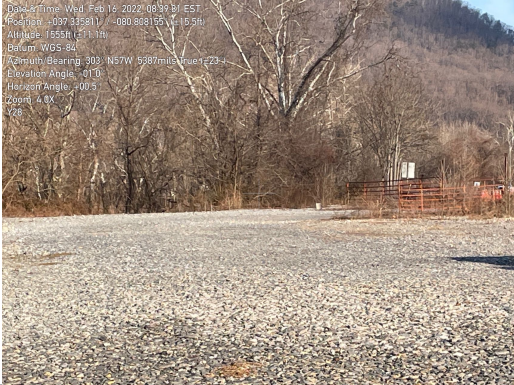
<b>GPS Location</b>	See photo	<b>GPS Location</b>	See photo		
<b>Field Station#</b>	12005+00	<b>Field Station#</b>	12005+00		
<b>Pic 3 Desc.</b>	RCE functional	<b>Pic 4 Desc.</b>	Perimeter controls & RCE in good condition

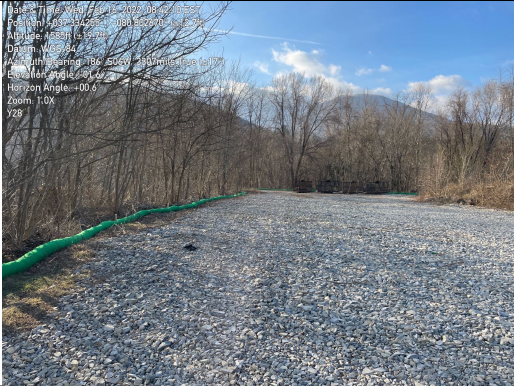
<p>Date &amp; Time: Wed, Feb 16, 2022, 08:42:28 EST Position: +037.340129° / -080.803022° (-16.11ft) Altitude: 1567ft (-11.1ft) Datum: WGS-84 Azimuth Bearing: 141° S30E 350ft/mile True (+10°) Elevation Angle: +01.2° Horizon Angle: +00.2° Zoom: 1.0X Y28</p>			
<b>GPS Location</b>	See photo	<b>GPS Location</b>	See photo		
<b>Field Station#</b>	12005+00	<b>Field Station#</b>	12005+00		
<b>Pic 5 Desc.</b>	CFS perimeter controls functional	<b>Pic 6 Desc.</b>	Housekeeping trash in place

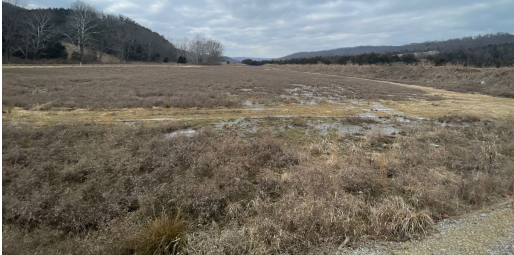
<b>GPS Location</b>	See Photo		<b>GPS Location</b>	See Photo	
<b>Field Station#</b>	12005+00		<b>Field Station#</b>	11980+28	
<b>Pic 1 Desc.</b>	Temporary stabilization of row at spread break.		<b>Pic 2 Desc.</b>	Final Restoration Area with slight two track L/O access.	
<p>Date &amp; Time: Wed, Feb 16, 2022, 11:24:00 EST  Position: +38°32'53.93" / -88°32'23.17" (+1.2M)  Altitude: 1830 (+12.3M)  Datum: WGS-84  Azimuth Bearing: 161° S45E 343mils True (+13°)  Elevation Grade: +002  Horizon Grade: +002  Zoom: 0.5X  11978+88</p>

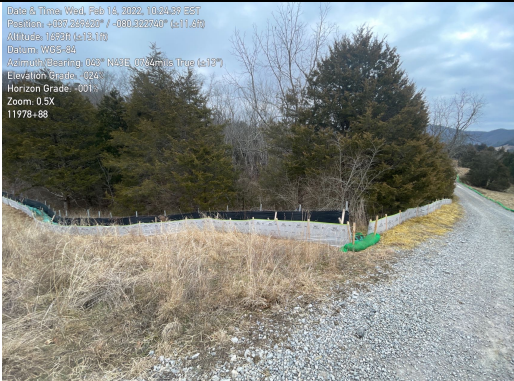
<b>GPS Location</b>	See Photo		<b>GPS Location</b>	See Photo	
<b>Field Station#</b>	11978+88		<b>Field Station#</b>	11971+00	
<b>Pic 3 Desc.</b>	266 AR and perimeter super silt fencing and P1 silt fencing conditions		<b>Pic 4 Desc.</b>	Final Restoration Area.	
<p>Date &amp; Time: Wed, Feb 16, 2022, 11:24:00 EST  Position: +38°32'53.93" / -88°32'23.17" (+1.2M)  Altitude: 1830 (+12.3M)  Datum: WGS-84  Azimuth Bearing: 161° S45E 343mils True (+13°)  Elevation Grade: +002  Horizon Grade: +002  Zoom: 0.5X  11951+00</p>

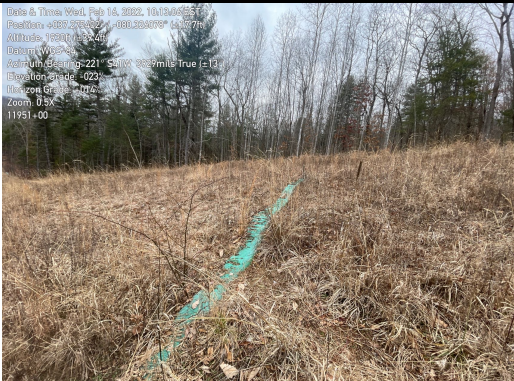
<b>Pic 5 Desc.</b>	Final Restoration Area. Weathered CFS remains in heavy vegetation		<b>Pic 6 Desc.</b>	Example of water bars extending across the row in final Restoration Area.

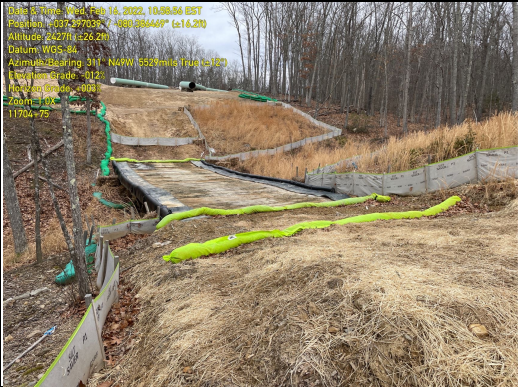
<p>Date &amp; Time: Wed, Feb 16, 2022, 11:00:04 EST Position: +007.270236° / -080.384449° (s14.20) Altitude: 2427ft (s26.26) Datum: WGS-84 Azimuth: 244.7deg 3H° NAWW 1954mils True (s10) Elevation Grade: +00% Horizon Grade: +00% Zoom: 1.0X 11714+00</p>	
GPS Location	See photo	GPS Location	See photo		
Field Station#	11704+75	Field Station#	11714+00		
Pic 7 Desc.	Sediment filter logs in place	Pic 8 Desc.	Waterbars in place

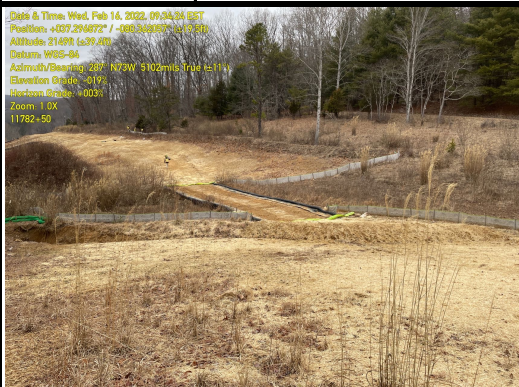
<p>Date &amp; Time: Wed, Feb 16, 2022, 09:04:04 EST Position: +007.296130° / -080.383819° (s12.10) Altitude: 1973ft (s11.50) Datum: WGS-84 Azimuth: 244.7deg 3H° NAWW 1954mils True (s10) Elevation Grade: +00% Horizon Grade: +00% Zoom: 1.0X 11782+50</p>	
GPS Location	See photo	GPS Location	See photo		
Field Station#	11766+25	Field Station#	11782+50		
Pic 11 Desc.	RCE in place	Pic 12 Desc.	Cleanwater drainage feature in place

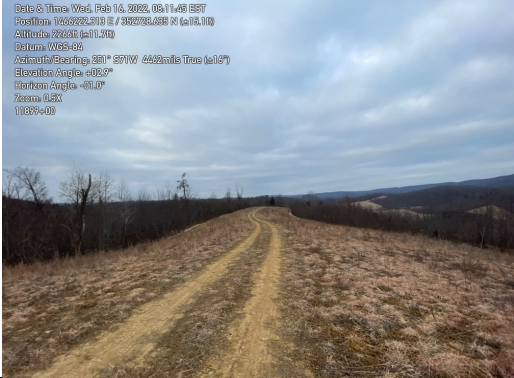
GPS Location 1		GPS Location 2			
Field Station# 11899+00		Field Station# 11886+00			
Pic 1 Desc. Section of restored RoW showing conditions and controls.		Pic 2 Desc. Section of restored RoW showing conditions and controls.			
<p>Date &amp; Time: Wed, Feb 16, 2022, 09:15:00 EST  Position: 1452935.553 E / 352845.491 N (±10.10)  Altitude: 2079ft (±11.3ft)  Datum: WGS-84  Azimuth/Bearing: 330° 55'W 4176mils True (±12°)  Elevation Angle: +01.2°  Machon Angle: +03.8°  Zoom: 0.5X  11878+00</p>  		<p>Date &amp; Time: Wed, Feb 16, 2022, 09:15:45 EST  Position: 1452772.210 E / 352816.771 N (±10.10)  Altitude: 2039ft (±11.3ft)  Datum: WGS-84  Azimuth/Bearing: 330° 10'W 4220mils True (±12°)  Elevation Angle: +0.8°  Machon Angle: +03.8°  Zoom: 0.5X  11863+65</p>

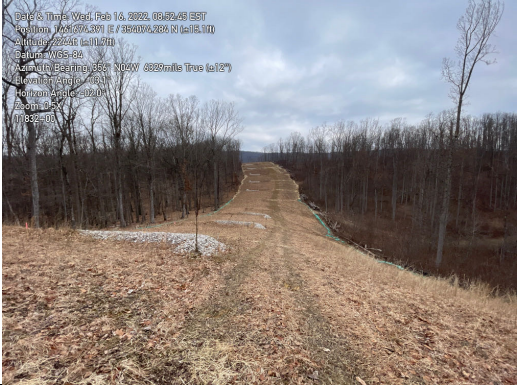
<b>Field Station#</b>	11832+00	<b>Field Station#</b>	11821+00		
<b>Pic 7 Desc.</b>	Section of restored RoW showing conditions and controls.	<b>Pic 8 Desc.</b>	Section of restored RoW showing conditions and controls.		
  <p>             Date &amp; Time: Wed, Feb 16, 2022, 09:04:38 EST              Position: 1457831.779 E / 353824.779 N (a15.510)              Altitude: 21310 (a11.240)              Datum: WGS-84              Azimuth/Heading: 83° S83W 4539mils True (a13°)              Slope/Angle: +0.3°              Horizontal Angle: +0.7°              Speed: 0.5X              User: 11832+00           </p>		<div style="text-align: center;">Insert image here</div>			
<b>GPS Location</b>	9	<b>GPS Location</b>			
<b>Field Station#</b>	11789+50	<b>Field Station#</b>			
<b>Pic 9 Desc.</b>	Section of restored RoW showing conditions and controls.	<b>Pic 10 Desc.</b>			
<div style="text-align: center;">Insert image here</div>		<div style="text-align: center;">Insert image here</div>

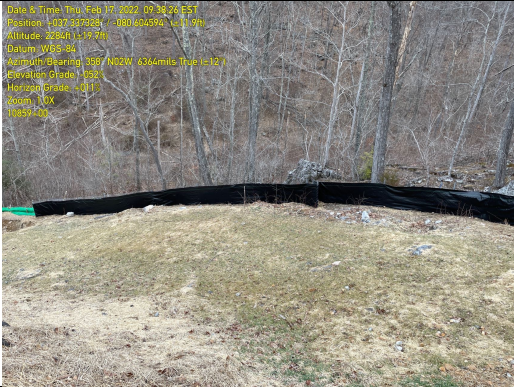
<b>GPS Location</b>	See photo	<b>GPS Location</b>	See photo		
<b>Field Station#</b>	10859+00	<b>Field Station#</b>	10858+00		
<b>Pic 1 Desc.</b>	Supersilt fence perimeter control in place	<b>Pic 2 Desc.</b>	Slope drain in place		
<p>Date &amp; Time: Thu, Feb 17, 2022, 09:40:52 EST  Position: +037.3337457° / -080.605194° (±11.00)  Altitude: 2234ft (±13.10)  Datum: WGS-84  Azimuth/Bearing: 295° N65W 5264mils True (±12°)  Elevation Grade: -012%  Horizon Grade: -001%  Zoom: 1.0X  10855+00</p>

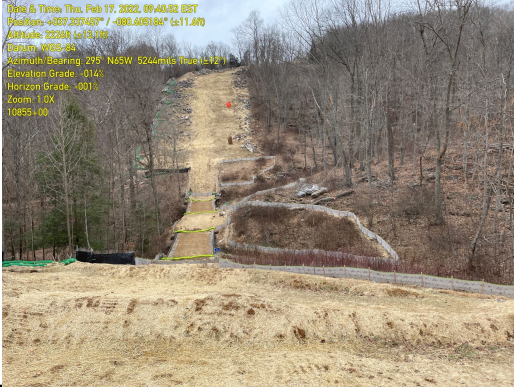
<b>GPS Location</b>	See photo	<b>GPS Location</b>	See photo		
<b>Field Station#</b>	10855+00	<b>Field Station#</b>	10806+50		
<b>Pic 3 Desc.</b>	Stream buffer in place	<b>Pic 4 Desc.</b>	End treatments in place		
<p>Date &amp; Time: Thu, Feb 17, 2022, 09:45:39 EST  Position: +037.3392927° / -080.608640° (±11.00)  Altitude: 2430ft (±9.00)  Datum: WGS-84  Azimuth/Bearing: 320° N00W 5943mils True (±12°)  Elevation Grade: -000%  Horizon Grade: -000%  Zoom: 1.0X  10843+75</p>

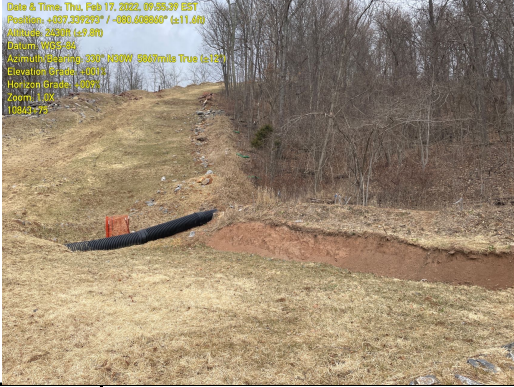
<b>GPS Location</b>	See photo	<b>GPS Location</b>	See photo		
<b>Field Station#</b>	10843+75	<b>Field Station#</b>	10833+00		
<b>Pic 5 Desc.</b>	Cleanwater diversion berm in place	<b>Pic 6 Desc.</b>	Waterbars in place

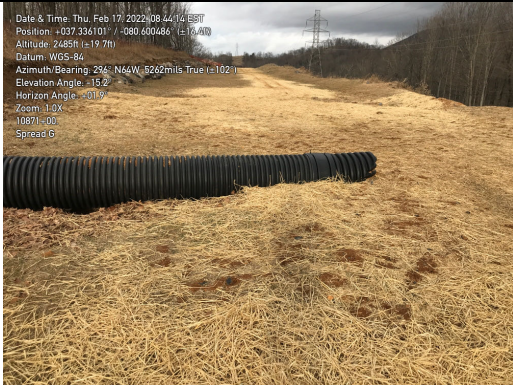
GPS Location		see photo		GPS Location		see photo			
Field Station#		10871+00		Field Station#		10875+00			
Pic 3 Desc.		Stabilized ROW		Pic 4 Desc.		Stabilized ROW, water bars.

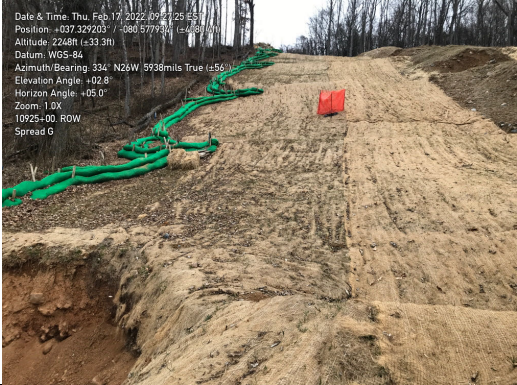
<p>Date &amp; Time: Thu, Feb 17, 2022 09:28:17 EST  Position: +037.331905° / -080.583466° (±10.4m)  Altitude: 2123ft (±25.2m)  Datum: WGS-84  Azimuth/Bearing: 136° S44E 2418mils True (±12°)  Elevation Angle: -13.5°  Horizon Angle: +00.4°  Zoom: 1.0x  10928+00, S-Y 3  Spread G</p>	
GPS Location	See photo		GPS Location	see photo	
Field Station#	10925+00		Field Station#	10928+00	
Pic 7 Desc.	Erosion blanket, perimeter ECDs, water bars and sumps		Pic 8 Desc.	S-Y 3

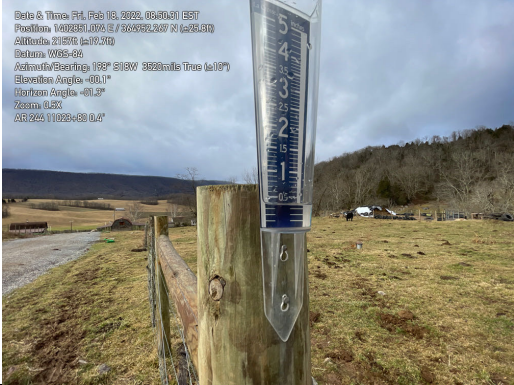
<p>Date &amp; Time: Fri, Feb 18, 2022, 09:05:16 EST Position: 1497224.228 N / 761972.742 W (+24.84) Altitude: 2242ft (+17.4ft) Datum: WGS-84 Azimuth/Bearing: 110° 54'30" 333m True (+18°) Elevation Angle: -01.3° Horizon Angle: -01.3° Zoom: 0.5X AR 242 01 10971+74</p>			
GPS Location 1		GPS Location 2			
Field Station# 11023+80		Field Station# 10971+74			
Pic 1 Desc. Rain gauge on AR 244 indicating 0.4" of accumulation.		Pic 2 Desc. AR 242.01.

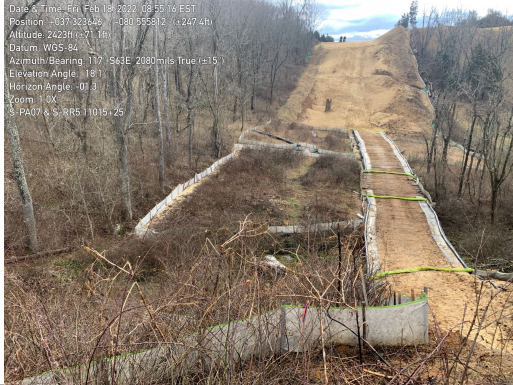
GPS Location 3		GPS Location 4			
Field Station# 10971+75		Field Station# 11015+25			
Pic 3 Desc. AR 242.01.		Pic 4 Desc. Overview of S-PA07/S-RR5.

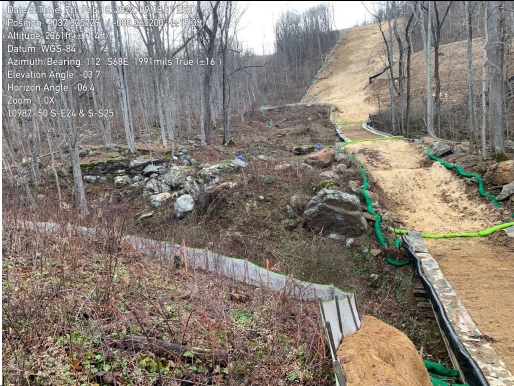
<p>Date &amp; Time: Fri, Feb 18, 2022, 09:12:33 EST Position: 1497224.228 N / 761972.742 W (+24.84) Altitude: 2242ft (+17.4ft) Datum: WGS-84 Azimuth/Bearing: 112° 54'30" 333m True (+16°) Elevation Angle: -03.7° Horizon Angle: -06.4° Zoom: 1.0X 10987+50 S-E24 &amp; S-E25</p>			
GPS Location 5		GPS Location 6			
Field Station# 10987+50		Field Station# 10977+11			
Pic 5 Desc. Overview of S-E24/S-E25.		Pic 6 Desc. Punch list item.

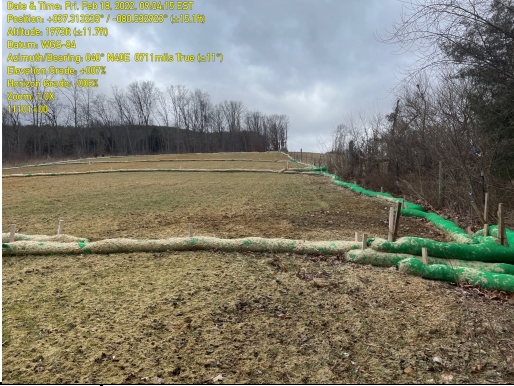
<b>GPS Location</b>	See photo	<b>GPS Location</b>	See photo		
<b>Field Station#</b>	11101+00	<b>Field Station#</b>	11134+00		
<b>Pic 1 Desc.</b>	CFS end treatments in place	<b>Pic 2 Desc.</b>	Level spreaders in place		
<p>Date &amp; Time Fri, Feb 18, 2022, 09:35:04 EST  Position: +407.312968° / -900.321914° (±18.1ft)  Altitude: 2148ft (±9.8ft)  Datum: WGS-84  Azimuth/Bearing: 103° MAGN 1049mils True (±12°)  Elevation Grade: +003%  Horizon Grade: +003%  Zoom: 1.0x  11141+00</p>

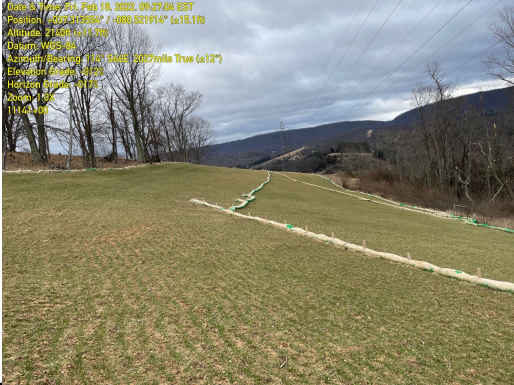
<b>GPS Location</b>	See photo	<b>GPS Location</b>	See photo		
<b>Field Station#</b>	11141+00	<b>Field Station#</b>	11146+25		
<b>Pic 3 Desc.</b>	Permanent vegetation present	<b>Pic 4 Desc.</b>	Cleanwater diversion berm in place		
<p>Date &amp; Time Fri, Feb 18, 2022, 09:39:48 EST  Position: +407.313991° / -900.319991° (±18.1ft)  Altitude: 2052ft (±11.3ft)  Datum: WGS-84  Azimuth/Bearing: 169° S11E 3004mils True (±12°)  Elevation Grade: +052%  Horizon Grade: +002%  Zoom: 1.0x  11148+00</p>

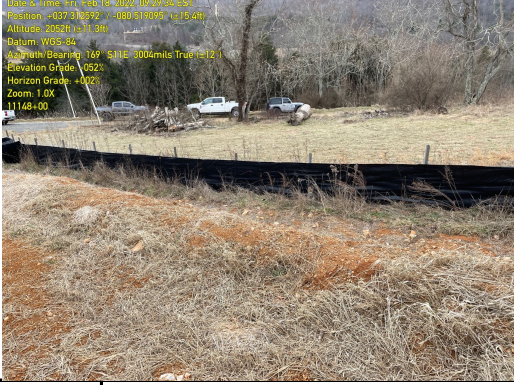
<b>GPS Location</b>	See photo	<b>GPS Location</b>	See photo		
<b>Field Station#</b>	11148+00	<b>Field Station#</b>	11152+50		
<b>Pic 5 Desc.</b>	Supersilt fence perimeter control in place	<b>Pic 6 Desc.</b>	Waterbars in place

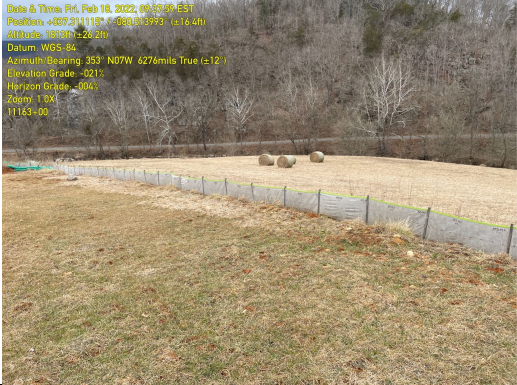
<b>GPS Location</b>	See photo	<b>GPS Location</b>	See photo		
<b>Field Station#</b>	11163+00	<b>Field Station#</b>	11167+50		
<b>Pic 7 Desc.</b>	P1 silt fence perimeter control in place	<b>Pic 8 Desc.</b>	Cleanwater outlet protection in place		
<p><small>Date &amp; Time: Fri, Feb 18, 2022, 09:46:04 EST Position: +007.308447° / -000.014247° (±15.1ft) Altitude: 1920ft (±11.2ft) Datum: WGS-84 Azimuth/Bearing: 241° W06° S21W 3573mils True (±12°) Elevation Grade: +004° Horizon Grade: -002° Zoom: 1.0X 11168+00</small></p>

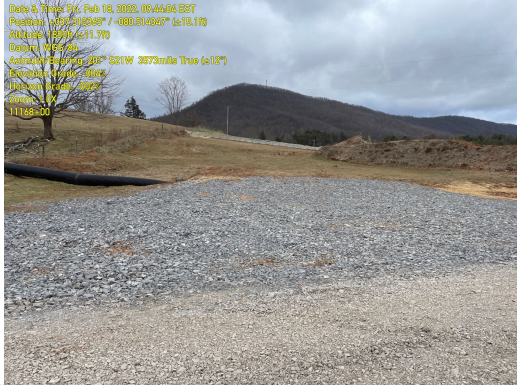
<b>GPS Location</b>	See photo	<b>GPS Location</b>	See photo		
<b>Field Station#</b>	11168+00	<b>Field Station#</b>	11175+00		
<b>Pic 9 Desc.</b>	RCE in place	<b>Pic 10 Desc.</b>	CFS perimeter control in place		
<p><small>Date &amp; Time: Fri, Feb 18, 2022, 09:55:40 EST Position: +007.308201° / -000.013219° (±15.1ft) Altitude: 1939ft (±11.2ft) Datum: WGS-84 Azimuth/Bearing: 308° NS4W 5540mils True (±12°) Elevation Grade: +009° Horizon Grade: +006° Zoom: 1.0X 11178+50</small></p>

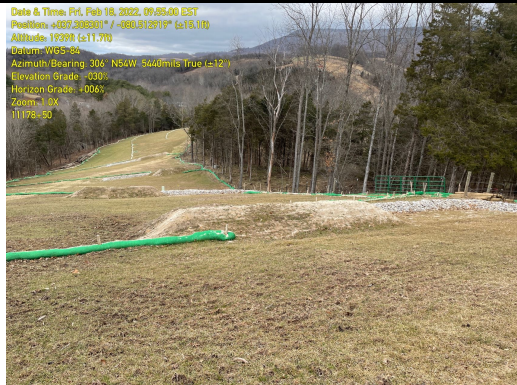
<b>GPS Location</b>	See photo	<b>GPS Location</b>	See photo		
<b>Field Station#</b>	11178+50	<b>Field Station#</b>	11184+15		
<b>Pic 11 Desc.</b>	Permanent waterbars in place	<b>Pic 12 Desc.</b>	Daylight drain in place
