# Visual Site Inspection Report

<b>Project Name</b>	H-600 Pipeline Spread G	<b>AFE</b>	124300137	<b>Spread</b>	H-600 Pipeline Spread G
<b>Contractor</b>	Precision			<b>Report #</b>	34636
<b>Inspector</b>	Chris Burns			<b>Date/Time</b>	2/21/2022 7:29 AM
<b>Permit #</b>	TBD	<b>Inspection Type</b>	VA SWPP	<b>Station Begin</b>	11471+56
<b>State</b>	VA	<b>Inspection Area</b>	Partial	<b>Station End</b>	11524+16
<b>County</b>	Giles	<b>Ground</b>	Dry	<b>Temperature (°F)</b>	57.00
<b>Municipality</b>	N/A	<b>Weather</b>	Sunny	<b>Rain Gauge (in)</b>	0.00
				<b>Rain Accumulation Time (days)</b>	1.00

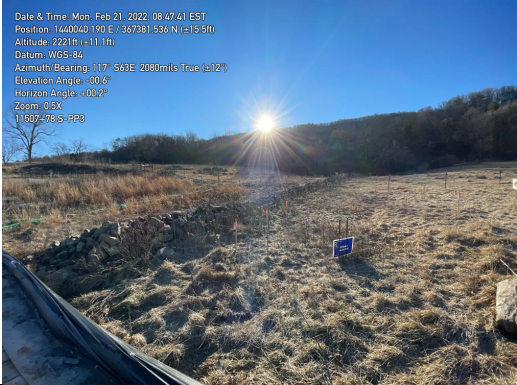
<b>Field Station#</b>	11507+78	<b>Field Station#</b>	11518+32		
<b>Pic 7 Desc.</b>	S-PP3.	<b>Pic 8 Desc.</b>	Overview S-PP4.		
Insert image here		Insert image here			
<b>GPS Location</b>		<b>GPS Location</b>			
<b>Field Station#</b>		<b>Field Station#</b>			
<b>Pic 9 Desc.</b>		<b>Pic 10 Desc.</b>			
Insert image here		Insert image here			
<b>GPS Location</b>		<b>GPS Location</b>			
<b>Field Station#</b>		<b>Field Station#</b>			
<b>Pic 11 Desc.</b>		<b>Pic 12 Desc.</b>

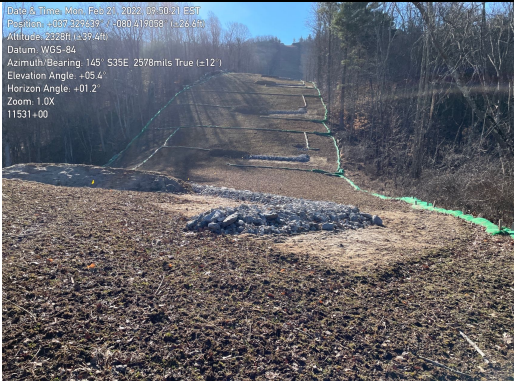
<b>GPS Location</b>	See photo		<b>GPS Location</b>	See photo	
<b>Field Station#</b>	11531+00		<b>Field Station#</b>	11600+01	
<b>Pic 3 Desc.</b>	CFS perimeter controls functional		<b>Pic 4 Desc.</b>	Culvert functional	
<p>Date &amp; Time: Mon, Feb 21, 2022 08:50:44 EST  Position: +037.912557° / +080.427882° (s:15.1ft)  Altitude: 2331ft (s:39.7ft)  Datum: WGS-84  Azimuth Bearing: 152° S35E 2738mils True (±12°)  Elevation Angle: +02.9°  Horizon Angle: +02.1°  Zoom: 1.0X  11592+00</p>

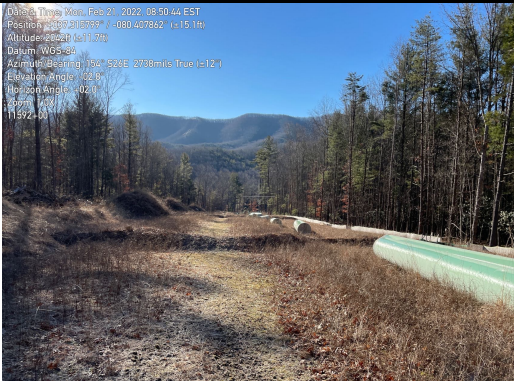
<b>GPS Location</b>	See photo		<b>GPS Location</b>	See photo	
<b>Field Station#</b>	11592+00		<b>Field Station#</b>	11588+00	
<b>Pic 5 Desc.</b>	Water bars in place		<b>Pic 6 Desc.</b>	Wattles in place

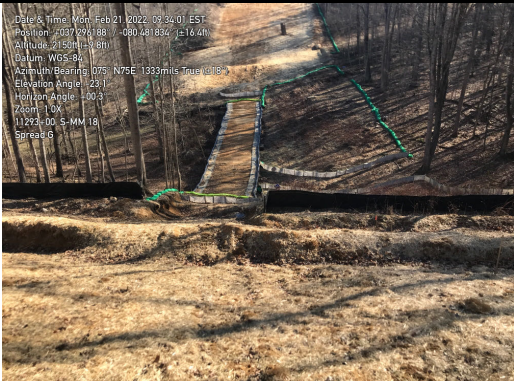
<b>GPS Location</b>	see photo		<b>GPS Location</b>	see photo	
<b>Field Station#</b>	11293+00		<b>Field Station#</b>	11297+89	
<b>Pic 5 Desc.</b>	S-MM 18		<b>Pic 6 Desc.</b>	AR seven Oaks

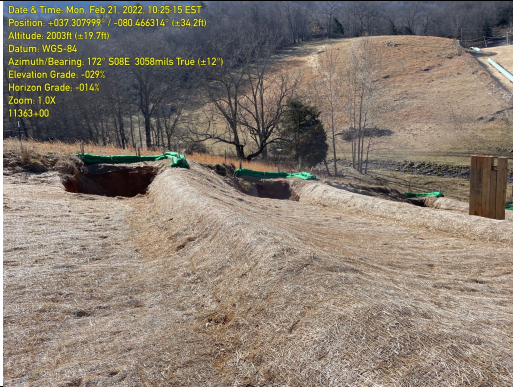
<b>GPS Location</b>	See photo	<b>GPS Location</b>	See photo		
<b>Field Station#</b>	11353+50	<b>Field Station#</b>	11363+00		
<b>Pic 1 Desc.</b>	RCE in place	<b>Pic 2 Desc.</b>	End treatments in place

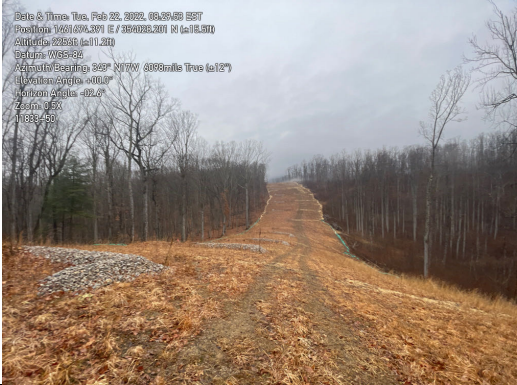
<b>GPS Location</b>	7		<b>GPS Location</b>	8	
<b>Field Station#</b>	11833+50		<b>Field Station#</b>	11819+00	
<b>Pic 7 Desc.</b>	Section of restored RoW showing conditions and controls.		<b>Pic 8 Desc.</b>	Section of restored RoW showing conditions and controls.	
Insert image here			Insert image here		
<b>GPS Location</b>			<b>GPS Location</b>		
<b>Field Station#</b>			<b>Field Station#</b>		
<b>Pic 9 Desc.</b>			<b>Pic 10 Desc.</b>		
Insert image here			Insert image here		
<b>GPS Location</b>			<b>GPS Location</b>		
<b>Field Station#</b>			<b>Field Station#</b>		
<b>Pic 11 Desc.</b>			<b>Pic 12 Desc.</b>

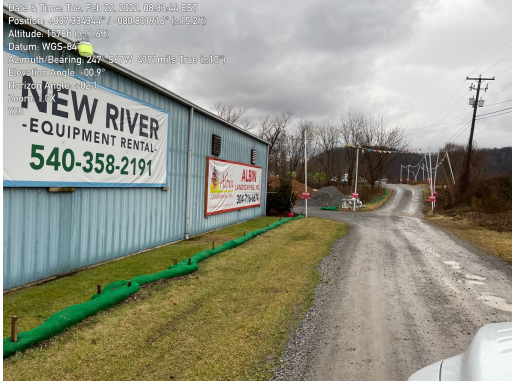
<p>Date &amp; Time Tue Feb 22 2022 12:30 PM EST Position: +027.336110° / -030.803123° (+10.0m) Altitude: 1565ft (+11.0m) Datum: WGS-84 Azimuth/Bearing: 267° 53'W 263mils True (+10°) Elevation Angle: -03.9° Horizon Angle: -02.4° Zoom: 1.0x FPS: 28</p>			
GPS Location	See photo	GPS Location	See photo		
Field Station#	12005+00	Field Station#	12005+00		
Pic 1 Desc.	RCE functional Permanent vegetation in good condition	Pic 2 Desc.	CFS perimeter controls functional

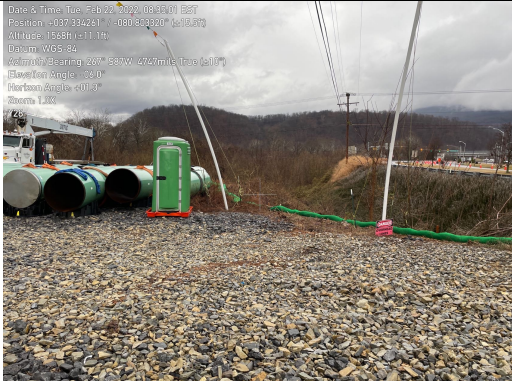
<p>Date &amp; Time Tue Feb 22 2022 12:30 PM EST Position: +027.336110° / -030.803123° (+10.0m) Altitude: 1565ft (+11.0m) Datum: WGS-84 Azimuth/Bearing: 009° N09E 0160mils True (+10°) Elevation Angle: -13.0° Horizon Angle: -01.0° Zoom: 1.0x FPS: 28</p>			
GPS Location	See photo	GPS Location	See photo		
Field Station#	12005+00	Field Station#	12005+00		
Pic 5 Desc.	CFS perimeter controls in place	Pic 6 Desc.	Permanent vegetation in place

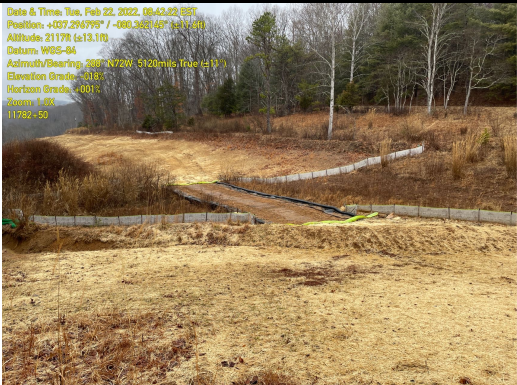
<b>GPS Location</b>	See photo	<b>GPS Location</b>	See photo		
<b>Field Station#</b>	11766+25	<b>Field Station#</b>	11782+50		
<b>Pic 11 Desc.</b>	RCE in place	<b>Pic 12 Desc.</b>	Cleanwater drainage feature in place

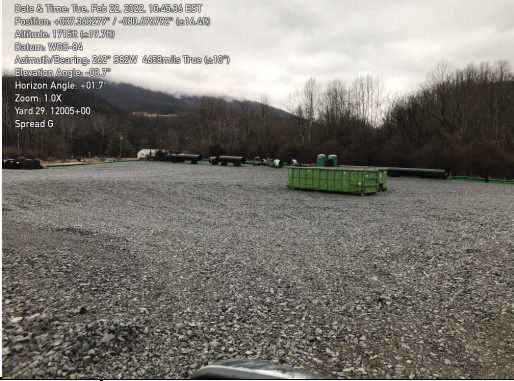
<b>Field Station#</b>	12005+00	<b>Field Station#</b>	12005+00	<b>GPS Location</b>	see photo
<b>Pic 1 Desc.</b>	Waste containers	<b>Pic 2 Desc.</b>	Temporary stabilization	<b>Field Station#</b>	12005+00

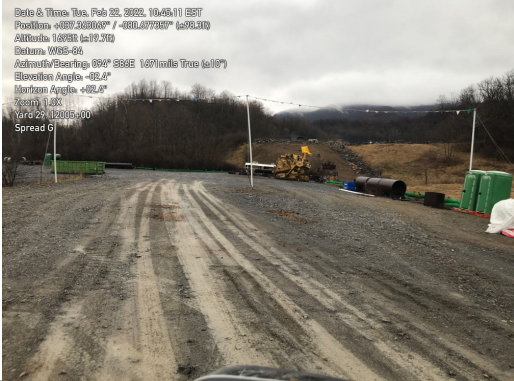
<b>Field Station#</b>	12005+00	<b>Field Station#</b>	12005+00	<b>GPS Location</b>	see photo
<b>Pic 3 Desc.</b>	Yard 29	<b>Pic 4 Desc.</b>	Perimeter controls	<b>Field Station#</b>	12005+00

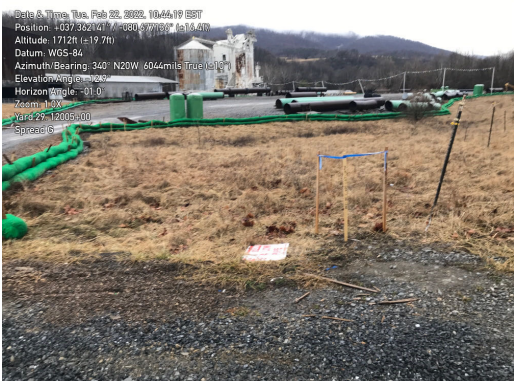
<b>Field Station#</b>	12005+00	<b>Field Station#</b>	12005+00	<b>GPS Location</b>	see photo
<b>Pic 5 Desc.</b>	Perimeter controls	<b>Pic 6 Desc.</b>	RCE	<b>Field Station#</b>	12005+00

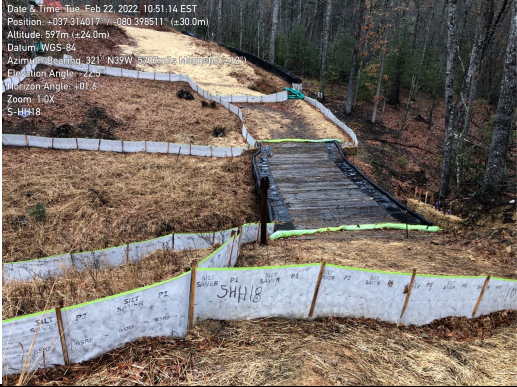
<p><small>Date &amp; Time: Tue, Feb 22, 2022, 10:51:14 EST Position: +037.314017, -080.398511 (+30.0m) Altitude: 597m (+24.0m) Datum: WGS-84 Azimuth/Bearing: 92.1° N33W 3573mils Magnetic (+12°) Elevation Angle: -15.0° Horizon Angle: +01.6° Zoom: 1.0X S-HH18</small></p>

<p><small>Date &amp; Time: Tue, Feb 22, 2022, 10:58:58 EST Position: +037.313426, -080.392263 (+30.0m) Altitude: 591m (+12.0m) Datum: WGS-84 Azimuth/Bearing: 99.0° S16E 1600mils Magnetic (+12°) Elevation Angle: -11.6° Horizon Angle: +00.3° Zoom: 1.0X S-RR14</small></p>			
<b>GPS Location</b>	On photo	<b>GPS Location</b>	On photo		
<b>Field Station#</b>	11626+04	<b>Field Station#</b>	11614+20		
<b>Pic 7 Desc.</b>	The S-HH18 crossing is stable.	<b>Pic 8 Desc.</b>	The S-RR14 crossing is stable.

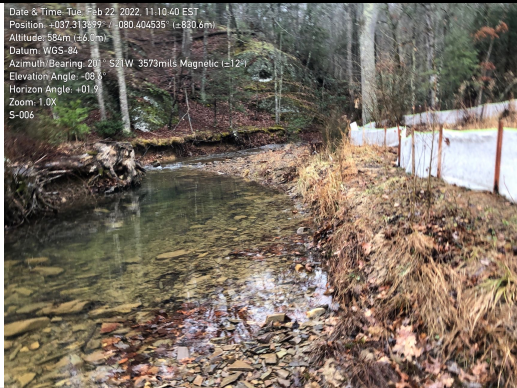
<p><small>Date &amp; Time: Tue, Feb 22, 2022, 11:10:40 EST Position: +037.313199, -080.404535 (+30.0m) Altitude: 560m (+24.0m) Datum: WGS-84 Azimuth/Bearing: 201° S21W 3573mils Magnetic (+12°) Elevation Angle: -08.3° Horizon Angle: +01.9° Zoom: 1.0X S-006</small></p>

<b>GPS Location</b>	On photo	<b>GPS Location</b>	On photo		
<b>Field Station#</b>	11608+17	<b>Field Station#</b>	11613+69		
<b>Pic 9 Desc.</b>	The S-006 crossing is stable.	<b>Pic 10 Desc.</b>	S-RR13 crossing on access road MN-258.04 is in acceptable condition.		
Insert image here		Insert image here			
<b>GPS Location</b>		<b>GPS Location</b>			
<b>Field Station#</b>		<b>Field Station#</b>			
<b>Pic 11 Desc.</b>		<b>Pic 12 Desc.</b>

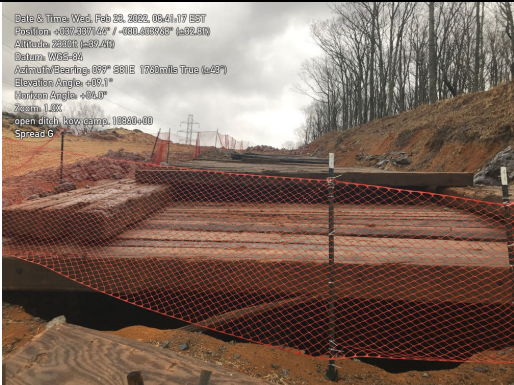
<b>GPS Location</b>	see photo		<b>GPS Location</b>	see photo	
<b>Field Station#</b>	10860+00		<b>Field Station#</b>	10860+00	
<b>Pic 3 Desc.</b>	Open ditch		<b>Pic 4 Desc.</b>	Kow camp RCE

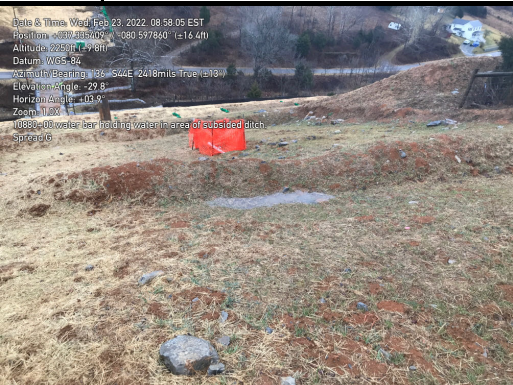
<b>GPS Location</b>	see photo		<b>GPS Location</b>	see photo	
<b>Field Station#</b>	10874+00		<b>Field Station#</b>	10880+00	
<b>Pic 5 Desc.</b>	Ditch subsidence		<b>Pic 6 Desc.</b>	Ditch subsidence, holding water over ditch line.

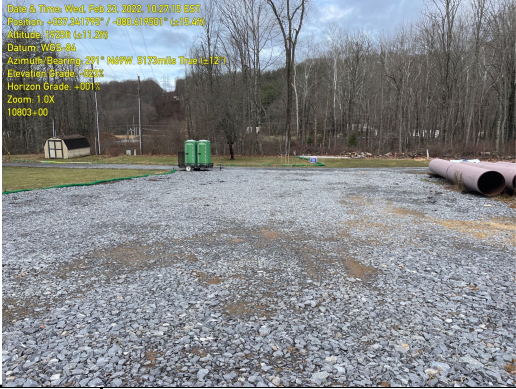
<p>Date &amp; Time: Wed Feb 23, 2022, 10:54:38 EST Position: +407.341748° / -880.618034° (±13.1m) Altitude: 1920ft (±13.1m) Datum: WGS-84 Azimuth/Bearing: 007° N07E 0124mils True (±12°) Elevation Grade: -0002 Horizon Grade: +0002 Zoom: 1.0X 10803+00</p>

<b>Field Station#</b>	10803+00	<b>Field Station#</b>	10805+00	<b>GPS Location</b>	See photo
<b>Pic 3 Desc.</b>	RCE in place	<b>Pic 4 Desc.</b>	P1 Silt fence in place at sensitive resource	<b>GPS Location</b>	See photo

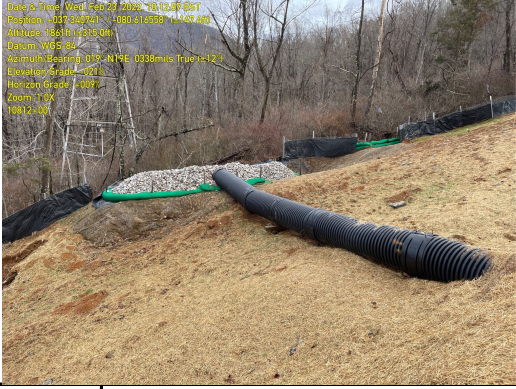
<p>Date &amp; Time: Wed Feb 23, 2022, 10:12:49 EST Position: +407.341748° / -880.618034° (±13.1m) Altitude: 1920ft (±13.1m) Datum: WGS-84 Azimuth/Bearing: 012° N12E 0338mils True (±12°) Elevation Grade: -0002 Horizon Grade: +0002 Zoom: 1.0X 10812+00</p>

<p>Date &amp; Time: Wed Feb 23, 2022, 10:12:49 EST Position: +407.341748° / -880.618034° (±13.1m) Altitude: 2299ft (±13.1m) Datum: WGS-84 Azimuth/Bearing: 278° N82W 4942mils True (±12°) Elevation Grade: -0345 Horizon Grade: -0051 Zoom: 1.0X 10815+00</p>		<b>GPS Location</b>	See photo
<b>Field Station#</b>	10812+00	<b>Field Station#</b>	10815+00	<b>GPS Location</b>	See photo
<b>Pic 5 Desc.</b>	Cleanwater diversion outlet protection in place	<b>Pic 6 Desc.</b>	Erosion control blanket in place	<b>GPS Location</b>	See photo

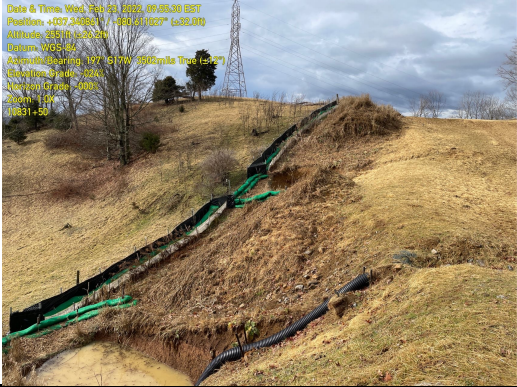
<p>Date &amp; Time: Wed, Feb 23, 2022, 09:53:21 EST  Position: +437.341709° / -90.609943° (s=0.00)  Altitude: 2467 ft (s=19.70)  Datum: WGS 84  Geotagging: 107° 54' 00" 000mils True (s=0.00)  Camera: 3400x (s=0.00)  Horizon Grade: +005  Zoom: 1.0X  10833+00</p>

<b>GPS Location</b>	See photo	<b>GPS Location</b>	See photo		
<b>Field Station#</b>	10831+50	<b>Field Station#</b>	10833+00		
<b>Pic 7 Desc.</b>	Triple protection ECDs in place at karst feature	<b>Pic 8 Desc.</b>	Waterbars in place		
<p>Date &amp; Time: Wed, Feb 23, 2022, 09:48:13 EST  Position: +437.349281° / -90.61022° (s=0.00)  Altitude: 2458 ft (s=0.00)  Datum: WGS 84  Geotagging: 107° 54' 00" 000mils True (s=0.00)  Camera: 3400x (s=0.00)  Horizon Grade: +005  Zoom: 1.0X  10843+75</p>

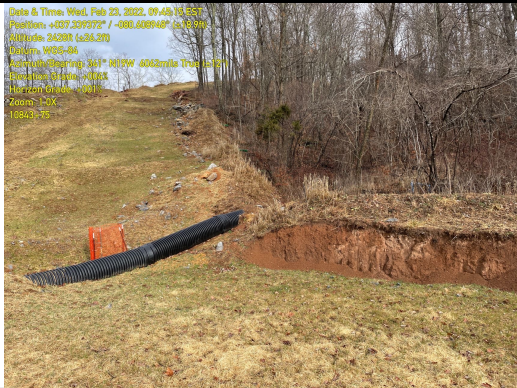
<p>Date &amp; Time: Wed, Feb 23, 2022, 09:57:10 EST  Position: +437.341709° / -90.609943° (s=0.00)  Altitude: 2467 ft (s=19.70)  Datum: WGS 84  Geotagging: 107° 54' 00" 000mils True (s=0.00)  Camera: 3400x (s=0.00)  Horizon Grade: +005  Zoom: 1.0X  10856+00</p>

<b>GPS Location</b>	See photo	<b>GPS Location</b>	See photo		
<b>Field Station#</b>	10843+75	<b>Field Station#</b>	10856+00		
<b>Pic 9 Desc.</b>	Cleanwater diversion berm in place	<b>Pic 10 Desc.</b>	Stream buffer in place		
<p>Date &amp; Time: Wed, Feb 23, 2022, 09:58:01 EST  Position: +437.341709° / -90.609943° (s=0.00)  Altitude: 2467 ft (s=19.70)  Datum: WGS 84  Geotagging: 107° 54' 00" 000mils True (s=0.00)  Camera: 3400x (s=0.00)  Horizon Grade: +005  Zoom: 1.0X  10858+00</p>

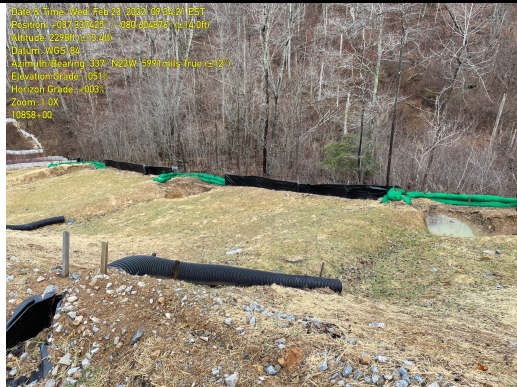
<p>Date &amp; Time: Wed, Feb 23, 2022, 09:58:01 EST  Position: +437.341709° / -90.609943° (s=0.00)  Altitude: 2467 ft (s=19.70)  Datum: WGS 84  Geotagging: 107° 54' 00" 000mils True (s=0.00)  Camera: 3400x (s=0.00)  Horizon Grade: +005  Zoom: 1.0X  10859+00</p>

<b>GPS Location</b>	See photo	<b>GPS Location</b>	See photo		
<b>Field Station#</b>	10858+00	<b>Field Station#</b>	10859+00		
<b>Pic 11 Desc.</b>	End treatments in place	<b>Pic 12 Desc.</b>	Supersilt fence perimeter control in place

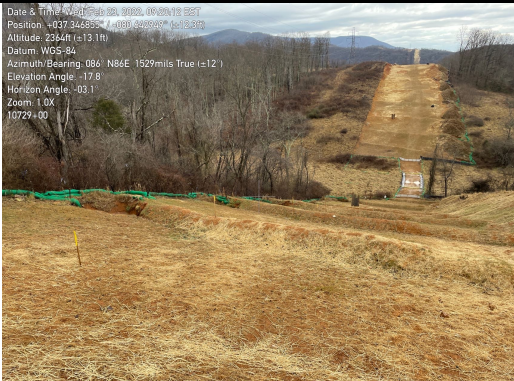
<b>GPS Location</b>	See photo		<b>GPS Location</b>	See photo	
<b>Field Station#</b>	10729+00		<b>Field Station#</b>	10733+18	
<b>Pic 5 Desc.</b>	Water bars and ET functional		<b>Pic 6 Desc.</b>	Resource buffers in place

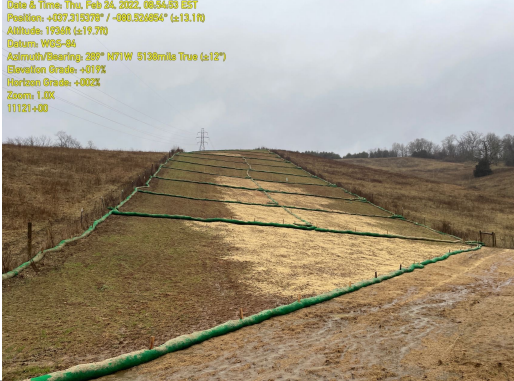
<p>Date &amp; Time: Thu, Feb 24, 2022, 09:01:19 EST  Position: +437.314477° / -080.523670° (±11.60)  Altitude: 19858 (±19.70)  Datum: WGS-84  Azimuth/Bearing: 147° S33E 2613mils True (±12°)  Elevation Grade: +012%  Horizon Grade: -00%  Zoom: 1.0X  11133+00</p>

<b>GPS Location</b>	See photo	<b>GPS Location</b>	See photo		
<b>Field Station#</b>	11121+00	<b>Field Station#</b>	11133+00		
<b>Pic 3 Desc.</b>	CFS temporary waterbars in place	<b>Pic 4 Desc.</b>	Permanent waterbars in place		
<p>Date &amp; Time: Thu, Feb 24, 2022, 09:04:56 EST  Position: +437.3153531° / -080.521792° (±40.10)  Altitude: 20008 (±20.40)  Datum: WGS-84  Azimuth/Bearing: 172° S22W 3460mils True (±12°)  Elevation Grade: +0%  Horizon Grade: -01%  Zoom: 1.0X  11141+00</p>

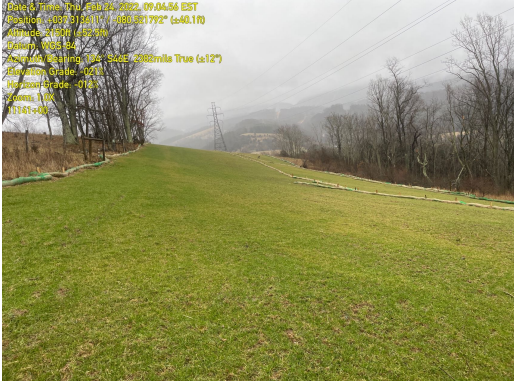
<p>Date &amp; Time: Thu, Feb 24, 2022, 09:09:13 EST  Position: +437.312780° / -080.519597° (±23.00)  Altitude: 20308 (±20.40)  Datum: WGS-84  Azimuth/Bearing: 300° S22W 3891mils True (±12°)  Elevation Grade: +24%  Horizon Grade: -01%  Zoom: 1.0X  11147+15</p>

<b>GPS Location</b>	See photo	<b>GPS Location</b>	See photo		
<b>Field Station#</b>	11141+00	<b>Field Station#</b>	11147+15		
<b>Pic 5 Desc.</b>	Permanent vegetation present	<b>Pic 6 Desc.</b>	Cleanwater diversion berm in place

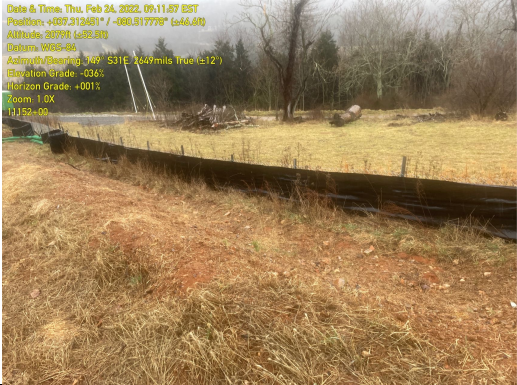
<p><small>Date &amp; Time: Thu, Feb 24, 2022, 09:11:07 EST Position: +037.312481° / -080.517770° (±44.60) Altitude: 20790 (±32.80) Datum: WGS-84 Azimuth/Bearing: 349° S31E 3247mils True (±12°) Elevation Grade: -036% Horizon Grade: +001% Zoom: 1.0X 11152+00</small></p>

<p><small>Date &amp; Time: Thu, Feb 24, 2022, 09:21:19 EST Position: +037.311412° / -080.514245° (±133.90) Altitude: 18339 (±39.40) Datum: WGS-84 Azimuth/Bearing: 118° S40E 2044mils True (±12°) Elevation Grade: -014% Horizon Grade: +000% Zoom: 1.0X 11163+00</small></p>			
<b>GPS Location</b>	See photo	<b>GPS Location</b>	See photo		
<b>Field Station#</b>	11152+00	<b>Field Station#</b>	11163+00		
<b>Pic 7 Desc.</b>	Supersilt fence perimeter control in place	<b>Pic 8 Desc.</b>	Silt fence perimeter control in place

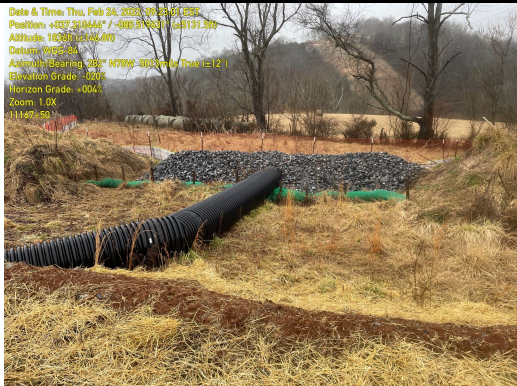
<p><small>Date &amp; Time: Thu, Feb 24, 2022, 09:24:51 EST Position: +037.310444° / -080.516531° (±131.20) Altitude: 18205 (±44.60) Datum: WGS-84 Azimuth/Bearing: 200° N70W 3034mils True (±12°) Elevation Grade: -020% Horizon Grade: -004% Zoom: 1.0X 11165+00</small></p>

<b>GPS Location</b>	See photo	<b>GPS Location</b>	See photo		
<b>Field Station#</b>	11162+50	<b>Field Station#</b>	11168+00		
<b>Pic 9 Desc.</b>	Cleanwater outlet protection in place	<b>Pic 10 Desc.</b>	RCE in place

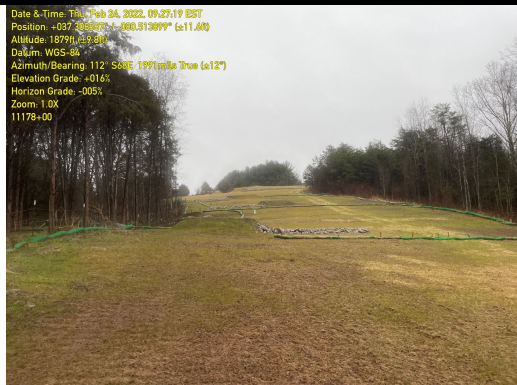
<p><small>Date &amp; Time: Thu, Feb 24, 2022, 09:27:19 EST Position: +037.305872° / -080.513899° (±11.60) Altitude: 18750 (±9.80) Datum: WGS-84 Azimuth/Bearing: 112° S88E 1991mils True (±12°) Elevation Grade: +014% Horizon Grade: -005% Zoom: 1.0X 11178+00</small></p>		<div style="text-align: center; height: 150px;">Insert image here</div>			
<b>GPS Location</b>	See photo	<b>GPS Location</b>			
<b>Field Station#</b>	11178+00	<b>Field Station#</b>			
<b>Pic 11 Desc.</b>	Level spreaders in place	<b>Pic 12 Desc.</b>

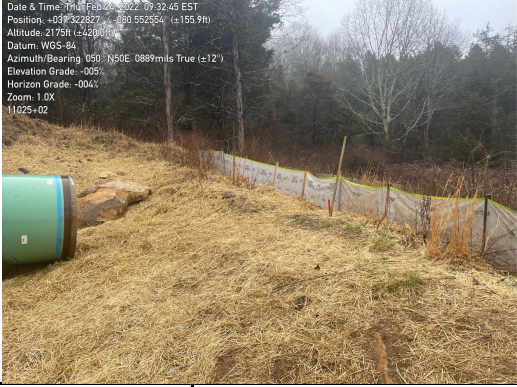
<b>GPS Location</b>	See Photo	<b>GPS Location</b>	See Photo		
<b>Field Station#</b>	11025+02	<b>Field Station#</b>	11025+50		
<b>Pic 13 Desc.</b>	Repaired P1 silt fencing	<b>Pic 14 Desc.</b>	S-IJ Stream equipment bridge condition		
Insert image here		Insert image here

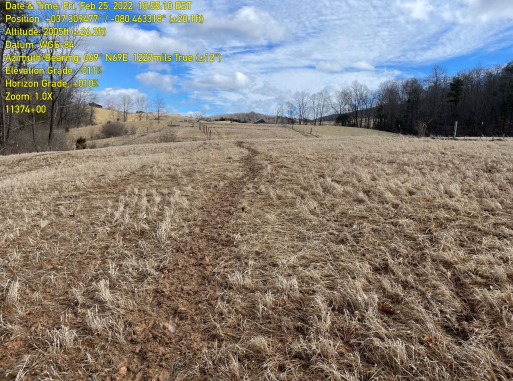
<b>GPS Location</b>		See photo		<b>GPS Location</b>	
<b>Field Station#</b>		11387+00		<b>Field Station#</b>	
<b>Pic 1 Desc.</b>		Area damaged by livestock		<b>Pic 2 Desc.</b>	
<p>Date &amp; Time: Fri, Feb 25, 2022 11:10:39 EST  Position: +037 306903° / -080 457192° (±101ft, 40ft)  Altitude: 1921ft (±107.3ft)  Datum: WGS-84  Azimuth Bearing: 212° S32W: 374mils True (±12°)  Elevation Grade: -021%  Horizon Grade: -002%  Zoom: 1.0X  11353+75</p>

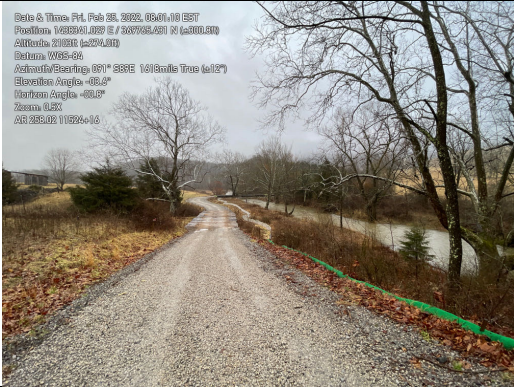
<b>GPS Location</b>	1	<b>GPS Location</b>	2		
<b>Field Station#</b>	11524+16	<b>Field Station#</b>	11472+50		
<b>Pic 1 Desc.</b>	AR 258.02.	<b>Pic 2 Desc.</b>	Karst feature protection functional.

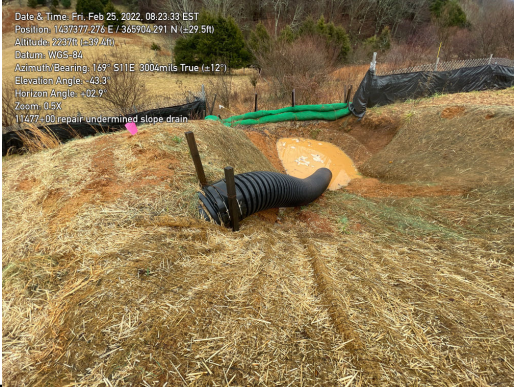
<b>GPS Location</b>	3	<b>GPS Location</b>	4		
<b>Field Station#</b>	11477+00	<b>Field Station#</b>	11486+86		
<b>Pic 3 Desc.</b>	Repair undermined slope drain.	<b>Pic 4 Desc.</b>	Repair undermined and damaged CWDP.
