# Visual Site Inspection Report

<b>Project Name</b>	H-600 Pipeline Spread G	<b>AFE</b>	124300137	<b>Spread</b>	H-600 Pipeline Spread G
<b>Contractor</b>	Precision			<b>Report #</b>	34121
<b>Inspector</b>	Chris Burns			<b>Date/Time</b>	2/7/2022 11:38 AM
<b>Permit #</b>	TBD	<b>Inspection Type</b>	VA SWPP	<b>Station Begin</b>	10749+92
<b>State</b>	VA	<b>Inspection Area</b>	Partial	<b>Station End</b>	10798+92
<b>County</b>	Giles	<b>Ground</b>	Frozen	<b>Temperature (°F)</b>	31.00
<b>Municipality</b>	N/A	<b>Weather</b>	Snow/Sleet	<b>Rain Gauge (in)</b>	0.00
				<b>Rain Accumulation Time (days)</b>	1.00

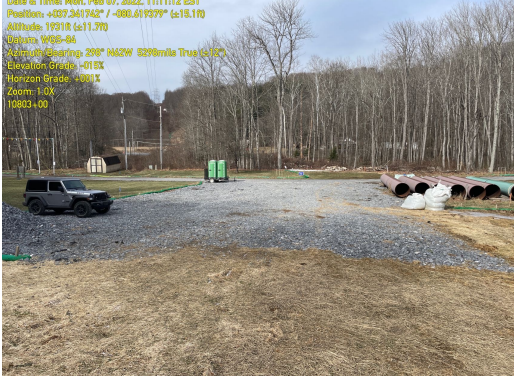
<b>GPS Location</b>	See photo	<b>GPS Location</b>	See photo		
<b>Field Station#</b>	10803+00	<b>Field Station#</b>	10805+00		
<b>Pic 1 Desc.</b>	RCE in place	<b>Pic 2 Desc.</b>	P1 silt fence in place at sensitive resource buffer		
<p>Date &amp; Time: Mon, Feb 07, 2022, 11:08:21 EST  Position: +037.340855° / -080.618304° (±18.200)  Altitude: 1897ft (±15.370)  Datum: WGS-84  Azimuth/Bearing: 310° N10W 5000mils True (±1.2°)  Elevation Grade: -030%  Horizon Grade: -010%  Zoom: 1.0x  10808+15</p>

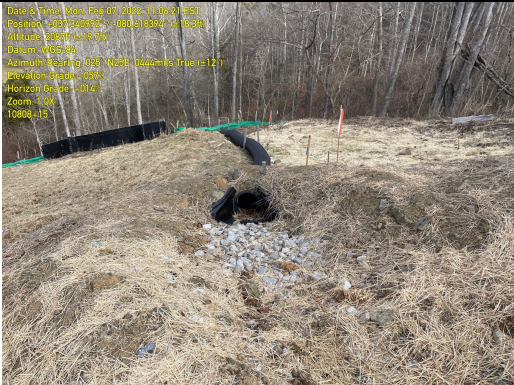
<b>GPS Location</b>	See photo	<b>GPS Location</b>	See photo		
<b>Field Station#</b>	10808+15	<b>Field Station#</b>	10812+00		
<b>Pic 3 Desc.</b>	Stone inlet protection in place	<b>Pic 4 Desc.</b>	Cleanwater diversion outlet protection in place		
<p>Date &amp; Time: Mon, Feb 07, 2022, 10:46:04 EST  Position: +037.340106° / -080.616667° (±18.100)  Altitude: 2394ft (±26.200)  Datum: WGS-84  Azimuth/Bearing: 269° S89W 4782mils True (±1.2°)  Elevation Grade: -032%  Horizon Grade: -001%  Zoom: 1.0x  10815+00</p>

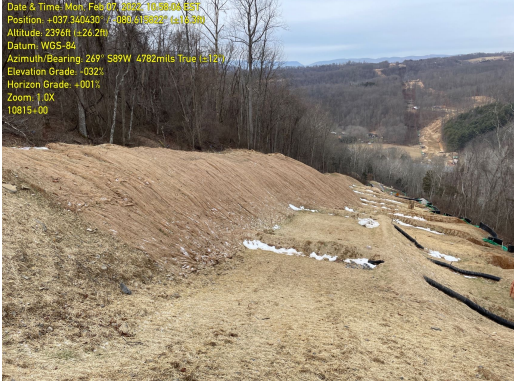
<b>Pic 5 Desc.</b>	Erosion control blanket in place	<b>Pic 6 Desc.</b>	Triple protection ECDs in place at karst feature

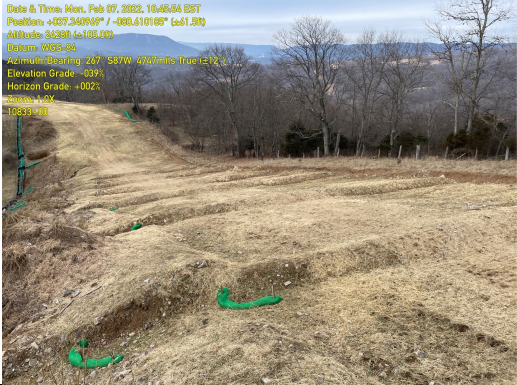
<b>GPS Location</b>	See photo	<b>GPS Location</b>	See photo		
<b>Field Station#</b>	10833+00	<b>Field Station#</b>	10843+75		
<b>Pic 7 Desc.</b>	Waterbars in place	<b>Pic 8 Desc.</b>	Cleanwater diversion berm in place		
<p>Date &amp; Time: Mon, Feb 07, 2022, 10:47:07 CST  Position: +037.338798° / -080.607745° (s=12.44)  Altitude: 22809 (s=18.79)  Datum: WGS 84  Azimuth/Bearing: 138° S42E 2653 mile True (s=12°)  Elevation Grade: -030°  Horizon Grade: +006°  Zoom: 1.0X  10848+50</p>

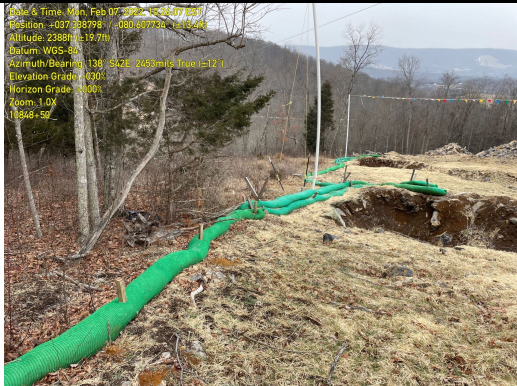
<b>GPS Location</b>	See photo	<b>GPS Location</b>	See photo		
<b>Field Station#</b>	10848+50	<b>Field Station#</b>	10855+00		
<b>Pic 9 Desc.</b>	CFS perimeter control in place	<b>Pic 10 Desc.</b>	Stream buffer in place		
<p>Date &amp; Time: Mon, Feb 07, 2022, 10:12:21 CST  Position: +037.337381° / -080.604389° (s=11.41)  Altitude: 22641 (s=16.81)  Datum: WGS 84  Azimuth/Bearing: 001° N29W 8886 mile True (s=12°)  Elevation Grade: +058°  Horizon Grade: +006°  Zoom: 1.0X  10858+00</p>

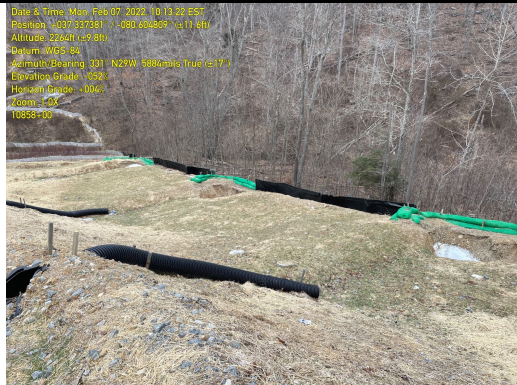
<b>GPS Location</b>	See photo	<b>GPS Location</b>	See photo		
<b>Field Station#</b>	10858+00	<b>Field Station#</b>	10859+00		
<b>Pic 11 Desc.</b>	End treatments in place	<b>Pic 12 Desc.</b>	Supersilt fence perimeter control in place

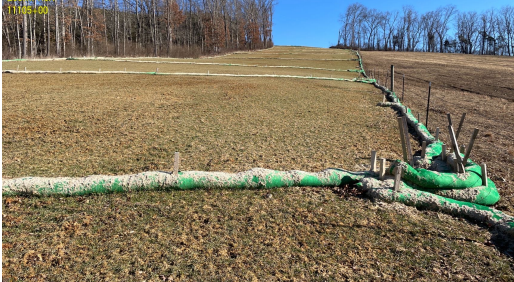
<b>GPS Location</b>	See photo	<b>GPS Location</b>	See photo		
<b>Field Station#</b>	11105+00	<b>Field Station#</b>	11112+00		
<b>Pic 1 Desc.</b>	CFS end treatments in place	<b>Pic 2 Desc.</b>	CFS triple stack perimeter control in place		
<p>Date &amp; Time Tue Feb 08 2022 10:02:28 EST  Position: +037.315468° / -080.527111° (+12.3m)  Altitude: 1971ft (+19.7m)  Datum: WGS-84  Azimuth/Bearing: 281° N79W 4996mils True (+12°)  Elevation Grade: -02m  Horizon Grade: -00m  Zoom: 1.0X  11120+00</p>

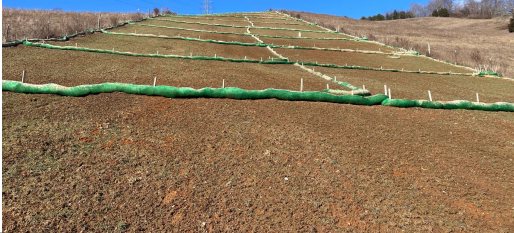
<b>GPS Location</b>	See photo	<b>GPS Location</b>	See photo		
<b>Field Station#</b>	11120+00	<b>Field Station#</b>	11133+00		
<b>Pic 3 Desc.</b>	CFS temporary waterbars in place	<b>Pic 4 Desc.</b>	Level spreaders in place		
<p>Date &amp; Time Tue Feb 08 2022 10:18:26 EST  Position: +037.315467° / -080.527157° (+12.3m)  Altitude: 2037ft (+19.7m)  Datum: WGS-84  Azimuth/Bearing: 124° S30E 2206mils True (+12°)  Elevation Grade: -01m  Horizon Grade: -01m  Zoom: 1.0X  11141+00</p>

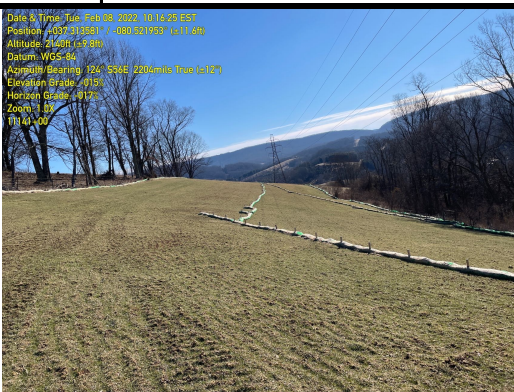
<b>GPS Location</b>	See photo	<b>GPS Location</b>	See photo		
<b>Field Station#</b>	11141+00	<b>Field Station#</b>	11147+00		
<b>Pic 5 Desc.</b>	Permanent vegetation present	<b>Pic 6 Desc.</b>	Stone inlet protection in place

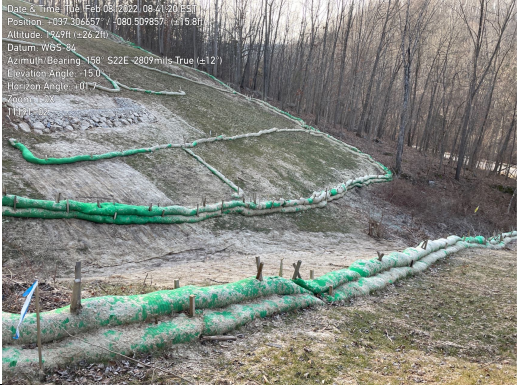
<p><small>Date &amp; Time: Tue, Feb 08, 2022 08:37:35 EST Position: -037.307341° / -080.511905° (-15.5°) Altitude: 8945ft (-11.1m) Datum: WGS-84 Azimuth Bearing: 087° N87E 1547mils True (-12°) Elevation Angle: 06.1° Horizon Angle: 100.2° Zoom: 10X 11185+00</small></p>		
<b>GPS Location</b>	See photo		<b>GPS Location</b>	See photo	
<b>Field Station#</b>	11191+02		<b>Field Station#</b>	11185+00	
<b>Pic 7 Desc.</b>	Clean water drainage feature		<b>Pic 8 Desc.</b>	P1, CFS & RCE functional

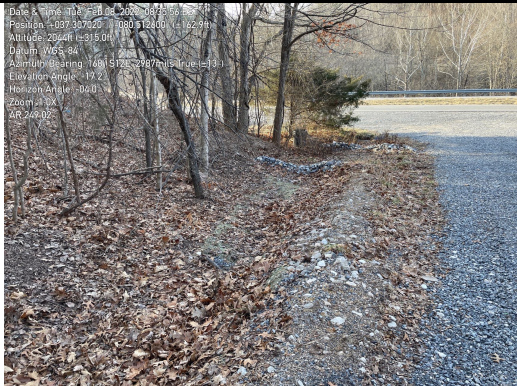
<b>GPS Location</b>	See photo		<b>GPS Location</b>		
<b>Field Station#</b>	11184+79		<b>Field Station#</b>		
<b>Pic 9 Desc.</b>	Rock check dams in place		<b>Pic 10 Desc.</b>		
Insert image here			Insert image here		
<b>GPS Location</b>			<b>GPS Location</b>		
<b>Field Station#</b>			<b>Field Station#</b>		
<b>Pic 11 Desc.</b>			<b>Pic 12 Desc.</b>

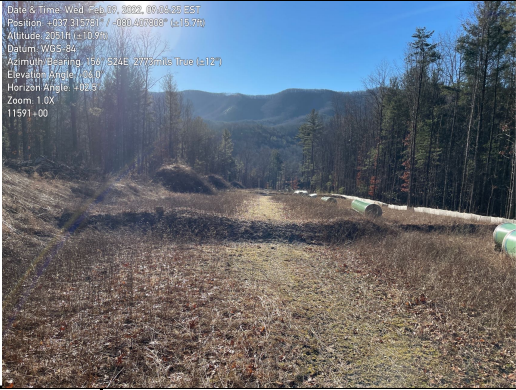
<p>Date &amp; Time: Wed Feb 09 2022 09:04:09 EST  Position: +037 319423 / -080 408289 (x14.87ft)  Altitude: 20274 ft (6180m)  Datum: WGS 84  Azimuth Bearing: 101° N54W 516mils True (±12°)  Elevation Angle: +10.0°  Horizon Angle: +02.9°  Zoom: 1.0x  11588+50</p>  			
<b>GPS Location</b>	See photo		<b>GPS Location</b>	See photo	
<b>Field Station#</b>	11591+00		<b>Field Station#</b>	11588+50	
<b>Pic 5 Desc.</b>	Water bars in place		<b>Pic 6 Desc.</b>	Equipment bridge functional

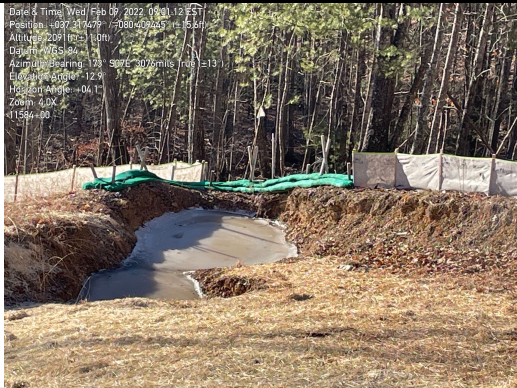
<b>GPS Location</b>	See photo		<b>GPS Location</b>	See photo	
<b>Field Station#</b>	11584+00		<b>Field Station#</b>	11600+01	
<b>Pic 9 Desc.</b>	ET in place		<b>Pic 10 Desc.</b>	RCE functional	
<p>Insert image here</p>			<p>Insert image here</p>		
<b>GPS Location</b>			<b>GPS Location</b>		
<b>Field Station#</b>			<b>Field Station#</b>		
<b>Pic 11 Desc.</b>			<b>Pic 12 Desc.</b>

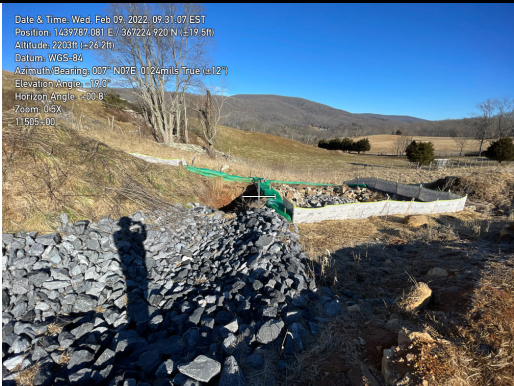
<p>Date &amp; Time: Wed, Feb 09, 2022, 09:32:28 EST Position: 1440005.167 E / 367353.975 N (±15.6ft) Altitude: 2212ft (±11.0ft) Datum: WGS-84 Azimuth/Bearing: 073° N73E 1298mils True (±12°) Elevation Angle: -03.7° Horizon Angle: -00.0° Zoom: 0.5X 11507+78 S-PP3</p>			
<b>GPS Location</b>	5	<b>GPS Location</b>	6		
<b>Field Station#</b>	11505+00	<b>Field Station#</b>	11507+78		
<b>Pic 5 Desc.</b>	Rock lined channel and plunge pool functional.		<b>Pic 6 Desc.</b>	Overview of S-PP3.

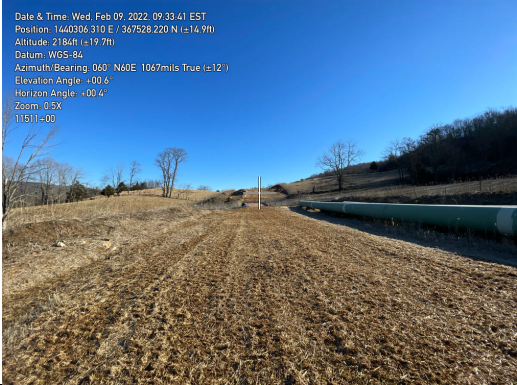
<b>GPS Location</b>	7	<b>GPS Location</b>	8		
<b>Field Station#</b>	11511+00	<b>Field Station#</b>	11518+32		
<b>Pic 7 Desc.</b>	Section of RoW showing conditions and controls.		<b>Pic 8 Desc.</b>	Overview of S-PP4.	
Insert image here		Insert image here

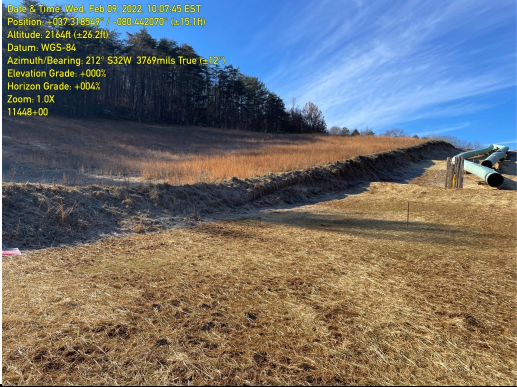
<b>GPS Location</b>		See photo		<b>GPS Location</b>	
<b>Field Station#</b>		11448+00		<b>Field Station#</b>	
<b>Pic 7 Desc.</b>		Cleanwater diversion berm in place		<b>Pic 8 Desc.</b>	
				Permanent vegetation present	
<p>Date &amp; Time: Wed, Feb 09, 2022, 10:39:15 EST  Position: +037°31'52.0" / -080°45'28.0" (+11412)  Altitude: 2304ft (+19.7ft)  Datum: WGS-84  Azimuth/Bearing: 090° N50E 10809mils True (+12°)  Elevation Grade: +002%  Horizon Grade: +002%  Zoom: 1.0X  11412+00</p>

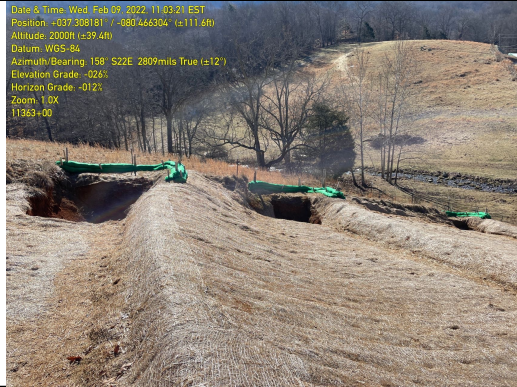
<b>GPS Location</b>		See photo		<b>GPS Location</b>	
<b>Field Station#</b>		11363+00		<b>Field Station#</b>	
<b>Pic 11 Desc.</b>		End treatments in place		<b>Pic 12 Desc.</b>

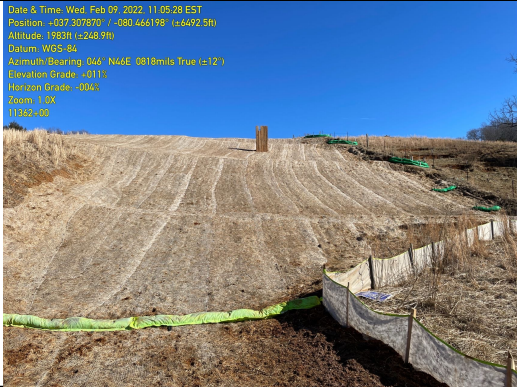
Erosion control blanket in place

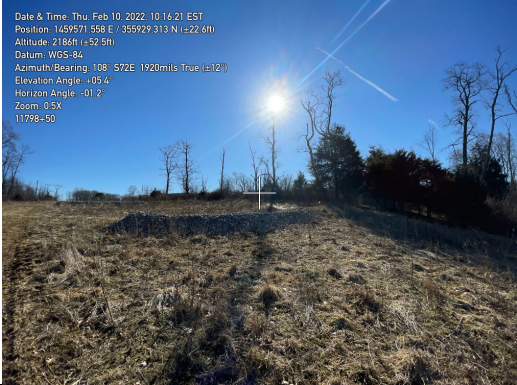
<b>GPS Location</b>	7	<b>GPS Location</b>	8		
<b>Field Station#</b>	11798+50	<b>Field Station#</b>	11788+52		
<b>Pic 7 Desc.</b>	Permanent controls.	<b>Pic 8 Desc.</b>	RCE off of Mt Tabor rd.		
Insert image here		Insert image here			
<b>GPS Location</b>		<b>GPS Location</b>

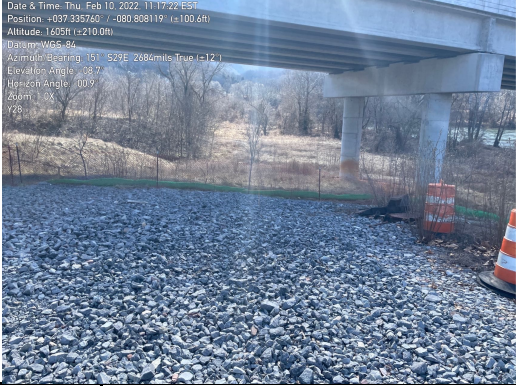
<p>Date &amp; Time: Thu, Feb 10, 2022, 11:19:45 EST Position: +037.335945, -080.808233 (+100.0ft) Altitude: 1607ft (+112.0ft) Datum: WGS-84 Azimuth/Bearing: 304° N56W 9404mils True (+12°) Elevation Angle: -09.2 Horizon Angle: +05.0 Zoom: 1.0X Y2B:</p>			
<b>GPS Location</b>	See photo		<b>GPS Location</b>	See photo	
<b>Field Station#</b>	12005+00		<b>Field Station#</b>	12005+00	
<b>Pic 1 Desc.</b>	CFS perimeter controls & safety fence in place		<b>Pic 2 Desc.</b>	CFS perimeter controls in place

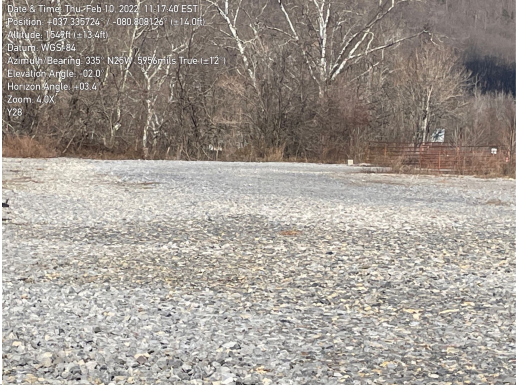
<b>GPS Location</b>	See photo		<b>GPS Location</b>	See photo	
<b>Field Station#</b>	12005+00		<b>Field Station#</b>	12005+00	
<b>Pic 3 Desc.</b>	RCE in good condition		<b>Pic 4 Desc.</b>	CFS perimeter controls in place

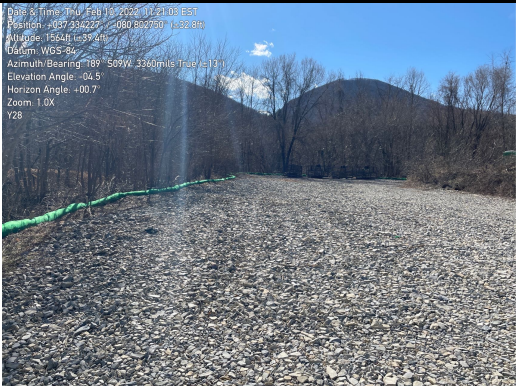
<p>Date &amp; Time: Thu, Feb 10, 2022, 11:21:44 EST Position: +037.336236, -080.802785 (+120.0ft) Altitude: 1575ft (+26.2ft) Datum: WGS-84 Azimuth/Bearing: 151° S29E 2684mils True (+12°) Elevation Angle: -00.1 Horizon Angle: -02.7 Zoom: 1.0X Y2B:</p>			
<b>GPS Location</b>	See photo		<b>GPS Location</b>	See photo	
<b>Field Station#</b>	12005+00		<b>Field Station#</b>	12005+00	
<b>Pic 5 Desc.</b>	CFS perimeter controls functional in place		<b>Pic 6 Desc.</b>	Housekeeping in place

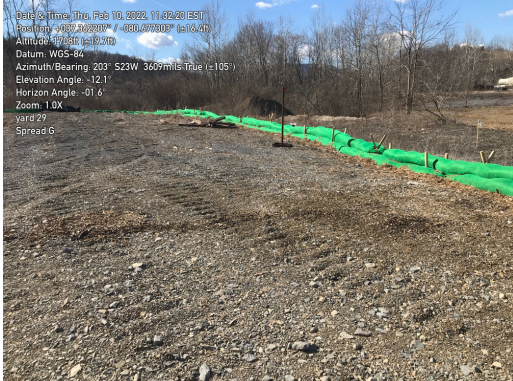
<p>Date &amp; Time: Thu, Feb 10, 2022, 11:42:45 EST Position: +037.247221° / -080.497101° (-16.4M) Altitude: 1705ft (-16.3M) Datum: WGS-84 Azimuth/Bearing: 033° N33E 488mils True (-65°) Elevation Angle: -09.4° Horizon Angle: -01.8° Zoom: 1.0X yard 29 Spread G</p>			
GPS Location				See photo				GPS Location				see photo			
Field Station#				12005+00				Field Station#				12005+00			
Pic 1 Desc.				Yard 29 perimeter compost sock				Pic 2 Desc.				Yard 29 perimeter compost sock

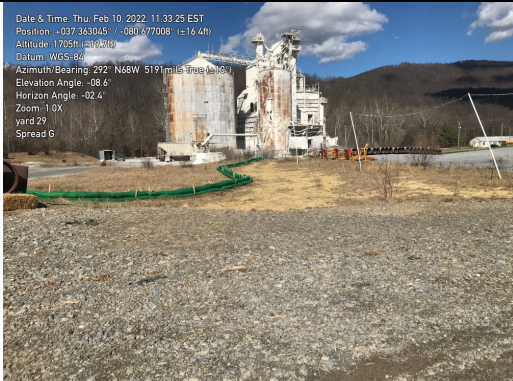
GPS Location				see photo				GPS Location				see photo			
Field Station#				12005+00				Field Station#				12005+00			
Pic 3 Desc.				Yard 29 perimeter compost sock				Pic 4 Desc.				Equipment trash receptacles

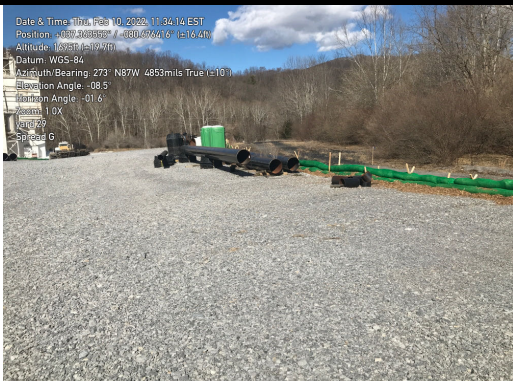
<p>Date &amp; Time: Thu, Feb 10, 2022, 11:34:44 EST Position: +037.243947° / -080.676110° (-16.4M) Altitude: 1693ft (-16.3M) Datum: WGS-84 Azimuth/Bearing: 210° S69W 3840mils True (-10°) Elevation Angle: -10.6° Horizon Angle: -01.0° Zoom: 1.0X yard 29 Spread G</p>			
GPS Location				see photo				GPS Location				see photo			
Field Station#				12005+00				Field Station#				12005+00			
Pic 5 Desc.				Yard 29 perimeter compost sock				Pic 6 Desc.				Stored pipe

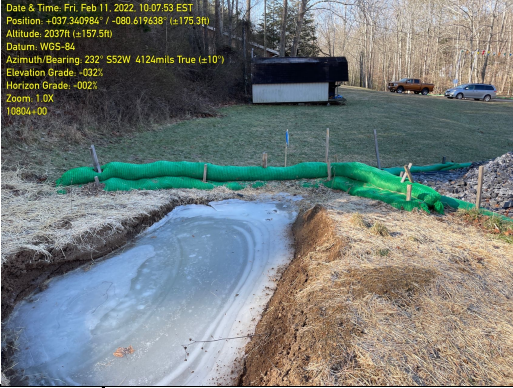
<b>GPS Location</b>	See photo	<b>GPS Location</b>	See photo		
<b>Field Station#</b>	10803+00	<b>Field Station#</b>	10804+00		
<b>Pic 1 Desc.</b>	RCE in place	<b>Pic 2 Desc.</b>	End treatment in place

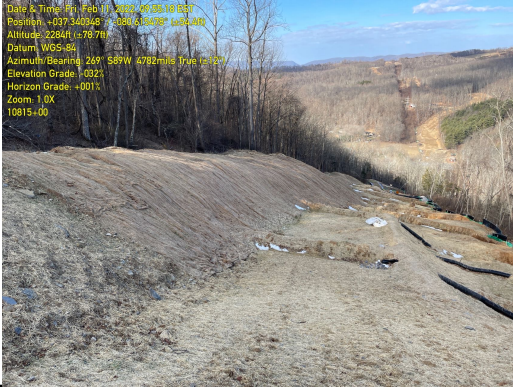
<b>GPS Location</b>	See photo	<b>GPS Location</b>	See photo		
<b>Field Station#</b>	10805+00	<b>Field Station#</b>	10815+00		
<b>Pic 3 Desc.</b>	P1 silt fence in place at sensitive resource	<b>Pic 4 Desc.</b>	Erosion control blanket in place

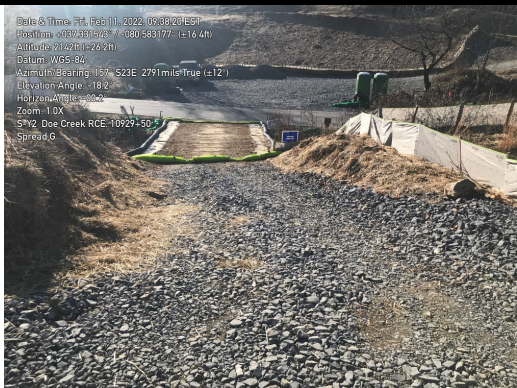
<b>GPS Location</b>	see photo	<b>GPS Location</b>			
<b>Field Station#</b>	10929+50	<b>Field Station#</b>			
<b>Pic 9 Desc.</b>	S-Y 2, Doe Creek	<b>Pic 10 Desc.</b>			
<div style="text-align: center;">Insert image here</div>		<div style="text-align: center;">Insert image here</div>			
<b>GPS Location</b>		<b>GPS Location</b>			
<b>Field Station#</b>		<b>Field Station#</b>			
<b>Pic 11 Desc.</b>		<b>Pic 12 Desc.</b>

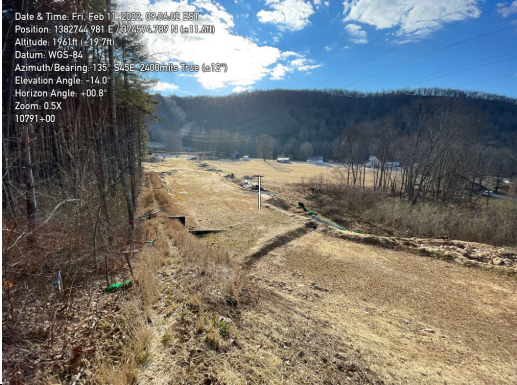
<b>GPS Location</b>	7	<b>GPS Location</b>	8		
<b>Field Station#</b>	10791+00	<b>Field Station#</b>	10798+50		
<b>Pic 7 Desc.</b>	Section of RoW showing conditions and controls.		<b>Pic 8 Desc.</b>	RCE off of Cascade dr.	
Insert image here		Insert image here			
<b>GPS Location</b>		<b>GPS Location</b>			
<b>Field Station#</b>		<b>Field Station#</b>			
<b>Pic 9 Desc.</b>		<b>Pic 10 Desc.</b>			
Insert image here		Insert image here			
<b>GPS Location</b>		<b>GPS Location</b>			
<b>Field Station#</b>		<b>Field Station#</b>			
<b>Pic 11 Desc.</b>		<b>Pic 12 Desc.</b>
