Visual Site Inspection Report

Project Name	H-600 Pipeline Spread H	AFE	124300138	Spread	H-600 Pipeline Spread H
Contractor	Precision			Report #	33571
Inspector	Norm Kitchen			Date/Time	1/24/2022 5:00 PM
Permit #	TBD	Inspection Type	VA SWPP	Station Begin	12119+17
State	VA	Inspection Area	Partial	Station End	12284+75
County	Montgomery	Ground	Frozen	Temperature (°F)	43.00
Municipality	N/A	Weather	Sunny	Rain Gauge (in)	0.00
				Rain Accumulation Time (days)	1.00

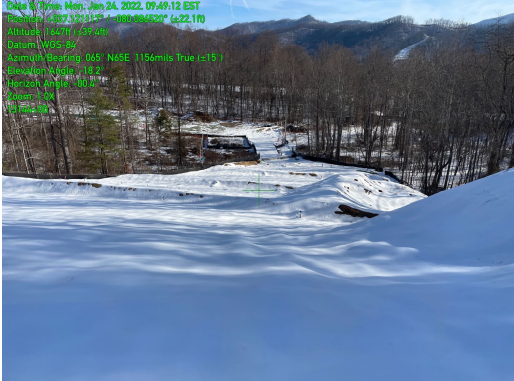
GPS Location	0	GPS Location	0		
Field Station#	13144+00	Field Station#	13146+56		
Pic 1 Desc.	ROW and ECDs In good condition and stable	Pic 2 Desc.	MVP-S-D12/13 and Corresponding buffer zone In good condition

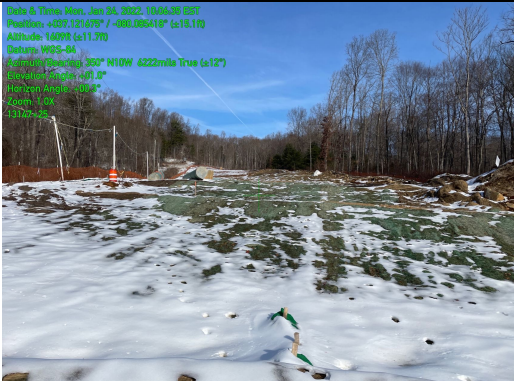
GPS Location	0	GPS Location	0		
Field Station#	13147+25	Field Station#	13154+00		
Pic 3 Desc.	ROW and ECDs In good condition and stable	Pic 4 Desc.	Slope drain pipe in good condition and functioning properly

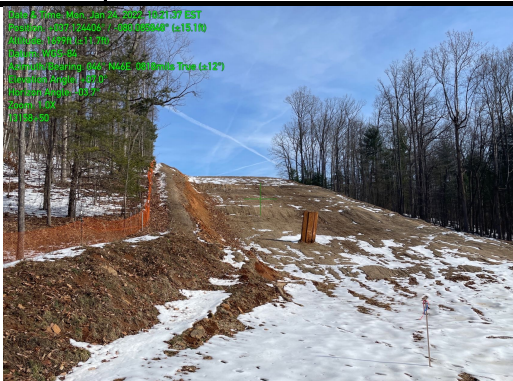
GPS Location	0	GPS Location	0		
Field Station#	13157+22	Field Station#	13158+50		
Pic 5 Desc.	MVP-S-D11 and Corresponding buffer zone In good condition	Pic 6 Desc.	ROW and ECDs In good condition and stable

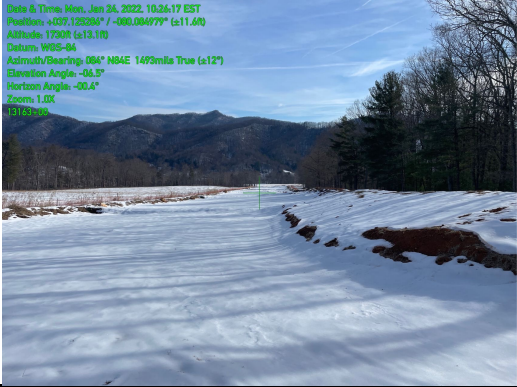
GPS Location 0		GPS Location 0			
Field Station# 13163+00		Field Station# 13169+00			
Pic 7 Desc. ROW and ECDs In good condition and stable		Pic 8 Desc. ROW and ECDs In good condition and stable			
<p>Date & Time: Mon, Jan 24, 2022, 11:07:14 EST Position: +037.124993° / -080.077761° (s15.1ft) Altitude: 1590ft (s11.7ft) Datum: WGS-84 Azimuth/Bearing: 292° N88W 5191mils True (s12°) Elevation Angle: +02.5° Horizon Angle: -00.1° Zoom: 1.0X 13185+00</p>

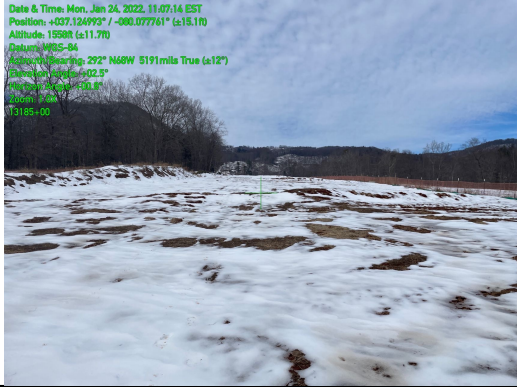
GPS Location 0		GPS Location 0			
Field Station# 13185+00		Field Station# 13197+55			
Pic 9 Desc. ROW and ECDs In good condition and stable		Pic 10 Desc. ROW and ECDs In good condition and stable, covered in snow and ice and unsafe to walk			
<p>Date & Time: Mon, Jan 24, 2022, 11:25:11 EST Position: +037.119610° / -080.096607° (s15.3ft) Altitude: 1443ft (s11.3ft) Datum: WGS-84 Azimuth/Bearing: 080° N80E 8452mils True (s11°) Elevation Angle: +07.1° Horizon Angle: -02.3° Zoom: 1.0X 13196+31</p>

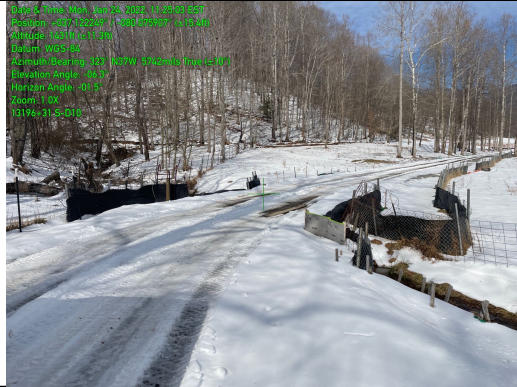
GPS Location 0		GPS Location 0			
Field Station# 13196+31		Field Station# 13262+62			
Pic 11 Desc. MVP-S-D10 and Corresponding buffer zone In good condition		Pic 12 Desc. Flanders Road Crossing in good condition

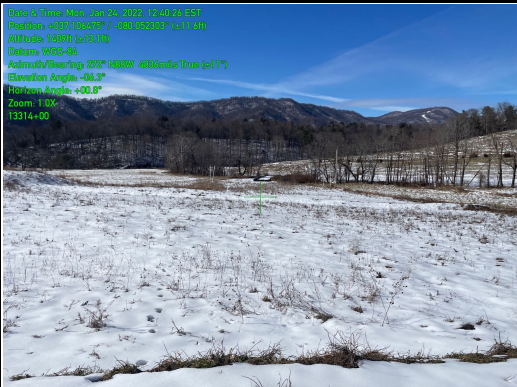
GPS Location	0	GPS Location	0		
Field Station#	13314+00	Field Station#	13309+09		
Pic 17 Desc.	ROW and ECDs In good condition and stable	Pic 18 Desc.	MVP-S-GH7 and Corresponding buffer zone In good condition

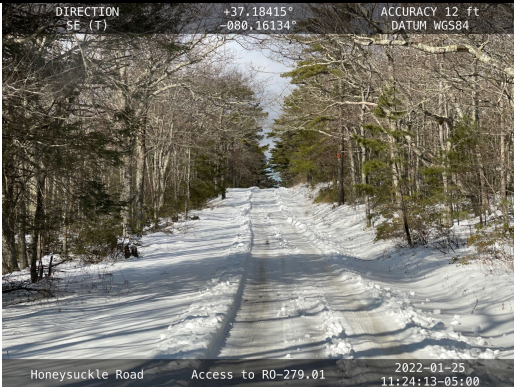
GPS Location	See photo for gps location data.		GPS Location	See photo for gps location data.	
Field Station#	12703+00		Field Station#	12689+00	
Pic 1 Desc.	Photo shows Honeysuckle just past RO-280. Access road RO-279.01 is not accessible.		Pic 2 Desc.	Photo shows the RCE at Honeysuckle Road.

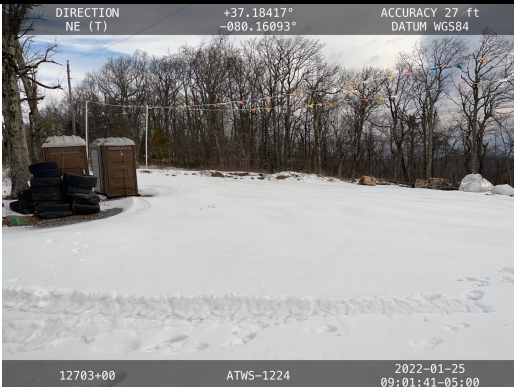
GPS Location	See photo for gps location data.		GPS Location	See photo for gps location data.	
Field Station#	12703+00		Field Station#	12690+00	
Pic 3 Desc.	Photo shows ATWS-1224 and access road RO-280.		Pic 4 Desc.	Photo shows the ROW condition. ECDs are installed and functioning as designed.

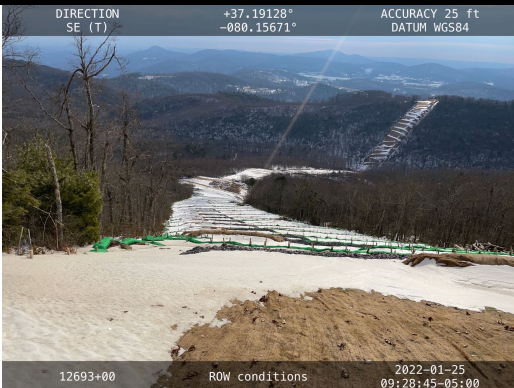
GPS Location	See photo for gps location data.		GPS Location	See photo for gps location data.	
Field Station#	12693+00		Field Station#	12703+00	
Pic 5 Desc.	Photo shows the ROW condition. ECDs are installed and functioning as designed.		Pic 6 Desc.	Photo shows the ROW condition. ECDs are installed and functioning as designed.

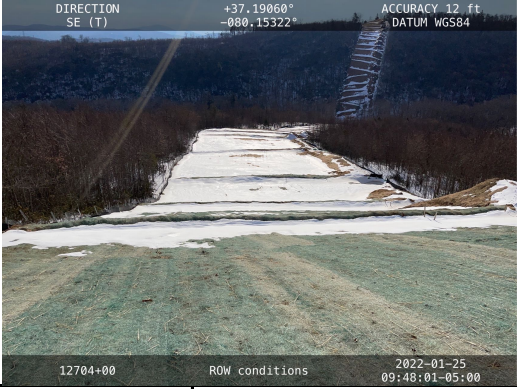
GPS Location	See photo for gps location data.		GPS Location	See photo for gps location data.	
Field Station#	12704+00		Field Station#	12705+00	
Pic 7 Desc.	Photo shows the ROW condition. ECDs are installed and functioning as designed.		Pic 8 Desc.	Photo shows the ROW condition. ECDs are installed and functioning as designed.

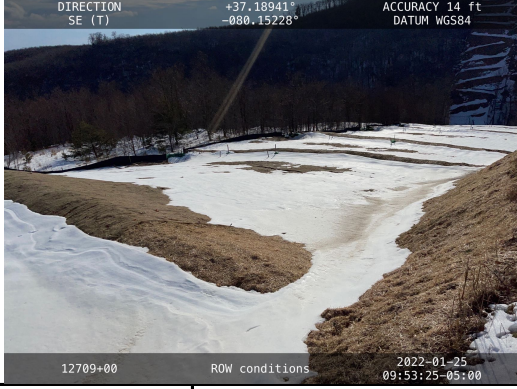
GPS Location	See photo for gps location data.		GPS Location	See photo for gps location data.	
Field Station#	12709+00		Field Station#	12712+00	
Pic 9 Desc.	Photo shows the ROW condition. ECDs are installed and functioning as designed.		Pic 10 Desc.	Photo shows the ROW condition. ECDs are installed and functioning as designed.

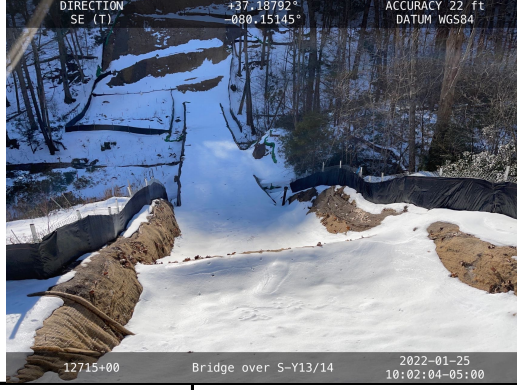
GPS Location	See photo for gps location data.		GPS Location	See photo for gps location data.	
Field Station#	12715+00		Field Station#	12715+80	
Pic 11 Desc.	Photo shows the ROW conditions and bridge over streams S-Y13 and S-Y14.		Pic 12 Desc.	Photo shows S-Y13 downstream from the bridge.

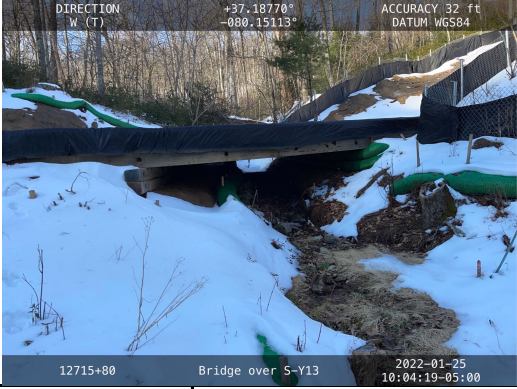
GPS Location	See photo for gps location data.		GPS Location	See photo for gps location data.	
Field Station#	12715+80		Field Station#	12716+20	
Pic 13 Desc.	Photo shows the bridge over stream S-Y13.		Pic 14 Desc.	Photo shows the bridge over stream S-Y14.

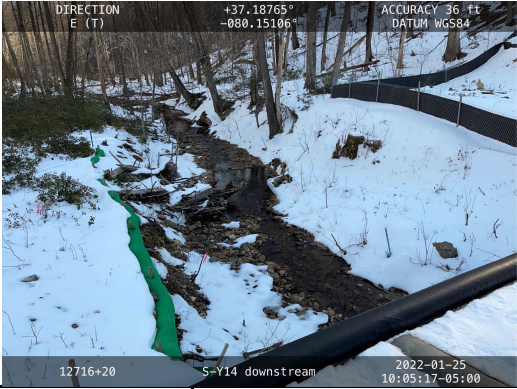
GPS Location	See photo for gps location data.		GPS Location	See photo for gps location data.	
Field Station#	12716+20		Field Station#	12716+20	
Pic 15 Desc.	Photo shows stream S-Y14 downstream from the bridge.		Pic 16 Desc.	Photo shows stream S-Y14 upstream from the bridge.

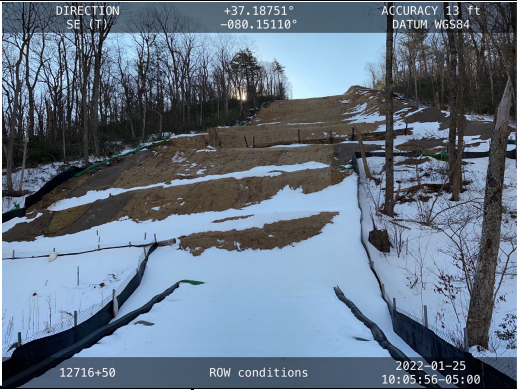
GPS Location	See photo for gps location data.		GPS Location	See photo for gps location data.	
Field Station#	12716+50		Field Station#	12718+00	
Pic 17 Desc.	Photo shows the ROW condition.		Pic 18 Desc.	Photo shows the ROW condition and bridge over streams S-Y13 and S-Y14.

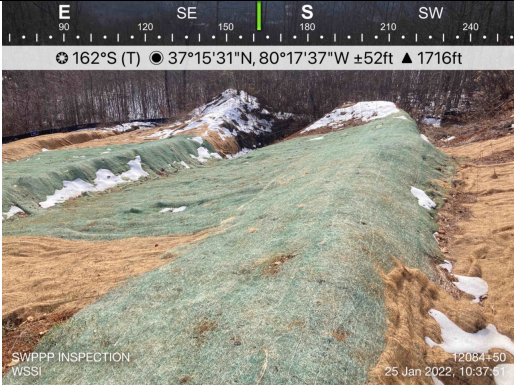
GPS Location	See Photo Watermark		GPS Location	See Photo Watermark	
Field Station#	12084+50		Field Station#	12072+00	
Pic 1 Desc.	Waterbars in good condition along the ROW. No maintenance needed.		Pic 2 Desc.	Temporary vegetation on the ROW in good condition.

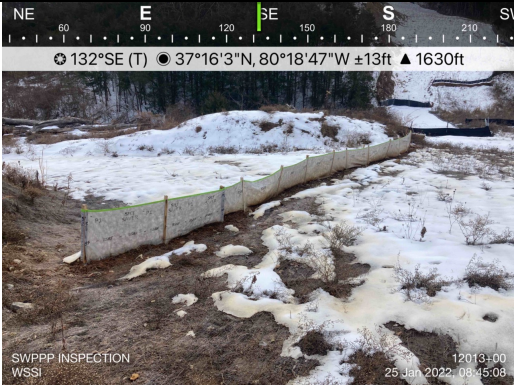
GPS Location	See Photo Watermark		GPS Location	See Photo Watermark	
Field Station#	12013+00		Field Station#	12005+00	
Pic 3 Desc.	Installed SF on ROW in good condition. No maintenance needed.		Pic 4 Desc.	Construction entrances installed at roads in good condition. No maintenance needed.

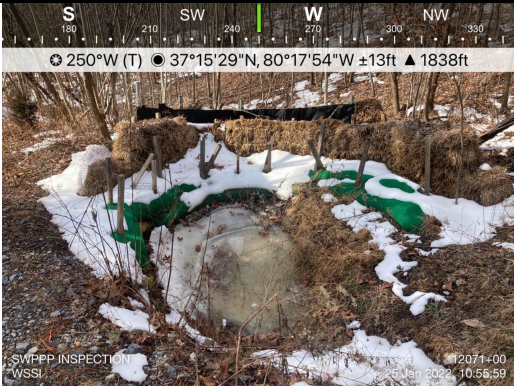
GPS Location	See Photo Watermark		GPS Location	See Photo Watermark	
Field Station#	12071+00		Field Station#	12078+00	
Pic 5 Desc.	Sump pits installed along the ROW in good condition. No maintenance needed.		Pic 6 Desc.	Recently installed erosion control blankets in good condition with no signs of erosion. No maintenance needed.

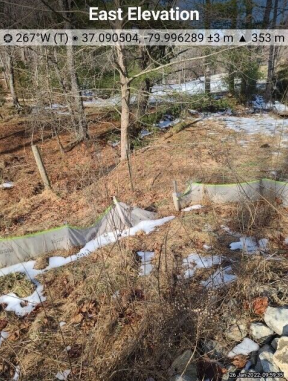
GPS Location	0000	GPS Location	0000		
Field Station#	13525+10	Field Station#	13522+50		
Pic 1 Desc.	P1 requires maintenance due to being weathered and torn, added to the punch list for repair.		Pic 2 Desc.	P1 requires maintenance due to being weathered and torn, added to the punch list for repair.	
	South West Elevation

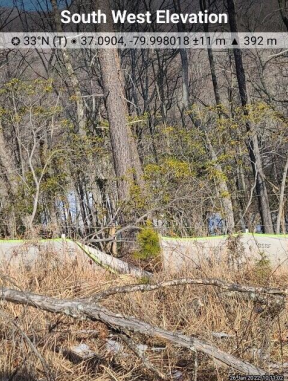
GPS Location	0000	GPS Location	0000		
Field Station#	13520+00	Field Station#	13522+50		
Pic 3 Desc.	P1 requires maintenance due to being weathered and torn, added to the punch list for repair.		Pic 4 Desc.	P1 requires maintenance due to being weathered and torn, added to the punch list for repair.	
	West Elevation

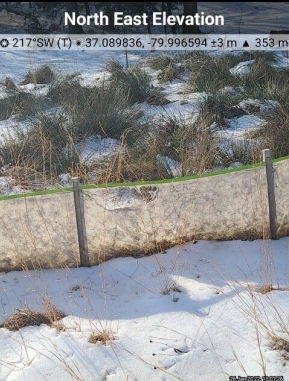
GPS Location	0000	GPS Location	000000		
Field Station#	13518+00	Field Station#	13524+30		
Pic 5 Desc.	Construction debris needs removed from the row, documented and added to the punch list.		Pic 6 Desc.	P1 requires maintenance due to being weathered and torn, added to the punch list for repair.

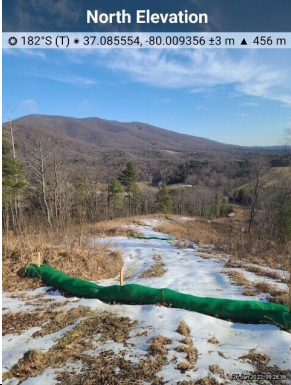
<p>Insert image here</p>		<p>Insert image here</p>	
GPS Location	0000	GPS Location			
Field Station#	13455+00	Field Station#			
Pic 7 Desc.	Monitored water bars and ECDs throughout the row, no environmental issues observed at the time of inspection.		Pic 8 Desc.		
<p>Insert image here</p>		<p>Insert image here</p>			
GPS Location		GPS Location			
Field Station#		Field Station#			
Pic 9 Desc.		Pic 10 Desc.			
<p>Insert image here</p>		<p>Insert image here</p>			
GPS Location		GPS Location			
Field Station#		Field Station#			
Pic 11 Desc.		Pic 12 Desc.

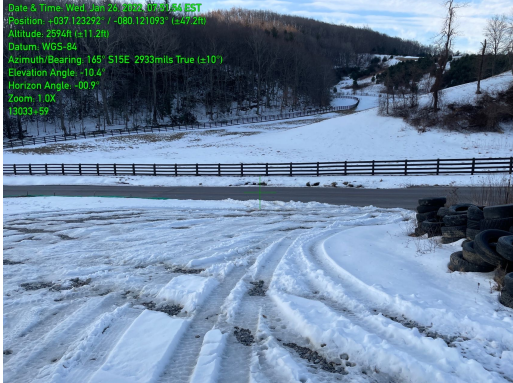
GPS Location	0		GPS Location	0	
Field Station#	13033+59		Field Station#	13024+06	
Pic 1 Desc.	RCE in good condition		Pic 2 Desc.	MVP-S-G24/25 and Corresponding buffer zone in good condition

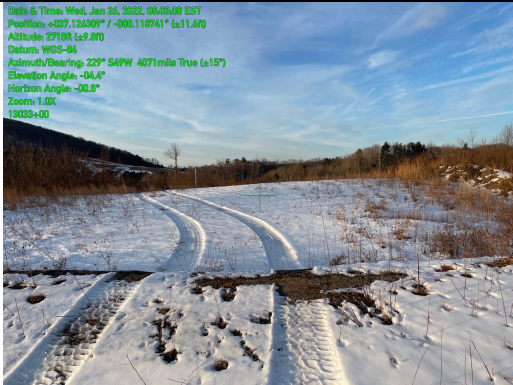
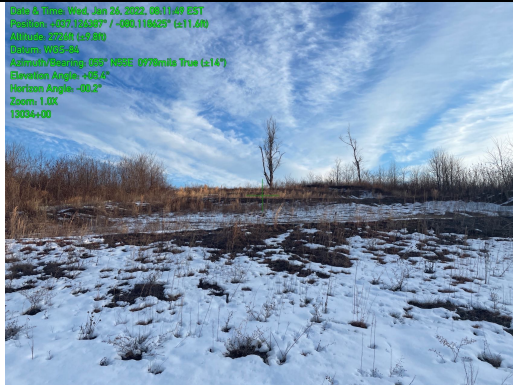
GPS Location	0		GPS Location	0	
Field Station#	13033+00		Field Station#	13034+00	
Pic 3 Desc.	ROW and ECDs In good condition and stable		Pic 4 Desc.	ROW and ECDs In good condition and stable

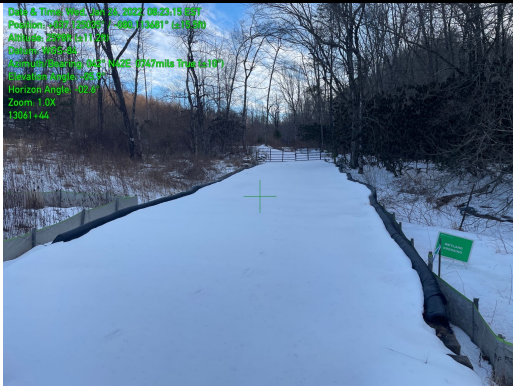
GPS Location	0		GPS Location	0	
Field Station#	13061+44		Field Station#	13061+00	
Pic 5 Desc.	Equipment bridge in good condition		Pic 6 Desc.	ROW and ECDs In good condition and stable

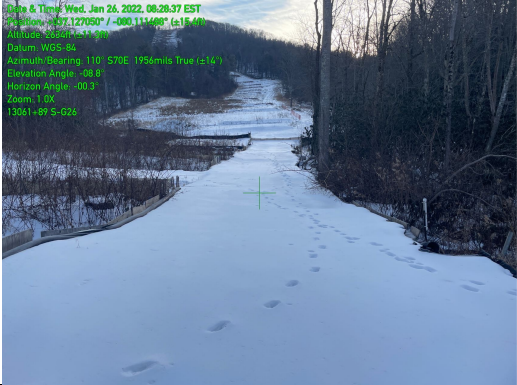
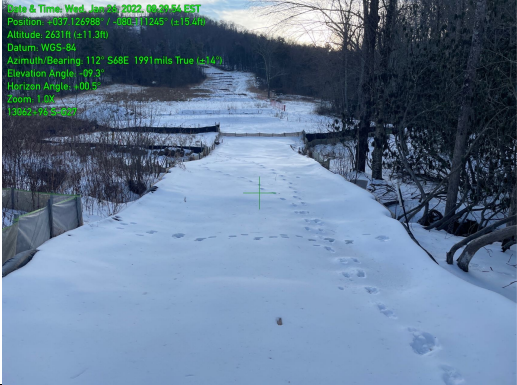
GPS Location	0	GPS Location	0		
Field Station#	13061+89	Field Station#	13062+96		
Pic 7 Desc.	MVP-S-G24/25 and Corresponding buffer zone in good condition		Pic 8 Desc.	MVP-S-G24/25 and Corresponding buffer zone in good condition

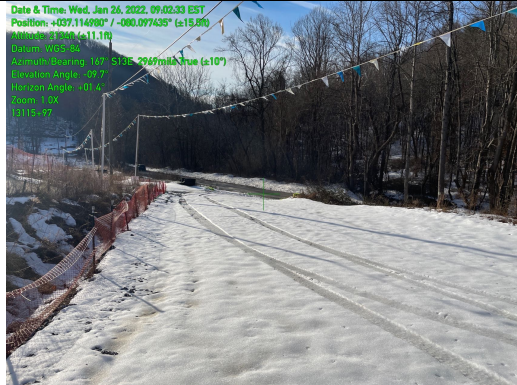
GPS Location	0	GPS Location	0		
Field Station#	13115+97	Field Station#	13141+53		
Pic 11 Desc.	RCE in good condition		Pic 12 Desc.	MVP-S-D14 and Corresponding buffer zone in good condition

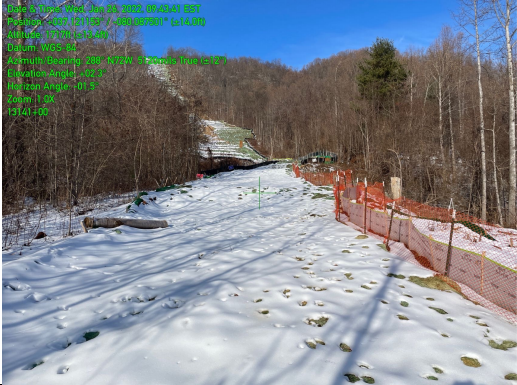
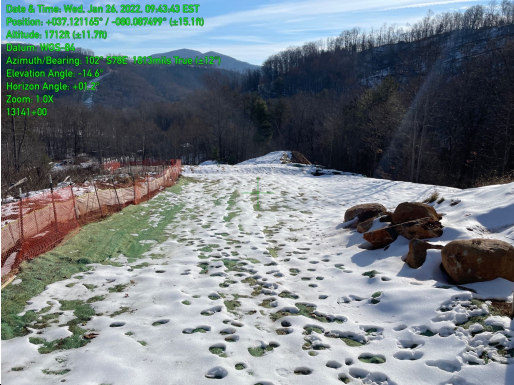
<p>Date & Time: Wed, Jan 26, 2022, 09:43:43 EST Position: +437.121165° / -900.007499° (s15.10) Altitude: 1712ft (s11.70) Datum: NAD83-84 Azimuth Bearing: 289° (N21W 5138mW True to 1) Elevation Angle: -11.3° Horizontal Angle: -01.9° Zoom: 1.0x 13141+00</p>			
GPS Location	0	GPS Location	0		
Field Station#	13141+00	Field Station#	13141+00		
Pic 13 Desc.	ROW and ECDs In good condition and stable	Pic 14 Desc.	ROW and ECDs In good condition and stable

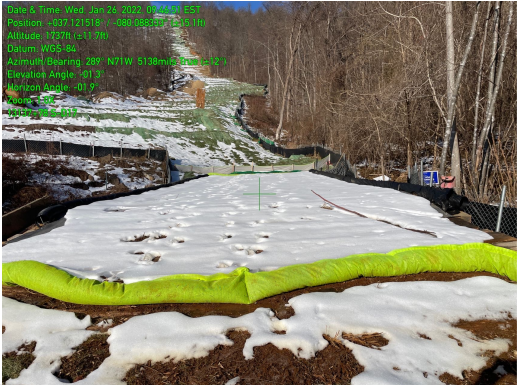
GPS Location	0	GPS Location	0		
Field Station#	13137+78	Field Station#	13137+78		
Pic 15 Desc.	MVP-S-D17 and Corresponding buffer zone in good condition	Pic 16 Desc.	MVP-S-D17 Upstream and Corresponding buffer zone in good condition

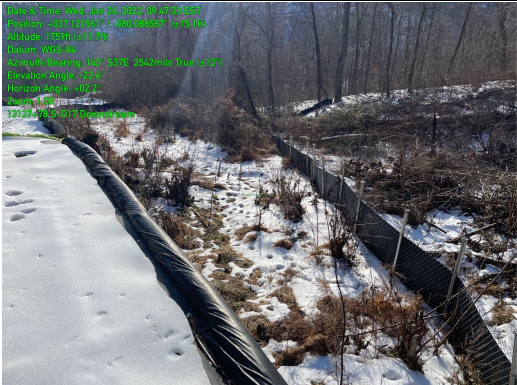
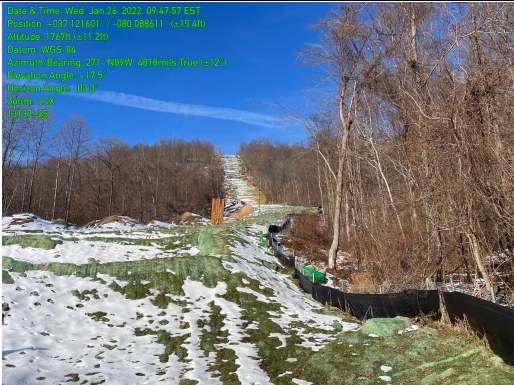
<p>Date & Time: Wed, Jan 26, 2022, 09:43:41 EST Position: +437.121165° / -900.007499° (s14.00) Altitude: 1712ft (s14.00) Datum: NAD83-84 Azimuth Bearing: 289° (N21W 5138mW True to 1) Elevation Angle: -11.3° Horizontal Angle: -01.9° Zoom: 1.0x 13137+25</p>			
GPS Location	0	GPS Location	0		
Field Station#	13137+78	Field Station#	13137+25		
Pic 17 Desc.	MVP-S-D17 Downstream and Corresponding buffer zone in good condition	Pic 18 Desc.	ROW and ECDs In good condition and stable

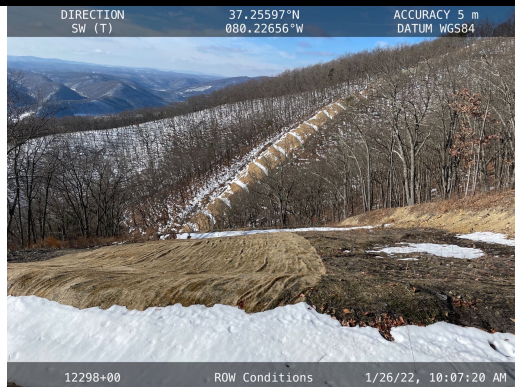
<div>12298+00</div> <div>ROW Conditions</div> <div>1/26/22, 10:07:20 AM</div>

GPS Location	See photo		GPS Location	See photo	
Field Station#	12284+75		Field Station#	12298+00	
Pic 3 Desc.	Current ROW conditions. ROW is stable. ECDs are functional		Pic 4 Desc.	Current ROW conditions. ROW is stable. ECDs are functional	
	<div>DIRECTION E (T)</div> <div>37.25508°N 080.22513°W</div> <div>ACCURACY 4 m DATUM WGS84</div>   <div>12304+00</div> <div>Functional waterbar</div> <div>1/26/22, 10:11:39 AM</div>		<div>DIRECTION E (T)</div> <div>37.25423°N 080.22324°W</div> <div>ACCURACY 7 m DATUM WGS84</div>   <div>12310+50</div> <div>ROW Conditions</div> <div>1/26/22, 10:18:52 AM</div>		
GPS Location	See photo		GPS Location	See photo	
Field Station#	12304+00		Field Station#	12310+50	
Pic 5 Desc.	Current ROW conditions. ROW is stable. ECDs are functional		Pic 6 Desc.	Current ROW conditions. ROW is stable. ECDs are functional

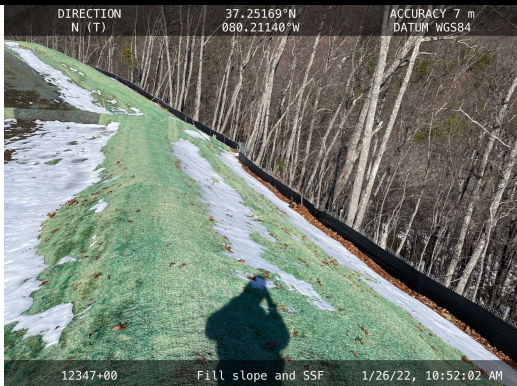
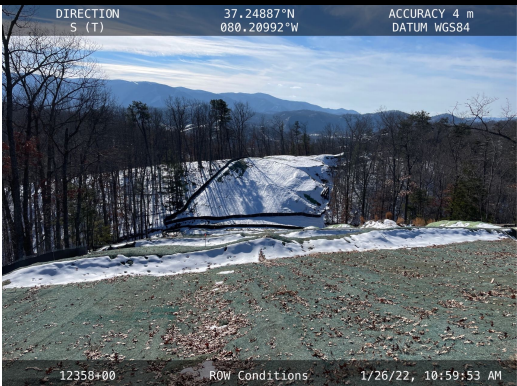
GPS Location	See photo		GPS Location	See photo	
Field Station#	12347+00		Field Station#	12358+00	
Pic 9 Desc.	Current ROW conditions. ROW is stable. ECDs are functional		Pic 10 Desc.	Current ROW conditions. ROW is stable. ECDs are functional

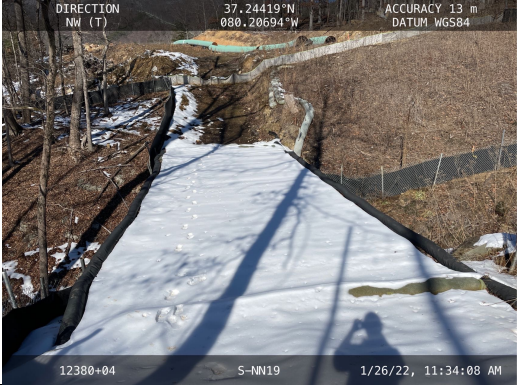
GPS Location	See photo		GPS Location	See photo	
Field Station#	12380+04		Field Station#	12382+00	
Pic 13 Desc.	Equipment Bridge over Stream S-NN19		Pic 14 Desc.	Drainage Feature is functional

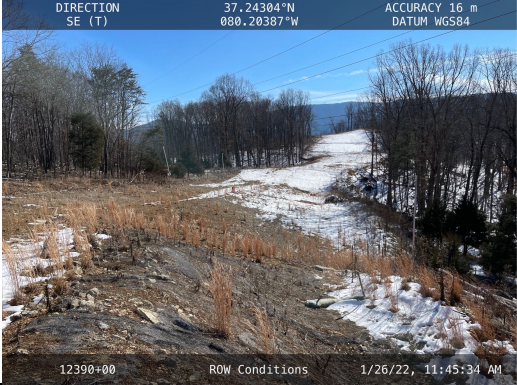
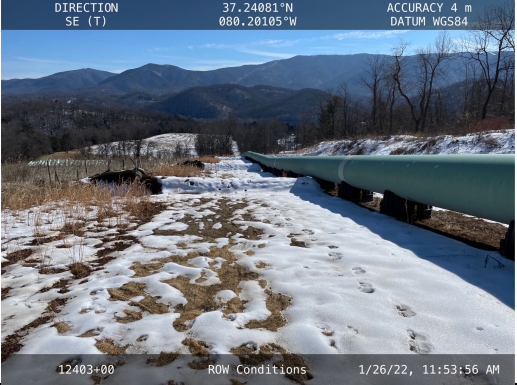
GPS Location	See photo		GPS Location	See photo	
Field Station#	12390+00		Field Station#	12403+00	
Pic 15 Desc.	Current ROW conditions. ROW is stable. ECDs are functional		Pic 16 Desc.	Current ROW conditions. ROW is stable. ECDs are functional

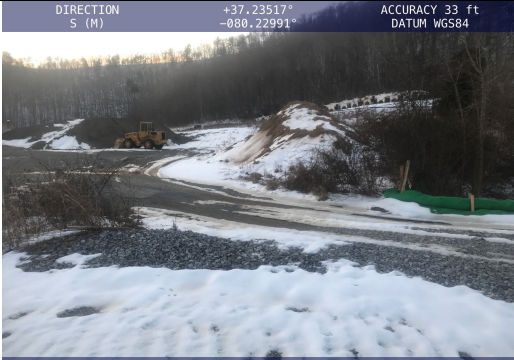
<p>DIRECTION S (M) +37.23517° -080.22991° ACCURACY 33 ft DATUM WGS84</p> <p>MVP-PY-006_012622 Status of spoil pile adjacent to LOD 2022-01-26 07:43:10-05:00</p>

<p>DIRECTION W (M) +37.23624° -080.22781° ACCURACY 33 ft DATUM WGS84</p> <p>MVP-PY-006_012622 Condition of project posted documents 2022-01-26 07:49:07-05:00</p>			
GPS Location	MVP-PY-006 See photo for gps data		GPS Location	MVP-PY-006 See photo for gps data	
Field Station#	+0		Field Station#	+0	
Pic 1 Desc.	Status of spoil pile adjacent to LOD. Soil pile not stabilized. Looking S.		Pic 2 Desc.	Condition of posted project documents at the main entrance. Looking W.

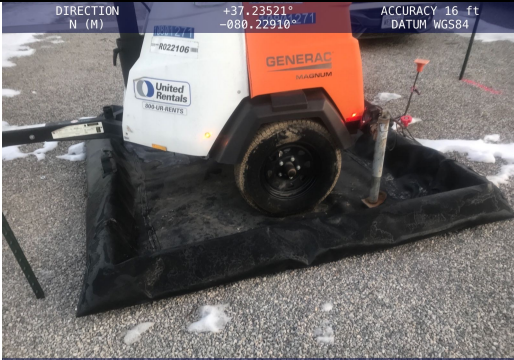
<p>DIRECTION N (M) +37.23521° -080.22910° ACCURACY 16 ft DATUM WGS84</p> <p>MVP-PY-006_012622 Containment under light plant 2022-01-26 07:44:36-05:00</p>

GPS Location	MVP-PY-006 See photo for gps data		GPS Location	MVP-PY-006 See photo for gps data	
Field Station#	+0		Field Station#	+0	
Pic 3 Desc.	Secondary containment under light plant. Free of fluids and ice. Looking N.		Pic 4 Desc.	Condition of signage and triple stack compost filter sock along feature W-008. Looking NE.

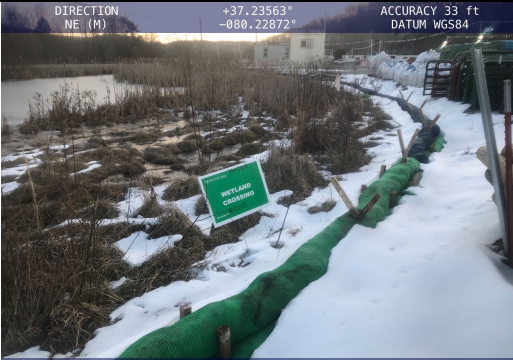
<p>DIRECTION NE (M) +37.23563° -080.22872° ACCURACY 33 ft DATUM WGS84</p> <p>MVP-PY-006_012622 Condition of signage & CFS at feature 2022-01-26 07:46:35-05:00</p>

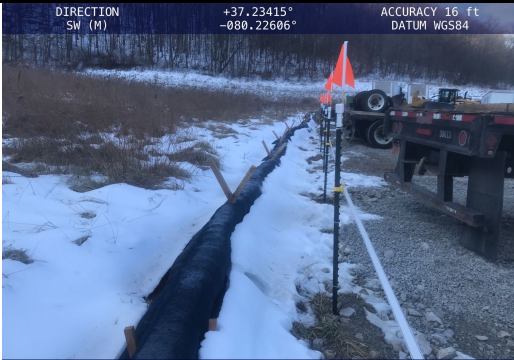
<p>DIRECTION SW (M) +37.23415° -080.22606° ACCURACY 16 ft DATUM WGS84</p> <p>MVP-PY-006_012622 Condition of CFS along south LOD 2022-01-26 09:08:01-05:00</p>

<p>DIRECTION N (M) +37.23511° -080.22710° ACCURACY 213 ft DATUM WGS84</p> <p>MVP-PY-006_012622 Condition of CFS along east LOD 2022-01-26 09:09:11-05:00</p>			
GPS Location	MVP-PY-006 See photo for gps data		GPS Location	MVP-PY-006 See photo for gps data	
Field Station#	+0		Field Station#	+0	
Pic 5 Desc.	Condition of triple stack compost filter sock along south LOD. Looking SW.		Pic 6 Desc.	Condition of triple stack compost filter sock along east LOD. Looking N.

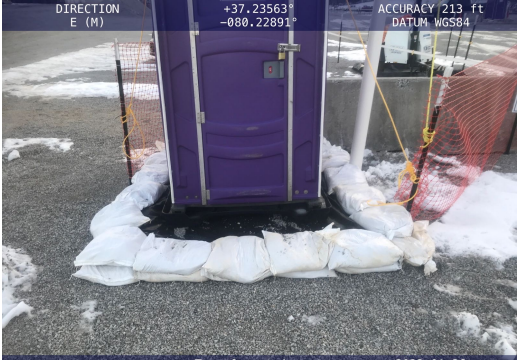
GPS Location	MVP-PY-006 See photo for gps data	GPS Location	MVP-PY-006 See photo for gps data		
Field Station#	+0	Field Station#	+0		
Pic 7 Desc.	Trays and containment under toilets. Holding fluids and ice. Looking E.	Pic 8 Desc.	No loose trash around dumpsters or in the yard. Looking S.

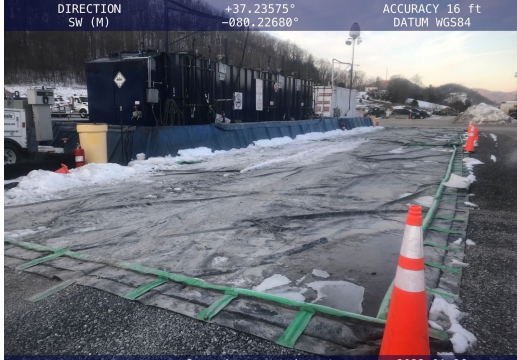
GPS Location	MVP-PY-006 See photo for gps data	GPS Location	MVP-PY-006 See photo for gps data		
Field Station#	+0	Field Station#	+0		
Pic 9 Desc.	Secondary containment in place for tankers offloading fuel. Looking SW.	Pic 10 Desc.	Blue Bulk Fuel tanks containment holding ice. Looking N.

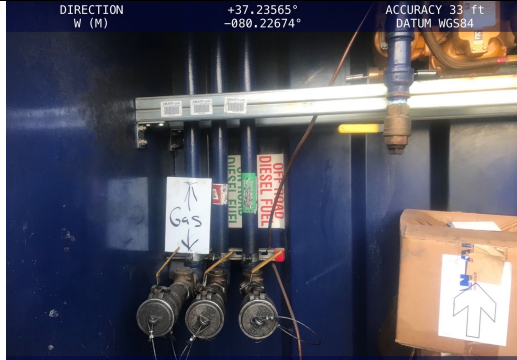
GPS Location	MVP-PY-006 See photo for gps data	GPS Location	MVP-PY-006 See photo for gps data		
Field Station#	+0	Field Station#	+0		
Pic 11 Desc.	Blue Bulk Fuel tanks no leaky internal fittings. Looking W.	Pic 12 Desc.	Off Road Fuel unit containment holding ice. Looking N.

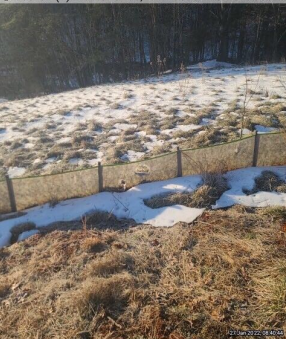
GPS Location	0000	GPS Location	0000		
Field Station#	13662+57	Field Station#	13664+90		
Pic 1 Desc.	P1 requires routine maintenance, added to the punch list for repair.		Pic 2 Desc.	P1 requires routine maintenance, added to the punch list for repair.	
	North East Elevation <small>219°SW (T) • 37.090463, -79.954149 ±3 m ▲ 326 m</small>

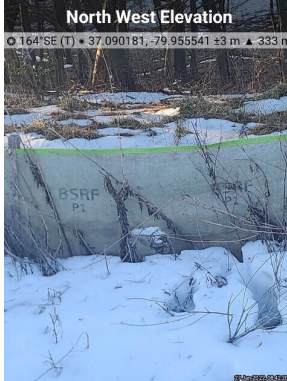
GPS Location	0000	GPS Location	0000		
Field Station#	13665+90	Field Station#	13661+70		
Pic 3 Desc.	P1 requires routine maintenance, added to the punch list for repair.		Pic 4 Desc.	P1 requires routine maintenance, added to the punch list for repair.

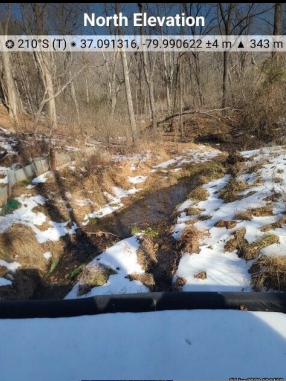
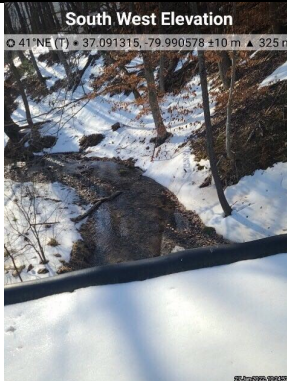
GPS Location	0000	GPS Location	0000		
Field Station#	13543+32	Field Station#	13543+32		
Pic 5 Desc.	Stream observation photo facing upstream during routine inspection, no environmental issues observed at the time of inspection.		Pic 6 Desc.	Stream observation photo facing downstream during routine inspection today, no environmental issues observed at the time of inspection.

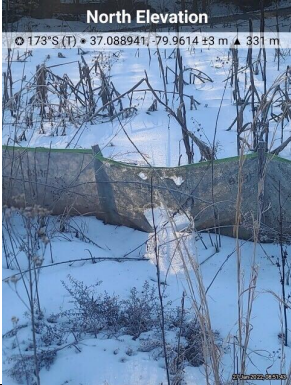
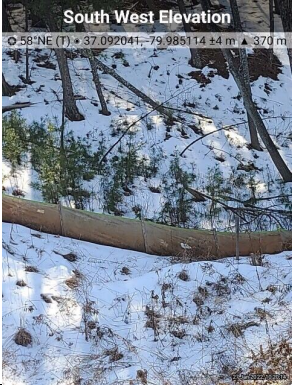
GPS Location	0000	GPS Location	0000		
Field Station#	13643+00	Field Station#	13561+00		
Pic 7 Desc.	P1 requires routine maintenance, added to the punch list for repair.	Pic 8 Desc.	P1 requires routine maintenance, added to the punch list for repair.

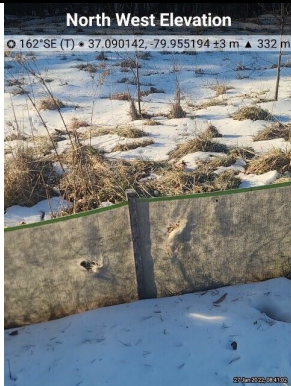
<p style="text-align: center;">Insert image here</p>			
GPS Location	0000	GPS Location			
Field Station#	13662+57	Field Station#			
Pic 9 Desc.	P1 requires routine maintenance, added to the punch list for repair.	Pic 10 Desc.			
<p style="text-align: center;">Insert image here</p>		<p style="text-align: center;">Insert image here</p>			
GPS Location		GPS Location			
Field Station#		Field Station#			
Pic 11 Desc.		Pic 12 Desc.

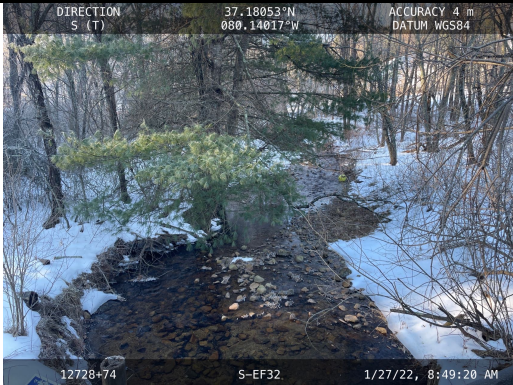
GPS Location	See photo		GPS Location	See photo	
Field Station#	12728+74		Field Station#	12728+74	
Pic 1 Desc.	Downstream of crossing at Stream S-EF32		Pic 2 Desc.	Downstream of crossing at Stream S-EF32

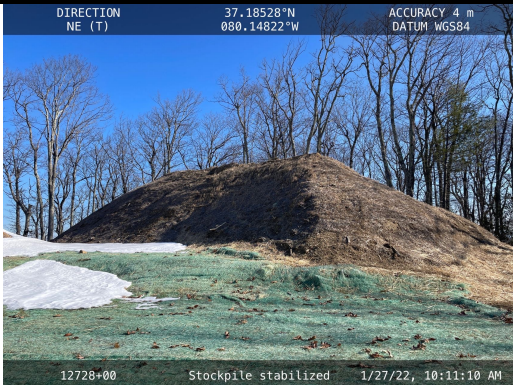
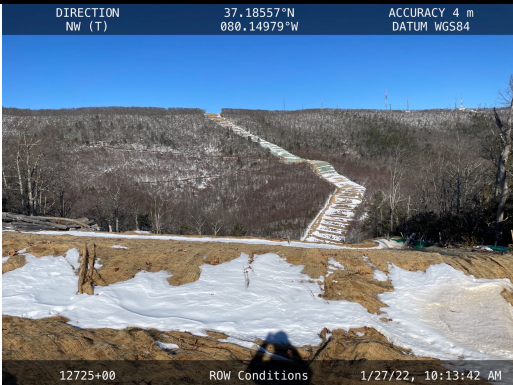
GPS Location	See photo		GPS Location	See photo	
Field Station#	12728+00		Field Station#	12725+00	
Pic 3 Desc.	Stockpiles are well stabilized		Pic 4 Desc.	Current ROW conditions. ROW is stable. ECDs are functional.

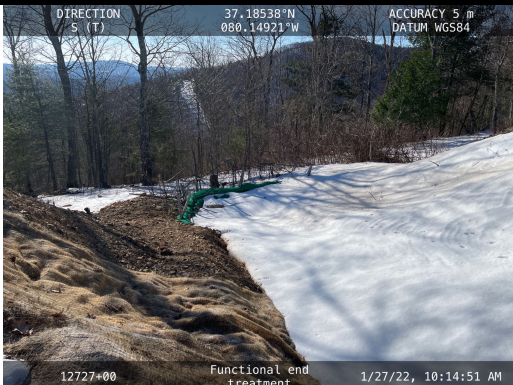
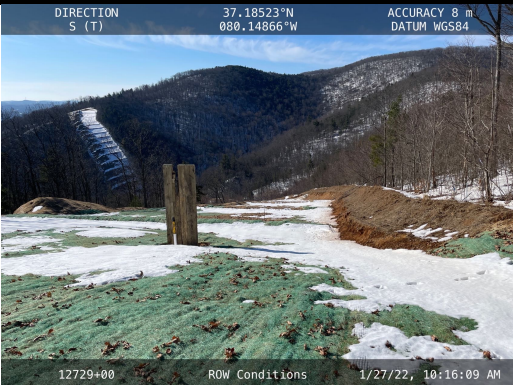
GPS Location	See photo		GPS Location	See photo	
Field Station#	12727+00		Field Station#	12729+00	
Pic 5 Desc.	Functional Waterbar end treatment		Pic 6 Desc.	Current ROW conditions. ROW is stable. ECDs are functional.

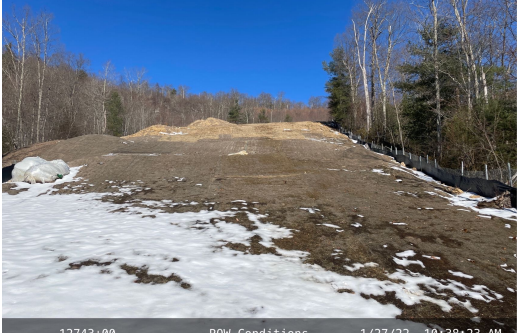
12743+00 ROW Conditions 1/27/22, 10:38:23 AM			
GPS Location	See photo		GPS Location	See photo	
Field Station#	12737+00		Field Station#	12743+00	
Pic 9 Desc.	Current ROW conditions. ROW is stable. ECDs are functional.		Pic 10 Desc.	Current ROW conditions. ROW is stable. ECDs are functional.

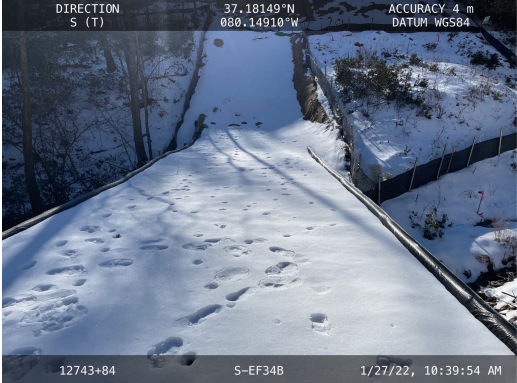
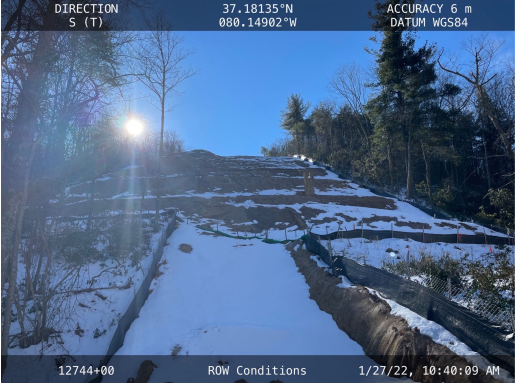
GPS Location	See photo		GPS Location	See photo	
Field Station#	12743+84		Field Station#	12744+00	
Pic 13 Desc.	Equipment Bridge over Stream S-EF34B		Pic 14 Desc.	Current ROW conditions. ROW is stable. ECDs are functional.

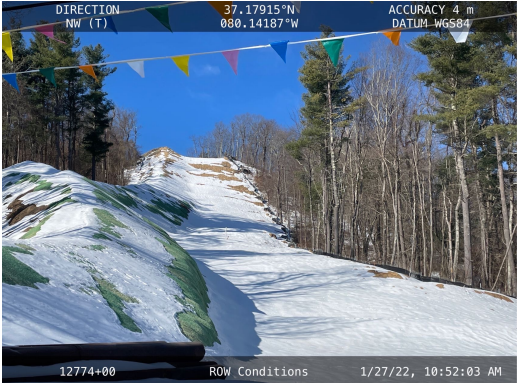
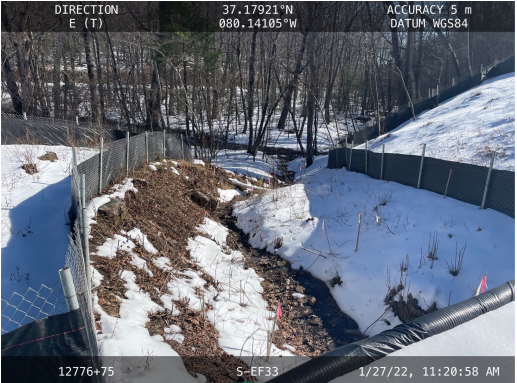
GPS Location	See photo		GPS Location	See photo	
Field Station#	12774+00		Field Station#	12776+75	
Pic 15 Desc.	Current ROW conditions. ROW is stable. ECDs are functional.		Pic 16 Desc.	Downstream of crossing at Stream S-EF33

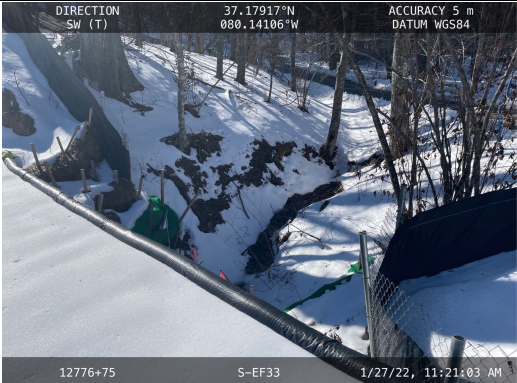
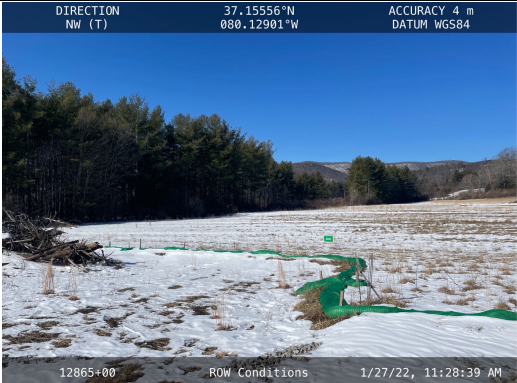
GPS Location	See photo		GPS Location	See photo	
Field Station#	12776+75		Field Station#	12865+00	
Pic 17 Desc.	Upstream of crossing at Stream S-EF33		Pic 18 Desc.	Current ROW conditions. ROW is stable. ECDs are functional.

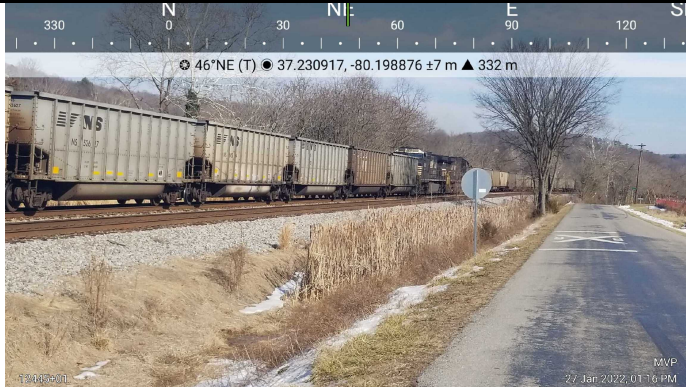
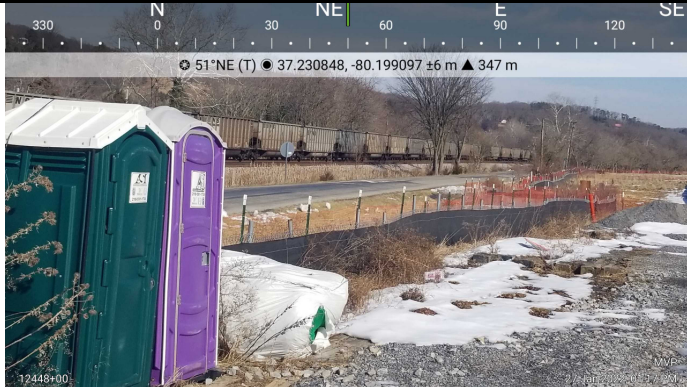
GPS Location	See Above		GPS Location	See Above	
Field Station#	12405+01		Field Station#	12448+00	
Pic 1 Desc.	Overview of Waterbody S-I1. ROW is stable. No erosion or sedimentation concerns noted.		Pic 2 Desc.	ROW Overview (temporary stabilization). ECDs are functional and ROW is stable.

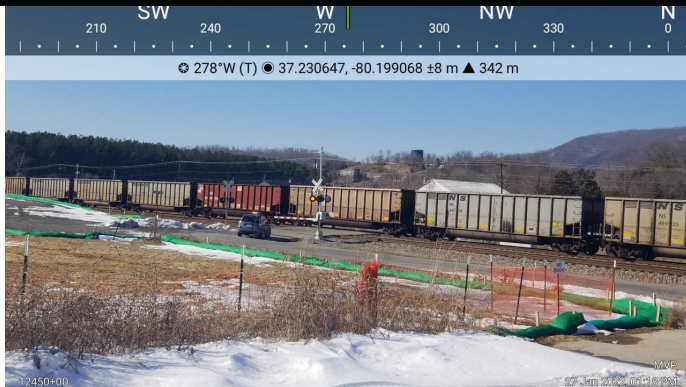
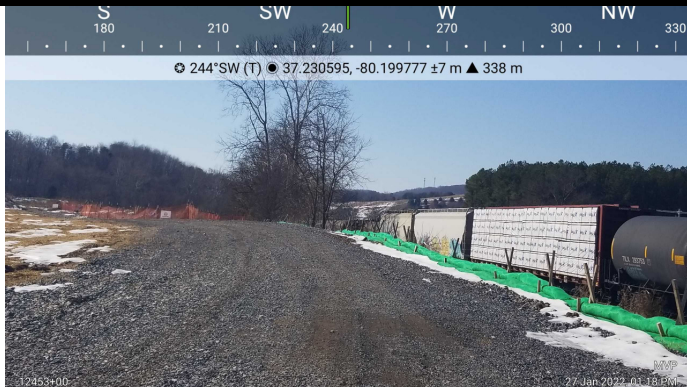
GPS Location	See Above		GPS Location	See Above	
Field Station#	12450+00		Field Station#	12453+00	
Pic 3 Desc.	ROW Overview (temporary stabilization). ECDs are functional and ROW is stable.		Pic 4 Desc.	ROW Overview (temporary stabilization). ECDs are functional and ROW is stable.

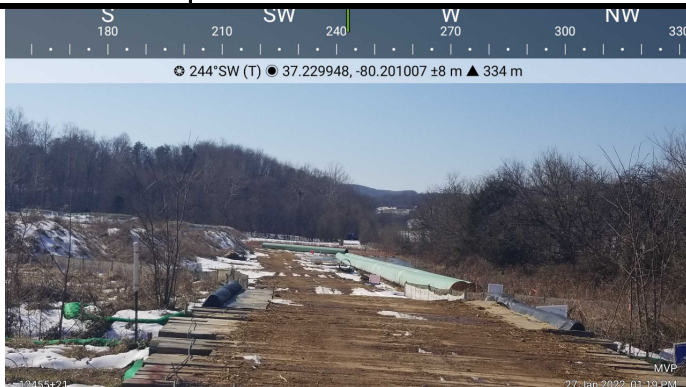
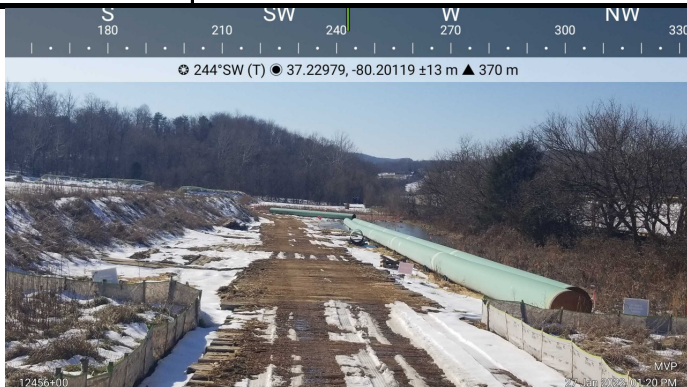
GPS Location	See Above		GPS Location	See Above	
Field Station#	12455+21		Field Station#	12456+00	
Pic 5 Desc.	Overview of Waterbody S-CD12b. ECDs are functional and ROW is stable.		Pic 6 Desc.	ROW Overview (temporary stabilization). ECDs are functional and ROW is stable.

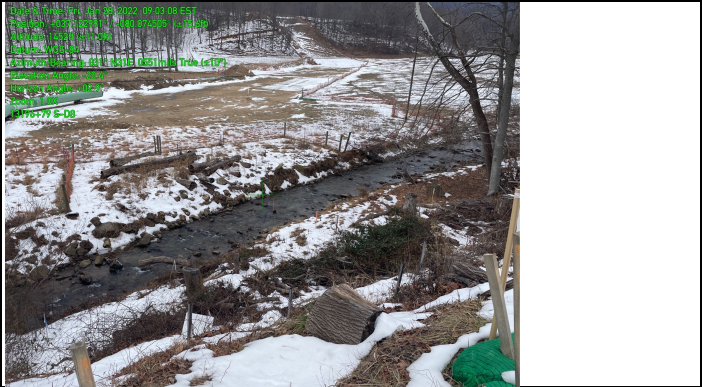
<p>Date & Time: Fri, Jan 28, 2022, 09:53:45 EST Position: +037.122912° / -080.075754° (±15.5m) Altitude: 1441ft (±11.1m) Datum: WGS-84 Azimuth/Bearing: 351° 40' 00" N 356.7mils True (±13°) Horizontal Angle: 0.0° Vertical Angle: 0.0° Photo: MVP-S-D8</p>	
GPS Location	0	GPS Location	0		
Field Station#	13193+00	Field Station#	13196+79		
Pic 7 Desc.	ROW and ECDs In good condition and stable		Pic 8 Desc.	MVP-S-D8 and Corresponding buffer zone in good condition

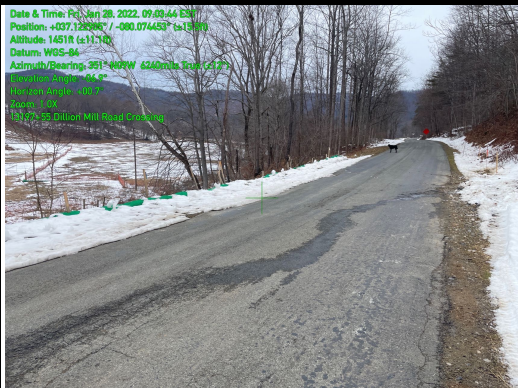
GPS Location	0	GPS Location	0		
Field Station#	13197+55	Field Station#	13198+00		
Pic 9 Desc.	Dillion Mill Road Crossing in good condition		Pic 10 Desc.	ROW and ECDs In good condition and stable	
  <p>Date & Time: Fri, Jan 28, 2022, 09:53:45 EST Position: +037.122912° / -080.075754° (±15.5m) Altitude: 1441ft (±11.1m) Datum: WGS-84 Azimuth/Bearing: 351° 40' 00" N 356.7mils True (±13°) Horizontal Angle: 0.0° Vertical Angle: 0.0° Photo: MVP-S-D8</p>

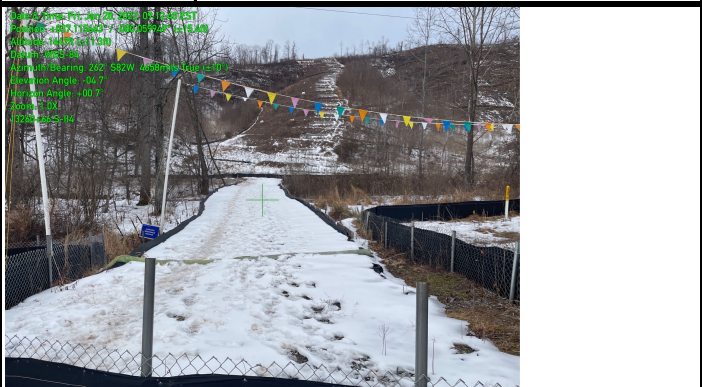
<p>Date & Time: Fri, Jan 28, 2022, 09:53:45 EST Position: +037.122912° / -080.075754° (±15.5m) Altitude: 1441ft (±11.1m) Datum: WGS-84 Azimuth/Bearing: 351° 40' 00" N 356.7mils True (±13°) Horizontal Angle: 0.0° Vertical Angle: 0.0° Photo: MVP-S-D8</p>	
GPS Location	0	GPS Location	0		
Field Station#	13262+62	Field Station#	13260+66		
Pic 11 Desc.	Flanders Road Crossing in good condition		Pic 12 Desc.	MVP-S-II4 and Corresponding buffer zone in good condition

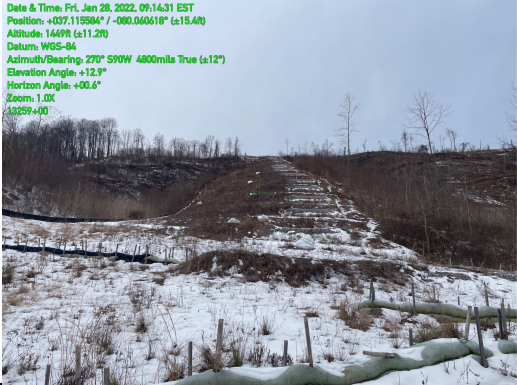
GPS Location 0		GPS Location 0			
Field Station# 13259+00		Field Station# 13259+00			
Pic 15 Desc. ROW and ECDs In good condition and stable		Pic 16 Desc. Continuing to monitor logging activity adjacent to row
