Visual Site Inspection Report

Project Name	H-600 Pipeline Spread H	AFE	124300138	Spread	H-600 Pipeline Spread H
Contractor	Precision			Report #	32835
Inspector	Joe Scott			Date/Time	1/3/2022 3:55 PM
Permit #	TBD	Inspection Type	VA SWPP	Station Begin	12865+00
State	VA	Inspection Area	Partial	Station End	13024+00
County	Roanoke	Ground	Frozen	Temperature (°F)	32.00
Municipality	N/A	Weather	Snow/Sleet	Rain Gauge (in)	1.10
				Rain Accumulation Time (days)	1.00

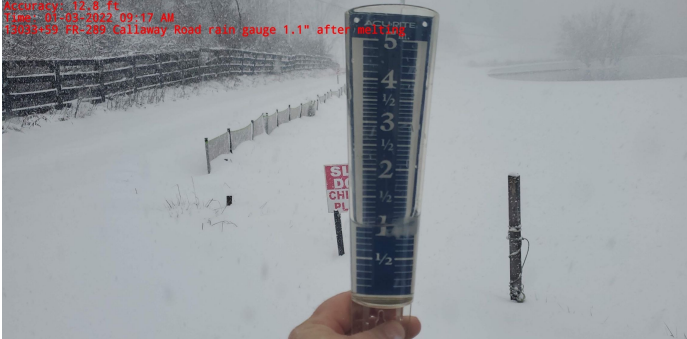
GPS Location	See pic for GPS location.		GPS Location	See pic for GPS location.	
Field Station#	13033+59		Field Station#	13033+59	
Pic 1 Desc.	Callaway Road rain gauge at FR-289.		Pic 2 Desc.	Callaway Road rain gauge. 1.1" total precipitation accumulation.	
<small>Latitude: 37.125625 Longitude: -80.124473 Elevation: 2717.36±10 ft Accuracy: 12.5 ft Time: 01-03-2022 09:20 AM 13015+00 GAS of the BRP motorway</small>

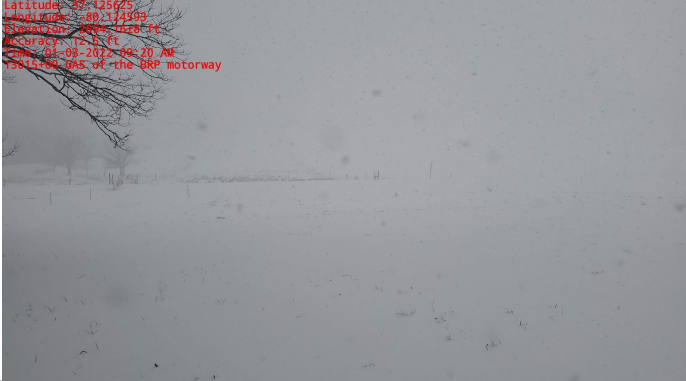
GPS Location	See pic for GPS location.		GPS Location	See pic for GPS location.	
Field Station#	13015+00		Field Station#	13015+00	
Pic 3 Desc.	BRP motorway from the GAS.		Pic 4 Desc.	GAS of the BRP motorway.	
<small>Latitude: 37.128608 Longitude: -80.129639 Elevation: 2655.77±12 ft Accuracy: 12.5 ft Time: 01-03-2022 09:25 AM 12996+00 GAS of US-221</small>

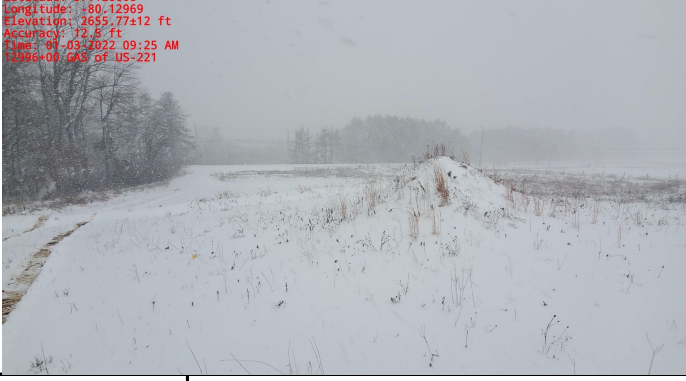
GPS Location	See pic for GPS location.		GPS Location	See pic for GPS location.	
Field Station#	12996+00		Field Station#	12996+00	
Pic 5 Desc.	US-221 road crossing from the GAS.		Pic 6 Desc.	Current ROW conditions on the GAS of US-221.

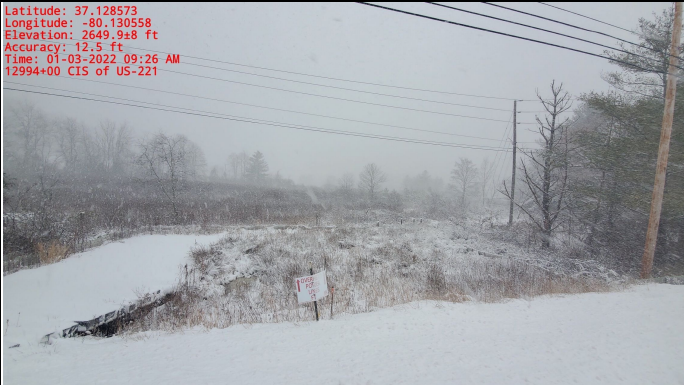
GPS Location	See pic for GPS location.		GPS Location	See pic for GPS location.	
Field Station#	12994+00		Field Station#	12975+00	
Pic 7 Desc.	Current ROW conditions on the CIS of US-221.		Pic 8 Desc.	GAS of RO-288 CWDB, CWDP and Plunge Pool.	
<div>Latitude: 37.13059 Longitude: -80.136874 Elevation: 2730.68±11 ft Accuracy: 12.5 ft Time: 01-03-2022 10:00 AM 12974+00 CIS of RO-288</div>

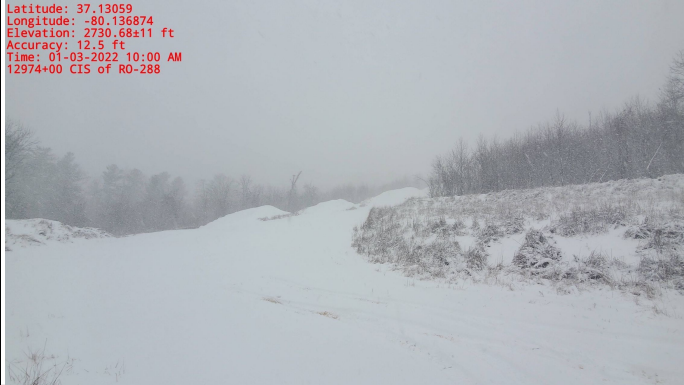
GPS Location	See pic for GPS location.		GPS Location	See pic for GPS location.	
Field Station#	12974+00		Field Station#	12974+29	
Pic 9 Desc.	Current ROW conditions on the CIS of RO-288.		Pic 10 Desc.	Stream S-KL4 along access road RO-288.	
<div>Latitude: 37.13059 Longitude: -80.136874 Elevation: 2730.68±11 ft Accuracy: 12.5 ft Time: 01-03-2022 10:00 AM 12974+00 CIS of RO-288</div>

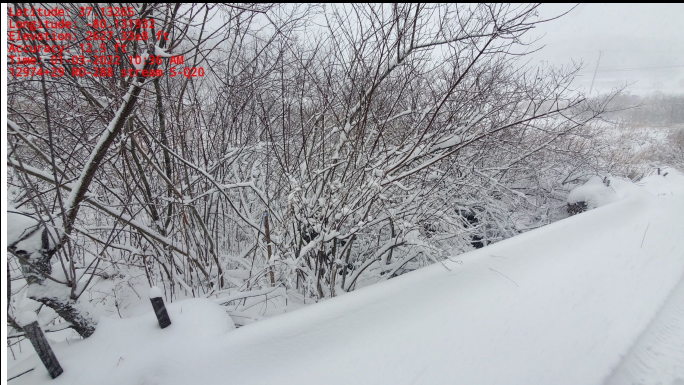
GPS Location	See pic for GPS location.		GPS Location	See pic for GPS location.	
Field Station#	12974+29		Field Station#	12958+00	
Pic 11 Desc.	Stream S-Q20 along access road RO-288.		Pic 12 Desc.	Stream crossing S-Y7 on the GAS of RO-287.

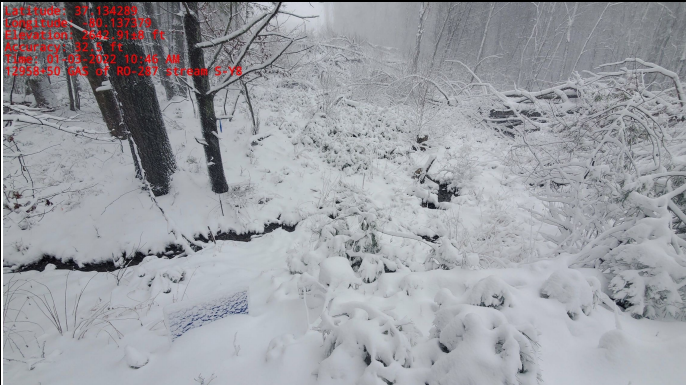
GPS Location	See pic for GPS location.		GPS Location	See pic for GPS location.	
Field Station#	12958+50		Field Station#	12956+93	
Pic 13 Desc.	Stream crossing S-Y8 on the GAS of RO-287.		Pic 14 Desc.	Landowner's spring box and streams S-Y7 and S-Y9.	
<div>Latitude: 37.134833 Longitude: -80.13803 Elevation: 2678.22±10 ft Accuracy: 32.5 ft Time: 01-03-2022 10:49 AM 12956+00 CIS of RO-287</div>

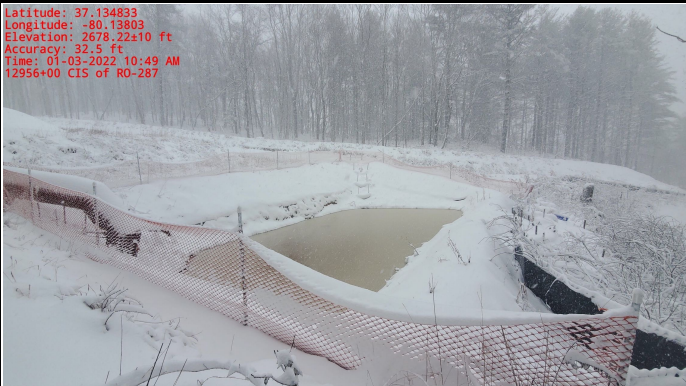
GPS Location	See pic for GPS location.		GPS Location	See pic for GPS location.	
Field Station#	12956+00		Field Station#	12955+00	
Pic 15 Desc.	Sediment trap on the CIS of RO-287.		Pic 16 Desc.	Current ROW conditions on the CIS of RO-287.	
<div>Latitude: 37.144848 Longitude: -80.136551 Elevation: 2716.4±49 ft Accuracy: 66.6 ft Time: 01-03-2022 11:39 AM 12915+50 GAS of RO-286</div>

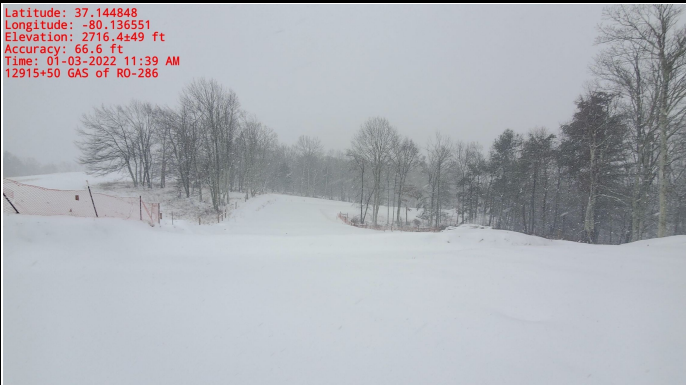
GPS Location	See pic for GPS location.		GPS Location	See pic for GPS location.	
Field Station#	12915+50		Field Station#	12915+00	
Pic 17 Desc.	GAS of access road RO-286.		Pic 18 Desc.	CIS of access road RO-286.

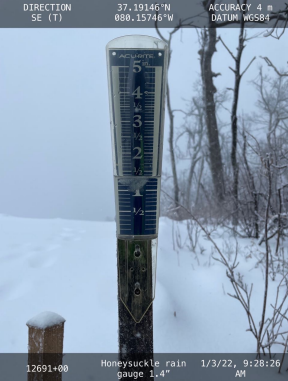
<p>DIRECTION SE (T) 37.19146°N 080.15746°W ACCURACY 4 m DATUM WGS84</p> <p>12691+00 Honeysuckle rain gauge 1.4" 1/3/22, 9:28:26 AM</p>

<p>DIRECTION E (T) 37.19141°N 080.15719°W ACCURACY 5 m DATUM WGS84</p> <p>12691+00 ROW is covered in snow 1/3/22, 8:53:41 AM</p>			
GPS Location	See photo		GPS Location	See photo	
Field Station#	12691+00		Field Station#	12691+00	
Pic 1 Desc.	Rain Gauge shows 1.4" of precipitation at Honeysuckle Road		Pic 2 Desc.	ROW is covered in snow. ROW is stable.

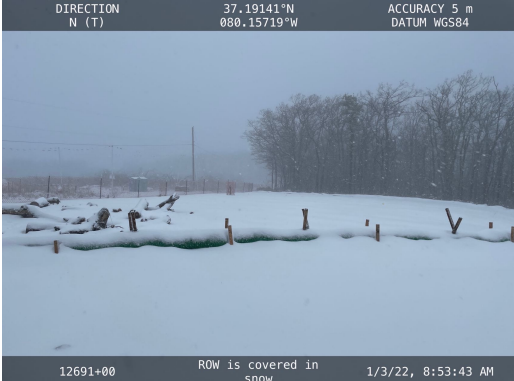
<p>DIRECTION N (T) 37.19141°N 080.15719°W ACCURACY 5 m DATUM WGS84</p> <p>12691+00 ROW is covered in snow 1/3/22, 8:53:43 AM</p>

Pic 3 Desc.	ROW is covered in snow. ROW is stable.		Pic 4 Desc.	ROW is covered in snow. ROW is stable.

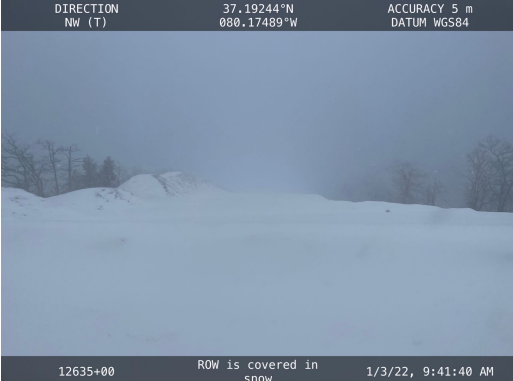
<p>DIRECTION NW (T) 37.19244°N 080.17489°W ACCURACY 5 m DATUM WGS84</p> <p>12635+00 ROW is covered in snow 1/3/22, 9:41:40 AM</p>			
GPS Location	See photo		GPS Location	See photo	
Field Station#	12691+00		Field Station#	12635+00

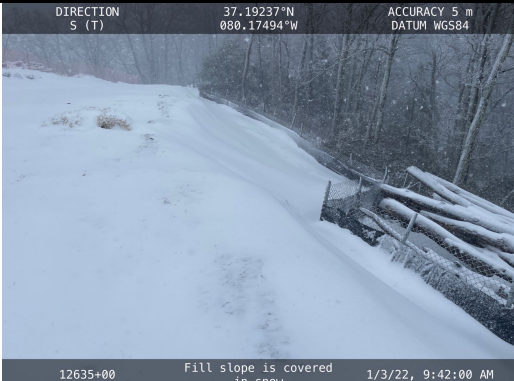
<p>DIRECTION S (T) 37.19237°N 080.17494°W ACCURACY 5 m DATUM WGS84</p> <p>12635+00 Fill slope is covered in snow 1/3/22, 9:42:00 AM</p>

<p>DIRECTION W (T) 37.19239°N 080.17499°W ACCURACY 5 m DATUM WGS84</p> <p>12634+00 Stockpiles covered in snow 1/3/22, 9:42:25 AM</p>			
GPS Location	See photo		GPS Location	See photo	
Field Station#	12635+00		Field Station#	12634+00	
Pic 5 Desc.	ROW is covered in snow. ROW is stable.		Pic 6 Desc.	ROW is covered in snow. ROW is stable.

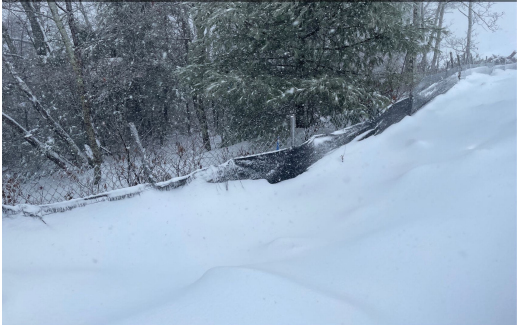
<div>12635+50</div> <div>Perimeter controls are in place</div> <div>1/3/22, 9:44:44 AM</div>		<div> <div>DIRECTION S (T)</div> <div>37.19175°N 080.17471°W</div> <div>ACCURACY 5 m DATUM WGS84</div> </div>

<div>12638+24</div> <div>RO-279.01</div> <div>1/3/22, 9:46:22 AM</div>			
GPS Location	See photo		GPS Location	See photo	
Field Station#	12635+50		Field Station#	12638+24	
Pic 7 Desc.	Perimeter Controls are in place.		Pic 8 Desc.	RO-279.01 is covered in snow. Broad Based Dips are in place.	
<div> <div>DIRECTION N (T)</div> <div>37.19173°N 080.17475°W</div> <div>ACCURACY 5 m DATUM WGS84</div> </div>

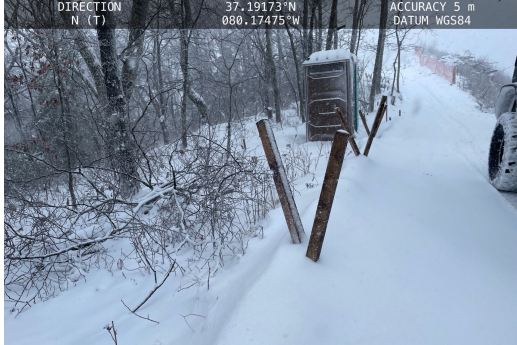
<div>12638+24</div> <div>Perimeter controls along RO-279.01</div> <div>1/3/22, 9:46:38 AM</div>		<div> <div>DIRECTION N (T)</div> <div>37.18412°N 080.16079°W</div> <div>ACCURACY 4 m DATUM WGS84</div> </div>

GPS Location	See photo		GPS Location	See photo	
Field Station#	12638+24		Field Station#	12703+04	
Pic 9 Desc.	Perimeter controls are in place along RO-279.01		Pic 10 Desc.	ATWS-1224 is covered in snow. Perimeter controls are in place. Area is stable.	
<div> <div>DIRECTION S (T)</div> <div>37.18395°N 080.16064°W</div> <div>ACCURACY 5 m DATUM WGS84</div> </div>

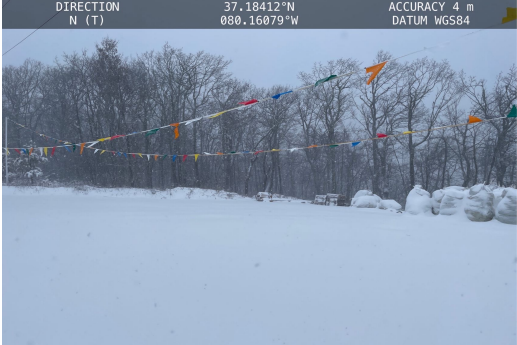
<div>12703+04</div> <div>ATWS-1224</div> <div>1/3/22, 10:02:09 AM</div>

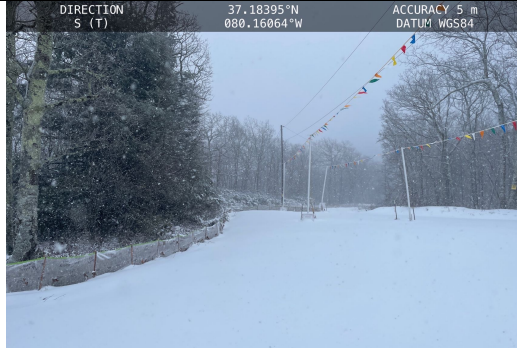
<div>12703+04</div> <div>ATWS-1225</div> <div>1/3/22, 10:02:35 AM</div>		<div> <div>DIRECTION NW (T)</div> <div>37.19202°N 080.15766°W</div> <div>ACCURACY 8 m DATUM WGS84</div> </div>

<div>12688+00</div> <div>ROW is covered in snow</div> <div>1/3/22, 10:08:03 AM</div>			
GPS Location	See photo		GPS Location	See photo	
Field Station#	12703+04		Field Station#	12688+00	
Pic 11 Desc.	ATWS-1225 is covered in snow. Perimeter controls are in place. Area is stable.		Pic 12 Desc.	ROW is covered in snow. ROW is stable.

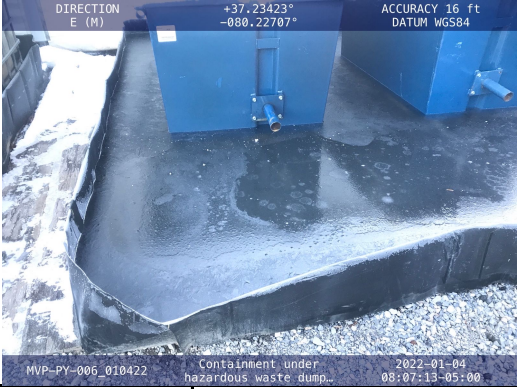
GPS Location	MVP-PY-006 See photo for gps data	GPS Location	MVP-PY-006 See photo for gps data		
Field Station#	+0	Field Station#	+0		
Pic 13 Desc.	Secondary containment under hazardous waste dumpsters. Holding stormwater and ice. Looking E.	Pic 14 Desc.	Condition of poly lined containments holding some fluids. Looking SE.

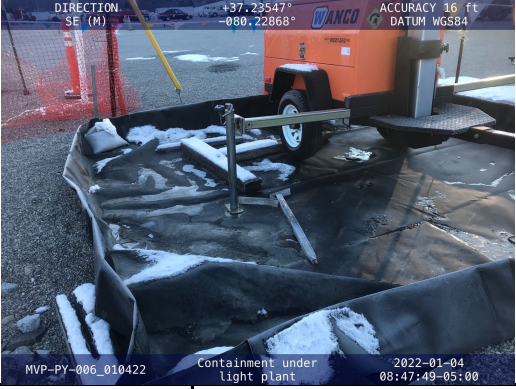
GPS Location	MVP-PY-006 See photo for gps data	GPS Location	MVP-PY-006 See photo for gps data		
Field Station#	+0	Field Station#	+0		
Pic 15 Desc.	Status of spoil pile adjacent to LOD on VDOT property. Soil pile not stabilized. Looking SE.	Pic 16 Desc.	Secondary containment under light plant holding some stormwater and ice. Looking SE.

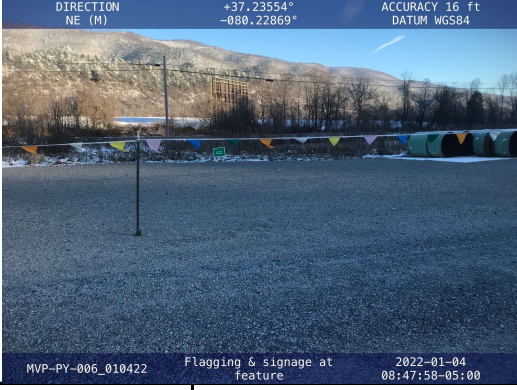
GPS Location	MVP-PY-006 See photo for gps data	GPS Location	MVP-PY-006 See photo for gps data		
Field Station#	+0	Field Station#	+0		
Pic 17 Desc.	Condition of flagging and signage at feature W-008. Looking NE.	Pic 18 Desc.	Condition of signage and triple stack compost filter sock at feature W-008. Over grown with vegetation. Looking E.

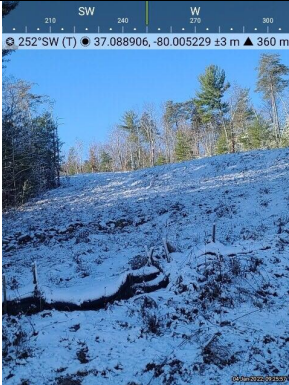
GPS Location	0000	GPS Location	0000		
Field Station#	13496+86	Field Station#	13416+00		
Pic 1 Desc.	Monitored ECDs that were visible after recent snow events , photo showing snow covered row. No environmental issues observed at the time of inspection.		Pic 2 Desc.	Monitored ECDs that were visible after recent snow events, no environmental issues observed at the time of inspection.

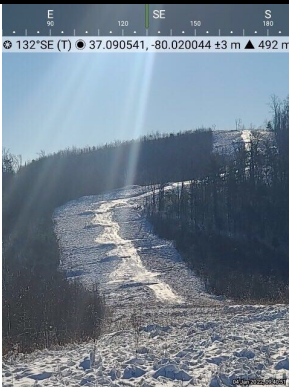
GPS Location	0000	GPS Location	0000		
Field Station#	13438+77	Field Station#	13416+80		
Pic 3 Desc.	Row photo showing snow throughout the row, monitored ECDs that were visible after recent snow events. No environmental issues observed at the time of inspection.		Pic 4 Desc.	Snow covered row on hill side above road crossing at CAHAS#1. No environmental issues observed at the time of inspection.

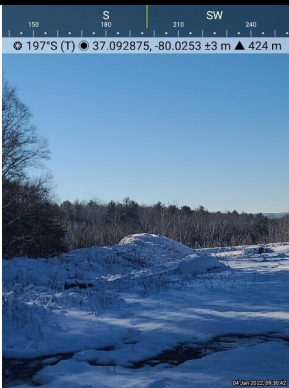
Field Station#	13420+50	Field Station#	13420+00		
Pic 5 Desc.	Photo showing snow covered top soil piles, no environmental issues observed at the time of inspection.		Pic 6 Desc.	Work space covered in snow after recent snow events. No environmental issues observed at the time of inspection

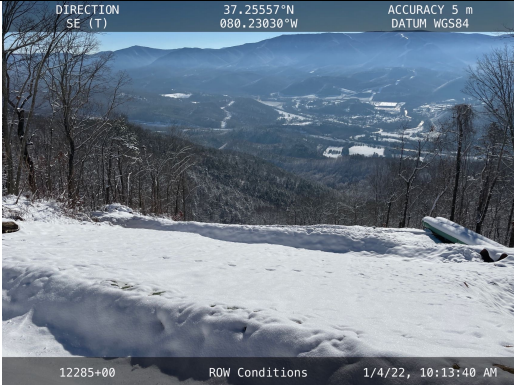
GPS Location	See photo		GPS Location	See photo	
Field Station#	12285+00		Field Station#	12298+00	
Pic 1 Desc.	ROW is covered in snow. ECDs are functional.		Pic 2 Desc.	ROW is covered in snow. ECDs are functional.

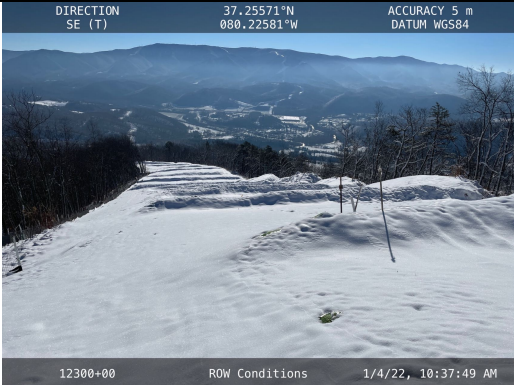
GPS Location	See photo		GPS Location	See photo	
Field Station#	12300+00		Field Station#	12308+00	
Pic 3 Desc.	ROW is covered in snow. ECDs are functional.		Pic 4 Desc.	ROW is covered in snow. ECDs are functional.

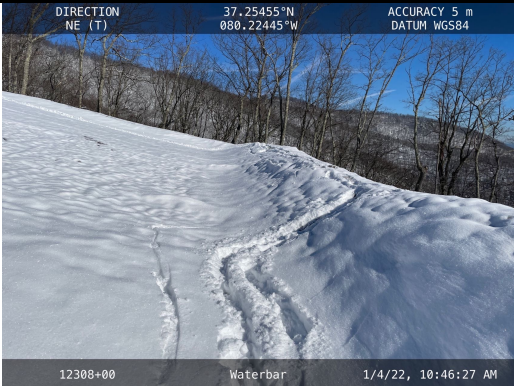
GPS Location	See photo		GPS Location	See photo	
Field Station#	12308+00		Field Station#	12315+00	
Pic 5 Desc.	ROW is covered in snow. ECDs are functional.		Pic 6 Desc.	ROW is covered in snow. ECDs are functional.

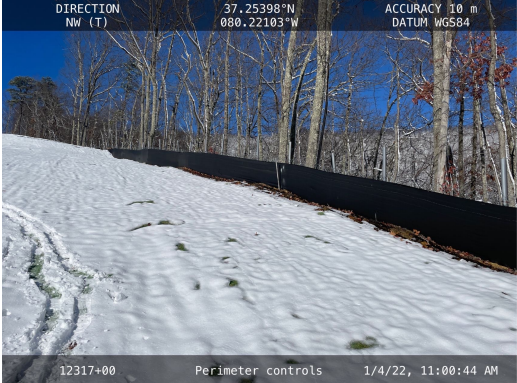
GPS Location	See photo		GPS Location	See photo	
Field Station#	12317+00		Field Station#	12328+00	
Pic 7 Desc.	ROW is covered in snow. ECDs are functional.		Pic 8 Desc.	ROW is covered in snow. ECDs are functional.

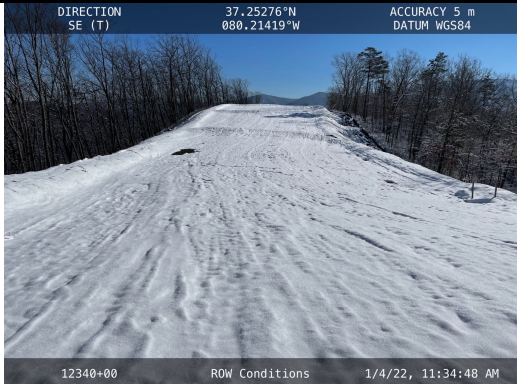
GPS Location	See photo		GPS Location	See photo	
Field Station#	12340+00		Field Station#	12350+00	
Pic 9 Desc.	ROW is covered in snow. ECDs are functional.		Pic 10 Desc.	ROW is covered in snow. ECDs are functional.

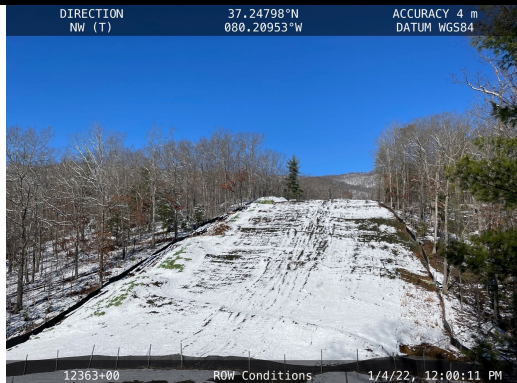
GPS Location	See photo		GPS Location	See photo	
Field Station#	12363+00		Field Station#	12367+00	
Pic 11 Desc.	ROW is covered in snow. ECDs are functional.		Pic 12 Desc.	ROW is covered in snow. ECDs are functional.

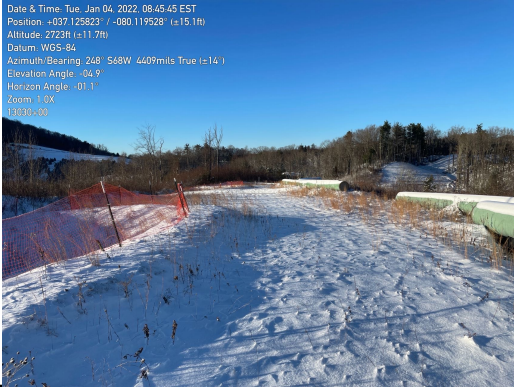
GPS Location	0	GPS Location	0		
Field Station#	13030+00	Field Station#	13024+06		
Pic 3 Desc.	ROW and ECDs In good condition and stable	Pic 4 Desc.	MVP-S-G24/25 and Corresponding buffer zone in good condition		
<p> Date & Time: Tue, Jan 04, 2022, 08:55:12 EST Position: +037.126360° / -080.118607° (±15.1ft) Altitude: 2735ft (±11.7ft) Datum: WGS-84 Azimuth/Bearing: 051° N51E 0907mils True (±12°) Elevation Angle: +07.4° Horizon Angle: -00.7° Zoom: 1.0X 13034+00 </p>

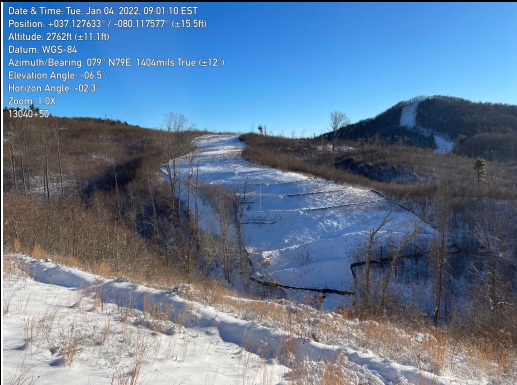
GPS Location		0		GPS Location	
Field Station#		13040+50		Field Station#	
Pic 7 Desc.		ROW and ECDs In good condition and stable		Pic 8 Desc.	
				MVP-S-H1 and Corresponding buffer zone in good condition	
<p>Date & Time: Tue, Jan 04, 2022, 09:56:25 EST Position: +037.126927 / -080.113110 (±15.5ft) Altitude: 2627ft (±11.1ft) Datum: WGS-84 Azimuth/Bearing: 111 S49E 1973mils True (±12°) Elevation Angle: -08.9 Horizon Angle: -00.6 Zoom: 1.0X 13061+89 S-G22</p>

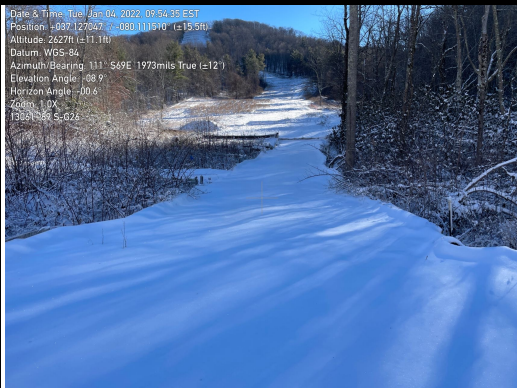
GPS Location		0		GPS Location	
Field Station#		13061+89		Field Station#	
Pic 9 Desc.		MVP-S-G26 and Corresponding buffer zone in good condition		Pic 10 Desc.	
				MVP-S-G27 and Corresponding buffer zone in good condition	
<p>Date & Time: Tue, Jan 04, 2022, 09:56:33 EST Position: +037.126827 / -080.110797 (±15.4ft) Altitude: 2629ft (±11.2ft) Datum: WGS-84 Azimuth/Bearing: 112 S68E 1991mils True (±12°) Elevation Angle: -06.6 Horizon Angle: -00.2 Zoom: 1.0X 13064+00</p>

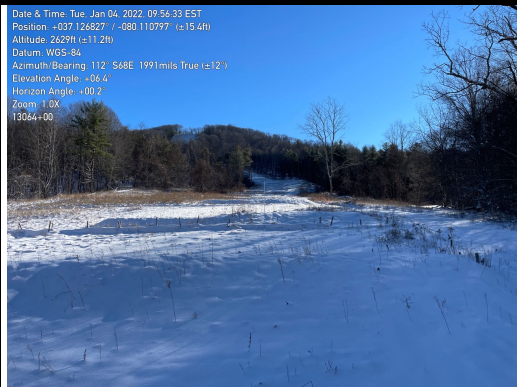
GPS Location		0		GPS Location	
Field Station#		13064+00		Field Station#	
Pic 11 Desc.		ROW and ECDs In good condition and stable		Pic 12 Desc.	
				Access road and ECDs in good condition

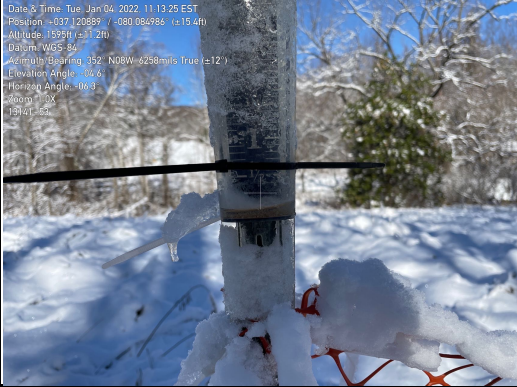
GPS Location						0					
Field Station#						13141+53					
Pic 13 Desc.						Rain gauge with 0.20" of precipitation in past 24 hours					
Pic 14 Desc.						MVP-S-D14 and Corresponding buffer zone in good condition					
<p>Date & Time: Tue, Jan 04, 2022, 11:21:28 EST Position: +037.121211 / -080.087481 (±15.1ft) Altitude: 1700ft (±11.7ft) Datum: WGS-84 Azimuth/Bearing: 289° N71W 5138mils True (±12°) Elevation Angle: +03.5° Horizon Angle: +01.3° Zoom: 1.0X 13141+00</p>

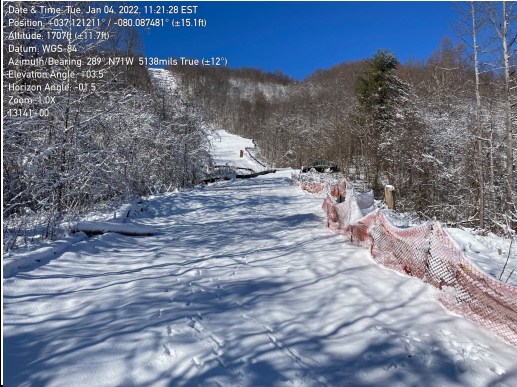
GPS Location						0					
Field Station#						13141+00					
Pic 15 Desc.						ROW and ECDs In good condition and stable					
Pic 16 Desc.						ROW and ECDs In good condition and stable					
<p>Date & Time: Tue, Jan 04, 2022, 11:25:14 EST Position: +037.121523 / -080.088411 (±15.1ft) Altitude: 1763ft (±11.7ft) Datum: WGS-84 Azimuth/Bearing: 293° N67W 5209mils True (±12°) Elevation Angle: +01.8° Horizon Angle: +00.2° Zoom: 1.0X 13137+78 S-D17</p>

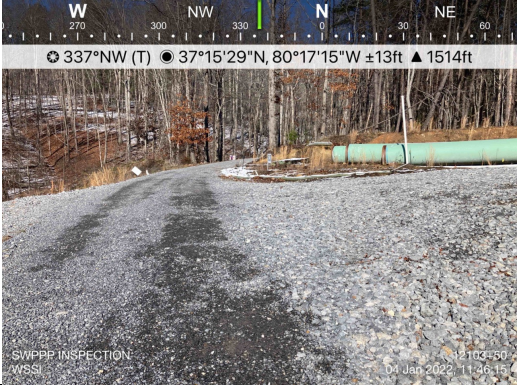
GPS Location	See photo above		GPS Location	See photo above	
Field Station#	12103+50		Field Station#	12109+00	
Pic 13 Desc.	Access roads are well graveled and need no maintenance.		Pic 14 Desc.	SSF along stream crossings are in good condition.

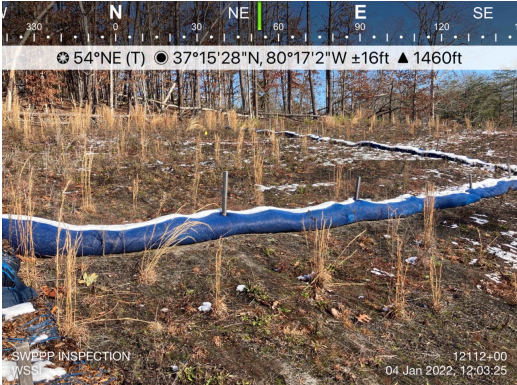
GPS Location	See photo above		GPS Location	See photo above	
Field Station#	12112+00		Field Station#	12111+50	
Pic 15 Desc.	CFS is present and functioning properly. No maintenance is needed.		Pic 16 Desc.	Waterbars are present and there are no signs of off-site discharge.

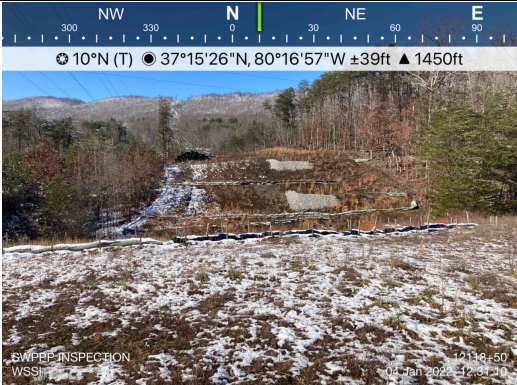
GPS Location	See photo above		GPS Location	See photo above	
Field Station#	12116+50		Field Station#	12119+17	
Pic 17 Desc.	Perimeter controls and erosion control blanketing are functioning properly. No maintenance is needed.		Pic 18 Desc.	Rock construction entrances are in good condition and no material is present along roadways.

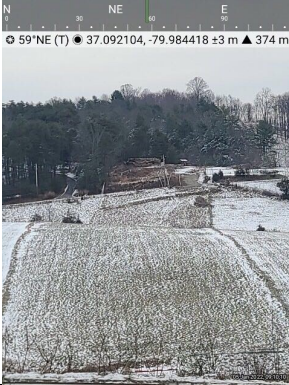
GPS Location	00000	GPS Location	0000		
Field Station#	13564+02	Field Station#	13640+00		
Pic 1 Desc.	Monitored vegetation and ECDs throughout the row in areas that were visible after recent snow . No environmental issues observed at the time of inspection.		Pic 2 Desc.	Monitored P1 along the row edge during routine inspection, no environmental issues observed at the time of inspection.

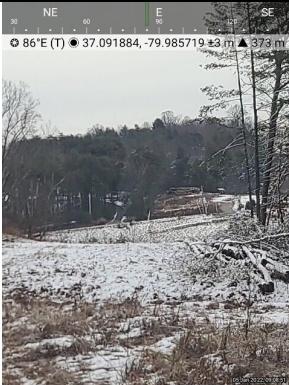
GPS Location	00000	GPS Location	00000		
Field Station#	13558+32	Field Station#	13642+00		
Pic 3 Desc.	Monitored vegetation and ECDs throughout the row in areas that were visible after recent snow . No environmental issues observed at the time of inspection.		Pic 4 Desc.	Monitored vegetation and ECDs throughout the row in areas that were visible after recent snow . No environmental issues observed at the time of inspection.

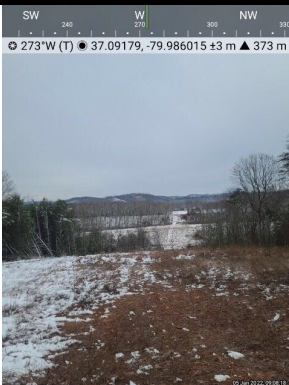
GPS Location	0000	GPS Location	000		
Field Station#	13553+53	Field Station#	13572+82		
Pic 5 Desc.	Monitored vegetation and ECDs throughout the row in areas that were visible after recent snow . No environmental issues observed at the time of inspection.		Pic 6 Desc.	Monitored vegetation and ECDs throughout the row in areas that were visible after recent snow . No environmental issues observed at the time of inspection.

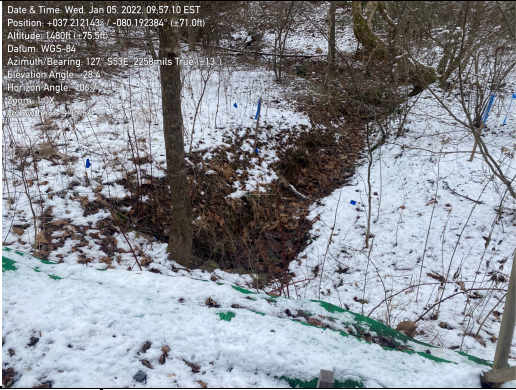
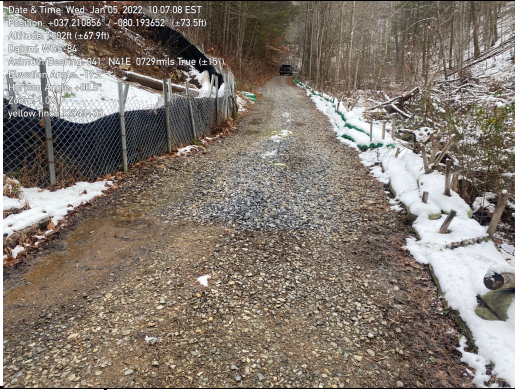
<p>Date & Time: Wed Jan 05 2022 10:07:08 EST Position: +037.210854° / +060.193652° (+73.9N) Altitude: 1501ft (+82.9ft) Datum: WGS-84 Azimuth/Bearing: 164.1N41E 07.29mils True (+10.1) Elevation Angle: -19.5 Horizon Angle: +00.0 Zoom: 1.0X Yellow Line: 12544+06</p>			
GPS Location	See photo for coordinates.		GPS Location	See photo for coordinates.	
Field Station#	12544+20		Field Station#	12544+06	
Pic 1 Desc.	S-EF54, downstream, access road MVP-MN-278.01, no impacts noted.		Pic 2 Desc.	MVP-MN-278.01, perimeter controls along access road in acceptable condition.

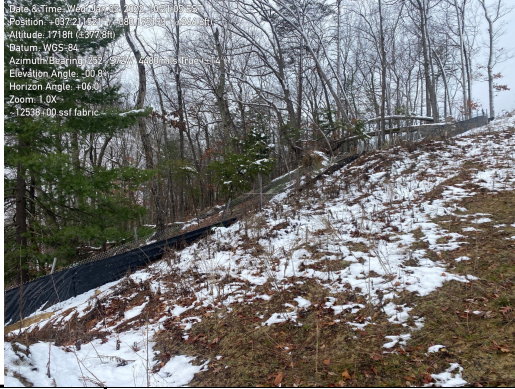
GPS Location	See photo for coordinates.		GPS Location	See photo for coordinates.	
Field Station#	12540+50		Field Station#	12538+00	
Pic 3 Desc.	ROW stabilized, sumps holding water.		Pic 4 Desc.	SSF fabric detached from chain link fence, added to Punch List as a maintenance item.

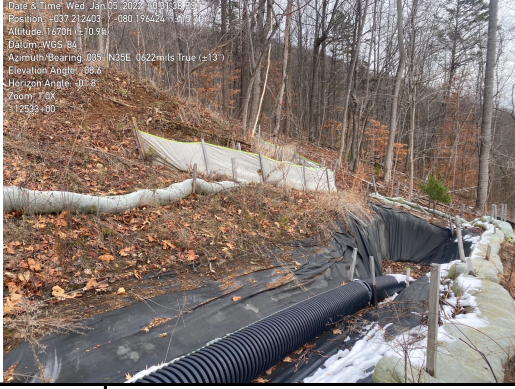
Pic 5 Desc.	ROW temporarily stabilized.		Pic 6 Desc.	Slope drain functioning acceptably, hole noted in P1 silt fence and added to the Punch List.

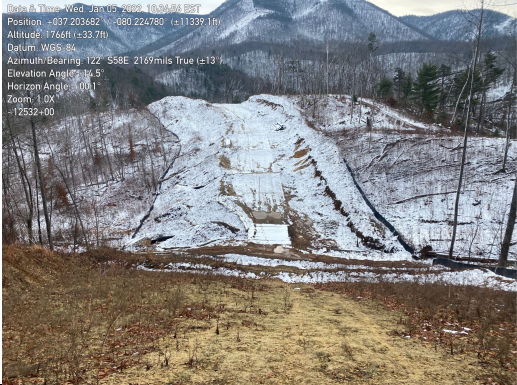
GPS Location		See photo for coordinates.		GPS Location	
Field Station#		12532+00		Field Station#	
Pic 7 Desc.		ROW stabilized.		Pic 8 Desc.	
<p><small>Date & Time: Wed Jan 05 2022 10:56:00 EST Position: +037 203692° / -080 224780° (+11339.1ft) Altitude: 1766ft (+33.7ft) Datum: WGS-84 Azimuth/Bearing: 007° (R11W 620mils True (+13°) Elevation Angle: +02.2° Horizontal Angle: +02.3° Zoom: 1.0X +12524+00 S-EF19</small></p>

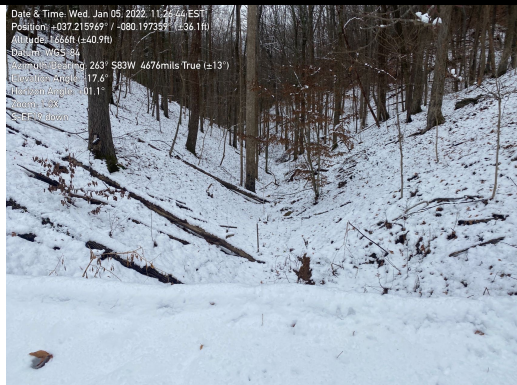
GPS Location		See photo for coordinates.		GPS Location	
Field Station#		12519+41		Field Station#	
Pic 11 Desc.		S-EF19, downstream, no ROW observed at stream crossing.		Pic 12 Desc.	
				S-EF19, upstream, no ROW observed at stream crossing.

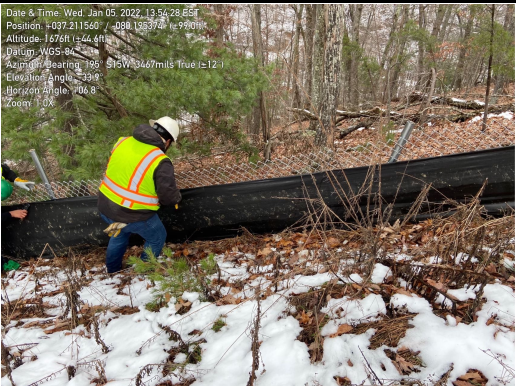
GPS Location	See photo for coordinates.		GPS Location	See photo for coordinates.	
Field Station#	12518+00		Field Station#	12538+00	
Pic 15 Desc.	SSF repaired.		Pic 16 Desc.	SSF repaired.

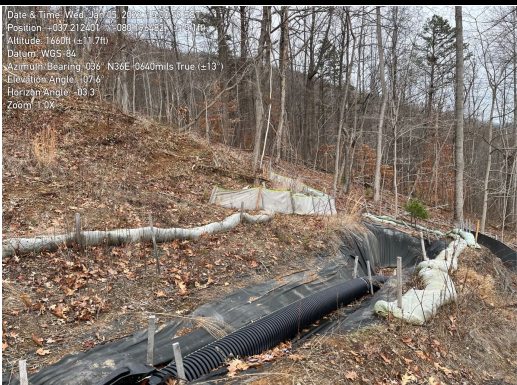
<p>Date & Time: Wed Jan 05, 2022, 14:23:25 EST Position: -037.215718, -038.019718, -116.4m Altitude: 1725ft (+52.2m) Datum: WGS-84 Azimuth Bearing: 057° N57E 1013mils True (+12°) Elevation Angle: -16.5° Horizon Angle: -01.7° Zoom: 1.0X</p>			
GPS Location	See photo for coordinates.		GPS Location	See photo for coordinates.	
Field Station#	12553+00		Field Station#	12520+00	
Pic 17 Desc.	Priority one silt fence repaired.		Pic 18 Desc.	CFS outlet protection repaired.

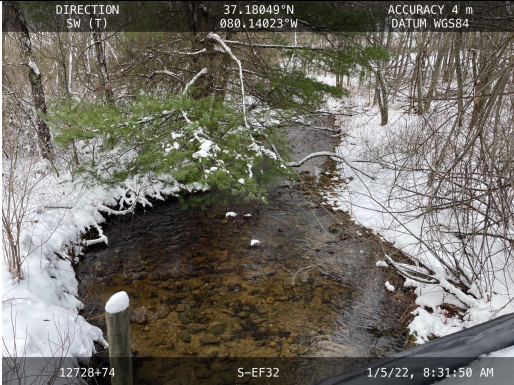
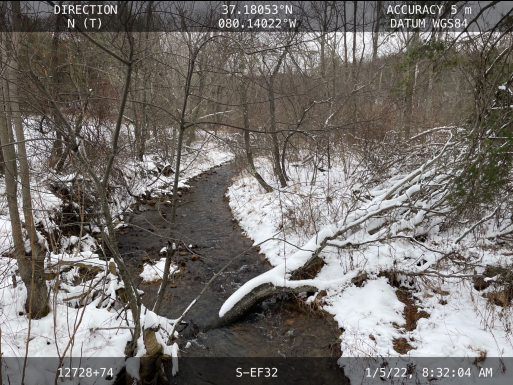
GPS Location	See photo		GPS Location	See photo	
Field Station#	12728+74		Field Station#	12728+74	
Pic 1 Desc.	Downstream of crossing at Stream S-EF32		Pic 2 Desc.	Upstream of crossing at Stream S-EF32

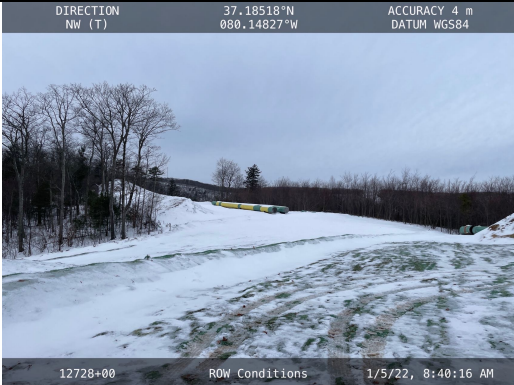
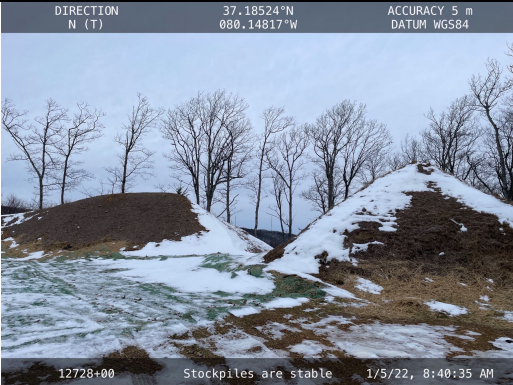
GPS Location	See photo		GPS Location	See photo	
Field Station#	12728+00		Field Station#	12728+00	
Pic 3 Desc.	Current ROW conditions. ROW is covered in snow. ROW is stable.		Pic 4 Desc.	Stockpiles are stable

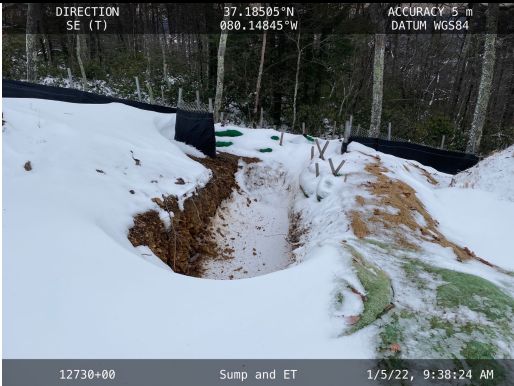
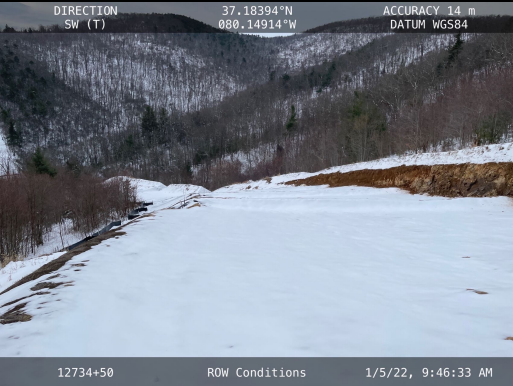
GPS Location	See photo		GPS Location	See photo	
Field Station#	12730+00		Field Station#	12734+50	
Pic 5 Desc.	Sump and End treatment are functional.		Pic 6 Desc.	Current ROW conditions. ROW is covered in snow. ROW is stable.

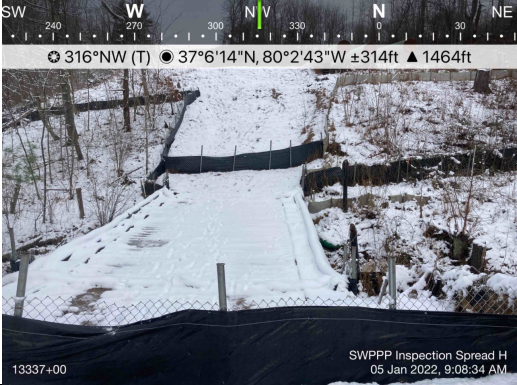
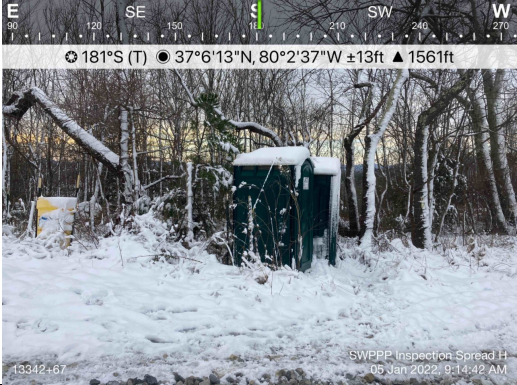
GPS Location	See photo above		GPS Location	See photo above	
Field Station#	13337+00		Field Station#	13342+67	
Pic 7 Desc.	Timber mat stream crossings are in good condition and surrounding erosion control measures are in place.		Pic 8 Desc.	Portable toilets are present along the ROW and there were no signs of leaks observed.

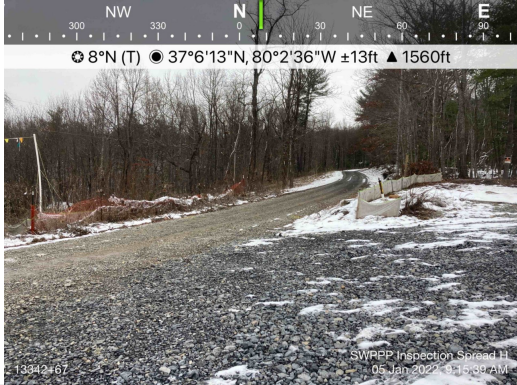
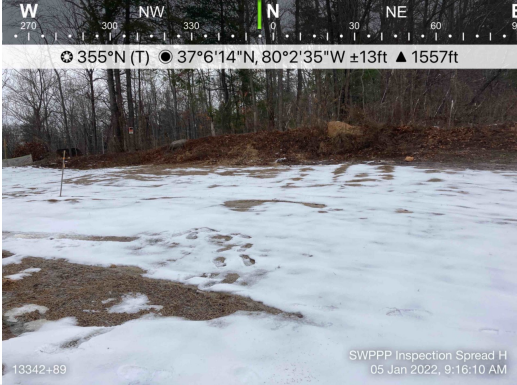
GPS Location	See photo above		GPS Location	See photo above	
Field Station#	13342+67		Field Station#	13342+89	
Pic 9 Desc.	Access roads and ATWS are in good condition. No maintenance is needed.		Pic 10 Desc.	Erosion control blanketing is present and functioning under the recent snowfall.

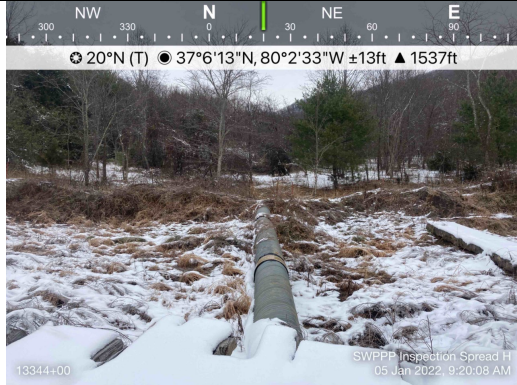
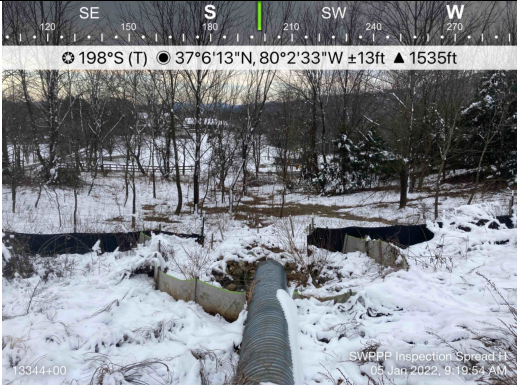
GPS Location	See photo above		GPS Location	See photo above	
Field Station#	13344+00		Field Station#	13344+00	
Pic 11 Desc.	Cleanwater diversion pipe is in good condition.		Pic 12 Desc.	Plunge pool and end treatments are in acceptable condition. No maintenance is needed.

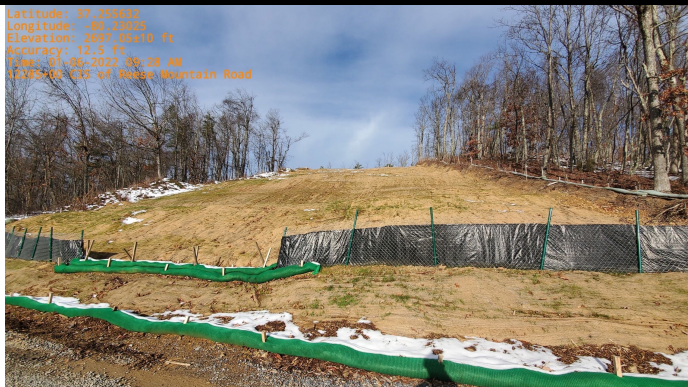
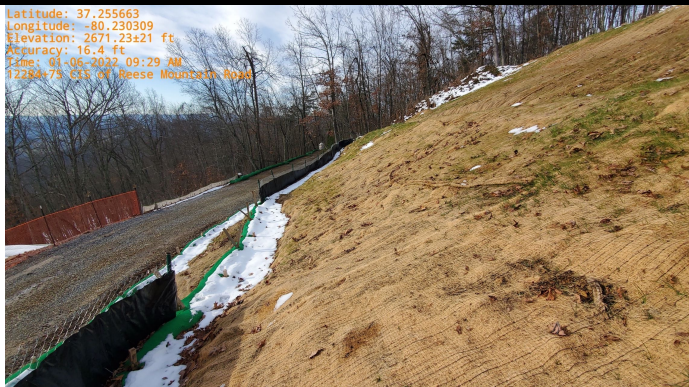
GPS Location	See pic for GPS location.		GPS Location	See pic for GPS location.	
Field Station#	12285+00		Field Station#	12284+75	
Pic 1 Desc.	ECD's and BMP's in place and remain functional.		Pic 2 Desc.	ECD's and BMP's in place and remain functional.	
<div>Latitude: 37.251732 Longitude: -80.245856 Elevation: 2104.03±8 ft Accuracy: 32.3 ft Time: 01-06-2022 10:11 AM 12235+00 GAS of MN-276</div>

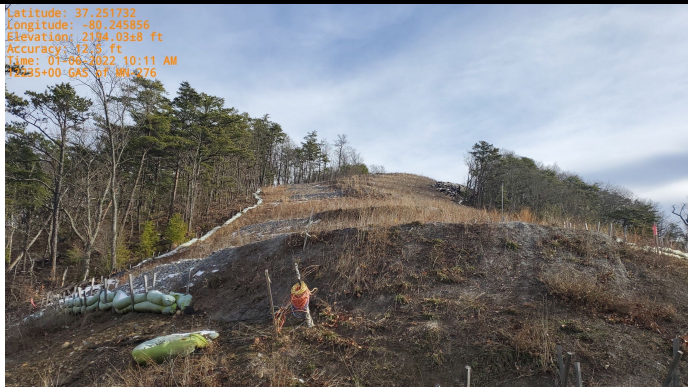
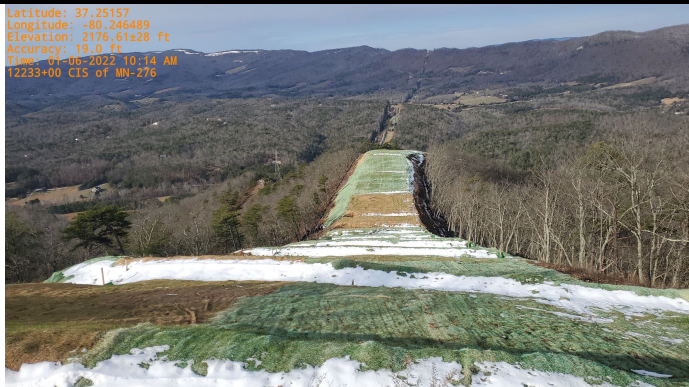
GPS Location	See pic for GPS location.		GPS Location	See pic for GPS location.	
Field Station#	12235+00		Field Station#	12233+00	
Pic 3 Desc.	Current conditions of the ROW on the GAS of MN-276.03		Pic 4 Desc.	Current conditions of the ROW on the CIS of MN-276.03	
<div>Latitude: 37.251894 Longitude: -80.257139 Elevation: 1314.11±18 ft Accuracy: 15.7 ft Time: 01-06-2022 11:14 AM 12214+00 GAS of Broadshaw Rd</div>

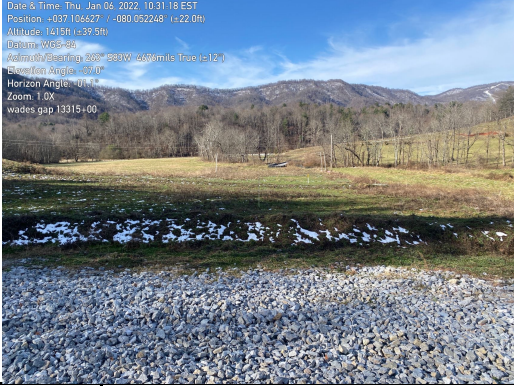
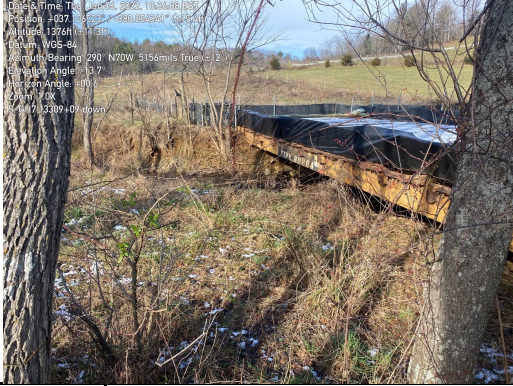
GPS Location 0		GPS Location 0			
Field Station# 13315+00		Field Station# 13309+09			
Pic 1 Desc. ROW and ECDs In good condition and stable		Pic 2 Desc. MVP-S-GH7 and Corresponding buffer zone in good condition			
<p>Date & Time: Thu Jan 06, 2022 09:28:35 EST Position: +037114596 / -080055932 / +15.5m Altitude: 1455ft (+11.1m) Datum: WGS-84 Azimuth Bearing: 262° N45W 4658mils True (+12°) Elevation Angle: +0.5° Horizon Angle: 00.3° Zoom: 1.0x 13262+62 Flanders Road Crossing</p>

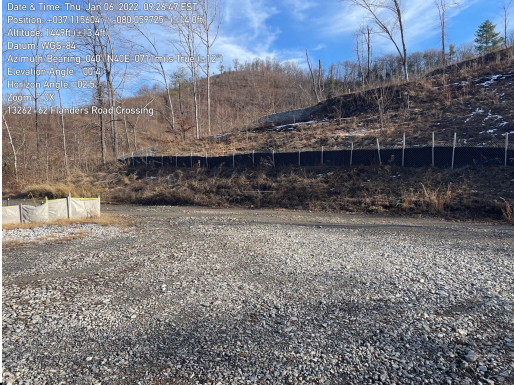
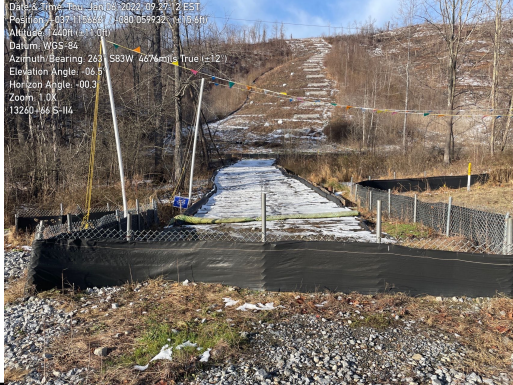
GPS Location 0		GPS Location 0			
Field Station# 13262+62		Field Station# 13260+66			
Pic 3 Desc. Flanders Road Crossing in good condition		Pic 4 Desc. MVP-S-II4 and Corresponding buffer zone in good condition			
<p>Date & Time: Thu Jan 06, 2022 09:28:38 EST Position: +037114596 / -080055949 / +15.5m Altitude: 1455ft (+11.1m) Datum: WGS-84 Azimuth Bearing: 262° N45W 4658mils True (+12°) Elevation Angle: +0.5° Horizon Angle: 00.0° Zoom: 1.0x 13259+00</p>

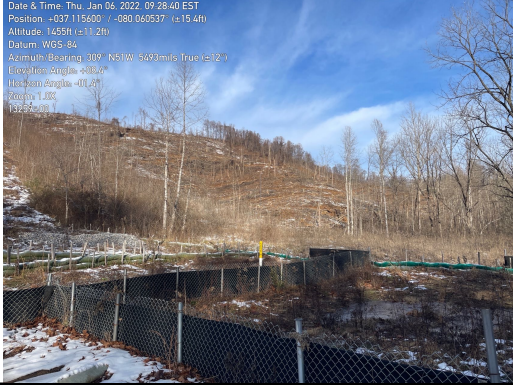
GPS Location 0		GPS Location 0			
Field Station# 13259+00		Field Station# 13259+00			
Pic 5 Desc. ROW and ECDs In good condition and stable		Pic 6 Desc. Continuing to monitor logging activity, no change observed

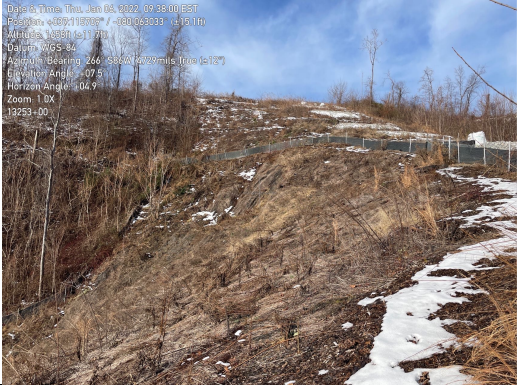
GPS Location		0		GPS Location	
Field Station#		13253+00		Field Station#	
Pic 7 Desc.		Slip observed to be stable, no notable changes		Pic 8 Desc.	
				ROW and ECDs In good condition and stable	
<p>Date & Time: Thu Jan 06 2022 09:49:36 EST Position: +037.118811° / -080.064931° (+15.1m) Altitude: 1993ft (+9.8m) Datum: WGS-84 Azimuth/Bearing: 000° N00E 000mils True (+12°) Elevation Angle: +06.0° Horizon Angle: -05.4° Zoom: 1.0X 13247+00</p>

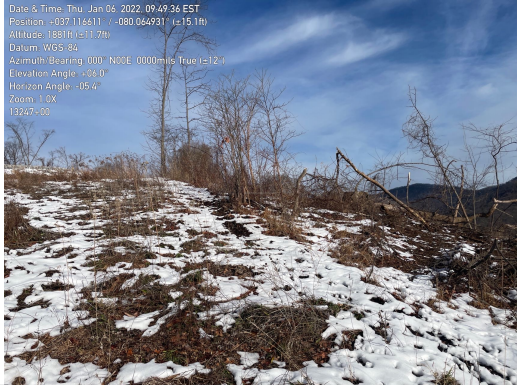
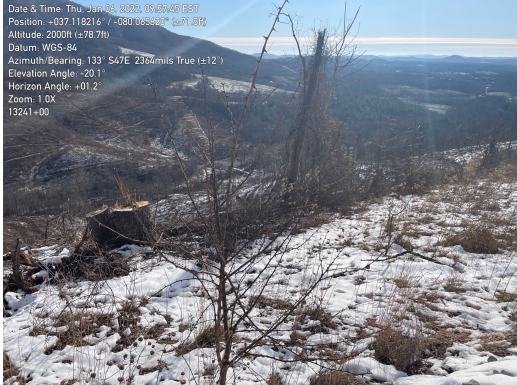
GPS Location		0		GPS Location	
Field Station#		13247+00		Field Station#	
Pic 9 Desc.		Continuing to monitor logging activity, no change observed. Trees cut along row but logging didn't encroach onto row		Pic 10 Desc.	
				Continuing to monitor logging activity, no change observed. Trees cut along row but logging didn't encroach onto row	
<p>Date & Time: Thu Jan 06 2022 10:28:00 EST Position: +037.122215° / -080.067184° (+11.8ft) Altitude: 2053ft (+9.8m) Datum: WGS-84 Azimuth/Bearing: 169° S16E 240mils True (+12°) Elevation Angle: +11.9° Horizon Angle: -02.9° Zoom: 1.0X 13224+00</p>

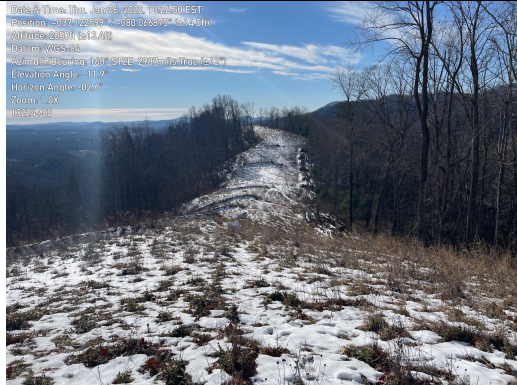
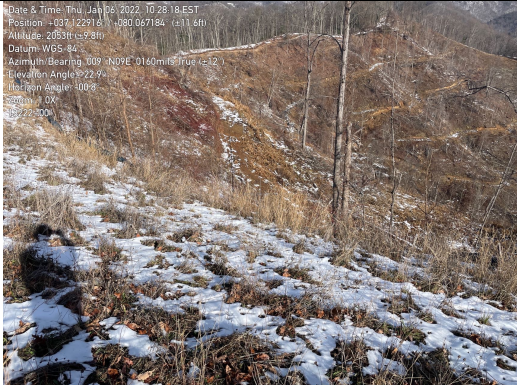
Pic 11 Desc.		ROW and ECDs In good condition and stable		Pic 12 Desc.	
				Slip observed to be stable, no notable changes

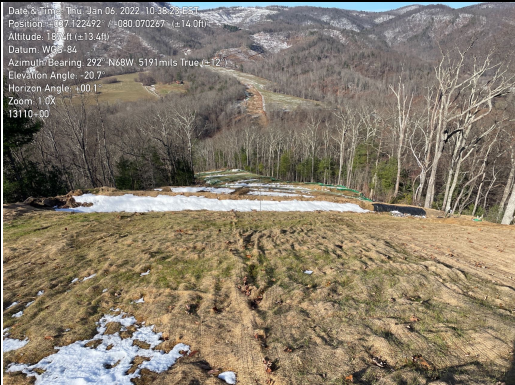
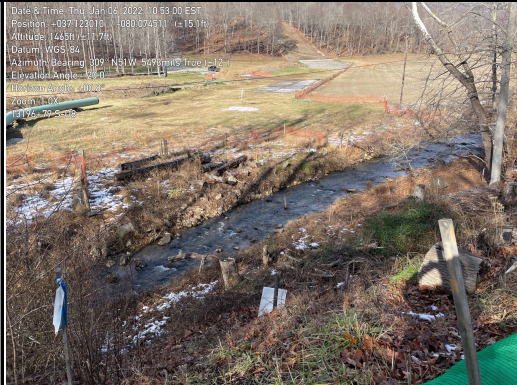
GPS Location		0		GPS Location		0					
Field Station#		13210+00		Field Station#		13196+79					
Pic 13 Desc.		ROW and ECDs In good condition and stable				Pic 14 Desc.		MVP-S-D8 and Corresponding buffer zone in good condition			
<p>Date & Time: Thu Jan 06, 2022 10:55:54 EST Position: +07123187, +080075119 (±15.1ft) Altitude: 1531ft (±13.7ft) Datum: WGS-84 Azimuth/Bearing: 334° N26W 4918mils True (±2°) Elevation Angle: -10.1° Horizon Angle: -10.3° Zoom: 1.0X 13194+31 S-D10</p>  						<p>Date & Time: Thu Jan 06, 2022 09:55:26 EST Position: +037124342, +080088074 (±15.0ft) Altitude: 1489ft (±11.8ft) Datum: WGS-84 Azimuth/Bearing: 282° N78W 5013mils True (±13°) Elevation Angle: -14.6° Horizon Angle: -00.5° Zoom: 1.0X 13157+31 OPS S-D11 up</p>

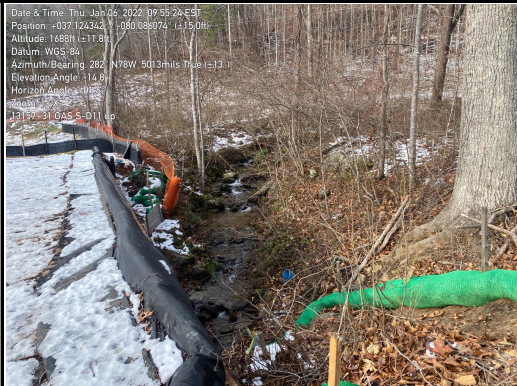
GPS Location		0		GPS Location		0					
Field Station#		13196+31		Field Station#		13157+31					
Pic 15 Desc.		MVP-S-D10 and Corresponding buffer zone in good condition				Pic 16 Desc.		MVP-S-D11 and Corresponding buffer zone in good condition			
<p>Date & Time: Thu Jan 06, 2022 11:55:55 EST Position: +037123440, +080088136 (±15.4ft) Altitude: 1661ft (±11.3ft) Datum: WGS-84 Azimuth/Bearing: 126° S54E 2240mils True (±13°) Elevation Angle: -22.0° Horizon Angle: -01.4° Zoom: 1.0X 13154+00</p>

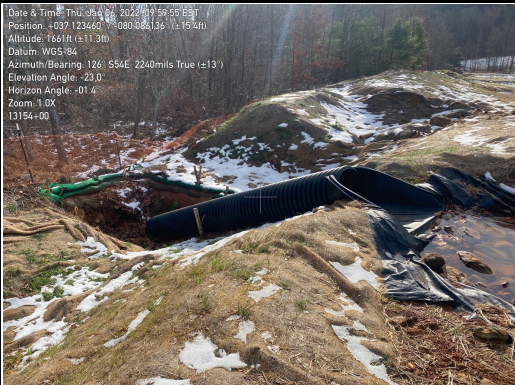
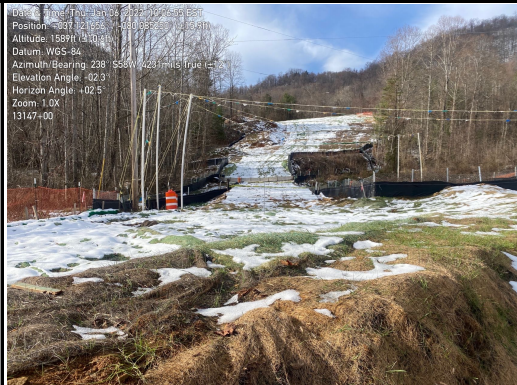
GPS Location		0		GPS Location		0					
Field Station#		13154+00		Field Station#		13147+00					
Pic 17 Desc.		Slope drain pipe in good condition and functioning properly				Pic 18 Desc.		MVP-S-D12/13 and Corresponding buffer zone in good condition
