Visual Site Inspection Report

Project Name	H-600 Pipeline Spread H	AFE	124300138	Spread	H-600 Pipeline Spread H
Contractor	Precision			Report #	32835
Inspector	Joe Scott			Date/Time	1/3/2022 3:55 PM
Permit #	TBD	Inspection Type	VA SWPP	Station Begin	12865+00
State	VA	Inspection Area	Partial	Station End	13024+00
County	Roanoke	Ground	Frozen	Temperature (°F)	32.00
Municipality	N/A	Weather	Snow/Sleet	Rain Gauge (in)	1.10
				Rain Accumulation Time (days)	1.00

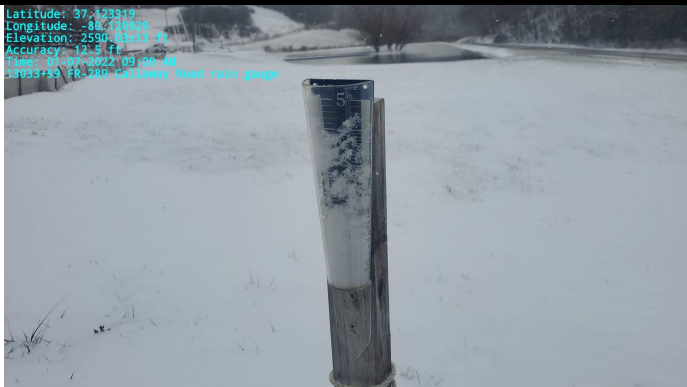
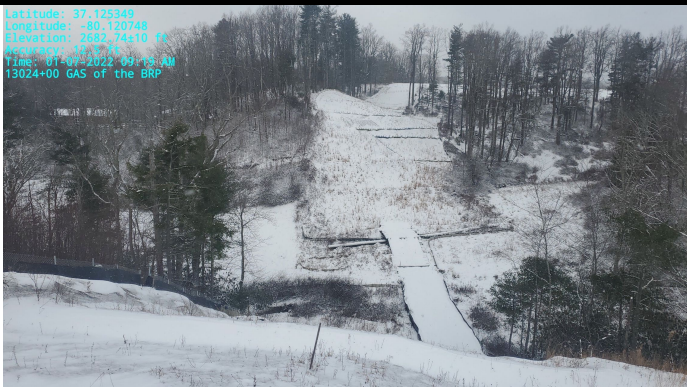
GPS Location	See pic for GPS location.		GPS Location	See pic for GPS location.	
Field Station#	13033+59		Field Station#	13024+00	
Pic 1 Desc.	Callaway Road rain gauge.		Pic 2 Desc.	Current ROW conditions on the GAS of the BRP.	
<div>Latitude: 37.123393 Longitude: -80.121108 Elevation: 2586.67±34 ft Accuracy: 25.3 ft Time: 01-07-2022 09:27 AM 13033+59 FR-289 Callaway Road rain gauge 0.4"</div>

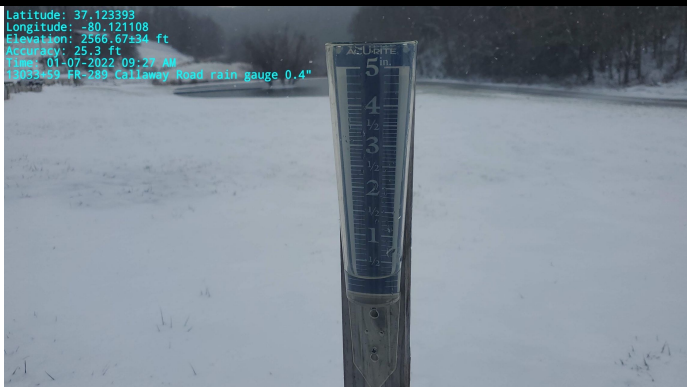
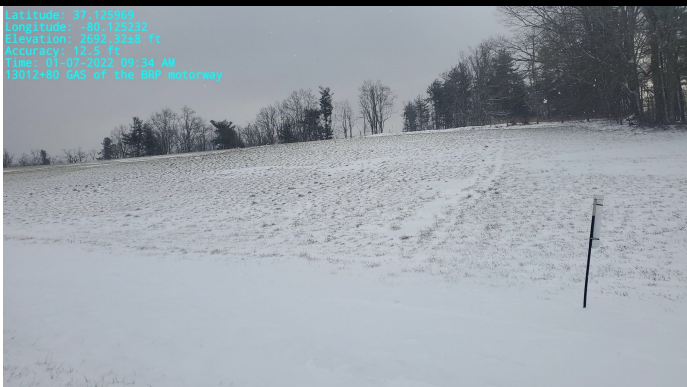
GPS Location	See pic for GPS location.		GPS Location	See pic for GPS location.	
Field Station#	13033+59		Field Station#	13012+80	
Pic 3 Desc.	Callaway Road rain gauge. 0.4" after melting snow and ice.		Pic 4 Desc.	Current ROW conditions on the GAS of the BRP.	
<div>Latitude: 37.125987 Longitude: -80.125235 Elevation: 2682.71±8 ft Accuracy: 12.5 ft Time: 01-07-2022 09:34 AM 13012+40 CIS of the BRP motorway</div>

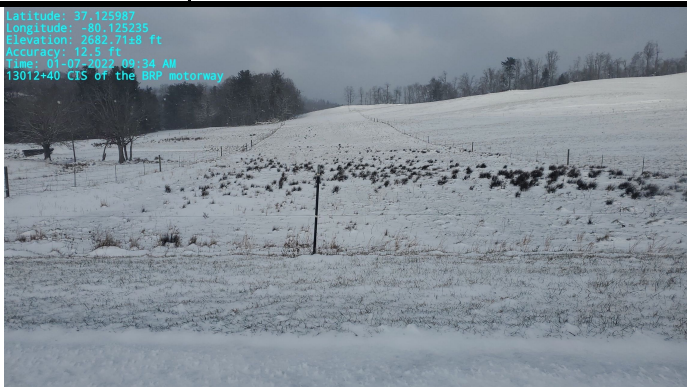
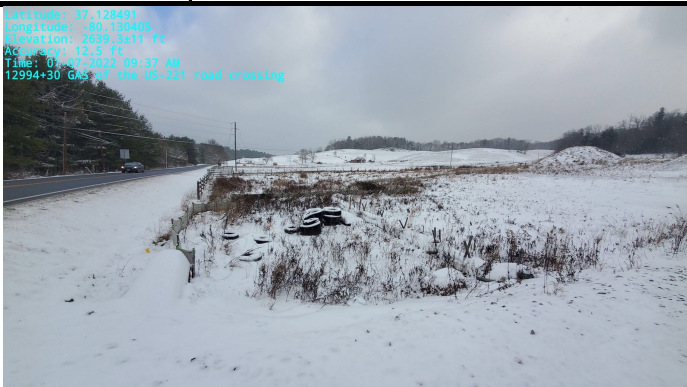
GPS Location	See pic for GPS location.		GPS Location	See pic for GPS location.	
Field Station#	13012+40		Field Station#	12994+30	
Pic 5 Desc.	Current ROW conditions on the CIS of the BRP.		Pic 6 Desc.	Current ROW conditions on the GAS of the US-221 road crossing.

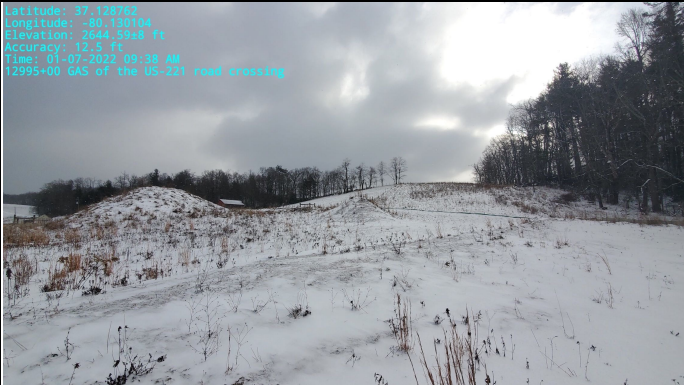
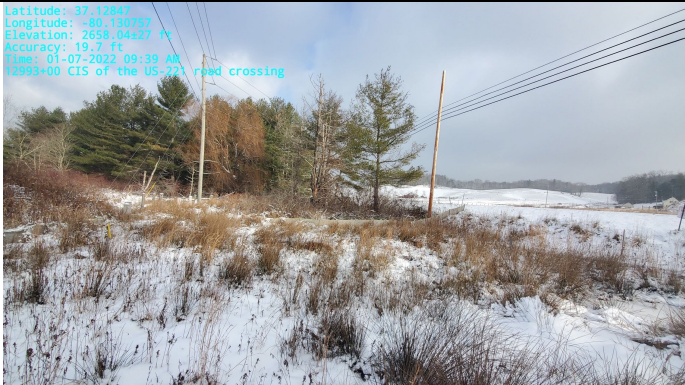
GPS Location	See pic for GPS location.		GPS Location	See pic for GPS location.	
Field Station#	12995+00		Field Station#	12993+00	
Pic 7 Desc.	Current ROW conditions on the GAS of the US-221 road crossing.		Pic 8 Desc.	Current ROW conditions on the CIS of the US-221 road crossing.	
<div>Latitude: 37.129191 Longitude: -80.130482 Elevation: 2705.6±11 ft Accuracy: 12.5 ft Time: 01-07-2022 09:44 AM 12975+00 GAS of RO-288</div>

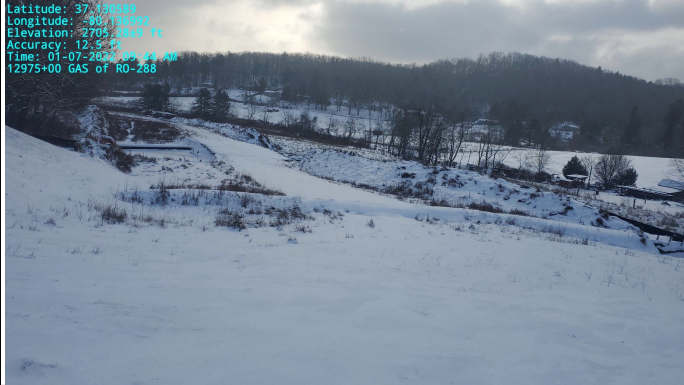
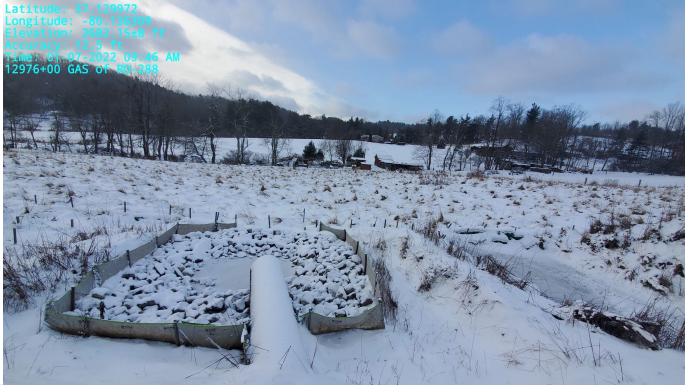
GPS Location	See pic for GPS location.		GPS Location	See pic for GPS location.	
Field Station#	12975+00		Field Station#	12976+00	
Pic 9 Desc.	Current ROW conditions on the GAS of RO-288.		Pic 10 Desc.	CWDP and plunge pool on the GAS of RO-288.	
<div>Latitude: 37.130587 Longitude: -80.137151 Elevation: 2710.26±8 ft Accuracy: 17.5 ft Time: 01-07-2022 09:47 AM 12973+00 CIS of RO-288</div>

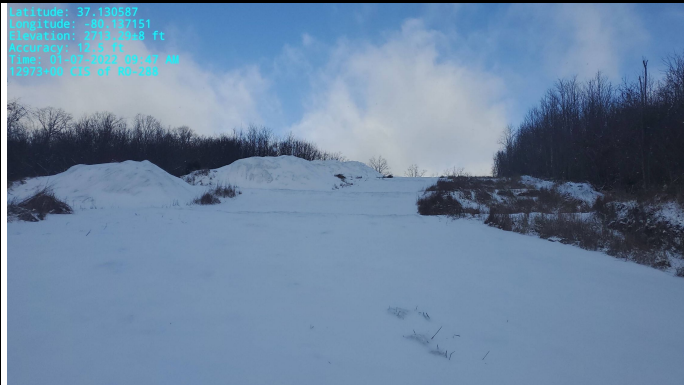
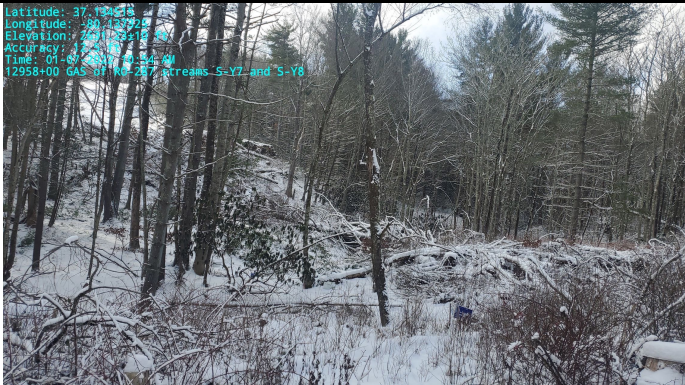
GPS Location	See pic for GPS location.		GPS Location	See pic for GPS location.	
Field Station#	12973+00		Field Station#	12958+00	
Pic 11 Desc.	Current ROW conditions on the GAS of RO-288.		Pic 12 Desc.	Streams S-Y7 and S-Y8 on the GAS of RO-287.

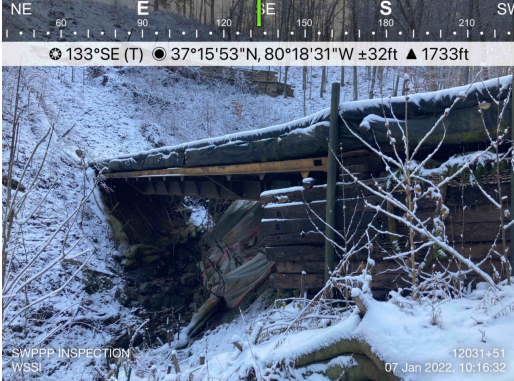
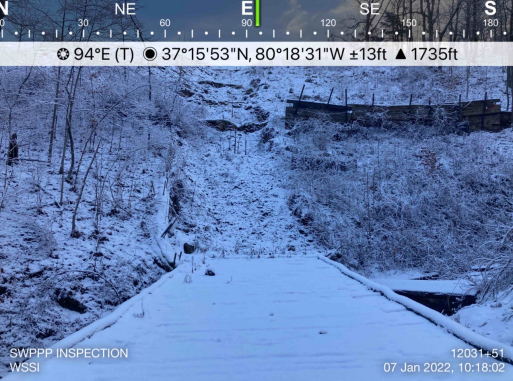
GPS Location	See Photo Above		GPS Location	See Photo Above	
Field Station#	12031+51		Field Station#	12031+51	
Pic 1 Desc.	Timber mat crossing is in good condition. No maintenance is required.		Pic 2 Desc.	Erosion control measures along steep slopes are present and functioning properly.

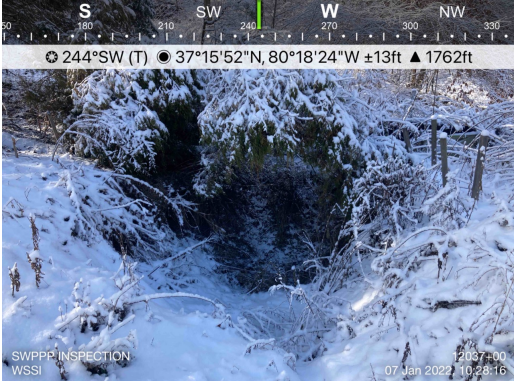
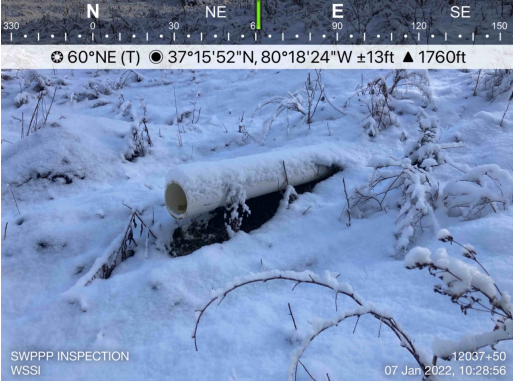
GPS Location	See Photo Above		GPS Location	See Photo Above	
Field Station#	12037+00		Field Station#	12037+50	
Pic 3 Desc.	Sump pits are holding run-off water and end treatments are functioning as designed.		Pic 4 Desc.	Trench drain is in acceptable condition. No maintenance required.

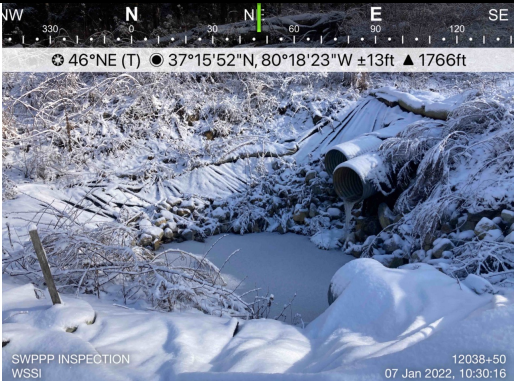
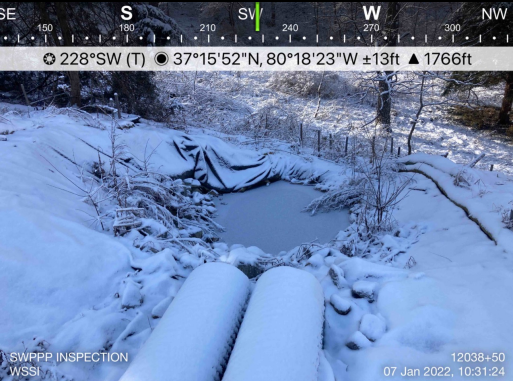
GPS Location	See Photo Above		GPS Location	See Photo Above	
Field Station#	12038+50		Field Station#	12038+50	
Pic 5 Desc.	Clean water diversion pipe is present and functioning properly.		Pic 6 Desc.	Plunge pools along the ROW are in acceptable condition. No maintenance necessary.

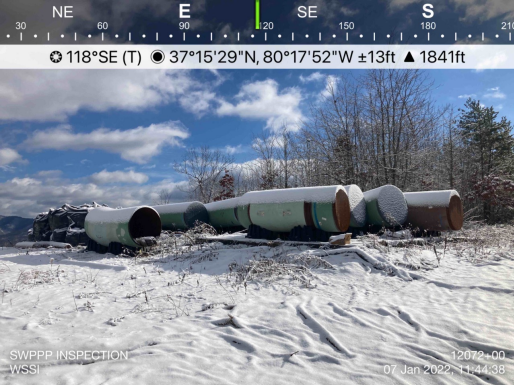
GPS Location	See Photo Above		GPS Location	See Photo Above	
Field Station#	12072+00		Field Station#	12072+00	
Pic 7 Desc.	Temporary vegetation is in acceptable condition. No maintenance required.		Pic 8 Desc.	Material storage along the ROW is in good condition.

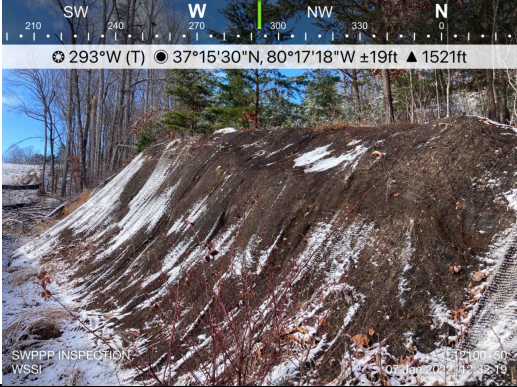
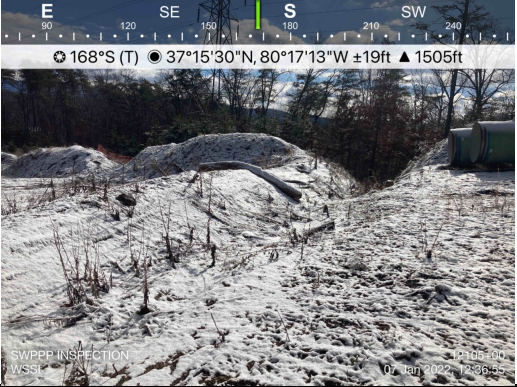
GPS Location	See Photo Above		GPS Location	See Photo Above	
Field Station#	12100+50		Field Station#	12105+90	
Pic 13 Desc.	Erosion control blanketing remains in place and in good condition.		Pic 14 Desc.	Waterbar end treatments are present and in good condition.

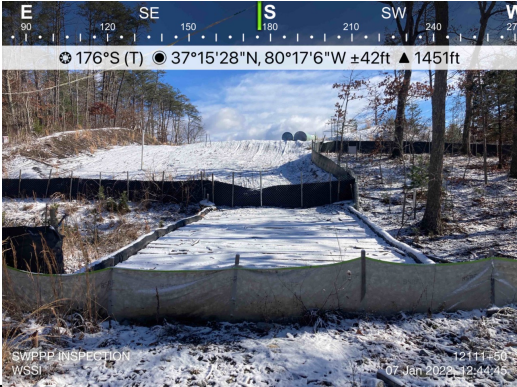
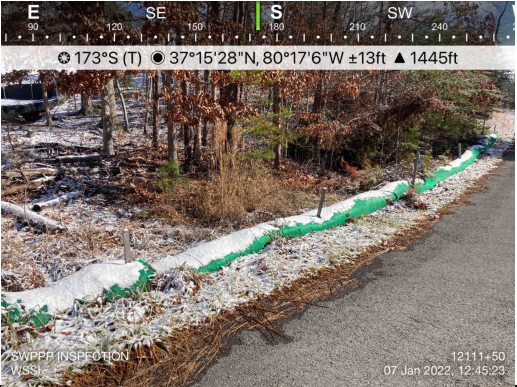
GPS Location	See Photo Above		GPS Location	See Photo Above	
Field Station#	12111+50		Field Station#	12111+50	
Pic 15 Desc.	SF & SSF along stream crossings are in good condition.		Pic 16 Desc.	CFS is present and functioning appropriately. No maintenance is required.

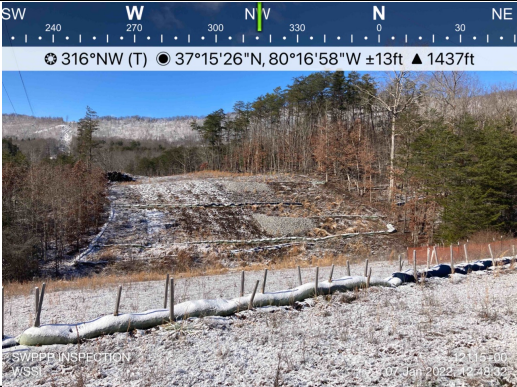
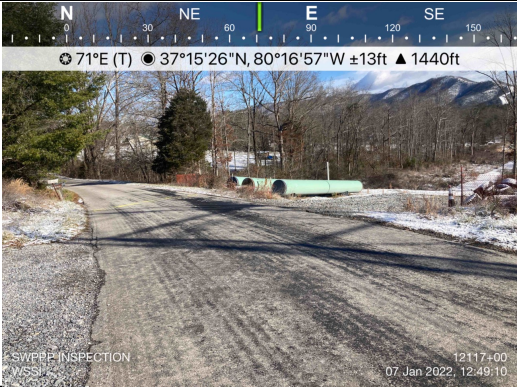
GPS Location	See Photo Above		GPS Location	See Photo Above	
Field Station#	12115+00		Field Station#	12119+00	
Pic 17 Desc.	Perimeter controls and erosion control blanketing are functioning properly.		Pic 18 Desc.	Rock construction entrances are in good condition and no tracked material is present within the roadways.

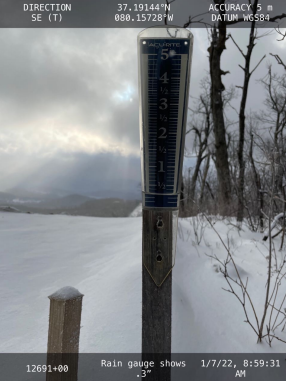
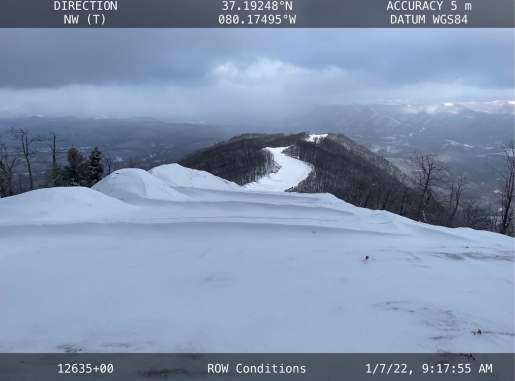
GPS Location	See photo		GPS Location	See photo	
Field Station#	12691+00		Field Station#	12635+00	
Pic 1 Desc.	Rain gauge shows .3" of precipitation		Pic 2 Desc.	Current ROW conditions. ROW is covered in snow. ROW is stable. ECDs are in place.

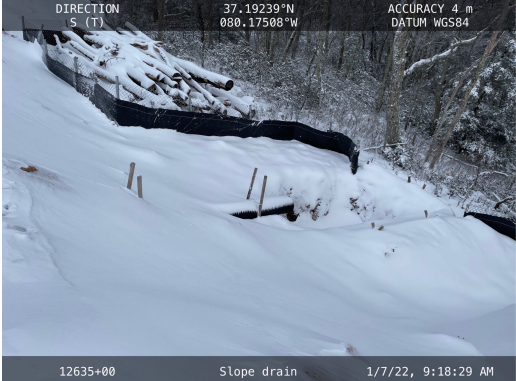
GPS Location	See photo		GPS Location	See photo	
Field Station#	12635+00		Field Station#	12634+00	
Pic 3 Desc.	Slope drain is covered in snow		Pic 4 Desc.	Slope drain is covered in snow

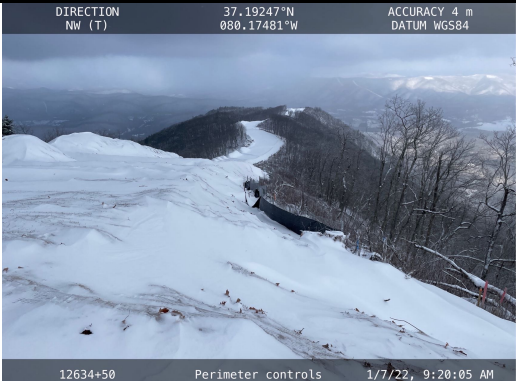
GPS Location	See photo		GPS Location	See photo	
Field Station#	12634+50		Field Station#	12638+24	
Pic 5 Desc.	Current ROW conditions. ROW is covered in snow. ROW is stable. ECDs are in place.		Pic 6 Desc.	Access Road RO-279.02. ECDs are in place and functional.

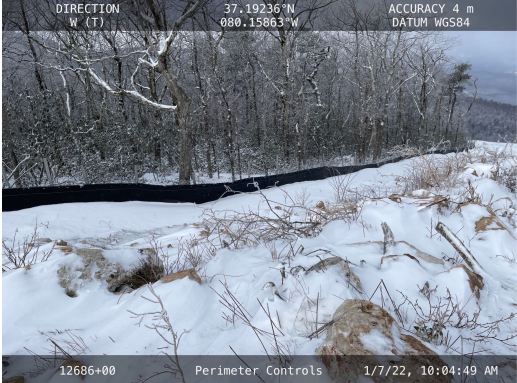
GPS Location	See photo		GPS Location	See photo	
Field Station#	12686+00		Field Station#	12688+00	
Pic 13 Desc.	Perimeter controls are functional		Pic 14 Desc.	Perimeter controls are functional

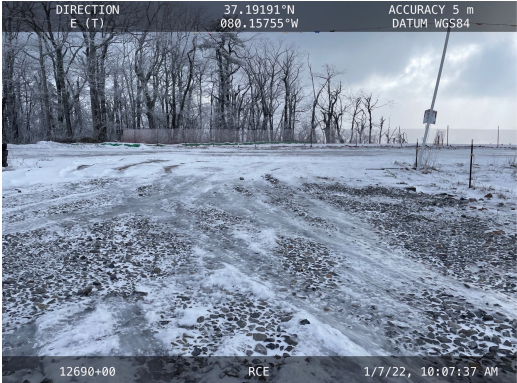
GPS Location	See photo		GPS Location	See photo	
Field Station#	12690+00		Field Station#	12691+00	
Pic 15 Desc.	RCE is functional		Pic 16 Desc.	Slope breaker and level spreader are functional

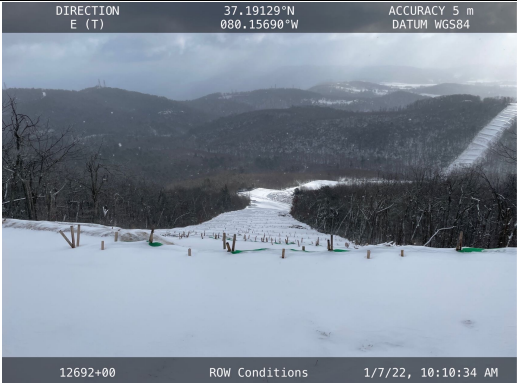
GPS Location	See photo		GPS Location	See photo	
Field Station#	12692+00		Field Station#	12692+50	
Pic 17 Desc.	Current ROW conditions. ROW is covered in snow. ROW is stable. ECDs are in place.		Pic 18 Desc.	Perimeter controls are functional
