Visual Site Inspection Report

Project Name	H-600 Pipeline Spread H	AFE	124300138	Spread	H-600 Pipeline Spread H
Contractor	Precision			Report #	33829
Inspector	Dustin Lyons			Date/Time	1/31/2022 3:30 PM
Permit #	TBD	Inspection Type	VA SWPP	Station Begin	12600+00
State	VA	Inspection Area	Partial	Station End	12725+00
County	Roanoke	Ground	Frozen	Temperature (°F)	27.00
Municipality	N/A	Weather	Sunny	Rain Gauge (in)	0.20
				Rain Accumulation Time (days)	3.00

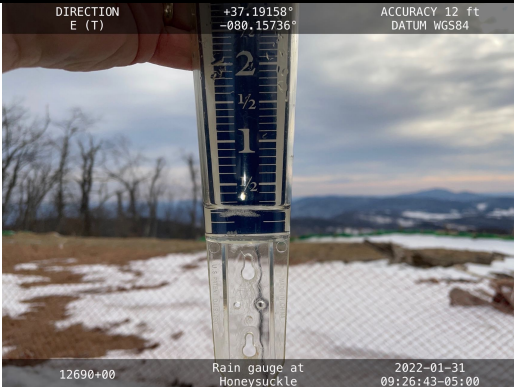
<p>DIRECTION E (T) +37.19158° -080.15736° ACCURACY 12 ft DATUM WGS84</p> <p>12690+00 Rain gauge at Honeysuckle 2022-01-31 09:26:43-05:00</p>

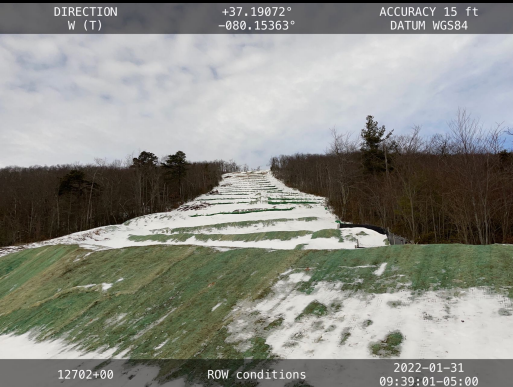
<p>DIRECTION W (T) +37.19072° -080.15363° ACCURACY 15 ft DATUM WGS84</p> <p>12702+00 ROW conditions 2022-01-31 09:39:01-05:00</p>	
GPS Location	See photo for gps location data.		GPS Location	See photo for gps location data.	
Field Station#	12690+00		Field Station#	12702+00	
Pic 1 Desc.	Photo shows the rain gauge at Honeysuckle Road. 0.2" of precipitation was recorded at Honeysuckle Road within the last 72 hours.		Pic 2 Desc.	Photo shows the ROW condition. ECDs are installed and functioning as designed.

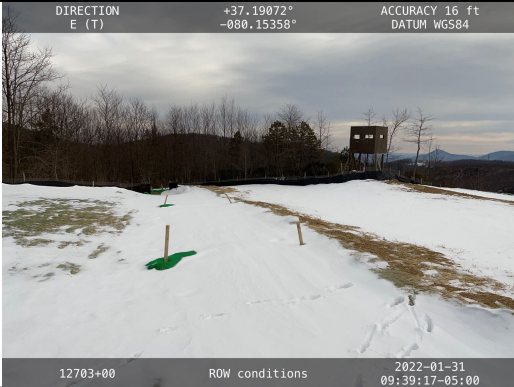
<p>DIRECTION E (T) +37.19072° -080.15358° ACCURACY 16 ft DATUM WGS84</p> <p>12703+00 ROW conditions 2022-01-31 09:39:17-05:00</p>

GPS Location	See photo for gps location data.		GPS Location	See photo for gps location data.	
Field Station#	12703+00		Field Station#	12704+00	
Pic 3 Desc.	Photo shows the ROW condition. ECDs are installed and functioning as designed.		Pic 4 Desc.	Photo shows the ROW condition. ECDs are installed and functioning as designed.

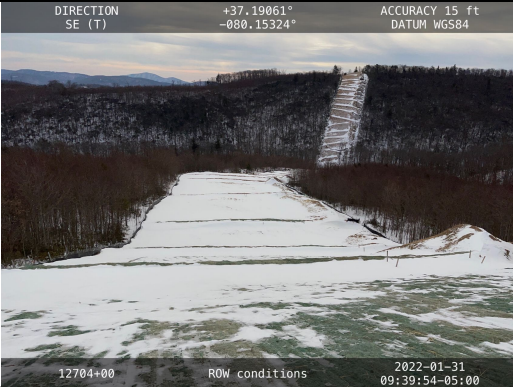
<p>DIRECTION SE (T) +37.19061° -080.15324° ACCURACY 15 ft DATUM WGS84</p> <p>12704+00 ROW conditions 2022-01-31 09:39:54-05:00</p>

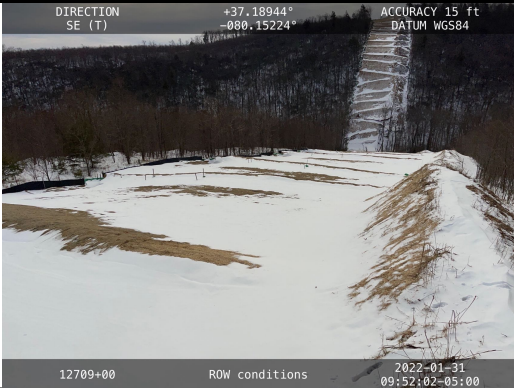
<p>DIRECTION SE (T) +37.18944° -080.15224° ACCURACY 15 ft DATUM WGS84</p> <p>12709+00 ROW conditions 2022-01-31 09:52:02-05:00</p>

<p>DIRECTION SE (T) +37.18876° -080.15199° ACCURACY 23 ft DATUM WGS84</p> <p>12712+00 ROW conditions 2022-01-31 09:53:37-05:00</p>	
GPS Location	See photo for gps location data.		GPS Location	See photo for gps location data.	
Field Station#	12709+00		Field Station#	12712+00	
Pic 5 Desc.	Photo shows the ROW condition. ECDs are installed and functioning as designed.		Pic 6 Desc.	Photo shows the ROW condition. ECDs are installed and functioning as designed.

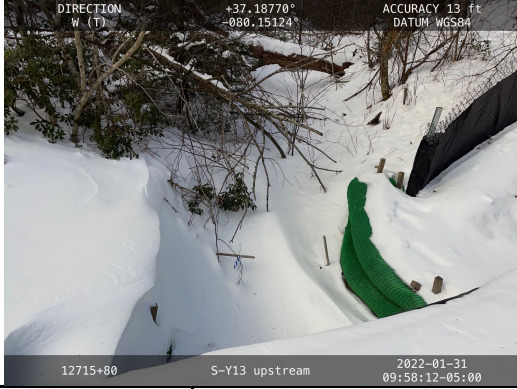
GPS Location	See photo for gps location data.		GPS Location	See photo for gps location data.	
Field Station#	12715+80		Field Station#	12716+20	
Pic 9 Desc.	Photo shows stream S-Y13 upstream from the bridge.		Pic 10 Desc.	Photo shows stream S-Y14 upstream from the bridge.

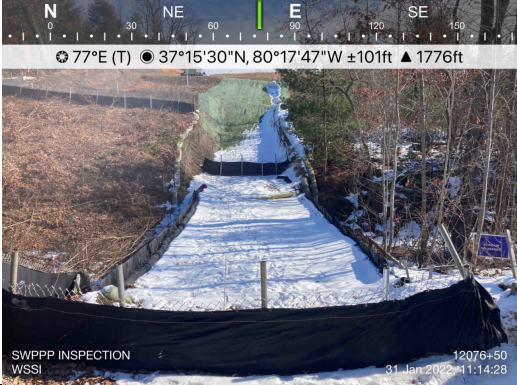
GPS Location	See Photo Watermark		GPS Location	See Photo Watermark	
Field Station#	12071+00		Field Station#	12076+50	
Pic 7 Desc.	Materials are stored properly. No maintenance needed.		Pic 8 Desc.	Super silt fence across the site is in acceptable condition.

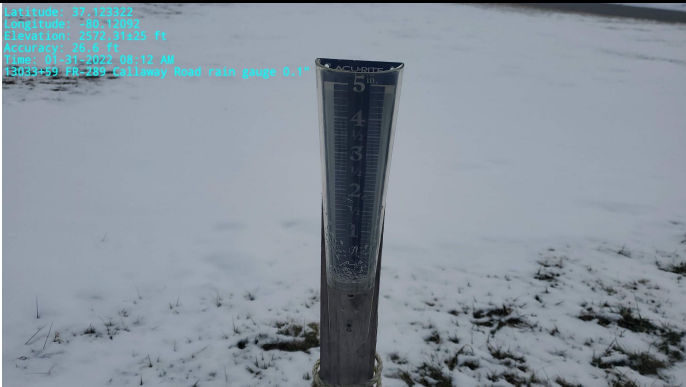
AFE	124300138	Date/Time	1/31/2022 3:24 PM	Report #	
Pictures					
<small>Latitude: 37.123222 Longitude: -80.13493 Elevation: 2573.51±0.5 ft Accuracy: 26.6 ft Time: 01-31-2022 08:12 AM 13033+59 Callaway Road rain gauge 0.1"</small>

GPS Location	See pic for GPS location.		GPS Location	See pic for GPS location.	
Field Station#	13033+59		Field Station#	13015+00	
Pic 1 Desc.	Callaway Road rain gauge. 0.1" total precipitation.		Pic 2 Desc.	BRP motorway crossing from the GAS.	
<small>Latitude: 37.128565 Longitude: -80.130049 Elevation: 2634.71±0.5 ft Accuracy: 27.2 ft Time: 01-31-2022 10:00 AM 12995+00 GAS of US-221</small>

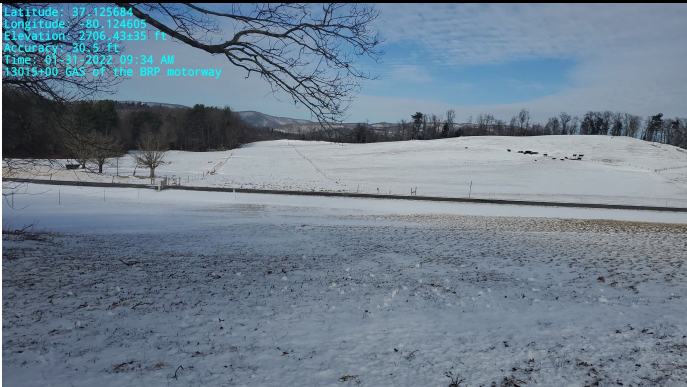
<small>Latitude: 37.125654 Longitude: -80.124466 Elevation: 2706.43±0.5 ft Accuracy: 20.5 ft Time: 01-31-2022 09:34 AM 13015+00 GAS of the BRP motorway</small>

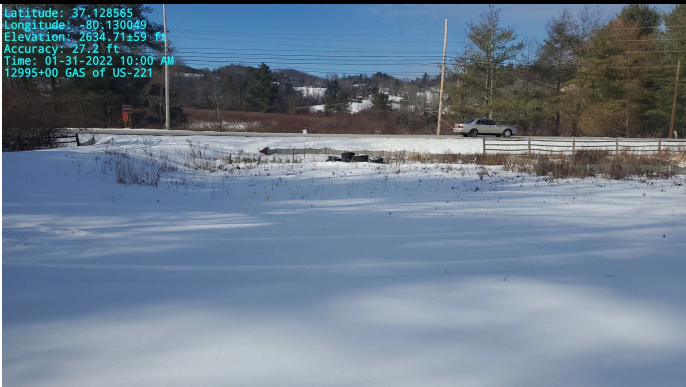
GPS Location	See pic for GPS location.		GPS Location	See pic for GPS location.	
Field Station#	12995+00		Field Station#	12995+00	
Pic 3 Desc.	US-221 Road crossing from the GAS.		Pic 4 Desc.	GAS of the US-221 road crossing.	
<small>Latitude: 37.130494 Longitude: -80.137049 Elevation: 2680.25±0.5 ft Accuracy: 12.5 ft Time: 01-31-2022 10:05 AM 12975+00 GAS of RO-288</small>

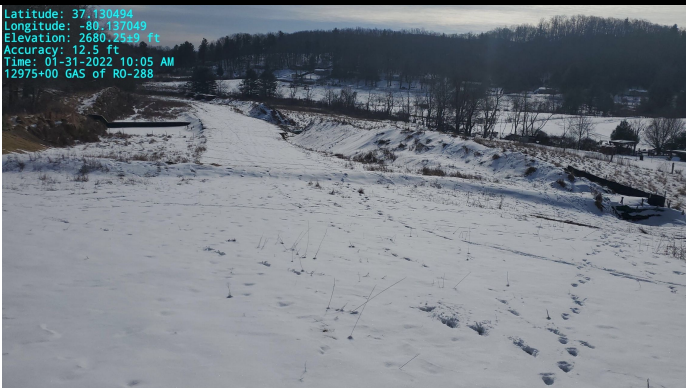
GPS Location	See pic for GPS location.		GPS Location	See pic for GPS location.	
Field Station#	12975+00		Field Station#	12973+00	
Pic 5 Desc.	Current ROW conditions on the GAS of RO-288.		Pic 6 Desc.	Current ROW conditions on the CIS of RO-288.

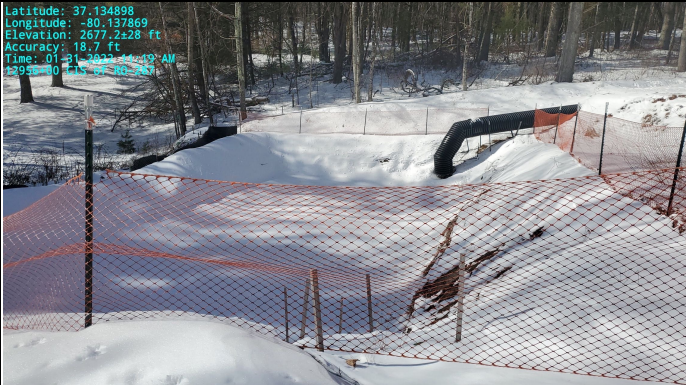
GPS Location	See pic for GPS location.		GPS Location	See pic for GPS location.	
Field Station#	12956+00		Field Station#	12955+00	
Pic 7 Desc.	Sediment trap on the CIS of RO-287.		Pic 8 Desc.	Waterbars, sumps and end treatments remain in place and functional.	
<div>Latitude: 37.135184 Longitude: -80.137979 Elevation: 2645.5±11 ft Accuracy: 32.5 ft Time: 01-31-2022 11:21 AM 12954+00 CIS of RO-287</div>

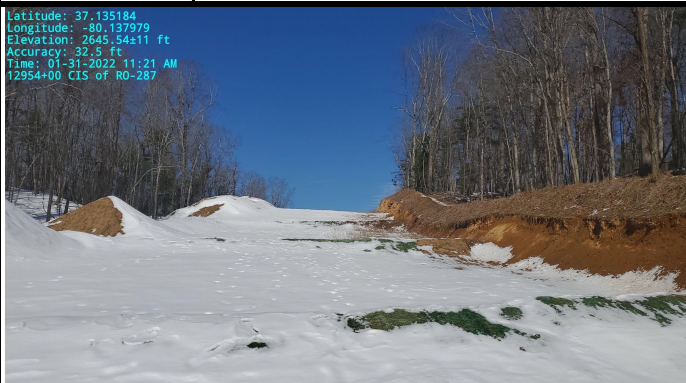
GPS Location	See pic for GPS location.		GPS Location	See pic for GPS location.	
Field Station#	12954+00		Field Station#	12958+00	
Pic 9 Desc.	Current ROW conditions on the CIS of RO-287.		Pic 10 Desc.	Streams S-Y7 and S-Y8 from the CIS.	
<div>Latitude: 37.13469 Longitude: -80.137626 Elevation: 2612.86±10 ft Accuracy: 46.3 ft Time: 01-31-2022 11:54 AM 12956+80 CIS of RO-287 landowner's spring box and streams S-Y7 and S-Y9</div>

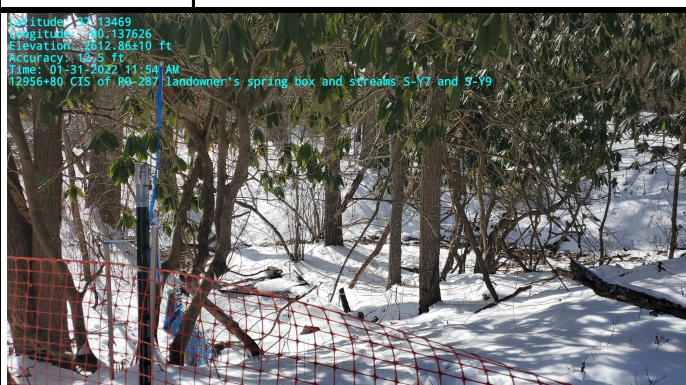
GPS Location	See pic for GPS location.		GPS Location	See pic for GPS location.	
Field Station#	12956+80		Field Station#	12922+00	
Pic 11 Desc.	Streams S-Y7 and S-Y9 on the upstream side of the ROW.		Pic 12 Desc.	Streams S-EF44 from the CIS.

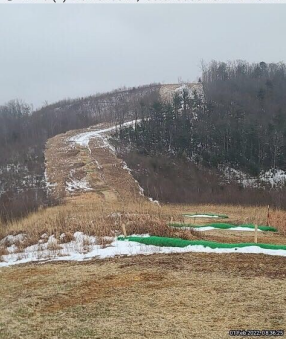
GPS Location	00000	GPS Location	0000		
Field Station#	13440+00	Field Station#	13420+00		
Pic 1 Desc.	Monitored water bars and level spreaders in permanent area, no environmental issues observed at the time of inspection.		Pic 2 Desc.	Observed sump pits and end treatment, no environmental issues observed at the time of inspection.	
	North East Elevation <small>246°SW (T) • 37.090374, -80.020571 ±3 m ▲ 485 m</small>

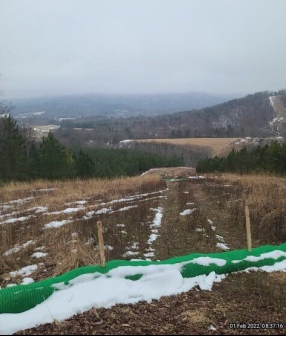
GPS Location	0000	GPS Location	0000		
Field Station#	13433+34	Field Station#	13418+00		
Pic 3 Desc.	Observed ECDs along the row row in permanent area, all up to date at the time of inspection.		Pic 4 Desc.	Monitored erosion control blanket on hill side above road crossing, no environmental issues observed at the time of inspection.

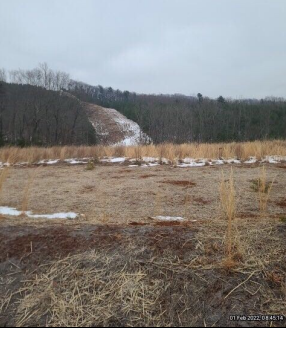
GPS Location	00000	GPS Location	000000		
Field Station#	13420+40	Field Station#	13497+25		
Pic 5 Desc.	Row photo showing vegetation, no environmental issues observed at the time of inspection.		Pic 6 Desc.	Row photo showing ECDs in place at stream crossing, no environmental issues observed at the time of inspection.

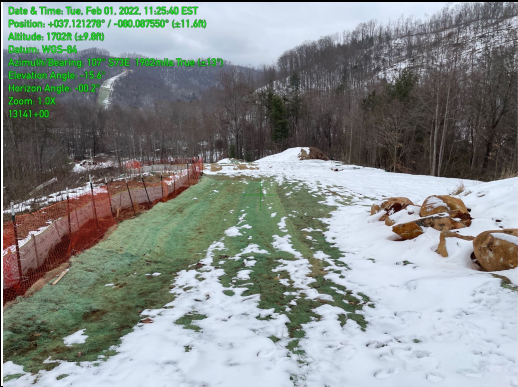
GPS Location	0	GPS Location	0		
Field Station#	13141+00	Field Station#	13141+00		
Pic 13 Desc.	ROW and ECDs In good condition and stable		Pic 14 Desc.	ROW and ECDs In good condition and stable	
<p>Date & Time: Tue, Feb 01, 2022, 11:27:29 EST Position: +037.121441° / -080.088075° (s=11.60) Altitude: 1729ft (s=9.80) Datum: WGS-84 Azimuth/Bearing: 304° N54W 8404mils True (s=12°) Elevation Angle: -0.0° Horizon Angle: -0.0° Zoom: 1.0X 13138+50</p>

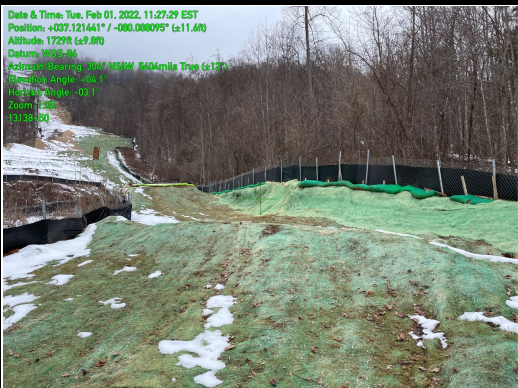
GPS Location	0	GPS Location	0		
Field Station#	13138+50	Field Station#	13137+78		
Pic 15 Desc.	ROW and ECDs In good condition and stable		Pic 16 Desc.	MVP-S-D17 and Corresponding buffer zone in good condition	
<p>Date & Time: Tue, Feb 01, 2022, 11:30:05 EST Position: +037.121609° / -080.086695° (s=11.60) Altitude: 1752ft (s=11.10) Datum: WGS-84 Azimuth/Bearing: 278° N82W 4942mils True (s=12°) Elevation Angle: +22.2° Horizon Angle: -01.9° Zoom: 2.0X 13137+00</p>

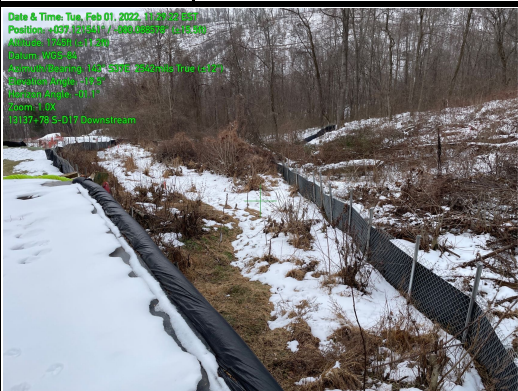
GPS Location	0	GPS Location	0		
Field Station#	13137+78	Field Station#	13137+00		
Pic 17 Desc.	MVP-S-D17 Downstream and Corresponding buffer zone in good condition		Pic 18 Desc.	ROW and ECDs In good condition and stable

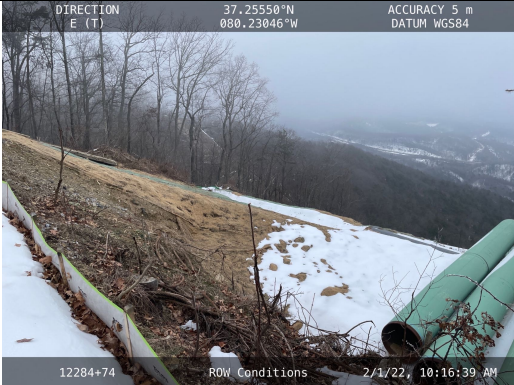
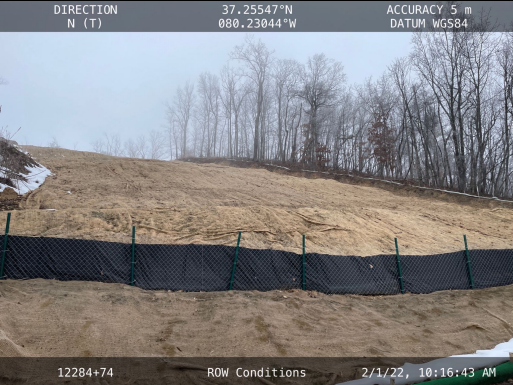
GPS Location	See photo		GPS Location	See photo	
Field Station#	12284+75		Field Station#	12284+75	
Pic 1 Desc.	Current ROW conditions. ROW is stable. ECDs are functional.		Pic 2 Desc.	Current ROW conditions. ROW is stable. ECDs are functional.

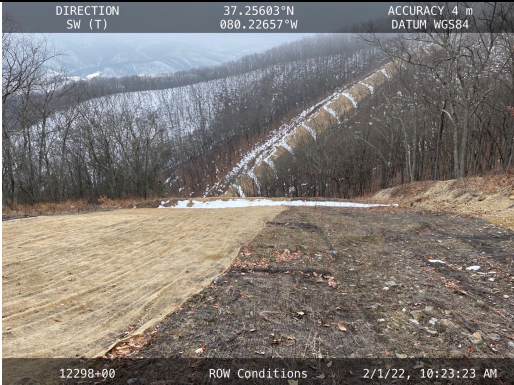
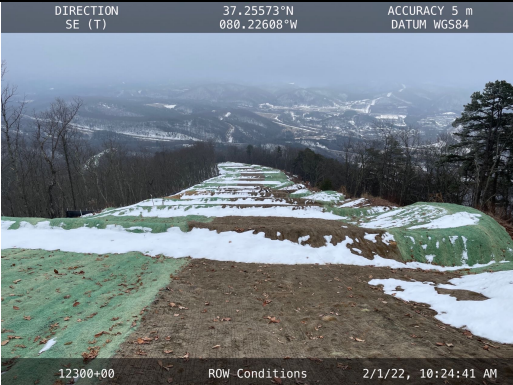
GPS Location	See photo		GPS Location	See photo	
Field Station#	12298+00		Field Station#	12300+00	
Pic 3 Desc.	Current ROW conditions. ROW is stable. ECDs are functional.		Pic 4 Desc.	Current ROW conditions. ROW is stable. ECDs are functional.

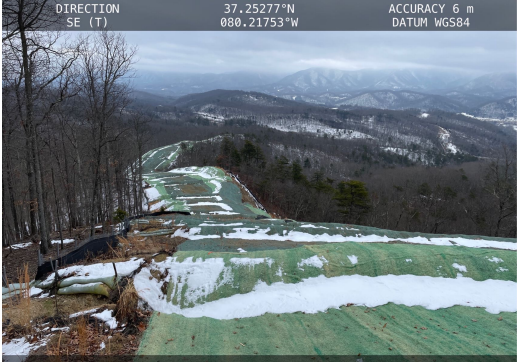
12327+50 ROW Conditions 2/1/22, 10:47:55 AM		12335+00 ROW Conditions 2/1/22, 10:54:09 AM			
GPS Location	See photo		GPS Location	See photo	
Field Station#	12327+50		Field Station#	12335+00	
Pic 7 Desc.	Current ROW conditions. ROW is stable. ECDs are functional.		Pic 8 Desc.	Current ROW conditions. ROW is stable. ECDs are functional.	
DIRECTION 37.25269°N ACCURACY 4 m S (T) 080.21439°W DATUM WGS84

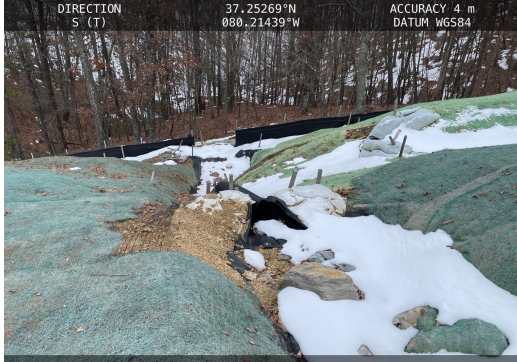
12337+00 Slope drain 2/1/22, 10:57:21 AM		12342+00 Fill slope is stable 2/1/22, 11:00:42 AM			
GPS Location	See photo		GPS Location	See photo	
Field Station#	12337+00		Field Station#	12342+00	
Pic 9 Desc.	Slope drain is functional		Pic 10 Desc.	Fill slope is stable. Perimeter controls are functional.

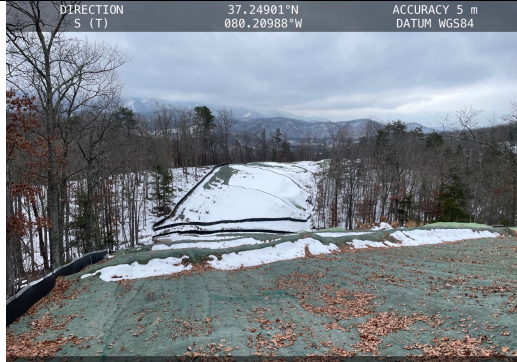
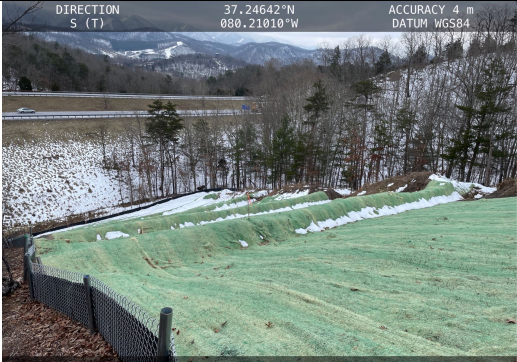
12358+00 ROW Conditions 2/1/22, 11:10:57 AM		12368+00 ROW Conditions 2/1/22, 11:22:23 AM			
GPS Location	See photo		GPS Location	See photo	
Field Station#	12358+00		Field Station#	12368+00	
Pic 11 Desc.	Current ROW conditions. ROW is stable. ECDs are functional.		Pic 12 Desc.	Current ROW conditions. ROW is stable. ECDs are functional.

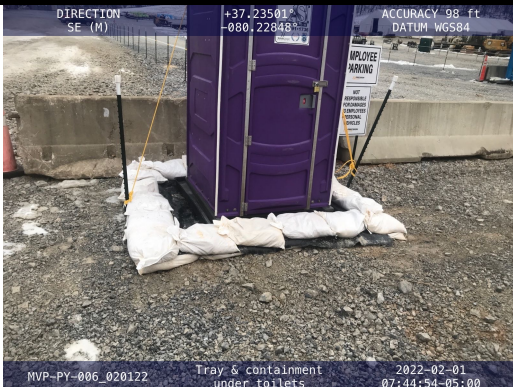
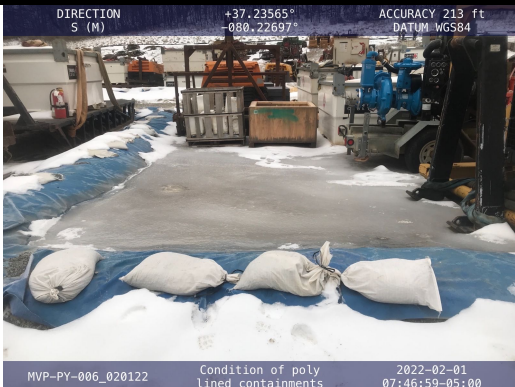
GPS Location	MVP-PY-006 See photo for gps data		GPS Location	MVP-PY-006 See photo for gps data	
Field Station#	+0		Field Station#	+0	
Pic 1 Desc.	Trays and containment under toilets. Trays holding ice. Looking SE.		Pic 2 Desc.	Condition of poly lined rock berm containments. Holding ice. Looking S.

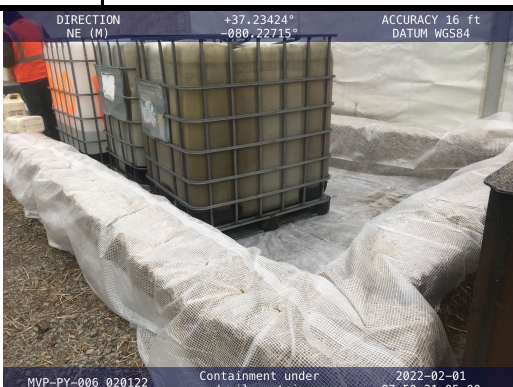
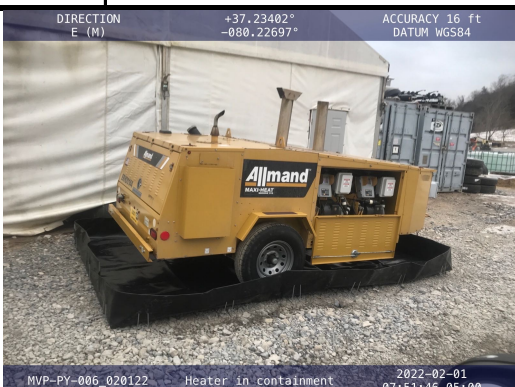
GPS Location	MVP-PY-006 See photo for gps data		GPS Location	MVP-PY-006 See photo for gps data	
Field Station#	+0		Field Station#	+0	
Pic 5 Desc.	Secondary containment under used oil containers. Free of fluids. Looking NE.		Pic 6 Desc.	Secondary containment under heater. Free of fluids. Looking NE.

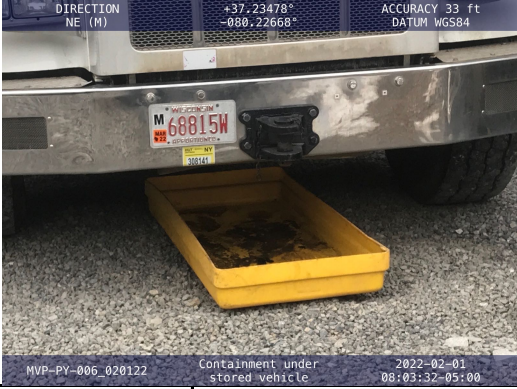
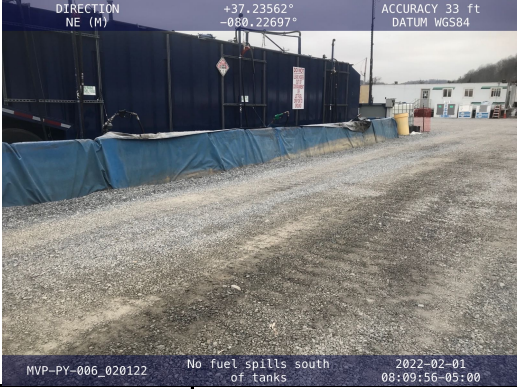
GPS Location	MVP-PY-006 See photo for gps data	GPS Location	MVP-PY-006 See photo for gps data		
Field Station#	+0	Field Station#	+0		
Pic 7 Desc.	Secondary containment under stored vehicle. Looking NE.	Pic 8 Desc.	Blue Bulk Fuel tanks No fuel spills south of the tanks. Looking NE.

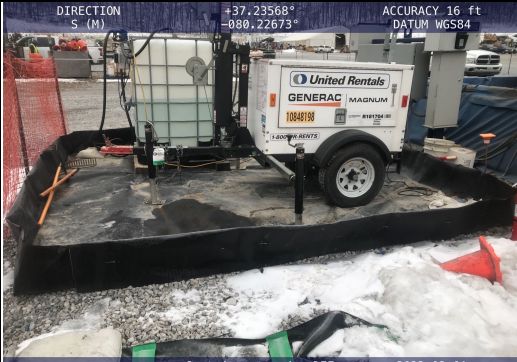
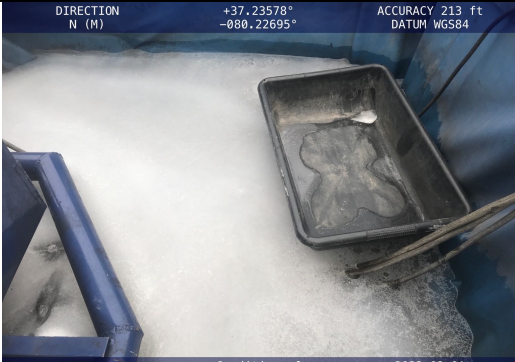
<p>DIRECTION N (M) +37.23578° -080.22695° ACCURACY 213 ft DATUM WGS84</p> <p>MVP-PY-006_020122 Condition of containment 2022-02-01 08:13:48-05:00</p>		
GPS Location	MVP-PY-006 See photo for gps data		GPS Location	MVP-PY-006 See photo for gps data	
Field Station#	+0		Field Station#	+0	
Pic 13 Desc.	Secondary containment under DEF container and light plant free of fluids. Looking S.		Pic 14 Desc.	Blue Bulk Fuel tanks containment holding ice. Looking N.

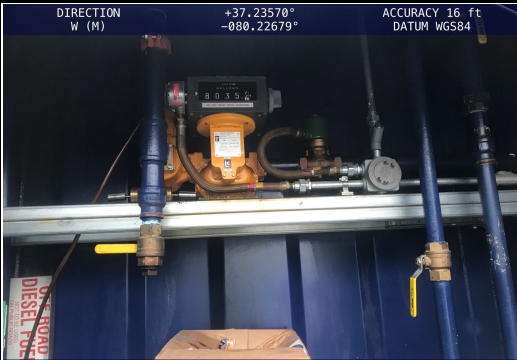
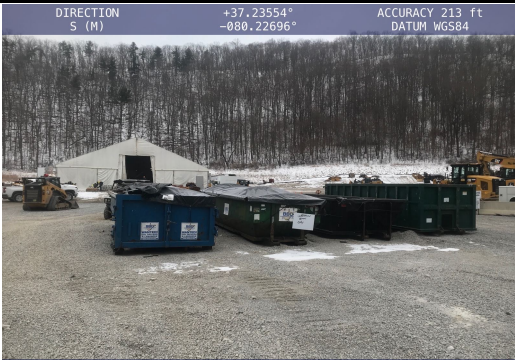
GPS Location	MVP-PY-006 See photo for gps data		GPS Location	MVP-PY-006 See photo for gps data	
Field Station#	+0		Field Station#	+0	
Pic 15 Desc.	Blue Bulk Fuel tanks no leaky internal fittings. Looking W.		Pic 16 Desc.	No fluids or deposits around hazardous waste dumpsters. Looking S.

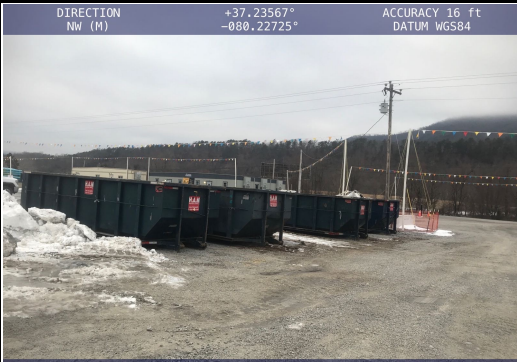
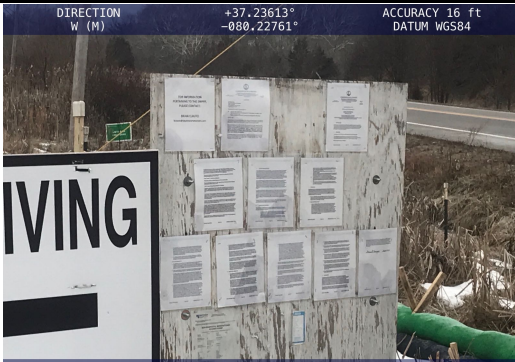
<p>DIRECTION W (M) +37.23613° -080.22761° ACCURACY 16 ft DATUM WGS84</p> <p>MVP-PY-006_020122 Condition of posted project documents 2022-02-01 08:20:20-05:00</p>		
GPS Location	MVP-PY-006 See photo for gps data		GPS Location	MVP-PY-006 See photo for gps data	
Field Station#	+0		Field Station#	+0	
Pic 17 Desc.	No loose trash around dumpsters or in the yard. Looking NW.		Pic 18 Desc.	Condition of posted project documents at main entrance. Looking W.

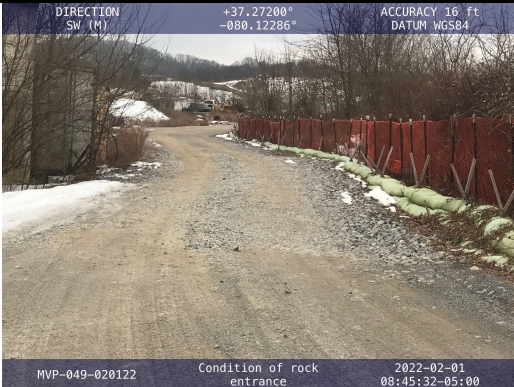
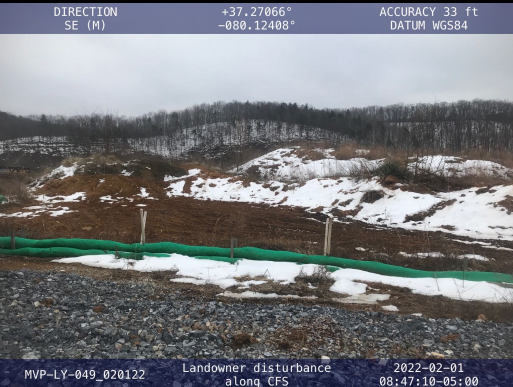
GPS Location	MVP-LY-049 See photo for gps data		GPS Location	MVP-LY-049 See photo for gps data	
Field Station#	+0		Field Station#	+0	
Pic 1 Desc.	Condition of rock entrance on north drive. No sediment or debris on stone. Looking SW.		Pic 2 Desc.	Landowner soil disturbance along triple stack compost filter sock. No new damage to installed ECD's. Looking SE.

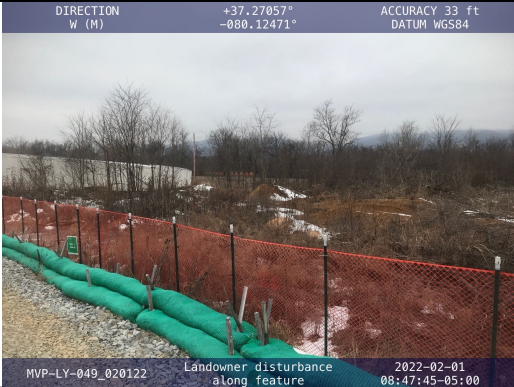
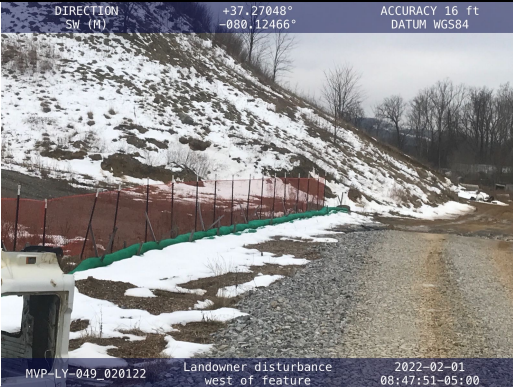
GPS Location	MVP-LY-049 See photo for gps data		GPS Location	MVP-LY-049 See photo for gps data	
Field Station#	+0		Field Station#	+0	
Pic 3 Desc.	Landowner soil disturbance along edge of feature W-CV21A. Area not stabilized. Looking W.		Pic 4 Desc.	Landowner soil disturbance west of feature W-CV21B. Areas not stabilized. Looking SW.

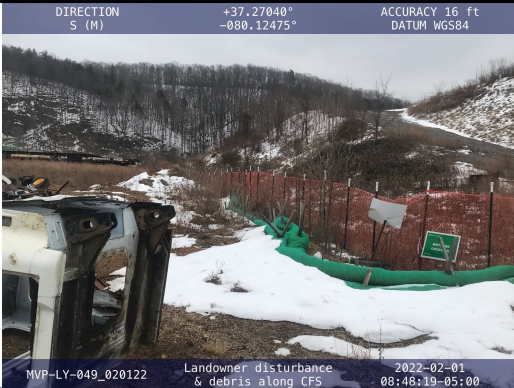
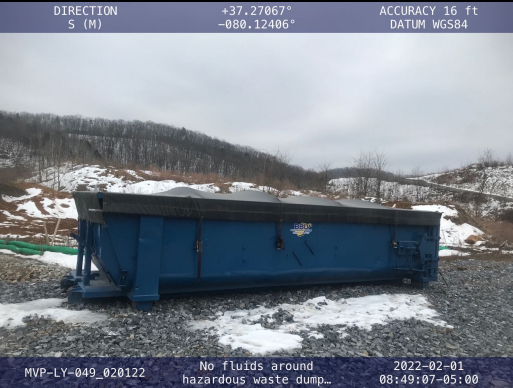
Pic 5 Desc.	Landowner soil disturbance and debris piled along triple stack compost filter sock and east of feature W-CV21B. Looking S.		Pic 6 Desc.	No fluids or deposits around hazardous waste dumpster. Looking S.

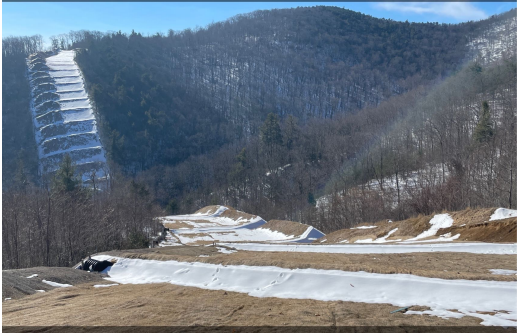
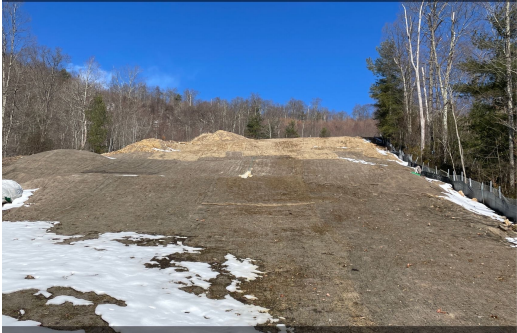
12743+00 ROW Conditions 2/2/22, 10:58:36 AM			
GPS Location	See photo		GPS Location	See photo	
Field Station#	12737+00		Field Station#	12743+00	
Pic 7 Desc.	Current ROW conditions. ROW is stable. ECDs are functional.		Pic 8 Desc.	Current ROW conditions. ROW is stable. ECDs are functional.	
DIRECTION S (T) 37.18134°N 080.14899°W ACCURACY 8 m DATUM WGS84

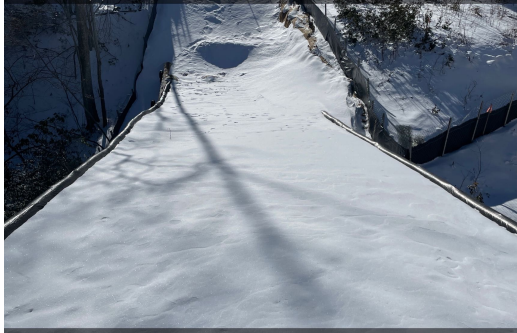
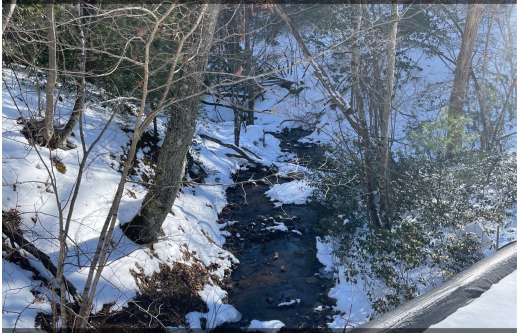
12743+84 S-EF34B 2/2/22, 10:59:51 AM			
GPS Location	See photo		GPS Location	See photo	
Field Station#	12743+84		Field Station#	12743+84	
Pic 9 Desc.	Equipment Bridge over Stream S-EF34B		Pic 10 Desc.	Downstream from crossing at Stream S-EF34B

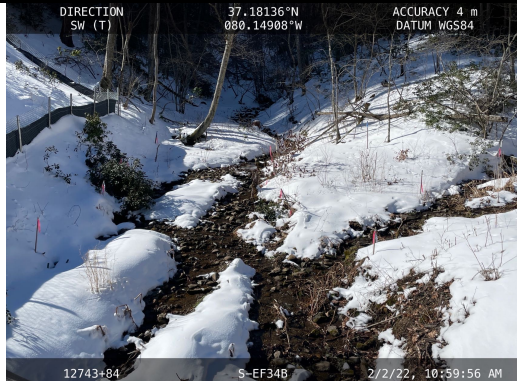
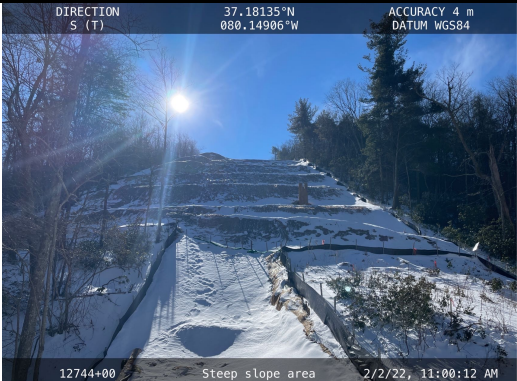
12744+00 Steep slope area 2/2/22, 11:00:12 AM			
GPS Location	See photo		GPS Location	See photo	
Field Station#	12743+84		Field Station#	12744+00	
Pic 11 Desc.	Upstream from crossing at Stream S-EF34B		Pic 12 Desc.	Current ROW conditions. ROW is stable. ECDs are functional.

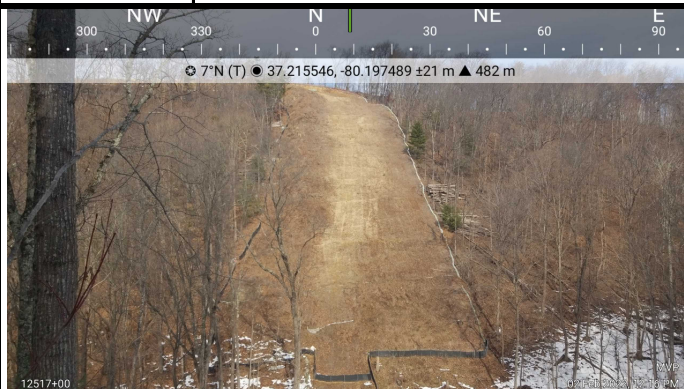
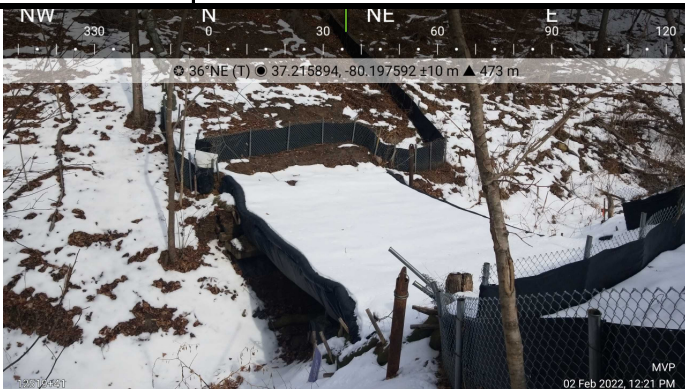
GPS Location	See Above		GPS Location	See Above	
Field Station#	12517+00		Field Station#	12519+41	
Pic 11 Desc.	ROW Overview (temporary stabilization). ECDs are functional and ROW is stable.		Pic 12 Desc.	Overview of Waterbody S-EF19. ECDs are functional and ROW is stable.

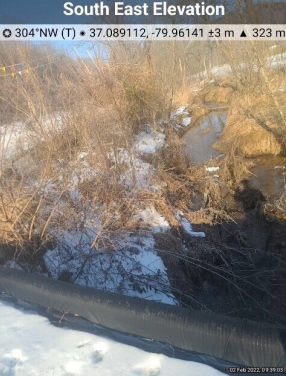
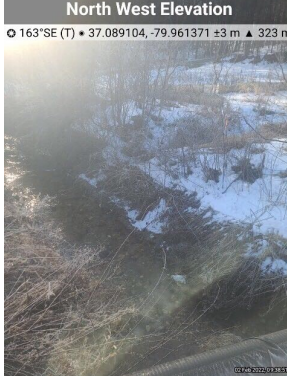
GPS Location	0000	GPS Location	0000		
Field Station#	13643+67	Field Station#	13643+67		
Pic 1 Desc.	Stream observation photo facing upstream during routine inspection today, no environmental issues observed at the time of inspection.		Pic 2 Desc.	Stream observation photo facing downstream during routine inspection today, no environmental issues observed at the time of inspection.	
	East Elevation <small>292°W (T) • 37.08905, -79.961444 ±3 m ▲ 324 m</small>

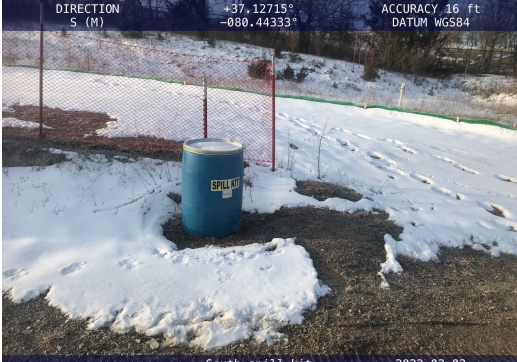
<p>DIRECTION S (M) +37.12715° -080.44333° ACCURACY 16 ft DATUM WGS84</p> <p>MVP-LY-071_020222 South spill kit barrel in place 2022-02-02 08:22:24-05:00</p>		  <p>DIRECTION N (M) +37.12727° -080.44363° ACCURACY 16 ft DATUM WGS84</p> <p>MVP-LY-071_020222 No debris around storage trailers 2022-02-02 08:22:50-05:00</p>			
GPS Location	MVP-LY-071 See photo for gps data		GPS Location	MVP-LY-071 See photo for gps data	
Field Station#	+0		Field Station#	+0	
Pic 13 Desc.	South spill kit barrel in place. Looking S.		Pic 14 Desc.	No loose debris around storage trailers. Looking N.	
  <p>DIRECTION N (M) +37.12727° -080.44363° ACCURACY 16 ft DATUM WGS84</p> <p>MVP-LY-071_020222 No loose trash in the south west section 2022-02-02 08:22:53-05:00</p>		  <p>DIRECTION SW (M) +37.12777° -080.44355° ACCURACY 33 ft DATUM WGS84</p> <p>MVP-LY-071_020222 Condition of CFS along west LOD 2022-02-02 08:24:14-05:00</p>

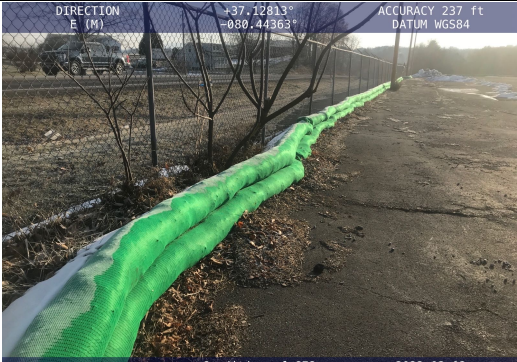
<p>DIRECTION E (M) +37.12813° -080.44363° ACCURACY 237 ft DATUM WGS84</p> <p>MVP-LY-071_020222 Condition of CFS along north LOD 2022-02-02 08:25:56-05:00</p>		  <p>DIRECTION SE (M) +37.12831° -080.44289° ACCURACY 16 ft DATUM WGS84</p> <p>MVP-LY-071_020222 Non loose trash in north section of yard 2022-02-02 08:26:13-05:00</p>			
GPS Location	MVP-LY-071 See photo for gps data		GPS Location	MVP-LY-071 See photo for gps data	
Field Station#	+0		Field Station#	+0	
Pic 17 Desc.	Condition of triple stack compost filter sock along north LOD. Looking E.		Pic 18 Desc.	No loose trash around north section of the yard. Looking SE.

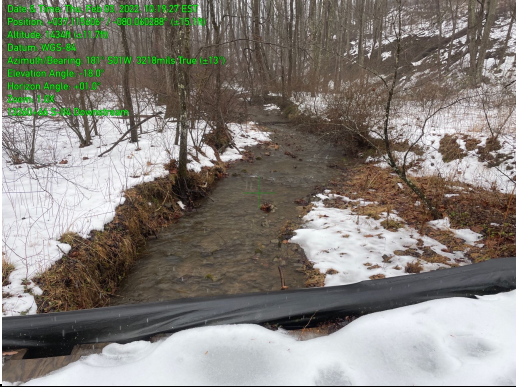
GPS Location	0	GPS Location	0		
Field Station#	13260+66	Field Station#	13259+00		
Pic 13 Desc.	MVP-S-II4 Downstream and Corresponding buffer zone in good condition	Pic 14 Desc.	ROW and ECDs In good condition and stable		
<p><small>Date & Time: Thu, Feb 03, 2022, 10:20:05 EST Position: +037.115491° / -080.040707° (±12.98) Altitude: 1458R (±19.70) Datum: WGS-84 Azimuth/Bearing: 321° N39W 5707mils True (±13°) Elevation Angle: +08.6° Horizon Angle: +01.7° Zoom: 1.0X 13259+00</small></p>

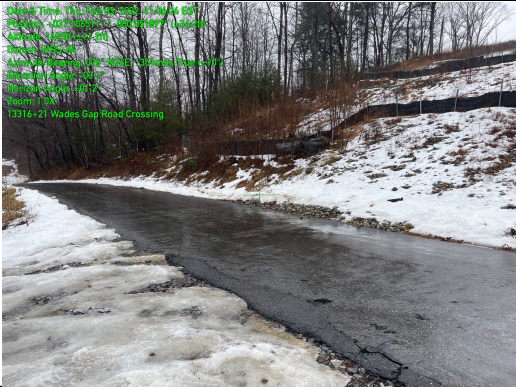
GPS Location	0	GPS Location	0		
Field Station#	13316+21	Field Station#	13314+00		
Pic 17 Desc.	Wades Gap Road Crossing in good condition	Pic 18 Desc.	ROW and ECDs In good condition and stable

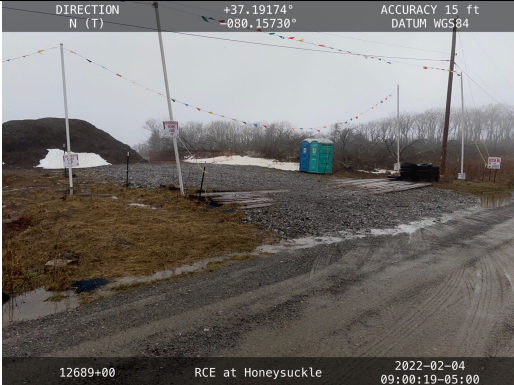
GPS Location	See photo for gps location data.		GPS Location	See photo for gps location data.	
Field Station#	12689+00		Field Station#	12702+00	
Pic 1 Desc.	Photo shows the RCE at Honeysuckle Road.		Pic 2 Desc.	Photo shows the ROW conditions. ECDs are installed and functioning as designed.

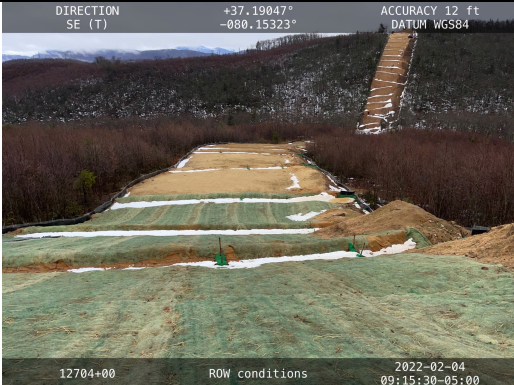
GPS Location	See photo for gps location data.		GPS Location	See photo for gps location data.	
Field Station#	12704+00		Field Station#	12706+00	
Pic 3 Desc.	Photo shows the ROW conditions. ECDs are installed and functioning as designed.		Pic 4 Desc.	Photo shows the water bar end treatment and sump pit. ECDs are installed and functioning as designed.

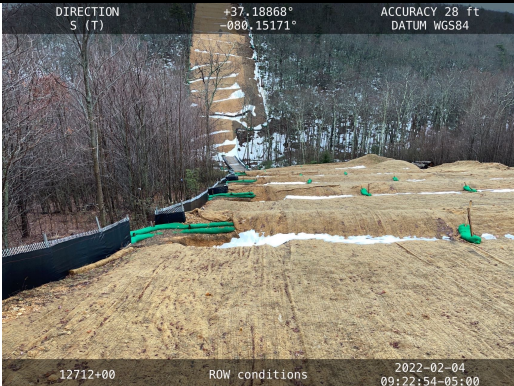
GPS Location	See photo for gps location data.		GPS Location	See photo for gps location data.	
Field Station#	12712+00		Field Station#	12715+00	
Pic 5 Desc.	Photo shows the ROW conditions. ECDs are installed and functioning as designed.		Pic 6 Desc.	Photo shows the bridge over streams S-Y13 and S-Y14. ECDs are installed and functioning as designed.

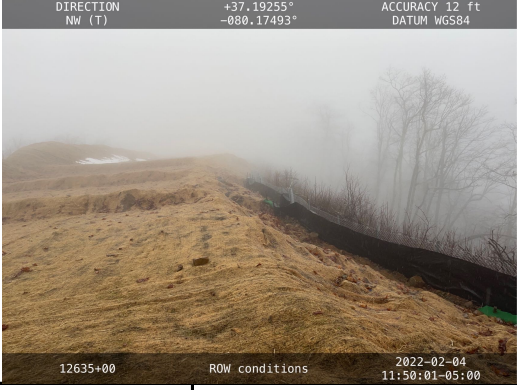
Pic 17 Desc.	Photo shows the ROW conditions. ECDs are installed and functioning as designed.		Pic 18 Desc.	Photo shows the ROW conditions. ECDs are installed and functioning as designed.

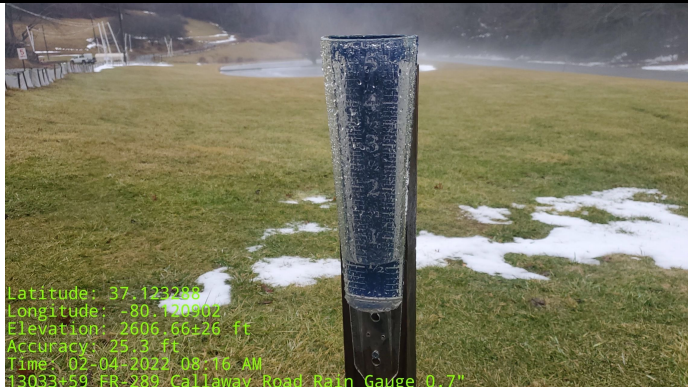
Latitude: 37.123286 Longitude: -80.120962 Elevation: 2606.66±26 ft Accuracy: 25.3 ft Time: 02-04-2022 08:16 AM 13033+59 BR-289 Callaway Road Rain Gauge 0.7"			Latitude: 37.125969 Longitude: -80.125209 Elevation: 2750.79±42 ft Accuracy: 34.1 ft Time: 02-04-2022 08:51 AM 13012+80 GAS of the BRP motorway		
GPS Location	See pic for GPS location.		GPS Location	See pic for GPS location.	
Field Station#	13033+59		Field Station#	13012+80	
Pic 1 Desc.	0.7" precipitation at Callaway Road.		Pic 2 Desc.	Current ROW conditions on the GAS of the BRP motorway.

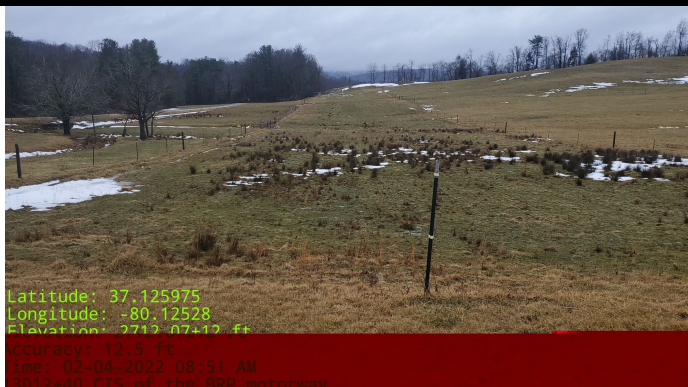
GPS Location	See pic for GPS location.		GPS Location	See pic for GPS location.	
Field Station#	13012+40		Field Station#	12994+50	
Pic 3 Desc.	Current ROW conditions on the CIS of the BRP motorway.		Pic 4 Desc.	Current ROW conditions on the GAS of the US-221 road crossing.

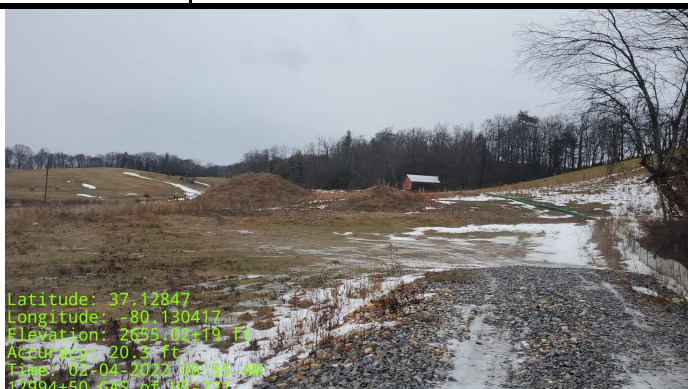
Latitude: 37.12847 Longitude: -80.130417 Elevation: 2659.04±19 ft Accuracy: 20.3 ft Time: 02-04-2022 08:55 AM 12994+50 GAS of the US-221			Latitude: 37.128499 Longitude: -80.130765 Elevation: 2642.65±8 ft Accuracy: 12.5 ft Time: 02-04-2022 08:56 AM 12994+50 CIS of the US-221		
GPS Location	See pic for GPS location.		GPS Location	See pic for GPS location.	
Field Station#	12994+50		Field Station#	12993+50	
Pic 5 Desc.	Current ROW conditions on the GAS of the US-221 road crossing.		Pic 6 Desc.	Current ROW conditions on the CIS of the US-221 road crossing.

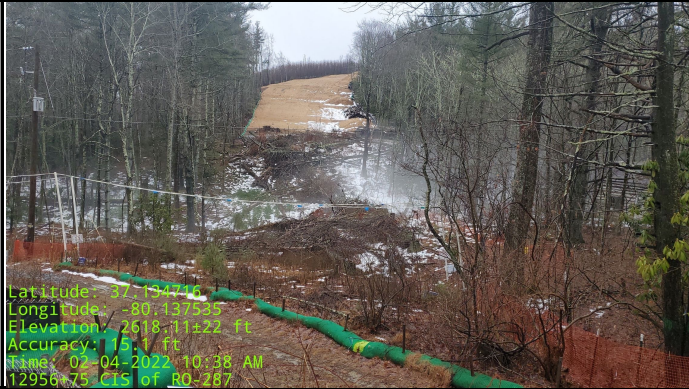
GPS Location	See pic for GPS location.		GPS Location	See pic for GPS location.	
Field Station#	12955+00		Field Station#	12956+75	
Pic 13 Desc.	Current ROW conditions on the CIS of RO-286.		Pic 14 Desc.	Current ROW conditions on the GAS of RO-286.

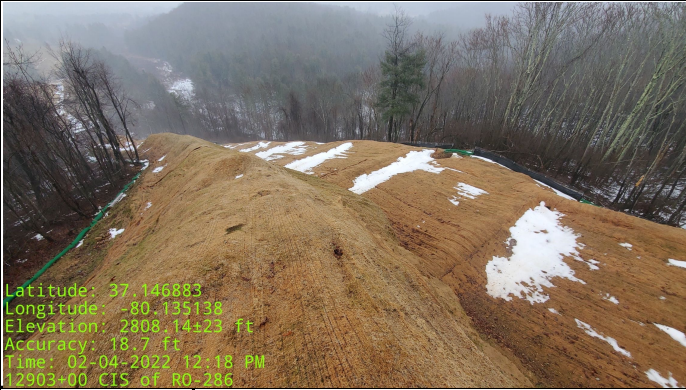
GPS Location	See pic for GPS location.		GPS Location	See pic for GPS location.	
Field Station#	12903+00		Field Station#	12920+00	
Pic 17 Desc.	Current ROW conditions on the CIS of RO-286.		Pic 18 Desc.	Current ROW conditions at stream crossing S-EF44.
