Visual Site Inspection Report

Project Name	H-600 Pipeline Spread H	AFE	124300138	Spread	H-600 Pipeline Spread H
Contractor	Precision			Report #	32479
Inspector	Tanner Cullop			Date/Time	12/20/2021 5:08 PM
Permit #	TBD	Inspection Type	VA SWPP	Station Begin	13316+21
State	VA	Inspection Area	Partial	Station End	13422+15
County	Franklin	Ground	Frozen	Temperature (°F)	31.00
Municipality	N/A	Weather	Sunny	Rain Gauge (in)	0.00
				Rain Accumulation Time (days)	0.00

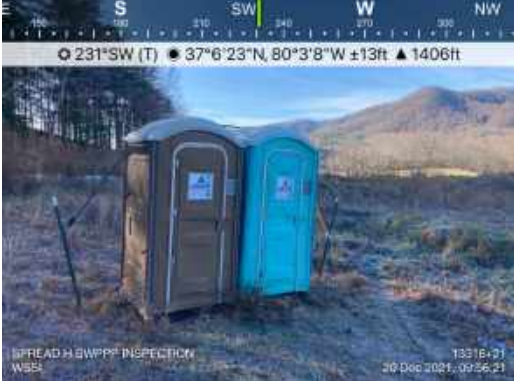
GPS Location	See photo above		GPS Location	See photo above	
Field Station#	13316+21		Field Station#	13316+21	
Pic 1 Desc.	Portable toilets are in good condition and there were no leaks observed.		Pic 2 Desc.	Construction entrance off of Wades Gap Rd. is in acceptable condition.

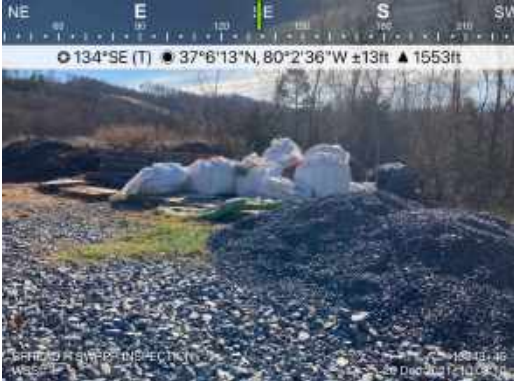
GPS Location	See photo above		GPS Location	See photo above	
Field Station#	13343+46		Field Station#	13341+50	
Pic 3 Desc.	On-site materials are stored properly. No maintenance needed.		Pic 4 Desc.	Erosion matting is in place and functioning properly.

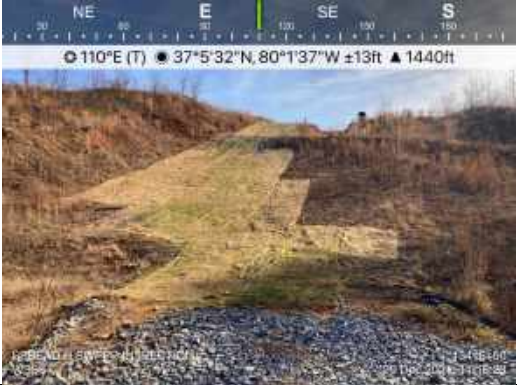
GPS Location	See photo above		GPS Location	See photo above	
Field Station#	13414+50		Field Station#	13416+50	
Pic 13 Desc.	Aquatic resource buffers are in place and functioning properly.		Pic 14 Desc.	Straw matting is in place and new vegetation has begun to establish.

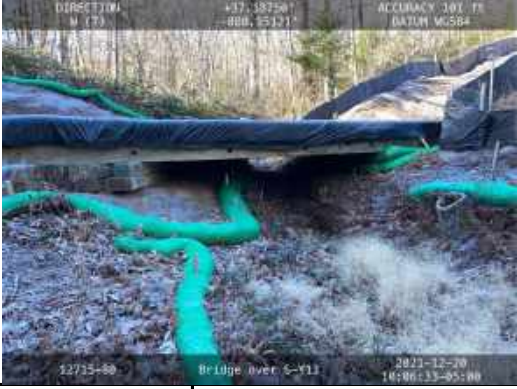
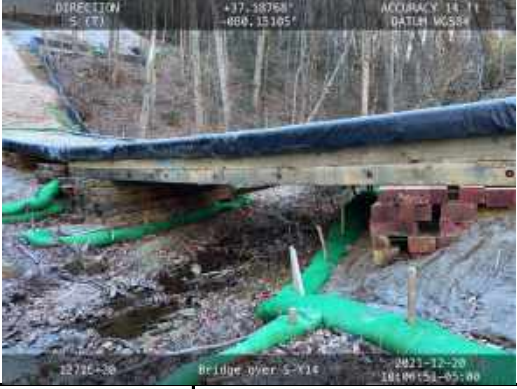
GPS Location	See photo for gps location data.		GPS Location	See photo for gps location data.	
Field Station#	12715+80		Field Station#	12716+20	
Pic 15 Desc.	Photo shows the bridge over stream S-Y13.		Pic 16 Desc.	Photo shows the bridge over stream S-Y14.

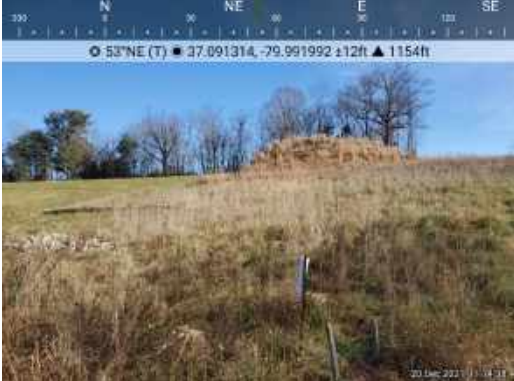
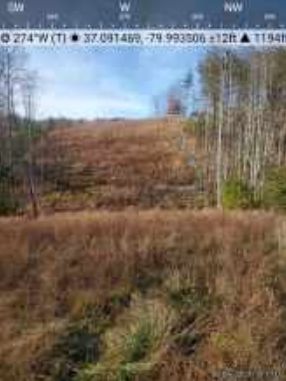
GPS Location	0	GPS Location	0		
Field Station#	13539+50	Field Station#	13536+00		
Pic 1 Desc.	GAS W-II8 Vegetation	Pic 2 Desc.	Permanent vegetation

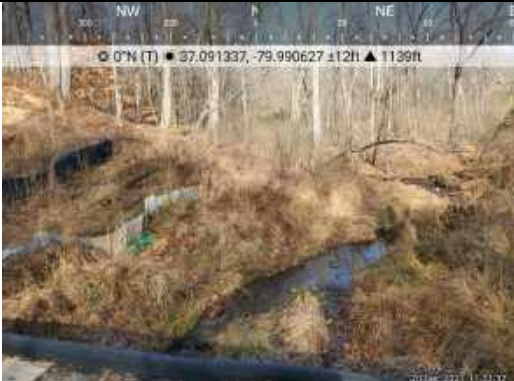
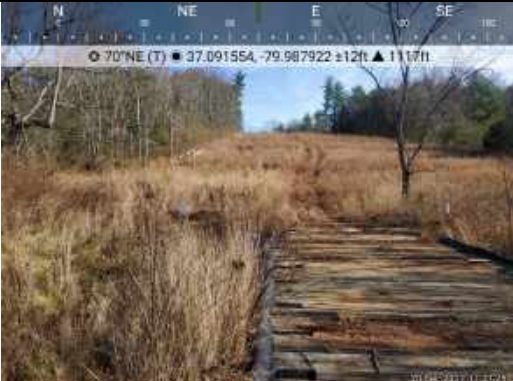
GPS Location	0	GPS Location	0		
Field Station#	13543+25	Field Station#	13551+50		
Pic 3 Desc.	S-II9 Banks and channel	Pic 4 Desc.	GAS S-II2 Permanent vegetation

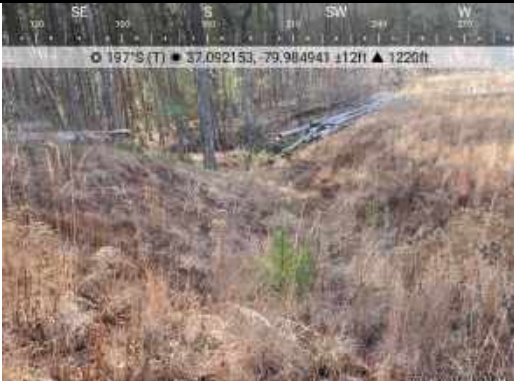
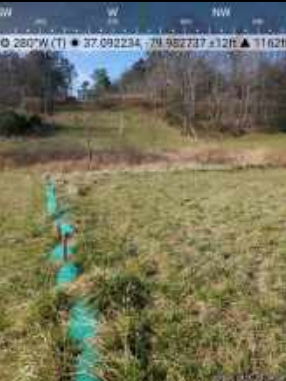
GPS Location	0	GPS Location	0		
Field Station#	13560+00	Field Station#	13568+00		
Pic 5 Desc.	CIS Bethlehem Rd Vegetation in swale	Pic 6 Desc.	GAS W-GH2 Perimeter CFS and vegetation

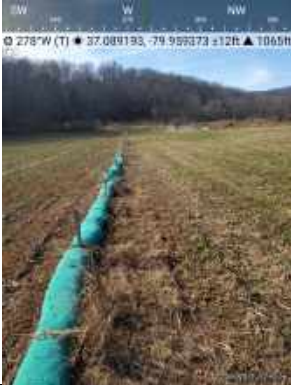
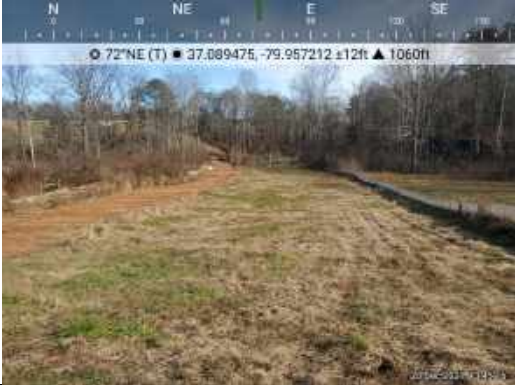
GPS Location	0	GPS Location	0		
Field Station#	13650+00	Field Station#	13656+00		
Pic 13 Desc.	GAS Leaning Oak Rd Perimeter CFS	Pic 14 Desc.	CIS S-GH4 Vegetation and perimeter silt fence		
Insert image here		Insert image here			
GPS Location		GPS Location			
Field Station#		Field Station#			
Pic 15 Desc.		Pic 16 Desc.			
Insert image here		Insert image here			
GPS Location		GPS Location			
Field Station#		Field Station#			
Pic 17 Desc.		Pic 18 Desc.

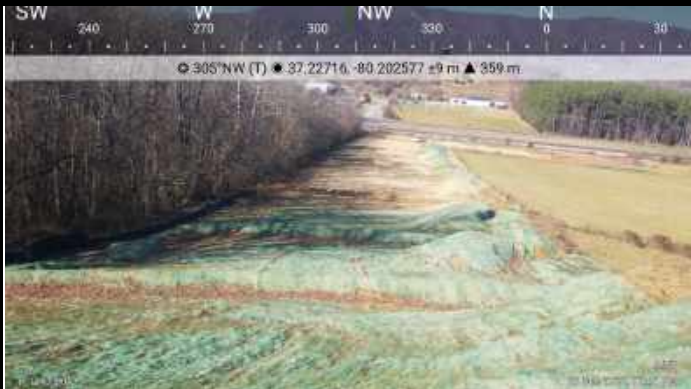
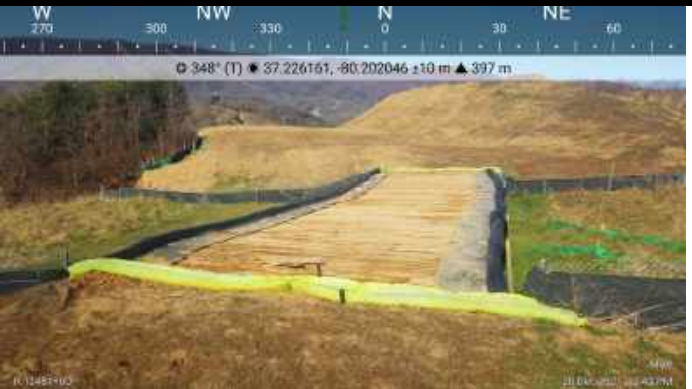
GPS Location	See Above		GPS Location	See Above	
Field Station#	12475+00		Field Station#	12481+00	
Pic 7 Desc.	(reroute stationing) ROW Overview (temporary stabilization). ECDs are functional and ROW is stable.		Pic 8 Desc.	(reroute stationing) ROW Overview (temporary stabilization). ECDs are functional and ROW is stable.

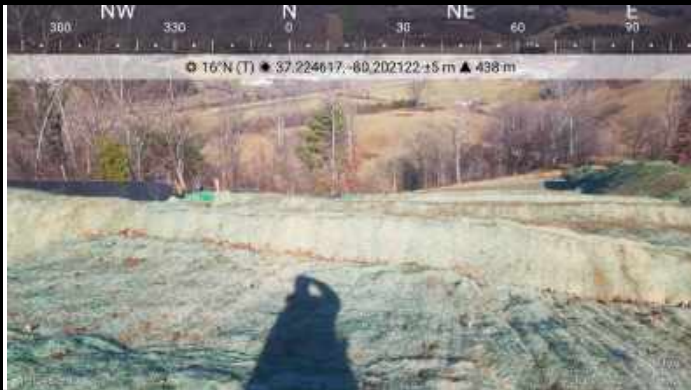
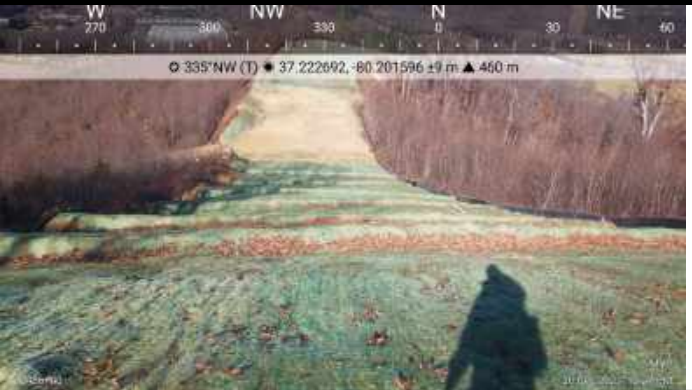
GPS Location	See Above		GPS Location	See Above	
Field Station#	12487+00		Field Station#	12486+00	
Pic 9 Desc.	(reroute stationing) ROW Overview (temporary stabilization). ECDs are functional and ROW is stable.		Pic 10 Desc.	ROW Overview (temporary stabilization). ECDs are functional and ROW is stable.

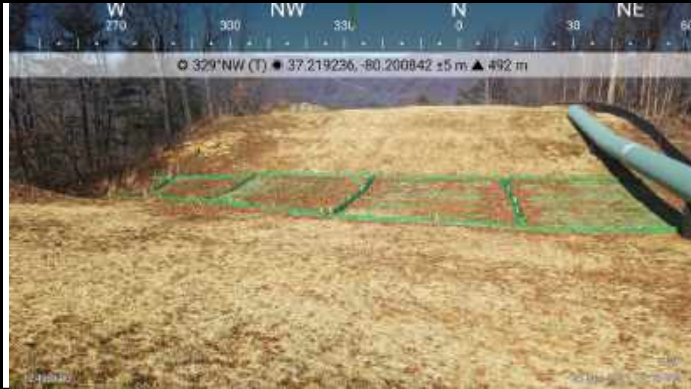
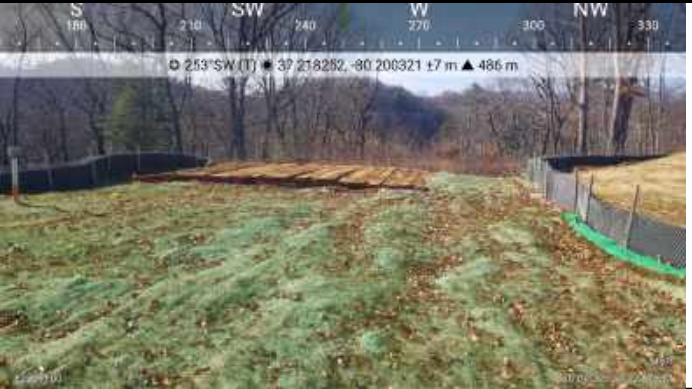
GPS Location	See Above		GPS Location	See Above	
Field Station#	12498+00		Field Station#	12501+00	
Pic 11 Desc.	ROW Overview (temporary stabilization). ECDs are functional and ROW is stable.		Pic 12 Desc.	ROW Overview (temporary stabilization). ECDs are functional and ROW is stable.

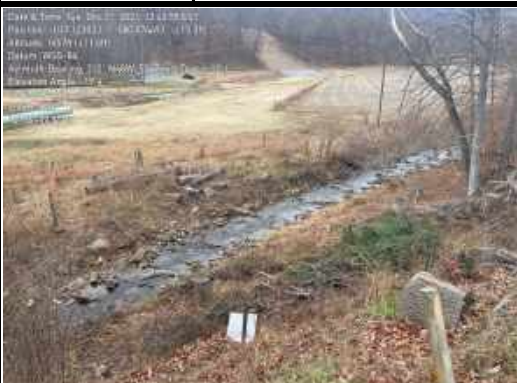
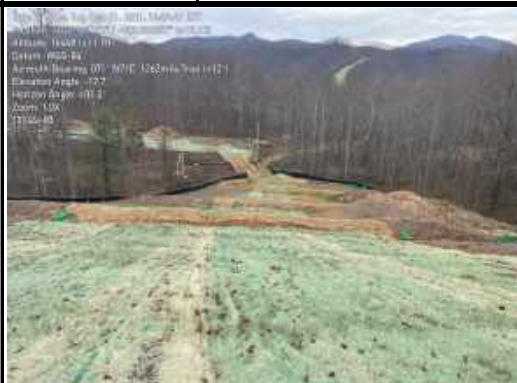
GPS Location	0		GPS Location	0	
Field Station#	13196+79		Field Station#	13144+00	
Pic 17 Desc.	MVP-S-D8 and Corresponding buffer zone In good condition		Pic 18 Desc.	ROW and ECDs In good condition and stable

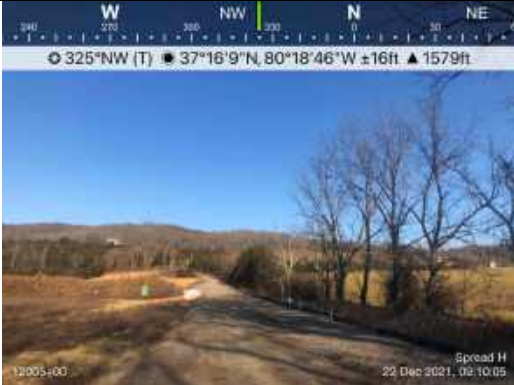
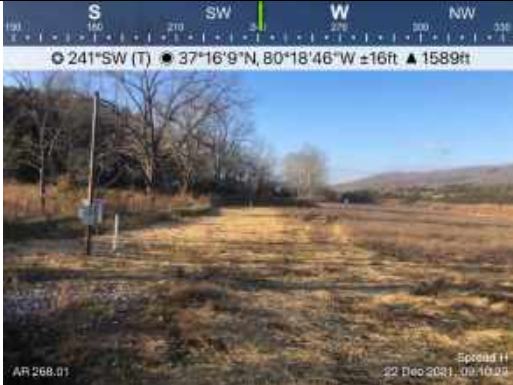
GPS Location	See photo above		GPS Location	See photo above	
Field Station#	12005+00		Field Station#	12007+50	
Pic 1 Desc.	AR-268 is well graveled and in good condition.		Pic 2 Desc.	Cleared section of the ROW is well maintained and erosion control measures are in place.

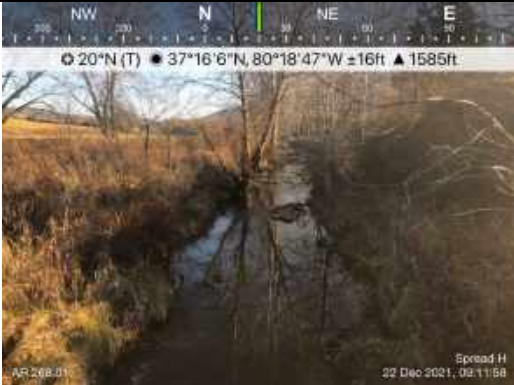
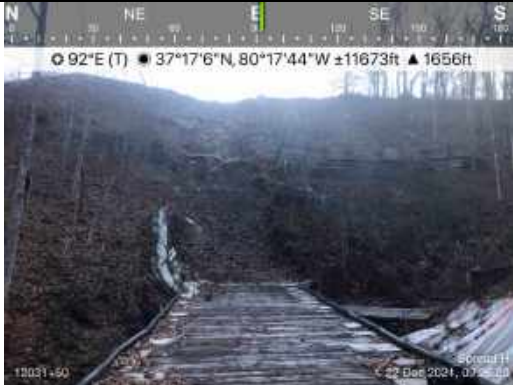
GPS Location	See photo above		GPS Location	See photo above	
Field Station#	12009+00		Field Station#	12031+50	
Pic 3 Desc.	Stream crossing located along the ROW is in acceptable condition. No maintenance is needed.		Pic 4 Desc.	Steep slopes are well maintained with waterbars and buffer zones.

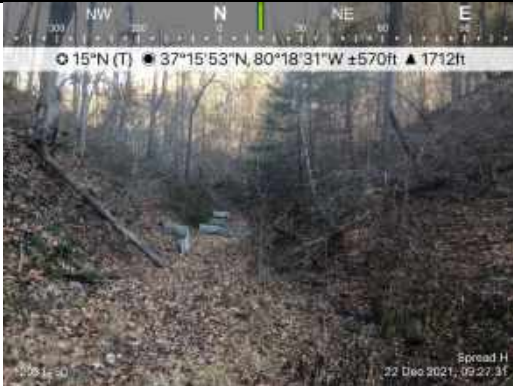
GPS Location	See photo above		GPS Location	See photo above	
Field Station#	12031+50		Field Station#	12031+50	
Pic 5 Desc.	SSF and perimeter controls are functioning properly and in good condition.		Pic 6 Desc.	PPL footpath is well marked, easily accessible, and in acceptable condition.

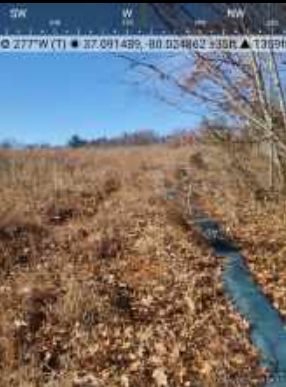
GPS Location	0	GPS Location	0		
Field Station#	13420+00	Field Station#	13423+00		
Pic 1 Desc.	CFS Checks and sump	Pic 2 Desc.	Perimeter CFS

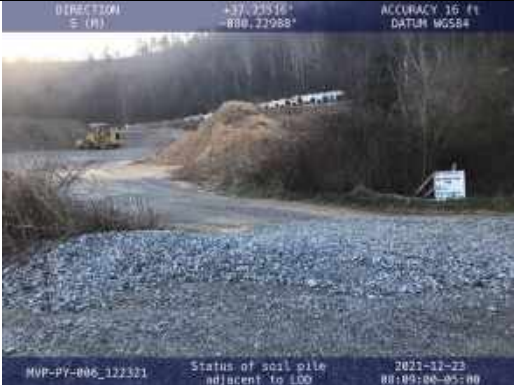
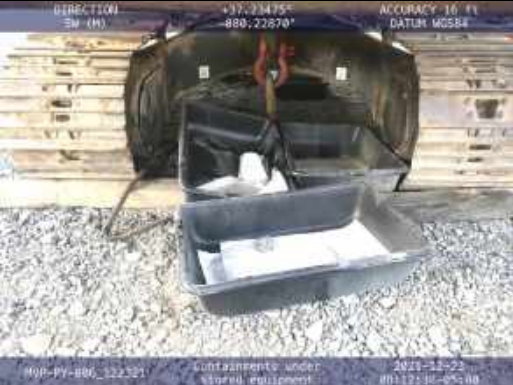
GPS Location	MVP-PY-006 See photo for gps data	GPS Location	MVP-PY-006 See photo for gps data		
Field Station#	+0	Field Station#	+0		
Pic 1 Desc.	Status of spoil pile adjacent to LOD. Soil pile not stabilized. Looking S.	Pic 2 Desc.	Secondary containments under stored equipment. Catching fluids. Looking SW.

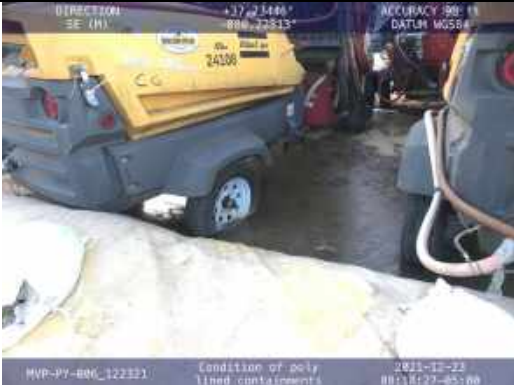
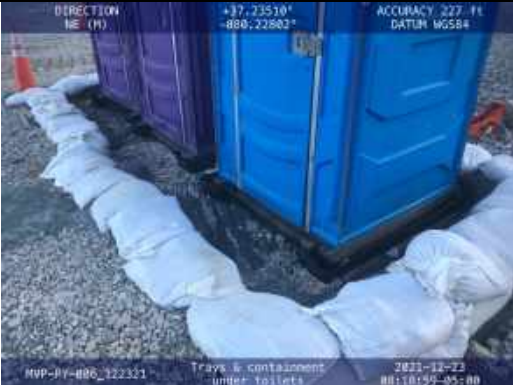
GPS Location	MVP-PY-006 See photo for gps data	GPS Location	MVP-PY-006 See photo for gps data		
Field Station#	+0	Field Station#	+0		
Pic 3 Desc.	Condition of poly lined rock berm containments holding stormwater and ice. Looking SE.	Pic 4 Desc.	Trays and containment under toilets. Trays free of fluids. Looking NE.

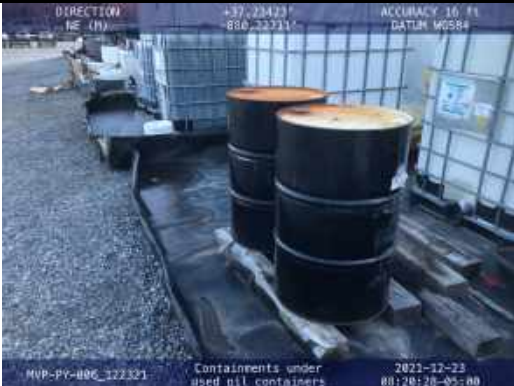
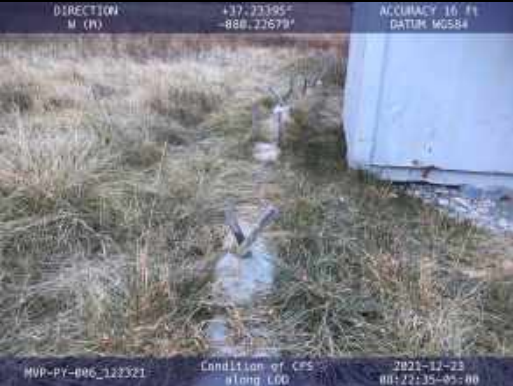
GPS Location	MVP-PY-006 See photo for gps data	GPS Location	MVP-PY-006 See photo for gps data		
Field Station#	+0	Field Station#	+0		
Pic 5 Desc.	Secondary containment under used oil containers. Holding stormwater and ice. Looking NE.	Pic 6 Desc.	Condition of triple stack compost filter sock along south LOD. Over grown with vegetation. Looking W.

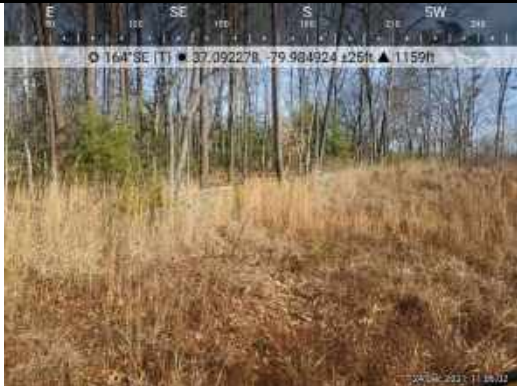
GPS Location	0	GPS Location	0		
Field Station#	13560+00	Field Station#	13541+00		
Pic 9 Desc.	Perimeter vegetation and CFS	Pic 10 Desc.	S-I17 Adjacent vegetation

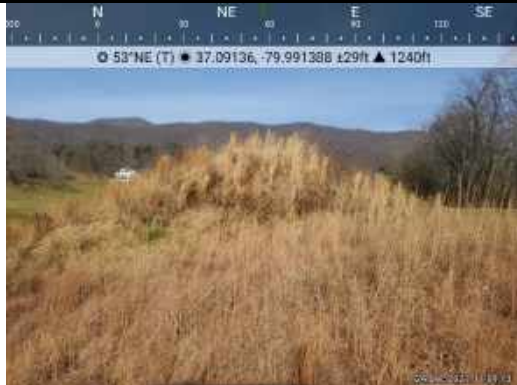
<p style="text-align: center;">Insert image here</p>			
GPS Location	0	GPS Location			
Field Station#	13541+00	Field Station#			
Pic 11 Desc.	Stockpile stabilization	Pic 12 Desc.

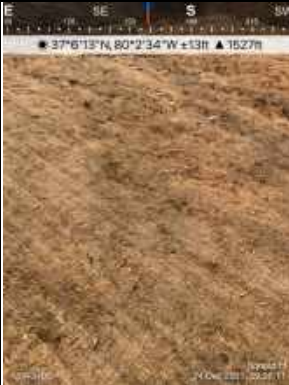
GPS Location	See Photograph		GPS Location	See Photograph	
Field Station#	13344+00		Field Station#	13422+00	
Pic 7 Desc.	EC blanket is in place and in acceptable condition. ROW is stable		Pic 8 Desc.	ATWS and construction entrance adjacent to Cahas road is in acceptable condition.

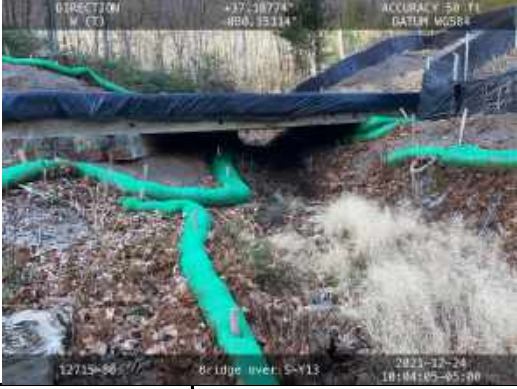
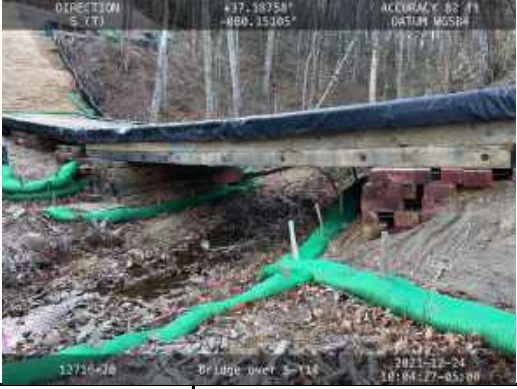
GPS Location	See photo for gps location data.		GPS Location	See photo for gps location data.	
Field Station#	12715+80		Field Station#	12716+20	
Pic 15 Desc.	Photo shows the bridge over stream S-Y13.		Pic 16 Desc.	Photo shows the bridge over stream S-Y14.
