# Visual Site Inspection Report

<b>Project Name</b>	H-600 Pipeline Spread H	<b>AFE</b>	124300138	<b>Spread</b>	H-600 Pipeline Spread H
<b>Contractor</b>	Precision			<b>Report #</b>	34647
<b>Inspector</b>	Bryan Cole			<b>Date/Time</b>	2/21/2022 2:16 PM
<b>Permit #</b>	TBD	<b>Inspection Type</b>	VA SWPP	<b>Station Begin</b>	13141+65
<b>State</b>	VA	<b>Inspection Area</b>	Partial	<b>Station End</b>	13316+21
<b>County</b>	Franklin	<b>Ground</b>	Damp	<b>Temperature (°F)</b>	59.00
<b>Municipality</b>	N/A	<b>Weather</b>	Sunny	<b>Rain Gauge (in)</b>	0.00
				<b>Rain Accumulation Time (days)</b>	0.00

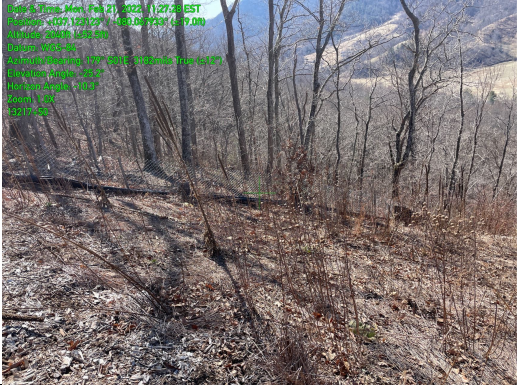
<b>GPS Location</b>	0	<b>GPS Location</b>	0		
<b>Field Station#</b>	13217+50	<b>Field Station#</b>	13203+50		
<b>Pic 13 Desc.</b>	Repair fence fabric - 72 hour maintenance item, repair completed, in good condition		<b>Pic 14 Desc.</b>	Slope drain pipe in good condition

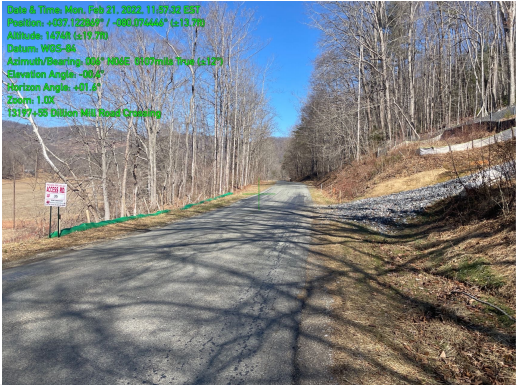
<b>GPS Location</b>	0	<b>GPS Location</b>	0		
<b>Field Station#</b>	13203+50	<b>Field Station#</b>	13197+55		
<b>Pic 15 Desc.</b>	ROW and ECDs in good condition and stable		<b>Pic 16 Desc.</b>	Dillion Mill Road Crossing in good condition

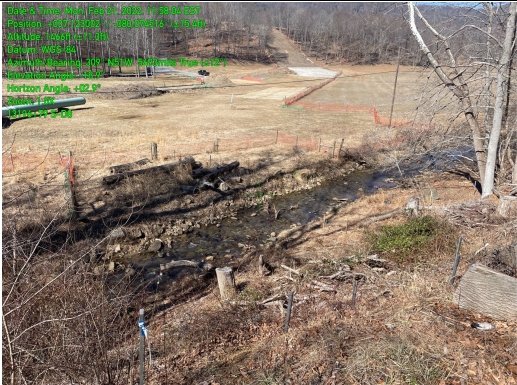
<b>GPS Location</b>	0	<b>GPS Location</b>	0		
<b>Field Station#</b>	13196+79	<b>Field Station#</b>	13165+00		
<b>Pic 17 Desc.</b>	MVP-S-D8 and corresponding buffer zone in good condition		<b>Pic 18 Desc.</b>	ROW and ECDs in good condition and stable

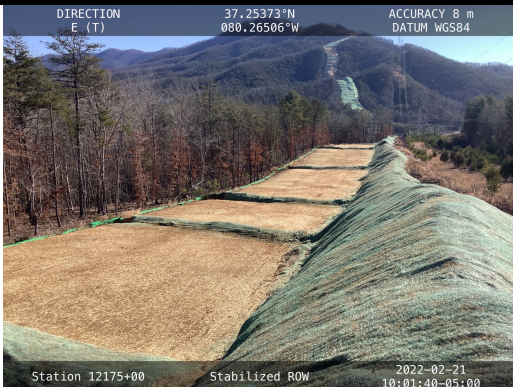
GPS Location	Please see photo for details.		GPS Location	Please see photo for details.	
Field Station#	12175+00		Field Station#	12169+00	
Pic 1 Desc.	Photo shows the stabilized ROW conditions with water bars and that all ECDs are installed and are functioning as designed.		Pic 2 Desc.	Slope drain inlet installed and functioning as designed.

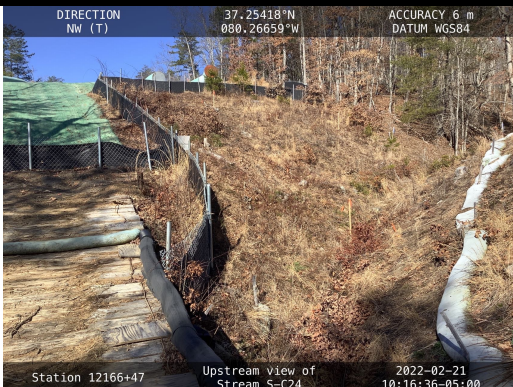
GPS Location	Please see photo for details.		GPS Location	Please see photo for details.	
Field Station#	12166+47		Field Station#	12159+70	
Pic 3 Desc.	Upstream view of Stream S-C24 from equipment bridge spanning channel.		Pic 4 Desc.	Plunge pool for slope drain. Installed and functioning as designed.

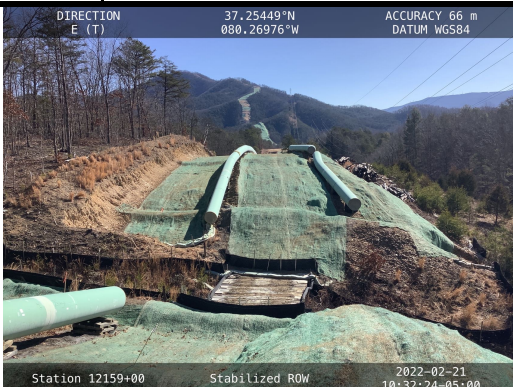
GPS Location	Please see photo for details.		GPS Location	Please see photo for details.	
Field Station#	12159+00		Field Station#	12153+28	
Pic 5 Desc.	Photo shows the stabilized ROW conditions with water bars and that all ECDs are installed and are functioning as designed.		Pic 6 Desc.	Photo shows MVP-MN-273 where it meets the ROW. Location of restrooms and P1 silt since installed around topsoil pile.

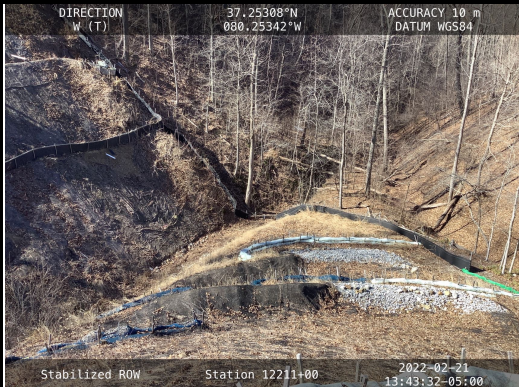
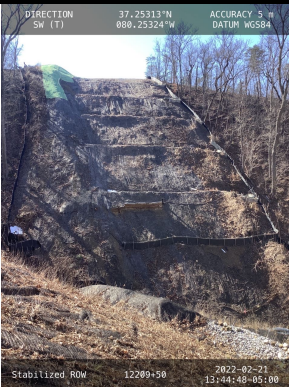
Insert image here	
GPS Location	Please see photo for details.		GPS Location	Please see photo for details.	
Field Station#	12211+00		Field Station#	12209+50	
Pic 13 Desc.	Photo shows the stabilized ROW conditions with permanent water bars with level spreaders that are functioning as designed.		Pic 14 Desc.	Photo shows the stabilized ROW conditions with water bars and that all ECDs are installed and are functioning as designed.

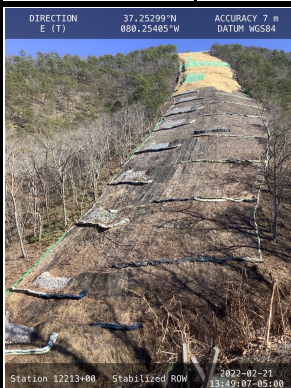
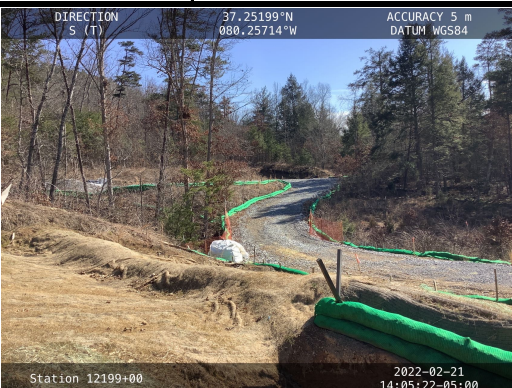
Insert image here	
GPS Location	Please see photo for details.		GPS Location	Please see photo for details.	
Field Station#	12213+00		Field Station#	12199+00	
Pic 15 Desc.	Photo shows the stabilized ROW conditions with water bars and that all ECDs are installed and are functioning as designed.		Pic 16 Desc.	Photo shows the stabilized ROW conditions with water bars and that all ECDs are installed and are functioning as designed.

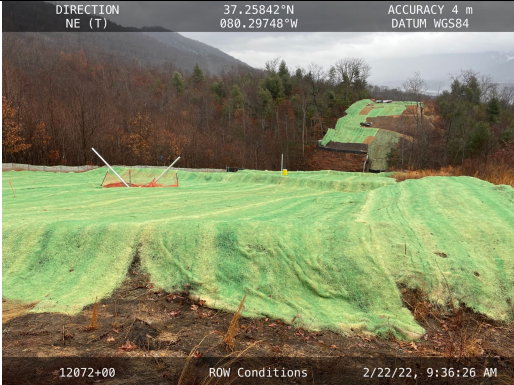
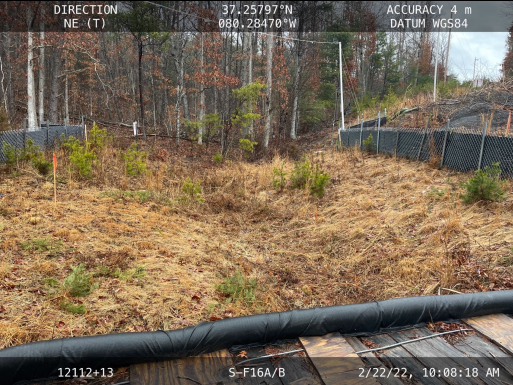
<b>GPS Location</b>	Please see photo for details.		<b>GPS Location</b>	Please see photo for details.	
<b>Field Station#</b>	12072+00		<b>Field Station#</b>	12112+13	
<b>Pic 1 Desc.</b>	Photo shows the stabilized ROW conditions with water bars and that all ECDs are installed and are functioning as designed.		<b>Pic 2 Desc.</b>	Photo shows Stream S-F16A/B from equipment bridge.

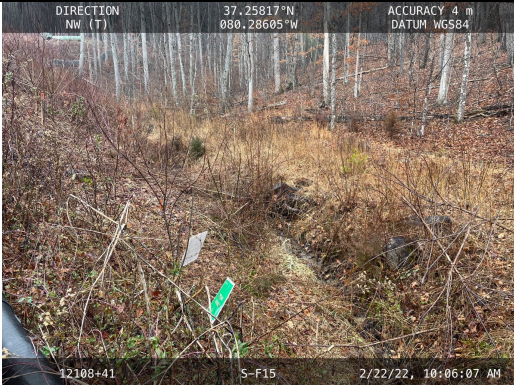
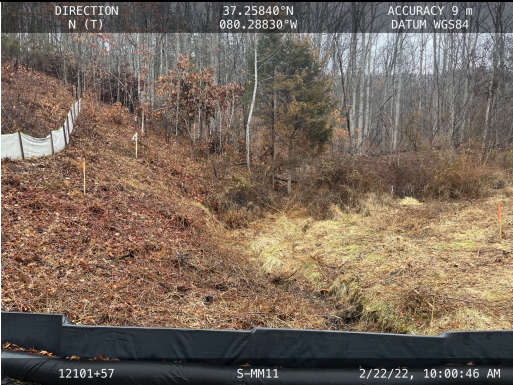
<b>GPS Location</b>	Please see photo for details.		<b>GPS Location</b>	Please see photo for details.	
<b>Field Station#</b>	12108+41		<b>Field Station#</b>	12101+57	
<b>Pic 3 Desc.</b>	Photo shows Stream S-F15 from equipment bridge.		<b>Pic 4 Desc.</b>	Photo shows Stream S-MM11 from equipment bridge.

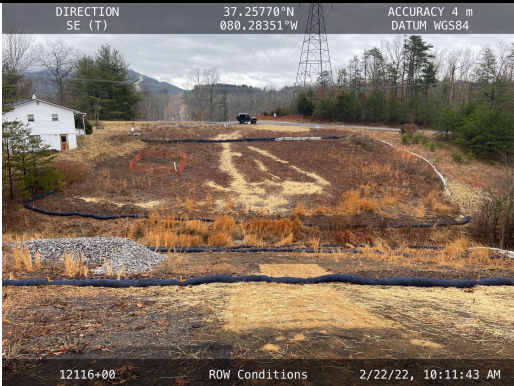
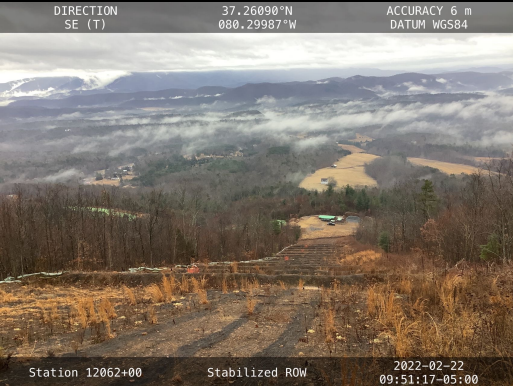
<b>Field Station#</b>	12116+00		<b>Field Station#</b>	12062+00	
<b>Pic 5 Desc.</b>	Photo shows stabilized ROW with permanent water bars and level spreaders.		<b>Pic 6 Desc.</b>	Photo shows the stabilized ROW conditions with water bars and that all ECDs are installed and are functioning as designed.

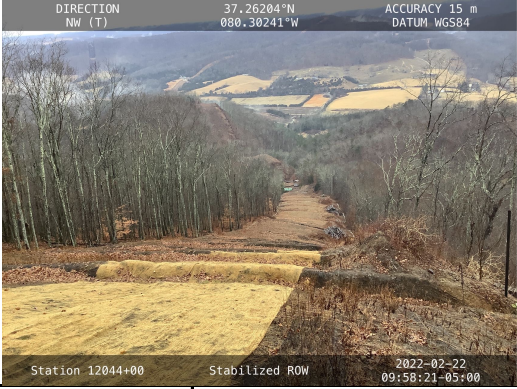
<p>DIRECTION NW (T) 37.26204°N 080.30241°W ACCURACY 15 m DATUM WGS84</p> <p>Station 12044+00 Stabilized ROW 2022-02-22 09:58:21-05:00</p>			
<b>GPS Location</b>	Please see photo for details.		<b>GPS Location</b>	Please see photo for details.	
<b>Field Station#</b>	12067+00		<b>Field Station#</b>	12044+00	
<b>Pic 7 Desc.</b>	Photo shows water bar, sump and end treatment.		<b>Pic 8 Desc.</b>	Photo shows the stabilized ROW conditions with water bars and that all ECDs are installed and are functioning as designed.

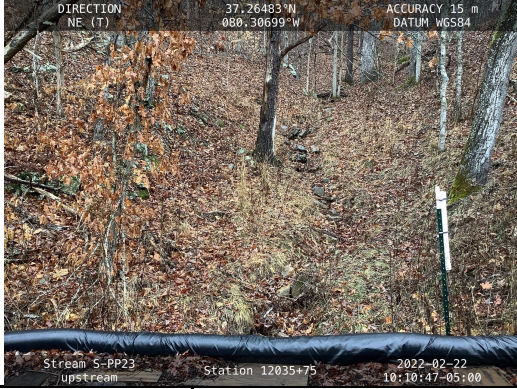
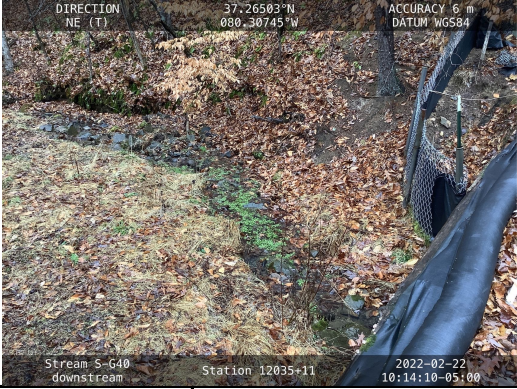
<b>GPS Location</b>	Please see photo for details.		<b>GPS Location</b>	Please see photo for details.	
<b>Field Station#</b>	12035+75		<b>Field Station#</b>	12035+11	
<b>Pic 9 Desc.</b>	Photo shows upstream of Stream S-PP23 from equipment bridge.		<b>Pic 10 Desc.</b>	Photo shows Stream S-G40 downstream from equipment bridge.

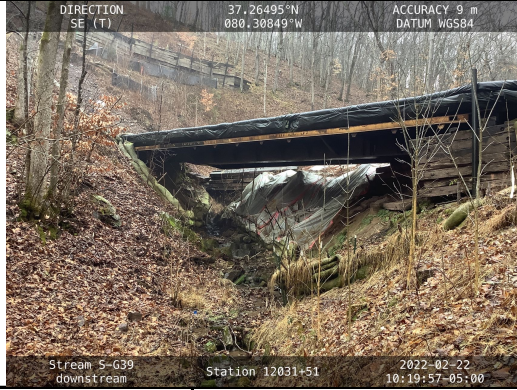
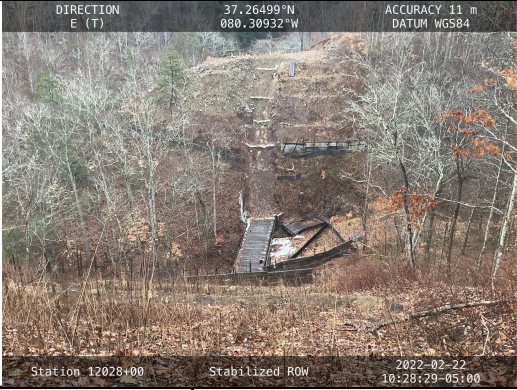
<p>DIRECTION E (T) 37.26499°N 080.30932°W ACCURACY 11 m DATUM WGS84</p> <p>Station 12028+00 Stabilized ROW 2022-02-22 10:28:29-05:00</p>			
<b>GPS Location</b>	Please see photo for details.		<b>GPS Location</b>	Please see photo for details.	
<b>Field Station#</b>	12031+51		<b>Field Station#</b>	12028+00	
<b>Pic 11 Desc.</b>	Photo shows down stream of Stream S-G39.		<b>Pic 12 Desc.</b>	Photo shows the stabilized ROW conditions with water bars and that all ECDs are installed and are functioning as designed.

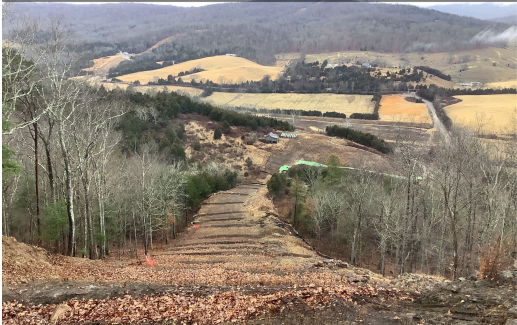
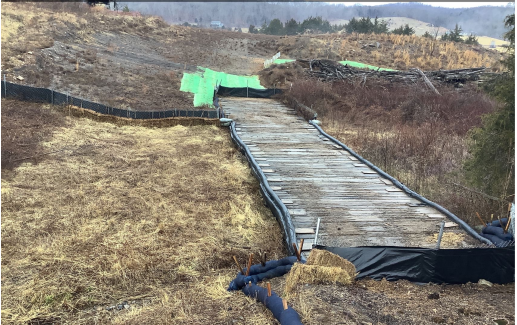
Stream S-G38 Station 12015+84 2022-02-22 10:46:04-05:00			
<b>GPS Location</b>	Please see photo for details.		<b>GPS Location</b>	Please see photo for details.	
<b>Field Station#</b>	12025+00		<b>Field Station#</b>	12015+84	
<b>Pic 13 Desc.</b>	Photo shows the stabilized ROW conditions with water bars and that all ECDs are installed and are functioning as designed.		<b>Pic 14 Desc.</b>	Photo shows Stream S-G38 location and maintenance of compost filter sock recently maintained.	
DIRECTION NE (T) 37.26747°N 080.31313°W ACCURACY 9 m DATUM WGS84

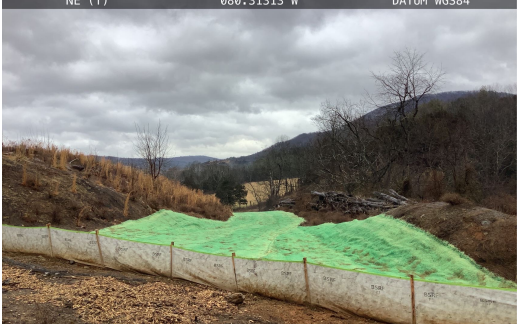
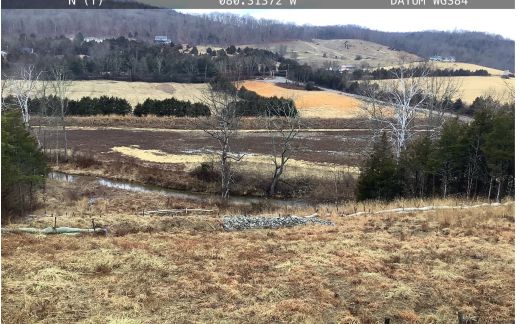
<b>GPS Location</b>	Please see photo for details.		<b>GPS Location</b>	Please see photo for details.	
<b>Field Station#</b>	12015+00		<b>Field Station#</b>	12012+00	
<b>Pic 15 Desc.</b>	Photo shows newly installed Erosion control blanket installed.		<b>Pic 16 Desc.</b>	Photo shows stabilized ROW with permanent water bars with level spreaders.	
DIRECTION NE (T) 37.26976°N 080.31311°W ACCURACY 136 m DATUM WGS84

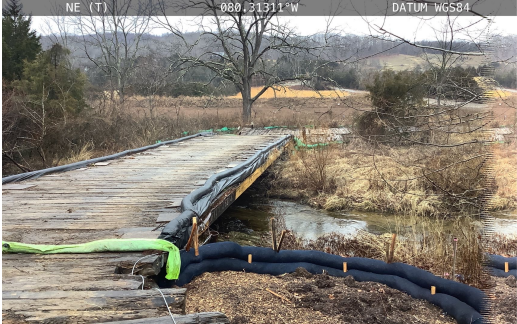
Station 12020+50 Downed SSF fabric 2022-02-22 10:39:42-05:00			
<b>GPS Location</b>	Please see photo for details.		<b>GPS Location</b>	Please see photo for details.	
<b>Field Station#</b>	12008+79		<b>Field Station#</b>	12020+50	
<b>Pic 17 Desc.</b>	Photo shows upstream of Stream S-G36 and the recent maintenance of compost filter sock on the going away side.		<b>Pic 18 Desc.</b>	Photo shows today's only punch list item of super silt fence fabric blown off of the chain link due to windy weather conditions.

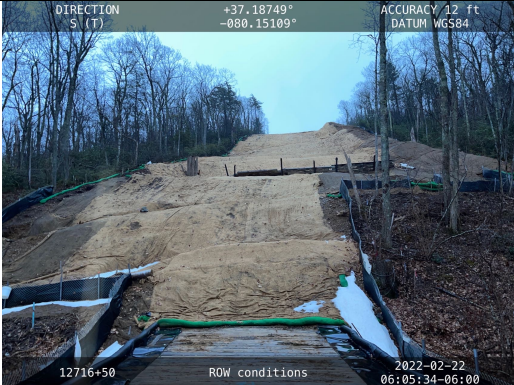
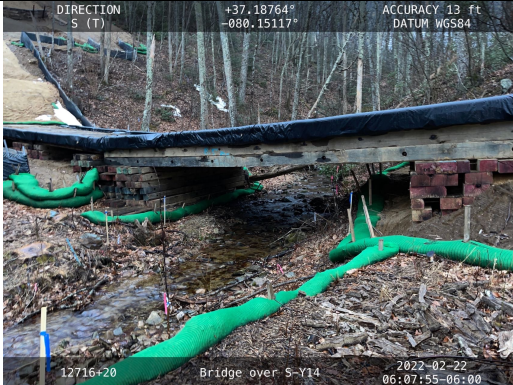
<b>GPS Location</b>	See photo for gps location data		<b>GPS Location</b>	See photo for gps location data	
<b>Field Station#</b>	12716+50		<b>Field Station#</b>	12716+20	
<b>Pic 1 Desc.</b>	Photo shows the ROW condition. ECDs are installed and functioning as designed.		<b>Pic 2 Desc.</b>	Photo shows the bridge over stream S-Y14.

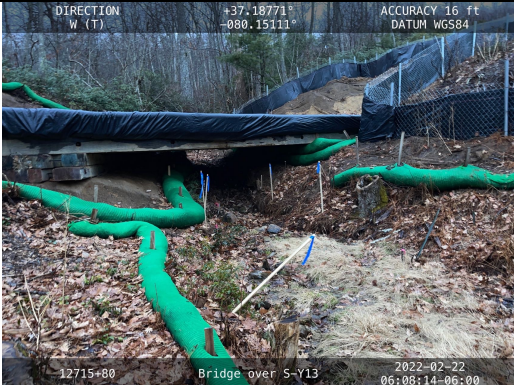
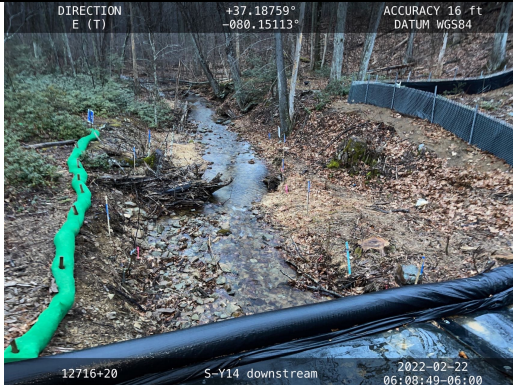
<b>GPS Location</b>	See photo for gps location data		<b>GPS Location</b>	See photo for gps location data	
<b>Field Station#</b>	12715+80		<b>Field Station#</b>	12716+20	
<b>Pic 3 Desc.</b>	Photo shows the bridge over stream S-Y13.		<b>Pic 4 Desc.</b>	Photo shows stream S-Y14 downstream from the bridge.

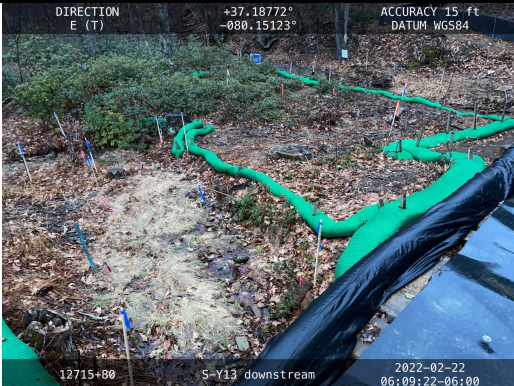
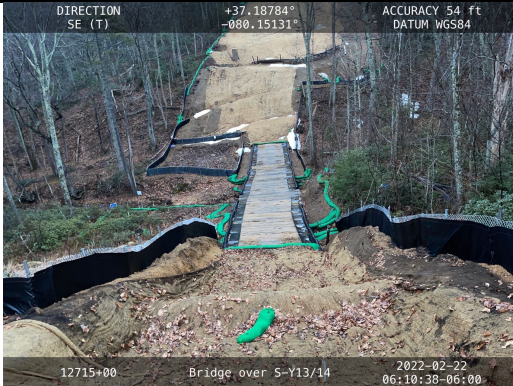
<b>Pic 5 Desc.</b>	Photo shows stream S-Y13 downstream from the bridge.		<b>Pic 6 Desc.</b>	Photo shows bridge over streams S-Y13 and S-Y14.

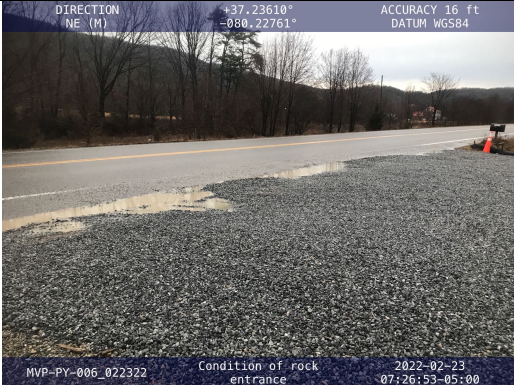
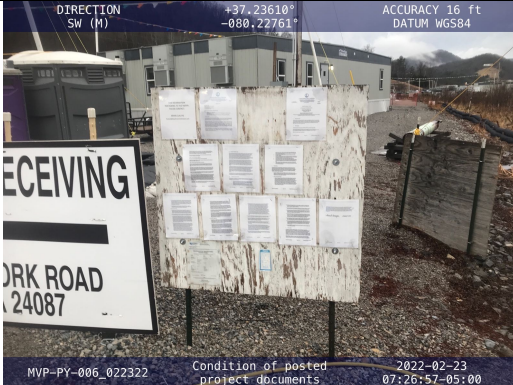
<b>GPS Location</b>	MVP-PY-006 See photo for gps data		<b>GPS Location</b>	MVP-PY-006 See photo for gps data	
<b>Field Station#</b>	+0		<b>Field Station#</b>	+0	
<b>Pic 1 Desc.</b>	Condition of rock entrance. No stone on public roadway. Looking NE.		<b>Pic 2 Desc.</b>	Condition of posted project documents at main entrance. Looking SW.

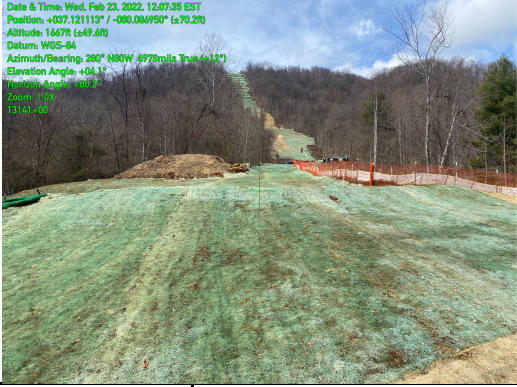
<b>GPS Location</b>	See pic for GPS location.		<b>GPS Location</b>	See pic for GPS location.	
<b>Field Station#</b>	13141+00		<b>Field Station#</b>	13138+50	
<b>Pic 13 Desc.</b>	Current ROW conditions on the CIS of FR-292.		<b>Pic 14 Desc.</b>	Downstream side of stream S-D17.

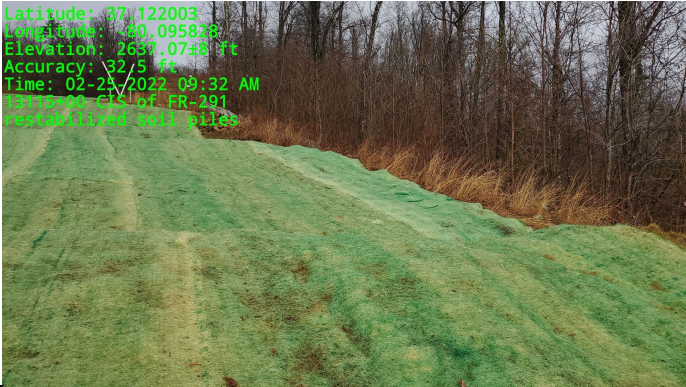
<p>Latitude: 37.122003  Longitude: -80.095828  Elevation: 2657.07±8 ft  Accuracy: 32.5 ft  Time: 02-23-2022 09:32 AM  13115+00 - CIS of FR-291  13115+00 Soil piles</p>

<b>GPS Location</b>	See pic for GPS location.		<b>GPS Location</b>	See pic for GPS location.	
<b>Field Station#</b>	13115+00		<b>Field Station#</b>	13115+00	
<b>Pic 15 Desc.</b>	Bare soils need stabilization, added to the punch list. Addressed 2/25/22		<b>Pic 16 Desc.</b>	Bare soils need stabilization, added to the punch list. Addressed 2/25/22	
<p>Date &amp; Time: Fri, Feb 25, 2022, 14:37:06 EST  Position: +037.121113° / -080.086950° (s=70.20)  Altitude: 1731ft (s=50.6ft)  Datum: WGS-84  Azimuth/Bearing: 190° S00W 3362mils True (s=127)  Elevation Angle: +07.2°  Horizontal Angle: +07.2°  Zoom: 1.0X  13137+50</p>

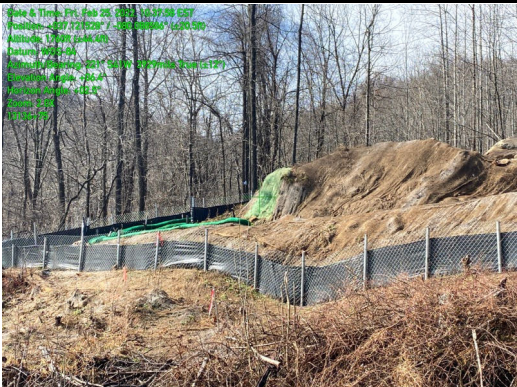
<b>GPS Location</b>	See pic for GPS location.		<b>GPS Location</b>	See pic for GPS location.	
<b>Field Station#</b>	13137+50		<b>Field Station#</b>	13137+78	
<b>Pic 17 Desc.</b>	Bare soils need stabilization, added to the punch list. Addressed 2/25/22		<b>Pic 18 Desc.</b>	Hole in CFS needs repair. Added to the punch list. Addressed 2/25/22

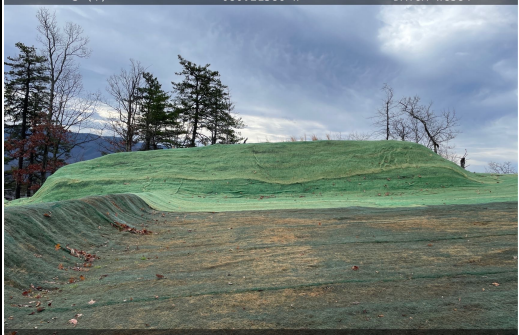
<div>12338+00      Full slope is stable      2/23/22, 10:15:17 AM</div> </div>				<div> <div>DIRECTION S (T)</div> <div>37.25272°N 080.21586°W</div> <div>ACCURACY 4 m DATUM WGS84</div>

GPS Location	Please see photo for details.		GPS Location	Please see photo for details.	
Field Station#	12338+00		Field Station#	12332+80	
Pic 15 Desc.	Photo shows slope fully stabilized with erosion control blanket.		Pic 16 Desc.	Photo shows the stabilized stock pile of subsoil on the side of the ROW.	
<div> <div>DIRECTION S (T)</div> <div>37.25106°N 080.21067°W</div> <div>ACCURACY 4 m DATUM WGS84</div>

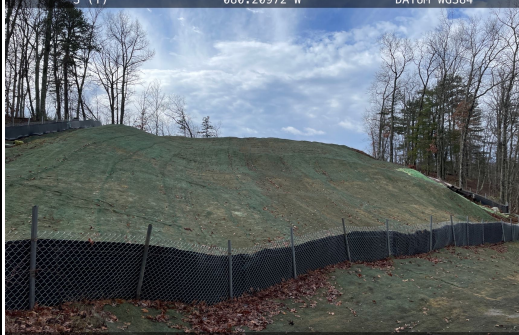
<div>12350+00      ROW Conditions      2/23/22, 10:20:42 AM</div> </div>				<div> <div>DIRECTION S (T)</div> <div>37.24818°N 080.20972°W</div> <div>ACCURACY 4 m DATUM WGS84</div>

<div>12360+5-0      ROW Conditions      2/23/22, 10:28:42 AM</div> </div>	
GPS Location	Please see photo for details.		GPS Location	Please see photo for details.	
Field Station#	12350+00		Field Station#	12360+50	
Pic 17 Desc.	Photo shows the stabilized ROW conditions with water bars and that all ECDs are installed and are functioning as designed.		Pic 18 Desc.	Photo shows the stabilized ROW conditions with water bars and that all ECDs are installed and are functioning as designed.

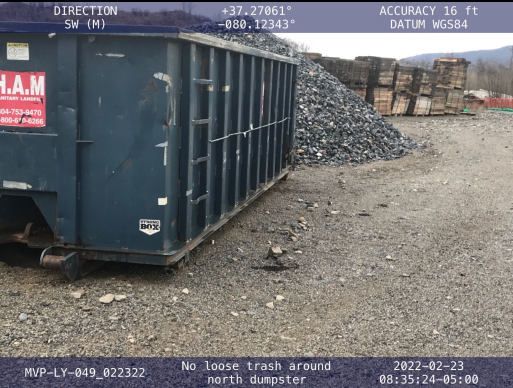
<p>DIRECTION W (M) +37.27049° -080.12335° ACCURACY 33 ft DATUM WGS84</p> <p>MVP-LY-049_022322 Condition of temporary trash tran_ 2022-02-23 08:35:11-05:00</p>

<p>DIRECTION SW (M) +37.27061° -080.12343° ACCURACY 16 ft DATUM WGS84</p> <p>MVP-LY-049_022322 No loose trash around north dumpster 2022-02-23 08:35:24-05:00</p>		<b>GPS Location</b> MVP-LY-049 See photo for gps data	
<b>Field Station#</b> +0		<b>Field Station#</b> +0		<b>Pic 5 Desc.</b> Condition of temporary trash transfer pit. Pit empty of debris. Looking W.

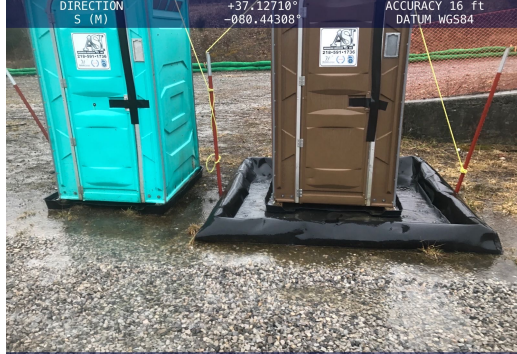
MVP-LY-071_022422 Trays & containment under toilets 2022-02-24 07:56:49-05:00		DIRECTION E (M) +37.12700° -080.44285° ACCURACY 16 ft DATUM WGS84   MVP-LY-071_022422 No loose trash around fenced dumpster area 2022-02-24 07:57:28-05:00			
<b>GPS Location</b>	MVP-LY-071 See photo for gps data		<b>GPS Location</b>	MVP-LY-071 See photo for gps data	
<b>Field Station#</b>	+0		<b>Field Station#</b>	+0	
<b>Pic 11 Desc.</b>	Trays and containment under toilets. Trays holding fluids. Looking S.		<b>Pic 12 Desc.</b>	No loose trash around fenced dumpster area. Looking E.

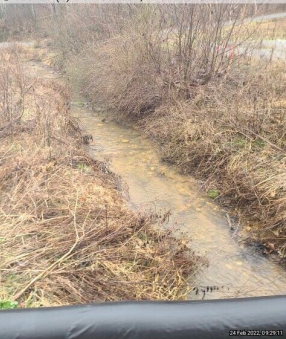
<b>A/E</b>	124300138	<b>Date/Time</b>	2/24/2022 4:07 PM	<b>Report #</b>	
<b>Pictures</b>					
	<b>North West Elevation</b> <small>158°SE (T) • 37.089087, -79.961398 ±3 m ▲ 326 m</small>

<b>GPS Location</b>	00000	<b>GPS Location</b>	00000		
<b>Field Station#</b>	13643+67	<b>Field Station#</b>	13643+67		
<b>Pic 1 Desc.</b>	Stream observation photo facing downstream during rain events, no environmental issues observed at the time of inspection.		<b>Pic 2 Desc.</b>	Stream observation photo facing upstream during rain events, no environmental issues observed at the time of inspection.	
	<b>South West Elevation</b> <small>78°NE (T) • 37.091277, -79.9911 ±3 m ▲ 357 m</small>

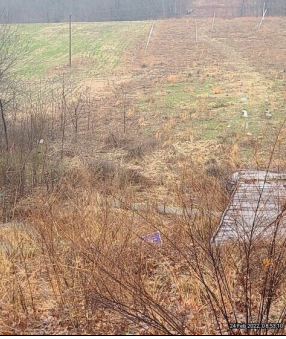
<b>Field Station#</b>	13541+72	<b>Field Station#</b>	13644+97		
<b>Pic 3 Desc.</b>	Traveled road crossings during rain events, monitoring row conditions, no environmental issues observed at the time of inspection.		<b>Pic 4 Desc.</b>	Photo showing saturated row conditions, good vegetation noted in the area with no environmental issues observed at the time of inspection.	
	<b>East Elevation</b> <small>260°W (T) • 37.091279, -79.991115 ±3 m ▲ 358 m</small>

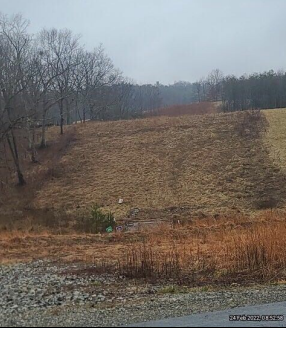
<b>GPS Location</b>	0000	<b>GPS Location</b>	00000		
<b>Field Station#</b>	13541+50	<b>Field Station#</b>	13575+11		
<b>Pic 5 Desc.</b>	Traveled road crossings during rain events, monitoring row conditions, no environmental issues observed at the time of inspection.		<b>Pic 6 Desc.</b>	Traveled road crossings during rain events, monitoring row conditions, no environmental issues observed at the time of inspection.

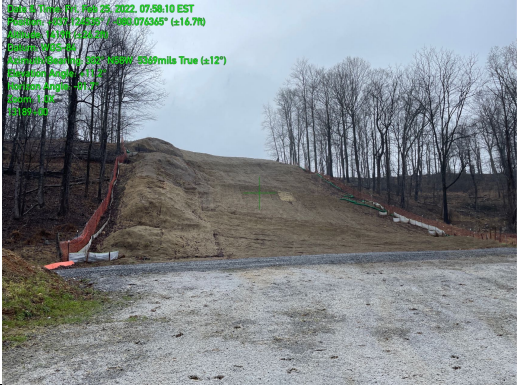
<b>GPS Location</b>	0	<b>GPS Location</b>	0		
<b>Field Station#</b>	13189+00	<b>Field Station#</b>	13193+00		
<b>Pic 7 Desc.</b>	ROW and ECDs In good condition and stable	<b>Pic 8 Desc.</b>	ROW and ECDs In good condition and stable		
<p>Date &amp; Time: Fri, Feb 25, 2022, 07:56:52 EST  Position: +437.123884° / -080.075775° (±15.59)  Altitude: 14418 (±11.110)  Datum: NAD83  Geoid Height: 14418.5597m True (±12")  Horizontal Accuracy: 1.00m  Vertical Accuracy: 1.00m  Scale: 1:00  13193+00</p>  		<p>Date &amp; Time: Fri, Feb 25, 2022, 08:00:00 EST  Position: +437.123884° / -080.075775° (±15.59)  Altitude: 14418 (±11.110)  Datum: NAD83  Geoid Height: 14418.5597m True (±12")  Horizontal Accuracy: 1.00m  Vertical Accuracy: 1.00m  Scale: 1:00  13196+79 S-D8</p>

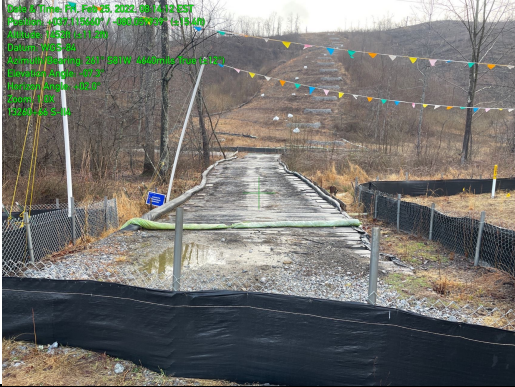
<b>GPS Location</b>	0	<b>GPS Location</b>	0		
<b>Field Station#</b>	13262+62	<b>Field Station#</b>	13260+66		
<b>Pic 13 Desc.</b>	Flanders Road Crossing in good condition	<b>Pic 14 Desc.</b>	MVP-S-II4 and corresponding buffer zone in good condition

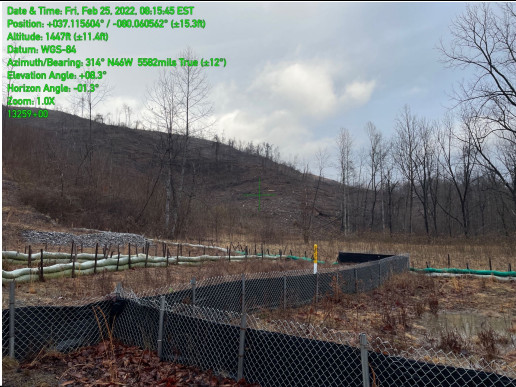
<b>GPS Location</b>	0	<b>GPS Location</b>	0		
<b>Field Station#</b>	13259+00	<b>Field Station#</b>	13314+00		
<b>Pic 17 Desc.</b>	Continuing to monitor logging activity adjacent to row, no issues observed after rain event	<b>Pic 18 Desc.</b>	ROW and ECDs In good condition and stable
