## Visual Site Inspection Report

<b>Project Name</b>	H-600 Pipeline Spread I	<b>AFE</b>	124300139	<b>Spread</b>	H-600 Pipeline Spread I
<b>Contractor</b>	Precision			<b>Report #</b>	33099
<b>Inspector</b>	Frank Craycroft			<b>Date/Time</b>	1/10/2022 2:26 PM
<b>Permit #</b>	TBD	<b>Inspection Type</b>	VA SWPP	<b>Station Begin</b>	14694+77
<b>State</b>	VA	<b>Inspection Area</b>	Full	<b>Station End</b>	14802+19
<b>County</b>	Franklin	<b>Ground</b>	Wet	<b>Temperature (°F)</b>	45.00
<b>Municipality</b>	N/A	<b>Weather</b>	Sunny	<b>Rain Gauge (in)</b>	0.50
				<b>Rain Accumulation Time (days)</b>	1.00

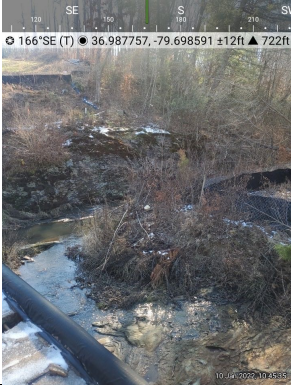
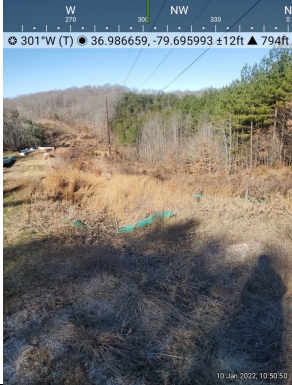
<b>GPS Location</b>	0	<b>GPS Location</b>	0		
<b>Field Station#</b>	14729+19	<b>Field Station#</b>	14740+00		
<b>Pic 7 Desc.</b>	S-A20 Channel	<b>Pic 8 Desc.</b>	Dry swale with CFS Checks

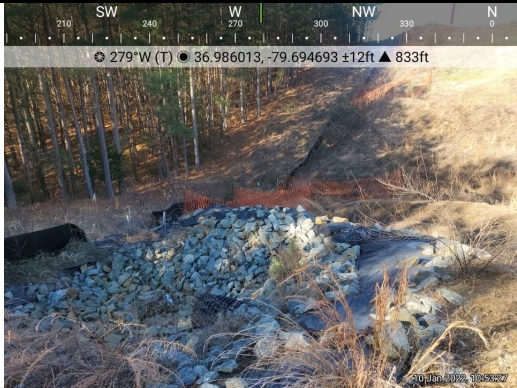
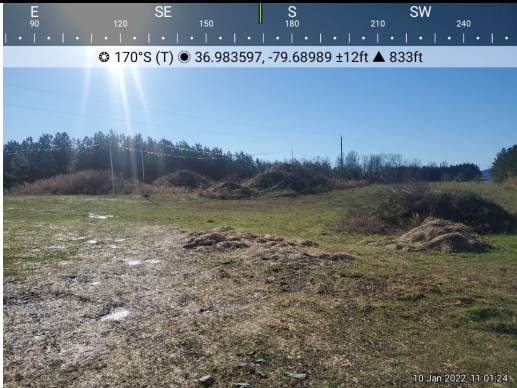
<b>GPS Location</b>	0	<b>GPS Location</b>	0		
<b>Field Station#</b>	14745+00	<b>Field Station#</b>	14760+00		
<b>Pic 9 Desc.</b>	Clean water diversion outlet	<b>Pic 10 Desc.</b>	GAS Indian Cave Rd vegetation

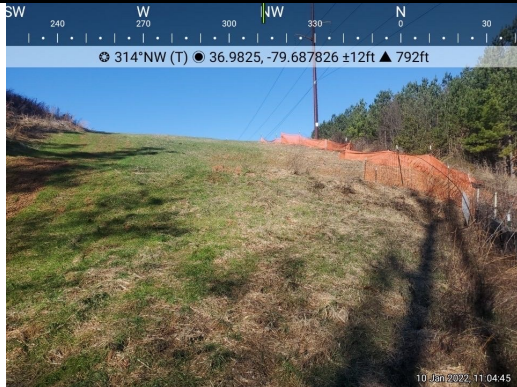
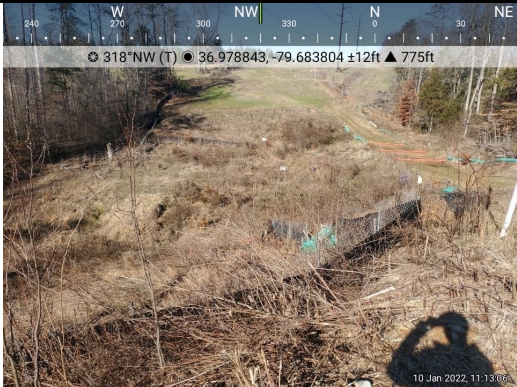
<b>GPS Location</b>	0	<b>GPS Location</b>	0		
<b>Field Station#</b>	14766+00	<b>Field Station#</b>	14783+00		
<b>Pic 11 Desc.</b>	CIS S-MM44 Vegetation	<b>Pic 12 Desc.</b>	GAS S-MM48 Buffer and ECDs

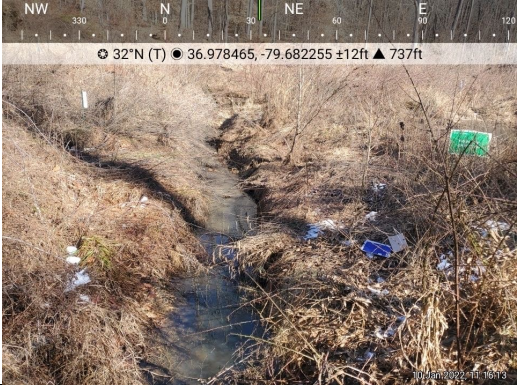
<b>GPS Location</b>	0	<b>GPS Location</b>			
<b>Field Station#</b>	14788+77	<b>Field Station#</b>			
<b>Pic 13 Desc.</b>	S-H25 Channel	<b>Pic 14 Desc.</b>			
Insert image here		Insert image here			
<b>GPS Location</b>		<b>GPS Location</b>			
<b>Field Station#</b>		<b>Field Station#</b>			
<b>Pic 15 Desc.</b>		<b>Pic 16 Desc.</b>			
Insert image here		Insert image here			
<b>GPS Location</b>		<b>GPS Location</b>			
<b>Field Station#</b>		<b>Field Station#</b>			
<b>Pic 17 Desc.</b>		<b>Pic 18 Desc.</b>

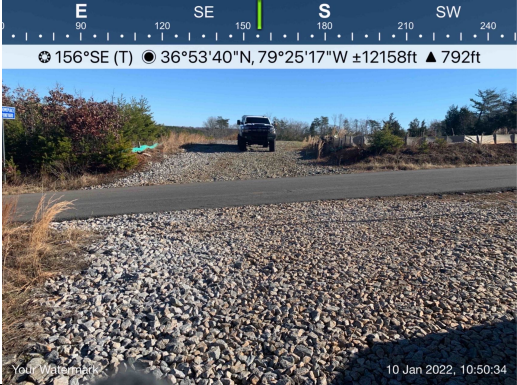
<p>GPS data: 156°SE (T) 36°53'40"N, 79°25'17"W ±12158ft ▲ 792ft</p> <p>10 Jan 2022, 10:50:34</p>		<p>Insert image here</p>			
<b>GPS Location</b>	O				
<b>Field Station#</b>	15619+48	<b>Field Station#</b>			
<b>Pic 7 Desc.</b>	Observing road crossing and RCE's	<b>Pic 8 Desc.</b>			
<p>Insert image here</p>		<p>Insert image here</p>			
<b>GPS Location</b>		<b>GPS Location</b>			
<b>Field Station#</b>		<b>Field Station#</b>			
<b>Pic 9 Desc.</b>		<b>Pic 10 Desc.</b>			
<p>Insert image here</p>		<p>Insert image here</p>			
<b>GPS Location</b>		<b>GPS Location</b>			
<b>Field Station#</b>		<b>Field Station#</b>			
<b>Pic 11 Desc.</b>		<b>Pic 12 Desc.</b>

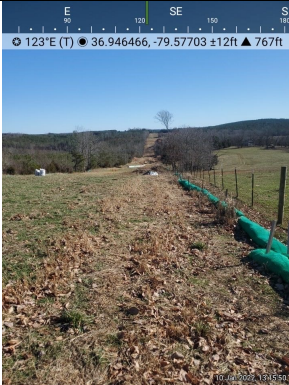
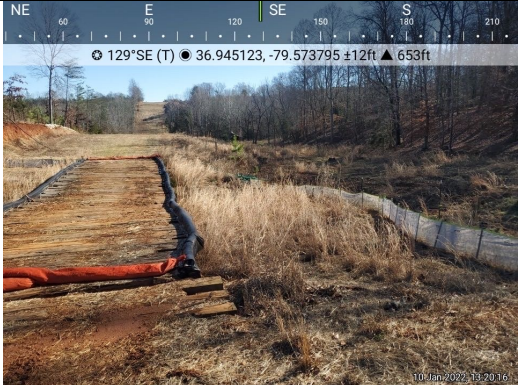
<b>GPS Location</b>	0	<b>GPS Location</b>	0		
<b>Field Station#</b>	15145+00	<b>Field Station#</b>	15160+00		
<b>Pic 1 Desc.</b>	CIS MVP-PI-326 Perimeter CFS	<b>Pic 2 Desc.</b>	Dry swale bridge and ECDs

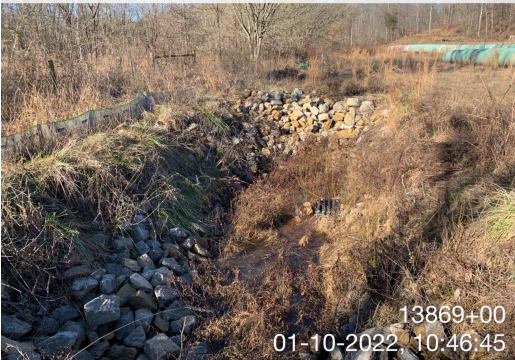
<b>GPS Location</b>	0	<b>GPS Location</b>	0		
<b>Field Station#</b>	13958+00	<b>Field Station#</b>	13869+00		
<b>Pic 3 Desc.</b>	Hole in P1 silt fence		<b>Pic 4 Desc.</b>	Clean water diversion pipe and plunge pool in acceptable conditions

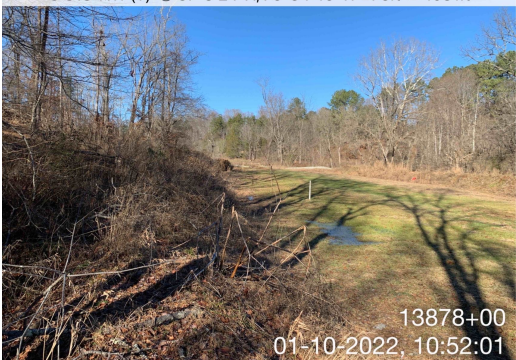
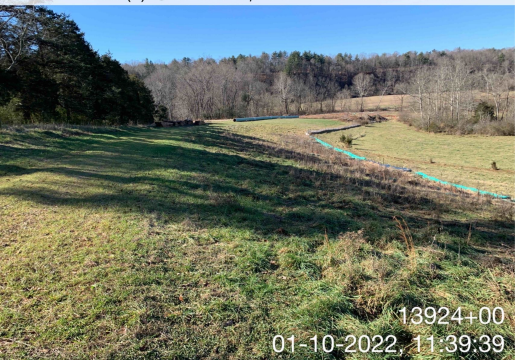
<b>GPS Location</b>	0	<b>GPS Location</b>	0		
<b>Field Station#</b>	13878+00	<b>Field Station#</b>	13924+00		
<b>Pic 5 Desc.</b>	Clean water diversion berm and temporary vegetative stabilization in acceptable conditions		<b>Pic 6 Desc.</b>	Permanent vegetative stabilization in acceptable condition

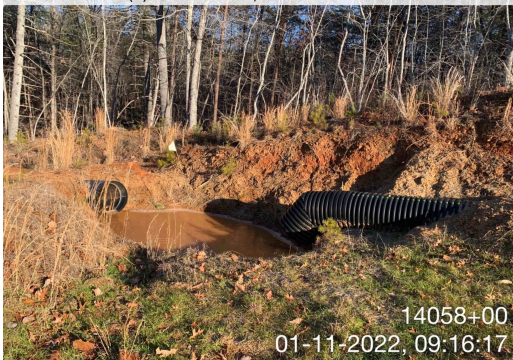
<b>GPS Location</b>	0	<b>GPS Location</b>	0		
<b>Field Station#</b>	14036+50	<b>Field Station#</b>	14058+00		
<b>Pic 5 Desc.</b>	P1 silt fence requiring maintenance (4 panels)	<b>Pic 6 Desc.</b>	Slope drain pipe and sump pit in acceptable conditions

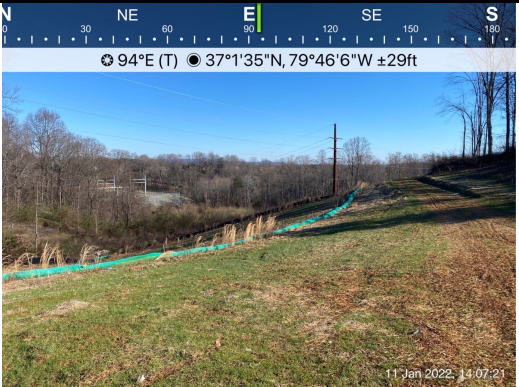
GPS Location	0		GPS Location	0	
Field Station#	14456+00		Field Station#	14529+00	
Pic 1 Desc.	Approximately 14456+00. Overview of ROW.		Pic 2 Desc.	Approximately 14529+00. Overview of ROW.

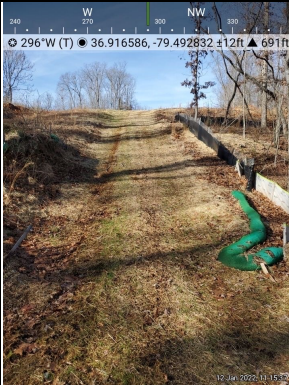
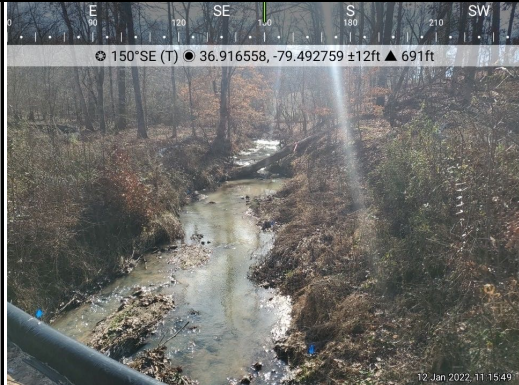
GPS Location	0	GPS Location	0		
Field Station#	15426+00	Field Station#	15426+50		
Pic 7 Desc.	CIS S-G4 Travel lane stabilization	Pic 8 Desc.	S-G4 Channel across centerline

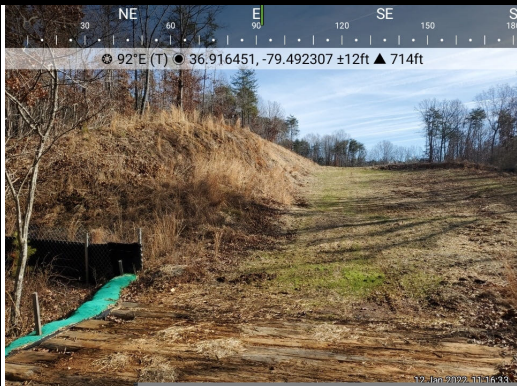
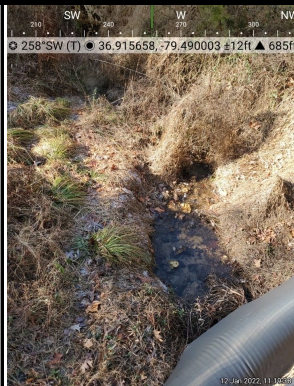
GPS Location	0	GPS Location	0		
Field Station#	15428+00	Field Station#	15447+70		
Pic 9 Desc.	GAS W-B3 Soil stockpile stabilization	Pic 10 Desc.	S-G3 Channel across centerline

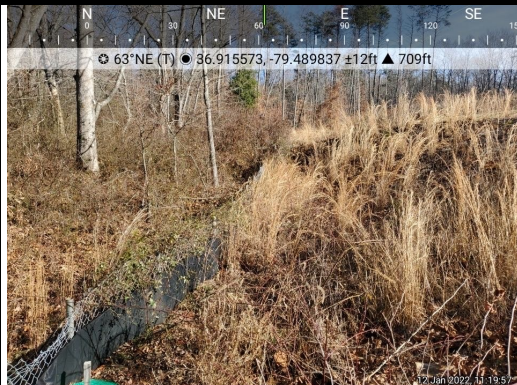
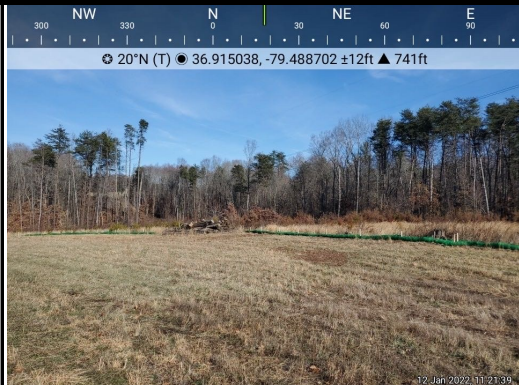
GPS Location	0	GPS Location	0		
Field Station#	15436+00	Field Station#	15440+00		
Pic 11 Desc.	GAS S-G3 ATWS Reinforced silt fence	Pic 12 Desc.	Vegetation and perimeter CFS

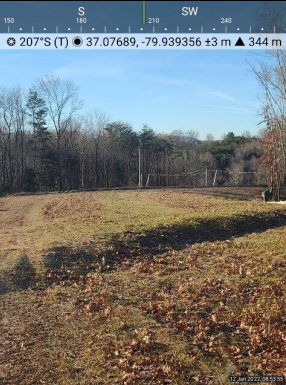
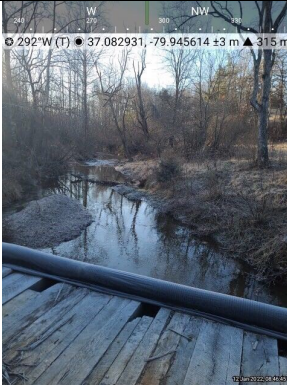
<b>GPS Location</b>	00000	<b>GPS Location</b>	00000		
<b>Field Station#</b>	13738+00	<b>Field Station#</b>	13704+90		
<b>Pic 1 Desc.</b>	Vegetation observation photo showing good coverage. No environmental issues observed at the time of inspection.		<b>Pic 2 Desc.</b>	Stream observation photo facing downstream during routine inspection today, no environmental issues observed at the time of inspection.

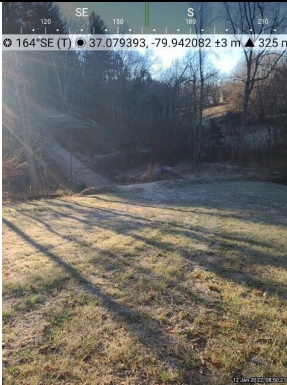
<b>GPS Location</b>	00000	<b>GPS Location</b>	00000		
<b>Field Station#</b>	13718+00	<b>Field Station#</b>	13727+40		
<b>Pic 3 Desc.</b>	Reinforced silt fence requires maintenance due to being weathered and torn, documented and added to the punch list for repair.		<b>Pic 4 Desc.</b>	Vegetation observation photo above stream crossing, good coverage observed, no environmental issues observed at the time of inspection.

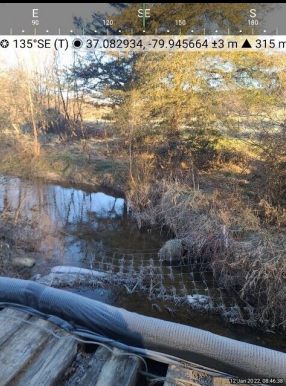
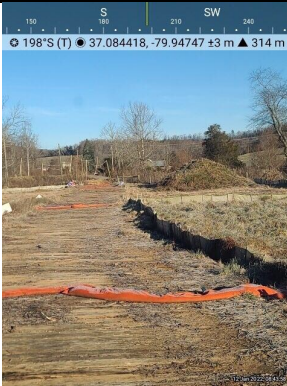
<b>GPS Location</b>	00000	<b>GPS Location</b>	00000		
<b>Field Station#</b>	13704+90	<b>Field Station#</b>	13696+20		
<b>Pic 5 Desc.</b>	Stream observation photo facing upstream during routine inspection today, no environmental issues observed at the time of inspection.		<b>Pic 6 Desc.</b>	Monitored ECDs along the row and wetland areas, no environmental issues observed at the time of inspection.

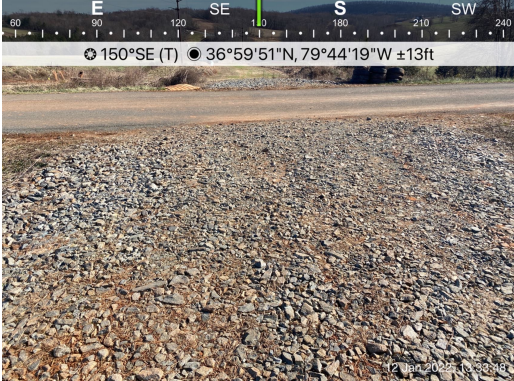
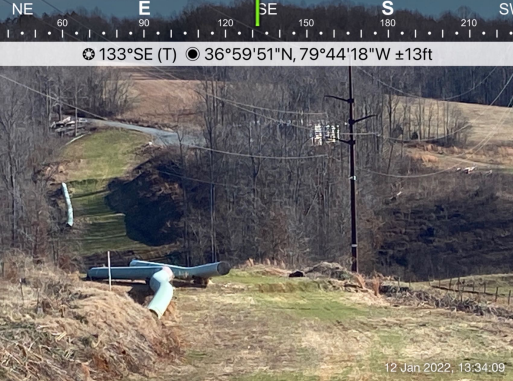
<b>GPS Location</b>	0	<b>GPS Location</b>	0		
<b>Field Station#</b>	14599+00	<b>Field Station#</b>	14604+00		
<b>Pic 1 Desc.</b>	Approximately 14599+00. Overview of road crossing and RCEs.		<b>Pic 2 Desc.</b>	Approximately 14604+00. Overview of ROW.

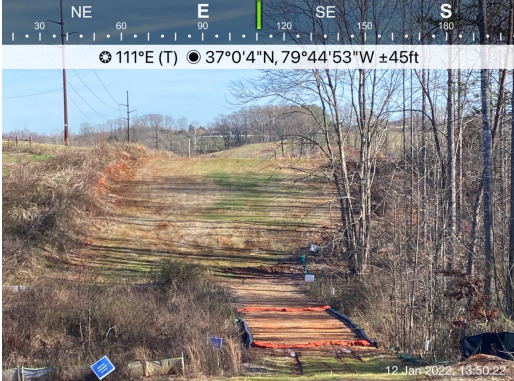
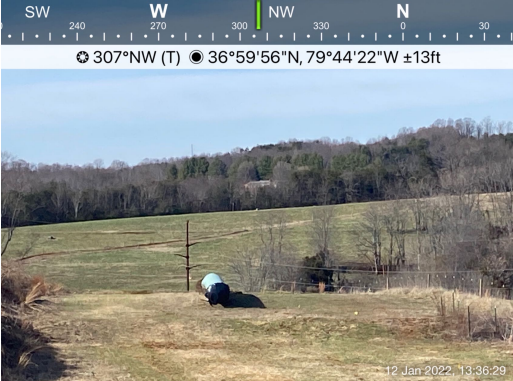
<b>GPS Location</b>	0	<b>GPS Location</b>	0		
<b>Field Station#</b>	14568+10	<b>Field Station#</b>	14591+00		
<b>Pic 3 Desc.</b>	Approximately 14568+10. Overview of stream crossing, equipment bridge and ECDs at stream S-E18.		<b>Pic 4 Desc.</b>	Approximately 14591+00. Overview of ROW.

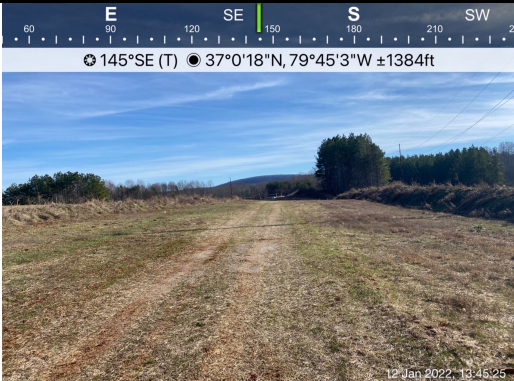
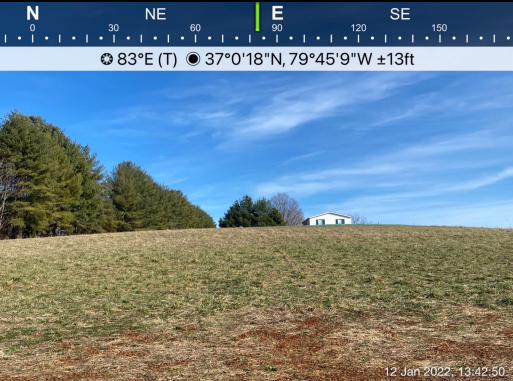
<b>GPS Location</b>	0	<b>GPS Location</b>	0		
<b>Field Station#</b>	14556+00	<b>Field Station#</b>	14548+00		
<b>Pic 5 Desc.</b>	Approximately 14556+00. Overview of ROW.		<b>Pic 6 Desc.</b>	Approximately 14548+00. Overview of ROW.

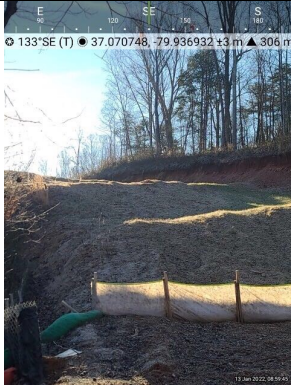
<b>GPS Location</b>	0000	<b>GPS Location</b>	0000		
<b>Field Station#</b>	13770+20	<b>Field Station#</b>	13770+70		
<b>Pic 1 Desc.</b>	Stream observation photo facing downstream during routine inspection today. No environmental issues observed at the time of inspection.		<b>Pic 2 Desc.</b>	Ecds in place , good stabilization on hill side above stream crossing, no environmental issues observed at the time of inspection.

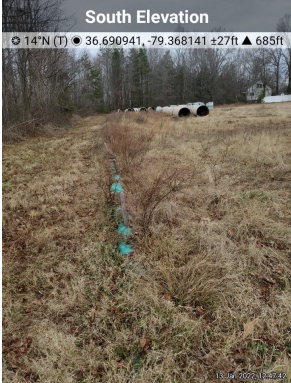
<b>GPS Location</b>	0	<b>GPS Location</b>	0		
<b>Field Station#</b>	0+00	<b>Field Station#</b>	0+00		
<b>Pic 7 Desc.</b>	LY-048 West perimeter CFS	<b>Pic 8 Desc.</b>	LY-048 Temporary vegetation		
Insert image here		Insert image here			
<b>GPS Location</b>		<b>GPS Location</b>			
<b>Field Station#</b>		<b>Field Station#</b>			
<b>Pic 9 Desc.</b>		<b>Pic 10 Desc.</b>			
Insert image here		Insert image here			
<b>GPS Location</b>		<b>GPS Location</b>			
<b>Field Station#</b>		<b>Field Station#</b>			
<b>Pic 11 Desc.</b>		<b>Pic 12 Desc.</b>

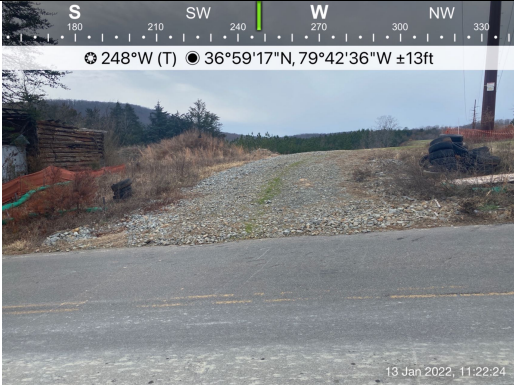
<b>GPS Location</b>	0	<b>GPS Location</b>	0		
<b>Field Station#</b>	14694+75	<b>Field Station#</b>	14689+36		
<b>Pic 1 Desc.</b>	Approximately 14694+75. Overview of road crossing and RCE.		<b>Pic 2 Desc.</b>	Approximately 14689+36. Overview of stream crossing, equipment bridge and ECDs at stream S-H34.

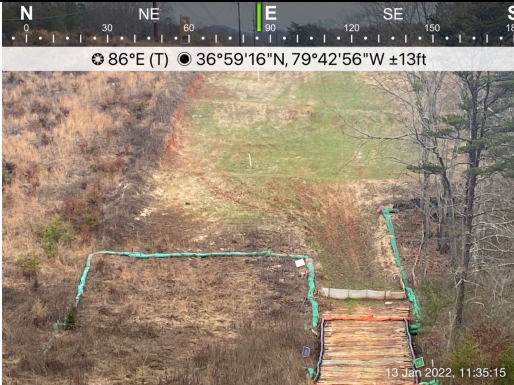
<b>GPS Location</b>	0	<b>GPS Location</b>	0		
<b>Field Station#</b>	14680+30	<b>Field Station#</b>	14673+10		
<b>Pic 3 Desc.</b>	Approximately 14680+30. Overview of stream crossing, equipment bridge and ECDs at stream S-H36.		<b>Pic 4 Desc.</b>	Approximately 14673+10. Overview of stream crossing, equipment bridge and ECDs at stream S-H37.

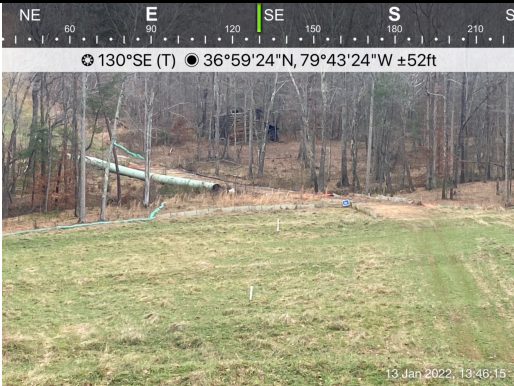
<b>GPS Location</b>	0	<b>GPS Location</b>	0		
<b>Field Station#</b>	14656+00	<b>Field Station#</b>	14651+00		
<b>Pic 5 Desc.</b>	Approximately 14656+00. Overview of ROW.		<b>Pic 6 Desc.</b>	Approximately 14651+00. Observed third party/landowner using agricultural equipment to drag and carry downed timber uphill on ROW in order to cut into firewood. Will.

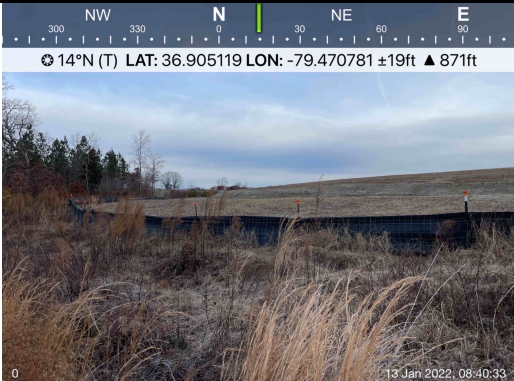
<b>GPS Location</b>	See photo		<b>GPS Location</b>	See photo	
<b>Field Station#</b>	15510+00		<b>Field Station#</b>	15515+00	
<b>Pic 5 Desc.</b>	3rd party ECDs appear to be in good condition.		<b>Pic 6 Desc.</b>	CWDs are functioning as intended.

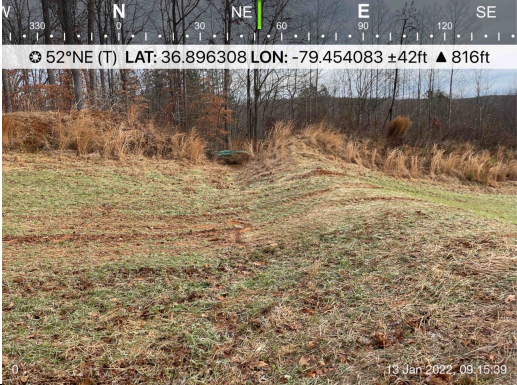
<b>GPS Location</b>	See photo	<b>GPS Location</b>	See photo		
<b>Field Station#</b>	15570+00	<b>Field Station#</b>	15575+00		
<b>Pic 13 Desc.</b>	Waterbars are in good condition and functioning.	<b>Pic 14 Desc.</b>	Slope drain is in good condition and functioning

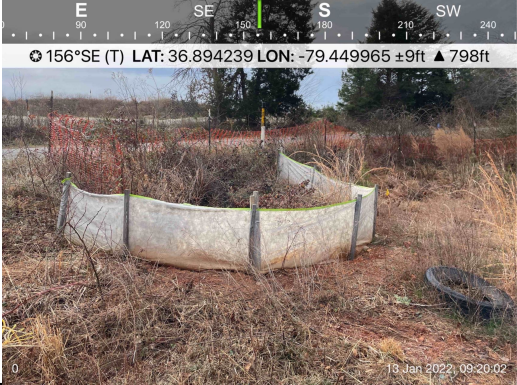
<p style="text-align: center;">Insert image here</p>			
<b>GPS Location</b>	See photo	<b>GPS Location</b>			
<b>Field Station#</b>	15584+00	<b>Field Station#</b>			
<b>Pic 15 Desc.</b>	P1 is in good condition around road pipe outlet.	<b>Pic 16 Desc.</b>			
<p style="text-align: center;">Insert image here</p>		<p style="text-align: center;">Insert image here</p>			
<b>GPS Location</b>		<b>GPS Location</b>			
<b>Field Station#</b>		<b>Field Station#</b>			
<b>Pic 17 Desc.</b>		<b>Pic 18 Desc.</b>

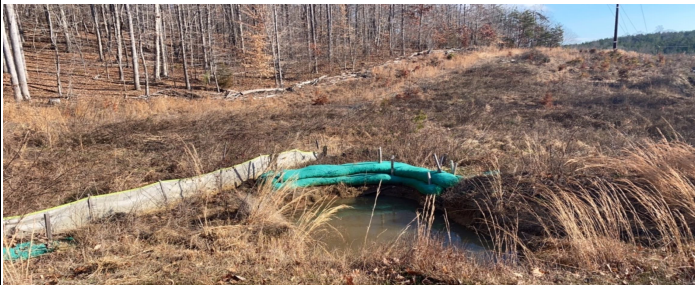
<p>236°SW 01.14.2022 10:11:12 Accur +/-23.6 Ft</p>		
GPS Location	1		GPS Location	2	
Field Station#	14707+00		Field Station#	14716+15	
Pic 1 Desc.	Routine maintenance. Repair and stabilize disturbed area from landowner damage.		Pic 2 Desc.	Routine maintenance. Replace perimeter CFS torn out from landowner damage.

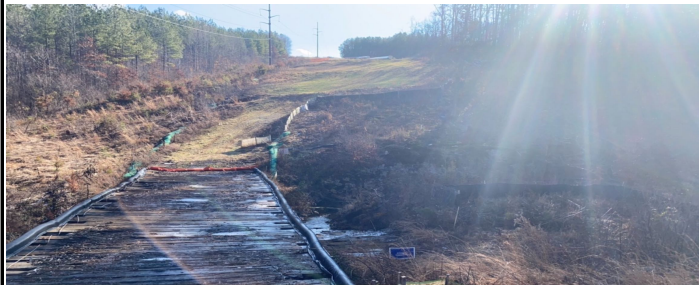
Pic 3 Desc.	Sump pit and CFS end treatment performing intended functions; perimeter P1 silt fence in good condition.		Pic 4 Desc.	Equipment bridge and surrounding ECDs in place and functional at stream crossing and resource buffer; signage visible and intact.

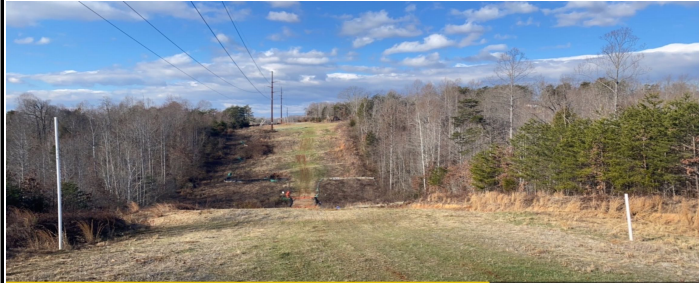
<p>36°59'17" N 79°42'25" W 358°N COURSE 281° GPS Union Hall, VA 24176, United States 01.14.2022 10:33:28 Accur +/-16.0 Ft ALT 933 Ft</p>		
GPS Location	5		GPS Location	6	
Field Station#	14736+00		Field Station#	14700+80	
Pic 5 Desc.	Water bar performing intended function; ROW stabilized and vegetated in temporary area.		Pic 6 Desc.	Equipment bridge and surrounding ECDs in place and functional at stream crossing and resource buffer; signage visible and intact.
