Visual Site Inspection Report

Project Name	H-600 Pipeline Spread I	AFE	124300139	Spread	H-600 Pipeline Spread I
Contractor	Precision			Report #	33542
Inspector	Charles Head			Date/Time	1/24/2022 11:07 AM
Permit #	TBD	Inspection Type	VA SWPP	Station Begin	14546+75
State	VA	Inspection Area	Full	Station End	14649+67
County	Franklin	Ground	Wet	Temperature (°F)	37.00
Municipality	N/A	Weather	Sunny	Rain Gauge (in)	0.00
				Rain Accumulation Time (days)	1.00

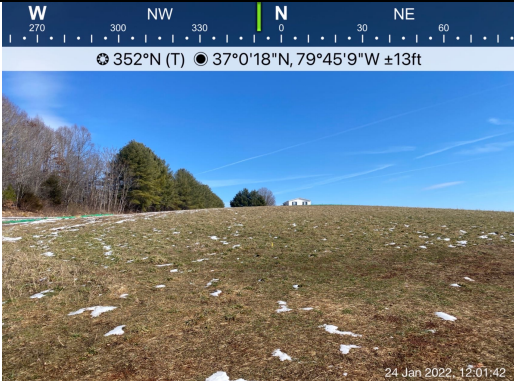
GPS Location	0	GPS Location	0		
Field Station#	14648+00	Field Station#	14611+25		
Pic 3 Desc.	Approximately 14548+00. Overview of ROW.		Pic 4 Desc.	Approximately 14611+25. Overview of stream crossing, equipment bridge and ECDs at stream S-E14.

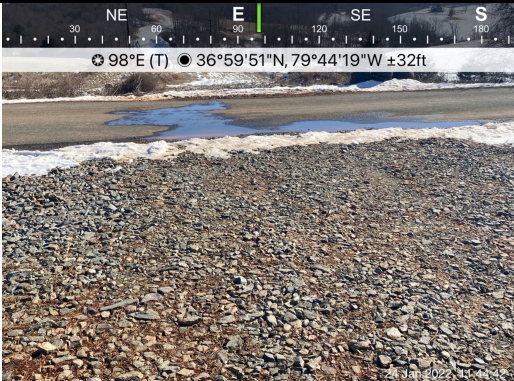
GPS Location	0	GPS Location	0		
Field Station#	14599+00	Field Station#	14596+00		
Pic 5 Desc.	Approximately 14599+00. Overview of road crossing and RCEs.		Pic 6 Desc.	Approximately 14596+00. Overview of ROW.

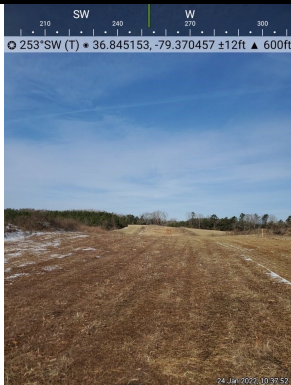
GPS Location	0		GPS Location	0	
Field Station#	15900+00		Field Station#	15884+00	
Pic 3 Desc.	Temporary stabilization		Pic 4 Desc.	Clean water diversion inlet

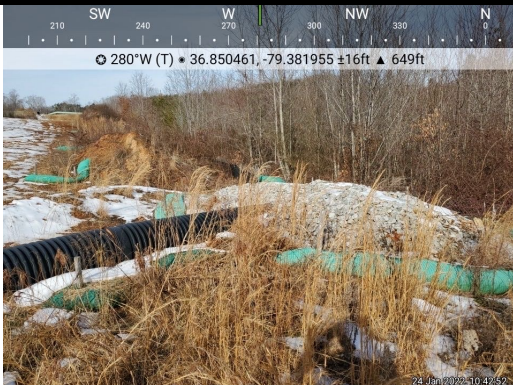
GPS Location	0		GPS Location	0	
Field Station#	15884+00		Field Station#	15865+00	
Pic 5 Desc.	Clean water outlet		Pic 6 Desc.	Waterbar checks

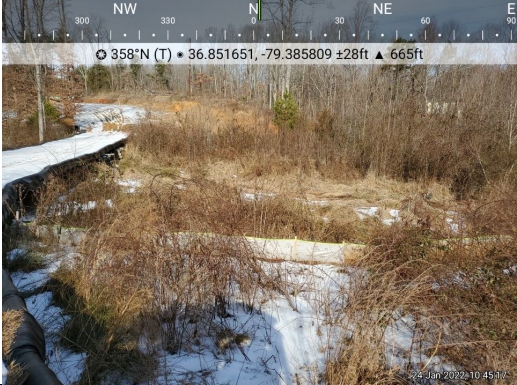
GPS Location	0		GPS Location	0	
Field Station#	15853+00		Field Station#	15845+00	
Pic 7 Desc.	W-G2 buffer zone		Pic 8 Desc.	Dry swale ECDs

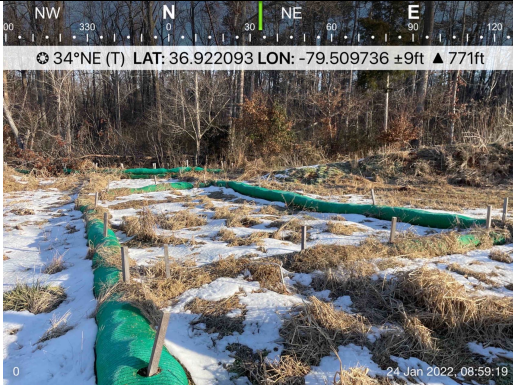
GPS Location	See photo		GPS Location	See photo	
Field Station#	15371+00		Field Station#	15375+00	
Pic 1 Desc.	ROW remains stabilized. Vegetation continues to fill in throughout this section.		Pic 2 Desc.	Drainage ECDs are in good condition and functioning.

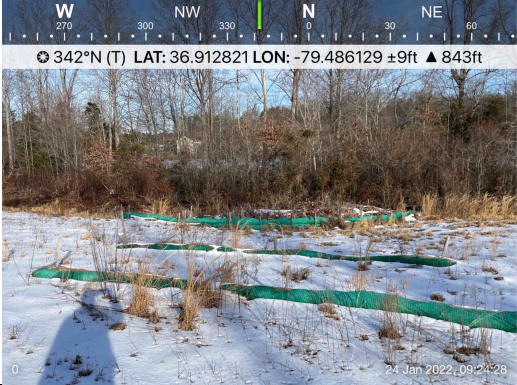
GPS Location	See photo		GPS Location	See photo	
Field Station#	15443+00		Field Station#	15453+00	
Pic 7 Desc.	Perimeter CFS is in good condition.		Pic 8 Desc.	CWD remains in good condition.

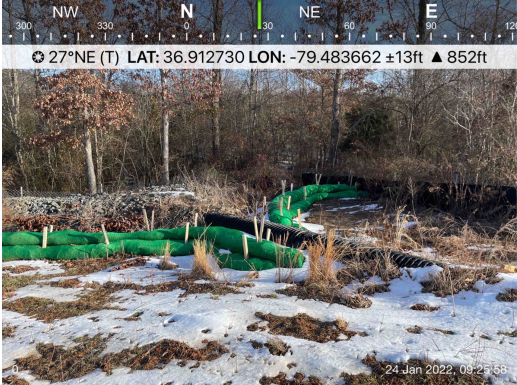
GPS Location	See photo		GPS Location	See photo	
Field Station#	15457+00		Field Station#	15460+81	
Pic 9 Desc.	No evidence of sedimentation from 3rd party disturbance within drainage feature.		Pic 10 Desc.	CWD remains in good condition.

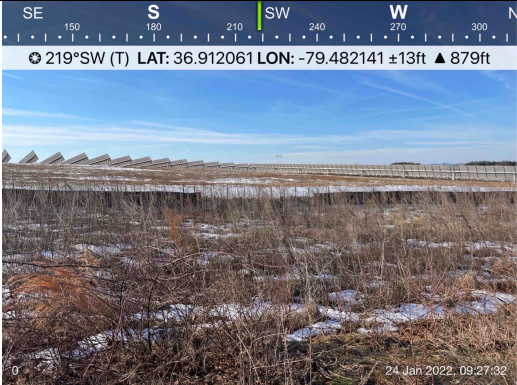
GPS Location	See photo		GPS Location	See photo	
Field Station#	15460+81		Field Station#	15465+00	
Pic 11 Desc.	No evidence of sedimentation from 3rd party disturbance into CWD inlet.		Pic 12 Desc.	No evidence of sedimentation from 3rd party disturbance.

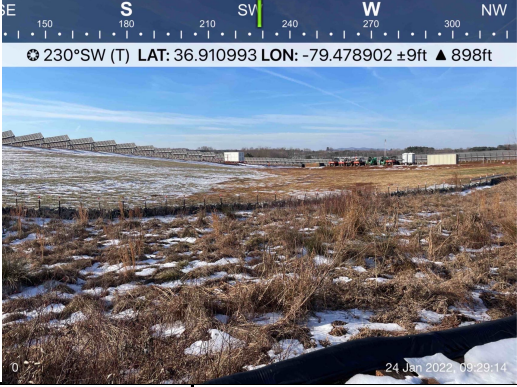
GPS Location		See photo		GPS Location	
Field Station#		15475+00		Field Station#	
Pic 13 Desc.		3rd party rock outlet appears to be in good condition along this drainage.		Pic 14 Desc.	
Insert image here		Insert image here			
GPS Location				GPS Location	
Field Station#				Field Station#	
Pic 15 Desc.				Pic 16 Desc.	
Insert image here		Insert image here			
GPS Location				GPS Location	
Field Station#				Field Station#	
Pic 17 Desc.				Pic 18 Desc.

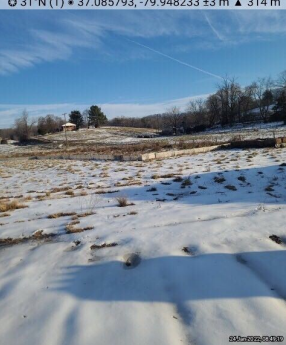
GPS Location	0000	GPS Location	0000		
Field Station#	13691+30	Field Station#	13692+69		
Pic 1 Desc.	Monitored ECDs around wetland area inside work space, no environmental issues observed at the time of inspection Flow conditions were still frozen		Pic 2 Desc.	Stream observation photo facing downstream during routine inspection today, no environmental issues observed at the time of inspection as snow/ice begins to slowly melt	
	North East Elevation <small>233°SW (T) • 37.088536, -79.950262 ±3 m ▲ 317 m</small>

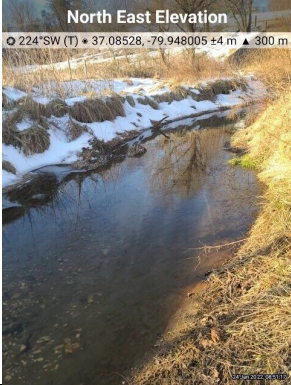
<p>Insert image here</p>		<p>Insert image here</p>	
GPS Location	0000	GPS Location			
Field Station#	13692+69	Field Station#			
Pic 7 Desc.	Stream observation photo facing upstream during routine inspection today, no environmental issues observed at the time of inspection.		Pic 8 Desc.		
<p>Insert image here</p>		<p>Insert image here</p>			
GPS Location		GPS Location			
Field Station#		Field Station#			
Pic 9 Desc.		Pic 10 Desc.			
<p>Insert image here</p>		<p>Insert image here</p>			
GPS Location		GPS Location			
Field Station#		Field Station#			
Pic 11 Desc.		Pic 12 Desc.

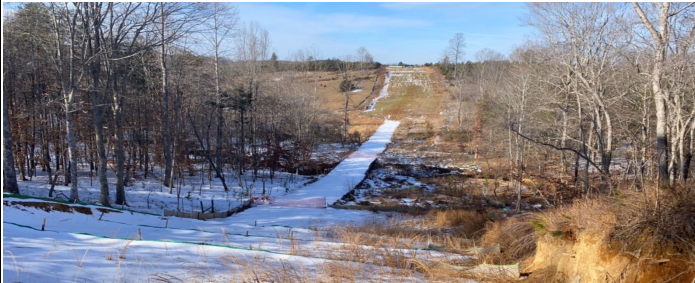
GPS Location	3		GPS Location	4	
Field Station#	14934+46		Field Station#	14950+47	
Pic 3 Desc.	Perimeter SSF and CFS in good condition.		Pic 4 Desc.	Equipment bridge and surrounding ECDs appear to be in place and functional at stream crossing and resource buffer; snow/ice continues to cover ROW.

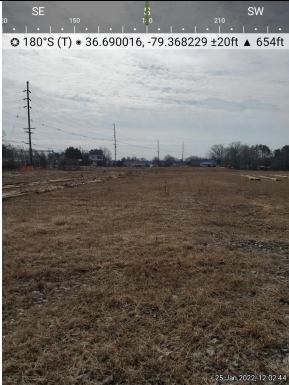
GPS Location	0	GPS Location	0		
Field Station#	0+00	Field Station#	0+00		
Pic 1 Desc.	LY-048 Temporary vegetation		Pic 2 Desc.	LY-048 South perimeter CFS

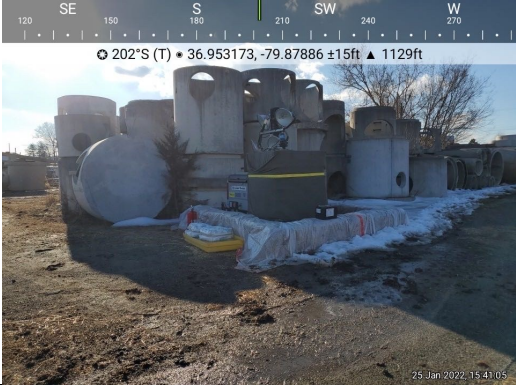
GPS Location	0	GPS Location	0		
Field Station#	0+00	Field Station#	0+00		
Pic 7 Desc.	ANC-006 Secondary containment	Pic 8 Desc.	ANC-006 Stormwater drain inlet		
Insert image here		Insert image here			
GPS Location		GPS Location			
Field Station#		Field Station#			
Pic 9 Desc.		Pic 10 Desc.			
Insert image here		Insert image here			
GPS Location		GPS Location			
Field Station#		Field Station#			
Pic 11 Desc.		Pic 12 Desc.

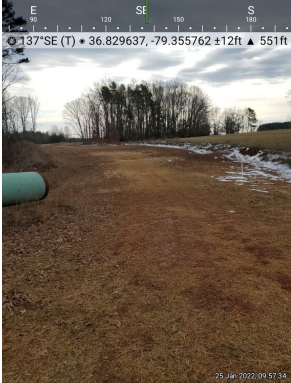
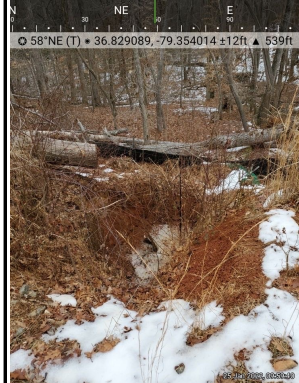
GPS Location	0	GPS Location	0	GPS Location	0
Field Station#	15982+00	Field Station#	15985+00	Field Station#	15985+00
Pic 7 Desc.	Temporary vegetation	Pic 8 Desc.	Sump	Pic 8 Desc.	Sump

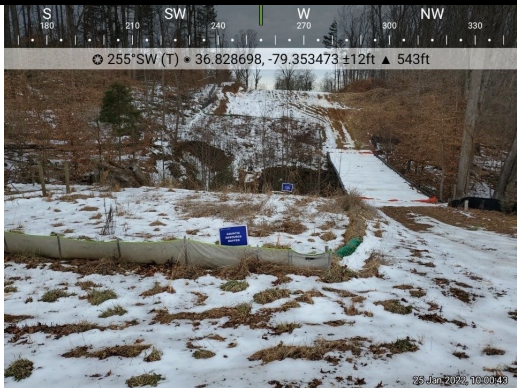
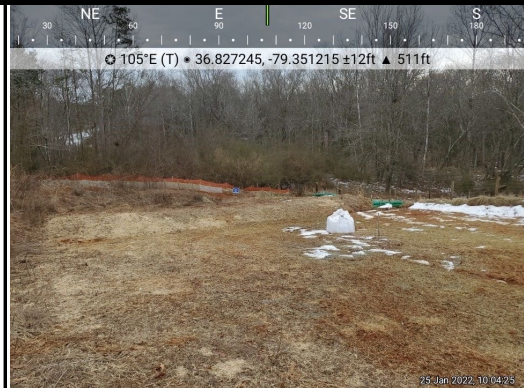
GPS Location	0	GPS Location	0	GPS Location	0
Field Station#	15989+00	Field Station#	15998+00	Field Station#	15998+00
Pic 9 Desc.	GAS S-OO2 Buffer zone	Pic 10 Desc.	CIS W-IJ22-PFO Temporary vegetation and perimeter ECDs	Pic 10 Desc.	CIS W-IJ22-PFO Temporary vegetation and perimeter ECDs

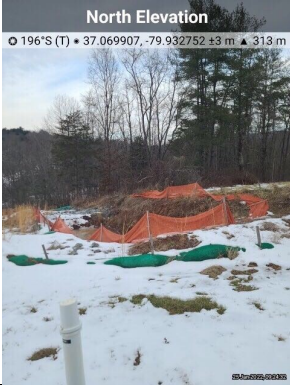
<p>North Elevation <small>196°S (T) • 37.069907, -79.932752 ±3 m ▲ 313 m</small></p>

<p>West Elevation <small>110°E (T) • 37.060637, -79.921094 ±3 m ▲ 291 m</small></p>			
GPS Location	0000	GPS Location	0000		
Field Station#	13785+00	Field Station#	13846+78		
Pic 7 Desc.	Safety fence around sump pit requires maintenance, documented and added to the punch list.		Pic 8 Desc.	Stream observation photo facing downstream during routine inspection today, no environmental issues observed at the time of inspection.	
Insert image here		Insert image here			
GPS Location		GPS Location			
Field Station#		Field Station#			
Pic 9 Desc.			Pic 10 Desc.		
Insert image here		Insert image here			
GPS Location		GPS Location			
Field Station#		Field Station#			
Pic 11 Desc.			Pic 12 Desc.

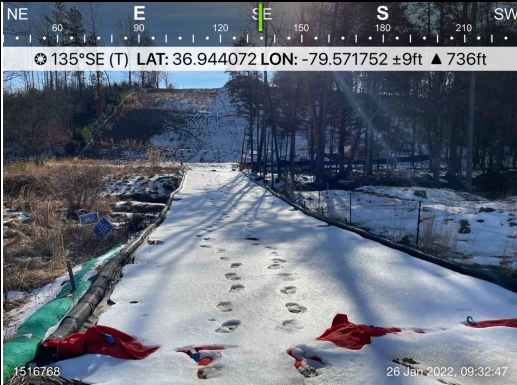
GPS Location	See photo		GPS Location	See photo	
Field Station#	15167+68		Field Station#	15167+68	
Pic 7 Desc.	Equipment bridge ECDs are in place and functioning.		Pic 8 Desc.	Stream buffer remains in good condition.

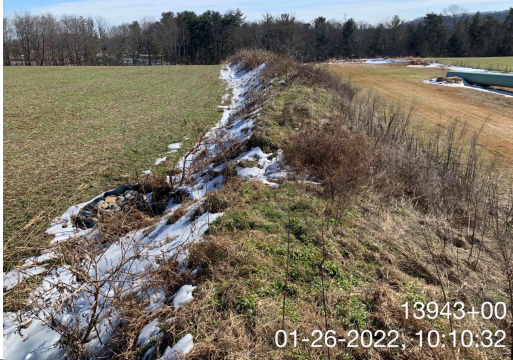
GPS Location			0		
Field Station#			13943+00		
Pic 5 Desc.			Clean water diversion berm and temporary vegetative stabilization in acceptable conditions		
GPS Location			0		
Field Station#			13853+45		
Pic 6 Desc.			Perimeter CFS and temporary vegetative stabilization in acceptable conditions

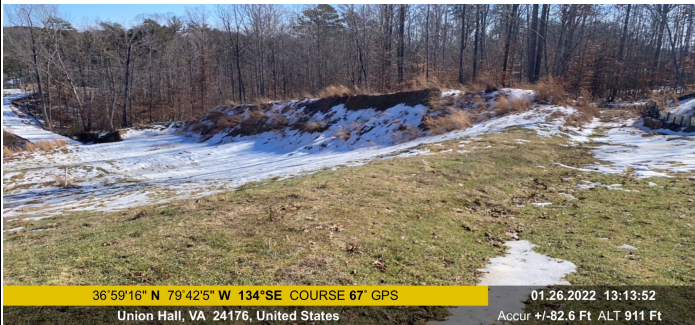
GPS Location	3		GPS Location	4	
Field Station#	14721+00		Field Station#	14769+52	
Pic 3 Desc.	Water bar performing intended function; ROW stabilized and vegetated in temporary area.		Pic 4 Desc.	Equipment bridge and surrounding ECDs in place and functional at stream crossing and resource buffer; signage visible and intact.

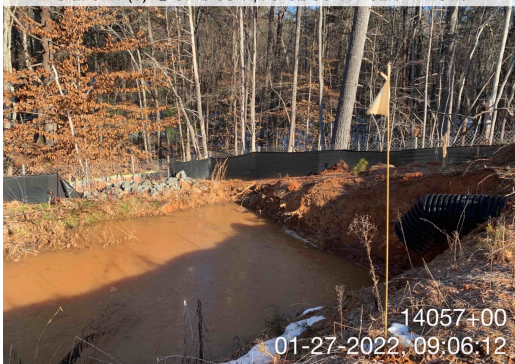
<p>279°W (T) 37°3'58"N, 79°52'36"W ±62ft ▲1151ft</p> <p>14057+00 01-27-2022, 09:06:12</p>

<p>318°NW (T) 37°3'56"N, 79°52'38"W ±65ft ▲1167ft</p> <p>14054+00 01-27-2022, 09:07:58</p>		
GPS Location	00		GPS Location	0	
Field Station#	14057+00		Field Station#	14054+00	
Pic 1 Desc.	Slope drain pipe and sump pit in acceptable conditions		Pic 2 Desc.	Waterbar end treatment in acceptable condition

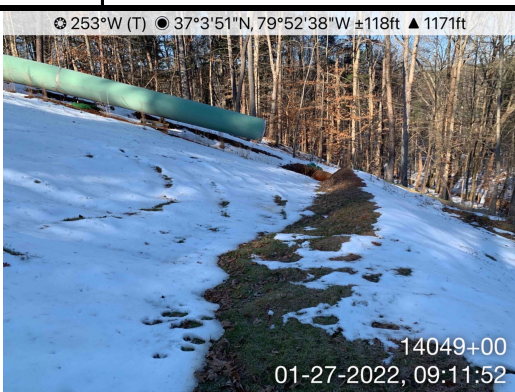
<p>253°W (T) 37°3'51"N, 79°52'38"W ±118ft ▲1171ft</p> <p>14049+00 01-27-2022, 09:11:52</p>

<p>152°SE (T) 37°3'48"N, 79°52'41"W ±36ft ▲1158ft</p> <p>14045+71 01-27-2022, 09:35:24</p>		
GPS Location	0		GPS Location	0	
Field Station#	14049+00		Field Station#	14045+71	
Pic 3 Desc.	Waterbar in acceptable condition		Pic 4 Desc.	Equipment bridge in acceptable condition

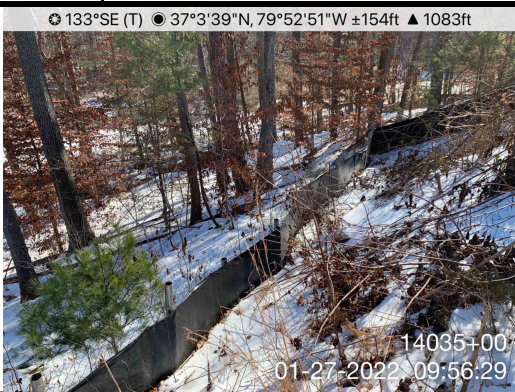
<p>133°SE (T) 37°3'39"N, 79°52'51"W ±154ft ▲1083ft</p> <p>14035+00 01-27-2022, 09:56:29</p>

GPS Location	0		GPS Location	0	
Field Station#	14035+00		Field Station#	14011+00	
Pic 5 Desc.	Super silt fence in acceptable condition		Pic 6 Desc.	P1 silt fence is deteriorated (4 panels)

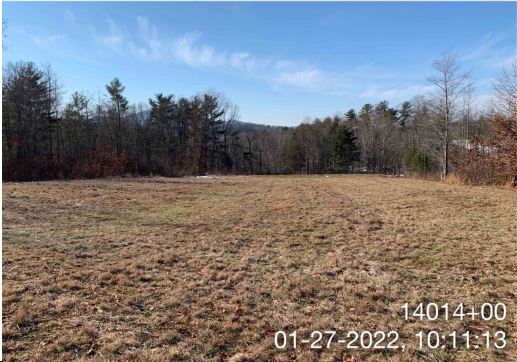
<p>14014+00 01-27-2022, 10:11:13</p>

<p>13963+00 01-27-2022, 10:56:33</p>			
GPS Location	0	GPS Location	0		
Field Station#	14014+00	Field Station#	13963+00		
Pic 7 Desc.	Permanent vegetative stabilization in acceptable condition		Pic 8 Desc.	Temporary vegetative stabilization in acceptable condition	
Insert image here			Insert image here		
GPS Location		GPS Location			
Field Station#		Field Station#			
Pic 9 Desc.			Pic 10 Desc.		
Insert image here			Insert image here		
GPS Location		GPS Location			
Field Station#		Field Station#			
Pic 11 Desc.			Pic 12 Desc.

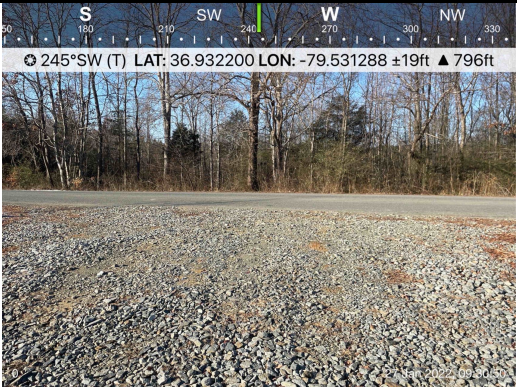
GPS Location	See photo		GPS Location	See photo	
Field Station#	15296+00		Field Station#	15299+00	
Pic 1 Desc.	RCEs are in good condition at all road crossings.		Pic 2 Desc.	CWD is in good condition and functioning.

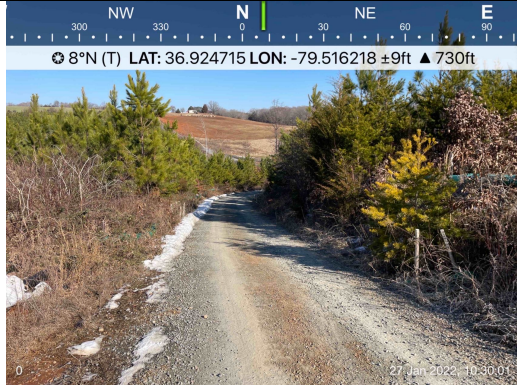
GPS Location	See photo		GPS Location	See photo	
Field Station#	15350+00		Field Station#	15360+00	
Pic 11 Desc.	MVP-PI-332 is in good condition with controls in place.		Pic 12 Desc.	Vegetation continues to fill in throughout this section.

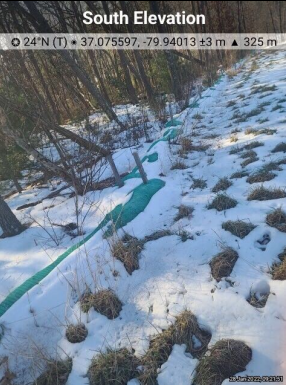
<p>South Elevation <small>24°N (T) • 37.075597, -79.94013 ±3 m ▲ 325 m</small></p>

<p>South West Elevation <small>59°NE (T) • 37.086083, -79.948684 ±3 m ▲ 311 m</small></p>	
GPS Location	00000	GPS Location	0000		
Field Station#	13746+20	Field Station#	13690+00		
Pic 1 Desc.	Monitored ECDs along the edge of row. No environmental issues observed at the time of inspection I		Pic 2 Desc.	Row photo showing equipment mats and vegetation. No environmental issues observed at the time of inspection.

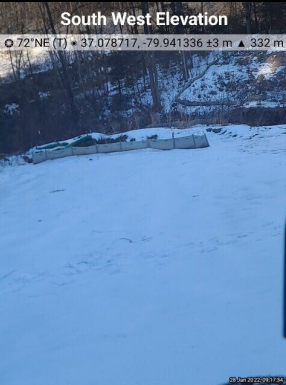
<p>South West Elevation <small>72°NE (T) • 37.078717, -79.941336 ±3 m ▲ 332 m</small></p>

<p>South East Elevation <small>342°NW (T) • 37.077836, -79.939433 ±4 m ▲ 339 m</small></p>	
GPS Location	0000	GPS Location	00000		
Field Station#	13729+00	Field Station#	13738+00		
Pic 3 Desc.	Observed ECDs on hill side above stream crossing, all functioning at the time of inspection.		Pic 4 Desc.	Monitored ECDs along the edge of row. No environmental issues observed at the time of inspection I

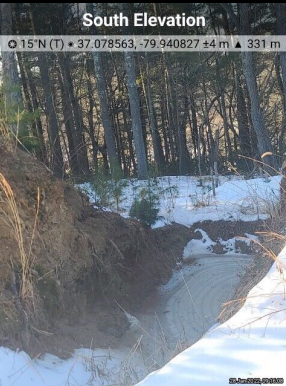
<p>South Elevation <small>15°N (T) • 37.078563, -79.940827 ±4 m ▲ 331 m</small></p>

<p>South West Elevation <small>49°NE (T) • 37.078751, -79.941317 ±6 m ▲ 322 m</small></p>	
GPS Location	0000	GPS Location	0000		
Field Station#	13732+80	Field Station#	13729+99		
Pic 5 Desc.	Monitored ECDs along the edge of row. No environmental issues observed at the time of inspection I		Pic 6 Desc.	Row photo up hill from stream crossing, ECDs and equipment bridge in place, no environmental issues observed at the time of inspection

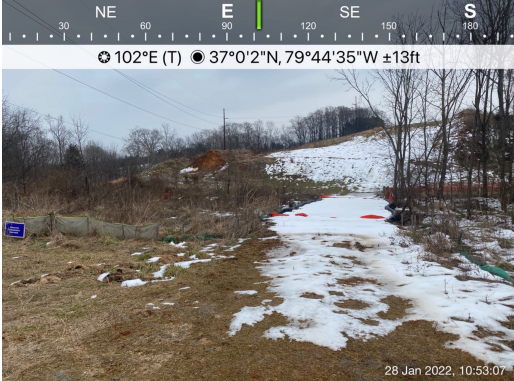
GPS Location	0	GPS Location	0		
Field Station#	14582+85	Field Station#	14576+00		
Pic 3 Desc.	Approximately 14582+85. Overview of stream crossing, equipment bridge and ECDs at stream S-E17.		Pic 4 Desc.	Approximately 14576+00. Overview of ROW.

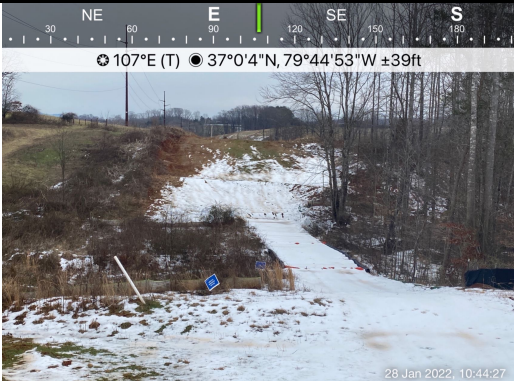
GPS Location	0	GPS Location	0		
Field Station#	14568+10	Field Station#	14555+00		
Pic 5 Desc.	Approximately 14568+10. Overview of stream crossing, equipment bridge and ECDs at stream S-E18.		Pic 6 Desc.	Approximately 14555+00. Overview of ROW.

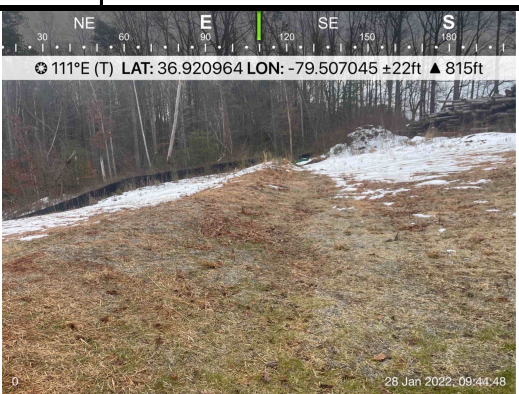
GPS Location		See photo			
Field Station#		15371+00			
Pic 1 Desc.		This area remains stabilized.

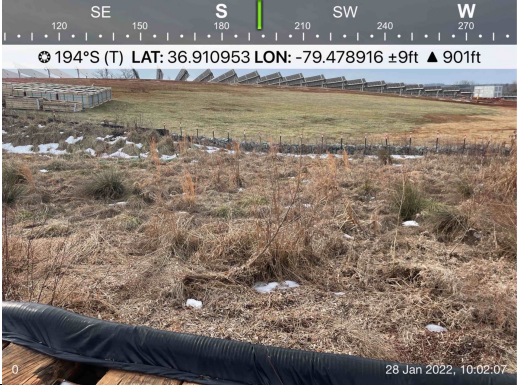
GPS Location	See photo	GPS Location			
Field Station#	15475+00	Field Station#			
Pic 13 Desc.	3rd party rock outlet appears to be in good condition along this drainage.	Pic 14 Desc.			
Insert image here		Insert image here			
GPS Location		GPS Location			
Field Station#		Field Station#			
Pic 15 Desc.		Pic 16 Desc.			
Insert image here		Insert image here			
GPS Location		GPS Location			
Field Station#		Field Station#			
Pic 17 Desc.		Pic 18 Desc.

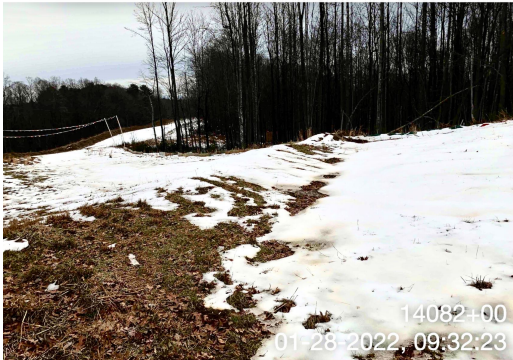
GPS Location		0		GPS Location		0	
Field Station#		14082+00		Field Station#		14082+00	
Pic 1 Desc.		Waterbar in acceptable condition		Pic 2 Desc.		Waterbar end treatment in acceptable condition

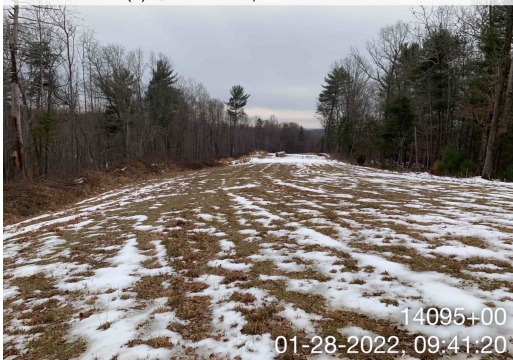
GPS Location		0		GPS Location		0	
Field Station#		14095+00		Field Station#		14128+00	
Pic 3 Desc.		Temporary vegetative stabilization in acceptable condition		Pic 4 Desc.		Clean water diversion berm and temporary vegetative stabilization in acceptable conditions

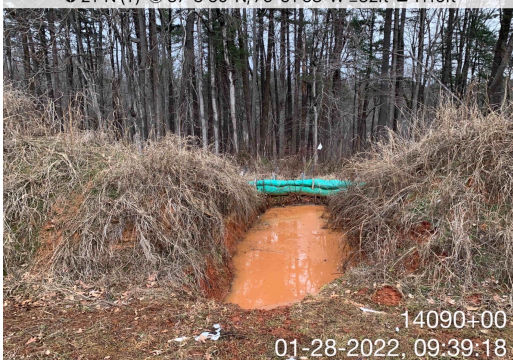
GPS Location		0		GPS Location		0	
Field Station#		14090+00		Field Station#		14128+00	
Pic 5 Desc.		Sump pit in acceptable condition		Pic 6 Desc.		Perimeter CFS in acceptable condition
