Visual Site Inspection Report

Project Name	H-603 Pipeline Spread I	AFE	124300139	Spread	H-603 Pipeline Spread I	
Contractor	Precision			Report #	32850	
Inspector	John White			Date/Time	1/3/2022 2:33 PM	
Permit #	TBD	Inspection Type	VA SWPP	Station Begin	00+00	
State	VA	Inspection Area	Full	Station End	24+53	
County	Pittsylvania	Ground	Wet	Temperature (°F)	38.00	
Municipality	Chatham	Weather	Snow/Sleet	Rain Gauge (in)	2.30	
				Rain Accumulation Time (days)	6.00

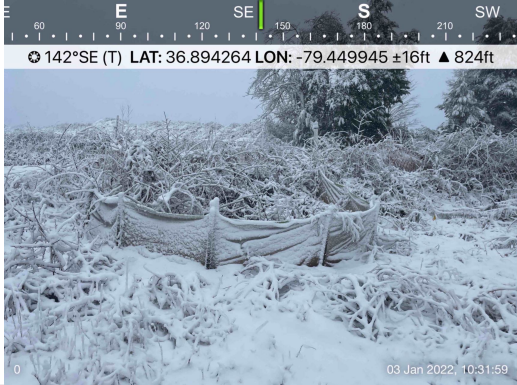
<div style="text-align: center;">Insert image here</div>			
GPS Location	See photo	GPS Location			
Field Station#	15584+00	Field Station#			
Pic 9 Desc.	P1 remains in good condition at road pipe outlet.	Pic 10 Desc.			
<div style="text-align: center;">Insert image here</div>		<div style="text-align: center;">Insert image here</div>			
GPS Location		GPS Location			
Field Station#		Field Station#			
Pic 11 Desc.		Pic 12 Desc.

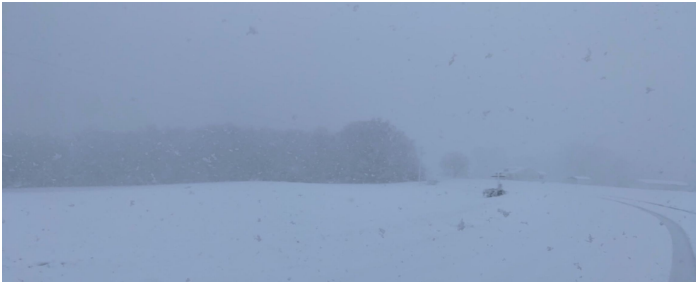
<small>36°57'48" N 79°34'48" W 260°W COURSE 117° GPS 9355-9399 Museville Rd, Sandy Level, VA 24161, United States Accur +/-15.4 Ft ALT 922 Ft</small>			<small>36°57'48" N 79°34'48" W 245°SW COURSE 117° GPS 9355-9399 Museville Rd, Sandy Level, VA 24161, United States Accur +/-15.4 Ft ALT 922 Ft</small>		
GPS Location	1		GPS Location	2	
Field Station#	15063+85		Field Station#	15113+00	
Pic 1 Desc.	ROW covered in snow; stabilized		Pic 2 Desc.	ROW covered in snow; stabilized

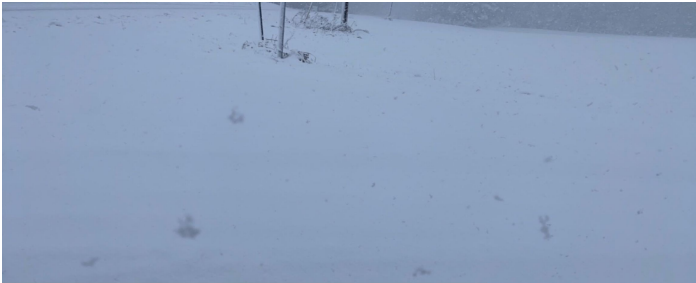
Pic 3 Desc.	ROW covered in snow; stabilized		Pic 4 Desc.	ROW covered in snow; stabilized	
Insert image here			Insert image here		
GPS Location	5		GPS Location	6	
Field Station#			Field Station#		
Pic 5 Desc.			Pic 6 Desc.

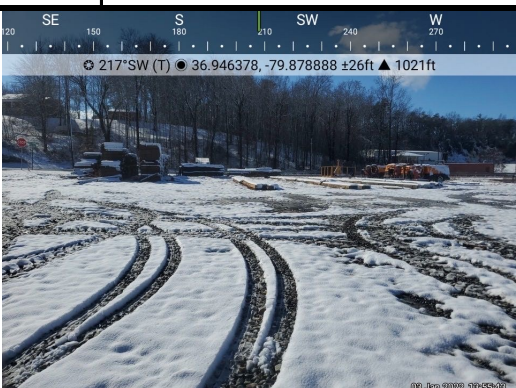
GPS Location	0		GPS Location	0	
Field Station#	0+00		Field Station#	0+00	
Pic 5 Desc.	ANC-006 Perimeter CFS		Pic 6 Desc.	ANC-006 Stormwater drain inlet protection

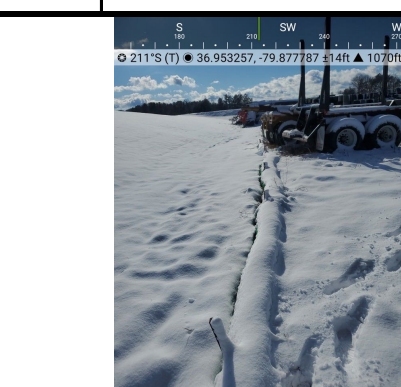
A/E	124300139	Date/Time	1/3/2022 4:33 PM	Report #	
Pictures					
GPS Location	0	GPS Location	0		
Field Station#	0+00	Field Station#	0+00		
Pic 7 Desc.	LY-048 Waste management	Pic 8 Desc.	LY-048 Equipment staging		
Insert image here		Insert image here			
GPS Location		GPS Location			
Field Station#		Field Station#			
Pic 9 Desc.		Pic 10 Desc.			
Insert image here		Insert image here			
GPS Location		GPS Location			
Field Station#		Field Station#			
Pic 11 Desc.		Pic 12 Desc.

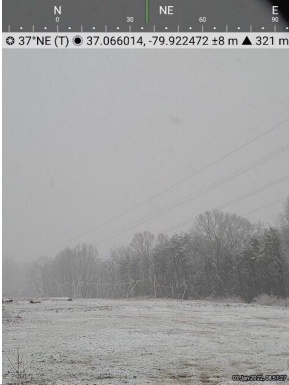
GPS Location	00000	GPS Location	000000		
Field Station#	13826+95	Field Station#	13826+99		
Pic 3 Desc.	Snow event , monitored areas of the row that was accessible, no environmental issues observed at the time of inspection.		Pic 4 Desc.	Row photo showing snow during the early part of the day. No environmental issues observed at the time of inspection.

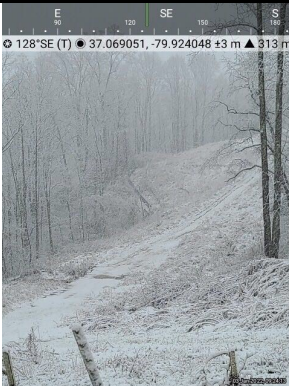
GPS Location	0000	GPS Location	00000		
Field Station#	13812+40	Field Station#	13784+35		
Pic 5 Desc.	Row photo showing snow events throughout the early morning . No environmental issues observed at the time of inspection.		Pic 6 Desc.	Snow conditions on row , no environmental issues observed at the time of inspection.

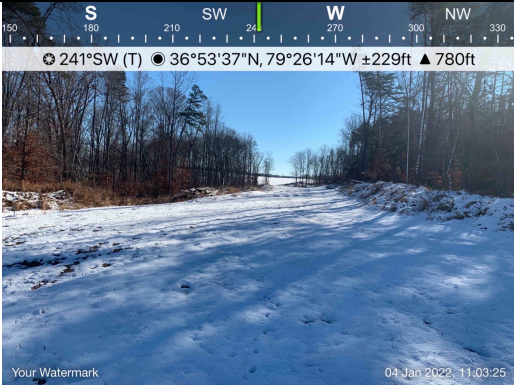
GPS Location	O	GPS Location	O		
Field Station#	15630+00	Field Station#	15624+00		
Pic 3 Desc.	Observing temporary stabilization and CWD Berm	Pic 4 Desc.	Observing temporary stabilization, CWD outlet and ECD's

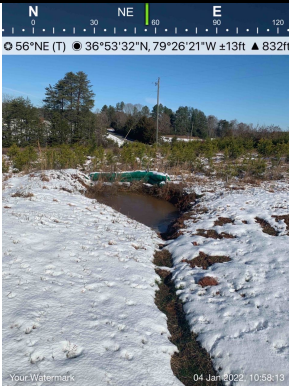
GPS Location	O	GPS Location	O		
Field Station#	15616+00	Field Station#	15619+48		
Pic 5 Desc.	Observing water bar, sump and end treatment	Pic 6 Desc.	Observing road crossing and RCE's

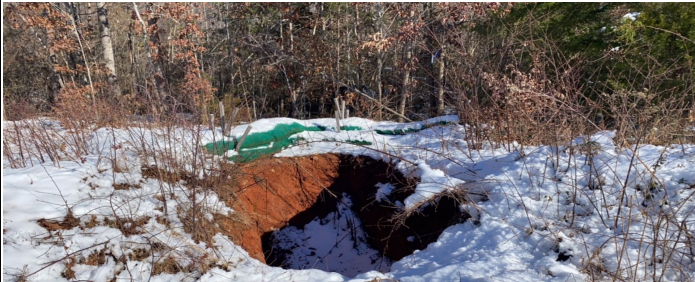
36°59'17" N 79°42'35" W 108°E COURSE 27° GPS Union Hall, VA 24176, United States 01.04.2022 12:42:51 Accur +/-366.2 Ft ALT 951 Ft			36°59'15" N 79°41'58" W 252°W COURSE 94° GPS Union Hall, VA 24176, United States 01.04.2022 13:05:17 Accur +/-347.8 Ft ALT 866 Ft		
GPS Location	1	GPS Location	2		
Field Station#	14730+00	Field Station#	14721+62		
Pic 1 Desc.	Sump pit and CFS end treatment performing intended functions.		Pic 2 Desc.	Spoil pile stabilized and P1 silt fence in place at base of pile.

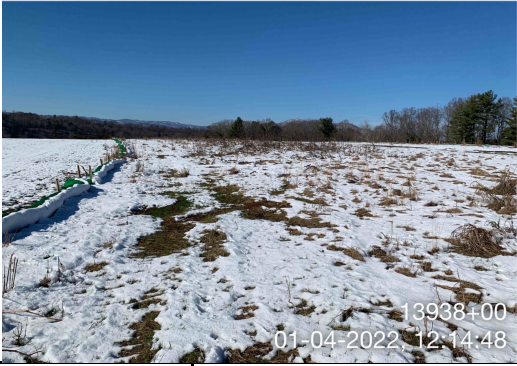
<p>13938+00 01-04-2022 12:14:48</p>					
GPS Location	0	GPS Location			
Field Station#	14938+00	Field Station#			
Pic 7 Desc.	Permanent vegetative stabilization and perimeter CFS in acceptable conditions	Pic 8 Desc.			
Insert image here		Insert image here			
GPS Location		GPS Location			
Field Station#		Field Station#			
Pic 9 Desc.		Pic 10 Desc.			
Insert image here		Insert image here			
GPS Location		GPS Location			
Field Station#		Field Station#			
Pic 11 Desc.		Pic 12 Desc.

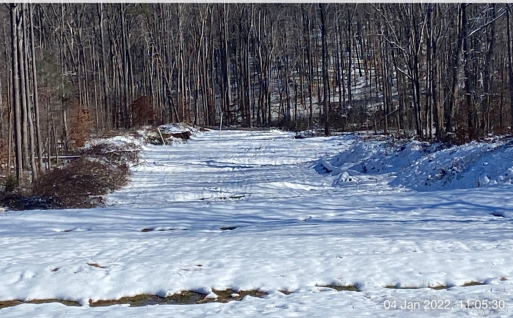
GPS Location	0	GPS Location	0		
Field Station#	14451+00	Field Station#	14415+00		
Pic 1 Desc.	Approximately 14451+00. Overview of ROW. Observed third party ATV tracks in area.	Pic 2 Desc.	Approximately 14415+00. Overview of ROW.

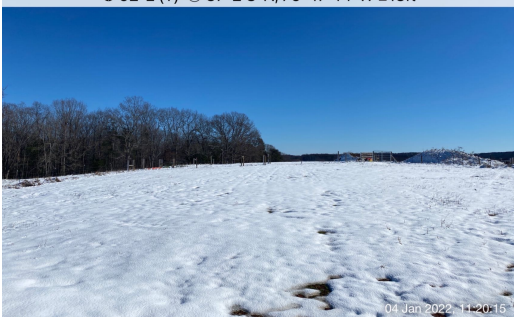
GPS Location	0	GPS Location	0		
Field Station#	14366+00	Field Station#	14360+00		
Pic 3 Desc.	Approximately 14366+00. Overview of ROW.	Pic 4 Desc.	Approximately 14360+00. Overview of ROW.

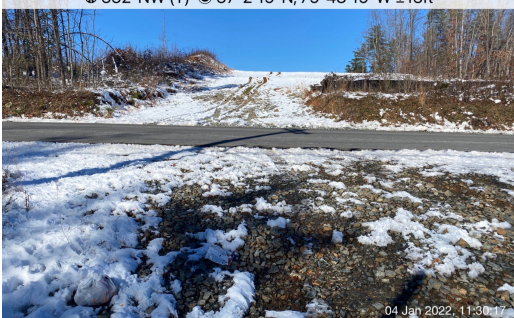
GPS Location	0	GPS Location	0		
Field Station#	14333+50	Field Station#	14314+79		
Pic 5 Desc.	Approximately 14333+50. Overview of road crossing and RCEs.	Pic 6 Desc.	Approximately 14314+79. Overview of stream crossing, equipment bridge and ECDs at stream S-GG4.

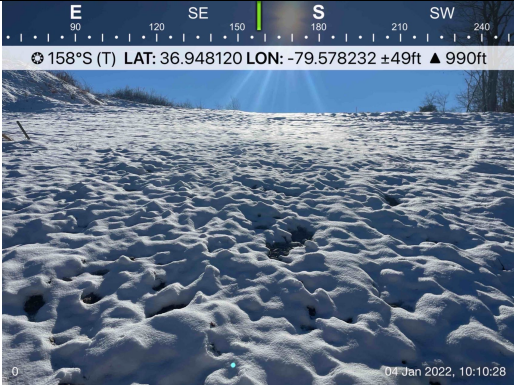
GPS Location	See photo		GPS Location	See photo	
Field Station#	15142+66		Field Station#	15150+00	
Pic 1 Desc.	RCE is in good condition at Rockcreek Rd.		Pic 2 Desc.	Tree has fallen across perimeter CFS and needs to be removed.

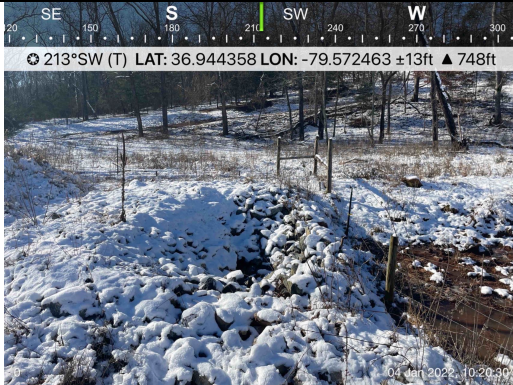
GPS Location	See photo		GPS Location	See photo	
Field Station#	15164+00		Field Station#	15165+57	
Pic 3 Desc.	Perimeter P1 has been damaged and needs to be replaced.		Pic 4 Desc.	Rock inlet remains in good condition.

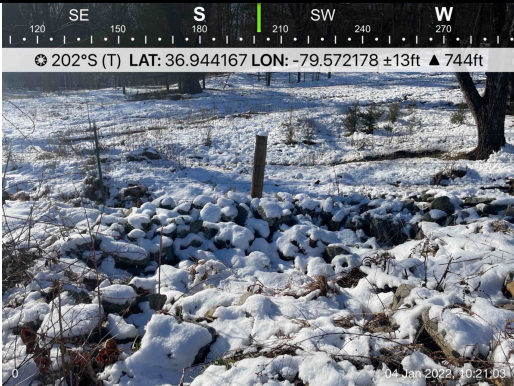
GPS Location	See photo		GPS Location	See photo	
Field Station#	15166+00		Field Station#	15168+00	
Pic 5 Desc.	Rock outlet remains in good condition.		Pic 6 Desc.	Buffer P1 has been damaged and needs to be replaced.

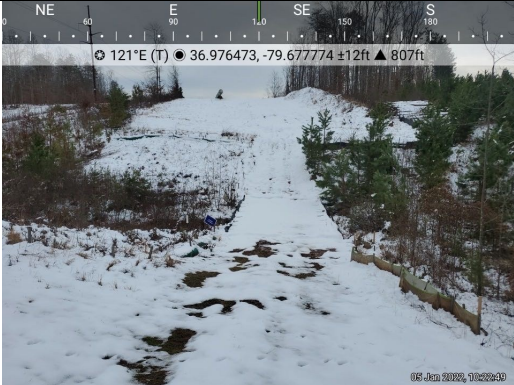
GPS Location	0	GPS Location	0		
Field Station#	14804+00	Field Station#	14810+00		
Pic 1 Desc.	S-H23	Pic 2 Desc.	Sideslope stabilization

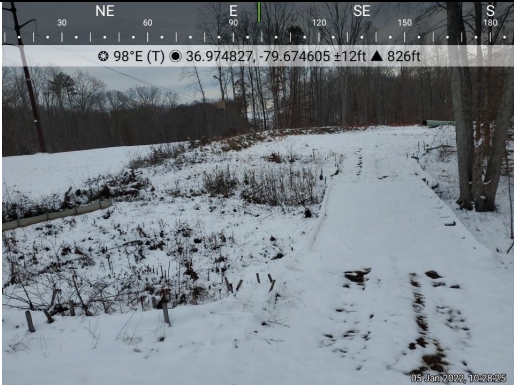
GPS Location	0	GPS Location	0		
Field Station#	14816+00	Field Station#	14823+54		
Pic 3 Desc.	S-HH1	Pic 4 Desc.	S-A13 Channel across centerline during snow melt

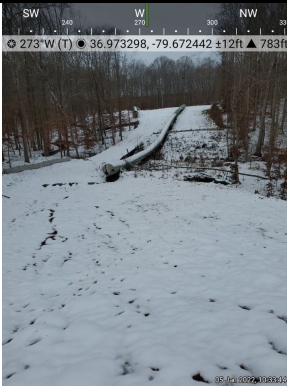
GPS Location	0	GPS Location	0		
Field Station#	14825+00	Field Station#	14837+00		
Pic 5 Desc.	GAS S-A13	Pic 6 Desc.	Plunge pool outlet

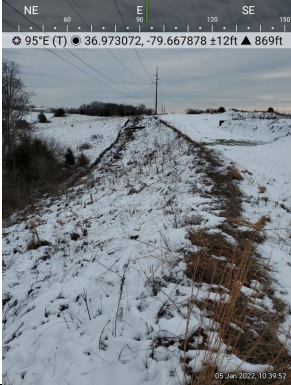
GPS Location	0	GPS Location	0		
Field Station#	14838+00	Field Station#	14852+00		
Pic 7 Desc.	Sideslope stabilization	Pic 8 Desc.	CIS S-H17

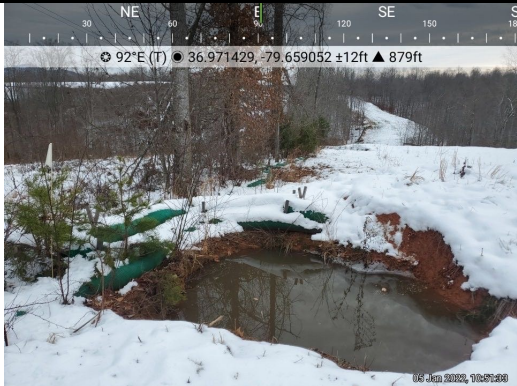
GPS Location	0	GPS Location	0		
Field Station#	14865+00	Field Station#	14869+00		
Pic 9 Desc.	Sump pit	Pic 10 Desc.	S-SS8

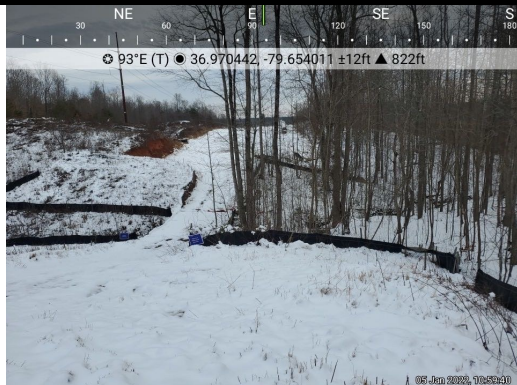
GPS Location	0	GPS Location	0		
Field Station#	14880+00	Field Station#	14900+00		
Pic 11 Desc.	CIS S-CD8 with perimeter ECDs	Pic 12 Desc.	Dry swale outlet

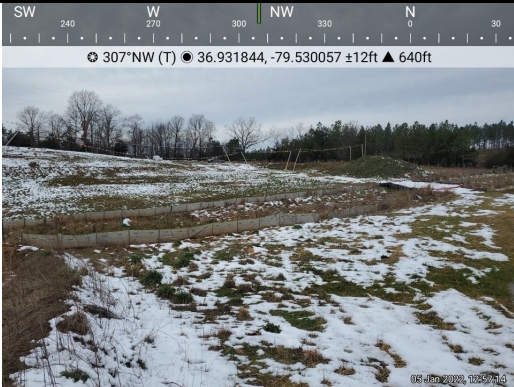
GPS Location	0	GPS Location	0		
Field Station#	15303+00	Field Station#	15308+00		
Pic 1 Desc.	GAS Dry swale	Pic 2 Desc.	Vegetation during snowmelt

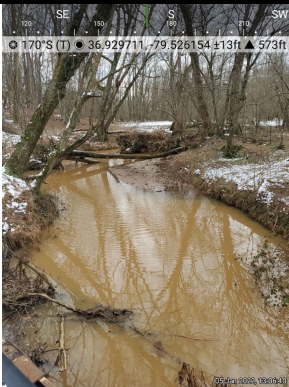
GPS Location	0	GPS Location	0		
Field Station#	15314+25	Field Station#	15314+25		
Pic 3 Desc.	S-C3 Channel upstream of ROW during snowmelt	Pic 4 Desc.	S-C3 Channel across centerline during snowmelt

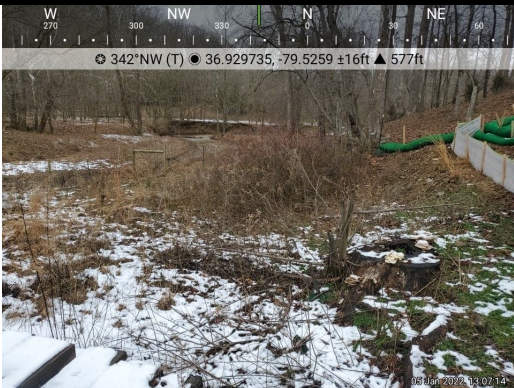
GPS Location	0	GPS Location	0		
Field Station#	15314+40	Field Station#	15322+00		
Pic 5 Desc.	GAS S-C3 Buffer zone	Pic 6 Desc.	CIS Lark Rd CFS checks

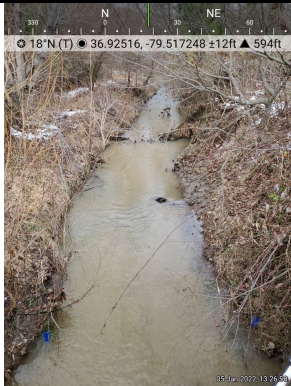
GPS Location	0	GPS Location	0		
Field Station#	15346+70	Field Station#	15346+70		
Pic 9 Desc.	S-H13 Channel upstream of ROW during snowmelt	Pic 10 Desc.	S-H13 Channel across centerline during snowmelt

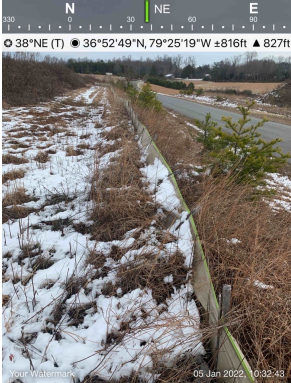
GPS Location	O	GPS Location	O		
Field Station#	15693+60	Field Station#	15700+40		
Pic 7 Desc.	Observing P1 that requires maintenance	Pic 8 Desc.	Observing temporary stabilization,buffer, equipment crossing and ECD's		
Insert image here		Insert image here			
GPS Location		GPS Location			
Field Station#		Field Station#			
Pic 9 Desc.		Pic 10 Desc.			
Insert image here		Insert image here			
GPS Location		GPS Location			
Field Station#		Field Station#			
Pic 11 Desc.		Pic 12 Desc.

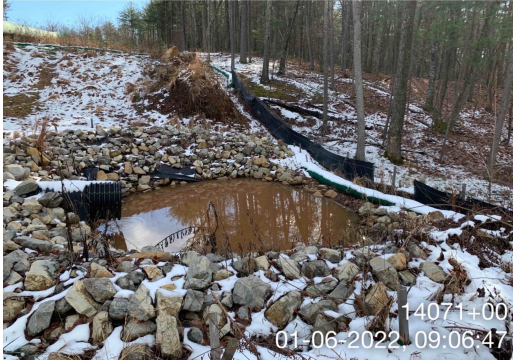
GPS Location	0	GPS Location	0		
Field Station#	14063+00	Field Station#	14071+00		
Pic 1 Desc.	Safety fence along access road MVP-FR-309.05 requires maintenance	Pic 2 Desc.	Clean water diversion pipe and plunge pool in acceptable conditions

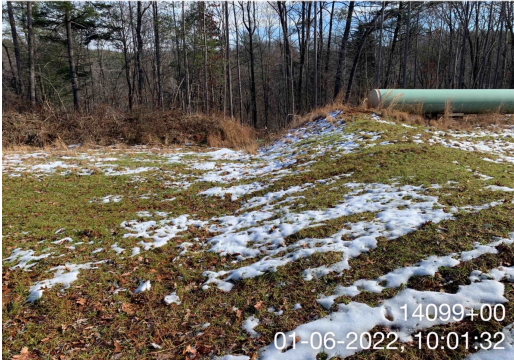
GPS Location	0	GPS Location	0		
Field Station#	14099+00	Field Station#	14099+00		
Pic 3 Desc.	Waterbar in acceptable condition	Pic 4 Desc.	Waterbar end treatment in acceptable condition

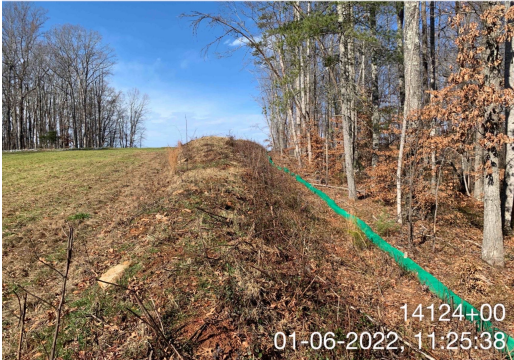
GPS Location	0	GPS Location	0		
Field Station#	14124+00	Field Station#	14101+00		
Pic 5 Desc.	Perimeter CFS and temporary vegetative stabilization in acceptable condition	Pic 6 Desc.	Super silt fence in acceptable condition

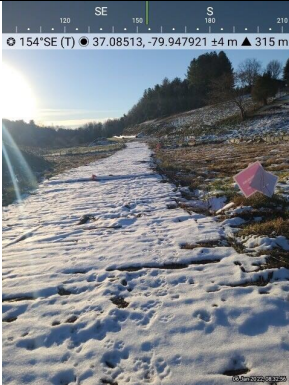
GPS Location	0000	GPS Location	000		
Field Station#	13693+18	Field Station#	13693+05		
Pic 1 Desc.	Row photo showing equipment mats in place as well as ECDs , no environmental issues observed at the time of inspection I		Pic 2 Desc.	Monitored ECDs along the row edge during routine inspection, no environmental issues observed at the time of inspection.

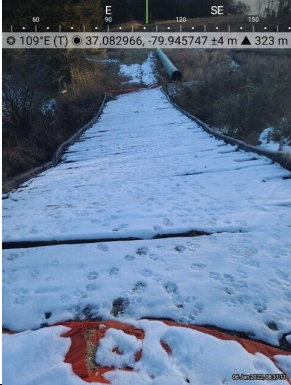
<p>Insert image here</p>		<p>Insert image here</p>	
GPS Location	0000	GPS Location			
Field Station#	13705+00	Field Station#			
Pic 7 Desc.	Monitored equipment bridge and protection, ECDs in place on stream banks and buffer, no environmental issues observed at the time of inspection.		Pic 8 Desc.		
<p>Insert image here</p>		<p>Insert image here</p>			
GPS Location		GPS Location			
Field Station#		Field Station#			
Pic 9 Desc.		Pic 10 Desc.			
<p>Insert image here</p>		<p>Insert image here</p>			
GPS Location		GPS Location			
Field Station#		Field Station#			
Pic 11 Desc.		Pic 12 Desc.

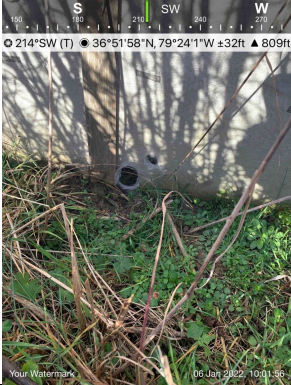
GPS Location	O	GPS Location	O		
Field Station#	15781+50	Field Station#	15800+00		
Pic 7 Desc.	Observing P1 that requires maintenance	Pic 8 Desc.	Observing CFS that requires maintenance

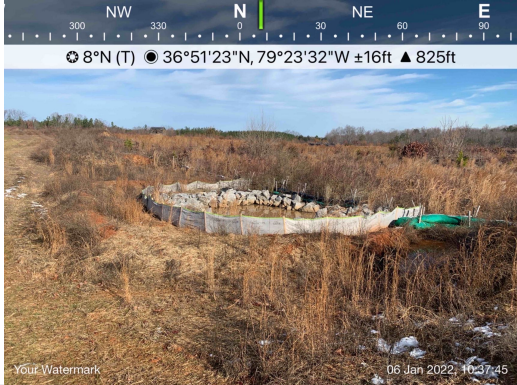
<p>Insert image here</p>			
GPS Location	O	GPS Location			
Field Station#	15825+00	Field Station#			
Pic 9 Desc.	Observing temporary stabilization,plunge pool and ECD's	Pic 10 Desc.			
<p>Insert image here</p>		<p>Insert image here</p>			
GPS Location		GPS Location			
Field Station#		Field Station#			
Pic 11 Desc.		Pic 12 Desc.

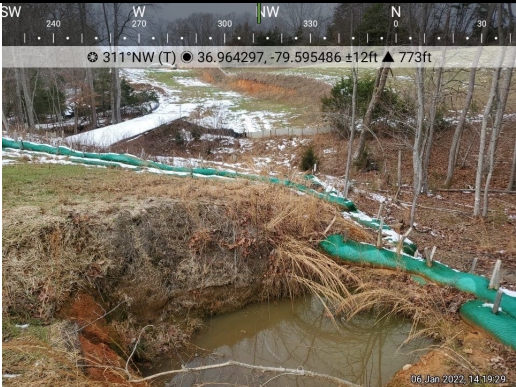
GPS Location	0	GPS Location	0		
Field Station#	15057+00	Field Station#	15052+00		
Pic 1 Desc.	GAS S-D2-EPH Perimeter ECDs		Pic 2 Desc.	Plunge pool

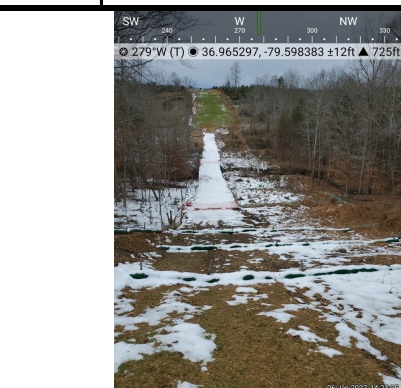
GPS Location	0	GPS Location	0		
Field Station#	15048+00	Field Station#	15045+00		
Pic 3 Desc.	GAS S-D2 Vegetation		Pic 4 Desc.	S-D2 Channel across ROW

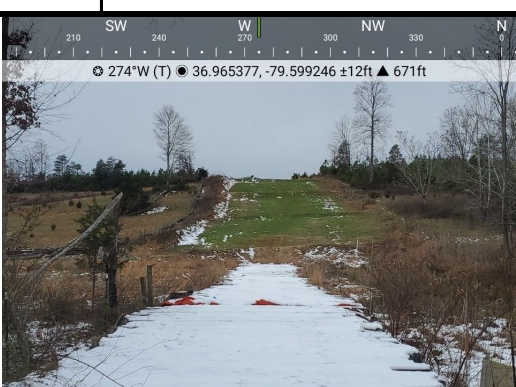
GPS Location	0	GPS Location	0		
Field Station#	15045+00	Field Station#	14990+00		
Pic 5 Desc.	CIS S-D2		Pic 6 Desc.	CIS S-D7

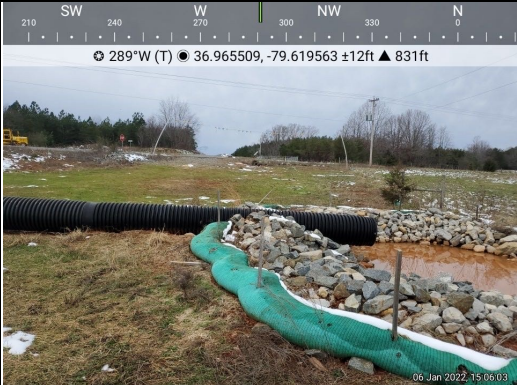
<div>ert image here</div>			
GPS Location	0	GPS Location	0		
Field Station#	14984+00	Field Station#	14978+00		
Pic 7 Desc.	Plunge pool outlet	Pic 8 Desc.	Perimeter CFS

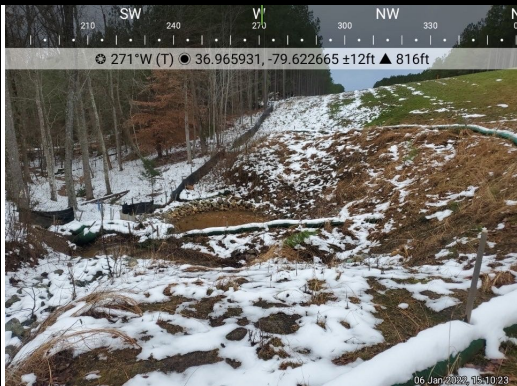
<div>ert image here</div>			
GPS Location	0	GPS Location	0		
Field Station#	14975+00	Field Station#	14966+00		
Pic 9 Desc.	Plunge pool outlet	Pic 10 Desc.	Dry swale

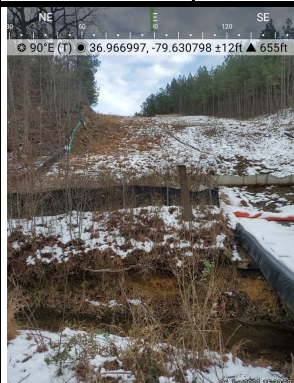
<div>ert image here</div>			
GPS Location	0	GPS Location	0		
Field Station#	14950+00	Field Station#	14941+20		
Pic 11 Desc.	S-G13 Vegetation and ECDs	Pic 12 Desc.	Perimeter CFS

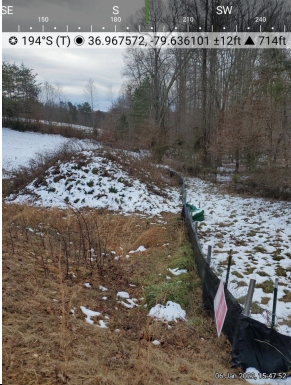
<p>GPS photo of ATWS Perimeter silt fence. Metadata: 194°S (T), 36.967572, -79.636101 ±12ft ▲ 714ft.</p>

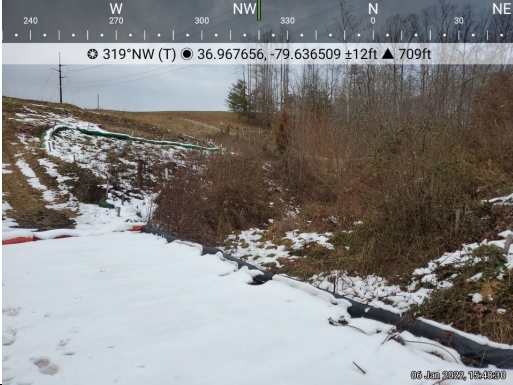
<p>GPS photo of S-G15 Buffer zone vegetation. Metadata: 319°NW (T), 36.967656, -79.636509 ±12ft ▲ 709ft.</p>			
GPS Location	0	GPS Location	0		
Field Station#	14934+50	Field Station#	14932+90		
Pic 13 Desc.	ATWS Perimeter silt fence	Pic 14 Desc.	S-G15 Buffer zone vegetation		
Insert image here		Insert image here			
GPS Location		GPS Location			
Field Station#		Field Station#			
Pic 15 Desc.		Pic 16 Desc.			
Insert image here		Insert image here			
GPS Location		GPS Location			
Field Station#		Field Station#			
Pic 17 Desc.		Pic 18 Desc.
