Visual Site Inspection Report

Project Name	H-600 Pipeline Spread I		AFE	124300139	Spread	H-600 Pipeline Spread I	
Contractor	Precision				Report #	33721	
Inspector	Ben Davenport				Date/Time	1/31/2022 10:30 AM	
Permit #	TBD	Inspection Type	VA SWPP		Station Begin	15063+85	
State	VA	Inspection Area	Partial		Station End	15142+66	
County	Pittsylvania	Ground	Frozen		Temperature (°F)	40.00	
Municipality	Chatham	Weather	Sunny		Rain Gauge (in)	1.00	
					Rain Accumulation Time (days)	0.00

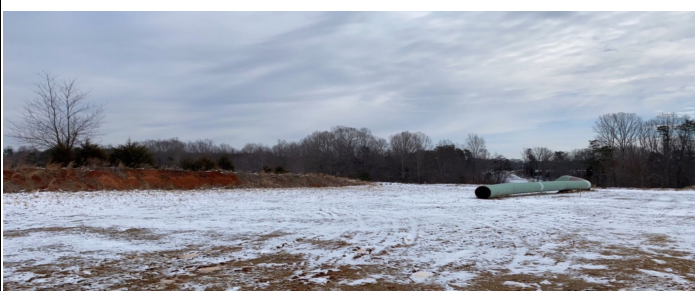
36°57'47" N 79°35'35" W 318°NW COURSE 103° GPS 1918-2164 Armstrong Rd, Penhook, VA 24137, United States 01.31.2022 11:11:19 Accur +/-28.7 Ft ALT 925 Ft			36°57'46" N 79°35'35" W 162°S COURSE 183° GPS 1918-2164 Armstrong Rd, Penhook, VA 24137, United States 01.31.2022 11:11:33 Accur +/-16.6 Ft ALT 923 Ft		
GPS Location	1	GPS Location	2		
Field Station#	15065+00	Field Station#	15067+00		
Pic 1 Desc.	ROW stabilized and vegetated in temporary area; snow still covering much of ROW.		Pic 2 Desc.	Temporary diversion berm stabilized and vegetated.

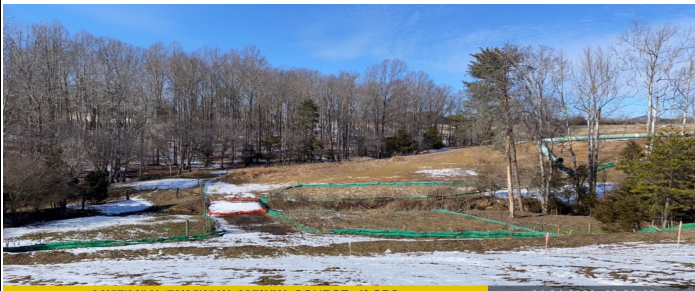
Field Station#	15092+05	Field Station#	15099+00		
Pic 3 Desc.	Equipment bridge and surrounding ECDs in place and functional at stream crossing and resource buffer; signage visible and intact.		Pic 4 Desc.	ROW stabilized and vegetated in final cleanup area.

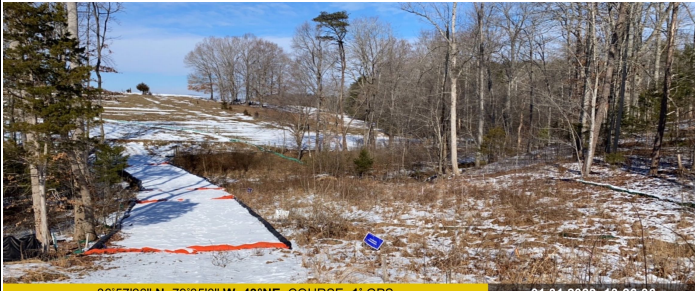
36°57'26" N 79°35'0" W 43°NE COURSE -1° GPS 8776 Museville Rd, Sandy Level, VA 24161, United States 01.31.2022 13:26:36 Accur +/-263.1 Ft ALT 927 Ft			36°57'26" N 79°35'0" W 37°NE COURSE 326° GPS Sandy Level, VA 24161, United States 01.31.2022 13:26:48 Accur +/-43.7 Ft ALT 874 Ft		
GPS Location	5	GPS Location	6		
Field Station#	15103+45	Field Station#	15105+00		
Pic 5 Desc.	Equipment bridge and surrounding ECDs in place and functional at stream crossing and resource buffer; signage visible and intact.		Pic 6 Desc.	Perimeter SSF in place and functional.

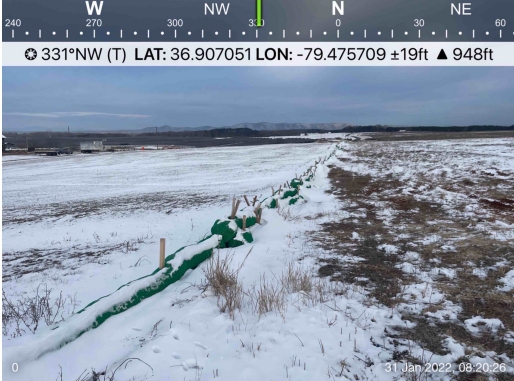
GPS Location	See photo		GPS Location	See photo	
Field Station#	15490+00		Field Station#	15495+00	
Pic 1 Desc.	Perimeter CFS is in good condition.		Pic 2 Desc.	This section of ROW remains temporarily stabilized.

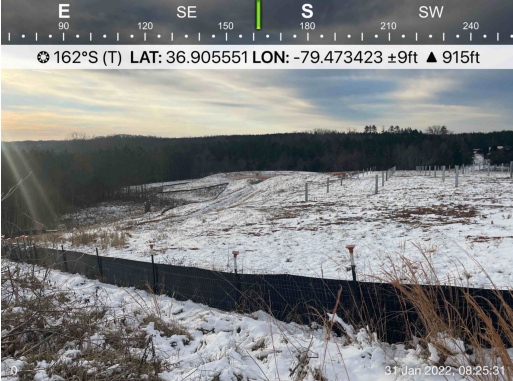
GPS Location	See photo		GPS Location	See photo	
Field Station#	15496+00		Field Station#	15501+00	
Pic 3 Desc.	RCEs are in good condition at all road crossings.		Pic 4 Desc.	No evidence of sedimentation from 3rd party disturbance.

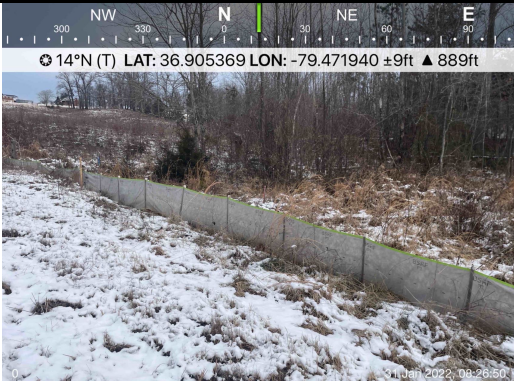
GPS Location	See photo		GPS Location	See photo	
Field Station#	15507+00		Field Station#	15510+00	
Pic 5 Desc.	P1 is in good condition at all stream and wetland buffers.		Pic 6 Desc.	3rd party ECDs appear to be in good condition.

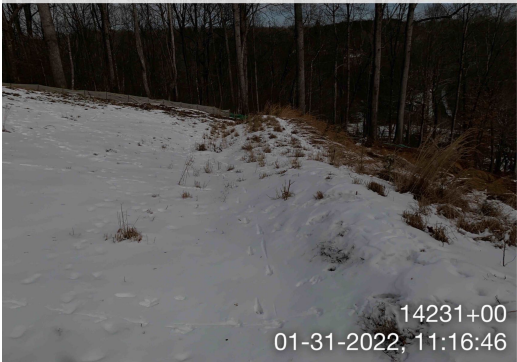
<p>19°N (T) 37°3'18"N, 79°49'51"W ±16ft ▲976ft 14231+00 01-31-2022, 11:16:46</p>

<p>302°NW (T) 37°2'42"N, 79°50'25"W ±13123ft ▲898ft 14209+0 01-31-2022, 09:57:07</p>			
GPS Location	0	GPS Location	0		
Field Station#	14231+00	Field Station#	14209+00		
Pic 7 Desc.	Waterbar in acceptable condition		Pic 8 Desc.	Equipment bridges in acceptable conditions

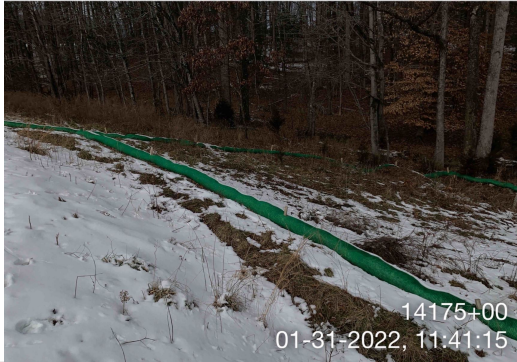
<p>331°NW (T) 37°3'29"N, 79°50'42"W ±419ft ▲1003ft 14175+00 01-31-2022, 11:41:15</p>		<p style="text-align: center;">Insert image here</p>			
GPS Location	0	GPS Location			
Field Station#	14175+00	Field Station#			
Pic 9 Desc.	CFS in acceptable condition		Pic 10 Desc.		
<p style="text-align: center;">Insert image here</p>			<p style="text-align: center;">Insert image here</p>		
GPS Location		GPS Location			
Field Station#		Field Station#			
Pic 11 Desc.			Pic 12 Desc.

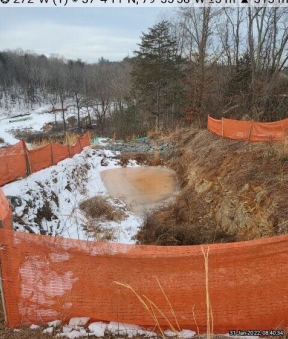
GPS Location	00000	GPS Location	00000		
Field Station#	13784+44	Field Station#	13755+49		
Pic 1 Desc.	Observed sump pit and plunge pool after recent snow event, no environmental issues observed at the time of inspection.		Pic 2 Desc.	Stream observation photo facing upstream during routine inspection today, no environmental issues observed at the time of inspection.	
	North East Elevation

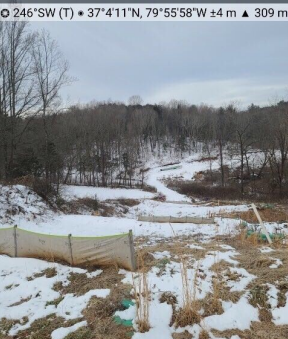
GPS Location	0000	GPS Location	00000		
Field Station#	13784+00	Field Station#	13748+97		
Pic 3 Desc.	Monitored ECDs on hill side above stream crossing after recent snow event, no environmental issues observed at the time of inspection.		Pic 4 Desc.	Monitored ECDs at stream crossing, all functioning properly at the time of inspection.

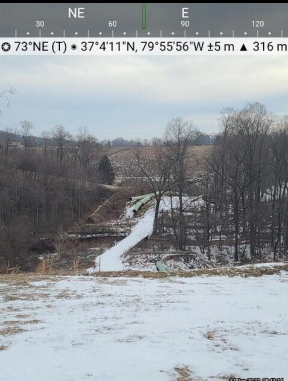
Field Station#	13786+00	Field Station#	13755+49		
Pic 5 Desc.	Row photo showing snow after snow events from the weekend, no environmental issues observed at the time of inspection.		Pic 6 Desc.	Monitored equipment bridge and protection, inspected ECDs at stream crossing, no environmental issues observed at the time of inspection.

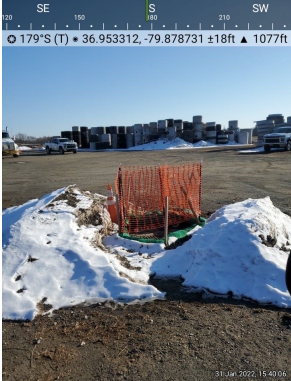
GPS Location	0	GPS Location	0		
Field Station#	0+00	Field Station#	0+00		
Pic 7 Desc.	ANC-006 Stormwater drain inlet perimeter protection	Pic 8 Desc.	ANC-006 Southeast perimeter CFS		
Insert image here		Insert image here			
GPS Location		GPS Location			
Field Station#		Field Station#			
Pic 9 Desc.		Pic 10 Desc.			
Insert image here		Insert image here			
GPS Location		GPS Location			
Field Station#		Field Station#			
Pic 11 Desc.		Pic 12 Desc.

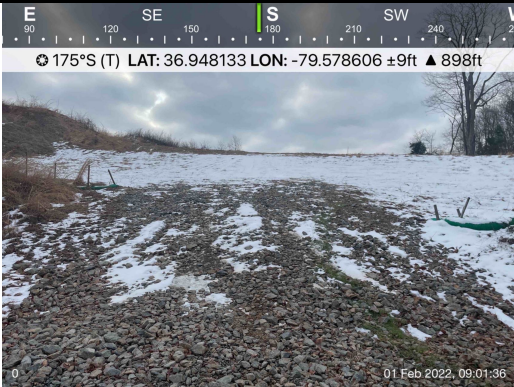
GPS Location	See photo		GPS Location	See photo	
Field Station#	15142+66		Field Station#	15150+00	
Pic 1 Desc.	RCE is in good condition at Rockcreek Rd.		Pic 2 Desc.	Perimeter CFS is in good condition.

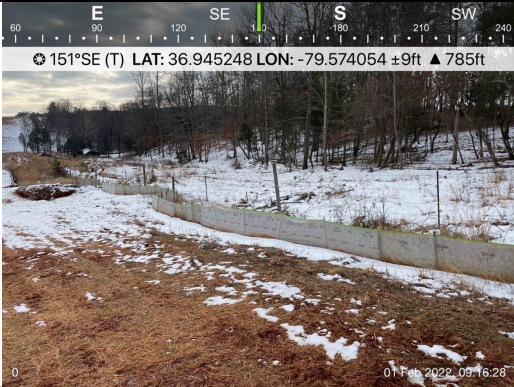
GPS Location	See photo		GPS Location	See photo	
Field Station#	15160+00		Field Station#	15165+57	
Pic 3 Desc.	Perimeter P1 is in good condition		Pic 4 Desc.	Rock inlet remains in good condition.

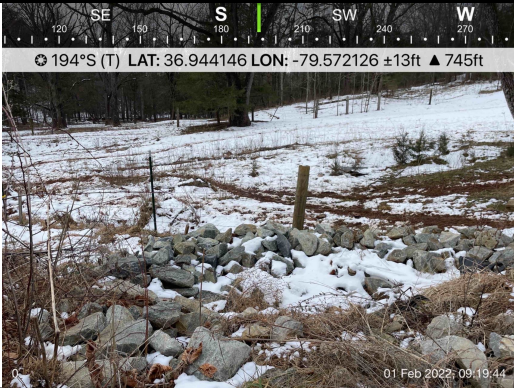
GPS Location	See photo		GPS Location	See photo	
Field Station#	15166+00		Field Station#	15167+68	
Pic 5 Desc.	Rock outlet remains in good condition		Pic 6 Desc.	P1 is in good condition at stream buffer.

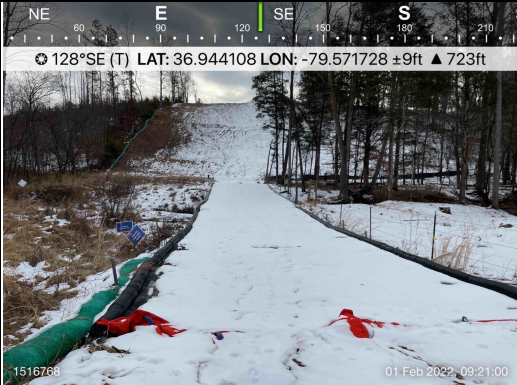
GPS Location	See photo		GPS Location	See photo	
Field Station#	15167+68		Field Station#	15170+00	
Pic 7 Desc.	Equipment bridge ECDs are in place and functioning.		Pic 8 Desc.	Slope drain is in good condition and functioning as intended.

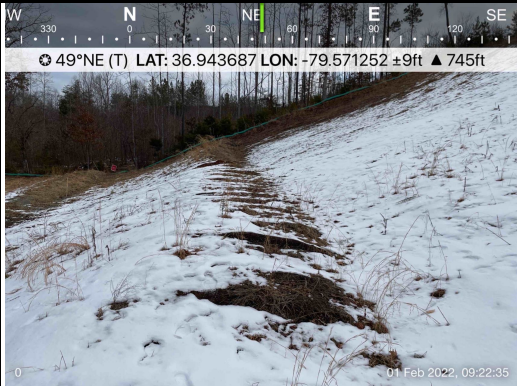
GPS Location	See photo		GPS Location	See photo	
Field Station#	15170+00		Field Station#	15195+00	
Pic 9 Desc.	Waterbars are in good condition.		Pic 10 Desc.	Drainage ECDs are in good condition and functioning.

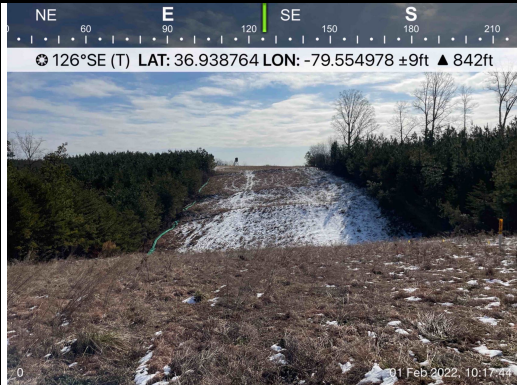
<div>Insert image here</div>			
GPS Location	See photo		GPS Location		
Field Station#	15225+00		Field Station#		
Pic 11 Desc.	Vegetation continues to fill in throughout this section.		Pic 12 Desc.

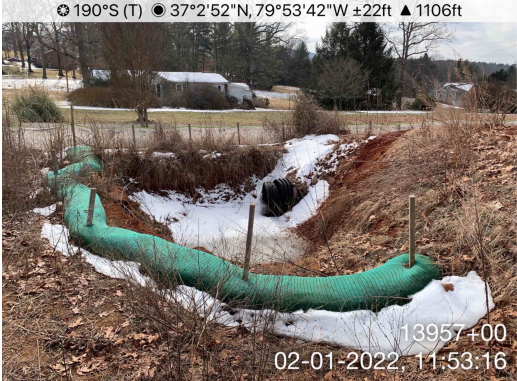
<p>13957+00 02-01-2022, 11:53:16</p>

<p>13949+70 02-01-2022, 11:57:12</p>			
GPS Location	0	GPS Location	0		
Field Station#	13957+00	Field Station#	13949+70		
Pic 7 Desc.	Slope drain pipe in acceptable condition		Pic 8 Desc.	Equipment bridge in acceptable condition	
Insert image here			Insert image here		
GPS Location		GPS Location			
Field Station#		Field Station#			
Pic 9 Desc.			Pic 10 Desc.		
Insert image here			Insert image here		
GPS Location		GPS Location			
Field Station#		Field Station#			
Pic 11 Desc.			Pic 12 Desc.

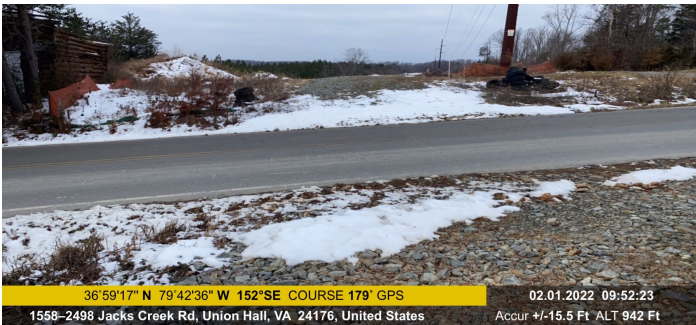
GPS Location			3	GPS Location		4					
Field Station#			14764+00	Field Station#		14694+77					
Pic 3 Desc.			Routine maintenance. Repair damaged perimeter SSF.			Pic 4 Desc.			RCE in good condition.

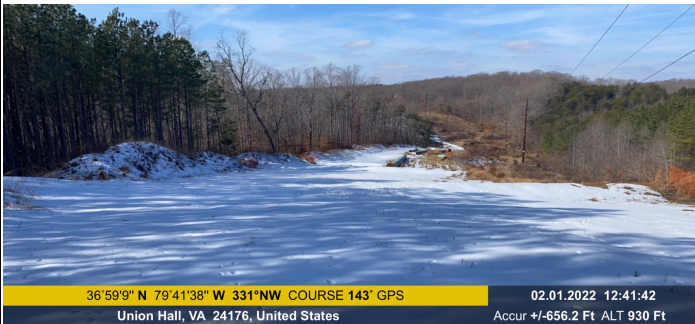
GPS Location			5	GPS Location		6					
Field Station#			14738+00	Field Station#		14766+11					
Pic 5 Desc.			ROW covered in snow; stabilized and vegetated in temporary area.			Pic 6 Desc.			Equipment bridge and surrounding ECDs in place and functional at stream crossing and resource buffer.

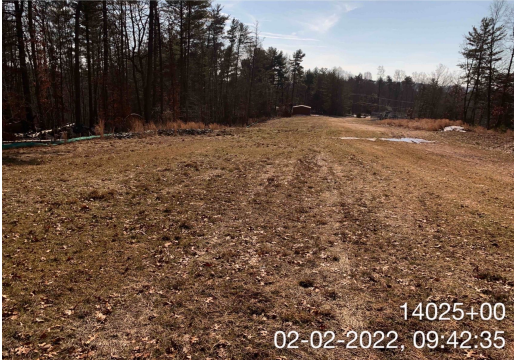
GPS Location	0	GPS Location	0		
Field Station#	14025+00	Field Station#	14031+00		
Pic 1 Desc.	Temporary vegetative stabilization in acceptable condition		Pic 2 Desc.	Waterbar in acceptable

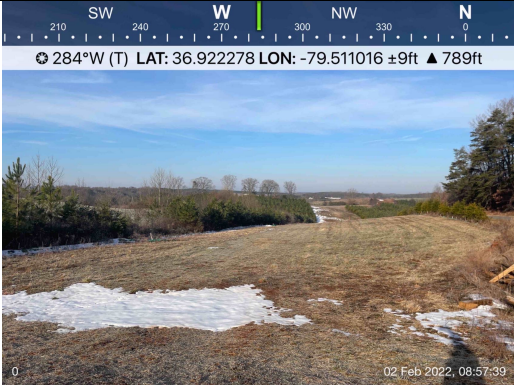
GPS Location	See photo		GPS Location	See photo	
Field Station#	15370+00		Field Station#	15350+00	
Pic 1 Desc.	Vegetation continues to fill in throughout this section.		Pic 2 Desc.	MVP-PI-332 remains in good condition with controls in place.

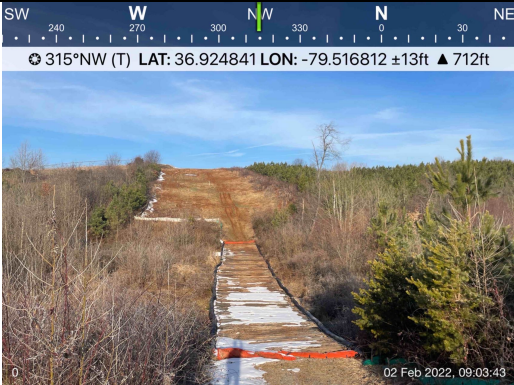
GPS Location	See photo		GPS Location	See photo	
Field Station#	15346+87		Field Station#	15346+00	
Pic 3 Desc.	Equipment bridge ECDs are in place and functioning.		Pic 4 Desc.	P1 is in good condition at all stream and wetland buffers.

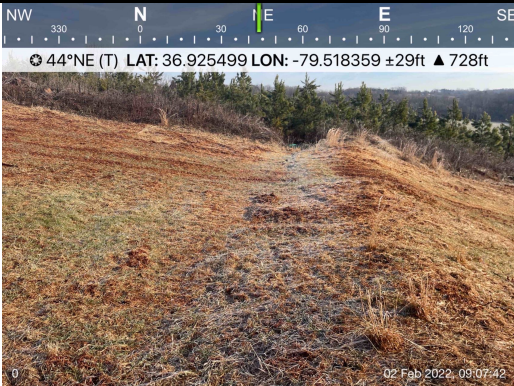
GPS Location	See photo		GPS Location	See photo	
Field Station#	15345+00		Field Station#	15338+00	
Pic 5 Desc.	Waterbars are in good condition.		Pic 6 Desc.	CWDs are functioning as intended.

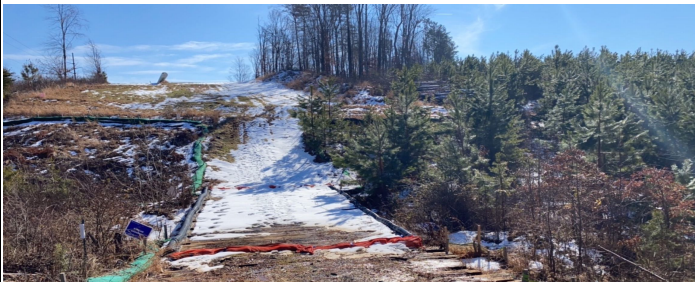
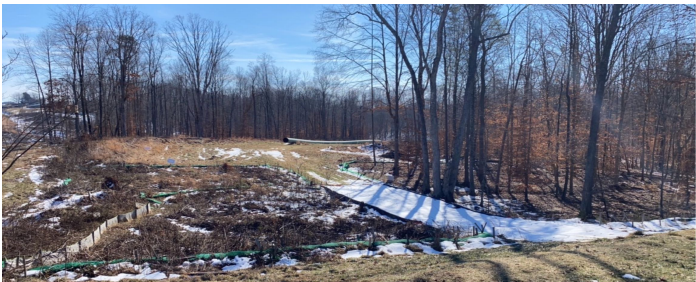
36°58'35" N 79°40'39" W 147°SE COURSE 112° GPS Penhook, VA 24137, United States 02.02.2022 11:13:38 Accur +/-62.8 Ft ALT 0 Ft			36°58'29" N 79°40'29" W 195°S COURSE 77° GPS Penhook, VA 24137, United States 02.02.2022 11:18:53 Accur +/-72.5 Ft ALT 921 Ft		
GPS Location	1	GPS Location	2		
Field Station#	14804+99	Field Station#	14816+07		
Pic 1 Desc.	Equipment bridge and surrounding ECDs in place and functional at stream crossing and resource buffer; all signage visible and intact.		Pic 2 Desc.	Equipment bridge and surrounding ECDs in place and functional at stream crossing and resource buffer; all signage visible and intact.

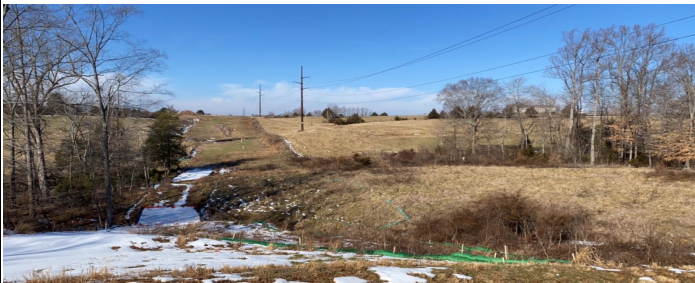
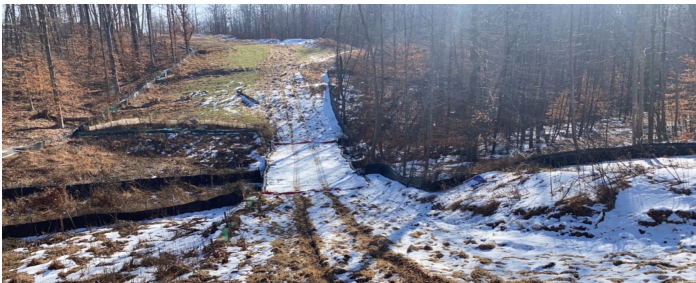
GPS Location	3	GPS Location	4		
Field Station#	14854+75	Field Station#	14870+43		
Pic 3 Desc.	Equipment bridge and surrounding ECDs in place and functional at stream crossing and resource buffer; all signage visible and intact.		Pic 4 Desc.	Equipment bridge and surrounding ECDs in place and functional at stream crossing and resource buffer; all signage visible and intact.

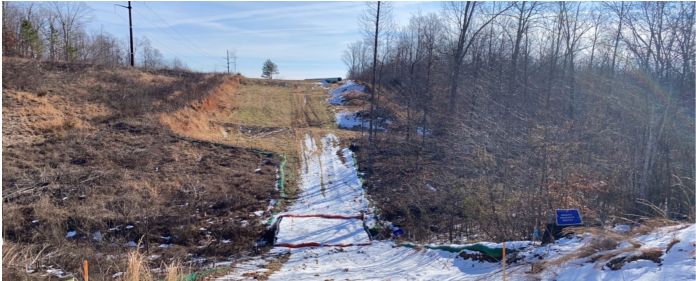
36°58'13" N 79°39'14" W 116°SE COURSE 50° GPS 1760 Bar Ridge Rd, Penhook, VA 24137, United States 02.02.2022 10:14:57 Accur +/-76.1 Ft ALT 936 Ft			36°58'13" N 79°39'10" W 127°SE COURSE 85° GPS Penhook, VA 24137, United States 02.02.2022 10:19:23 Accur +/-237.2 Ft ALT 916 Ft		
GPS Location	5	GPS Location	6		
Field Station#	14881+54	Field Station#	1888+69		
Pic 5 Desc.	Equipment bridge and surrounding ECDs in place and functional at stream crossing and resource buffer; all signage visible and intact.		Pic 6 Desc.	Equipment bridge and surrounding ECDs in place and functional at stream crossing and resource buffer; all signage visible and intact.

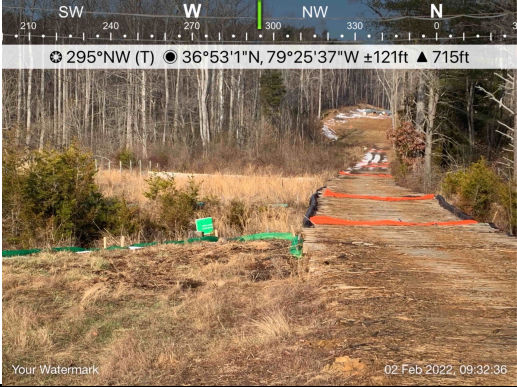
GPS Location O		GPS Location O			
Field Station# 15671+93		Field Station# 15647+90			
Pic 7 Desc. Observing temporary stabilization, signage, buffer, equipment crossing and ECD's		Pic 8 Desc. Observing CFS that requires maintenance

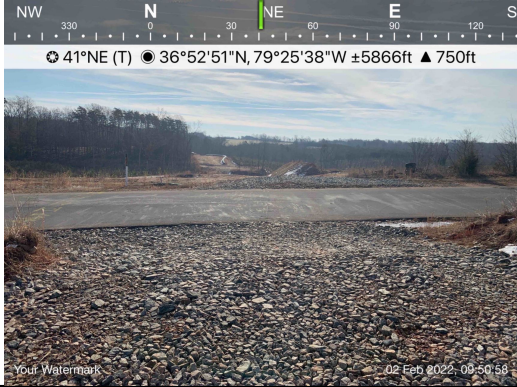
GPS Location O		GPS Location O			
Field Station# 15693+89		Field Station# 15739+50			
Pic 9 Desc. Observing road crossing and RCE's		Pic 10 Desc. Observing trash that needs to be removed from the ATWS.			
<div style="text-align: center; height: 150px;">Insert image here</div>		<div style="text-align: center; height: 150px;">Insert image here</div>			
GPS Location		GPS Location			
Field Station#		Field Station#			
Pic 11 Desc.		Pic 12 Desc.

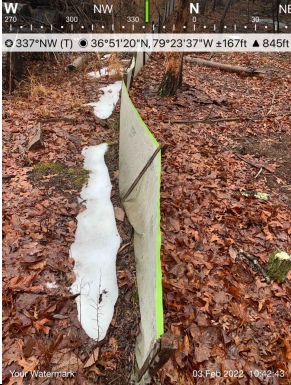
GPS Location	O	GPS Location	O		
Field Station#	15827+50	Field Station#	15825+00		
Pic 7 Desc.	Observing P1 that requires maintenance	Pic 8 Desc.	Observing temporary stabilization, plunge pool and ECD's

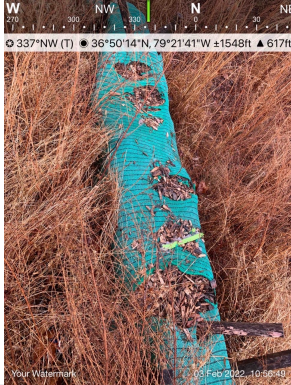
GPS Location	O	GPS Location	O		
Field Station#	15944+50	Field Station#	15944+50		
Pic 9 Desc.	Observing CFS that requires maintenance	Pic 10 Desc.	Observing P1 that requires maintenance		
Insert image here		Insert image here			
GPS Location		GPS Location			
Field Station#		Field Station#			
Pic 11 Desc.		Pic 12 Desc.

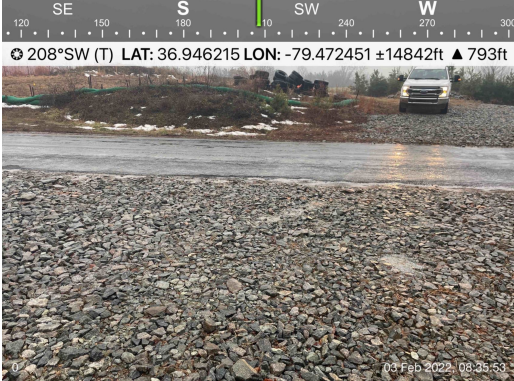
GPS Location	See photo	GPS Location	See photo		
Field Station#	15370+62	Field Station#	15375+00		
Pic 1 Desc.	RCEs are in good condition at all road crossings.	Pic 2 Desc.	Drainage ECDs are in good condition and functioning.

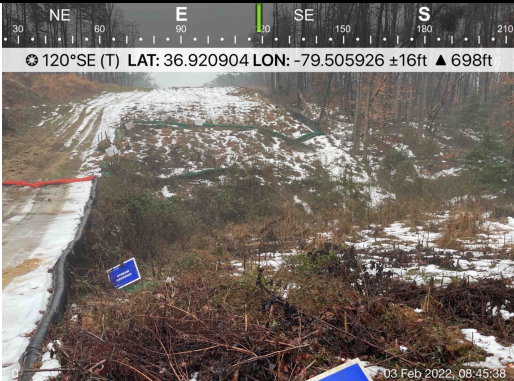
GPS Location	See photo	GPS Location	See photo		
Field Station#	15384+74	Field Station#	15384+74		
Pic 5 Desc.	Resource buffers remain in good condition.	Pic 6 Desc.	Equipment bridge ECDs are in good condition and functioning.

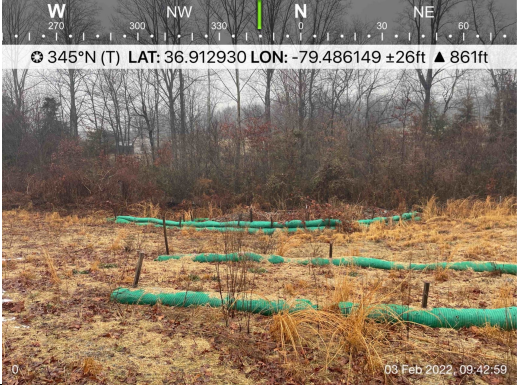
GPS Location	See photo		GPS Location	See photo	
Field Station#	15445+00		Field Station#	15453+00	
Pic 7 Desc.	Perimeter CFS is in good condition throughout this section.		Pic 8 Desc.	CWD are in good condition.

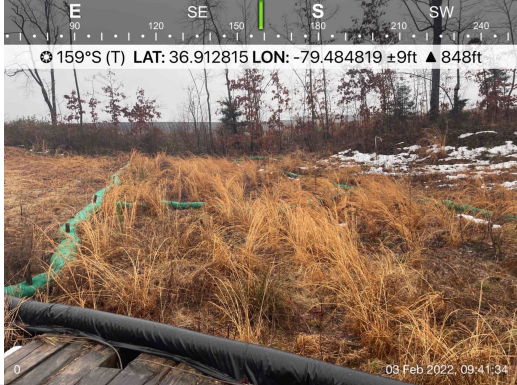
GPS Location	See photo		GPS Location	See photo	
Field Station#	15457+00		Field Station#	15460+81	
Pic 9 Desc.	No evidence of sedimentation from 3rd party disturbance within drainage feature.		Pic 10 Desc.	CWD remains in good condition.

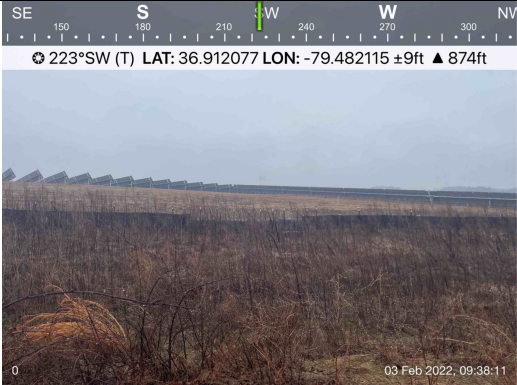
GPS Location	See photo		GPS Location	See photo	
Field Station#	15460+81		Field Station#	15465+00	
Pic 11 Desc.	No evidence of sedimentation from 3rd party disturbance into CWD inlet.		Pic 12 Desc.	No evidence of sedimentation from 3rd party disturbance.

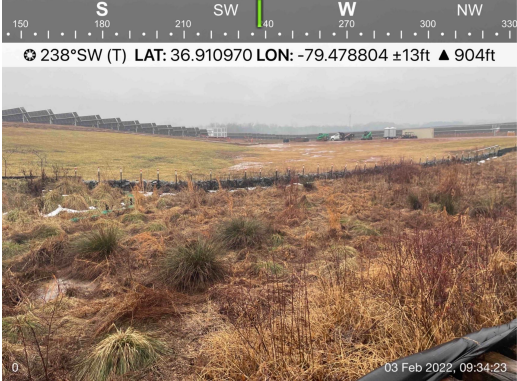
GPS Location	See photo	GPS Location			
Field Station#	15475+00	Field Station#			
Pic 13 Desc.	3rd party rock outlet appears to be in good condition along this drainage.	Pic 14 Desc.			
Insert image here		Insert image here			
GPS Location		GPS Location			
Field Station#		Field Station#			
Pic 15 Desc.		Pic 16 Desc.			
Insert image here		Insert image here			
GPS Location		GPS Location			
Field Station#		Field Station#			
Pic 17 Desc.		Pic 18 Desc.

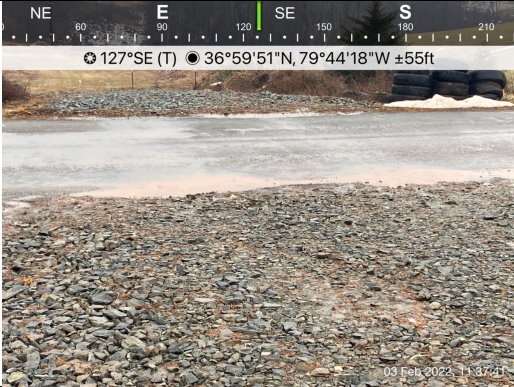
GPS Location	0	GPS Location	0		
Field Station#	14599+50	Field Station#	14604+00		
Pic 1 Desc.	Approximately 14599+50. Overview of road crossing and RCEs.	Pic 2 Desc.	Approximately 14604+00. Overview of ROW.

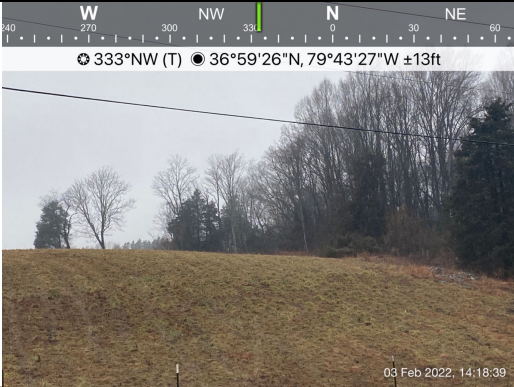
GPS Location	0	GPS Location	0		
Field Station#	14647+00	Field Station#	14568+10		
Pic 3 Desc.	Approximately 14647+00. Overview of ROW.	Pic 4 Desc.	Approximately 14568+10. Overview of stream crossing, equipment bridge and ECDs at stream S-E18.

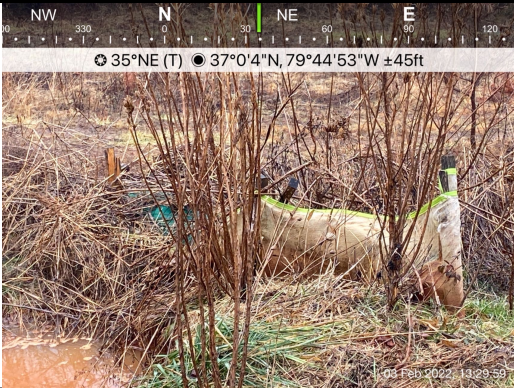
GPS Location	0	GPS Location	0		
Field Station#	14566+50	Field Station#	14555+00		
Pic 5 Desc.	Approximately 14566+50. P-1 requires maintenance. Weathered and torn fabric and stakes.	Pic 6 Desc.	Approximately 14555+00. Overview of ROW.

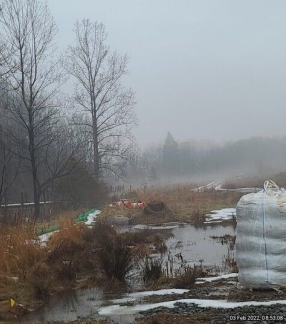
GPS Location	0000	GPS Location	0000		
Field Station#	1369+00	Field Station#	13678+71		
Pic 1 Desc.	Monitored LOD ECDs during rain events today, no environmental issues observed at the time of inspection.		Pic 2 Desc.	Stream observation photo facing upstream during routine inspection today, no environmental issues observed at the time of inspection during light rain events.	
	North East Elevation 223°SW (T) • 37.088524, -79.95024 ±3 m ▲ 316 m

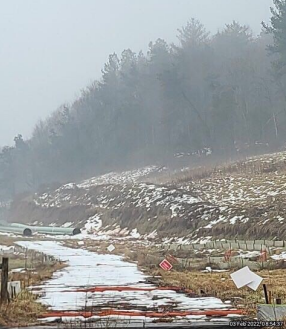
GPS Location	0000	GPS Location	0000		
Field Station#	13678+71	Field Station#	13691+25		
Pic 3 Desc.	Stream observation photo facing downstream during routine inspection today, no issues observed during rain events throughout today.		Pic 4 Desc.	Observed ECDs around wetland area during rain events, no environmental issues observed at the time of inspection I

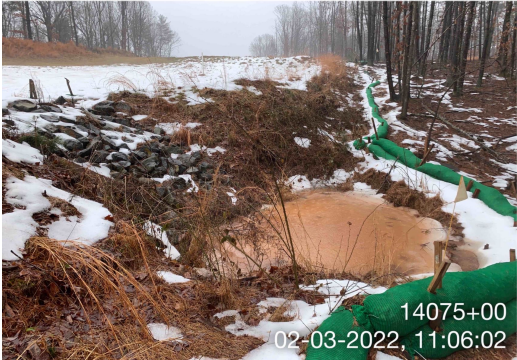
<p>14075+00 02-03-2022, 11:06:02</p>

<p>14072+00 02-03-2022, 11:07:51</p>			
GPS Location	0	GPS Location	0		
Field Station#	14075+00	Field Station#	14072+00		
Pic 7 Desc.	Sump pit and perimeter CFS in acceptable conditions	Pic 8 Desc.	Temporary vegetative stabilization in acceptable condition		
Insert image here		Insert image here			
GPS Location		GPS Location			
Field Station#		Field Station#			
Pic 9 Desc.		Pic 10 Desc.			
Insert image here		Insert image here			
GPS Location		GPS Location			
Field Station#		Field Station#			
Pic 11 Desc.		Pic 12 Desc.

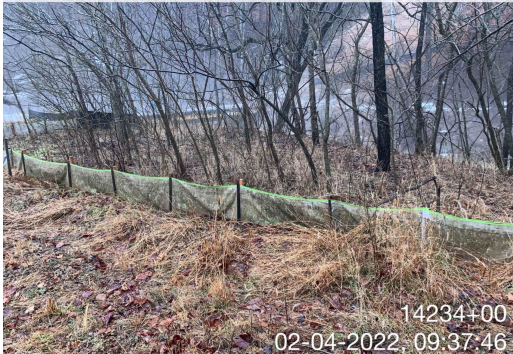
<div>14234+00 02-04-2022 12:05:23</div>			
GPS Location	0		GPS Location	0	
Field Station#	14234+00		Field Station#	14234+00	
Pic 1 Desc.	P1 silt fence is old and weathered. The contractor replaced it immediately		Pic 2 Desc.	P1 silt fence after replacement.	
<div>☉ 225°SW (T) ● 37°3'19"N, 79°49'47"W ±16ft ▲ 872ft</div>

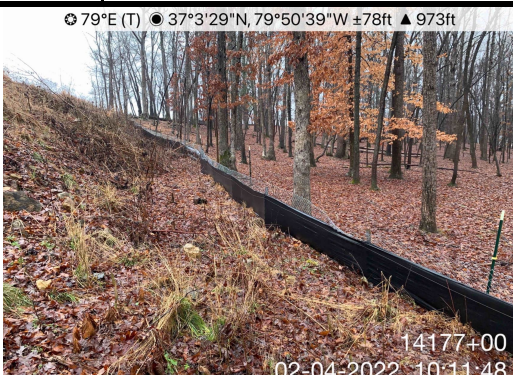
<div>14222+00 02-04-2022 10:44:44</div>			
GPS Location	0		GPS Location	0	
Field Station#	14177+00		Field Station#	14222+00	
Pic 5 Desc.	Super silt fence in acceptable condition		Pic 6 Desc.	Waterbar in acceptable condition

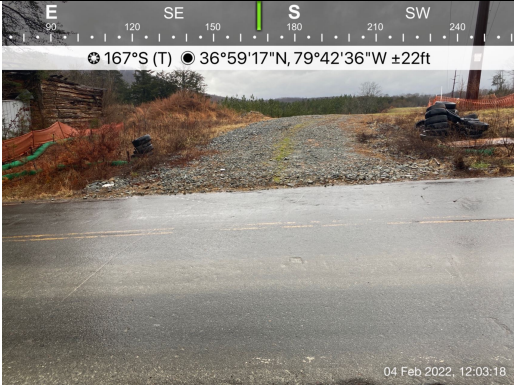
GPS Location	0	GPS Location	0		
Field Station#	14694+77	Field Station#	14569+00		
Pic 1 Desc.	Approximately 14694+77. Overview of road crossing and RCE.		Pic 2 Desc.	Approximately 14569+00. Overview of the property northeast of ROW. Runoff from disturbed adjacent property in flowing across ROW into wetland W-H17 and stream S-H38.

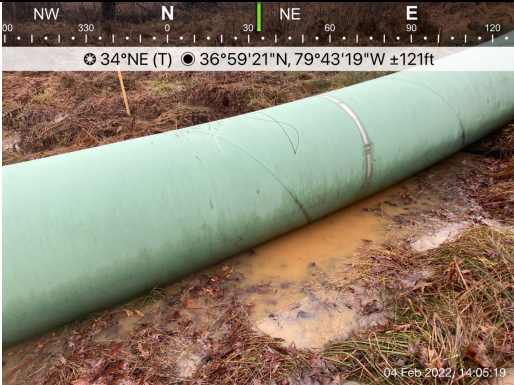
GPS Location	0	GPS Location	0		
Field Station#	14657+75	Field Station#	14656+91		
Pic 3 Desc.	Approximately 14657+75. Wetland W-H17.		Pic 4 Desc.	Approximately 14656+91. Downstream view of stream S-H38.

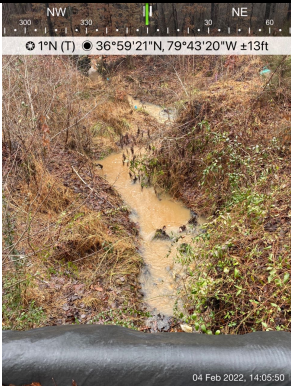
GPS Location	0	GPS Location	0		
Field Station#	14656+91	Field Station#	14658+75		
Pic 5 Desc.	Approximately 14656+91. Upstream view of stream S-H38.		Pic 6 Desc.	Approximately 14658+75. P-1 requires maintenance. Appears to have been damaged by wildlife.

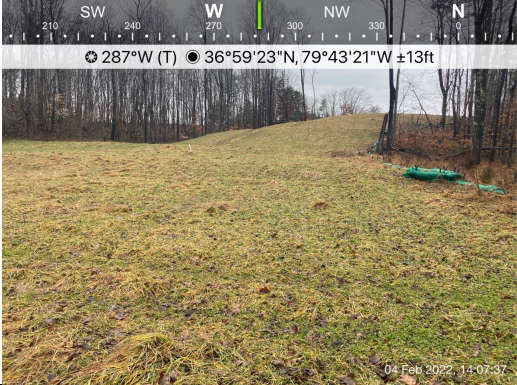
GPS Location	0	GPS Location			
Field Station#	14653+00	Field Station#			
Pic 13 Desc.	Approximately 14653+00. Overview of ROW.	Pic 14 Desc.			
Insert image here		Insert image here			
GPS Location		GPS Location			
Field Station#		Field Station#			
Pic 15 Desc.		Pic 16 Desc.			
Insert image here		Insert image here			
GPS Location		GPS Location			
Field Station#		Field Station#			
Pic 17 Desc.		Pic 18 Desc.

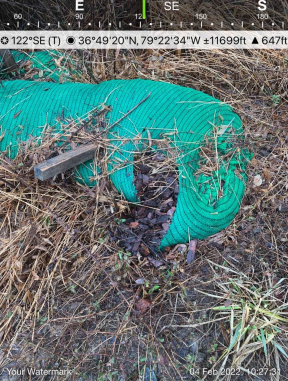
GPS Location	O	GPS Location	O		
Field Station#	16026+50	Field Station#	16026+30		
Pic 1 Desc.	Observing CFS that requires maintenance	Pic 2 Desc.	Observing P1 that requires maintenance

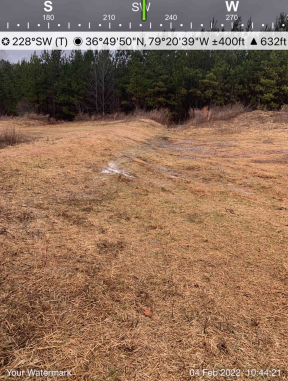
GPS Location	O	GPS Location	O		
Field Station#	16020+00	Field Station#	16022+00		
Pic 3 Desc.	Observing temporary stabilization and water bar	Pic 4 Desc.	Observing temporary stabilization, sump and end treatment

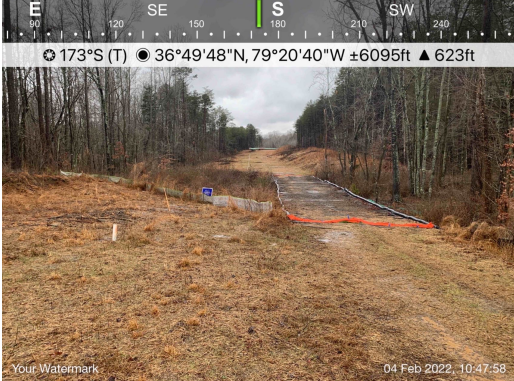
GPS Location	O	GPS Location	O		
Field Station#	16016+36	Field Station#	16010+00		
Pic 5 Desc.	Observing temporary stabilization, signage, buffer, equipment crossing and ECD's	Pic 6 Desc.	Observing temporary stabilization, CWD outlet and ECD's

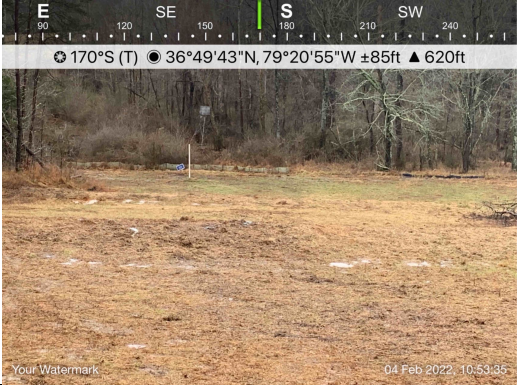
GPS Location	O	GPS Location	O		
Field Station#	16004+00	Field Station#	16006+00		
Pic 7 Desc.	Observing temporary stabilization, signage and buffer	Pic 8 Desc.	Observing CWD berm and temporary stabilization		
Insert image here		Insert image here			
GPS Location		GPS Location			
Field Station#		Field Station#			
Pic 9 Desc.		Pic 10 Desc.			
Insert image here		Insert image here			
GPS Location		GPS Location			
Field Station#		Field Station#			
Pic 11 Desc.		Pic 12 Desc.

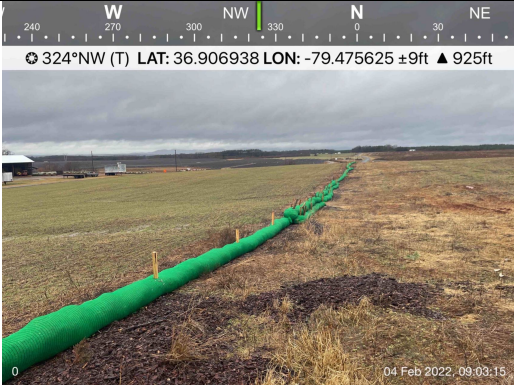
GPS Location	See photo	GPS Location	See photo		
Field Station#	15490+00	Field Station#	15495+00		
Pic 1 Desc.	Perimeter CFS is in good condition.	Pic 2 Desc.	Vegetation continues to fill in throughout this section.

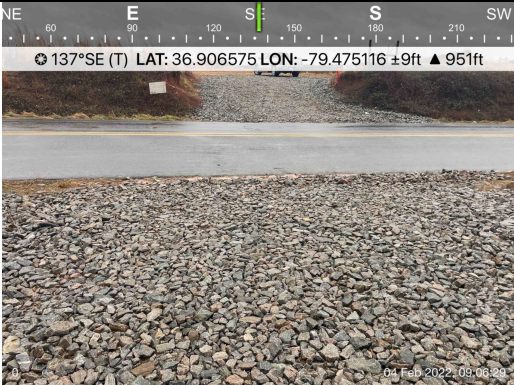
GPS Location	See photo	GPS Location	See photo		
Field Station#	15496+70	Field Station#	15501+00		
Pic 3 Desc.	RCEs are in good condition at all road crossings.	Pic 4 Desc.	No evidence of sedimentation from 3rd party disturbance.

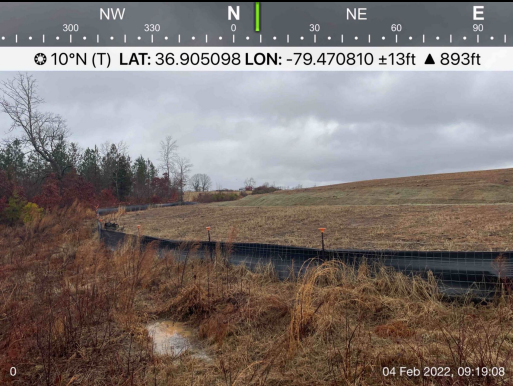
GPS Location	See photo	GPS Location	See photo		
Field Station#	15508+57	Field Station#	15510+00		
Pic 5 Desc.	P1 has been damaged and needs to be replaced.	Pic 6 Desc.	3rd party ECDs appear to be in good condition.

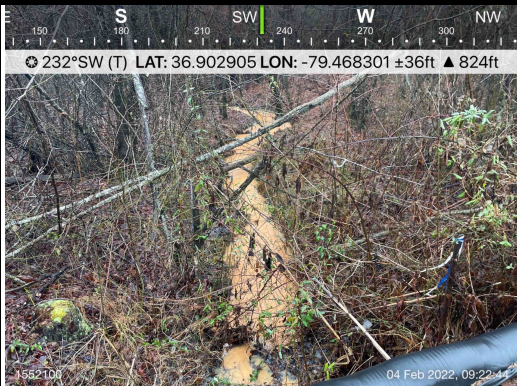
GPS Location	See photo		GPS Location	See photo	
Field Station#	15521+00		Field Station#	15525+00	
Pic 9 Desc.	S-MM8 downstream of ROW.		Pic 10 Desc.	Safety fence needs to be restaked.

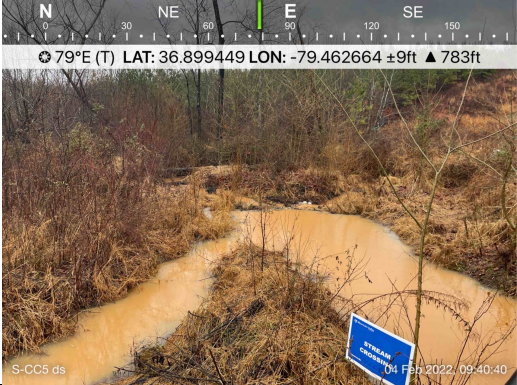
GPS Location	See photo		GPS Location	See photo	
Field Station#	15542+11		Field Station#	15575+00	
Pic 13 Desc.	S-CC5 crossing ROW.		Pic 14 Desc.	Slope drain is in good condition and functioning.

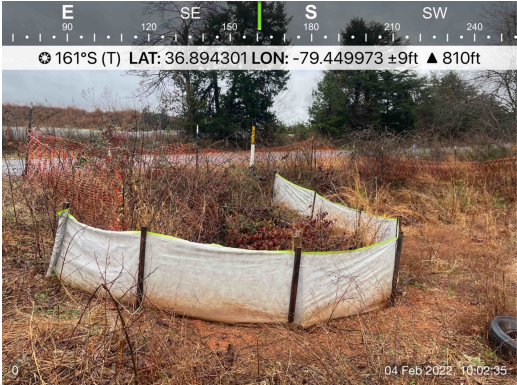
GPS Location	See photo		GPS Location	See photo	
Field Station#	15584+00		Field Station#	15542+11	
Pic 15 Desc.	P1 remains in good condition around road pipe outlet.		Pic 16 Desc.	S-CC5 crossing under Toshes Rd. upstream of ROW.	
Insert image here			Insert image here		
GPS Location			GPS Location		
Field Station#			Field Station#		
Pic 17 Desc.			Pic 18 Desc.

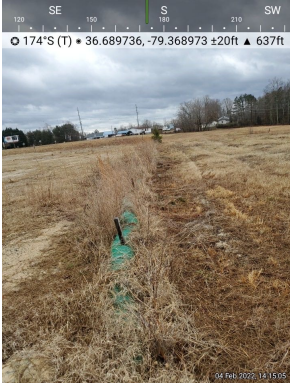
GPS Location	0	GPS Location	0		
Field Station#	0+00	Field Station#	0+00		
Pic 7 Desc.	LY-048 West perimeter CFS	Pic 8 Desc.	LY-048 Temporary vegetation		
Insert image here		Insert image here			
GPS Location		GPS Location			
Field Station#		Field Station#			
Pic 9 Desc.		Pic 10 Desc.			
Insert image here		Insert image here			
GPS Location		GPS Location			
Field Station#		Field Station#			
Pic 11 Desc.		Pic 12 Desc.
