Visual Site Inspection Report

Project Name	H-600 Pipeline Spread I	AFE	124300139	Spread	H-600 Pipeline Spread I
Contractor	Precision			Report #	32463
Inspector	Justin Burch			Date/Time	12/20/2021 12:00 PM
Permit #	TBD	Inspection Type	VA SWPP	Station Begin	13958+31
State	VA	Inspection Area	Full	Station End	14062+17
County	Franklin	Ground	Damp	Temperature (°F)	44.00
Municipality	N/A	Weather	Sunny	Rain Gauge (in)	0.10
				Rain Accumulation Time (days)	6.00

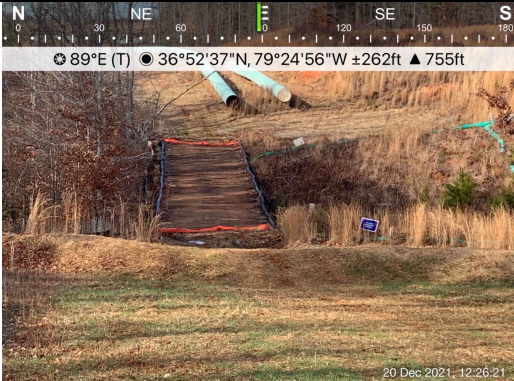
GPS Location	O	GPS Location	O		
Field Station#	15740+00	Field Station#	15735+00		
Pic 1 Desc.	Observing temporary stabilization, sump and end treatment	Pic 2 Desc.	Observing temporary stabilization, CWD outlet and ECD's

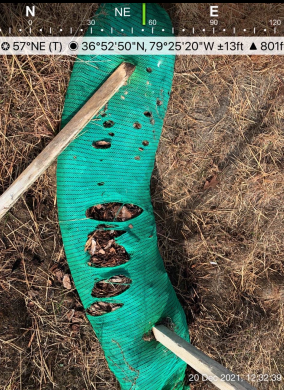
GPS Location	O	GPS Location	O		
Field Station#	15713+52	Field Station#	15693+89		
Pic 3 Desc.	Observing temporary stabilization, water bar, signage, buffer, equipment crossing and ECD's	Pic 4 Desc.	Observing road crossing and RCE's

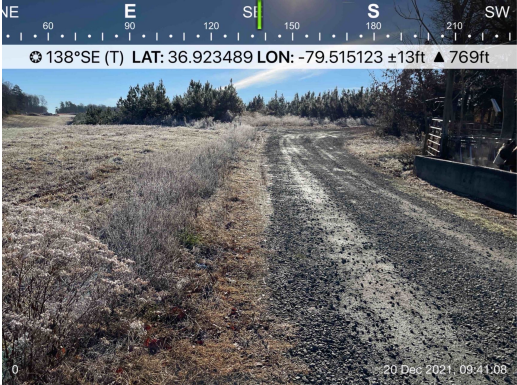
GPS Location	See photo		GPS Location	See photo	
Field Station#	15338+00		Field Station#	15345+00	
Pic 7 Desc.	CWD is in good condition and functioning.		Pic 8 Desc.	Waterbars are in good condition throughout this section.

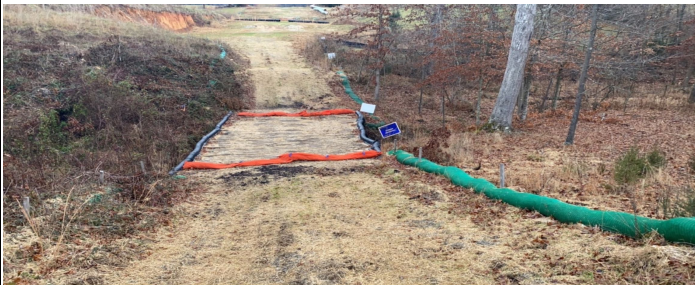
36°58'4" N 79°38'15" W 134°SE COURSE -1' GPS 2082 Ramsey Memorial Rd, Penhook, VA 24137, United States 12.21.2021 10:10:36 Accur +/-47.6 Ft ALT 865 Ft			36°58'4" N 79°38'14" W 148°SE COURSE 121' GPS 2082 Ramsey Memorial Rd, Penhook, VA 24137, United States 12.21.2021 10:10:54 Accur +/-14.7 Ft ALT 860 Ft		
GPS Location	1		GPS Location	2	
Field Station#	14929+50		Field Station#	14930+00	
Pic 1 Desc.	Perimeter SSF in good condition.		Pic 2 Desc.	Rock-lined channel performing intended function.

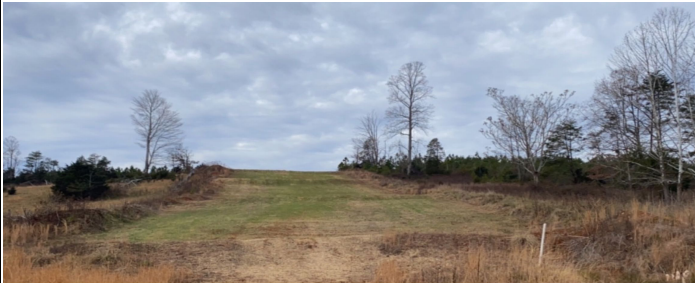
Field Station#	14932+89		Field Station#	14939+00	
Pic 3 Desc.	Equipment bridge and surrounding ECDs in place and functional at stream crossing and resource buffer.		Pic 4 Desc.	Natural drainage area performing intended function.

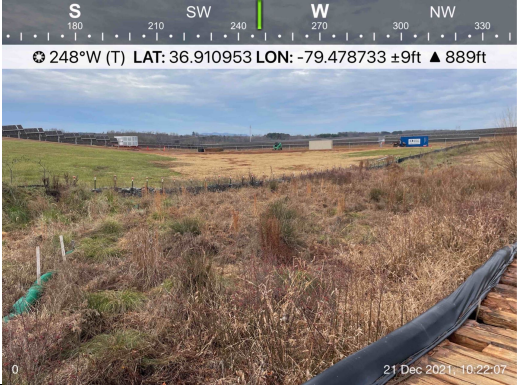
<p> S 180 SW 210 W 270 NW 330 248°W (T) LAT: 36.910953 LON: -79.478733 ±9ft ▲ 889ft 21 Dec 2021 10:22:07 </p>					
GPS Location	See photo	GPS Location			
Field Station#	15475+00	Field Station#			
Pic 13 Desc.	3rd party rock outlet appears to be in good condition.	Pic 14 Desc.			
Insert image here		Insert image here			
GPS Location		GPS Location			
Field Station#		Field Station#			
Pic 15 Desc.		Pic 16 Desc.			
Insert image here		Insert image here			
GPS Location		GPS Location			
Field Station#		Field Station#			
Pic 17 Desc.		Pic 18 Desc.

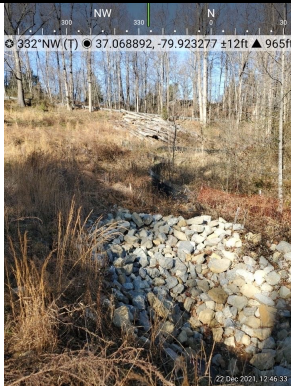
GPS Location	0	GPS Location	0		
Field Station#	13791+00	Field Station#	13789+00		
Pic 7 Desc.	S-D23 Equipment bridge	Pic 8 Desc.	S-D22 Buffer zone vegetation

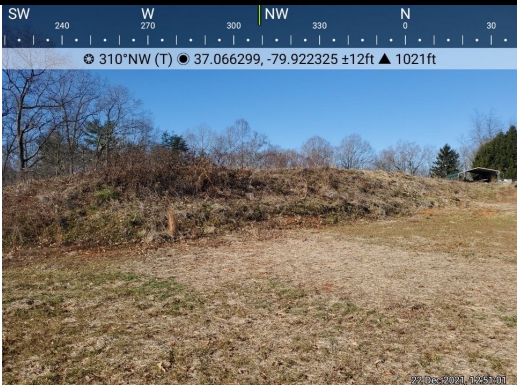
GPS Location	0	GPS Location	0		
Field Station#	13821+00	Field Station#	13823+00		
Pic 11 Desc.	Travel lane stabilization	Pic 12 Desc.	Soil stockpile stabilization

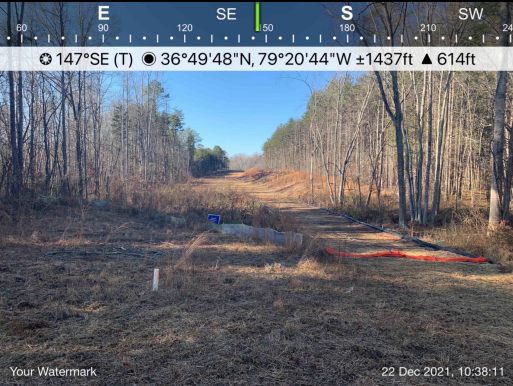
GPS Location	O	GPS Location	O		
Field Station#	16010+00	Field Station#	16012+00		
Pic 3 Desc.	Observing temporary stabilization, CWD outlet and ECD's	Pic 4 Desc.	Observing temporary stabilization, sump and end treatment

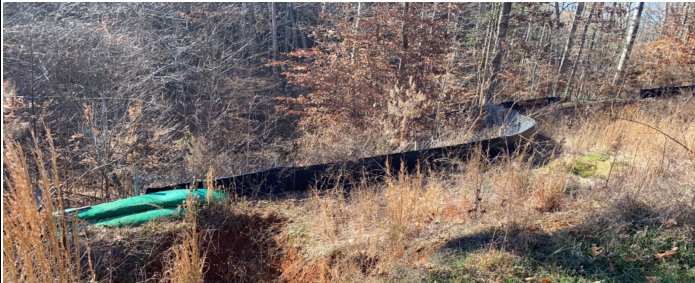
36°58'54" N 79°41'11" W 10°N COURSE 341' GPS Union Hall, VA 24176, United States Accur +/-27.9 Ft ALT 928 Ft			36°58'46" N 79°41'3" W 205°SW COURSE -1' GPS Union Hall, VA 24176, United States Accur +/-57.4 Ft ALT 869 Ft		
GPS Location 3			GPS Location 4		
Field Station# 14769+52			Field Station# 14782+25		
Pic 3 Desc. Equipment bridge and surrounding ECDs in place and functional at stream crossing and resource buffer; all signage visible and intact.			Pic 4 Desc. Equipment bridge and surrounding ECDs in place and functional at stream crossing and resource buffer; all signage visible and intact.

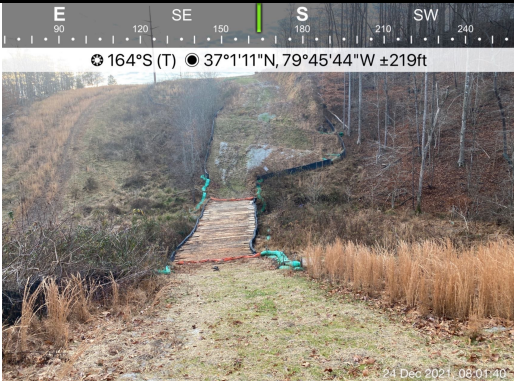
GPS Location	0	GPS Location	0		
Field Station#	14531+58	Field Station#	14524+50		
Pic 3 Desc.	Approximately 14531+58. Overview of stream crossing, equipment bridge and ECDs at stream S-G18.		Pic 4 Desc.	Approximately 14524+50. Overview of road crossing and RCEs.

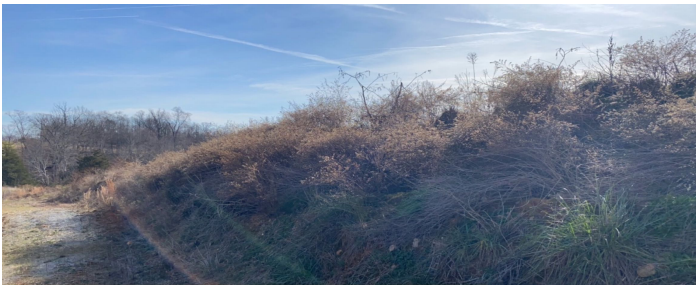
36°58'23" N 79°40'5" W 116°SE COURSE 36° GPS 1120 Listening Hill Rd, Penhook, VA 24137, United States 12.24.2021 11:20:02 Accur +/-15.4 Ft ALT 964 Ft			36°58'22" N 79°40'2" W 2°N COURSE 297° GPS 1120 Listening Hill Rd, Penhook, VA 24137, United States 12.24.2021 11:18:23 Accur +/-15.4 Ft ALT 964 Ft		
GPS Location	1		GPS Location	2	
Field Station#	14834+00		Field Station#	14839+00	
Pic 1 Desc.	Contractor repaired perimeter SSF per punch list item.		Pic 2 Desc.	Contractor replaced damaged P1 silt fence per punch list item.
