Visual Site Inspection Report

Project Name	H-600 Pipeline Spread I	AFE	124300139	Spread	H-600 Pipeline Spread I
Contractor	Precision			Report #	32656
Inspector	Justin Burch			Date/Time	12/27/2021 7:02 AM
Permit #	TBD	Inspection Type	VA SWPP	Station Begin	14062+17
State	VA	Inspection Area	Full	Station End	14171+36
County	Franklin	Ground	Damp	Temperature (°F)	60.00
Municipality	N/A	Weather	Cloudy	Rain Gauge (in)	0.00
				Rain Accumulation Time (days)	6.00

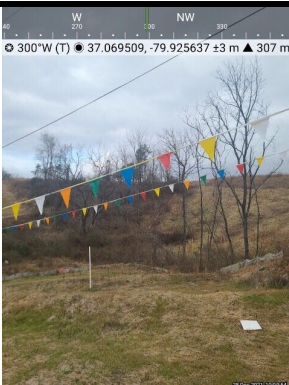
Field Station#	13807+10	Field Station#	13806+90		
Pic 5 Desc.	Vegetation observation photo sowing good growth. Water bars in place and functioning, no environmental issues observed at the time of inspection		Pic 6 Desc.	Monitored equipment bridge and ECDs at. Stream crossing, good vegetation above stream crossing, no environmental issues observed at the time of inspection

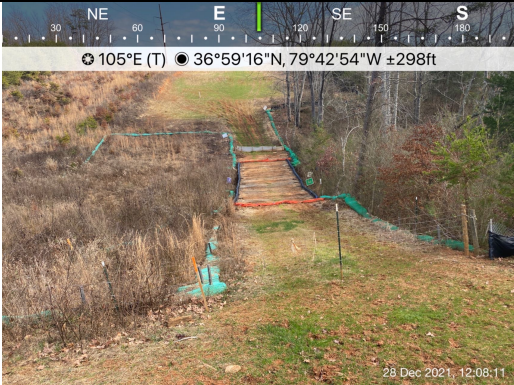
GPS Location	0	GPS Location	0		
Field Station#	14680+30	Field Station#	14673+10		
Pic 3 Desc.	Approximately 14680+30. Overview of stream crossing, equipment bridge and ECDs at stream S-H36.		Pic 4 Desc.	Approximately 14673+10. Overview of stream crossing, equipment bridge and ECDs at stream S-H37.

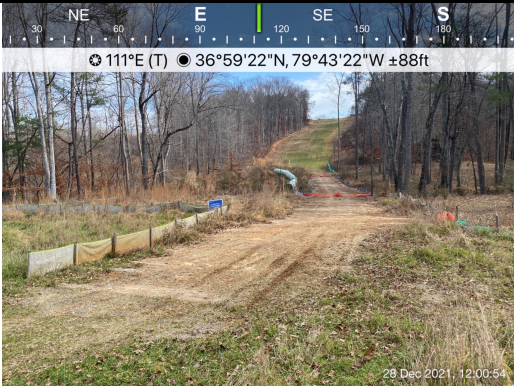
GPS Location	0	GPS Location	0		
Field Station#	14656+90	Field Station#	14653+00		
Pic 5 Desc.	Approximately 14656+90. Overview of stream crossing, equipment bridge and ECDs at stream S-H38.		Pic 6 Desc.	Approximately 14653+00. Overview of ROW.

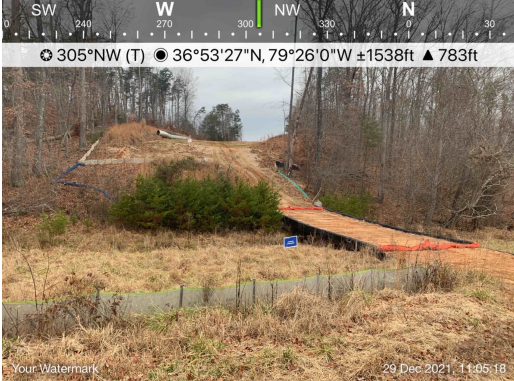
GPS Location	O	GPS Location	O		
Field Station#	15636+45	Field Station#	15630+00		
Pic 3 Desc.	Observing temporary stabilization, signage, buffer, equipment crossing and ECD's	Pic 4 Desc.	Observing temporary stabilization, CWD outlet and ECD's

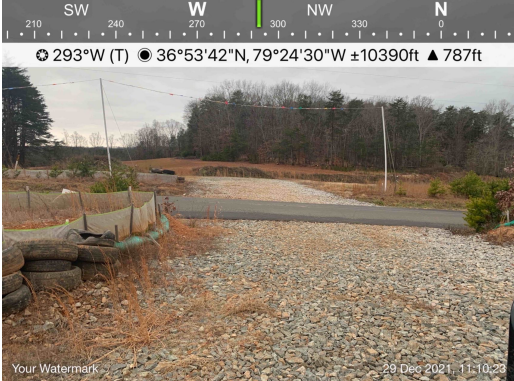
GPS Location	O	GPS Location	O		
Field Station#	15619+48	Field Station#	15610+00		
Pic 5 Desc.	Observing road crossing and RCE's	Pic 6 Desc.	Observing temporary stabilization and ECD's
