# Visual Site Inspection Report

<b>Project Name</b>	H-600 Pipeline Spread I	<b>AFE</b>	124300139	<b>Spread</b>	H-600 Pipeline Spread I
<b>Contractor</b>	Precision			<b>Report #</b>	31937
<b>Inspector</b>	Justin Burch			<b>Date/Time</b>	12/6/2021 10:56 AM
<b>Permit #</b>	TBD	<b>Inspection Type</b>	VA SWPP	<b>Station Begin</b>	14171+36
<b>State</b>	VA	<b>Inspection Area</b>	Full	<b>Station End</b>	14311+57
<b>County</b>	Franklin	<b>Ground</b>	Dry	<b>Temperature (°F)</b>	67.00
<b>Municipality</b>	N/A	<b>Weather</b>	Sunny	<b>Rain Gauge (in)</b>	0.00
				<b>Rain Accumulation Time (days)</b>	6.00

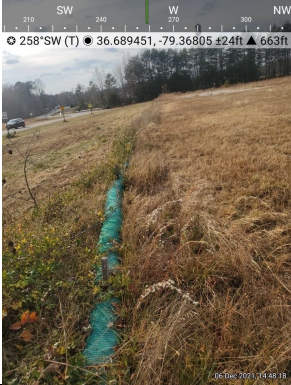
<b>GPS Location</b>	0	<b>GPS Location</b>	0		
<b>Field Station#</b>	0+00	<b>Field Station#</b>	0+00		
<b>Pic 7 Desc.</b>	LY-048 Temporary stabilization	<b>Pic 8 Desc.</b>	LY-048 South perimeter CFS		
Insert image here		Insert image here			
<b>GPS Location</b>		<b>GPS Location</b>			
<b>Field Station#</b>		<b>Field Station#</b>			
<b>Pic 9 Desc.</b>		<b>Pic 10 Desc.</b>			
Insert image here		Insert image here			
<b>GPS Location</b>		<b>GPS Location</b>			
<b>Field Station#</b>		<b>Field Station#</b>			
<b>Pic 11 Desc.</b>		<b>Pic 12 Desc.</b>

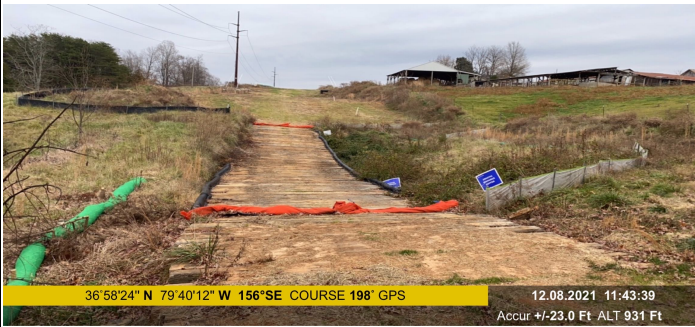
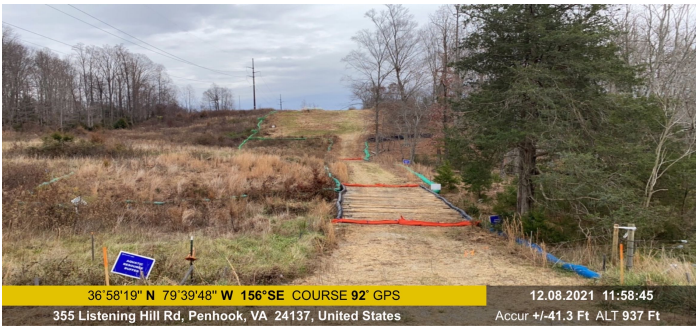
GPS Location			3	GPS Location		4					
Field Station#			14833+02	Field Station#		14853+39					
Pic 3 Desc.			Equipment bridge and surrounding ECDs in place and functional at stream crossing and resource buffer; signage visible and intact.			Pic 4 Desc.			Equipment bridge and surrounding ECDs in place and functional at stream crossing and resource buffer; signage visible and intact.

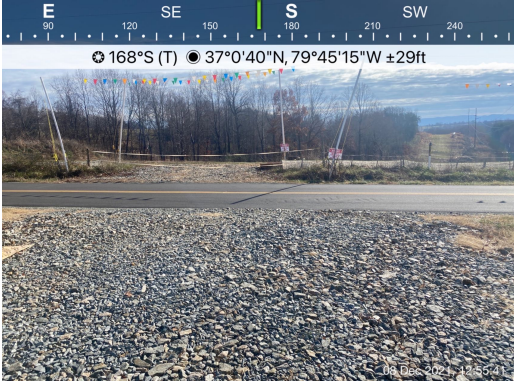
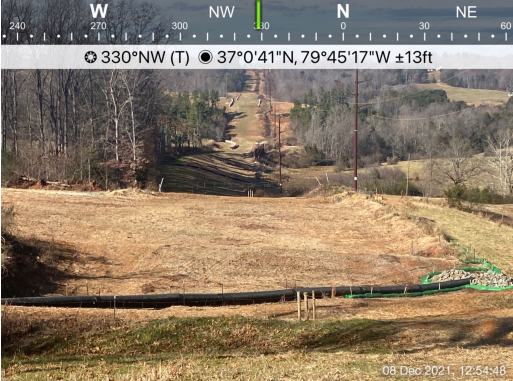
<b>GPS Location</b>	0	<b>GPS Location</b>	0		
<b>Field Station#</b>	14531+58	<b>Field Station#</b>	14546+33		
<b>Pic 1 Desc.</b>	Approximately 14531+58. Overview of stream crossing, equipment bridge and ECDs at stream S-G18.		<b>Pic 2 Desc.</b>	Approximately 14546+33. Overview of stream crossing, equipment bridge and ECDs at stream S-G17.

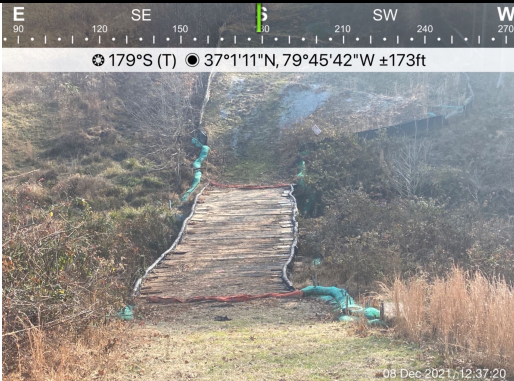
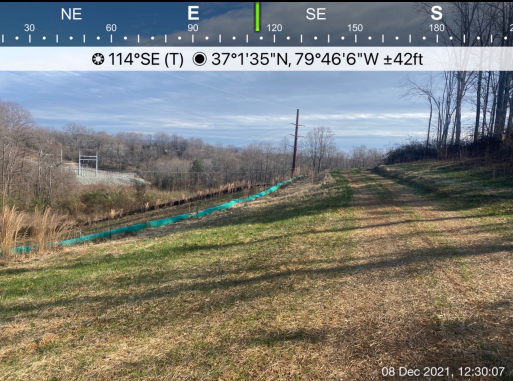
<b>GPS Location</b>	0	<b>GPS Location</b>	0		
<b>Field Station#</b>	14524+60	<b>Field Station#</b>	14520+00		
<b>Pic 3 Desc.</b>	Approximately 14524+60. Overview of road crossing and RCEs.		<b>Pic 4 Desc.</b>	Approximately 14520+00. Overview of ROW.

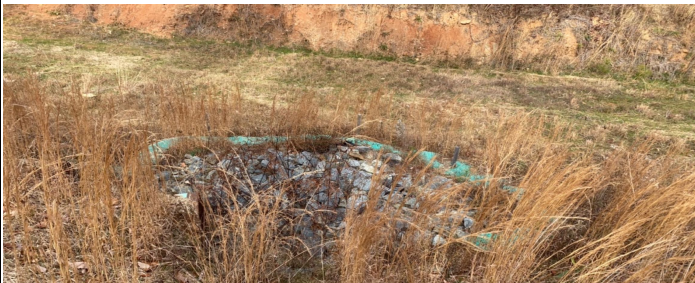
36°57'57" N 79°37'26" W 273°W COURSE 296° GPS Penhook, VA 24137, United States 12.09.2021 11:54:31 Accur +/-109.6 Ft ALT 922 Ft			36°57'57" N 79°37'26" W 326°NW COURSE 247° GPS Penhook, VA 24137, United States 12.09.2021 11:54:09 Accur +/-29.9 Ft ALT 920 Ft		
<b>GPS Location</b>	1	<b>GPS Location</b>	2		
<b>Field Station#</b>	14963+00	<b>Field Station#</b>	14969+00		
<b>Pic 1 Desc.</b>	ROW stabilized and vegetated in final cleanup area.		<b>Pic 2 Desc.</b>	Natural drainage area in place and functional. Perimeter CFS recently replaced by contractor.

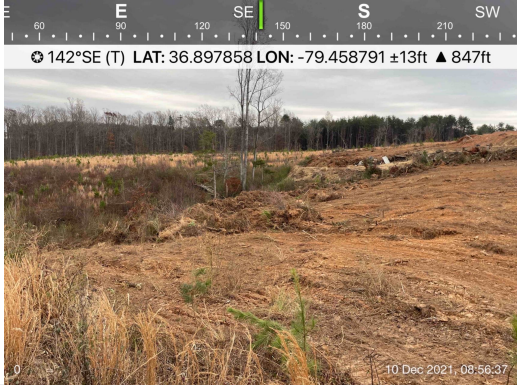
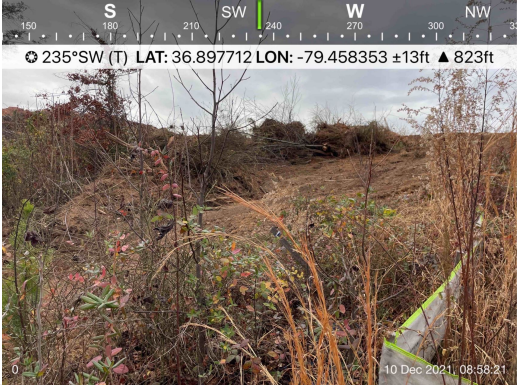
<b>GPS Location</b>	See photo	<b>GPS Location</b>	See photo		
<b>Field Station#</b>	15515+00	<b>Field Station#</b>	15540+00		
<b>Pic 7 Desc.</b>	CWDs are functioning as intended.	<b>Pic 8 Desc.</b>	Equipment bridge ECDs are in place and functioning.

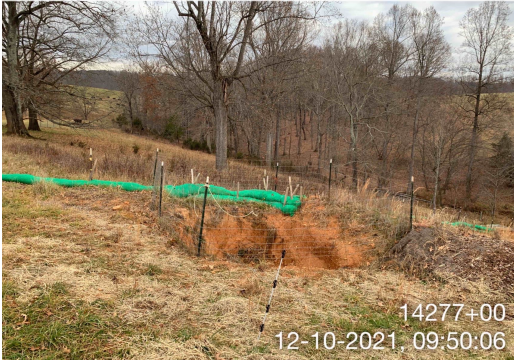
<p>14277+00 12-10-2021, 09:50:06</p>

<p>14277+00 12-10-2021, 09:49:45</p>			
<b>GPS Location</b>	0	<b>GPS Location</b>	0		
<b>Field Station#</b>	14282+00	<b>Field Station#</b>	14277+00		
<b>Pic 3 Desc.</b>	Sump pit in acceptable condition	<b>Pic 4 Desc.</b>	Waterbar in acceptable condition

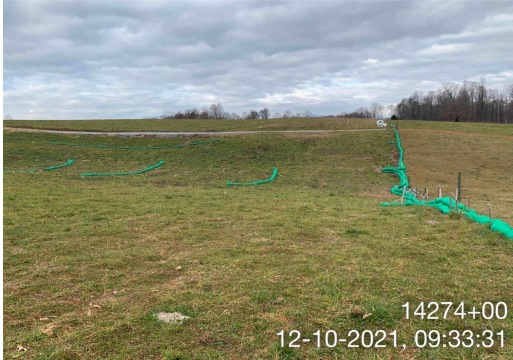
<p>14274+00 12-10-2021, 09:33:31</p>			
<b>GPS Location</b>	0	<b>GPS Location</b>	0		
<b>Field Station#</b>	14277+00	<b>Field Station#</b>	14274+00

<b>Pic 5 Desc.</b>	Waterbar end treatment in acceptable condition	<b>Pic 6 Desc.</b>	Permanent vegetative stabilization in acceptable condition

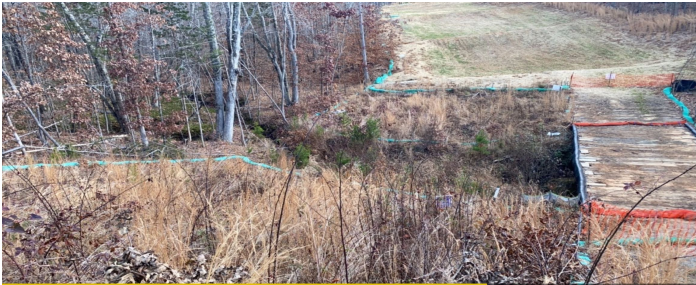
36°57'47" N 79°35'35" W 301°NW COURSE 138' GPS 1918-2164 Armstrong Rd, Penhook, VA 24137, United States 12.10.2021 10:43:38 Accur +/-40.7 Ft ALT 0 Ft			36°57'46" N 79°35'30" W 257°W COURSE 147' GPS Penhook, VA 24137, United States 12.10.2021 10:45:47 Accur +/-135.4 Ft ALT 914 Ft		
<b>GPS Location</b>	1	<b>GPS Location</b>	2		
<b>Field Station#</b>	15065+00	<b>Field Station#</b>	15069+00		
<b>Pic 1 Desc.</b>	ROW stabilized and vegetated in temporary area.	<b>Pic 2 Desc.</b>	Sump pit and CFS end treatment performing intended functions.

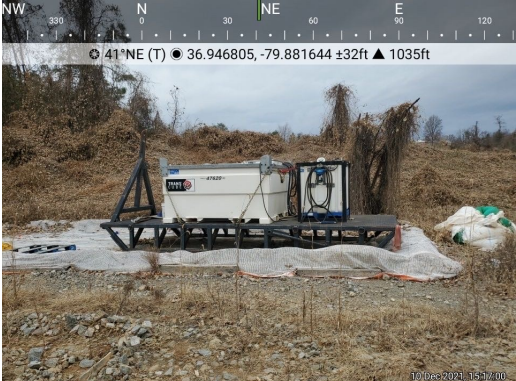
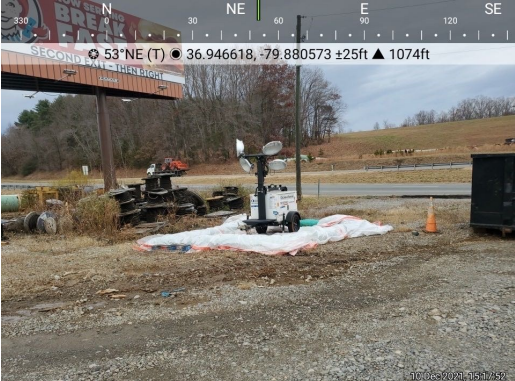
<b>GPS Location</b>	0	<b>GPS Location</b>	0		
<b>Field Station#</b>	0+00	<b>Field Station#</b>	0+00		
<b>Pic 1 Desc.</b>	LY-048 West perimeter CFS	<b>Pic 2 Desc.</b>	LY-048 Housekeeping

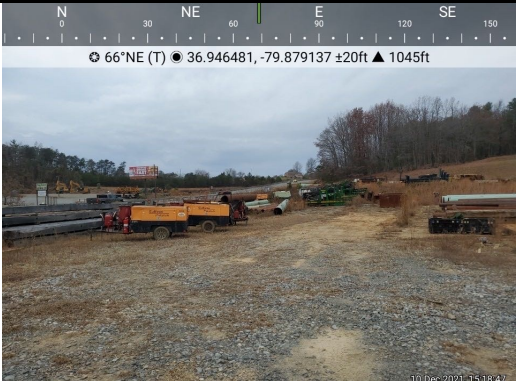
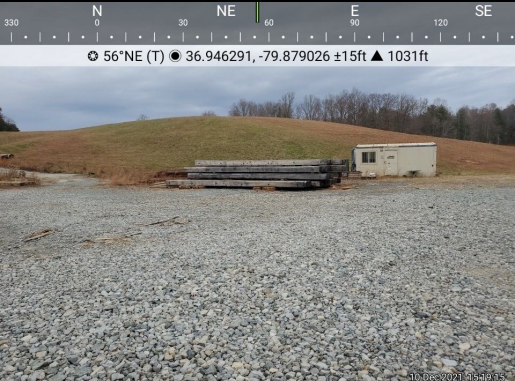
<b>GPS Location</b>	0	<b>GPS Location</b>	0		
<b>Field Station#</b>	0+00	<b>Field Station#</b>	0+00		
<b>Pic 3 Desc.</b>	LY-032 Secondary containment	<b>Pic 4 Desc.</b>	LY-032 Secondary containment

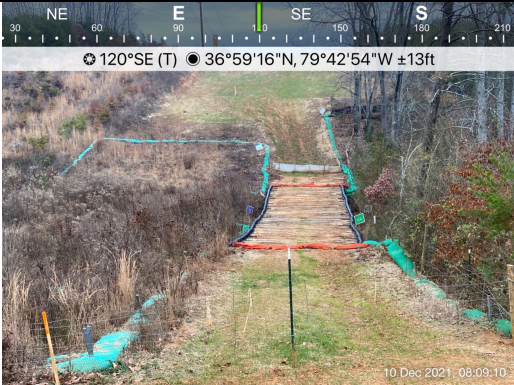
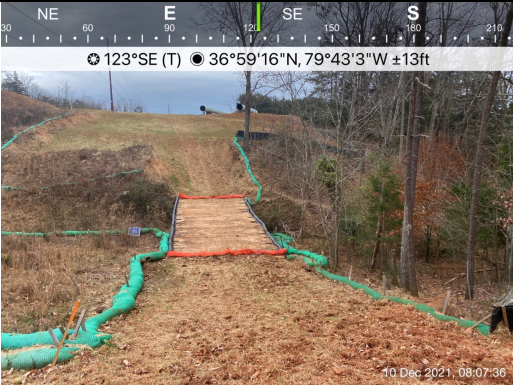
<b>GPS Location</b>	0	<b>GPS Location</b>	0		
<b>Field Station#</b>	14694+50	<b>Field Station#</b>	14689+36		
<b>Pic 1 Desc.</b>	Approximately 14694+50. Overview of road crossing and RCE.		<b>Pic 2 Desc.</b>	Approximately 14689+36. Overview of stream crossing, equipment bridge and ECDs at stream S-H34.

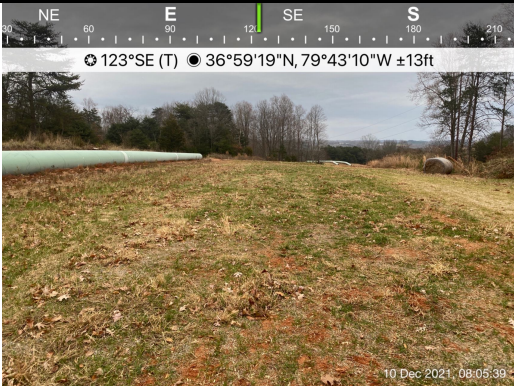
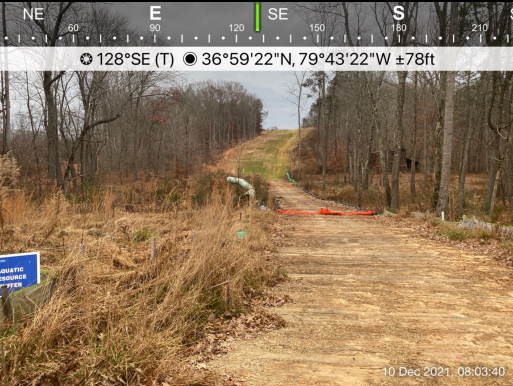
<b>GPS Location</b>	0	<b>GPS Location</b>	0		
<b>Field Station#</b>	14680+30	<b>Field Station#</b>	14673+10		
<b>Pic 3 Desc.</b>	Approximately 14680+30. Overview of stream crossing, equipment bridge and ECDs at stream S-H36.		<b>Pic 4 Desc.</b>	Approximately 14673+10. Overview of stream crossing, equipment bridge and ECDs at stream S-H37.

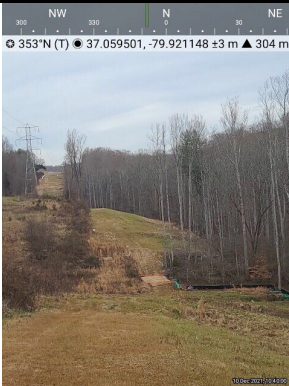
<b>GPS Location</b>	0000	<b>GPS Location</b>	0000		
<b>Field Station#</b>	13755+49	<b>Field Station#</b>	13850+00		
<b>Pic 3 Desc.</b>	Monitored equipment bridge and protection, checked all ECDs in the area. No environmental issues observed at the time of inspection.		<b>Pic 4 Desc.</b>	Vegetation observation photo showing good coverage
