Visual Site Inspection Report

Project Name	H-600 Pipeline Spread I	AFE	124300139	Spread	H-600 Pipeline Spread I
Contractor	Precision	Report #	34359		
Inspector	Justin Burch	Date/Time	2/14/2022 12:09 PM		
Permit #	TBD	Inspection Type	VA SWPP	Station Begin	13958+31
State	VA	Inspection Area	Full	Station End	14062+17
County	Franklin	Ground	Wet	Temperature (°F)	41.00
Municipality	N/A	Weather	Sunny	Rain Gauge (in)	0.10
			Rain Accumulation Time (days)	6.00

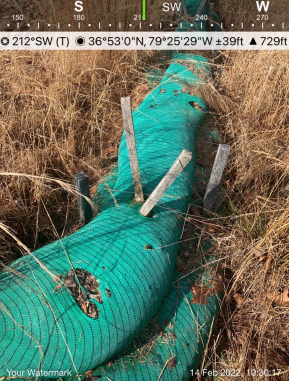
GPS Location	O	GPS Location	O		
Field Station#	15679+10	Field Station#	15694+20		
Pic 3 Desc.	Observing CFS that requires maintenance	Pic 4 Desc.	Observing CFS that requires maintenance

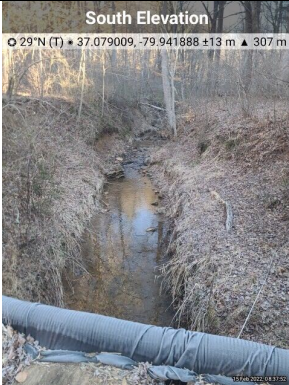
<p>North Elevation 211°S (T) • 37.085788, -79.948214 ±3 m ▲ 315 m</p>	
GPS Location	0000	GPS Location	0000		
Field Station#	13728+23	Field Station#	13691+02		
Pic 1 Desc.	Stream observation photo facing upstream during routine inspection today, no environmental issues observed at the time of inspection.		Pic 2 Desc.	Monitored ECDs along the eve of the LOD, all functioning at the time of inspection.

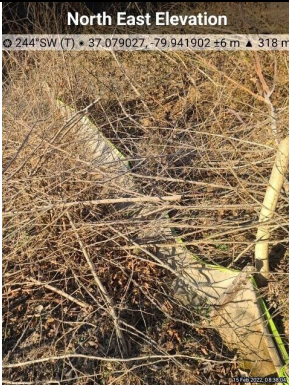
<p>North East Elevation 224°SW (T) • 37.078543, -79.940779 ±3 m ▲ 325 m</p>	
GPS Location	0000	GPS Location	0000		
Field Station#	13728+51	Field Station#	13732+15		
Pic 3 Desc.	P1 requires routine maintenance due to being weathered, the EI Documented and added to the punch list for repair.		Pic 4 Desc.	Monitored sump pits and end treatment, no environmental issues observed at the time of inspection.

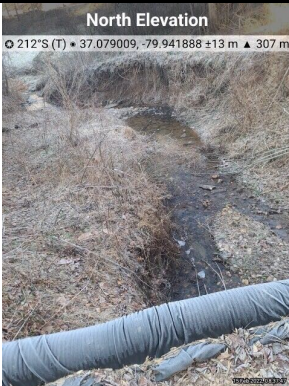
<p>South Elevation 356°N (T) • 37.079451, -79.942029 ±3 m ▲ 325 m</p>	
GPS Location	00000	GPS Location	00000		
Field Station#	13728+23	Field Station#	13726+00		
Pic 5 Desc.	Stream observation photo facing downstream during routine inspection today, no environmental issues observed at the time of inspection.		Pic 6 Desc.	Row photo showing frozen row conditions during routine inspection, no environmental issues observed at the time of inspection.

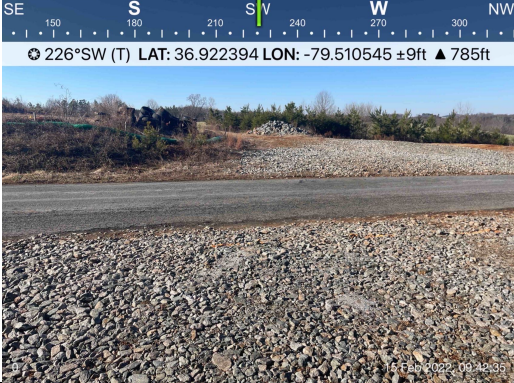
GPS Location	See photo		GPS Location	See photo	
Field Station#	15370+62		Field Station#	15375+00	
Pic 1 Desc.	RCEs are in good condition at all road crossings.		Pic 2 Desc.	Drainage ECDs are in good condition and functioning.

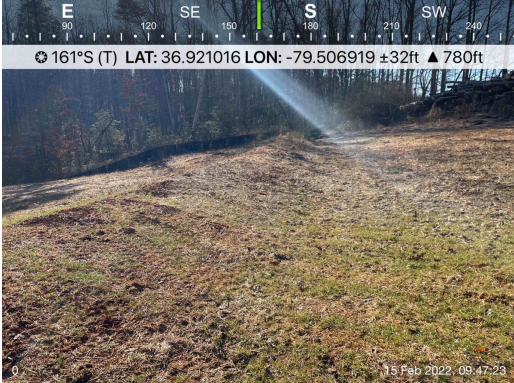
GPS Location	See photo		GPS Location	See photo	
Field Station#	15380+00		Field Station#	15384+50	
Pic 3 Desc.	Waterbars are in good condition throughout this section.		Pic 4 Desc.	P1 is in good condition at all stream and wetland buffers

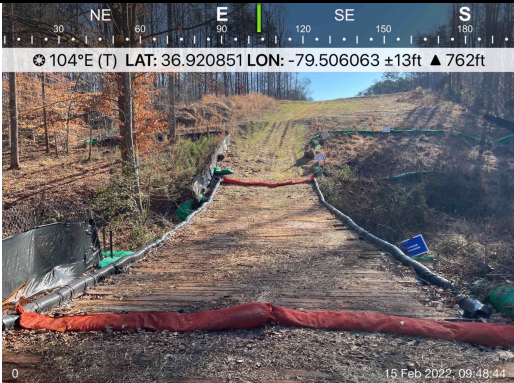
GPS Location	See photo		GPS Location	See photo	
Field Station#	15384+73		Field Station#	15427+43	
Pic 5 Desc.	Equipment bridge ECDs are in place and functioning		Pic 6 Desc.	Resource buffers remain well vegetated.

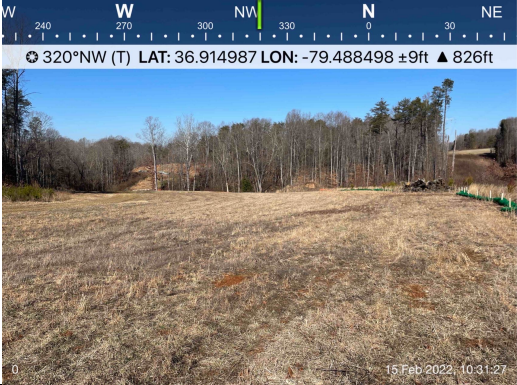
<p>10°N (T) LAT: 36.913887 LON: -79.487877 ±19ft ▲ 829ft</p> <p>15 Feb 2022, 10:29:32</p>			
GPS Location	See photo		GPS Location	See photo	
Field Station#	15442+00		Field Station#	15444+00	
Pic 7 Desc.	Vegetation continues to fill in throughout this section.		Pic 8 Desc.	Perimeter CFS is in good condition

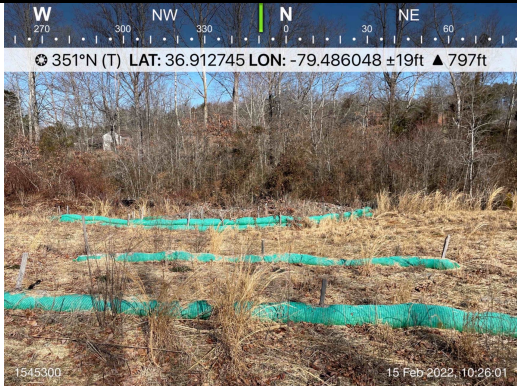
<p>351°N (T) LAT: 36.912745 LON: -79.486048 ±19ft ▲ 797ft</p> <p>15 Feb 2022, 10:26:01</p>		  <p>169°S (T) LAT: 36.912628 LON: -79.484733 ±29ft ▲ 904ft</p> <p>15 Feb 2022, 10:24:26</p>			
GPS Location	See photo		GPS Location	See photo	
Field Station#	15453+00		Field Station#	15457+00	
Pic 9 Desc.	CWD remains in good condition.		Pic 10 Desc.	Drainage ECDs are in good condition. No evidence of sedimentation from 3rd party disturbance.

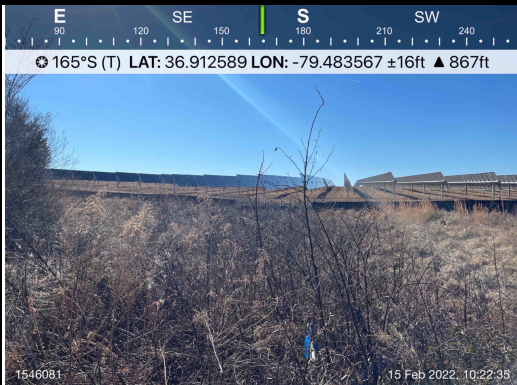
<p>165°S (T) LAT: 36.912589 LON: -79.483567 ±16ft ▲ 867ft</p> <p>15 Feb 2022, 10:22:35</p>			
GPS Location	See photo		GPS Location	See photo	
Field Station#	15460+81		Field Station#	15460+81	
Pic 11 Desc.	CWD remains in good condition		Pic 12 Desc.	No evidence of sedimentation from 3rd party disturbance into CWD inlet.

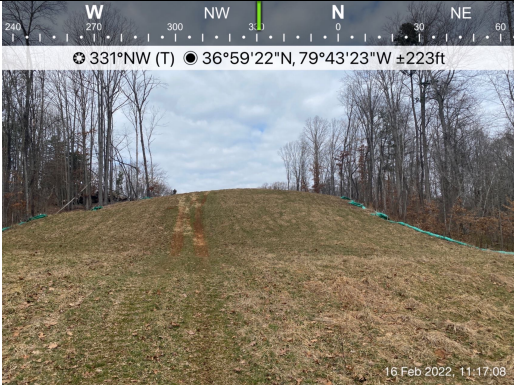
GPS Location	0	GPS Location	0		
Field Station#	14654+00	Field Station#	14656+90		
Pic 1 Desc.	Approximately 14654+00. Overview of ROW.		Pic 2 Desc.	Approximately 14656+90. Overview of stream crossing, equipment bridge and ECDs at stream S-H38.

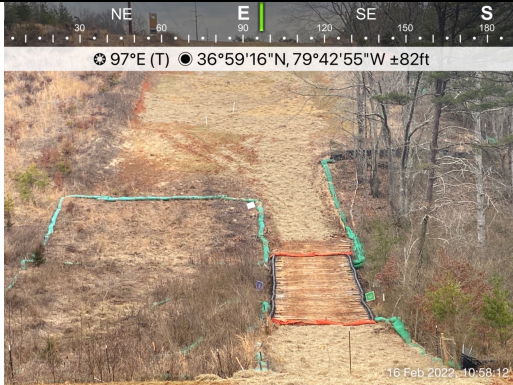
GPS Location	0	GPS Location	0		
Field Station#	14673+10	Field Station#	14680+30		
Pic 3 Desc.	Approximately 14673+10. Overview of stream crossing, equipment bridge and ECDs at stream S-H37.		Pic 4 Desc.	Approximately 14680+30. Overview of stream crossing, equipment bridge and ECDs at stream S-H36.

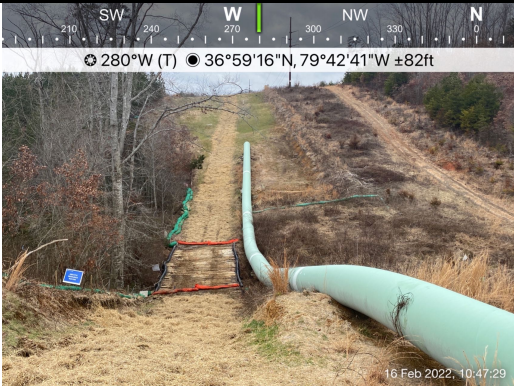
GPS Location	0	GPS Location	0		
Field Station#	14689+36	Field Station#	14694+00		
Pic 5 Desc.	Approximately 14689+36. Overview of stream crossing, equipment bridge and ECDs at stream S-H34.		Pic 6 Desc.	Approximately 14694+00. Overview of ROW.

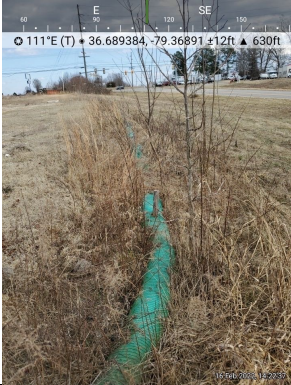
GPS Location	0	GPS Location	0		
Field Station#	0+00	Field Station#	0+00		
Pic 7 Desc.	LY-048 South perimeter CFS	Pic 8 Desc.	LY-048 West perimeter CFS		
Insert image here		Insert image here			
GPS Location		GPS Location			
Field Station#		Field Station#			
Pic 9 Desc.		Pic 10 Desc.			
Insert image here		Insert image here			
GPS Location		GPS Location			
Field Station#		Field Station#			
Pic 11 Desc.		Pic 12 Desc.

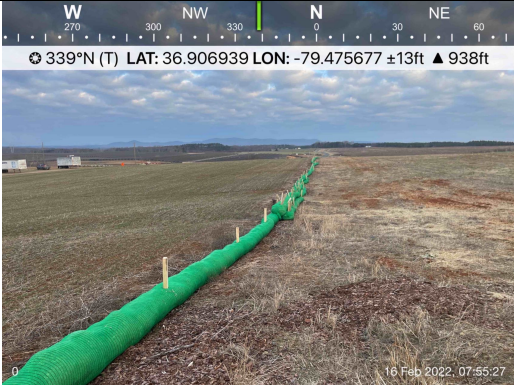
GPS Location	See photo		GPS Location	See photo	
Field Station#	15490+00		Field Station#	15493+00	
Pic 1 Desc.	Perimeter CFS is in good condition throughout this section.		Pic 2 Desc.	Vegetation continues to fill in throughout this section.

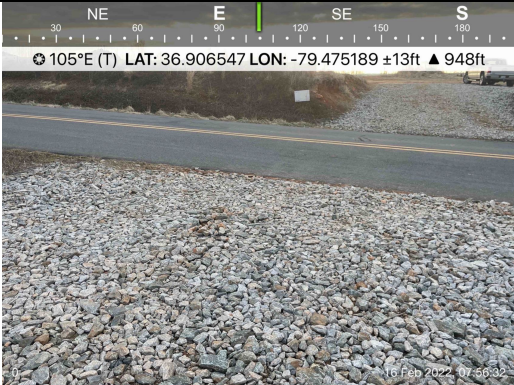
GPS Location	See photo		GPS Location	See photo	
Field Station#	15496+70		Field Station#	15501+00	
Pic 3 Desc.	RCEs are in good condition at all road crossings		Pic 4 Desc.	No evidence of sedimentation from 3rd party disturbance.

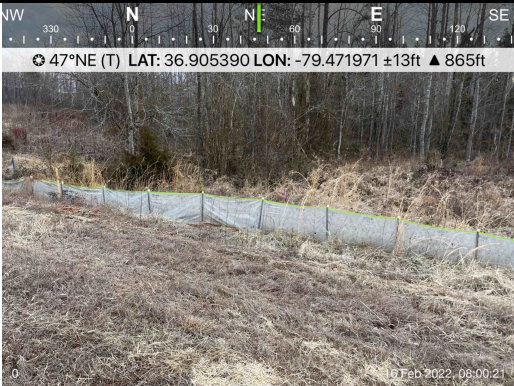
GPS Location	See photo		GPS Location	See photo	
Field Station#	15507+00		Field Station#	15508+02	
Pic 5 Desc.	P1 is in good condition at all stream and wetland buffers		Pic 6 Desc.	Equipment bridge ECDs are in place and functioning.

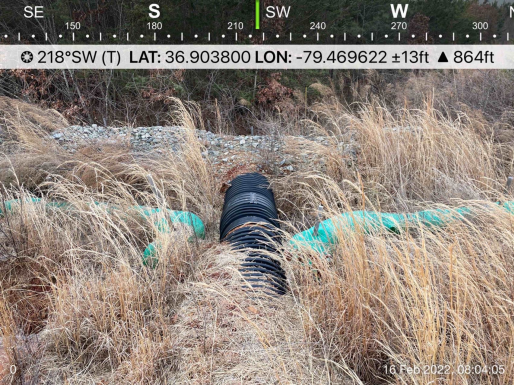
GPS Location	See photo		GPS Location	See photo	
Field Station#	15510+00		Field Station#	15515+00	
Pic 7 Desc.	3rd party ECDs appear to be in good condition.		Pic 8 Desc.	CWDs are functioning as intended

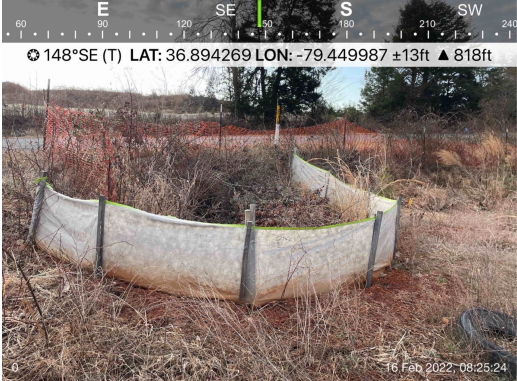
GPS Location	See photo	GPS Location			
Field Station#	15584+00	Field Station#			
Pic 13 Desc.	P1 is in good condition around road pipe outlet.	Pic 14 Desc.			
Insert image here		Insert image here			
GPS Location		GPS Location			
Field Station#		Field Station#			
Pic 15 Desc.		Pic 16 Desc.			
Insert image here		Insert image here			
GPS Location		GPS Location			
Field Station#		Field Station#			
Pic 17 Desc.		Pic 18 Desc.

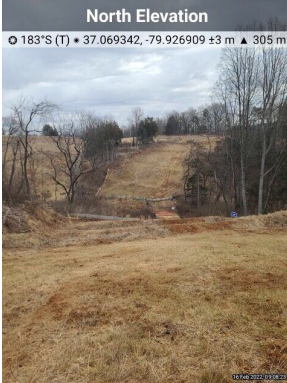
<p>North Elevation <small>183°S (T) • 37.069342, -79.926909 ±3 m ▲ 305 m</small></p>	
GPS Location	0000	GPS Location	0000		
Field Station#	13794+57	Field Station#	13804+50		
Pic 1 Desc.	Stream observation photo facing downstream during routine inspection today, no environmental issues observed at the time of inspection.		Pic 2 Desc.	Row photo above stream crossing showing stabilization and ECDs in place. No environmental issues observed at the time of inspection.	
	  <p>North East Elevation <small>241°SW (T) • 37.070781, -79.937021 ±3 m ▲ 303 m</small></p>			  <p>North West Elevation <small>134°SE (T) • 37.070049, -79.929749 ±3 m ▲ 295 m</small></p>	
GPS Location	0000	GPS Location	00000		
Field Station#	13770+69	Field Station#	13794+57

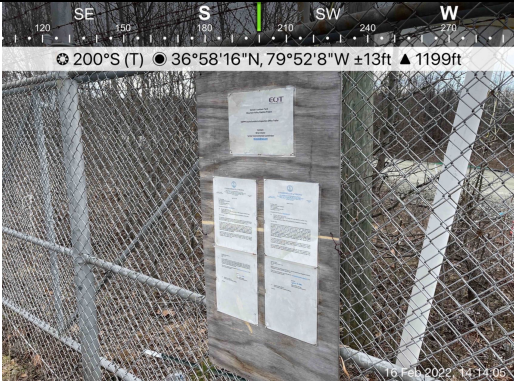
GPS Location	See picture	GPS Location	See picture		
Field Station#	0000+00	Field Station#	0000+00		
Pic 3 Desc.	General construction permits and contact information are posted at LY-046 as required.	Pic 4 Desc.	RCE at LY-045 in good condition

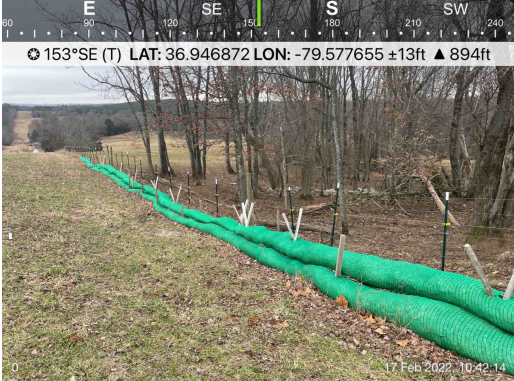
GPS Location	See photo		GPS Location	See photo	
Field Station#	15150+00		Field Station#	15160+00	
Pic 1 Desc.	Perimeter CFS is in good condition		Pic 2 Desc.	Perimeter P1 is in good condition

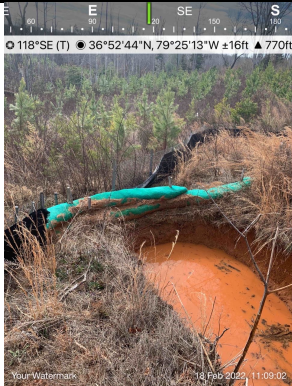
GPS Location	O	GPS Location	O		
Field Station#	15693+89	Field Station#	15698+00		
Pic 3 Desc.	Observing road crossing and RCE's		Pic 4 Desc.	Observing temporary stabilization, sump and end treatment

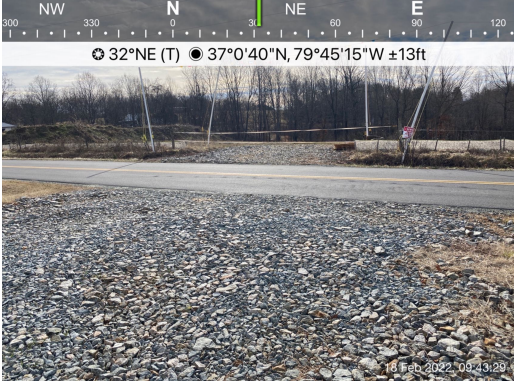
GPS Location	0	GPS Location	0		
Field Station#	14524+50	Field Station#	14546+33		
Pic 1 Desc.	Approximately 14524+50. Overview of road crossing and RCEs.	Pic 2 Desc.	Approximately 14546+33. Overview of stream crossing, equipment bridge and ECDs at stream S-G17.

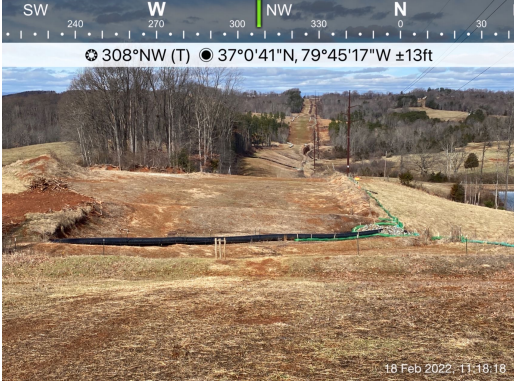
GPS Location	0	GPS Location	0		
Field Station#	14519+00	Field Station#	14458+00		
Pic 3 Desc.	Approximately 14519+00. Overview of ROW.	Pic 4 Desc.	Approximately 14458+00. Overview of ROW.

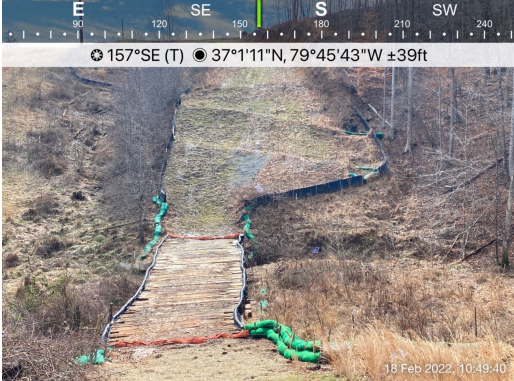
GPS Location	0	GPS Location	0		
Field Station#	14486+60	Field Station#	14472+00		
Pic 5 Desc.	Approximately 14486+60. Overview of stream crossing, equipment bridge and ECDs at stream S-G22.	Pic 6 Desc.	Approximately 14472+00. Overview of ROW.

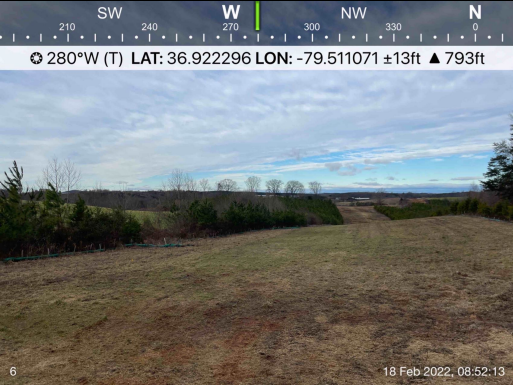
GPS Location	See photo	GPS Location	See photo		
Field Station#	15370+62	Field Station#	15370+00		
Pic 1 Desc.	RCEs are in good condition at all road crossings.	Pic 2 Desc.	Vegetation continues to fill in throughout this section

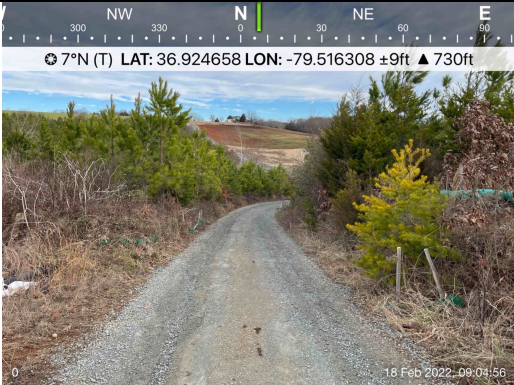
GPS Location	See photo	GPS Location	See photo		
Field Station#	15350+00	Field Station#	15348+00		
Pic 3 Desc.	MVP-PI-332 remains in good condition with controls in place.	Pic 4 Desc.	Resource buffers remain well vegetated

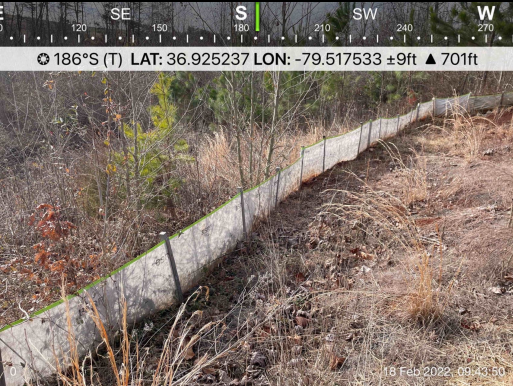
GPS Location	See photo	GPS Location	See photo		
Field Station#	15348+00	Field Station#	15346+00		
Pic 5 Desc.	Equipment bridge ECDs are in place and functioning	Pic 6 Desc.	P1 is in good condition at all stream and wetland buffers.

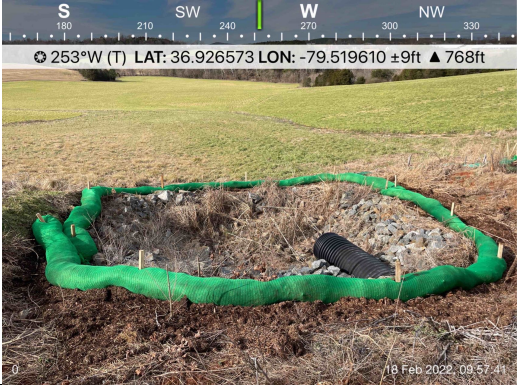
GPS Location	See photo		GPS Location	See photo	
Field Station#	15338+00		Field Station#	15337+00	
Pic 7 Desc.	CWDs are functioning as intended.		Pic 8 Desc.	Perimeter CFS is in good condition

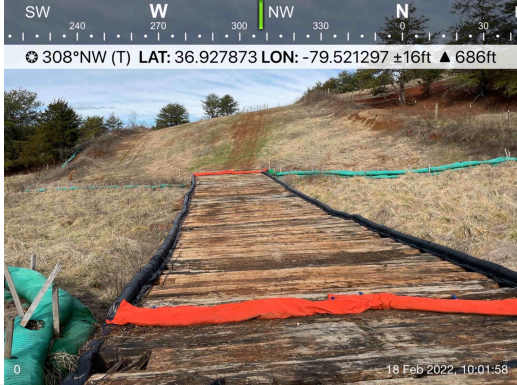
GPS Location	See photo		GPS Location	See photo	
Field Station#	15330+00		Field Station#	15315+00	
Pic 9 Desc.	ECDs are in good condition at drainage feature.		Pic 10 Desc.	Waterbars are in good condition
