Visual Site Inspection Report

Project Name	H-600 Pipeline Spread I	AFE	124300139	Spread	H-600 Pipeline Spread I
Contractor	Precision			Report #	34654
Inspector	Ben Farmer			Date/Time	2/21/2022 2:45 PM
Permit #	TBD	Inspection Type	VA SWPP	Station Begin	15772+27
State	VA	Inspection Area	Partial	Station End	15947+64
County	Pittsylvania	Ground	Dry	Temperature (°F)	40.00
Municipality	Chatham	Weather	Sunny	Rain Gauge (in)	0.00
				Rain Accumulation Time (days)	0.00

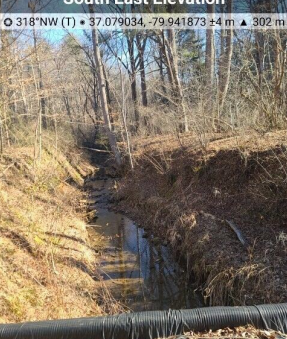
West Elevation <small>118°E (T) • 37.079027, -79.941876 ±3 m ▲ 303 m</small>  			South East Elevation <small>318°NW (T) • 37.079034, -79.941873 ±4 m ▲ 302 m</small>

GPS Location	00000	GPS Location	00000		
Field Station#	13728+11	Field Station#	13728+11		
Pic 5 Desc.	Stream observation photo facing downstream during routine inspection today. No environmental issues observed at the time of inspection.		Pic 6 Desc.	Stream observation photo facing upstream during routine inspection today, no environmental issues observed at the time of inspection.
