Visual Site Inspection Report

Project Name	H-600 Pipeline Spread I	AFE	124300139	Spread	H-600 Pipeline Spread I	
Contractor	Precision			Report #	34942	
Inspector	Glenn Mike Renfro			Date/Time	2/28/2022 1:33 PM	
Permit #	TBD	Inspection Type	VA SWPP	Station Begin	0000+00	
State	VA	Inspection Area	Full	Station End	0000+00	
County	Franklin	Ground	Dry	Temperature (°F)	56.00	
Municipality	N/A	Weather	Sunny	Rain Gauge (in)	1.20	
				Rain Accumulation Time (days)	6.00

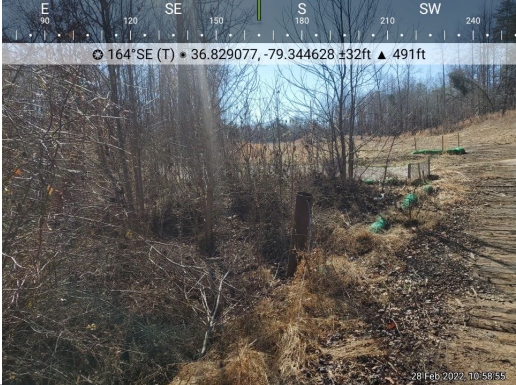
GPS Location	0	GPS Location	0		
Field Station#	12+50	Field Station#	9+00		
Pic 3 Desc.	CIS S-H42 Buffer zone	Pic 4 Desc.	Temporary stabilization

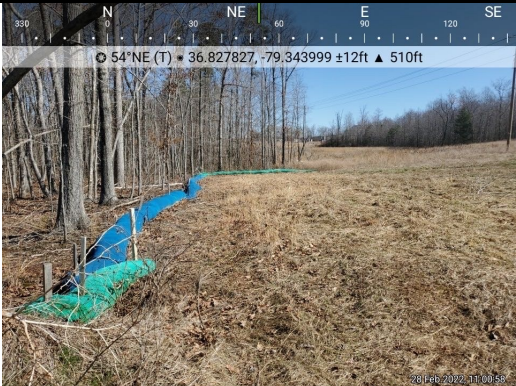
Insert image here			
GPS Location	0	GPS Location			
Field Station#	7+50	Field Station#			
Pic 5 Desc.	Perimeter CFS	Pic 6 Desc.

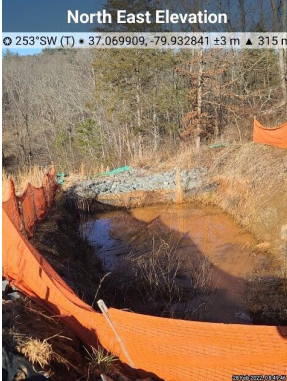
GPS Location	0000	GPS Location	0000		
Field Station#	13755+49	Field Station#	13784+40		
Pic 3 Desc.	Stream observation photo facing upstream during routine inspection, no issues observed at the time of inspection.		Pic 4 Desc.	Photo showing sump pit functioning properly. No issues observed at the time of inspection.	
	West Elevation

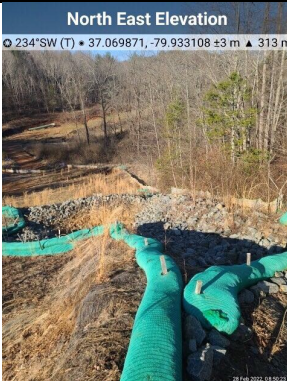
Pic 5 Desc.	Row photo showing stabilization on hill side above stream crossing, no environmental issues observed at the time of inspection.		Pic 6 Desc.	Monitored sump pit and plunge pool, all ECDs in place and functioning at the time of inspection.

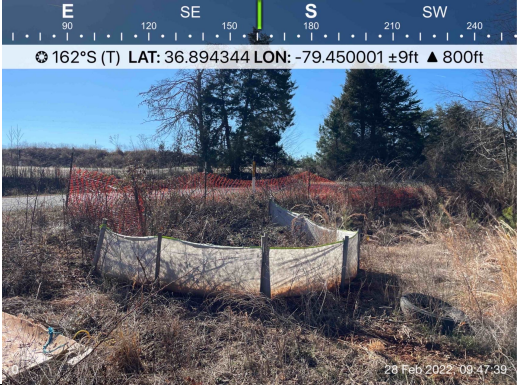
<p>Insert image here</p>			
GPS Location	See photo	GPS Location			
Field Station#	15584+00	Field Station#			
Pic 13 Desc.	P1 is in good condition at road pipe outlet.	Pic 14 Desc.			
<p>Insert image here</p>		<p>Insert image here</p>			
GPS Location		GPS Location			
Field Station#		Field Station#			
Pic 15 Desc.		Pic 16 Desc.			
<p>Insert image here</p>		<p>Insert image here</p>			
GPS Location		GPS Location			
Field Station#		Field Station#			
Pic 17 Desc.		Pic 18 Desc.

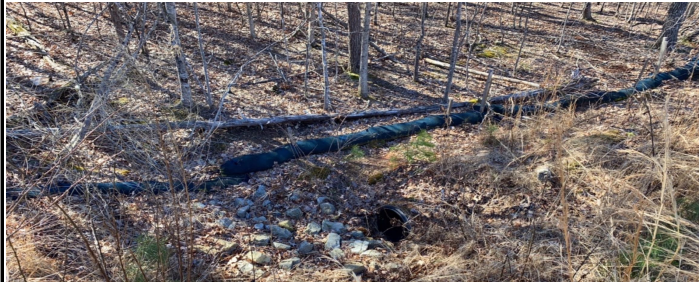
36°57'45" N 79°35'29" W 117°SE COURSE 155° GPS Sandy Level, VA 24161, United States 02.27.2022 10:10:35 Accur +/-656.2 Ft ALT 903 Ft			36°57'42" N 79°35'17" W 228°SW COURSE 288° GPS Sandy Level, VA 24161, United States 02.27.2022 10:40:55 Accur +/-639.8 Ft ALT 905 Ft		
GPS Location	1	GPS Location	2		
Field Station#	15072+86	Field Station#	15075+00		
Pic 1 Desc.	Equipment bridge and surrounding ECDs in place and functional at stream crossing and resource buffer.		Pic 2 Desc.	Slope drain tile inlet and surrounding ECDs in good condition.

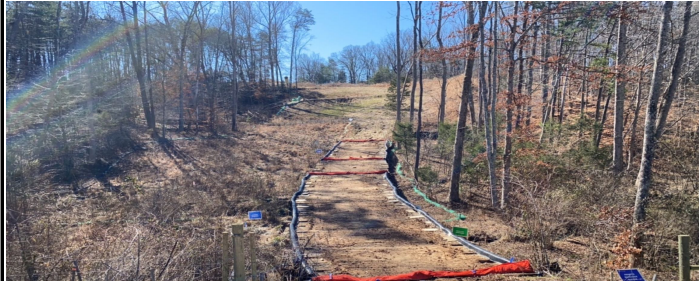
36°57'33" N 79°35'11" W 135°SE COURSE 256° GPS Sandy Level, VA 24161, United States 02.27.2022 10:22:13 Accur +/-52.7 Ft ALT 903 Ft			36°57'29" N 79°35'1" W 203°S COURSE 75° GPS Sandy Level, VA 24161, United States 02.27.2022 10:26:56 Accur +/-37.1 Ft ALT 858 Ft		
GPS Location	5	GPS Location	6		
Field Station#	15092+95	Field Station#	15104+28		
Pic 5 Desc.	Equipment bridge and surrounding ECDs in place and functional at stream crossing and resource buffer.		Pic 6 Desc.	Equipment bridge and surrounding ECDs in place and functional at stream crossing and resource buffer.

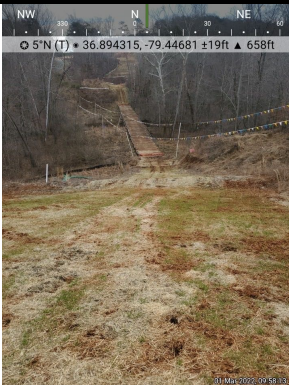
GPS Location	0	GPS Location	0		
Field Station#	15593+00	Field Station#	15594+50		
Pic 3 Desc.	CIS W-MM9 Travel lane stabilization		Pic 4 Desc.	Clean water diversion outlet

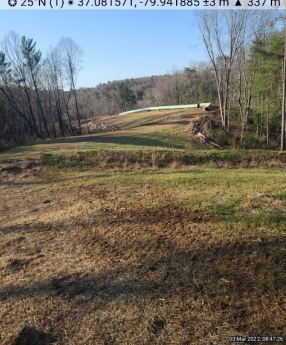
North Elevation 204°S (T) • 37.079037, -79.941827 ±3 m ▲ 304 m  	
GPS Location	00000	GPS Location	00000		
Field Station#	13719+90	Field Station#	13728+11		
Pic 1 Desc.	Row photo showing vegetation, good coverage observed.		Pic 2 Desc.	Stream observation photo facing upstream during routine inspection today, no environmental issues observed at the time of inspection.	
	South West Elevation 53°NE (T) • 37.079034, -79.941828 ±3 m ▲ 304 m

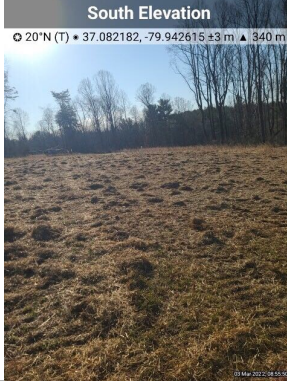
GPS Location	00000	GPS Location	00000		
Field Station#	13728+11	Field Station#	13715+00		
Pic 3 Desc.	Stream observation photo facing downstream during routine inspection today, no environmental issues observed at the time of inspection.		Pic 4 Desc.	Row photo showing stabilization after recent anode activities were done, no environmental issues observed at the time of inspection.

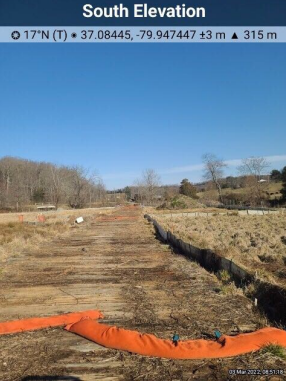
GPS Location	00000	GPS Location	00000		
Field Station#	13696+50	Field Station#	13728+11		
Pic 5 Desc.	Monitored equipment mats and ECDs near wetland area, all functioning at the time of inspection.		Pic 6 Desc.	Photo showing stabilization on hill side at stream crossing, equipment bridge and protection in place, no environmental issues observed at the time of inspection.

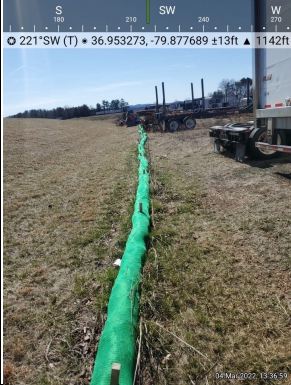
GPS Location	0	GPS Location	0		
Field Station#	0+00	Field Station#	0+00		
Pic 7 Desc.	ANC-006 Southeast perimeter CFS	Pic 8 Desc.	ANC-006 Secondary containment		
Insert image here		Insert image here			
GPS Location		GPS Location			
Field Station#		Field Station#			
Pic 9 Desc.		Pic 10 Desc.			
Insert image here		Insert image here			
GPS Location		GPS Location			
Field Station#		Field Station#			
Pic 11 Desc.		Pic 12 Desc.
