Visual Site Inspection Report

Project Name	H-600 Pipeline Spread I	AFE	124300139	Spread	H-600 Pipeline Spread I
Contractor	Precision			Report #	34118
Inspector	John White			Date/Time	2/7/2022 11:05 AM
Permit #	TBD	Inspection Type	VA SWPP	Station Begin	15584+23
State	VA	Inspection Area	Full	Station End	15647+03
County	Pittsylvania	Ground	Frozen	Temperature (°F)	32.00
Municipality	Chatham	Weather	Snow/Sleet	Rain Gauge (in)	0.50
				Rain Accumulation Time (days)	6.00

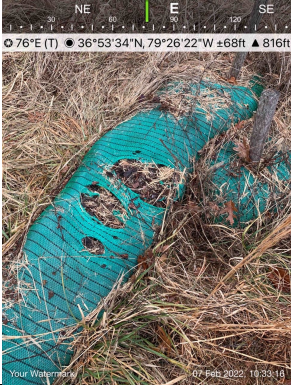
GPS Location	O	GPS Location	O		
Field Station#	15616+00	Field Station#	15630+00		
Pic 7 Desc.	Observing CFS that requires maintenance	Pic 8 Desc.	Observing temporary stabilization, CWD outlet and ECD's		
Insert image here		Insert image here			
GPS Location		GPS Location			
Field Station#		Field Station#			
Pic 9 Desc.		Pic 10 Desc.			
Insert image here		Insert image here			
GPS Location		GPS Location			
Field Station#		Field Station#			
Pic 11 Desc.		Pic 12 Desc.

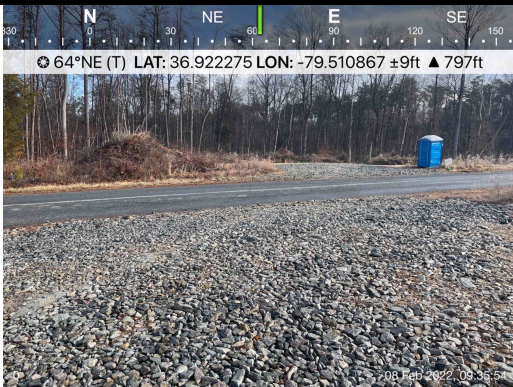
GPS Location	See photo		GPS Location	See photo	
Field Station#	15370+62		Field Station#	15370+00	
Pic 1 Desc.	RCEs are in good condition at all road crossings.		Pic 2 Desc.	Vegetation continues to fill in throughout this section.

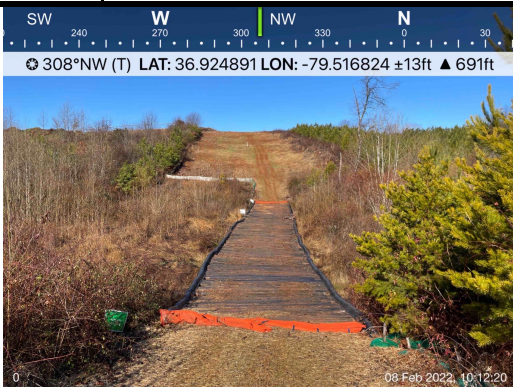
GPS Location	See photo		GPS Location	See photo	
Field Station#	15346+87		Field Station#	15346+50	
Pic 5 Desc.	Equipment bridge ECDs are in good condition and functioning.		Pic 6 Desc.	P1 is in good condition at all stream and wetland buffers.

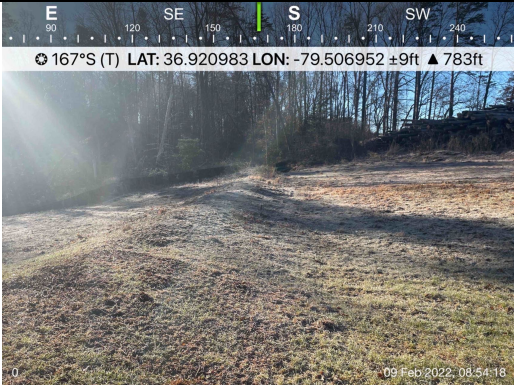
GPS Location	See photo	GPS Location	See photo		
Field Station#	15380+00	Field Station#	15383+00		
Pic 3 Desc.	Waterbars remain in good condition.	Pic 4 Desc.	Perimeter SSF is in good condition.

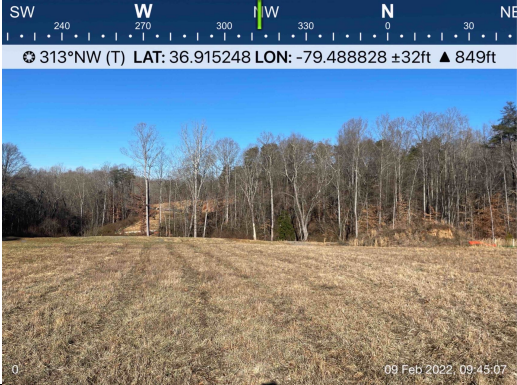
GPS Location	See photo		GPS Location	See photo	
Field Station#	15427+43		Field Station#	15442+00	
Pic 7 Desc.	Resource buffers remain in good condition.		Pic 8 Desc.	Vegetation continues to fill in throughout this section.

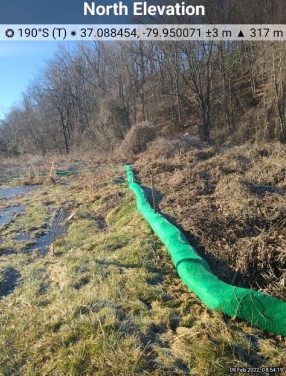
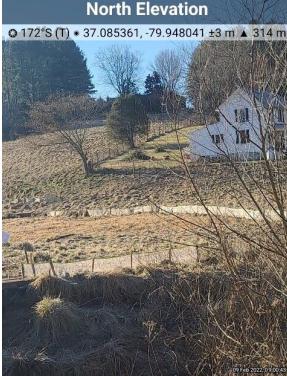
GPS Location	00000	GPS Location	00000		
Field Station#	13678+63	Field Station#	13692+77		
Pic 1 Desc.	Monitored ECDs along the LOD, all functioning at the time of inspection.		Pic 2 Desc.	Observed ECDs near stream crossing and along wetland areas, all up to date and functioning at the time of inspection.	
	North East Elevation

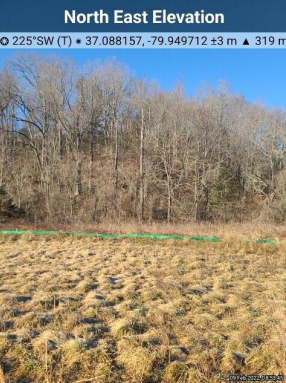
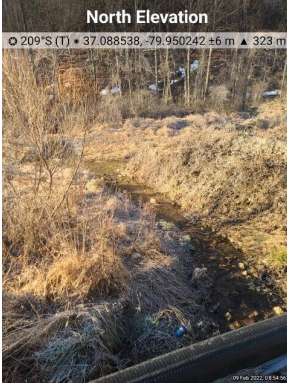
GPS Location	00000	GPS Location	00000		
Field Station#	13688+00	Field Station#	13678+71		
Pic 3 Desc.	Observed ECDs along the LOD, all functioning at the time of inspection.		Pic 4 Desc.	Stream observation photo facing upstream during routine inspection today, no environmental issues observed at the time of inspection.	
	South East Elevation

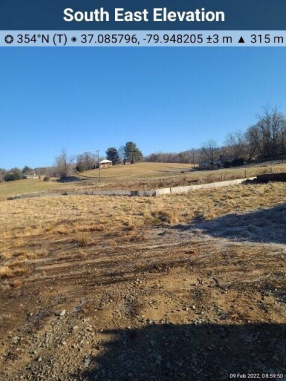
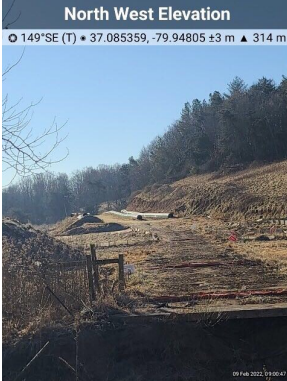
Pic 5 Desc.	Monitored ECDs around wetland area inside work space, ECDs up to date and functioning.		Pic 6 Desc.	Row photo at stream crossing showing equipment mats, ECDs and vegetation in wetland area. No environmental issues observed at the time of inspection.

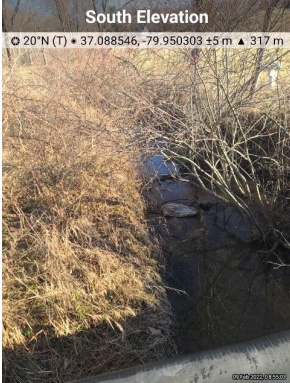
<p>South Elevation <small>20°N (T) • 37.088546, -79.950303 +5 m ▲ 317 m</small></p>		Insert image here		Insert image here	
GPS Location	0000	GPS Location			
Field Station#	13678+71	Field Station#			
Pic 7 Desc.	Stream observation photo facing upstream during routine inspection today, no environmental issues observed at the time of inspection.		Pic 8 Desc.		
Insert image here		Insert image here			
GPS Location		GPS Location			
Field Station#		Field Station#			
Pic 9 Desc.		Pic 10 Desc.			
Insert image here		Insert image here			
GPS Location		GPS Location			
Field Station#		Field Station#			
Pic 11 Desc.		Pic 12 Desc.

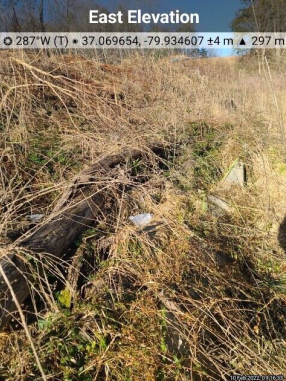
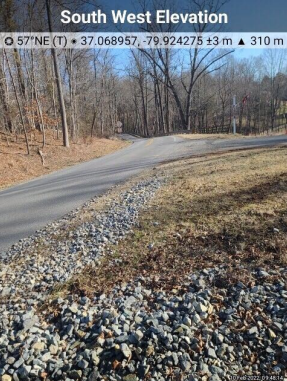
GPS Location	0000	GPS Location	0000		
Field Station#	13780+25	Field Station#	13811+91		
Pic 3 Desc.	P1 requires maintenance due to being weathered and torn, documented and added to the punch list for repair.		Pic 4 Desc.	Rock pushed into a land owners yard during snow plow activities, added to the punch list to have the rock removed.	
	South Elevation

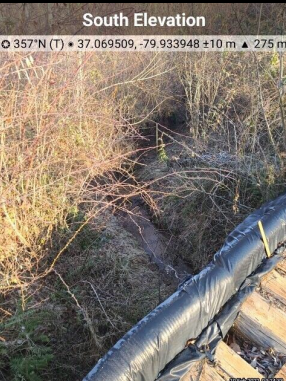
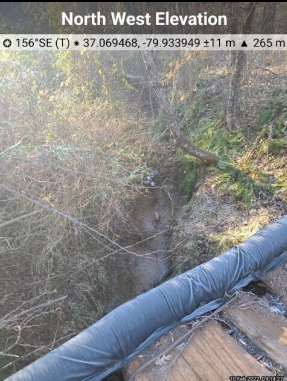
Field Station#	13781+79	Field Station#	13781+79		
Pic 5 Desc.	Stream observation photo facing downstream during routine inspection today, no environmental issues observed at the time of inspection.		Pic 6 Desc.	Stream observation photo facing upstream during routine inspection today, no environmental issues observed at the time of inspection.

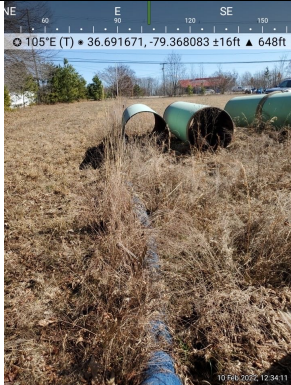
GPS Location	0	GPS Location	0		
Field Station#	0+00	Field Station#	0+00		
Pic 1 Desc.	LY-048 Temporary vegetation	Pic 2 Desc.	LY-048 North perimeter CFS

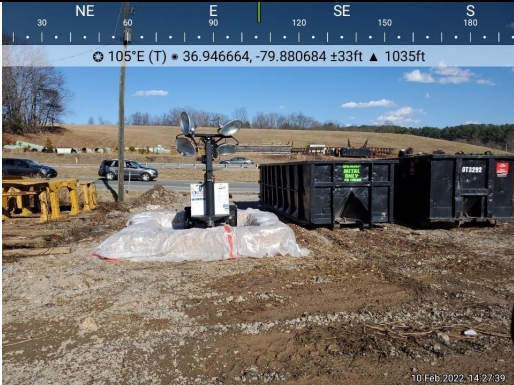
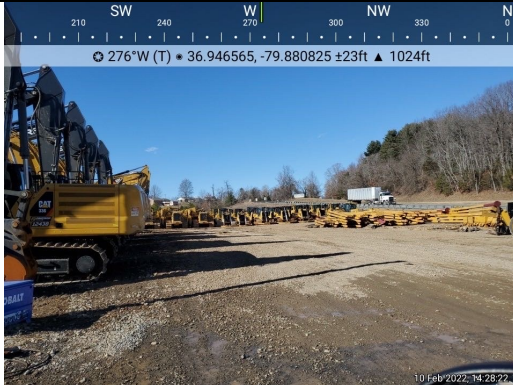
GPS Location	0	GPS Location	0		
Field Station#	0+00	Field Station#	0+00		
Pic 3 Desc.	LY-032 Secondary containment	Pic 4 Desc.	LY-032 Equipment staging

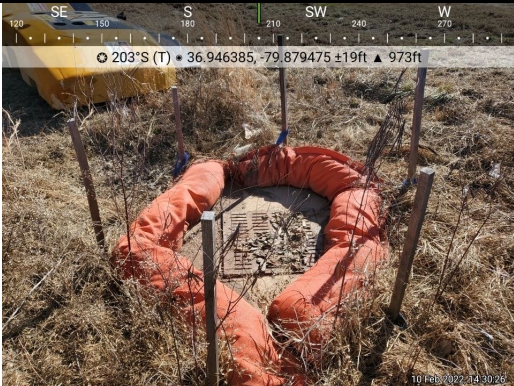
GPS Location	0	GPS Location	0		
Field Station#	0+00	Field Station#	0+00		
Pic 5 Desc.	LY-033 Stormwater drain inlet protection	Pic 6 Desc.	LY-033 Equipment staging

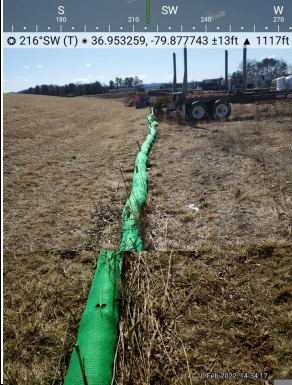
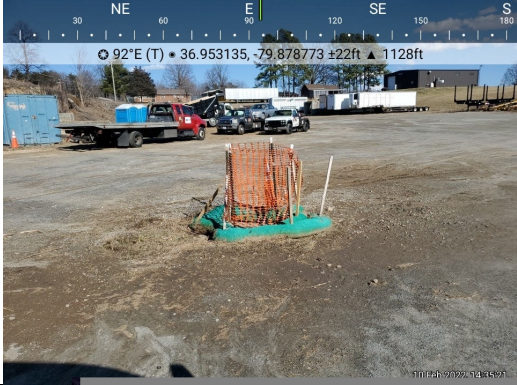
GPS Location	0	GPS Location	0		
Field Station#	0+00	Field Station#	0+00		
Pic 7 Desc.	ANC-006 Southeast perimeter CFS	Pic 8 Desc.	ANC-006 Stormwater drain inlet protection		
Insert image here		Insert image here			
GPS Location		GPS Location			
Field Station#		Field Station#			
Pic 9 Desc.		Pic 10 Desc.			
Insert image here		Insert image here			
GPS Location		GPS Location			
Field Station#		Field Station#			
Pic 11 Desc.		Pic 12 Desc.

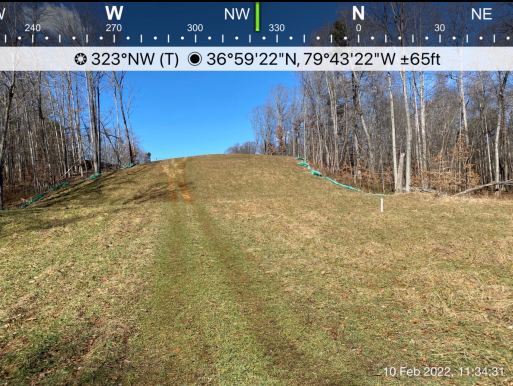
GPS Location	0	GPS Location	0		
Field Station#	14658+75	Field Station#	14654+00		
Pic 5 Desc.	Approximately 14658+75. Maintenance item. Install erosion control blanket on CWD dike and channel.		Pic 6 Desc.	Approximately 14654+00. Overview of ROW.

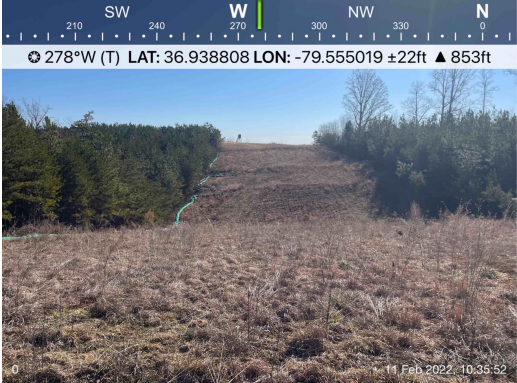
GPS Location	See photo	GPS Location			
Field Station#	15225+00	Field Station#			
Pic 13 Desc.	Vegetation continues to fill in throughout this section.	Pic 14 Desc.			
Insert image here		Insert image here			
GPS Location		GPS Location			
Field Station#		Field Station#			
Pic 15 Desc.		Pic 16 Desc.			
Insert image here		Insert image here			
GPS Location		GPS Location			
Field Station#		Field Station#			
Pic 17 Desc.		Pic 18 Desc.

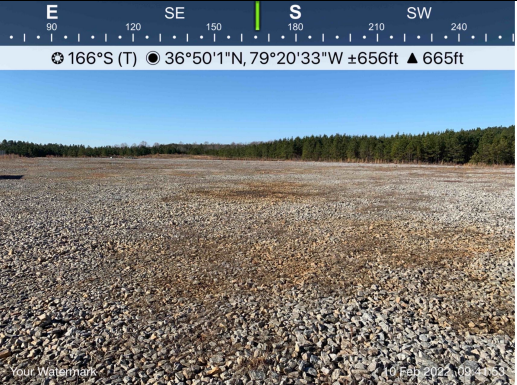
GPS Location	O	GPS Location	O		
Field Station#	00+00	Field Station#	00+00		
Pic 1 Desc.	Observing CFS that requires maintenance		Pic 2 Desc.	Observing lay down yard
