Visual Site Inspection Report

Project Name	H-600 Pipeline Spread G	AFE	124300137	Spread	H-600 Pipeline Spread G
Contractor	Precision			Report #	35439
Inspector	Chris Burns			Date/Time	3/14/2022 12:04 PM
Permit #	TBD	Inspection Type	VA SWPP	Station Begin	11023+80
State	VA	Inspection Area	Partial	Station End	11098+47
County	Giles	Ground	Wet	Temperature (°F)	60.00
Municipality	N/A	Weather	Sunny	Rain Gauge (in)	0.00
				Rain Accumulation Time (days)	1.00

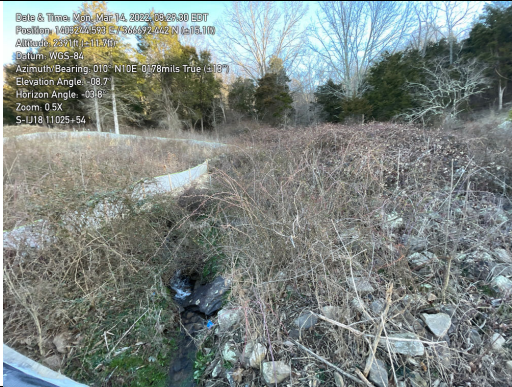
<p>Date & Time: Mon, Mar 14, 2022, 08:25:30 EDT Position: 140324.533 E / 36043.533 N (=15.11) Altitude: 2048 ft Datum: WGS-84 Azimuth/Bearing: 010° N10E 10.78mils True (=12°) Elevation Angle: -03.7° Horizon Angle: -03.6° Zoom: 0.5X S-IJ18 11025+54</p>

<p>Date & Time: Mon, Mar 14, 2022, 08:24:28 EDT Position: 140334.513 E / 36043.533 N (=15.11) Altitude: 2048 ft Datum: WGS-84 Azimuth/Bearing: 200° S20W 300mils True (=12°) Elevation Angle: -27.1° Horizon Angle: -00.7° Zoom: 0.5X 11034+50</p>			
GPS Location	1	GPS Location	2		
Field Station#	11025+54	Field Station#	11034+50		
Pic 1 Desc.	S-IJ18.	Pic 2 Desc.	CFS perimeter controls functional.

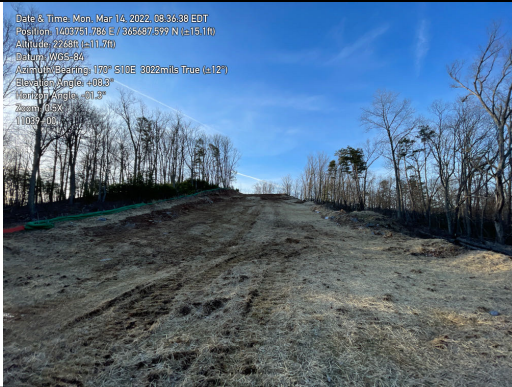
<p>Date & Time: Mon, Mar 14, 2022, 08:36:38 EDT Position: 140370.123 E / 36037.130 N (=15.11) Altitude: 2236 ft (=11.21) Datum: WGS-84 Azimuth/Bearing: 170° S10E 302mils True (=12°) Elevation Angle: -05.8° Horizon Angle: -00.3° Zoom: 0.5X 11039+00</p>

GPS Location	3	GPS Location	4		
Field Station#	11039+00	Field Station#	11050+10		
Pic 3 Desc.	Section of RoW showing conditions and controls.	Pic 4 Desc.	S-IJ16B/S-IJ17.

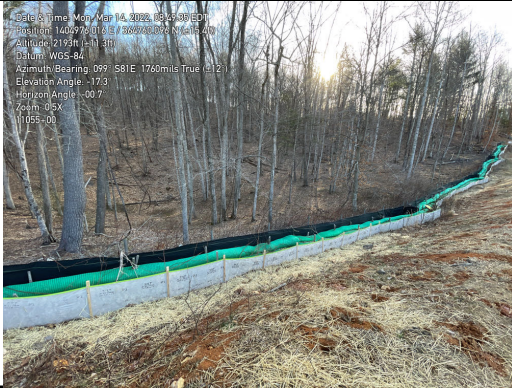
<p>Date & Time: Mon, Mar 14, 2022, 08:45:09 EDT Position: 140570.513 E / 36050.533 N (=15.11) Altitude: 2139 ft (=11.31) Datum: WGS-84 Azimuth/Bearing: 099° S81E 1760mils True (=12°) Elevation Angle: -17.3° Horizon Angle: -00.7° Zoom: 0.5X 11055+00</p>

<p>Date & Time: Mon, Mar 14, 2022, 08:55:47 EDT Position: 140540.013 E / 36063.877 N (=15.41) Altitude: 2176 ft (=11.21) Datum: WGS-84 Azimuth/Bearing: 128° S47E 304mils True (=12°) Elevation Angle: -09.3° Horizon Angle: -01.4° Zoom: 0.5X 11062+50</p>			
GPS Location	5	GPS Location	6		
Field Station#	11055+00	Field Station#	11062+50		
Pic 5 Desc.	Karst feature protection functional.	Pic 6 Desc.	Section of RoW showing conditions and controls.

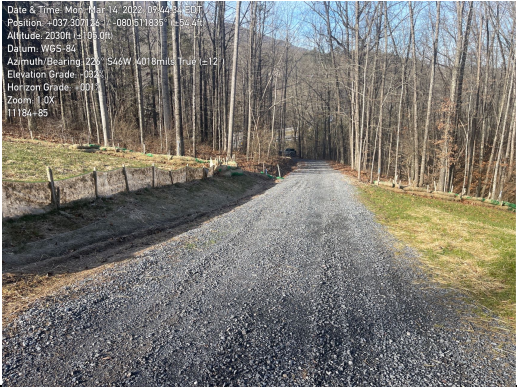
GPS Location	See Photo	GPS Location	See Photo		
Field Station#	11188+04	Field Station#	11184+85		
Pic 15 Desc.	Final Restoration Area	Pic 16 Desc.	AR 249 conditions		
Insert image here		Insert image here			
GPS Location		GPS Location			
Field Station#		Field Station#			
Pic 17 Desc.		Pic 18 Desc.

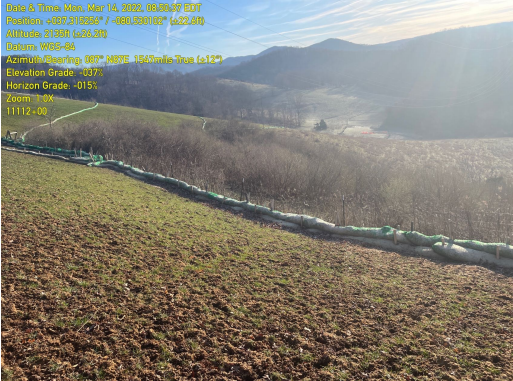
GPS Location		See photo				GPS Location		See photo			
Field Station#		11106+00				Field Station#		11112+00			
Pic 1 Desc.		CFS end treatments in place				Pic 2 Desc.		CFS triple stack perimeter control in place			
<p>Date & Time: Mon, Mar 14, 2022, 08:57:04 EDT Position: +037.313392° / +080.526739° (+13.9m) Altitude: 1950ft (+5.9m) Datum: WGS 84 Azimuth Bearing: 292° N48W 510mils True (+12°) Elevation Grade: +010° Horizon Grade: +002° Zoom: 1.0X 11120+00</p>  								<p>Date & Time: Mon, Mar 14, 2022, 09:05:10 EDT Position: +037.313944° / +080.522784° (+12.8m) Altitude: 2100ft (+3.0m) Datum: WGS 84 Azimuth Bearing: 017° N43W 308mils True (+12°) Elevation Grade: +024° Horizon Grade: +003° Zoom: 1.0X 11135+00</p>

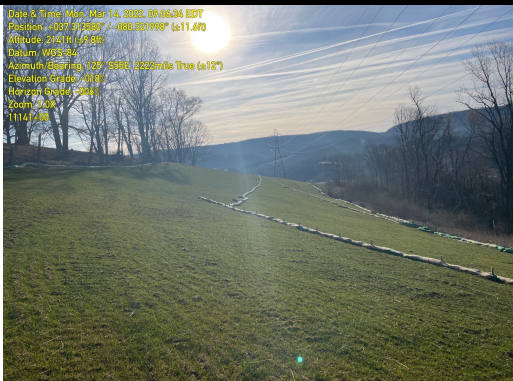
<p>Date & Time: Mon, Mar 14, 2022, 09:09:19 EDT Position: +037.313741° / +080.528017° (+21.3m) Altitude: 2143ft (+26.2m) Datum: WGS 84 Azimuth Bearing: 006° N04E 1118mils True (+12°) Elevation Grade: +025° Horizon Grade: +001° Zoom: 1.0X 11146+00</p>  			
GPS Location		See photo				GPS Location		See photo			
Field Station#		11141+00				Field Station#		11146+40			
Pic 5 Desc.		Permanent vegetation present				Pic 6 Desc.		Cleanwater diversion berm in place

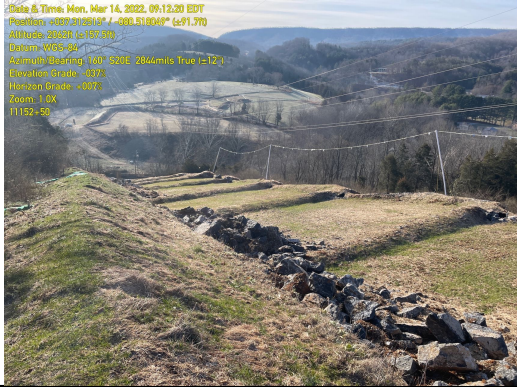
GPS Location		See photo		GPS Location	
Field Station#		11152+50		Field Station#	
Pic 9 Desc.		Waterbars in place		Pic 10 Desc.	
<p>Date & Time: Mon, Mar 14, 2022, 10:11:43 EDT Position: +037.512351° / -880.518257° (+15.50') Altitude: 1920ft (+7.20') Datum: WGS-84 Azimuth/Bearing: 230° (340°) 1000mils True (+12°) Elevation Grade: -00% Horizon Grade: -00% Zoom: 1.0X 11167+50</p>

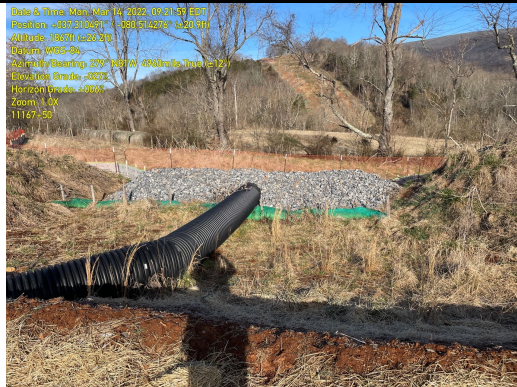
GPS Location		See photo		GPS Location	
Field Station#		11167+50		Field Station#	
Pic 11 Desc.		Cleanwater diversion outlet protection in place		Pic 12 Desc.

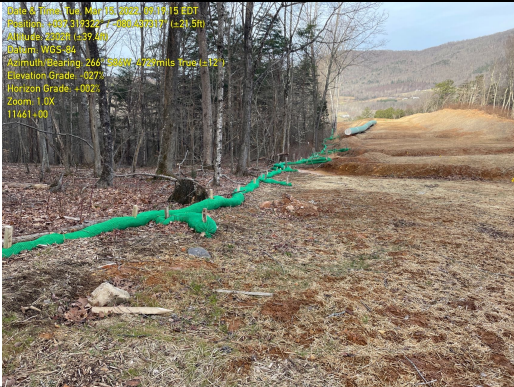
GPS Location	See photo	GPS Location	See photo		
Field Station#	11461+00	Field Station#	11456+00		
Pic 3 Desc.	CFS perimeter control in place	Pic 4 Desc.	Stone inlet protection in place		
<p>Date & Time: Tue, Mar 15, 2022, 09:20:47 EDT Position: +097.318827 / -089.492266 (s13.81) Altitude: 2247ft (s13.79) Datum: WGS-84 Azimuth/Bearing: 264° S00W 3664mils True (s12°) Elevation Grade: +025 Horizon Grade: +0025 Zoom: 1.0X 11452+00</p>

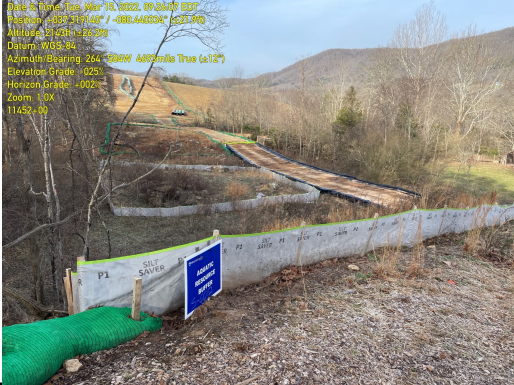
GPS Location	See photo	GPS Location	See photo		
Field Station#	11452+00	Field Station#	11448+00		
Pic 5 Desc.	Stream buffer in place	Pic 6 Desc.	Cleanwater diversion berm in place

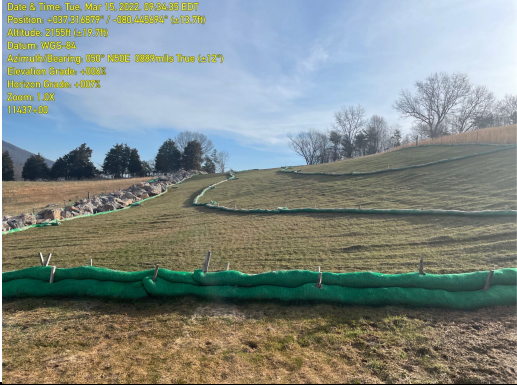
GPS Location	See photo	GPS Location	See photo		
Field Station#	11437+00	Field Station#	11431+00		
Pic 7 Desc.	Permanent vegetation present	Pic 8 Desc.	Permanent waterbar in place

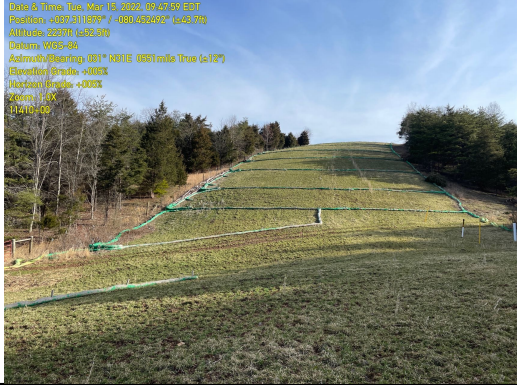
GPS Location	See photo	GPS Location	See photo		
Field Station#	11410+00	Field Station#	11397+00		
Pic 9 Desc.	CFS temporary waterbars in place	Pic 10 Desc.	Level spreader in place

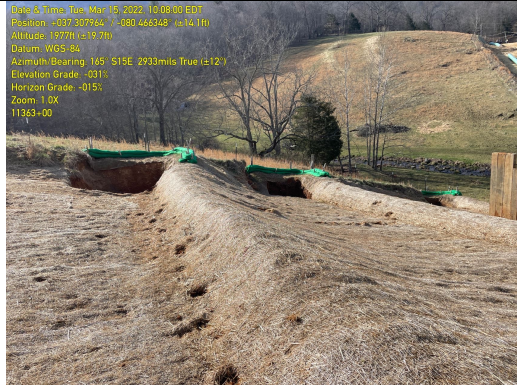
GPS Location	See photo	GPS Location	See photo		
Field Station#	11363+00	Field Station#	11353+75		
Pic 11 Desc.	End treatments in place	Pic 12 Desc.	RCE in place

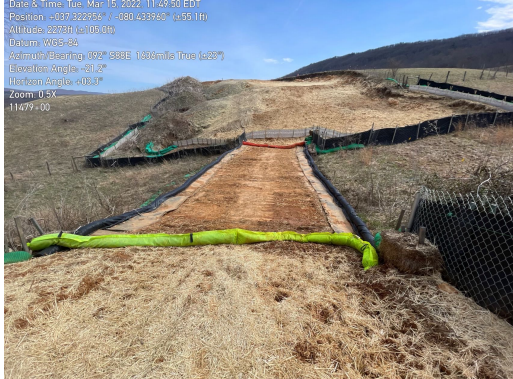
GPS Location		See photo		GPS Location	
Field Station#		11470+00		See photo	
Field Station#		11479+00			
Pic 1 Desc.		Section of Row showing conditions and controls		Pic 2 Desc.	
				Section of Row showing conditions and controls	
<p>Date & Time: Tue Mar 15 2022 11:48:45 EDT Position: +037 226600 / -080 435379 (s11.24) Altitude: 21841 (+6.8ft) Datum: WGS-84 Azimuth/Bearing: 330° N20W 800mils True (+12°) Elevation Angle: -15.3° Horizon Angle: -10.3° Zoom: 0.5X 11487+00</p>

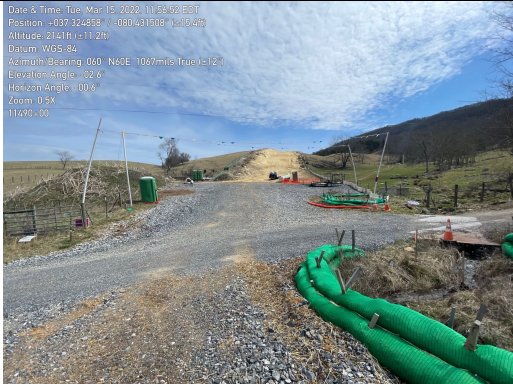
GPS Location		See photo		GPS Location	
Field Station#		11490+00		See photo	
Field Station#		11504+25			
Pic 5 Desc.		RCE and perimeter controls are maintained in acceptable condition		Pic 6 Desc.

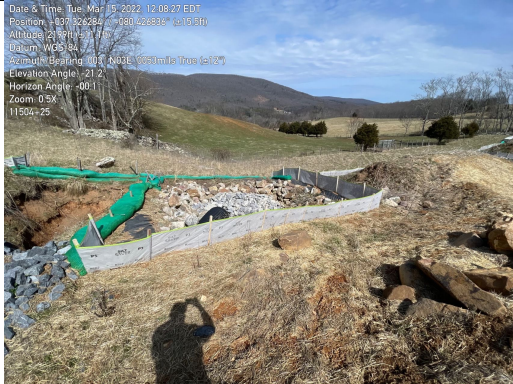
Section of Row showing conditions and controls

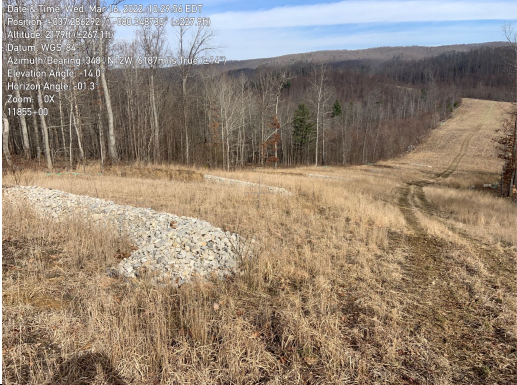
GPS Location	See photo		GPS Location	See photo	
Field Station#	11855+00		Field Station#	11859+00	
Pic 7 Desc.	Section of Row showing conditions and controls		Pic 8 Desc.	Section of Row showing conditions where temporary ECD's have been removed	
<small>Date & Time: Wed, Mar 16, 2022, 10:19:20 EDT Position: +437.283821° / -70.938781° / 1265.21 Altitude: 27710.12471m Datum: WGS-84 Azimuth Bearing: 330° 53'00" Azimuth True (+10°) Deviation Angle: -16.0° Horizon Angle: -01.3° Zoom: 1.0X 11873+00</small>

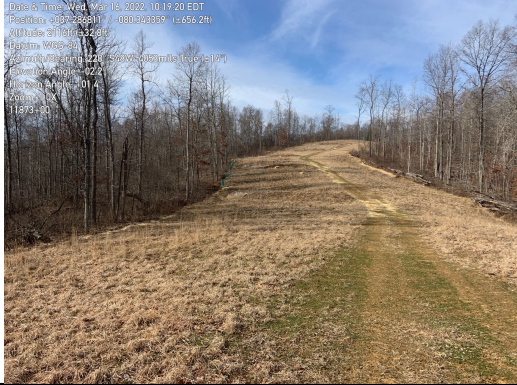
GPS Location	See photo		GPS Location	See photo	
Field Station#	11873+00		Field Station#	11898+00	
Pic 9 Desc.	Section of Row showing conditions and controls		Pic 10 Desc.	Section of Row showing conditions and controls	
Insert image here			Insert image here		
GPS Location			GPS Location		
Field Station#			Field Station#		
Pic 11 Desc.			Pic 12 Desc.

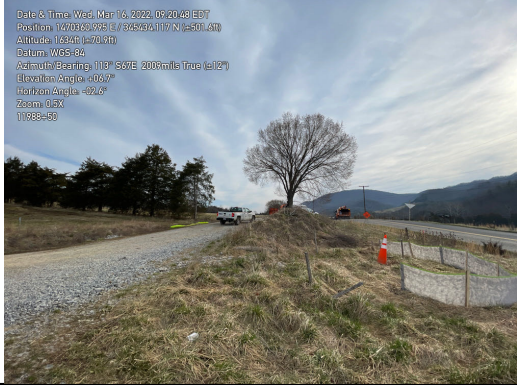
<div style="text-align: center;">Insert image here</div>			
GPS Location	9	GPS Location			
Field Station#	11988+50	Field Station#			
Pic 9 Desc.	Asplundh continued use of AR 266 access.		Pic 10 Desc.		
<div style="text-align: center;">Insert image here</div>		<div style="text-align: center;">Insert image here</div>			
GPS Location		GPS Location			
Field Station#		Field Station#			
Pic 11 Desc.		Pic 12 Desc.

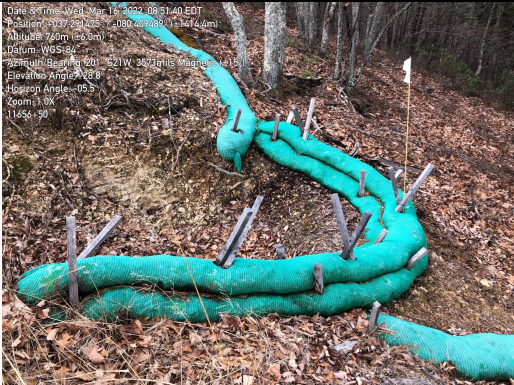
GPS Location	On photo	GPS Location	On photo		
Field Station#	11656+50	Field Station#	11641+00		
Pic 3 Desc.	Sumps and end treatments functioning.	Pic 4 Desc.	Slope breakers functional.

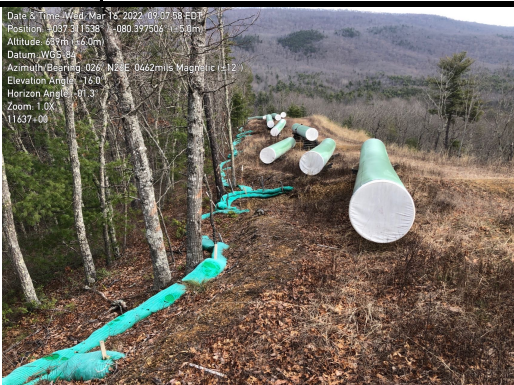
<p><small>Date & Time: Wed, Mar 16, 2022, 09:12:25 EDT Position: 43°31'22.21"N / -80°45:37" W (6462.6m) Altitude: 656m (±2.0m) Datum: WGS-84 Azimuth Bearing: 026° NNE / 042mils Magnetic (±1.2°) Elevation Angle: -21.8° Horizon Angle: -00.7° Zoom: 1.0X 11628+50</small></p>			
GPS Location	On photo	GPS Location	On photo		
Field Station#	11637+00	Field Station#	11628+50		
Pic 5 Desc.	No sediment migration. Surface stable.	Pic 6 Desc.	Perimeter ECDs are in place. ROW stable.

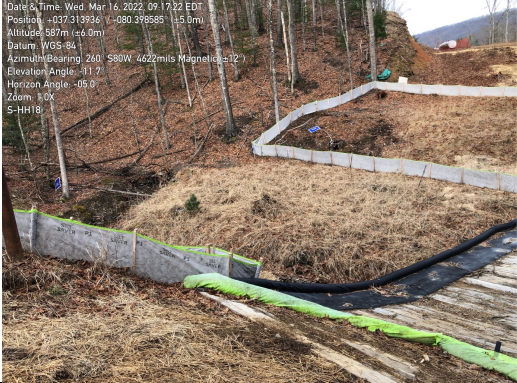
<p><small>Date & Time: Wed, Mar 16, 2022, 09:20:18 EDT Position: +037.313843° / -080.401394° (+5.0m) Altitude: 587m (+6.0m) Datum: WGS-84 Azimuth/Bearing: 104° N16W 6116mils Magnetic (+12°) Elevation Angle: +13.4° Horizon Angle: -00.7° Zoom: 1.0X 11624+00</small></p>			
GPS Location	On photo	GPS Location	On photo		
Field Station#	11626+04	Field Station#	11624+00		
Pic 7 Desc.	The S-HH18 crossing is stable.	Pic 8 Desc.	Perimeter ECDs in place and functional.

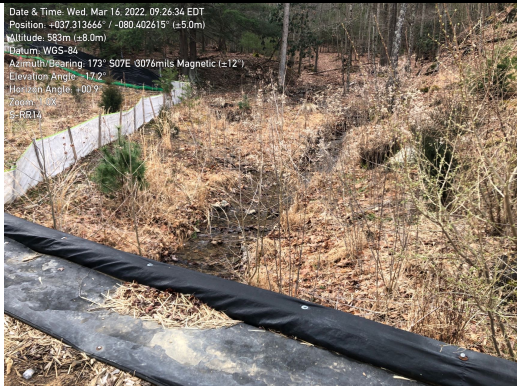
GPS Location	On photo	GPS Location	On photo		
Field Station#	11614+20	Field Station#	11608+17		
Pic 9 Desc.	The S-RR14 crossing is stable.	Pic 10 Desc.	The S-006 crossing is stable.		
Insert image here		Insert image here			
GPS Location		GPS Location			
Field Station#		Field Station#			
Pic 11 Desc.		Pic 12 Desc.

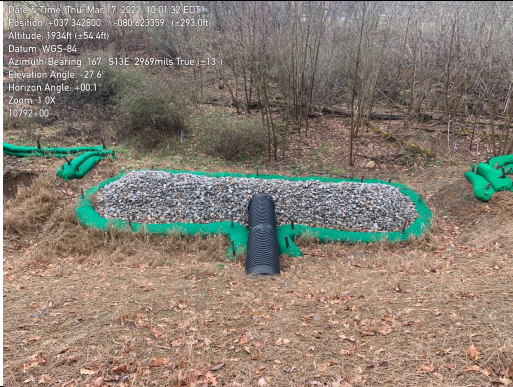
<p>Date & Time Thu Mar 17 2022 10:01:32 EDT Position: +377.24203N +080.62339W (+292.0m) Altitude: 1924ft (+56.4m) Datum: WGS-84 Azimuth/Bearing: 167.513E 2969mils True (+13.1) Elevation Angle: -27.6 Horizon Angle: +00.1 Zoom: 1.0X 10792+00</p>		  <p>Date & Time Thu Mar 17 2022 03:59:29 EDT Position: +377.34203N +080.62339W (+291.1m) Altitude: 1924ft (+60.0m) Datum: WGS-84 Azimuth/Bearing: 102.578E 1849mils True (+12.1) Elevation Angle: -22.0 Horizon Angle: -02.8 Zoom: 1.0X 10790+00</p>			
GPS Location	See photo		GPS Location	see photo	
Field Station#	10792+00		Field Station#	10790+00	
Pic 1 Desc.	Clean water diversion pipe and level spreader are in acceptable condition		Pic 2 Desc.	Section of Row showing conditions and controls

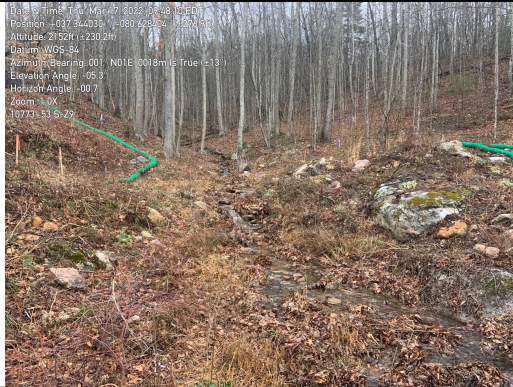
GPS Location	See photo		GPS Location	See photo	
Field Station#	10780+75		Field Station#	10773+53	
Pic 3 Desc.	S-Z7 showing conditions and controls		Pic 4 Desc.	S-Z9 showing conditions and controls

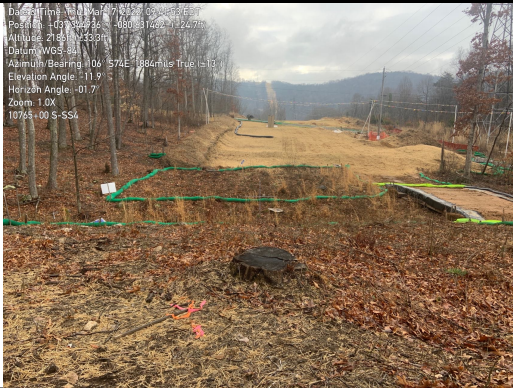
<p>Date & Time Thu Mar 17 2022 09:36:16 EDT Position: +377.34203N +080.62339W (+291.1m) Altitude: 2095ft (+63.5m) Datum: WGS-84 Azimuth/Bearing: 026.026E 0462mils True (+13.1) Elevation Angle: -08.1 Horizon Angle: -00.4 Zoom: 1.0X 10758+15 S-G35</p>			
GPS Location	See photo		GPS Location	See photo	
Field Station#	10765+00		Field Station#	10758+15	
Pic 5 Desc.	S-SS4 showing conditions and controls		Pic 6 Desc.	S-G35 showing conditions and controls

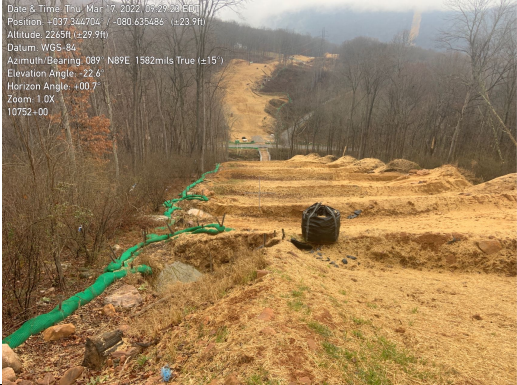
GPS Location	See photo	GPS Location	See photo		
Field Station#	10752+00	Field Station#	10777+90		
Pic 7 Desc.	Section of Row showing conditions and controls	Pic 8 Desc.	Equipment bridge and ECD's are in acceptable condition		
Insert image here		Insert image here			
GPS Location		GPS Location			
Field Station#		Field Station#			
Pic 9 Desc.		Pic 10 Desc.			
Insert image here		Insert image here			
GPS Location		GPS Location			
Field Station#		Field Station#			
Pic 11 Desc.		Pic 12 Desc.

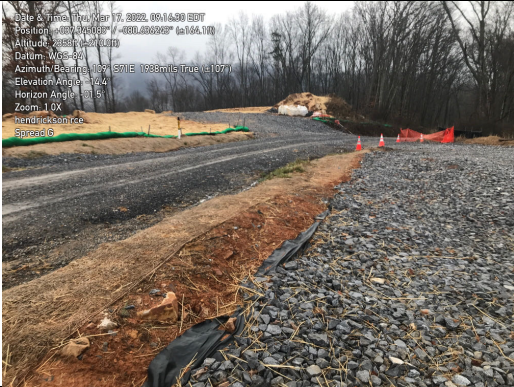
<p>Date & Time: Thu, Mar 17, 2022, 09:22:10 EDT Position: +037 346230° / -080 640144° (±16.4ft) Altitude: 2374ft (±9.8ft) Datum: WGS-84 Azimuth/Bearing: 306° N54W 5440mils True (±13°) Elevation Angle: -02.5° Horizon Angle: -02.5° Zoom: 1.0X 10729+00 Spread: 0</p>		GPS Location	See photo
Field Station#	10749+92	Field Station#	10737+00	GPS Location	see photo
Pic 1 Desc.	Hendrickson RCE	Pic 2 Desc.	Stabilized ROW	Field Station#	10737+00

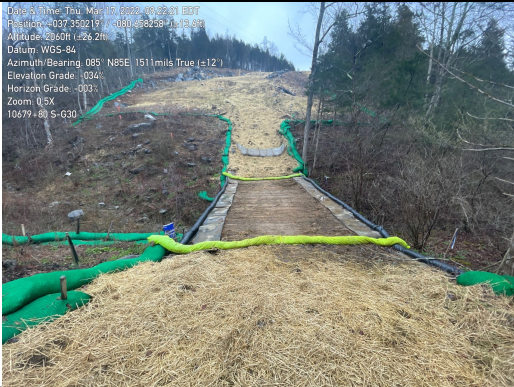
Field Station#	10679+80	Field Station#	10732+41	GPS Location	see photo
Pic 3 Desc.	S G 30	Pic 4 Desc.	Wetland Z 11	Field Station#	10732+41

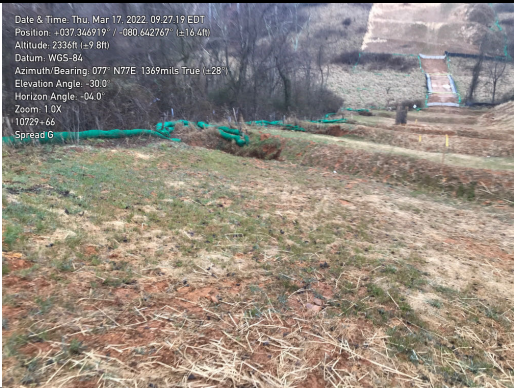
<p>Date & Time: Thu, Mar 17, 2022, 09:32:39 EDT Position: +037 346570° / -080 645136° (±16.4ft) Altitude: 2336ft (±9.8ft) Datum: WGS-84 Azimuth/Bearing: 169° S 128 2987mils True (±15°) Elevation Angle: -24.3° Horizon Angle: -00.4° Zoom: 1.0X 10719+00 Spread: 0</p>		GPS Location	see photo
Field Station#	10729+66	Field Station#	10719+00	GPS Location	see photo
Pic 5 Desc.	Sumps/water bars/perimeter ECDs	Pic 6 Desc.	Slope drain/sump	Field Station#	10719+00

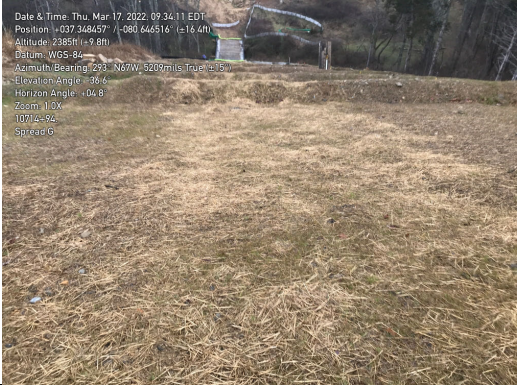
<p><small>Date & Time: Thu, Mar 17, 2022 09:38:57 EDT Position: +037.348450° / -080.647574° (±16.4m) Altitude: 2286ft (±9.8m) Datum: WGS-84 Azimuth/Bearing: 079° N79E 1404mils True (±13°) Elevation Angle: -19.9° Horizon Angle: +02.0° Zoom: 1.0X S G 32 Spread: G</small></p>			
GPS Location	See photo	GPS Location	see photo		
Field Station#	10714+94	Field Station#	10712+60		
Pic 7 Desc.	Stabilized ROW	Pic 8 Desc.	S G 32

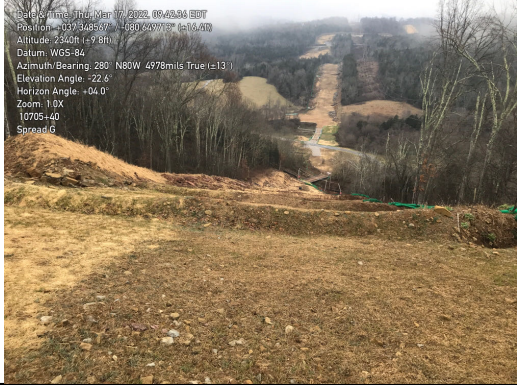
GPS Location	see photo	GPS Location			
Field Station#	10705+40	Field Station#			
Pic 9 Desc.	Water bars/sumps	Pic 10 Desc.			
<p style="text-align: center;">Insert image here</p>		<p style="text-align: center;">Insert image here</p>			
GPS Location		GPS Location			
Field Station#		Field Station#			
Pic 11 Desc.		Pic 12 Desc.

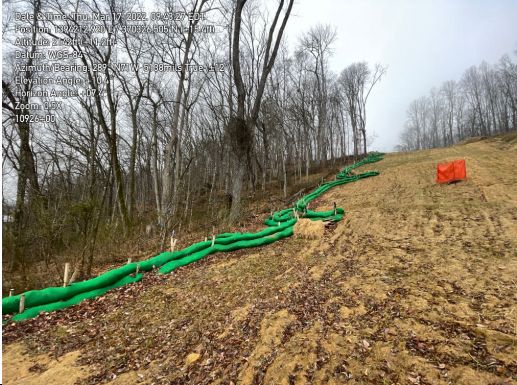
GPS Location	7	GPS Location	8		
Field Station#	10926+00	Field Station#	10927+75		
Pic 7 Desc.	CFS perimeter controls functional.	Pic 8 Desc.	S-Y3.

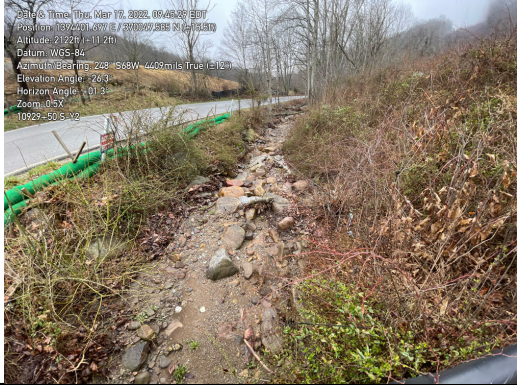
<div style="text-align: center;">Insert image here</div>			
GPS Location	9	GPS Location			
Field Station#	10929+50	Field Station#			
Pic 9 Desc.	S-Y2.	Pic 10 Desc.			
<div style="text-align: center;">Insert image here</div>		<div style="text-align: center;">Insert image here</div>			
GPS Location		GPS Location			
Field Station#		Field Station#			
Pic 11 Desc.		Pic 12 Desc.

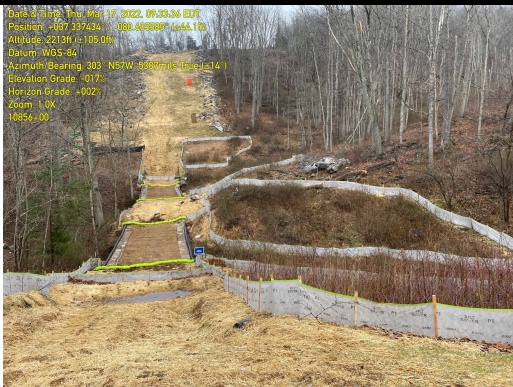
<p>Date & Time: Thu, Mar 17, 2022, 09:40:39 EDT Position: +407.334332° / -88.463887° (s44.11) Altitude: 2213ft (s105.04) Datum: WGS-84 Azimuth/Bearing: 156° S24E 2970mils True (s13.1) Elevation Grade: +02% Horizon Grade: +00% Zoom: 1.0X 10848+00</p>			
GPS Location	See photo		GPS Location	See photo	
Field Station#	10856+00		Field Station#	10848+00	
Pic 1 Desc.	Stream buffer in place		Pic 2 Desc.	CFS perimeter control in place

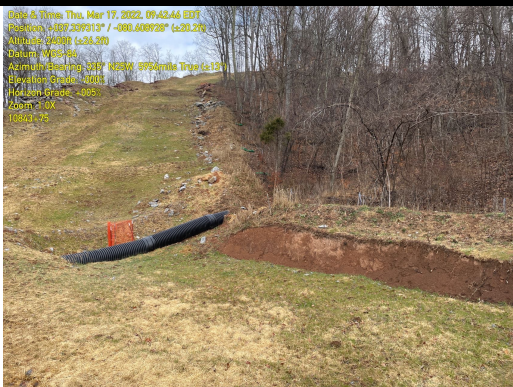
GPS Location	See photo		GPS Location	See photo	
Field Station#	10843+75		Field Station#	10833+00	
Pic 3 Desc.	Cleanwater diversion berm in place		Pic 4 Desc.	Waterbars in place

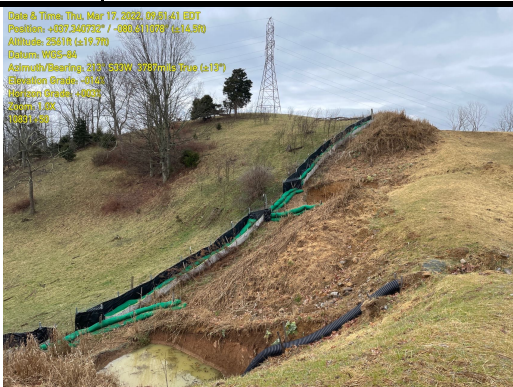
<p>Date & Time: Thu, Mar 17, 2022, 10:04:18 EDT Position: +407.346482° / -88.416482° (s47.11) Altitude: 2184ft (s102.31) Datum: WGS-84 Azimuth/Bearing: 356° N4W 4329mils True (s12.1) Elevation Grade: +01% Horizon Grade: +00% Zoom: 1.0X 10812+00</p>			
GPS Location	See photo		GPS Location	See photo	
Field Station#	10831+50		Field Station#	10812+00	
Pic 5 Desc.	Triple protection ECDs in place at karst feature		Pic 6 Desc.	Cleanwater diversion outlet protection in place

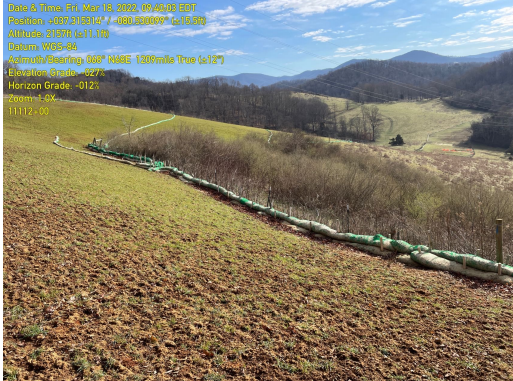
GPS Location				See photo				GPS Location				See photo			
Field Station#				11112+00				Field Station#				11120+00			
Pic 1 Desc.				CFS triple stack perimeter control in place				Pic 2 Desc.				Temporary CFS waterbars in place			
<p>Date & Time P1, Mar 18, 2022, 09:51:33 EDT Position: +407.215284° / -886.524457° (+26.26) Altitude: 21838 (+26.26) Datum: WGS-84 Azimuth/Bearing: 343° N17W 6098mils True (+12°) Elevation Grade: +822° Horizon Grade: +011° Zoom: 1.0X 11113+00</p>

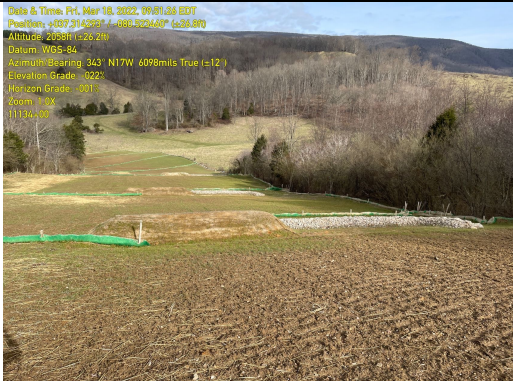
Field Station#				11134+00				Field Station#				11141+00			
Pic 3 Desc.				Permanent waterbars in place				Pic 4 Desc.				Permanent vegetation present			
<p>Date & Time P1, Mar 18, 2022, 09:57:33 EDT Position: +407.215284° / -886.524457° (+26.26) Altitude: 21705 (+11.70) Datum: WGS-84 Azimuth/Bearing: 343° N17W 6098mils True (+12°) Elevation Grade: +827° Horizon Grade: +012° Zoom: 1.0X 11114+00</p>

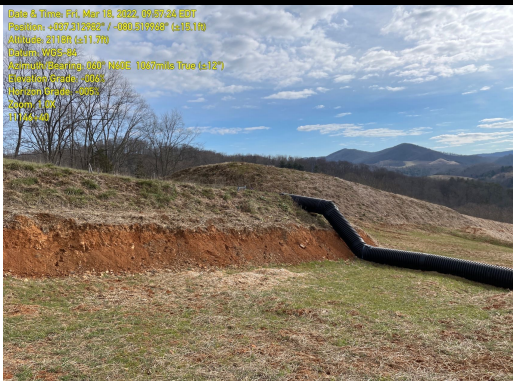
GPS Location				See photo				GPS Location				See photo			
Field Station#				11146+40				Field Station#				11147+25			
Pic 5 Desc.				Cleanwater diversion berm in place				Pic 6 Desc.				Stone inlet protection in place

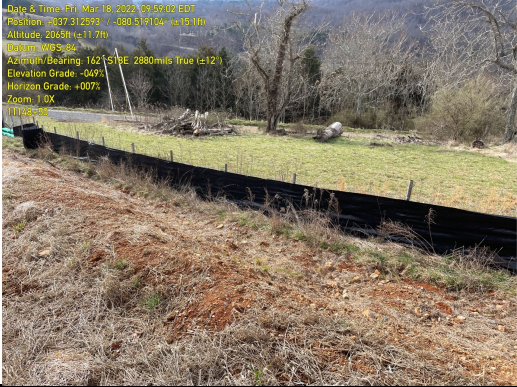
GPS Location	See photo	GPS Location	See photo		
Field Station#	11148+50	Field Station#	11152+50		
Pic 7 Desc.	Supersilt fence perimeter control in place	Pic 8 Desc.	Waterbars in place		
<p>Date & Time: Fri, Mar 18, 2022, 10:07:00 EDT Position: +407.311554° / -080.514822° (s=19.10) Altitude: 18940ft (s=34.20) Datum: WGS-84 Azimuth/Bearing: 110° S45E 1954mils True (s=12°) Elevation Grade: -008% Horizon Grade: +002% Zoom: 1.0X 11163+00</p>

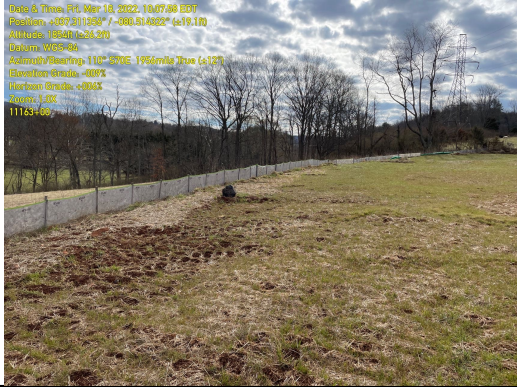
GPS Location	See photo	GPS Location	See photo		
Field Station#	11163+00	Field Station#	11167+50		
Pic 9 Desc.	P1 silt fence perimeter control in place	Pic 10 Desc.	Cleanwater diversion outlet protection in place		
<p>Date & Time: Fri, Mar 18, 2022, 10:12:00 EDT Position: +407.310255° / -080.514403° (s=31.80) Altitude: 18480ft (s=36.30) Datum: WGS-84 Azimuth/Bearing: 205° S25W 9891mils True (s=12°) Elevation Grade: -002% Horizon Grade: -001% Zoom: 1.0X 11168+00</p>

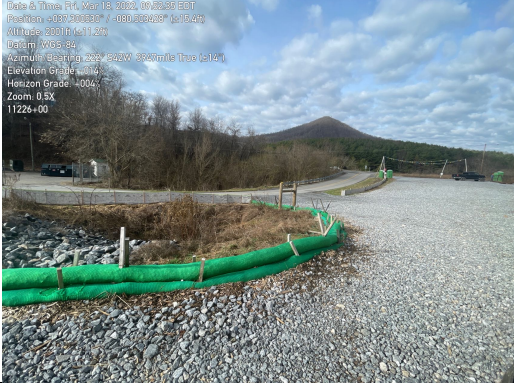
GPS Location	See Photo	GPS Location	See Photo		
Field Station#	11226+00	Field Station#	11226+00		
Pic 1 Desc.	Winding way RCE area with storm drain protection in view.		Pic 2 Desc.	Rock lined channel with rock checks near winding way access road.

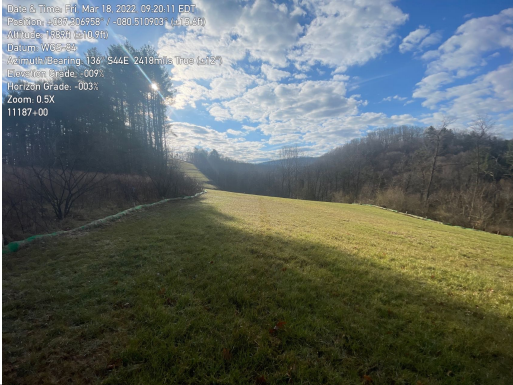
GPS Location	See Photo	GPS Location	See Photo		
Field Station#	11184+85	Field Station#	11187+00		
Pic 3 Desc.	Ditch line settling in the final restoration area near AR 249.02		Pic 4 Desc.	Final Restoration Area.

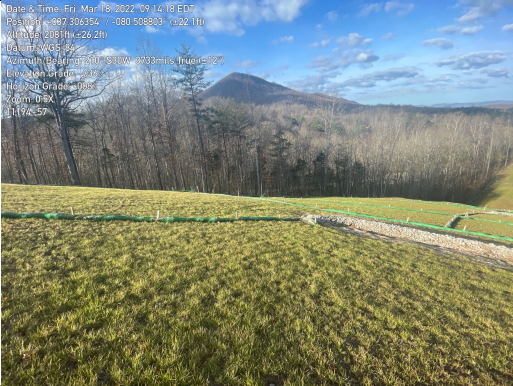
GPS Location	See Photo	GPS Location	See Photo		
Field Station#	11191+27	Field Station#	11194+57		
Pic 5 Desc.	Final Restoration Area drainage feature.		Pic 6 Desc.	Final Restoration Area

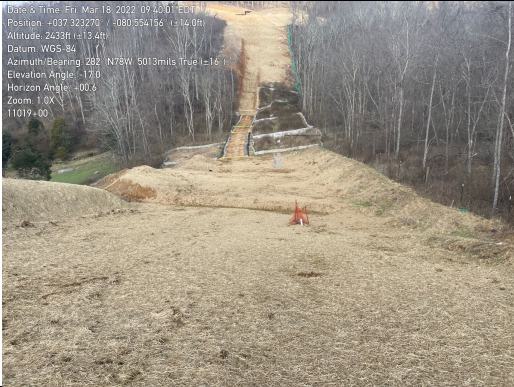
GPS Location	See photo		GPS Location	See photo	
Field Station#	11019+00		Field Station#	11016+00	
Pic 1 Desc.	Section of Row showing conditions and controls		Pic 2 Desc.	Section of Row showing conditions and controls at S-PA07

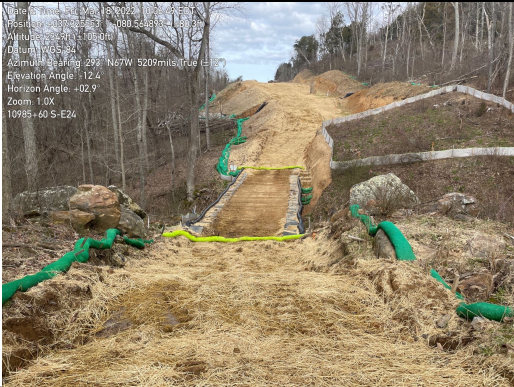
GPS Location	See photo		GPS Location	See photo	
Field Station#	10985+60		Field Station#	10976+00	
Pic 3 Desc.	Section of Row showing conditions and controls at S-E24		Pic 4 Desc.	Section of Row showing conditions and controls

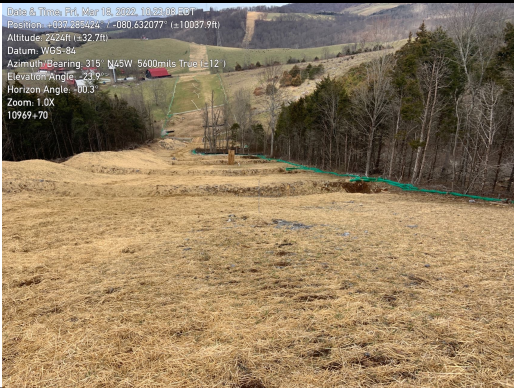
GPS Location	See photo		GPS Location	See photo	
Field Station#	10969+70		Field Station#	10966+38	
Pic 5 Desc.	Section of Row showing conditions and controls		Pic 6 Desc.	Karst ECD's are in acceptable condition
