Visual Site Inspection Report

Project Name	H-600 Pipeline Spread G	AFE	124300137	Spread	H-600 Pipeline Spread G
Contractor	Precision			Report #	35666
Inspector	Clint Sears			Date/Time	3/21/2022 10:31 AM
Permit #	TBD	Inspection Type	VA SWPP	Station Begin	11471+56
State	VA	Inspection Area	Partial	Station End	11524+16
County	Giles	Ground	Damp	Temperature (°F)	50.00
Municipality	N/A	Weather	Sunny	Rain Gauge (in)	0.00
				Rain Accumulation Time (days)	1.00

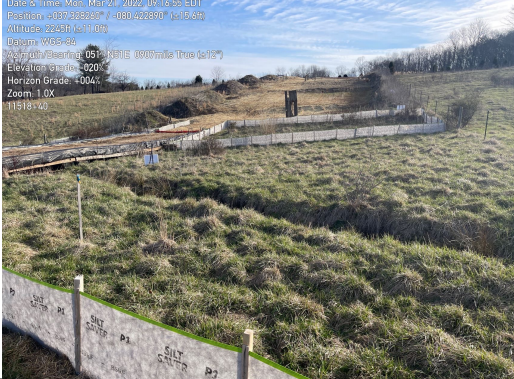
<p>Date & Time: Mon, Mar 21, 2022 09:18:39 EDT Position: +037.22618° / -080.42251° (±15.4ft) Altitude: 2235ft (±11.2ft) Datum: WGS 84 Azimuth/Bearing: 262 S62W 4302mils True (±12.1) Elevation Grade: -012.1 Horizon Grade: -003.1 Zoom: 1.0X 11518+40 S-PP4</p>

GPS Location	See photo	GPS Location	See photo		
Field Station#	11518+40	Field Station#	11518+40		
Pic 5 Desc.	Section of Row showing conditions and controls	Pic 6 Desc.	Section of Row showing conditions and controls at S-PP4

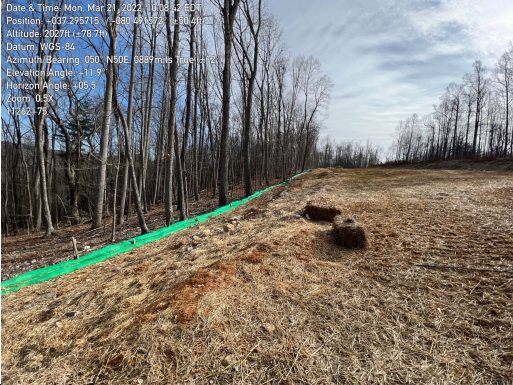
GPS Location	See Photo	GPS Location	See Photo		
Field Station#	11257+15	Field Station#	11262+75		
Pic 1 Desc.	Waterbars	Pic 2 Desc.	Perimeter controls

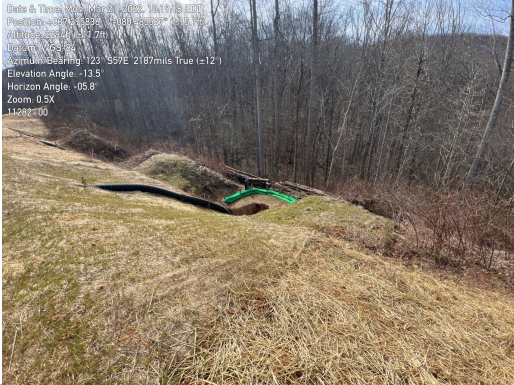
GPS Location	See Photo	GPS Location	See Photo		
Field Station#	11282+00	Field Station#	11292+80		
Pic 3 Desc.	Slope drain and sump pit	Pic 4 Desc.	S-MM18

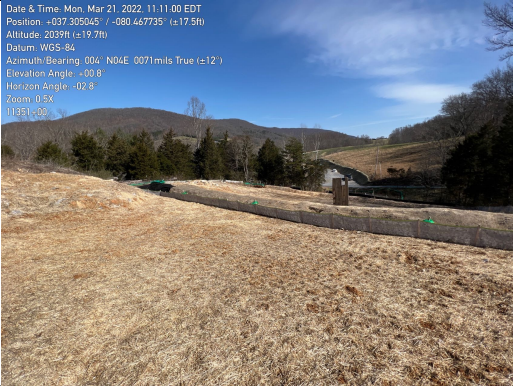
GPS Location	See Photo	GPS Location	See Photo		
Field Station#	11327+85	Field Station#	11351+00		
Pic 5 Desc.	S-NN12	Pic 6 Desc.	Karst Protection ECDs

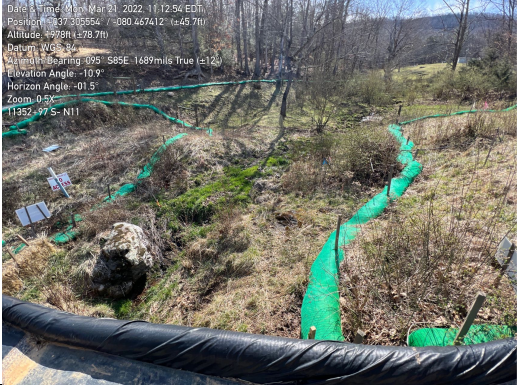
<p>Insert image here</p>			
GPS Location	See Photo	GPS Location			
Field Station#	11352+97	Field Station#			
Pic 7 Desc.	S-NN11	Pic 8 Desc.			
<p>Insert image here</p>		<p>Insert image here</p>			
GPS Location		GPS Location			
Field Station#		Field Station#			
Pic 9 Desc.		Pic 10 Desc.			
<p>Insert image here</p>		<p>Insert image here</p>			
GPS Location		GPS Location			
Field Station#		Field Station#			
Pic 11 Desc.		Pic 12 Desc.

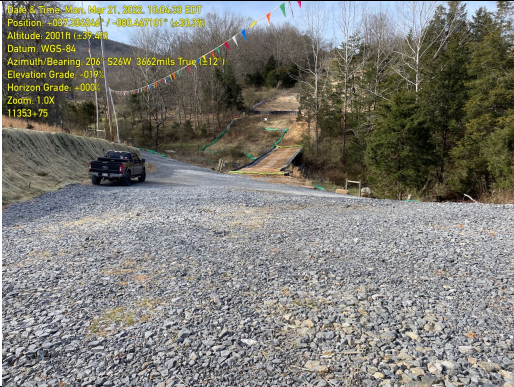
GPS Location	See photo	GPS Location	See photo		
Field Station#	11353+75	Field Station#	11363+00		
Pic 1 Desc.	RCE in place	Pic 2 Desc.	End treatments in place

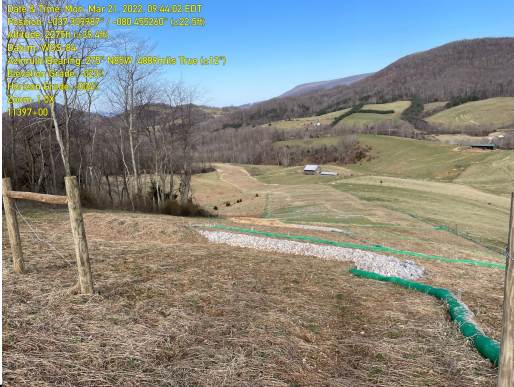
GPS Location	See photo	GPS Location	See photo		
Field Station#	11397+00	Field Station#	11411+00		
Pic 3 Desc.	Level spreader in place	Pic 4 Desc.	Temporary CFS waterbars in place

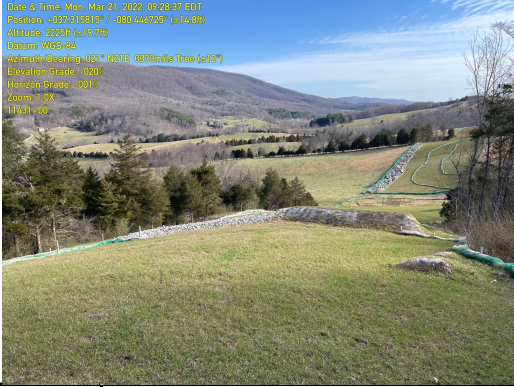
GPS Location	See photo	GPS Location	See photo		
Field Station#	11431+00	Field Station#	11437+00		
Pic 5 Desc.	Permanent waterbar in place	Pic 6 Desc.	Permanent vegetation present

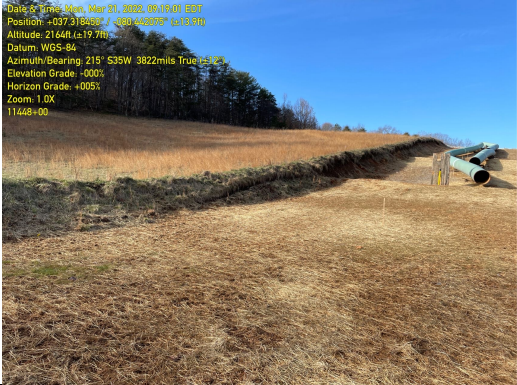
<p>Date & Time: Mon, Mar 21, 2022 09:14:16 EDT Position: +037.318483° / -380.440579° (-11448) Altitude: 2164ft (-19.7m) Datum: WGS-84 Azimuth/Bearing: 215° S35W 3822mils True (-12°) Elevation Grade: -000% Horizon Grade: +005% Zoom: 1.0X 11448+00</p>

<p>Date & Time: Mon, Mar 21, 2022 09:14:19 EDT Position: +037.318483° / -380.440579° (-11452) Altitude: 2190ft (-19.7m) Datum: WGS-84 Azimuth/Bearing: 241° S41W 3400mils True (-14°) Elevation Grade: -022% Horizon Grade: +001% Zoom: 1.0X 11452+66</p>			
GPS Location	See photo	GPS Location	See photo		
Field Station#	11448+00	Field Station#	11452+66		
Pic 7 Desc.	Cleanwater diversion berm in place	Pic 8 Desc.	Stream buffer in place

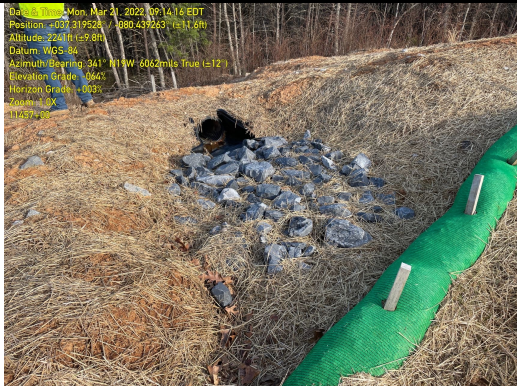
<p>Date & Time: Mon, Mar 21, 2022 09:14:16 EDT Position: +037.318483° / -380.440579° (-11457) Altitude: 2200ft (-19.7m) Datum: WGS-84 Azimuth/Bearing: 341° N14W 6002mils True (-12°) Elevation Grade: -064% Horizon Grade: -003% Zoom: 1.0X 11457+00</p>

GPS Location	See photo	GPS Location	See photo		
Field Station#	11457+00	Field Station#	11461+00		
Pic 9 Desc.	Stone inlet protection in place	Pic 10 Desc.	CFS perimeter control in place

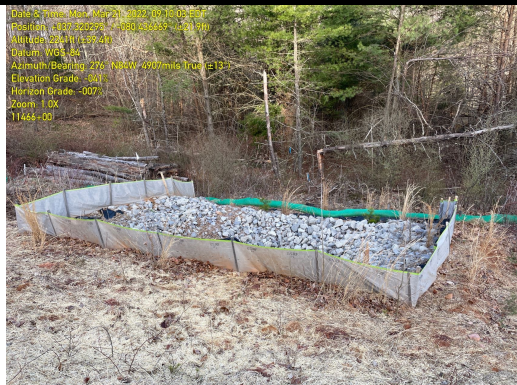
<p>Date & Time: Mon, Mar 21, 2022 09:14:17 EDT Position: +037.318483° / -380.440579° (-11466) Altitude: 2200ft (-19.7m) Datum: WGS-84 Azimuth/Bearing: 245° S45W 3400mils True (-14°) Elevation Grade: -007% Horizon Grade: -007% Zoom: 1.0X 11466+00</p>

<p>Date & Time: Mon, Mar 21, 2022 09:14:17 EDT Position: +037.318483° / -380.440579° (-11469) Altitude: 2200ft (-19.7m) Datum: WGS-84 Azimuth/Bearing: 245° S45W 3400mils True (-14°) Elevation Grade: -007% Horizon Grade: -007% Zoom: 1.0X 11469+00</p>			
GPS Location	See photo	GPS Location	See photo		
Field Station#	11466+00	Field Station#	11469+00		
Pic 11 Desc.	Plunge pool in place	Pic 12 Desc.	Triple protection ECDs in place

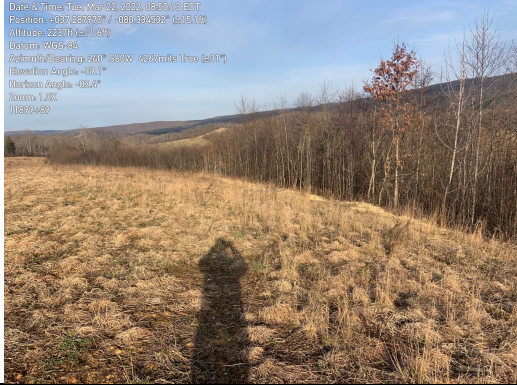
<small>Date & Time: Tue Mar 22, 2022, 06:05:18 EST Position: +38.52653° / -80.94335° (Lat/Lon) Altitude: 3207m (10521) Datum: WGS-84 Azimuth/Bearing: 340° (340°) 220mils True (±1°) Roll: 0.0° (0.0°) Pitch: 0.0° (0.0°) Horizon Angle: -0.3° Zoom: 1.0X 11873+00</small>

GPS Location	See photo	GPS Location	See photo		
Field Station#	11899+89	Field Station#	11873+00		
Pic 9 Desc.	Vegetation is acceptable	Pic 10 Desc.	Section of Row showing conditions and controls		
Insert image here		Insert image here			
GPS Location		GPS Location			
Field Station#		Field Station#			
Pic 11 Desc.		Pic 12 Desc.

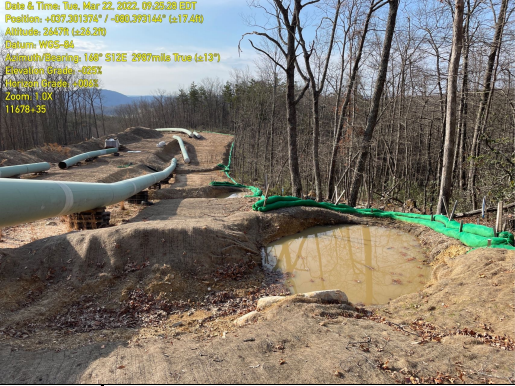
GPS Location	See photo	GPS Location	See photo		
Field Station#	11670+00	Field Station#	11678+35		
Pic 1 Desc.	P1 silt fence perimeter control in place	Pic 2 Desc.	End treatments in place		
<p>Date & Time: Tue, Mar 22, 2022, 09:31:21 EDT Position: +037.202504° / -000.391845° (±16.8ft) Altitude: 2820ft (±17.9ft) Datum: WGS-84 Azimuth/Bearing: 118° S30E 3096mils True (±14°) Elevation Grade: -002% Horizontal Grade: -002% Zoom: 1.0X 11682+50</p>

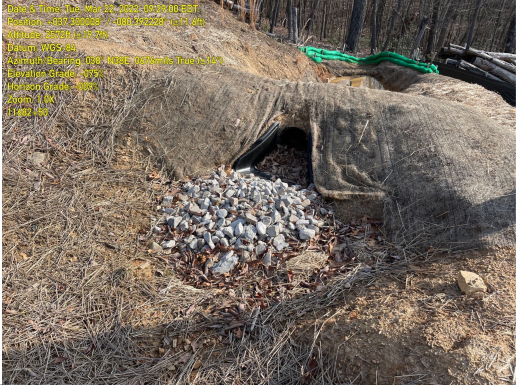
<p>Date & Time: Tue, Mar 22, 2022, 09:31:21 EDT Position: +037.202504° / -000.391845° (±16.8ft) Altitude: 2820ft (±17.9ft) Datum: WGS-84 Azimuth/Bearing: 118° S30E 3096mils True (±14°) Elevation Grade: -002% Horizontal Grade: -002% Zoom: 1.0X 11688+00</p>

GPS Location	See photo	GPS Location	See photo		
Field Station#	11682+50	Field Station#	11688+00		
Pic 3 Desc.	Stone inlet protection in place	Pic 4 Desc.	Erosion control blanket in place		
<p>Date & Time: Tue, Mar 22, 2022, 09:37:57 EDT Position: +037.202401° / -000.394567° (±17.1m) Altitude: 2814ft (±13.1ft) Datum: WGS-84 Azimuth/Bearing: 141° S30E 2507mils True (±13°) Elevation Grade: -002% Horizontal Grade: -002% Zoom: 1.0X 11714+00</p>

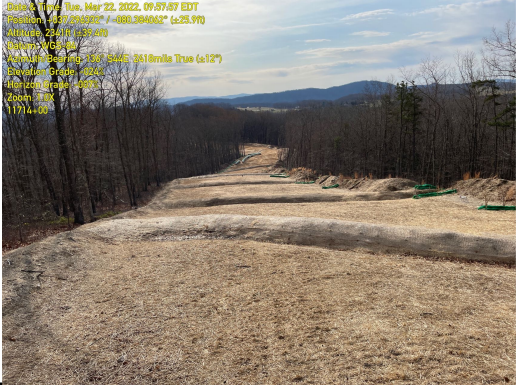
<p>Date & Time: Tue, Mar 22, 2022, 09:37:57 EDT Position: +037.202401° / -000.394567° (±17.1m) Altitude: 2814ft (±13.1ft) Datum: WGS-84 Azimuth/Bearing: 141° S30E 2507mils True (±13°) Elevation Grade: -002% Horizontal Grade: -002% Zoom: 1.0X 11741+00</p>

GPS Location	See photo	GPS Location	See photo		
Field Station#	11714+00	Field Station#	11741+00		
Pic 5 Desc.	Waterbars in place	Pic 6 Desc.	Steam buffer in place

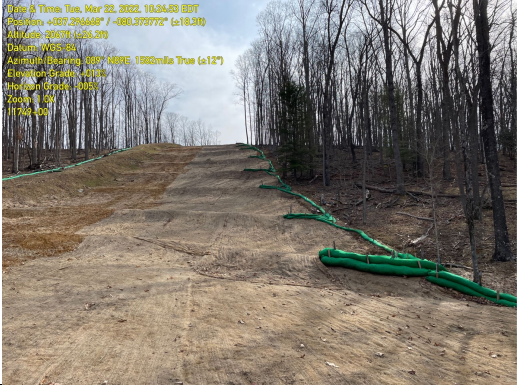
GPS Location	See photo	GPS Location	See photo		
Field Station#	11749+00	Field Station#	11758+00		
Pic 7 Desc.	End treatments in place	Pic 8 Desc.	Supersilt fence perimeter control in place

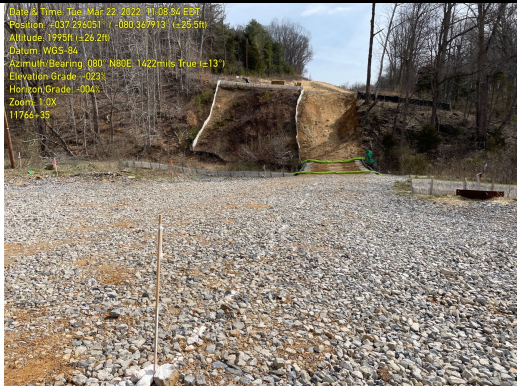
GPS Location	See photo	GPS Location	See photo		
Field Station#	11766+35	Field Station#	11782+50		
Pic 9 Desc.	RCE in place	Pic 10 Desc.	Cleanwater drainage feature in place

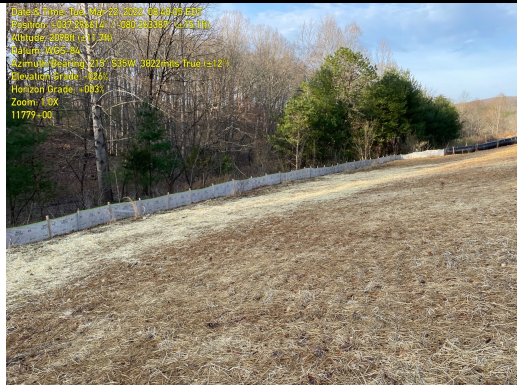
GPS Location	See photo	GPS Location	See photo		
Field Station#	11779+00	Field Station#	11690+00		
Pic 11 Desc.	P1 silt fence perimeter control in place	Pic 12 Desc.	Slope drain pipe in place

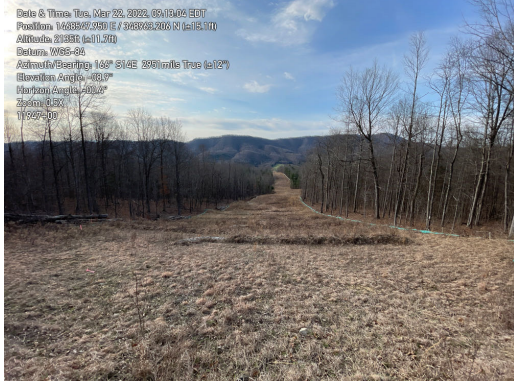
GPS Location	5	GPS Location	6		
Field Station#	11940+50	Field Station#	11947+00		
Pic 5 Desc.	Section of restored RoW showing conditions and controls.	Pic 6 Desc.	Section of restored RoW showing conditions and controls.

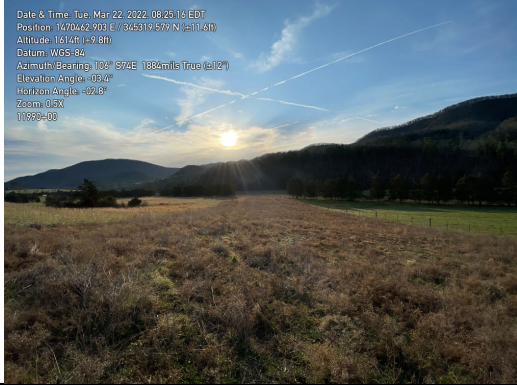
GPS Location	7	GPS Location	8		
Field Station#	11962+25	Field Station#	11978+85		
Pic 7 Desc.	P-1 perimeter controls functional.		Pic 8 Desc.	Karst feature protection functional.

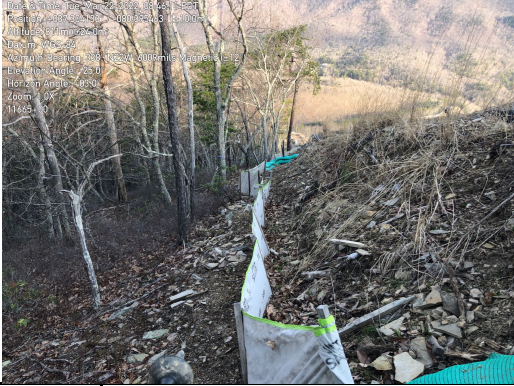
<p>Date & Time: Tue, Mar 22, 2022, 09:55:17 EDT Position: -037.29336, -080.411683 (±100.0m) Altitude: 738m (±4.0m) Datum: WGS-84 Azimuth/Bearing: 354° N40W, 6329mils Magnetic (±12°) Elevation Angle: -17.2° Horizon Angle: -01.5° Zoom: 1.0X 11665+00</p>			
GPS Location	On photo	GPS Location	On photo		
Field Station#	11665+00	Field Station#	11662+75		
Pic 1 Desc.	Perimeter ECDs are in place.	Pic 2 Desc.	Perimeter ECDs are in place.

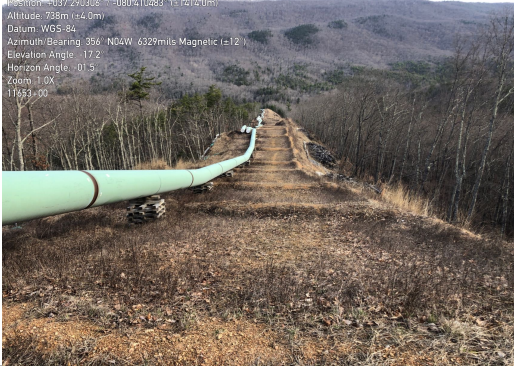
GPS Location	On photo	GPS Location	On photo		
Field Station#	11653+00	Field Station#	11637+00		
Pic 3 Desc.	Slope breakers in place and functioning properly. ROW surface stable.	Pic 4 Desc.	Sumps and end treatments remain functional.

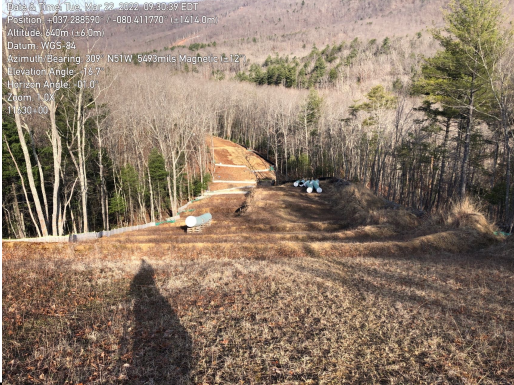
<p>Date & Time: Tue, Mar 22, 2022, 09:55:17 EDT Position: -037.29336, -080.411683 (±100.0m) Altitude: 738m (±4.0m) Datum: WGS-84 Azimuth/Bearing: 354° N40W, 6329mils Magnetic (±12°) Elevation Angle: -17.2° Horizon Angle: -01.5° Zoom: 1.0X 11665+00</p>			
GPS Location	On photo	GPS Location	On photo		
Field Station#	11630+00	Field Station#	11626+04		
Pic 5 Desc.	Slope breakers functioning properly.	Pic 6 Desc.	The S-HH18 crossing is stable.

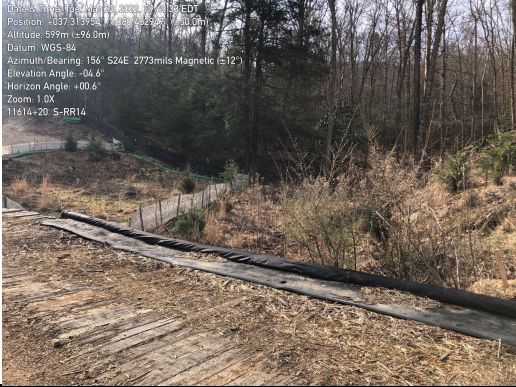
GPS Location	On photo		GPS Location	On photo	
Field Station#	11614+20		Field Station#	11608+17	
Pic 7 Desc.	The S-RR14 crossing is stable.		Pic 8 Desc.	The S-006 crossing is stable.	
Insert image here			Insert image here		
GPS Location			GPS Location		
Field Station#			Field Station#		
Pic 9 Desc.			Pic 10 Desc.		
Insert image here			Insert image here		
GPS Location			GPS Location		
Field Station#			Field Station#		
Pic 11 Desc.			Pic 12 Desc.

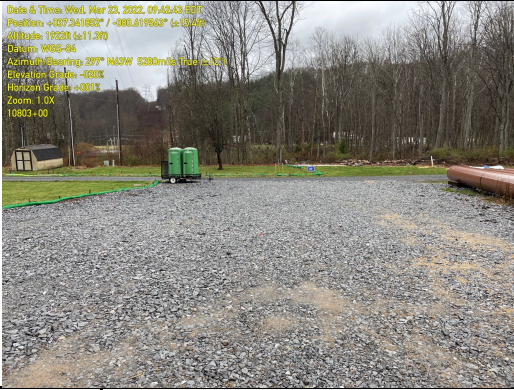
GPS Location	See photo	GPS Location	See photo		
Field Station#	10803+00	Field Station#	10805+00		
Pic 1 Desc.	RCE in place	Pic 2 Desc.	P1 silt fence in place at sensitive resource		
<p> <small> Date & Time: Wed, Mar 23, 2022, 09:34:04 EDT Position: +437.340443° / +886.617921° (+4.10) Altitude: 2520ft (+23.00) Datum: WGS-84 Azimuth/Bearing: 337° N31W 4380mils True (+12°) Elevation Grade: -05% Horizon Grade: +00% Zoom: 1.0x 10812+00 </small> </p>

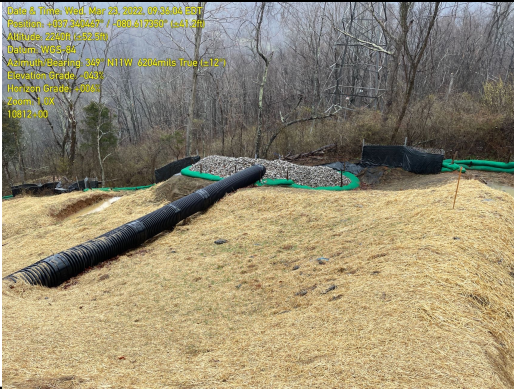
GPS Location	See photo	GPS Location	See photo		
Field Station#	10812+00	Field Station#	10814+00		
Pic 3 Desc.	Cleanwater diversion outlet protection in place	Pic 4 Desc.	Erosion control blanket in place		
<p> <small> Date & Time: Wed, Mar 23, 2022, 09:34:19 EDT Position: +437.340877° / +886.619444° (+10.70) Altitude: 2511ft (+9.40) Datum: WGS-84 Azimuth/Bearing: 257° S33W 5580mils True (+12°) Elevation Grade: -41% Horizon Grade: +00% Zoom: 1.0x 10830+00 </small> </p>

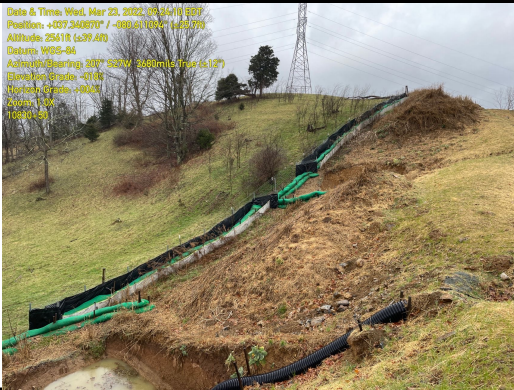
GPS Location	See photo	GPS Location	See photo		
Field Station#	10830+50	Field Station#	10833+00		
Pic 5 Desc.	Triple protection ECDs in place at karst feature	Pic 6 Desc.	Waterbars in place

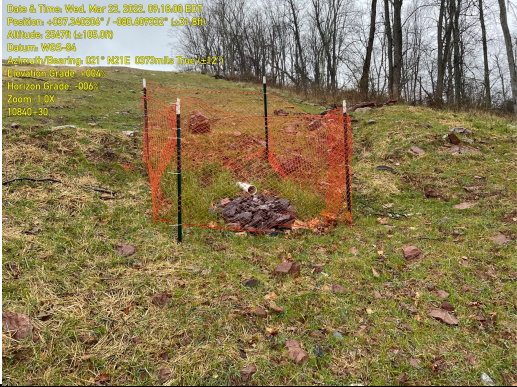
GPS Location	See photo	GPS Location	See photo		
Field Station#	10840+30	Field Station#	10843+75		
Pic 7 Desc.	Daylight drain in place	Pic 8 Desc.	Cleanwater diversion pipe in place		
<p>Date & Time: Wed, Mar 23, 2022, 09:04:31 EDT Position: +407.337623° / -080.409502° (s39.48) Altitude: 2270ft (s105.00) Datum: WGS-84 Azimuth/Bearing: 127° S33E 2088mils True (s127) Elevation Grade: -020 Horizontal Grade: -005 Zoom: 1.0X 10848+00</p>

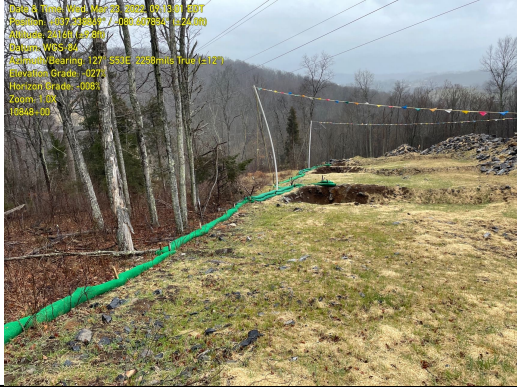
GPS Location	See photo	GPS Location	See photo		
Field Station#	10848+00	Field Station#	10856+00		
Pic 9 Desc.	CFS perimeter control in place	Pic 10 Desc.	Stream buffer in place		
<p>Date & Time: Wed, Mar 23, 2022, 09:04:14 EDT Position: +407.332394° / -080.409502° (s39.48) Altitude: 2278ft (s105.00) Datum: WGS-84 Azimuth/Bearing: 180° N10W 3222mils True (s180) Elevation Grade: -054 Horizontal Grade: +017 Zoom: 1.0X 10858+00</p>

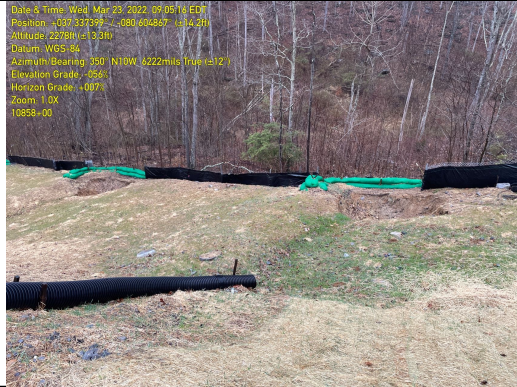
GPS Location	See photo	GPS Location	See photo		
Field Station#	10858+00	Field Station#	10859+00		
Pic 11 Desc.	End treatments in place	Pic 12 Desc.	Supersilt fence perimeter control in place

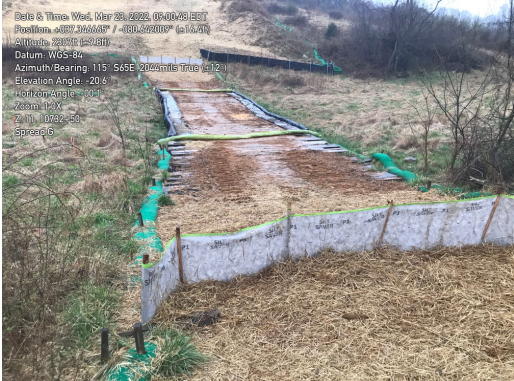
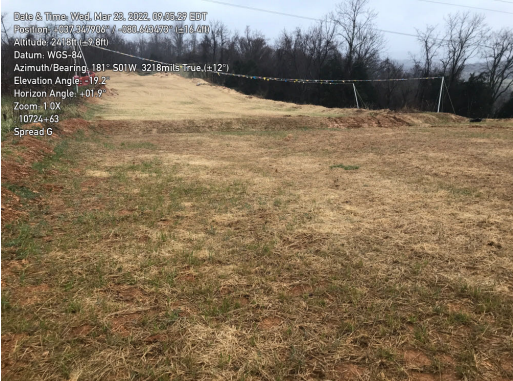
GPS Location	see photo		GPS Location	see photo	
Field Station#	10732+50		Field Station#	10724+63	
Pic 3 Desc.	Z 11		Pic 4 Desc.	Stabilized ROW

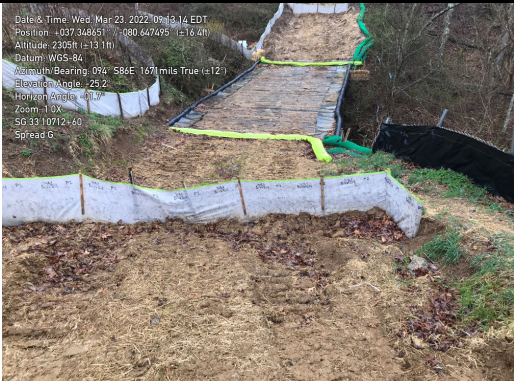
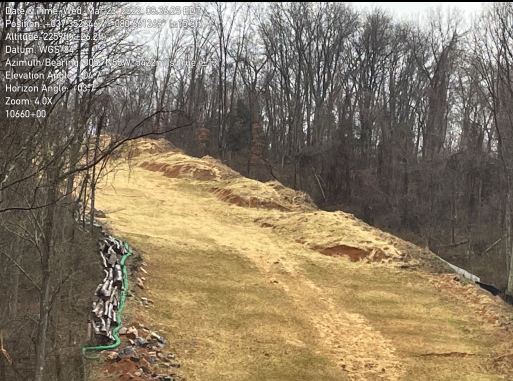
GPS Location	see photo		GPS Location	see photo	
Field Station#	10712+60		Field Station#	10660+00	
Pic 5 Desc.	S G 33		Pic 6 Desc.	Stabilized ROW

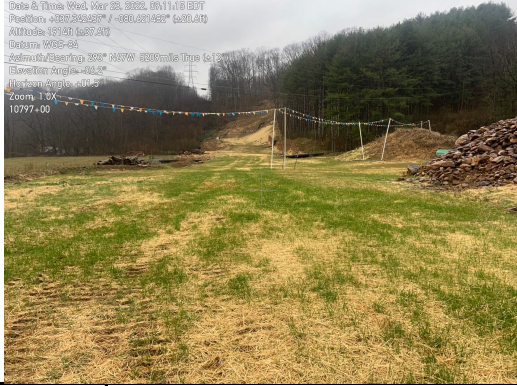
GPS Location	See photo	GPS Location	See photo		
Field Station#	10798+99	Field Station#	10797+00		
Pic 1 Desc.	RCE is maintained and in acceptable condition	Pic 2 Desc.	Temporary vegetation and stabilization are in acceptable condition		
<p>Date & Time: Wed Mar 23, 2022 09:58:40 EDT Position: +037 343113 / -080 623567 (+46.1ft) Altitude: 1965ft (+48.0ft) Datum: WGS-84 Azimuth Bearing: 138° S42E 2453mits True (±13) Elevation Angle: -15.8 Horizon Angle: -01.6 Zoom: 1.0X 10790+75</p>

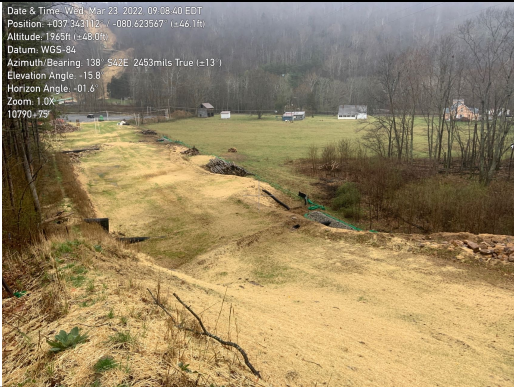
GPS Location	See photo	GPS Location	See photo		
Field Station#	10790+75	Field Station#	10788+30		
Pic 3 Desc.	Section of Row showing conditions and controls	Pic 4 Desc.	Section of Row showing conditions and controls		
<p>Date & Time: Wed Mar 23, 2022 09:00:16 EDT Position: +037 342888 / -080 622225 (+46.0ft) Altitude: 2039ft (+64.0ft) Datum: WGS-84 Azimuth Bearing: 312° N45W 5502mits True (±13) Elevation Angle: -04.8 Horizon Angle: +00.1 Zoom: 1.0X 10780+65 S-Z7</p>  		<p>Date & Time: Wed Mar 23, 2022 09:00:16 EDT Position: +037 342888 / -080 622225 (+46.0ft) Altitude: 2039ft (+64.0ft) Datum: WGS-84 Azimuth Bearing: 332° N28W 5902mits True (±13) Elevation Angle: -06.3 Horizon Angle: +00.8 Zoom: 1.0X 10773+75 S-Z9</p>

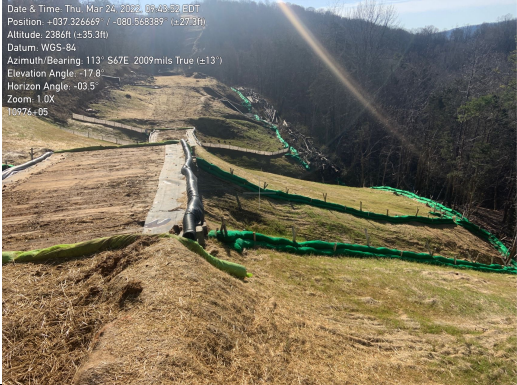
GPS Location	See photo	GPS Location	See photo		
Field Station#	10966+35	Field Station#	10976+05		
Pic 7 Desc.	Karst ECD's are in acceptable condition	Pic 8 Desc.	Section of Row showing conditions and controls		
<p>Date & Time: Thu, Mar 24, 2022 10:57:55 EDT Position: +037 326649 -080 568339 (±27.3ft) Altitude: 2366ft (±35.3ft) Datum: WGS-84 Azimuth: Bearing: 015° N15E 0267/mils True (±12°) Elevation Angle: -02°8' Horizon Angle: -00°0' Zoom: 1.0X 10985-68</p>

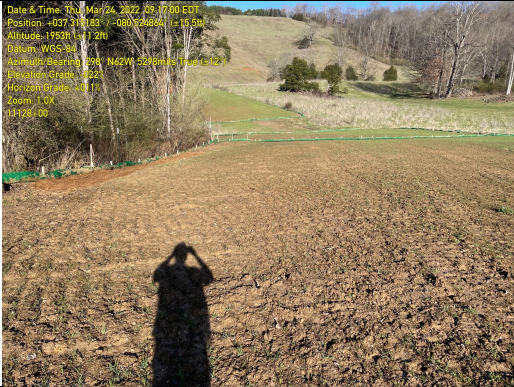
<p>Date & Time: Thu, Mar 24, 2022, 08:59:17 EDT Position: +037.315428 / -080.526195 (±17.1m) Altitude: 2040ft (±5.8ft) Datum: WGS 84 Azimuth Bearing: 080° N08E 3889mils True (±10°) Elevation Grade: +0075 Horizon Grade: +0025 Zoom: 1.0x 11107+00</p>		GPS Location	See photo
Field Station#	11128+00	Field Station#	11107+00	GPS Location	See photo
Pic 1 Desc.	Denuded soil needs stabilized	Pic 2 Desc.	CFS end treatments in place

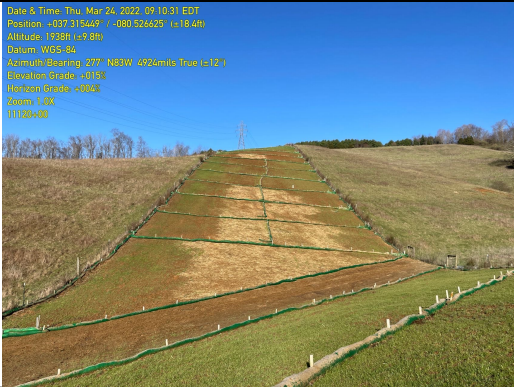
Field Station#	11120+00	Field Station#	11141+00	GPS Location	See photo
Pic 3 Desc.	Temporary CFS waterbars in place	Pic 4 Desc.	Permanent vegetation present

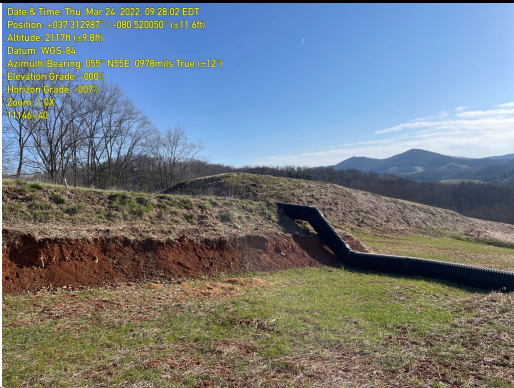
<p>Date & Time: Thu, Mar 24, 2022, 09:29:46 EDT Position: +037.315411 / -080.517632 (±33.6m) Altitude: 2053ft (±5.8ft) Datum: WGS 84 Azimuth Bearing: 150° S30E 2667mils True (±12°) Elevation Grade: +0245 Horizon Grade: +0025 Zoom: 1.0x 11148+50</p>		GPS Location	See photo
Field Station#	11146+40	Field Station#	11148+50	GPS Location	See photo
Pic 5 Desc.	Cleanwater diversion berm in place	Pic 6 Desc.	Supersilt fence perimeter control in place

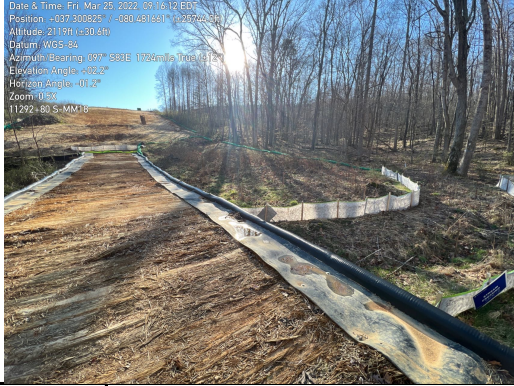
<p>Date & Time: Fri, Mar 25, 2022, 09:16:12 EDT Position: -037.300251 / -080.459191 (-11292.00) Altitude: 2119ft (-20.0ft) Datum: WGS-84 Azimuth: Bearing: 107.9° S01E 1324mils True (±11.1) Elevation Angle: -03.2° Horizon Angle: -01.2° Zoom: 0.5X 11292+80 S-MM18</p>			
GPS Location	See Photo	GPS Location	See Photo		
Field Station#	11282+00	Field Station#	11292+80		
Pic 1 Desc.	Sump Pit and lope Drain	Pic 2 Desc.	S-MM18

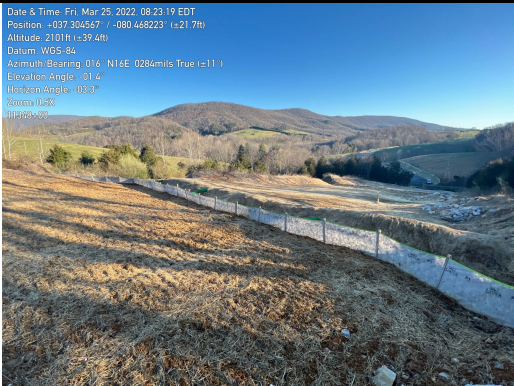
<p>Date & Time: Fri, Mar 25, 2022, 09:22:22 EDT Position: -037.304711 / -080.467651 (-11352.97) Altitude: 2031ft (-24.0ft) Datum: WGS-84 Azimuth: Bearing: 145.0° S05E 2044mils True (±11.1) Elevation Angle: -08.5° Horizon Angle: -02.4° Zoom: 0.5X 11352+97 S-NN11</p>			
GPS Location	See Photo	GPS Location	See Photo		
Field Station#	11348+00	Field Station#	11352+97		
Pic 5 Desc.	Karst Sump protection	Pic 6 Desc.	S-NN11

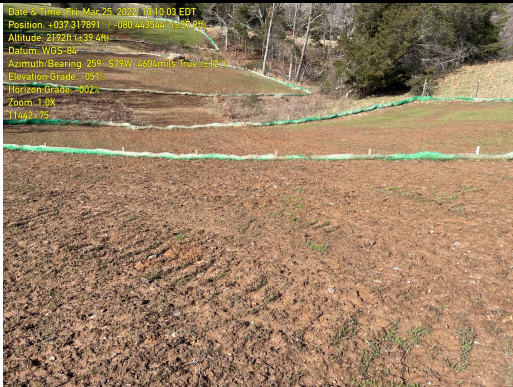
GPS Location				See photo				GPS Location				See photo			
Field Station#				11442+75				Field Station#				11469+00			
Pic 1 Desc.				Denuded soil needs stabilized				Pic 2 Desc.				Triple protection ECDs in place at karst feature			
<p>Date & Time Fri Mar 25, 2022 10:56:22 EDT Position: -037.320374 / -389.443701 / 11466.00 Altitude: 2227ft (678.0m) Datum: WGS 84 Azimuth/Bearing: 285.16300 (303mils True (s12°)) Elevation Grade: 04% Horizon Grade: -003° Zoom: 1.0x 11466+00</p>

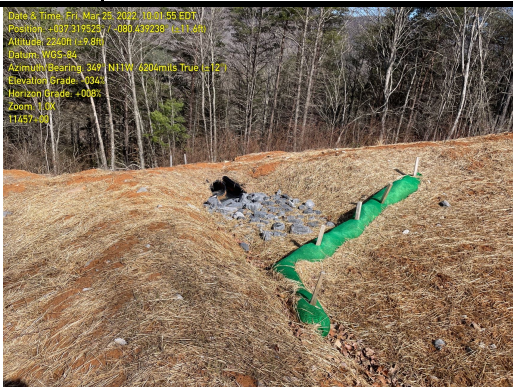
GPS Location				See photo				GPS Location				See photo			
Field Station#				11457+00				Field Station#				11452+66			
Pic 5 Desc.				Stone inlet protection in place				Pic 6 Desc.				Stream buffer in place

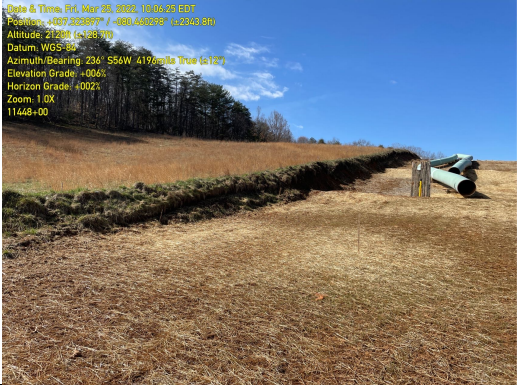
GPS Location		See photo		GPS Location	
Field Station#		11448+00		Field Station#	
Pic 7 Desc.		Cleanwater diversion berm in place		Pic 8 Desc.	
<p>Date & Time: Fri, Mar 25, 2022, 10:19:46 EDT Position: +037 316576° / -080 455716° (+23136.8N) Altitude: 2201ft (+66.2ft) Datum: WGS 84 Azimuth/Bearing: 022° N22E 039mils True (+12°) Elevation Grade: +003% Horizon Grade: +002% Zoom: 1.0X 11431+00</p>

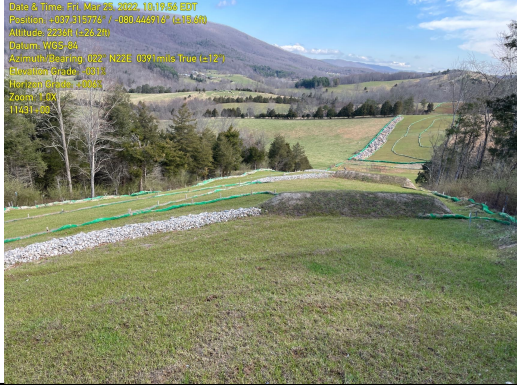
GPS Location		See photo		GPS Location	
Field Station#		11431+00		Field Station#	
Pic 9 Desc.		Permanent waterbar with level spreader in place		Pic 10 Desc.	
<p>Date & Time: Fri, Mar 25, 2022, 10:50:10 EDT Position: +037 329825° / -080 454193° (+3717.8ft) Altitude: 2158ft (+221.0ft) Datum: WGS 84 Azimuth/Bearing: 163° S37E 2542mils True (+12°) Elevation Grade: +22% Horizon Grade: +00% Zoom: 1.0X 11363+00</p>

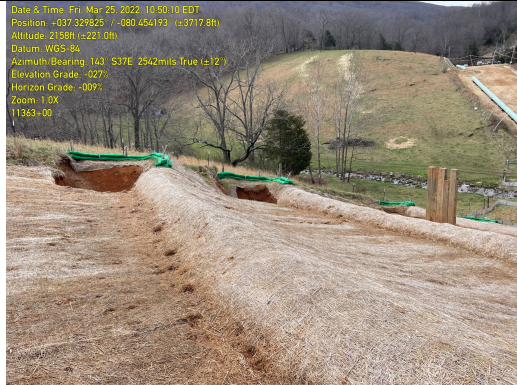
GPS Location		See photo		GPS Location	
Field Station#		11363+00		Field Station#	
Pic 11 Desc.		End treatments in place		Pic 12 Desc.
