Visual Site Inspection Report

Project Name	H-600 Pipeline Spread G	AFE	124300137	Spread	H-600 Pipeline Spread G
Contractor	Precision			Report #	35927
Inspector	Clint Sears			Date/Time	3/28/2022 10:47 AM
Permit #	TBD	Inspection Type	VA SWPP	Station Begin	11788+52
State	VA	Inspection Area	Partial	Station End	11899+89
County	Montgomery	Ground	Frozen	Temperature (°F)	33.00
Municipality	N/A	Weather	Sunny	Rain Gauge (in)	0.00
				Rain Accumulation Time (days)	1.00

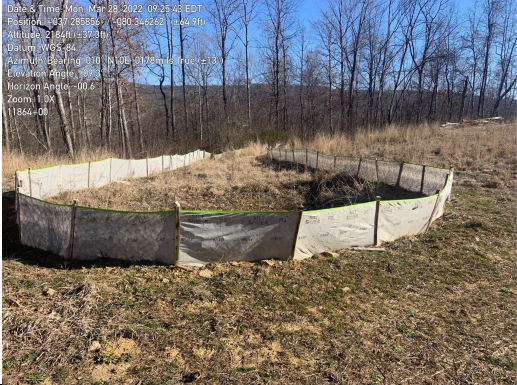
GPS Location	See photo	GPS Location	See photo		
Field Station#	11864+00	Field Station#	11898+00		
Pic 7 Desc.	Section of Row showing conditions and controls at P-KL2	Pic 8 Desc.	Section of Row showing conditions		
Insert image here		Insert image here			
GPS Location		GPS Location			
Field Station#		Field Station#			
Pic 9 Desc.		Pic 10 Desc.

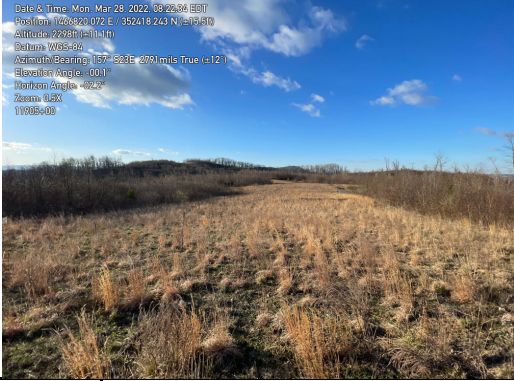
GPS Location	1	GPS Location	2		
Field Station#	11905+00	Field Station#	11914+00		
Pic 1 Desc.	Section of restored RoW showing conditions and controls.		Pic 2 Desc.	Representative photo of permanent waterbar and level spreaders installed.	
<p>Date & Time: Mon, Mar 28, 2022, 08:27:40 EDT Position: 1627107.474 E / 351306.841 N (=11.61m) Altitude: 2224ft (=6.78m) Datum: WGS-84 Azimuth/Bearing: 150° 530E 2667mils True (=12°) Elevation Angle: -00.3° Horizon Angle: -01.0° Zoom: 0.5X 11918+00</p>

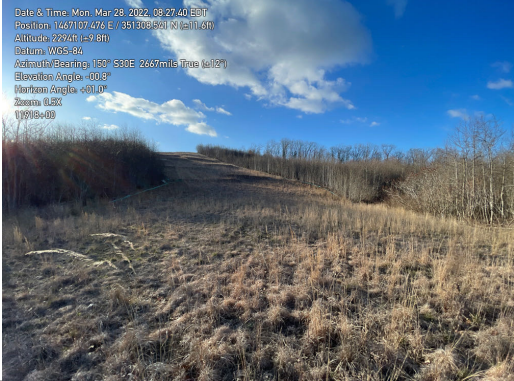
GPS Location	3	GPS Location	4		
Field Station#	11918+00	Field Station#	11927+50		
Pic 3 Desc.	Section of restored RoW showing conditions and controls.		Pic 4 Desc.	Section of restored RoW showing conditions and controls.	
<p>Date & Time: Mon, Mar 28, 2022, 08:36:26 EDT Position: 1628192.433 E / 345761.580 N (=15.51m) Altitude: 2238ft (=6.81m) Datum: WGS-84 Azimuth/Bearing: 183° 520E 3303mils True (=13°) Elevation Angle: -10.3° Horizon Angle: -02.3° Zoom: 0.5X 11937+00</p>

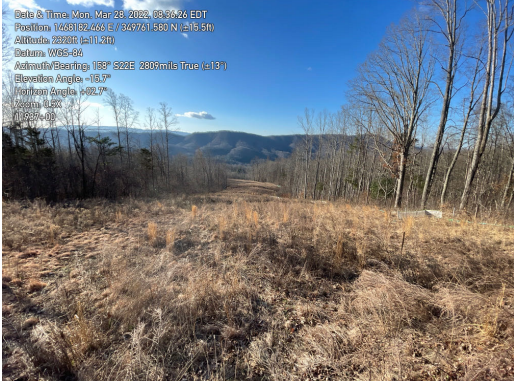
GPS Location	5	GPS Location	6		
Field Station#	11937+00	Field Station#	11948+00		
Pic 5 Desc.	Section of restored RoW showing conditions and controls.		Pic 6 Desc.	Section of restored RoW showing conditions and controls.

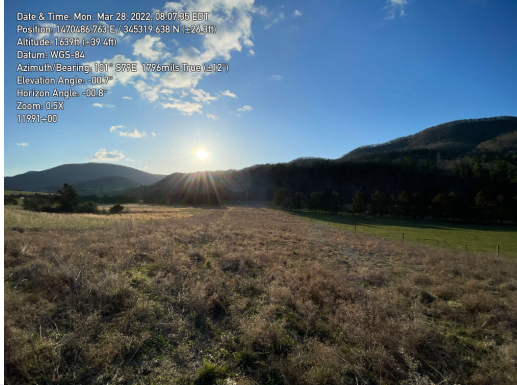
<p>Insert image here</p>			
GPS Location	9	GPS Location			
Field Station#	11991+00	Field Station#			
Pic 9 Desc.	Section of restored RoW showing conditions and controls.		Pic 10 Desc.		
<p>Insert image here</p>		<p>Insert image here</p>			
GPS Location		GPS Location			
Field Station#		Field Station#			
Pic 11 Desc.		Pic 12 Desc.

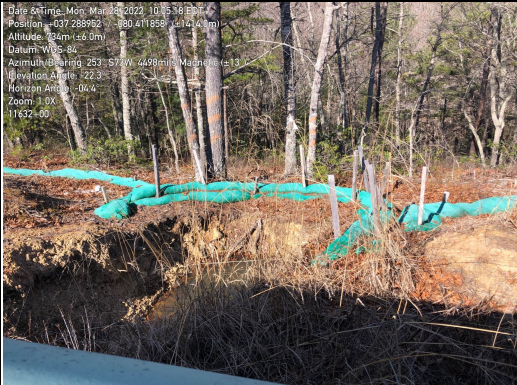
GPS Location	On photo		GPS Location	On photo	
Field Station#	11632+00		Field Station#	11626+50	
Pic 7 Desc.	Perimeter ECDs are functional.		Pic 8 Desc.	Resource buffer ECDs in acceptable condition.	
<p>Date & Time: Mon, Mar 28, 2022, 10:12:20 EDT Position: +037 314104, -030 386540 (+5.0m) Altitude: 570m (+8.0m) Datum: WGS-84 Azimuth/Bearing: 162.830°W, 262°mils Magnetic (+13) Elevation Angle: +11.2 Horizon Angle: -00.2 Zoom: 1.0X 11626+04 S-HH18</p>

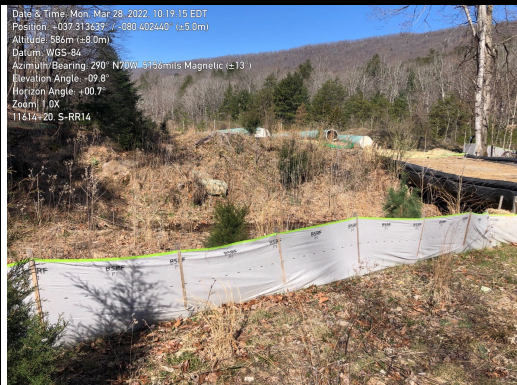
GPS Location	On photo		GPS Location	On photo	
Field Station#	11614+20		Field Station#	11613+69	
Pic 11 Desc.	The S-RR14 crossing is currently stable.		Pic 12 Desc.	The S-RR13 crossing on access road MN-258.04 is stable.

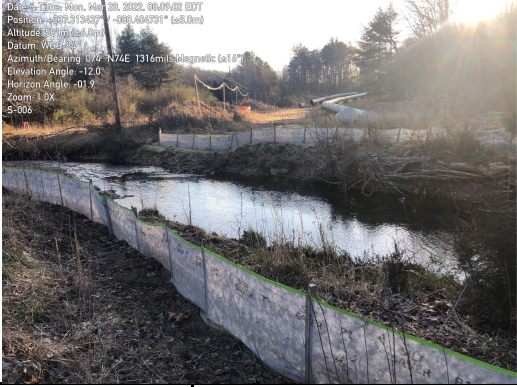
<p>Insert image here</p>			
GPS Location	On photo	GPS Location			
Field Station#	11608+17	Field Station#			
Pic 13 Desc.	The S-006 crossing is currently stable.	Pic 14 Desc.			
<p>Insert image here</p>		<p>Insert image here</p>			
GPS Location		GPS Location			
Field Station#		Field Station#			
Pic 15 Desc.		Pic 16 Desc.			
<p>Insert image here</p>		<p>Insert image here</p>			
GPS Location		GPS Location			
Field Station#		Field Station#			
Pic 17 Desc.		Pic 18 Desc.

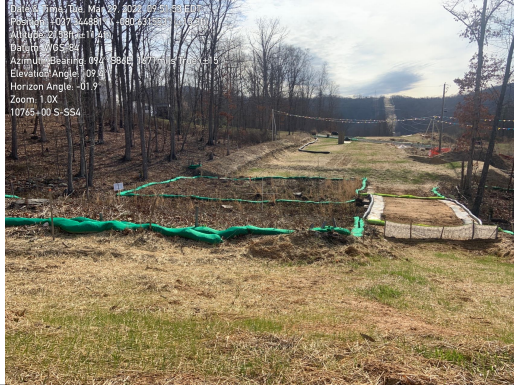
Field Station#	10773+75	Field Station#	10765+00	Field Station#	10765+00
Pic 3 Desc.	Section of Row showing conditions and controls	Pic 4 Desc.	Section of Row showing conditions and controls	Pic 4 Desc.	Section of Row showing conditions and controls

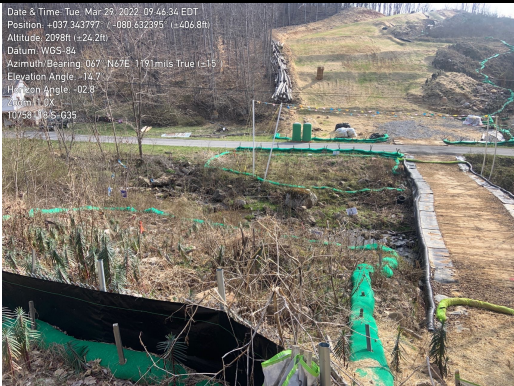
<p>Date & Time: Tue, Mar 29, 2022, 09:48:36 EDT Position: +037.340797, -089.632093, (+10758.6m) Altitude: 2098ft (+32.2ft) Datum: WGS-84 Azimuth/Bearing: 067.76576, 1191mils True (+15.1) Elevation Angle: -14.7 Horizon Angle: -02.8 Zoom: 1.0X 10758+18 S-035</p>

<p>Date & Time: Tue, Mar 29, 2022, 09:50:00 EDT Position: +037.340797, -089.632093, (+10798.4m) Altitude: 2113ft (+32.9ft) Datum: WGS-84 Azimuth/Bearing: 340.0000mils True (+15.1) Elevation Angle: -07.1 Horizon Angle: +01.1 Zoom: 1.0X 10798+40</p>		GPS Location	See photo
Field Station#	10758+18	Field Station#	10798+40	Field Station#	10798+40
Pic 5 Desc.	Section of Row showing conditions and controls	Pic 6 Desc.	RCE is maintained and in acceptable condition	Pic 6 Desc.	RCE is maintained and in acceptable condition

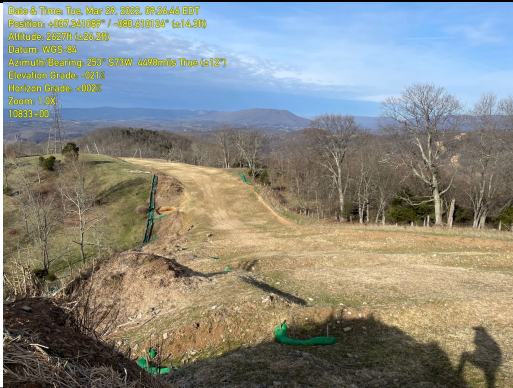
GPS Location	See photo	GPS Location	See photo		
Field Station#	10831+50	Field Station#	10833+00		
Pic 5 Desc.	Triple protection ECDs in place at karst feature	Pic 6 Desc.	Waterbars in place

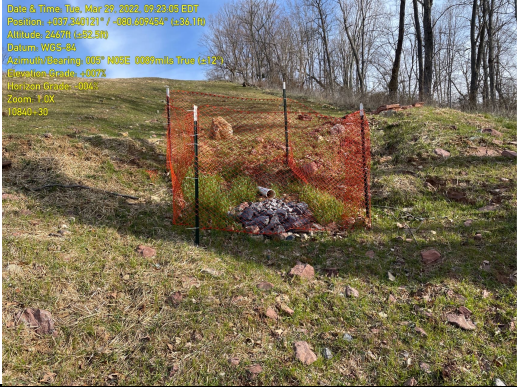
<p>Date & Time Tue, Mar 29, 2022 05:22:59 EDT Position +407.540121° / -88.98949° (-88.99) Altitude 5448 ft (1661 m) Datum WGS 84 Datum Bearing 100° S44E 2418m true (±12°) Elevation Grade -03% Horizon Grade -01% Zoom 1.24 10840+30</p>

<p>Date & Time Tue, Mar 29, 2022 05:23:04 EDT Position +407.539552° / -88.98949° (-88.99) Altitude 5448 ft (1661 m) Datum WGS 84 Datum Bearing 100° S44E 2418m true (±12°) Elevation Grade -03% Horizon Grade -01% Zoom 1.24 10843+75</p>			
GPS Location	See photo	GPS Location	See photo		
Field Station#	10840+30	Field Station#	10843+75		
Pic 7 Desc.	Daylight drain in place	Pic 8 Desc.	Cleanwater diversion pipe in place

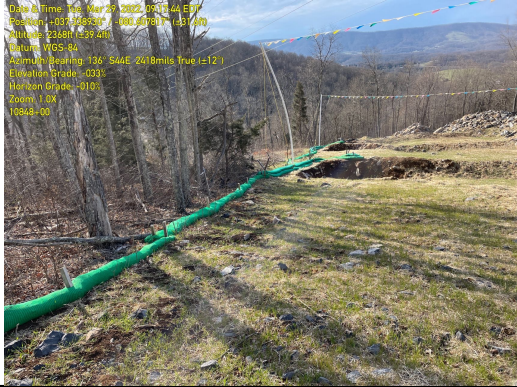
<p>Date & Time Tue, Mar 29, 2022 05:12:44 EDT Position +407.540121° / -88.98949° (-88.99) Altitude 5448 ft (1661 m) Datum WGS 84 Datum Bearing 100° S44E 2418m true (±12°) Elevation Grade -03% Horizon Grade -01% Zoom 1.24 10848+00</p>

GPS Location	See photo	GPS Location	See photo		
Field Station#	10848+00	Field Station#	10856+00		
Pic 9 Desc.	CFS perimeter control in place	Pic 10 Desc.	Stream buffer in place

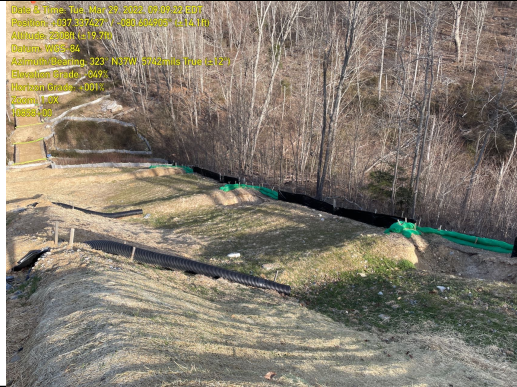
<p>Date & Time Tue, Mar 29, 2022 05:16:41 EDT Position +407.540121° / -88.98949° (-88.99) Altitude 5448 ft (1661 m) Datum WGS 84 Datum Bearing 100° S44E 2418m true (±12°) Elevation Grade -03% Horizon Grade -01% Zoom 1.24 10859+00</p>			
GPS Location	See photo	GPS Location	See photo		
Field Station#	10858+00	Field Station#	10859+00		
Pic 11 Desc.	End treatments in place	Pic 12 Desc.	Supersilt fence perimeter control in place

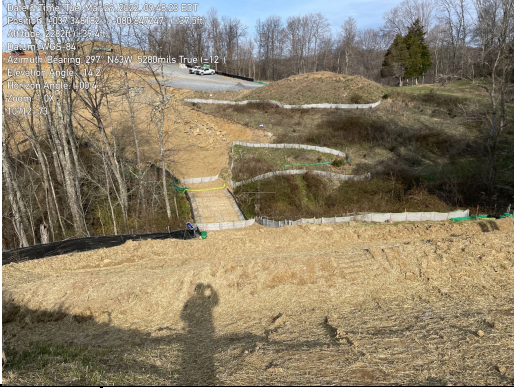
<p>Date & Time: Tue, Mar 29, 2022 07:28:00 EDT Position: +037 342469 / -080 653754 (+19.4ft) Altitude: 2261ft (+26.2ft) Datum: WGS-84 Azimuth: Bearing: 198 S18W 3520mils True (+12) Elevation Angle: -26.1 Horizon Angle: -04.2 Zoom: 1.0X 10715+22</p>			
GPS Location	See photo	GPS Location	See photo		
Field Station#	10712+83	Field Station#	10715+22		
Pic 1 Desc.	Resource buffers in place	Pic 2 Desc.	SSF falling in sump needs repaired

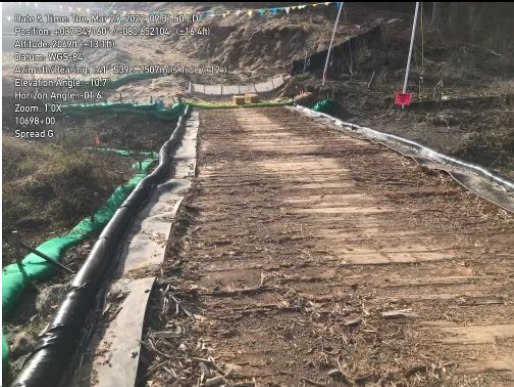
GPS Location	See photo	GPS Location	See photo		
Field Station#	10698+00	Field Station#	10733+18		
Pic 3 Desc.	Equipment bridge functional	Pic 4 Desc.	P1 & wattles in place

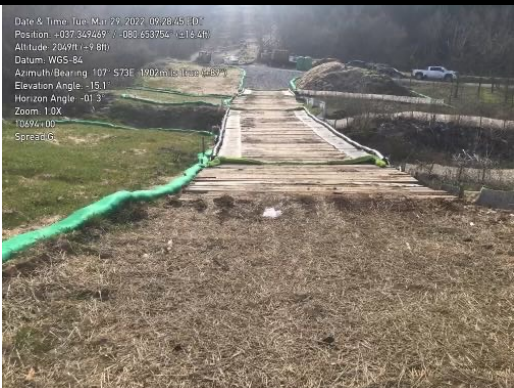
<p>Date & Time: Tue, Mar 29, 2022 09:29:00 EDT Position: +037 346562 / -080 651454 (+19.4ft) Altitude: 2266ft (+39.4ft) Datum: WGS-84 Azimuth: Bearing: 107 S73E 1902mils True (+12) Elevation Angle: -12.3 Horizon Angle: -04.2 Zoom: 1.0X 10739+00</p>			
GPS Location	See photo	GPS Location	See photo		
Field Station#	10694+00	Field Station#	10739+00		
Pic 5 Desc.	Clean water drainage feature functional	Pic 6 Desc.	Inlet in place

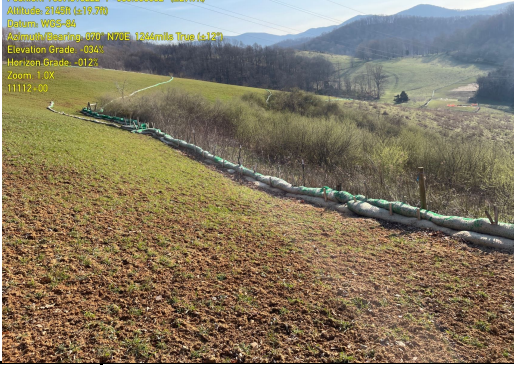
GPS Location	See photo	GPS Location	See photo		
Field Station#	11112+00	Field Station#	11120+00		
Pic 1 Desc.	CFS triple stack perimeter control in place	Pic 2 Desc.	Temporary CFS waterbars in place		
<p>Date & Time: Wed, Mar 30, 2022, 09:11:00 EDT Position: +037.212587° / -080.522072° (+19.970) Altitude: 21240 (+19.870) Datum: WGS-84 Azimuth/Bearing: 302° NWS 1130mils True (+12°) Elevation Grade: -003% Horizon Grade: -000% Zoom: 1.0x 11141+00</p>

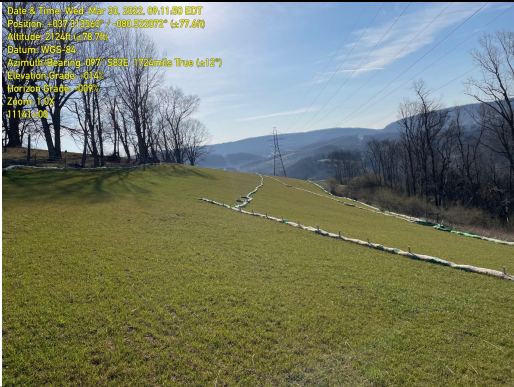
GPS Location	See photo	GPS Location	See photo		
Field Station#	11141+00	Field Station#	11146+40		
Pic 3 Desc.	Permanent vegetation present	Pic 4 Desc.	Cleanwater diversion berm in place		
<p>Date & Time: Wed, Mar 30, 2022, 09:15:47 EDT Position: +037.212587° / -080.519591° (+19.940) Altitude: 20810 (+19.120) Datum: WGS-84 Azimuth/Bearing: 161° SWS 2842mils True (+12°) Elevation Grade: -042% Horizon Grade: +003% Zoom: 1.0x 11147+50</p>

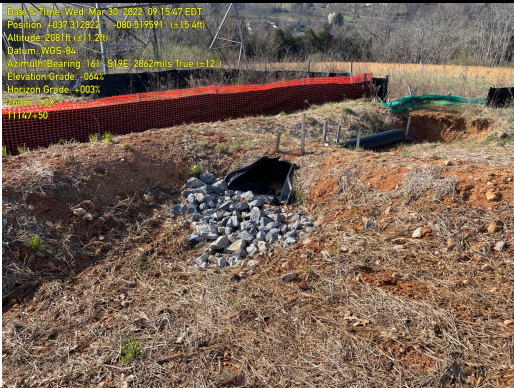
GPS Location	See photo	GPS Location	See photo		
Field Station#	11147+50	Field Station#	11148+50		
Pic 5 Desc.	Stone inlet protection in place	Pic 6 Desc.	Supersilt fence perimeter control in place

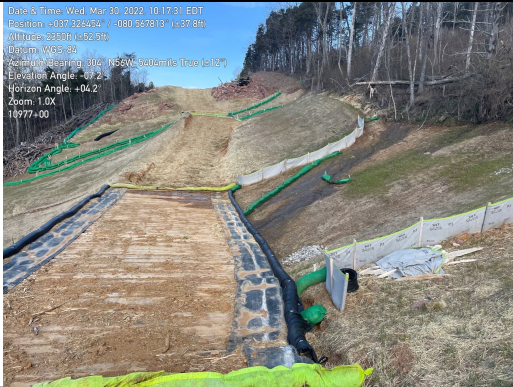
GPS Location	See photo		GPS Location	See photo	
Field Station#	10977+00		Field Station#	10966+38	
Pic 3 Desc.	Section of Row showing conditions and controls		Pic 4 Desc.	Karst ECD's are in acceptable condition

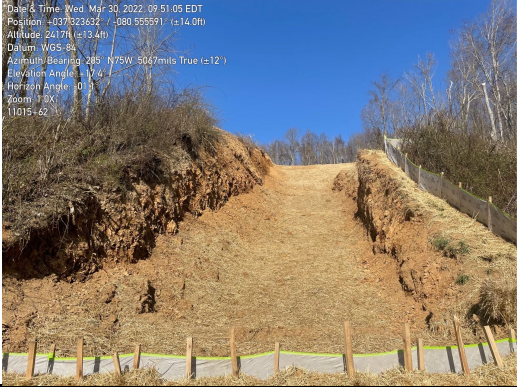
GPS Location	See photo	GPS Location	See photo		
Field Station#	11015+62	Field Station#	11019+00		
Pic 7 Desc.	Section of Row showing conditions and controls	Pic 8 Desc.	Section of Row showing conditions and controls		
Insert image here		Insert image here			
GPS Location		GPS Location			
Field Station#		Field Station#

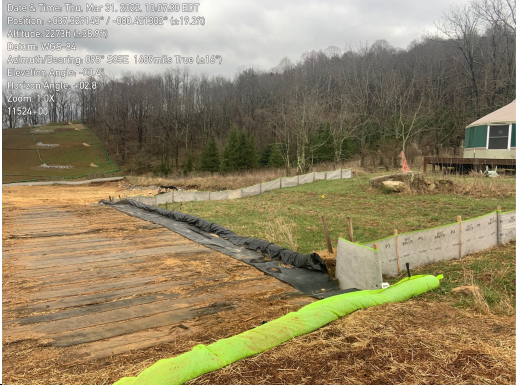
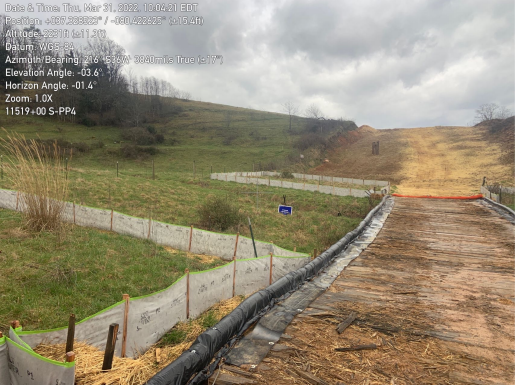
GPS Location	See photo	GPS Location	See photo		
Field Station#	11524+00	Field Station#	11519+00		
Pic 1 Desc.	Section of Row showing conditions and controls	Pic 2 Desc.	Section of Row showing conditions and controls at S-PP4		
<p>Insert image here</p>

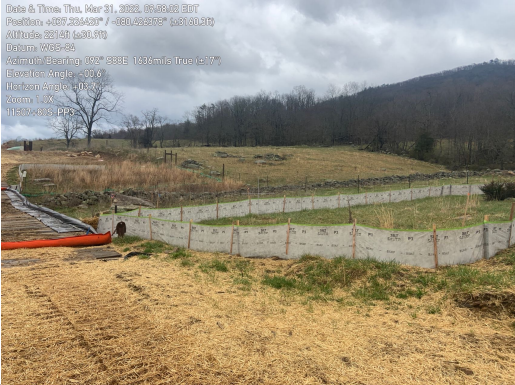
GPS Location		GPS Location	See photo		
Field Station#		Field Station#	11507+80		
Pic 3 Desc.		Pic 4 Desc.	Section of Row showing conditions and controls at S-PP3

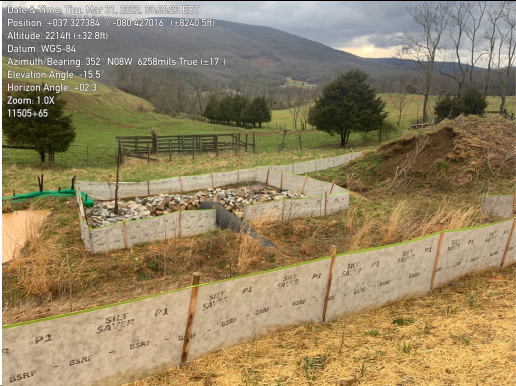
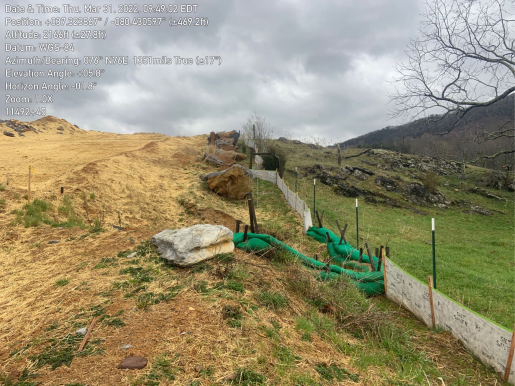
GPS Location	See photo	GPS Location	See photo		
Field Station#	11505+65	Field Station#	11492+45		
Pic 5 Desc.	Section of Row showing conditions and controls	Pic 6 Desc.	Section of Row showing conditions and controls

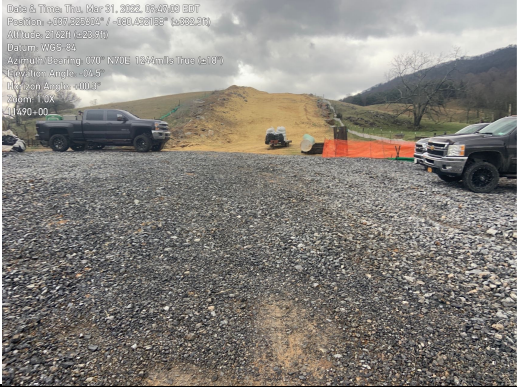
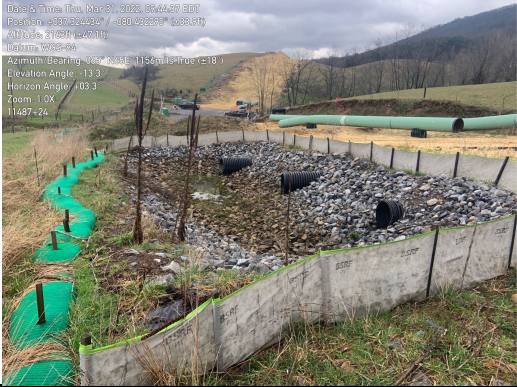
<p><small>Date & Time: Thu Mar 31, 2022, 05:54:29 EDT Position: +49.753322° / -90.423182° 11487+24 Altitude: 300m 980.00 Datum: WGS-84 Azimuth Bearing: 108.2° 035E 0.115km to true (218°) Elevation Angle: -13.3° Horizon Angle: -03.3° Zoom: 1.0X 11487+24</small></p>			
GPS Location	See photo	GPS Location	See photo		
Field Station#	11490+00	Field Station#	11487+24		
Pic 7 Desc.	RCE at Stevers Gap is in acceptable condition	Pic 8 Desc.	Section of Row showing conditions and controls

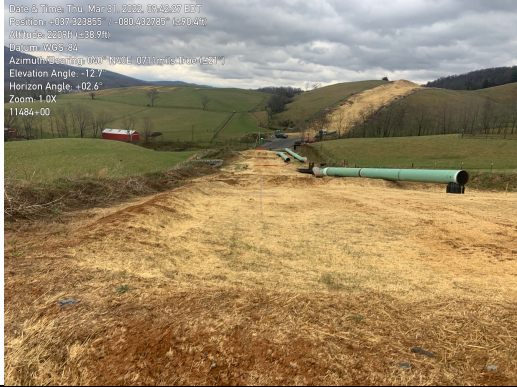
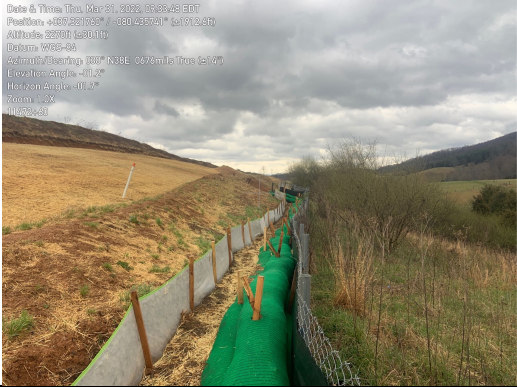
GPS Location	See photo	GPS Location	See photo		
Field Station#	11484+00	Field Station#	11472+60		
Pic 9 Desc.	Section of Row showing conditions and controls	Pic 10 Desc.	Perimeter controls are in acceptable condition		
Insert image here		Insert image here			
GPS Location		GPS Location			
Field Station#		Field Station#			
Pic 11 Desc.		Pic 12 Desc.

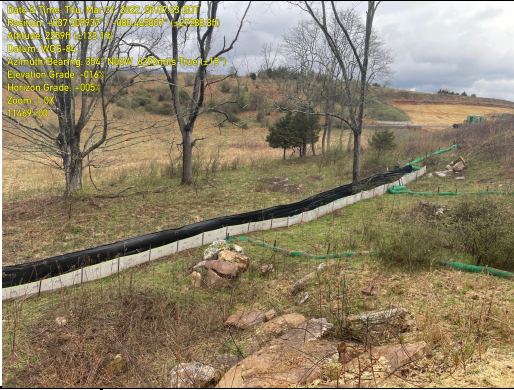
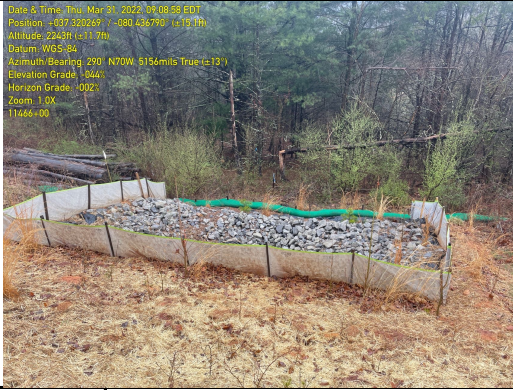
<p>Date & Time Thu Mar 31, 2022, 09:08:55 EDT Position: +037.510221° / -080.44660° (-13.110) Altitude: 2343m (-13.110) Datum: WGS-84 Azimuth/Bearing: 200° N20W 5136mils True (-13.1) Elevation Grade: +04% Horizon Grade: +00% Zoom: 1.0X 11469+00</p>			
GPS Location	See photo	GPS Location	See photo		
Field Station#	11469+00	Field Station#	11466+00		
Pic 1 Desc.	Triple protection ECDs in place at karst feature	Pic 2 Desc.	Plunge pool in place

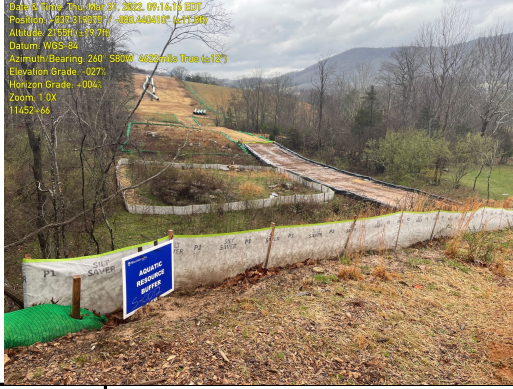
GPS Location	See photo	GPS Location	See photo		
Field Station#	11461+00	Field Station#	11452+66		
Pic 3 Desc.	CFS perimeter control in place	Pic 4 Desc.	Stream buffer in place

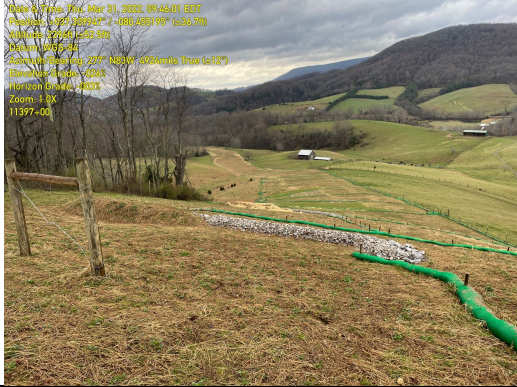
GPS Location	See photo	GPS Location	See photo		
Field Station#	11397+00	Field Station#	11395+00		
Pic 9 Desc.	Level spreader in place	Pic 10 Desc.	CFS controls in place		
<p>Date & Time Thu, Mar 31, 2022, 10:10:31 EDT Position: +407.307233° / -880.488816° (s18.00) Altitude: 1976ft (s18.00) Datum: WGS-84 Azimuth/Bearing: 172° 58'59" 3058mils True (s12°) Elevation Grade: +0000 Horizon Grade: +0111 Zoom: 1.0X 11363+00</p>

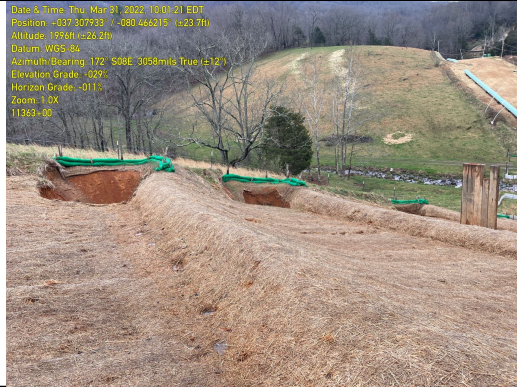
GPS Location	See photo	GPS Location	See photo		
Field Station#	11363+00	Field Station#	11353+75		
Pic 11 Desc.	End treatments in place	Pic 12 Desc.	RCE in place

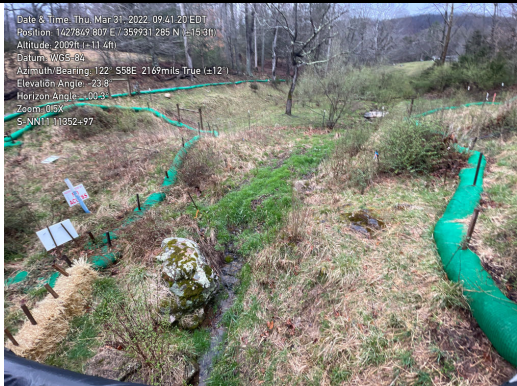
<p style="text-align: center;">Insert image here</p>			
GPS Location	9	GPS Location			
Field Station#	11352+97	Field Station#			
Pic 9 Desc.	S-NN11.	Pic 10 Desc.			
<p style="text-align: center;">Insert image here</p>		<p style="text-align: center;">Insert image here</p>			
GPS Location		GPS Location			
Field Station#		Field Station#			
Pic 11 Desc.		Pic 12 Desc.

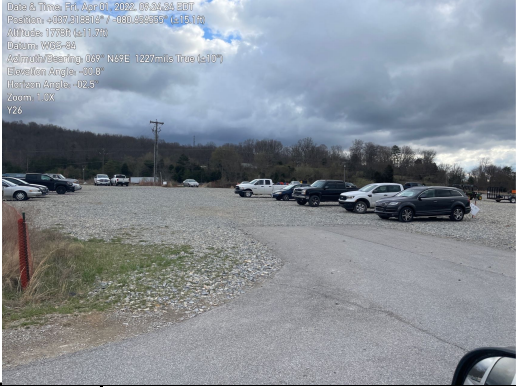
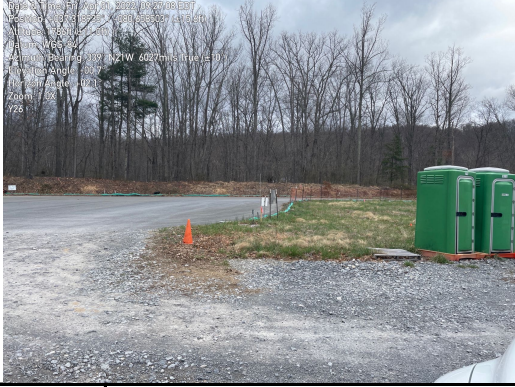
GPS Location	See photo	GPS Location	See photo		
Field Station#	12005+00	Field Station#	12005+00		
Pic 5 Desc.	RCE functional y26	Pic 6 Desc.	Permanent stabilization in place y26

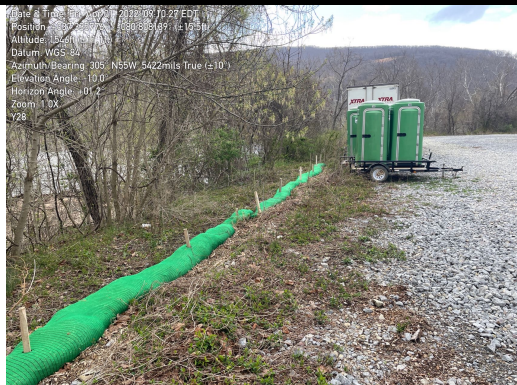
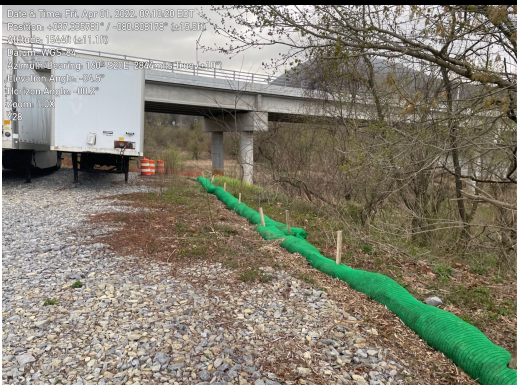
GPS Location	See photo	GPS Location	See photo		
Field Station#	12005+00	Field Station#	12005+00		
Pic 11 Desc.	CFS perimeter controls functional y28	Pic 12 Desc.	CFS perimeter controls in place y28

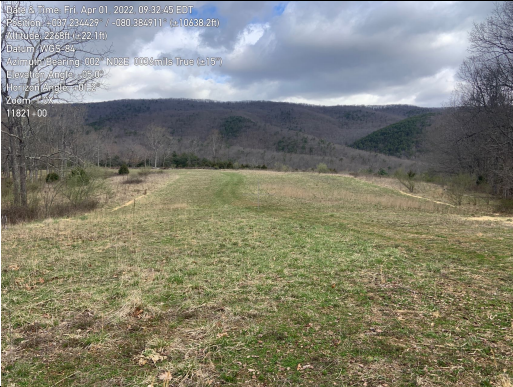
GPS Location	See photo		GPS Location	See photo	
Field Station#	11801+00		Field Station#	11821+00	
Pic 1 Desc.	Representational photo of water bar and level spreader		Pic 2 Desc.	Section of Row showing permanent vegetation and temporary vegetation.

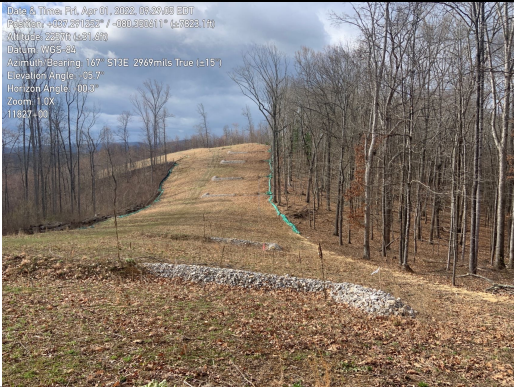
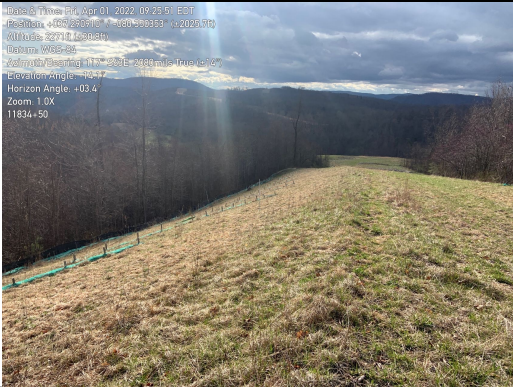
GPS Location	See photo		GPS Location	See photo	
Field Station#	11827+00		Field Station#	11834+50	
Pic 3 Desc.	Section of Row showing conditions and controls		Pic 4 Desc.	Section of Row showing conditions and controls

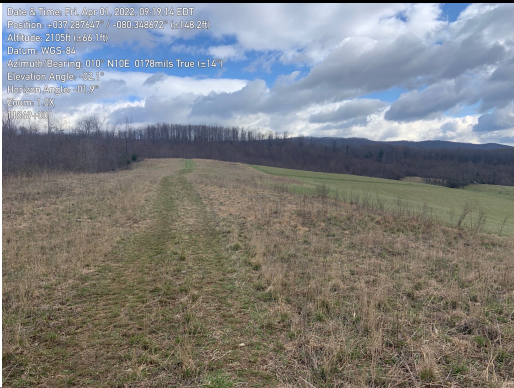
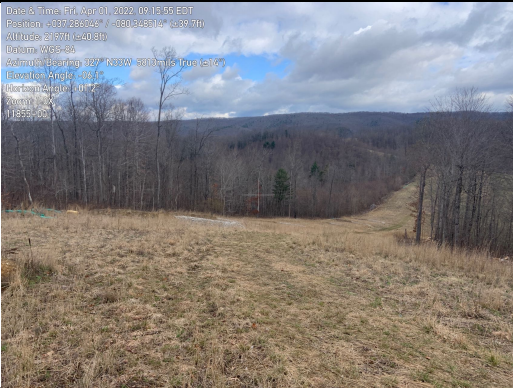
GPS Location	See photo		GPS Location	See photo	
Field Station#	11849+00		Field Station#	11855+00	
Pic 5 Desc.	Vegetation and stabilization acceptable		Pic 6 Desc.	Section of Row showing conditions and controls

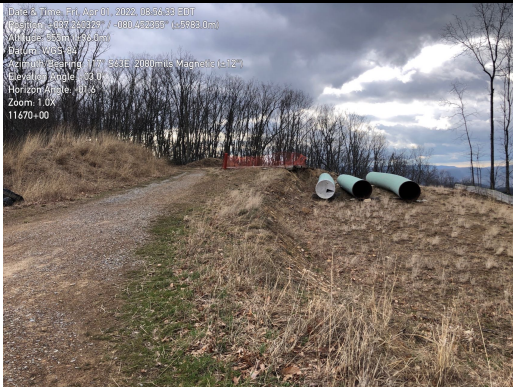
GPS Location	On photo		GPS Location	On photo	
Field Station#	11670+00		Field Station#	11666+00	
Pic 1 Desc.	Stable conditions at top of Brush Mountain.		Pic 2 Desc.	Perimeter ECDs in place.	
<p>Date & Time: Fri, Apr 01, 2022 09:58:25 EDT Position: +037.303204, -780.395475 (+5.0m) Altitude: 814m (+4.0m) Datum: WGS-84 Azimuth Bearing: 349° N11W 4200mils Magnetic (+12°) Elevation Angle: -25.9° Horizon Angle: -01.4° Zoom: 1.0X 11659+00</p>

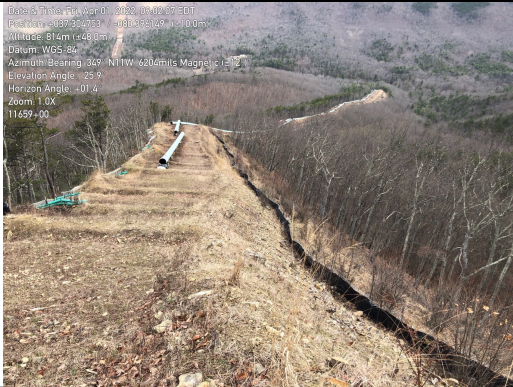
GPS Location	On photo		GPS Location	On photo	
Field Station#	11659+00		Field Station#	11658+00	
Pic 3 Desc.	Perimeter ECDs in place. Slope breakers functional. Surface stable.		Pic 4 Desc.	End treatments and sumps acceptable. No sediment movement from ROW.	
<p>Date & Time: Fri, Apr 01, 2022 09:06:41 EDT Position: +037.305761, -780.395845 (+5.0m) Altitude: 879m (+4.0m) Datum: WGS-84 Azimuth Bearing: 124° N36W 8740mils Magnetic (+12°) Elevation Angle: -30.4° Horizon Angle: -00.1° Zoom: 1.0X 11657+00</p>

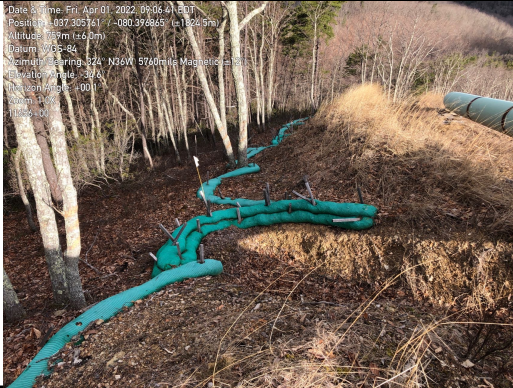
GPS Location	On photo		GPS Location	On photo	
Field Station#	11656+00		Field Station#	11637+00	
Pic 5 Desc.	Perimeter ECDs in place. CFS worn but adequate.		Pic 6 Desc.	ROW currently stable.

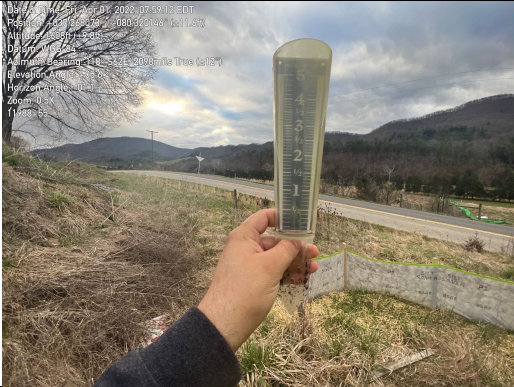
GPS Location	See Photo		GPS Location	See Photo	
Field Station#	11988+55		Field Station#	11905+00	
Pic 1 Desc.	Rain 0.05		Pic 2 Desc.	Section of ROW showing conditions and controls

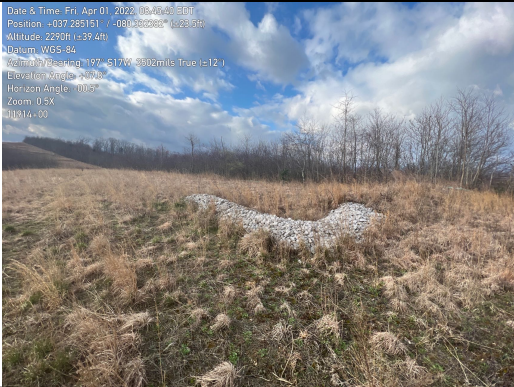
GPS Location	See Photo		GPS Location	See Photo	
Field Station#	11914+00		Field Station#	11962+00	
Pic 3 Desc.	Level spreader		Pic 4 Desc.	Perimeter controls

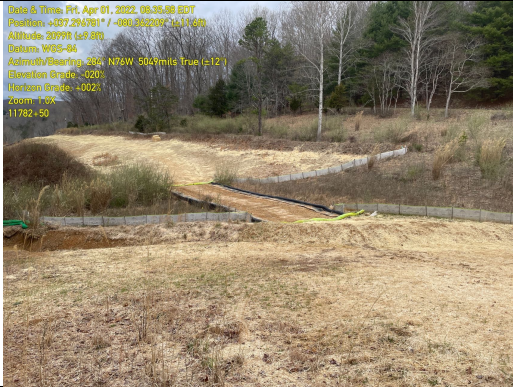
<p>Date & Time: Fri, Apr 01, 2022, 08:37:38 EDT Position: -037.294761° / -080.365994° (-15.41ft) Altitude: 2099ft (-67.80) Datum: WGS-84 Azimuth/Bearing: 324° N75W 500mils True (+12°) Elevation Grade: -020° Horizon Grade: -002° Zoom: 1.0X 11779+00</p>			
GPS Location				See photo				GPS Location				See photo			
Field Station#				11782+50				Field Station#				11779+00			
Pic 1 Desc.				Cleanwater drainage feature in place				Pic 2 Desc.				P1 silt fence perimeter control in place

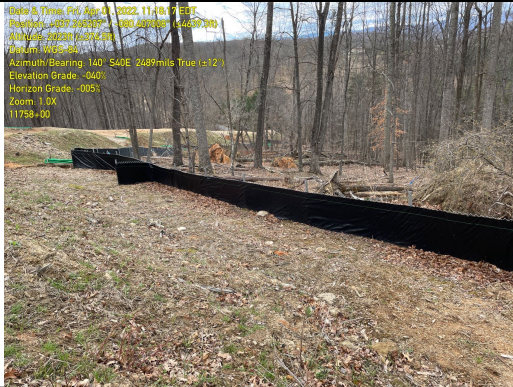
GPS Location				See photo				GPS Location				See photo			
Field Station#				11766+35				Field Station#				11758+00			
Pic 3 Desc.				RCE in place				Pic 4 Desc.				Supersilt fence perimeter control in place			
 				<p>Date & Time: Fri, Apr 01, 2022, 11:13:27 EDT Position: -037.294807° / -080.373702° (-15.81ft) Altitude: 2220ft (-69.40) Datum: WGS-84 Azimuth/Bearing: 030° N30E 1436mils True (+12°) Elevation Grade: -012° Horizon Grade: -009° Zoom: 1.0X 11749+00</p>

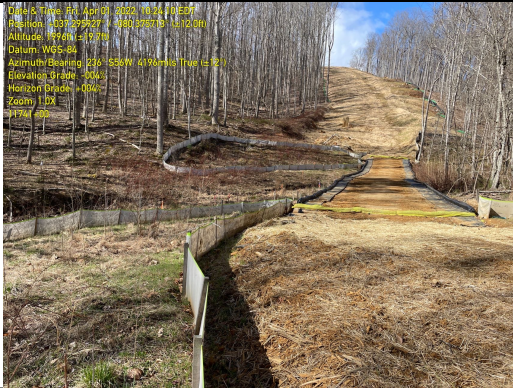
<p>Date & Time: Fri, Apr 01, 2022, 11:14:27 EDT Position: -037.294807° / -080.373702° (-15.81ft) Altitude: 2220ft (-69.40) Datum: WGS-84 Azimuth/Bearing: 030° N30E 1436mils True (+12°) Elevation Grade: -012° Horizon Grade: -009° Zoom: 1.0X 11741+00</p>			
GPS Location				See photo				GPS Location				See photo			
Field Station#				11749+00				Field Station#				11741+00			
Pic 5 Desc.				End treatments in place				Pic 6 Desc.				Stream buffer in place

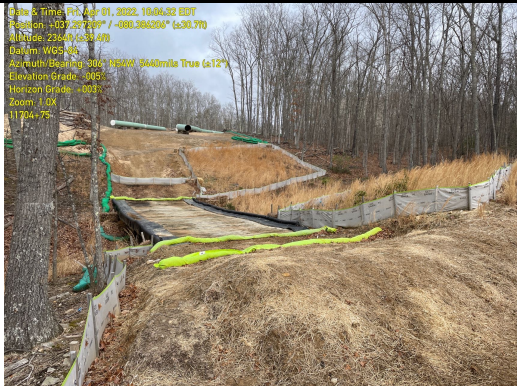
GPS Location	See photo	GPS Location	See photo		
Field Station#	11704+75	Field Station#	11688+00		
Pic 9 Desc.	Sediment filter logs in place	Pic 10 Desc.	Erosion control blanket in place		
  <p>Date & Time: Fri, Apr 01, 2022, 09:45:20 EDT Position: +337 200980 / -890 342302 (s11.49) Altitude: 2534ft (s13.18) Datum: WGS-84 Azimuth/Bearing: 100° S59E 200980 True (s12°) Elevation Grade: -005° Horizon Grade: -005° Zoom: 1.0X 11682+50</p>		  <p>Date & Time: Fri, Apr 01, 2022, 09:45:20 EDT Position: +337 200980 / -890 342302 (s11.49) Altitude: 2534ft (s13.18) Datum: WGS-84 Azimuth/Bearing: 100° S59E 200980 True (s12°) Elevation Grade: -005° Horizon Grade: -005° Zoom: 1.0X 11678+35</p>			
GPS Location	See photo	GPS Location	See photo		
Field Station#	11682+50	Field Station#	11678+35		
Pic 11 Desc.	Stone inlet protection in place	Pic 12 Desc.	End treatments in place
