Visual Site Inspection Report

Project Name	H-600 Pipeline Spread G	AFE	124300137	Spread	H-600 Pipeline Spread G
Contractor	Precision			Report #	35184
Inspector	Patrick Shields			Date/Time	3/7/2022 11:29 AM
Permit #	TBD	Inspection Type	VA SWPP	Station Begin	10798+92
State	VA	Inspection Area	Full	Station End	10859+46
County	Giles	Ground	Dry	Temperature (°F)	68.00
Municipality	N/A	Weather	Sunny	Rain Gauge (in)	0.00
				Rain Accumulation Time (days)	1.00

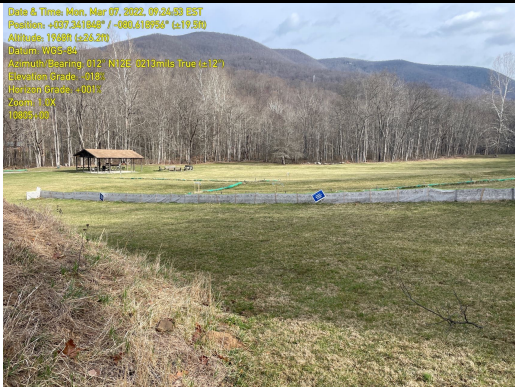
<p>Date & Time: Mon, Mar 07, 2022, 09:25:30 EST Position: +037.341777° / -080.61958° (±19.30) Altitude: 1920ft (±11.20) Datum: WGS-84 Azimuth/Bearing: 290° N09W 515mils True (±10°) Elevation Grade: -01.0% Horizon Grade: +00.0% Zoom: 1.0X 10803+00</p>				<p>Date & Time: Mon, Mar 07, 2022, 09:24:50 EST Position: +037.341548° / -080.618954° (±19.30) Altitude: 1940ft (±15.20) Datum: WGS-84 Azimuth/Bearing: 012° N43E 521mils True (±10°) Elevation Grade: -01.0% Horizon Grade: +00.0% Zoom: 1.0X 10805+00</p>							
GPS Location		See photo						GPS Location		See photo	
Field Station#		10803+00						Field Station#		10805+00	
Pic 1 Desc.		RCE in place						Pic 2 Desc.		P1 silt fence in place at sensitive resource

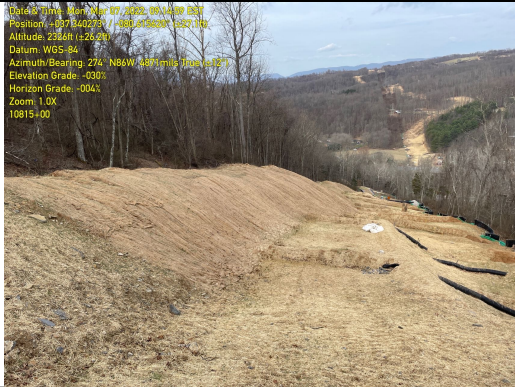
GPS Location		See photo						GPS Location		See photo	
Field Station#		10808+15						Field Station#		10815+00	
Pic 3 Desc.		Slope drain in place						Pic 4 Desc.		Erosion control blanket in place

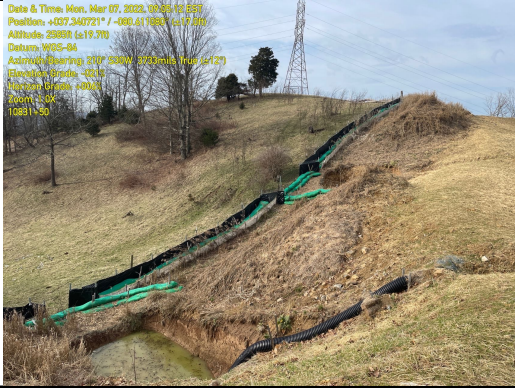
<p>Date & Time: Mon, Mar 07, 2022, 09:27:45 EST Position: +037.340555° / -080.618137° (±19.30) Altitude: 2269ft (±9.80) Datum: WGS-84 Azimuth/Bearing: 353° S29W 488mils True (±12°) Elevation Grade: -0.0% Horizon Grade: -00.4% Zoom: 1.0X 10828+00</p>				<p>Date & Time: Mon, Mar 07, 2022, 09:25:10 EST Position: +037.340721° / -080.617884° (±19.30) Altitude: 2265ft (±19.70) Datum: WGS-84 Azimuth/Bearing: 310° S30W 572mils True (±12°) Elevation Grade: -0.0% Horizon Grade: -00.0% Zoom: 1.0X 10831+00</p>							
GPS Location		See photo						GPS Location		See photo	
Field Station#		10828+00						Field Station#		10831+50	
Pic 5 Desc.		CFS triple stack perimeter control in place						Pic 6 Desc.		Triple protection ECDs in place at karst feature

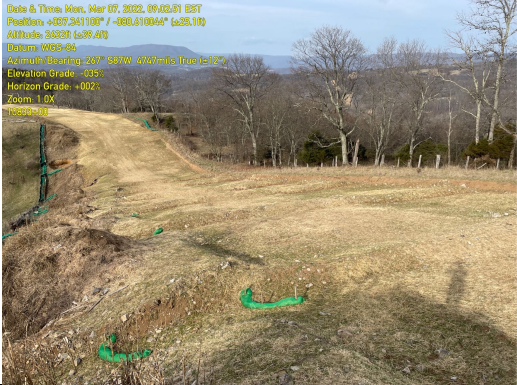
GPS Location	See photo	GPS Location	See photo		
Field Station#	10833+00	Field Station#	10840+30		
Pic 7 Desc.	Waterbars in place	Pic 8 Desc.	Daylight drain in place		
<p>Date & Time: Mon, Mar 07, 2022, 09:54:59 EST Position: +437.339222° / -080.608941° (s28.18) Altitude: 26378 (s119.20) Datum: WGS-84 Azimuth/Bearing: 334° N34W 89° True (s12) Elevation Grade: +004 Horizon Grade: -003 Zoom: 1.0X 10843+75</p>		<p>Date & Time: Mon, Mar 07, 2022, 09:55:31 EST Position: +437.340094° / -080.609241° (s28.18) Altitude: 26378 (s119.20) Datum: WGS-84 Azimuth/Bearing: 334° N34W 89° True (s12) Elevation Grade: +004 Horizon Grade: -003 Zoom: 1.0X 10856+00</p>

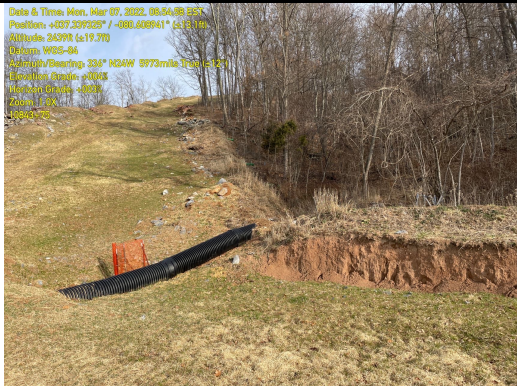
GPS Location	See photo	GPS Location	See photo		
Field Station#	10843+75	Field Station#	10856+00		
Pic 9 Desc.	Cleanwater diversion berm in place	Pic 10 Desc.	Stream buffer in place		
<p>Date & Time: Mon, Mar 07, 2022, 10:04:55 EST Position: +437.339222° / -080.608941° (s28.18) Altitude: 26378 (s119.20) Datum: WGS-84 Azimuth/Bearing: 334° N34W 89° True (s12) Elevation Grade: +004 Horizon Grade: -003 Zoom: 1.0X 10858+00</p>		<p>Date & Time: Mon, Mar 07, 2022, 10:05:07 EST Position: +437.339222° / -080.608941° (s28.18) Altitude: 26378 (s119.20) Datum: WGS-84 Azimuth/Bearing: 334° N34W 89° True (s12) Elevation Grade: +004 Horizon Grade: -003 Zoom: 1.0X 10859+00</p>

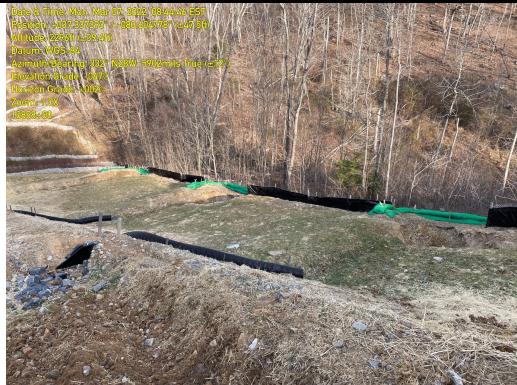
GPS Location	See photo	GPS Location	See photo		
Field Station#	10858+00	Field Station#	10859+00		
Pic 11 Desc.	End treatments in place	Pic 12 Desc.	Supersilt fence perimeter control in place

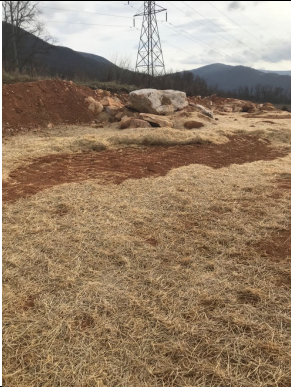
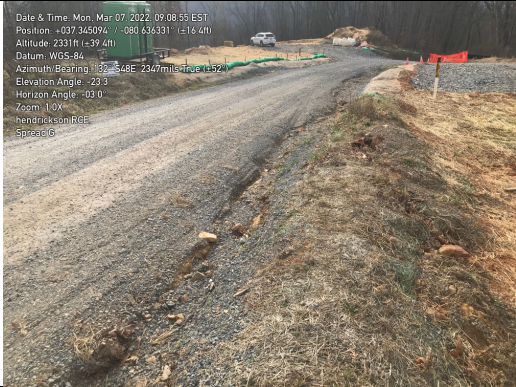
<p>Date & Time: Mon, Mar 07, 2022, 09:08:55 EST Position: +037.345094 / -080.636331 (-16.4ft) Altitude: 2331ft (+39.4ft) Datum: WGS-84 Azimuth/Bearing: 152.348E 2347mils True (+152) Elevation Angle: -23.3 Horizon Angle: -03.0 Zoom: 1.0X Hendrickson RCE Spread: 0</p>	
GPS Location	See photo	GPS Location	see photo		
Field Station#	10737+00	Field Station#	10749+92		
Pic 1 Desc.	PL item	Pic 2 Desc.	Hendrickson RCE

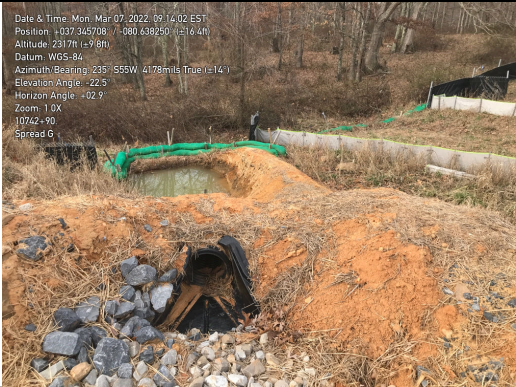
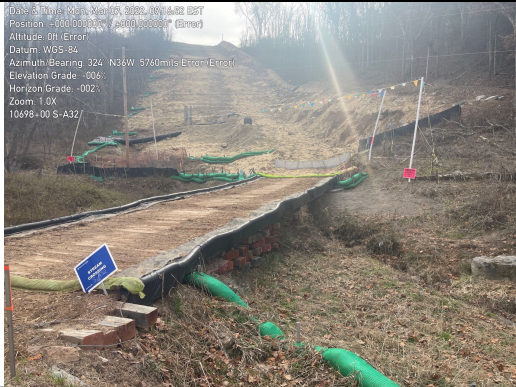
GPS Location	see photo	GPS Location	see photo		
Field Station#	10742+90	Field Station#	10698+00		
Pic 3 Desc.	Slope drain, sump, perimeter ECDs	Pic 4 Desc.	S-A 32

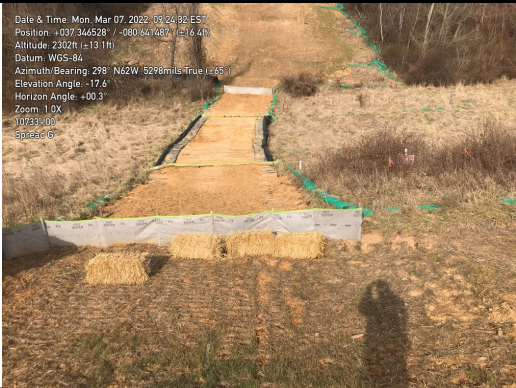
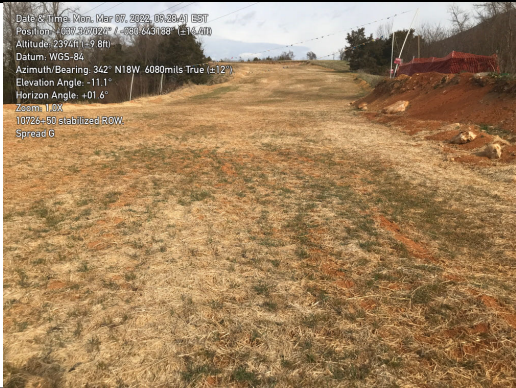
<p>Date & Time: Mon, Mar 07, 2022, 09:24:32 EST Position: +037.346528 / -080.641487 (-16.4ft) Altitude: 2302ft (+13.1ft) Datum: WGS-84 Azimuth/Bearing: 298. N62W 5298mils True (+65) Elevation Angle: -17.6 Horizon Angle: -00.3 Zoom: 1.0X 10733+00 Spread: 0</p> <p>Date & Time: Mon, Mar 07, 2022, 09:36:41 EST Position: +037.346022 / -080.643838 (-16.4ft) Altitude: 2374ft (+9.8ft) Datum: WGS-84 Azimuth/Bearing: 342. N18W 6080mils True (+12) Elevation Angle: -11.1 Horizon Angle: +01.6 Zoom: 1.0X 10726+50 stabilized ROW Spread: 0</p>	
GPS Location	see photo	GPS Location	see photo		
Field Station#	10733+00	Field Station#	10726+50		
Pic 5 Desc.	Wetland Z 11	Pic 6 Desc.	Stabilized ROW

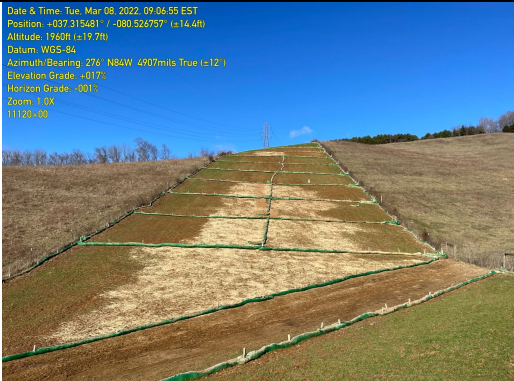
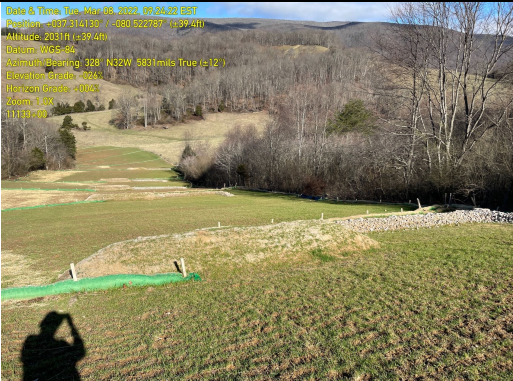
GPS Location	See photo		GPS Location	See photo	
Field Station#	11120+00		Field Station#	11133+00	
Pic 3 Desc.	CFS temporary waterbars in place		Pic 4 Desc.	Permanent waterbars in place

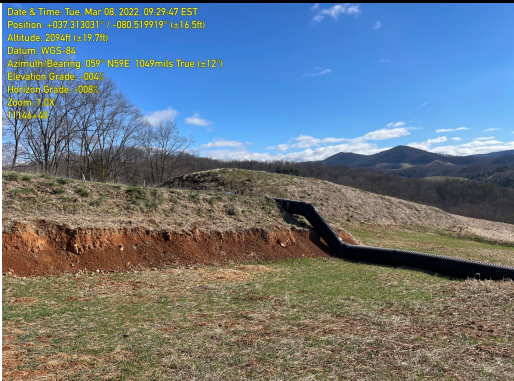
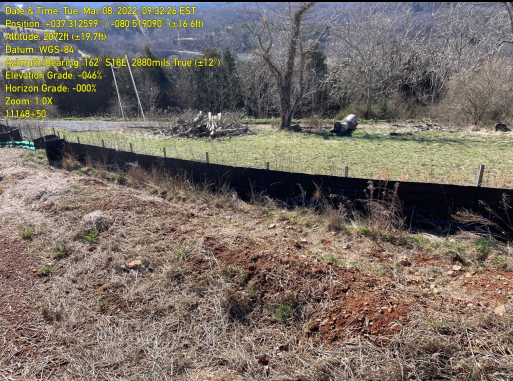
GPS Location	See photo		GPS Location	See photo	
Field Station#	11146+40		Field Station#	11148+50	
Pic 5 Desc.	Cleanwater diversion berm in place		Pic 6 Desc.	Supersilt fence perimeter control in place

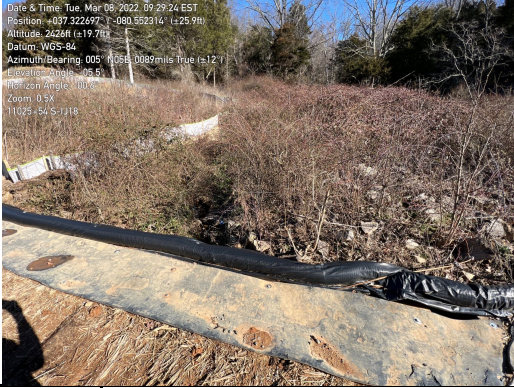
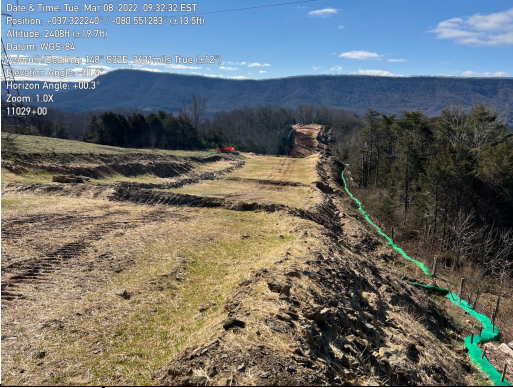
GPS Location	See Photo	GPS Location	See Photo		
Field Station#	11025+54	Field Station#	11029+00		
Pic 1 Desc.	S-IJ18	Pic 2 Desc.	Water bars and perimeter controls

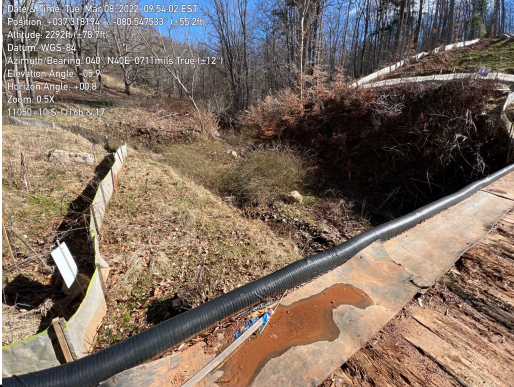
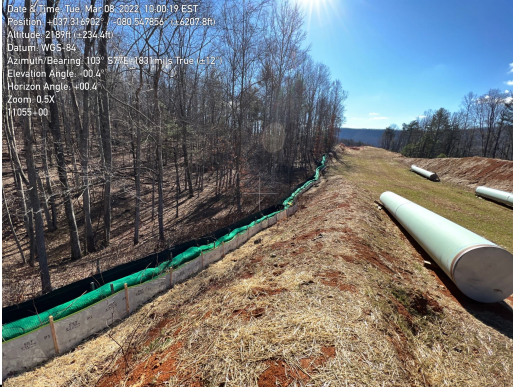
GPS Location	See Photo	GPS Location	See Photo		
Field Station#	11050+10	Field Station#	11055+00		
Pic 3 Desc.	S-IJ16b & 17	Pic 4 Desc.	Karst Protection ECDs

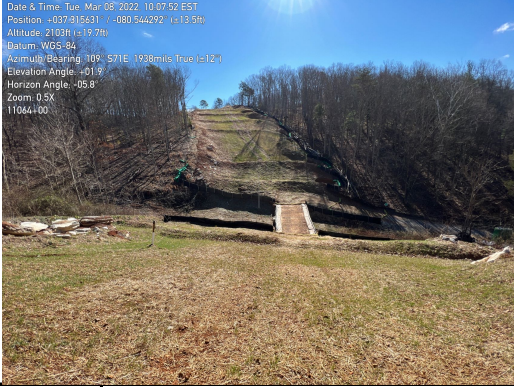
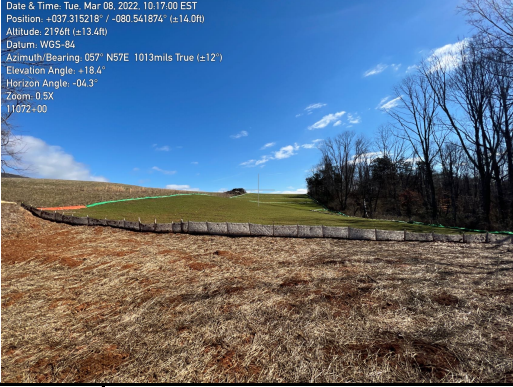
GPS Location	See Photo	GPS Location	See Photo		
Field Station#	11064+00	Field Station#	11072+00		
Pic 5 Desc.	Drainage Feature and equipment bridge	Pic 6 Desc.	Restoration

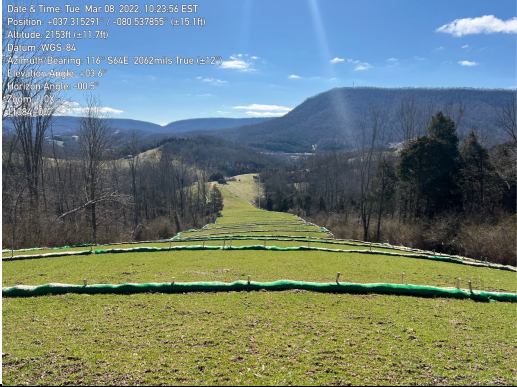
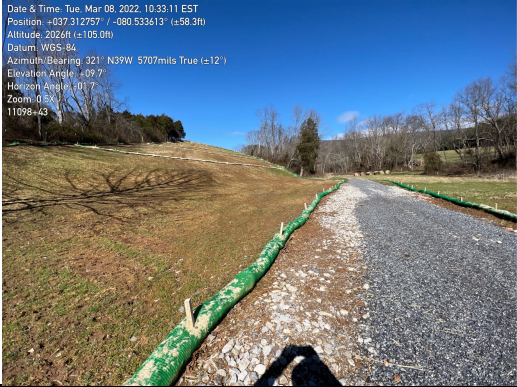
GPS Location	See Photo	GPS Location	See Photo		
Field Station#	11084+00	Field Station#	11098+43		
Pic 7 Desc.	CFS water bars restoration	Pic 8 Desc.	AR 245.01		
Insert image here		Insert image here			
GPS Location		GPS Location			
Field Station#		Field Station#			
Pic 9 Desc.		Pic 10 Desc.

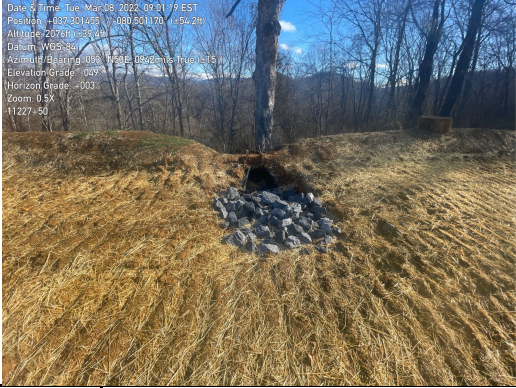
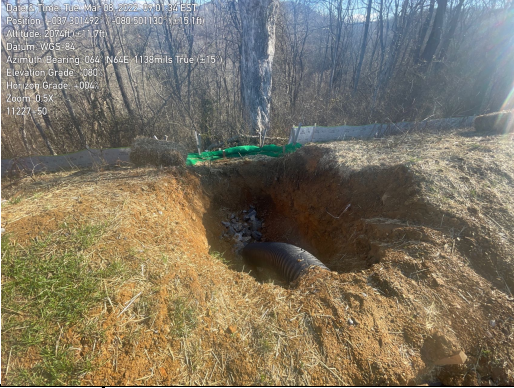
<p>Date & Time: Tue Mar 08 2022 09:34:03 EST Position: +037 301435 / -080 504302 (+14.0ft) Altitude: 2072ft (+39.4ft) Datum: WGS 84 Azimuth Bearing: 312.142W 5547mils True (+12°) Elevation Grade: +01° Horizon Grade: +00° Zoom: 0.5X 11227+50</p>			
GPS Location	See Photo	GPS Location	See Photo		
Field Station#	11227+50	Field Station#	11227+50		
Pic 1 Desc.	Stone inlet protection.	Pic 2 Desc.	Slope drain pipe conditions

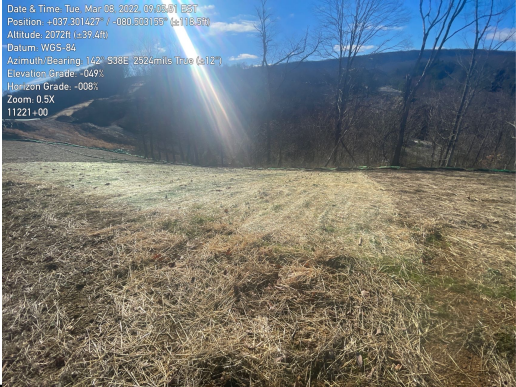
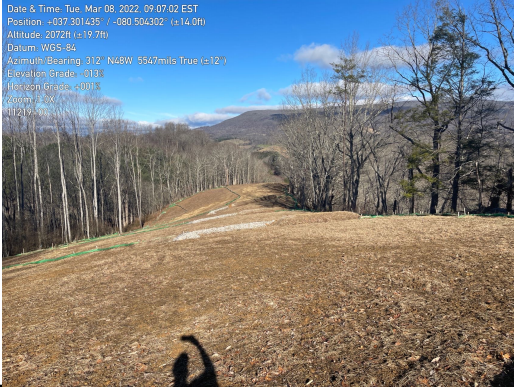
GPS Location	See Photo	GPS Location	See Photo		
Field Station#	11221+00	Field Station#	11219+00		
Pic 3 Desc.	Recently stabilized area. See Photo	Pic 4 Desc.	Final Restoration Area

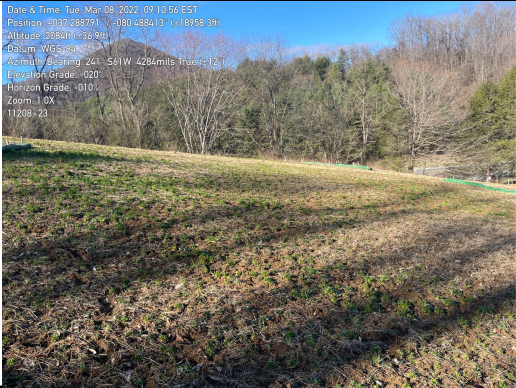
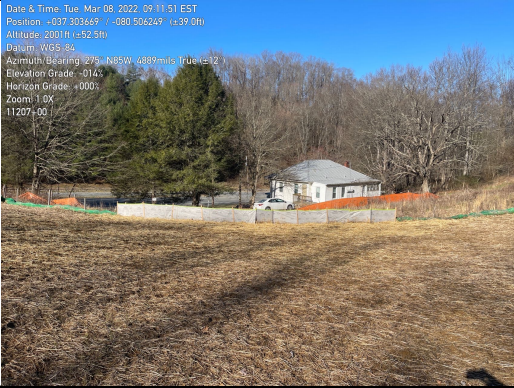
<p>Date & Time: Tue Mar 08 2022 09:11:51 EST Position: +037 301445 / -080 506249 (+13.9ft) Altitude: 2001ft (+32.5ft) Datum: WGS 84 Azimuth Bearing: 279.105W 4689mils True (+12°) Elevation Grade: +01° Horizon Grade: +00° Zoom: 1.0X 11207+00</p>			
GPS Location	See Photo	GPS Location	See Photo		
Field Station#	11208+23	Field Station#	11207+00		
Pic 5 Desc.	Final Restoration Area	Pic 6 Desc.	P1 silt fencing conditions

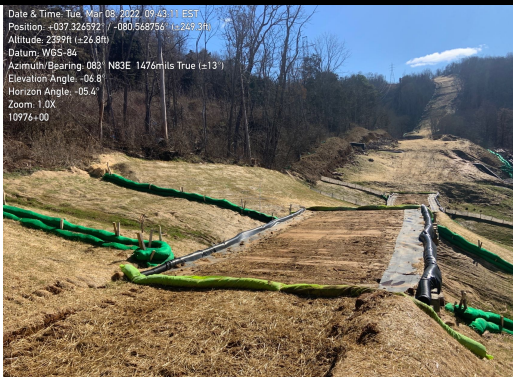
GPS Location				See photo							
Field Station#				10976+00							
Pic 5 Desc.				Section of Row showing conditions and controls

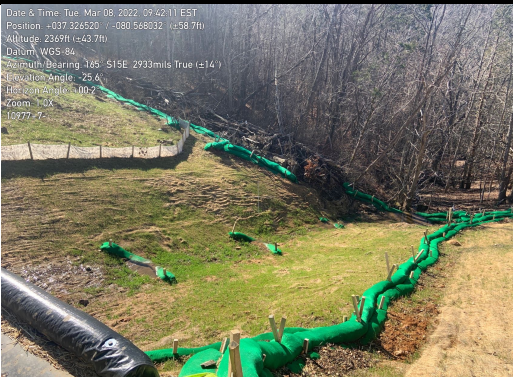
GPS Location				See photo							
Field Station#				10977+71							
Pic 6 Desc.				Section of Row showing conditions and controls

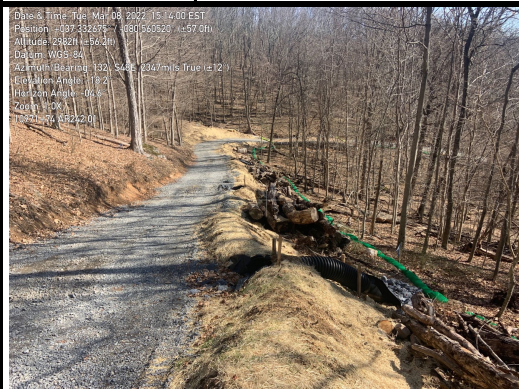
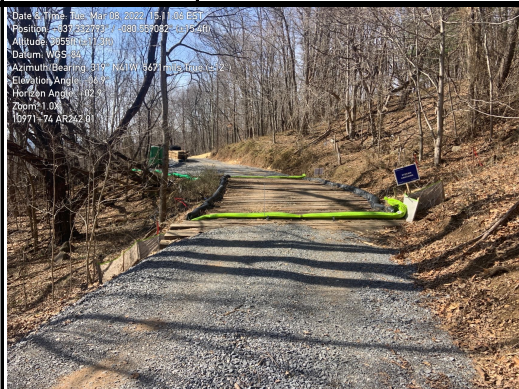
GPS Location	See photo		GPS Location	See photo	
Field Station#	10791+74		Field Station#	10971+74	
Pic 11 Desc.	Section of AR242.01 showing conditions and controls		Pic 12 Desc.	Section of AR242.01 showing conditions and controls

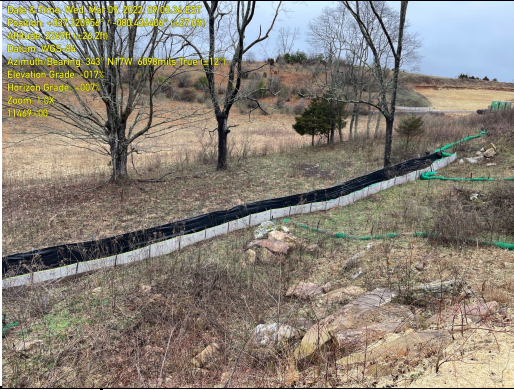
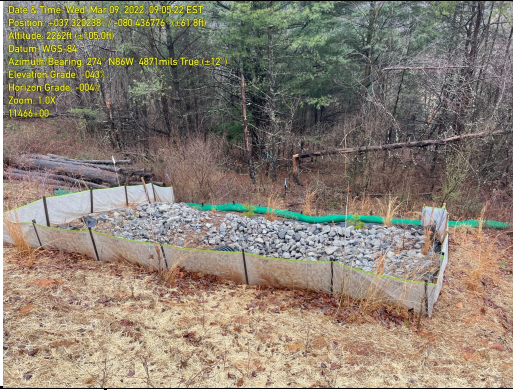
<p>Date & Time: Wed, Mar 09, 2022, 09:14:32 EST Position: 40°13'19.38"N / -88°43'03"W (-231.26) Altitude: 525.00 (+52.50) Datum: WGS-84 Azimuth/Bearing: 276.188W Azimuth True (+12°) Elevation Grade: +041% Horizon Grade: +004% Zoom: 1.0X 11466+00</p>			
GPS Location	See photo	GPS Location	See photo		
Field Station#	11469+00	Field Station#	11466+00		
Pic 1 Desc.	Triple protection ECDs in place at karst feature	Pic 2 Desc.	Plunge pool in place

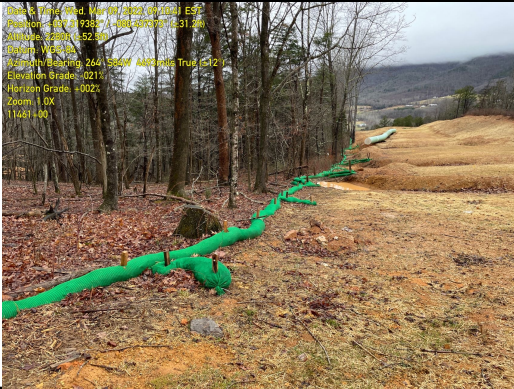
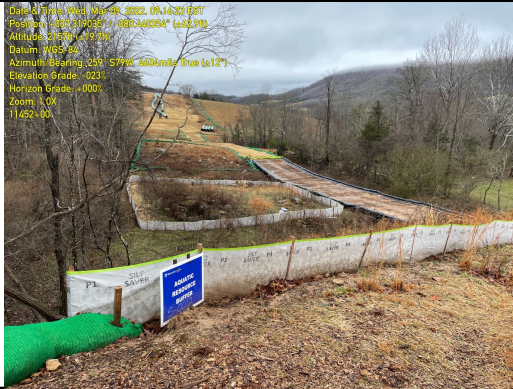
GPS Location	See photo	GPS Location	See photo		
Field Station#	11461+00	Field Station#	11452+00		
Pic 3 Desc.	CFS perimeter control in place	Pic 4 Desc.	Stream buffer in place

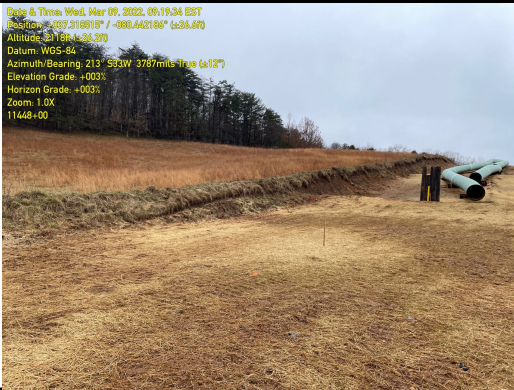
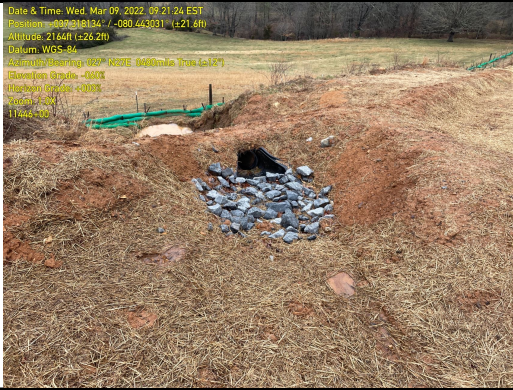
<p>Date & Time: Wed, Mar 09, 2022, 09:21:24 EST Position: 40°13'21.881"N / -88°44'21.84"W (-238.40) Altitude: 515.00 (+26.20) Datum: WGS-84 Azimuth/Bearing: 027.188E 3400mils True (+12°) Elevation Grade: +000% Horizon Grade: +000% Zoom: 1.0X 11446+00</p>			
GPS Location	See photo	GPS Location	See photo		
Field Station#	11448+00	Field Station#	11446+00		
Pic 5 Desc.	Cleanwater diversion berm in place	Pic 6 Desc.	Stone inlet protection in place

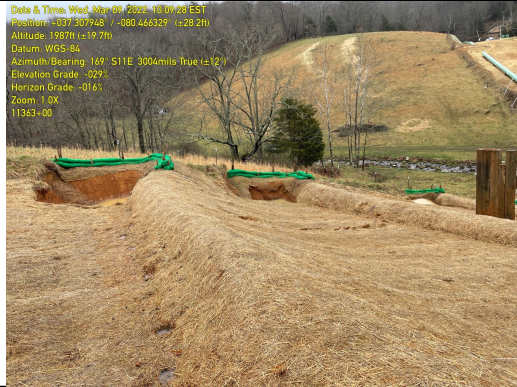
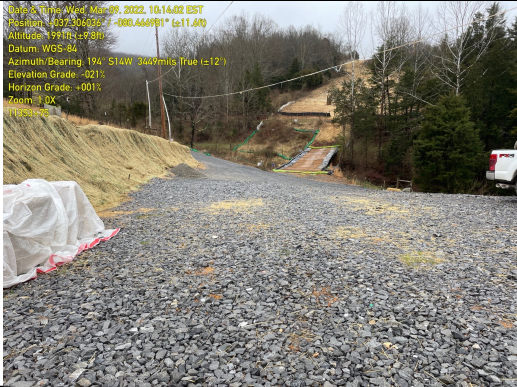
GPS Location		See photo		GPS Location	
Field Station#		11363+00		Field Station#	
Pic 11 Desc.		End treatments in place		Pic 12 Desc.	
				RCE in place

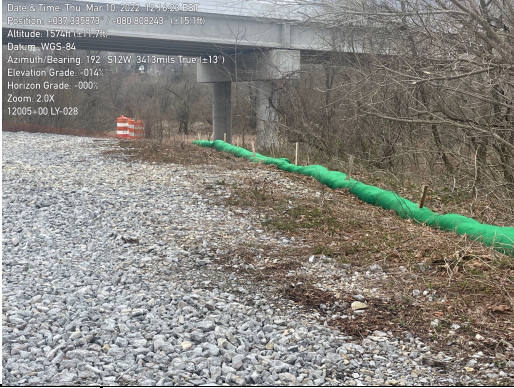
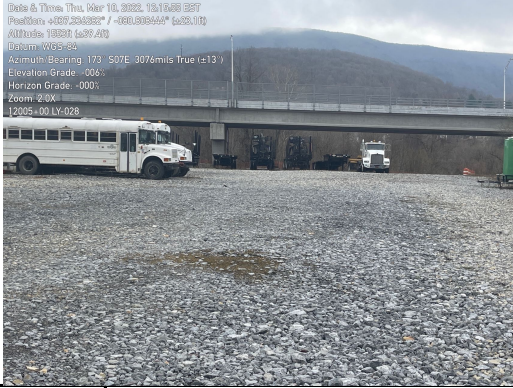
<p>Date & Time: Thu, Mar 10, 2022, 13:10:58 PM Position: +39°24'58.2" / -80°50'54.4" (±15.1M) Altitude: 1583ft (±1.7M) Datum: WGS-84 Azimuth/Bearing: 173.507E, 3076mils True (±13°) Elevation Grade: -005° Horizon Grade: -000° Zoom: 2.0X 12005+00 LY-028</p>			
GPS Location	See Photo	GPS Location	See Photo		
Field Station#	12005+00	Field Station#	12005+00		
Pic 1 Desc.	Perimeter CFS conditions	Pic 2 Desc.	RCE parking area

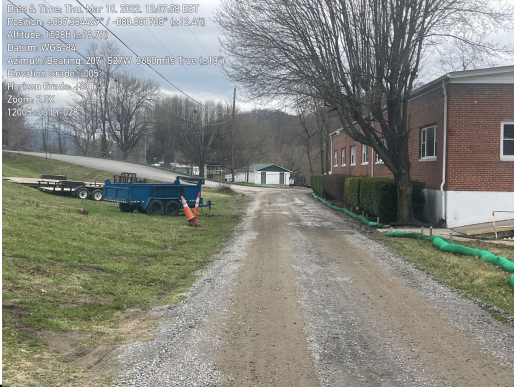
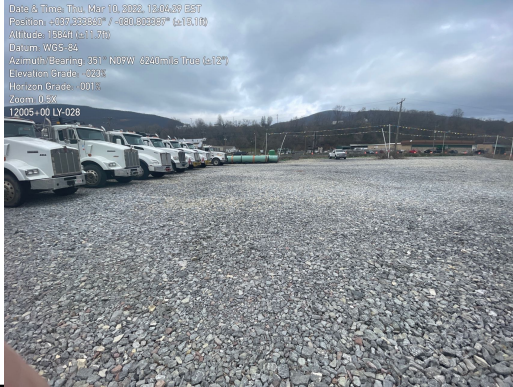
GPS Location	See Photo	GPS Location	See Photo		
Field Station#	12005+00	Field Station#	12005+00		
Pic 3 Desc.	AR to LY028	Pic 4 Desc.	LY28 RCE

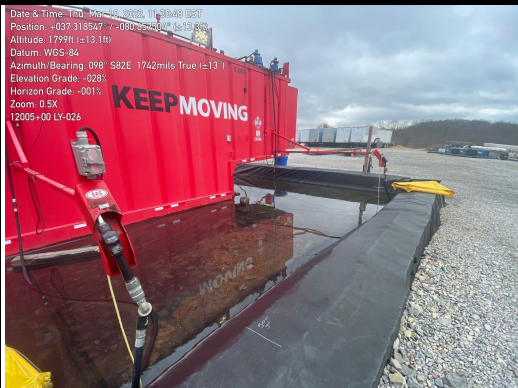
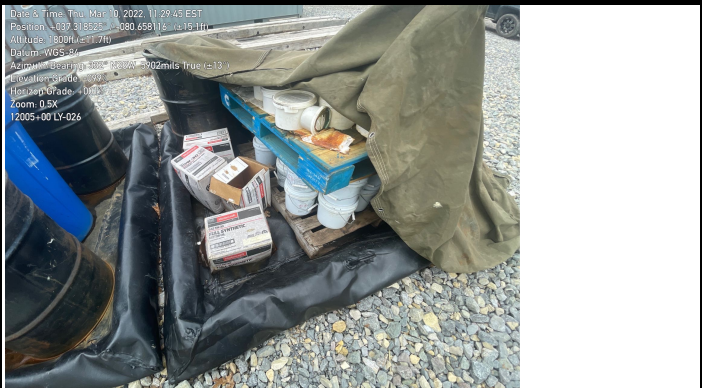
GPS Location	See Photo	GPS Location	See Photo		
Field Station#	12005+00	Field Station#	12005+00		
Pic 9 Desc.	Fuel secondary containment conditions	Pic 10 Desc.	Foreign fluid storage area containment.		
  <p>Date & Time: Thu, Mar 10, 2022, 11:56:48 EST Position: +037.318331° N, -80.653372° W (10.61) Altitude: 1797ft (+10.7m) Datum: WGS-84 Azimuth/Bearing: 098° S82E 1742mils True (+13.1) Elevation Grade: -028% Horizon Grade: -003% Zoom: 0.5X 12005+00 LY-026</p>

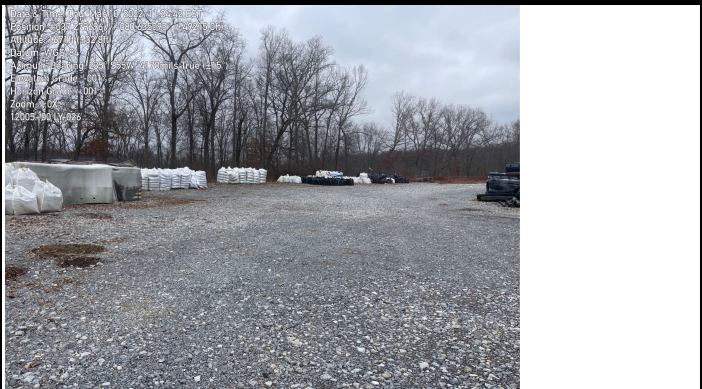
<p>Date & Time: Thu, Mar 10, 2022, 11:56:48 EST Position: +037.318331° N, -80.653372° W (10.61) Altitude: 1797ft (+10.7m) Datum: WGS-84 Azimuth/Bearing: 098° S82E 1742mils True (+13.1) Elevation Grade: -028% Horizon Grade: -003% Zoom: 0.5X 12005+00 LY-026</p>	
GPS Location	See Photo	GPS Location	See Photo		
Field Station#	12005+00	Field Station#	12005+00		
Pic 11 Desc.	Secondary containment conditions	Pic 12 Desc.	Material storage area and RCE conditions.

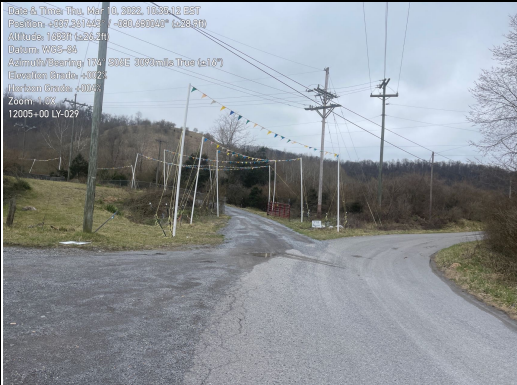
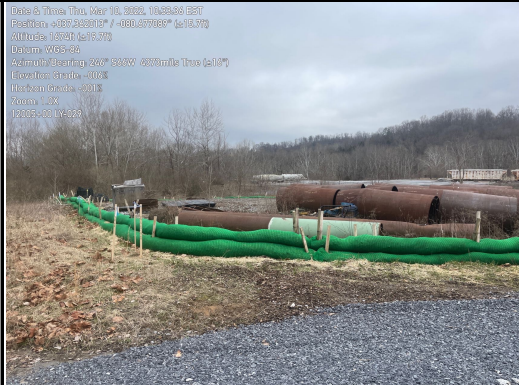
GPS Location	See Photo		GPS Location	See Photo	
Field Station#	12005+00		Field Station#	12005+00	
Pic 13 Desc.	AR to LY-029 conditions		Pic 14 Desc.	Perimeter CFS conditions

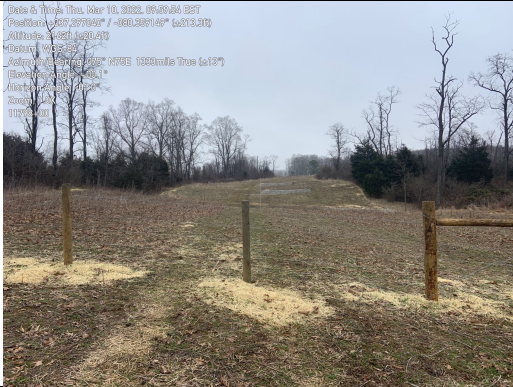
GPS Location	See photo	GPS Location	See photo		
Field Station#	11792+65	Field Station#	11798+00		
Pic 1 Desc.	ECD's are in acceptable condition	Pic 2 Desc.	Section of Row showing conditions and controls

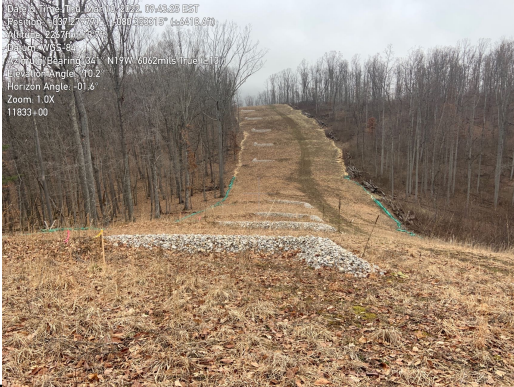
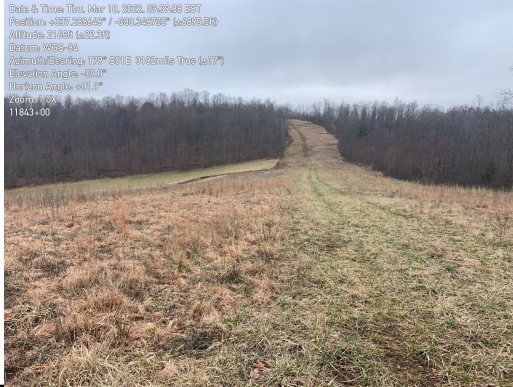
GPS Location	See photo	GPS Location	See photo		
Field Station#	11833+00	Field Station#	11843+00		
Pic 3 Desc.	Section of Row showing conditions and controls	Pic 4 Desc.	Section of Row showing conditions and controls

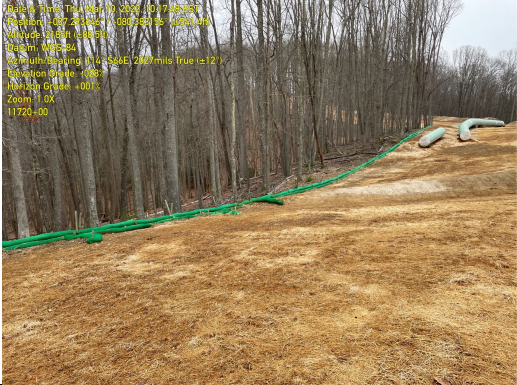
GPS Location	See photo		GPS Location	See photo	
Field Station#	11720+00		Field Station#	11741+00	
Pic 7 Desc.	CFS perimeter control in place		Pic 8 Desc.	Stream buffer in place

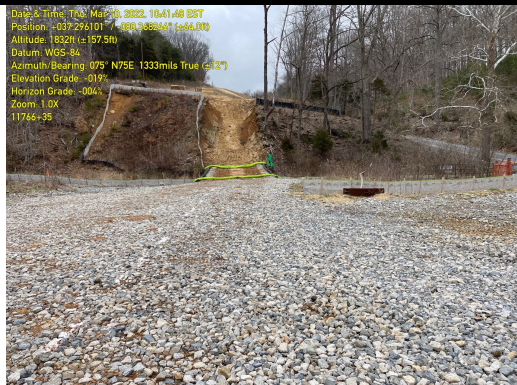
<p>Insert image here</p>	
GPS Location	See photo		GPS Location		
Field Station#	11766+35		Field Station#		
Pic 11 Desc.	RCE in place		Pic 12 Desc.

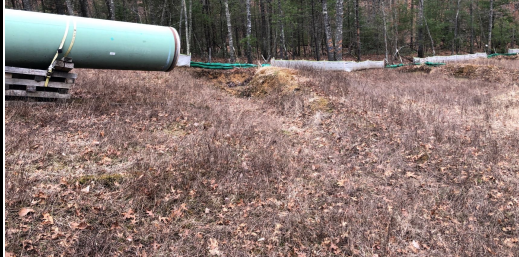
GPS Location	On photo		GPS Location	On photo	
Field Station#	11628+00		Field Station#	11626+04	
Pic 7 Desc.	ROW stable. Perimeter ECDs in place. Slope breakers functional.		Pic 8 Desc.	S-HH18 crossing is stable.	
<p>Date & Time: Thu, Mar 10, 2022, 09:30:00 EST Position: +037 219880 / -080 403402 (±30.0m) Altitude: 590m (±66.0m) Datum: WGS-84 Azimuth/Bearing: 108° S71E 1930mils Magnetic (±15°) Elevation Angle: +00.6° Horizon Angle: +03.0° Zoom: 1.0X 11615+00</p>

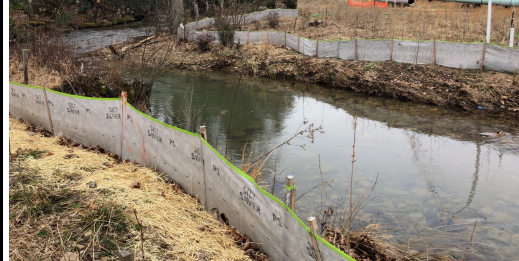
GPS Location	On photo		GPS Location	On photo	
Field Station#	11608+17		Field Station#	11601+00	
Pic 11 Desc.	S-006 crossing is currently stable.		Pic 12 Desc.	Functional slope breakers. Stable surface.

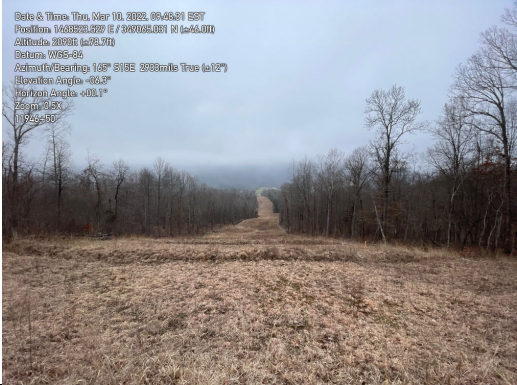
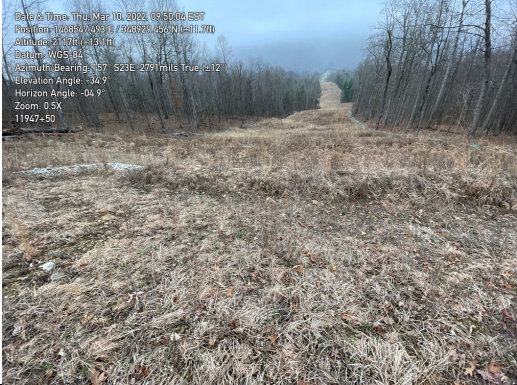
<p><small>Date & Time: Thu, Mar 10, 2022, 06:56:06 EST Position: 143824.237 E / 349035.454 N (±4.1m) Altitude: 2000ft (±4.1m) Datum: WGS-84 Azimuth/Bearing: 57° S23E 277mils True (±12°) Elevation Angle: -34.9° Horizon Angle: -04.9° Zoom: 0.5X 11947+50</small></p>		
GPS Location	7		GPS Location	8	
Field Station#	11946+50		Field Station#	11947+50	
Pic 7 Desc.	Section of partially restored RoW showing conditions and controls.		Pic 8 Desc.	Representative photo of permanent waterbar and level spreaders.

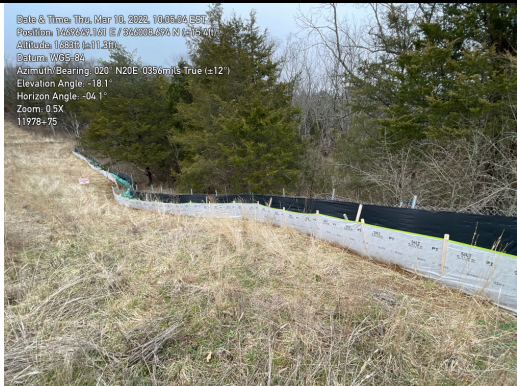
GPS Location	9		GPS Location	10	
Field Station#	11978+75		Field Station#	11957+00	
Pic 9 Desc.	Karst feature protection functional.		Pic 10 Desc.	Section of partially restored RoW showing conditions and controls.	
Insert image here			Insert image here		
GPS Location			GPS Location		
Field Station#			Field Station#		
Pic 11 Desc.			Pic 12 Desc.

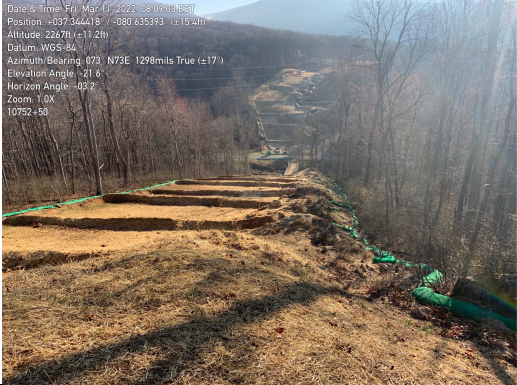
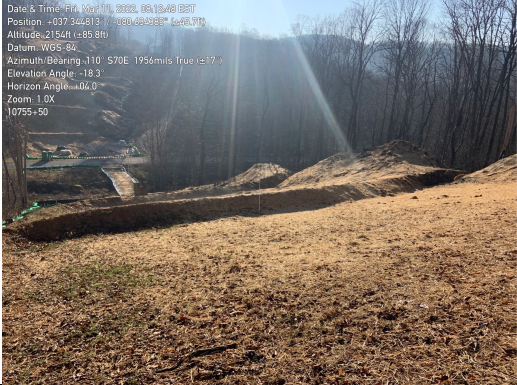
GPS Location	See photo	GPS Location	See photo		
Field Station#	10752+50	Field Station#	10755+50		
Pic 7 Desc.	Section of Row showing conditions and controls	Pic 8 Desc.	Section of Row showing conditions and controls		
Insert image here		Insert image here			
GPS Location		GPS Location			
Field Station#		Field Station#			
Pic 9 Desc.		Pic 10 Desc.			
Insert image here		Insert image here			
GPS Location		GPS Location			
Field Station#		Field Station#			
Pic 11 Desc.		Pic 12 Desc.

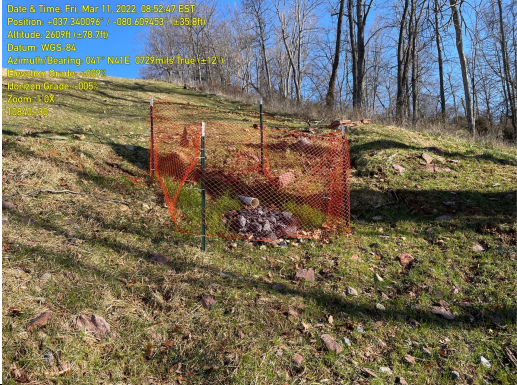
<p>Date & Time: Fri, Mar 11, 2022, 05:47:07 EST Position: 40° 53' 00.00" N / -80° 00' 00.00" W Altitude: 3200 ft (975.30 m) Datum: WGS-84 Azimuth/Bearing: 90° (0°) 00' 00" (true) (12.1) Elevation Grade: 0.00% Horizon Grade: 0.00% Zoom: 1.0x 10843+75</p>			
GPS Location	See photo	GPS Location	See photo		
Field Station#	10840+30	Field Station#	10843+75		
Pic 7 Desc.	Daylight drain in place	Pic 8 Desc.	Cleanwater diversion pipe in place

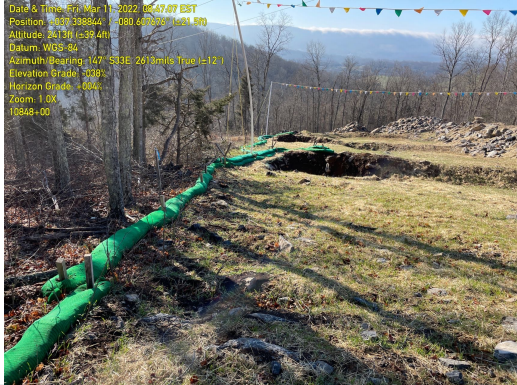
GPS Location	See photo	GPS Location	See photo		
Field Station#	10848+00	Field Station#	10856+00		
Pic 9 Desc.	CFS perimeter control in place	Pic 10 Desc.	Stream buffer in place

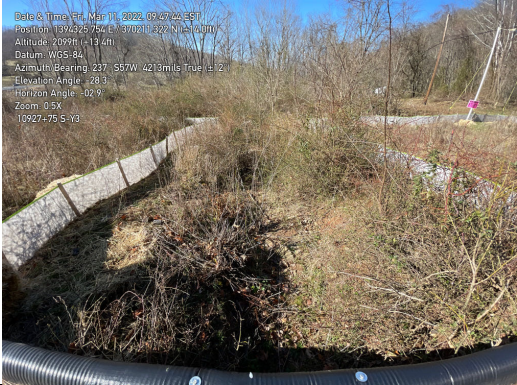
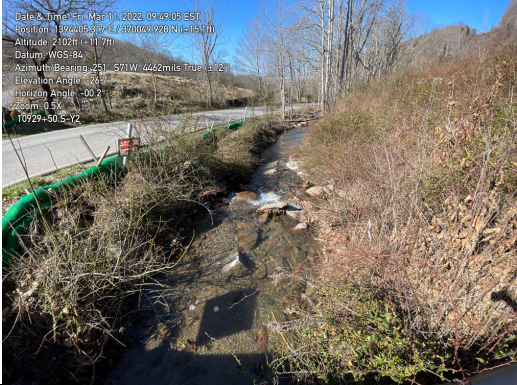
GPS Location	7	GPS Location	8		
Field Station#	10927+75	Field Station#	10929+50		
Pic 7 Desc.	S-Y3.	Pic 8 Desc.	S-Y2.		
Insert image here		Insert image here			
GPS Location		GPS Location			
Field Station#		Field Station#			
Pic 9 Desc.		Pic 10 Desc.			
Insert image here		Insert image here			
GPS Location		GPS Location			
Field Station#		Field Station#			
Pic 11 Desc.		Pic 12 Desc.

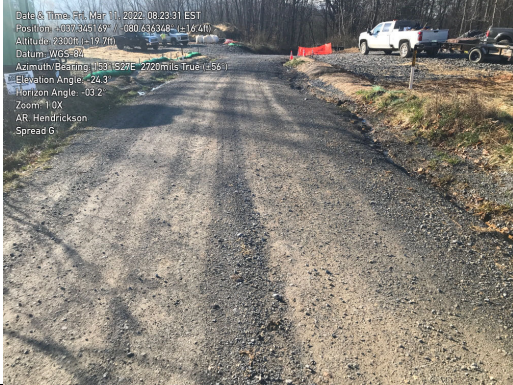
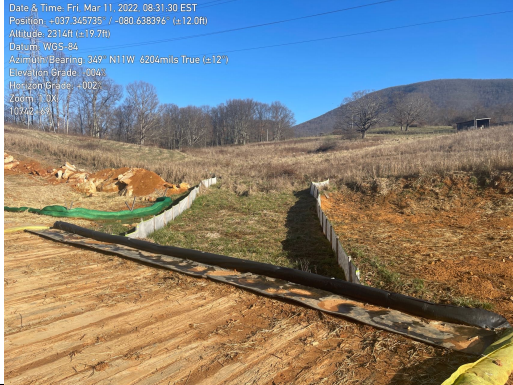
GPS Location		See photo						GPS Location		see photo					
Field Station#		10749+92						Field Station#		10742+69					
Pic 1 Desc.		Hendrickson						Pic 2 Desc.		Drainage

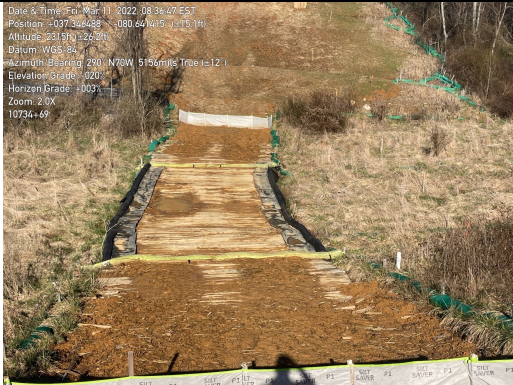
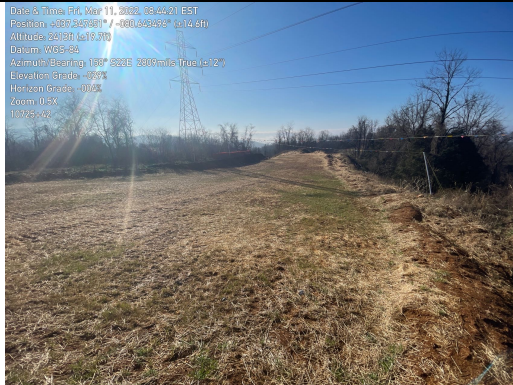
GPS Location		see photo						GPS Location		see photo					
Field Station#		10734+69						Field Station#		10725+42					
Pic 3 Desc.		Wetland Z-11						Pic 4 Desc.		Stabilized ROW

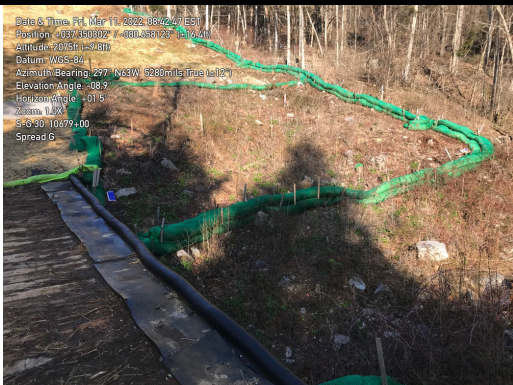
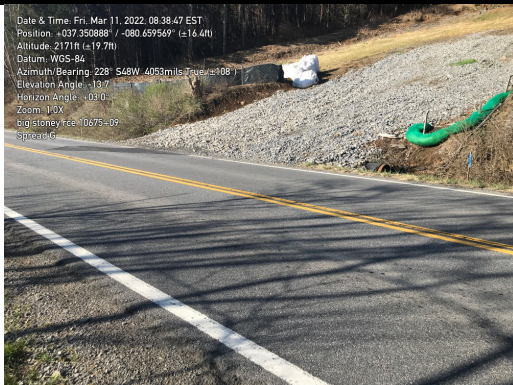
GPS Location		see photo						GPS Location		see photo					
Field Station#		10679+00						Field Station#		10675+09					
Pic 5 Desc.		S-G 30						Pic 6 Desc.		Big Stony

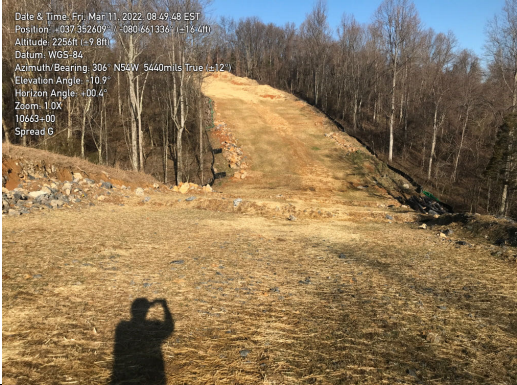
GPS Location	See photo	GPS Location	see photo		
Field Station#	10663+00	Field Station#	10712+80		
Pic 7 Desc.	Stabilized ROW	Pic 8 Desc.	S-G 33		
Insert image here		Insert image here			
GPS Location		GPS Location			
Field Station#		Field Station#			
Pic 9 Desc.		Pic 10 Desc.			
Insert image here		Insert image here			
GPS Location		GPS Location			
Field Station#		Field Station#			
Pic 11 Desc.		Pic 12 Desc.
