Visual Site Inspection Report

Project Name	H-600 Pipeline Spread H	AFE	124300138	Spread	H-600 Pipeline Spread H
Contractor	Precision			Report #	35694
Inspector	Norm Kitchen			Date/Time	3/21/2022 3:30 PM
Permit #	TBD	Inspection Type	VA SWPP	Station Begin	12119+17
State	VA	Inspection Area	Partial	Station End	12284+75
County	Montgomery	Ground	Dry	Temperature (°F)	65.00
Municipality	N/A	Weather	Sunny	Rain Gauge (in)	0.00
				Rain Accumulation Time (days)	1.00

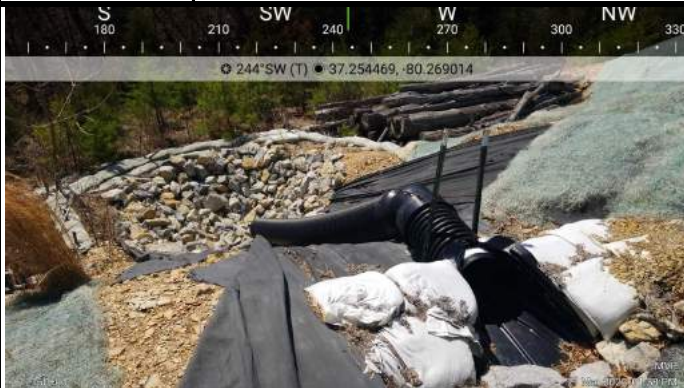
GPS Location	See Above		GPS Location	See Above	
Field Station#	12160+00		Field Station#	12163+05	
Pic 9 Desc.	ROW Overview. ECDs functional and in good condition and ROW is stable.		Pic 10 Desc.	Overview of Waterbody S-C25. ECDs functional and in good condition.

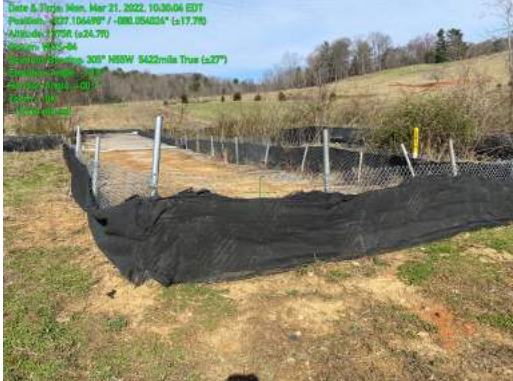
GPS Location	0		GPS Location	0	
Field Station#	13310+00		Field Station#	13311+00	
Pic 1 Desc.	Replace fence fabric - 72hr item		Pic 2 Desc.	ROW and ECDs In good condition and stable

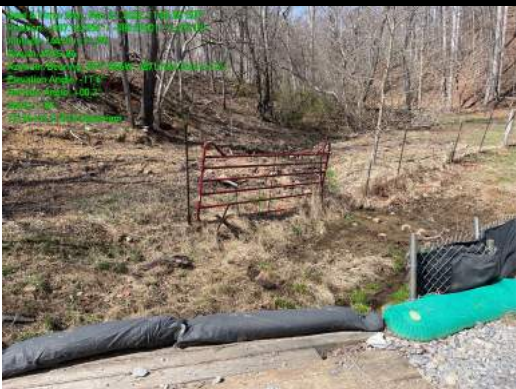
GPS Location				0				GPS Location				0			
Field Station#				13196+31				Field Station#				13185+00			
Pic 7 Desc.				MVP-S-D10 and corresponding buffer zone in good condition. Landowner has made a road for clearing property upstream of D10, will be completed by 3/22/22.				Pic 8 Desc.				ROW and ECDs In good condition and stable

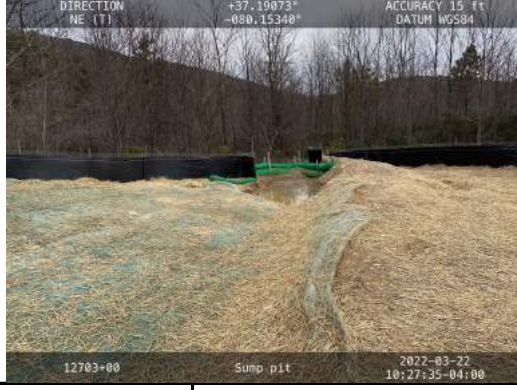
GPS Location	See photo for gps location data.		GPS Location	See photo for gps location data.	
Field Station#	12703+00		Field Station#	12707+00	
Pic 11 Desc.	Photo shows the ROW and ECD conditions. ECDs are installed and functioning as designed.		Pic 12 Desc.	Photo shows the ECB that had been blown loose by the wind.

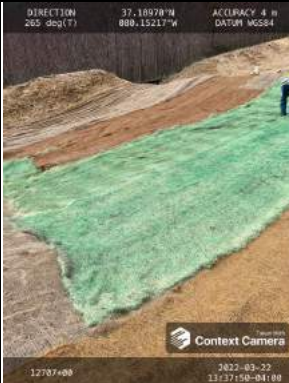
7. Identify all remedial measures that have been taken since the previous inspection was conducted. The following mitigation measures were performed in this area since the last SWPPP inspection: 12707+00 to 12708+00: Loose ECB was repaired					
Comments (Reference above questions as appropriate.) I traveled to the ROW near Honeysuckle Road this morning. No measurable precipitation was recorded at Honeysuckle Road within the last 24 hours. I performed a SWPPP inspection of the disturbed portions of the ROW between stations 12600+00 and 12725+00 to observe conditions of ECDs, stream crossings and general ROW conditions. The stream crossings observed in this area today included S-IJ50, S-Y13 and S-Y14. I also observed the RCEs at RO-279.01, RO-280 and Honeysuckle Road. A section of erosion control blanket (ECB) between stations 12707+00 and 12708+00 had been blown loose from the ground by the wind. I notified the contractor and Precisions environmental crew repair the ECB in this area today. No additional environmental issues, off-ROW sediment or stream impacts were observed during this SWPPP inspection.

GPS Location	See photo for gps location data.		GPS Location	See photo for gps location data.	
Field Station#	12707+00		Field Station#	12715+80	
Pic 13 Desc.	Photo shows the repaired ECB.		Pic 14 Desc.	Photo shows S-Y13 downstream from the bridge.

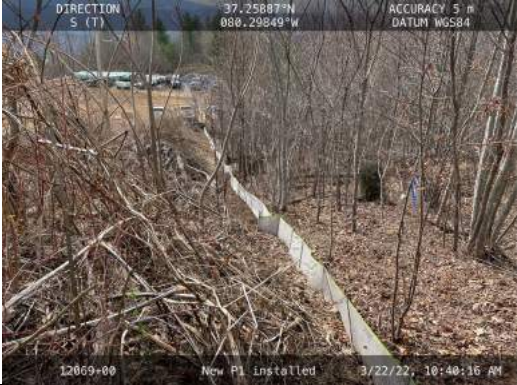
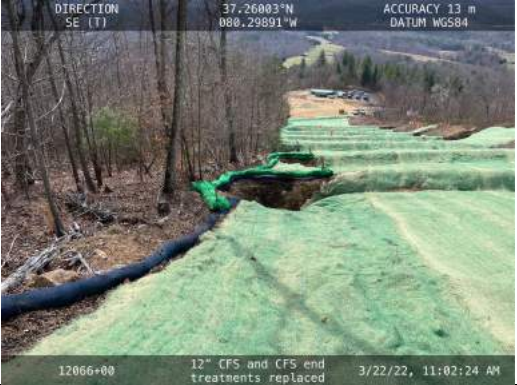
GPS Location	Please see photo for details.		GPS Location	Please see photo for details.	
Field Station#	12069+00		Field Station#	12066+00	
Pic 13 Desc.	Photo shows new P1 silt fence installed to refresh the old P1 silt fence that was already installed previously.		Pic 14 Desc.	Photo shows new 12" CFS installed for water bar end treatment to refresh the old 12" CFS that was installed previously.

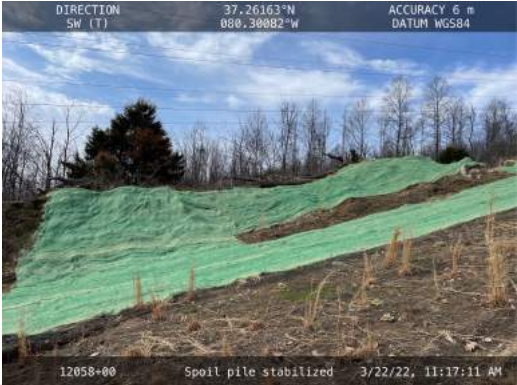
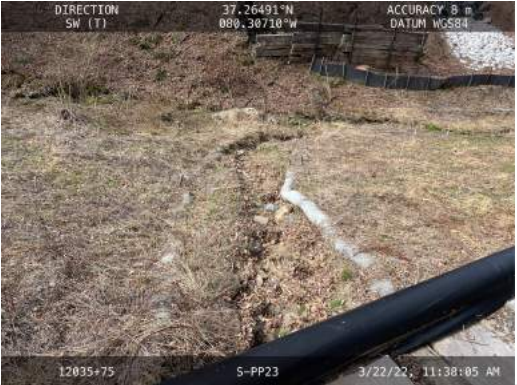
GPS Location	Please see photo for details.		GPS Location	Please see photo for details.	
Field Station#	12058+00		Field Station#	12035+75	
Pic 15 Desc.	Photo shows new erosion control blanket installed to stabilize stock pile.		Pic 16 Desc.	Photo shows downstream of Stream S-PP23.

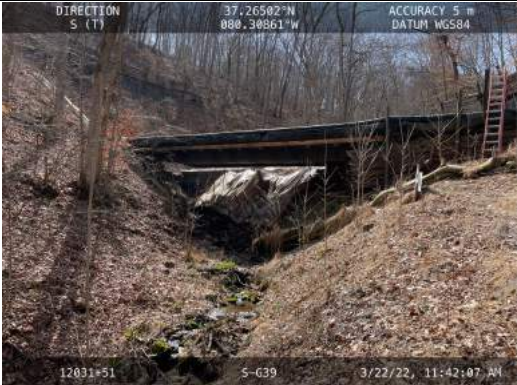
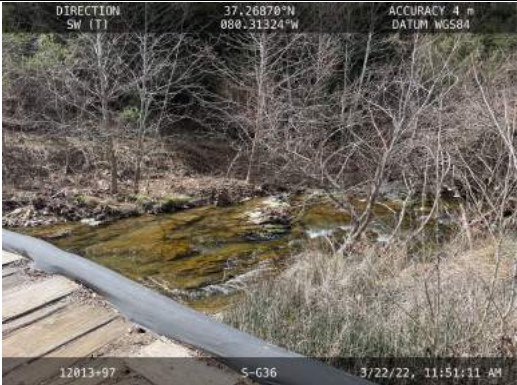
Pic 17 Desc.	Photo shows equipment bridge spanning the stream channel and downstream of Stream S-G39.		Pic 18 Desc.	Photo shows downstream of Stream S-G36.

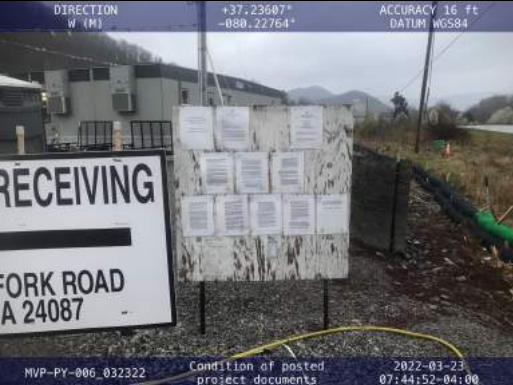
GPS Location	MVP-PY-006 See photo for gps data		GPS Location	MVP-PY-006 See photo for gps data	
Field Station#	+0		Field Station#	+0	
Pic 1 Desc.	Condition of rock entrance. No stone on public roadway. Looking NE.		Pic 2 Desc.	Condition of posted project documents at the main entrance. Looking W.

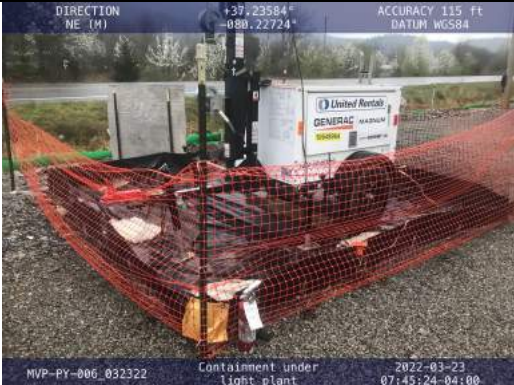
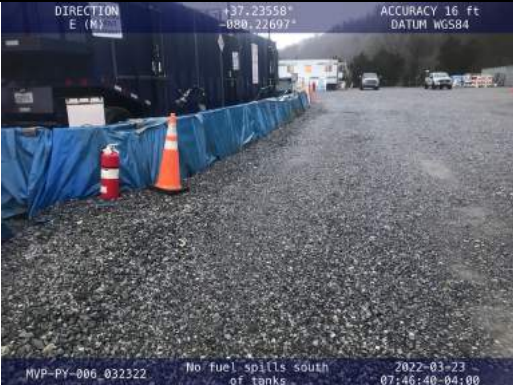
GPS Location	MVP-PY-006 See photo for gps data		GPS Location	MVP-PY-006 See photo for gps data	
Field Station#	+0		Field Station#	+0	
Pic 3 Desc.	Secondary containment under light plant. Holding some stormwater. Looking NE.		Pic 4 Desc.	Blue Bulk Fuel tanks no fuel spills south of the tanks. Looking E.

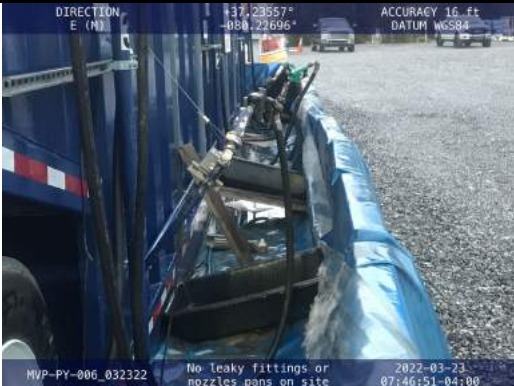
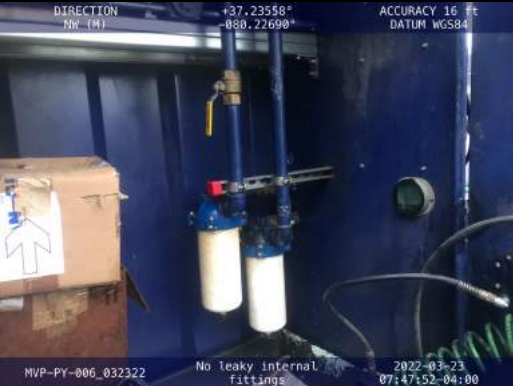
GPS Location	MVP-PY-006 See photo for gps data		GPS Location	MVP-PY-006 See photo for gps data	
Field Station#	+0		Field Station#	+0	
Pic 5 Desc.	Blue Bulk Fuel tanks no leaky fittings or nozzles. Catch pans on site. Looking E.		Pic 6 Desc.	Blue Bulk Fuel tanks no leaky internal fittings. Looking NW.

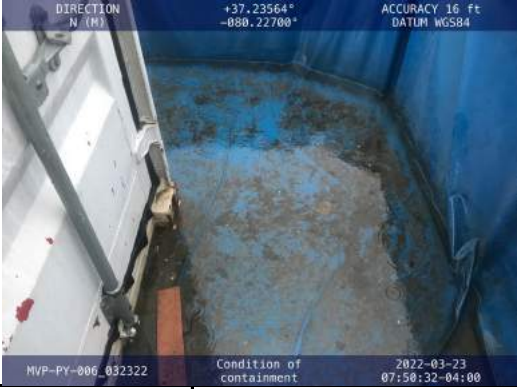
GPS Location	MVP-PY-006 See photo for gps data	GPS Location	MVP-PY-006 See photo for gps data		
Field Station#	+0	Field Station#	+0		
Pic 7 Desc.	Secondary containments in place for tankers offloading fuel. Looking W.	Pic 8 Desc.	Off Road Fuel unit secondary containment holding stormwater. Looking N.

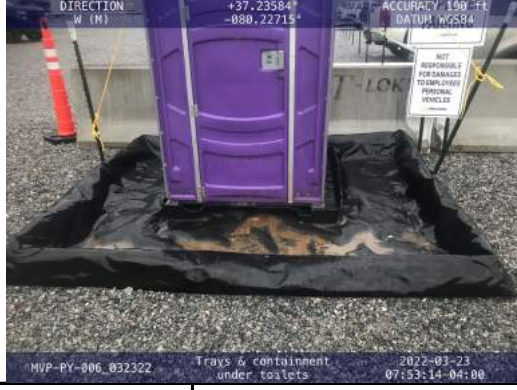
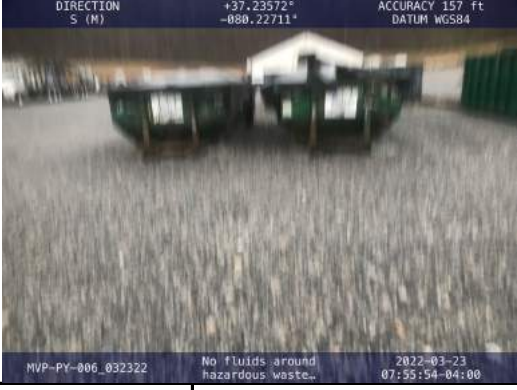
GPS Location	MVP-PY-006 See photo for gps data	GPS Location	MVP-PY-006 See photo for gps data		
Field Station#	+0	Field Station#	+0		
Pic 11 Desc.	Tray and containment under toilet. Trays holding stormwater. Looking W.	Pic 12 Desc.	No fluids or deposits around hazardous waste dumpsters. Looking S.

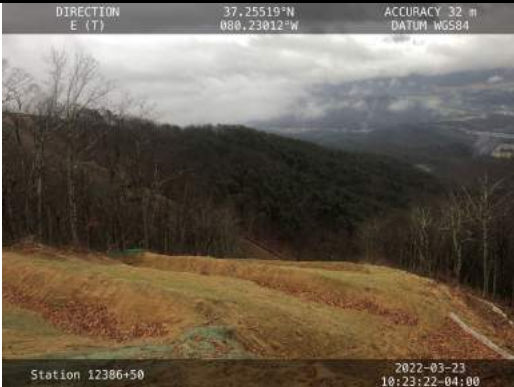
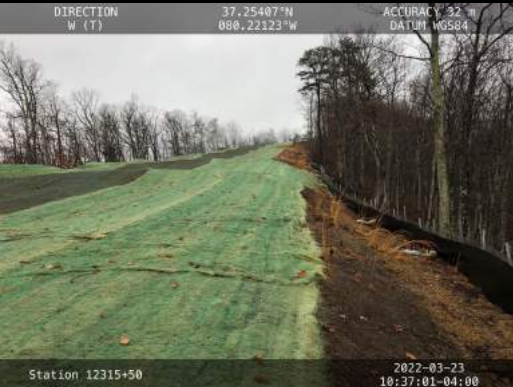
GPS Location	Please see photo for details.		GPS Location	Please see photo for details.	
Field Station#	12386+50		Field Station#	12315+50	
Pic 1 Desc.	Photo shows the stabilized ROW conditions with water bars and that all ECDs are installed and are functioning as designed.		Pic 2 Desc.	Photo shows the stabilized ROW conditions with water bars and that all ECDs are installed and are functioning as designed.

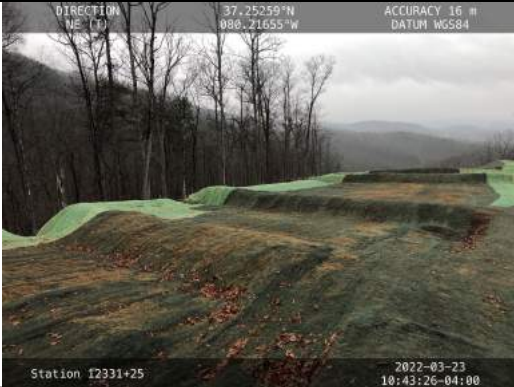
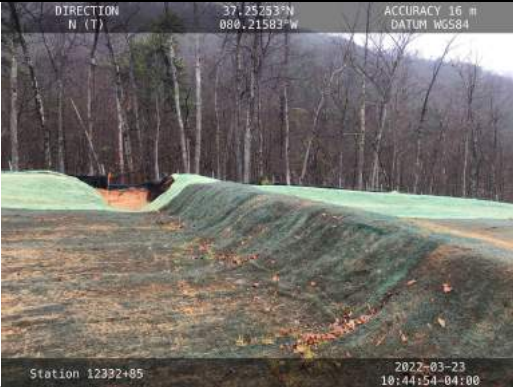
GPS Location	Please see photo for details.		GPS Location	Please see photo for details.	
Field Station#	12331+25		Field Station#	12332+85	
Pic 3 Desc.	Photo shows the stabilized ROW conditions with water bars and that all ECDs are installed and are functioning as designed.		Pic 4 Desc.	Photo shows water bar, sump and water bar end treatment functioning as designed.

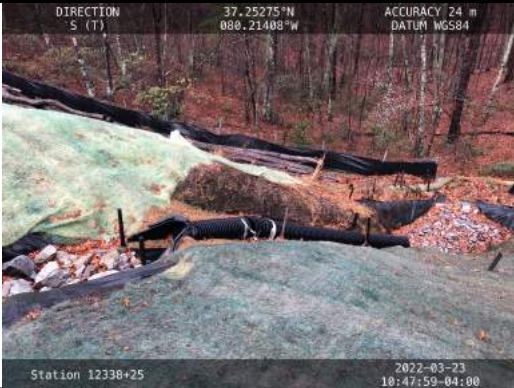
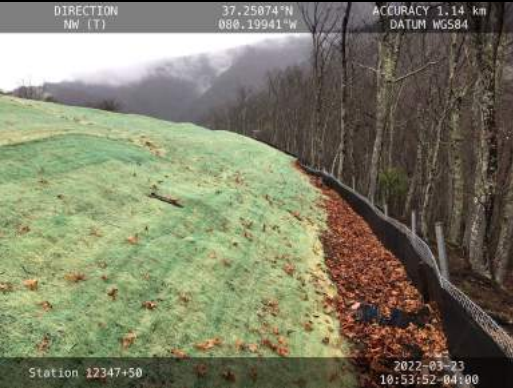
Field Station#	12338+25		Field Station#	12347+50	
Pic 5 Desc.	Photo shows slope drain pipe with stone inlet protection leading draining to plunge pool.		Pic 6 Desc.	Photo shows side slope stabilized and installed super silt fence installed is functioning as designed.

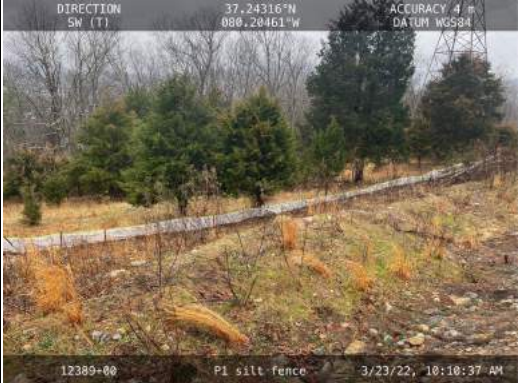
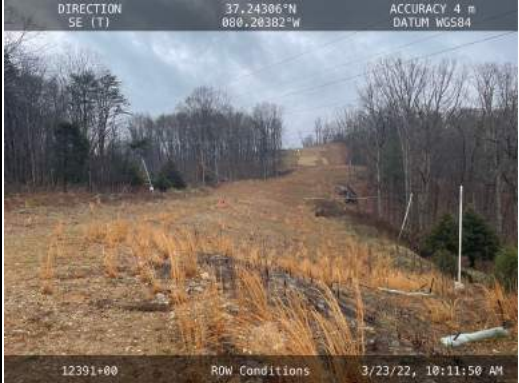
GPS Location	Please see photo for details.		GPS Location	Please see photo for details.	
Field Station#	12389+00		Field Station#	12391+00	
Pic 13 Desc.	Photo shows recently installed P1 silt fence for perimeter ECD.		Pic 14 Desc.	Photo shows the stabilized ROW conditions with water bars and that all ECDs are installed and are functioning as designed.

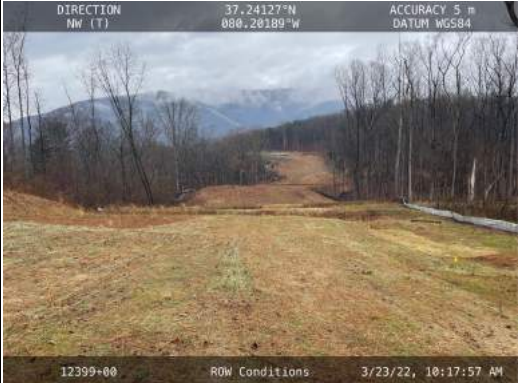
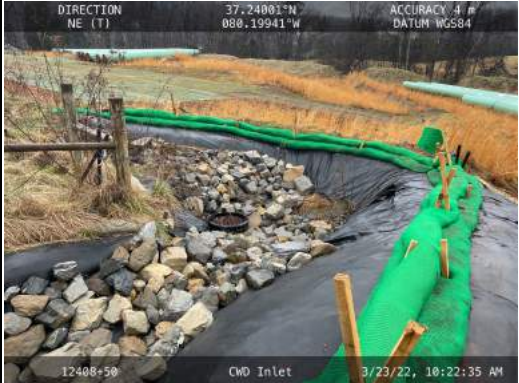
GPS Location	Please see photo for details.		GPS Location	Please see photo for details.	
Field Station#	12399+00		Field Station#	12408+50	
Pic 15 Desc.	Photo shows the stabilized ROW conditions with water bars and that all ECDs are installed and are functioning as designed.		Pic 16 Desc.	Photo shows clean water diversion inlet with stone inlet protection.

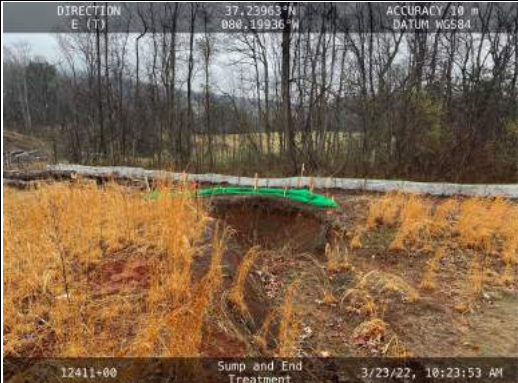
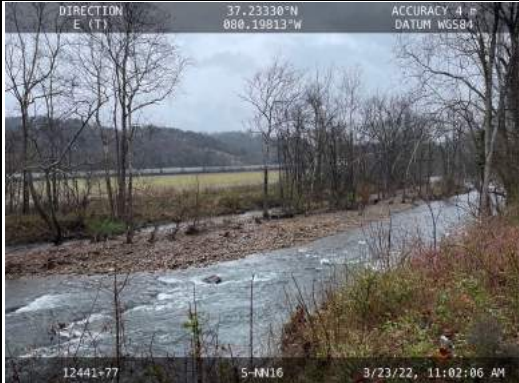
Pic 17 Desc.	Photo shows water bar, sump and water bar end treatment functioning as designed.		Pic 18 Desc.	Photo shows Stream S-NN16 from the going away side.

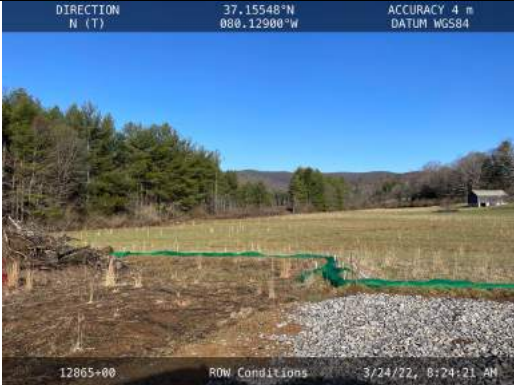
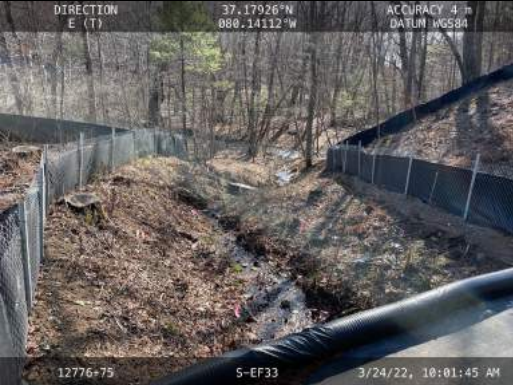
GPS Location	See photo		GPS Location	See photo	
Field Station#	12865+00		Field Station#	12776+75	
Pic 1 Desc.	Current ROW conditions. ROW is stable. ECDs are functional.		Pic 2 Desc.	Downstream of crossing at Stream S-EF33

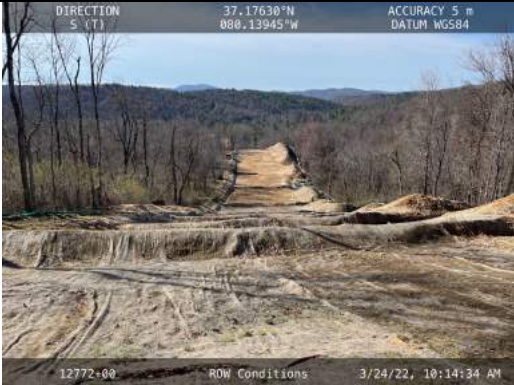
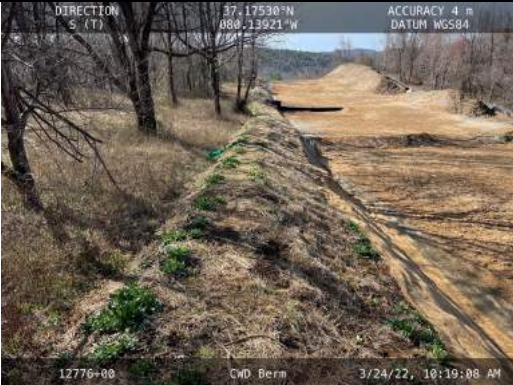
GPS Location	See photo		GPS Location	See photo	
Field Station#	12772+00		Field Station#	12776+00	
Pic 3 Desc.	Current ROW conditions. ROW is stable. ECDs are functional.		Pic 4 Desc.	CWD Berm is stable and functional

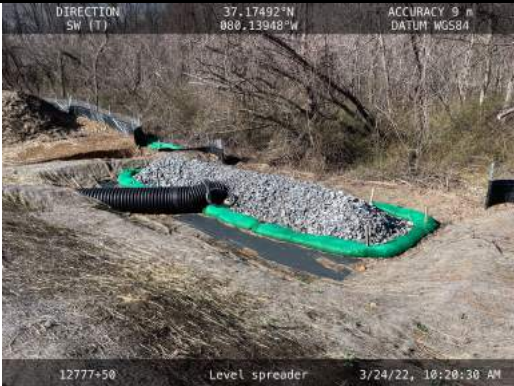
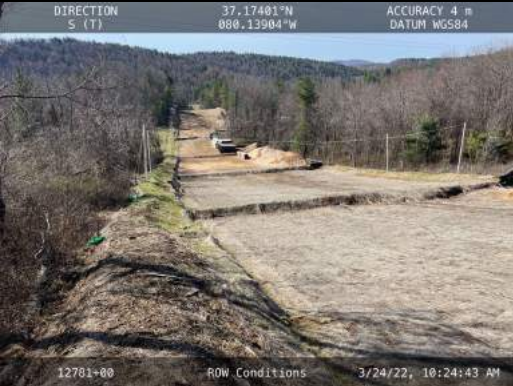
GPS Location	See photo		GPS Location	See photo	
Field Station#	12777+50		Field Station#	12781+00	
Pic 5 Desc.	Level Spreader is functional		Pic 6 Desc.	Current ROW conditions. ROW is stable. ECDs are functional.

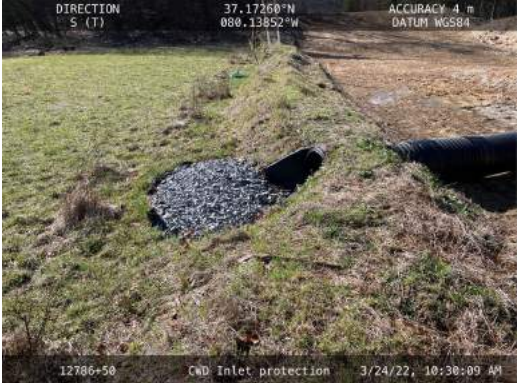
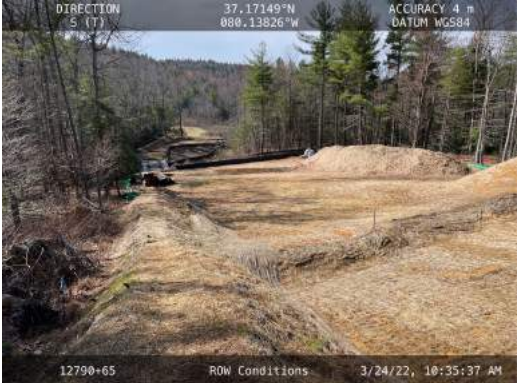
GPS Location	See photo		GPS Location	See photo	
Field Station#	12786+50		Field Station#	12790+65	
Pic 7 Desc.	CWD Inlet and Stone Inlet protection are functional		Pic 8 Desc.	Current ROW conditions. ROW is stable. ECDs are functional.

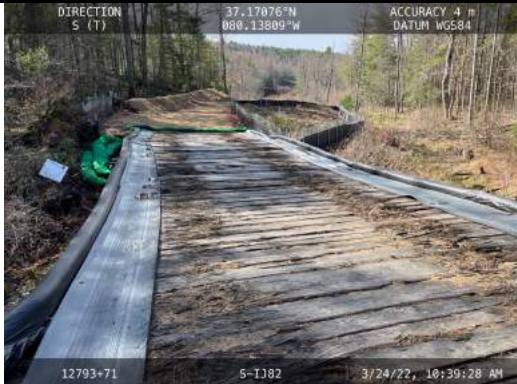
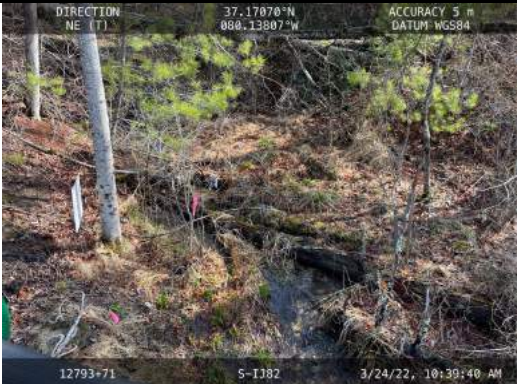
GPS Location	See photo		GPS Location	See photo	
Field Station#	12793+71		Field Station#	12793+71	
Pic 9 Desc.	Equipment Bridge over Stream S-IJ82		Pic 10 Desc.	Upstream of crossing at Stream S-IJ82

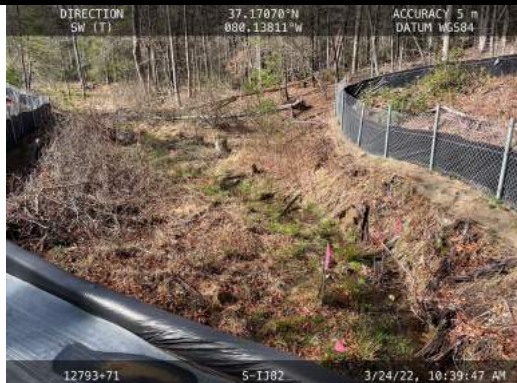
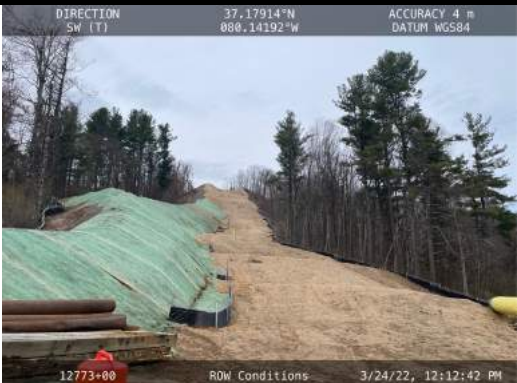
GPS Location	See photo		GPS Location	See photo	
Field Station#	12793+71		Field Station#	12773+00	
Pic 11 Desc.	Downstream of crossing at Stream S-IJ82		Pic 12 Desc.	Current ROW conditions. ROW is stable. ECDs are functional.

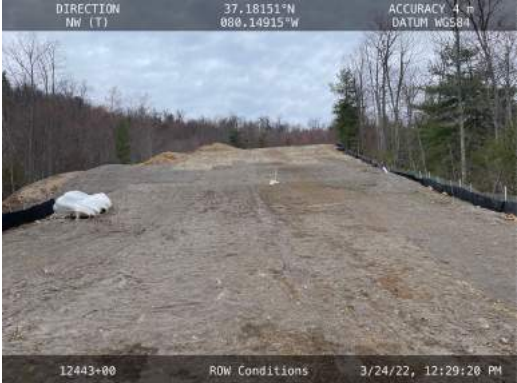
GPS Location	See photo		GPS Location	See photo	
Field Station#	12743+00		Field Station#	12743+00	
Pic 13 Desc.	Current ROW conditions. ROW is stable. ECDs are functional.		Pic 14 Desc.	Current ROW conditions. ROW is stable. ECDs are functional.

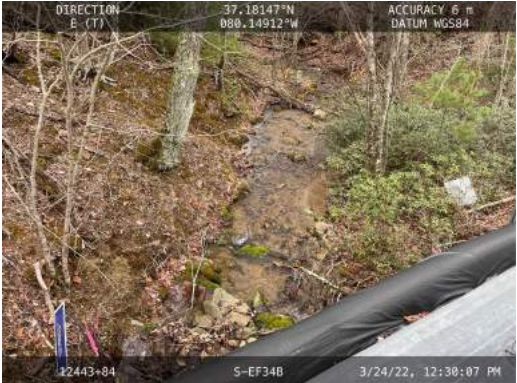
GPS Location	See photo		GPS Location	See photo	
Field Station#	12743+84		Field Station#	12743+84	
Pic 15 Desc.	Upstream of crossing at Stream S-EF34B		Pic 16 Desc.	Downstream of crossing at Stream S-EF34B

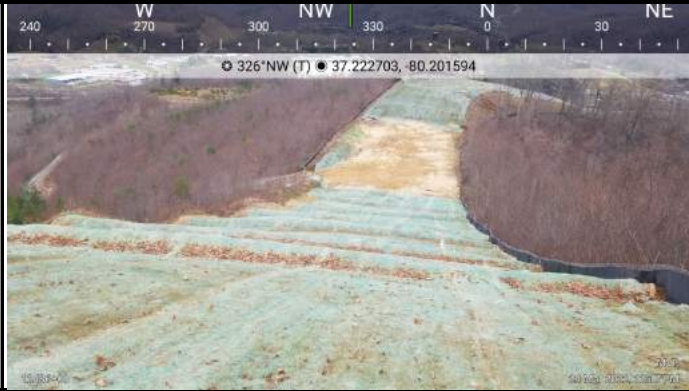
GPS Location	See Above		GPS Location	See Above	
Field Station#	12481+00		Field Station#	12486+00	
Pic 7 Desc.	ROW Overview (temporary stabilization). ECDs are functional and ROW is stable.		Pic 8 Desc.	ROW Overview (temporary stabilization). ECDs are functional and ROW is stable.

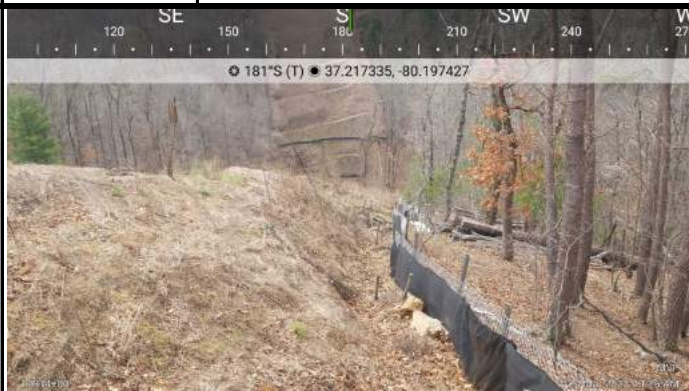
GPS Location	See Above		GPS Location	See Above	
Field Station#	12508+75		Field Station#	12514+00	
Pic 11 Desc.	ROW Overview (temporary stabilization). ECDs are functional and ROW is stable.		Pic 12 Desc.	ROW Overview (temporary stabilization). ECDs are functional and ROW is stable.

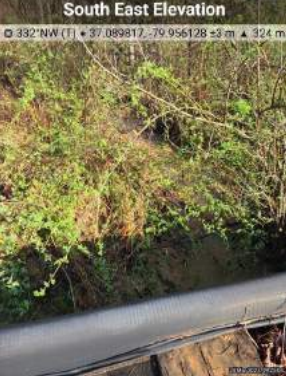
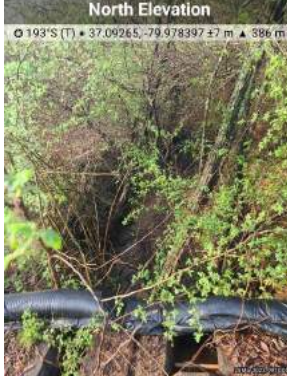
GPS Location	00000	GPS Location	0000		
Field Station#	13659+04	Field Station#	13579+93		
Pic 1 Desc.	Stream observation photo facing upstream during routine inspection today, no issues observed at the time of inspection.		Pic 2 Desc.	Stream observation photo facing downstream after recent rain events, no environmental issues observed at the time of inspection.	
	South West Elevation <small>46°NE (T) • 37.089588, -79.957237 ±3 m ▲ 331 m</small>

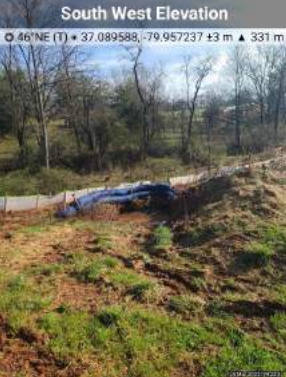
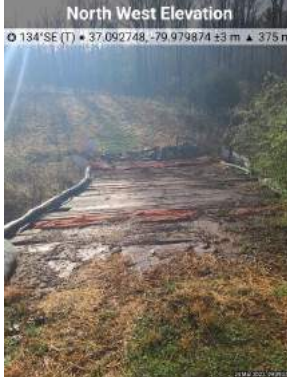
GPS Location	0000	GPS Location	0000		
Field Station#	13656+70	Field Station#	13579+75		
Pic 3 Desc.	Observed sump pits and end treatments after recent rain events, all functioning as intended.		Pic 4 Desc.	Monitored equipment bridges and protection after recent rain events, no environmental issues observed at the time of inspection.

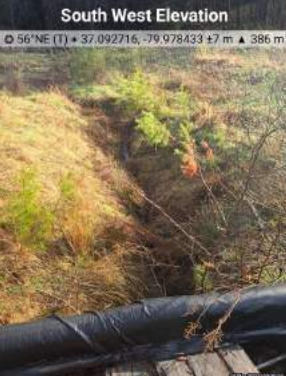
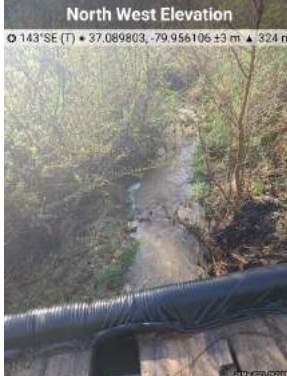
GPS Location	0000	GPS Location	00000		
Field Station#	13579+93	Field Station#	13659+04		
Pic 5 Desc.	Stream observation photo facing upstream during routine inspection today, no environmental issues observed at the time of inspection.		Pic 6 Desc.	Stream observation photo facing downstream during routine inspection today, no environmental issues observed after recent rain events.

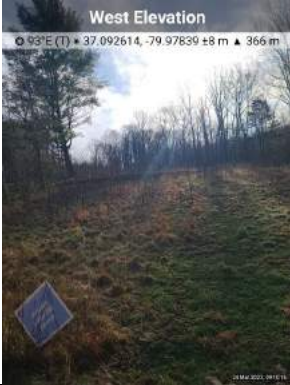
<p>Insert image here</p>		<p>Insert image here</p>	
GPS Location	0000	GPS Location			
Field Station#	13580+30	Field Station#			
Pic 7 Desc.	Row photo in permanent area of row showing locust trees and vegetation growth, no environmental issues observed at the time of inspection.		Pic 8 Desc.		
<p>Insert image here</p>		<p>Insert image here</p>			
GPS Location		GPS Location			
Field Station#		Field Station#			
Pic 9 Desc.		Pic 10 Desc.			
<p>Insert image here</p>		<p>Insert image here</p>			
GPS Location		GPS Location			
Field Station#		Field Station#			
Pic 11 Desc.		Pic 12 Desc.

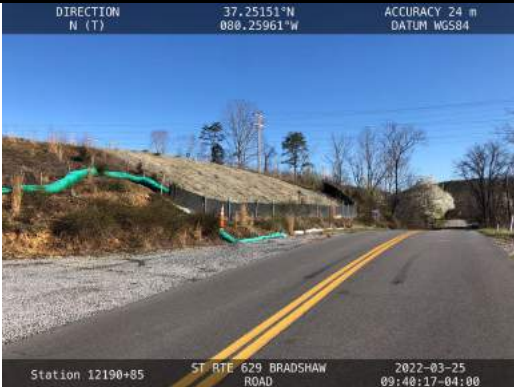
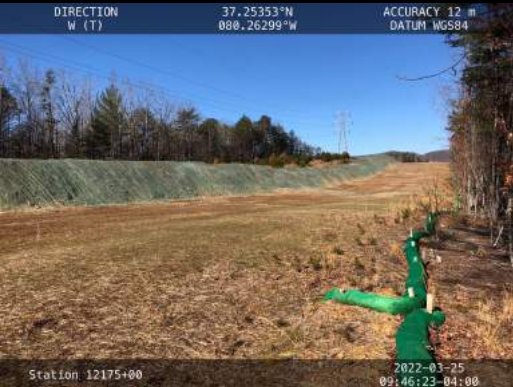
GPS Location	Please see photo for details.		GPS Location	Please see photo for details.	
Field Station#	12190+85		Field Station#	12175+00	
Pic 1 Desc.	Photo shows CIS of ST RTE 629 BRADSHAW ROAD.		Pic 2 Desc.	Photo shows stabilized ROW, stabilized stock piles and installed ECDs functioning as designed.

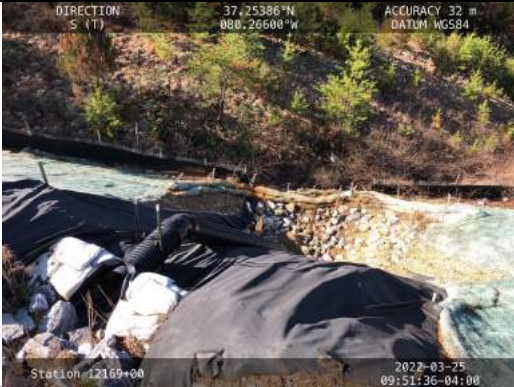
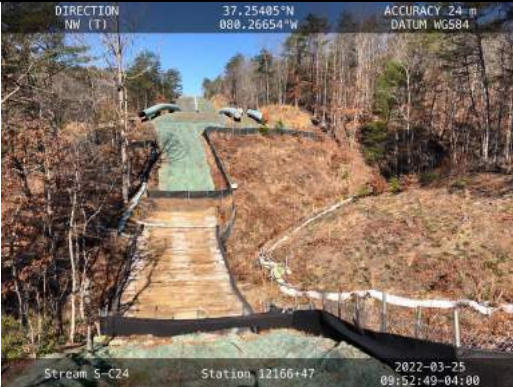
GPS Location	Please see photo for details.		GPS Location	Please see photo for details.	
Field Station#	12169+00		Field Station#	12166+47	
Pic 3 Desc.	Photo shows slope drain pipe with stone inlet protection and plunge pool.		Pic 4 Desc.	Photo shows sensitive resource buffer for Stream S-C24.

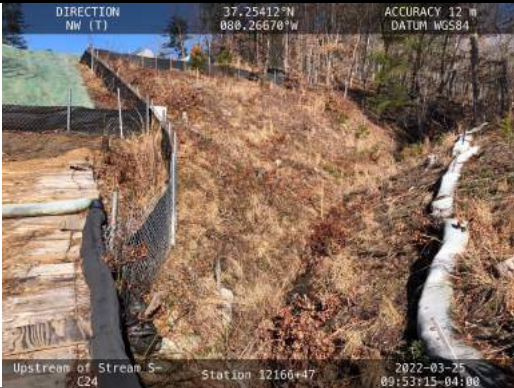
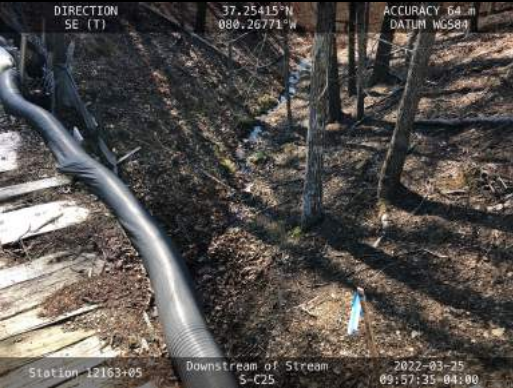
GPS Location	Please see photo for details.		GPS Location	Please see photo for details.	
Field Station#	12166+47		Field Station#	12163+05	
Pic 5 Desc.	Photo shows upstream view of Stream S-C24 and installed ECDs functioning as designed.		Pic 6 Desc.	Photo shows downstream view of Stream S-C25 and installed ECDs functioning as designed.
