Visual Site Inspection Report

Project Name	H-600 Pipeline Spread H	AFE	124300138	Spread	H-600 Pipeline Spread H
Contractor	Precision			Report #	35942
Inspector	Jordan Davis			Date/Time	3/28/2022 3:15 PM
Permit #	TBD	Inspection Type	VA SWPP	Station Begin	12005+00
State	VA	Inspection Area	Partial	Station End	12119+17
County	Montgomery	Ground	Damp	Temperature (°F)	45.00
Municipality	N/A	Weather	Sunny	Rain Gauge (in)	0.00
				Rain Accumulation Time (days)	0.00

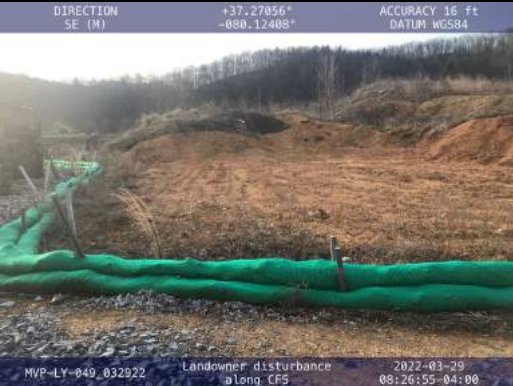
GPS Location	MVP-LY-049 See photo for gps data	GPS Location	MVP-LY-049 See photo for gps data		
Field Station#	+0	Field Station#	+0

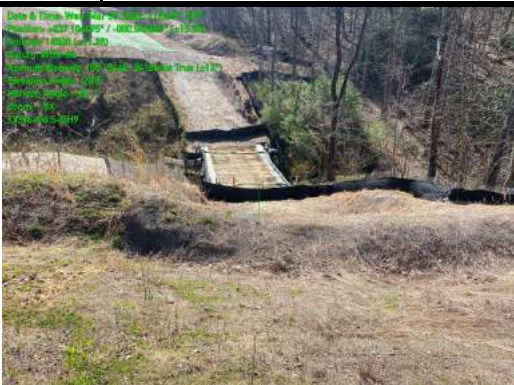
GPS Location	0	GPS Location	0		
Field Station#	13320+50	Field Station#	13323+43		
Pic 3 Desc.	MVP-S-GH15 and corresponding buffer zone in good condition		Pic 4 Desc.	MVP-S-GH14 and corresponding buffer zone in good condition

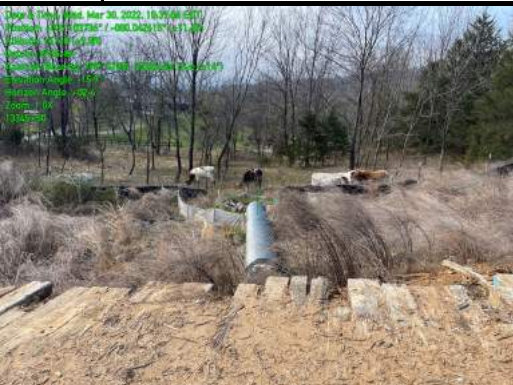
<p>Date & Time: Wed, Mar 30, 2022, 1:53:00 EST Position: 4027.10622117 / -88.0494448° (s118.29) Altitude: 1482R (s43.20) Deflection: W120-94 Azimuth: 110° (s12°) Azimuth: 110° (s12°) Horizontal Angle: 110° Vertical Angle: 110° Scale: 1:1 13345+50</p>			
GPS Location	0	GPS Location	0		
Field Station#	13336+06	Field Station#	13345+50		
Pic 5 Desc.	MVP-S-GH9 and corresponding buffer zone in good condition		Pic 6 Desc.	Clean water diversion pipe and outlet in good condition

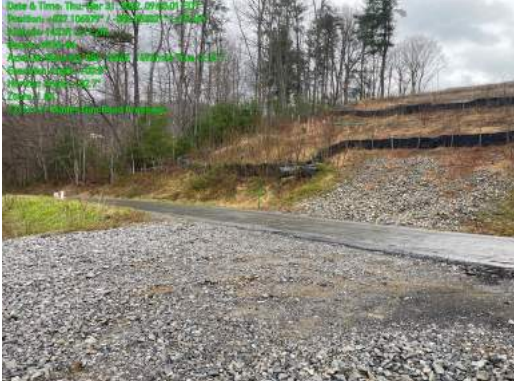
GPS Location	0	GPS Location	0		
Field Station#	13316+21	Field Station#	13314+00		
Pic 1 Desc.	Wades Gap Road Crossing in good condition		Pic 2 Desc.	ROW and ECDs In good condition and stable

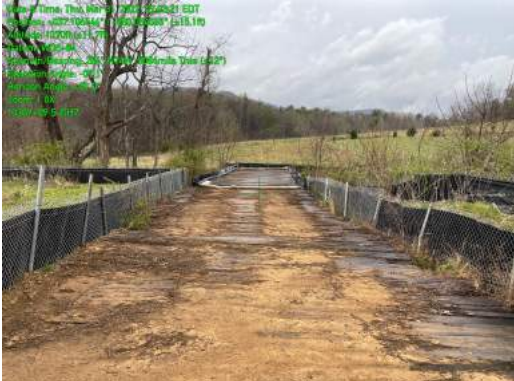
GPS Location	0	GPS Location	0		
Field Station#	13309+09	Field Station#	13308+50		
Pic 3 Desc.	MVP-S-GH7 and corresponding buffer zone in good condition		Pic 4 Desc.	ROW and ECDs In good condition and stable

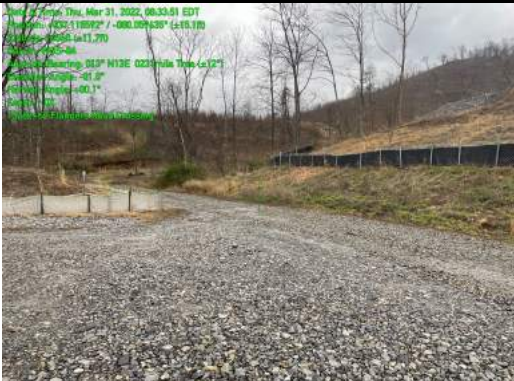
GPS Location	0	GPS Location	0		
Field Station#	13262+62	Field Station#	13260+66		
Pic 5 Desc.	Flanders Road Crossing in good condition		Pic 6 Desc.	MVP-S-II4 and corresponding buffer zone in good condition

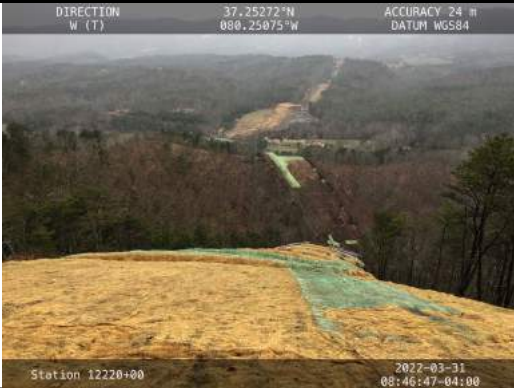
Field Station#	12220+00		Field Station#	12211+50	
Pic 5 Desc.	Photo shows the stabilized ROW conditions with water bars and that all ECDs are installed and are functioning as designed.		Pic 6 Desc.	Photo shows stabilized ROW conditions with permanent water bars equipped with level spreaders.

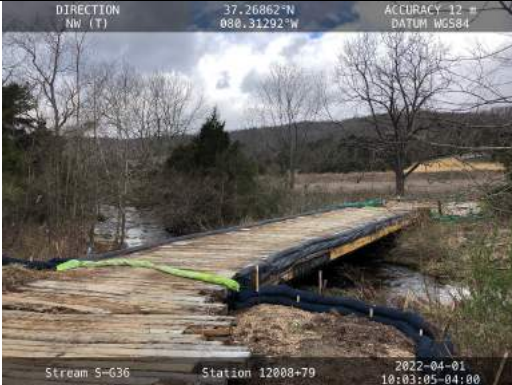
GPS Location	See Above		GPS Location	See Above	
Field Station#	12008+79		Field Station#	12210+00	
Pic 1 Desc.	Overview of Waterbody S-G36 (Access 268.01). ECDs are functional and ROW is stable.		Pic 2 Desc.	ROW Overview. ECDs are functional and ROW is stable.

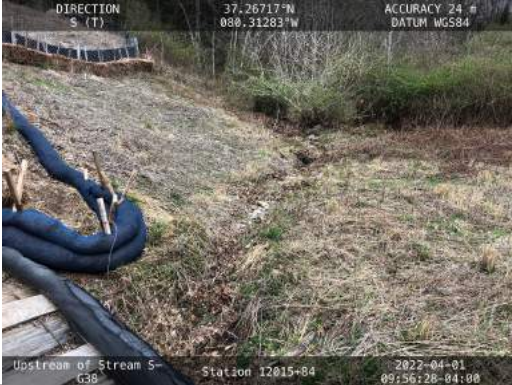
GPS Location	See Above		GPS Location	See Above	
Field Station#	12215+84		Field Station#	12031+51	
Pic 3 Desc.	Overview of Waterbody S-G38 (downstream). ECDs are functional and ROW is stable.		Pic 4 Desc.	Overview of Waterbody S-G39 (downstream). ECDs are functional and ROW is stable.

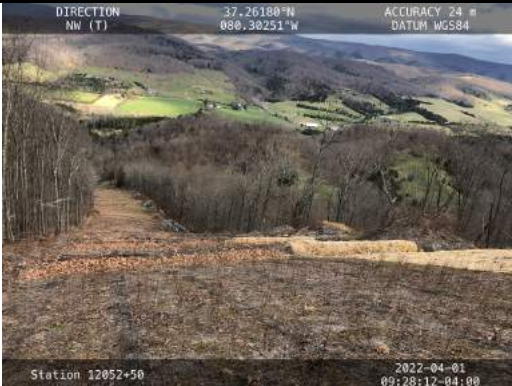
GPS Location	See Above		GPS Location	See Above	
Field Station#	12052+50		Field Station#	12062+00	
Pic 5 Desc.	ROW Overview. ECDs are functional and ROW is stable.		Pic 6 Desc.	ROW Overview. ECDs are functional and ROW is stable.

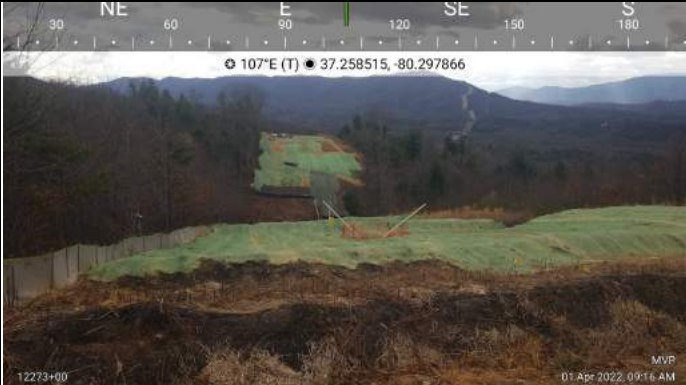
GPS Location	See Above		GPS Location	See Above	
Field Station#	12073+00		Field Station#	12076+95	
Pic 7 Desc.	ROW Overview. ECDs are functional and ROW is stable.		Pic 8 Desc.	Overview of Waterbody S-MM15. ECDs are functional and ROW is stable.

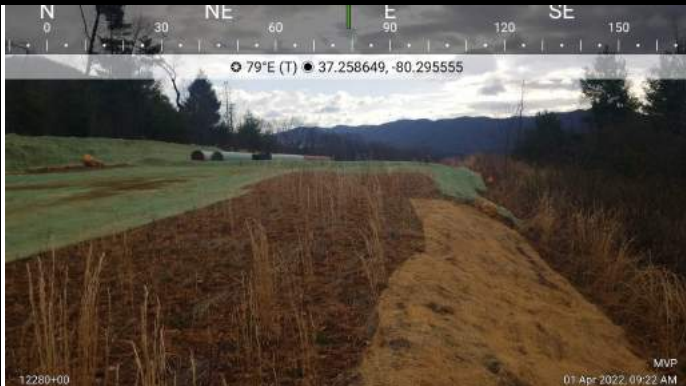
GPS Location	See Above		GPS Location	See Above	
Field Station#	12080+00		Field Station#	12085+00	
Pic 9 Desc.	ROW Overview. ECDs are functional and ROW is stable.		Pic 10 Desc.	ROW Overview. ECDs are functional and ROW is stable.

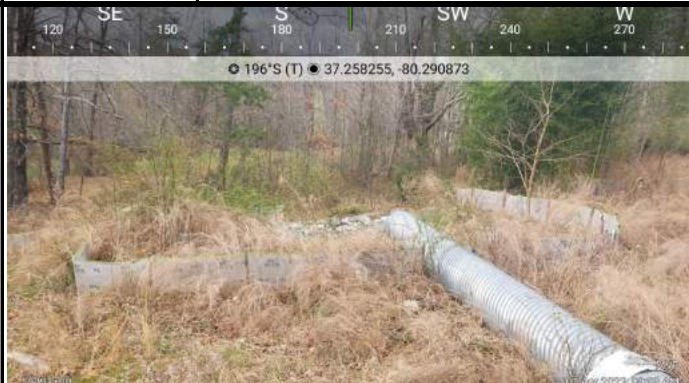
GPS Location	See Above		GPS Location	See Above	
Field Station#	12086+56		Field Station#	12093+00	
Pic 11 Desc.	Overview of Waterbody S-MM14. ECDs are functional and ROW is stable.		Pic 12 Desc.	ROW Overview. ECDs are functional and ROW is stable.

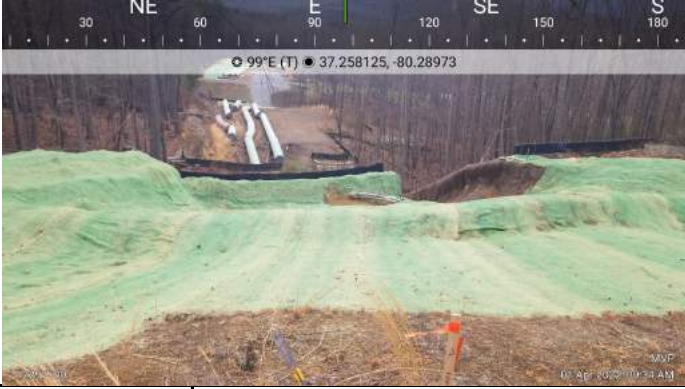
GPS Location	See Above	GPS Location	See Above		
Field Station#	12097+00	Field Station#	12098+44		
Pic 13 Desc.	ROW Overview. ECDs are functional and ROW is stable.	Pic 14 Desc.	Overview of Waterbody S-MM13. ECDs are functional and ROW is stable.

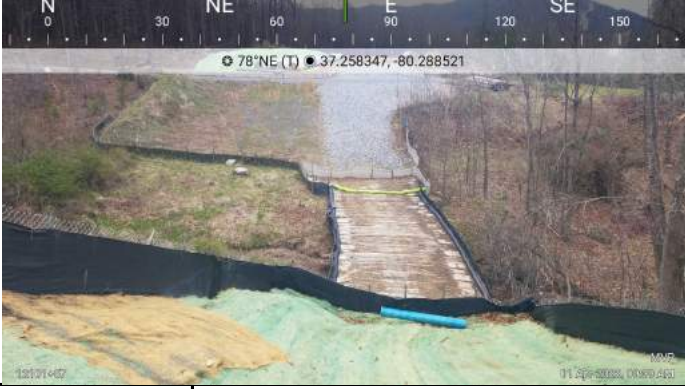
GPS Location	See Above	GPS Location	See Above		
Field Station#	12101+57	Field Station#	12108+41		
Pic 15 Desc.	Overview of Waterbody S-MM11. ECDs are functional and ROW is stable.	Pic 16 Desc.	Overview of Waterbody S-F15. ECDs are functional and ROW is stable.

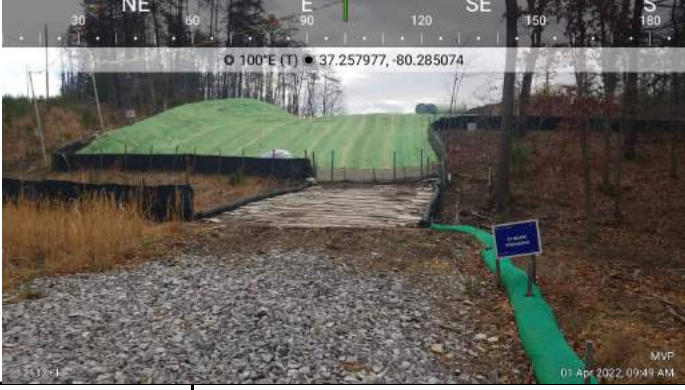
GPS Location	See Above	GPS Location	See Above		
Field Station#	12112+13	Field Station#	12118+00		
Pic 17 Desc.	Overview of Waterbody S-F16A/B. ECDs are functional and ROW is stable.	Pic 18 Desc.	ROW Overview. ECDs are functional and ROW is stable.

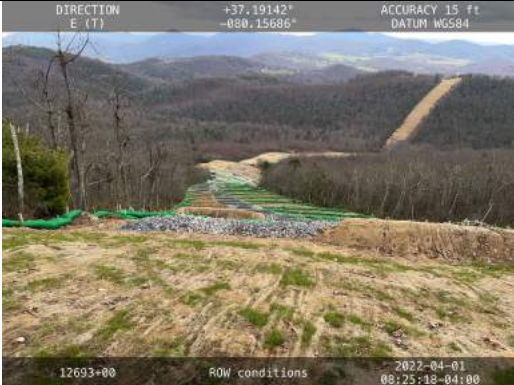
GPS Location	See photo for gps location data.		GPS Location	See photo for gps location data.	
Field Station#	12693+00		Field Station#	12627+00	
Pic 1 Desc.	Photo shows the ROW condition. ECDs are installed and functioning as designed.		Pic 2 Desc.	Photo shows the ROW condition. ECDs are installed and functioning as designed.

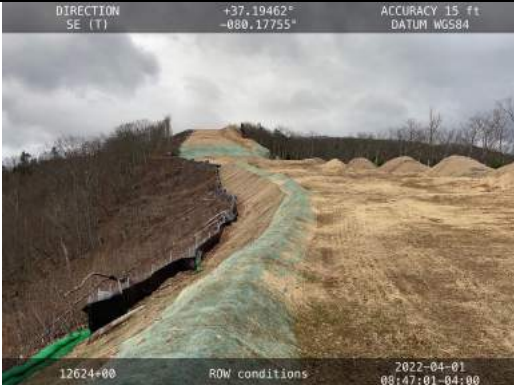
GPS Location	See photo for gps location data.		GPS Location	See photo for gps location data.	
Field Station#	12624+00		Field Station#	12613+00	
Pic 3 Desc.	Photo shows the ROW condition. ECDs are installed and functioning as designed.		Pic 4 Desc.	Photo shows the slope drain.

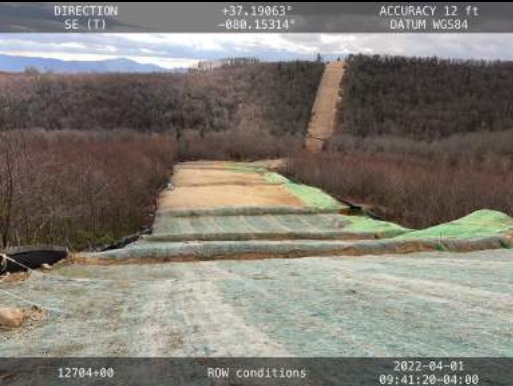
GPS Location	See photo for gps location data.		GPS Location	See photo for gps location data.	
Field Station#	12702+00		Field Station#	12704+00	
Pic 5 Desc.	Photo shows the ROW condition. ECDs are installed and functioning as designed.		Pic 6 Desc.	Photo shows the ROW condition. ECDs are installed and functioning as designed.

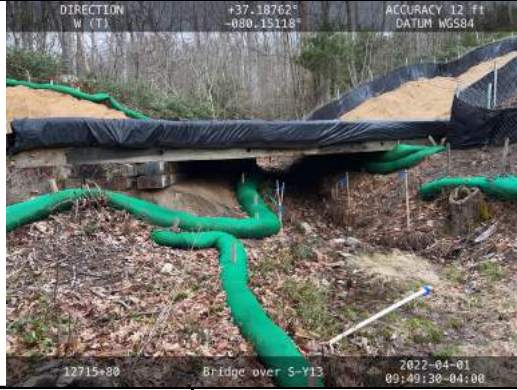
GPS Location	See photo for gps location data.		GPS Location	See photo for gps location data.	
Field Station#	12715+80		Field Station#	12716+20	
Pic 11 Desc.	Photo shows the bridge over stream S-Y13.		Pic 12 Desc.	Photo shows the bridge over stream S-Y14.
