# Visual Site Inspection Report

<b>Project Name</b>	H-600 Pipeline Spread I	<b>AFE</b>	124300139	<b>Spread</b>	H-600 Pipeline Spread I
<b>Contractor</b>	Precision			<b>Report #</b>	35391
<b>Inspector</b>	Ben Davenport			<b>Date/Time</b>	3/14/2022 12:21 PM
<b>Permit #</b>	TBD	<b>Inspection Type</b>	VA SWPP	<b>Station Begin</b>	14802+19
<b>State</b>	VA	<b>Inspection Area</b>	Partial	<b>Station End</b>	14928+52
<b>County</b>	Franklin	<b>Ground</b>	Muddy	<b>Temperature (°F)</b>	62.00
<b>Municipality</b>	N/A	<b>Weather</b>	Sunny	<b>Rain Gauge (in)</b>	0.50
				<b>Rain Accumulation Time (days)</b>	1.00

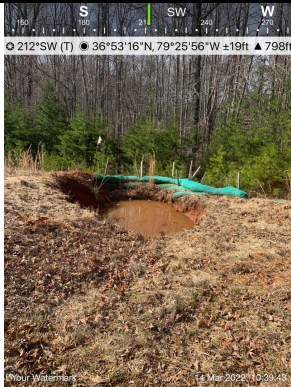
<p>212°SW (T) ● 36°53'16"N, 79°25'56"W ±19ft ▲ 798ft 14 Mar 2022, 10:39:43</p>

<p>157°SE (T) ● 36°53'14"N, 79°25'54"W ±3910ft ▲ 797ft 14 Mar 2022, 10:40:58</p>			
GPS Location	O	GPS Location	O		
Field Station#	15650+00	Field Station#	15658+43		
Pic 1 Desc.	Observing temporary stabilization, sump and end treatment	Pic 2 Desc.	Observing temporary stabilization, signage, buffer, equipment crossing and ECD's

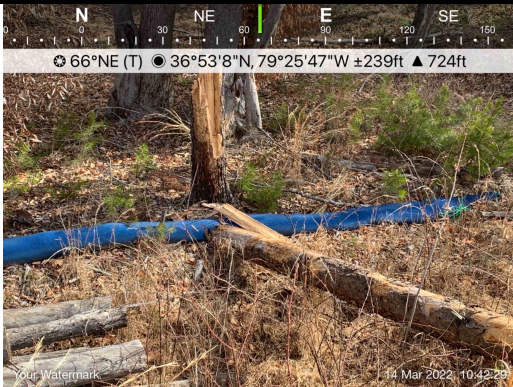
<p>66°NE (T) ● 36°53'8"N, 79°25'47"W ±239ft ▲ 724ft 14 Mar 2022, 10:42:29</p>

<p>133°SE (T) ● 36°53'6"N, 79°25'44"W ±459ft ▲ 696ft 14 Mar 2022, 10:45:16</p>			
GPS Location	O	GPS Location	O		
Field Station#	15662+00	Field Station#	15665+50		
Pic 3 Desc.	Observing tree that needs to be removed from CFS	Pic 4 Desc.	Observing temporary stabilization, signage, buffer, equipment crossing and ECD's

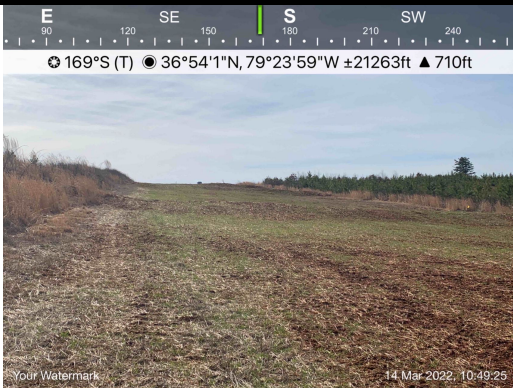
<p>169°S (T) ● 36°54'11"N, 79°23'59"W ±21263ft ▲ 710ft 14 Mar 2022, 10:49:25</p>

GPS Location	O	GPS Location	O		
Field Station#	15684+00	Field Station#	15693+89		
Pic 5 Desc.	Observing temporary stabilization and water bars	Pic 6 Desc.	Observing road crossing and RCE's

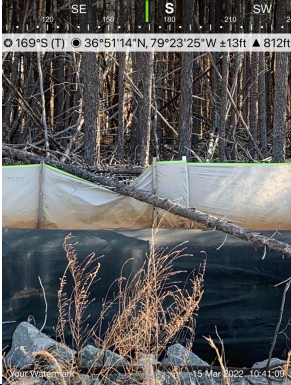
<b>GPS Location</b>	O	<b>GPS Location</b>	O		
<b>Field Station#</b>	15836+50	<b>Field Station#</b>	15845+50		
<b>Pic 7 Desc.</b>	Observing tree that needs to be removed from p1 and maintenance performed as needed	<b>Pic 8 Desc.</b>	Observing temporary stabilization,CWD outlet and ECD's		
Insert image here		Insert image here			
<b>GPS Location</b>		<b>GPS Location</b>			
<b>Field Station#</b>		<b>Field Station#</b>			
<b>Pic 9 Desc.</b>		<b>Pic 10 Desc.</b>			
Insert image here		Insert image here			
<b>GPS Location</b>		<b>GPS Location</b>			
<b>Field Station#</b>		<b>Field Station#</b>			
<b>Pic 11 Desc.</b>		<b>Pic 12 Desc.</b>

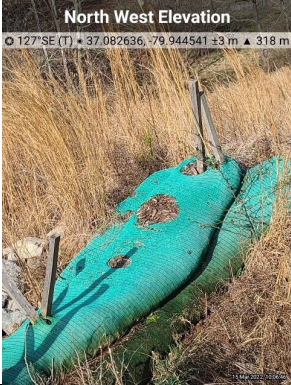
<p>North West Elevation  <small>127°SE (T) • 37.082636, -79.944541 ±3 m ▲ 318 m</small></p>		  <p>West Elevation  <small>92°E (T) • 37.082883, -79.945751 ±3 m ▲ 306 m</small></p>			
<p>Insert image here</p>		<p>Insert image here</p>			
<b>GPS Location</b>	0000	<b>GPS Location</b>	0000		
<b>Field Station#</b>	13708+30	<b>Field Station#</b>	13704+99		
<b>Pic 7 Desc.</b>	CFS end treatment requires maintenance, documented and added to the punch list.	<b>Pic 8 Desc.</b>	P1 requires maintenance, documented and added to the punch list.

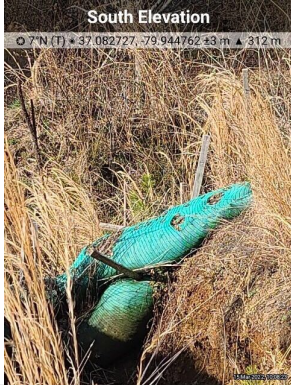
<b>Field Station#</b>	13707+60	<b>Field Station#</b>	13692+41		
<b>Pic 9 Desc.</b>	CFS end treatment requires maintenance, added to the punch list .	<b>Pic 10 Desc.</b>	P1 requires maintenance ,added to the punch list for repair.

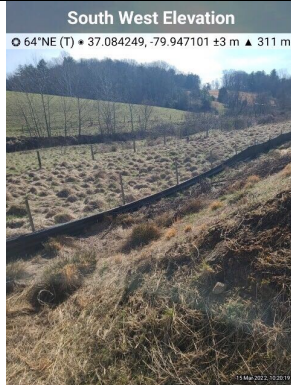
<p>South West Elevation  <small>64°NE (T) • 37.084249, -79.947101 ±3 m ▲ 311 m</small></p>		<p>Insert image here</p>			
<p>Insert image here</p>					
<b>GPS Location</b>	00000	<b>GPS Location</b>			
<b>Field Station#</b>	13697+70	<b>Field Station#</b>			
<b>Pic 11 Desc.</b>	Reinforced silt fence requires maintenance, added to the punch list for repair.	<b>Pic 12 Desc.</b>

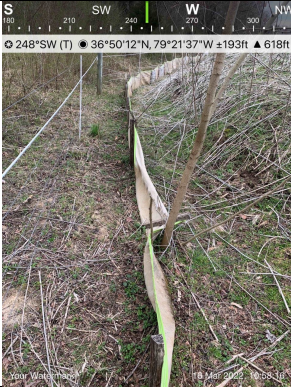
<b>GPS Location</b>	O	<b>GPS Location</b>	O		
<b>Field Station#</b>	15950+00	<b>Field Station#</b>	15951+72		
<b>Pic 1 Desc.</b>	Observing P1 that requires maintenance	<b>Pic 2 Desc.</b>	Observing buffer, equipment crossing and ECD's

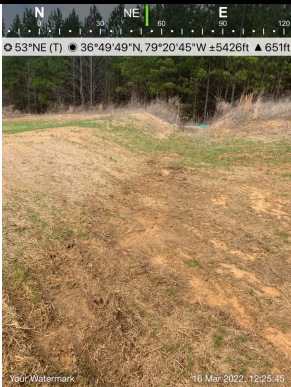
<b>GPS Location</b>	O	<b>GPS Location</b>	O		
<b>Field Station#</b>	16020+00	<b>Field Station#</b>	16018+00		
<b>Pic 3 Desc.</b>	Observing temporary stabilization and water bar	<b>Pic 4 Desc.</b>	Observing temporary stabilization, sump and end treatment

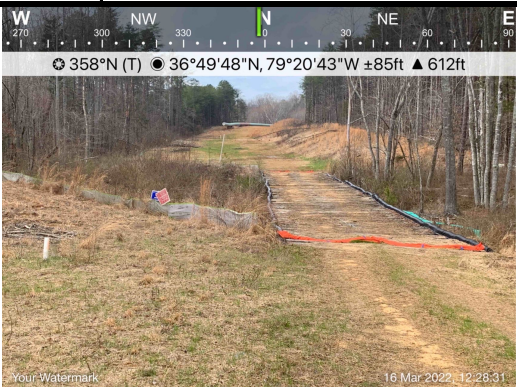
<b>GPS Location</b>	O	<b>GPS Location</b>	O		
<b>Field Station#</b>	16016+36	<b>Field Station#</b>	16010+00		
<b>Pic 5 Desc.</b>	Observing temporary stabilization, signage, buffer, equipment crossing and ECD's	<b>Pic 6 Desc.</b>	Observing temporary stabilization, CWD outlet and ECD's

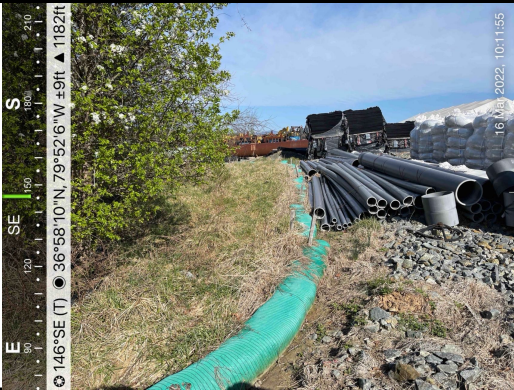
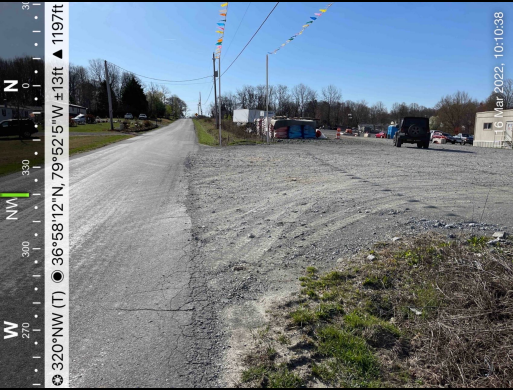
<b>GPS Location</b>	See picture		<b>GPS Location</b>	See picture	
<b>Field Station#</b>	0000+00		<b>Field Station#</b>	0000+00

<b>Pic 5 Desc.</b>	Perimeter ECD's on west side of LY-045 in good condition		<b>Pic 6 Desc.</b>	RCE at LY-045 in acceptable condition.

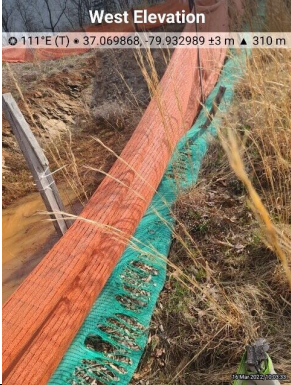
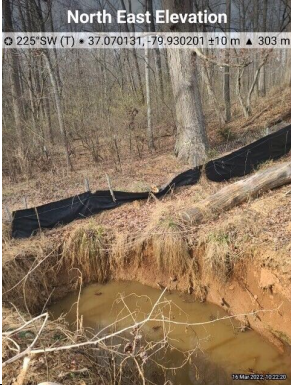
<b>GPS Location</b>	000	<b>GPS Location</b>	0000		
<b>Field Station#</b>	13784+50	<b>Field Station#</b>	13793+57		
<b>Pic 7 Desc.</b>	CFS around sump pit area requires maintenance, replace as needed.	<b>Pic 8 Desc.</b>	Reinforced silt fence requires maintenance, added to the punch list.		
<b>South West Elevation</b>

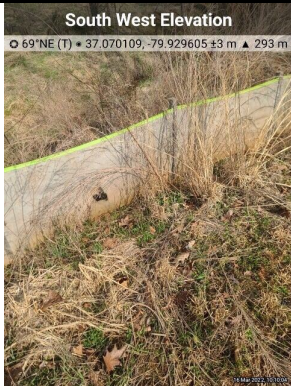
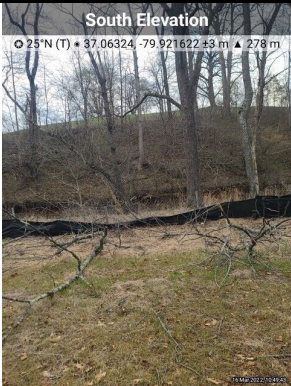
<b>GPS Location</b>	0000	<b>GPS Location</b>	0000		
<b>Field Station#</b>	13805+90	<b>Field Station#</b>	13840+00		
<b>Pic 9 Desc.</b>	P1 requires maintenance, added to the punch list.	<b>Pic 10 Desc.</b>	Reinforced silt fence requires maintenance, added to the punch list.		
<b>North Elevation</b>

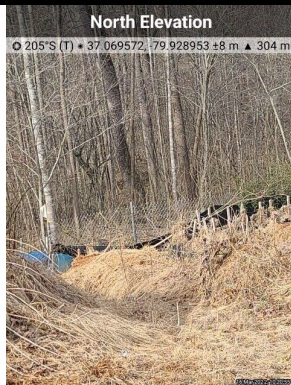
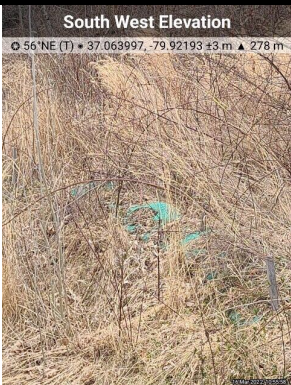
<b>GPS Location</b>	0000	<b>GPS Location</b>	0000		
<b>Field Station#</b>	13800+00	<b>Field Station#</b>	13834+04

<b>Pic 11 Desc.</b>	Reinforced silt fence requires maintenance.	<b>Pic 12 Desc.</b>	CFS requires maintenance, replace as needed.

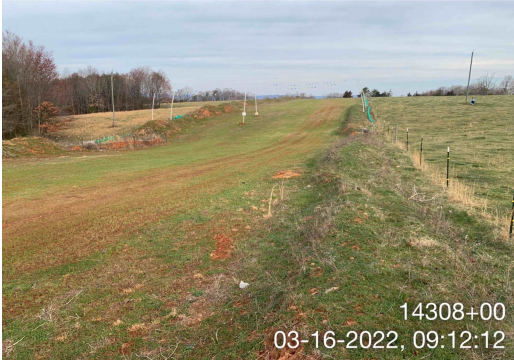
14308+00 03-16-2022, 09:12:12		358°N (T) 37°2'48"N, 79°48'46"W ±26ft ▲1008ft

14295+00 03-16-2022, 09:19:25			
<b>GPS Location</b>	0	<b>GPS Location</b>	0		
<b>Field Station#</b>	14308+00	<b>Field Station#</b>	14295+00		
<b>Pic 1 Desc.</b>	Clean water diversion berm and temporary vegetative stabilization in acceptable conditions	<b>Pic 2 Desc.</b>	P1 silt fence in acceptable condition		
217°SW (T) 37°2'56"N, 79°48'55"W ±45ft ▲992ft

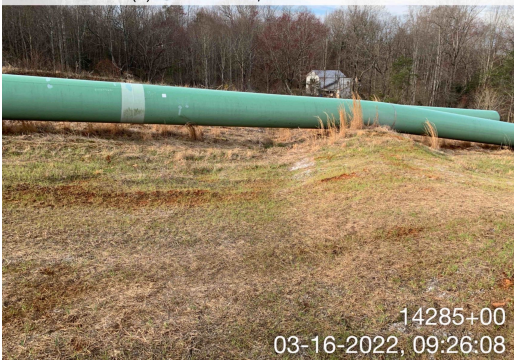
14285+00 03-16-2022, 09:26:08		233°SW (T) 37°2'55"N, 79°48'55"W ±13ft ▲983ft

14285+00 03-16-2022, 09:26:50			
<b>GPS Location</b>	0	<b>GPS Location</b>	0		
<b>Field Station#</b>	14285+00	<b>Field Station#</b>	14285+00		
<b>Pic 3 Desc.</b>	Waterbar in acceptable condition	<b>Pic 4 Desc.</b>	Waterbar end treatment in acceptable condition

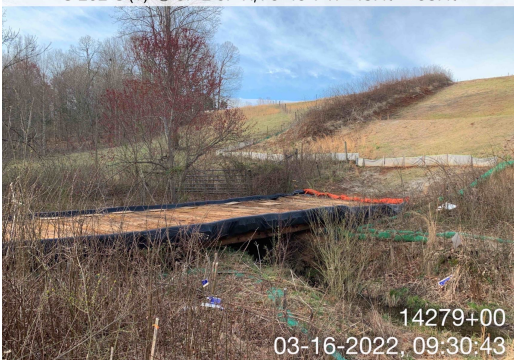
14279+00 03-16-2022, 09:30:43		311°NW (T) 37°3'11"N, 79°50'9"W ±4130ft ▲1006ft

14221+00 03-16-2022, 11:30:51			
<b>GPS Location</b>	0	<b>GPS Location</b>	0		
<b>Field Station#</b>	14279+00	<b>Field Station#</b>	14221+00		
<b>Pic 5 Desc.</b>	Equipment bridge in acceptable condition	<b>Pic 6 Desc.</b>	Temporary vegetative stabilization and waterbars in acceptable conditions

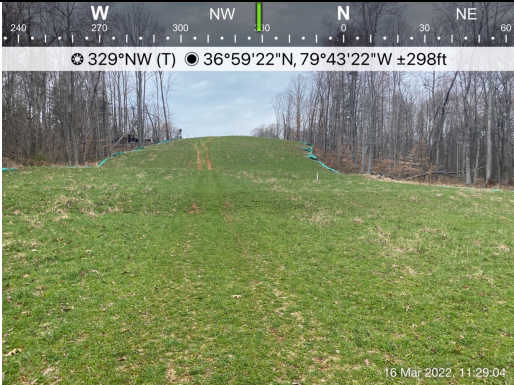
<b>GPS Location</b>	0	<b>GPS Location</b>	0		
<b>Field Station#</b>	14653+00	<b>Field Station#</b>	14680+35		
<b>Pic 3 Desc.</b>	Approximately 14653+00. Overview of ROW. Permanent vegetation.	<b>Pic 4 Desc.</b>	Approximately 14680+35. Overview of stream crossing, equipment bridge and ECDs at stream S-H36.

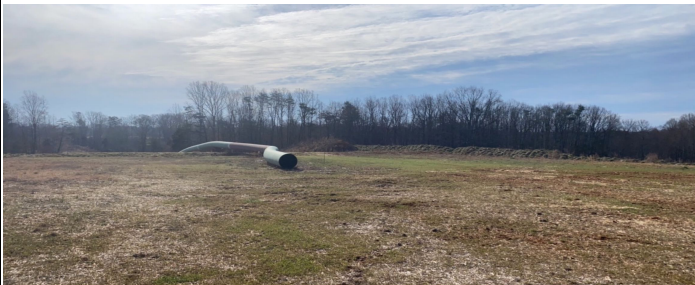
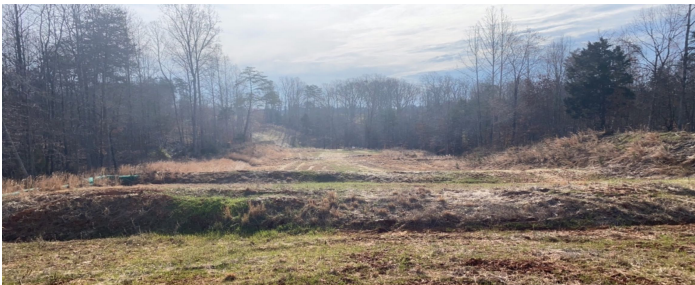
GPS Location	3		GPS Location	4	
Field Station#	15064+00		Field Station#	15069+00	
Pic 3 Desc.	ROW stabilized and vegetated in temporary area.		Pic 4 Desc.	Water bars performing intended function.

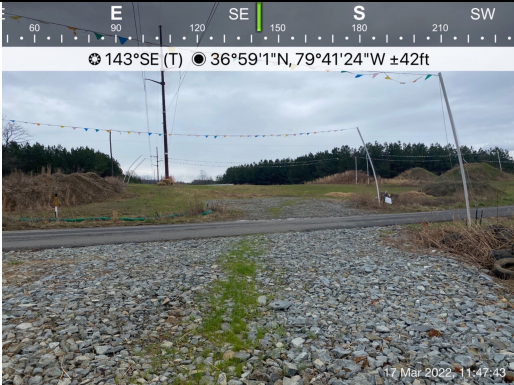
<b>GPS Location</b>	0	<b>GPS Location</b>	0		
<b>Field Station#</b>	14758+16	<b>Field Station#</b>	14797+00		
<b>Pic 3 Desc.</b>	Approximately 14758+16. Overview of road crossing and RCEs.		<b>Pic 4 Desc.</b>	Approximately 14797+00. Overview of ROW.

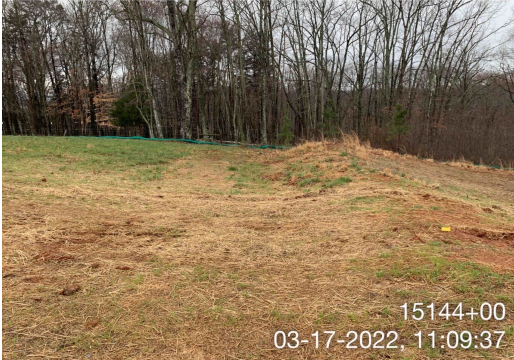
15144+00 03-17-2022, 11:10:02			
<b>GPS Location</b>	0	<b>GPS Location</b>	0		
<b>Field Station#</b>	15144+00	<b>Field Station#</b>	15144+00		
<b>Pic 1 Desc.</b>	Waterbar in acceptable condition		<b>Pic 2 Desc.</b>	Waterbar end treatment and CFS in acceptable conditions	
302°NW (T) 36°56'45"N, 79°34'32"W ±3868ft ▲ 822ft

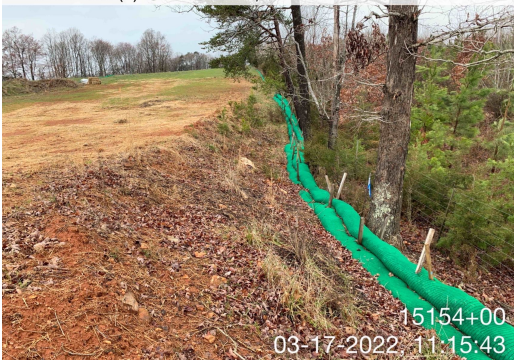
15169+00 03-17-2022, 11:26:08			
<b>GPS Location</b>	0	<b>GPS Location</b>	0		
<b>Field Station#</b>	15154+00	<b>Field Station#</b>	15169+00		
<b>Pic 3 Desc.</b>	Tripe stack perimeter CFS in acceptable condition		<b>Pic 4 Desc.</b>	P1 silt fence and equipment bridge in acceptable conditions

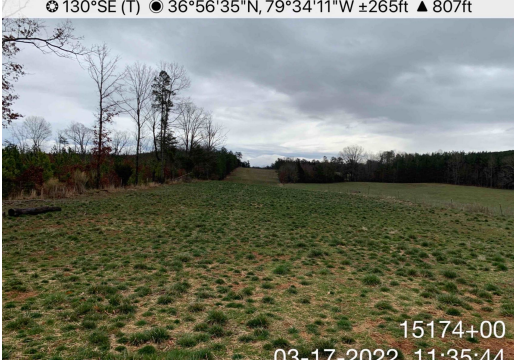
15237+00 03-17-2022, 13:06:44			
<b>GPS Location</b>	0	<b>GPS Location</b>	0		
<b>Field Station#</b>	15174+00	<b>Field Station#</b>	15237+00		
<b>Pic 5 Desc.</b>	Permanent vegetative stabilization in acceptable condition		<b>Pic 6 Desc.</b>	Permanent vegetative stabilization in acceptable condition

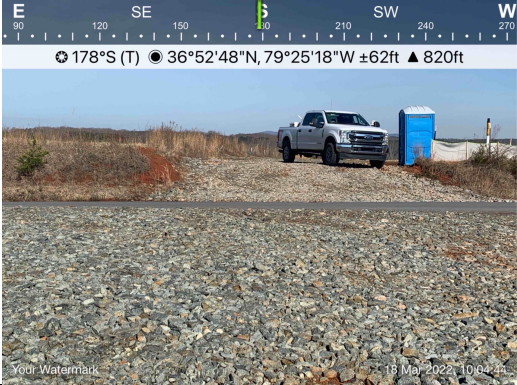
<b>GPS Location</b>	O	<b>GPS Location</b>	O		
<b>Field Station#</b>	15693+89	<b>Field Station#</b>	15668+30		
<b>Pic 7 Desc.</b>	Observing road crossing and RCE's	<b>Pic 8 Desc.</b>	Observing P1 that requires maintenance		
Insert image here		Insert image here			
<b>GPS Location</b>		<b>GPS Location</b>			
<b>Field Station#</b>		<b>Field Station#</b>			
<b>Pic 9 Desc.</b>		<b>Pic 10 Desc.</b>			
Insert image here		Insert image here			
<b>GPS Location</b>		<b>GPS Location</b>			
<b>Field Station#</b>		<b>Field Station#</b>			
<b>Pic 11 Desc.</b>		<b>Pic 12 Desc.</b>

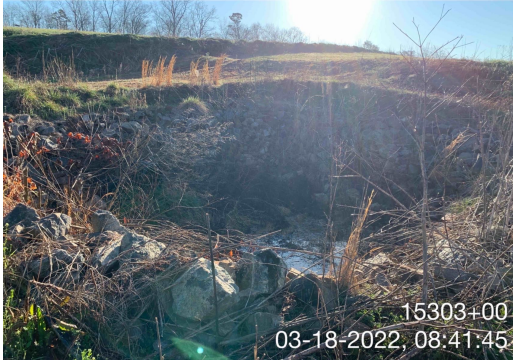
<b>GPS Location</b>	0	<b>GPS Location</b>	0		
<b>Field Station#</b>	15298+00	<b>Field Station#</b>	15303+00		
<b>Pic 1 Desc.</b>	P1 silt fence in acceptable condition	<b>Pic 2 Desc.</b>	Plunge pool in acceptable condition

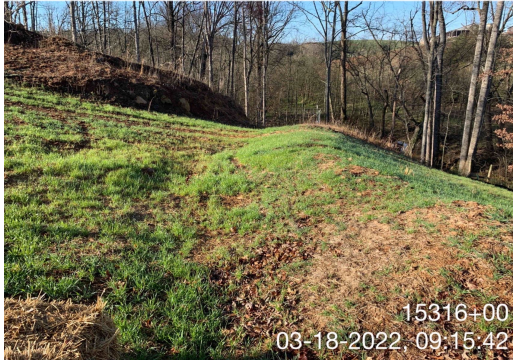
<b>GPS Location</b>	0	<b>GPS Location</b>	0		
<b>Field Station#</b>	15305+00	<b>Field Station#</b>	15316+00		
<b>Pic 3 Desc.</b>	Clean water diversion berm and temporary vegetative stabilization in acceptable conditions	<b>Pic 4 Desc.</b>	Waterbar in acceptable condition

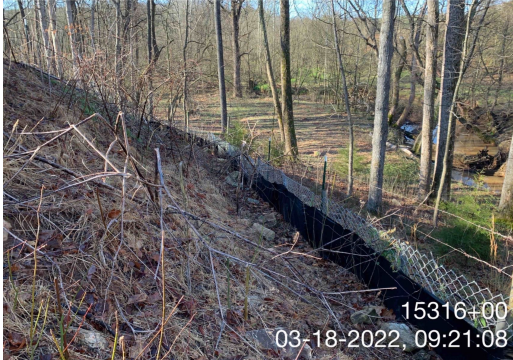
<b>GPS Location</b>	0	<b>GPS Location</b>	0		
<b>Field Station#</b>	15316+00	<b>Field Station#</b>	15316+00		
<b>Pic 5 Desc.</b>	Waterbar end treatment in acceptable condition	<b>Pic 6 Desc.</b>	Super silt fence in acceptable condition
