Visual Site Inspection Report

Project Name	H-600 Pipeline Spread I	AFE	124300139	Spread	H-600 Pipeline Spread I
Contractor	Precision			Report #	35664
Inspector	Justin Burch			Date/Time	3/21/2022 10:18 AM
Permit #	TBD	Inspection Type	VA SWPP	Station Begin	15370+62
State	VA	Inspection Area	Full	Station End	15480+67
County	Pittsylvania	Ground	Damp	Temperature (°F)	72.00
Municipality	Chatham	Weather	Sunny	Rain Gauge (in)	0.90
				Rain Accumulation Time (days)	6.00

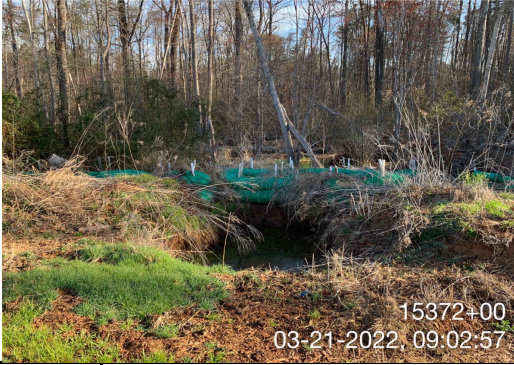
<p>357°N (T) 36°55'19"N, 79°30'36"W ±95ft ▲ 778ft 15372+00 03-21-2022, 09:02:57</p>

<p>91°E (T) 36°55'16"N, 79°30'23"W ±13ft ▲ 774ft 15383+00 03-21-2022, 09:52:43</p>			
GPS Location	0	GPS Location	0		
Field Station#	15372+00	Field Station#	15383+00		
Pic 1 Desc.	Sump pit in acceptable condition	Pic 2 Desc.	Super silt fence in acceptable condition

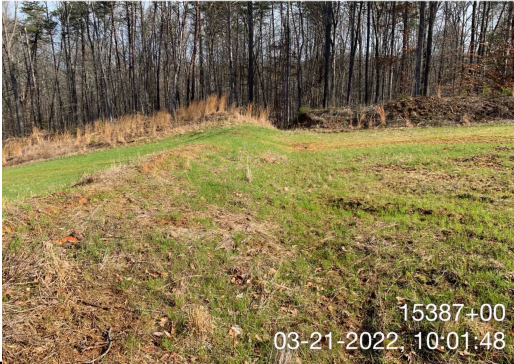
<p>7°N (T) 36°55'13"N, 79°30'19"W ±55ft ▲ 775ft 15387+00 03-21-2022, 10:01:48</p>

<p>11°N (T) 36°55'14"N, 79°30'19"W ±91ft ▲ 772ft 15387+00 03-21-2022, 10:01:17</p>			
GPS Location	0	GPS Location	0		
Field Station#	15387+00	Field Station#	15387+00		
Pic 3 Desc.	Waterbar in acceptable condition	Pic 4 Desc.	Waterbar end treatment in acceptable condition

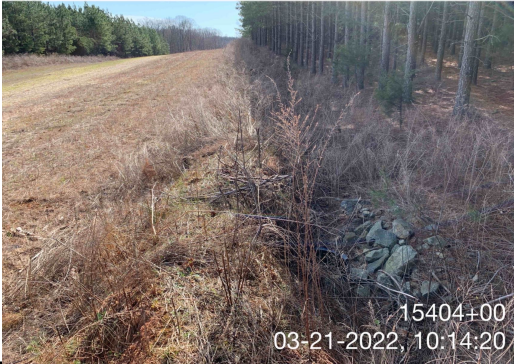
<p>113°SE (T) 36°55'7"N, 79°30'0"W ±82ft ▲ 840ft 15404+00 03-21-2022, 10:14:20</p>

GPS Location	0	GPS Location	0		
Field Station#	15404+00	Field Station#	15408+00		
Pic 5 Desc.	Clean water diversion berm in acceptable condition	Pic 6 Desc.	Temporary vegetative stabilization in acceptable condition

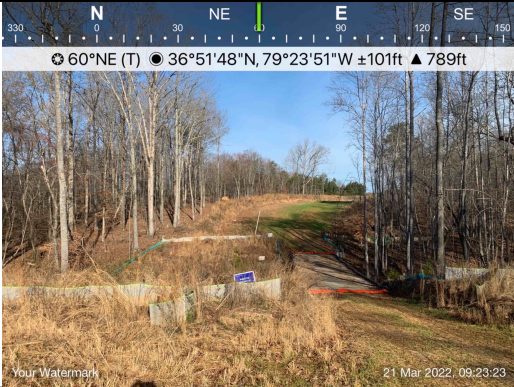
GPS Location	O	GPS Location	O		
Field Station#	15794+77	Field Station#	15794+17		
Pic 3 Desc.	Observing temporary stabilization, signage, buffer, equipment crossing and ECD's	Pic 4 Desc.	Observing P1 that requires maintenance

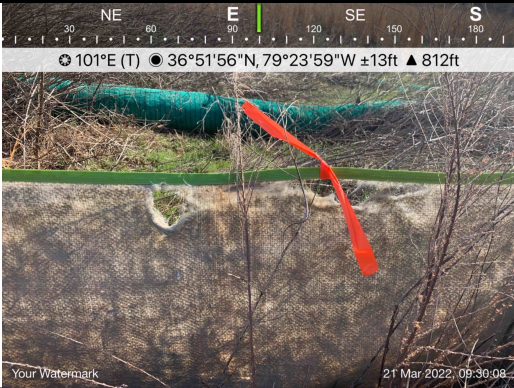
GPS Location	O	GPS Location	O		
Field Station#	15784+50	Field Station#	15776+00		
Pic 5 Desc.	Observing P1 that requires maintenance	Pic 6 Desc.	Observing CFS that requires maintenance

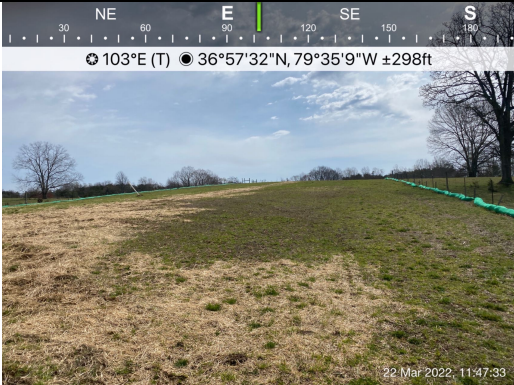
GPS Location	0		GPS Location	0	
Field Station#	15096+00		Field Station#	15103+45	
Pic 3 Desc.	Approximately 15096+00. Overview of ROW.		Pic 4 Desc.	Approximately 15103+45. Overview of stream crossing, equipment bridge and ECDs at stream S-G8.

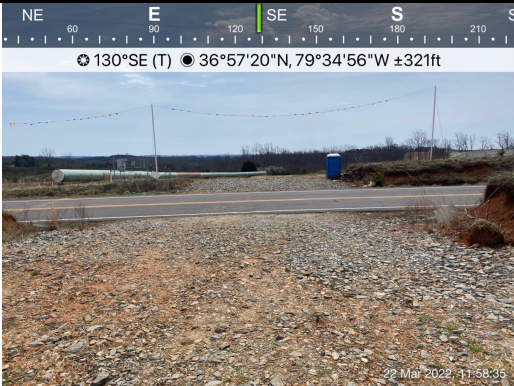
GPS Location	0		GPS Location	0	
Field Station#	15113+00		Field Station#	15122+00	
Pic 5 Desc.	Approximately 15113+00. Overview of road crossing and RCEs.		Pic 6 Desc.	Approximately 15122+00. Overview of ROW.

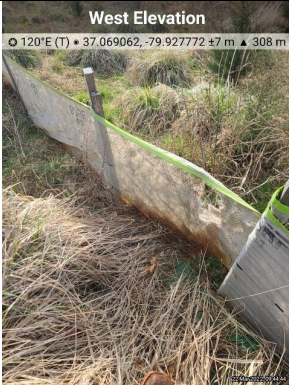
GPS Location	00000	GPS Location	00000		
Field Station#	13803+20	Field Station#	13771+12		
Pic 1 Desc.	P1 requires maintenance along the Deb of the LOD, documented and added to the punch list.	Pic 2 Desc.	CFS at stream buffer requires maintenance due to being weathered. Added to the punch list.

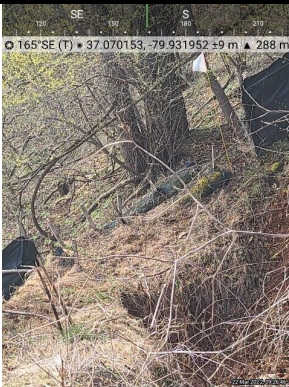
GPS Location	0000	GPS Location	0000		
Field Station#	13788+00	Field Station#	13807+50		
Pic 3 Desc.	CFS end treatment needs replaced.	Pic 4 Desc.	CFS end treatment needs replaced, added to the punch list.		
	South Elevation

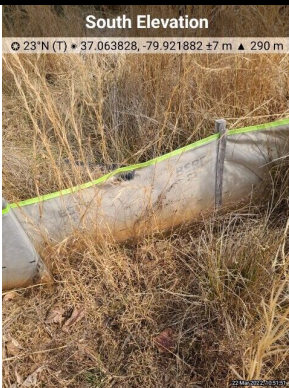
GPS Location	00000	GPS Location	00000		
Field Station#	13834+00	Field Station#	13800+00		
Pic 5 Desc.	P1 requires maintenance, added to the punch list.	Pic 6 Desc.	CFS needs replaced.

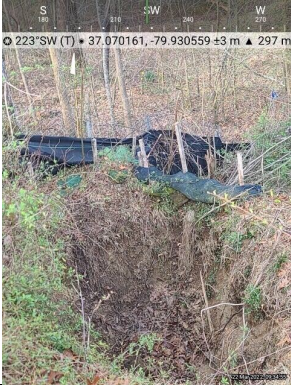
GPS Location	0000	GPS Location	00000		
Field Station#	13792+25	Field Station#	13845+70		
Pic 7 Desc.	CFS end treatment needs maintenance.	Pic 8 Desc.	CFS on row edge needs replaced. Added to the punch list.

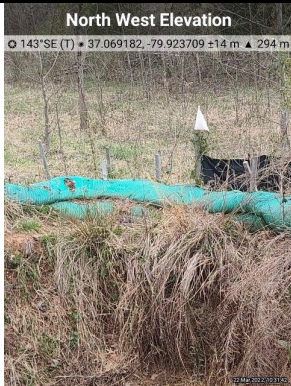
GPS Location	00000	GPS Location	00000		
Field Station#	13815+00	Field Station#	13786+55		
Pic 9 Desc.	CFS end treatment needs replaced, added to the punch list.	Pic 10 Desc.	Perimeter CFS needs replaced due to being weathered .

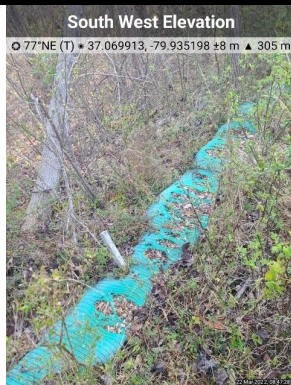
GPS Location	00000	GPS Location	00000		
Field Station#	13777+00	Field Station#	13820+00		
Pic 11 Desc.	Perimeter CFS needs replaced.	Pic 12 Desc.	P1 requires maintenance, added to the punch list.

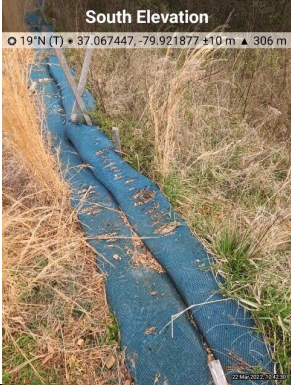
GPS Location	00000	GPS Location	00000		
Field Station#	13820+00	Field Station#	13803+00		
Pic 13 Desc.	Perimeter CFS requires maintenance.	Pic 14 Desc.	CFS end treatment needs maintenance.		
South West Elevation

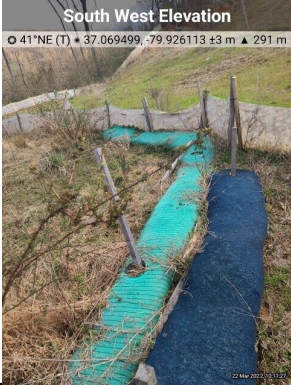
GPS Location	00000	GPS Location	000000		
Field Station#	13805+00	Field Station#	13787+00		
Pic 15 Desc.	CFS at stream crossing requires maintenance, added to the punch list.	Pic 16 Desc.	CFS end treatment requires maintenance.

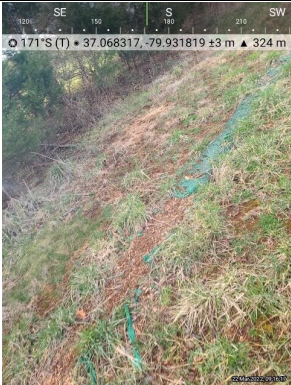
GPS Location	0000	GPS Location	00000		
Field Station#	13784+90	Field Station#	13782+20		
Pic 17 Desc.	Perimeter CFS around work space needs replaced.	Pic 18 Desc.	P1 at stream buffer needs replaced.

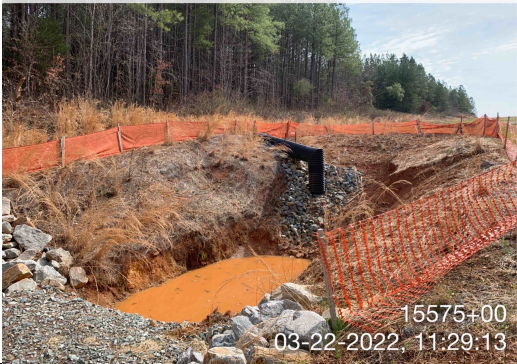
15575+00 03-22-2022, 11:29:13		314°NW (T) 36°54'28"N, 79°28'33"W ±16ft ▲ 928ft

15492+00 03-22-2022, 12:46:15			
GPS Location	0	GPS Location	0		
Field Station#	15575+00	Field Station#	15492+00		
Pic 7 Desc.	Slope drain pipe in acceptable condition	Pic 8 Desc.	Permanent vegetative stabilization in acceptable condition		
112°E (T) 36°54'20"N, 79°28'23"W ±26ft ▲ 887ft

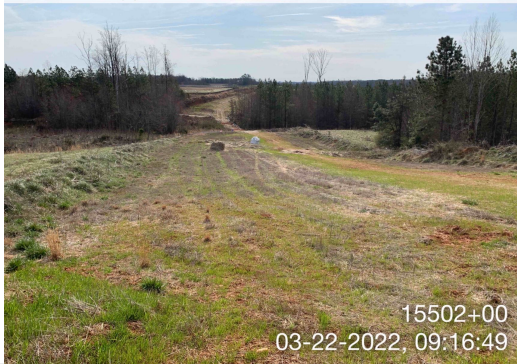
15502+00 03-22-2022, 09:16:49		114°SE (T) 36°54'18"N, 79°28'14"W ±13ft ▲ 871ft

15512+00 03-22-2022, 12:20:33			
GPS Location	0	GPS Location	0		
Field Station#	15502+00	Field Station#	15512+00		
Pic 9 Desc.	Temporary vegetative stabilization in acceptable condition	Pic 10 Desc.	Super silt fence on solar farm perimeter in acceptable condition		
156°SE (T) 36°54'16"N, 79°28'36"W ±1377ft ▲ 940ft

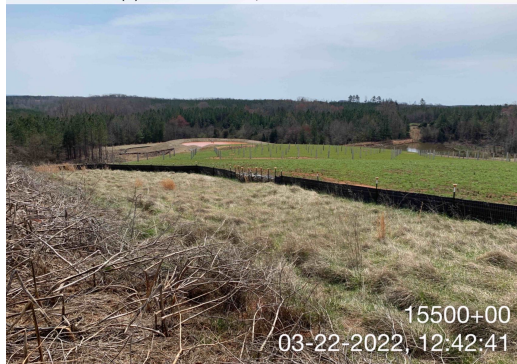
15500+00 03-22-2022, 12:42:41		49°NE (T) 36°53'59"N, 79°27'50"W ±652ft ▲ 812ft

GPS Location	0	GPS Location	0		
Field Station#	15500+00	Field Station#	15538+00		
Pic 11 Desc.	ECDs on Solar Farm perimeter in acceptable conditions	Pic 12 Desc.	Temporary vegetative stabilization in acceptable condition

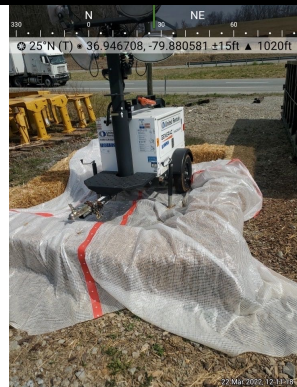
7. Identify all remedial measures that have been taken since the previous inspection was conducted.					
Comments (Reference above questions as appropriate.)					
Conducted SWPPP inspection of LY-032, -033, -048, and ANC-006. Secondary containment in LY-032 needed maintenance to restore liner around structure to contain any potential leaks. Light plant at LY-032 had no secondary containment. Contractor addressed both issues today. No other issues were observed.					
Note: It is a condition of National Pollutant Discharge Elimination System and Erosion and Sediment permits that a maintenance program be conducted to provide for the operation and maintenance of all BMPs to be inspected on a weekly basis and after each stormwater event. Please list in the space provided comments to note if repairs or replacement are needed or have been made for BMPs as a result of the inspection. Failure to conduct the required inspection may result in permit suspension or the imposition of civil penalties. If supplemental monitoring is required as part of a permit condition this form may be used to meet those monitoring requirements.

GPS Location	0		GPS Location	0	
Field Station#	0+00		Field Station#	0+00	
Pic 1 Desc.	LY-032 Rock entrance		Pic 2 Desc.	LY-032 Secondary containment needs maintenance

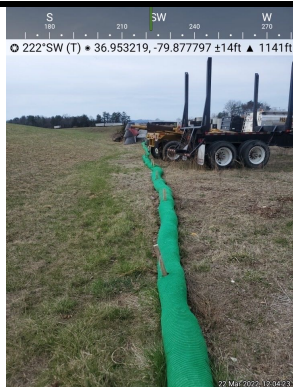
GPS Location	0		GPS Location	0	
Field Station#	0+00		Field Station#	0+00	
Pic 5 Desc.	ANC-006 Southeast perimeter CFS		Pic 6 Desc.	ANC-006 Stormwater drain inlet protection

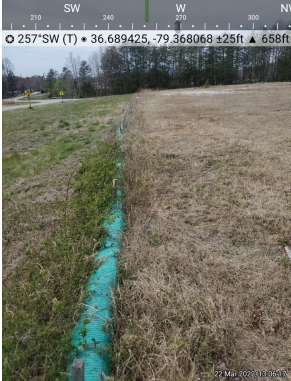
GPS Location	0	GPS Location	0		
Field Station#	0+00	Field Station#	0+00		
Pic 7 Desc.	LY-048 South perimeter CFS		Pic 8 Desc.	LY-048 North perimeter CFS	
Insert image here		Insert image here			
GPS Location		GPS Location			
Field Station#		Field Station#			
Pic 9 Desc.			Pic 10 Desc.		
Insert image here		Insert image here			
GPS Location		GPS Location			
Field Station#		Field Station#			
Pic 11 Desc.			Pic 12 Desc.

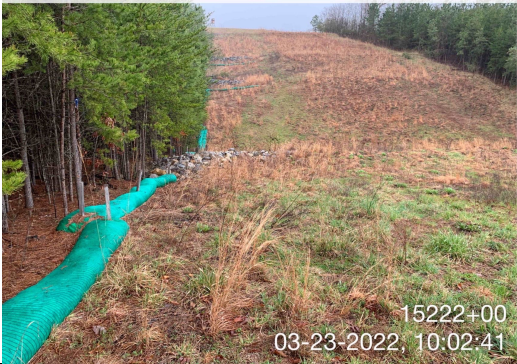
<p>15222+00 03-23-2022, 10:02:41</p>

<p>15142+80 03-23-2022, 10:55:59</p>			
GPS Location	0	GPS Location	0		
Field Station#	15222+00	Field Station#	15142+80		
Pic 7 Desc.	Perimeter CFS and permanent vegetative stabilization in acceptable conditions		Pic 8 Desc.	Rock construction entrance in acceptable condition	
Insert image here		Insert image here			
GPS Location		GPS Location			
Field Station#		Field Station#			
Pic 9 Desc.			Pic 10 Desc.		
Insert image here		Insert image here			
GPS Location		GPS Location			
Field Station#		Field Station#			
Pic 11 Desc.			Pic 12 Desc.

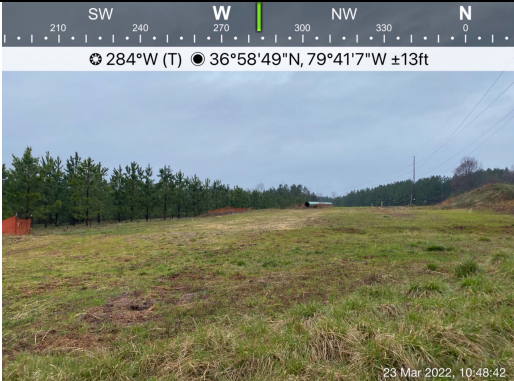
GPS Location	0	GPS Location	0		
Field Station#	14775+00	Field Station#	14778+00		
Pic 3 Desc.	Approximately 14775+00. Overview of ROW.	Pic 4 Desc.	Approximately 14778+00. Overview of ROW.

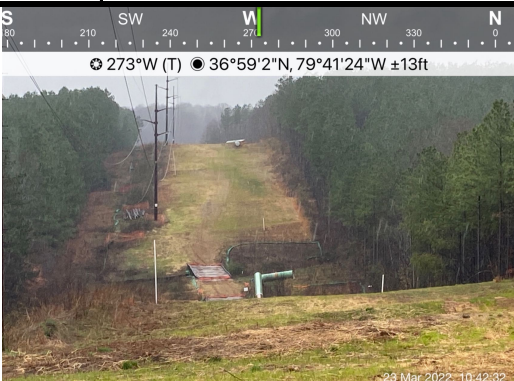
GPS Location	0	GPS Location	0		
Field Station#	14748+00	Field Station#	14761+00		
Pic 5 Desc.	Approximately 14748+00. Overview of ROW.	Pic 6 Desc.	Approximately 14761+00. Overview of ROW.

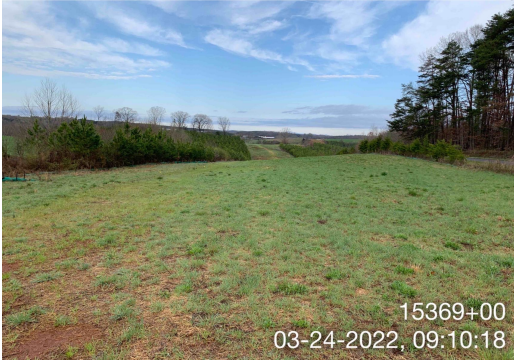
<p>15369+00 03-24-2022, 09:10:18</p>

<p>15310+00 03-24-2022, 09:45:34</p>		
GPS Location	0		GPS Location	0	
Field Station#	15369+00		Field Station#	15310+00	
Pic 1 Desc.	Permanent vegetative stabilization in acceptable condition		Pic 2 Desc.	P1 silt fence in acceptable condition

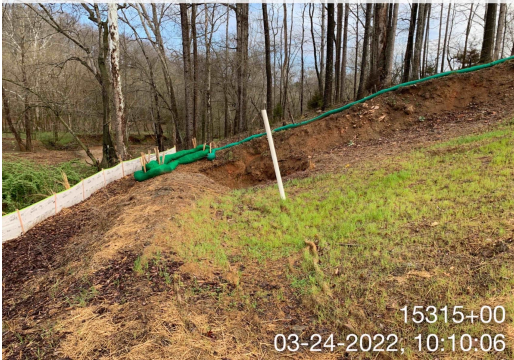
<p>15315+00 03-24-2022, 10:10:06</p>

<p>15315+00 03-24-2022, 10:10:23</p>		
GPS Location	0		GPS Location	0	
Field Station#	15315+00		Field Station#	15315+00	
Pic 3 Desc.	Waterbar in acceptable condition		Pic 4 Desc.	Waterbar end treatment in acceptable condition

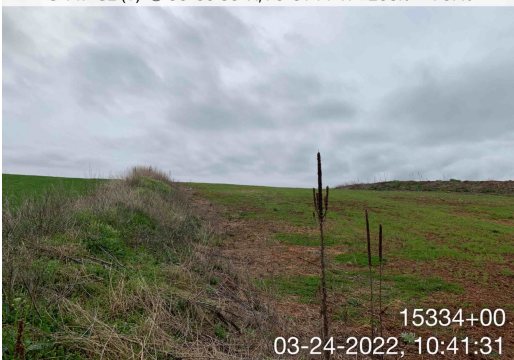
<p>15334+00 03-24-2022, 10:41:31</p>

<p>15338+00 03-24-2022, 10:47:06</p>		
GPS Location	0		GPS Location	0	
Field Station#	15334+00		Field Station#	15338+00	
Pic 5 Desc.	Clean water diversion berm and temporary vegetative stabilization in acceptable conditions		Pic 6 Desc.	Clean water diversion pipe and plunge pool in acceptable conditions

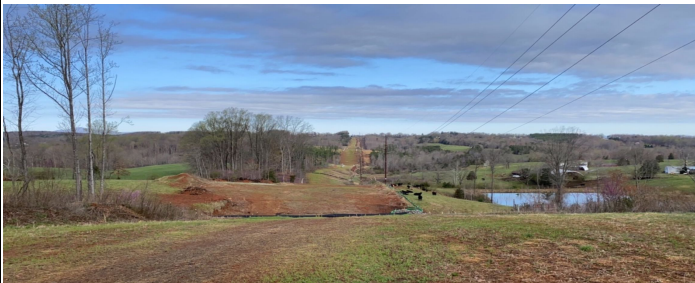
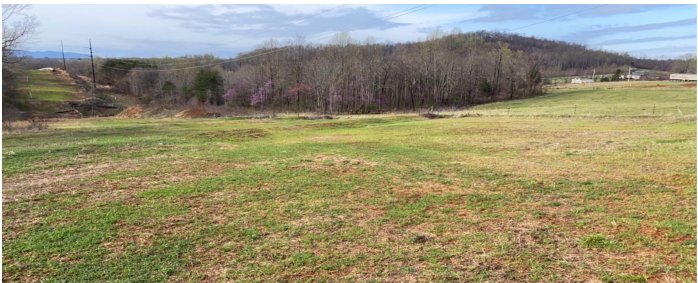
GPS Location	3	GPS Location	4		
Field Station#	14521+00	Field Station#	14527+00		
Pic 3 Desc.	ROW stabilized and vegetated in temporary area; perimeter controls in place and functional.		Pic 4 Desc.	ROW stabilized and vegetated in temporary area; perimeter controls in place and functional.

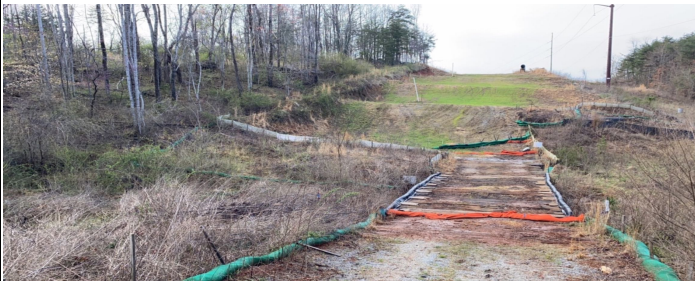
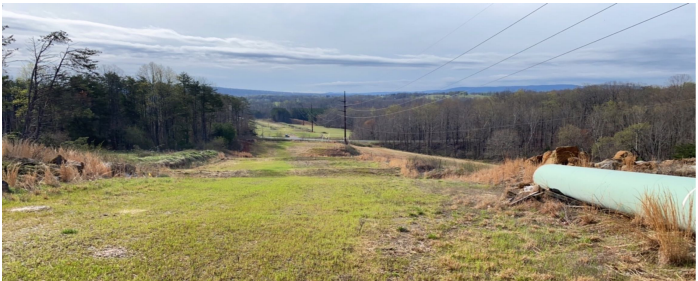
37°0'34" N 79°45'14" W 165°S COURSE 77' GPS Glade Hill, VA 24092, United States 03.24.2022 10:00:59 Accur +/-153.9 Ft ALT 1061 Ft			37°0'28" N 79°45'15" W 155°SE COURSE 117' GPS 1886 SR-674, Glade Hill, VA 24092, United States 03.24.2022 10:05:11 Accur +/-34.5 Ft ALT 1044 Ft		
GPS Location	5	GPS Location	6		
Field Station#	14531+58	Field Station#	14540+00		
Pic 5 Desc.	Equipment bridge and surrounding ECDs in place and functional at stream crossing and resource buffer.		Pic 6 Desc.	ROW stabilized and vegetated in temporary area; perimeter controls in place and functional.

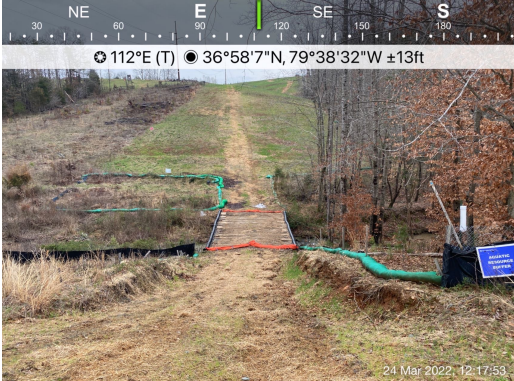
GPS Location	0	GPS Location	0		
Field Station#	14916+00	Field Station#	14896+00		
Pic 3 Desc.	Approximately 14916+00. Overview of stream crossing, equipment bridge and ECDs at stream S-G16.		Pic 4 Desc.	Approximately 14896+00. Overview of ROW.

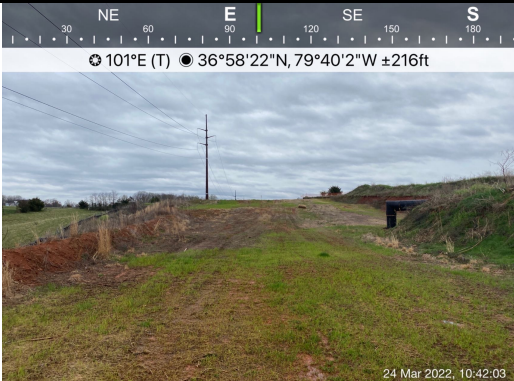
GPS Location	0	GPS Location	0		
Field Station#	14843+00	Field Station#	14804+00		
Pic 5 Desc.	Approximately 14843+00. Overview of ROW.		Pic 6 Desc.	Approximately 14804+00. Overview of ROW.

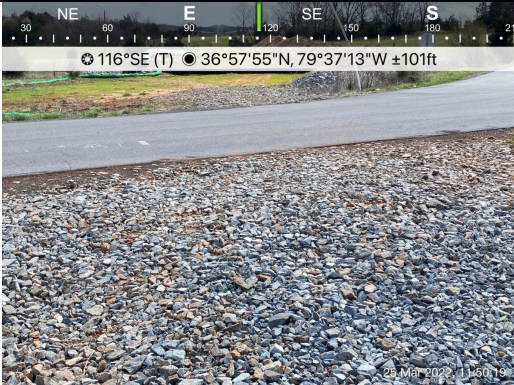
GPS Location	0	GPS Location	0		
Field Station#	14981+00	Field Station#	14970+00		
Pic 3 Desc.	Approximately 14981+00. Overview of road crossing and RCEs.		Pic 4 Desc.	Approximately 14970+00. Overview of ROW. Permanent vegetation.

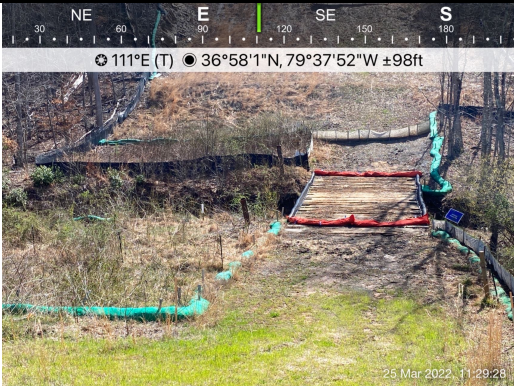
GPS Location	0	GPS Location	0		
Field Station#	14950+47	Field Station#	14937+00		
Pic 5 Desc.	Approximately 14950+47. Overview of stream crossing, equipment bridge and ECDs at stream S-G13.		Pic 6 Desc.	Approximately 14937+00. Overview of ROW.
