Visual Site Inspection Report

Project Name	H-603 Pipeline Spread I		AFE	124300139	Spread	H-603 Pipeline Spread I	
Contractor	Precision				Report #	35929	
Inspector	John White				Date/Time	3/28/2022 11:04 AM	
Permit #	TBD	Inspection Type	VA SWPP		Station Begin	00+00	
State	VA	Inspection Area	Full		Station End	24+53	
County	Pittsylvania	Ground	Damp		Temperature (°F)	44.00	
Municipality	Chatham	Weather	Sunny		Rain Gauge (in)	1.20	
					Rain Accumulation Time (days)	6.00

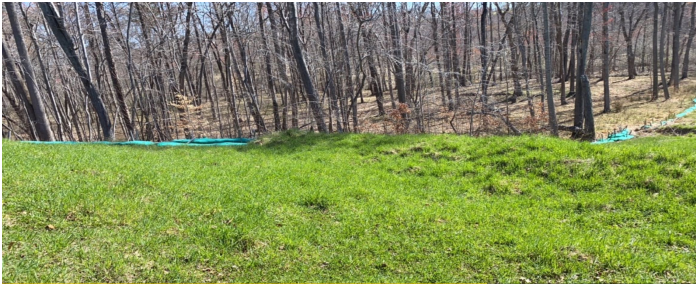
36°59'24" N 79°43'24" W 112°E COURSE 132' GPS 9400-9598 Old Franklin Tpke, Union Hall, VA 24176, United States 03.28.2022 10:53:33 Accur +/-151.5 Ft ALT 981 Ft			36°59'22" N 79°43'21" W 108°E COURSE 145' GPS Union Hall, VA 24176, United States 03.28.2022 10:55:03 Accur +/-213.5 Ft ALT 968 Ft		
GPS Location	1	GPS Location	2		
Field Station#	14653+00	Field Station#	14656+37		
Pic 1 Desc.	ROW stabilized and vegetated in final cleanup area; water bar performing intended function.	Pic 2 Desc.	P1 silt fence in good condition at resource buffer; signage visible and intact.

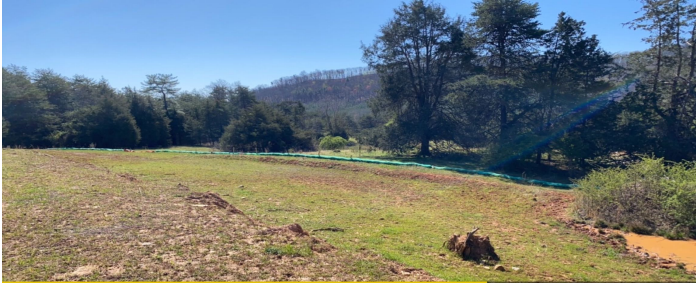
36°59'16" N 79°43'2" W 143°SE COURSE 87' GPS Union Hall, VA 24176, United States 03.28.2022 11:05:14 Accur +/-181.1 Ft ALT 950 Ft			36°59'16" N 79°42'56" W 2°N COURSE 116' GPS Union Hall, VA 24176, United States 03.28.2022 11:06:33 Accur +/-38.5 Ft ALT 958 Ft		
GPS Location	5	GPS Location	6		
Field Station#	14677+14	Field Station#	14676+75		
Pic 5 Desc.	Perimeter CFS in place and functional along ROW; no issues observed.	Pic 6 Desc.	Temporary access road in good condition at ROW crossing.

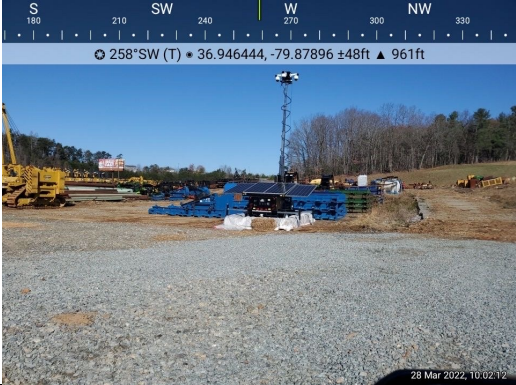
GPS Location	0	GPS Location	0		
Field Station#	0+00	Field Station#	0+00		
Pic 7 Desc.	LY-033 Secondary containment	Pic 8 Desc.	LY-033 Rock construction entrance		
Insert image here		Insert image here			
GPS Location		GPS Location			
Field Station#		Field Station#			
Pic 9 Desc.		Pic 10 Desc.			
Insert image here		Insert image here			
GPS Location		GPS Location			
Field Station#		Field Station#			
Pic 11 Desc.		Pic 12 Desc.

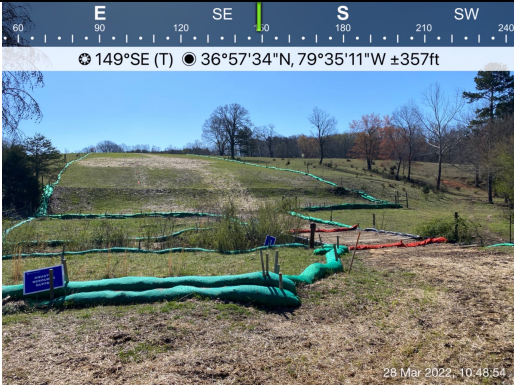
GPS Location	0	GPS Location	0		
Field Station#	15092+95	Field Station#	15119+00		
Pic 3 Desc.	Approximately 15092+95. Overview of stream crossing, equipment bridge and ECDs at stream S-G9.		Pic 4 Desc.	Approximately 15119+00. Overview of ROW.

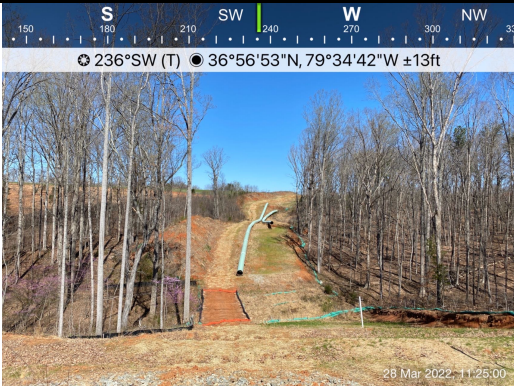
GPS Location	0	GPS Location	0		
Field Station#	15138+00	Field Station#	15113+50		
Pic 5 Desc.	Approximately 15138+00. Overview of ROW.		Pic 6 Desc.	Approximately 15113+50. Multiple panels of P-1 require maintenance.

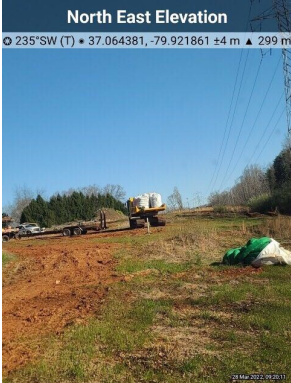
<p>North East Elevation <small>235°SW (T) • 37.064381, -79.921861 ±4 m ▲ 299 m</small></p>		<p>Insert image here</p>		<p>Insert image here</p>	
GPS Location	0000	GPS Location			
Field Station#	13826+95	Field Station#			
Pic 7 Desc.	Photo showing the contractor as they continued working to complete punch list repairs.		Pic 8 Desc.		
<p>Insert image here</p>		<p>Insert image here</p>			
GPS Location		GPS Location			
Field Station#		Field Station#			
Pic 9 Desc.		Pic 10 Desc.			
<p>Insert image here</p>		<p>Insert image here</p>			
GPS Location		GPS Location			
Field Station#		Field Station#			
Pic 11 Desc.		Pic 12 Desc.

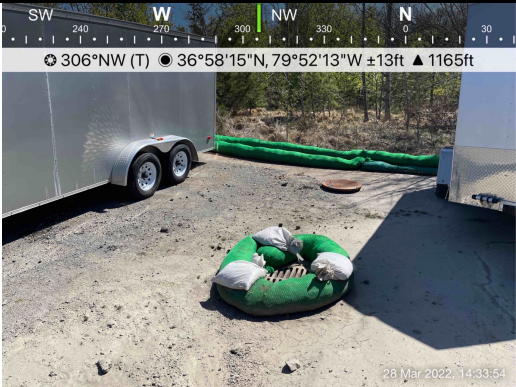
GPS Location	See picture		GPS Location	See picture	
Field Station#	0000+00		Field Station#	0000+00	
Pic 1 Desc.	Perimeter ECD's and inlet protection for catch basin on south end of LY-046 in acceptable condition.		Pic 2 Desc.	Secondary containment structure for fuel cell at LY-046 in good condition.

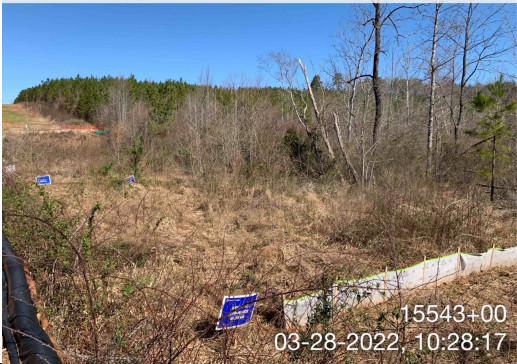
GPS Location	0	GPS Location	0		
Field Station#	15543+00	Field Station#	15568+00		
Pic 7 Desc.	Sensitive resource buffer and P1 silt fence in acceptable condition		Pic 8 Desc.	Temporary vegetative stabilization in acceptable condition	
57°NE (T) 36°54'16"N, 79°28'12"W ±26ft ▲ 873ft

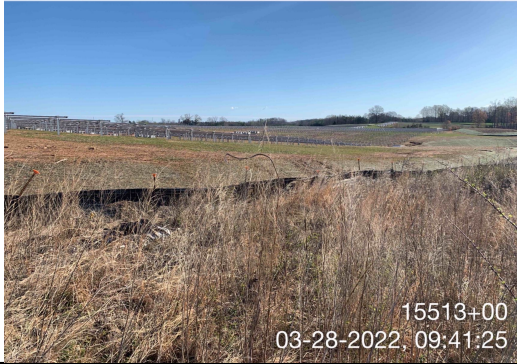
GPS Location	0	GPS Location	0		
Field Station#	15513+00	Field Station#	15499+00		
Pic 9 Desc.	Solar farm ECDs in acceptable condition		Pic 10 Desc.	Solar farm ECDs in acceptable condition	
Insert image here			Insert image here		
GPS Location		GPS Location			
Field Station#		Field Station#			
Pic 11 Desc.			Pic 12 Desc.

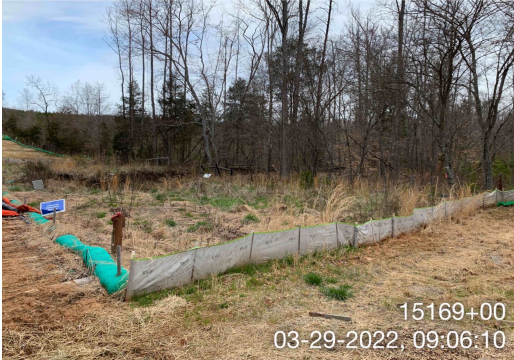
15169+00 03-29-2022, 09:06:10		235°SW (T) 36°56'26"N, 79°33'49"W ±108ft ▲796ft

15195+00 03-29-2022, 09:44:25			
GPS Location	0	GPS Location	0		
Field Station#	15169+00	Field Station#	15195+00		
Pic 1 Desc.	P1 silt fence and sensitive resource buffer in acceptable condition	Pic 2 Desc.	Perimeter CFS is dislocated		
347°N (T) 36°56'25"N, 79°33'49"W ±62ft ▲787ft

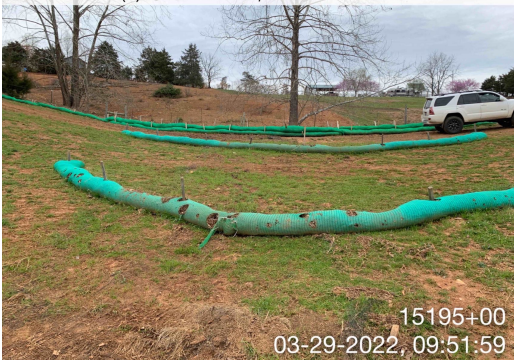
15195+00 03-29-2022, 09:51:59		178°S (T) 36°56'40"N, 79°34'21"W ±52ft ▲764ft

15165+00 03-29-2022, 09:16:38			
GPS Location	0	GPS Location	0		
Field Station#	15195+00	Field Station#	15165+00		
Pic 3 Desc.	CFS with stakes missing and holes in it	Pic 4 Desc.	Waterbar end treatment in acceptable condition		
49°NE (T) 36°56'40"N, 79°34'21"W ±5501ft ▲769ft

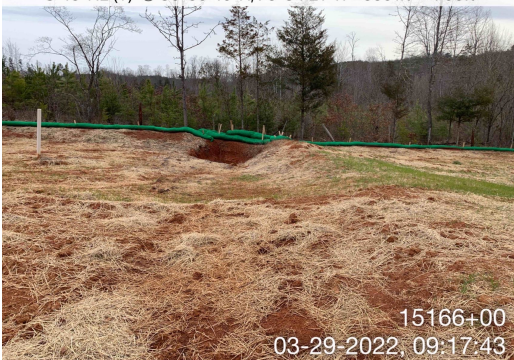
15166+00 03-29-2022, 09:17:43		261°W (T) 36°56'37"N, 79°34'16"W ±3169ft ▲724ft

GPS Location	0	GPS Location	0		
Field Station#	15166+00	Field Station#	15171+00		
Pic 5 Desc.	Waterbar in acceptable condition	Pic 6 Desc.	Slope drain pipe and sump pit in acceptable conditions

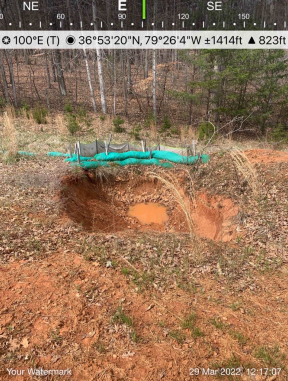
GPS Location	O	GPS Location	O		
Field Station#	15639+00	Field Station#	15636+45		
Pic 1 Desc.	Observing temporary stabilization, sump and end treatment	Pic 2 Desc.	Observing temporary stabilization, signage, buffer, equipment crossing and ECD's

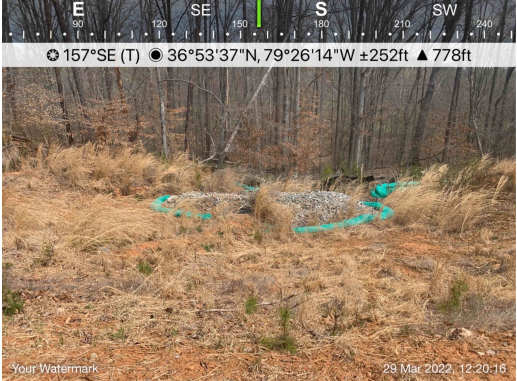
GPS Location	O	GPS Location	O		
Field Station#	15630+00	Field Station#	15619+48		
Pic 3 Desc.	Observing temporary stabilization, CWD outlet and ECD's	Pic 4 Desc.	Observing road crossing and RCE's

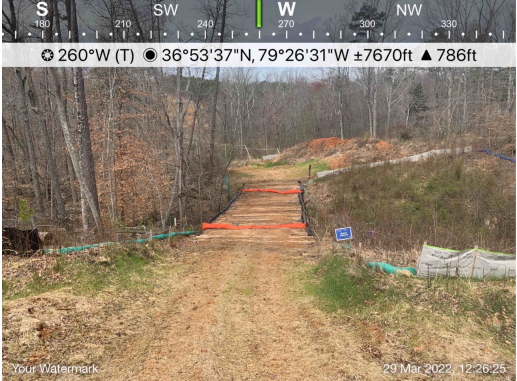
GPS Location	O	GPS Location	O		
Field Station#	15600+12	Field Station#	15590+00		
Pic 5 Desc.	Observing temporary stabilization, signage, buffer, equipment crossing and ECD's	Pic 6 Desc.	Observing temporary stabilization and water bars

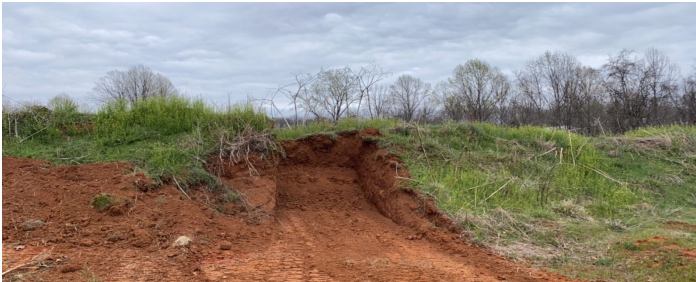
37°0'39" N 79°45'14" W 151°SE COURSE 317' GPS 1886 SR-674, Glade Hill, VA 24092, United States 03.30.2022 10:35:13 Accur +/-136.2 Ft ALT 981 Ft			37°0'39" N 79°45'15" W 147°SE COURSE -1' GPS 1760 SR-674, Glade Hill, VA 24092, United States 03.30.2022 10:37:51 Accur +/-45.4 Ft ALT 1062 Ft		
GPS Location	1		GPS Location	2	
Field Station#	14525+25		Field Station#	14525+25	
Pic 1 Desc.	Routine maintenance. Seed and stabilize denuded area of spoil pile.		Pic 2 Desc.	Routine maintenance. Seed and stabilize denuded area of spoil pile.

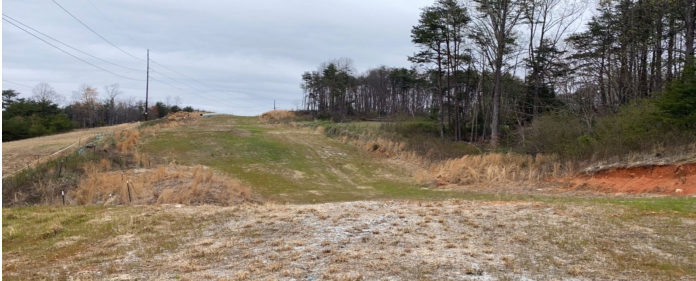
37°0'23" N 79°45'12" W 357°N COURSE 305' GPS 1886 SR-674, Glade Hill, VA 24092, United States 03.30.2022 10:24:43 Accur +/-126.0 Ft ALT 966 Ft			37°0'20" N 79°45'10" W 117°SE COURSE -1' GPS 1886 SR-674, Glade Hill, VA 24092, United States 03.30.2022 10:50:06 Accur +/-22.3 Ft ALT 943 Ft		
GPS Location	5		GPS Location	6	
Field Station#	14481+00		Field Station#	14546+33	
Pic 5 Desc.	ROW stabilized and vegetated in temporary area; perimeter controls and ECDs in place and functional.		Pic 6 Desc.	Equipment bridge and surrounding ECDs in place and functional at stream crossing and resource buffer.

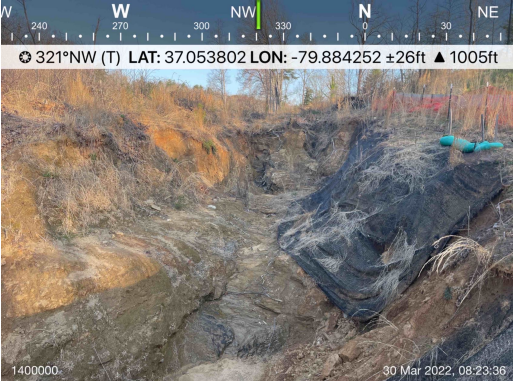
GPS Location	See photo		GPS Location	See photo	
Field Station#	13960+00		Field Station#	13997+00	
Pic 1 Desc.	CWD is functioning as intended		Pic 2 Desc.	ATWS-1446 remains stabilized

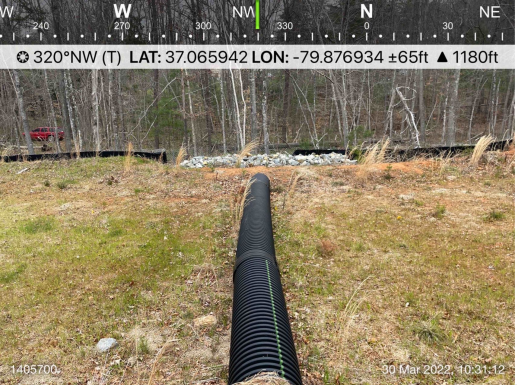
GPS Location	See photo		GPS Location	See photo	
Field Station#	14032+00		Field Station#	14035+28	
Pic 7 Desc.	Waterbars are functioning as intended		Pic 8 Desc.	Equipment bridge ECDs are in good condition and functioning

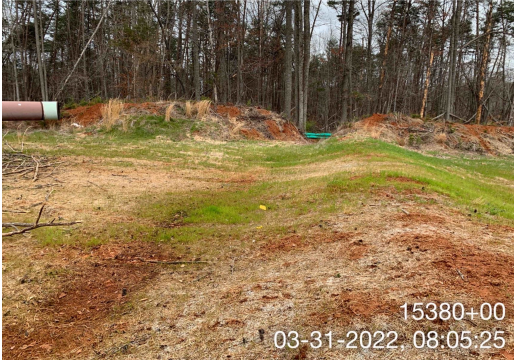
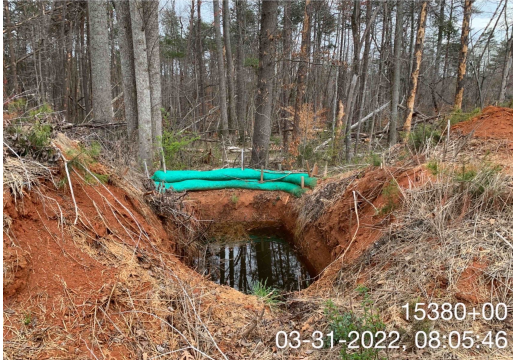
GPS Location	0	GPS Location	0		
Field Station#	15380+00	Field Station#	15380+00		
Pic 1 Desc.	Waterbar in acceptable condition	Pic 2 Desc.	Waterbar end treatment in acceptable condition

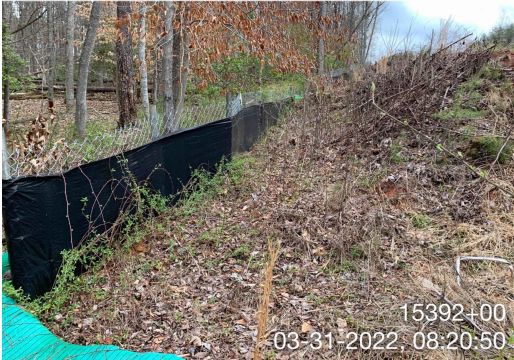
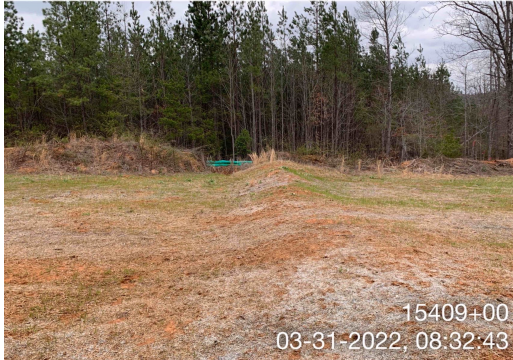
GPS Location	0	GPS Location	0		
Field Station#	15392+00	Field Station#	15409+00		
Pic 3 Desc.	Super silt fence in acceptable condition	Pic 4 Desc.	Waterbar in acceptable condition

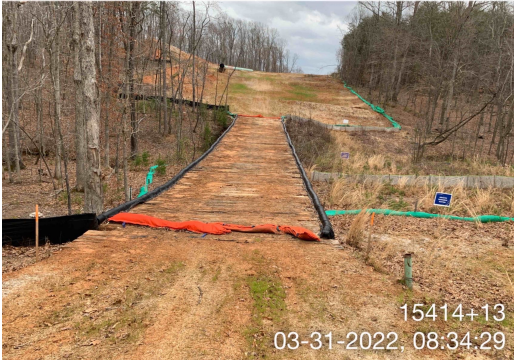
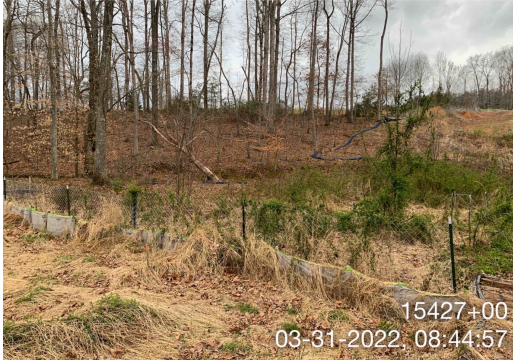
GPS Location	0	GPS Location	0		
Field Station#	15414+13	Field Station#	15427+00		
Pic 5 Desc.	Equipment bridge in acceptable condition	Pic 6 Desc.	Sensitive resource buffer in acceptable condition

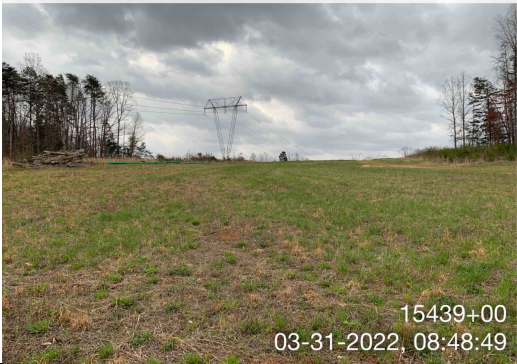
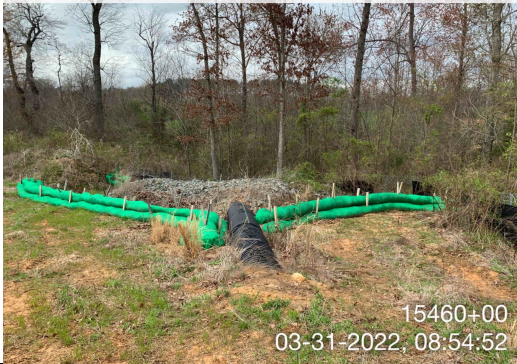
15460+00 03-31-2022, 08:54:52			
GPS Location	0	GPS Location	0		
Field Station#	15439+00	Field Station#	15460+00		
Pic 7 Desc.	Permanent vegetative stabilization in acceptable condition	Pic 8 Desc.	Clean water diversion pipe in acceptable condition		
135°SE (T) 36°54'42"N, 79°28'50"W ±65ft ▲ 897ft

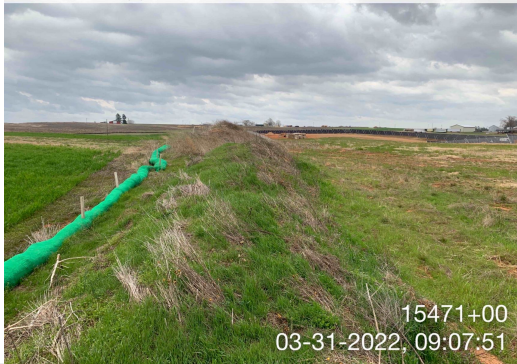
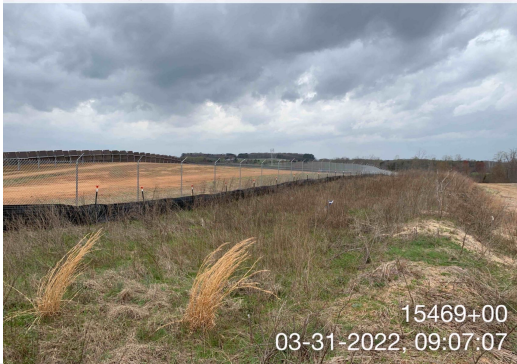
15469+00 03-31-2022, 09:07:07			
GPS Location	0	GPS Location	0		
Field Station#	15471+00	Field Station#	15469+00		
Pic 9 Desc.	Perimeter CFS and temporary vegetative stabilization in acceptable conditions	Pic 10 Desc.	Solar farm perimeter super silt fence in acceptable condition		
295°NW (T) 36°56'5"N, 79°28'27"W ±9163ft ▲ 838ft   15467+00 03-31-2022, 09:05:30		28°NE (T) 36°55'20"N, 79°30'38"W ±32ft ▲ 789ft   15371+00 03-31-2022, 10:09:34

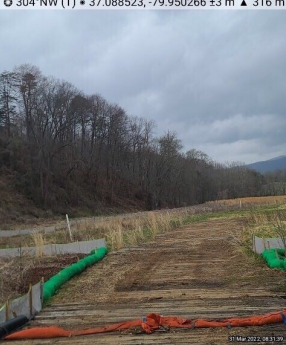
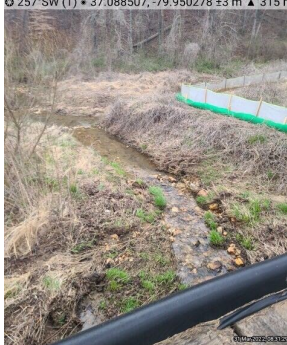
GPS Location	00000	GPS Location	0000		
Field Station#	13678+50	Field Station#	13678+71		
Pic 1 Desc.	Ecds in place and functioning as stream crossing, no issues observed at the time of inspection.		Pic 2 Desc.	Stream observation photo facing downstream during routine inspection, no issues were observed as rain events began today.	
	South West Elevation <small>36°NE (T) • 37.085732, -79.948171 ±8 m ▲ 302 m</small>

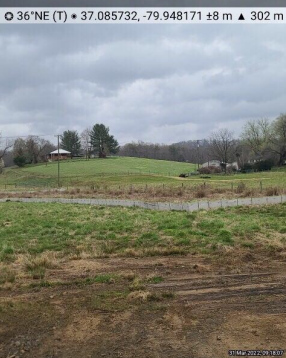
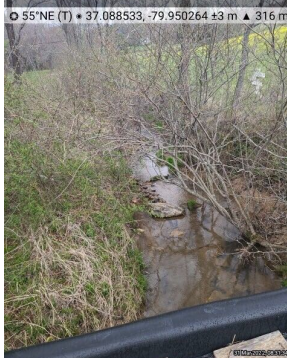
GPS Location	0000	GPS Location	00000		
Field Station#	13691+25	Field Station#	13678+71		
Pic 3 Desc.	Observed ECDs around wetland area, no issues observed at the time of inspection.		Pic 4 Desc.	Stream observation photo facing upstream during routine inspection, no issues observed at the time of inspection.

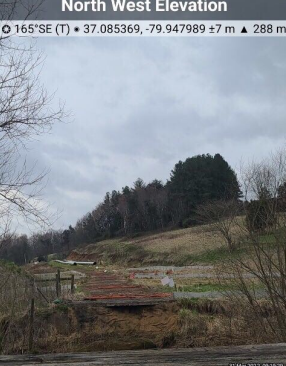
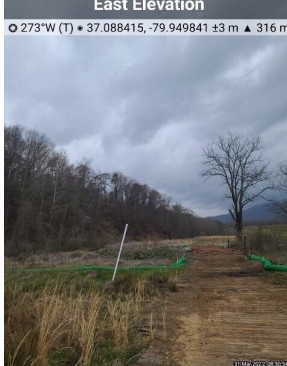
GPS Location	0000	GPS Location	0000		
Field Station#	13692+64	Field Station#	13679+00		
Pic 5 Desc.	Monitored ECDs at stream crossing as rain events began today, no issues were observed at the time of inspection.		Pic 6 Desc.	Photo showing ECDs in place at stream crossing, no issues observed at the time of inspection as rain events began.

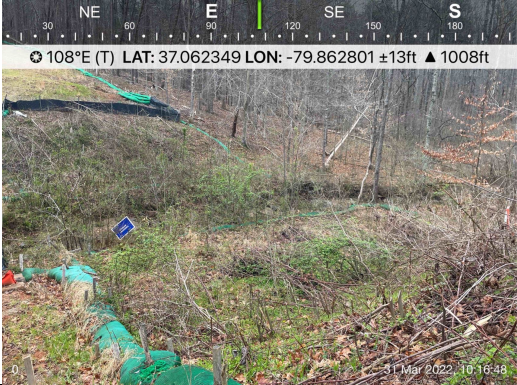
GPS Location	See photo		GPS Location	See photo	
Field Station#	14105+32		Field Station#	14106+00	
Pic 7 Desc.	Resource buffers remain well vegetated		Pic 8 Desc.	SSF is in good condition throughout this section

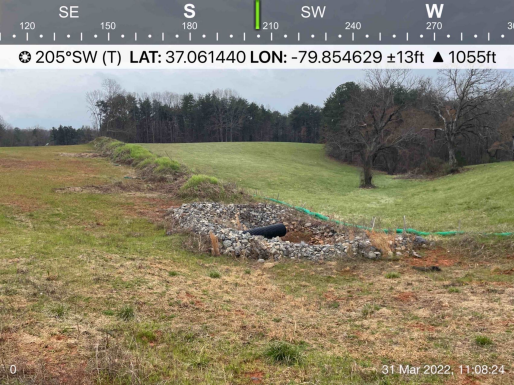
GPS Location	See photo		GPS Location	See photo	
Field Station#	14072+87		Field Station#	14131+50	
Pic 9 Desc.	MVP-FR-309.05 is in good condition with controls in place		Pic 10 Desc.	CWD is functioning as intended

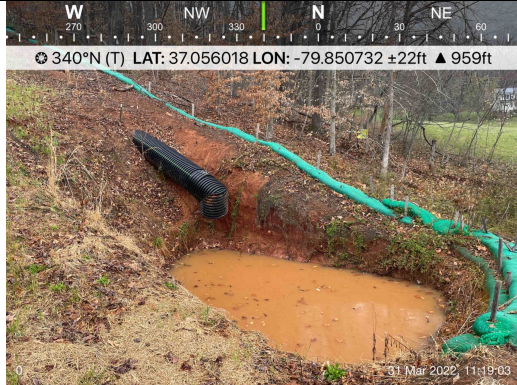
GPS Location	See photo		GPS Location	See photo	
Field Station#	14157+00		Field Station#	14171+36	
Pic 11 Desc.	Slope drain is in good condition and functioning		Pic 12 Desc.	RCEs are in good condition at all road crossings.

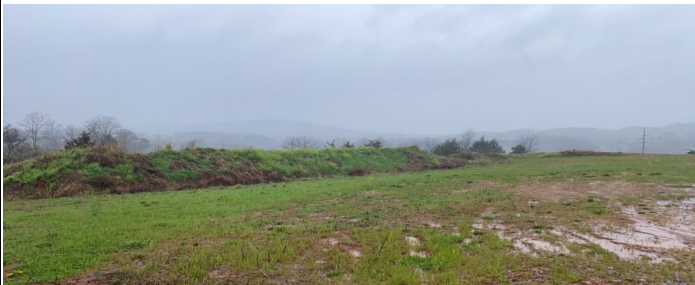
Pic 3 Desc.	Temporary diversion berm stabilized and vegetated.		Pic 4 Desc.	ROW stabilized and vegetated in temporary area.

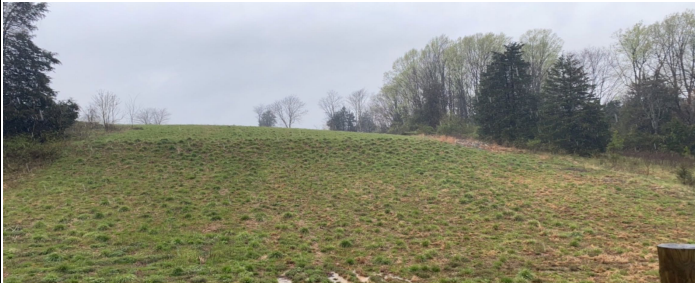
36°59'26" N 79°43'27" W 7°N COURSE -1° GPS 9400-9598 Old Franklin Tpke, Union Hall, VA 24176, United States 03.31.2022 13:14:24 Accur +/-15.6 Ft ALT 985 Ft			36°59'26" N 79°43'27" W 49°NE COURSE 186° GPS 9400-9598 Old Franklin Tpke, Union Hall, VA 24176, United States 03.31.2022 13:14:02 Accur +/-15.6 Ft ALT 986 Ft		
GPS Location	5		GPS Location	6	
Field Station#	14646+00		Field Station#	14649+67	
Pic 5 Desc.	ROW stabilized and vegetated in final cleanup area.		Pic 6 Desc.	RCE and culvert performing intended functions.

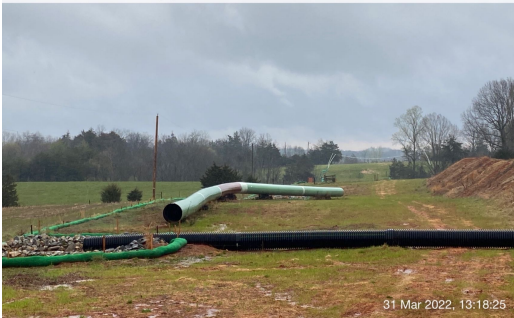
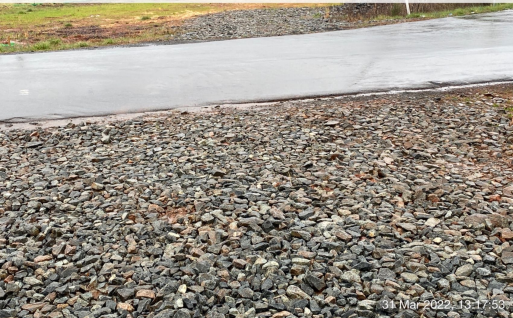
<small>31 Mar 2022, 13:17:58</small>			
GPS Location	0	GPS Location	0		
Field Station#	14984+00	Field Station#	14981+55		
Pic 1 Desc.	Approximately 14984+00. Overview of ROW.	Pic 2 Desc.	Approximately 14981+55. Overview of road crossing and RCEs.

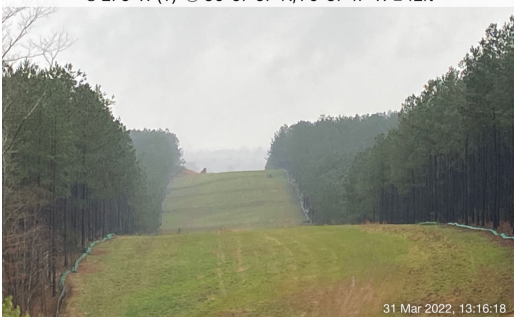
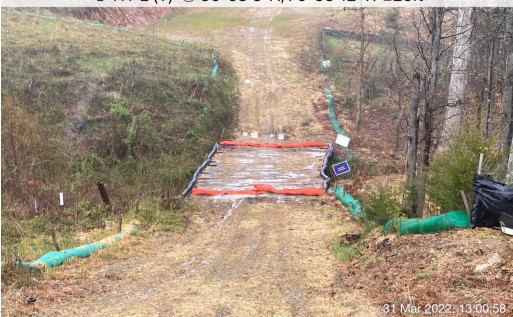
<small>31 Mar 2022, 13:00:58</small>			
GPS Location	0	GPS Location	0		
Field Station#	14972+00	Field Station#	14932+89		
Pic 3 Desc.	Approximately 14972+00. Overview of ROW. Permanent vegetation.	Pic 4 Desc.	Approximately 14932+89. Overview of stream crossing, equipment bridge and ECDs at stream S-G15.

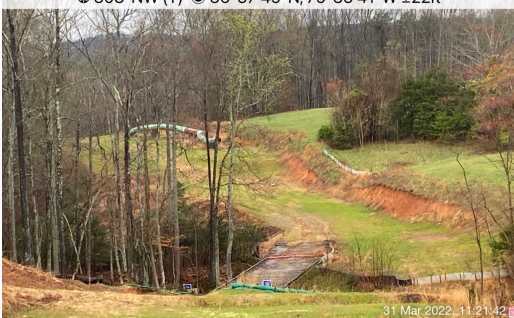
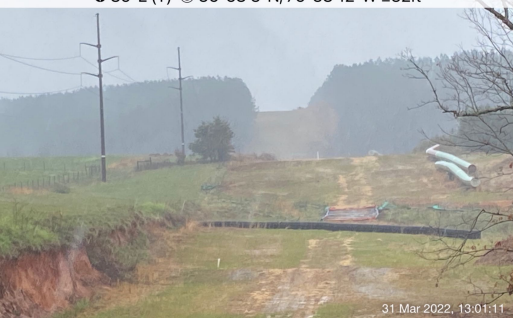
Pic 5 Desc.	Approximately 15055+80. Overview of ROW.	Pic 6 Desc.	Approximately 14938+00. Overview of ROW.

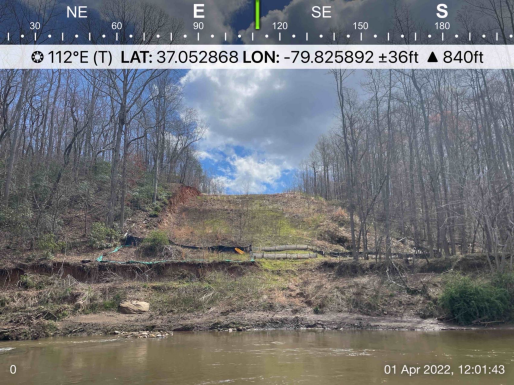
GPS Location	See photo		GPS Location	See photo	
Field Station#	14232+00		Field Station#	14236+00	
Pic 9 Desc.	Slope drain is functioning as intended		Pic 10 Desc.	GAS side slope of S-F11 remains stabilized.

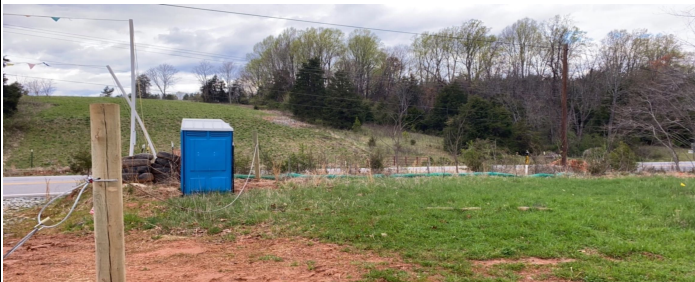
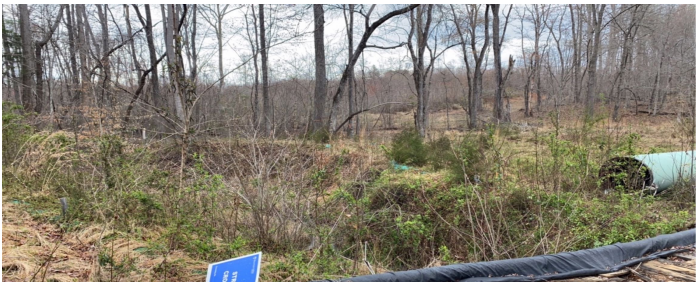
36°59'26" N 79°43'26" W 325°NW COURSE 352' GPS 9400-9598 Old Franklin Tpke, Union Hall, VA 24176, United States 04.01.2022 09:34:00 Accur +/-29.9 Ft ALT 985 Ft			36°59'22" N 79°43'20" W 89°E COURSE 65' GPS 9400-9598 Old Franklin Tpke, Union Hall, VA 24176, United States 04.01.2022 09:28:51 Accur +/-48.2 Ft ALT 926 Ft		
GPS Location	1	GPS Location	2		
Field Station#	14650+15	Field Station#	14657+00		
Pic 1 Desc.	Contractor installed wire fencing at approach.		Pic 2 Desc.	Upstream view at ROW crossing. Resource buffer and signage in good condition.

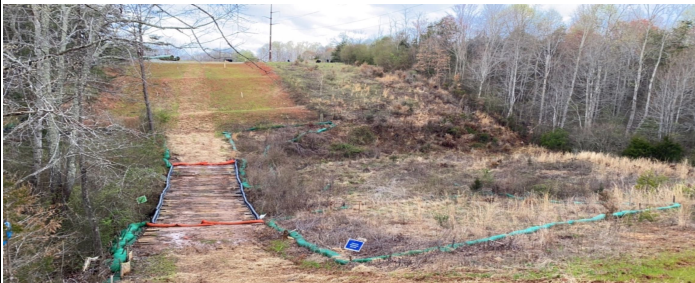
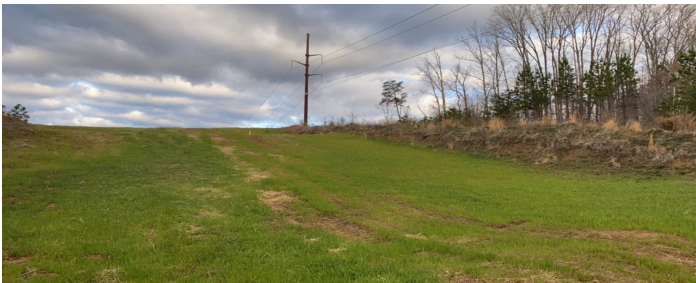
GPS Location	3	GPS Location	4		
Field Station#	14680+37	Field Station#	14686+00		
Pic 3 Desc.	Equipment bridge and surrounding ECDs in place and functional at stream crossing and resource buffer.		Pic 4 Desc.	ROW stabilized and vegetated in temporary area.

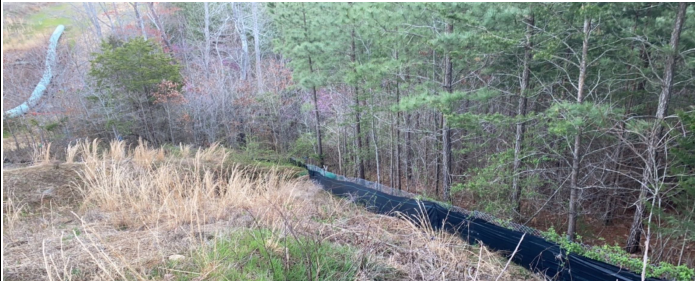
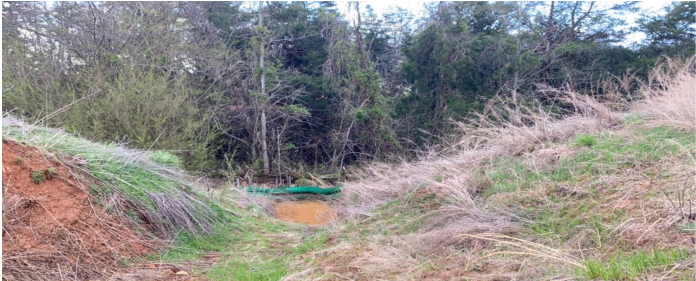
36°59'16" N 79°42'45" W 109°E COURSE 206' GPS Union Hall, VA 24176, United States 04.01.2022 07:54:50 Accur +/-79.1 Ft ALT 918 Ft			36°59'16" N 79°42'38" W 247°SW COURSE 358' GPS Union Hall, VA 24176, United States 04.01.2022 07:51:19 Accur +/-37.7 Ft ALT 941 Ft		
GPS Location	5	GPS Location	6		
Field Station#	14688+00	Field Station#	14692+00		
Pic 5 Desc.	Perimeter SSF in place and functional.		Pic 6 Desc.	Sump pit and CFS end treatment performing intended functions.

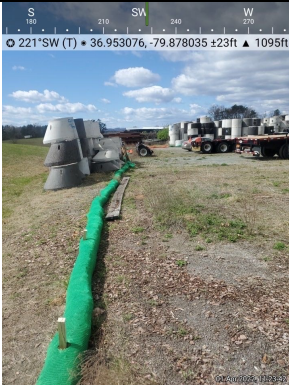
GPS Location	0	GPS Location	0		
Field Station#	0+00	Field Station#	0+00		
Pic 3 Desc.	ANC-006 Southeast perimeter CFS		Pic 4 Desc.	ANC-006 Secondary containment

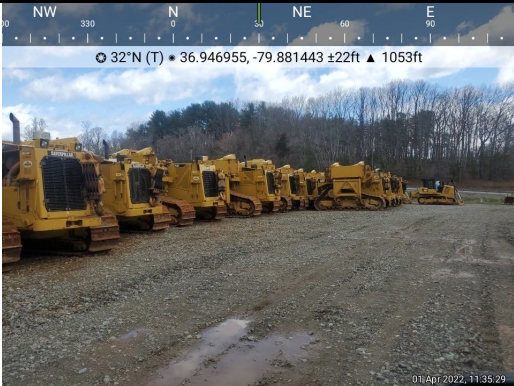
GPS Location	0	GPS Location	0		
Field Station#	0+00	Field Station#	0+00		
Pic 5 Desc.	LY-032 Equipment staging		Pic 6 Desc.	LY-032 Waste management

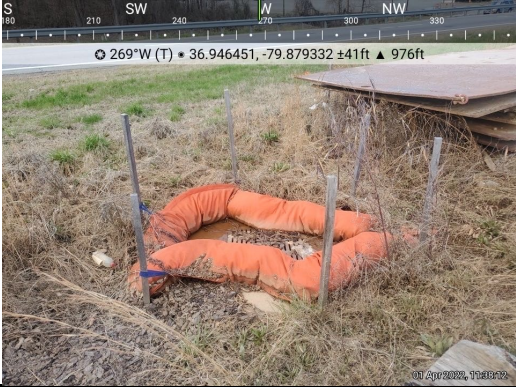
GPS Location	0	GPS Location	0		
Field Station#	0+00	Field Station#	0+00		
Pic 7 Desc.	LY-033 Stormwater drain inlet protection	Pic 8 Desc.	LY-033 RCE and Timber mats		
Insert image here		Insert image here			
GPS Location		GPS Location			
Field Station#		Field Station#			
Pic 9 Desc.		Pic 10 Desc.			
Insert image here		Insert image here			
GPS Location		GPS Location			
Field Station#		Field Station#			
Pic 11 Desc.		Pic 12 Desc.

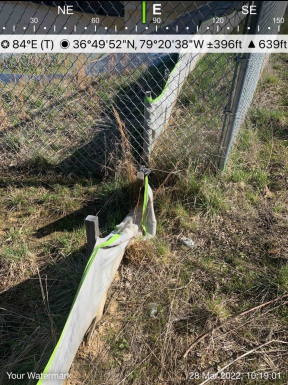
GPS Location	O	GPS Location	O		
Field Station#	00+00	Field Station#	00+00		
Pic 1 Desc.	Observing P1 that requires maintenance		Pic 2 Desc.	Observing P1 that requires maintenance

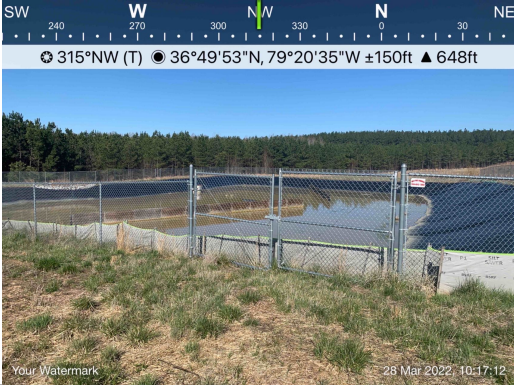
GPS Location	O	GPS Location	O		
Field Station#	00+00	Field Station#	00+00		
Pic 3 Desc.	Observing temporary stabilization, storm water pond and ECD's		Pic 4 Desc.	Observing temporary stabilization, rock drain, erosion control blanket and cfs checks

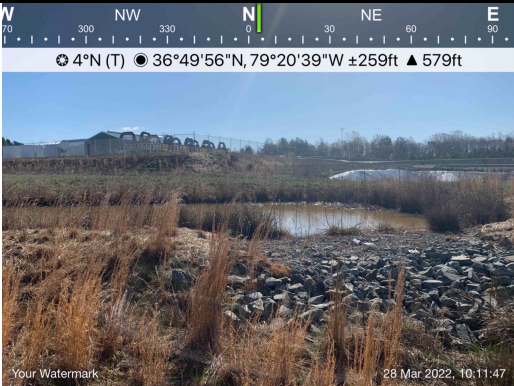
GPS Location	O	GPS Location	O		
Field Station#	00+00	Field Station#	00+00		
Pic 5 Desc.	Observing temporary stabilization, sediment basin and overflow		Pic 6 Desc.	Observing temporary stabilization, CFS Checks and ECD's
