Visual Site Inspection Report

Project Name	H-600 Pipeline Spread I		AFE	124300139	Spread	H-600 Pipeline Spread I	
Contractor	Precision				Report #	35192	
Inspector	Ben Davenport				Date/Time	3/7/2022 2:36 PM	
Permit #	TBD	Inspection Type	VA SWPP		Station Begin	14311+57	
State	VA	Inspection Area	Partial		Station End	14454+22	
County	Franklin	Ground	Dry		Temperature (°F)	70.00	
Municipality	N/A	Weather	Cloudy		Rain Gauge (in)	0.00	
					Rain Accumulation Time (days)	0.00

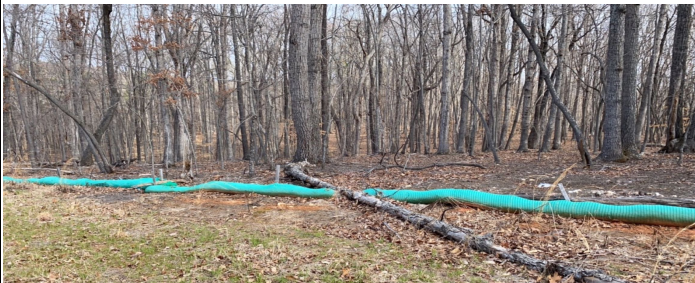
Pic 3 Desc.	Routine maintenance. Fallen tree down on perimeter CFS.		Pic 4 Desc.	Routine maintenance. Fallen tree down on perimeter CFS.

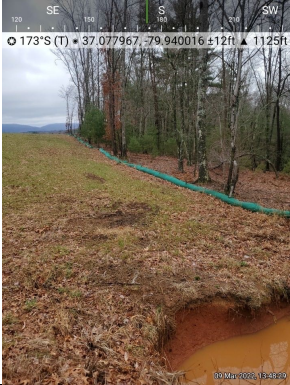
GPS Location	0	GPS Location	0		
Field Station#	13735+00	Field Station#	13740+00		
Pic 13 Desc.	Perimeter CFS and sump	Pic 14 Desc.	Permanent vegetation		
Insert image here		Insert image here			
GPS Location		GPS Location			
Field Station#		Field Station#			
Pic 15 Desc.		Pic 16 Desc.			
Insert image here		Insert image here			
GPS Location		GPS Location			
Field Station#		Field Station#			
Pic 17 Desc.		Pic 18 Desc.

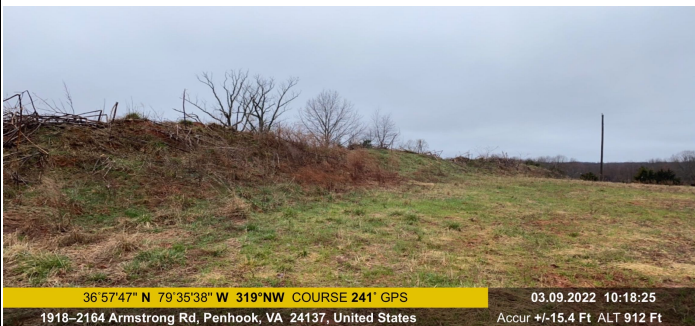
GPS Location	5	GPS Location	6		
Field Station#	15060+00	Field Station#	15063+85		
Pic 5 Desc.	Temporary diversion berm stabilized and vegetated along perimeter of ROW.	Pic 6 Desc.	Water ponding at approach on Armstrong Rd but causing no issues. Will monitor area.

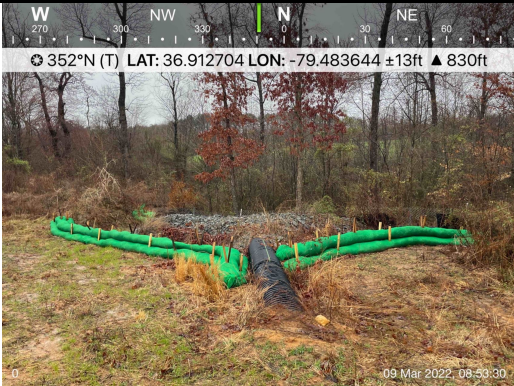
GPS Location	See photo		GPS Location	See photo	
Field Station#	15460+81		Field Station#	15457+00	
Pic 5 Desc.	CWD is functioning as intended		Pic 6 Desc.	No evidence of sedimentation into drainage feature.

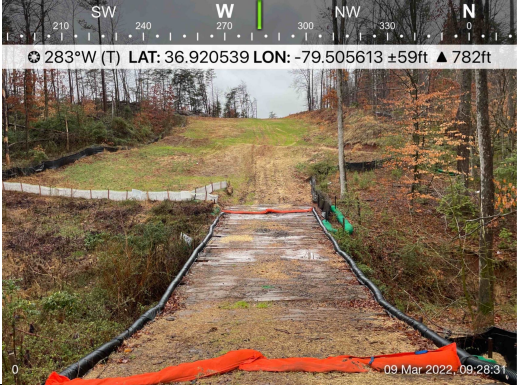
GPS Location	See photo	GPS Location	See photo		
Field Station#	15384+74	Field Station#	15381+00		
Pic 13 Desc.	Equipment bridge ECDs are in place and functioning	Pic 14 Desc.	Waterbars are functioning as intended

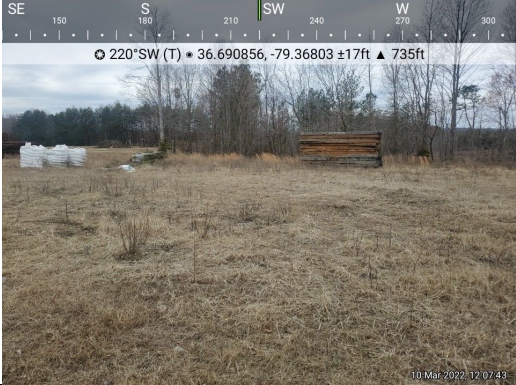
GPS Location	0	GPS Location	0		
Field Station#	0+00	Field Station#	0+00		
Pic 7 Desc.	LY-048 Temporary vegetation	Pic 8 Desc.	LY-048 West perimeter CFS		
Insert image here		Insert image here			
GPS Location		GPS Location			
Field Station#		Field Station#			
Pic 9 Desc.		Pic 10 Desc.			
Insert image here		Insert image here			
GPS Location		GPS Location			
Field Station#		Field Station#			
Pic 11 Desc.		Pic 12 Desc.

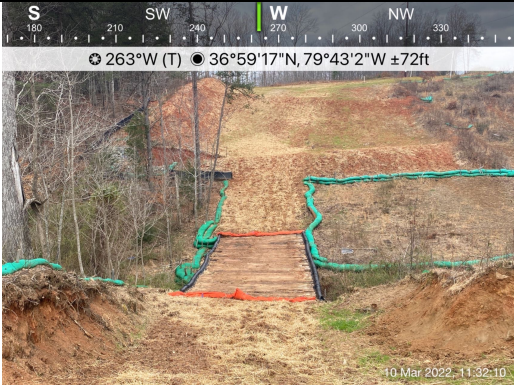
GPS Location	0	GPS Location	0		
Field Station#	14673+10	Field Station#	14680+40		
Pic 3 Desc.	Approximately 14673+10. Overview of stream crossing, equipment bridge and ECDs at stream S-H37. Livestock in area.	Pic 4 Desc.	Approximately 14680+40. Overview of stream crossing, equipment bridge and ECDs at stream S-H36.

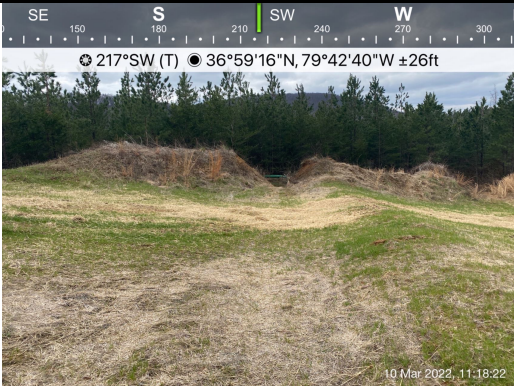
GPS Location	0	GPS Location	0		
Field Station#	14691+00	Field Station#	14694+40		
Pic 5 Desc.	Approximately 14691+00. Overview of ROW.	Pic 6 Desc.	Approximately 14694+40. Overview of road crossing and RCE.

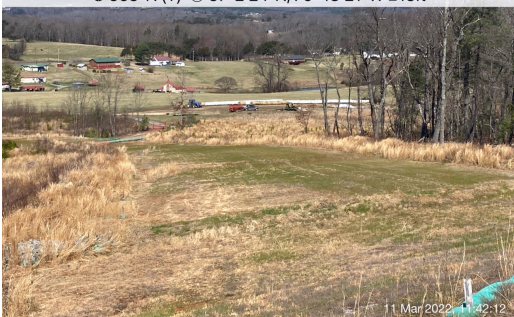
GPS Location	0	GPS Location	0		
Field Station#	14326+00	Field Station#	14416+00		
Pic 3 Desc.	Approximately 14326+00. Overview of ROW.		Pic 4 Desc.	Approximately 14416+00. Overview of ROW.

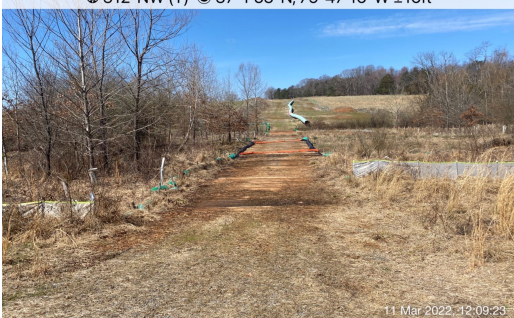
GPS Location	0	GPS Location	0		
Field Station#	14391+50	Field Station#	14394+00		
Pic 5 Desc.	Approximately 14391+50. Overview of stream crossing, equipment bridge and ECDs at stream S-A41.		Pic 6 Desc.	Approximately 14394+00. SSF requires maintenance.

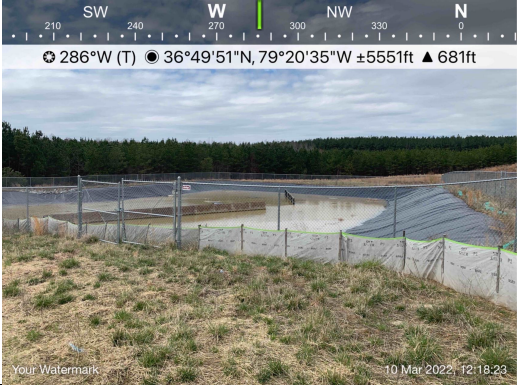
Insert image here			
GPS Location	O	GPS Location			
Field Station#	00+00	Field Station#			
Pic 7 Desc.	Observing storm water pond and ECD's	Pic 8 Desc.			
Insert image here		Insert image here			
GPS Location		GPS Location			
Field Station#		Field Station#			
Pic 9 Desc.		Pic 10 Desc.			
Insert image here		Insert image here			
GPS Location		GPS Location			
Field Station#		Field Station#			
Pic 11 Desc.		Pic 12 Desc.
