Visual Site Inspection Report

Project Name	H-600 Pipeline Spread G	AFE	124300137	Spread	H-600 Pipeline Spread G
Contractor	Precision			Report #	36425
Inspector	Eric Hanlon			Date/Time	4/11/2022 7:33 AM
Permit #	TBD	Inspection Type	VA SWPP	Station Begin	11184+85
State	VA	Inspection Area	Full	Station End	11254+99
County	Giles	Ground	Muddy	Temperature (°F)	60.00
Municipality	N/A	Weather	Sunny	Rain Gauge (in)	0.00
				Rain Accumulation Time (days)	1.00

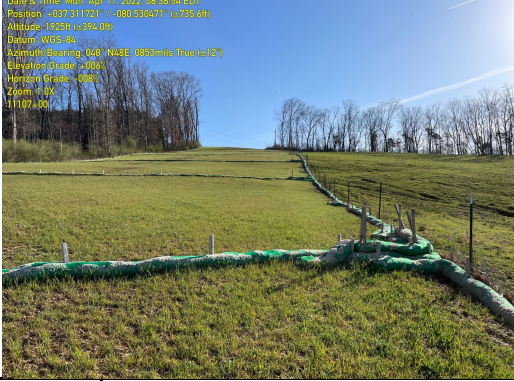
GPS Location	See photo	GPS Location	See photo		
Field Station#	11107+00	Field Station#	11112+00		
Pic 1 Desc.	CFS end treatments in place	Pic 2 Desc.	Triple stack CFS perimeter control in place		
<p>Date & Time: Mon, Apr 11, 2022, 09:53:04 EDT Position: +037.315629° / +080.526620° (+47.91%) Altitude: 19980 (+78.78) Datum: WGS-84 Azimuth/Bearing: 270° (000mils True (+12°)) Elevation Grade: +010 Horizon Grade: +000 Zoom: 1.0x 11120+00</p>

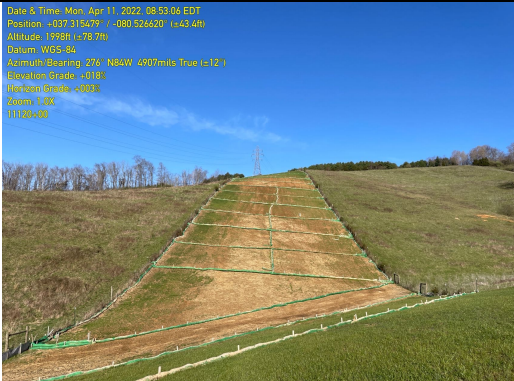
GPS Location	See photo	GPS Location	See photo		
Field Station#	11120+00	Field Station#	11141+00		
Pic 3 Desc.	Temporary CFS waterbars in place	Pic 4 Desc.	Permanent vegetation present		
<p>Date & Time: Mon, Apr 11, 2022, 09:14:30 EDT Position: +037.315624° / +080.517839° (+47.91%) Altitude: 20630 (+26.21) Datum: WGS-84 Azimuth/Bearing: 142° (S19E 2880mils True (+12°)) Elevation Grade: +040 Horizon Grade: +000 Zoom: 1.0x 11146+00</p>

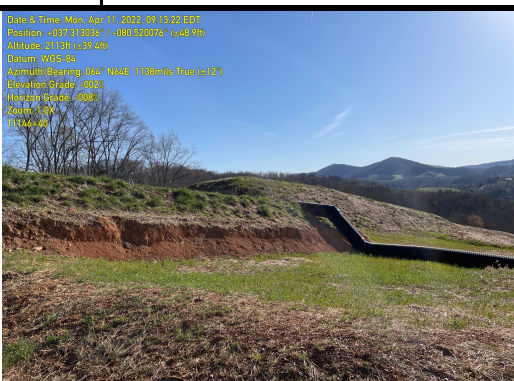
GPS Location	See photo	GPS Location	See photo		
Field Station#	11146+40	Field Station#	11148+00		
Pic 5 Desc.	Cleanwater diversion berm in place	Pic 6 Desc.	Supersilt fence perimeter control in place

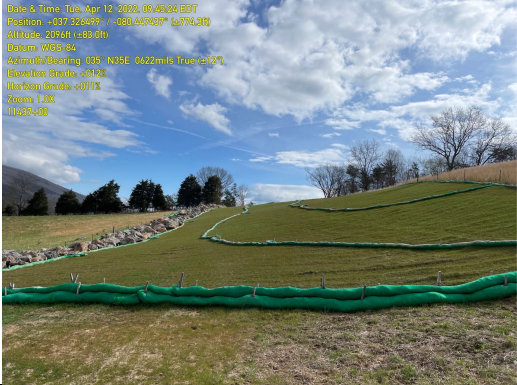
GPS Location	See photo	GPS Location	See photo		
Field Station#	11437+00	Field Station#	11448+00		
Pic 7 Desc.	Permanent vegetation present	Pic 8 Desc.	Cleanwater diversion berm in place		
<p>Date & Time: Tue, Apr 12, 2022, 09:38:00 EDT Position: +337.324780° / -920.440437° (s=11.40) Altitude: 2140ft (s=9.00) Datum: WGS-84 Azimuth/Bearing: 201° S21W 4449mN True (s=12°) Elevation Grade: +02% Horizon Grade: +00% Zoom: 1.0X 11452+00</p>

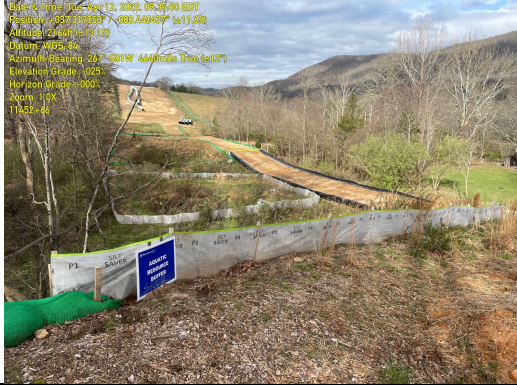
GPS Location	See photo	GPS Location	See photo		
Field Station#	11452+66	Field Station#	11461+00		
Pic 9 Desc.	Stream buffer in place	Pic 10 Desc.	CFS perimeter control in place		
<p>Date & Time: Tue, Apr 12, 2022, 09:28:36 EDT Position: +337.320265° / -920.436775° (s=15.10) Altitude: 2251ft (s=17.00) Datum: WGS-84 Azimuth/Bearing: 279° N89W 4899mN True (s=12°) Elevation Grade: +6% Horizon Grade: +000% Zoom: 1.0X 11466+00</p>

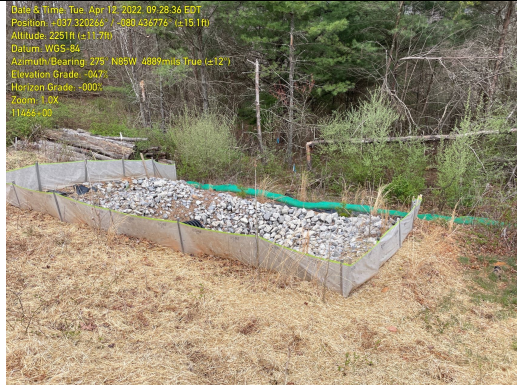
GPS Location	See photo	GPS Location	See photo		
Field Station#	11466+00	Field Station#	11469+00		
Pic 11 Desc.	Plunge pool in place	Pic 12 Desc.	Triple protection ECDs in place at karst feature

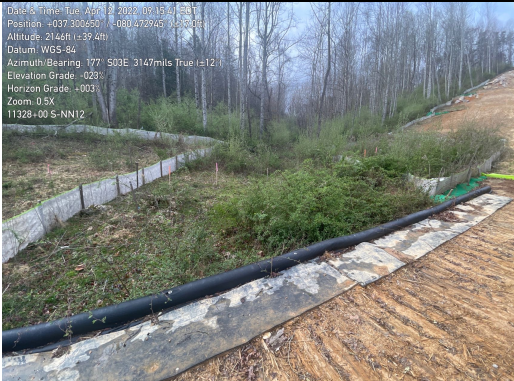
GPS Location	See Photo	GPS Location	See Photo		
Field Station#	11328+00	Field Station#	11282+00		
Pic 3 Desc.	S-NN12	Pic 4 Desc.	Sump pit and slope drain

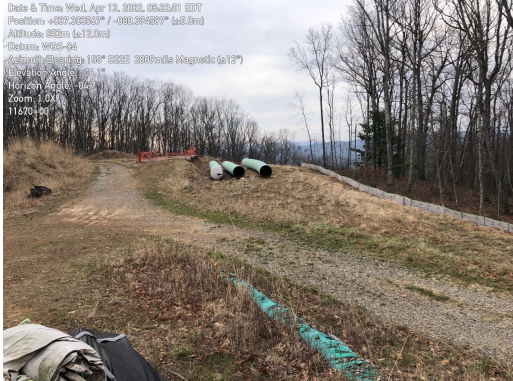
<p>Date & Time: Wed, Apr 13, 2022, 08:37:07 EDT Position: +037.30241° / -080.395427° (±5.0m) Altitude: 813m (±16.0m) Datum: WGS-84 Azimuth/Bearing: 053° N53E 0942mils Magnetic (±12°) Elevation Angle: -36.9° Horizon Angle: -07.5° Zoom: 1.0X 11665+50</p>			
GPS Location	On photo		GPS Location	On photo	
Field Station#	11670+00		Field Station#	11665+50	
Pic 1 Desc.	Top of Brush Mountain currently stable.		Pic 2 Desc.	COMMUNICATION, repair torn SSF fabric.

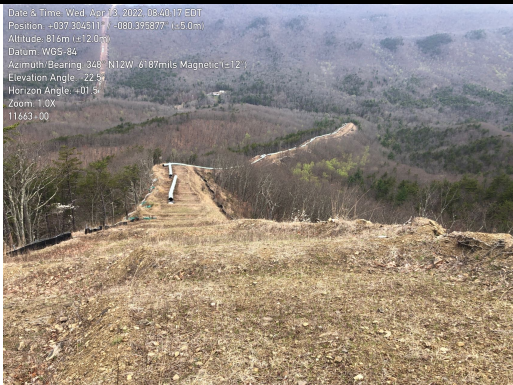
GPS Location	On photo		GPS Location	On photo	
Field Station#	11663+00		Field Station#	11660+00	
Pic 3 Desc.	Slope breakers in place and functioning properly.		Pic 4 Desc.	Perimeter ECDs in good condition.

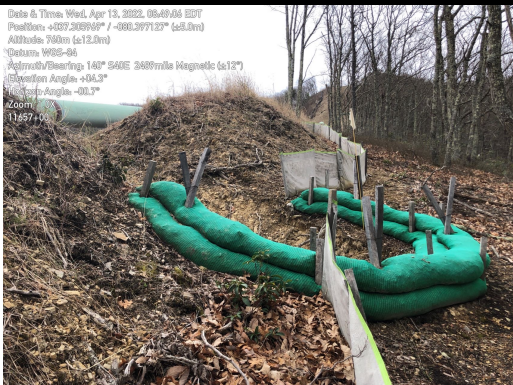
<p>Date & Time: Wed, Apr 13, 2022, 08:50:00 EDT Position: +037.30451° / -080.39701° (±5.0m) Altitude: 746m (±4.0m) Datum: WGS-84 Azimuth/Bearing: 336° N24W 3373mils Magnetic (±12°) Elevation Angle: -29.0° Horizon Angle: -00.1° Zoom: 1.0X 11656+00</p>			
GPS Location	On photo		GPS Location	On photo	
Field Station#	11657+00		Field Station#	11656+00	
Pic 5 Desc.	Perimeter ECDs in place, functional.		Pic 6 Desc.	CFS is worn on JNF and will be replaced before any ground disturbance occurs.

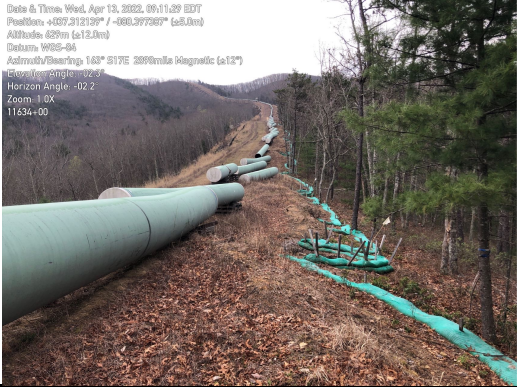
GPS Location	On photo	GPS Location	On photo		
Field Station#	11634+00	Field Station#	11630+00		
Pic 7 Desc.	ROW stable. Slope breakers controlling runoff.	Pic 8 Desc.	ECDs functional.		
<p>Date & Time: Wed, Apr 13, 2022 09:19:57 EDT Position: +037.313810° / -080.395578° (±5.0m) Altitude: 590m (±10.0m) Datum: WGS-84 Azimuth/Bearing: 238° S58W 4631mils Magnetic (±12°) Elevation Angle: -24.0° Horizon Angle: -00.8° Zoom: 1.0X 11626+50</p>

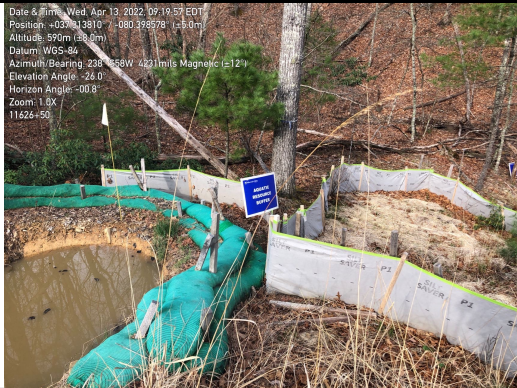
GPS Location	On photo	GPS Location	On photo		
Field Station#	11626+50	Field Station#	11626+04		
Pic 9 Desc.	ECDs in place.	Pic 10 Desc.	Resource buffers stable at the S-HH18 crossing.		
<p>Date & Time: Wed, Apr 13, 2022 09:23:51 EDT Position: +037.314075° / -080.401431° (±10.0m) Altitude: 594m (±24.0m) Datum: WGS-84 Azimuth/Bearing: 264° S86W 4728mils Magnetic (±13°) Elevation Angle: -15.9° Horizon Angle: -05.5° Zoom: 1.0X 11618+00</p>

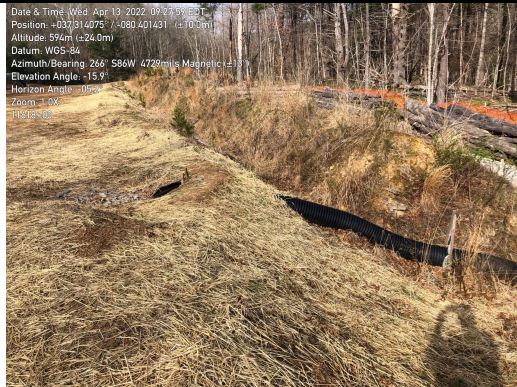
<p>Date & Time: Wed, Apr 13, 2022 09:29:58 EDT Position: +037.313625° / -080.401930° (±30.0m) Altitude: 596m (±12.0m) Datum: WGS-84 Azimuth/Bearing: 342° S42°W 6080mils Magnetic (±13°) Elevation Angle: -08.2° Horizon Angle: -00.8° Zoom: 1.0X 11614+75</p>  			
GPS Location	On photo	GPS Location	On		
Field Station#	11618+00	Field Station#	11614+75		
Pic 11 Desc.	ECDs functional.	Pic 12 Desc.	Perimeter ECDs in place.

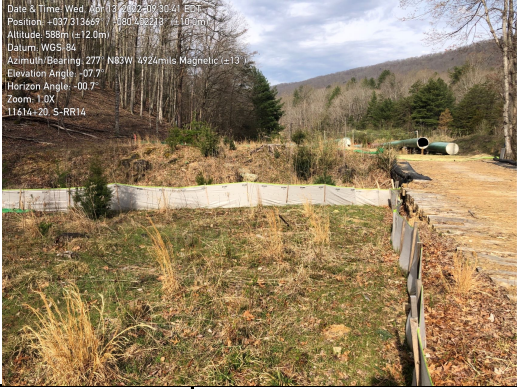
GPS Location	On photo	GPS Location	On photo		
Field Station#	11614+20	Field Station#	11608+17		
Pic 13 Desc.	The S-RR14 crossing is stable.	Pic 14 Desc.	The S-006 crossing is currently stable.		
Insert image here		Insert image here			
GPS Location		GPS Location			
Field Station#		Field Station#			
Pic 15 Desc.		Pic 16 Desc.

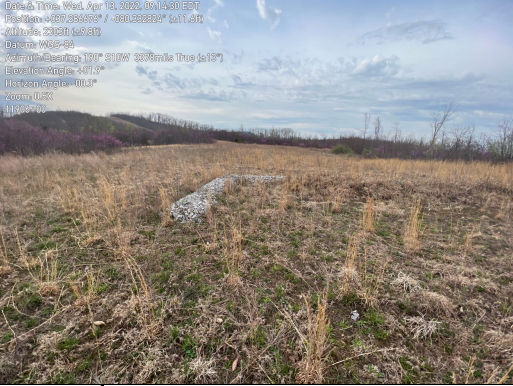
GPS Location	See Photo		GPS Location	See Photo	
Field Station#	11905+00		Field Station#	11906+00	
Pic 1 Desc.	Section of ROW showing conditions and controls		Pic 2 Desc.	Level Spreader	
<p>Date & Time: Wed, Apr 13, 2022 09:34:45 EDT Position: +437.237122° / -80.334328° (±12.11) Altitude: 2163 ft (±1.21) Datum: WGS-84 Azimuth/Bearing: 301° 28'W 338mils True (±10°) Elevation Angle: +03.3° Horizon Angle: -03.3° Zoom: 0.5X 11929+78</p>

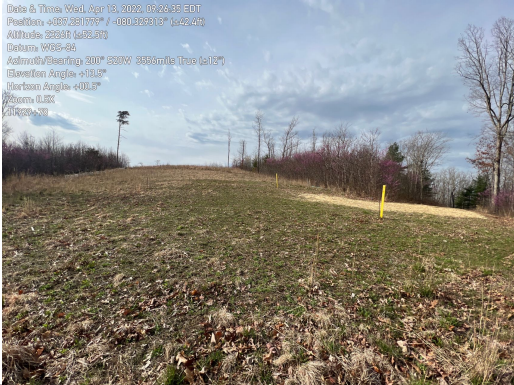
GPS Location	See Photo		GPS Location	See Photo	
Field Station#	11929+78		Field Station#	11945+00	
Pic 3 Desc.	Access 266		Pic 4 Desc.	Waterbars	
<p>Date & Time: Wed, Apr 13, 2022 10:07:42 EDT Position: +437.237122° / -80.334328° (±12.11) Altitude: 1630 ft (±3.44) Datum: WGS-84 Azimuth/Bearing: 020° N03E 302mils True (±10°) Elevation Angle: +1.1° Horizon Angle: -02.2° Zoom: 0.5X 11979+86</p>

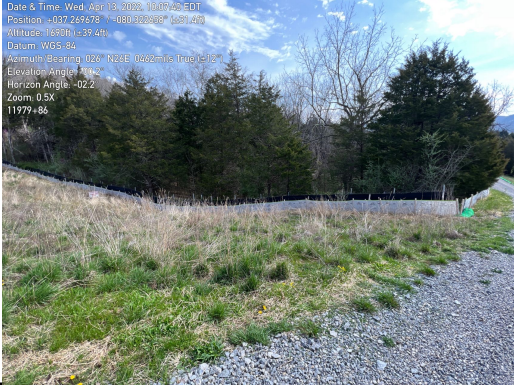
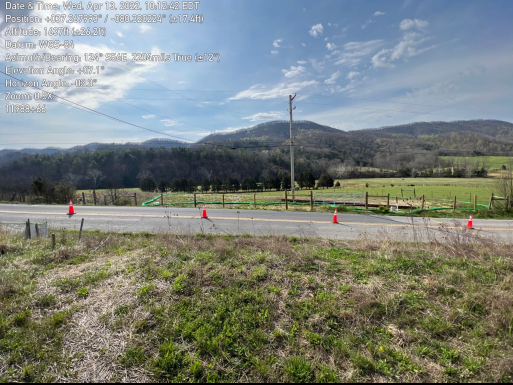
GPS Location	See Photo		GPS Location	See Photo	
Field Station#	11979+86		Field Station#	11988+66	
Pic 5 Desc.	Karst Protection ECDs		Pic 6 Desc.	Catawba Road Crossing

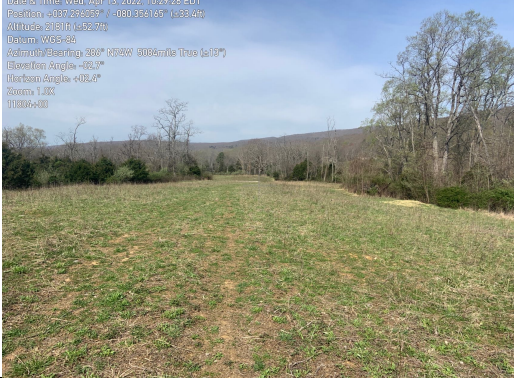
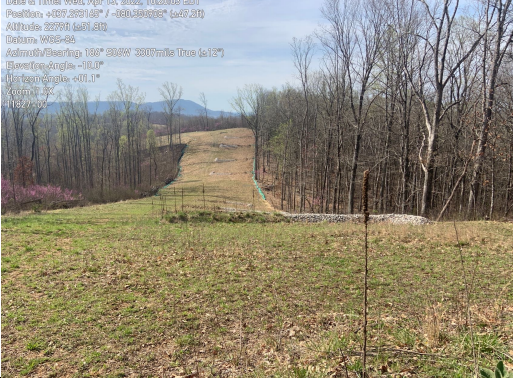
GPS Location	See photo	GPS Location	See photo		
Field Station#	11804+00	Field Station#	11827+00		
Pic 1 Desc.	Section of Row showing conditions	Pic 2 Desc.	Section of Row showing conditions and controls		
<p>Date & Time: Wed, Apr 13, 2022, 10:14:35 EDT Position: +387 289550 / +380 345731 (e49.1ft) Altitude: 2271 ft (692.3m) Datum: WGS-84 Azimuth/Bearing: 111° SSW 330/mile True (e1.6°) Elevation Angle: -17.2° Horizon Angle: +01.3° Zoom: 1.0x 11835+00</p>

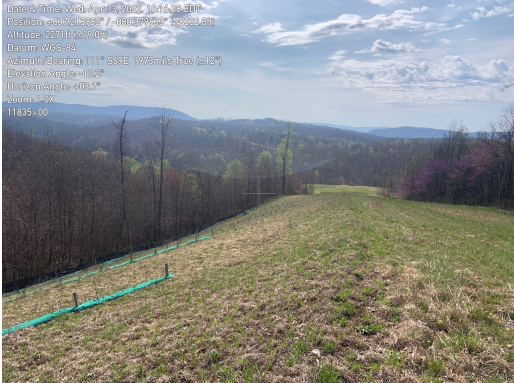
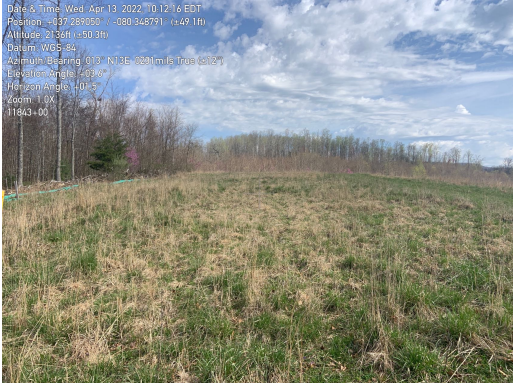
GPS Location	See photo	GPS Location	See photo		
Field Station#	11835+00	Field Station#	11843+00		
Pic 3 Desc.	Section of Row showing conditions and controls	Pic 4 Desc.	Section of Row showing conditions and controls		
<p>Date & Time: Wed, Apr 13, 2022, 10:09:55 EDT Position: +387 289547 / +380 345731 (e49.1ft) Altitude: 2234 ft (e68.0m) Datum: WGS-84 Azimuth/Bearing: 35° N57W 330/mile True (e1.6°) Elevation Angle: -11.6° Horizon Angle: +00.6° Zoom: 1.0x 11855+00</p>

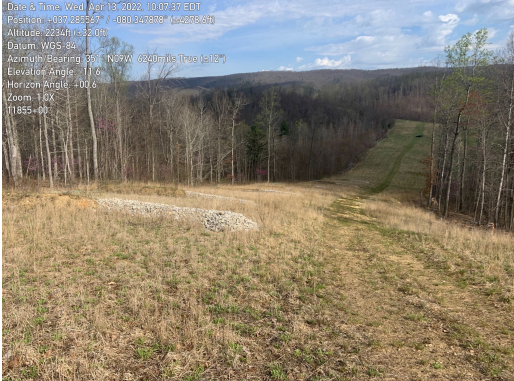
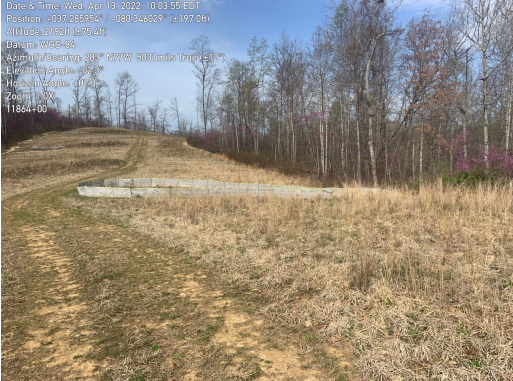
GPS Location	See photo	GPS Location	See photo		
Field Station#	11855+00	Field Station#	11864+00		
Pic 5 Desc.	Section of Row showing conditions and controls	Pic 6 Desc.	Section of Row showing conditions and controls at P-KL2

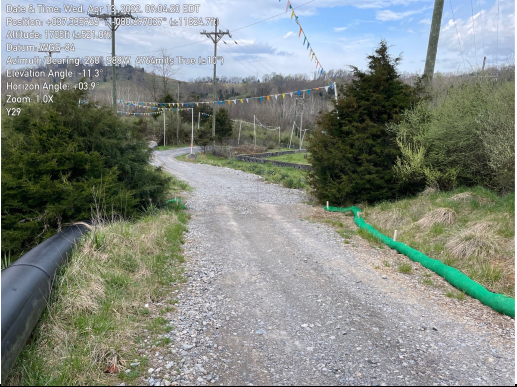
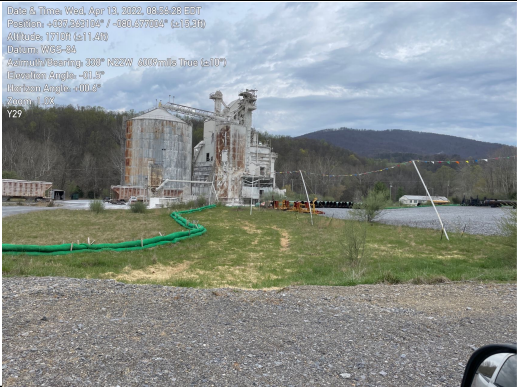
GPS Location	See photo	GPS Location	See photo		
Field Station#	12005+00	Field Station#	12005+00		
Pic 15 Desc.	Secondary containment in place y29	Pic 16 Desc.	Housekeeping trash in good y29

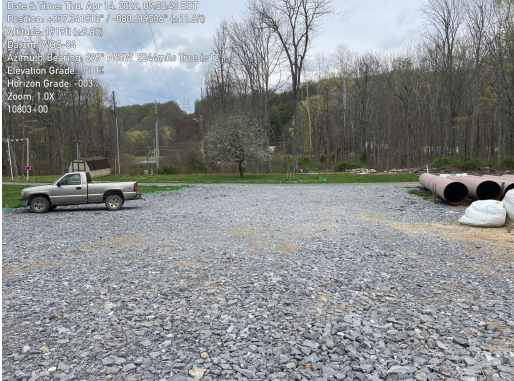
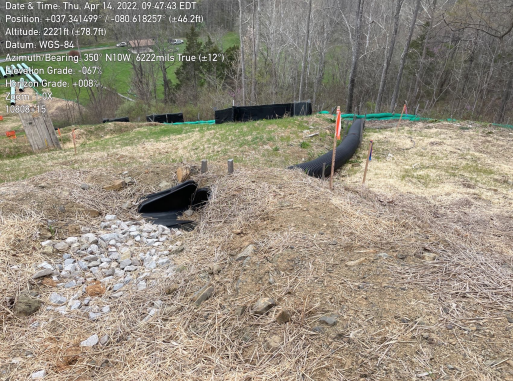
<p>Date & Time: Thu, Apr 14, 2022, 09:47:43 EDT Position: +387 341499 / -680 618237 (+46.21) Altitude: 2221ft (+78.7m) Datum: WGS-84 Azimuth: Bearing: 350° N10W 6222mils True (+12°) Elevation Grade: -067% Horizon Grade: +008% Zoom: 1.0X 10803+00</p>			
GPS Location	See photo		GPS Location	See photo	
Field Station#	10803+00		Field Station#	10808+15	
Pic 1 Desc.	RCE in place		Pic 2 Desc.	Stone inlet protection in place

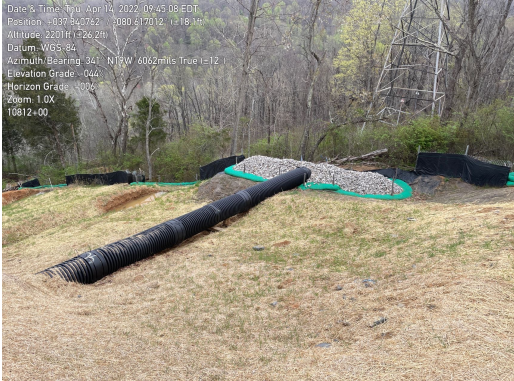
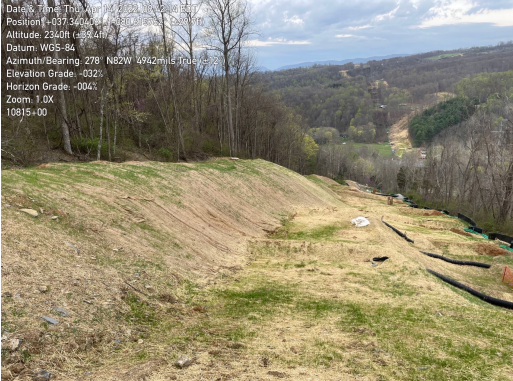
GPS Location	See photo		GPS Location	See photo	
Field Station#	10812+00		Field Station#	10815+00	
Pic 3 Desc.	Cleanwater diversion outlet protection in place		Pic 4 Desc.	Erosion control blanket in place

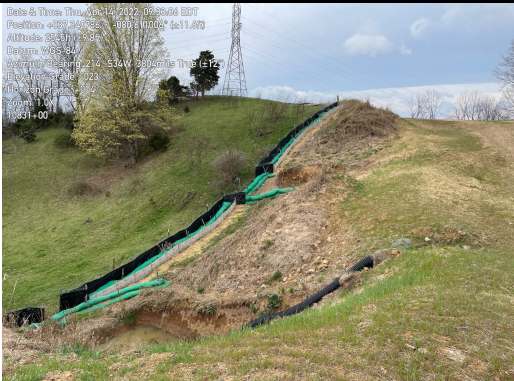
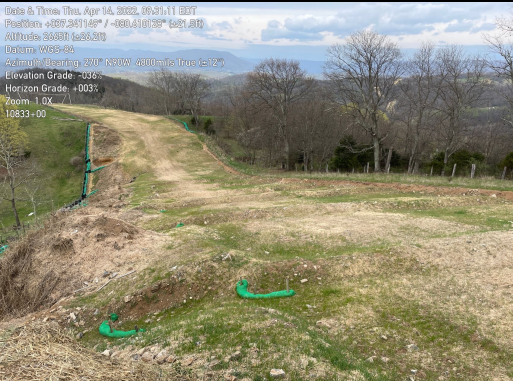
<p>Date & Time: Thu, Apr 14, 2022, 09:45:11 EDT Position: +387 341499 / -680 618237 (+46.21) Altitude: 2221ft (+78.7m) Datum: WGS-84 Azimuth: Bearing: 350° N10W 6222mils True (+12°) Elevation Grade: -067% Horizon Grade: +008% Zoom: 1.0X 10833+00</p>			
GPS Location	See photo		GPS Location	See photo	
Field Station#	10831+00		Field Station#	10833+00	
Pic 5 Desc.	Triple protection ECDs in place at karst feature		Pic 6 Desc.	Waterbars in place

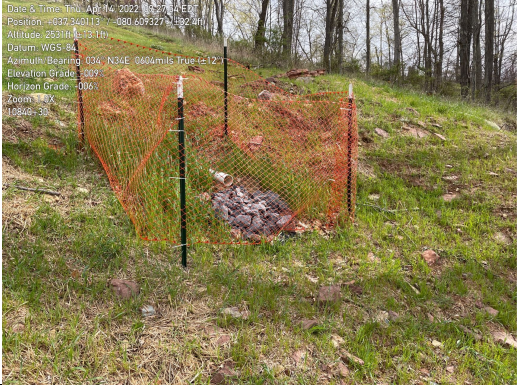
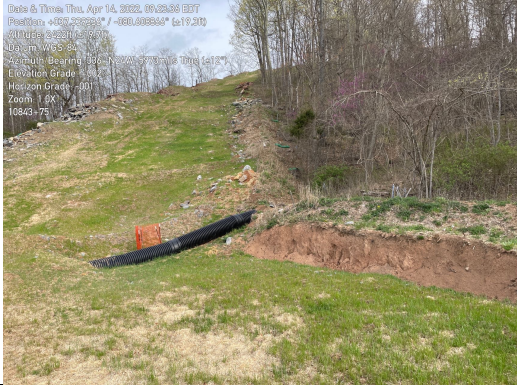
<p>Date & Time: Thu, Apr 14, 2022, 09:55:38 EDT Position: +037.339551, -080.608844, +119.210m Altitude: 2328ft (+1208ft) Datum: WGS-84 Azimuth/Bearing: 036° N36E 0573mils True (+12°) Elevation Grade: +009° Horizon Grade: +001° Zoom: 1.0X 10843+75</p>			
GPS Location	See photo	GPS Location	See photo		
Field Station#	10840+30	Field Station#	10843+75		
Pic 7 Desc.	Daylight drain in place	Pic 8 Desc.	Cleanwater diversion pipe in place

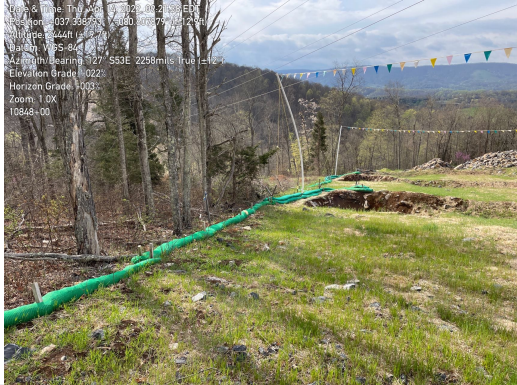
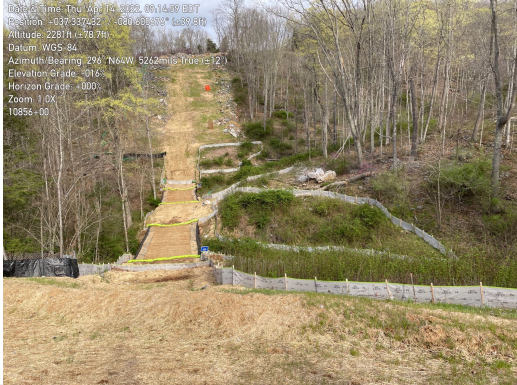
GPS Location	See photo	GPS Location	See photo		
Field Station#	10848+00	Field Station#	10856+00		
Pic 9 Desc.	CFS perimeter control in place	Pic 10 Desc.	Stream buffer in place

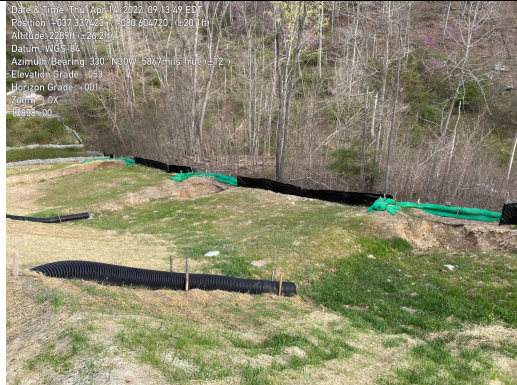
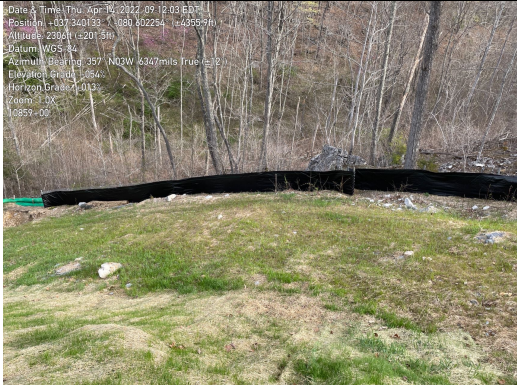
<p>Date & Time: Thu, Apr 14, 2022, 09:12:03 EDT Position: +037.340133, -080.602254, +139.959m Altitude: 2360ft (+1201ft) Datum: WGS-84 Azimuth/Bearing: 357° N03W 6307mils True (+12°) Elevation Grade: +054° Horizon Grade: +013° Zoom: 1.0X 10859+00</p>			
GPS Location	See photo	GPS Location	See photo		
Field Station#	10858+00	Field Station#	10859+00		
Pic 11 Desc.	End treatments in place	Pic 12 Desc.	Supersilt fence perimeter control in place

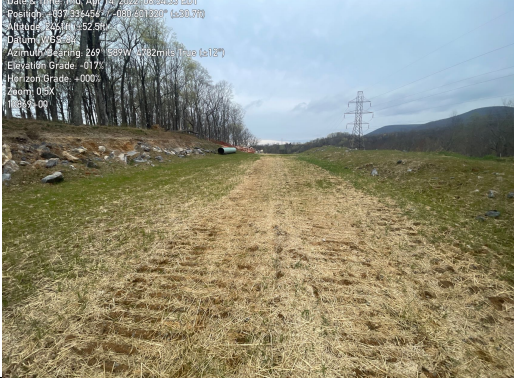
<p>Date & Time: Thu, Apr 14, 2022, 09:04:53 EDT Position: +037.332291 / -080.577671 (-15.7ft) Altitude: 2180ft (-39.4ft) Datum: WGS-84 Azimuth/Bearing: 269 S12E 232mils True (-18°) Elevation Angle: -017° Horizon Grade: +000° Zoom: 2.0x 10881+00</p>		  <p>Date & Time: Thu, Apr 14, 2022, 09:02:18 EDT Position: +037.332291 / -080.577671 (-15.7ft) Altitude: 2180ft (-39.4ft) Datum: WGS-84 Azimuth/Bearing: 168 S12E 2987mils True (-12°) Elevation Angle: -027° Horizon Grade: +010° Zoom: 2.0x 10881+20</p>			
GPS Location	See Photo		GPS Location	See Photo	
Field Station#	11869+00		Field Station#	10881+20	
Pic 1 Desc.	Stabilization		Pic 2 Desc.	Waterbar and CFS checks

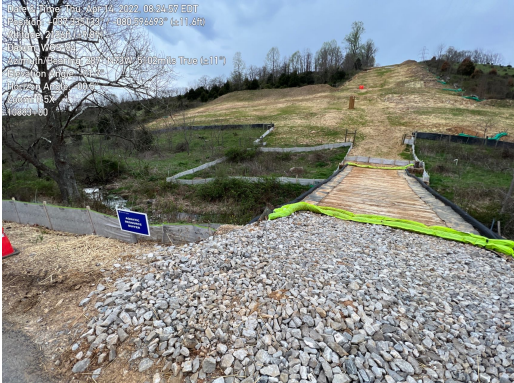
GPS Location	See Photo		GPS Location	See Photo	
Field Station#	10883+00		Field Station#	10887+75	
Pic 3 Desc.	S-A32		Pic 4 Desc.	Plunge Pool	
  <p>Date & Time: Thu, Apr 14, 2022, 08:43:57 EDT Position: +037.332291 / -080.577671 (-15.7ft) Altitude: 2257ft (-19.7ft) Datum: WGS-84 Azimuth/Bearing: 064 N45E 3630mils True (-12°) Elevation Angle: -015° Horizon Grade: +000° Zoom: 1.0x 10899+00</p>		  <p>Date & Time: Thu, Apr 14, 2022, 08:43:57 EDT Position: +037.332291 / -080.577671 (-15.7ft) Altitude: 2257ft (-19.7ft) Datum: WGS-84 Azimuth/Bearing: 064 N45E 3630mils True (-12°) Elevation Angle: -015° Horizon Grade: +000° Zoom: 1.0x 10899+00</p>			
GPS Location	See Photo		GPS Location	See Photo	
Field Station#	10888+50		Field Station#	10899+00	
Pic 5 Desc.	Erosion control blanket		Pic 6 Desc.	Perimeter controls

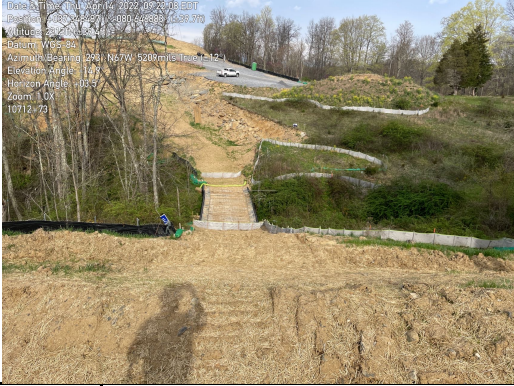
<p>Date & Time: Thu, Apr 14, 2022, 09:45:01 EDT Position: +037.342659, -080.622674 (+32.8H) Altitude: 2340ft (+39.4ft) Datum: WGS-84 Azimuth/Bearing: 107° S73E 1902mils True (+12°) Elevation Angle: 18.8° Horizon Angle: +00.3° Zoom: 1.0X 10712+73</p>

<p>Date & Time: Thu, Apr 14, 2022, 09:46:01 EDT Position: +037.342659, -080.622674 (+32.8H) Altitude: 2340ft (+39.4ft) Datum: WGS-84 Azimuth/Bearing: 107° S73E 1902mils True (+12°) Elevation Angle: 18.8° Horizon Angle: +00.3° Zoom: 1.0X 10729+82</p>		GPS Location	See photo
Field Station#	10712+73	Field Station#	10729+82	GPS Location	See photo
Pic 1 Desc.	Resource buffers in place	Pic 2 Desc.	Water bars and ET in place

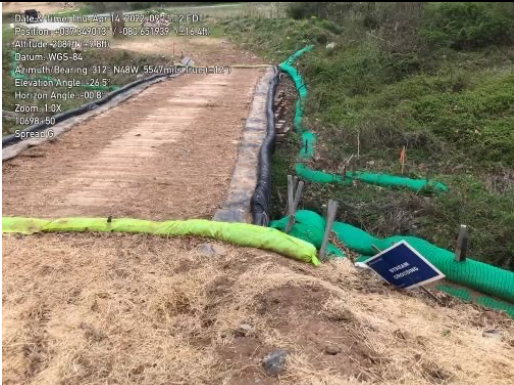
<p>Date & Time: Thu, Apr 14, 2022, 09:46:01 EDT Position: +037.342659, -080.622674 (+32.8H) Altitude: 2340ft (+39.4ft) Datum: WGS-84 Azimuth/Bearing: 107° S73E 1902mils True (+12°) Elevation Angle: 18.8° Horizon Angle: +00.3° Zoom: 1.0X 10698+50</p>

Field Station#	10698+50	Field Station#	10733+18	GPS Location	See photo
Pic 3 Desc.	Equipment bridge functional	Pic 4 Desc.	P1 and wattles in place

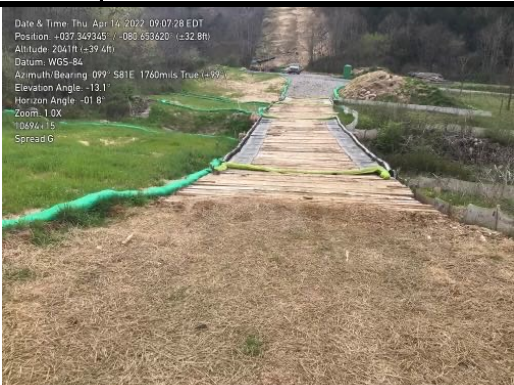
<p>Date & Time: Thu, Apr 14, 2022, 09:47:28 EDT Position: +037.342659, -080.622674 (+32.8H) Altitude: 2340ft (+39.4ft) Datum: WGS-84 Azimuth/Bearing: 107° S73E 1902mils True (+12°) Elevation Angle: 18.8° Horizon Angle: +00.3° Zoom: 1.0X 10694+15</p>

<p>Date & Time: Thu, Apr 14, 2022, 09:47:28 EDT Position: +037.342659, -080.622674 (+32.8H) Altitude: 2340ft (+39.4ft) Datum: WGS-84 Azimuth/Bearing: 107° S73E 1902mils True (+12°) Elevation Angle: 18.8° Horizon Angle: +00.3° Zoom: 1.0X 10742+69</p>		GPS Location	See photo
Field Station#	10694+15	Field Station#	10742+69	GPS Location	See photo
Pic 5 Desc.	Clean water drainage feature functional	Pic 6 Desc.	Clean water drainage feature functional

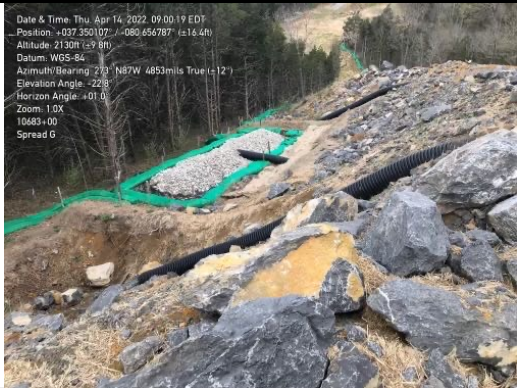
<div style="text-align: center;">Insert image here</div>			
GPS Location	See photo	GPS Location			
Field Station#	10683+00	Field Station#			
Pic 9 Desc.	Energy dissipater	Pic 10 Desc.			
<div style="text-align: center;">Insert image here</div>		<div style="text-align: center;">Insert image here</div>			
GPS Location		GPS Location			
Field Station#		Field Station#			
Pic 11 Desc.		Pic 12 Desc.

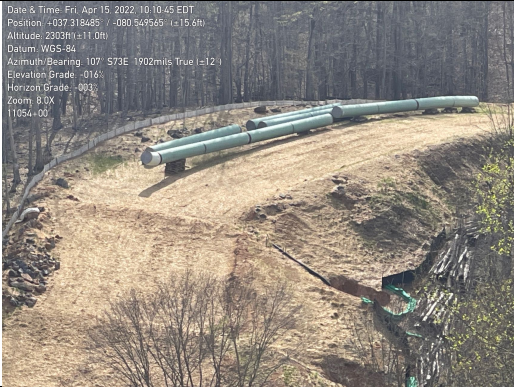
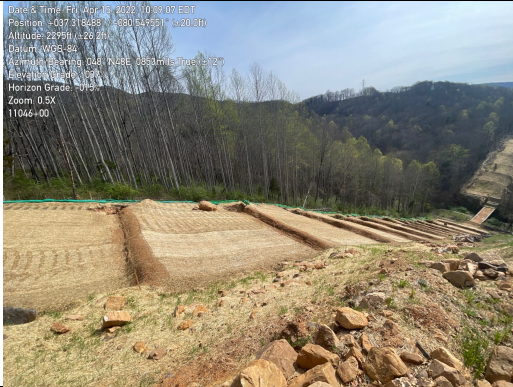
<p>Date & Time: Fri, Apr 15, 2022 10:10:50 EDT Position: +037.318485 / -080.549569 / ±15.6m Altitude: 2399m / ±20.0m Datum: WGS-84 Azimuth/Bearing: 044.806E 055mils True (±12) Elevation Grade: -016 Horizon Grade: -001 Zoom: 0.5X 11046+00</p>			
GPS Location	See Photo	GPS Location	See Photo		
Field Station#	11054+00	Field Station#	11046+00		
Pic 1 Desc.	Over view of temporary stabilization of row.	Pic 2 Desc.	Over view of additional stabilization of steep slope conditions with ECB and high velocity CC4 coconut blanket over the water bars.

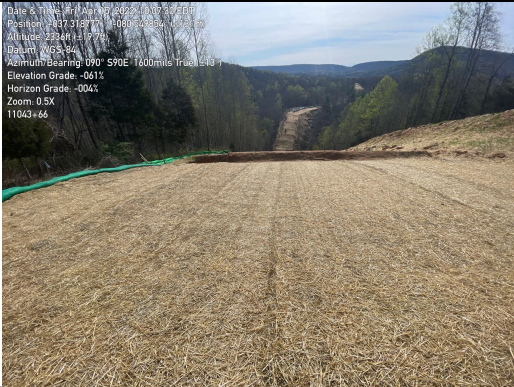
<p>Date & Time: Fri, Apr 15, 2022 10:40:06 EDT Position: +037.318485 / -080.549569 / ±15.6m Altitude: 2334m / ±19.0m Datum: WGS-84 Azimuth/Bearing: 090.590E 1600mils True (±12) Elevation Grade: -061 Horizon Grade: -004 Zoom: 0.5X 11043+66</p>

GPS Location	See Photo	GPS Location	See Photo		
Field Station#	11043+66	Field Station#	11038+00		
Pic 3 Desc.	View of re-worked sunken ditch line area with additional ECB stabilization.	Pic 4 Desc.	View of perimeter CFS and stabilized earthen berm.

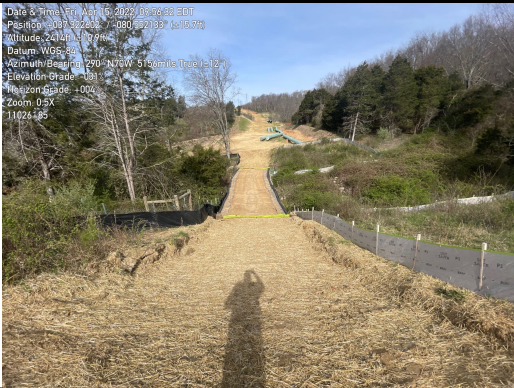
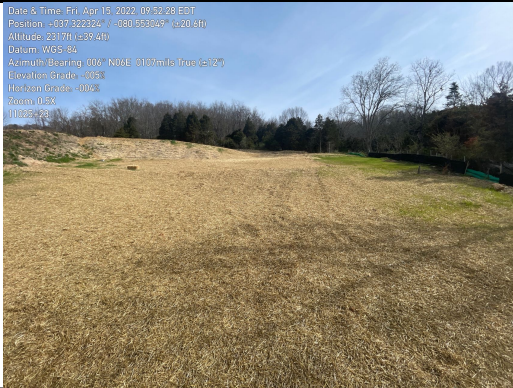
<p>Date & Time: Fri, Apr 15, 2022 09:32:28 EDT Position: +037.232224 / -080.538447 / ±20.4m Altitude: 2317m / ±29.4m Datum: WGS-84 Azimuth/Bearing: 006.310E 010mils True (±12) Elevation Grade: -052 Horizon Grade: -002 Zoom: 1.0X 11025+23</p>			
GPS Location	See Photo	GPS Location	1102523		
Field Station#	11026+85	Field Station#	11025+23		
Pic 5 Desc.	Over view of the S-IJ18 stream buffer zones and equipment bridge crossing conditions.	Pic 6 Desc.	AR 244 entrance to row. Travel lane has been recently temporary stabilized.

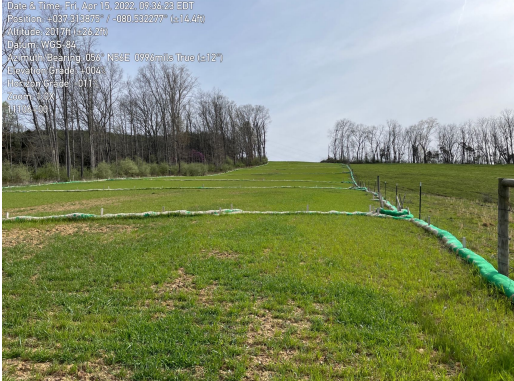
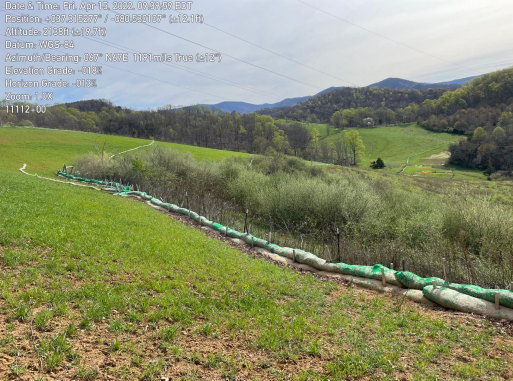
GPS Location	See photo	GPS Location	See photo		
Field Station#	11106+00	Field Station#	11112+00		
Pic 1 Desc.	CFS perimeter control in place	Pic 2 Desc.	CFS triple stack perimeter control in place

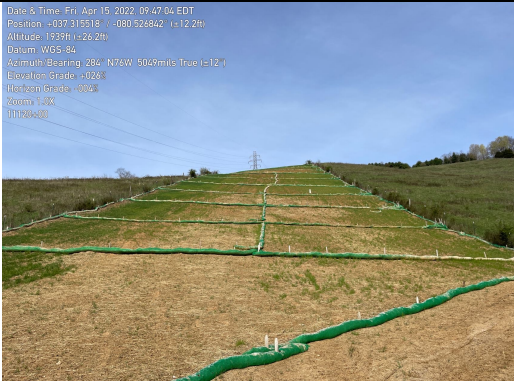
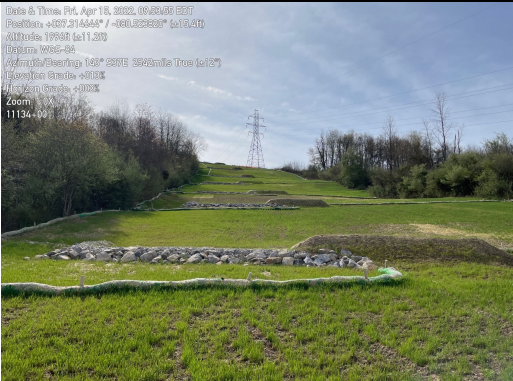
GPS Location	See photo	GPS Location	See photo		
Field Station#	11120+00	Field Station#	11134+00		
Pic 3 Desc.	Temporary CFS waterbars in place	Pic 4 Desc.	Permanent waterbars with level spreaders in place

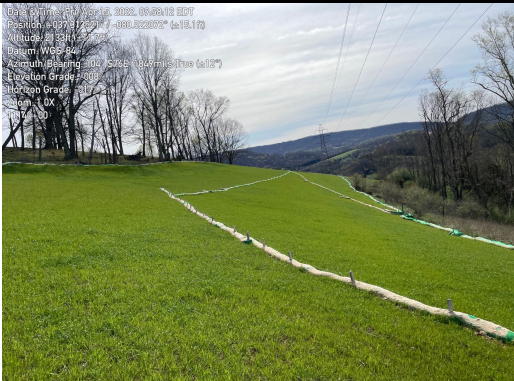
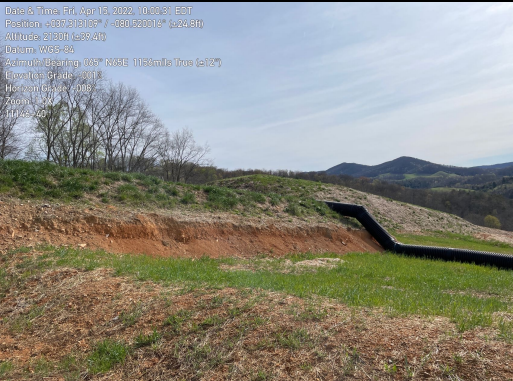
GPS Location	See photo	GPS Location	See photo		
Field Station#	11140+00	Field Station#	11146+00		
Pic 5 Desc.	Permanent vegetation present	Pic 6 Desc.	Cleanwater diversion berm in place
