Visual Site Inspection Report

Project Name	H-600 Pipeline Spread G	AFE	124300137	Spread	H-600 Pipeline Spread G
Contractor	Precision			Report #	36676
Inspector	Chris Burns			Date/Time	4/18/2022 9:02 AM
Permit #	TBD	Inspection Type	VA SWPP	Station Begin	11353+67
State	VA	Inspection Area	Partial	Station End	11471+56
County	Giles	Ground	Wet	Temperature (°F)	37.00
Municipality	N/A	Weather	Snow/Sleet	Rain Gauge (in)	0.00
				Rain Accumulation Time (days)	1.00

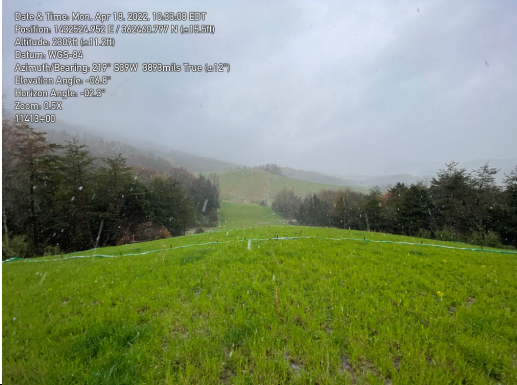
GPS Location	7	GPS Location	8		
Field Station#	11413+00	Field Station#	11405+00		
Pic 7 Desc.	Section of restored RoW showing conditions and controls.		Pic 8 Desc.	Section of restored RoW showing conditions and controls.	
<p><small>Date & Time: Mon, Apr 18, 2022, 11:44:58 EDT Position: 1429701.024 E / 367935.288 N (s15.70) Altitude: 2200ft (s15.10) Datum: WGS-84 Azimuth/Bearing: 297° WSW 516mils True (s12°) Horizon Angle: -05.4° Horizon Angle: -01.5° Zoom: 0.5X 11397+00</small></p>  		<p><small>Date & Time: Mon, Apr 18, 2022, 11:45:14 EDT Position: 1429703.576 E / 367937.288 N (s12.64.80) Altitude: 2175ft (s12.20) Datum: WGS-84 Azimuth/Bearing: 112° SSS 159mils True (s12°) Horizon Angle: -05.4° Horizon Angle: -02.0° Zoom: 0.5X 11385+50</small></p>

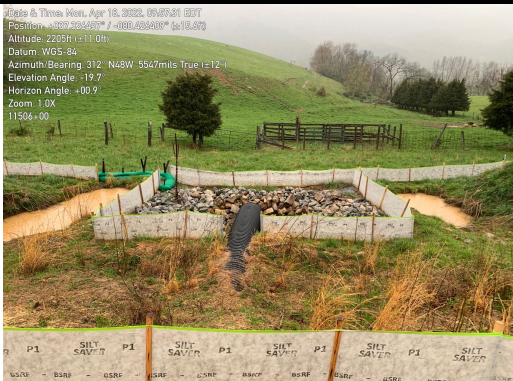
GPS Location	See photo.		
Field Station#	11506+00		
Pic 3 Desc.	Clean water diversion pipe and plunge pool in place.		
GPS Location		See photo.	
Field Station#		11504+00	
Pic 4 Desc.		Rock lined channel in place.	
<p>Date & Time Wed, Apr 13, 2022, 10:01:41 EDT Position: +389 222507 / +488 422675 (+10819.370) Altitude: 22270 (+2320ft) Datum: WGS-84 Azimuth/Bearing: 330° 53W 4438mils True (+12) Elevation Angle: +13.2 Horizon Angle: +00.0 Zoom: 1.0X 11497+00</p>

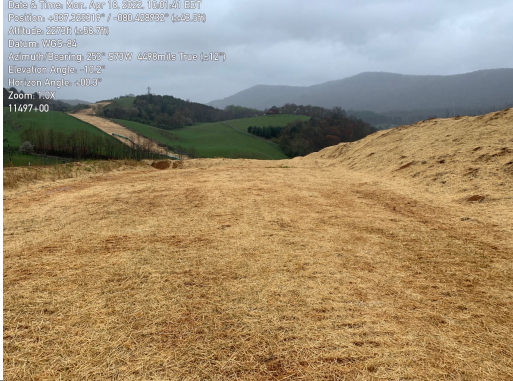
GPS Location	See photo.		
Field Station#	11497+00		
Pic 5 Desc.	ROW temporarily stabilized with seed and mulch.		
GPS Location		See photo.	
Field Station#		11490+00	
Pic 6 Desc.		RCE in place at Stevers Gap Road crossing.

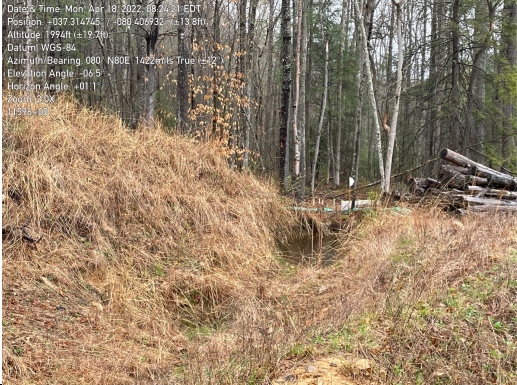
<p> <small> Date/Time: Mon Apr 18, 2022 08:24:50 EDT Position: +037 314725, -080 408532 (±18.1ft) Altitude: 1994ft (±12.1m) Datum: WGS-84 Azimuth/Bearing: 080° N80E 122mils True (±2°) Elevation Angle: +00.5° Horizon Angle: +01.1° Zoom: 1.0X 11596+00 </small> </p>			
GPS Location	See photo	GPS Location	See photo		
Field Station#	11588+00	Field Station#	11596+00		
Pic 7 Desc.	Resource buffers in place	Pic 8 Desc.	ET in place

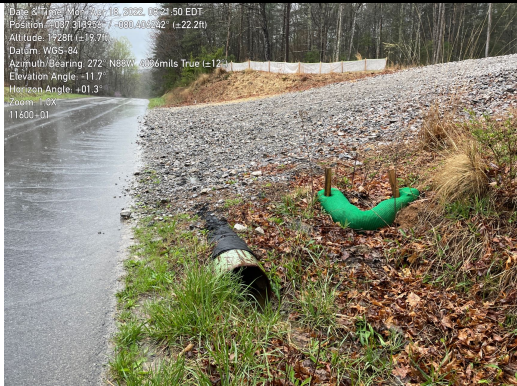
GPS Location	See photo	GPS Location			
Field Station#	11600+01	Field Station#			
Pic 9 Desc.	RCE functional Culvert in good condition	Pic 10 Desc.			
<p style="text-align: center;">Insert image here</p>		<p style="text-align: center;">Insert image here</p>			
GPS Location		GPS Location			
Field Station#		Field Station#			
Pic 11 Desc.		Pic 12 Desc.

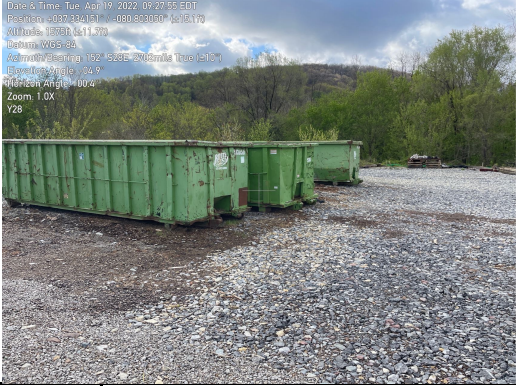
GPS Location	See photo	GPS Location	See photo		
Field Station#	12005+00	Field Station#	12005+00		
Pic 1 Desc.	Housekeeping trash in good condition y28	Pic 2 Desc.	CFS perimeter controls functional y28		
<p>Date & Time: Tue, Apr 19, 2022 09:26:46 EDT Position: +037.334873° / -86.860724° (+86.0ft) Altitude: 1571ft (+39.4ft) Datum: WGS-84 Azimuth Bearing: 184° S14W, 344mils True (+10°) Elevation Angle: -04.2° Horizon Angle: -02.6° Zoom: 1.0X Y28</p>

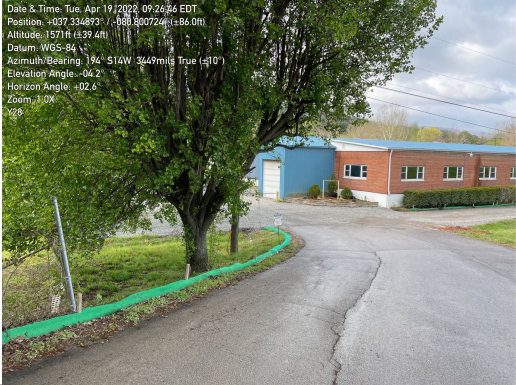
GPS Location	See photo	GPS Location	See photo		
Field Station#	12005+00	Field Station#	12005+00		
Pic 3 Desc.	CFS perimeter controls functional y28	Pic 4 Desc.	RCE functional y28		
<p>Date & Time: Tue, Apr 19, 2022 09:23:42 EDT Position: +037.334873° / -86.860724° (+86.0ft) Altitude: 1571ft (+39.4ft) Datum: WGS-84 Azimuth Bearing: 182° N42W, 341mils True (+10°) Elevation Angle: -03.5° Horizon Angle: -01.2° Zoom: 1.0X Y28</p>

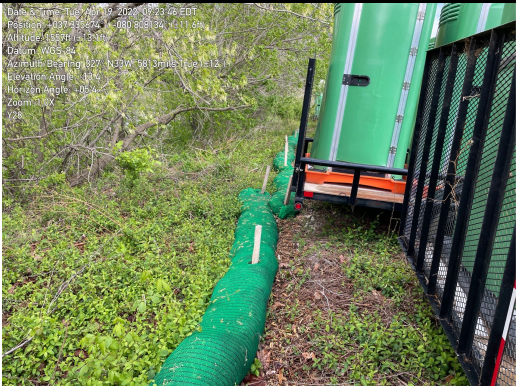
GPS Location	See photo	GPS Location	See photo		
Field Station#	12005+00	Field Station#	12005+00		
Pic 5 Desc.	CFS perimeter controls functional y28	Pic 6 Desc.	CFS perimeter controls functional y28

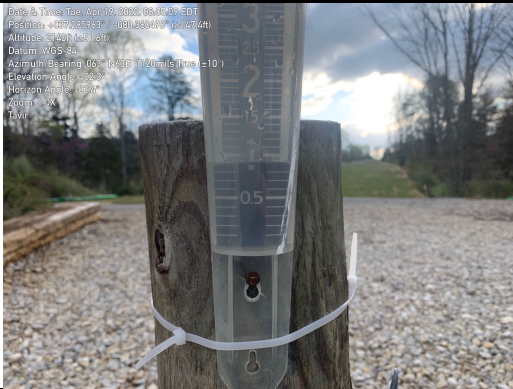
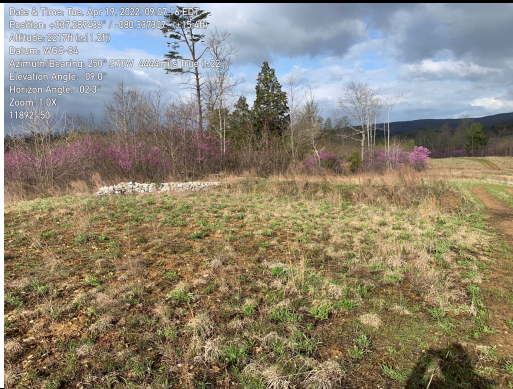
Date & Time: Tue, Apr 19, 2022 09:43:50 EDT Position: 4307.255337, -83.888497, 111224ft Altitude: 111224ft Datum: WGS 84 Azimuth/Bearing: 030° N28W 5120mils true (±10°) Elevation Angle: -08.0° Horizon Angle: -00.0° Zoom: 1.0x 11892+00		Date & Time: Tue, Apr 19, 2022 09:43:50 EDT Position: 4307.255337, -83.888497, 111224ft Altitude: 111224ft Datum: WGS 84 Azimuth/Bearing: 030° N28W 5120mils true (±10°) Elevation Angle: -08.0° Horizon Angle: -00.0° Zoom: 1.0x 11892+00			
GPS Location See photo.		GPS Location See photo.			
Field Station# 11789+00		Field Station# 11892+50			
Pic 1 Desc. Rain gauge at Mount Tabor Road crossing reads 0.9 inches.		Pic 2 Desc. Permanent waterbar and level spreader in place.

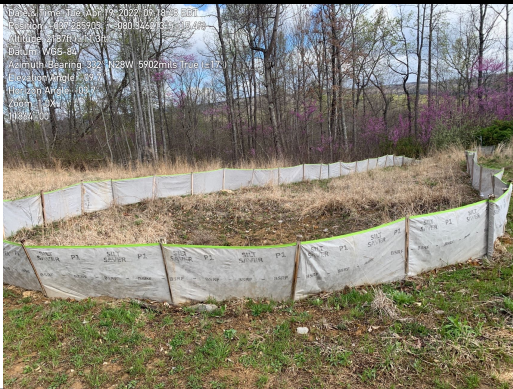
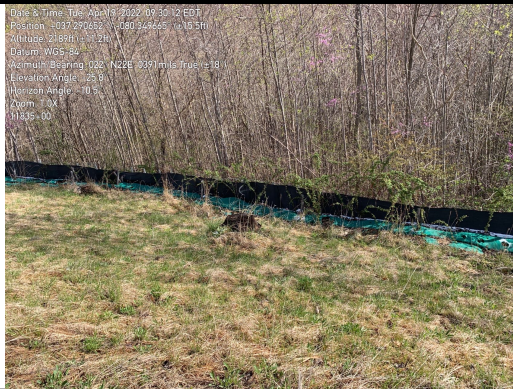
GPS Location See photo.		GPS Location See photo.			
Field Station# 11864+00		Field Station# 11835+00			
Pic 3 Desc. Priority one silt fence in place as buffer for pond P-KL2.		Pic 4 Desc. Super silt fence and triple stack 18 inch CFS in place along LOD.

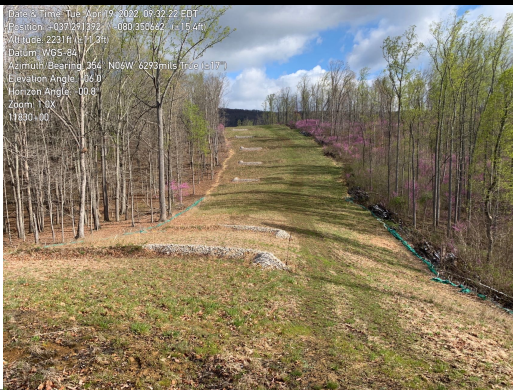
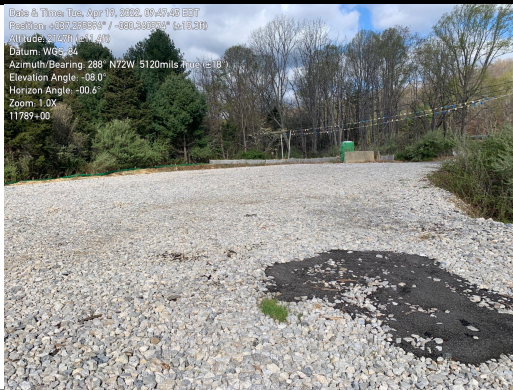
Date & Time: Tue, Apr 19, 2022 09:43:50 EDT Position: 4307.255337, -83.888497, 111224ft Altitude: 111224ft Datum: WGS 84 Azimuth/Bearing: 030° N28W 5120mils true (±10°) Elevation Angle: -08.0° Horizon Angle: -00.0° Zoom: 1.0x 11892+00		Date & Time: Tue, Apr 19, 2022 09:43:50 EDT Position: 4307.255337, -83.888497, 111224ft Altitude: 111224ft Datum: WGS 84 Azimuth/Bearing: 030° N28W 5120mils true (±10°) Elevation Angle: -08.0° Horizon Angle: -00.0° Zoom: 1.0x 11892+00			
GPS Location See photo.		GPS Location See photo.			
Field Station# 11830+00		Field Station# 11789+00			
Pic 5 Desc. Permanent waterbars with level spreaders in place.		Pic 6 Desc. RCE in place at Mount Tabor Road crossing.

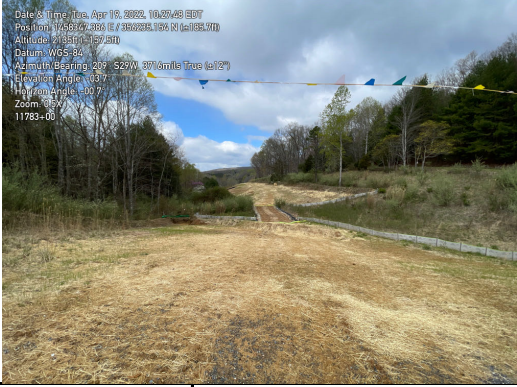
<p>Insert image here</p>	
GPS Location	13	GPS Location			
Field Station#	11783+00	Field Station#			
Pic 13 Desc.	Section of RoW showing conditions and controls.		Pic 14 Desc.		
<p>Insert image here</p>		<p>Insert image here</p>			
GPS Location		GPS Location			
Field Station#		Field Station#			
Pic 15 Desc.			Pic 16 Desc.		
<p>Insert image here</p>		<p>Insert image here</p>			
GPS Location		GPS Location			
Field Station#		Field Station#			
Pic 17 Desc.			Pic 18 Desc.

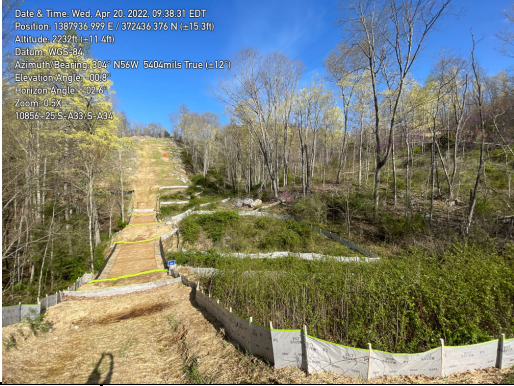
<p>Date & Time: Wed, Apr 20, 2022, 09:38:31 EDT Position: 1387211.931 E / 3729243.376 N (±15.4m) Altitude: 2222ft (±11.4m) Datum: WGS-84 Azimuth/Bearing: 264° N56W 5409mils True (±12°) Elevation Angle: -02.8° Horizon Angle: -02.8° Zoom: 0.2X 10856+25 S-A33/S-A34</p>

<p>Date & Time: Wed, Apr 20, 2022, 09:45:45 EDT Position: 1387211.931 E / 3729243.495 N (±15.4m) Altitude: 2015ft (±11.3m) Datum: WGS-84 Azimuth/Bearing: 264° S66W 4140mils True (±12°) Elevation Angle: -10.8° Horizon Angle: -10.8° Zoom: 0.2X 10847+00</p>			
GPS Location	1	GPS Location	2		
Field Station#	10856+25	Field Station#	10847+00		
Pic 1 Desc.	Overview S-A33/S-A34.	Pic 2 Desc.	CWDP outlet protection functional.

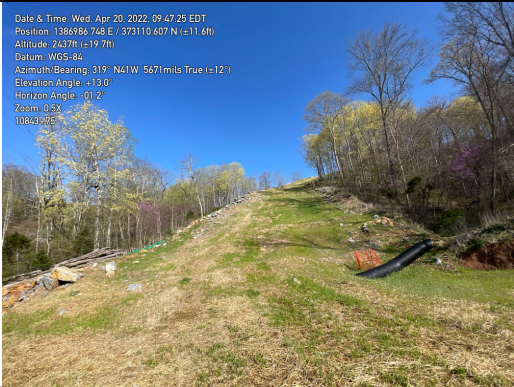
<p>Date & Time: Wed, Apr 20, 2022, 09:47:25 EDT Position: 1386988.748 E / 3731110.607 N (±11.6m) Altitude: 2437ft (±19.7m) Datum: WGS-84 Azimuth/Bearing: 319° N41W 5671mils True (±12°) Elevation Angle: -13.0° Horizon Angle: -01.2° Zoom: 0.2X 10843+75</p>

GPS Location	3	GPS Location	4		
Field Station#	10843+75	Field Station#	10834+00		
Pic 3 Desc.	Section of RoW showing conditions and controls.	Pic 4 Desc.	Section of RoW showing conditions and controls.

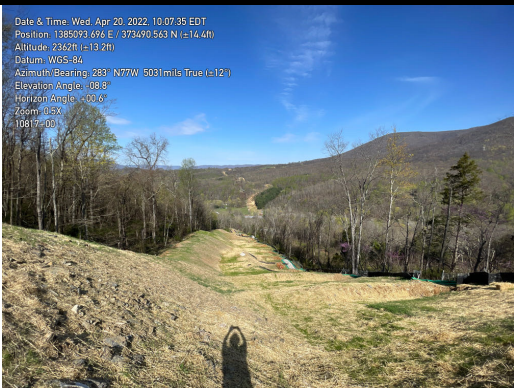
<p>Date & Time: Wed, Apr 20, 2022, 10:07:35 EDT Position: 1385093.694 E / 373490.563 N (±14.4m) Altitude: 2362ft (±13.2m) Datum: WGS-84 Azimuth/Bearing: 283° N77W 5031mils True (±12°) Elevation Angle: -08.3° Horizon Angle: -00.6° Zoom: 0.2X 10817+00</p>

<p>Date & Time: Wed, Apr 20, 2022, 10:12:59 EDT Position: 1384292.976 E / 3737424.482 N (±15.5m) Altitude: 2115ft (±11.1m) Datum: WGS-84 Azimuth/Bearing: 338° N22W 4009mils True (±12°) Elevation Angle: -05.8° Horizon Angle: -02.2° Zoom: 0.2X 10809+04 S-Z14</p>			
GPS Location	5	GPS Location	6		
Field Station#	10817+00	Field Station#	10809+04		
Pic 5 Desc.	Section of RoW showing conditions and controls.	Pic 6 Desc.	S-Z14.

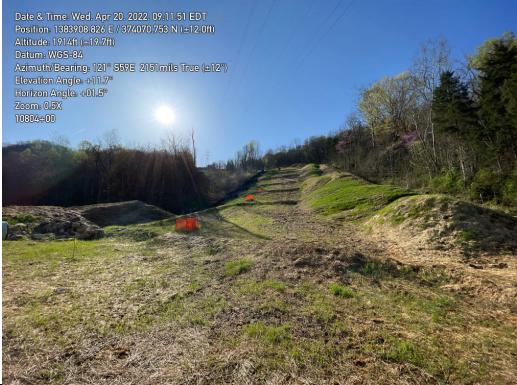
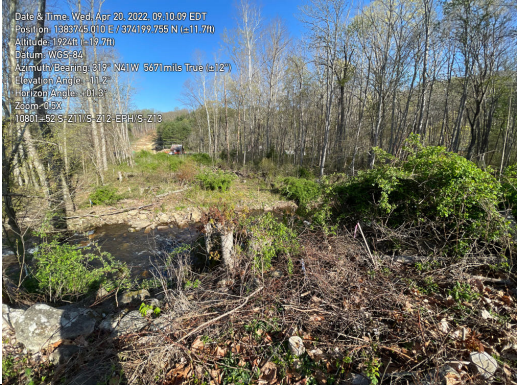
GPS Location	7	GPS Location	8		
Field Station#	10804+00	Field Station#	10801+52		
Pic 7 Desc.	Section of RoW showing conditions and controls.		Pic 8 Desc.	Overview S-Z11/S-Z12-EPH/S-Z13.

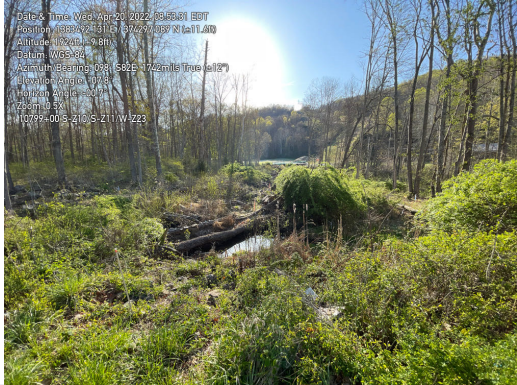
Insert image here	
GPS Location	9	GPS Location			
Field Station#	10799+00	Field Station#			
Pic 9 Desc.	Overview S-Z10/S-Z11/W-Z23.		Pic 10 Desc.		
Insert image here		Insert image here			
GPS Location		GPS Location			
Field Station#		Field Station#			
Pic 11 Desc.		Pic 12 Desc.

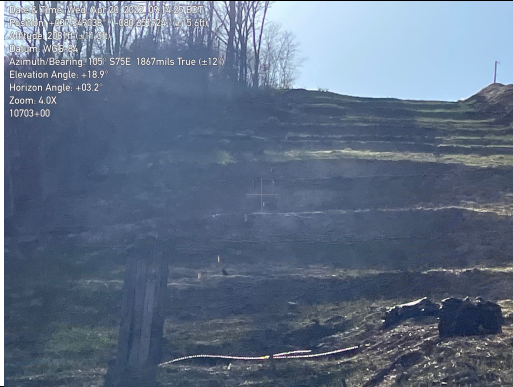
<p>Date & Time: Wed Apr 20, 2022, 09:40:07 EDT Position: -037.348789, -080.647887 (+26.1ft) Altitude: 2398ft (+26.2ft) Datum: WGS-84 Azimuth/Bearing: 103.57E 1867mils True (+12.1) Elevation Angle: -18.9 Horizon Angle: -03.2 Zoom: 4.0X 10703+00</p>			
GPS Location		See photo		GPS Location	
Field Station#		10712+73		Field Station#	
Pic 1 Desc.		Equipment bridge functional		Pic 2 Desc.	
				Water bars and ET in place

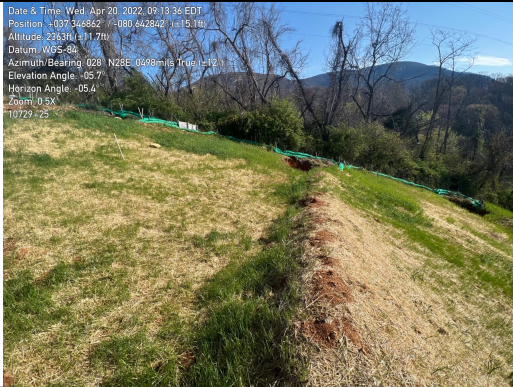
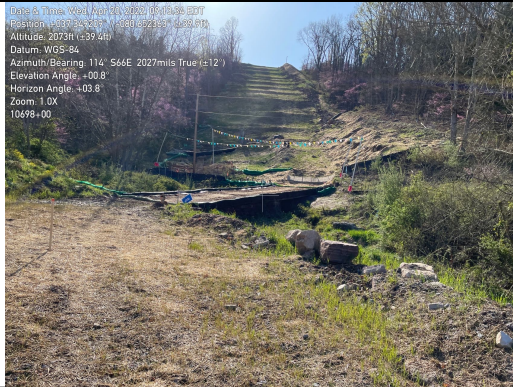
GPS Location		See photo		GPS Location	
Field Station#		10729+25		Field Station#	
Pic 3 Desc.		Temporary stabilization in place		Pic 4 Desc.	
				Wattles and P1 in place	
  <p>Date & Time: Wed Apr 20, 2022, 09:12:24 EDT Position: -037.349258, -080.653137 (+11.7ft) Altitude: 2016ft (+19.7ft) Datum: WGS-84 Azimuth/Bearing: 288.17W 5120mils True (+12.1) Elevation Angle: -03.1 Horizon Angle: -00.6 Zoom: 1.0X 10694+00</p>		  <p>Date & Time: Wed Apr 20, 2022, 09:09:27 EDT Position: -037.346603, -080.641941 (+20.4ft) Altitude: 2271ft (+52.5ft) Datum: WGS-84 Azimuth/Bearing: 040.07E 0771mils True (+12.1) Elevation Angle: -00.6 Horizon Angle: -04.8 Zoom: 0.5X 10732+00</p>			
GPS Location		See photo		GPS Location	
Field Station#		10694+00		Field Station#	
Pic 5 Desc.		Clean water drainage feature functional		Pic 6 Desc.	
				Equipment bridge functional

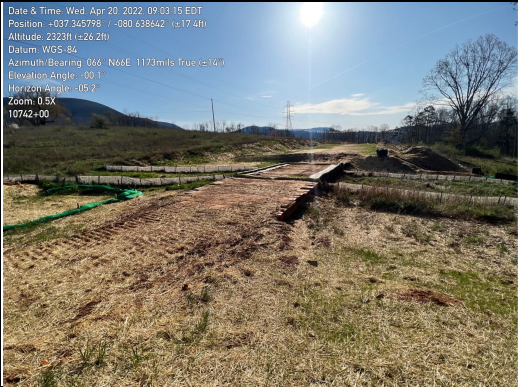
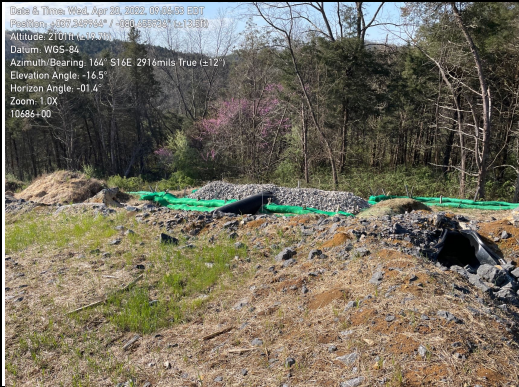
GPS Location	See photo		GPS Location	See photo	
Field Station#	10742+00		Field Station#	10686+00	
Pic 7 Desc.	Clean water drainage feature functional		Pic 8 Desc.	Energy dissipater in place	
<p>Date & Time: Wed, Apr 20, 2022, 09:03:15 EDT Position: +037.350287° / -080.638388° (+17.5ft) Altitude: 2007ft (+105.0ft) Datum: WGS-84 Azimuth/Bearing: 100° S80E 1129mils True (+12.1) Elevation Angle: +17.0° Horizon Angle: +00.6° Zoom: 1.0X 10678+00</p>

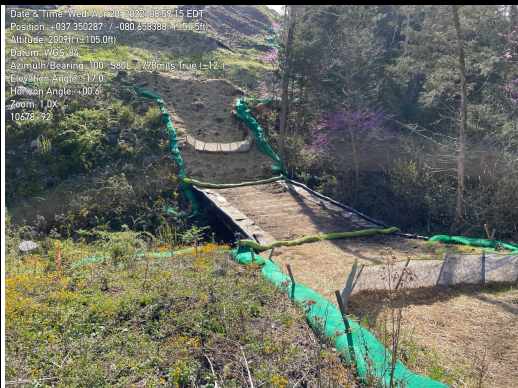
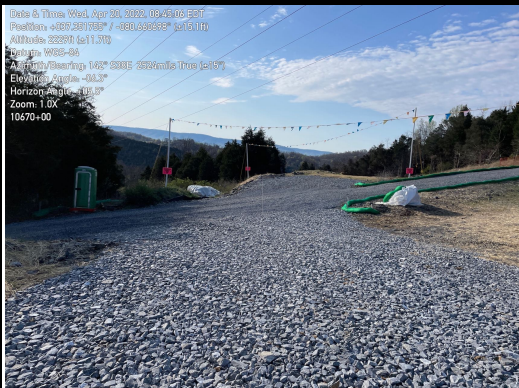
GPS Location	See photo		GPS Location	See photo	
Field Station#	10678+92		Field Station#	10670+00	
Pic 9 Desc.	P1 and wattles in place		Pic 10 Desc.	RCE functional	
<p>Date & Time: Wed, Apr 20, 2022, 09:03:08 EDT Position: +037.352393° / -080.638032° (+17.5ft) Altitude: 2221ft (+19.7ft) Datum: WGS-84 Azimuth/Bearing: 100° S80W 1004mils True (+12.1) Elevation Angle: +00.6° Horizon Angle: -01.0° Zoom: 1.0X 10660+00</p>

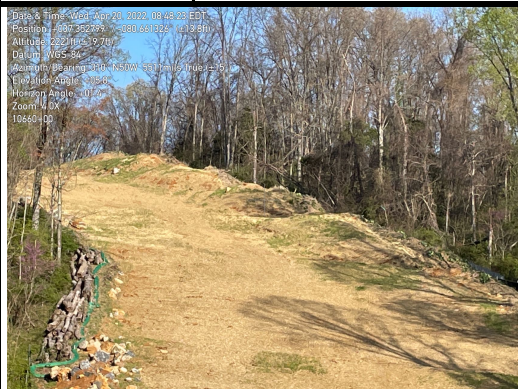
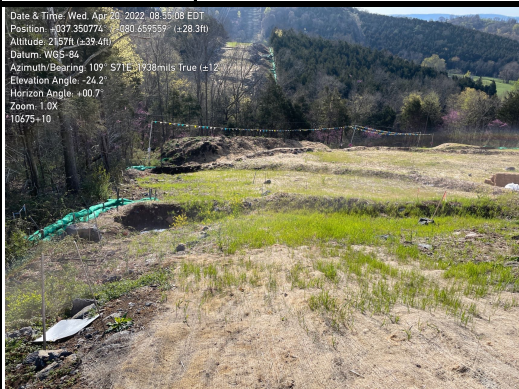
GPS Location	See photo		GPS Location	See photo	
Field Station#	10660+00		Field Station#	10675+10	
Pic 11 Desc.	Picture showing condition of row		Pic 12 Desc.	Erosion control blanket in place

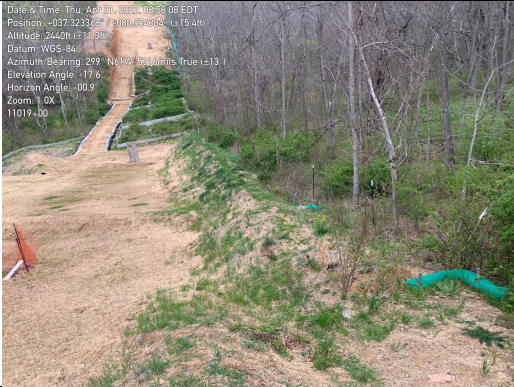
GPS Location	See photo for GPS location.		GPS Location	See photo for GPS location.	
Field Station#	11019+00		Field Station#	11004+00	
Pic 1 Desc.	Clean water diversion berm in place.		Pic 2 Desc.	Clean water diversion pipe and level spreader in place.

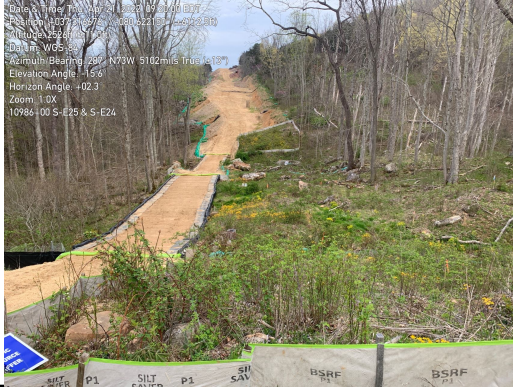
GPS Location	See photo for GPS location.		GPS Location	See photo for GPS location.	
Field Station#	10930+25		Field Station#	10986+00	
Pic 3 Desc.	RCE in place at Doe Creek road crossing.		Pic 4 Desc.	Sensitive resource buffer in place at streams S-E24 and S-E25.

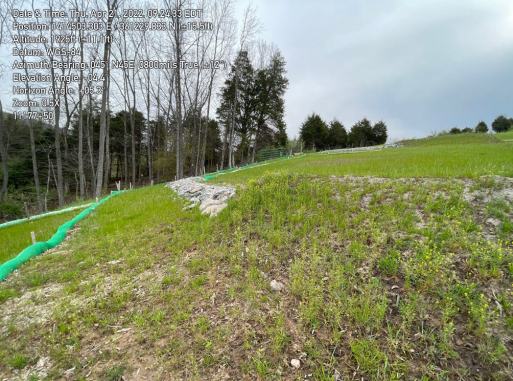
GPS Location	1	GPS Location	2		
Field Station#	11179+50	Field Station#	11177+50		
Pic 1 Desc.	Section of restored RoW showing conditions and controls.	Pic 2 Desc.	Representative photo of permanent waterbar and level spreaders.

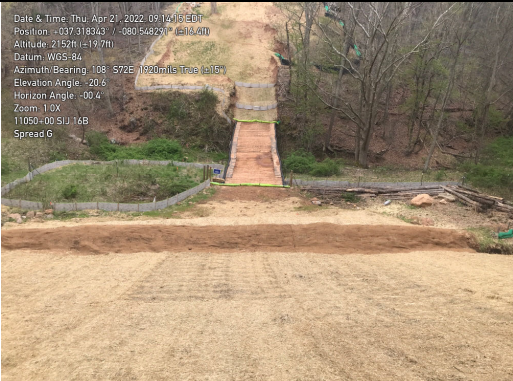
Field Station#	11039+00	Field Station#	11050+00	Field Station#	11050+00
Pic 3 Desc.	ECDs	Pic 4 Desc.	S-IJ-16B	Pic 4 Desc.	S-IJ-16B
  <p>Date & Time: Thu, Apr 21, 2022, 09:18:07 EDT Position: +037.318383 / -080.545766 (-14.4in) Altitude: 2189ft (-9.8ft) Datum: WGS-84 Azimuth/Bearing: 289 N71W 5138mils True (-19°) Elevation Angle: -02.5 Horizon Angle: -02.2 Zoom: 1.0X 11045+00 S-IJ-16B Spread G</p>		  <p>Date & Time: Thu, Apr 21, 2022, 09:24:31 EDT Position: +037.316273 / -080.545766 (-14.4in) Altitude: 2189ft (-9.8ft) Datum: WGS-84 Azimuth/Bearing: 035 N35E 0422mils True (-13°) Elevation Angle: -11.1 Horizon Angle: -01.2 Zoom: 1.0X 11060+99 S-IJ-16B Spread G</p>		GPS Location	see photo
Field Station#	11045+00	Field Station#	11060+99	Field Station#	11060+99
Pic 5 Desc.	Erosion blanket	Pic 6 Desc.	Trees that have been cut down on AR 245.01, up to valve location.	Pic 6 Desc.	Trees that have been cut down on AR 245.01, up to valve location.

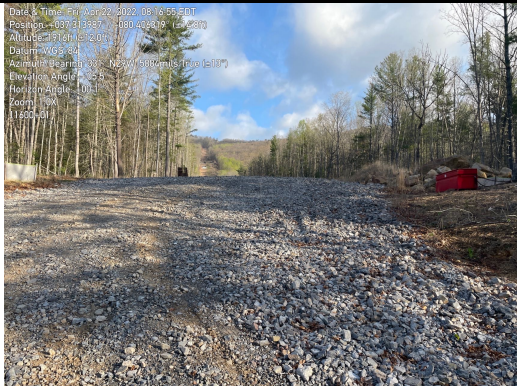
GPS Location	See photo	GPS Location			
Field Station#	11600+01	Field Station#			
Pic 9 Desc.	RCE functional	Pic 10 Desc.			
<p style="text-align: center;">Insert image here</p>		<p style="text-align: center;">Insert image here</p>			
GPS Location		GPS Location			
Field Station#		Field Station#			
Pic 11 Desc.		Pic 12 Desc.

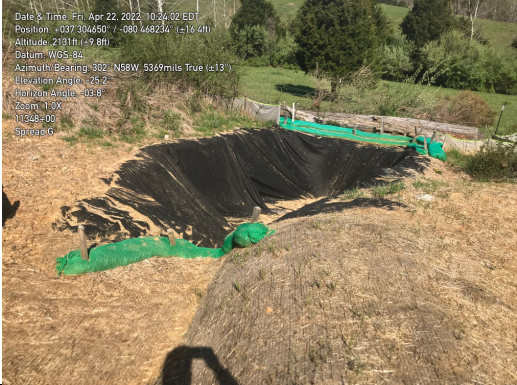
GPS Location	See photo	GPS Location	see photo		
Field Station#	11348+00	Field Station#	11352+00		
Pic 7 Desc.	KARST	Pic 8 Desc.	S NN 11		
Insert image here		Insert image here			
GPS Location		GPS Location			
Field Station#		Field Station#			
Pic 9 Desc.		Pic 10 Desc.			
Insert image here		Insert image here			
GPS Location		GPS Location			
Field Station#		Field Station#			
Pic 11 Desc.		Pic 12 Desc.

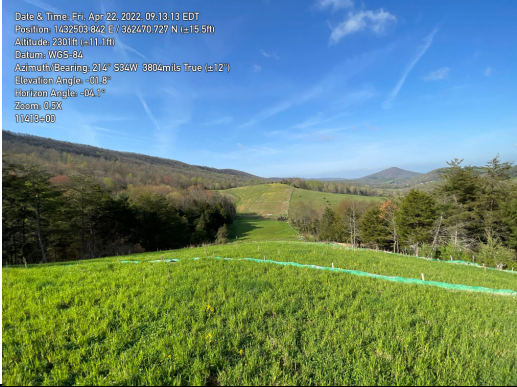
GPS Location	7	GPS Location	8		
Field Station#	11413+00	Field Station#	11397+00		
Pic 7 Desc.	Section of restored RoW showing conditions and controls.		Pic 8 Desc.	Section of restored RoW showing conditions and controls.	
<small>Date & Time: Fri, Apr 22, 2022, 09:35:02 EDT Position: 1428555.441 E / 361013.217 N (=15.5h) Altitude: 2031ft (=11.1h) Datum: WGS-84 Azimuth/Bearing: 051° N61E 0907mils True (=12°) Elevation Angle: -00.7° Horizon Angle: +02.0° Zoom: 0.5X 11367+00</small>

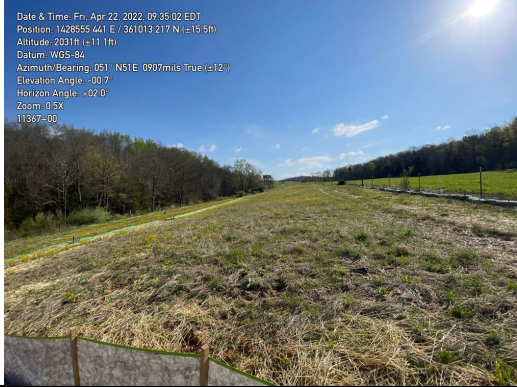
GPS Location	9	GPS Location	10		
Field Station#	11367+00	Field Station#	11360+54		
Pic 9 Desc.	Section of restored RoW showing conditions and controls.		Pic 10 Desc.	S-KL43.	
Insert image here		Insert image here			
GPS Location		GPS Location			
Field Station#		Field Station#			
Pic 11 Desc.		Pic 12 Desc.
