Visual Site Inspection Report

Project Name	H-600 Pipeline Spread G	AFE	124300137	Spread	H-600 Pipeline Spread G
Contractor	Precision			Report #	36933
Inspector	Rob Robertson			Date/Time	4/25/2022 11:18 AM
Permit #	TBD	Inspection Type	VA SWPP	Station Begin	11600+01
State	VA	Inspection Area	Full	Station End	11670+00
County	Montgomery	Ground	Dry	Temperature (°F)	61.00
Municipality	N/A	Weather	Sunny	Rain Gauge (in)	0.00
				Rain Accumulation Time (days)	1.00

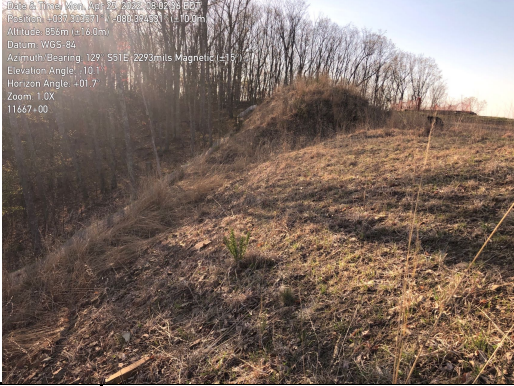
<p>Date & Time: Mon, Apr 25, 2022, 11:18:00 EDT Position: +037.312222 / +080.384331 (+5.0m) Altitude: 656m (+5.0m) Datum: WGS-84 Azimuth/Bearing: 220.540W (-39.1mils Magnetic (+15)) Elevation Angle: -36.7 Horizon Angle: -03.3 Zoom: 1.0X S-HH18</p>			
GPS Location	On photo	GPS Location	On photo		
Field Station#	11667+00	Field Station#	11665+50		
Pic 1 Desc.	ROW stable at top of Brush Mountain. ECDs are in place.	Pic 2 Desc.	ROW stable. End treatments acceptable.

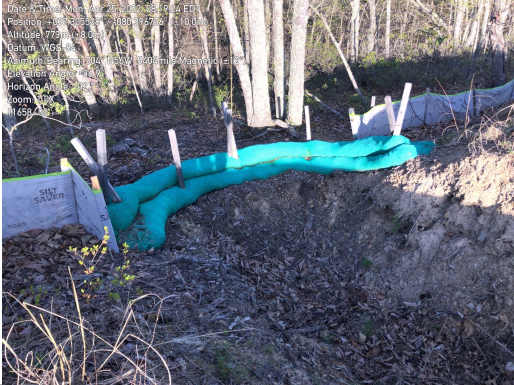
GPS Location	On photo	GPS Location	On photo		
Field Station#	11658+00	Field Station#	11638+00		
Pic 3 Desc.	Sumps and end treatments functional.	Pic 4 Desc.	Perimeter ECDs are acceptable.

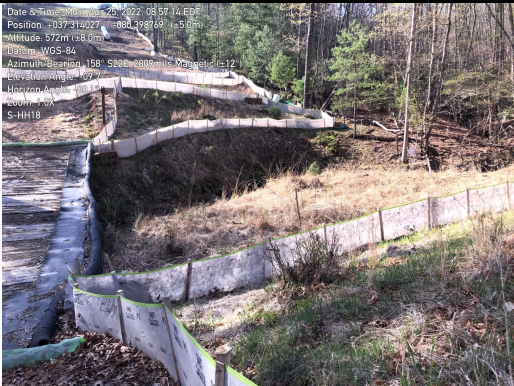
<p>Date & Time: Mon, Apr 25, 2022, 09:07:34 EDT Position: +037.312222 / +080.384331 (+5.0m) Altitude: 576m (+5.0m) Datum: WGS-84 Azimuth/Bearing: 160.540E (+60.5mils Magnetic (+12)) Elevation Angle: -11.6 Horizon Angle: +02.7 Zoom: 1.0X S-RR14</p>			
GPS Location	On photo	GPS Location	On photo		
Field Station#	11626+04	Field Station#	11614+20		
Pic 5 Desc.	The S-HH18 crossing is stable.	Pic 6 Desc.	The S-RR14 crossing is stable.

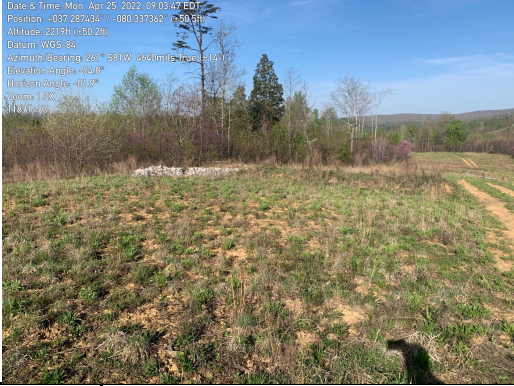
<p>Date & Time: Mon Apr 25 2022 09:16:36 EDT Position: +037.258729, -080.346101, +54.54m Altitude: 2213ft (+67.1m) Datum: WGS-84 Azimuth Bearing: 340° NW 4220mils True (+14) Elevation Angle: -11.2° Horizon Angle: -02.8° Zoom: 1.0X 11864+00</p>			
GPS Location	See photo.		GPS Location	See photo.	
Field Station#	11891+00		Field Station#	11864+00	
Pic 1 Desc.	ROW permanently restored. Waterbar and level spreader in place.		Pic 2 Desc.	Sensitive resource buffer in place at P-KL2.

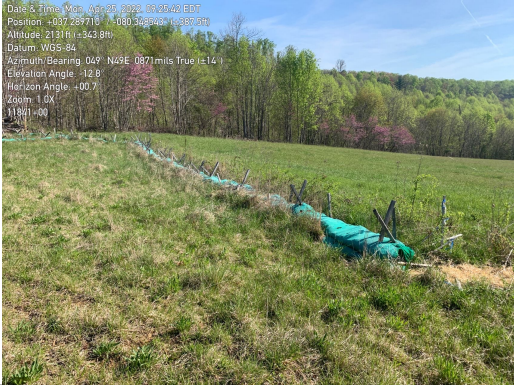
GPS Location	See photo.		GPS Location	See photo.	
Field Station#	11841+00		Field Station#	11836+00	
Pic 3 Desc.	Triple stack 18 inch CFS in place along LOD.		Pic 4 Desc.	Triple stack 18 inch CFS and super silt fence in place along LOD.

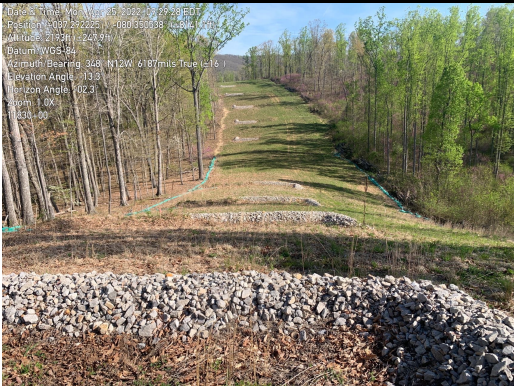
<p>Date & Time: Mon Apr 25 2022 10:13:09 EDT Position: +037.259370, -080.346593, +52.7m Altitude: 2135ft (+65.2m) Datum: WGS-84 Azimuth Bearing: 279° N81W 4960mils True (+20) Elevation Angle: -04.5° Horizon Angle: -03.2° Zoom: 1.0X 11789+00</p>			
GPS Location	See photo.		GPS Location	See photo.	
Field Station#	11830+00		Field Station#	11789+00	
Pic 5 Desc.	ROW permanently restored. Waterbar and level spreader in place.		Pic 6 Desc.	RCE in place at Mount Tabor Road crossing.

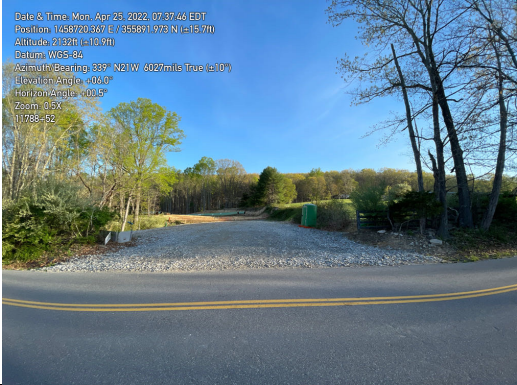
GPS Location	13	GPS Location			
Field Station#	11788+52	Field Station#			
Pic 13 Desc.	RCE off of Mt Tabor rd.	Pic 14 Desc.			
Insert image here		Insert image here			
GPS Location		GPS Location			
Field Station#		Field Station#			
Pic 15 Desc.		Pic 16 Desc.			
Insert image here		Insert image here			
GPS Location		GPS Location			
Field Station#		Field Station#			
Pic 17 Desc.		Pic 18 Desc.

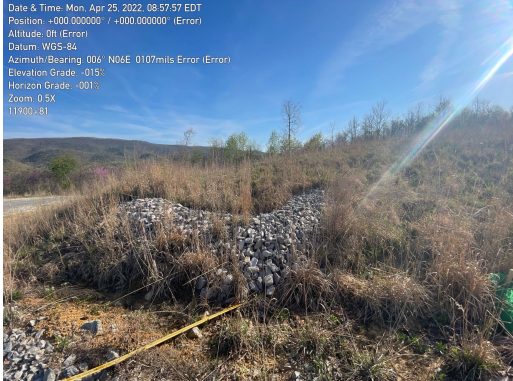
GPS Location				See Photo				GPS Location				See Photo			
Field Station#				11900+81				Field Station#				11920+00			
Pic 1 Desc.				Permanent level spreader condition				Pic 2 Desc.				Permanent water bar location and conditions. No Issues at this time.			
<p>Date & Time: Mon, Apr 25, 2022, 09:34:38 EDT Position: +037.272930 / -080.325122 (±24.4ft) Altitude: 2164ft (±75.7ft) Datum: WGS-84 Azimuth/Bearing: 275° S02W 444mils True (±12°) Elevation Grade: -015° Horizon Grade: -004° Zoom: 1.0X 11942+57</p>

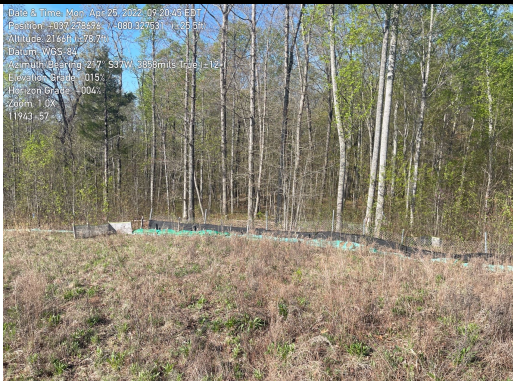
GPS Location				See Photo				GPS Location				See Photo			
Field Station#				119+43				Field Station#				11967+00			
Pic 3 Desc.				Super silt fence conditions. No issues at this time.				Pic 4 Desc.				P1 perimeter silt fencing conditions and final restoration area.			
<p>Date & Time: Mon, Apr 25, 2022, 09:49:50 EDT Position: +037.269702 / -080.322927 (±91.5ft) Altitude: 1756ft (±215.0ft) Datum: WGS-84 Azimuth/Bearing: 019° N19E 0338mils True (±12°) Elevation Grade: -024° Horizon Grade: -008° Zoom: 0.5X 11973+00</p>

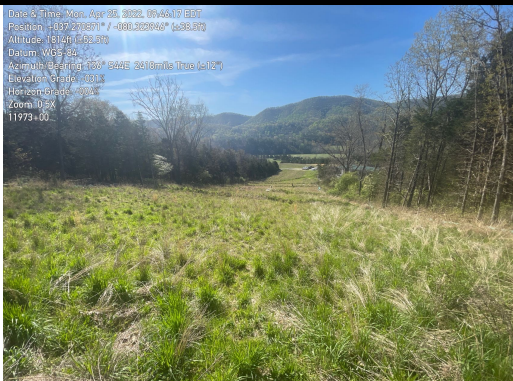
Pic 5 Desc.				Final Restoration Area				Pic 6 Desc.				Perimeter ECDs near presumed karst area.

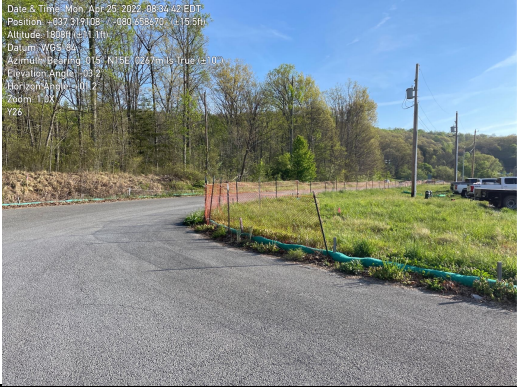
GPS Location		See photo		GPS Location	
Field Station#		12005+00		Field Station#	
Pic 7 Desc.		CFS perimeter controls functional Permanent stabilization in place y26		Pic 8 Desc.	
				Housekeeping trash in good condition y26	
<p>Date & Time: Mon, Apr 25, 2022, 08:33:27 EDT Position: +037.318680° / -080.657250° (-14.0ft) Altitude: 1804ft (-13.4ft) Datum: WGS-84 Azimuth/Bearing: 248° S48W 6609mils True (-10°) Elevation Angle: +00.9° Horizon Angle: +05.6° Zoom: 1.0X Y26</p>

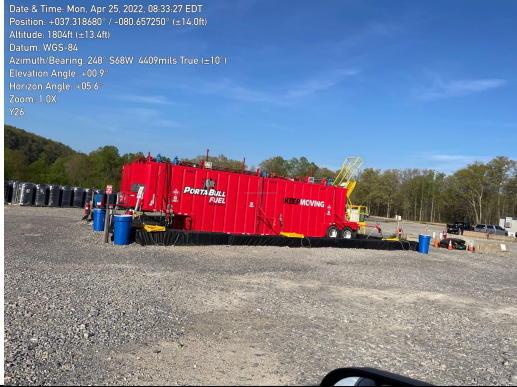
GPS Location		See photo		GPS Location	
Field Station#		12005+00		Field Station#	
Pic 9 Desc.		Secondary containment in place y26		Pic 10 Desc.	
				Secondary containment in place y26	
<p>Date & Time: Mon, Apr 25, 2022, 08:31:33 EDT Position: +037.318779° / -080.656503° (-14.5ft) Altitude: 1795ft (-13.4ft) Datum: WGS-84 Azimuth/Bearing: 032° N42E 1102mils True (-10°) Elevation Angle: +00.9° Horizon Angle: -02.2° Zoom: 1.0X Y26</p>

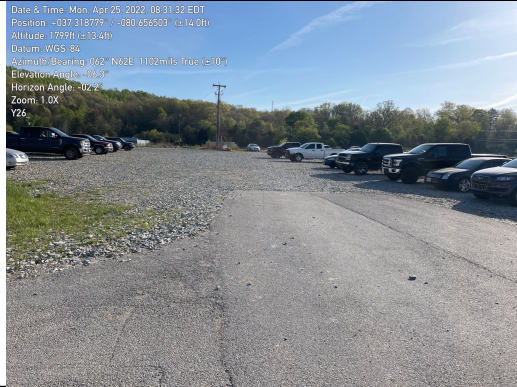
GPS Location		See photo		GPS Location	
Field Station#		12005+00		Field Station#	
Pic 11 Desc.		RCE functional y26		Pic 12 Desc.	
				CFS perimeter controls functional y26

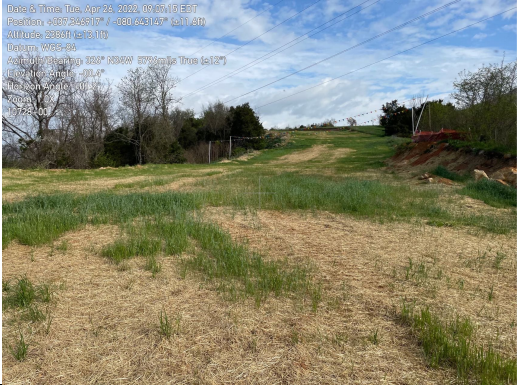
<p><small>Date & Time: Tue, Apr 26, 2022, 06:58:19 EDT Position: +087.243517° / +080.423156° Lat: 43° Altitude: 2331ft (±1.1ft) Datum: WGS-84 Azimuth/Bearing: 268° S88W 4764mils True (±12°) Elevation Angle: -20.4° Horizon Angle: +01.4° Zoom: 1.0X 10738+00</small></p>			
GPS Location	See Photo	GPS Location	See Photo		
Field Station#	10728+00	Field Station#	10738+00		
Pic 7 Desc.	Section of row showing conditions	Pic 8 Desc.	Slope drain

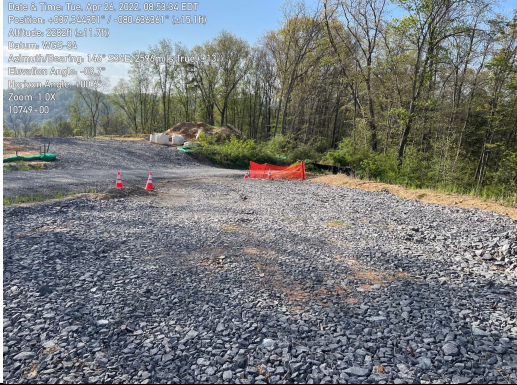
GPS Location	See Photo	GPS Location	See Photo		
Field Station#	10742+69	Field Station#	10749+00		
Pic 9 Desc.	Equipment bridge	Pic 10 Desc.	RCE		
Insert image here		Insert image here			
GPS Location		GPS Location			
Field Station#		Field Station#			
Pic 11 Desc.		Pic 12 Desc.

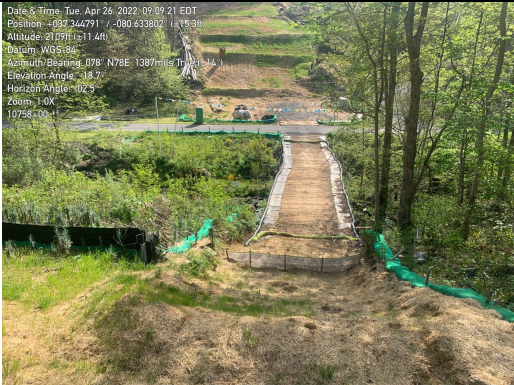
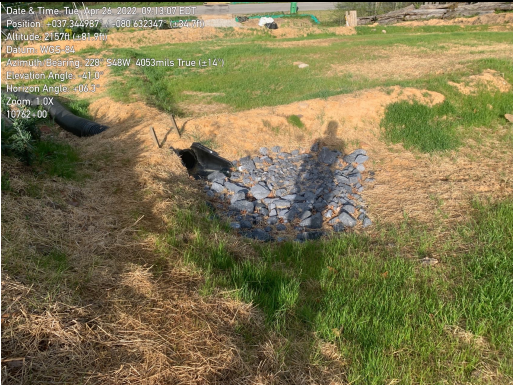
GPS Location	See photo.		GPS Location	See photo.	
Field Station#	10758+00		Field Station#	10762+00	
Pic 3 Desc.	Sensitive resource buffer in place at stream S-G35.		Pic 4 Desc.	Rock inlet in place at slope drain.

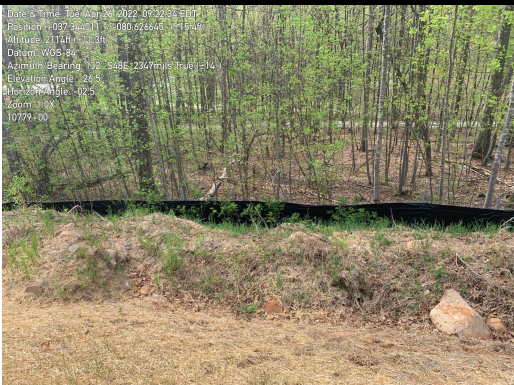
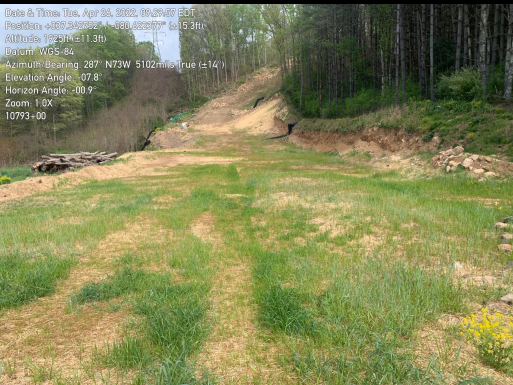
GPS Location	See photo.		GPS Location	See photo.	
Field Station#	10779+00		Field Station#	10793+00	
Pic 5 Desc.	Super silt fence in place along LOD.		Pic 6 Desc.	ROW temporarily stabilized with seed and mulch. Vegetation growth is present.

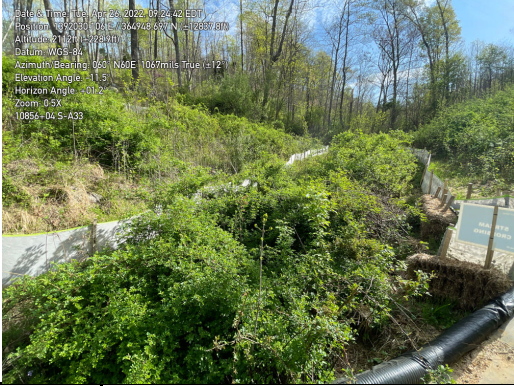
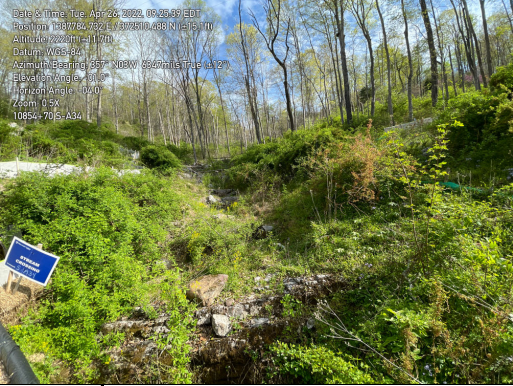
<p>Date & Time: Tue, Apr 26, 2022, 09:45:59 EST Position: 10854+70 E / 344810.438 N (+1515.71) Altitude: 2247 ft (+694.41) Datum: WGS-84 Azimuth/Bearing: 35° N 65° W 1087mils True (+12°) Elevation Angle: +11.5° Horizon Angle: +01.0° Zoom: 0.5X 10854+70 S-A34</p>			
GPS Location	1	GPS Location	2		
Field Station#	10856+04	Field Station#	10854+70		
Pic 1 Desc.	S-A33.	Pic 2 Desc.	S-A34.

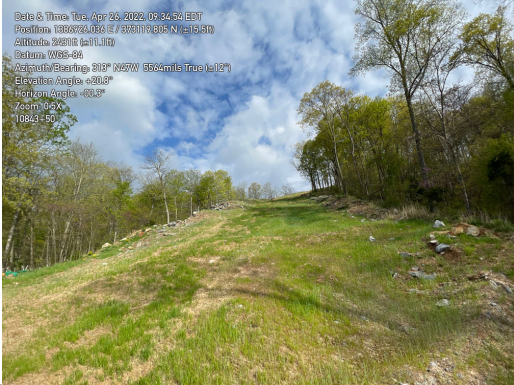
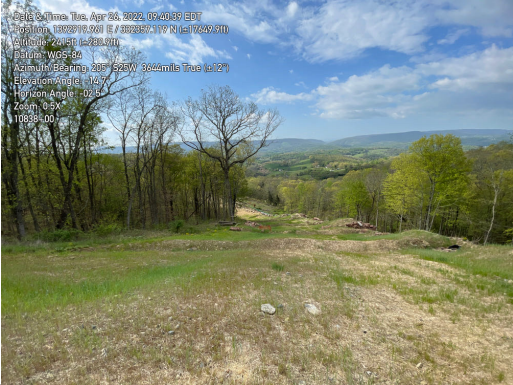
GPS Location	3	GPS Location	4		
Field Station#	10843+50	Field Station#	10838+00		
Pic 3 Desc.	Section of RoW showing conditions and controls.	Pic 4 Desc.	Section of RoW showing conditions and controls.

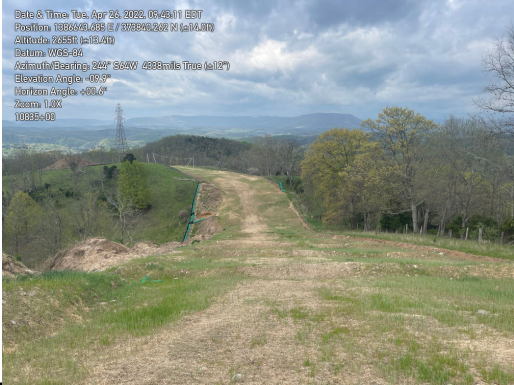
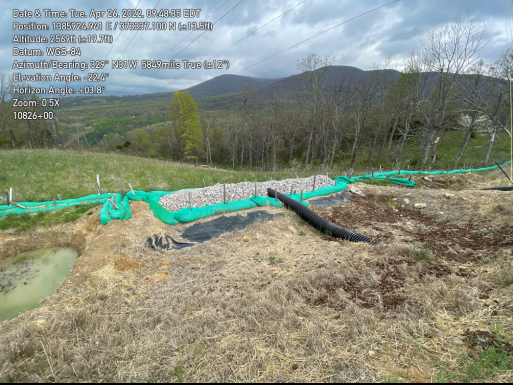
<p>Date & Time: Tue, Apr 26, 2022, 09:43:58 EST Position: 10826+00 E / 338377.100 N (+175.91) Altitude: 2530 ft (+780.11) Datum: WGS-84 Azimuth/Bearing: 326° N 51° W 534mils True (+12°) Elevation Angle: +22.4° Horizon Angle: +01.0° Zoom: 0.5X 10826+00</p>			
GPS Location	5	GPS Location	6		
Field Station#	10835+00	Field Station#	10826+00		
Pic 5 Desc.	Section of RoW showing conditions and controls.	Pic 6 Desc.	CWDP outlet protection functional.

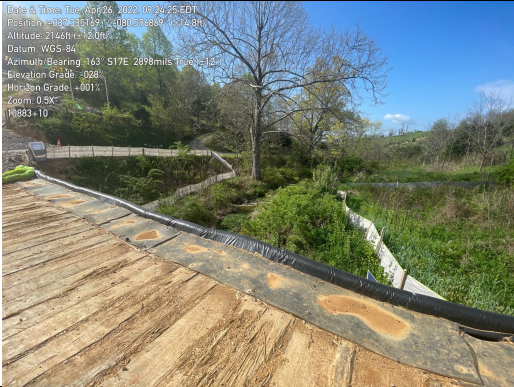
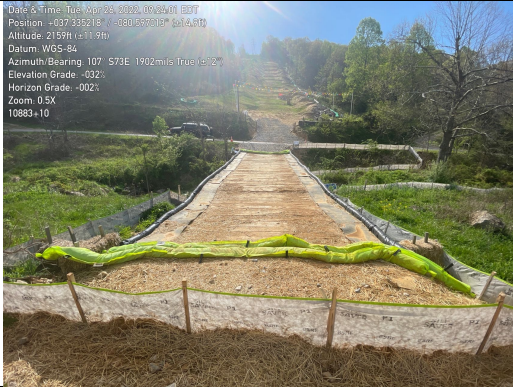
GPS Location	See Photo	GPS Location	See Photo		
Field Station#	10883+10	Field Station#	10883+10		
Pic 1 Desc.	S-A32 Stream resource and vegetated buffer zones	Pic 2 Desc.	Equipment bridge crossing condition.		
<p><small>Date & Time: Tue, Apr 26, 2022 09:23:42 EDT Position: +037.335228° / -080.597095° (+15.2ft) Altitude: 2163ft (+11.6ft) Datum: WGS-84 Azimuth/Bearing: 277° N81W 4960mils True (+12.1) Elevation Grade: +023° Horizon Grade: +006° Zoom: 0.5X 10882+00</small></p>

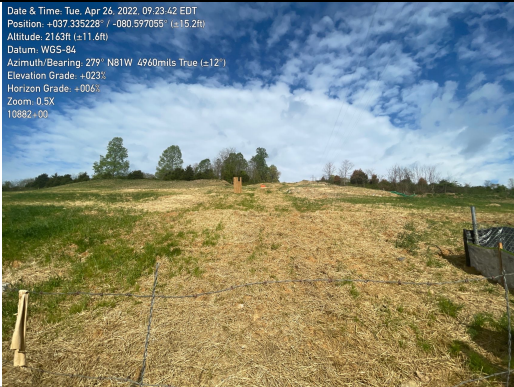
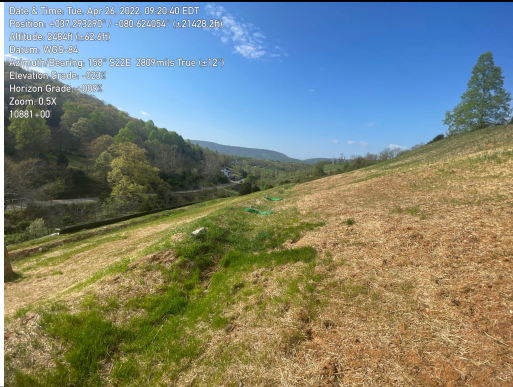
GPS Location	See Photo	GPS Location	See Photo		
Field Station#	10882+00	Field Station#	10881+00		
Pic 3 Desc.	Temporary stabilization of travel lane.	Pic 4 Desc.	Functional water bar throat with CFS checks.		
<p><small>Date & Time: Tue, Apr 26, 2022 09:10:37 EDT Position: +037.335228° / -080.600542° (+122.8ft) Altitude: 2451ft (+58.4ft) Datum: WGS-84 Azimuth/Bearing: 074° N74E 1816mils True (+12.1) Elevation Grade: -035° Horizon Grade: -001° Zoom: 0.5X 10871+00</small></p>

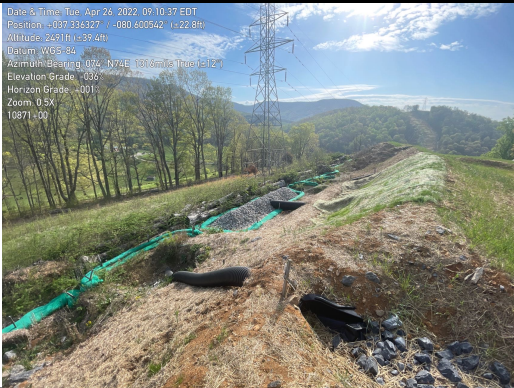
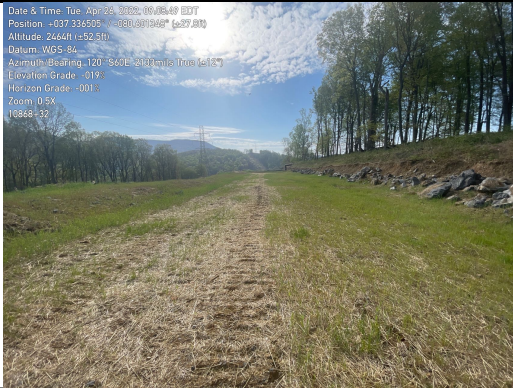
GPS Location	See Photo	GPS Location	See Photo		
Field Station#	10871+00	Field Station#	10868+32		
Pic 5 Desc.	Temporary level spreader with sump pits, slope drain pipes and ECB stabilization.	Pic 6 Desc.	Temporary stabilization of row

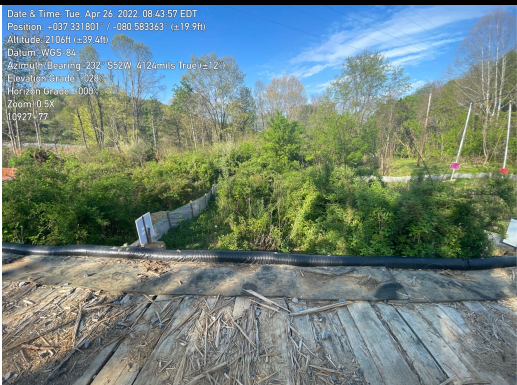
GPS Location	See Photo	GPS Location	See Photo		
Field Station#	10928+56	Field Station#	10927+77		
Pic 11 Desc.	CWDP to the TLS at the Doe Creek RCE area.		Pic 12 Desc.	S-Y3 vegetated stream bed conditions.

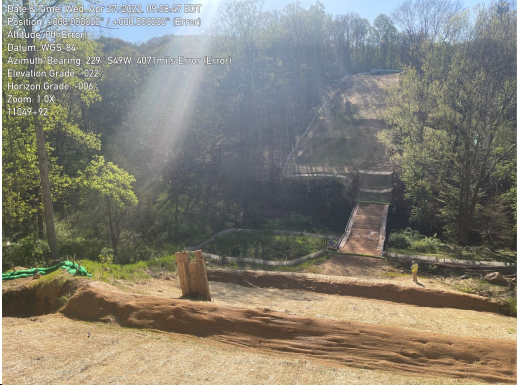
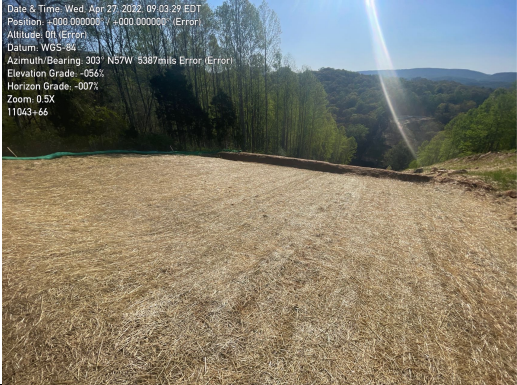
GPS Location	See Photo	GPS Location	See Photo		
Field Station#	11049+92	Field Station#	11043+66		
Pic 7 Desc.	View of temporary water bar and stabilization.	Pic 8 Desc.	Temporary stabilization of steep slopes.

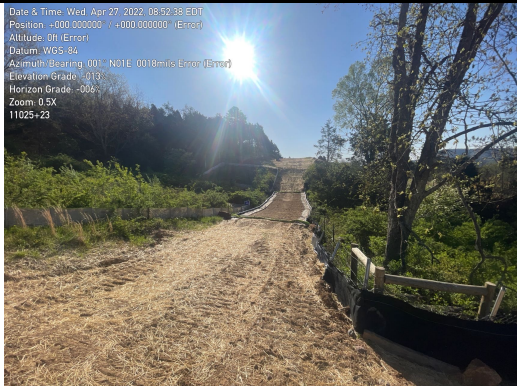
<div style="text-align: center;">Insert image here</div>			
GPS Location	See Photo	GPS Location			
Field Station#	11025+23	Field Station#			
Pic 9 Desc.	Over view of the S-IJ 18 stream resource	Pic 10 Desc.			
<div style="text-align: center;">Insert image here</div>		<div style="text-align: center;">Insert image here</div>			
GPS Location		GPS Location			
Field Station#		Field Station#			
Pic 11 Desc.		Pic 12 Desc.

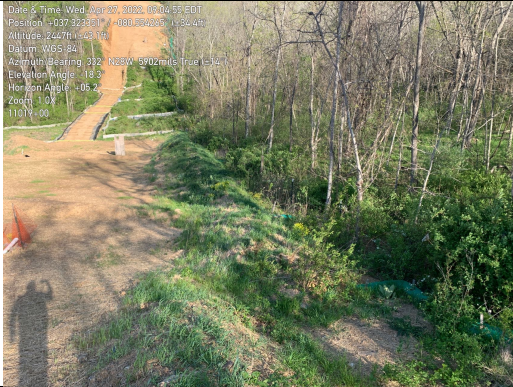
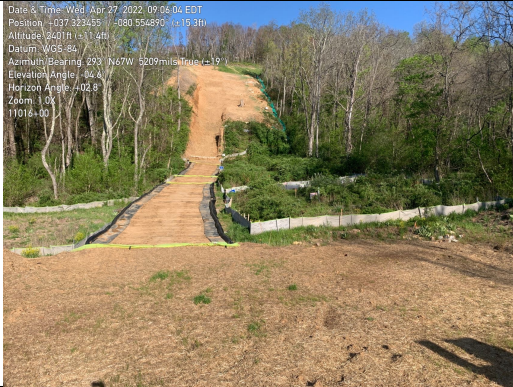
GPS Location		See photo.				GPS Location		See photo.			
Field Station#		11019+00				Field Station#		11016+00			
Pic 1 Desc.		Clean water diversion berm in place.				Pic 2 Desc.		Sensitive resource buffer in place at streams S-PA07 and S-RR5.			
<p>Date & Time: Wed Apr 27, 2022 09:18:31 EDT Position: -037.324026, -080.559423 (-15.4ft) Altitude: 2640ft (-11.3ft) Datum: WGS 84 Azimuth/Bearing: 201 S21W 3573mils True (-18) Elevation Angle: -22.7 Horizon Angle: -02.0 Zoom: 1.0X 11004+00</p>

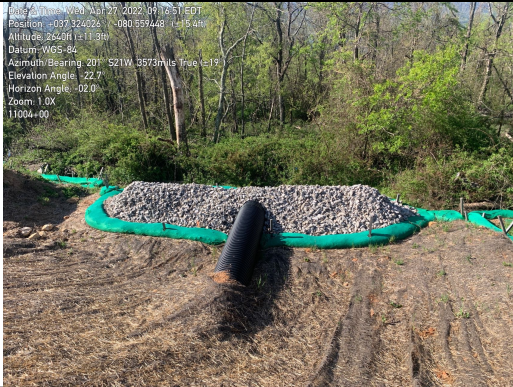
GPS Location		See photo.				GPS Location		See photo.			
Field Station#		11004+00				Field Station#		11016+75			
Pic 3 Desc.		Clean water diversion pipe and level spreader in place.				Pic 4 Desc.		Priority one silt fence stake broken at stream S-PA07 buffer.			
<p>Date & Time: Wed Apr 27, 2022 09:41:04 EDT Position: -037.327998, -080.572923 (-15.4ft) Altitude: 2273ft (-11.3ft) Datum: WGS 84 Azimuth/Bearing: 281 N75W 4996mils True (-16) Elevation Angle: -00.8 Horizon Angle: +05.8 Zoom: 1.0X 10961+75</p>

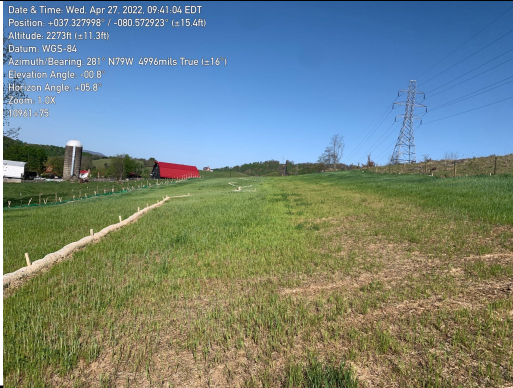
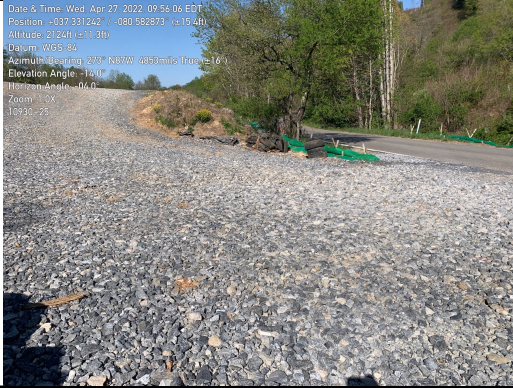
GPS Location		See photo.				GPS Location		See photo.			
Field Station#		10961+75				Field Station#		10930+25			
Pic 5 Desc.		ROW permanently restored.				Pic 6 Desc.		RCE in place at Doe Creek Road.

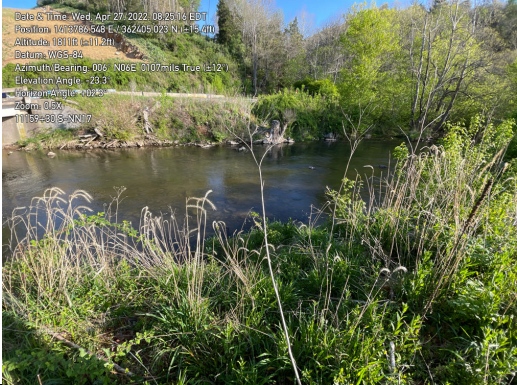
GPS Location	7	GPS Location	8		
Field Station#	11159+30	Field Station#	11167+00		
Pic 7 Desc.	S-NN17.	Pic 8 Desc.	CWDP outlet protection functional.

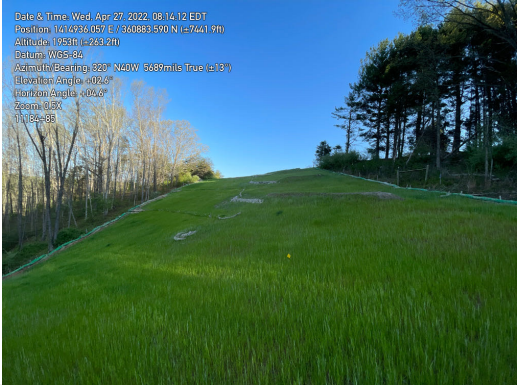
GPS Location	9	GPS Location	10		
Field Station#	11177+00	Field Station#	11184+85		
Pic 9 Desc.	Section of restored RoW showing conditions and controls.	Pic 10 Desc.	Section of restored RoW showing conditions and controls.		
<p>Insert image here</p>		<p>Insert image here</p>			
GPS Location	11	GPS Location	12		
Field Station#		Field Station#			
Pic 11 Desc.		Pic 12 Desc.

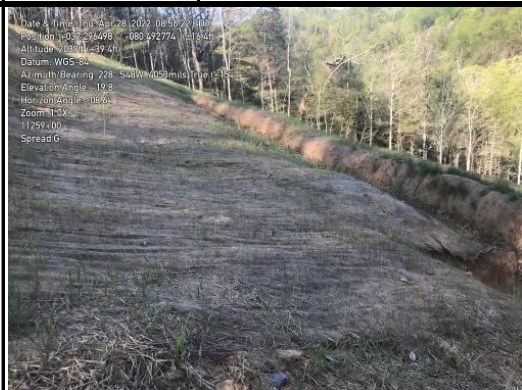
GPS Location	See Photo	GPS Location	See Photo		
Field Station#	11269+80	Field Station#	11259+00		
Pic 9 Desc.	Stone inlet protection	Pic 10 Desc.	Steep slope stabilization with CC4.		
Insert image here		Insert image here			
GPS Location		GPS Location			
Field Station#		Field Station#			
Pic 11 Desc.		Pic 12 Desc.

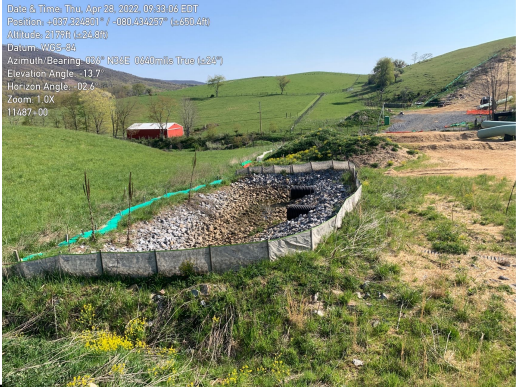
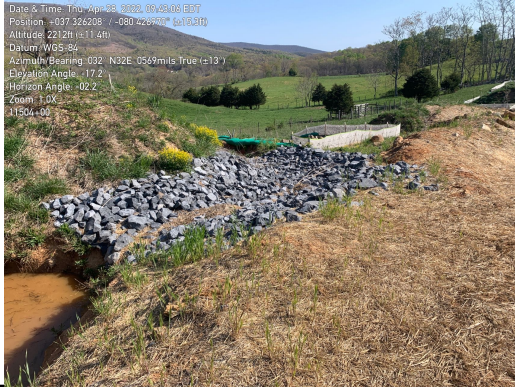
GPS Location	See photo.	GPS Location	See photo.
Field Station#	11487+00	Field Station#	11504+00
Pic 3 Desc.	Clean water diversion pipe and plunge pool in place.	Pic 4 Desc.	Rock lined channel in place.

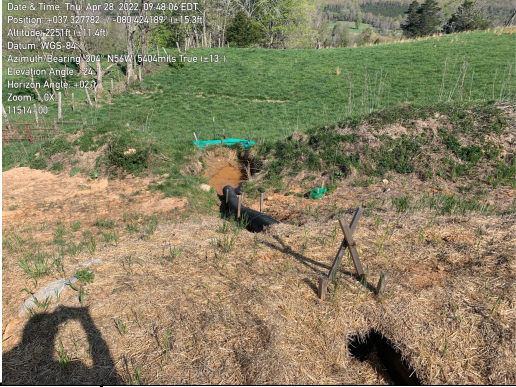
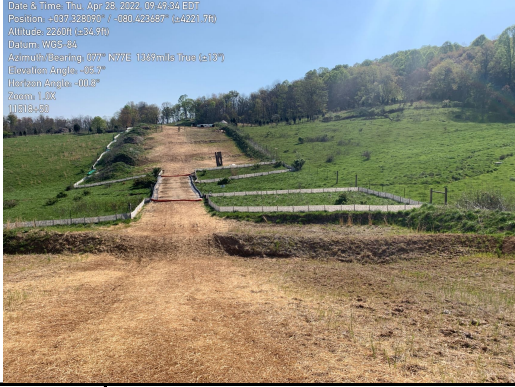
GPS Location	See photo.	GPS Location	See photo.
Field Station#	11514+00	Field Station#	11518+00
Pic 5 Desc.	Slope drain in place over fill slope.	Pic 6 Desc.	Sensitive resource buffer in place at stream S-PP4.

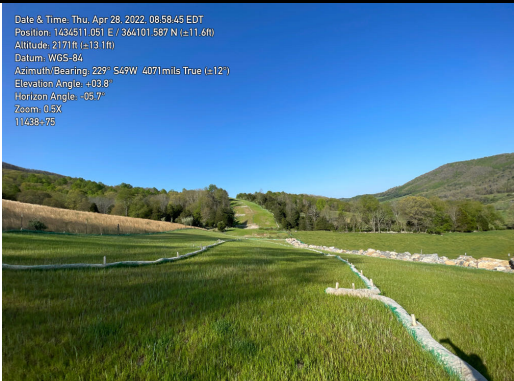
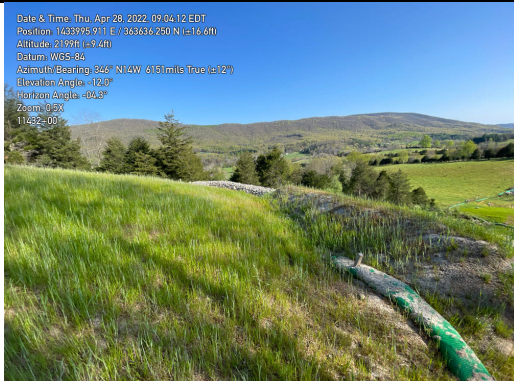
GPS Location	5	GPS Location	6		
Field Station#	11438+75	Field Station#	11432+00		
Pic 5 Desc.	Section of restored RoW showing conditions and controls.	Pic 6 Desc.	Representative photo of permanent waterbar and level spreaders installed.

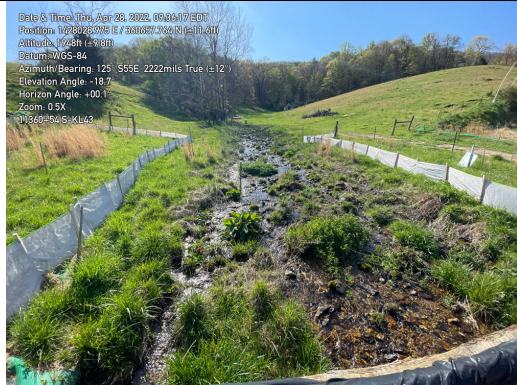
<p style="text-align: center;">Insert image here</p>			
GPS Location	11	GPS Location			
Field Station#	11360+54	Field Station#			
Pic 11 Desc.	S-KL43.	Pic 12 Desc.

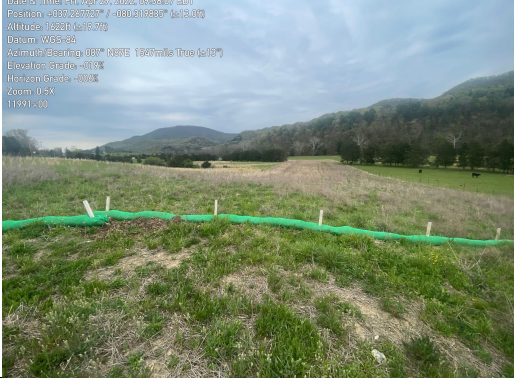
GPS Location	See Photo	GPS Location	See Photo		
Field Station#	11991+00	Field Station#	11978+00		
Pic 1 Desc.	Final Restoration Area near the spread break.	Pic 2 Desc.	Final Restoration Area		
<p>Date & Time: Fri, Apr 29, 2022, 06:30:00 Position: +37.92353° / -89.20639° (s13.57) Altitude: 1712 (s13.57) Datum: WGS-84 Azimuth/Bearing: 34° N74E 1316mils True (s13°) Elevation Grade: -000% Horizon Grade: -004% Zoom: 1.0X 11971+00</p>

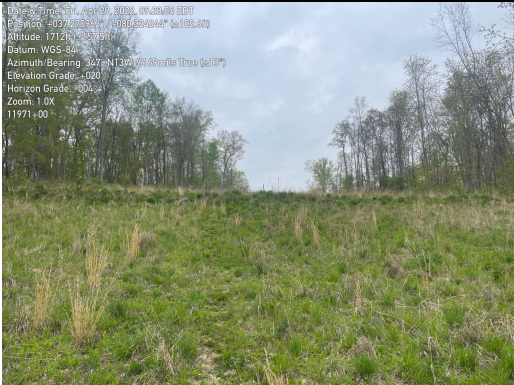
GPS Location	See Photo	GPS Location	See Photo		
Field Station#	11971+00	Field Station#	11946+69		
Pic 3 Desc.	Permanent vegetated steep slope area. (Final Restoration Area).	Pic 4 Desc.	Final Restoration Area and vegetated water bar conditions. Water bars functioning as intended		
<p>Date & Time: Fri, Apr 29, 2022, 06:40:00 Position: +37.92353° / -89.20639° (s13.57) Altitude: 2130 (s13.57) Datum: WGS-84 Azimuth/Bearing: 158° S22E 2809mils True (s12°) Elevation Grade: -038% Horizon Grade: -003% Zoom: 1.0X 11946+69</p>

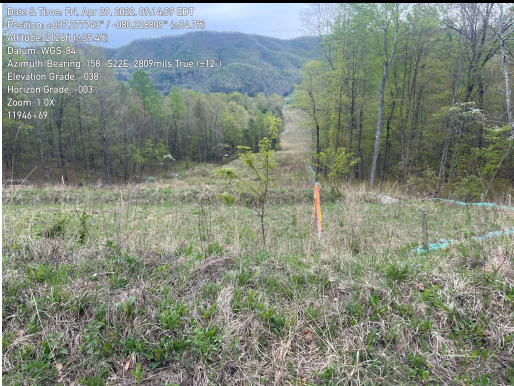
GPS Location	See Photo	GPS Location	See Photo		
Field Station#	11946+69	Field Station#	11944+10		
Pic 5 Desc.	Final Restoration Area with yearling re-growth over the ditch line.	Pic 6 Desc.	Final Restoration Area with perimeter P1 silt fencing conditions.

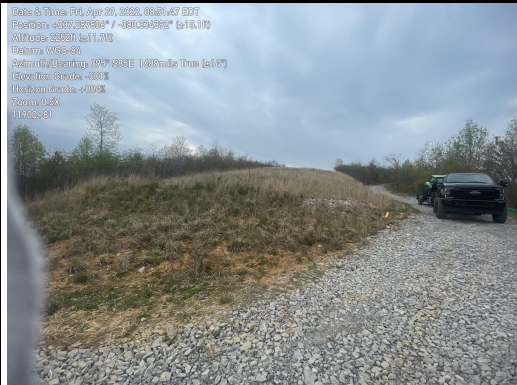
<div>Insert image here</div>			
GPS Location	See Photo	GPS Location			
Field Station#	11900+81	Field Station#			
Pic 11 Desc.	AR 266.03 and vegetated water bar and row conditions.	Pic 12 Desc.

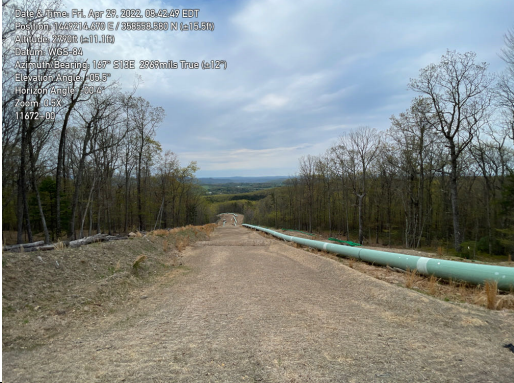
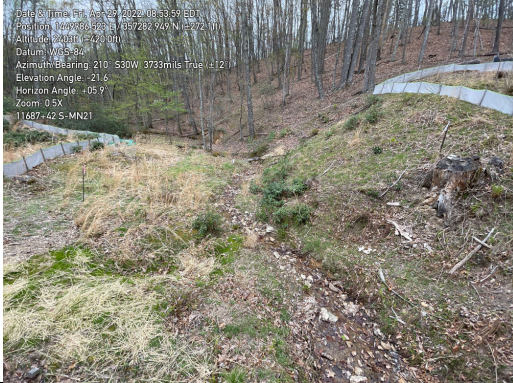
<p>Date & Time: Fri, Apr 29, 2022, 08:53:59 EDT Position: 11687+42 S / 357282.945 N (±15.47) Altitude: 2420.00 (±11.25) Datum: WGS-84 Azimuth/Bearing: 210° 530W 3733mils True (±12°) Elevation Angle: -21.6° Horizon Angle: -05.9° Zoom: 0.5X 11687+42 S-MN21</p>			
GPS Location	1	GPS Location	2		
Field Station#	11672+00	Field Station#	11687+42		
Pic 1 Desc.	Section of RoW showing conditions and controls.	Pic 2 Desc.	S-MN21.

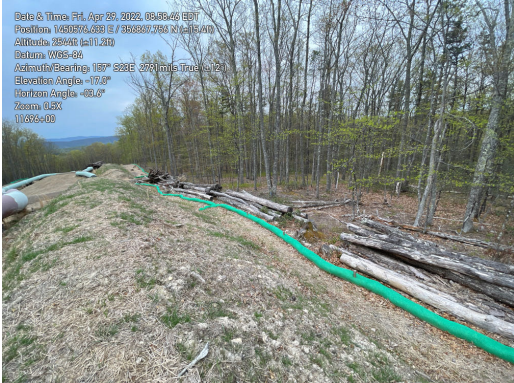
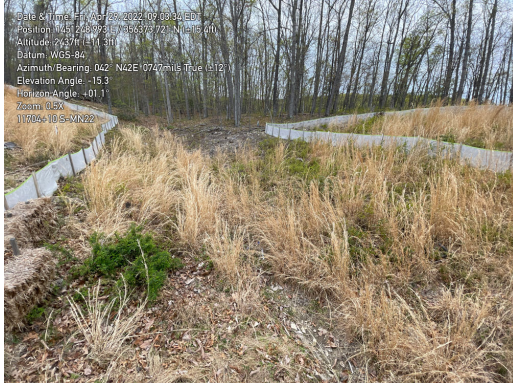
GPS Location	3	GPS Location	4		
Field Station#	11696+00	Field Station#	11704+10		
Pic 3 Desc.	CFS perimeter controls functional.	Pic 4 Desc.	S-MN22.

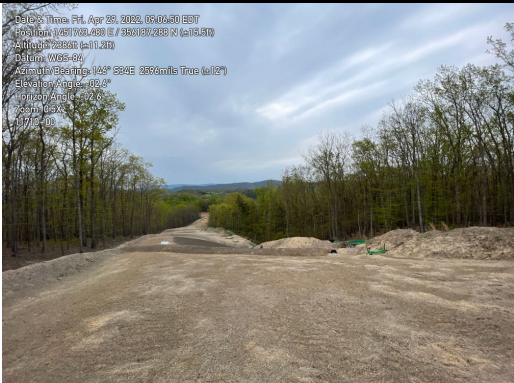
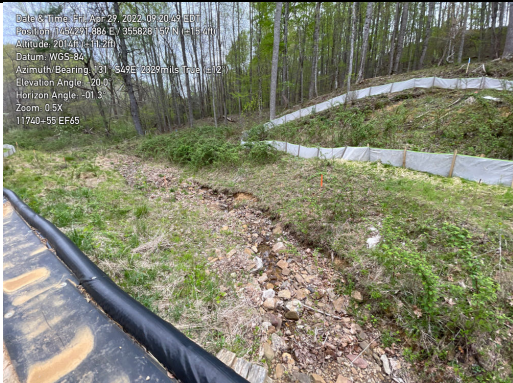
<p>Date & Time: Fri, Apr 29, 2022, 09:20:45 EDT Position: 11740+55 S / 355826.150 N (±15.47) Altitude: 2410.00 (±11.25) Datum: WGS-84 Azimuth/Bearing: 131° 349E 1029mils True (±12°) Elevation Angle: -20.0° Horizon Angle: -01.3° Zoom: 0.5X 11740+55 EF65</p>			
GPS Location	5	GPS Location	6		
Field Station#	11710+00	Field Station#	11740+55		
Pic 5 Desc.	Section of RoW showing conditions and controls.	Pic 6 Desc.	S-EF65.

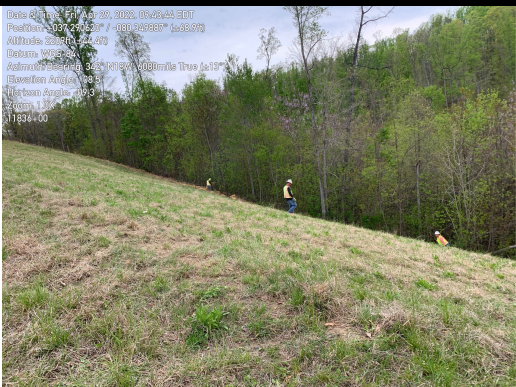
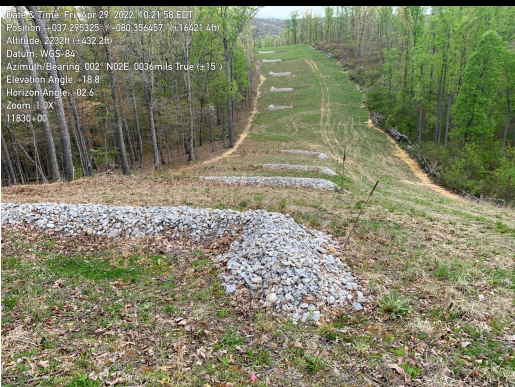
GPS Location	See photo.		GPS Location	See photo.	
Field Station#	11836+00		Field Station#	11830+00	
Pic 3 Desc.	Environmental crew mulching and seeding perimeter where ECDs were removed.		Pic 4 Desc.	Waterbars and level spreaders in place.

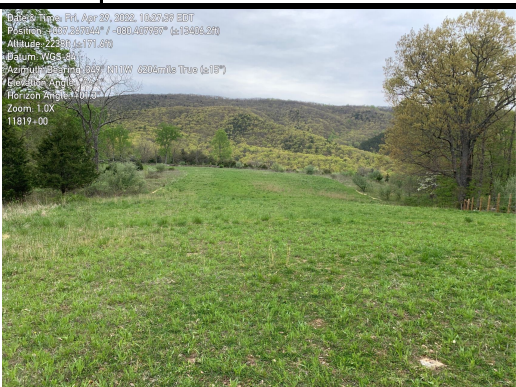
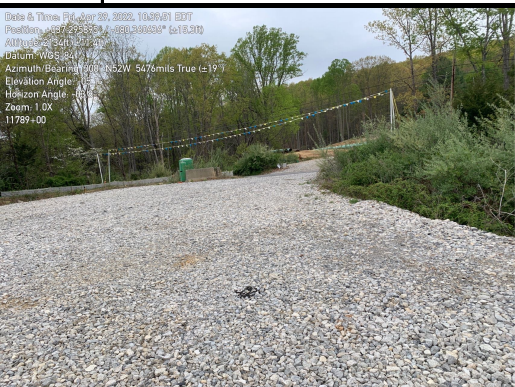
GPS Location	See photo.		GPS Location	See photo.	
Field Station#	11819+00		Field Station#	11789+00	
Pic 5 Desc.	ROW permanently restored.		Pic 6 Desc.	RCE in place at Mount Tabor Road crossing.

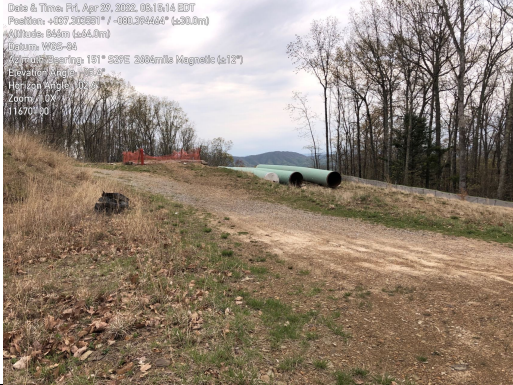
<p>Date & Time: Fri, Apr 29, 2022, 06:16:14 EDT Position: +037.305367, -080.394564 (+30.0m) Altitude: 845m (+30.0m) Datum: WGS-84 Azimuth/Bearing: 181° S09E 340km/mils Magnetic (+12°) Elevation Angle: +00.2° Horizon Angle: -09.4° Zoom: 1.0X 11670+00</p>

<p>Date & Time: Fri, Apr 29, 2022, 08:24:55 EDT Position: +037.306752, -080.398105 (+10.0m) Altitude: 825m (+10.0m) Datum: WGS-84 Azimuth/Bearing: 201° S61W 428km/mils Magnetic (+12°) Elevation Angle: +00.3° Horizon Angle: -09.4° Zoom: 1.0X 11665+00</p>					
GPS Location		On photo		GPS Location		On photo	
Field Station#		11670+00		Field Station#		11664+00	
Pic 1 Desc.		Stable conditions at top of Brush Mountain. No evidence of vandalism observed.		Pic 2 Desc.		Perimeter ECDs are in acceptable condition and functional.

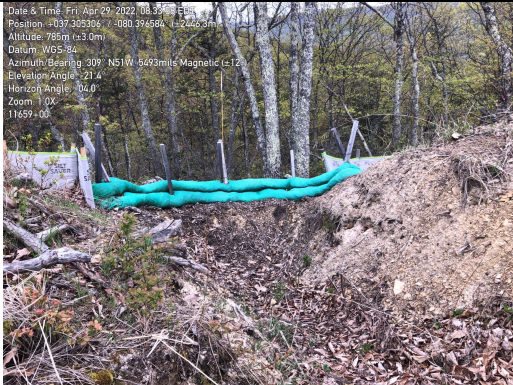
<p>Date & Time: Fri, Apr 29, 2022, 08:37:05 EDT Position: +037.305366, -080.394564 (+24.0m) Altitude: 785m (+3.0m) Datum: WGS-84 Azimuth/Bearing: 309° N51W 549km/mils Magnetic (+12°) Elevation Angle: +21.4° Horizon Angle: -04.0° Zoom: 1.0X 11659+00</p>

GPS Location		On photo		GPS Location		On photo	
Field Station#		11659+00		Field Station#		11646+00	
Pic 3 Desc.		Sumps and end treatments are functional.		Pic 4 Desc.		Perimeter ECDs are adequate at this time.

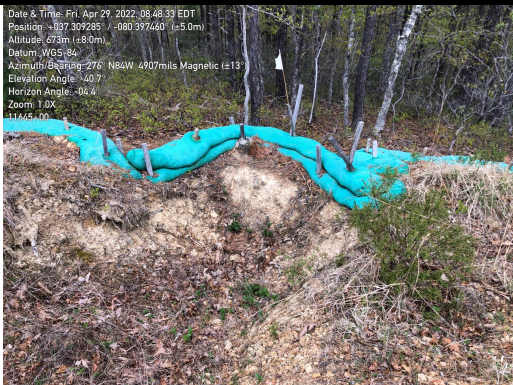
<p>Date & Time: Fri, Apr 29, 2022, 08:48:33 EDT Position: +037.307285, -080.397690 (+5.0m) Altitude: 623m (+8.0m) Datum: WGS-84 Azimuth/Bearing: 276° N54W 490km/mils Magnetic (+13°) Elevation Angle: +40.7° Horizon Angle: -02.4° Zoom: 1.0X 11645+00</p>

<p>Date & Time: Fri, Apr 29, 2022, 08:51:55 EDT Position: +037.312622, -080.397690 (+30.0m) Altitude: 578m (+32.0m) Datum: WGS-84 Azimuth/Bearing: 130° S08E 231km/mils Magnetic (+13°) Elevation Angle: +00.3° Horizon Angle: +00.2° Zoom: 1.0X 11627+00</p>					
GPS Location		On photo		GPS Location		On photo	
Field Station#		11645+00		Field Station#		11627+50	
Pic 5 Desc.		End treatments are functional at this time.		Pic 6 Desc.		Perimeter ECDs are in good condition.

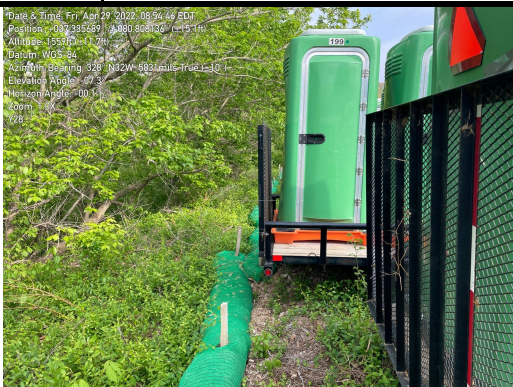
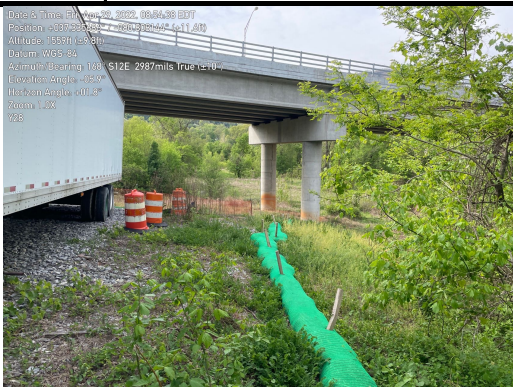
GPS Location		See photo				GPS Location		See photo			
Field Station#		12005+00				Field Station#		12005+00			
Pic 5 Desc.		CFS perimeter controls functional y28				Pic 6 Desc.		CFS perimeter controls functional y28

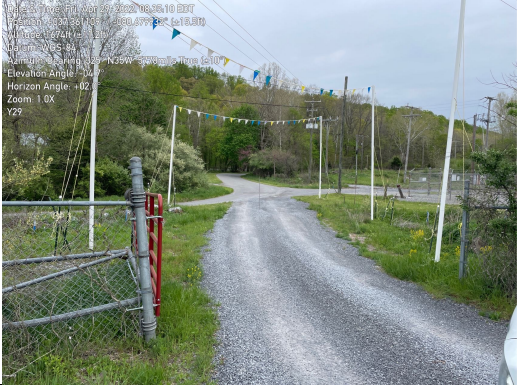
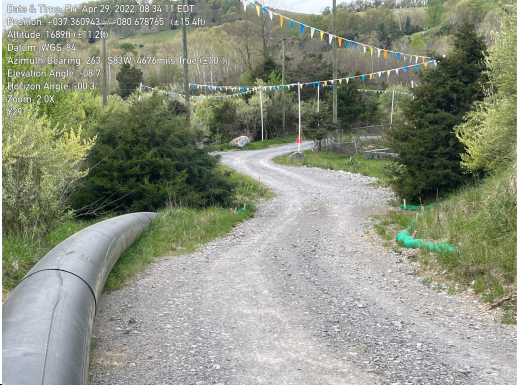
GPS Location	See photo	GPS Location	See photo		
Field Station#	12005+00	Field Station#	12005+00		
Pic 7 Desc.	RCE functional y29	Pic 8 Desc.	Broad base dips functional y29
